Voluntary Remediation Plan Application Form and Checklist

DAVIDSON-KENNEDY COMPANY PROPERTY 1195 VICTORY DRIVE, ATLANTA, FULTON COUNTY, GA HSI SITE NO. 10866

AMENDED VOLUNTARY REMEDIATION PLAN APPLICATION

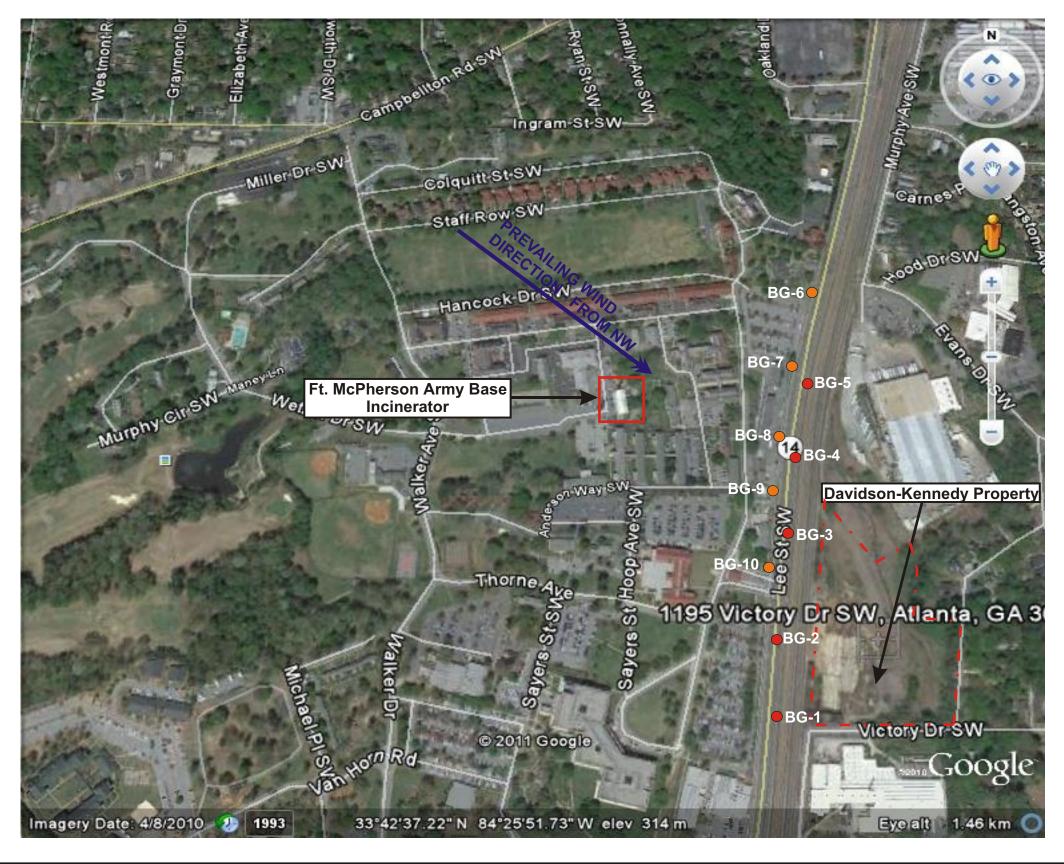
- Background Sample Locations - 2/21/11 (East Side Lee St Right of Way)

A series of ten (10) background soil samples were collected from the right-of-way of Lee Street located between the Davidson-Kennedy property and the incinerator. Five (5) of the samples (BG-1 to BG-5) were collected from the eastern right-of-way of Lee Street and five (5) samples (BG-6 to BG-10) were collected form the western side right-of-way along Lee Street. Samples were collected from the surface (0 to 6 inches) interval utilizing a decontaminated stainless steel sampling spoon. Recovered samples were placed in laboratory-supplied containers and submitted to Analytical Environmental Services, Inc. for testing of RCRA Metals via EPA Method 6010.

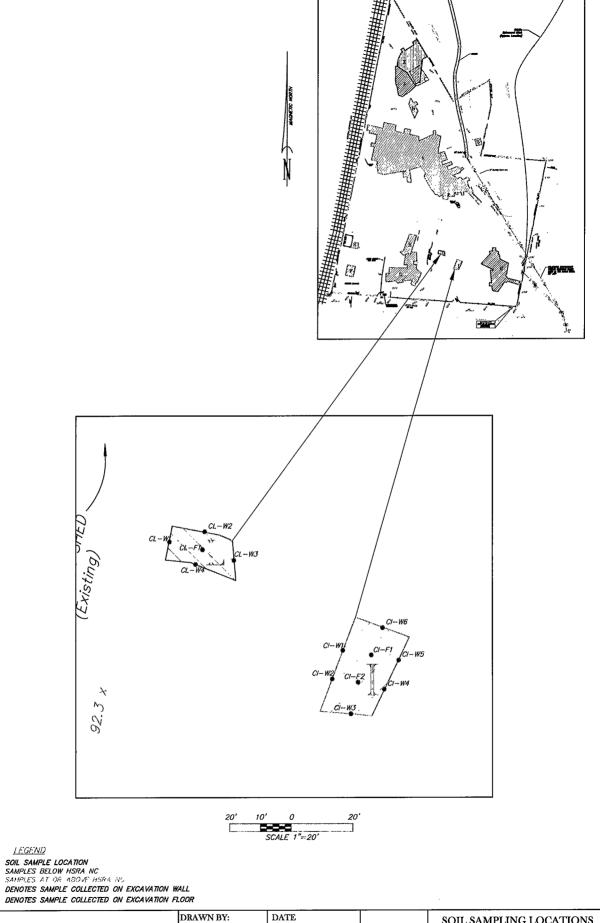
REVIEWED: PROJECT NO. SHEET No. 8 TY APPROVED: SE4294-001-001 DWG. EXCV. G & H KMcG

EXCAVATION AREA "G & H"

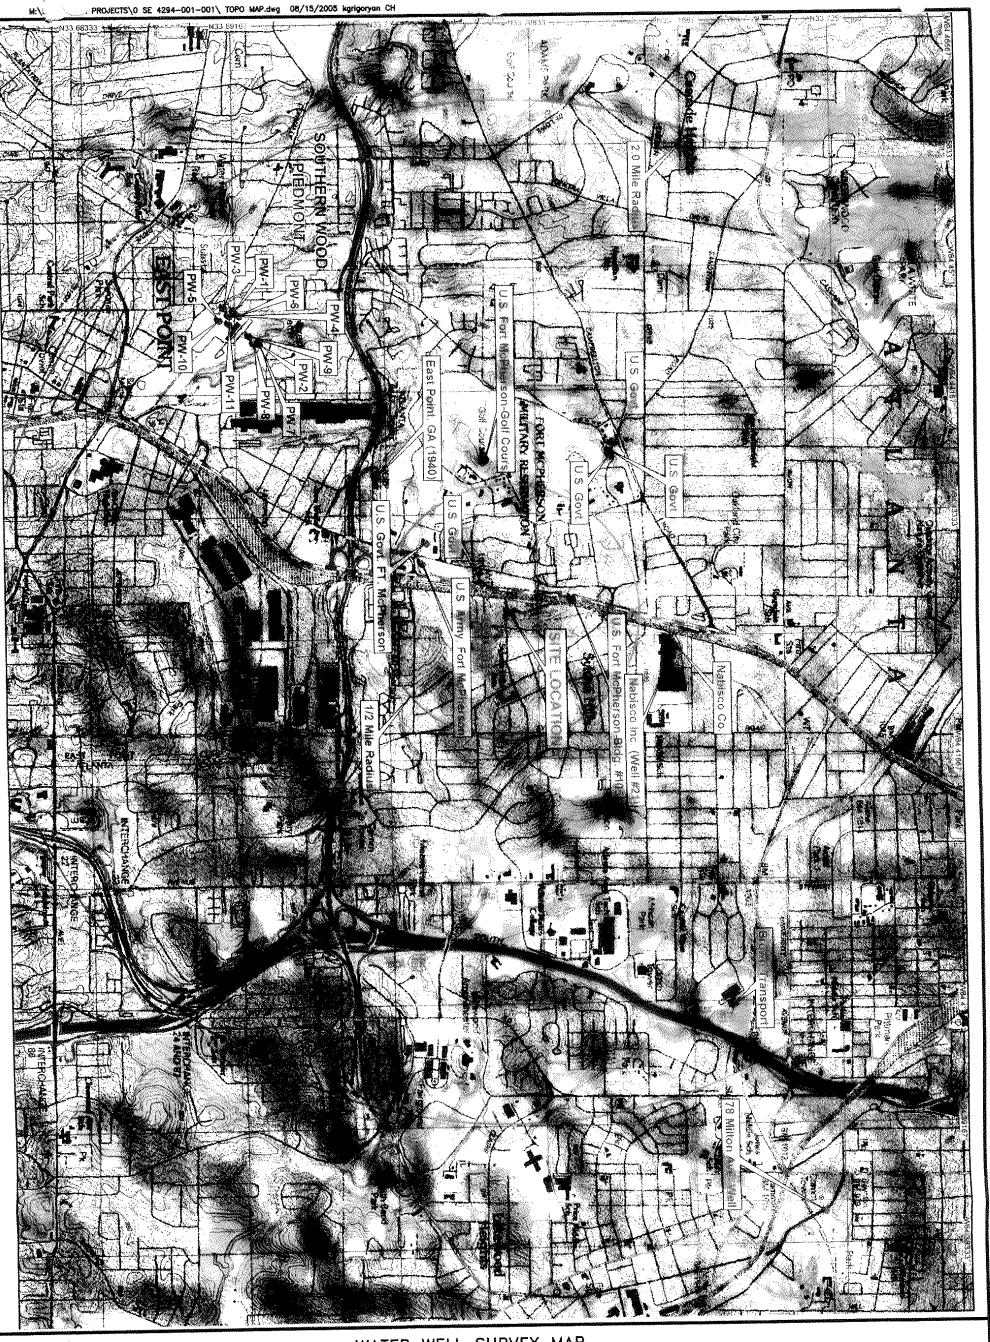
WATER WELL SURVEY MAP Davidson—Kennedy 1195 Victory drive S.W. Atlanta GA 30310

7.5 Minute USGS Topographic Quadrangle SOUTHWEST ATLANTA QUADRANGLE, GEORGIA
