Voluntary Remediation Plan Application Form and Checklist

SPALDING CORNERS SHOPPING CENTER SITE
NORCROSS, FULTON COUNTY, GEORGIA
HSI#10639

**SUPPLEMENTAL
VOLUNTARY REMEDIATION PROGRAM APPLICATION
INFORMATION FOR THE
SPALDING CORNERS SHOPPING CENTER SITE
NORCROSS, FULTON COUNTY, GEORGIA®**

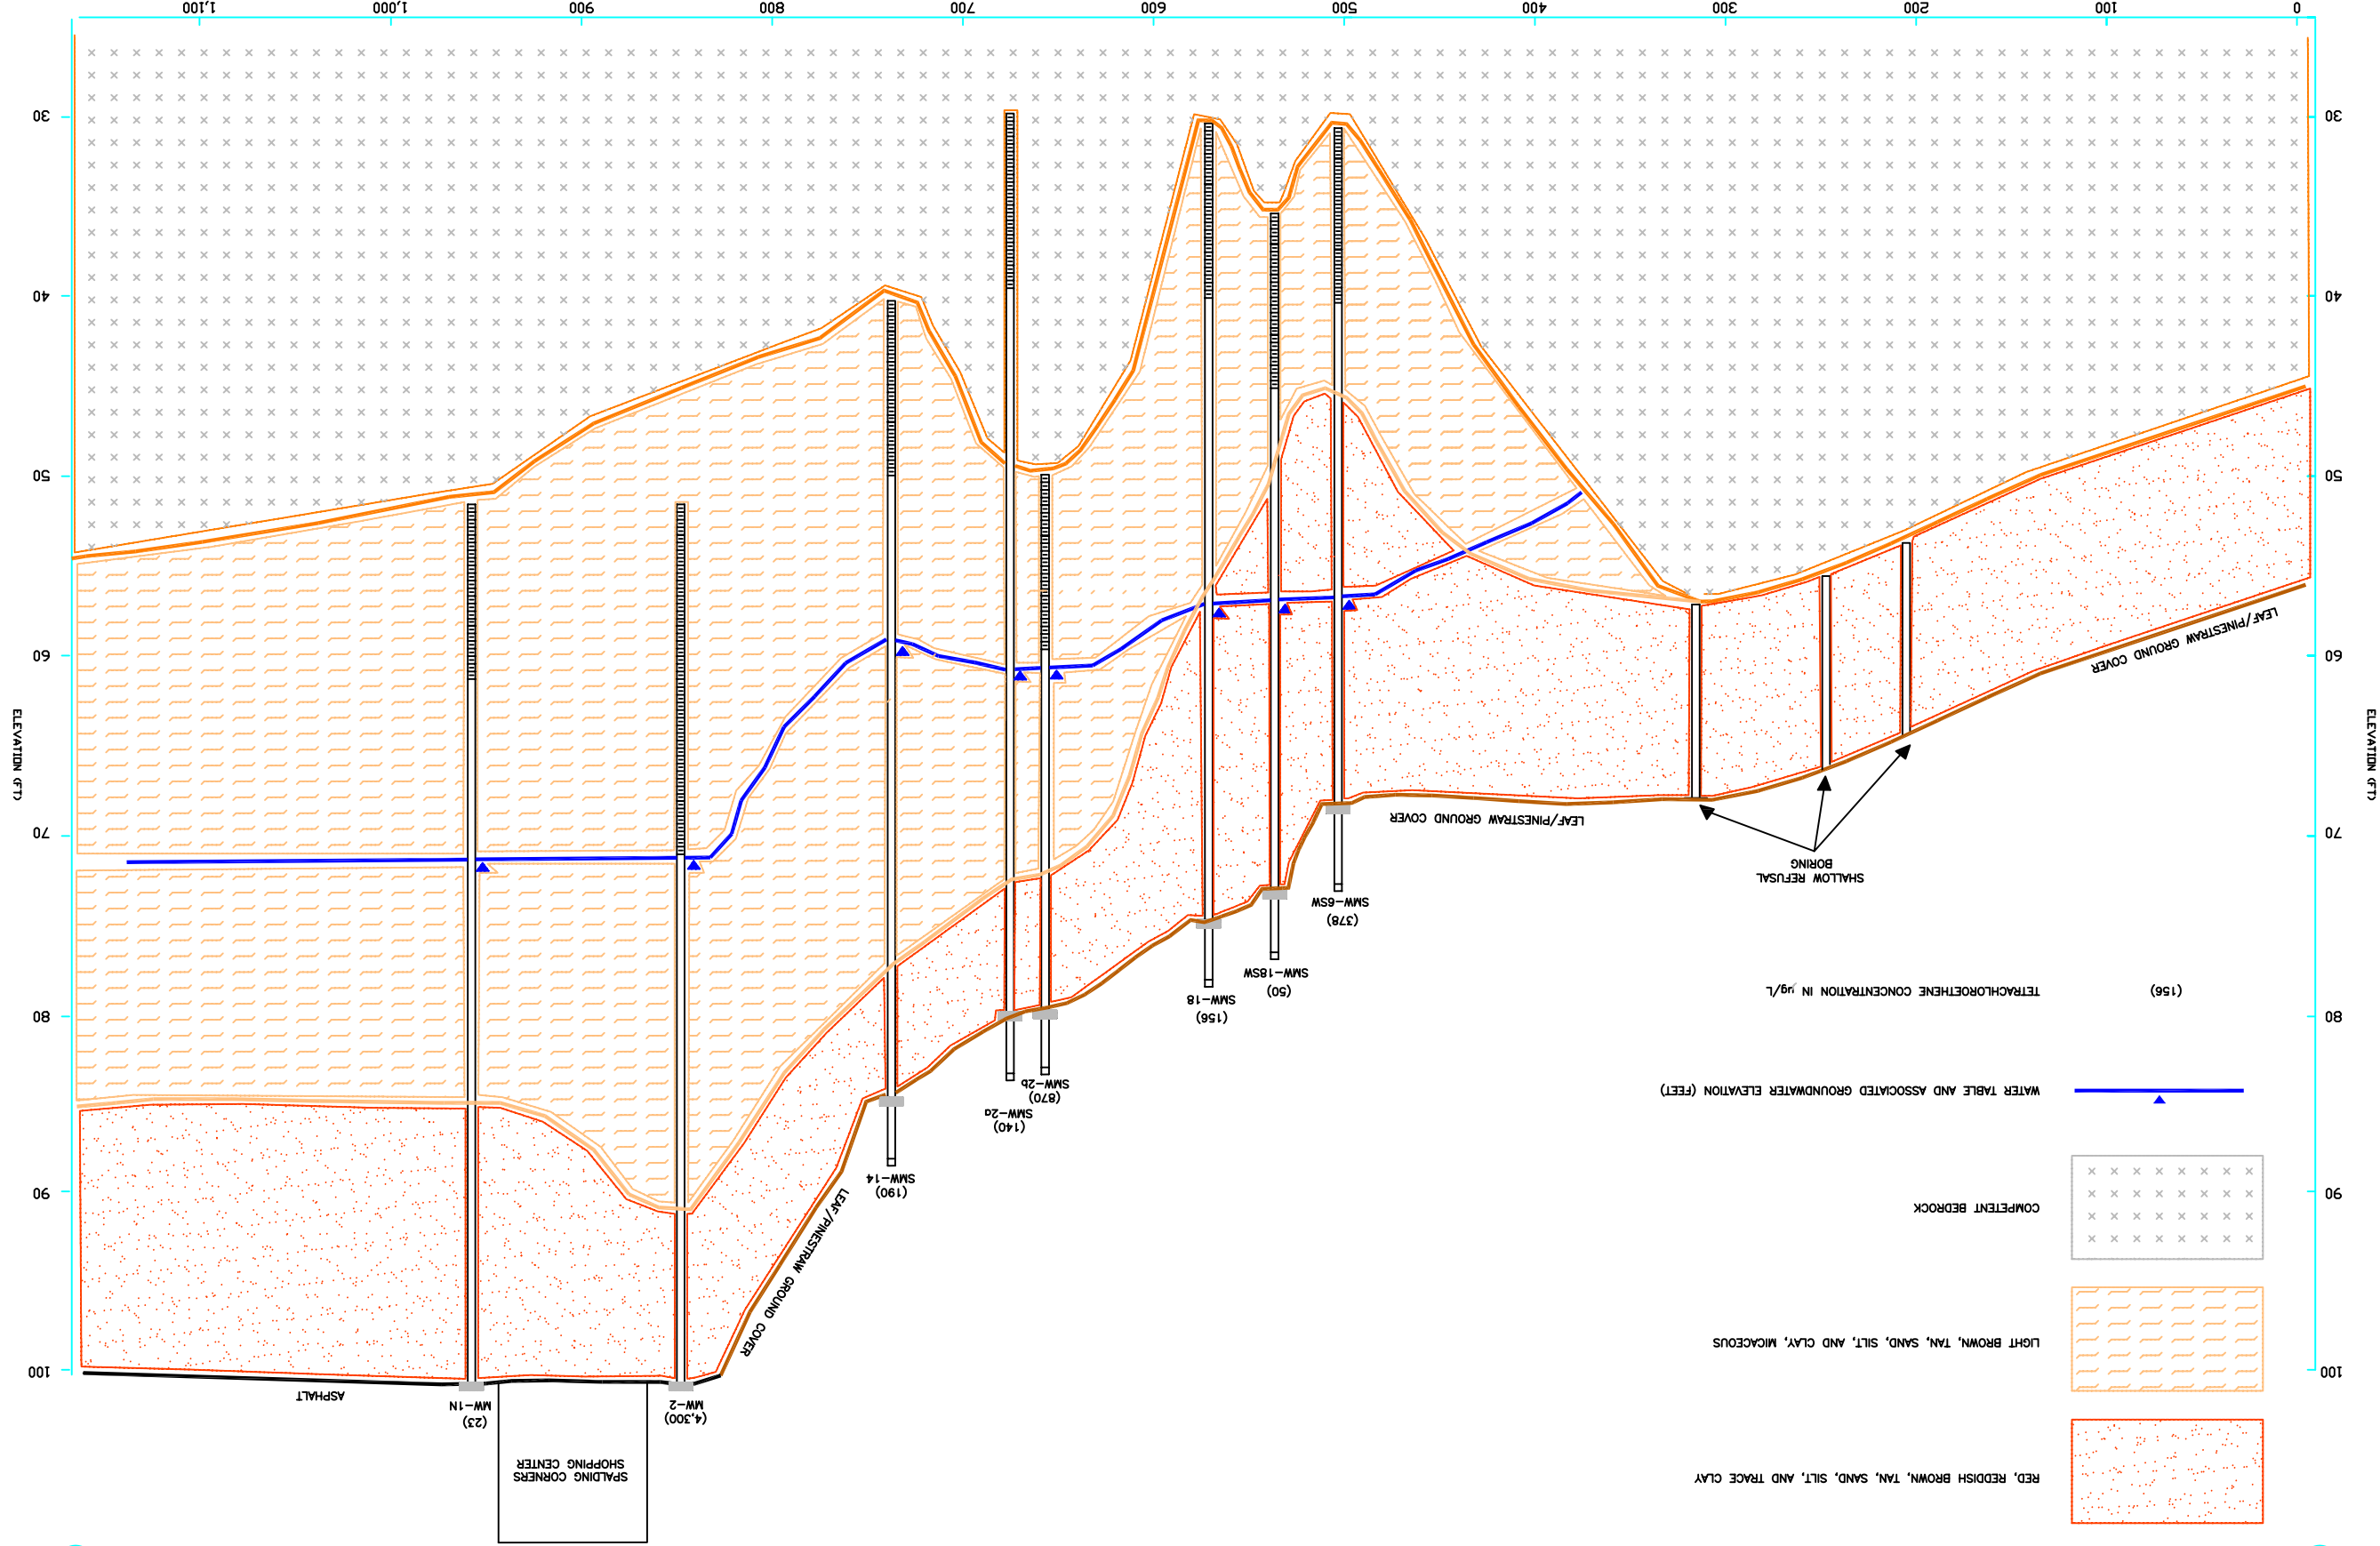
FIGURE NO. **12B**
Spalding Corners
2633

CROSS-SECTION A-A'

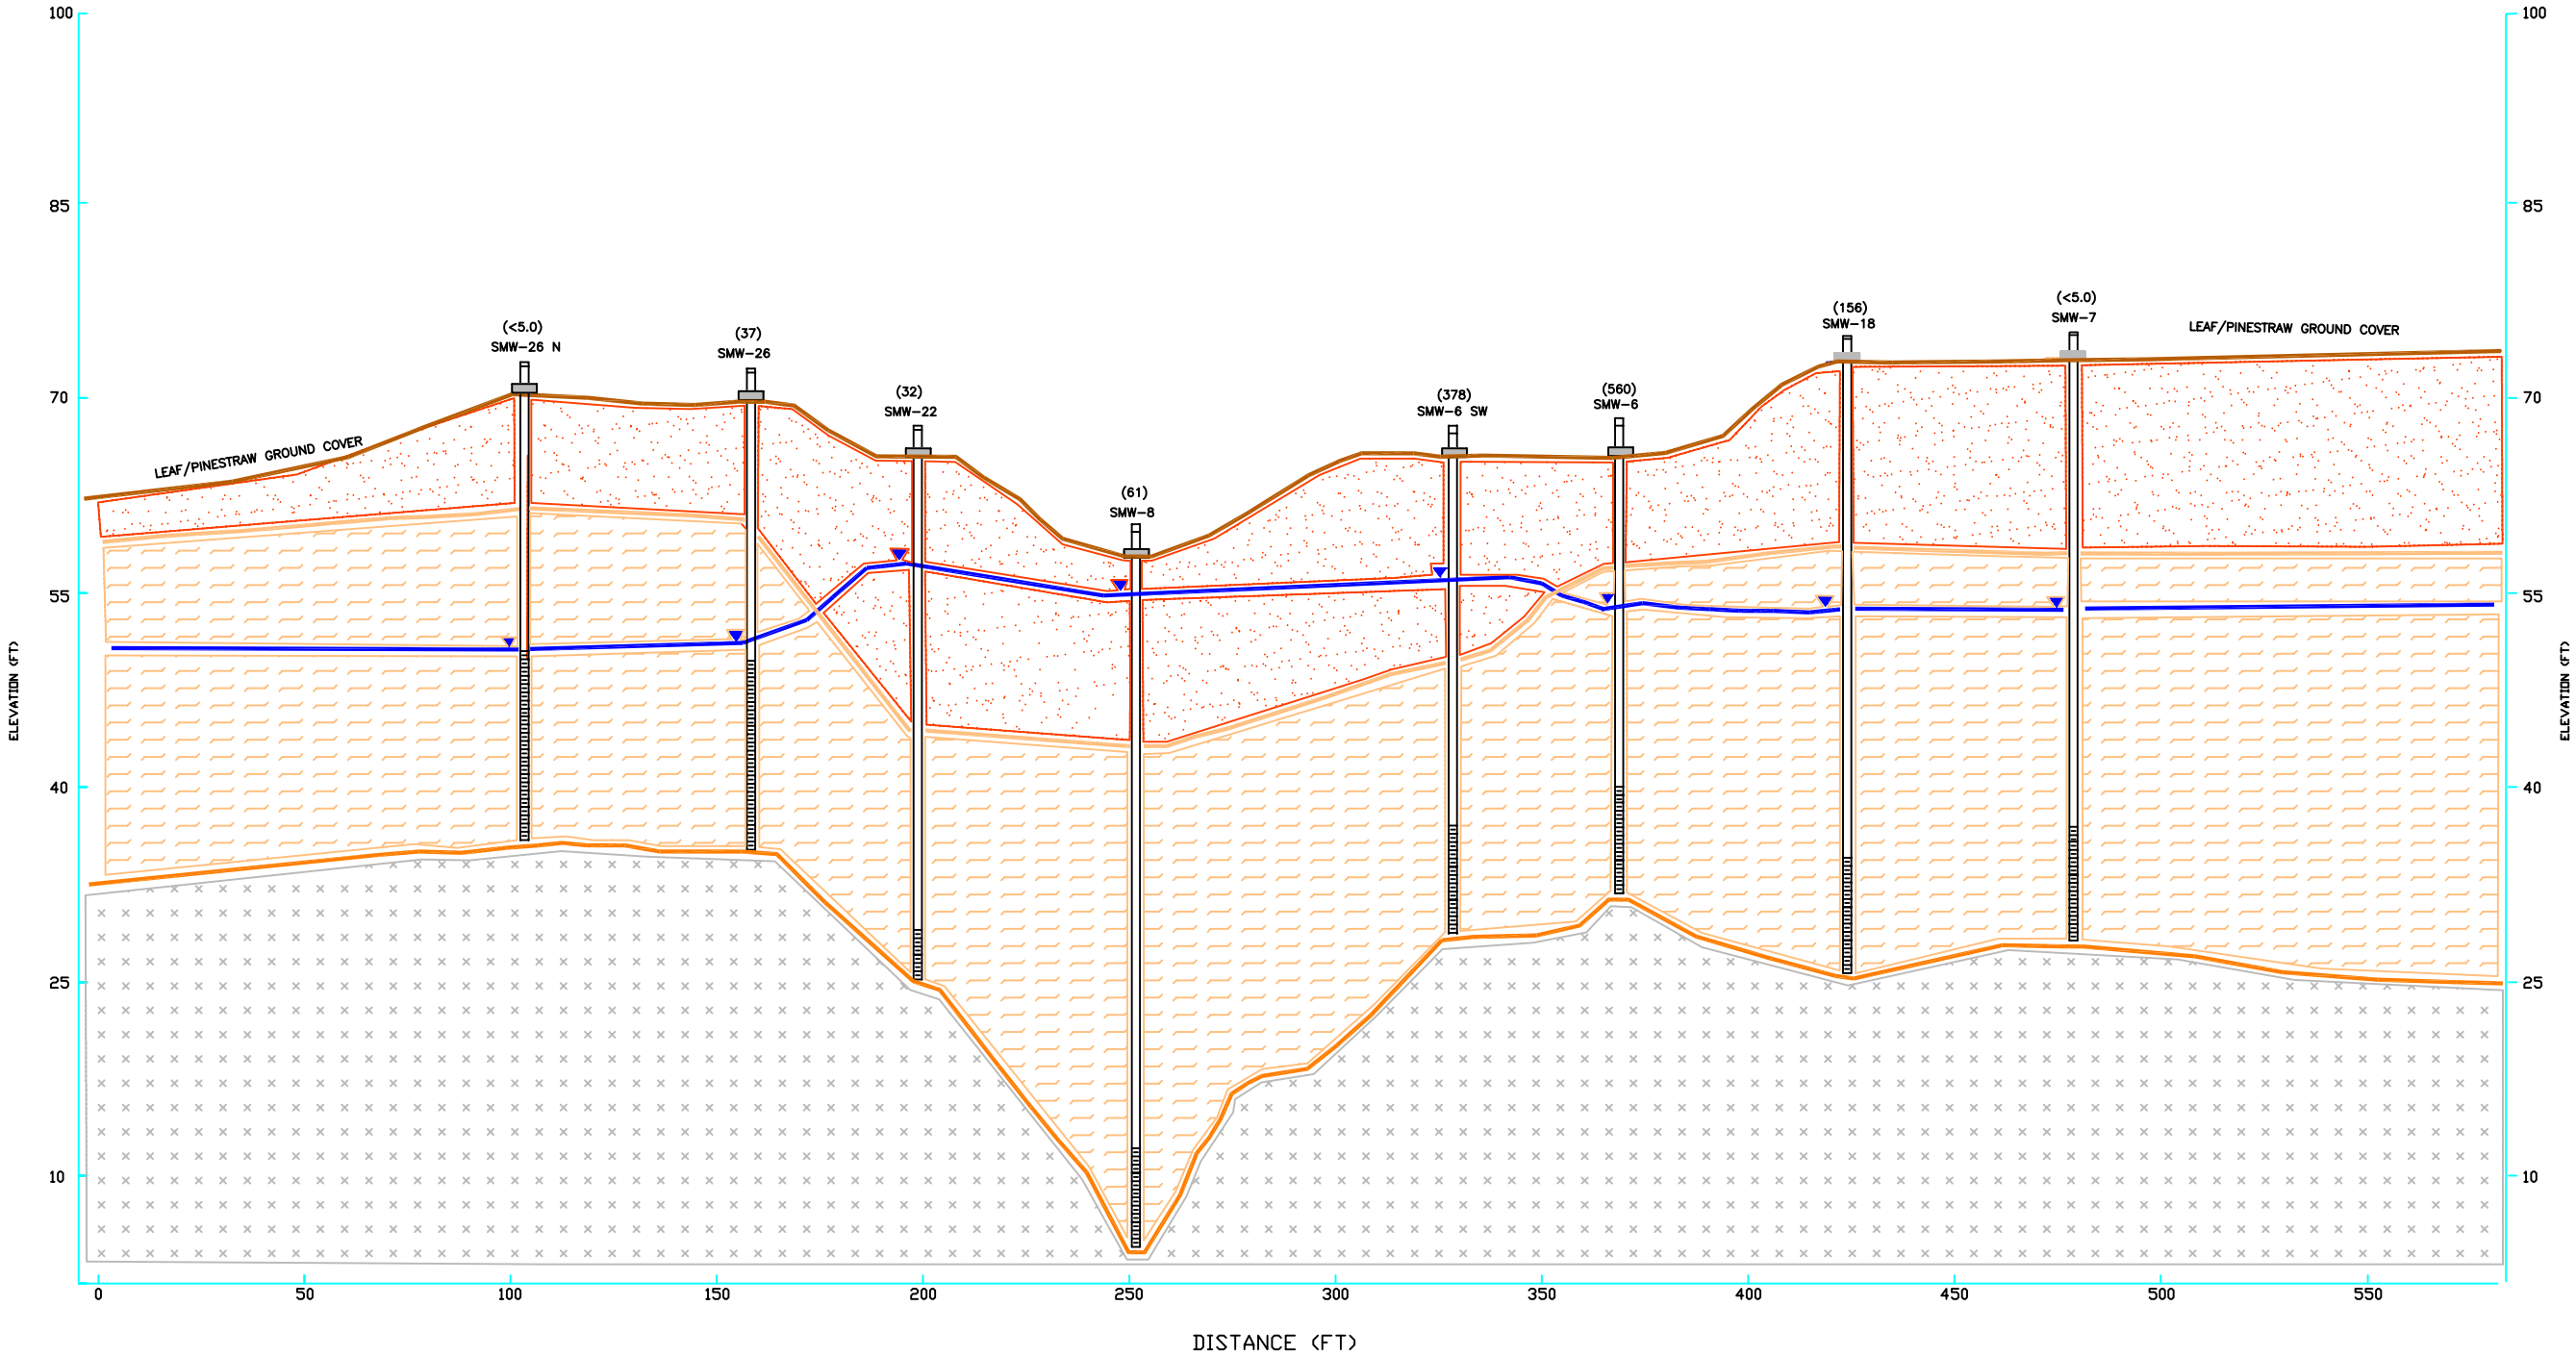
FIGURE NO.
12C
Spalding Corners
2633

CROSS-SECTION B-B'

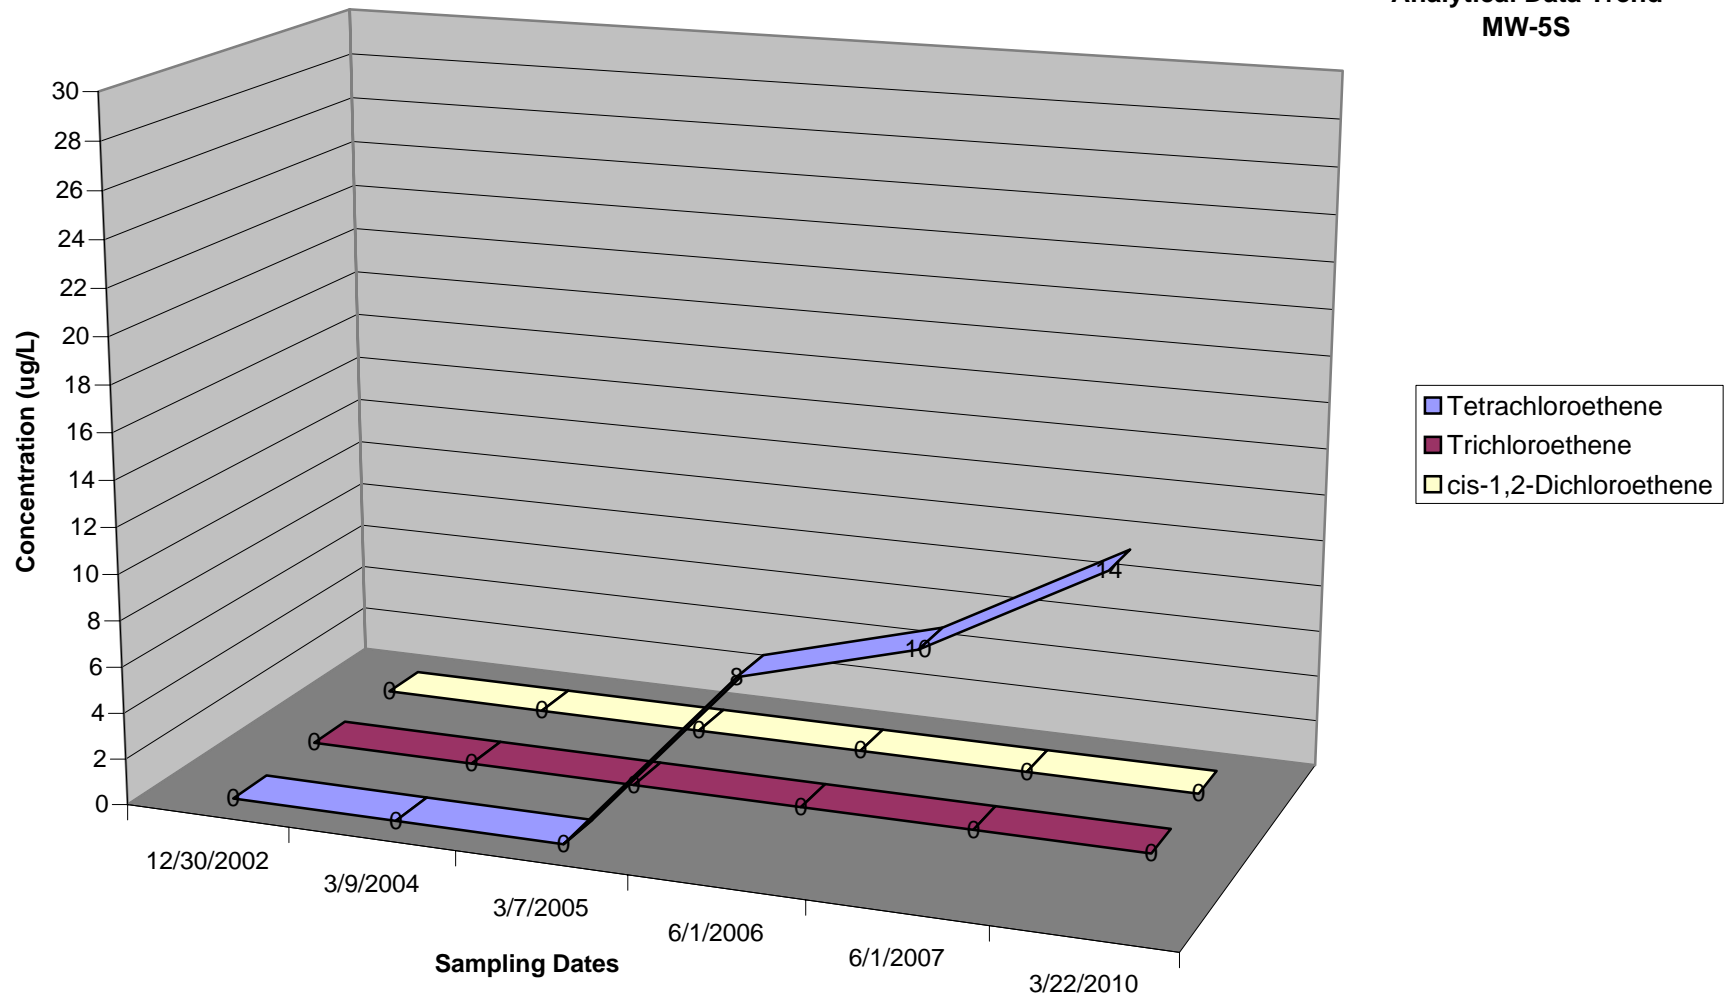
Analytical Data Trend
MW-5S

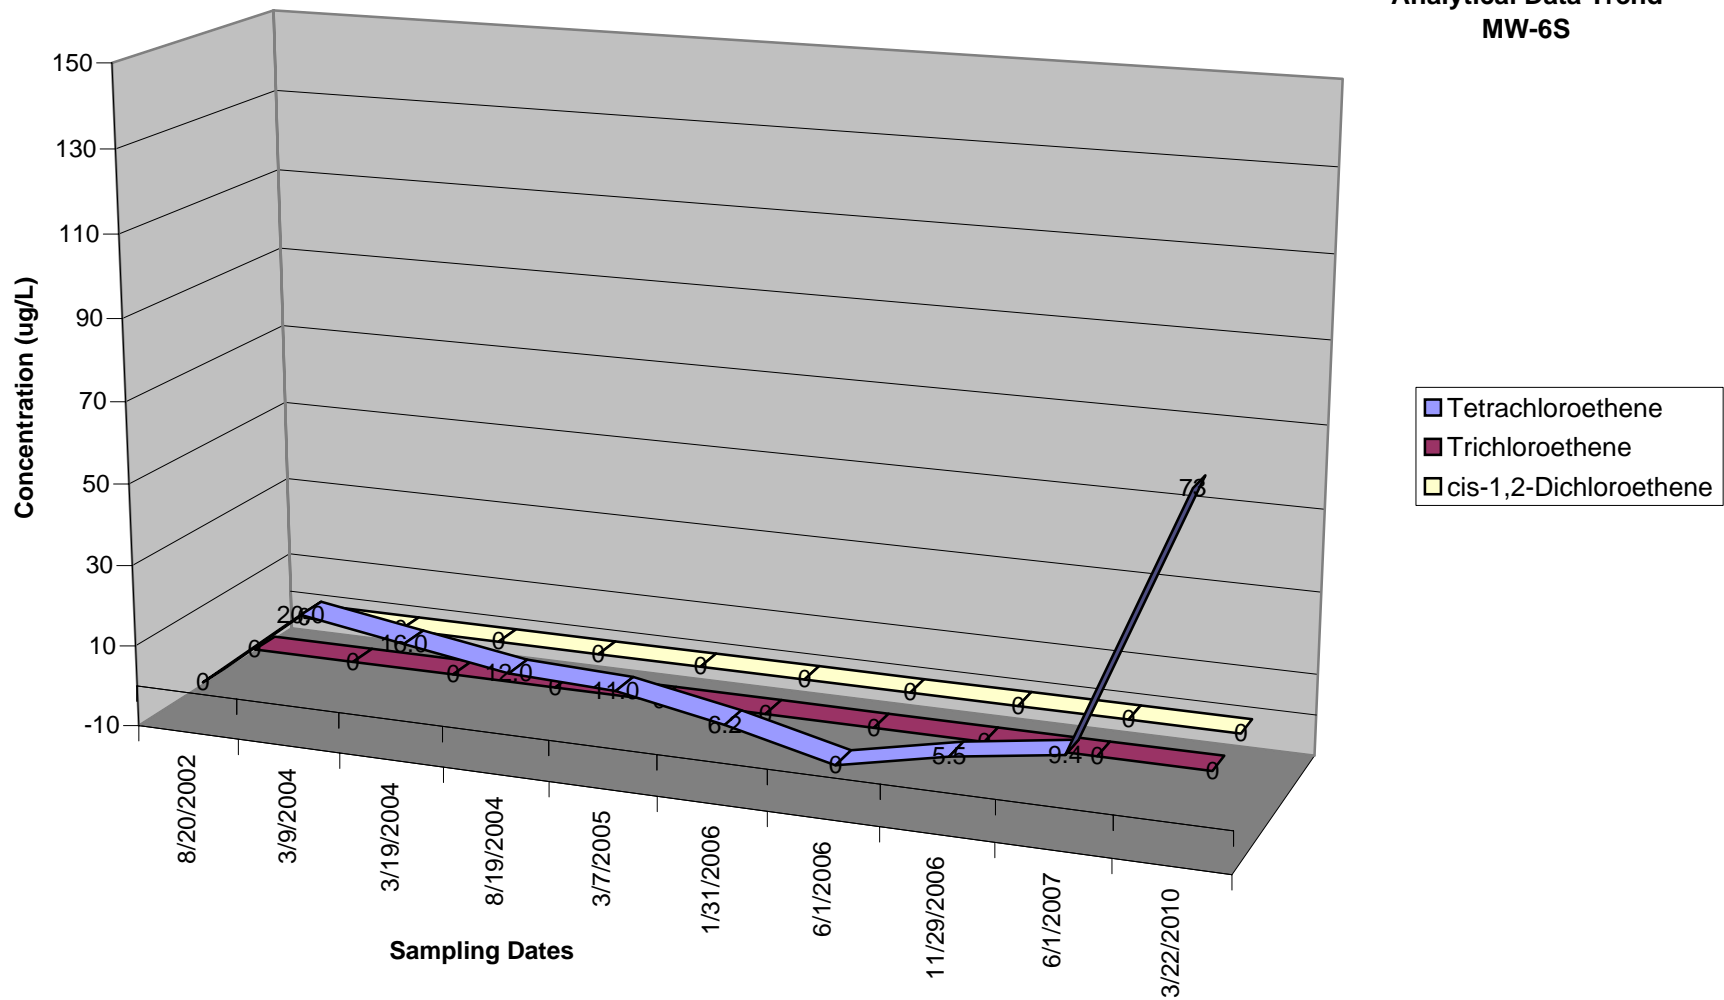
Analytical Data Trend
MW-6S

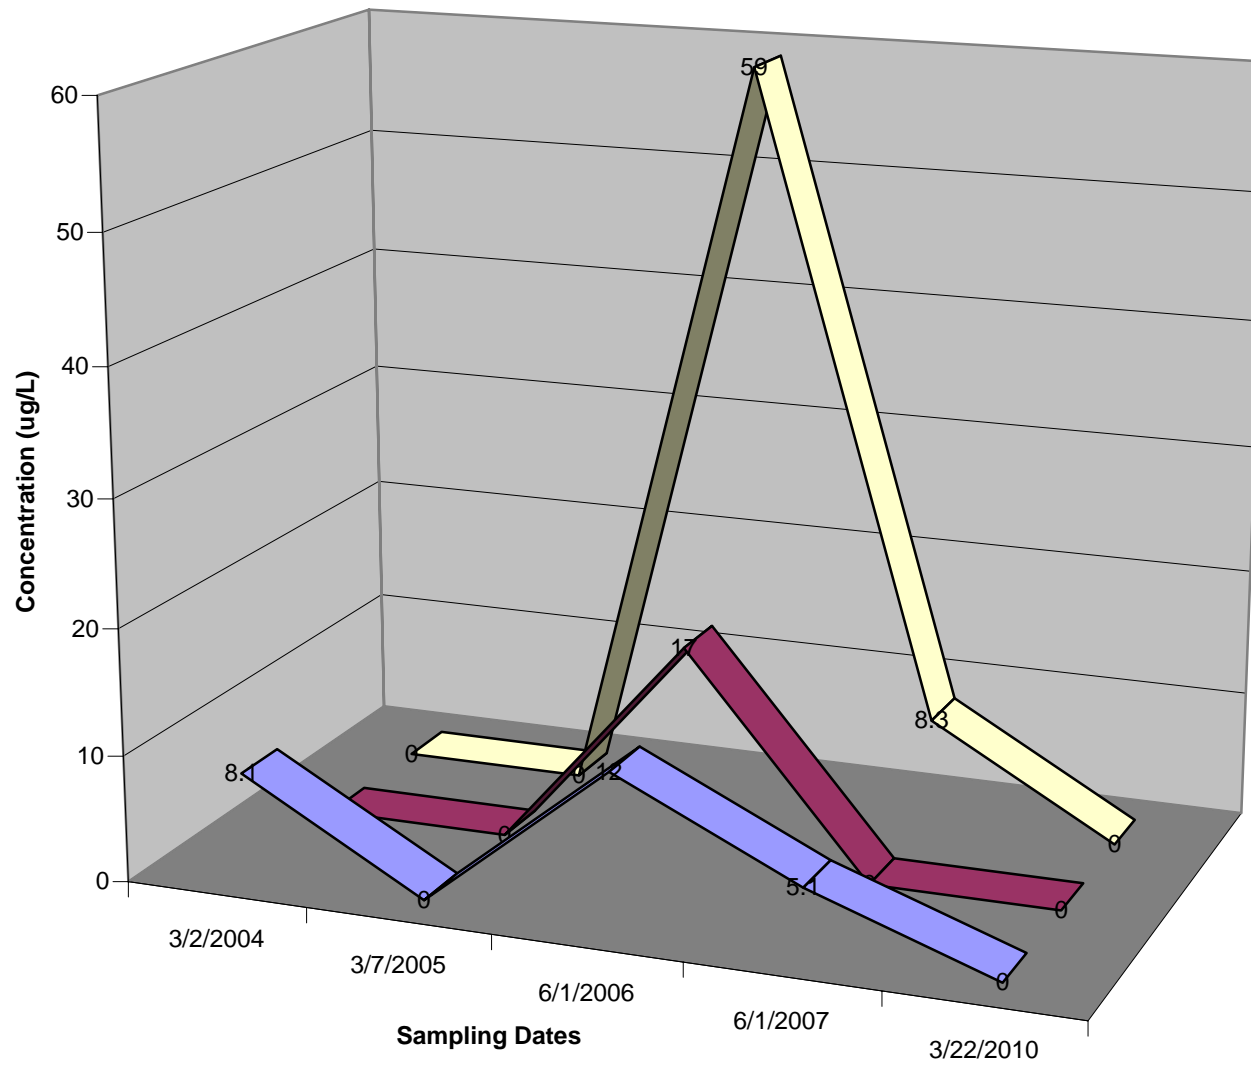
**Analytical Data Trend
MW-7S**

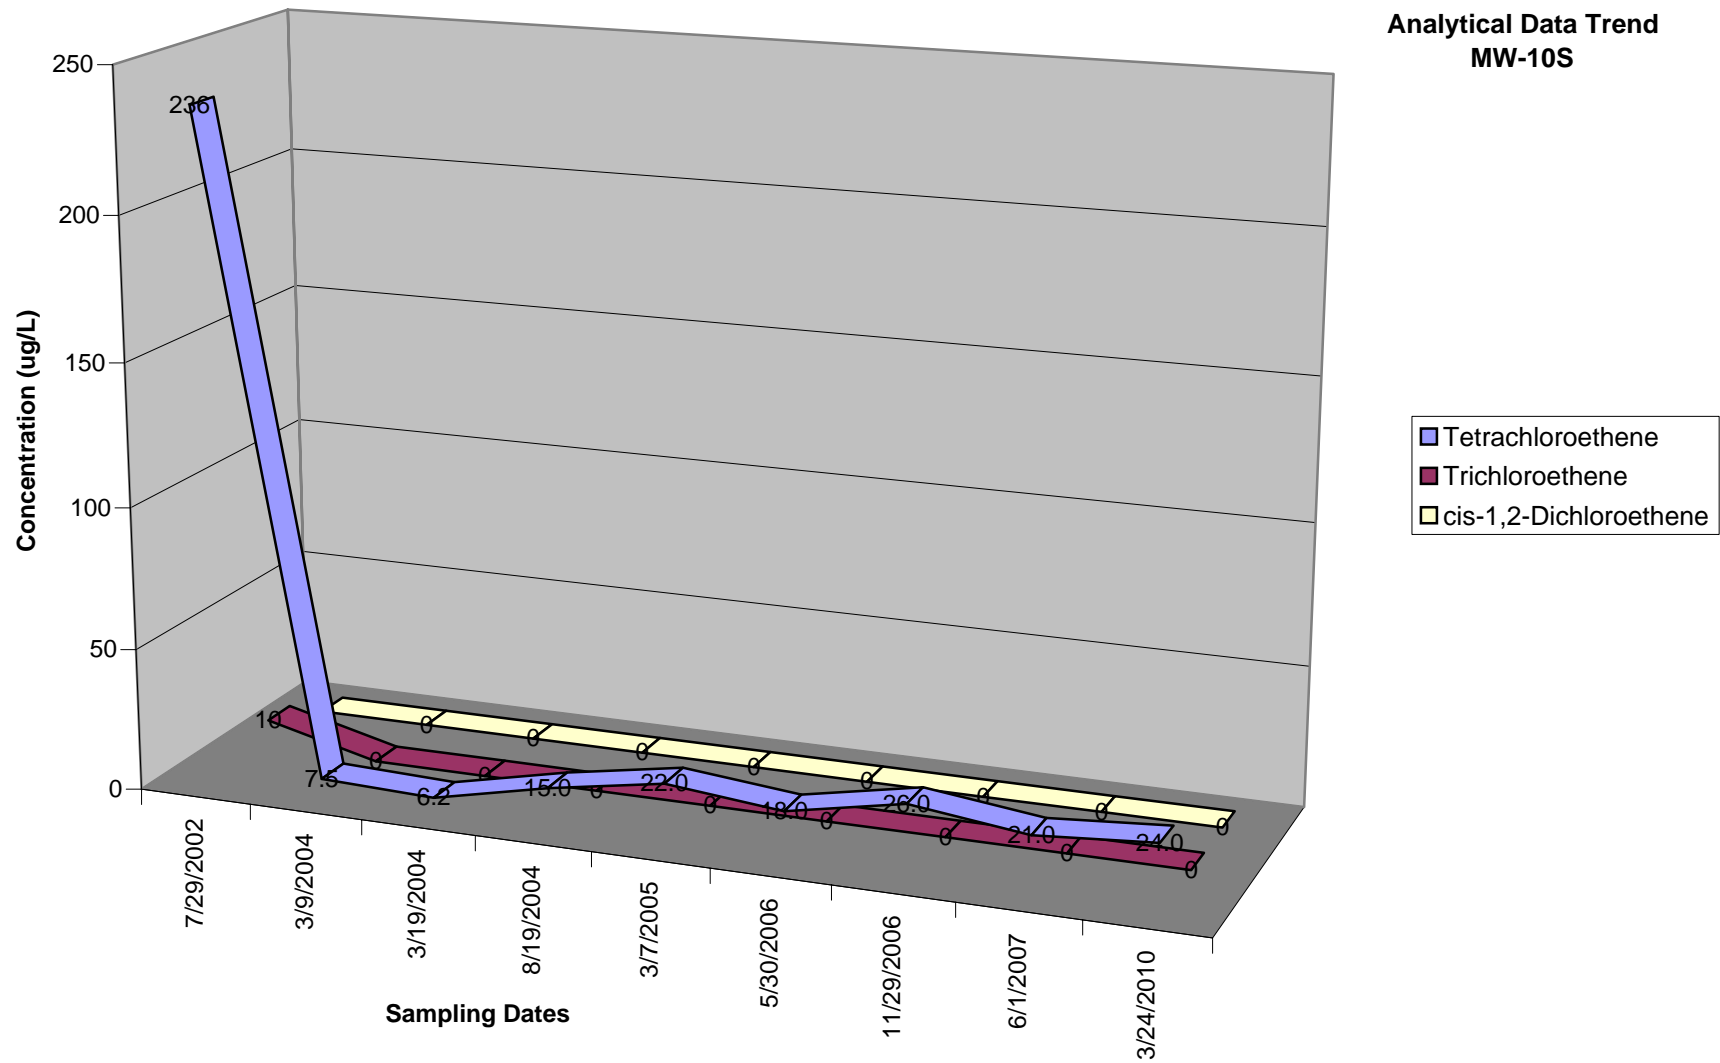
Analytical Data Trend
MW-10S

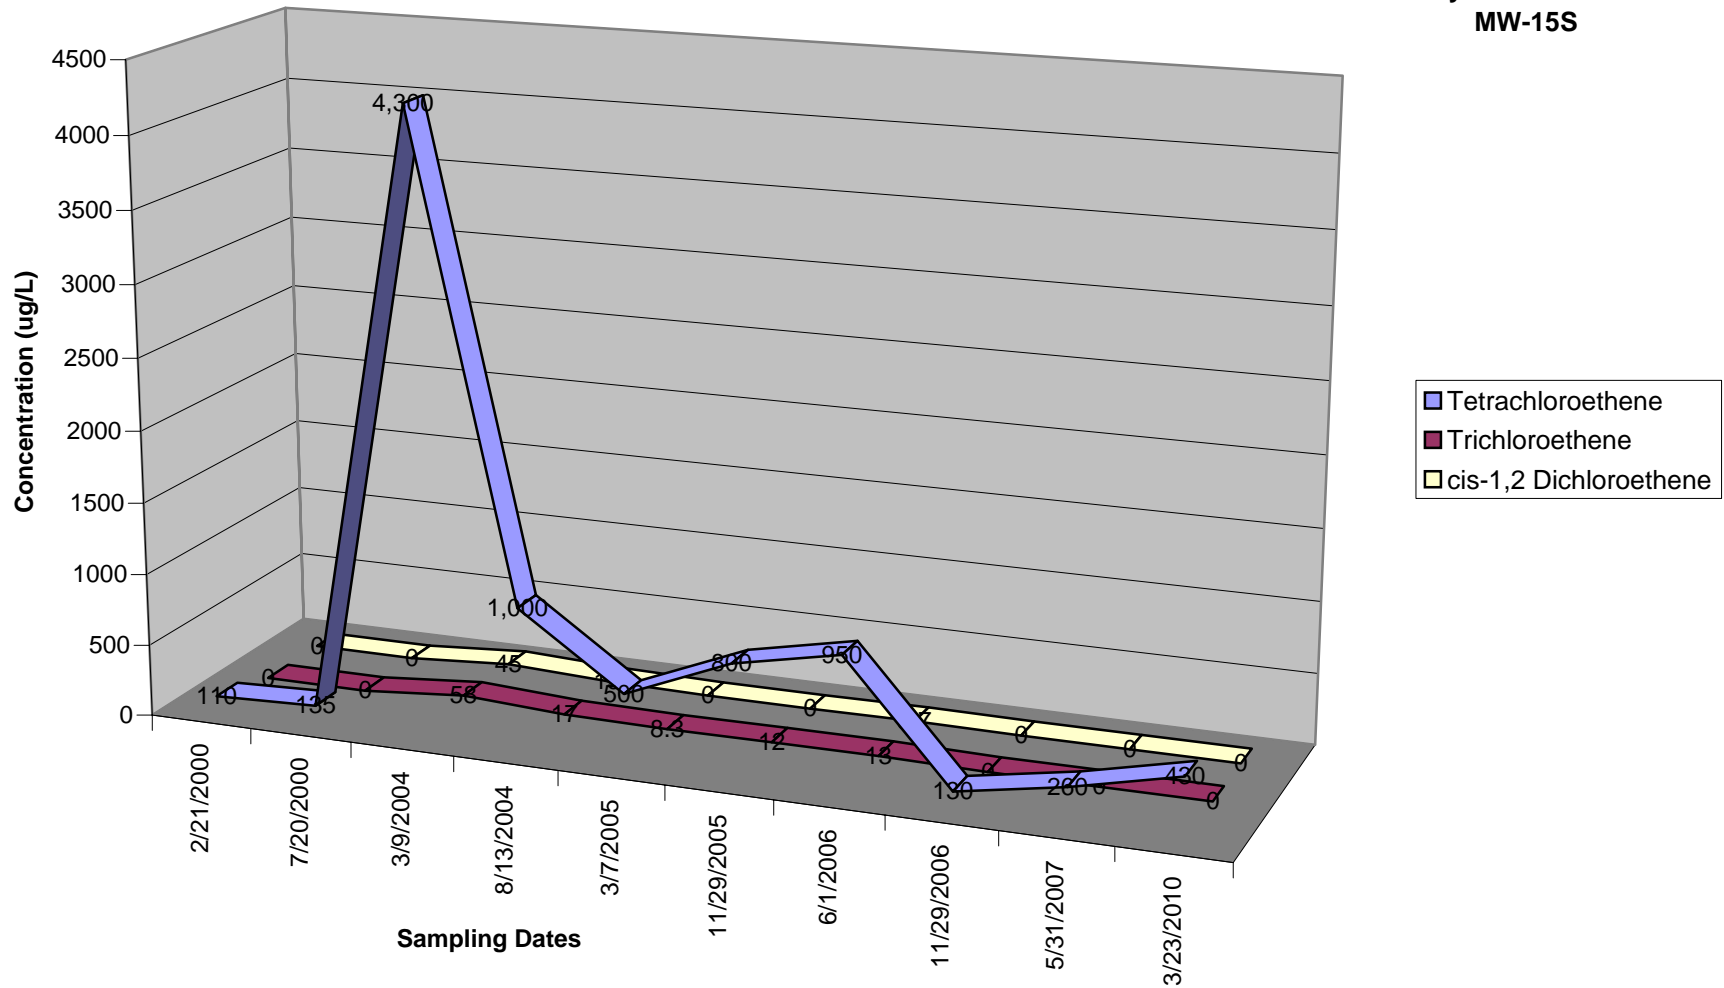
Analytical Data Trend
MW-15S

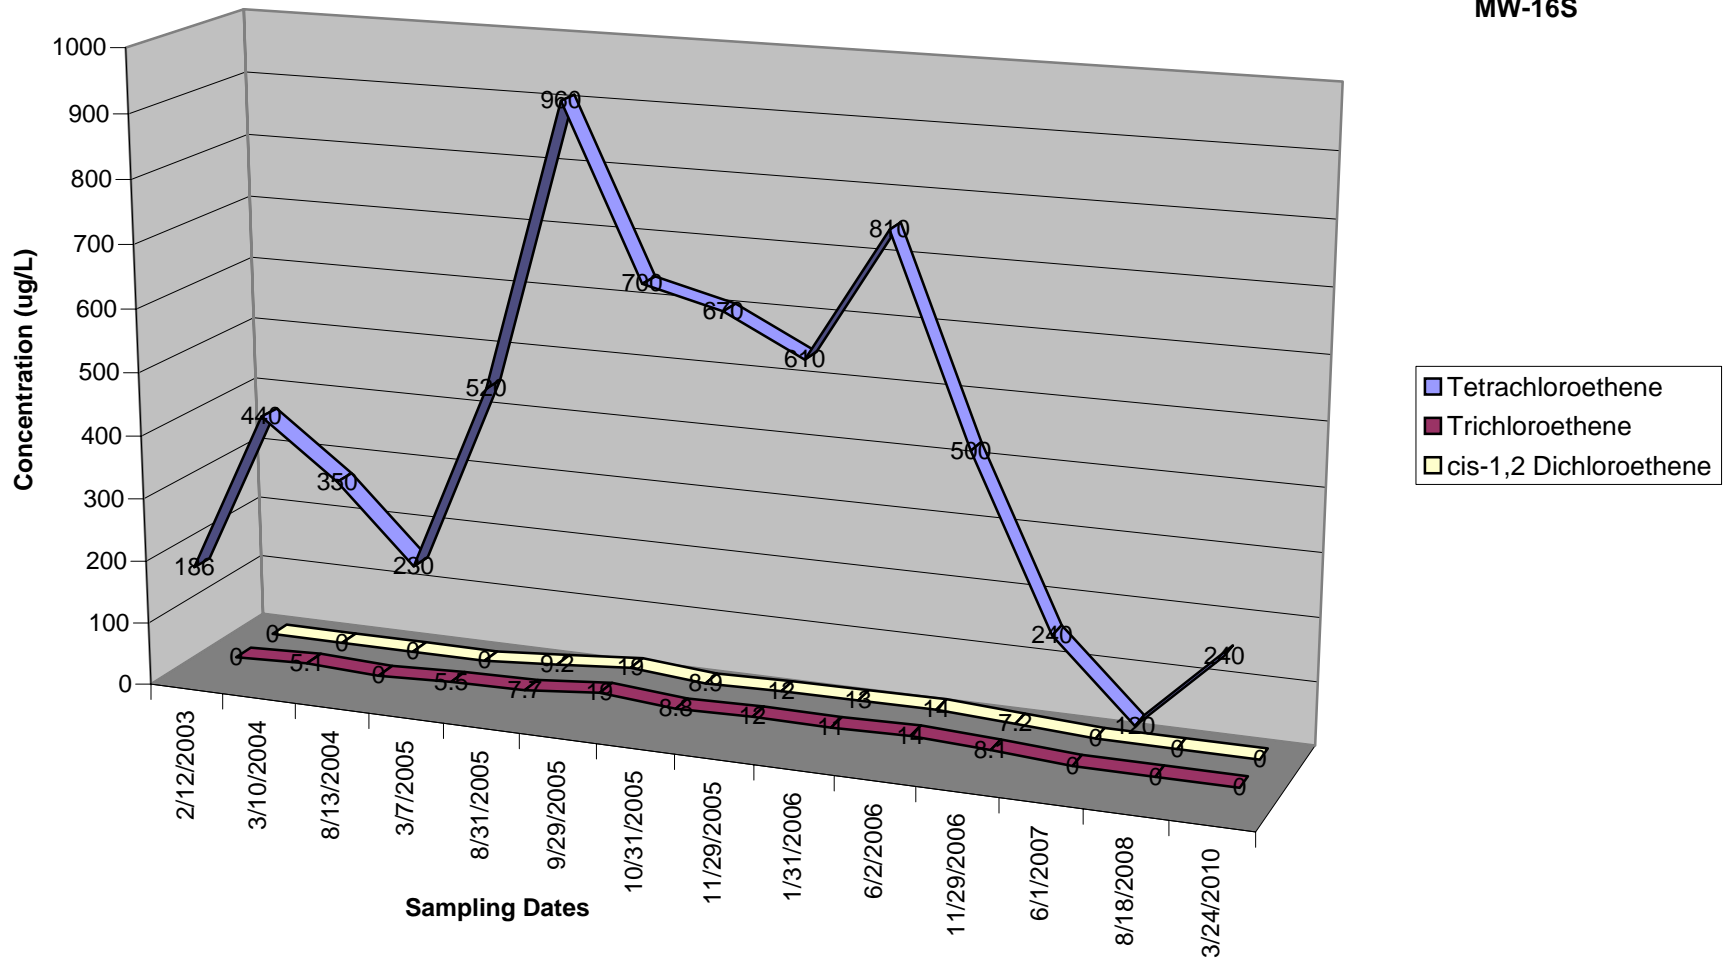
Analytical Data Trend
MW-16S

Specifically, PCE concentrations have been observed to decrease as compared to baseline,(pre-ISCO implementation) concentrations in the following plume-centerline wells:

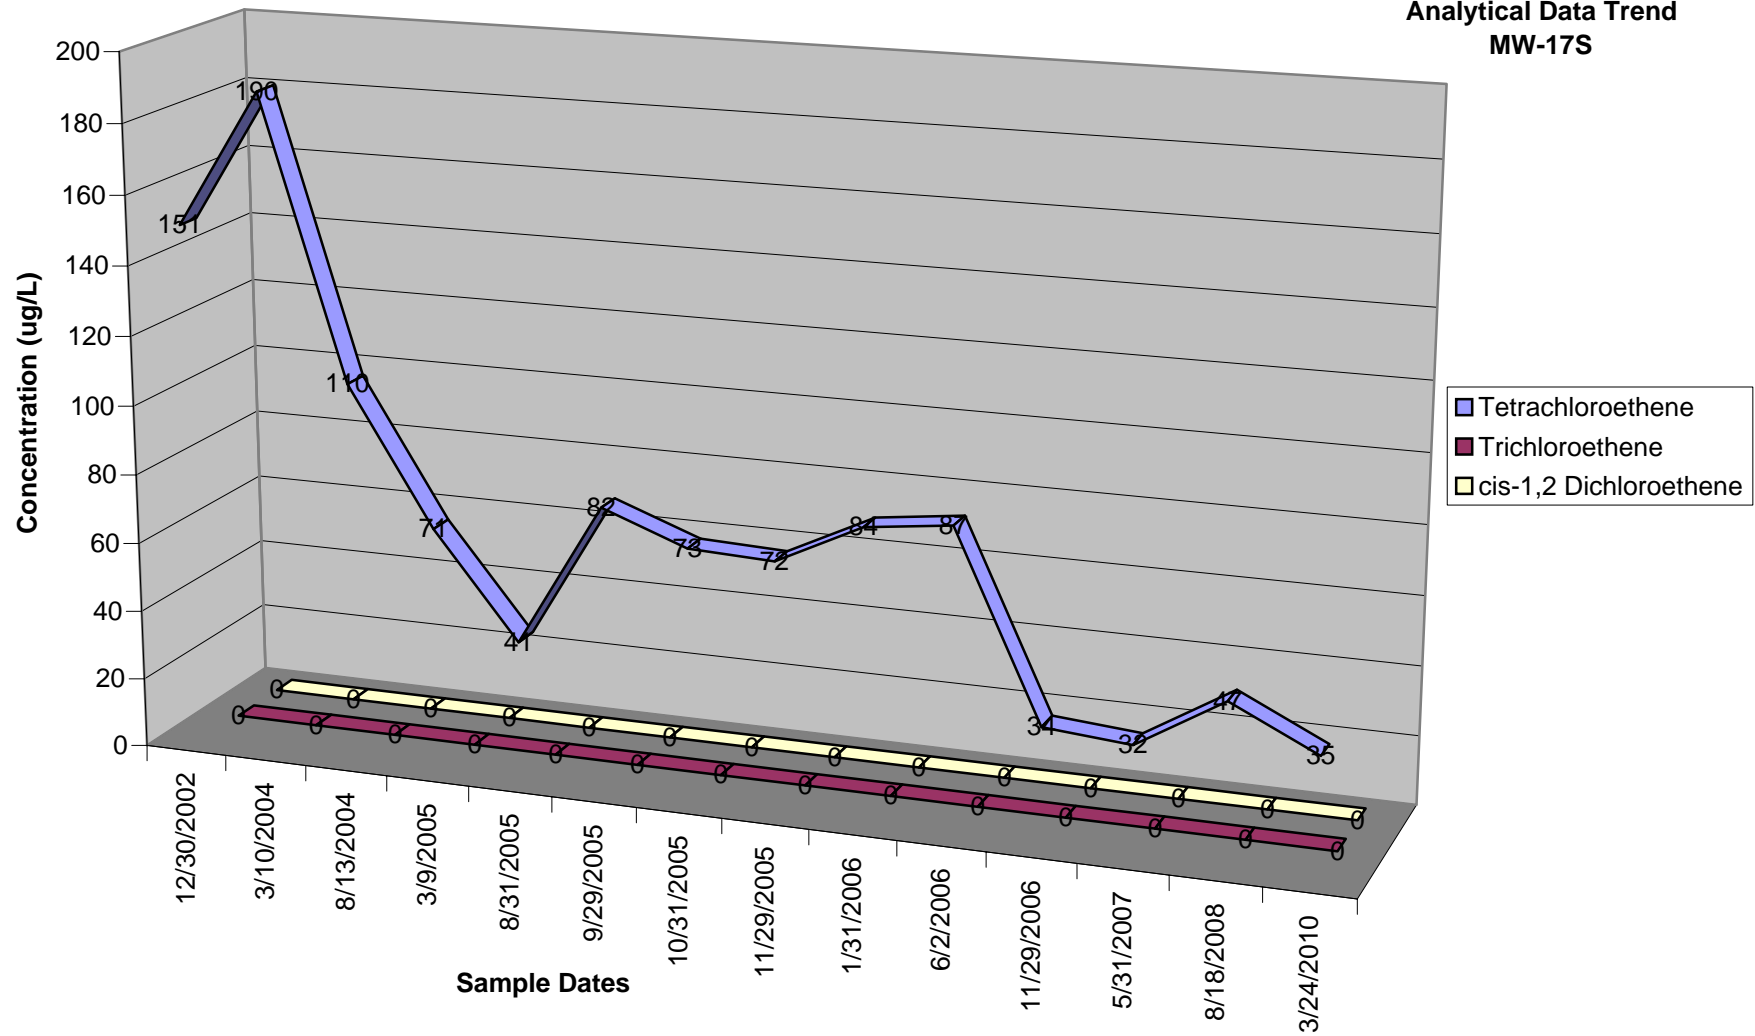
Analytical Data Trend
MW-17S

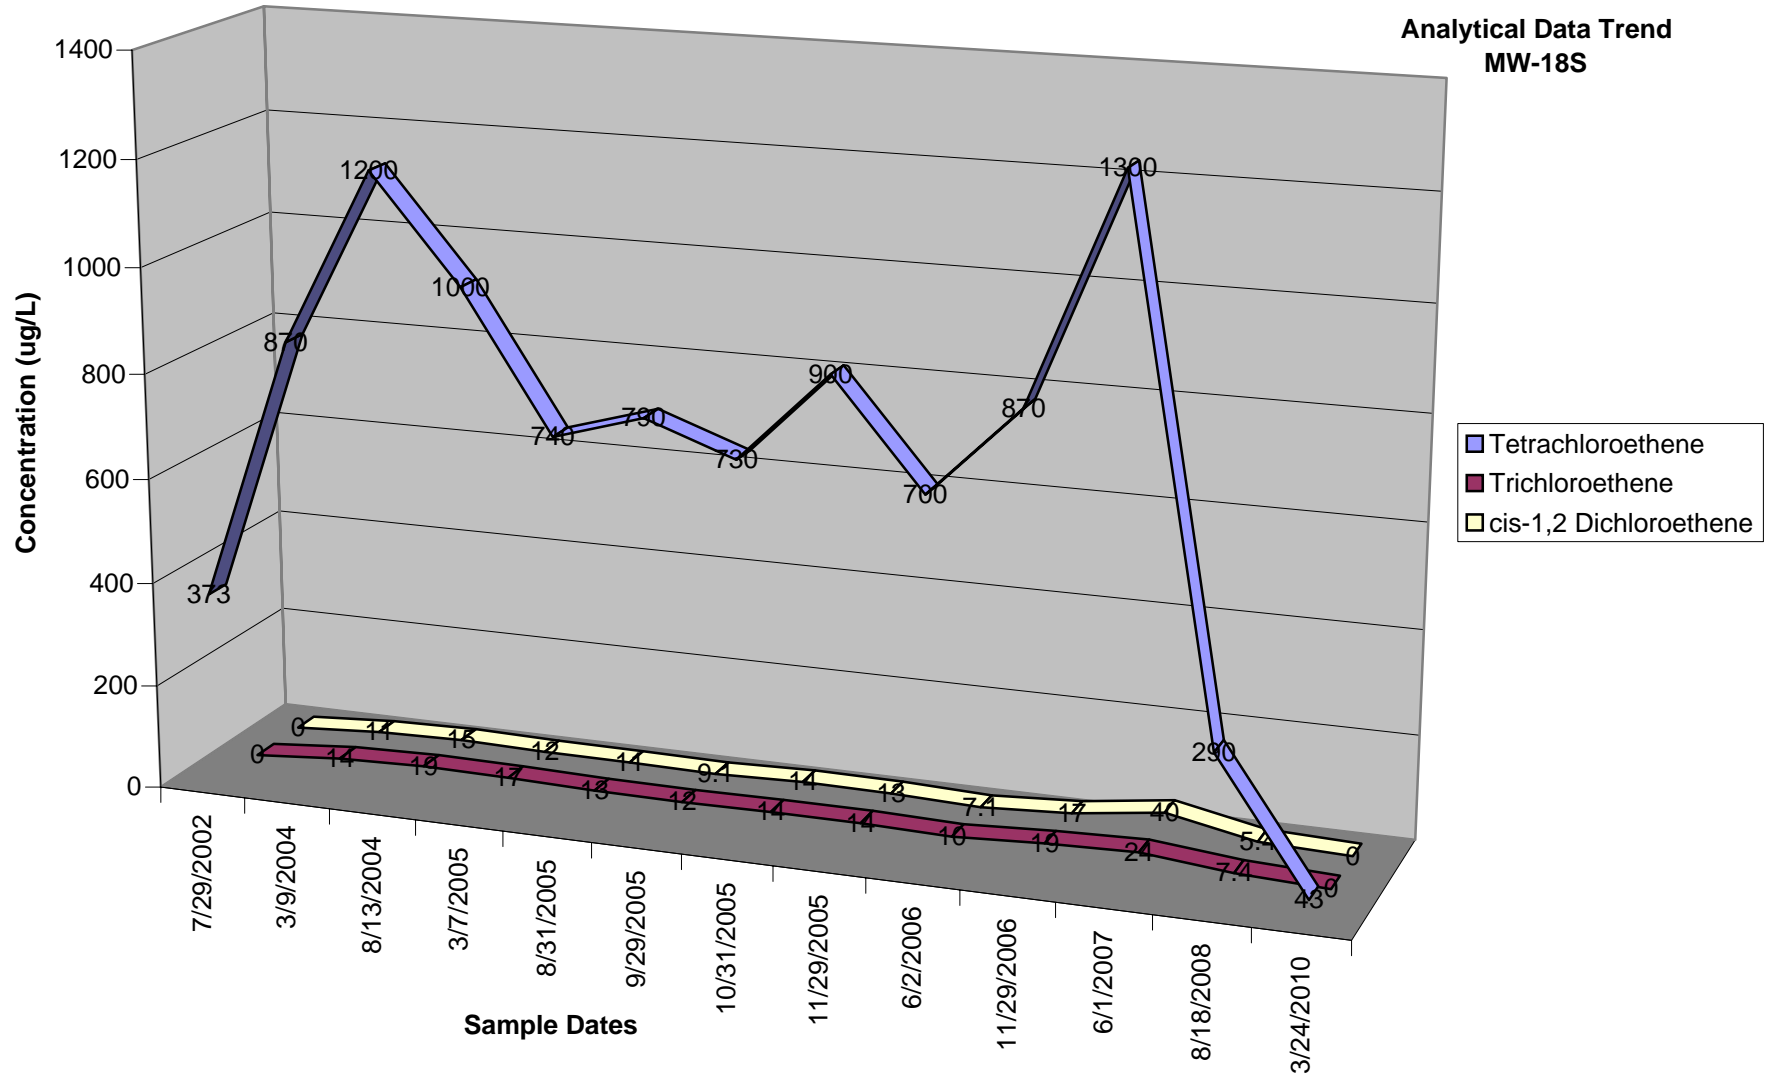
Analytical Data Trend
MW-18S

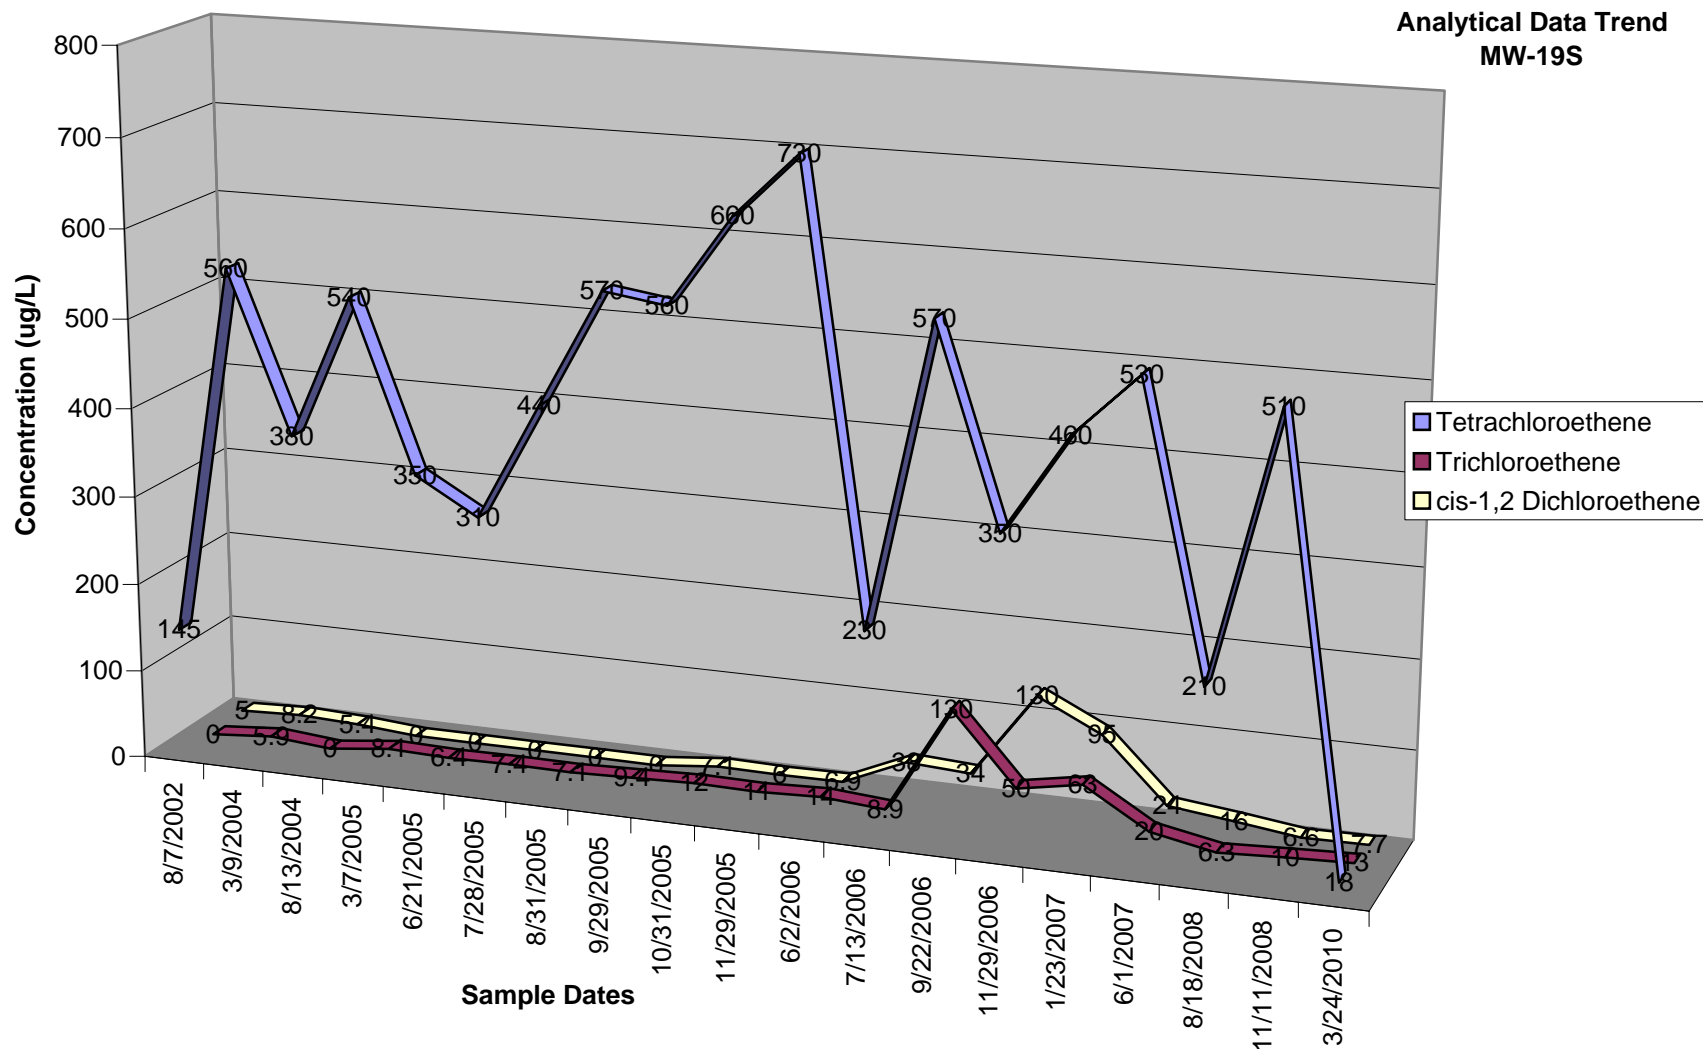
Analytical Data Trend
MW-19S
