Voluntary Remediation Plan Application Form and Checklist

SPALDING CORNERS SHOPPING CENTER SITE
NORCROSS, FULTON COUNTY, GEORGIA
HSI#10639

**SUPPLEMENTAL
VOLUNTARY REMEDIATION PROGRAM APPLICATION
INFORMATION FOR THE
SPALDING CORNERS SHOPPING CENTER SITE
NORCROSS, FULTON COUNTY, GEORGIA®**

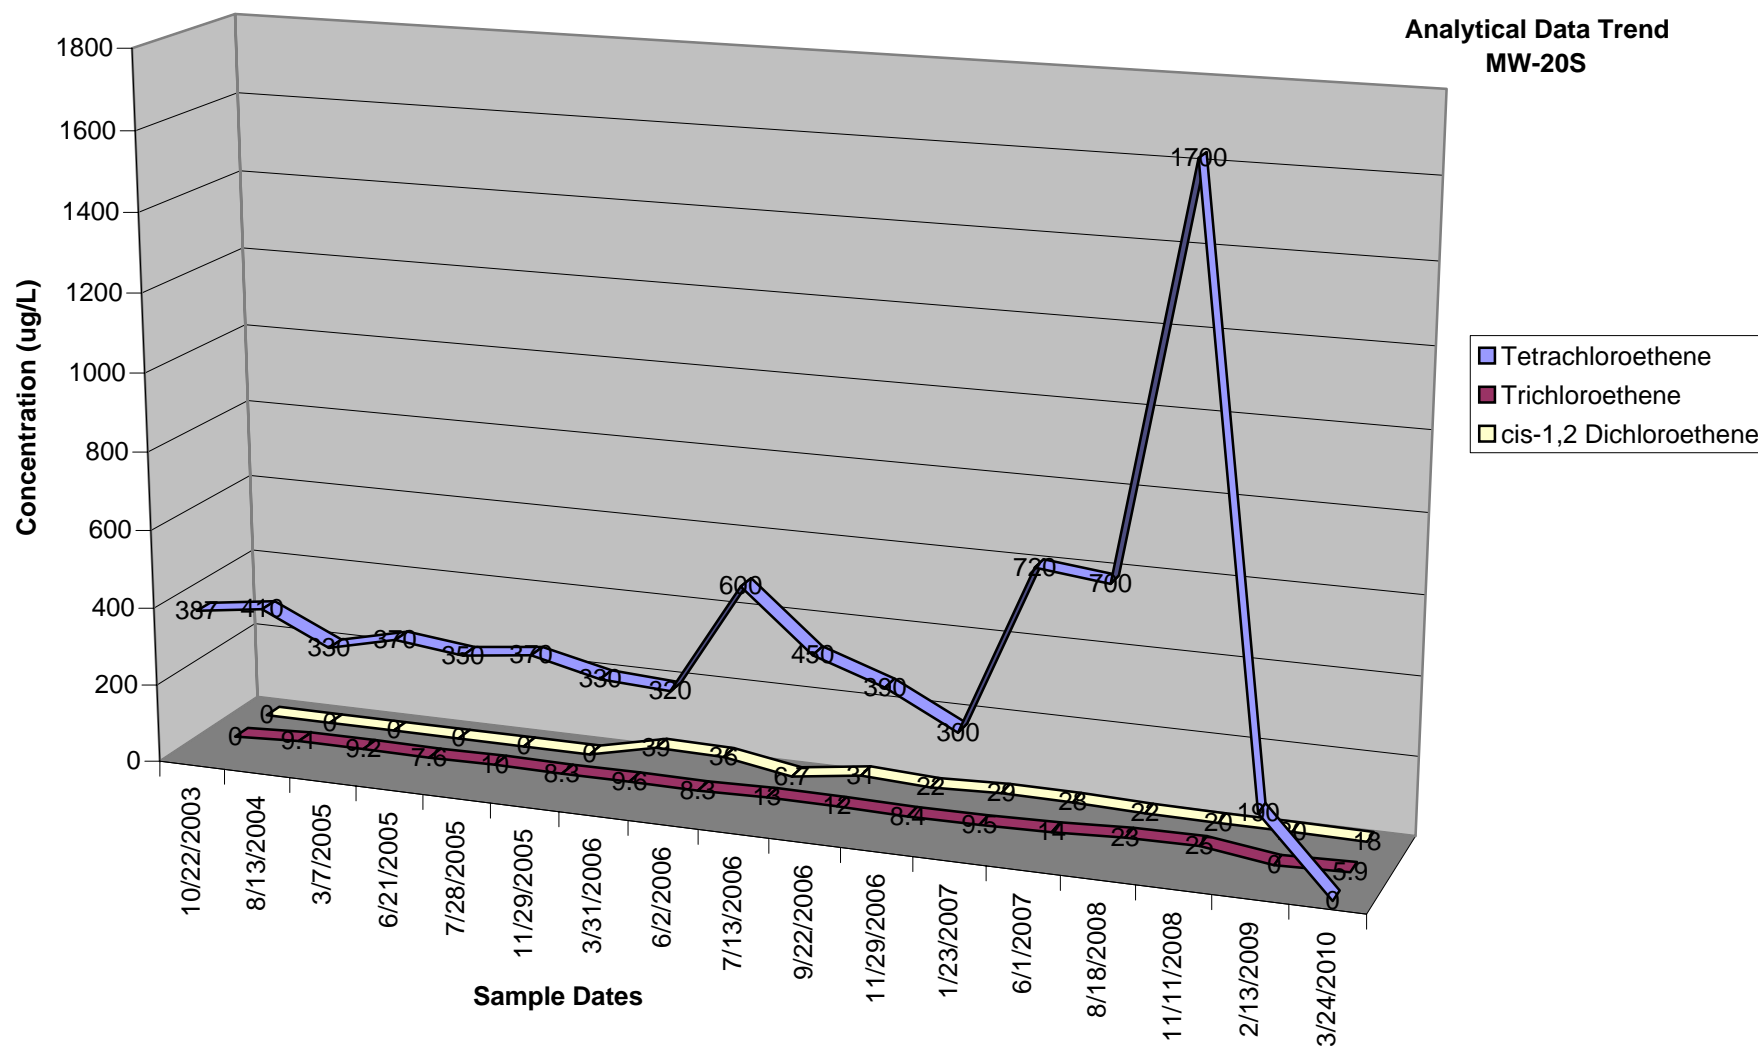
Analytical Data Trend
MW-20S

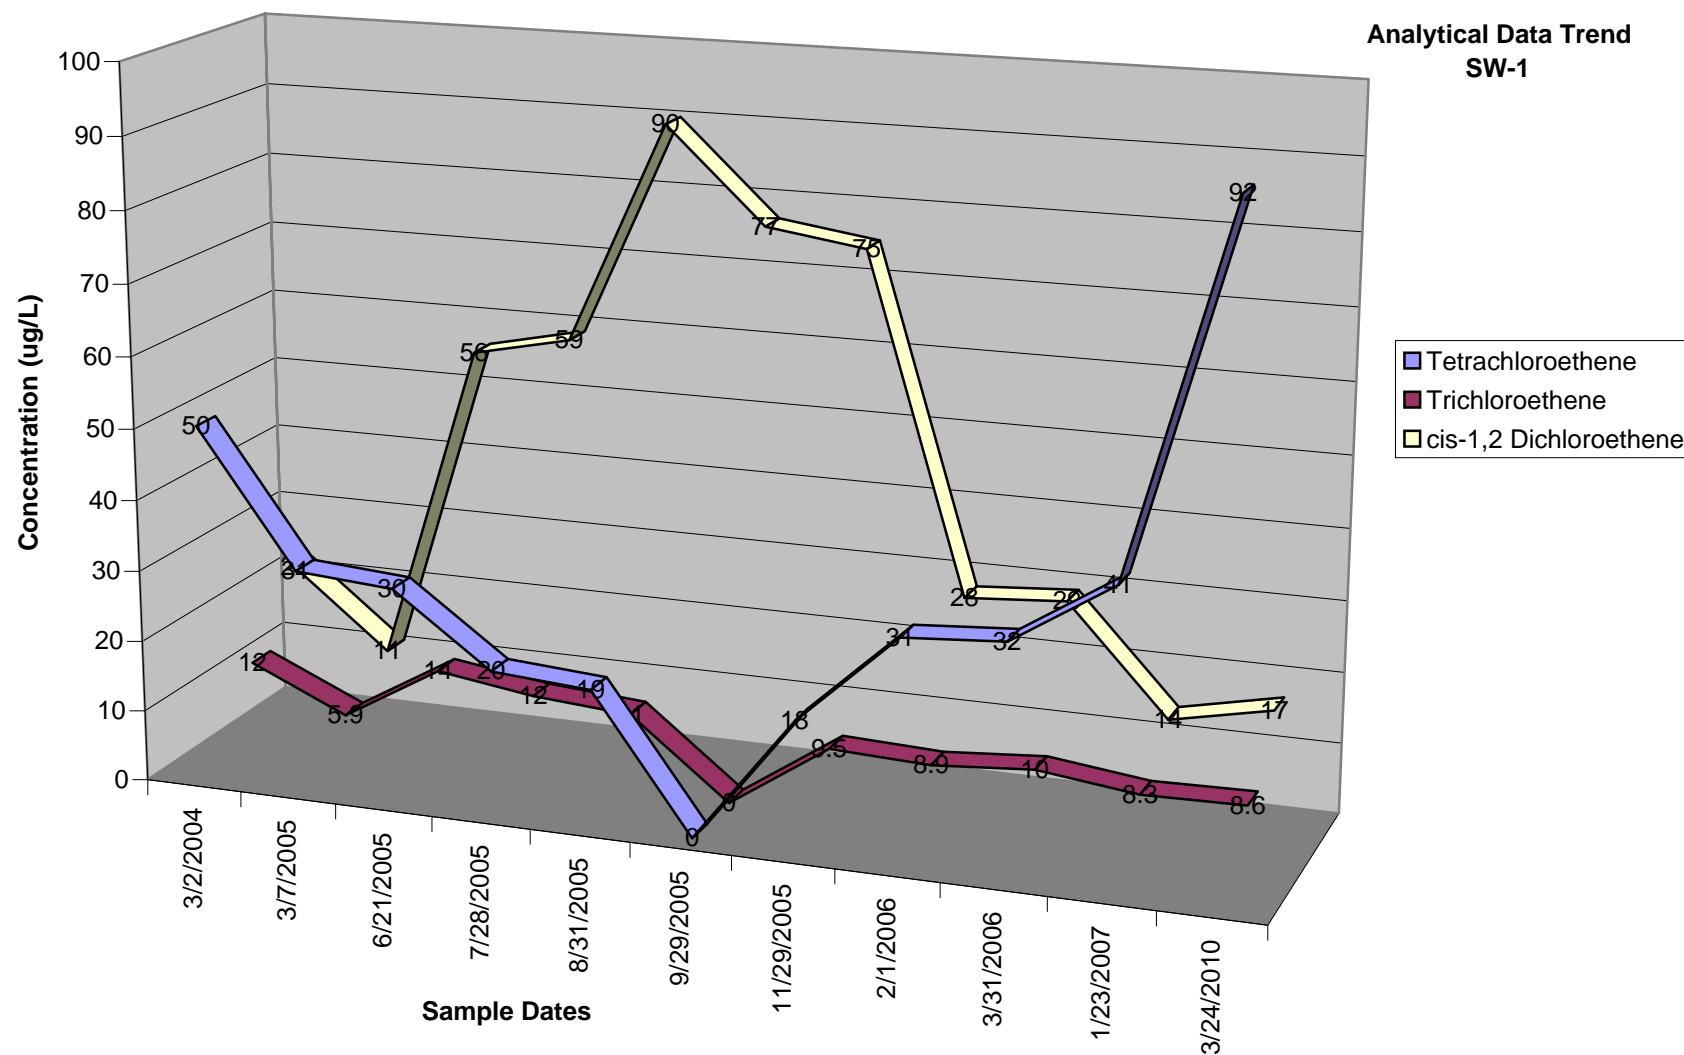
Analytical Data Trend
SW-1

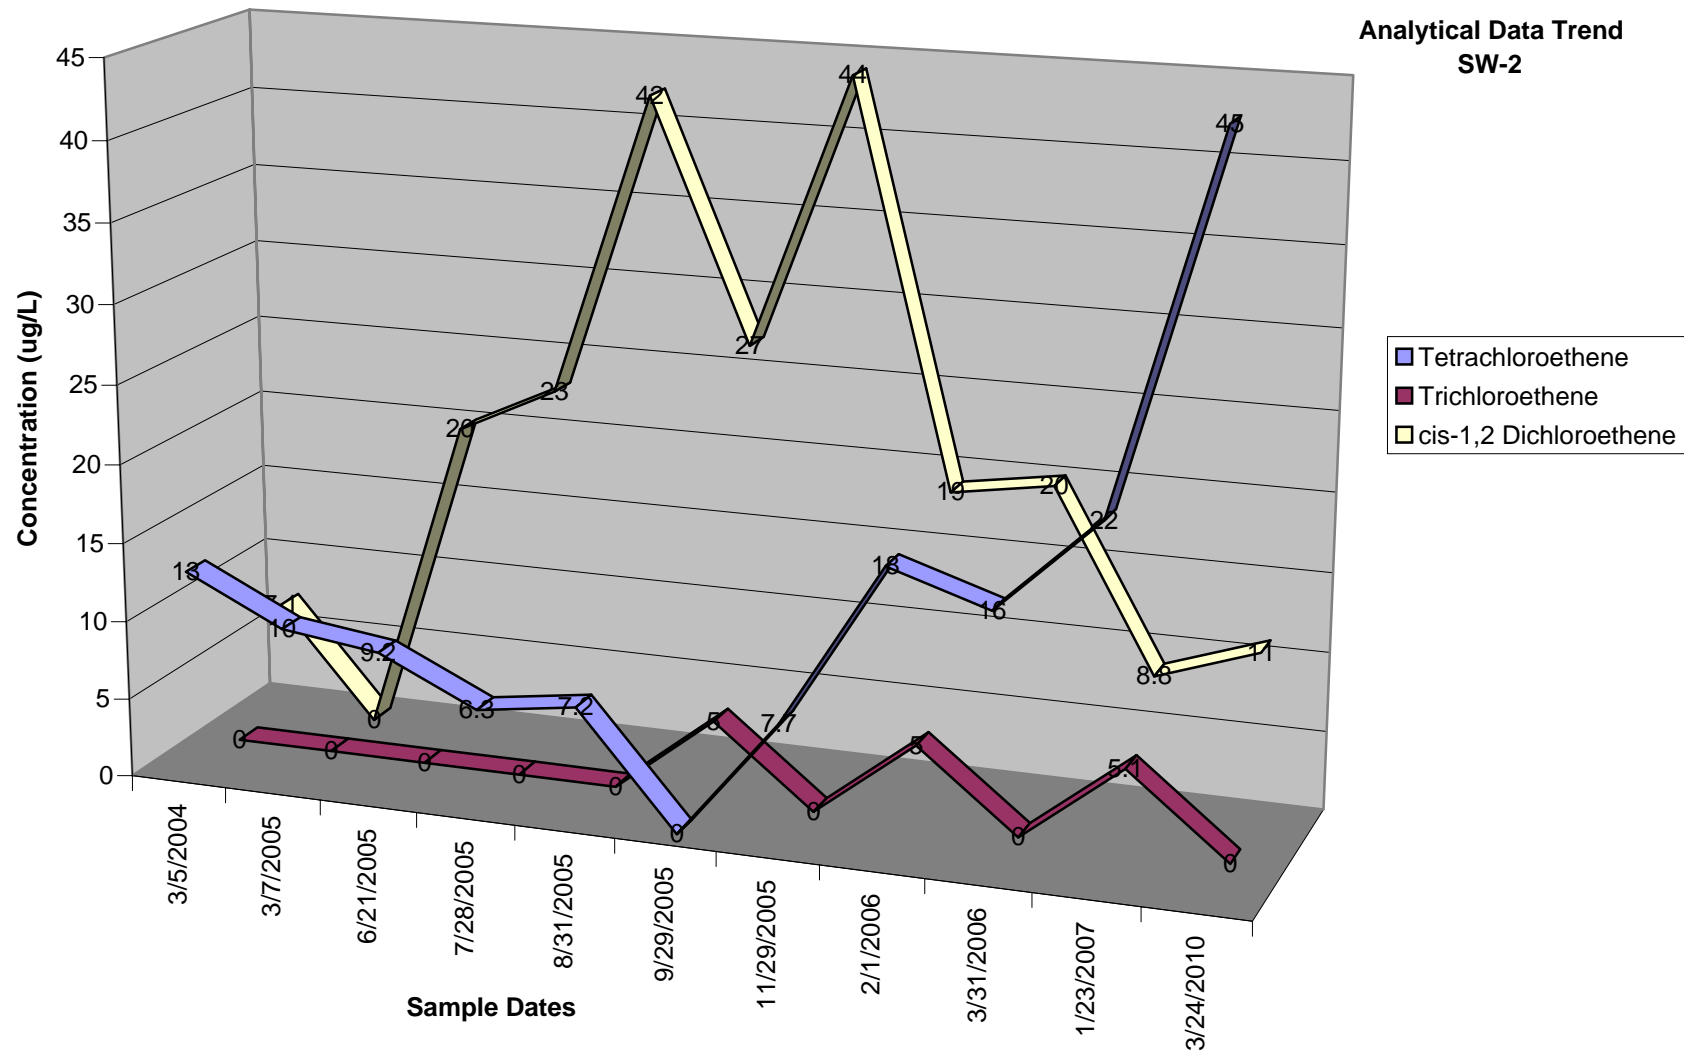
Analytical Data Trend
SW-2

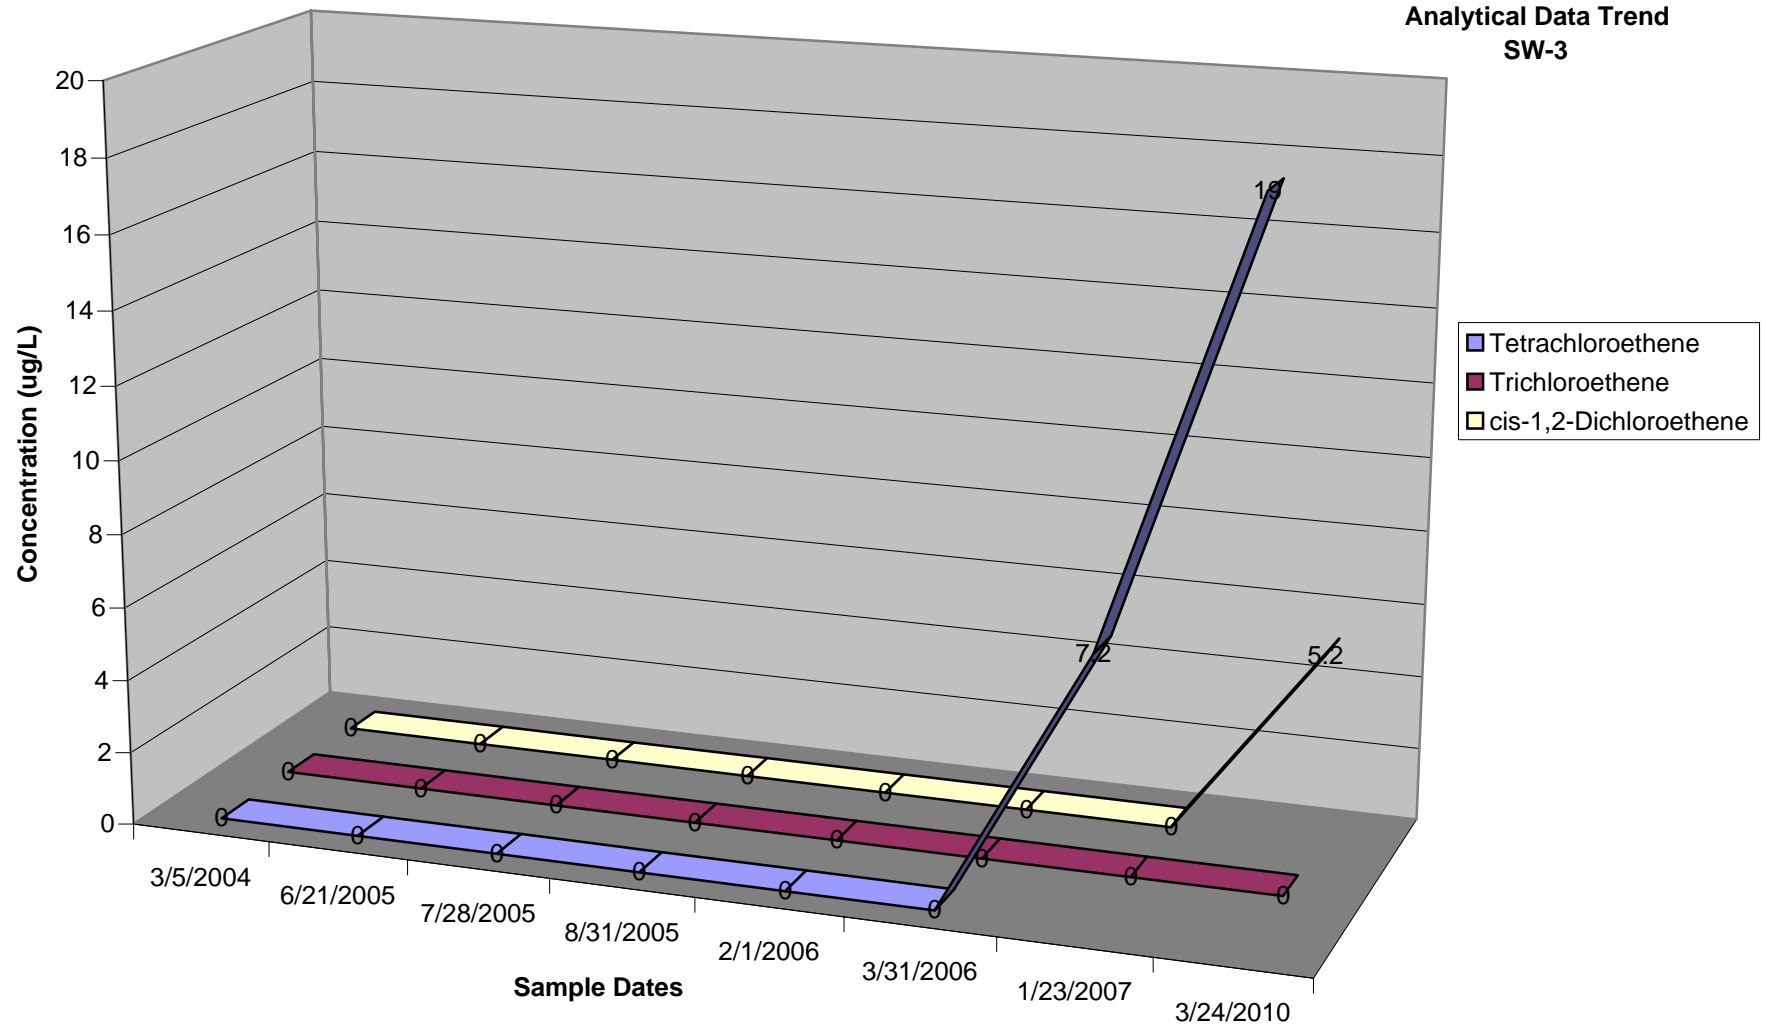
Analytical Data Trend
SW-3

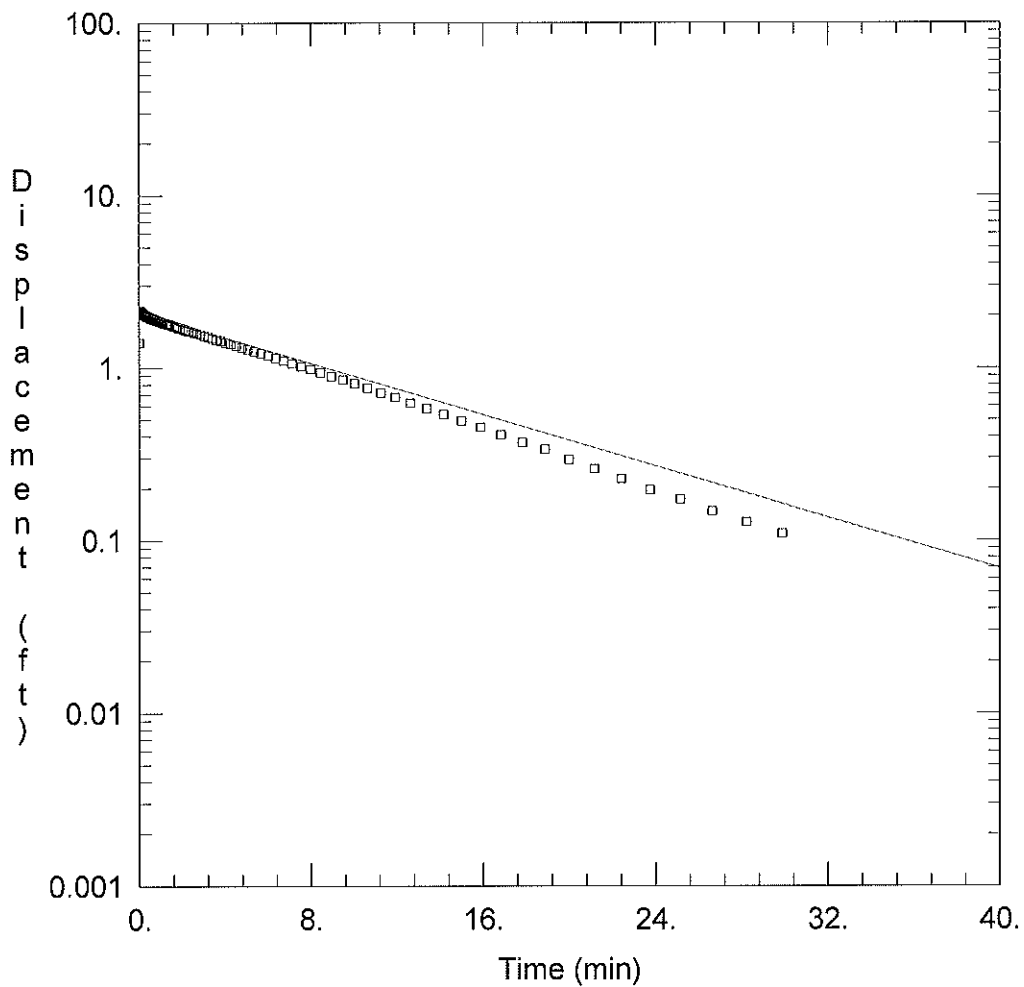
SLUG TEST - MW-17S

Initially, static water levels were measured within each well prior to performing slug testing activities. A Hermit Model 3000 datalogger with a pressure transducer was then lowered into the well along with a solid-core slug equipped with nylon cord. The water was then allowed to return to static conditions prior to initiating the slug test. Upon the return of water to static conditions, the slug test was initiated by quickly removing the solid-core slug from the well with the rate of groundwater recovery being measured using the datalogger and pressure transducer until water levels approached or returned to static conditions.

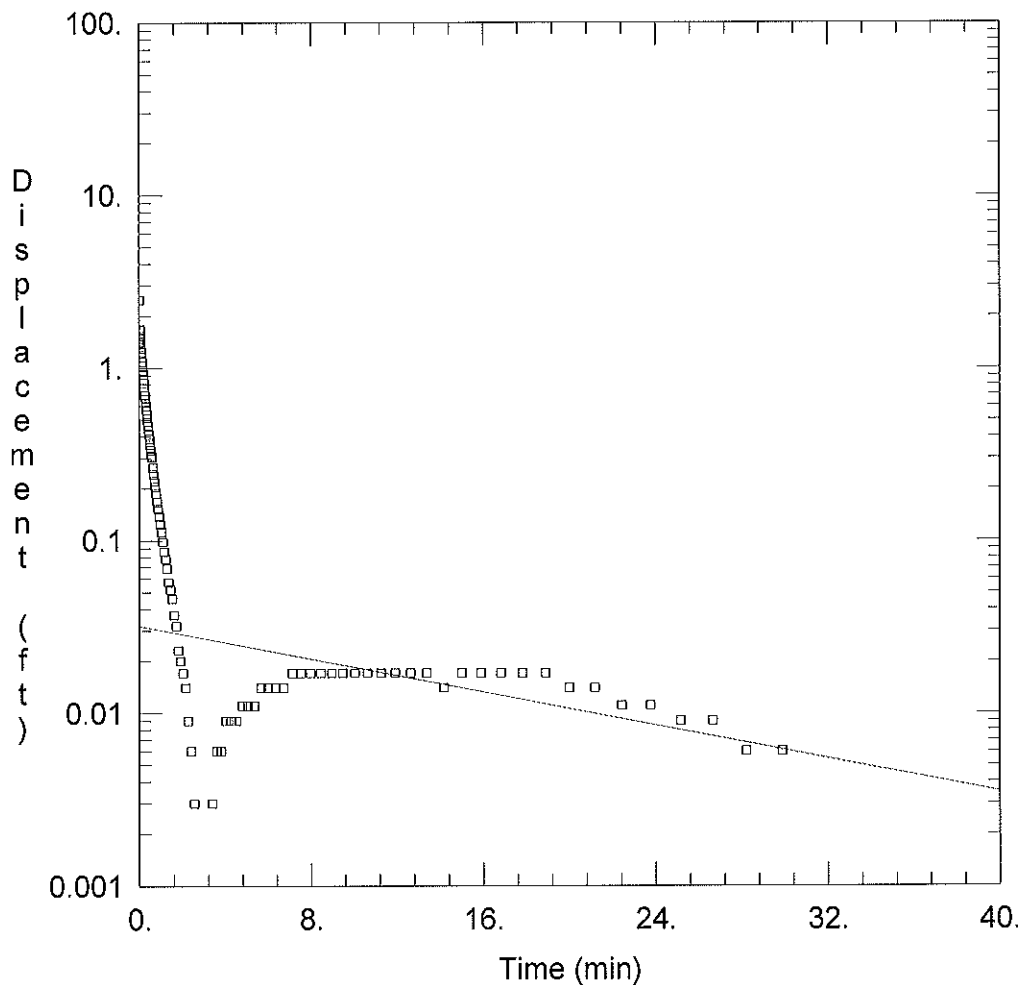
SLUG TEST - MW-20S
