**VOLUNTARY INVESTIGATION
AND REMEDIATION PLAN
TLC Cleaners
2060 Lower Roswell Road
Marietta, GA 30068**

VOLUNTARY INVESTIGATION AND REMEDIATION PLAN

TLC Cleaners

2060 Lower Roswell Road
Marietta, GA 30068

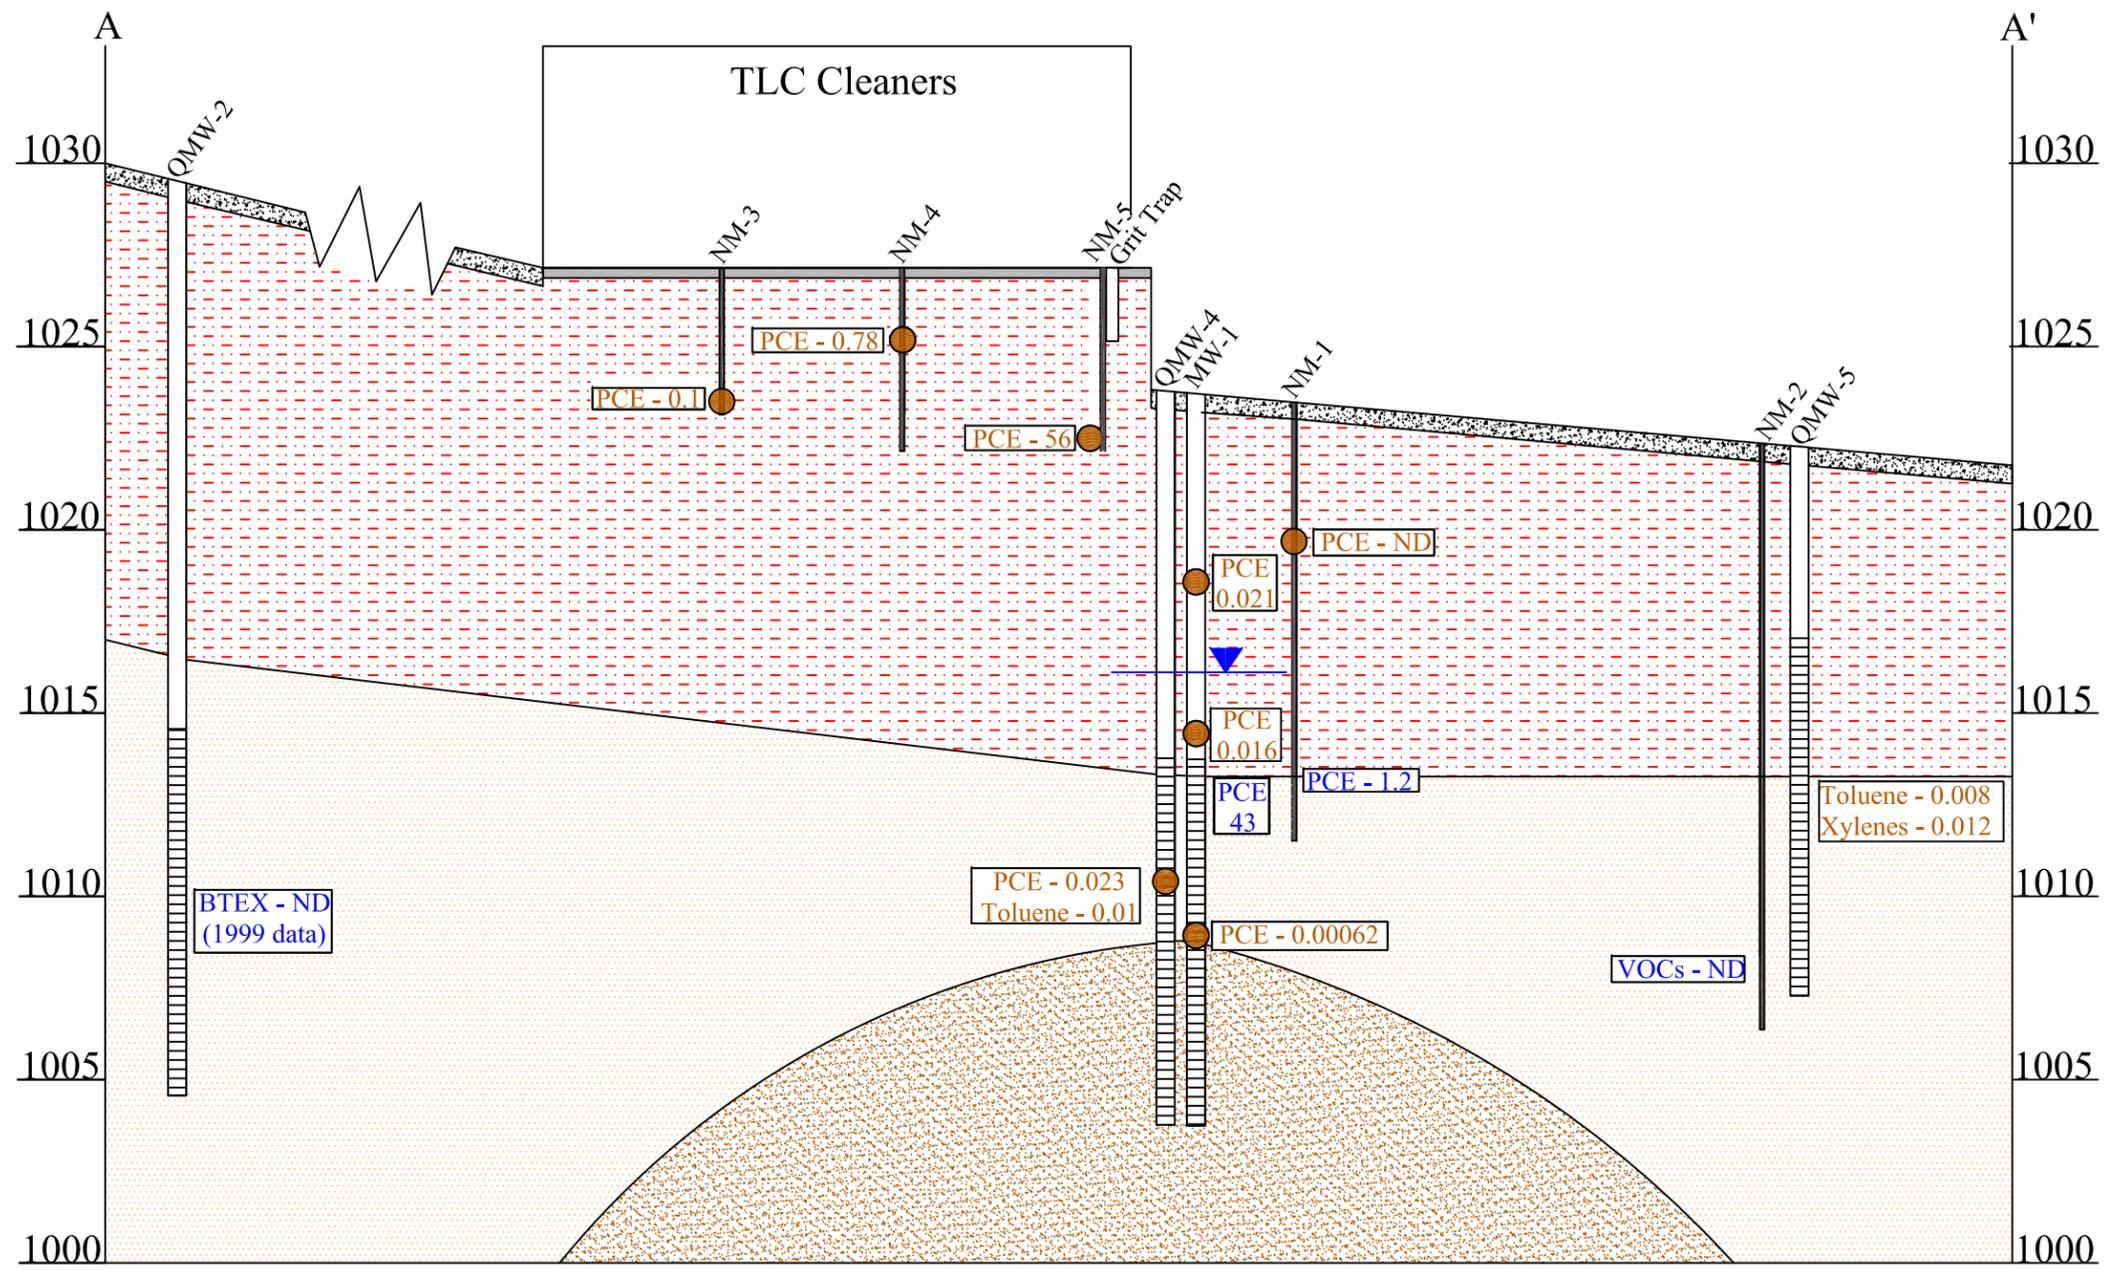
- PCE - 0.78 Soil Concentration (mg/kg)
- PCE - 43 Groundwater Concentration (ug/L)
- ▼ Water Table (May 2014)
- mg/kg Milligram per Kilogram
- ug/L Microgram per Liter
- PCE Tetrachloroethene
- cis-1,2-DCE cis-1,2-Dichloroethene
- BTEX Benzene, Toluene, Ethylbenzene, and Xylenes
- Clay & Sand Mix
- Sand
- Clay/Silt
- Asphalt/Gravel
- Concrete Slab
- Soil Sample Depth

Note: 1. QMW-2 is approximately 250 ft from TLC Cleaners.
 2. Soil lithology has been extrapolated where no soil lithology was available.
 3. 1999 groundwater data is not depicted on this figure (unless noted).
 4. Screen intervals for QMW-4 and QMW-5 are assumed.

1050 Crown Pointe Parkway Suite 550 Atlanta, GA 30338 (404) 315-9113	Cross-Section A-A'	FIGURE
	TLC Cleaners 2060 Lower Roswell Road Marietta, Georgia	
	September 2014

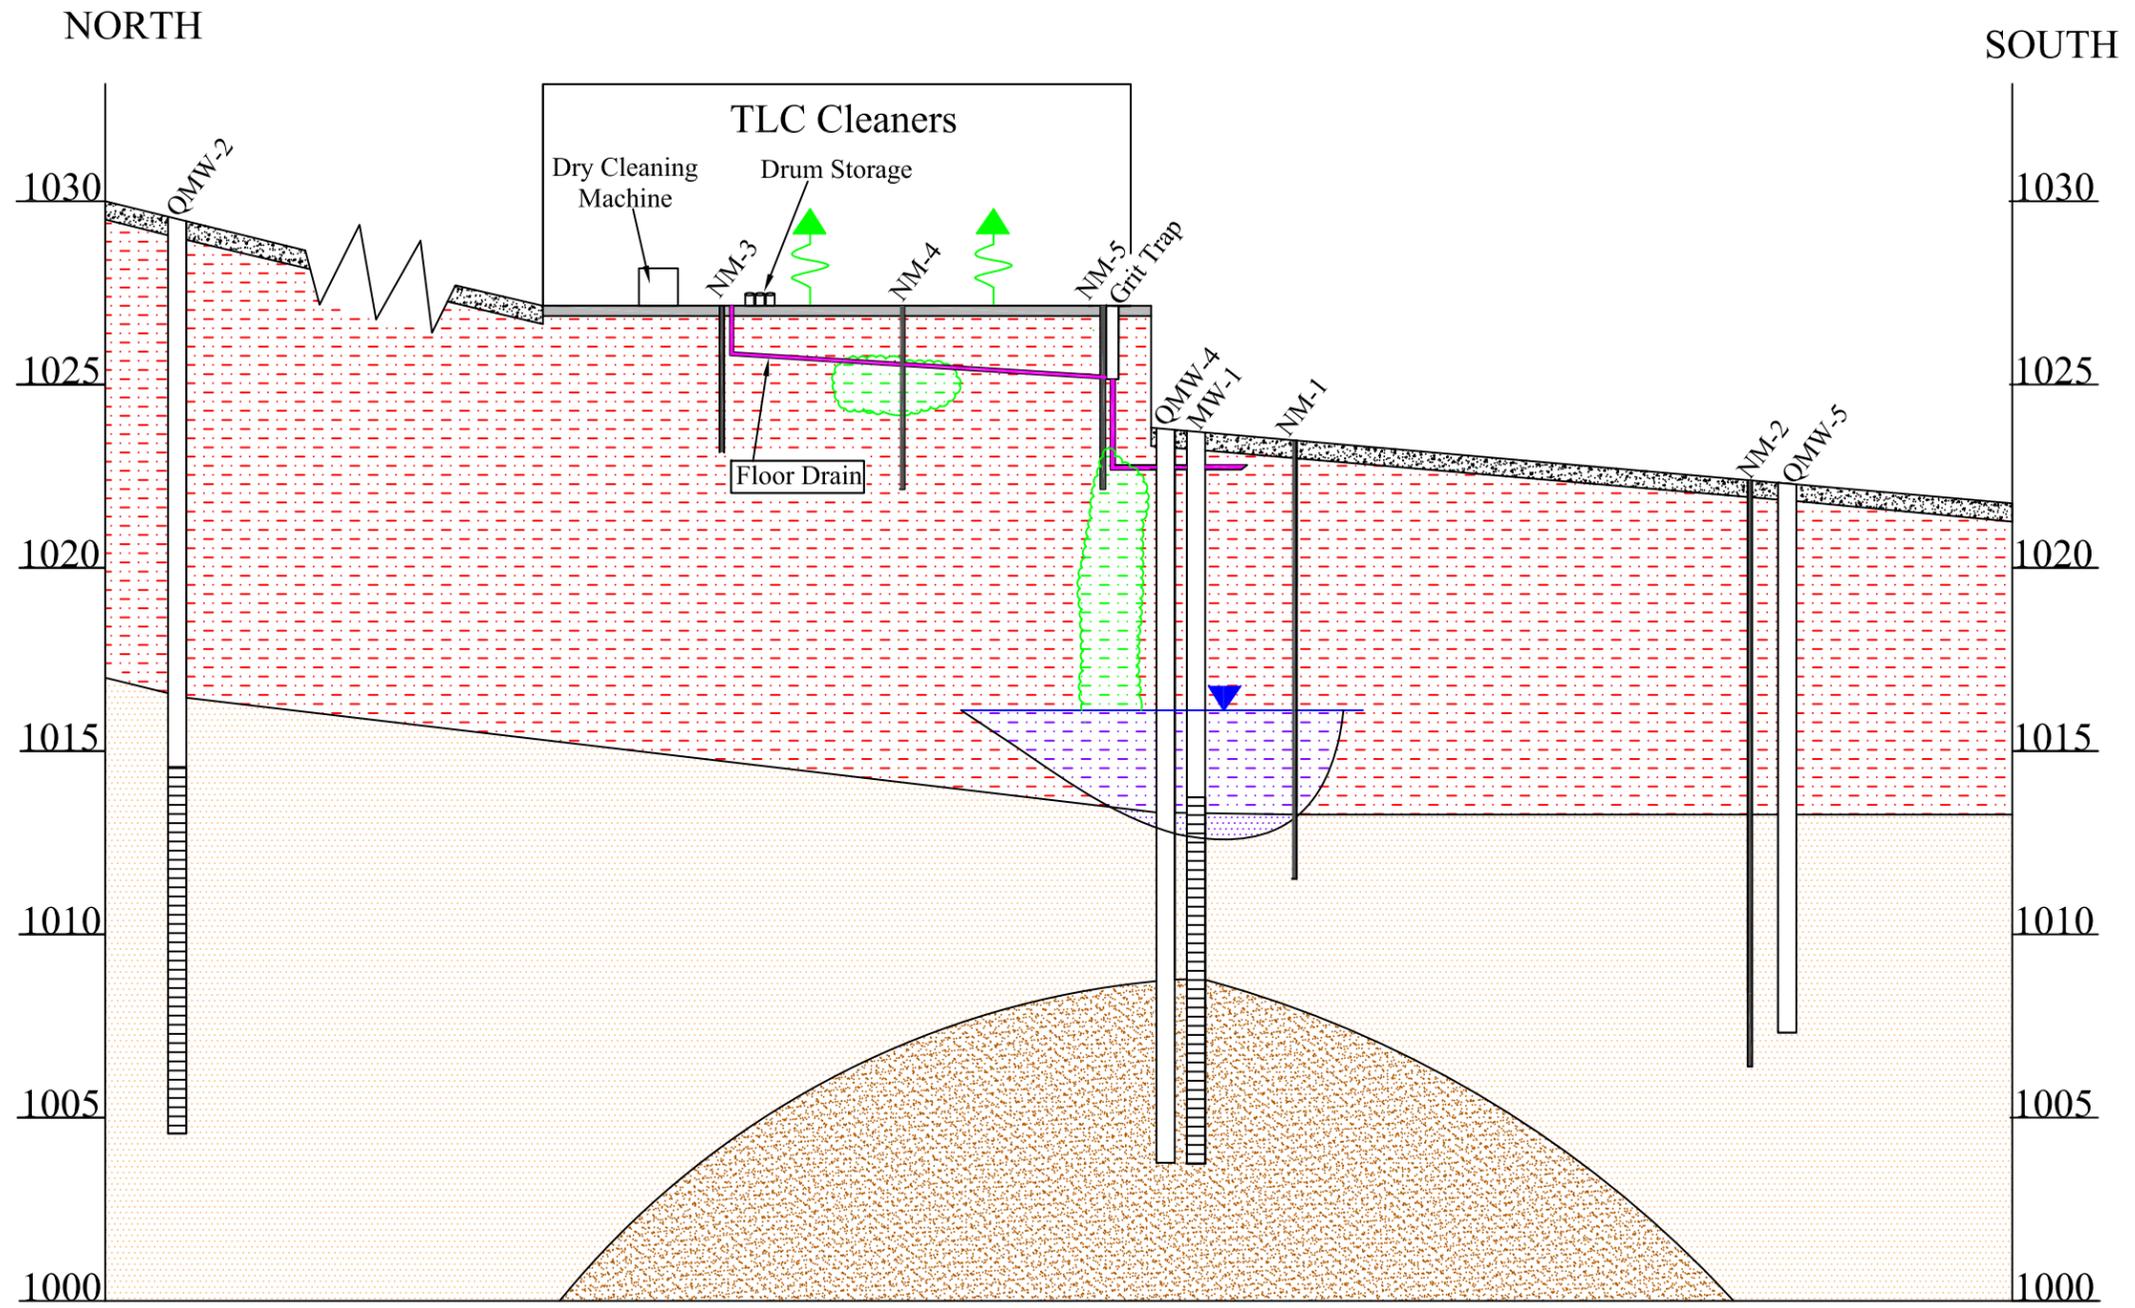
FIGURE

Figures 6 through 8 are plan view and profile diagrams depicting the extent of constituents in the subsurface. Viewed in total, these figures give a three-dimensional representation of the Site conditions.

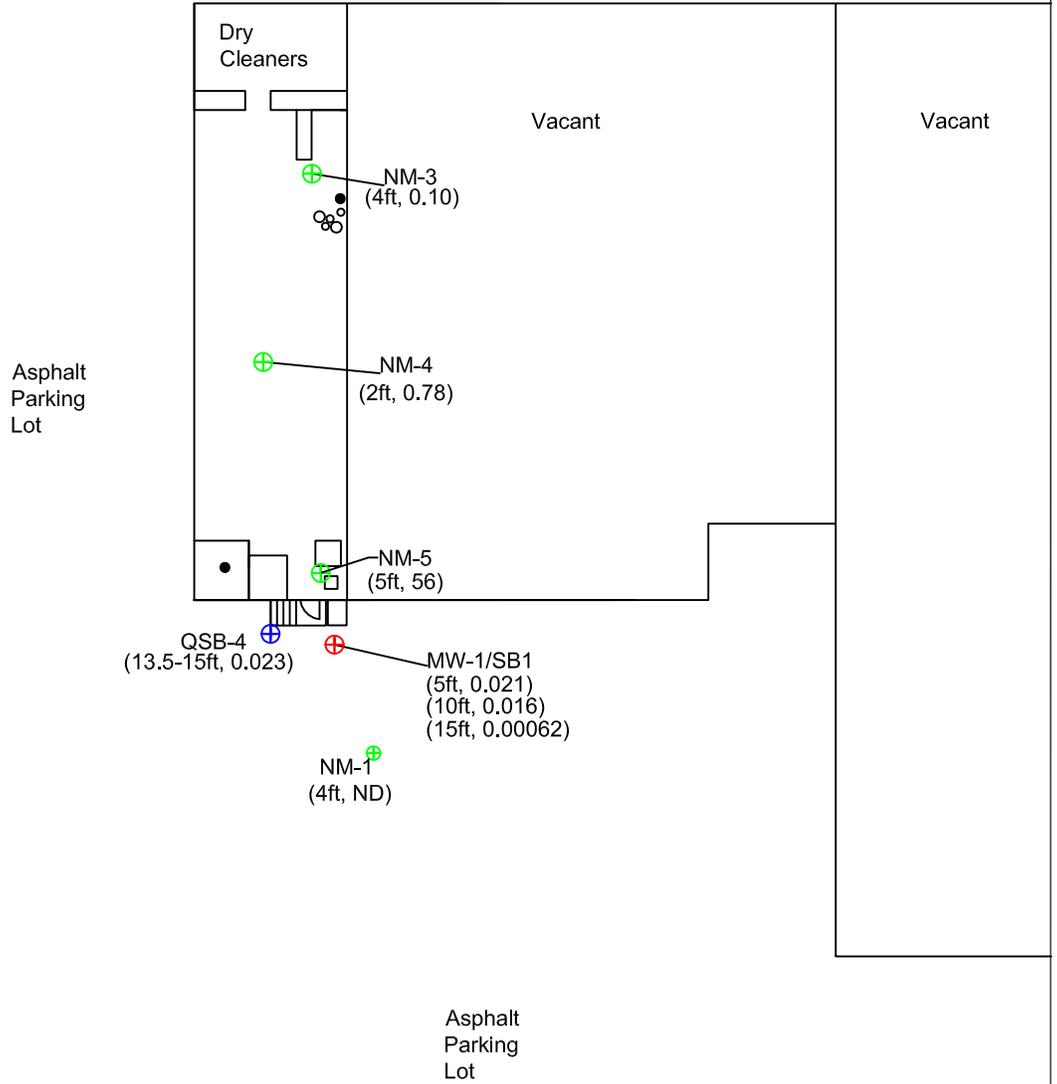
FIGURE

- Floor Drain
- ⊕ Qore Soil Sample Location (1999)
- ⊕ Partner Engineering Soil Sample Location (2013)
- ⊕ EPS Soil Sample Location (2014)

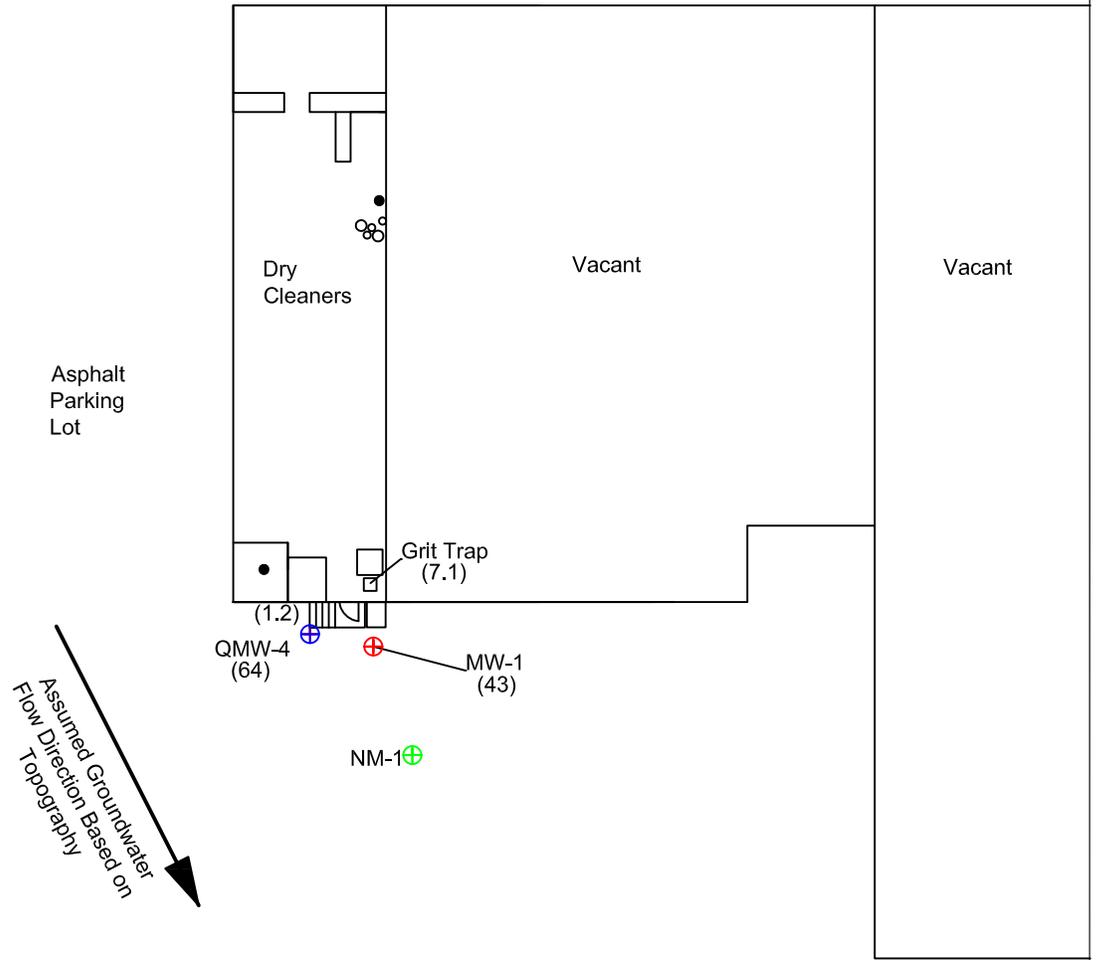
- Floor Drain
 - ⊕ Core Groundwater Sample Location (1999)
 - ⊕ Partner Engineering Groundwater Sample Location (2013)
 - ⊕ EPS Monitoring Well Location (2014)
- (43) (PCE Concentration (ug/L))
 ug/L micrograms per liter
 ND Not Detected
