**VOLUNTARY REMEDIATION  
PROGRAM APPLICATION  
Roper Pump Company  
Commerce, Georgia**

# VOLUNTARY REMEDIATION PROGRAM APPLICATION

**Roper Pump Company  
Commerce, Georgia**

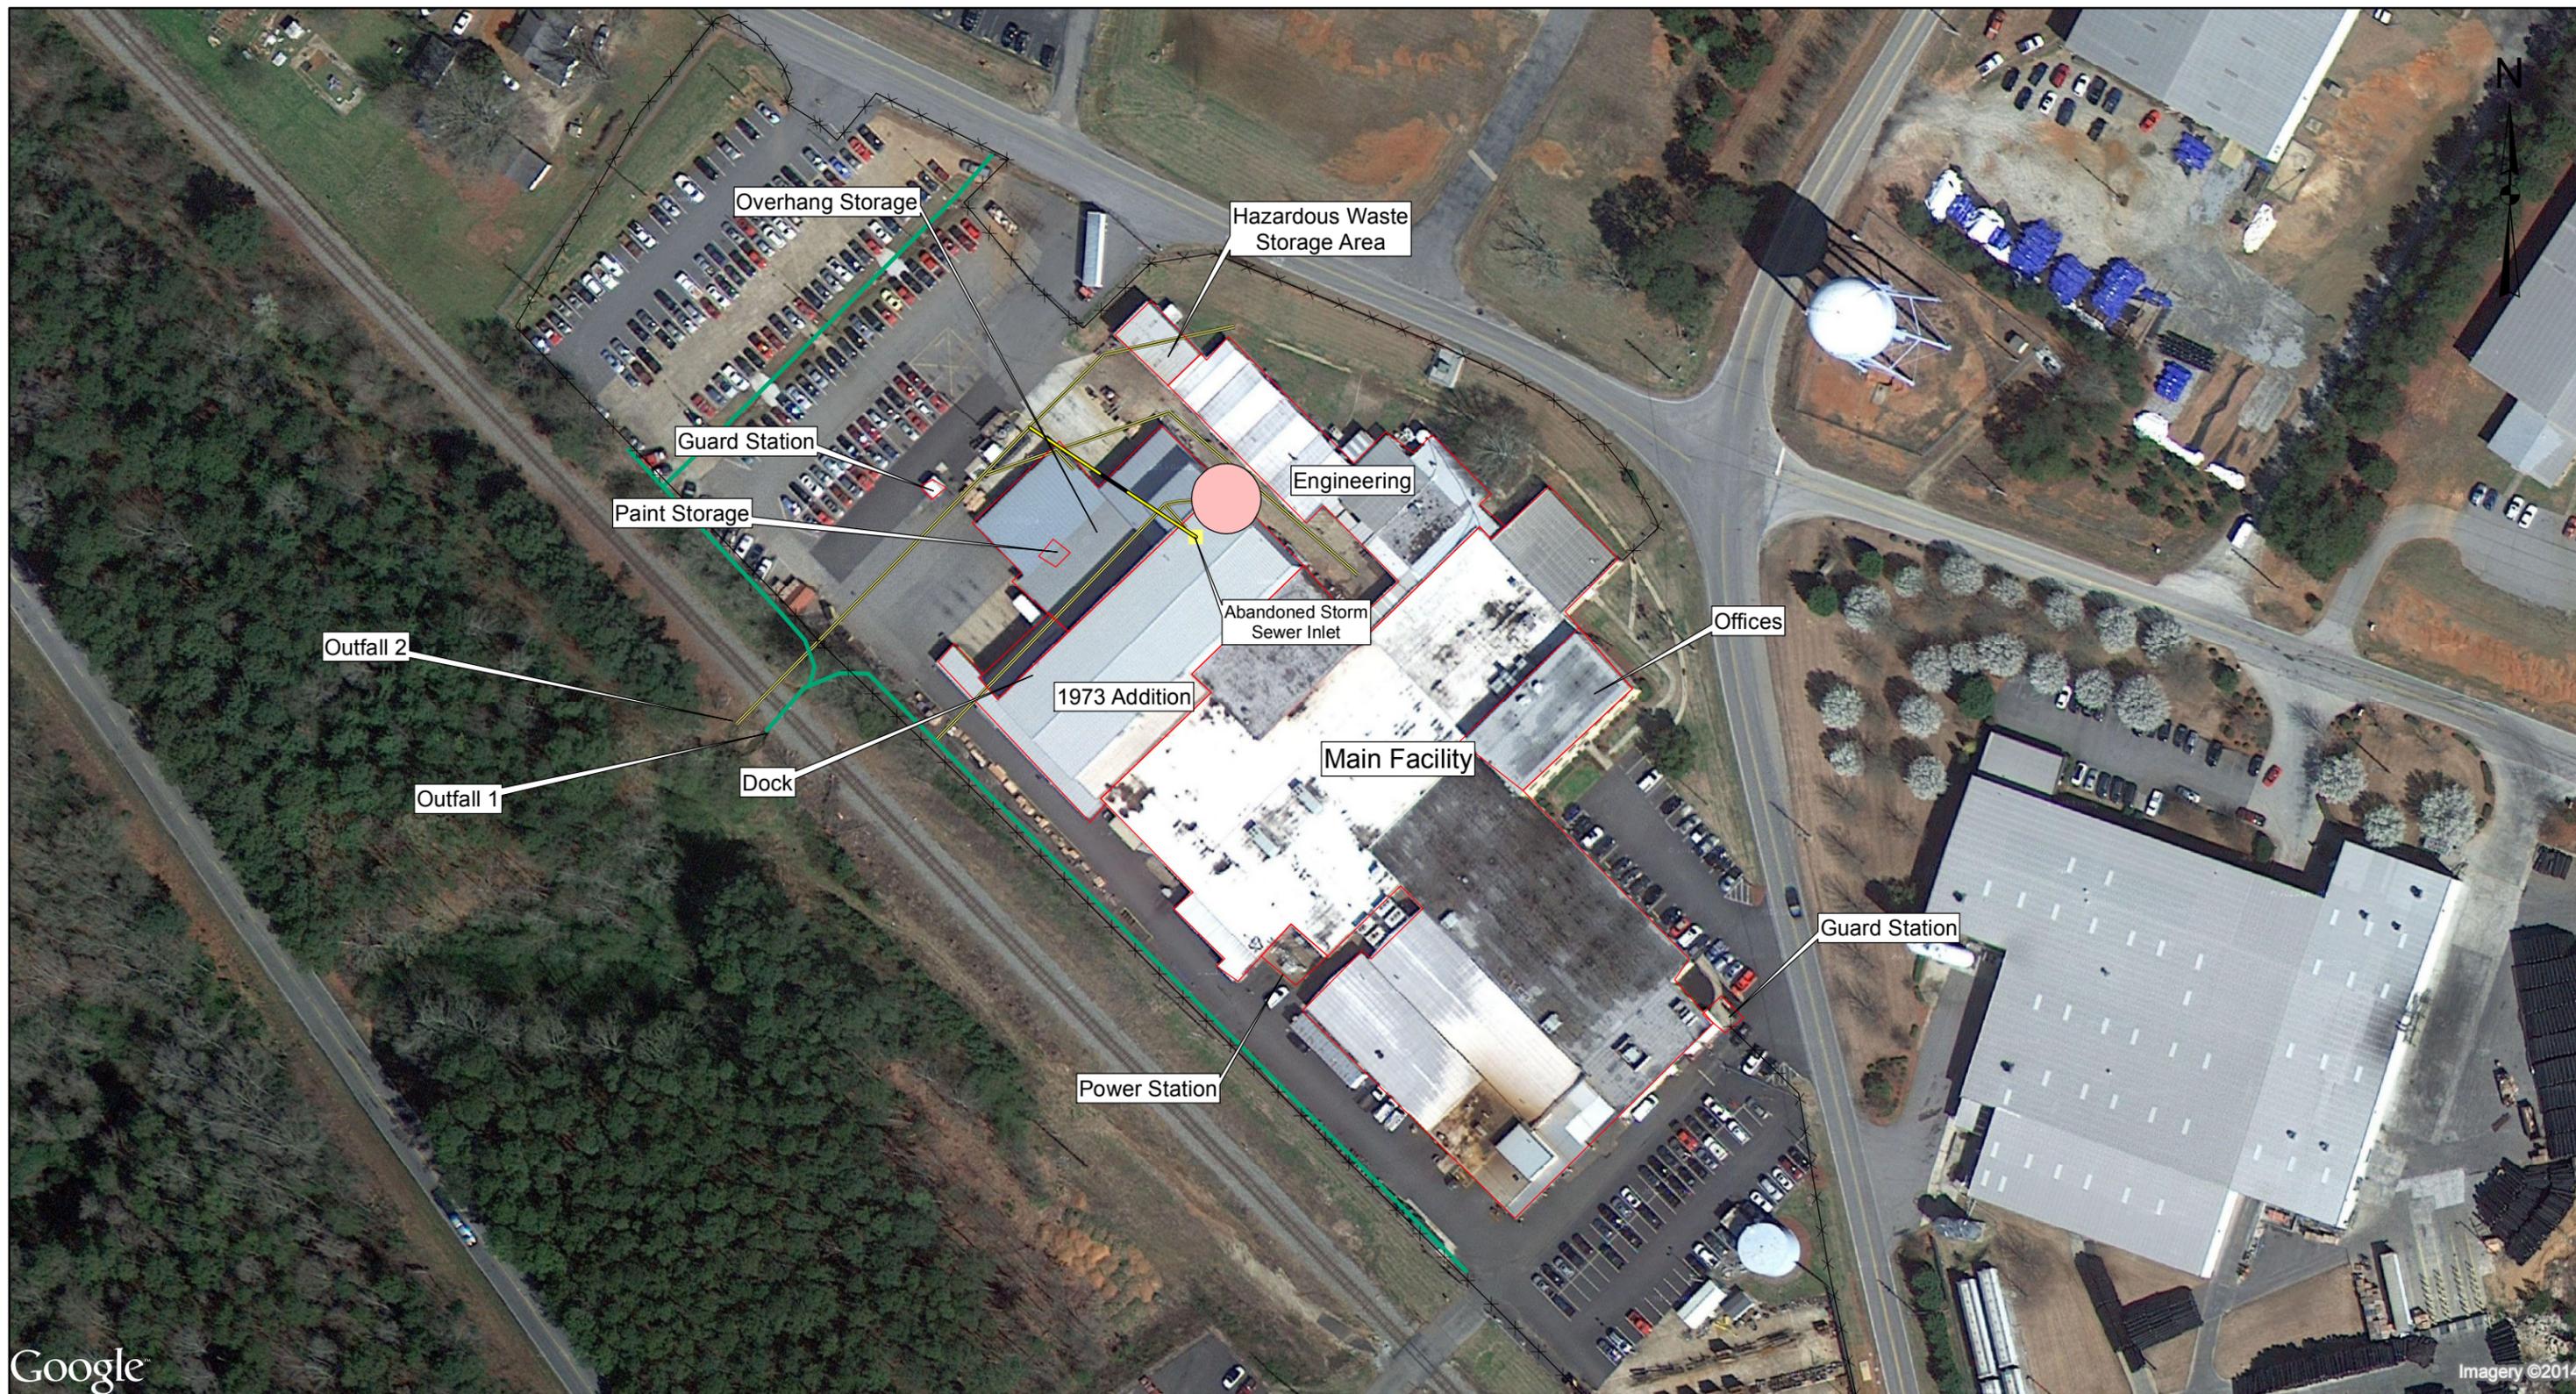
# Roper Pump Company 2009 Soil Removal Areas

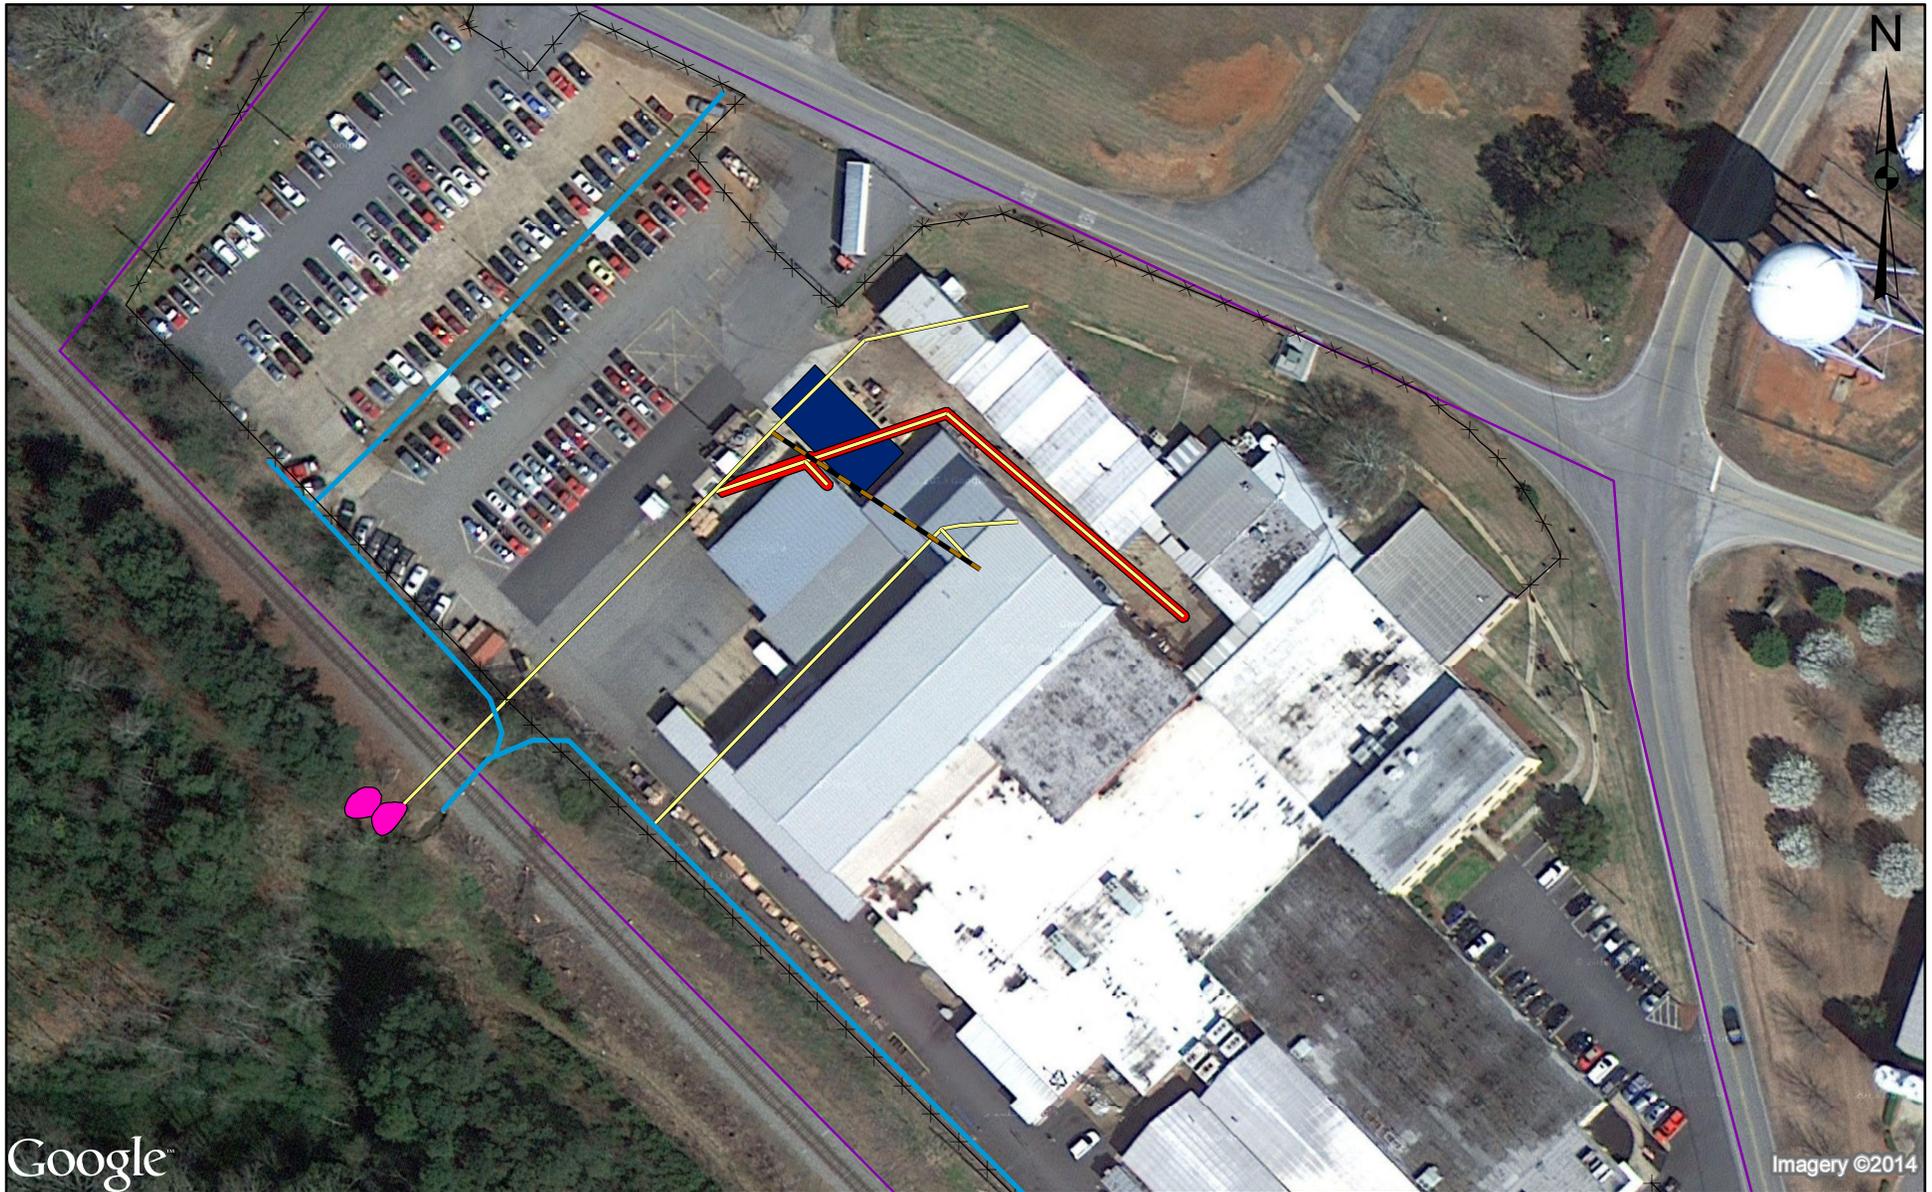
footprint of the graded area exhibited elevated concentrations of VOCs, primarily PCE, leading to the removal of approximately 1 foot (ft.) of soil across an area covering approximately 2,240 square feet (Figure 3). This activity also unearthed an abandoned storm sewer pipe segment at the southwest corner of the excavation area, where more significant staining and odor were observed. Also during excavation for the loading dock ramp, the active storm sewer was unearthed and a decision was made to excavate and replace a long segment of this line, in part because of excessive sediment buildup in the pipeline. Some staining was observed during this excavation and when encountered, the area was over-excavated to remove visibly stained soil and then soil samples were collected systematically along the base of the excavation (Figure 3).

On April 19, 2010, all stained soil and sediment, approximately 30 cubic yards, was excavated from the outfalls area (Figure 3). The excavation extended to a depth of 4 feet below grade. In addition, 2 inches of surficial soil were scraped from an overflow area northwest of the outfall.

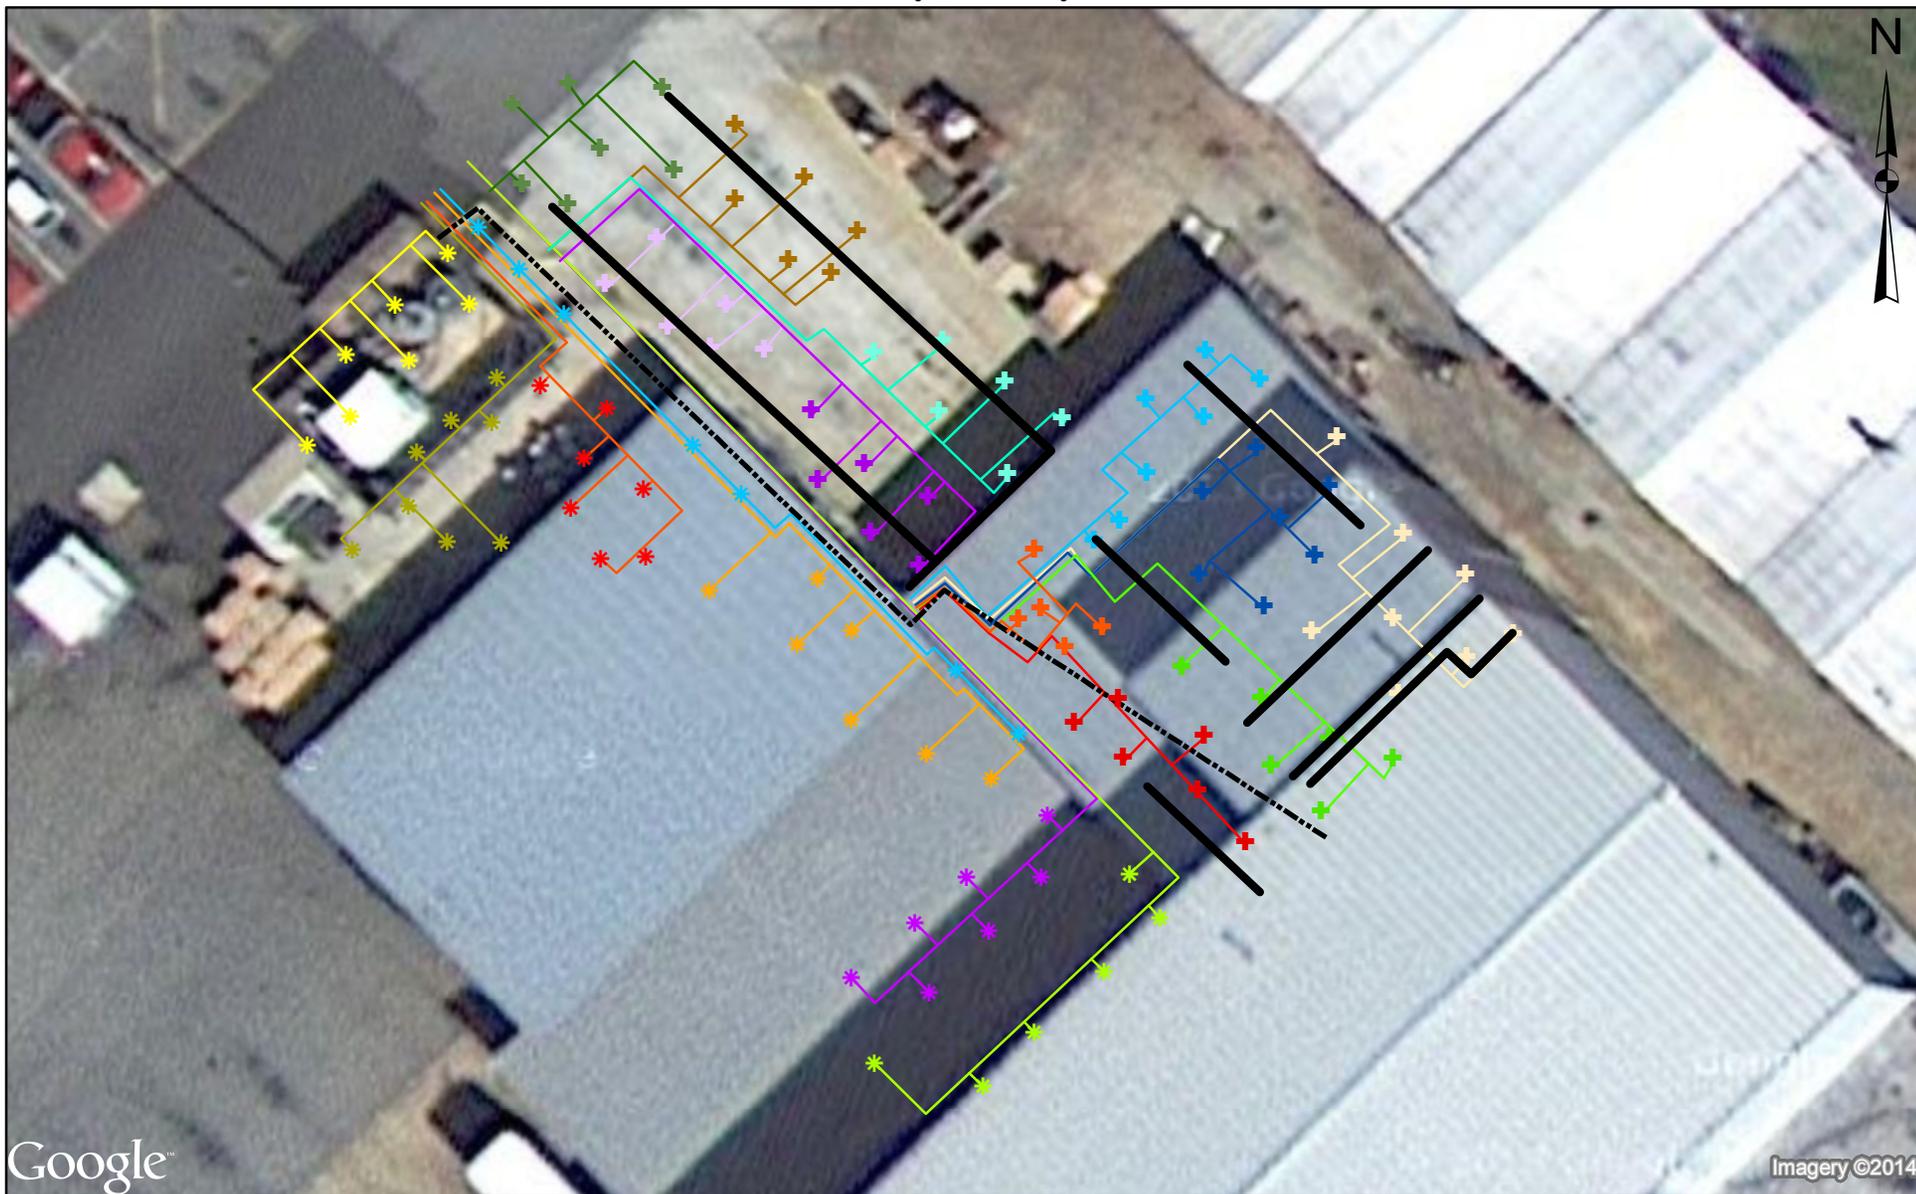
# Roper Pump Company SVE System Layout

The complete SVE system began operation in October 2010 and the system has been operating ever since, with the exception of minor maintenance and shutdowns for carbon change-out. As of September 2013, approximately 8,300 lbs. of VOCs (PCE and minor amounts of moisture) have been removed from the soils as shown in the following table.

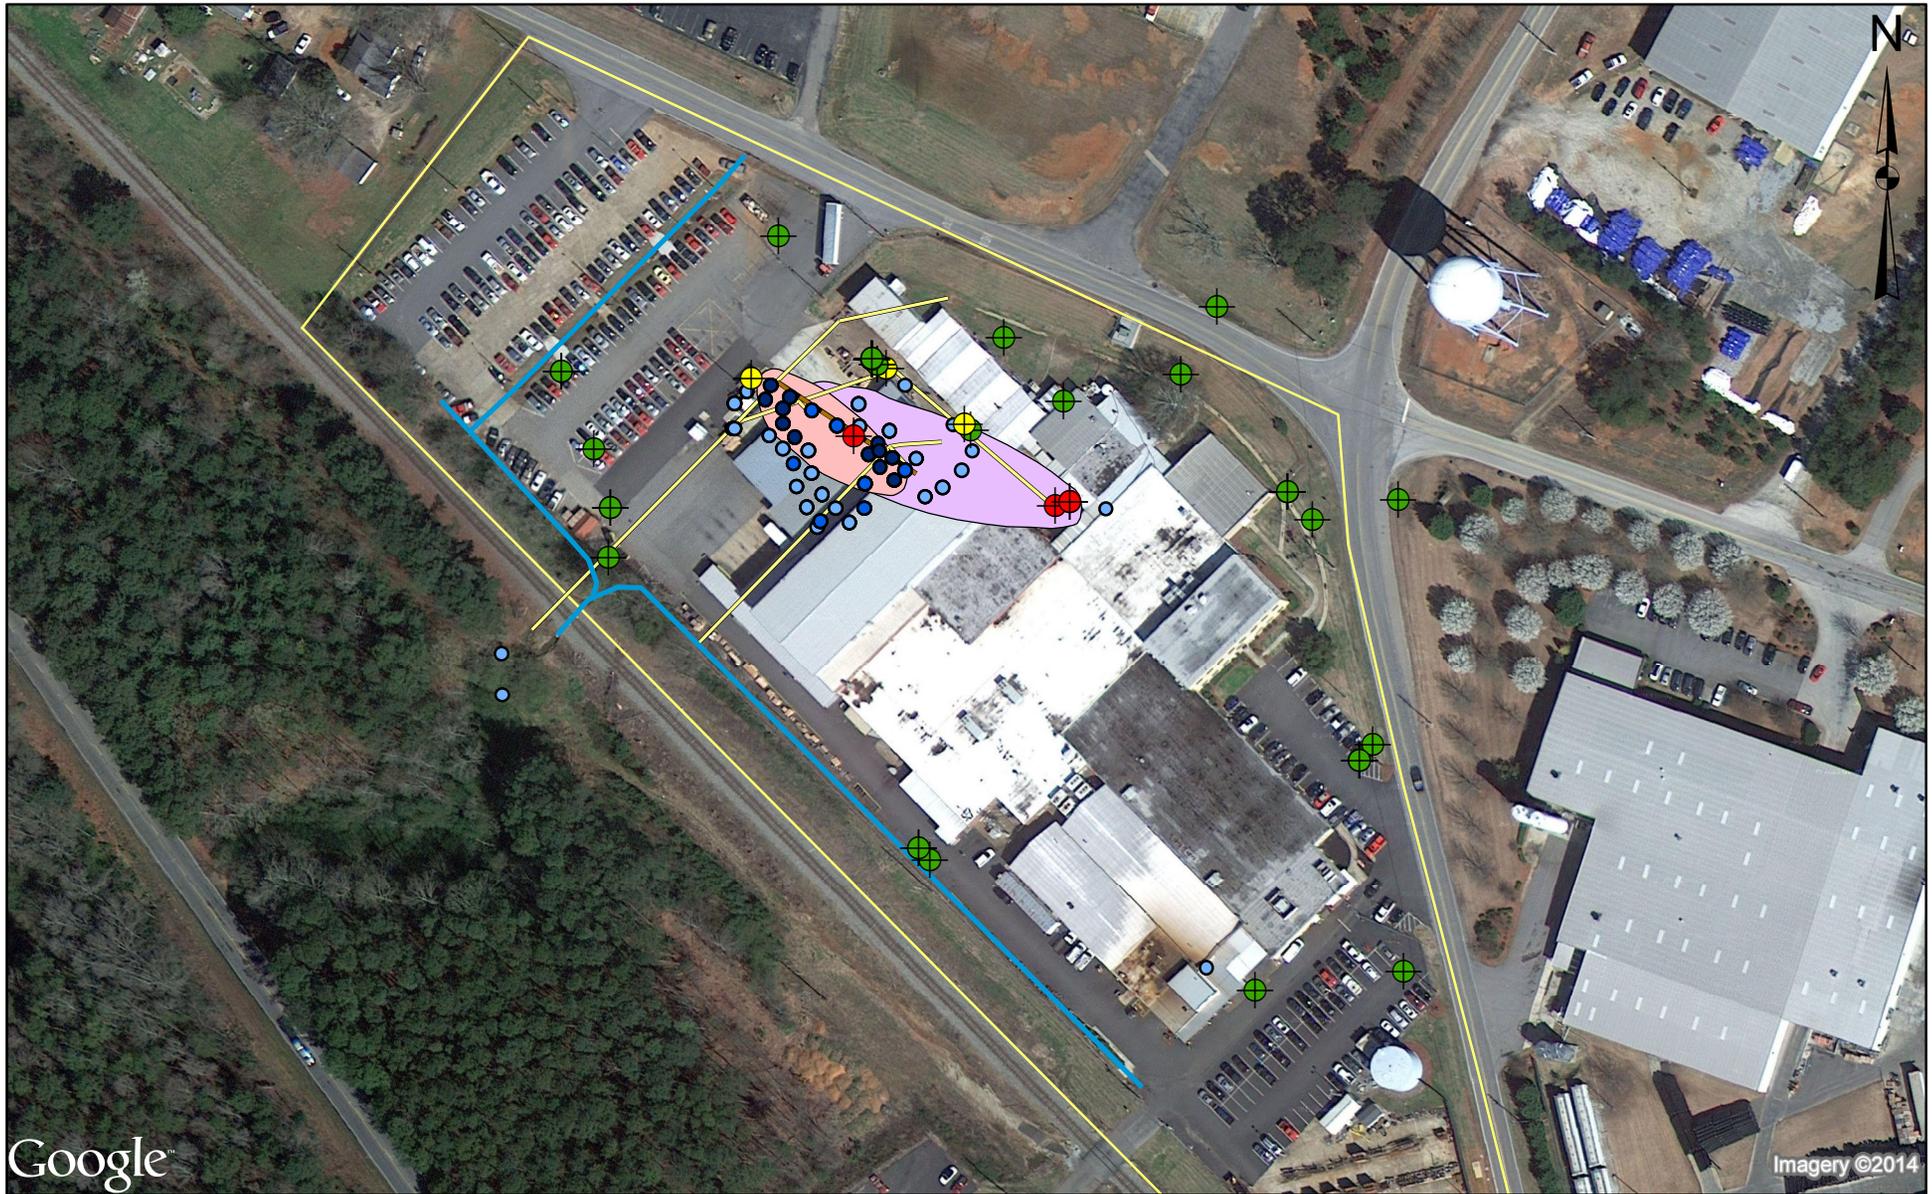
# PCE Source Delineation Roper Pump Company

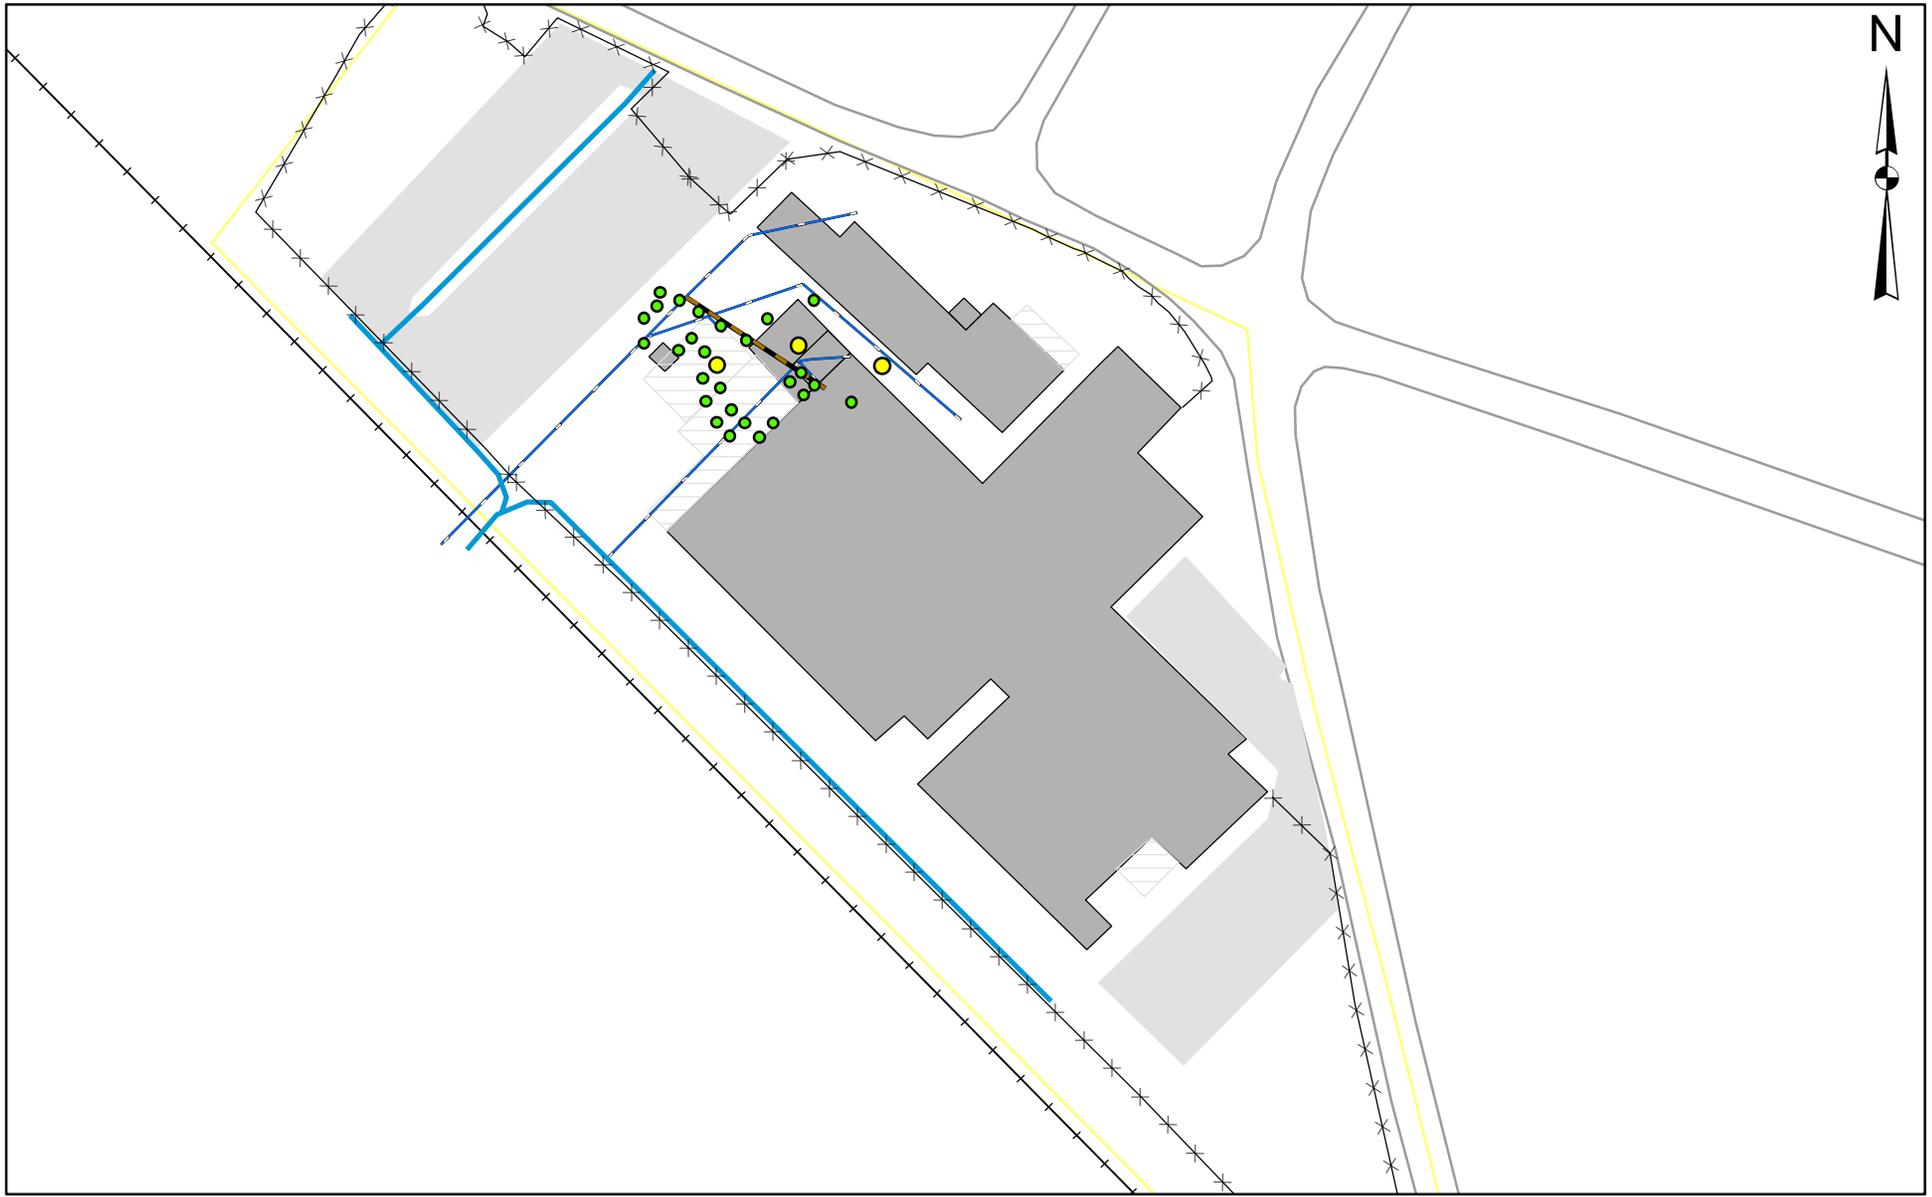
- < 1x
- 1 - 5x
- 5 - 10x
- 10 - 100x
- >100x

# Roper Pump Company Soil TCE as Multiple of Residential RRS (2 to 5 ft bgs)

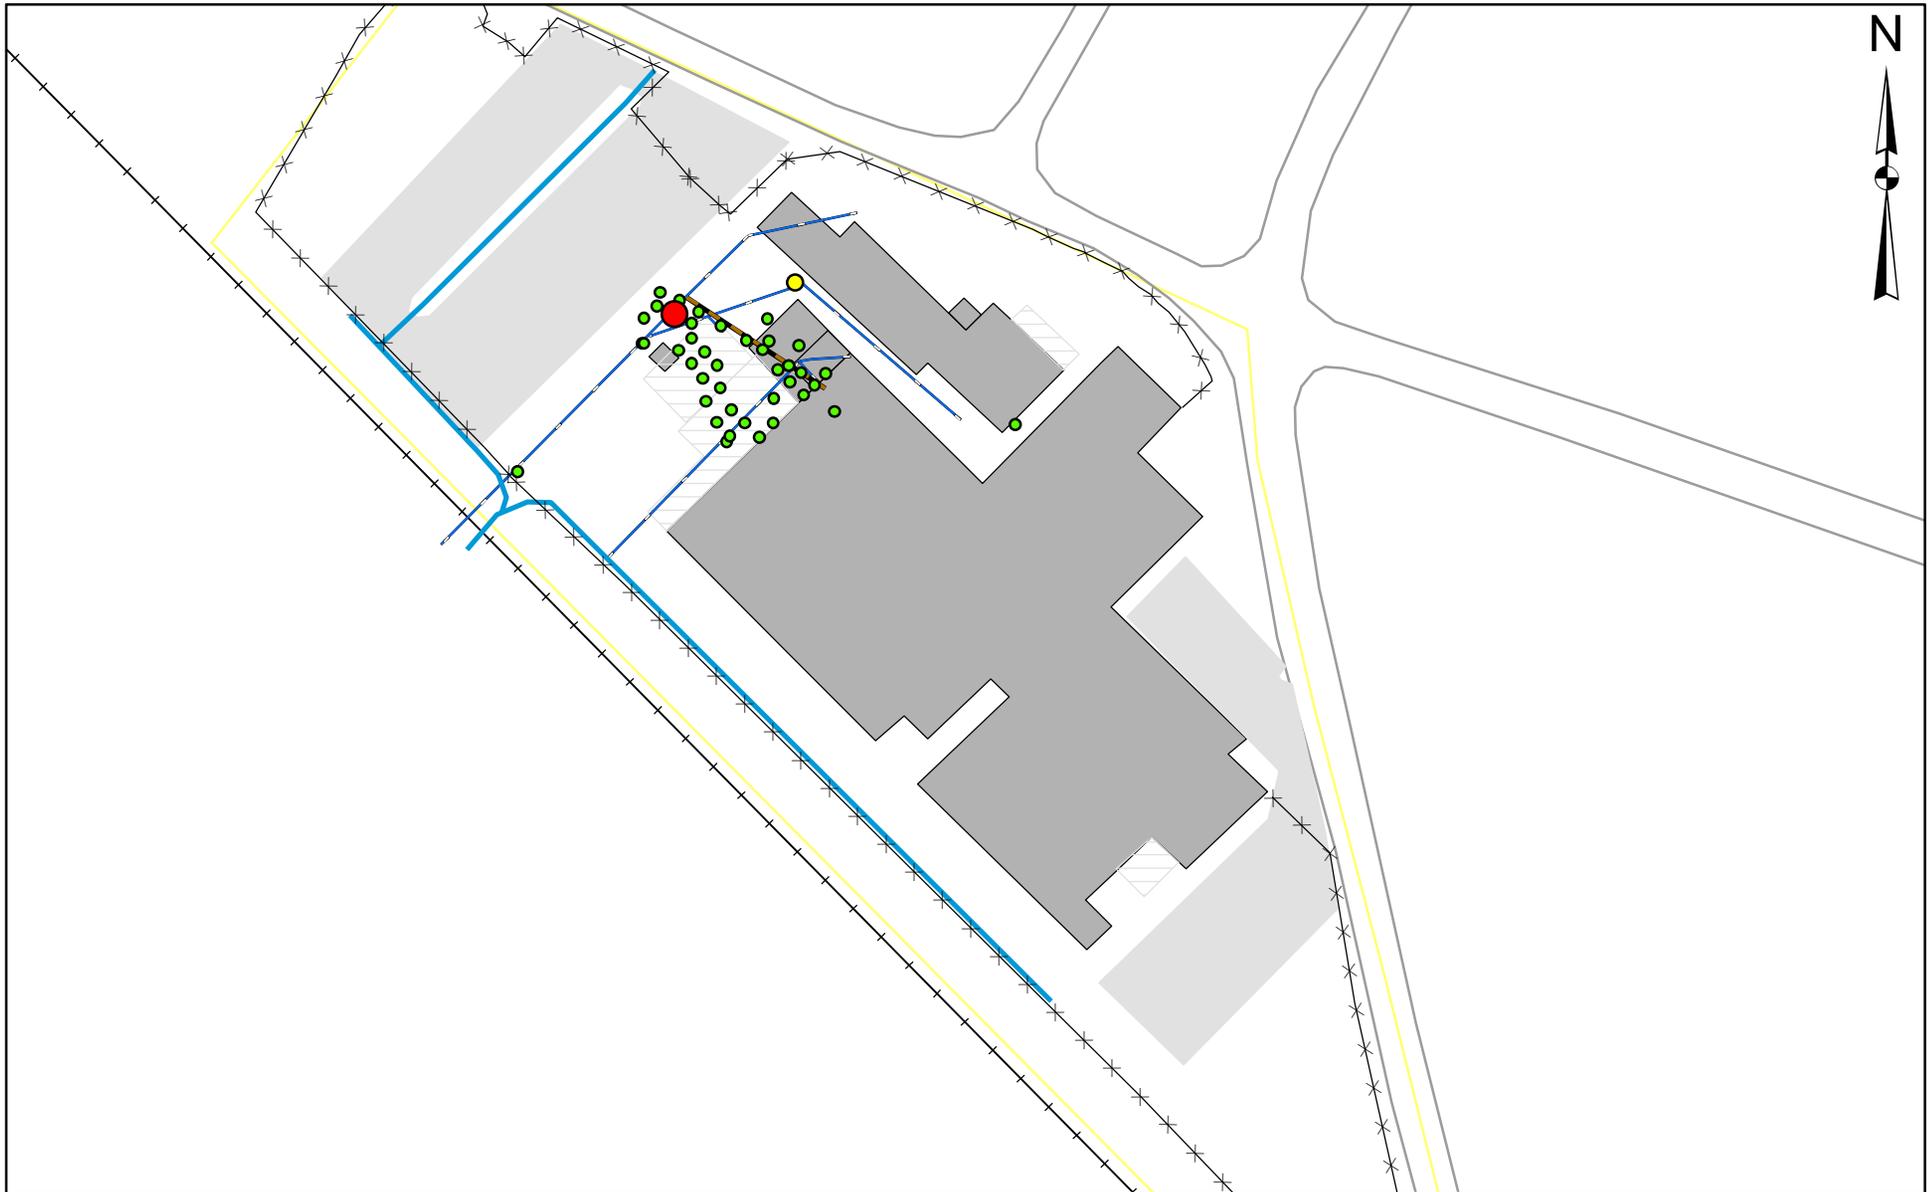
- < 1x
- 1 - 5x
- 5 - 10x
- 10 - 100x
- >100x

Roper Pump Company  
 Soil TCE as Multiple of Residential RRS (5 to 10 ft bgs)

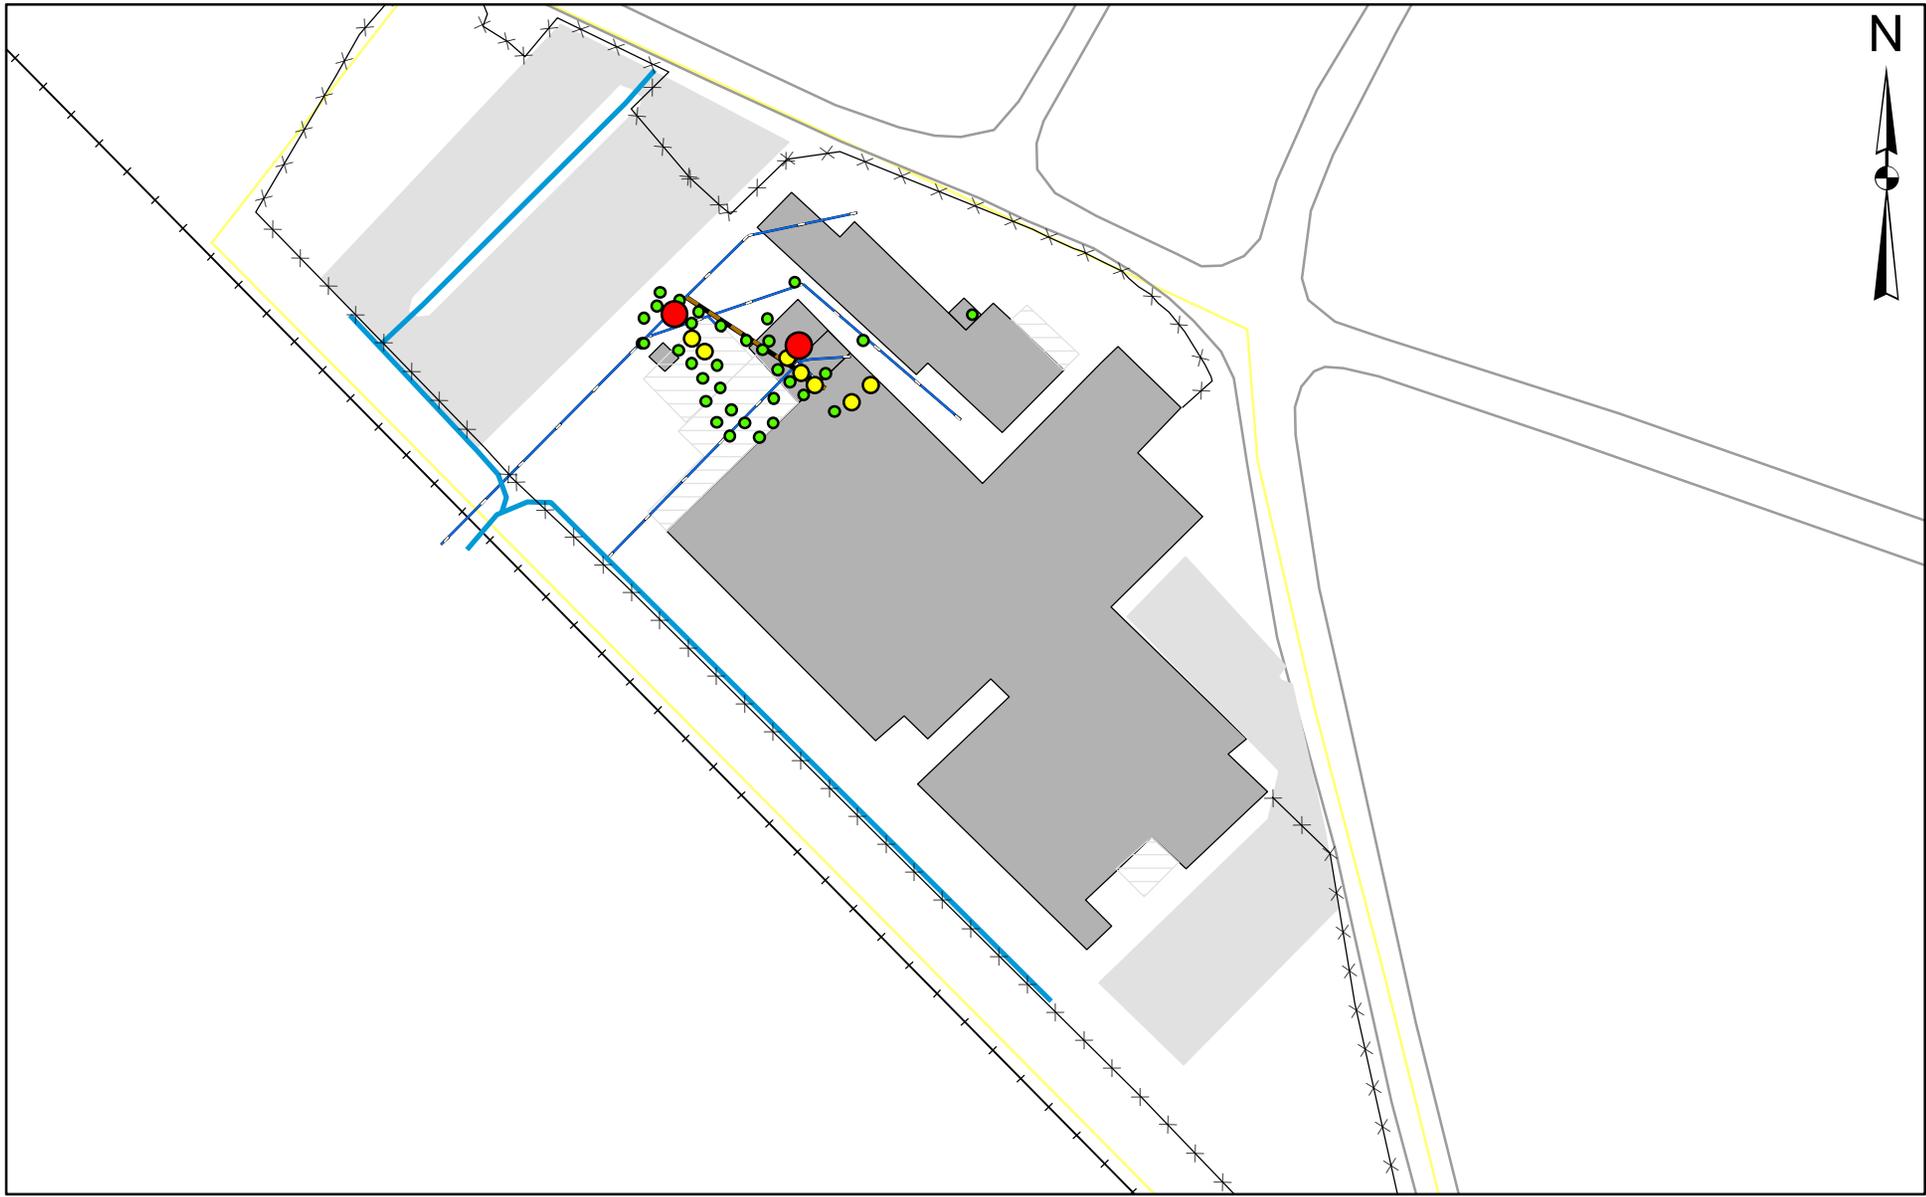
- < 1x
- 1 - 5x
- 5 - 10x
- 10 - 100x
- >100x

# Roper Pump Company Soil TCE as Multiple of Residential RRS (10 to 15 ft bgs)

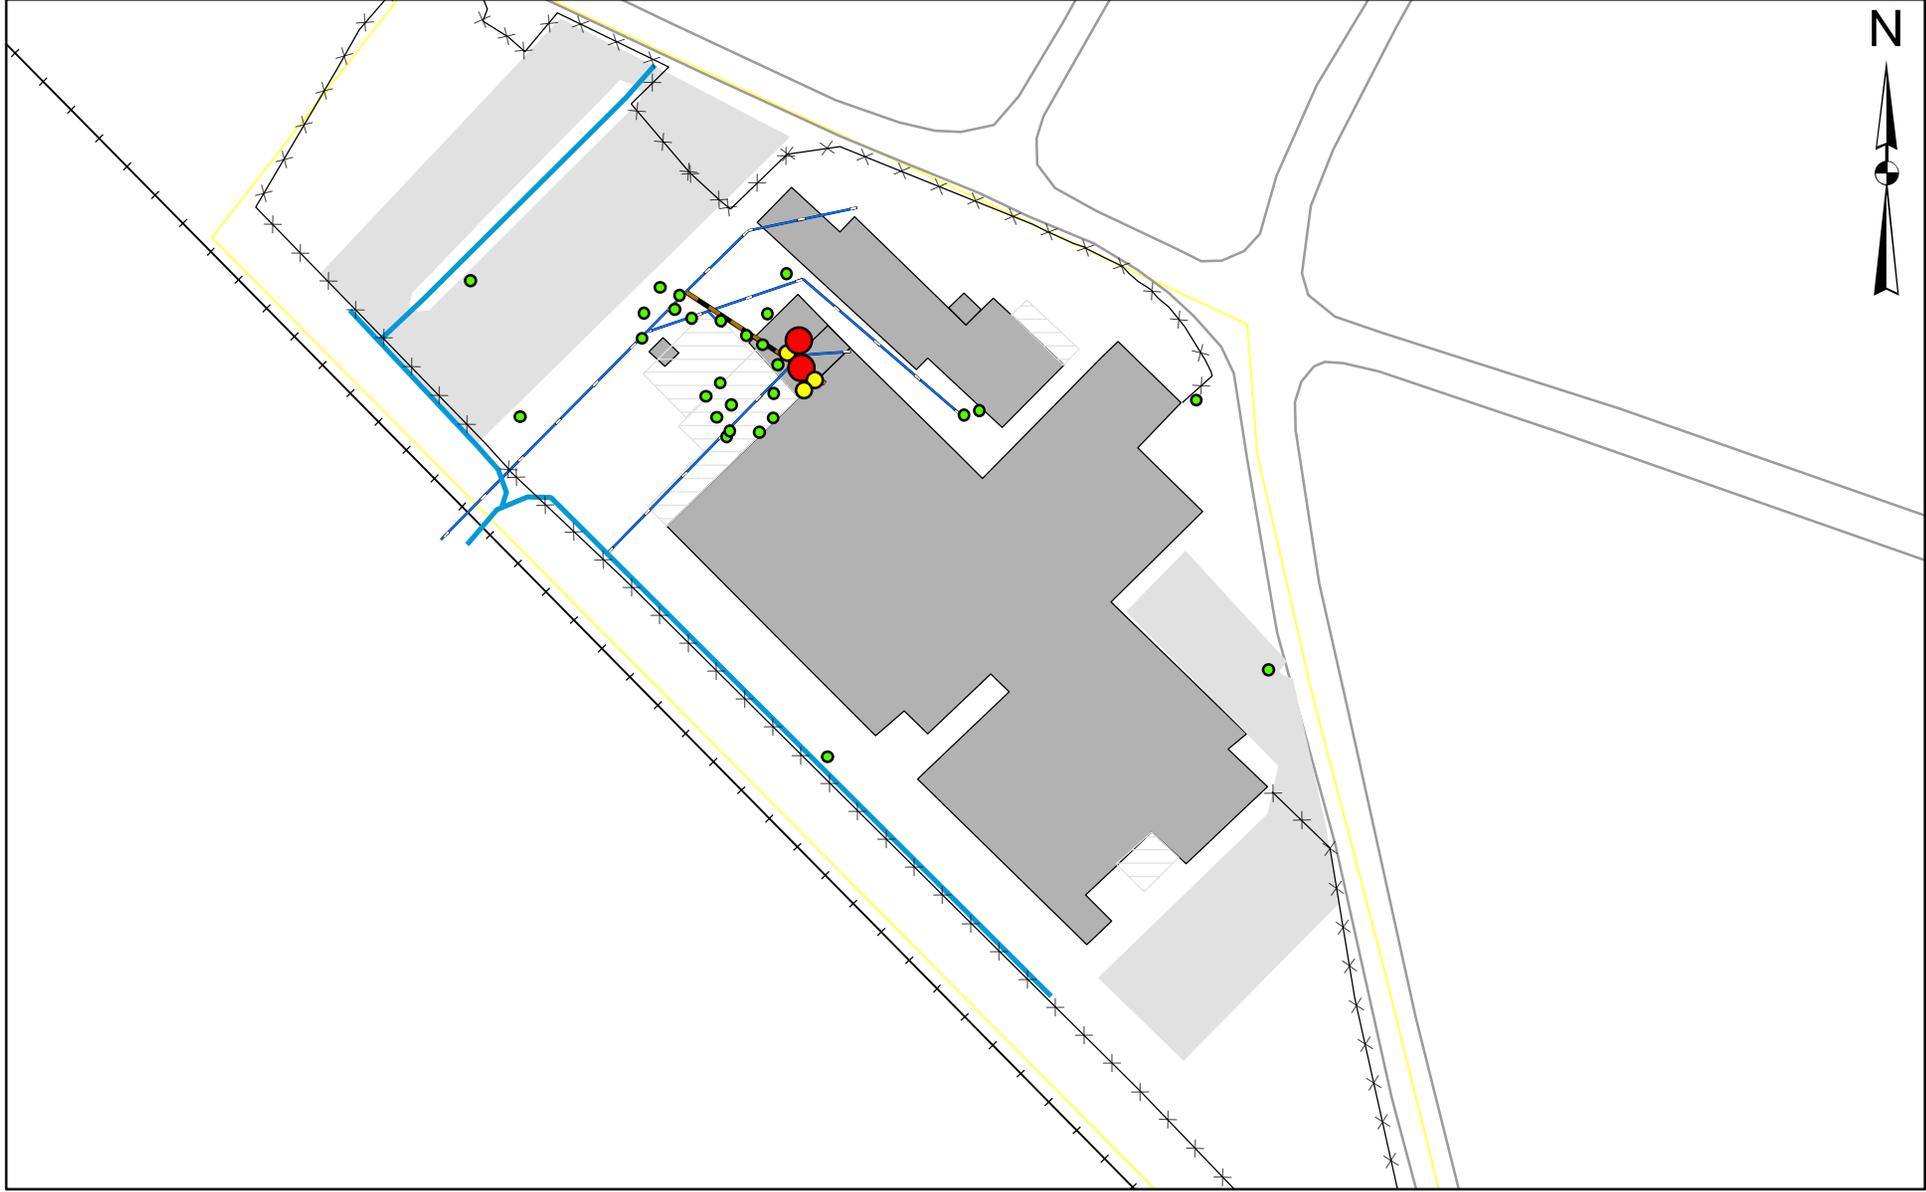
- < 1x
- 1 - 5x
- 5 - 10x
- 10 - 100x
- >100x

Roper Pump Company  
 Soil TCE as Multiple of Residential RRS (15 to 20 ft bgs)

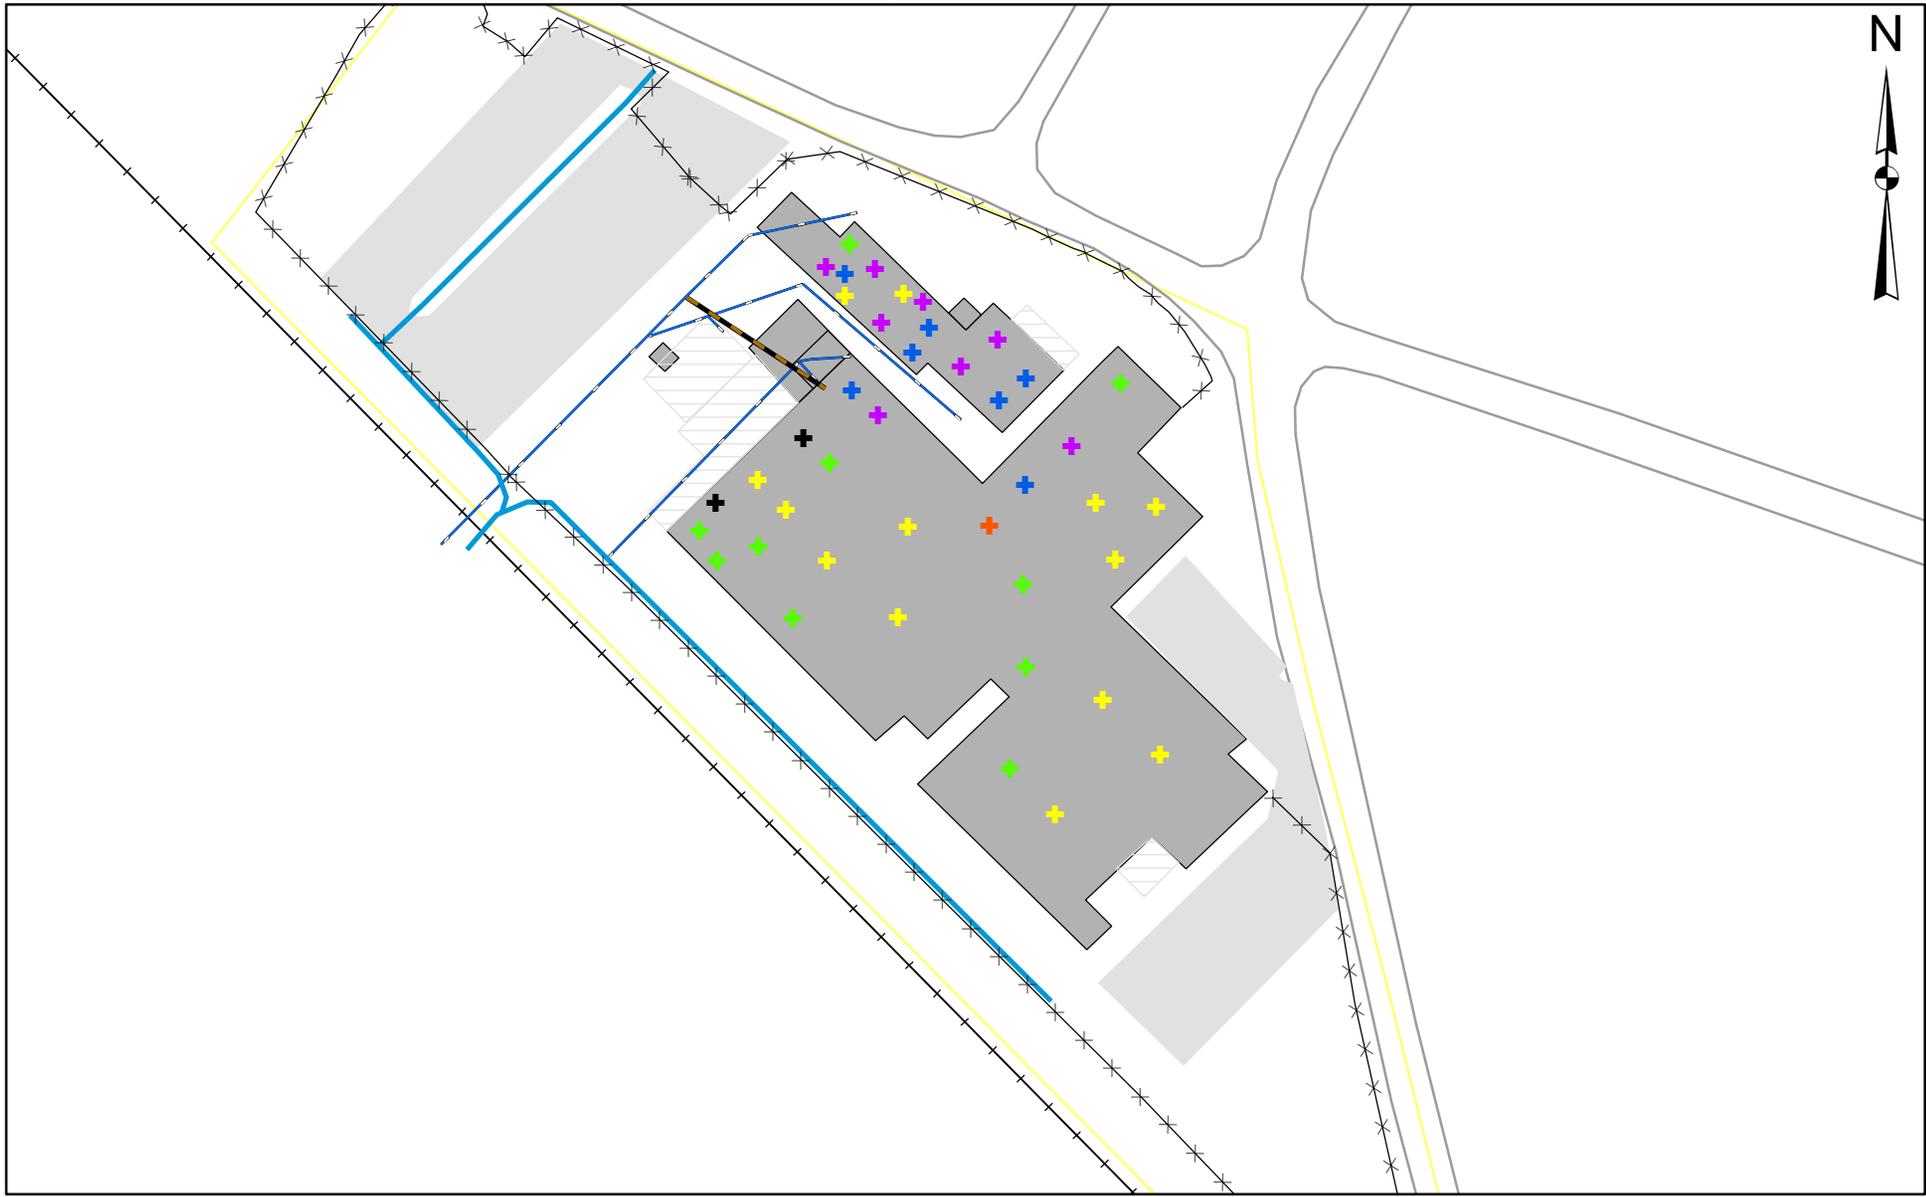
# Roper Pump Company Sub-Slab Vapor TCE Concentration

This TCE sub-slab soil vapor distribution pattern is quite similar to PCE, with perhaps a more focused region of the more elevated condition present in the north-northwest portion of the facility (Figure 14). The western margin of the facility exhibits a much lower TCE vapor condition. Also similar to the PCE distribution, the TCE concentration appears to diminish away from the release areas across the facility in a southerly direction, then increases somewhat near the southernmost portion of the facility. Seven sample locations were in excess of 50,000 µg/m<sup>3</sup>. Two of the 41 sub-slab sample locations were non-detect for TCE.
