**VOLUNTARY REMEDIATION  
PROGRAM APPLICATION  
Roper Pump Company  
Commerce, Georgia**

# VOLUNTARY REMEDIATION PROGRAM APPLICATION

**Roper Pump Company  
Commerce, Georgia**

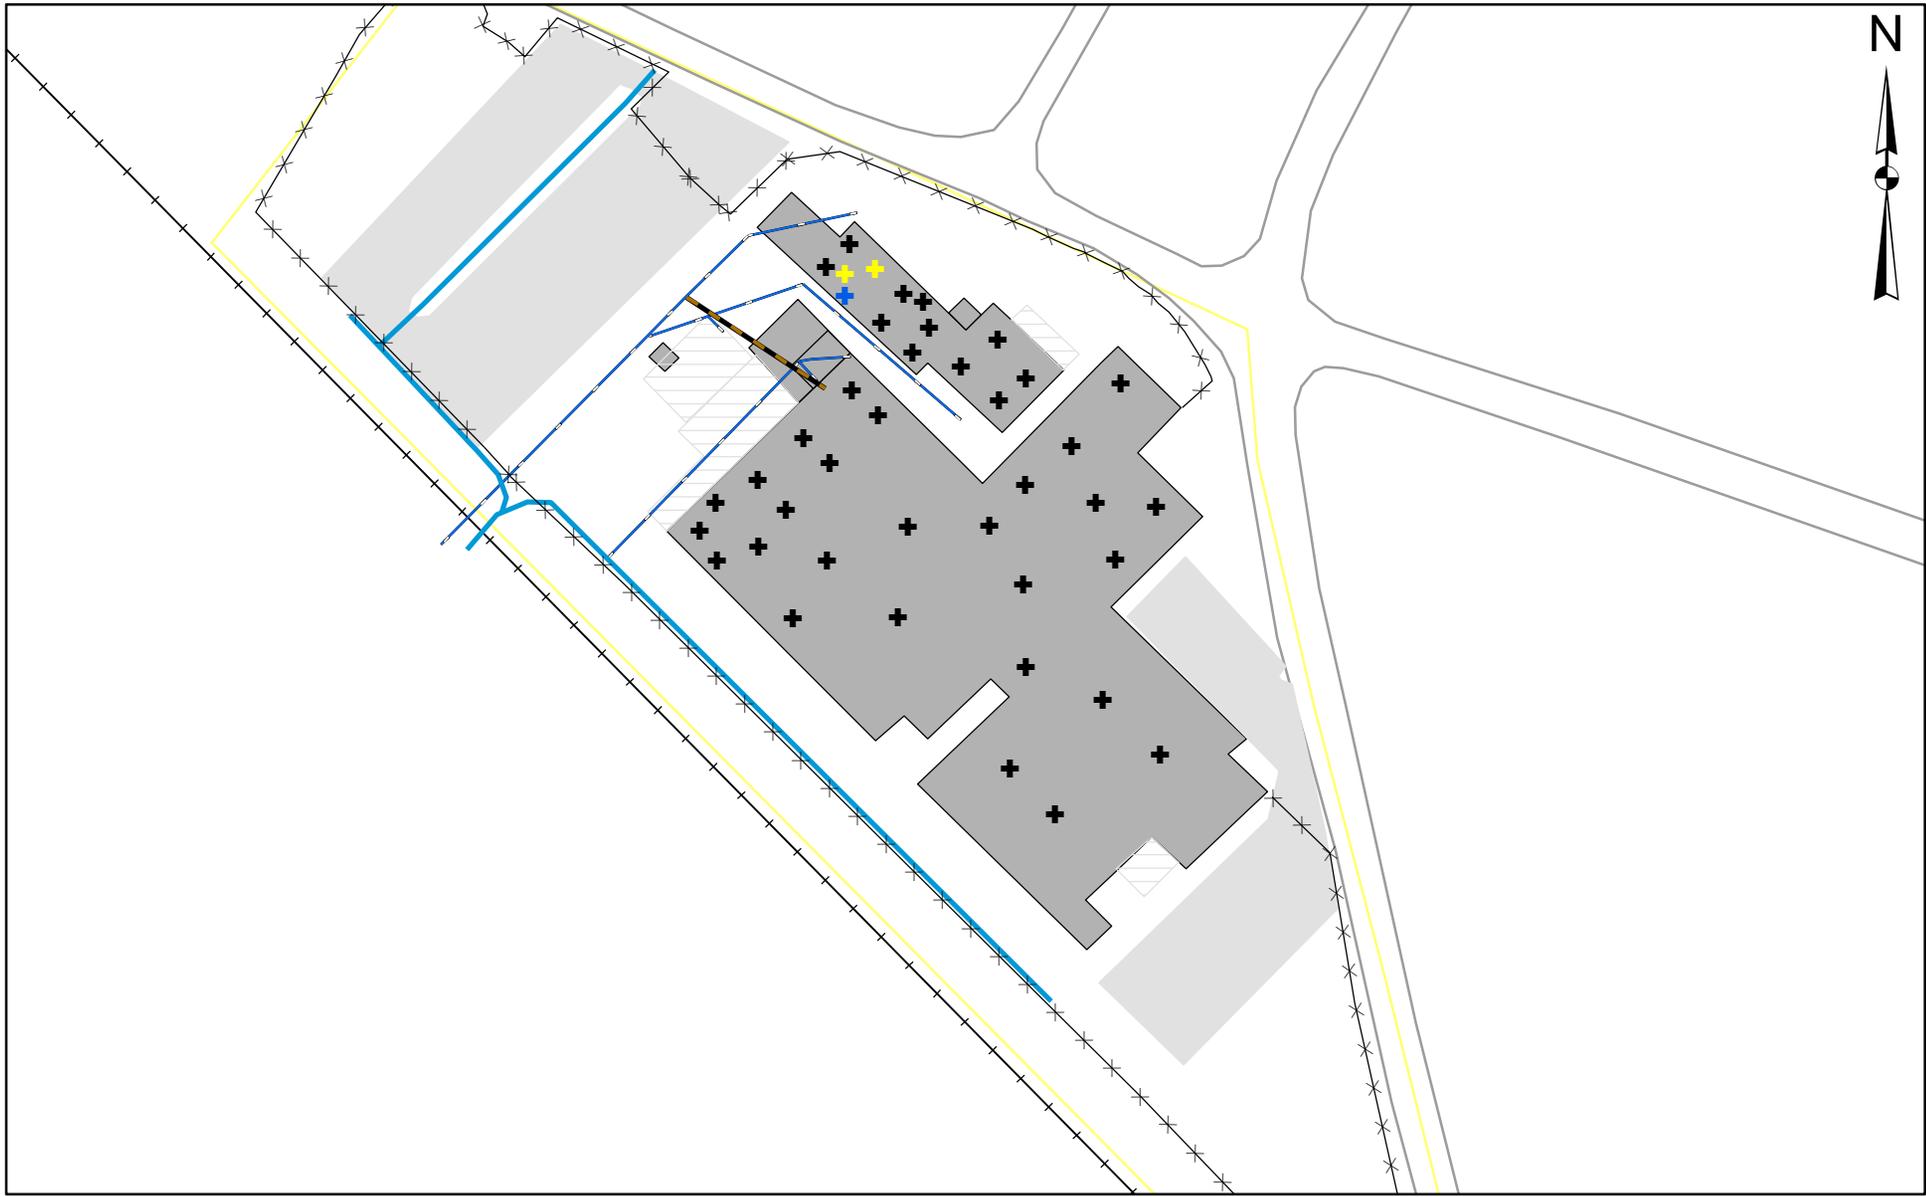
- < 1x
- 1 - 5x
- 5 - 10x
- 10 - 100x
- >100x

# Roper Pump Company Sub-Slab Vapor Benzene Concentration

The sub-slab soil gas sampling performed in 2009 preceded the installation of the SVE system. Operation of the SVE system has likely altered the sub-slab soil gas condition and possibly mitigated the vapor accumulation characterized in 2009. Accordingly, it is prudent to re-characterize the sub-slab soil gas condition prior to making a decision whether remedial action is necessary, and if so, which remedial option is preferred.

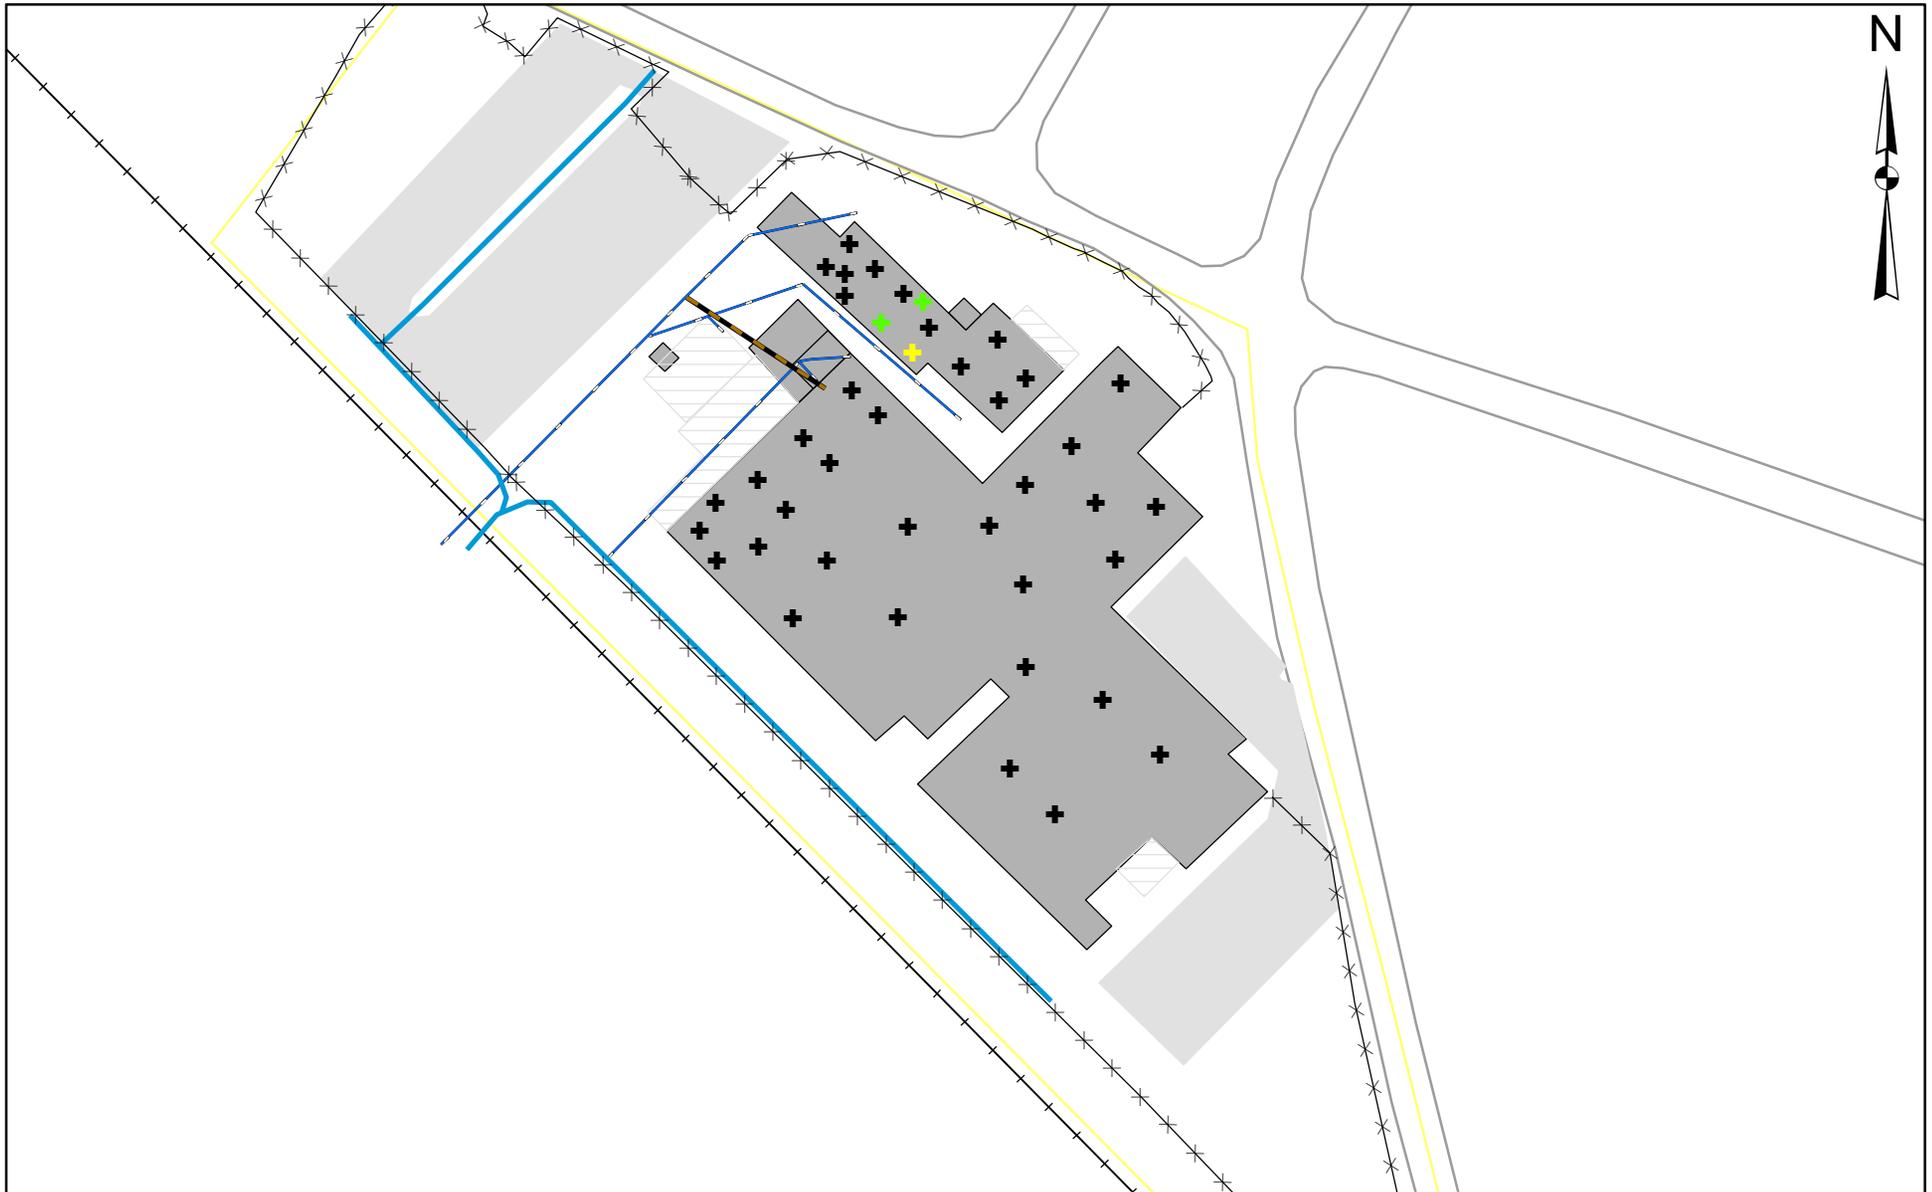
- ✕ Non-Detect (ND)
- ✕ ND - 2,000
- ✕ 2,000 - 5,000
- ✕ 5,000 - 10,000
- ✕ 10,000 - 50,000
- ✕ > 50,000

# Roper Pump Company Sub-Slab Vapor Chloroform Concentration

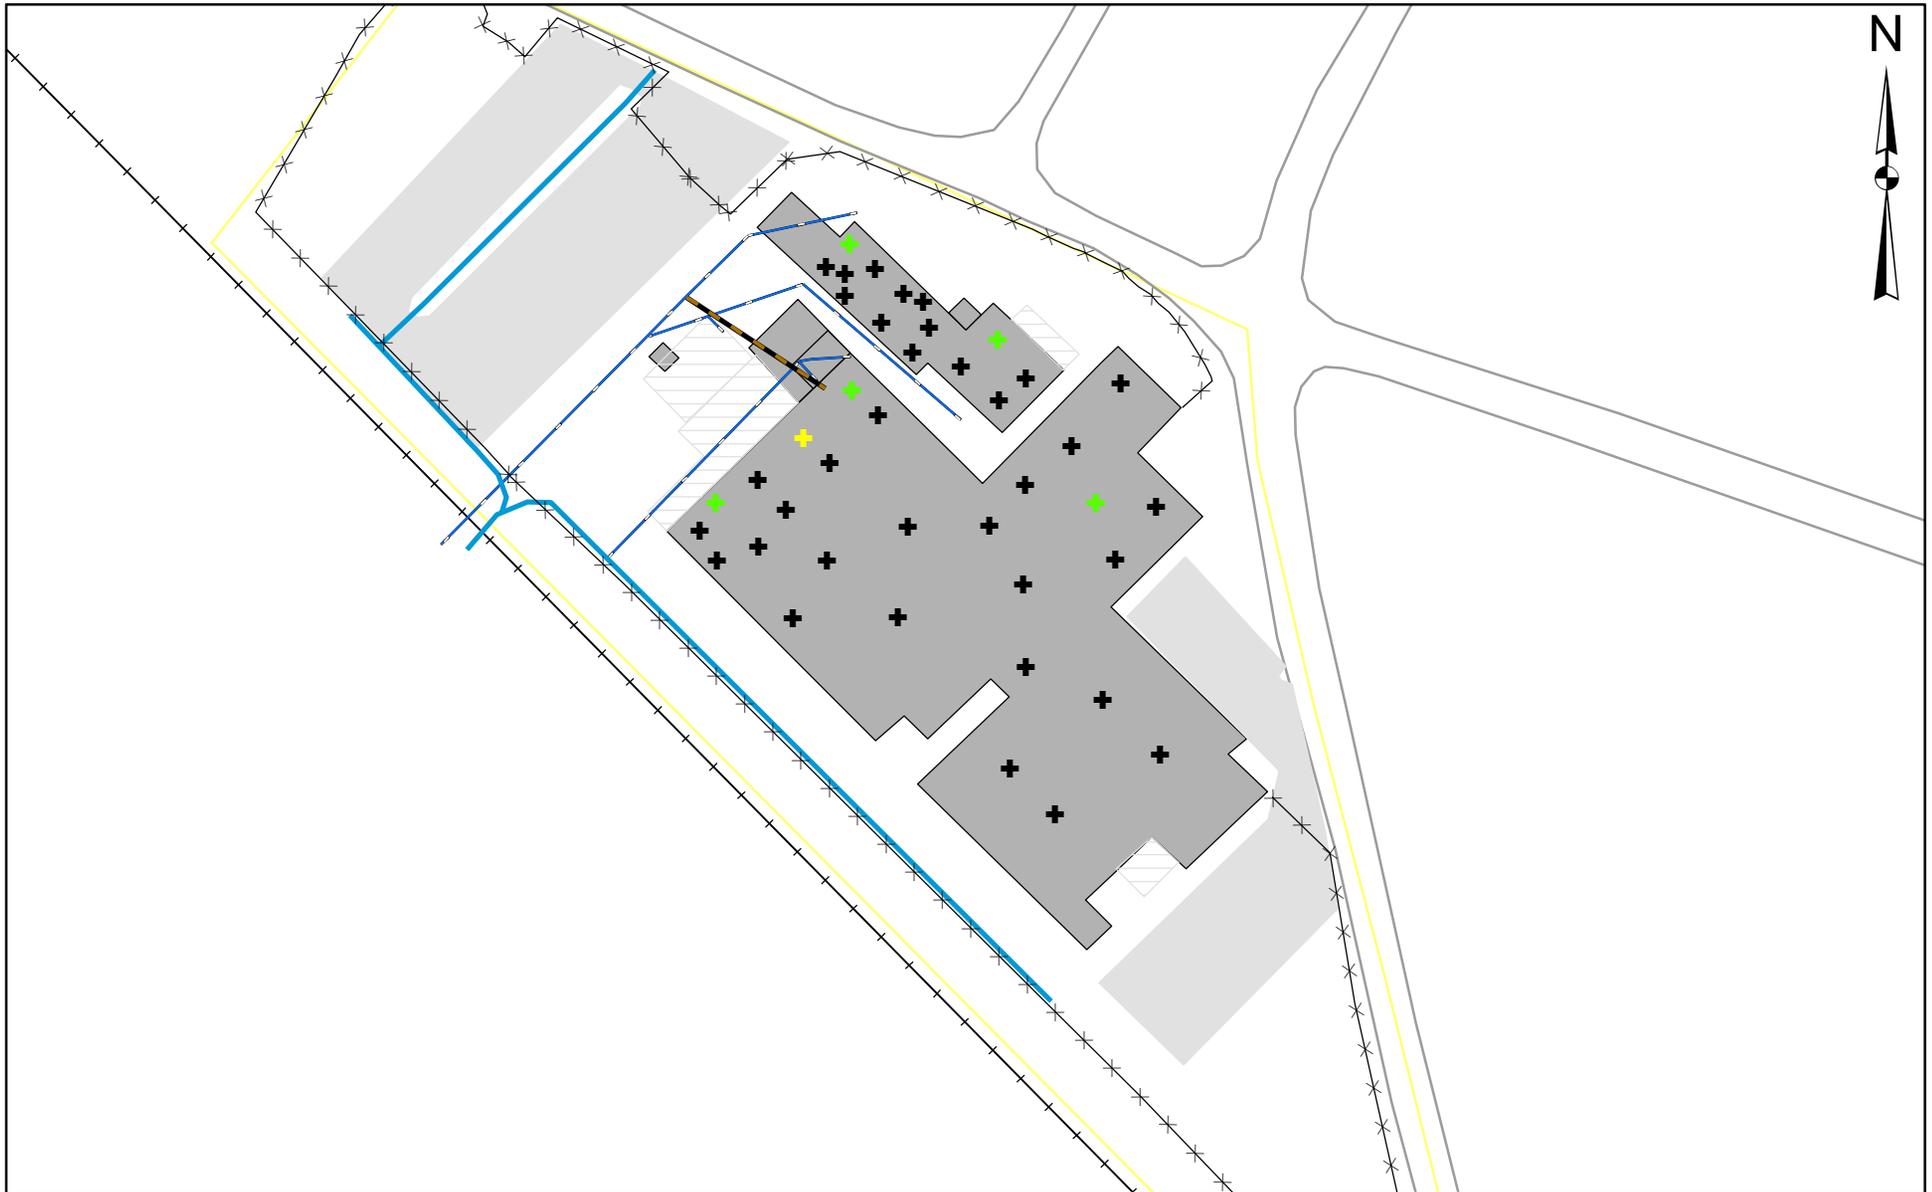
- ✕ Non-Detect (ND)
- ✕ ND - 2,000
- ✕ 2,000 - 5,000
- ✕ 5,000 - 10,000
- ✕ 10,000 - 50,000
- ✕ > 50,000

# Roper Pump Company Sub-Slab Vapor o-Xylene Concentration
