Subject: **Submittal of VIRP Application
SECHEM, INC. – HSI Site No. 10515
4580 South Berkeley Lake Road
Norcross, Georgia**

VOLUNTARY INVESTIGATION AND REMEDIATION PLAN

SECHEM, INC.
4580 SOUTH BERKELY LAKE ROAD
NORCROSS, GWINNETT COUNTY, GEORGIA 30092
HSI SITE NUMBER 10515

EarthCon Project No. 02.20160244.00

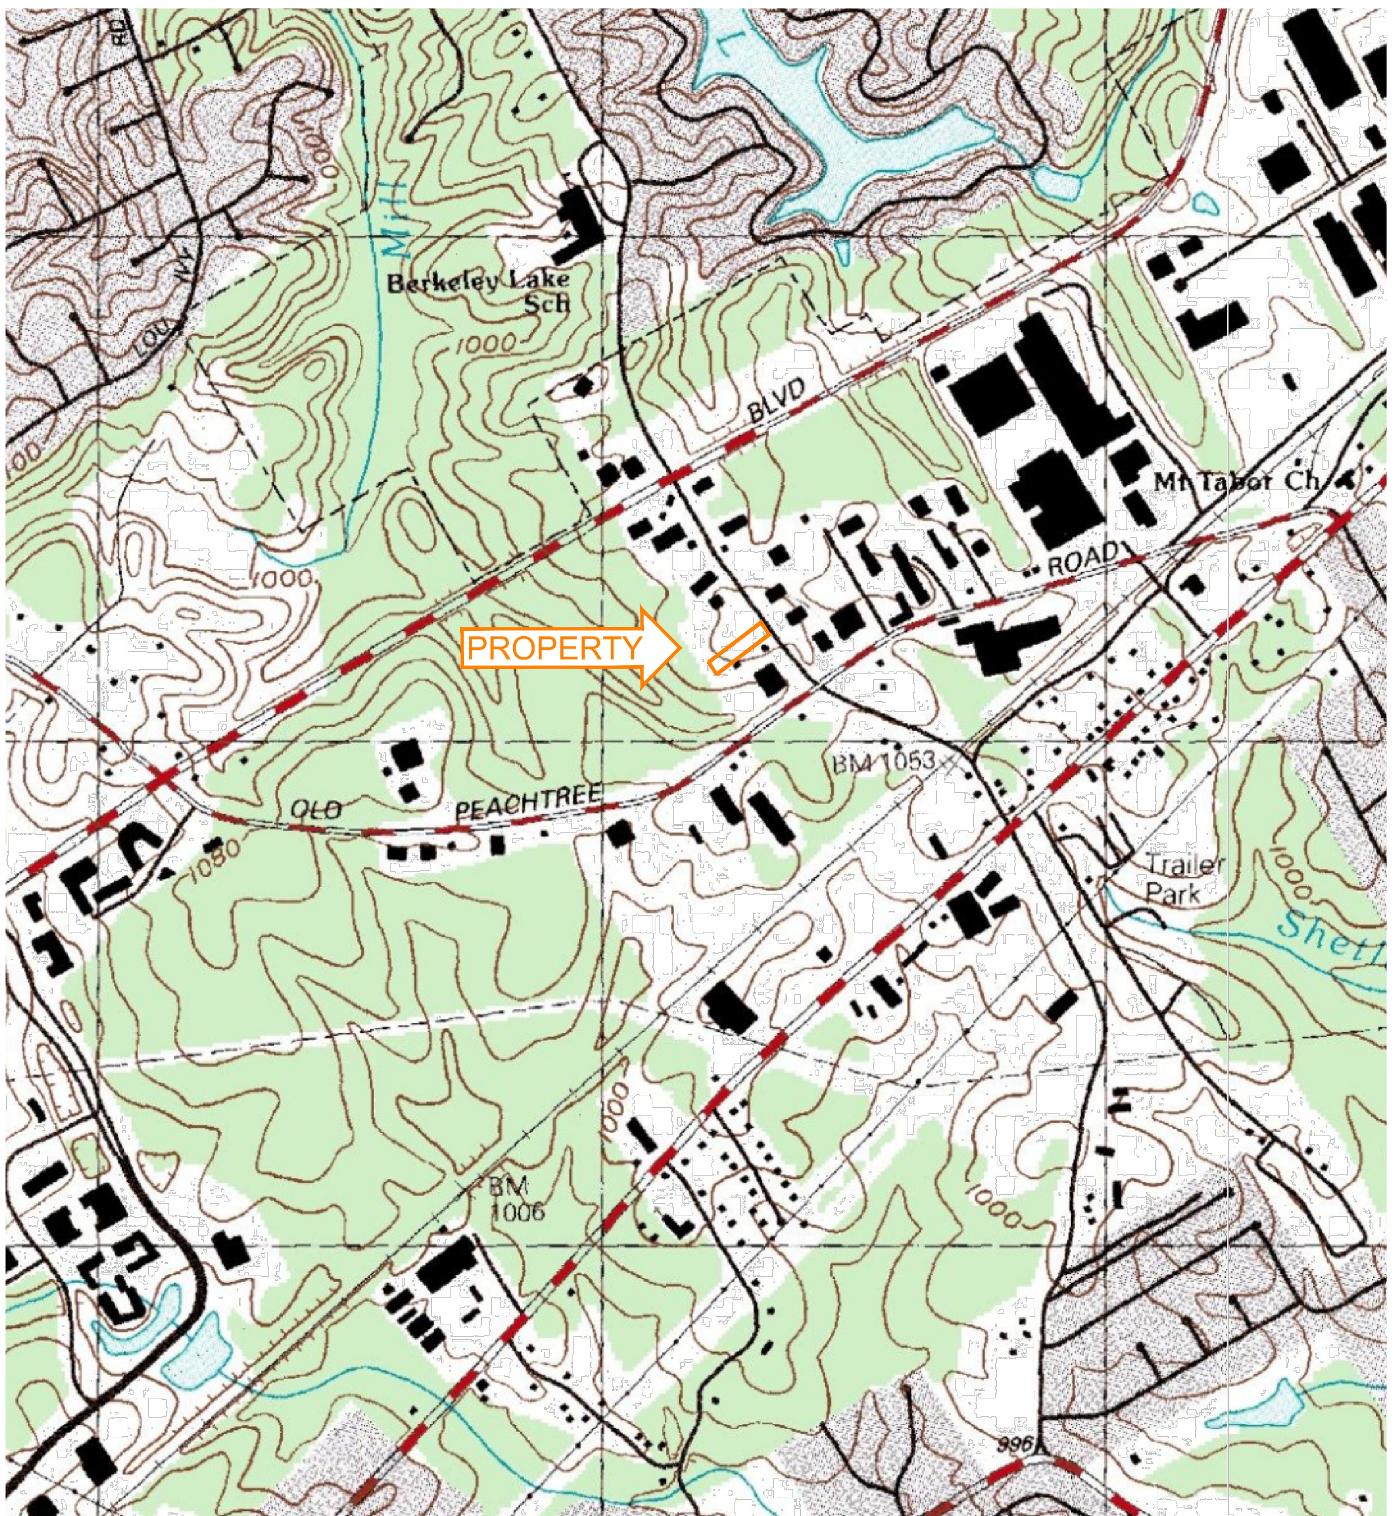
DRAWN: SNW CHECKED: CDN DATE: DEC 2016 FIGURE: 1

PROPERTY LOCATION

The Property consists of approximately 1.0 acre and is located approximately three miles northwest of Norcross in Gwinnett County, Georgia. The Property location and Site layout are shown on Figures 1 and 2, respectively.

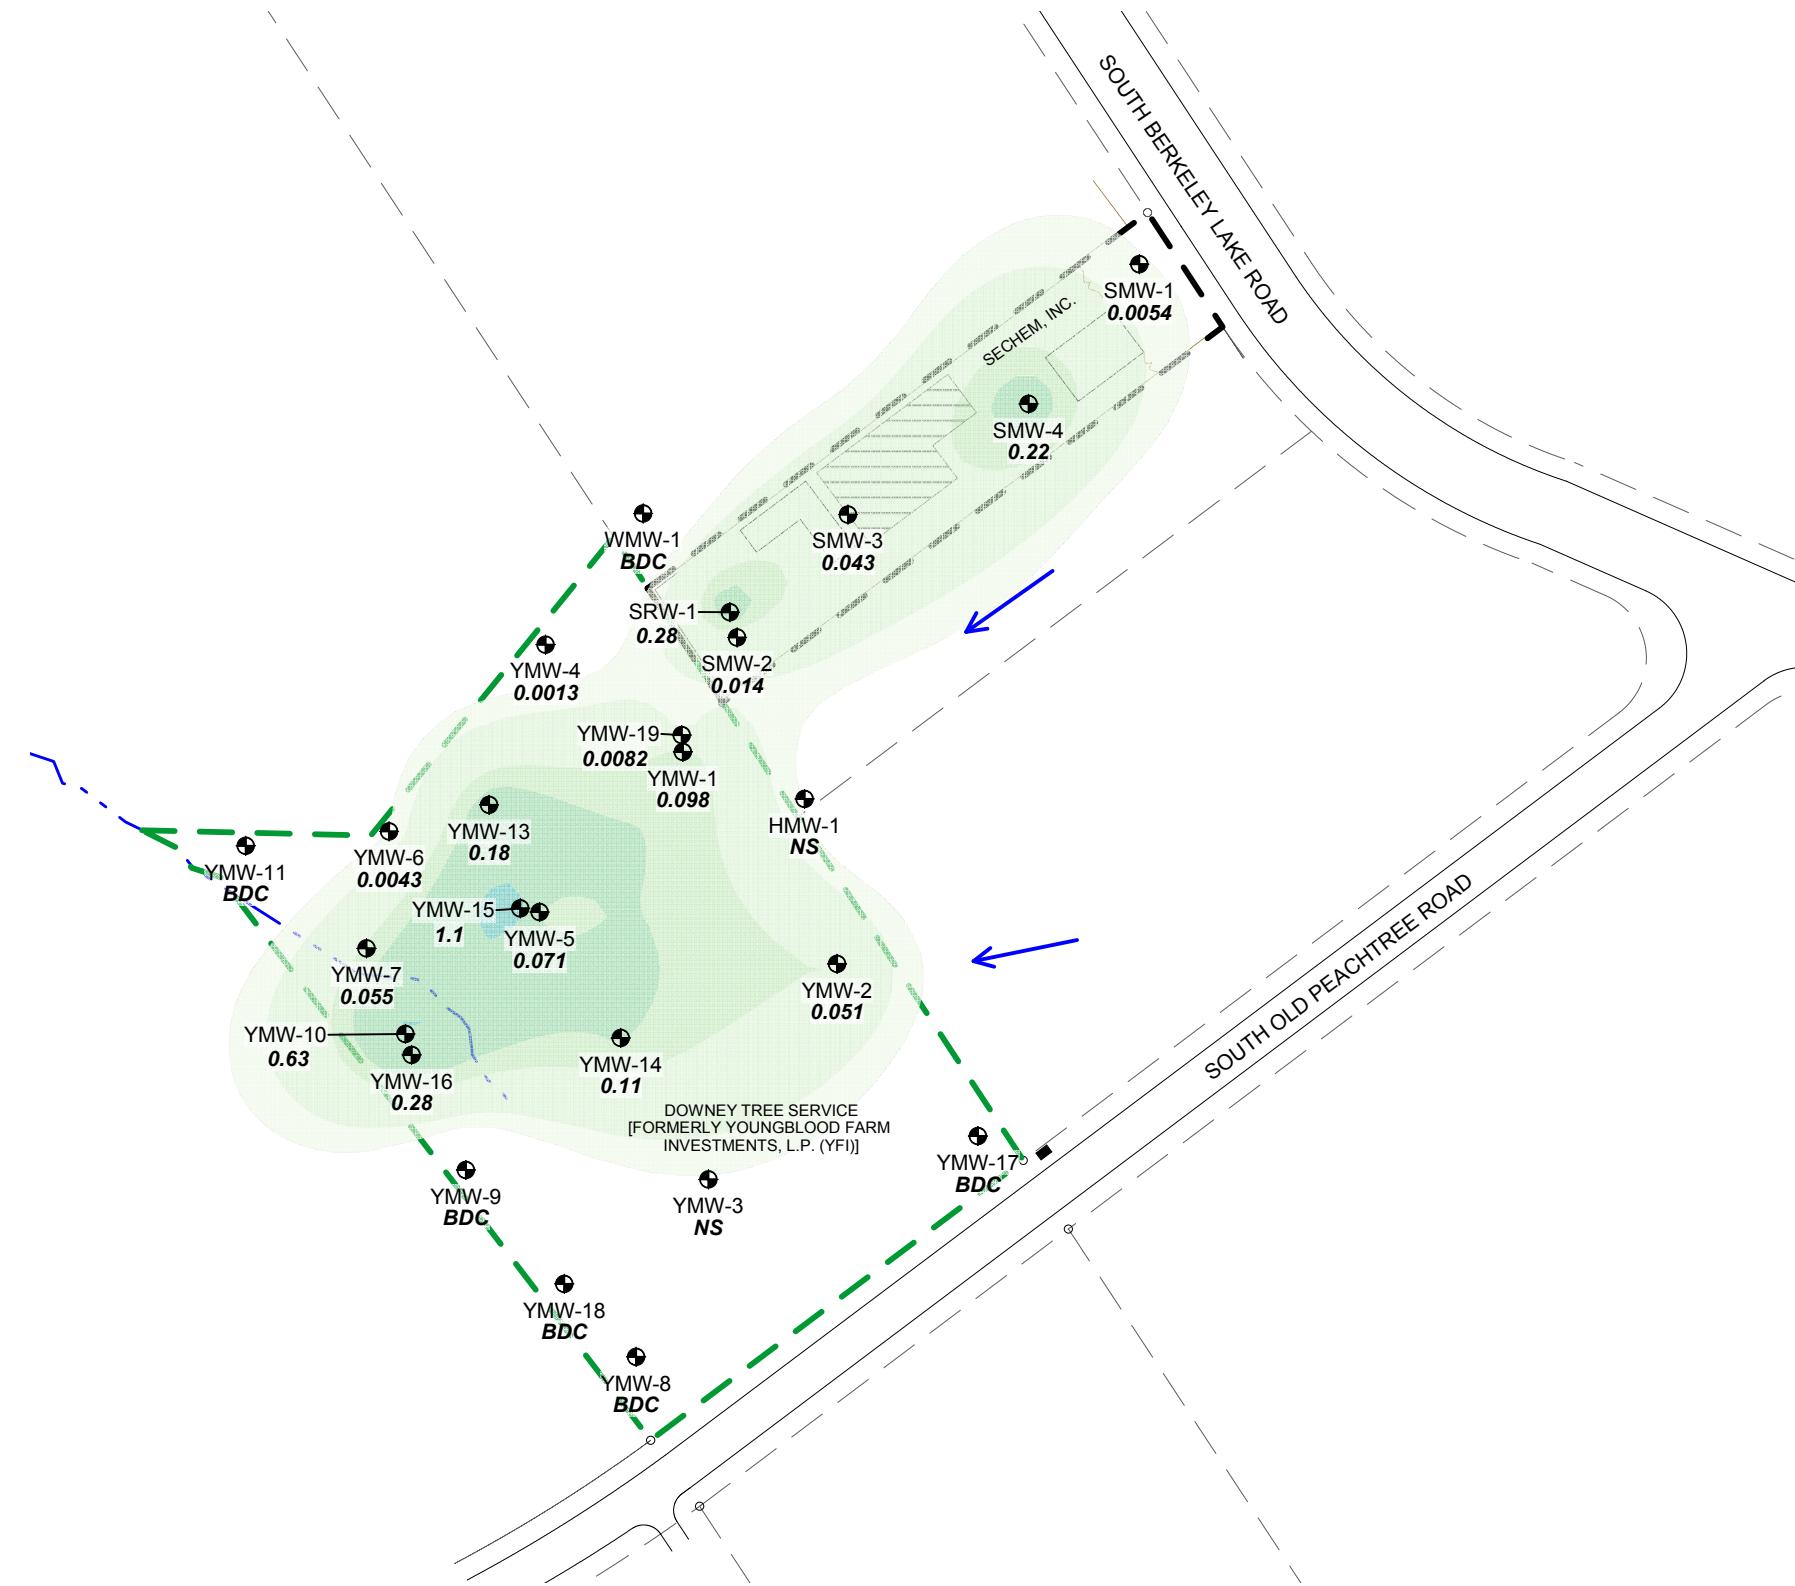
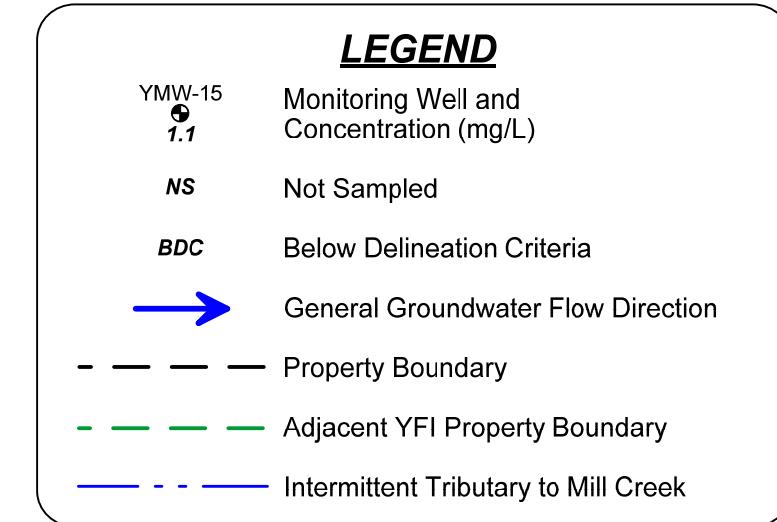
Prepared by: SNW Checked by: CDN Figure: 7

Delineation Criteria = Type 1 Risk Reduction Standard (RRS) = 0.005 mg/L

Isoconcentration Map
Tetrachloroethene (PCE)
May-2016

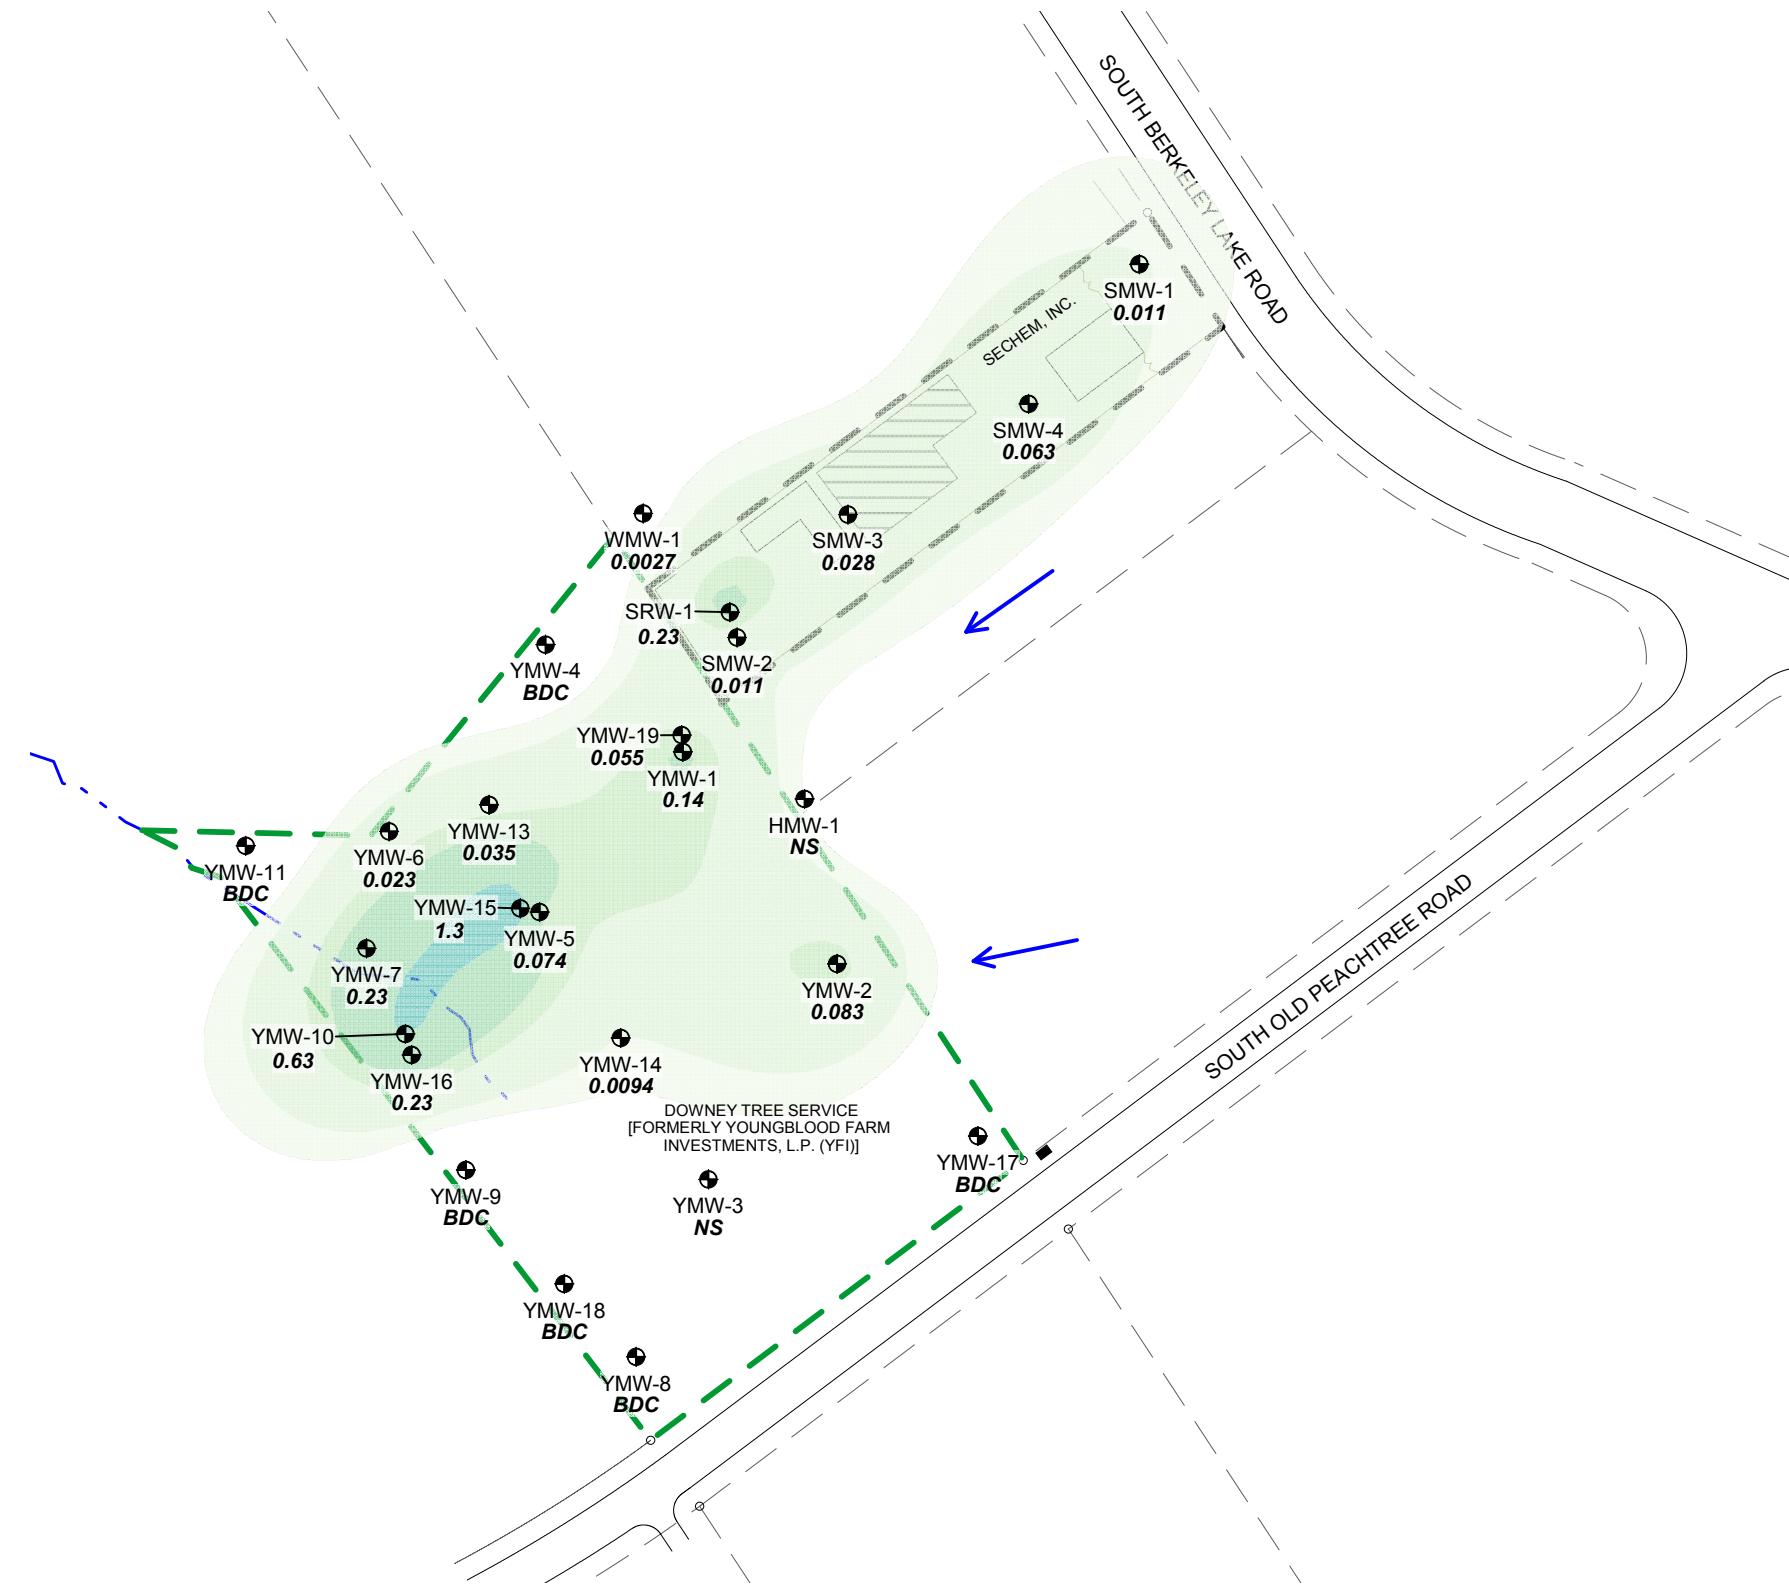
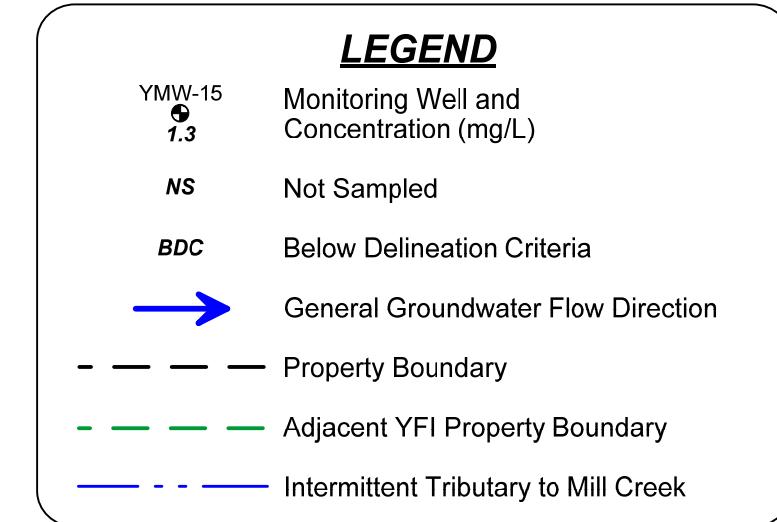
Prepared by: SNW Checked by: CDN Figure: 8

Delineation Criteria = Type 1 Risk Reduction Standard (RRS) = 0.005 mg/L

Isoconcentration Map
Trichloroethene (TCE)
May-2016

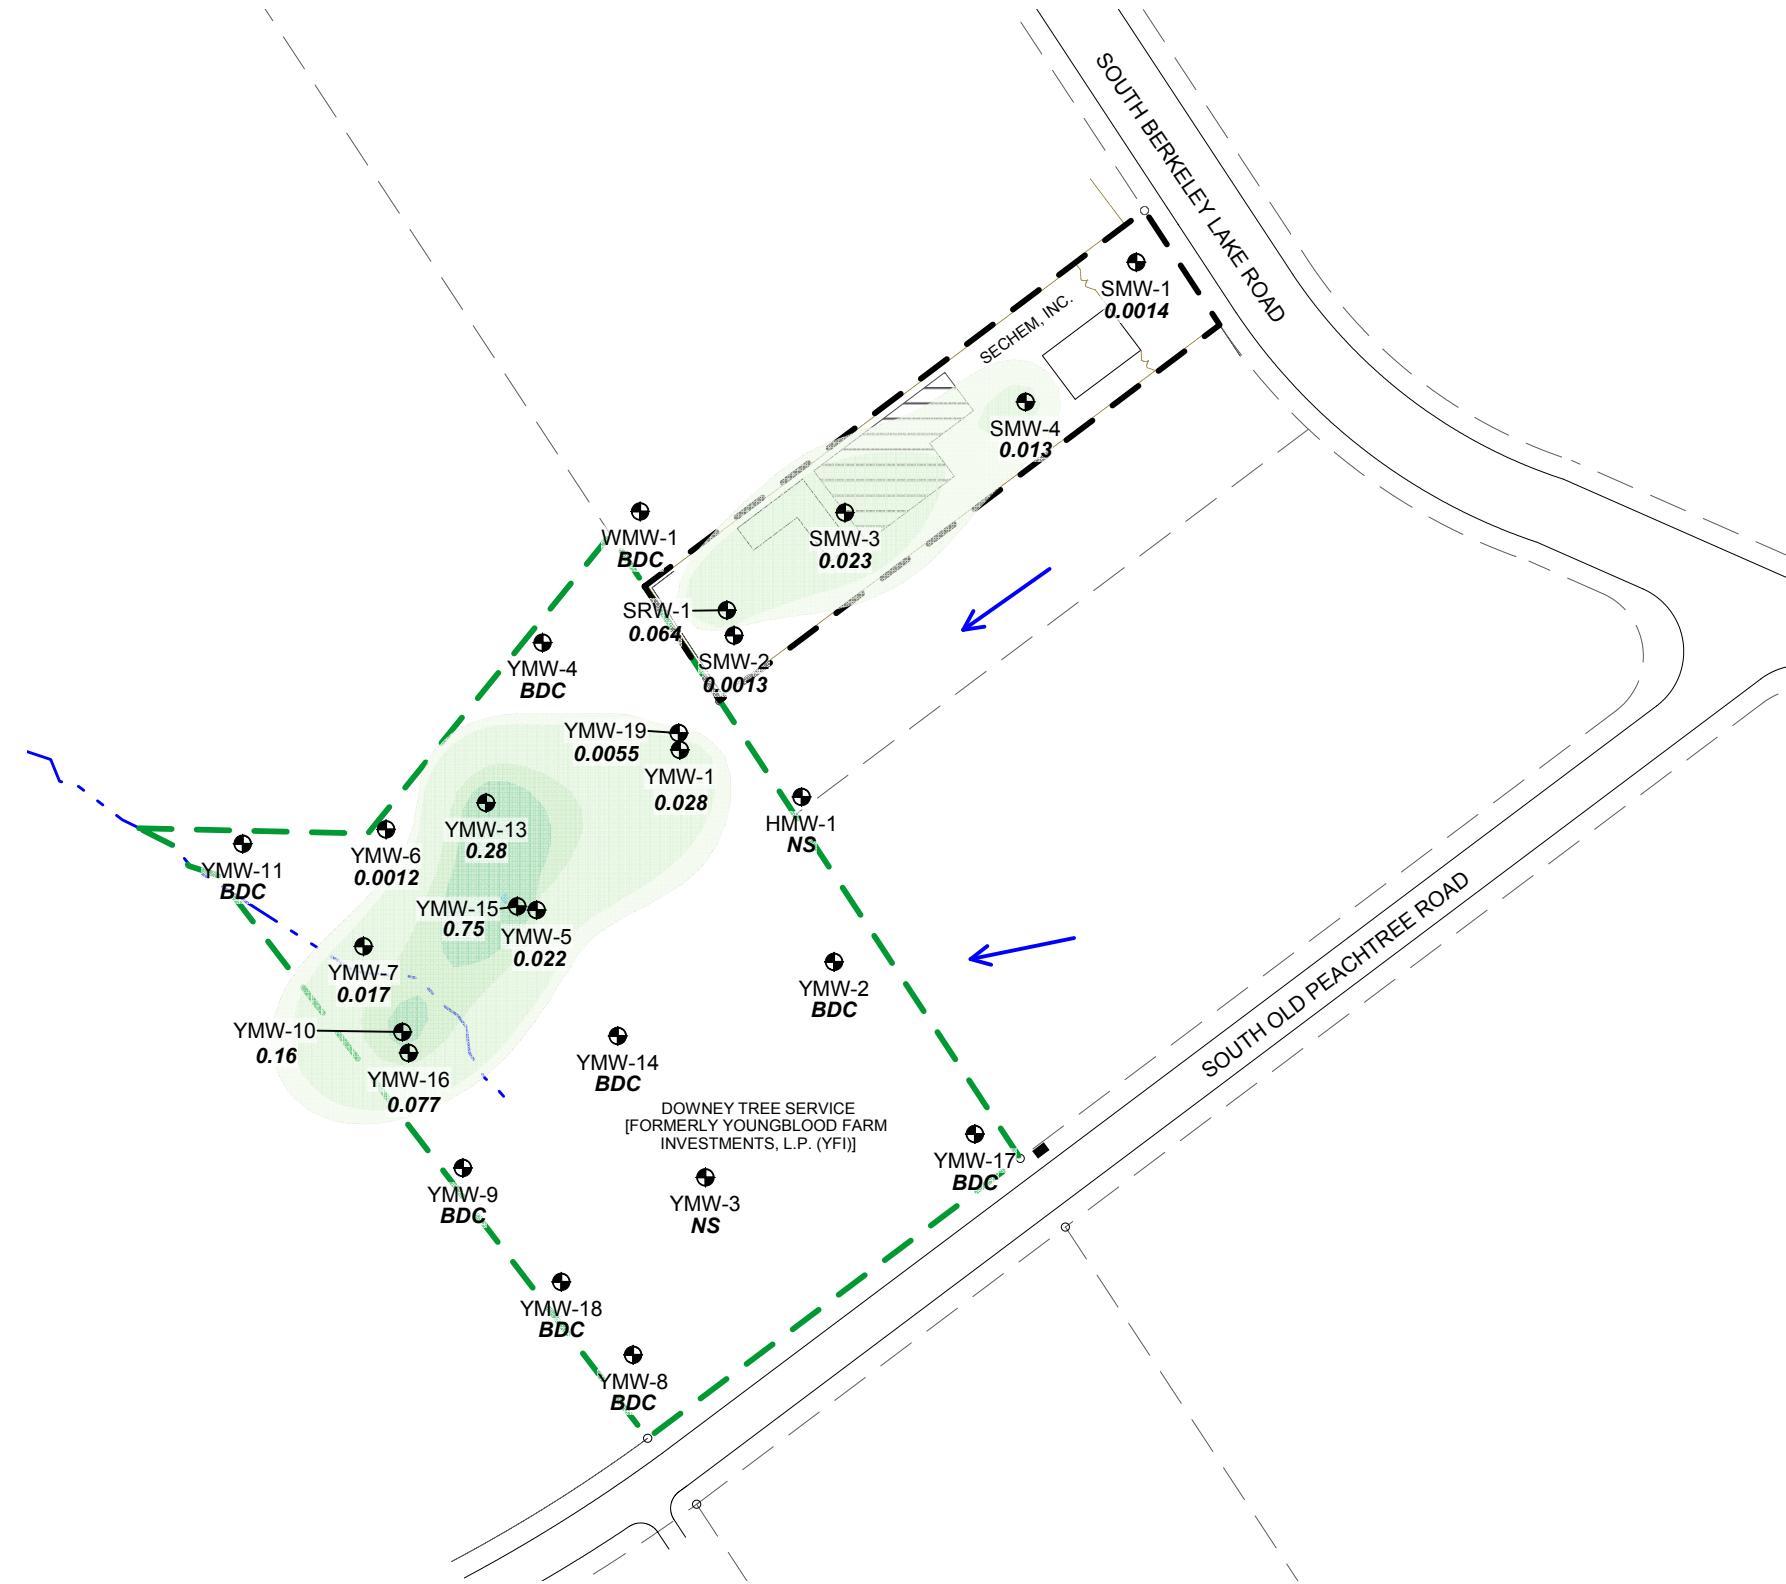
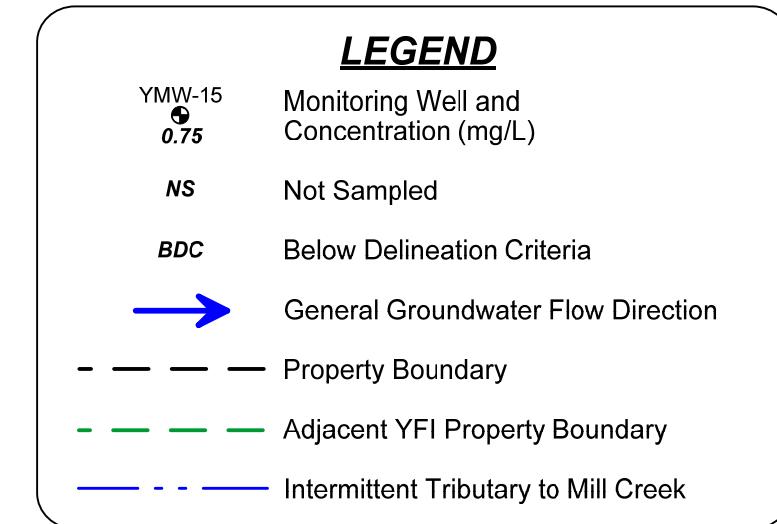
Prepared by: SNW Checked by: CDN Figure: 9

Delineation Criteria = Type 1 Risk Reduction Standard (RRS) = 0.007 mg/L

Isoconcentration Map
1,1-Dichloroethene (1,1-DCE)
May-2016

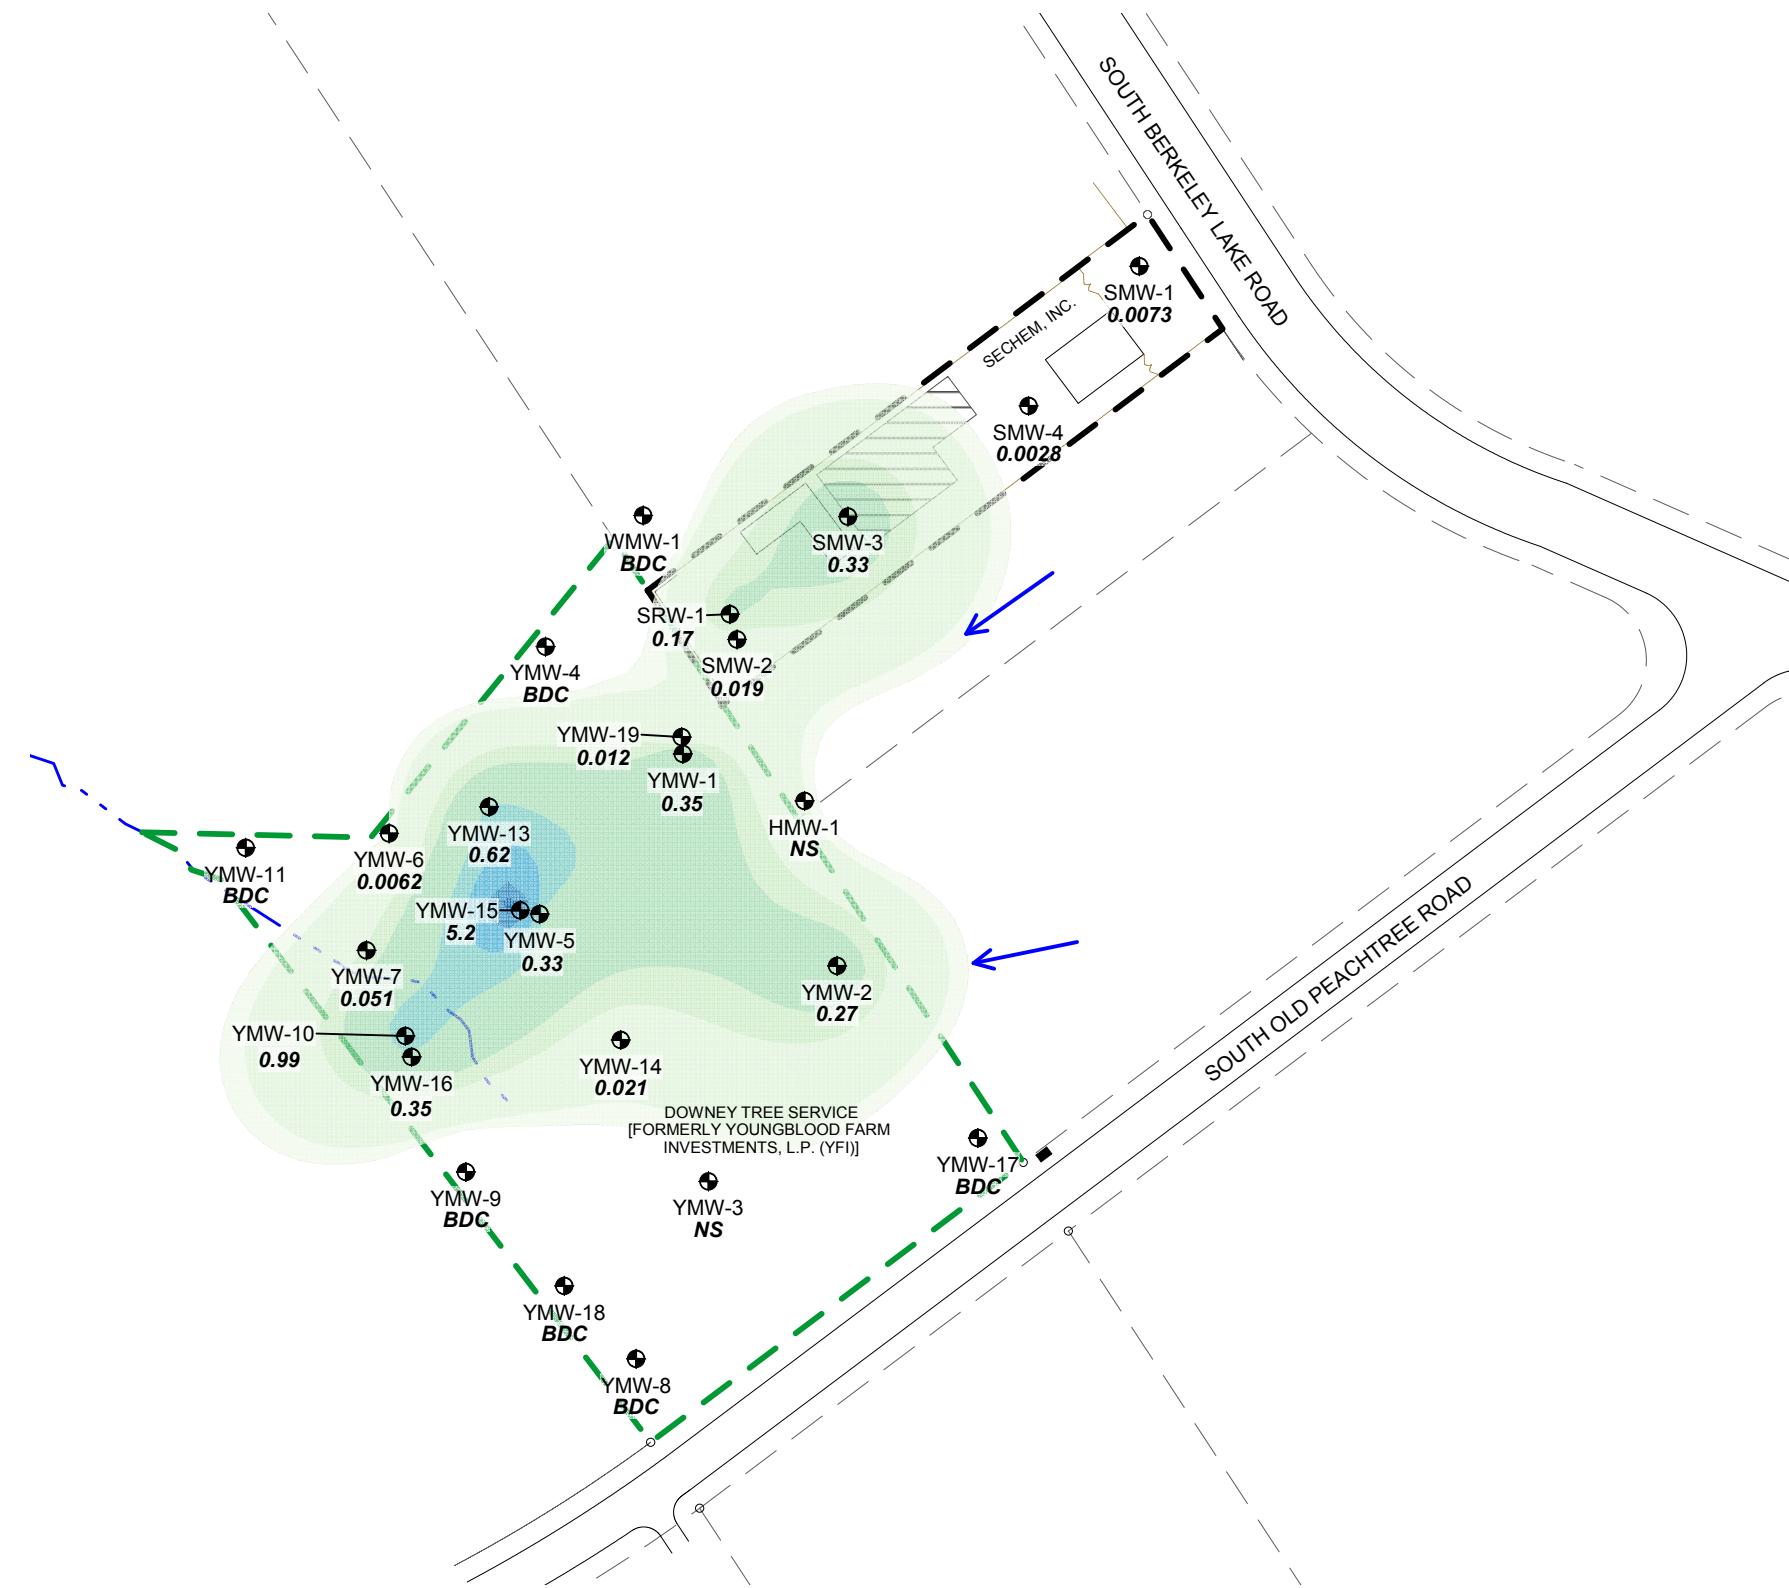
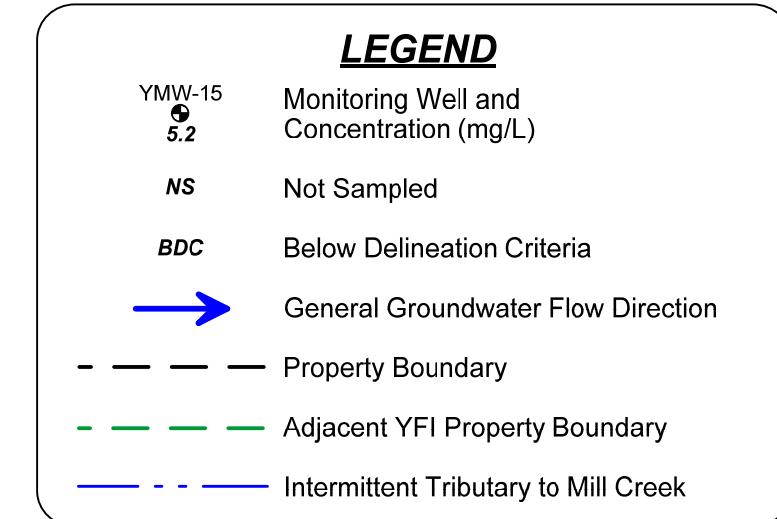
Prepared by: SNW Checked by: CDN Figure: 10

Delineation Criteria = Type 1 Risk Reduction Standard (RRS) = 0.007 mg/L

Isoconcentration Map
1,2-Dichloroethene (1,2-DCE) Total
May-2016

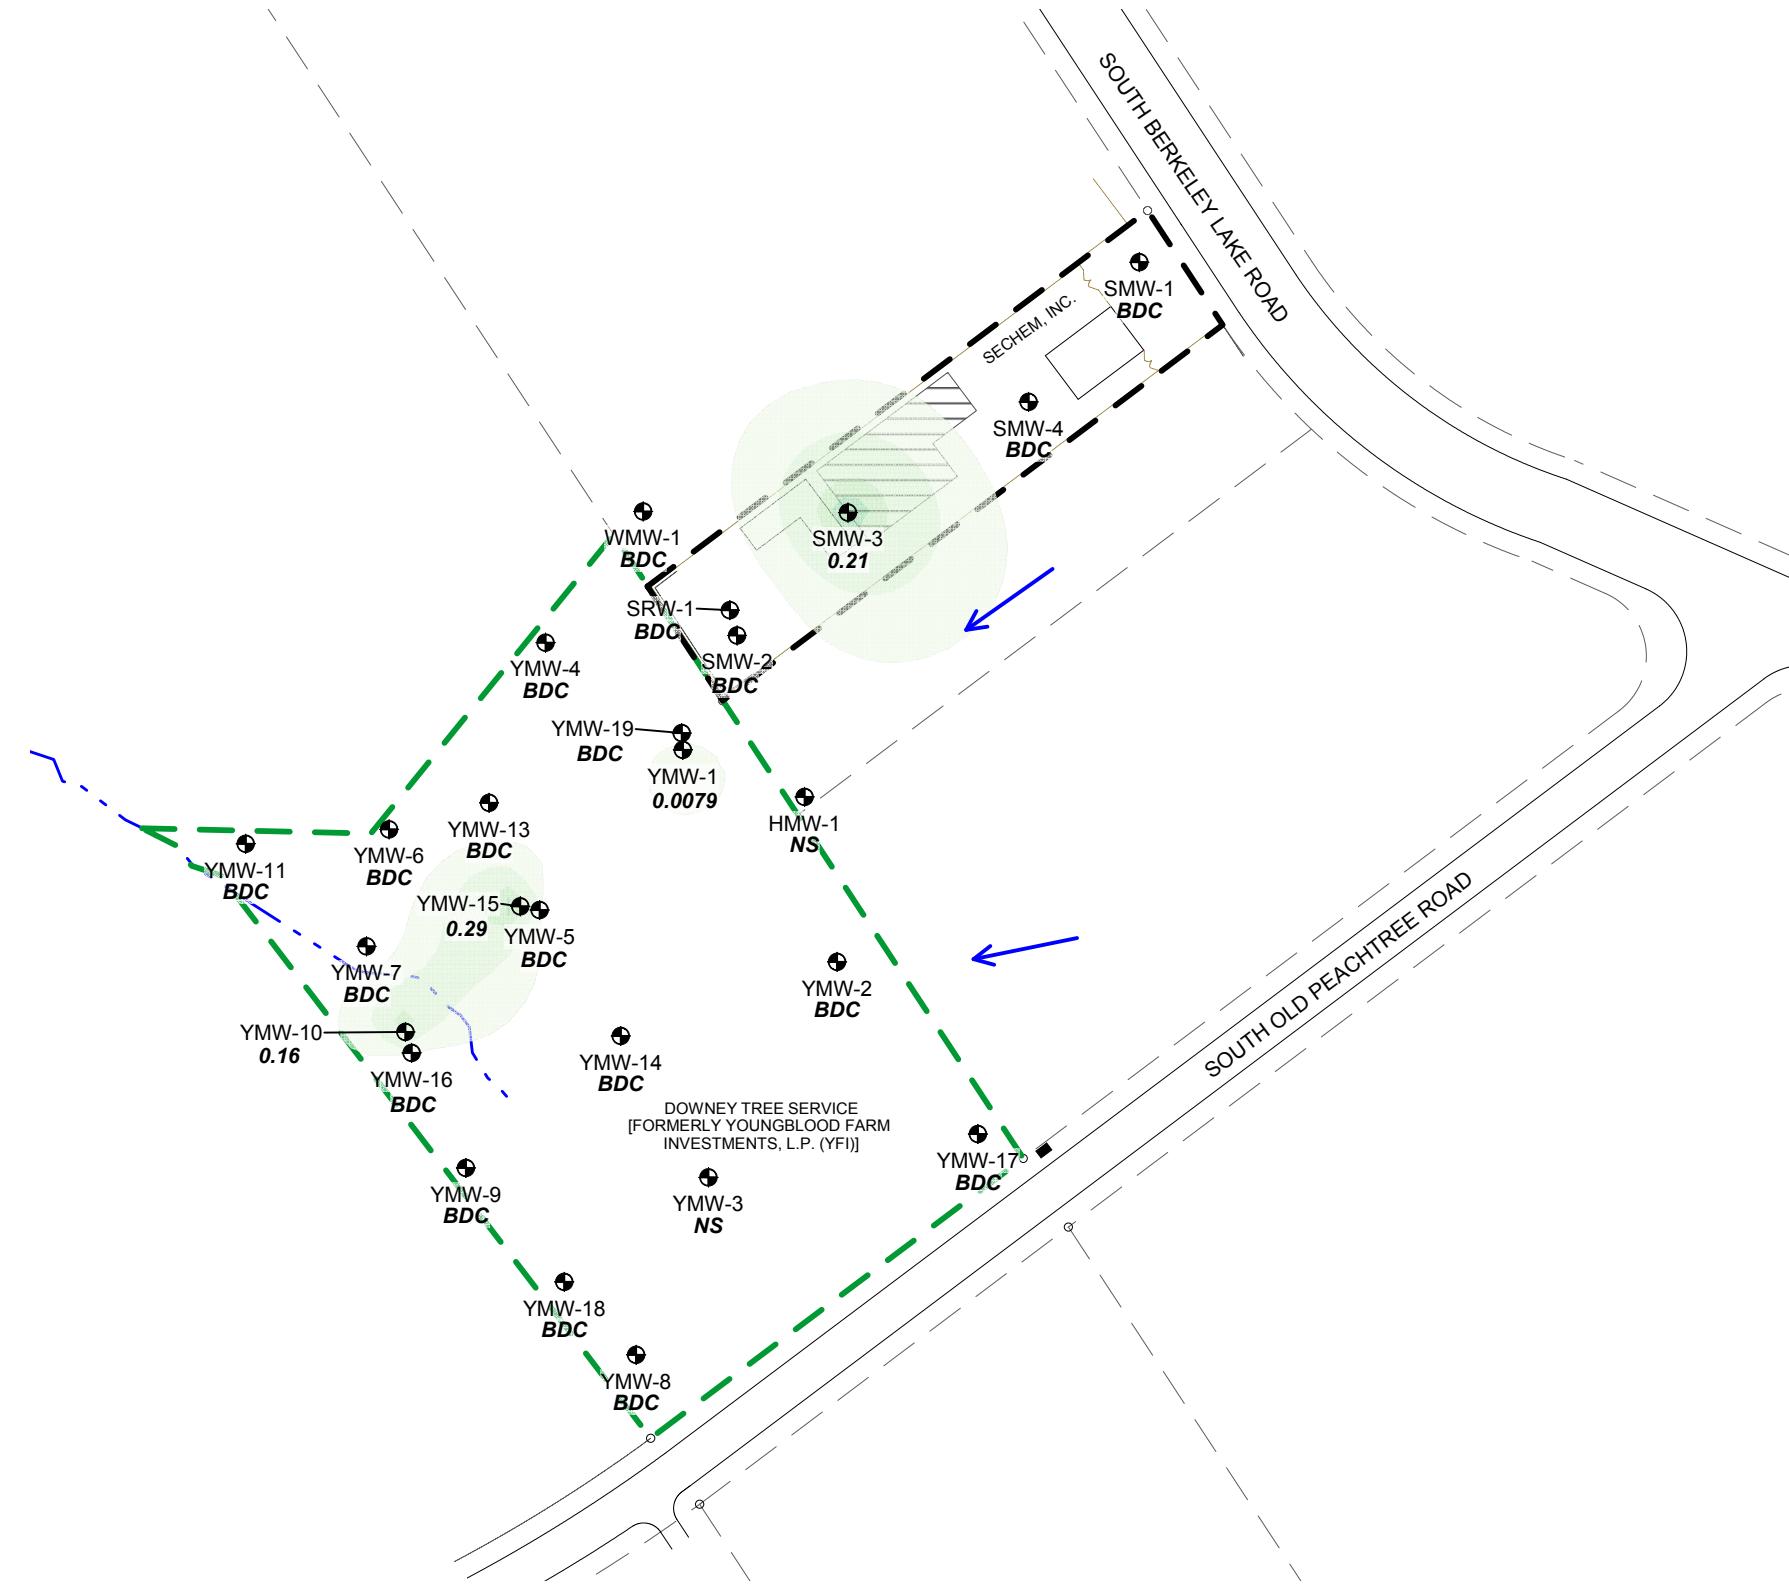
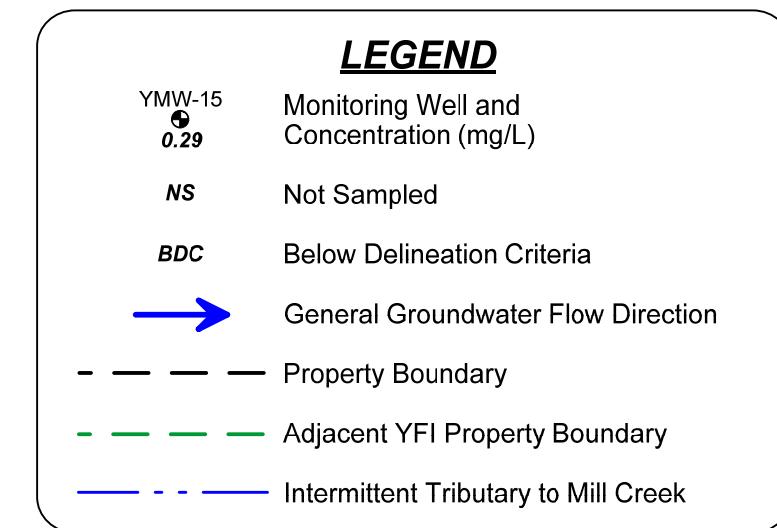
Prepared by: SNW Checked by: CDN Figure: 11

Delineation Criteria = Type 1 Risk Reduction Standard (RRS) = 0.002 mg/L

Isoconcentration Map
Vinyl Chloride (VC)
May-2016

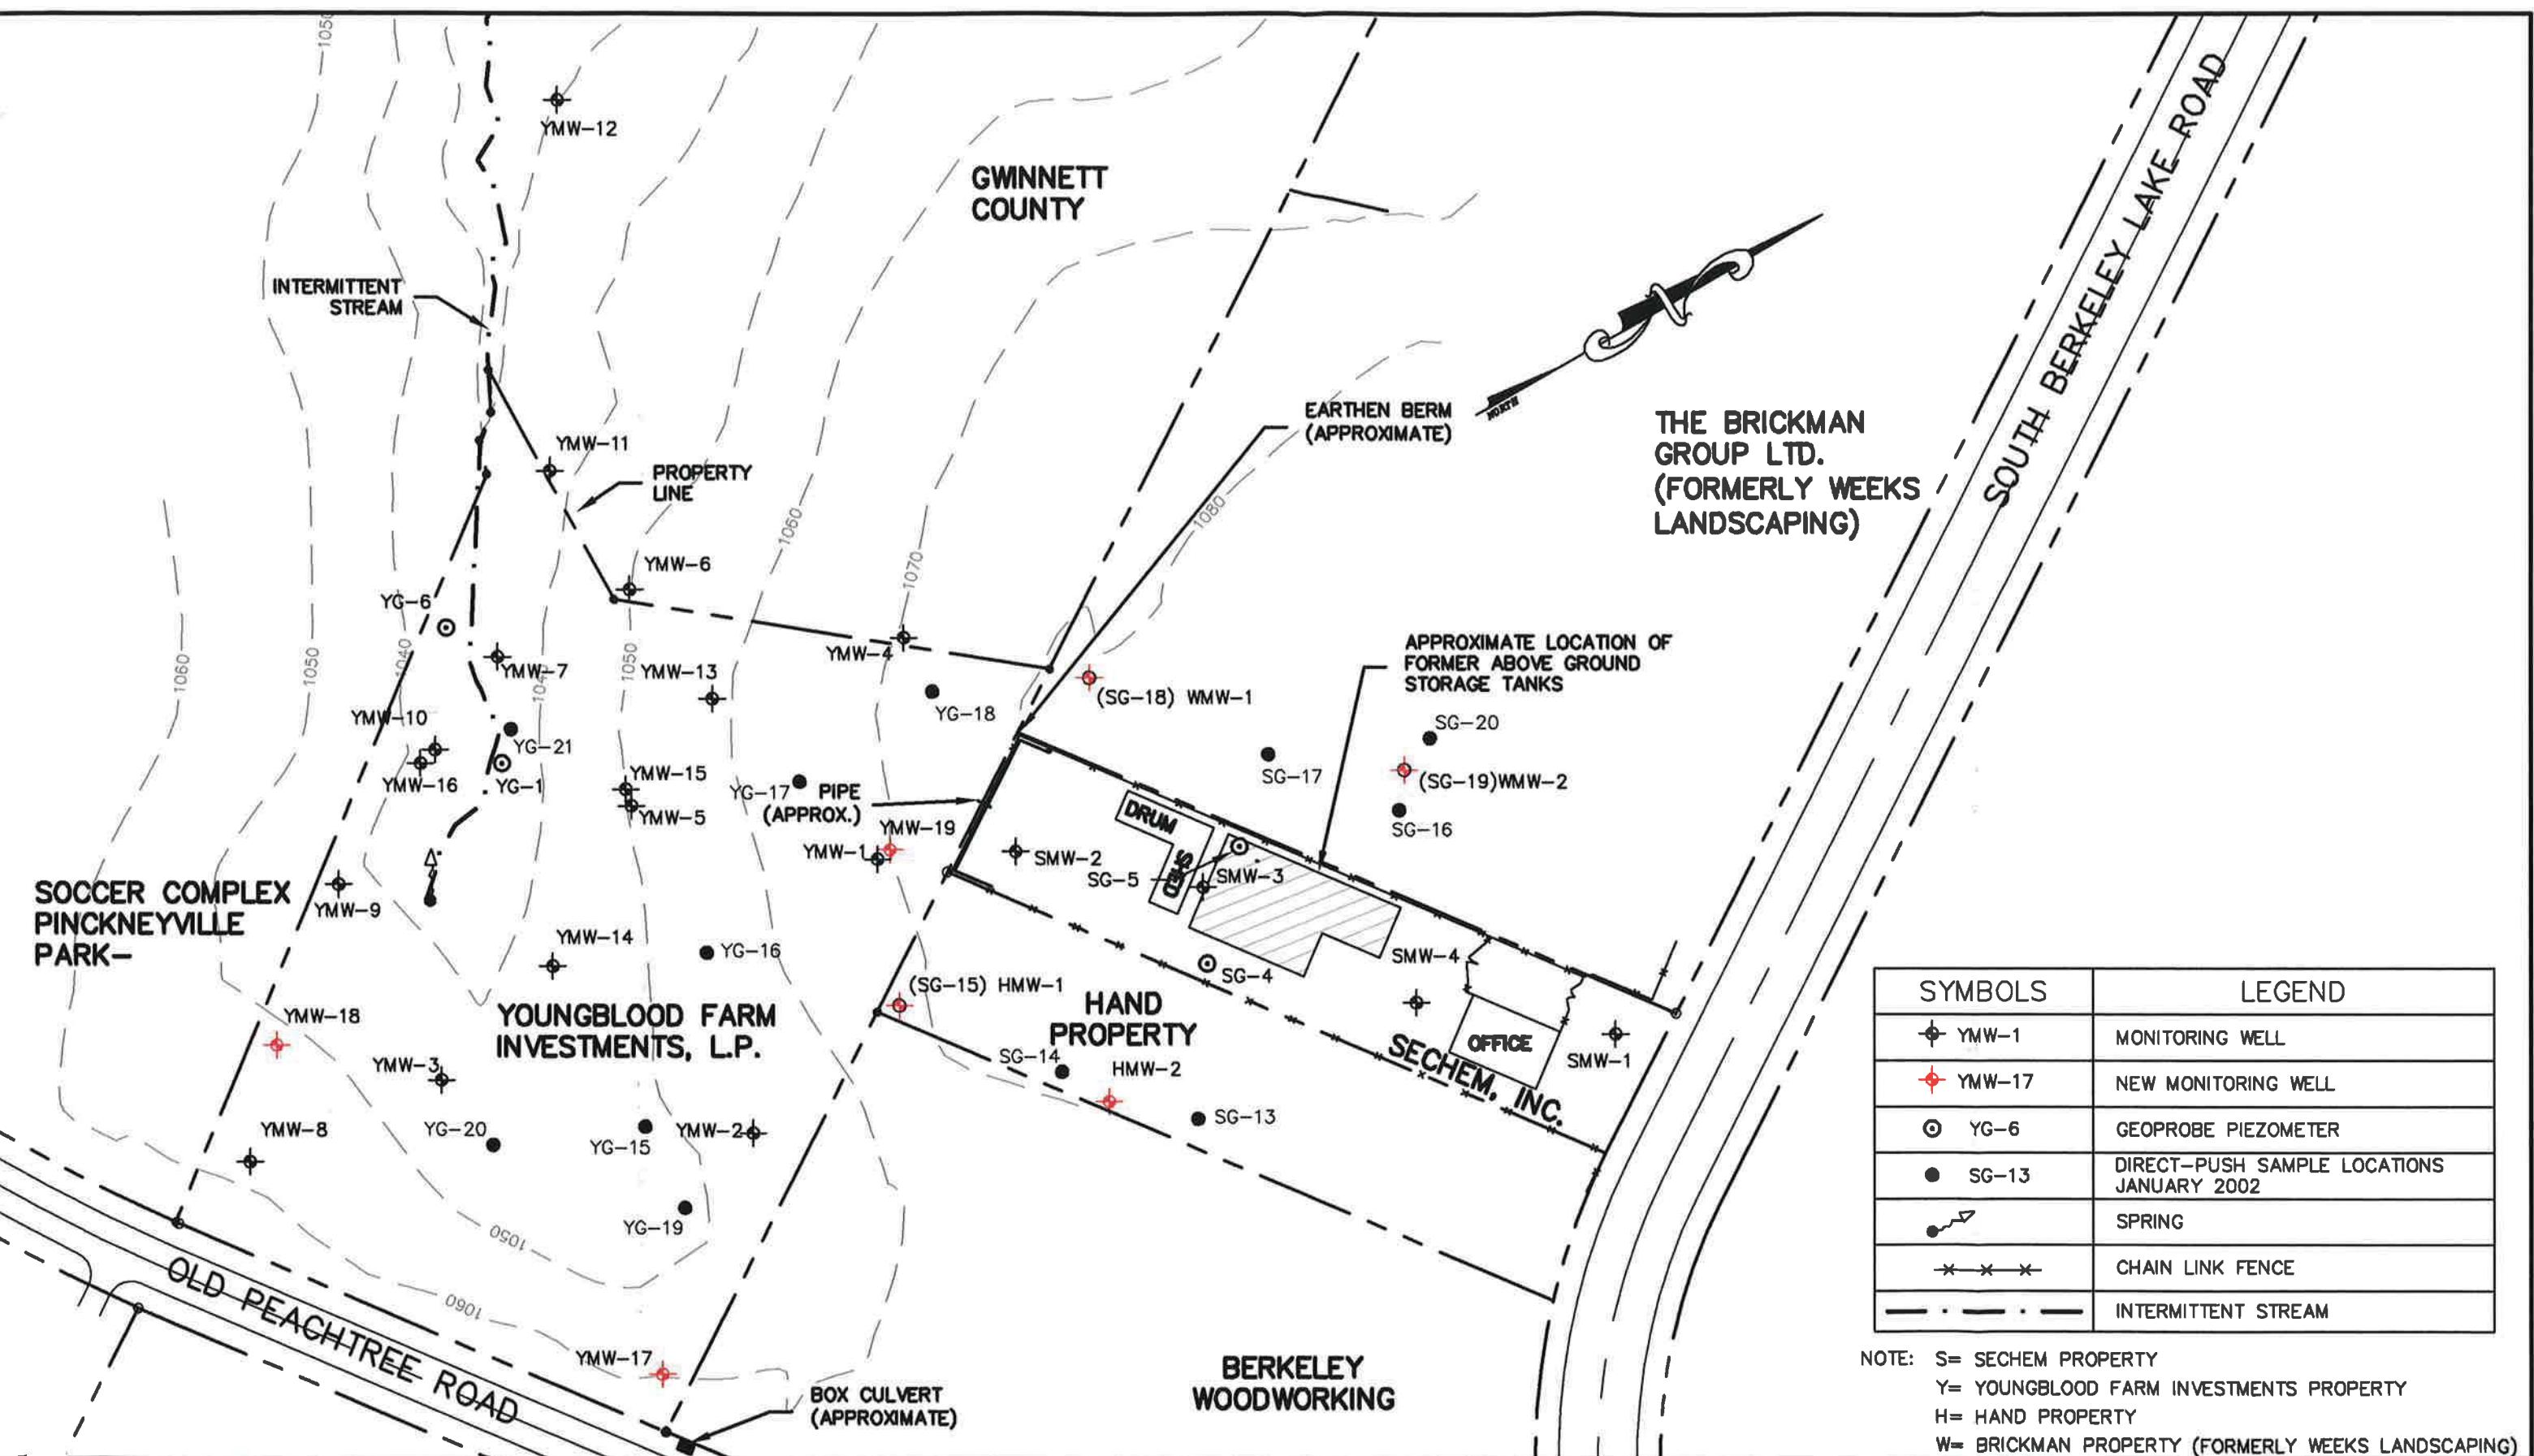
HISTORICAL DATA AND SAMPLING LOCATIONS 2013

**(PHASE II CORRECTIVE ACTION PLAN ADDENDUM REPORT,
GOLDER ASSOCIATES INC., JUNE 2013)**

According to the Phase II CAP Addendum, additional surface and subsurface soil samples were collected in April 2013 to assess the extent of contamination in the vicinity of the AS/SVE system. These samples were collected after the AS/SVE system had been in operation for approximately 5 years. The assessment showed significant reductions in surface and subsurface soil concentrations on the Property; however, residual source material was identified. Additional sampling may be needed to fully delineate the horizontal and vertical extent of soil contamination on the Site. Historical surface and subsurface soil sample results are summarized in Appendix D.
