Subject: **Submittal of VIRP Application
SECHEM, INC. – HSI Site No. 10515
4580 South Berkeley Lake Road
Norcross, Georgia**

VOLUNTARY INVESTIGATION AND REMEDIATION PLAN

SECHEM, INC.
4580 SOUTH BERKELY LAKE ROAD
NORCROSS, GWINNETT COUNTY, GEORGIA 30092
HSI SITE NUMBER 10515

EarthCon Project No. 02.20160244.00

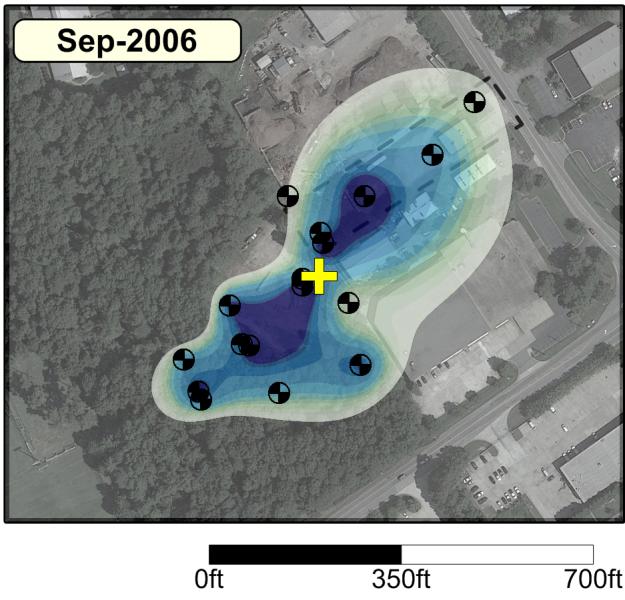
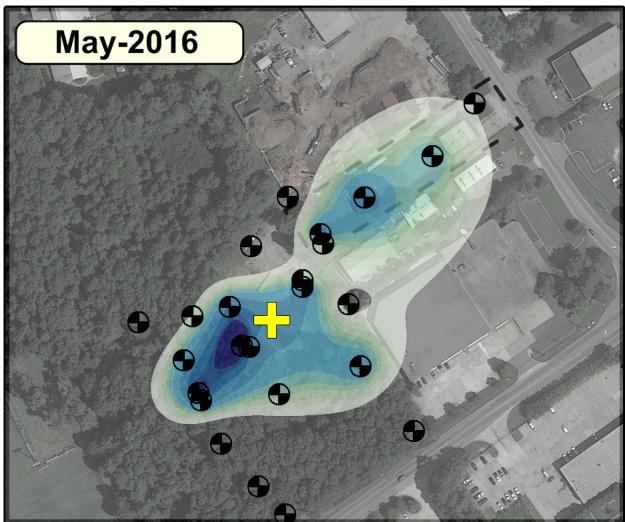
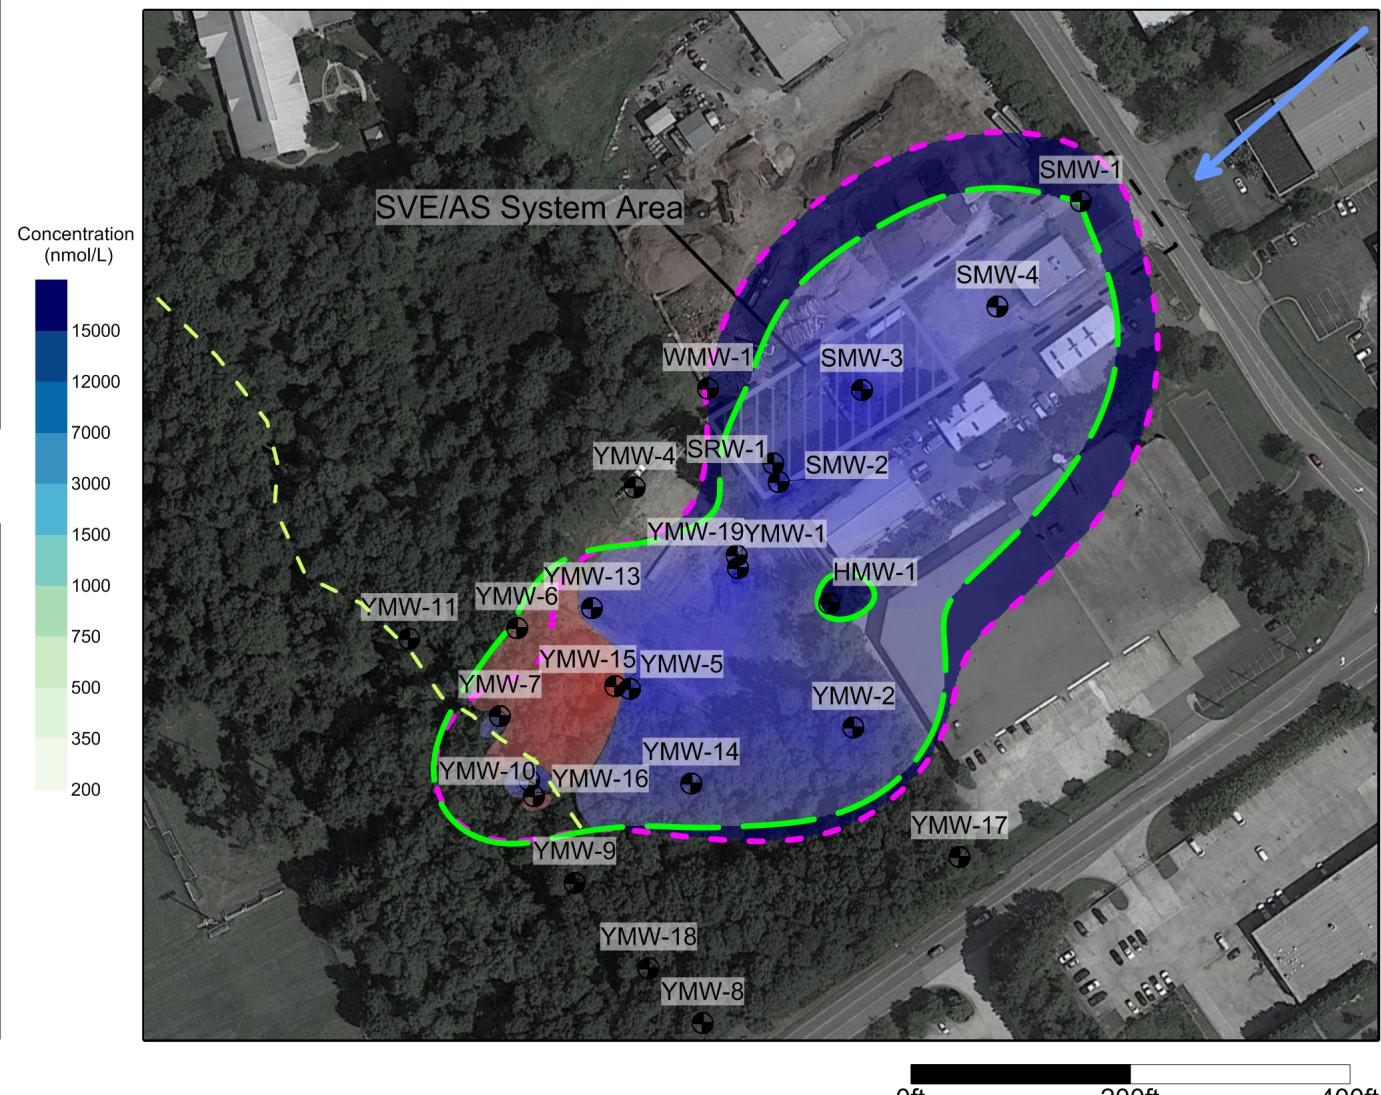
Total Chloroethenes

Plume Differences Sep-2006 vs May-2016

Likewise, the total chloroethane plume exhibited overall reductions of 47%, 69%, and 83%, respectively. Although the COM for both plumes exhibited downgradient trends, it is not due to plume expansion. Rather, the observed downgradient trending COMs are primarily due to the more significant reductions of the plume in the former source areas. Overall, both the chloroethene and chloroethane plumes are observed to be significantly decreasing during the evaluation period of 2006 through 2016. The plume difference maps for the chloroethene and chloroethane plumes are included in Appendix F.

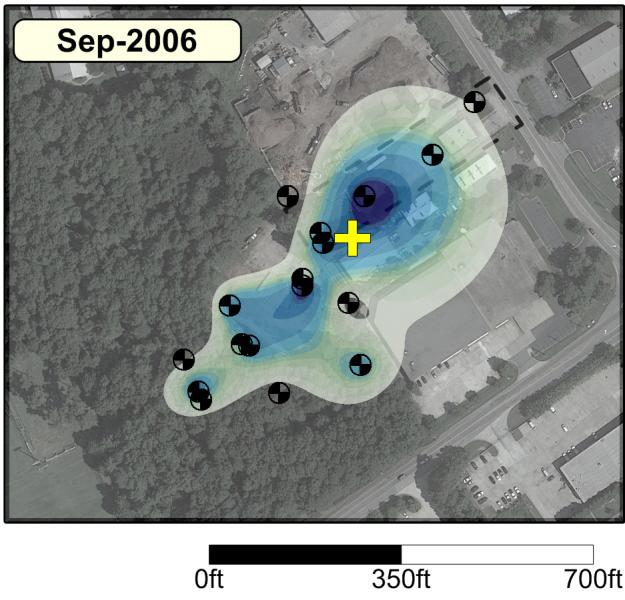
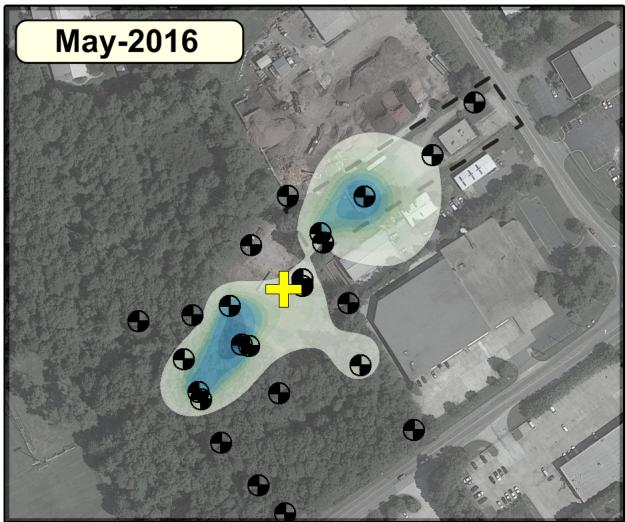
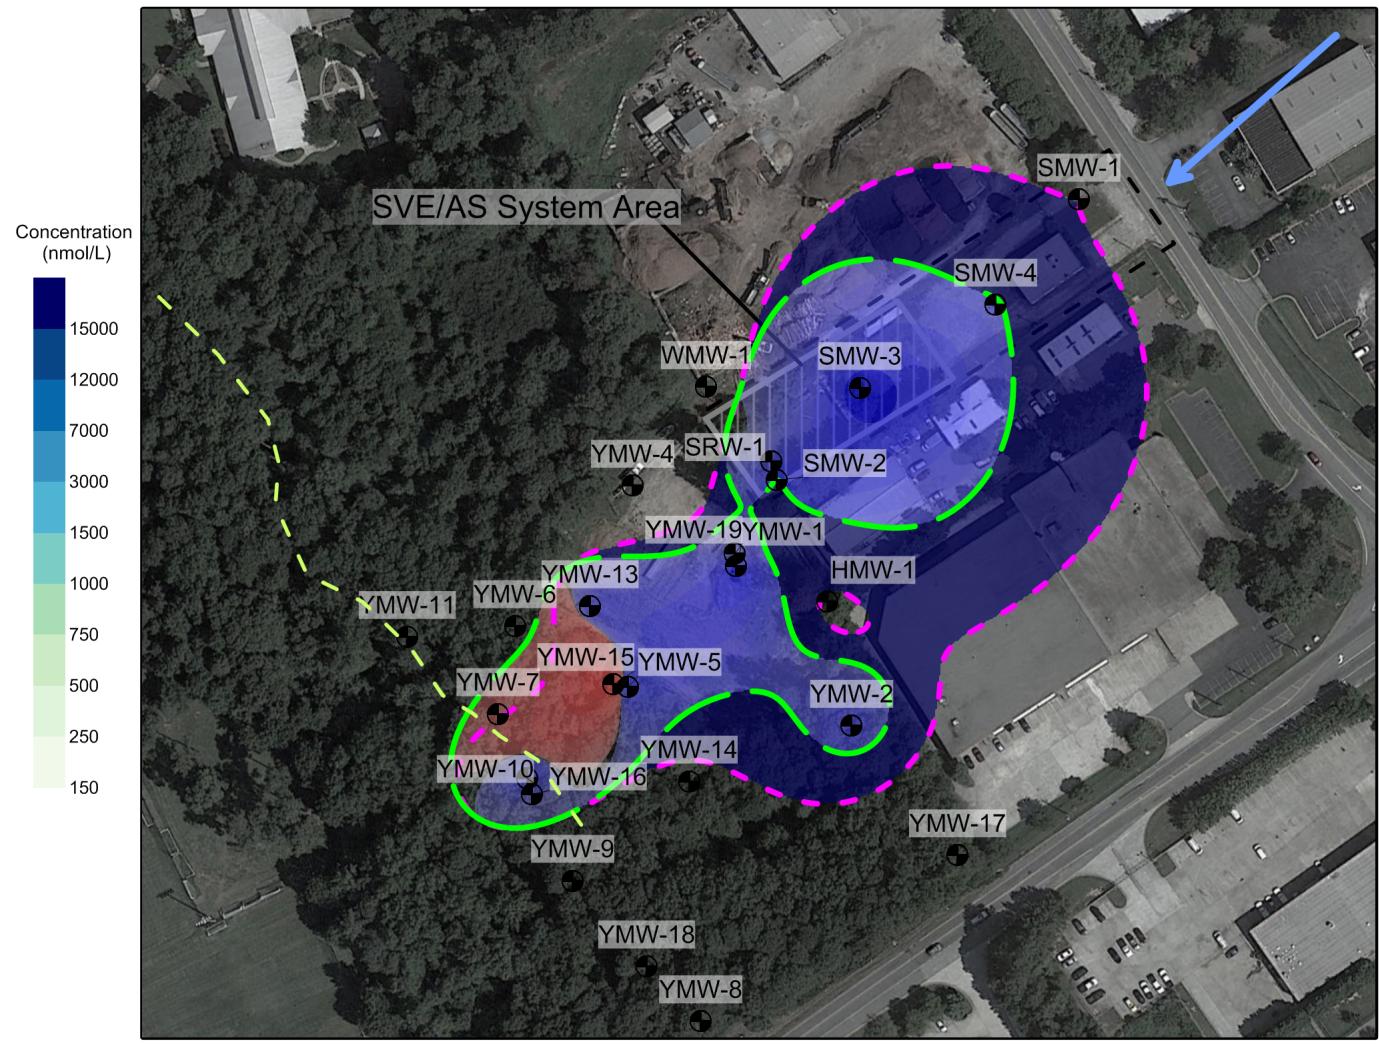
Total Chloroethanes

Plume Differences Sep-2006 vs May-2016

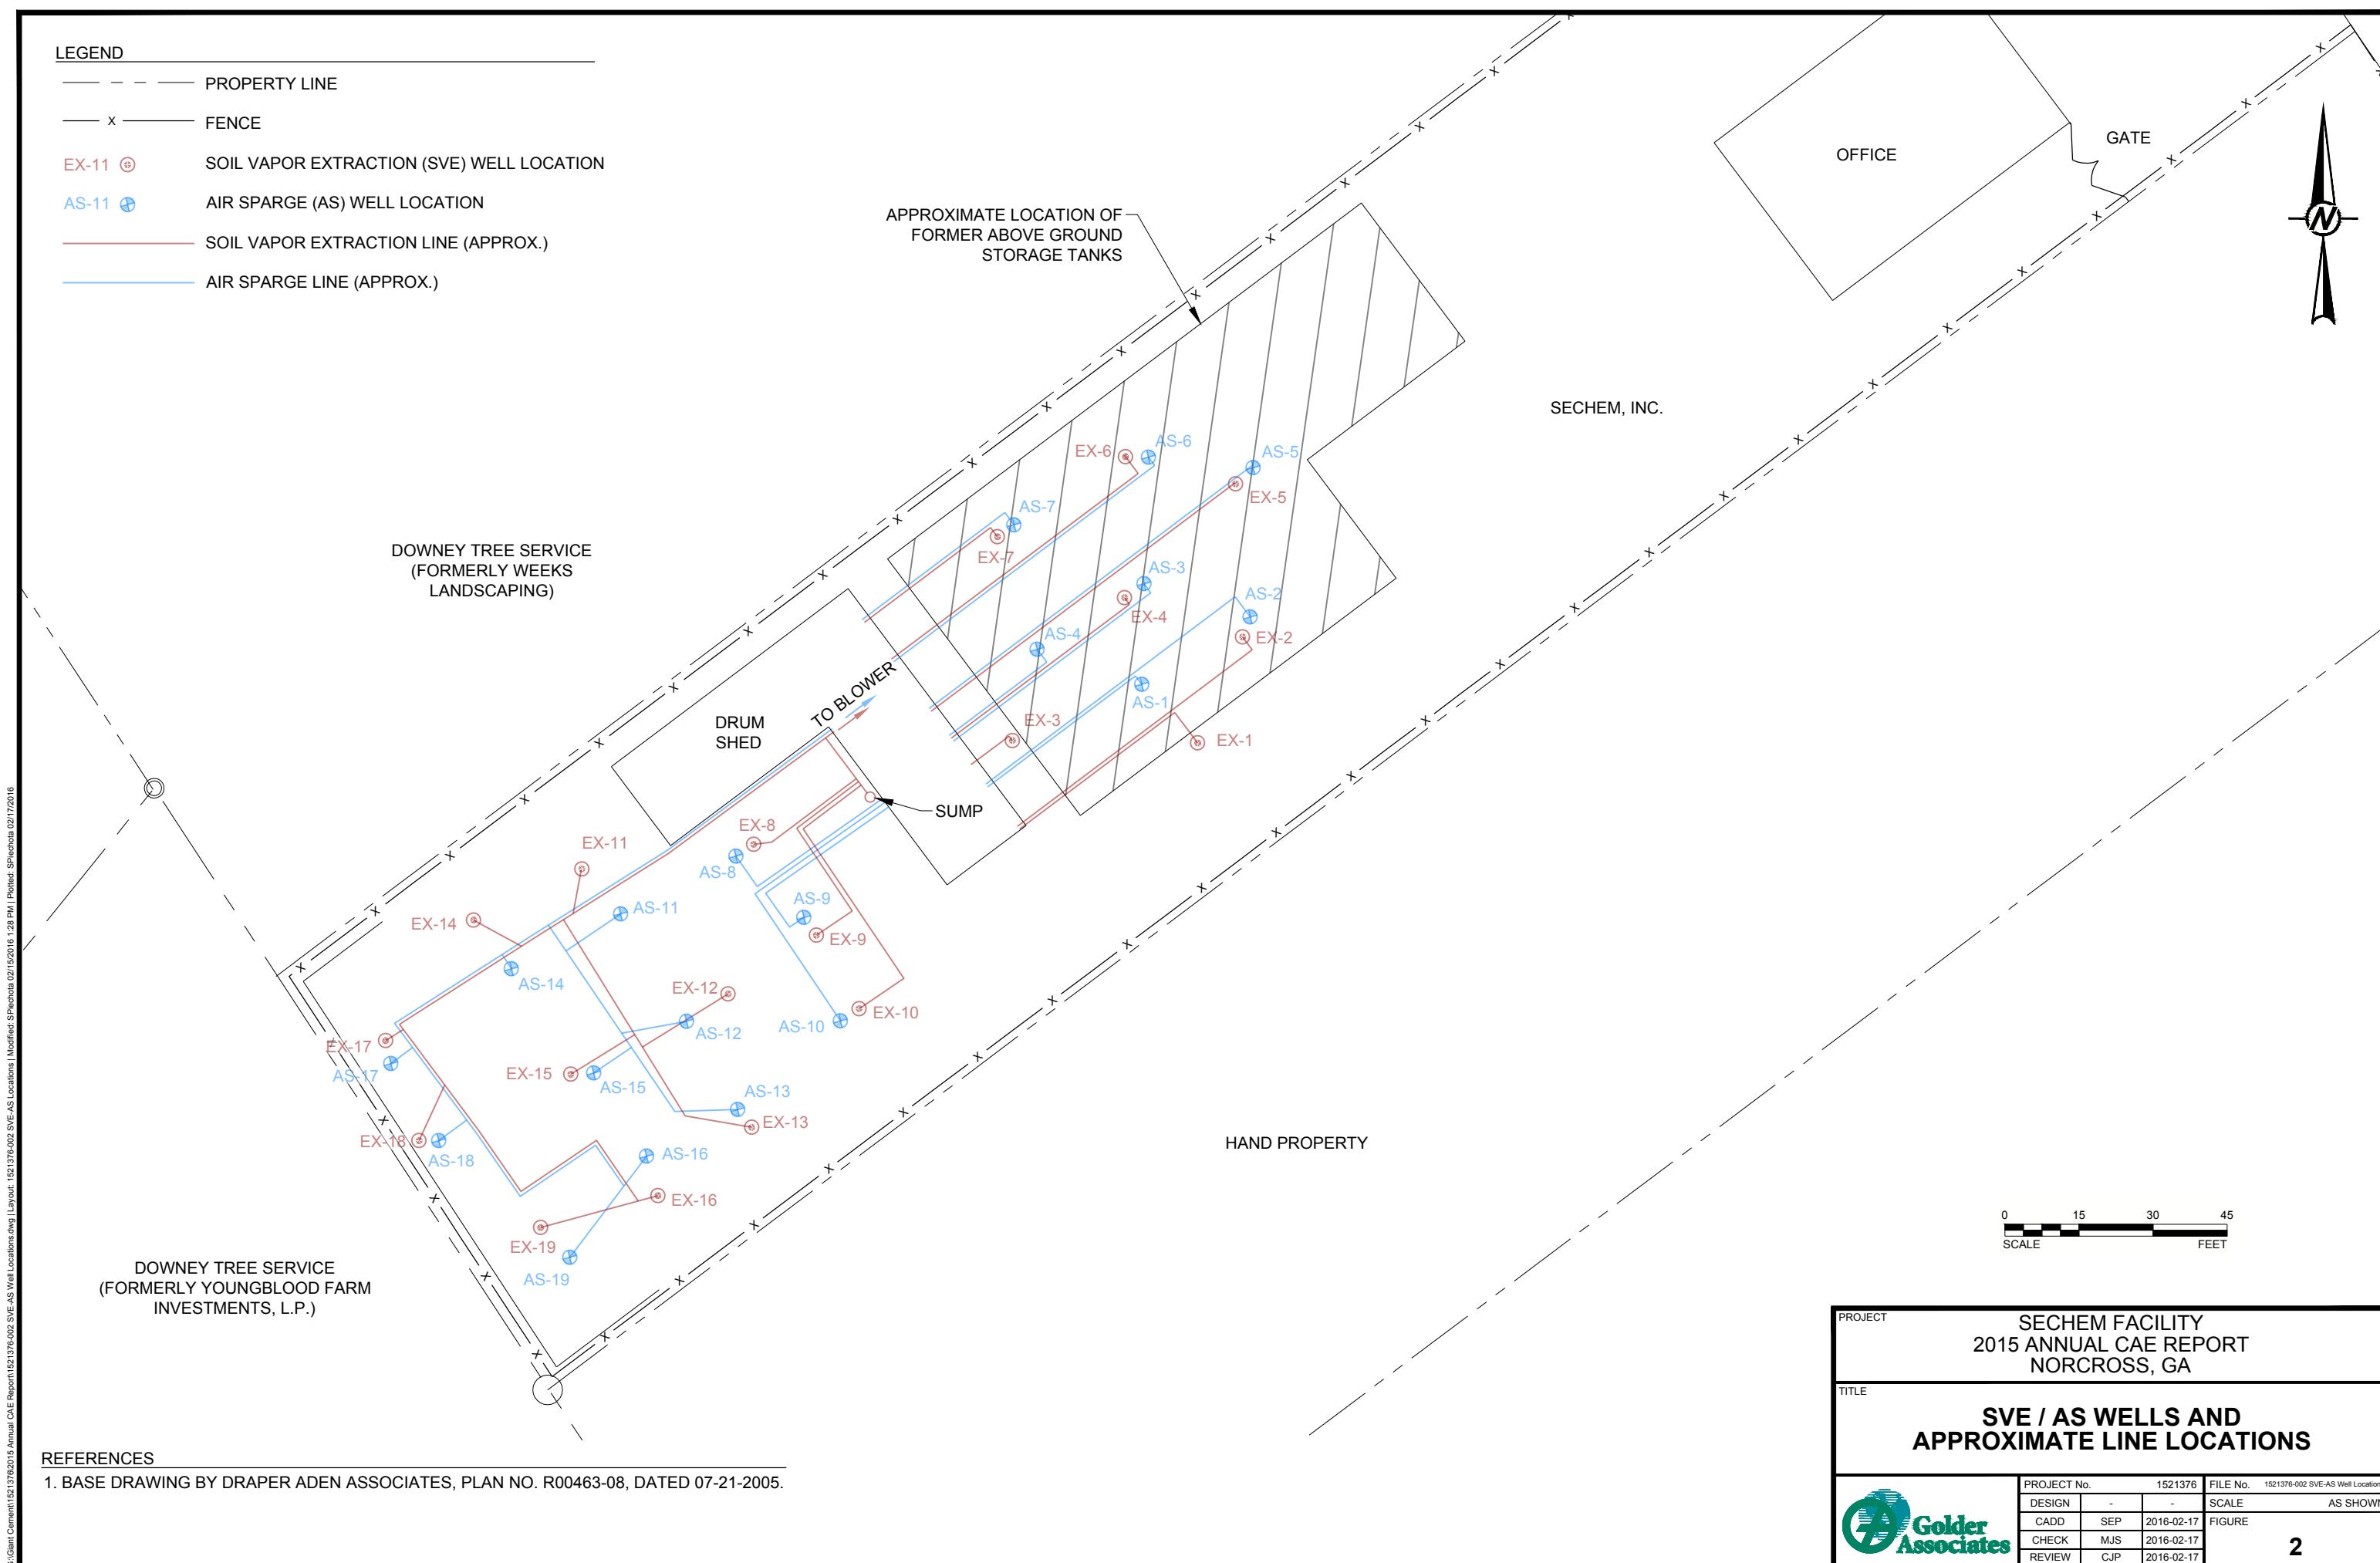
**APPENDIX H
AS/SVE WELLS AND LINES LOCATIONS FIGURE**

**(CORRECTIVE ACTION PROGRAM 2015 ANNUAL REPORT,
GOLDER ASSOCIATES INC., APRIL 2016)**

The AS/SVE system was installed in 2007 and began operation in January 2008 to assist with reducing soil and dissolved-phase VOC concentrations on the Property. The AS/SVE system consists of an air compressor, two vacuum blowers, an electric catalytic oxidizer, nineteen AS wells and nineteen SVE wells. One 10-horsepower (hp) dual type oil-less rotary vane compressor is used to inject compressed air into the groundwater and two 2.5-hp regenerative blowers are used to induce a vacuum on the subsurface to extract vapor-phase VOCs. Extracted vapors are routed through header pipes and directed to the catalytic oxidizer for treatment prior to discharge to the atmosphere. A figure illustrating the AS and SVE wells and associated lines is presented in Appendix H.
