Name of Document: Voluntary Investigation and Remediation Plan

## **Voluntary Investigation and Remediation Plan**

*Murata Electronics, N.A.  
308 Prospect Road  
Rockmart, Polk County, Georgia  
HSI Site No. 10771*

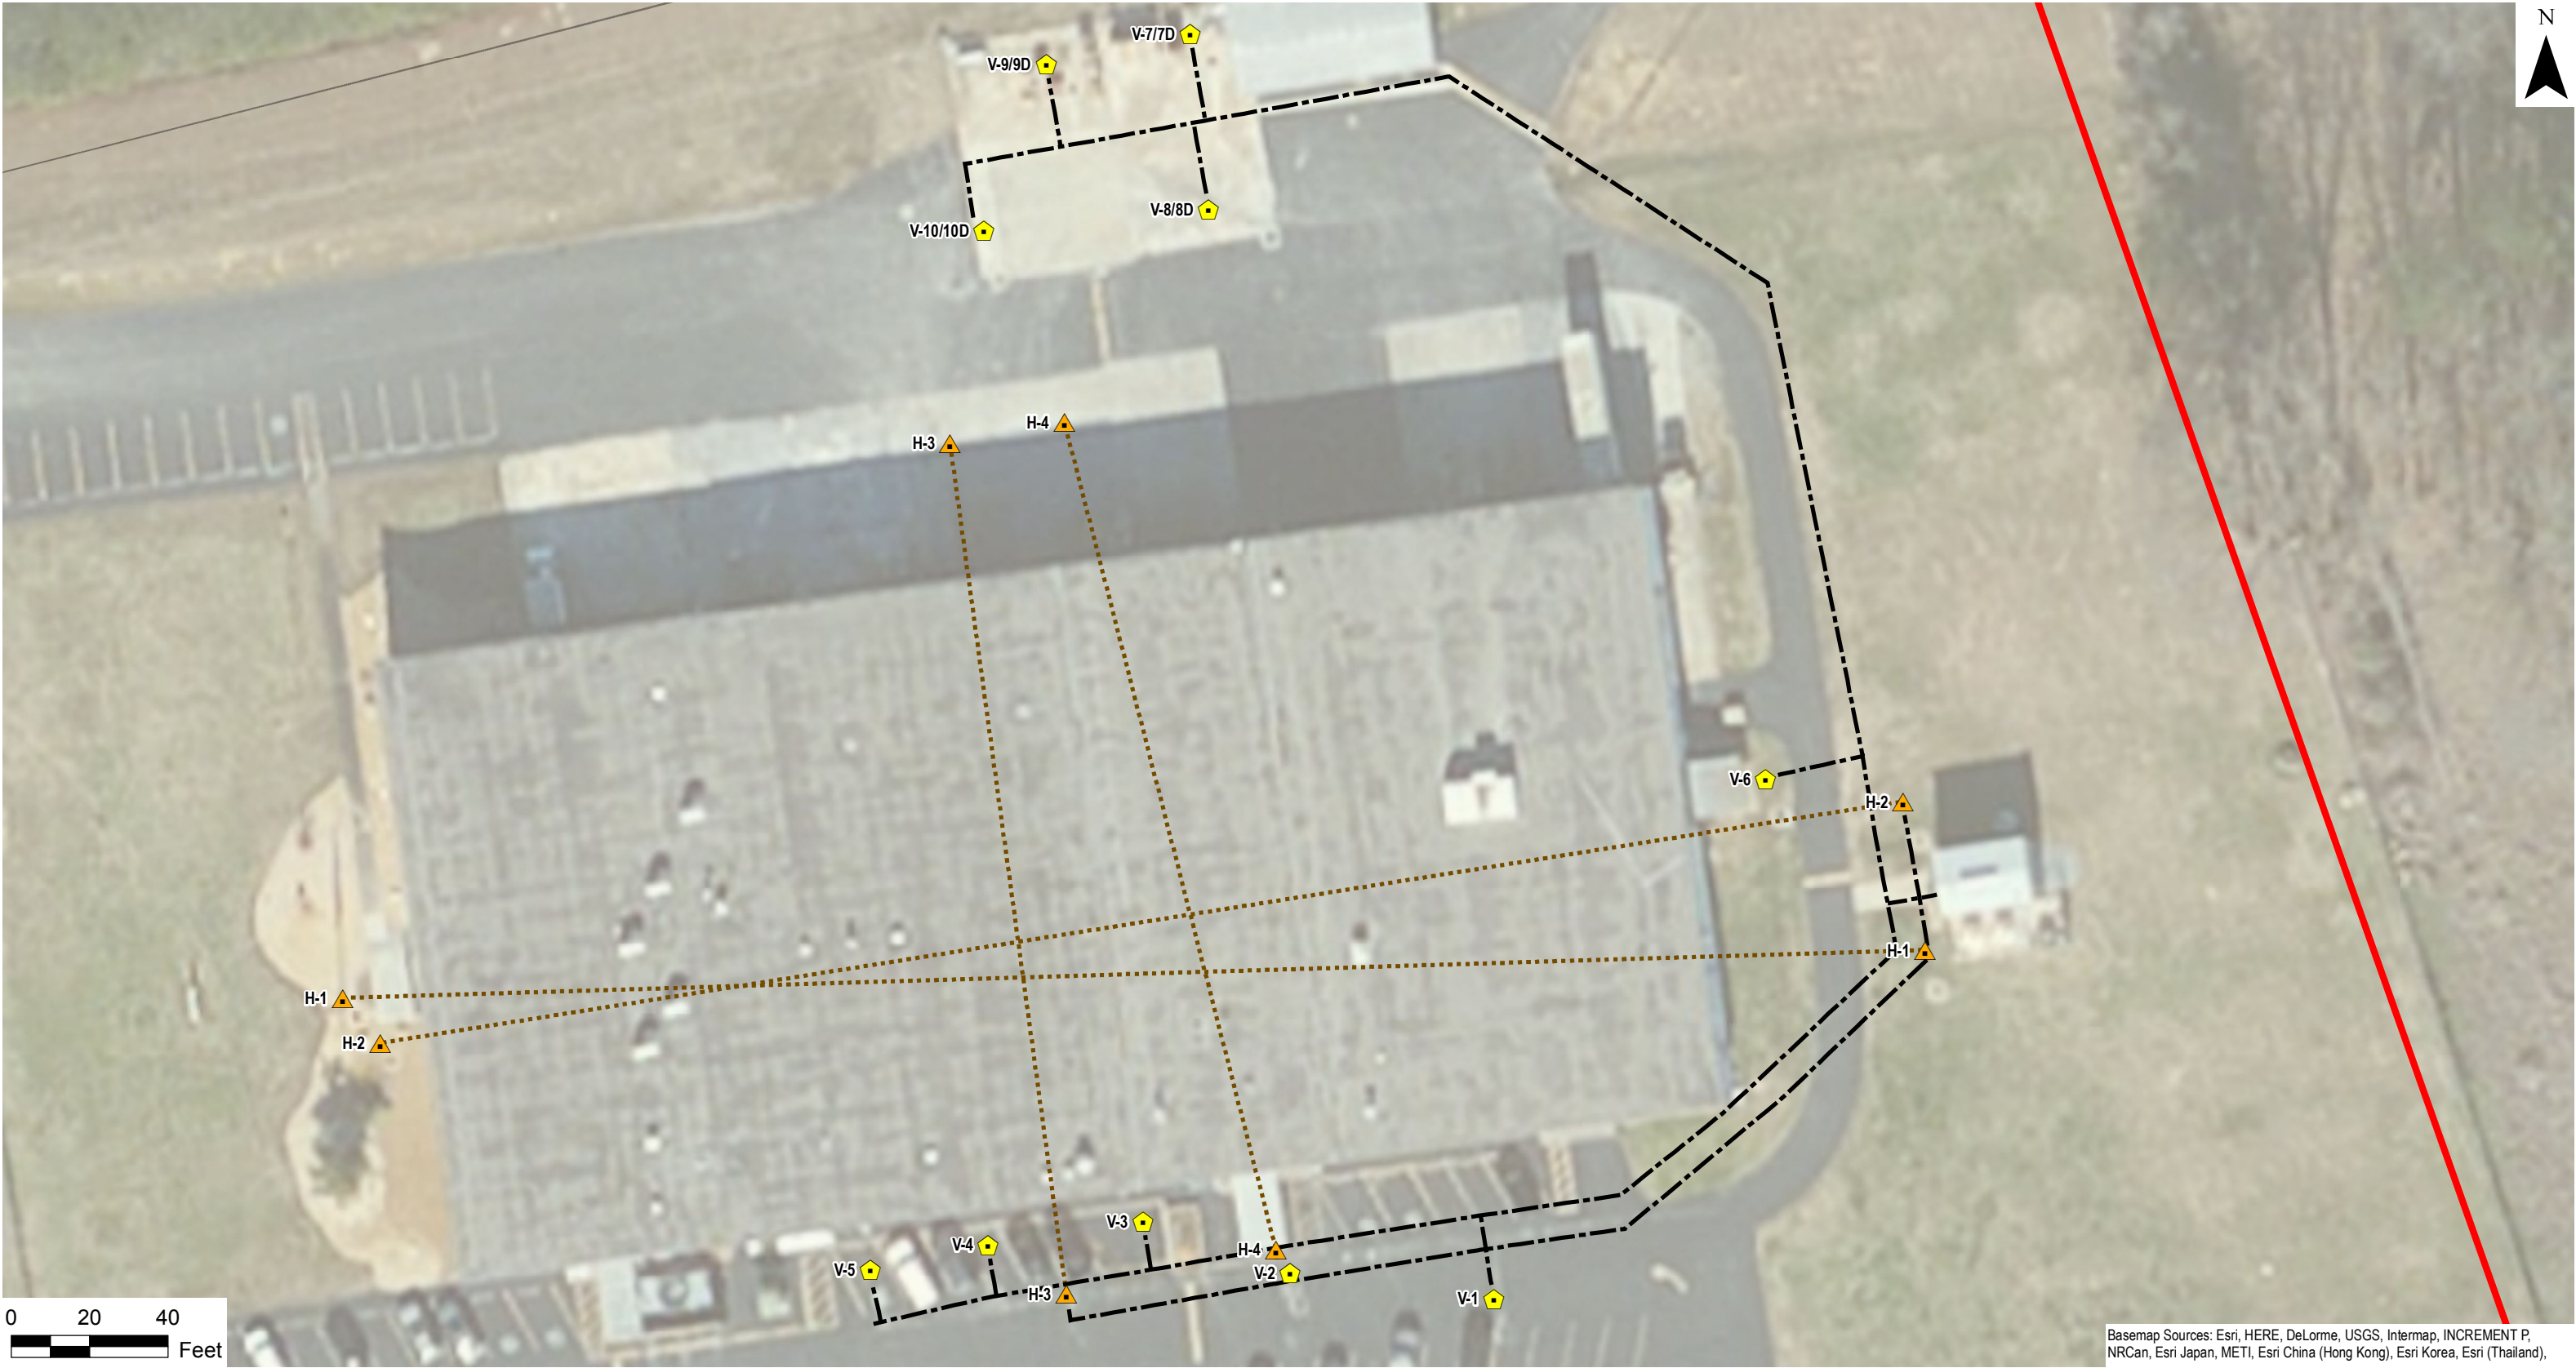
Historical Extent of Groundwater with Type 1 RRS Exceedances

Site investigations led to the delineation of chlorinated solvents in soil and groundwater, laterally and vertically. Investigations identified a former source area at or near the original PCE tank location and one source area identified near the former hazardous chemical storage area on the north side of the property. [Figure 2-1](#) presents the source areas and the extent contamination for soil and groundwater that reflect the extent of known historical contamination.

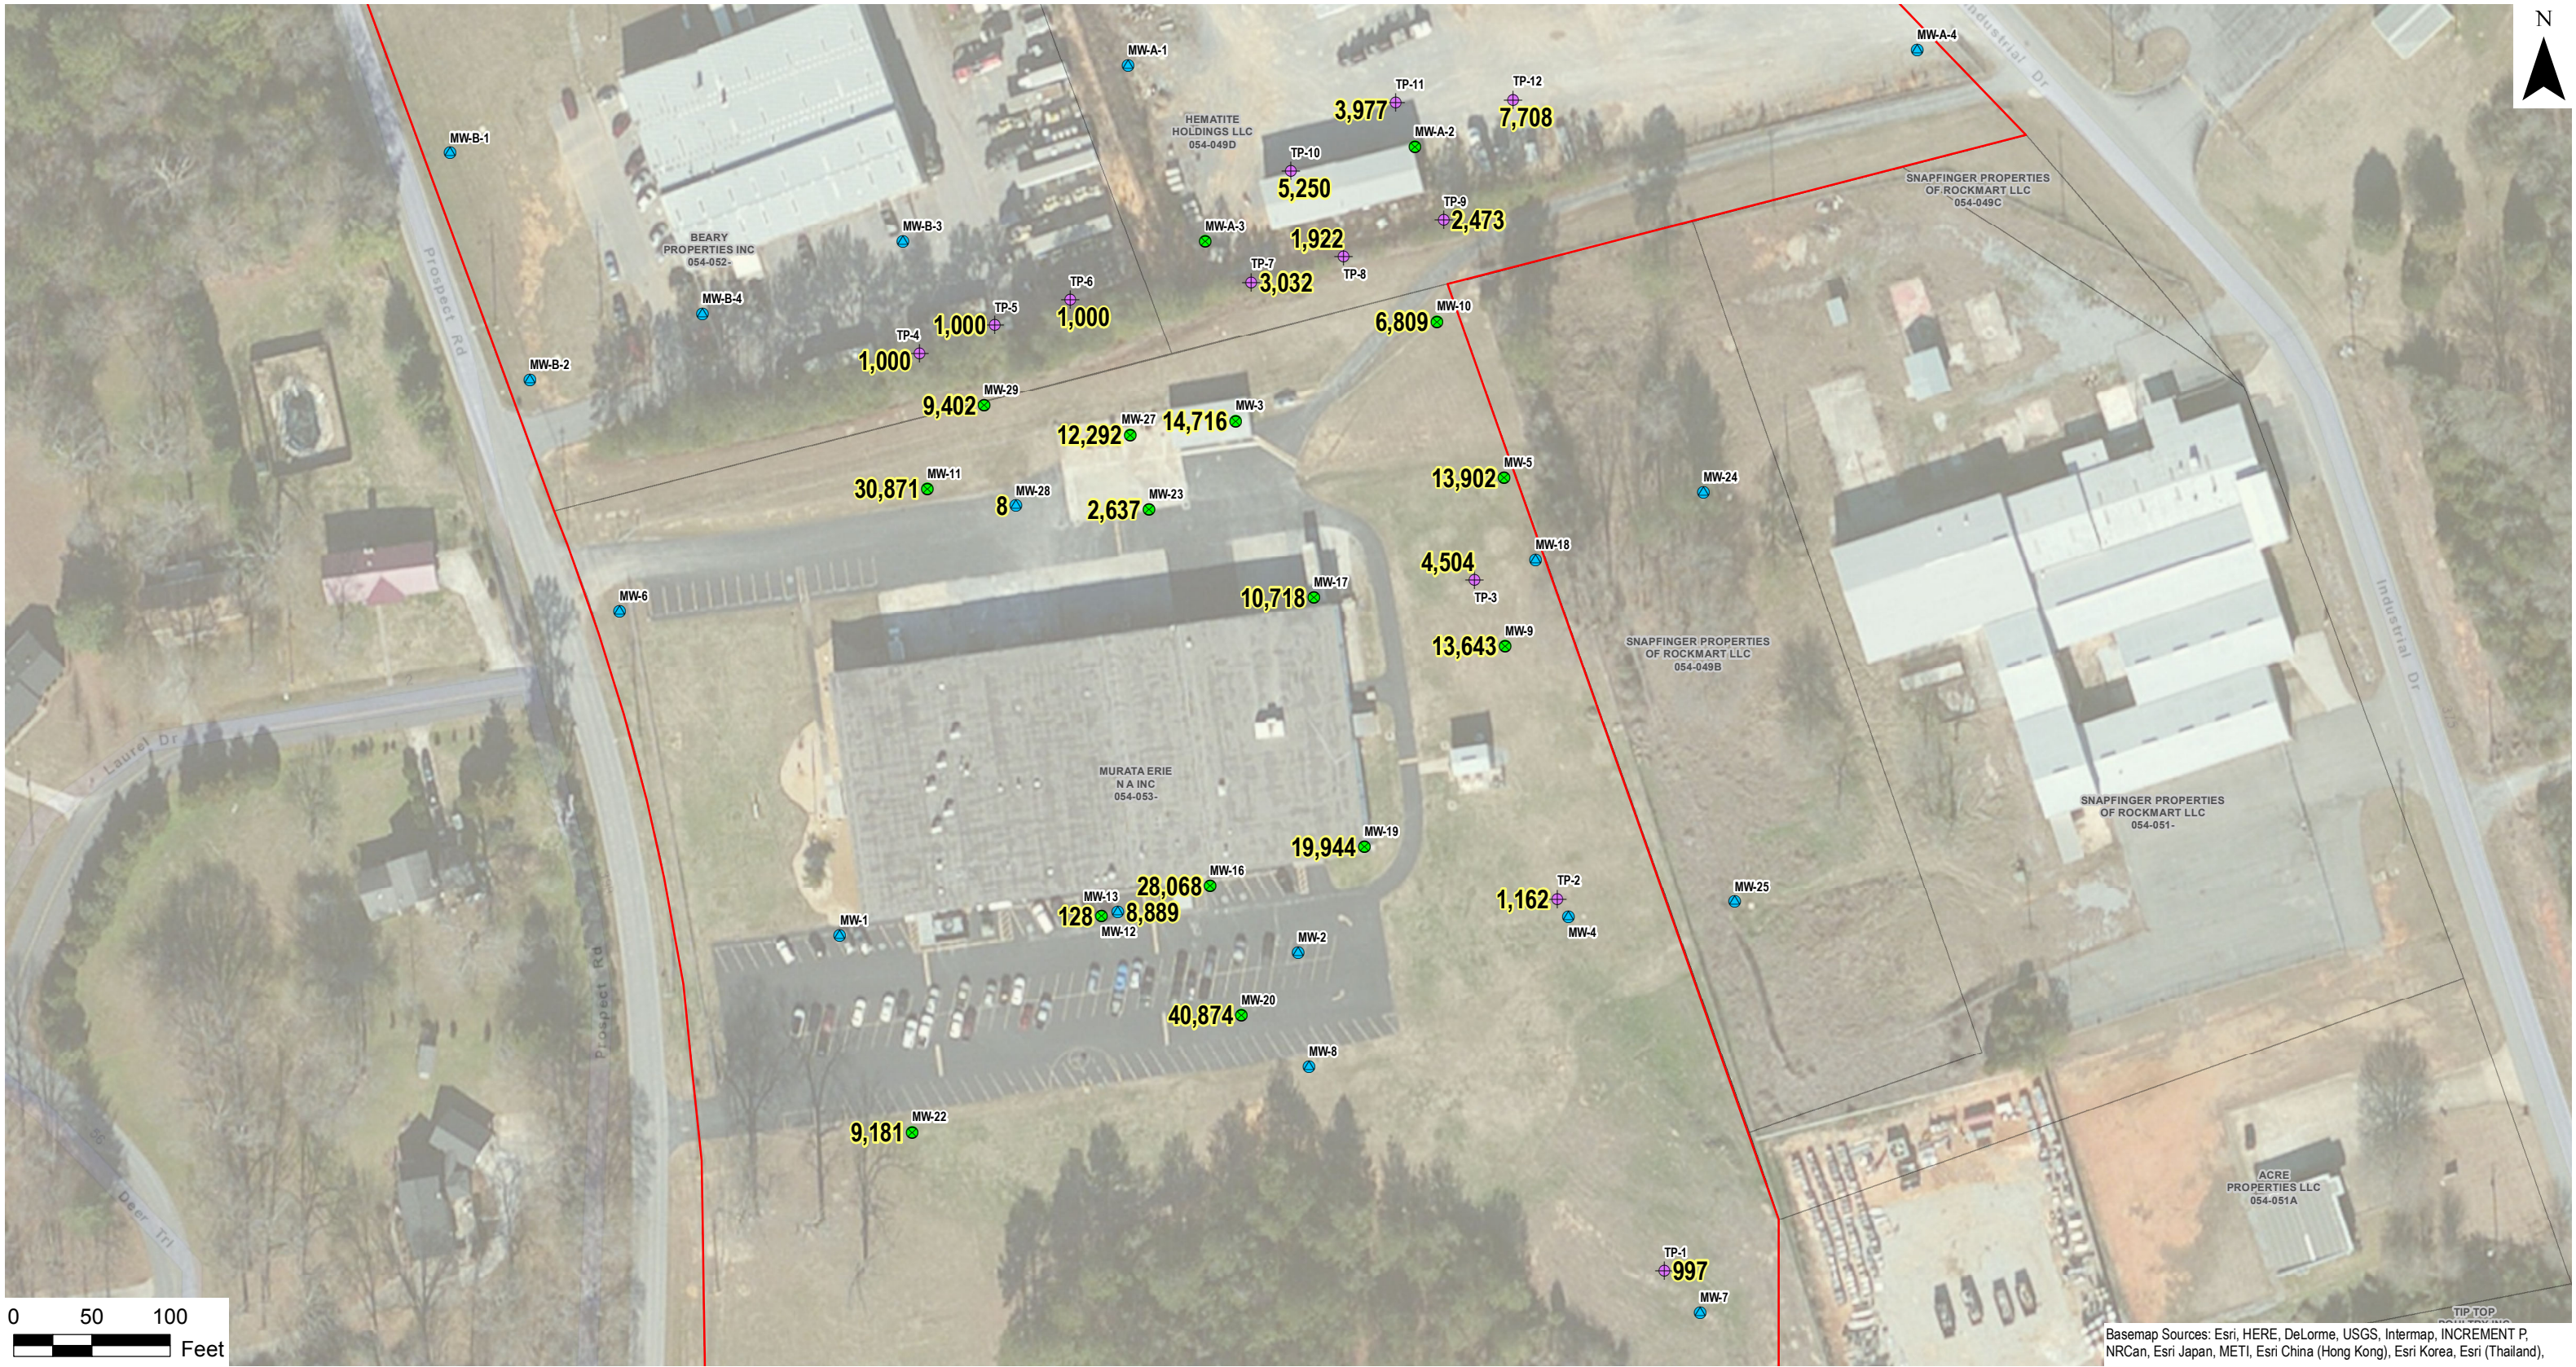
DESIGN:	S Vizuite	DRAWN:	N Vrey	CHKD.:	H Sartain
DATE:	3/22/2017	SCALE:	AS SHOWN	REVISION:	0
FILE:	E:\MurataGIS\MXD\2017\2017 03-Mar VIRP Rpt\F2-4_ChemInj-QtyLoc.mxd

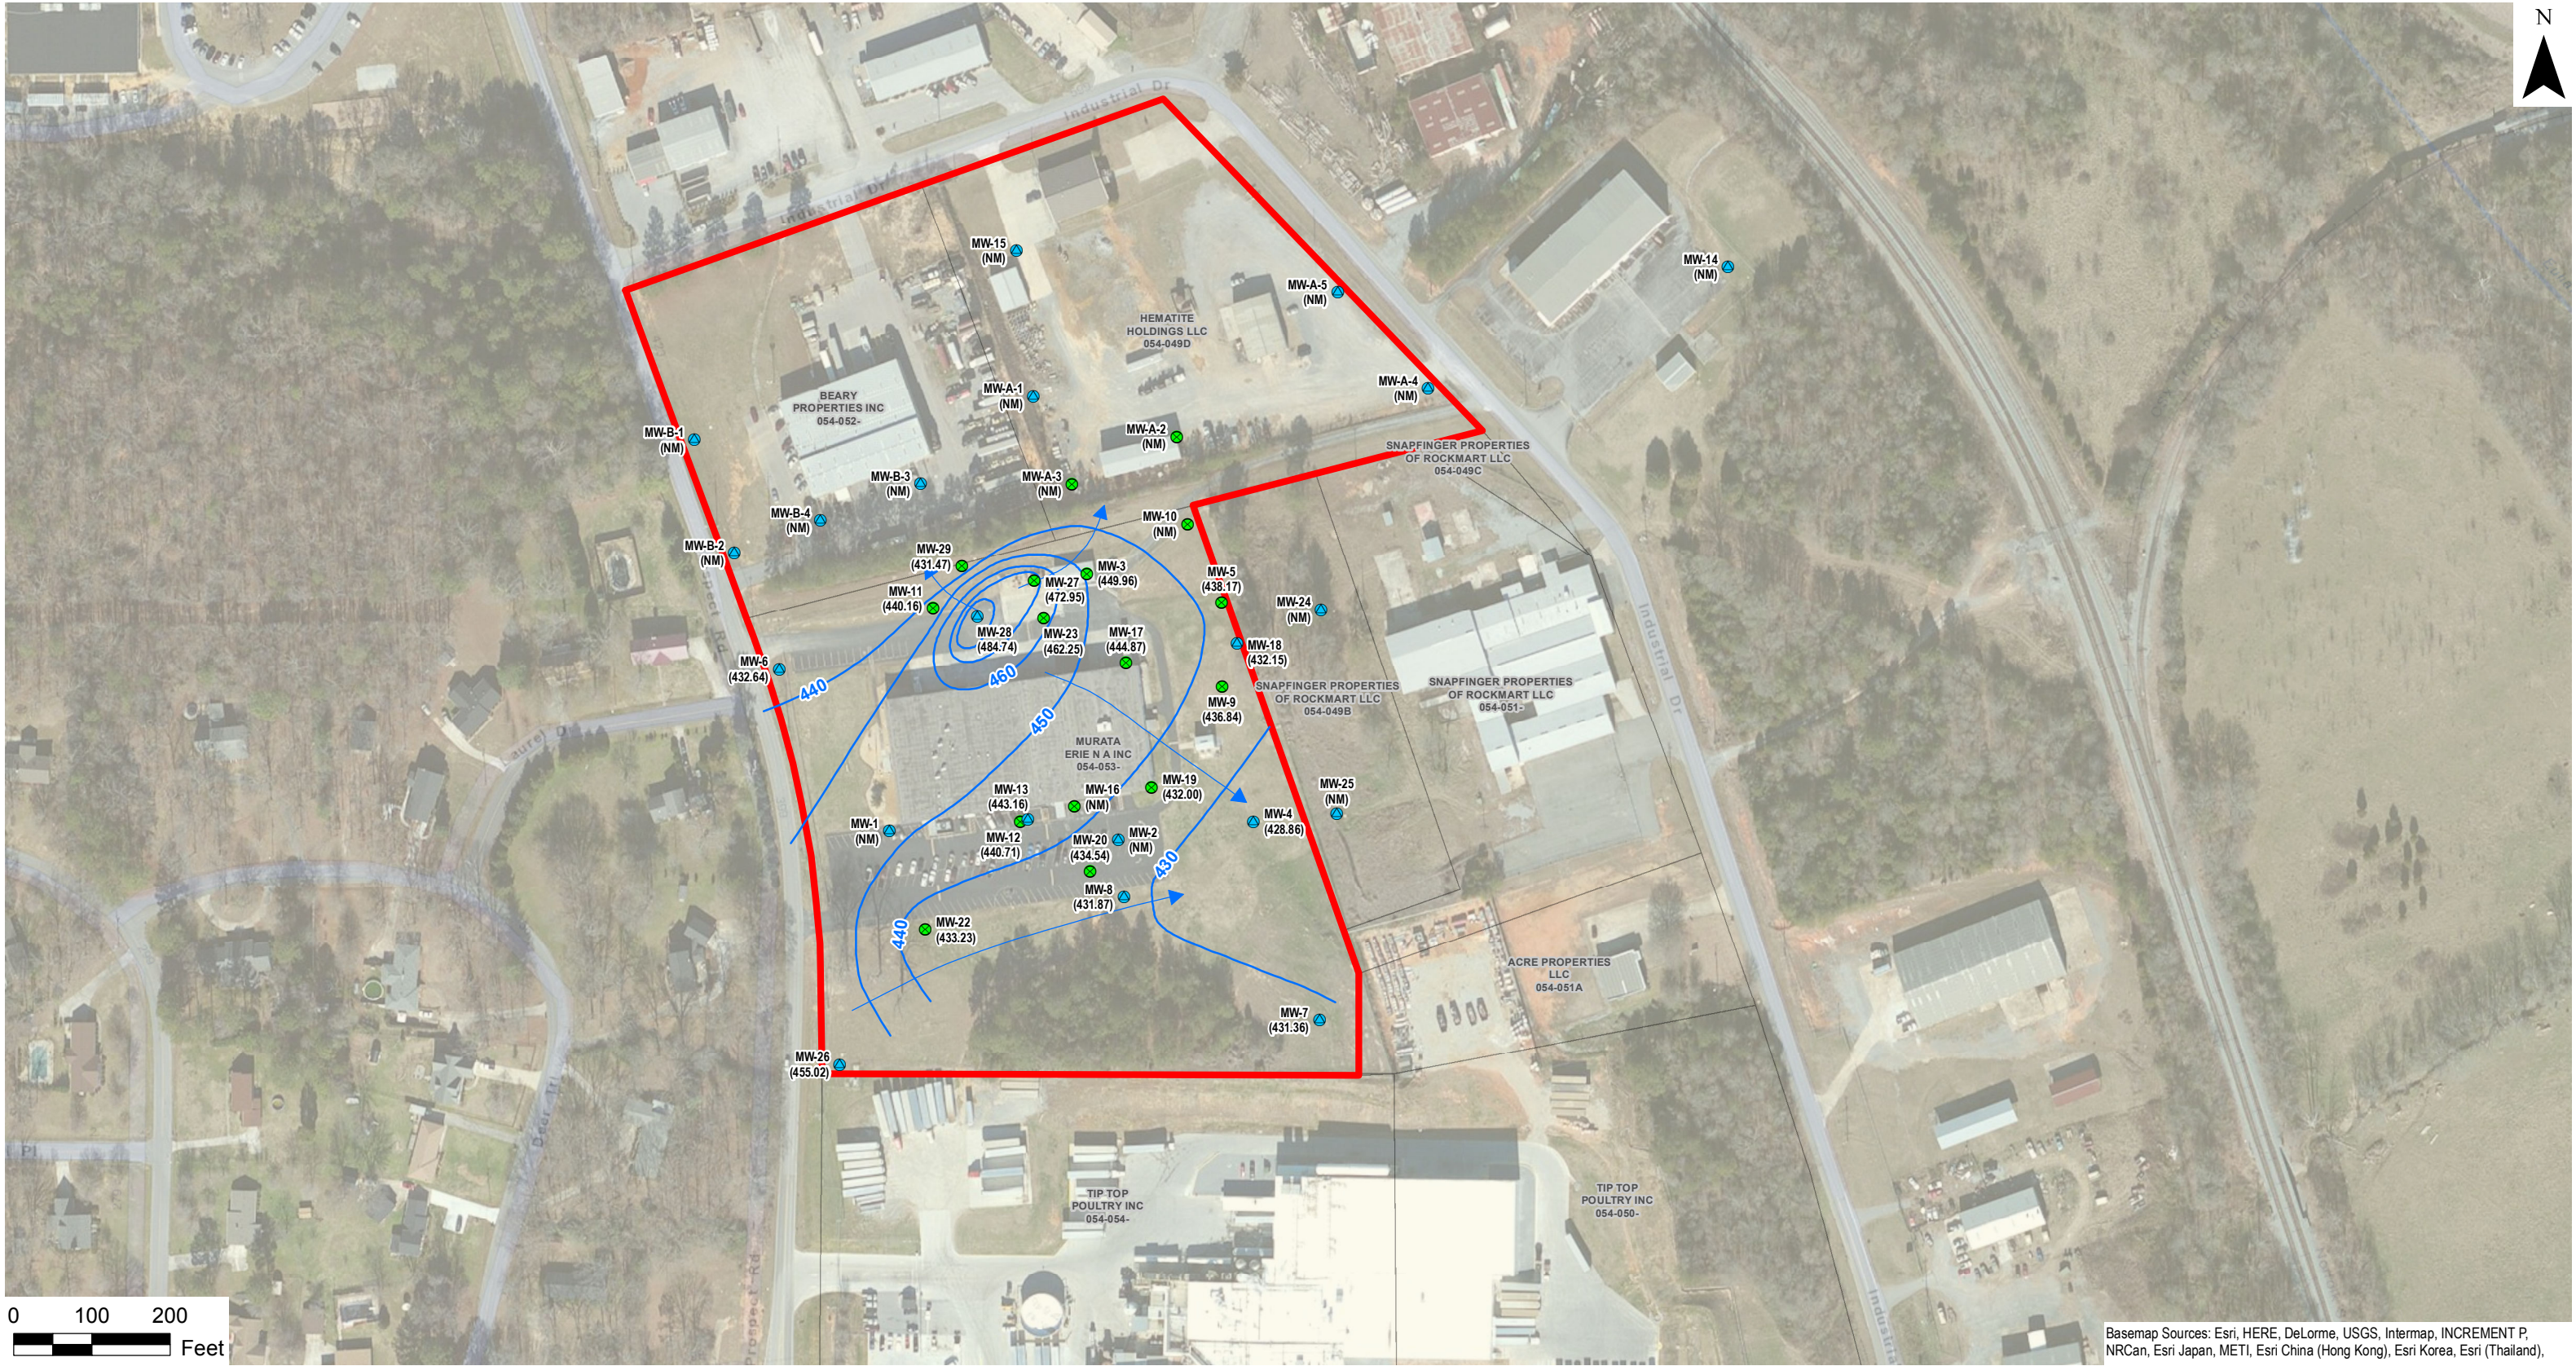
- Monitoring Well Location
- Injection Well Location
- Potentiometric Surface Contour
- Apparent Groundwater Flow Direction

Groundwater movement in the shallow water-bearing zone typically approximates ground surface topography, with the direction of ground water movement being from upland areas to lower nearby drainage features. Groundwater in the bedrock is located within fractures and other structural features of the rocks tend to be more complex and may be affected by the structural setting of the Site.

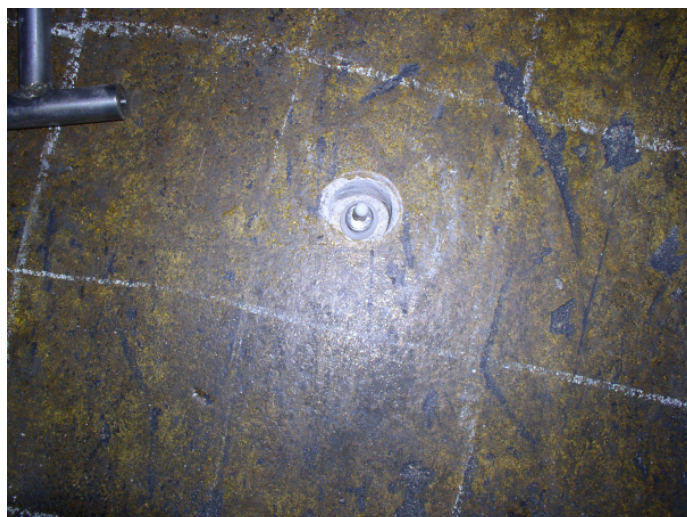
A typical installation of a soil vapor sampling point is shown below.

- sub-slab sampling ports will be installed immediately following completion of indoor sampling; and
- sub-slab sampling points will be left in place for ~2 hours to allow for re-equilibration with the surrounding soil prior to quality assurance checks and soil gas sampling.

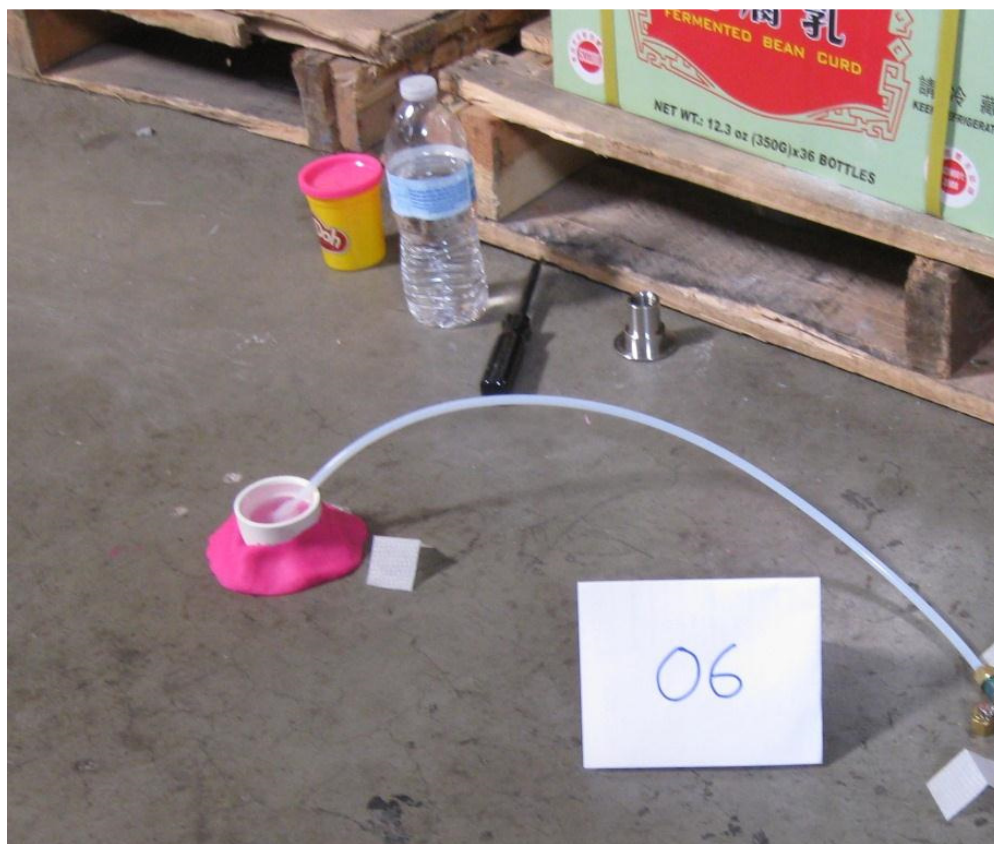
*Typical water dam set-up*

After installation of the sampling point, a water dam will be placed around the point and filled with water. The water will be monitored for five minutes to check for leaks in the seal between the concrete and the Vapor Pin™. If leaks are observed based on water draining into the sampling point, the sampling point will be extracted and reset. The water dam will be used until the seal is determined to be adequate.

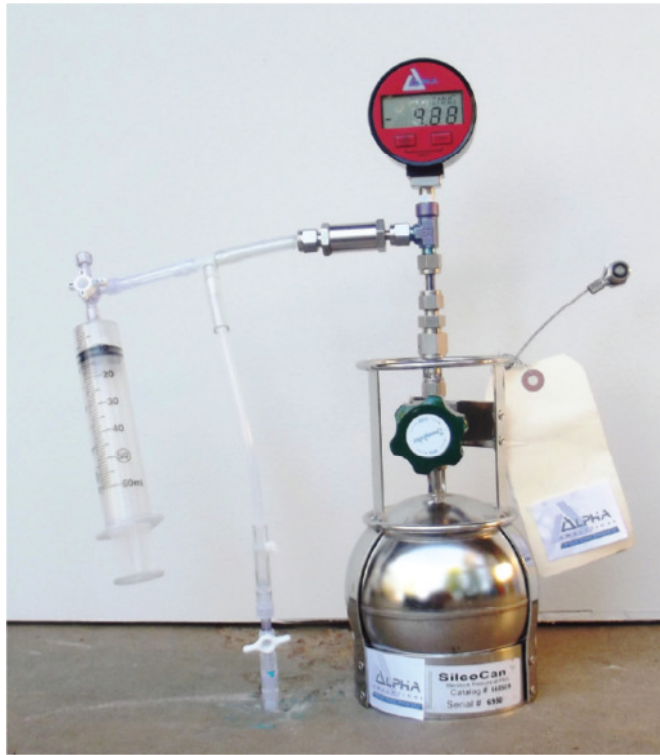
*Shut-in test and sampling configuration*

Nylon (or Teflon) tubing will be attached from the sampling port to a 2.7-liter Summa® canister and a shut-in test will be completed to determine the security of the sampling train between the sampling port and the sampling canister. The shut-in test is performed by generating a vacuum inside the sample tubing while keeping the sampling port and the sampling canister closed. A vacuum of approximately 100 inches of water is generated using a plastic syringe and the vacuum is monitored for 1 minute. If vacuum is maintained for the observed period, then the sampling train is deemed adequate and sampling can begin. If vacuum is lost during the observation period, then tubing connections should be tightened/alterd until there is no observable loss in vacuum during the test. After the shut-in test is validated, the sampling train should not be altered.

After completion of quality control activities, the sampling port will be opened and access to the plastic syringe will be closed. The sampling canister is equipped with a flow controller limiting flow to approximately 200 ml/min (i.e., approximately a 13.5 minute sampling time into a 2.7-liter sampling canister). The sampling canister is opened and the vacuum in the canister is monitored during sampling collection. Sampling is complete when vacuum measurements indicate approximately no vacuum in the canister (approximately 13.5 minutes). Residual vacuum is not required in the 2.7-liter sampling canisters because the full sampling period (i.e., 13.5 minutes) will be actively monitored by field personnel (i.e., a witnessed sample). If residual vacuum remains in the 2.7-liter sampling canisters, it cannot exceed 15 inches of mercury (in Hg) or laboratory reporting limits will be affected. Residual vacuum, if any, will be confirmed and recorded by the laboratory after receipt of the canisters.

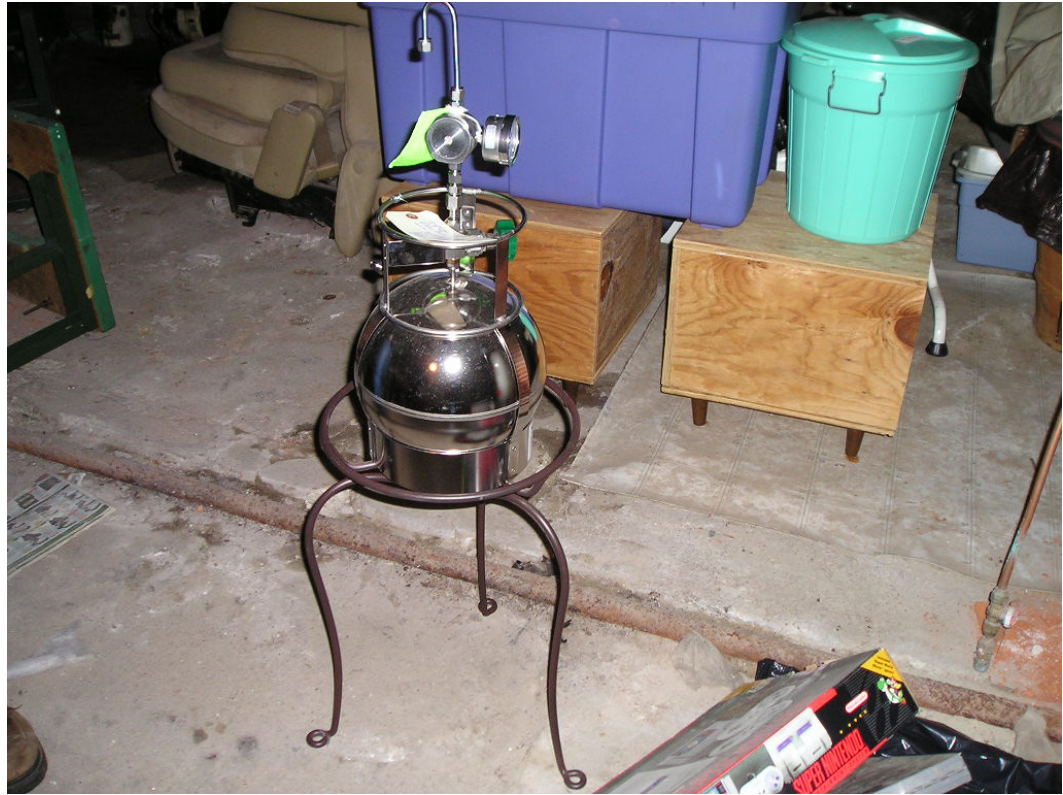
*Typical indoor air sampling set-up (with typical turned-down flow controller).*

The air intake of each canister will be located at breathing zone heights of approximately 3 to 5 feet above the floor surface. When feasible, areas

where chemicals or cleaning agents are used or stored will be avoided. The indoor air sample will be collected away from exterior windows or doors, if possible. At the time of sample retrieval, noticeable changes in the condition of the sampling area, such as open windows or doors, changes to the operation of the heating/ventilation system, or condition or location of items in proximity to the canister, will be noted on the air sample data sheet.

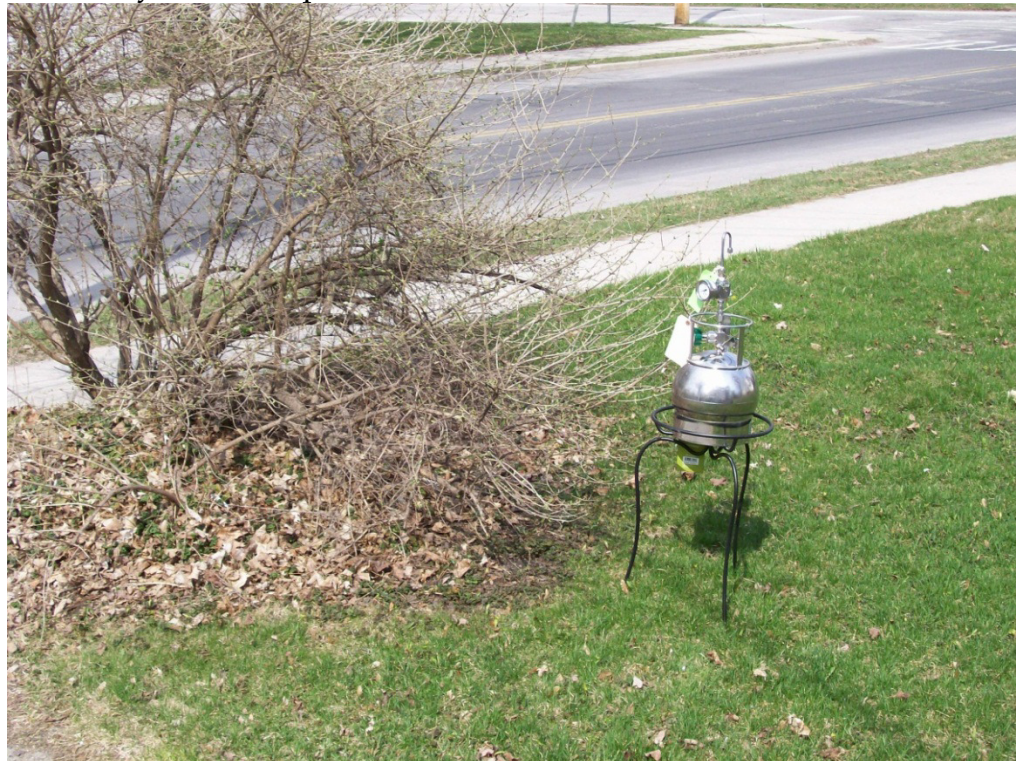
*Typical outdoor air sampling set-up*

The air intake of each canister will be located at breathing zone heights of approximately 3 to 5 feet above the floor surface. The air intake will be positioned facing downward to protect against rainwater. Outdoor ambient air samples will be collected with a Summa<sup>®</sup> canister equipped with an 8-hour flow regulator. The canister and flow regulator will be batch certified clean by the laboratory prior to use. The sample canister will be deployed after completion of the appropriate air sample data sheet and will be retrieved approximately 8 hours later. Personnel will periodically check on the Summa<sup>®</sup> canister over the 8-hour sampling period to monitor changes in vacuum and note activity and wind direction changes in the vicinity of the sample location. The vacuum reading of each canister will be recorded on the air sampling data sheet ([Attachment G-2](#)) prior to and upon recheck of the sample. Residual vacuum will also be recorded on the air sampling data sheet at the conclusion of the sampling period. The residual vacuum remaining in the outdoor ambient air canister at the conclusion of the sampling period will not be less than approximately 5 inches of mercury (in Hg). Maintaining a residual vacuum is recommended for sampling canisters to demonstrate that the canister was collecting air throughout the entire sampling period. The residual vacuum will also be confirmed and recorded by the laboratory after receipt of the canisters.
