**COMPLIANCE STATUS REPORT**

**FOR FORMER TAX PARCEL 14-82-6-3**

**NORTHSIDE DRIVE LANDFILL**

**HAZARDOUS SITE INVENTORY SITE NO. 10222**

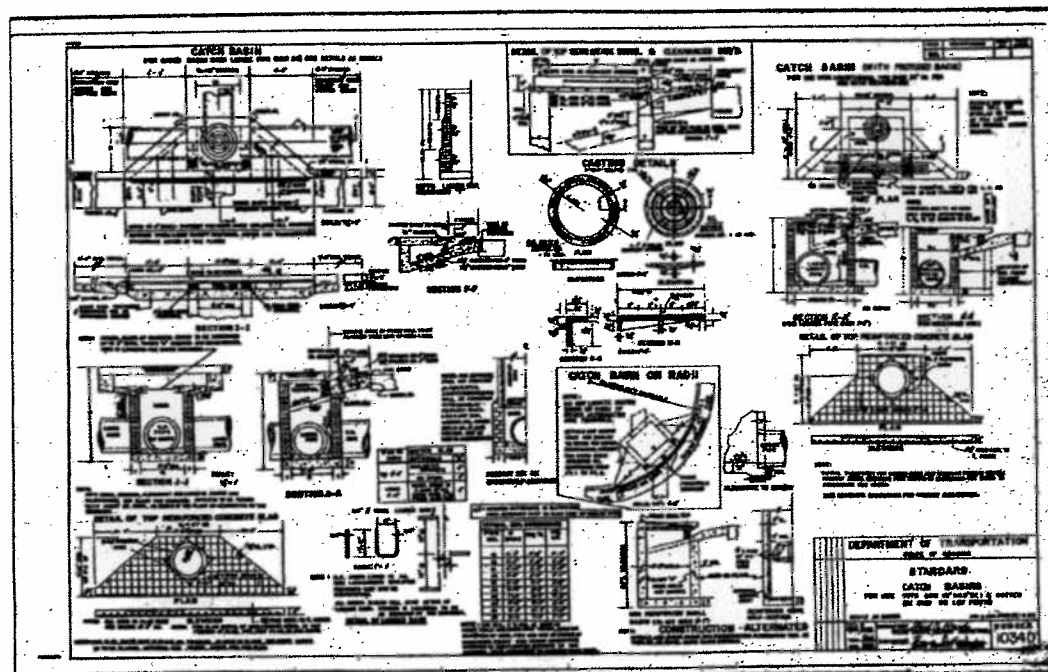
ODOT STANDARD CATCHBASIN (W/WING WALLS)

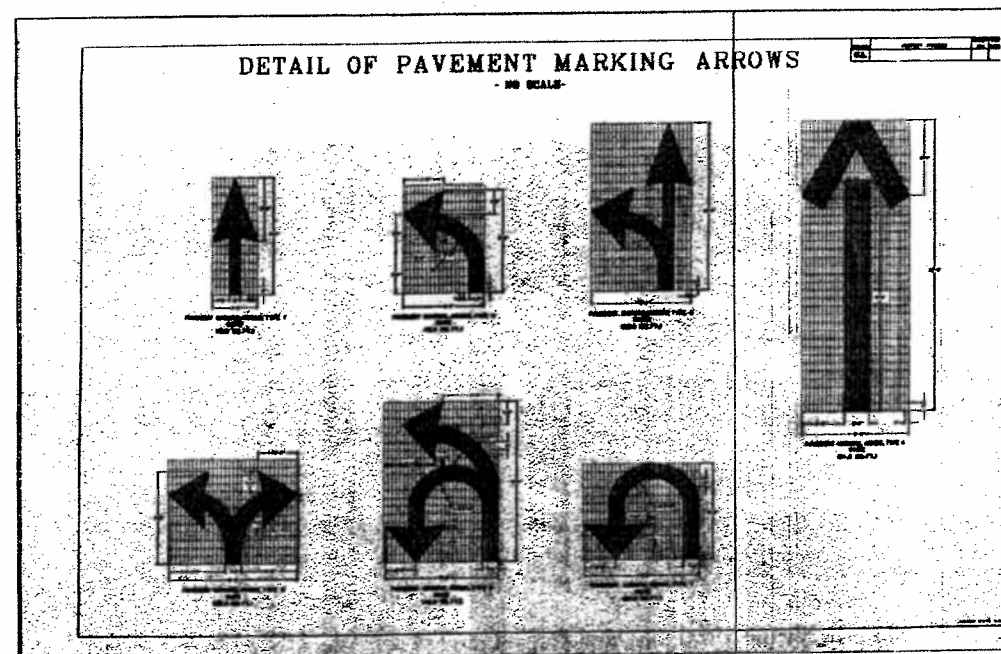
PAVEMENT MARKINGS DETAIL

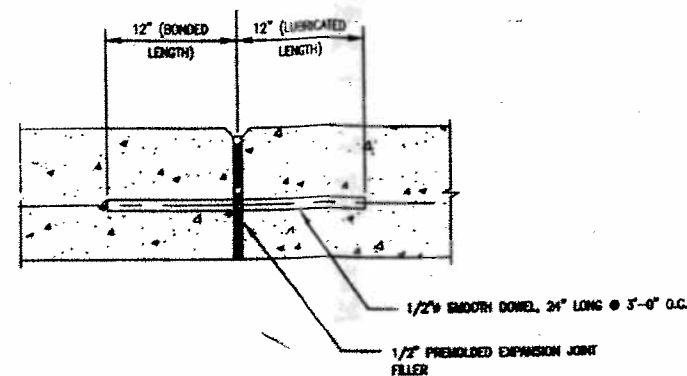
TYPICAL EXPANSION JOINT

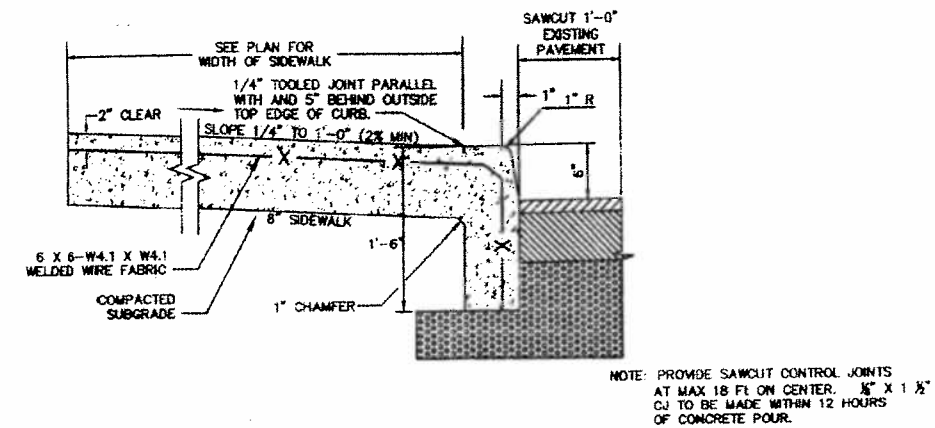
8" MONOLITHIC SIDEWALK AND CURB

1. SIDEWALK SHALL BE SCRIBED WITH TRAVERSE CONTROL JOINTS IN SQUARES EQUAL TO SIDEWALK WIDTH, BUT NOT TO EXCEED 10 FEET.  $\frac{1}{8}$ " X  $1\frac{1}{2}$ " CONTROL JOINT TO BE MADE WITHIN 12 HOURS OF CONCRETE POUR.
2. CONCRETE SHALL BE TYPE "A" 3,000 P.S.I. MIN STRENGTH.
3. EXPANSION JOINTS SHALL EXTEND ACROSS THE FULL WIDTH OF THE SIDEWALK. CONTROL JOINTS SHALL BE LOCATED ON EACH SIDE OF A DRIVEWAY AND NOT MORE THAN 100 FEET APART.
4. PREFORMED BITUMINOUS MATERIAL SHALL BE PLACED BETWEEN ALL FIXED OBJECTS AND THE NEW CONCRETE SIDEWALK.
5. ALL CONCRETE WORK SHALL BE PER CITY OF ATLANTA STANDARD SPECIFICATIONS FOR CONSTRUCTION.
6.  $\frac{1}{4}$ -INCH TOOLED JOINT BETWEEN CURB AND SIDEWALK.

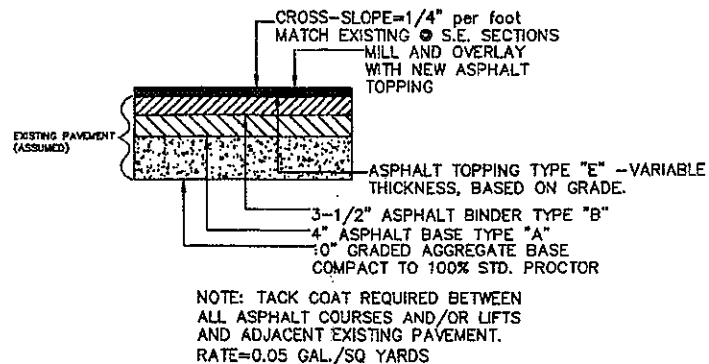
**PAVEMENT SECTION (FOR OVERLAY)**  
NOT TO SCALE

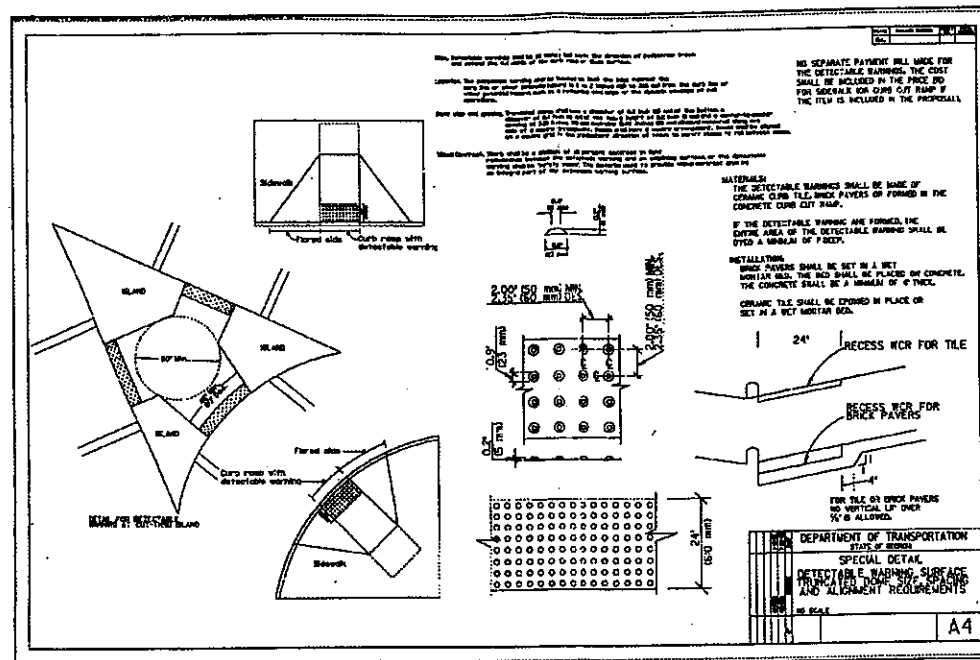
**DETECTABLE WARNING SURFACE**  
NOT TO SCALE

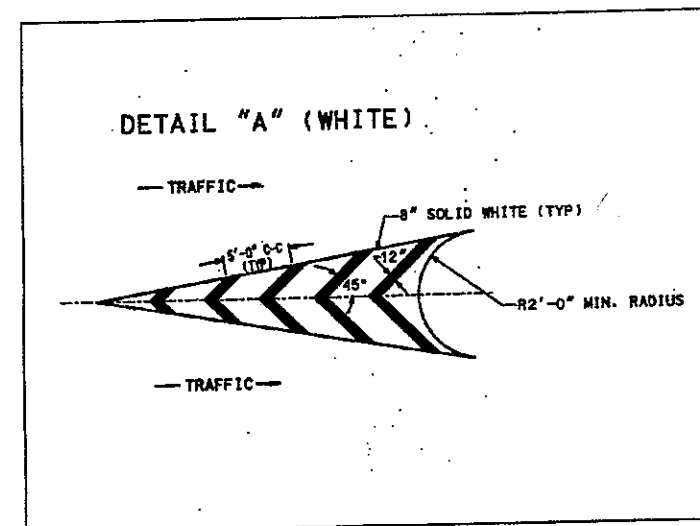
**GORE DETAIL**  
NOT TO SCALE

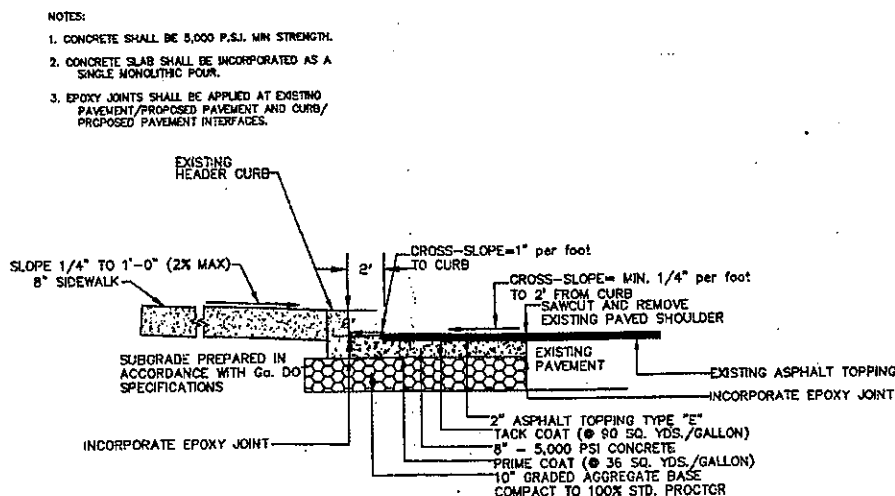
**PAVEMENT SECTION W/8" - 5,000 PSI CONCRETE**  
NOT TO SCALE

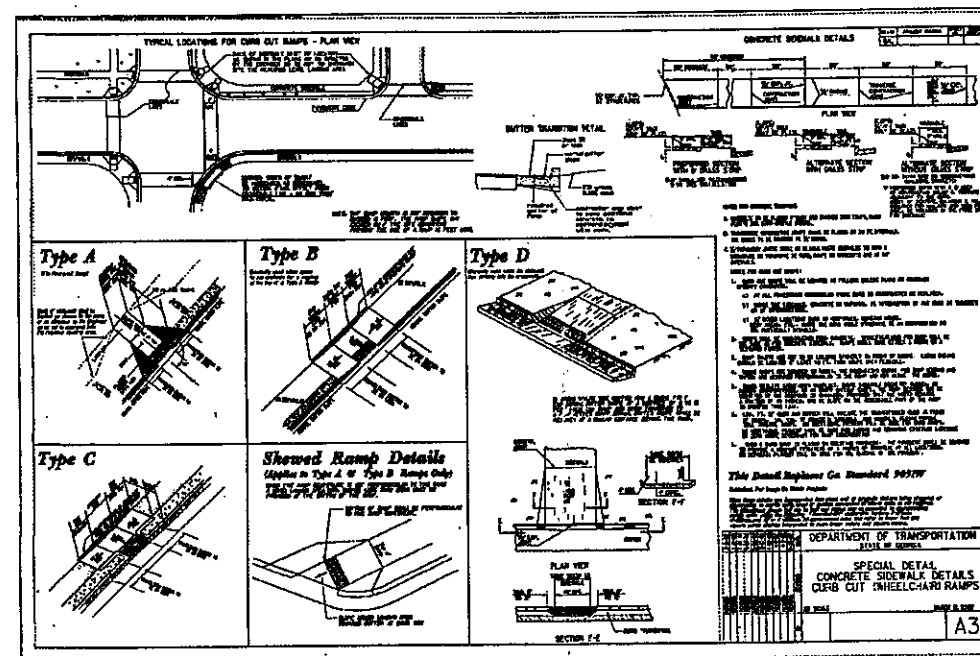
**GDOT SPECIAL DETAIL WHEELCHAIR RAMP**  
NOT TO SCALE

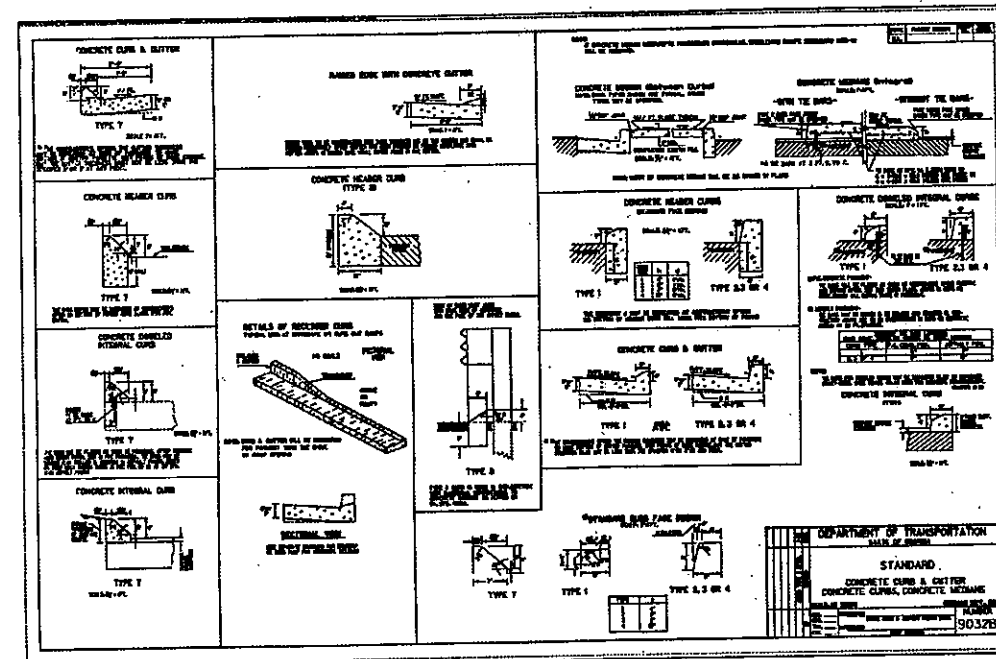
**GDOT HEADER CURB DETAIL**  
NOT TO SCALE

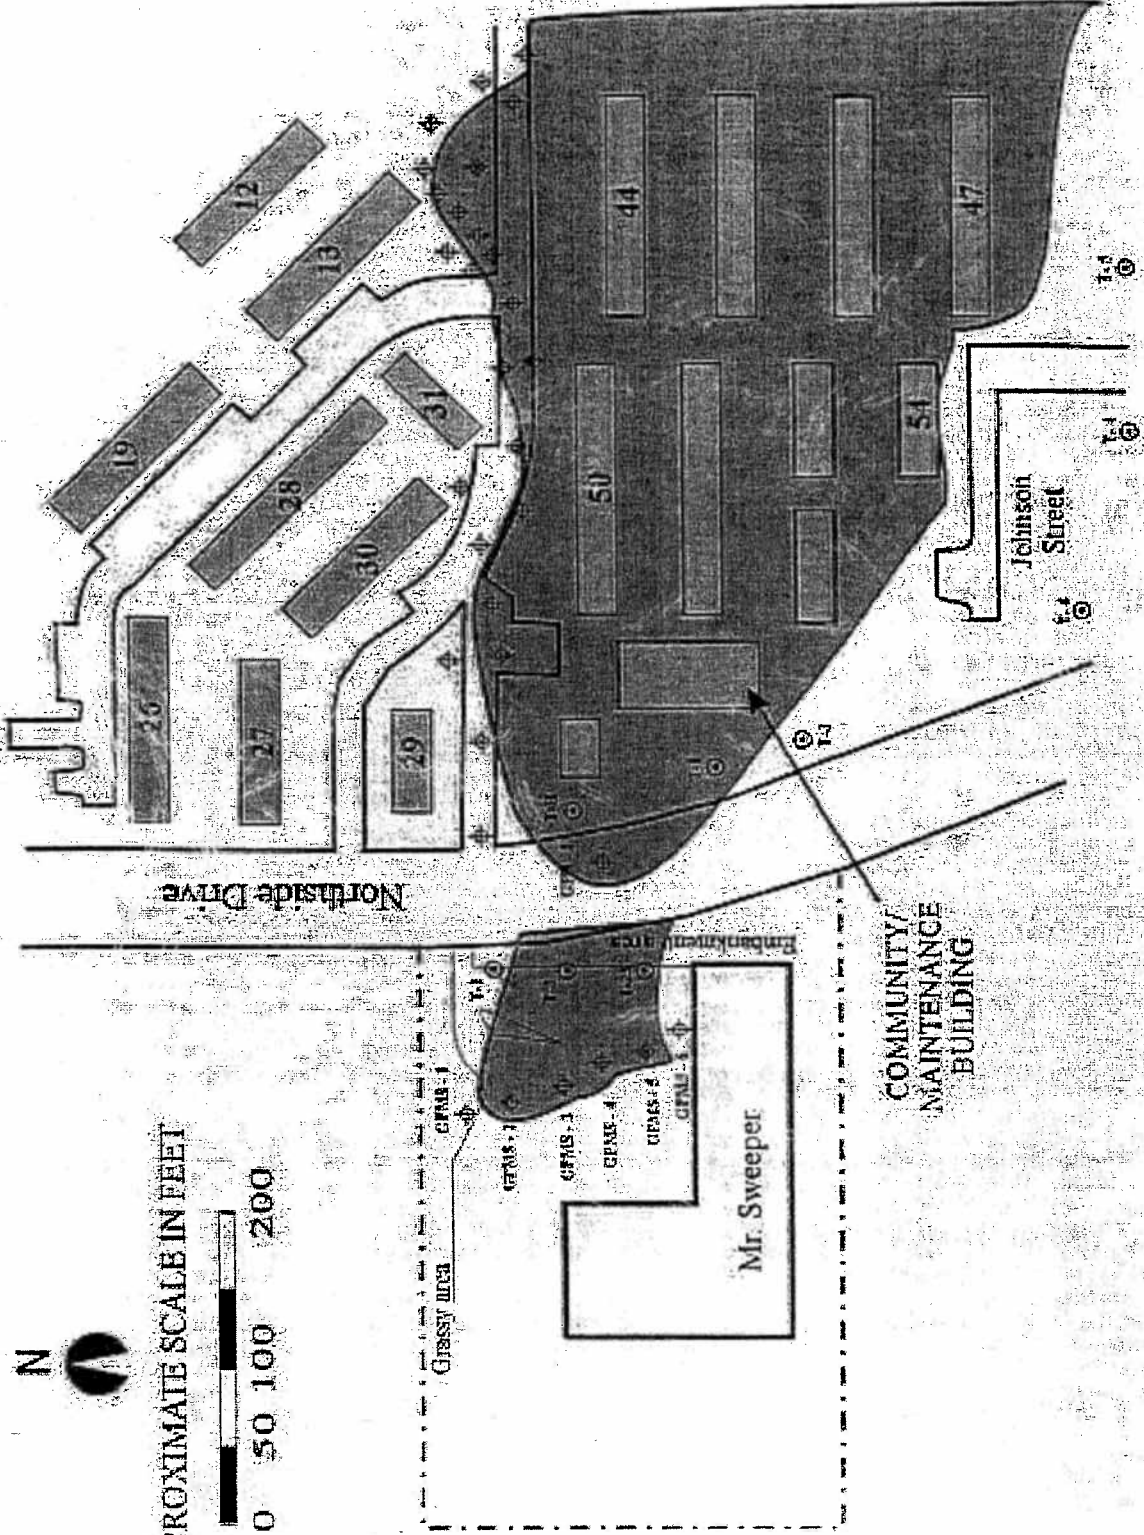
FIGURE 2-3

TEST TRENCHING AND GEOPROBE LOCATIONS  
AT MR. SWEEPER

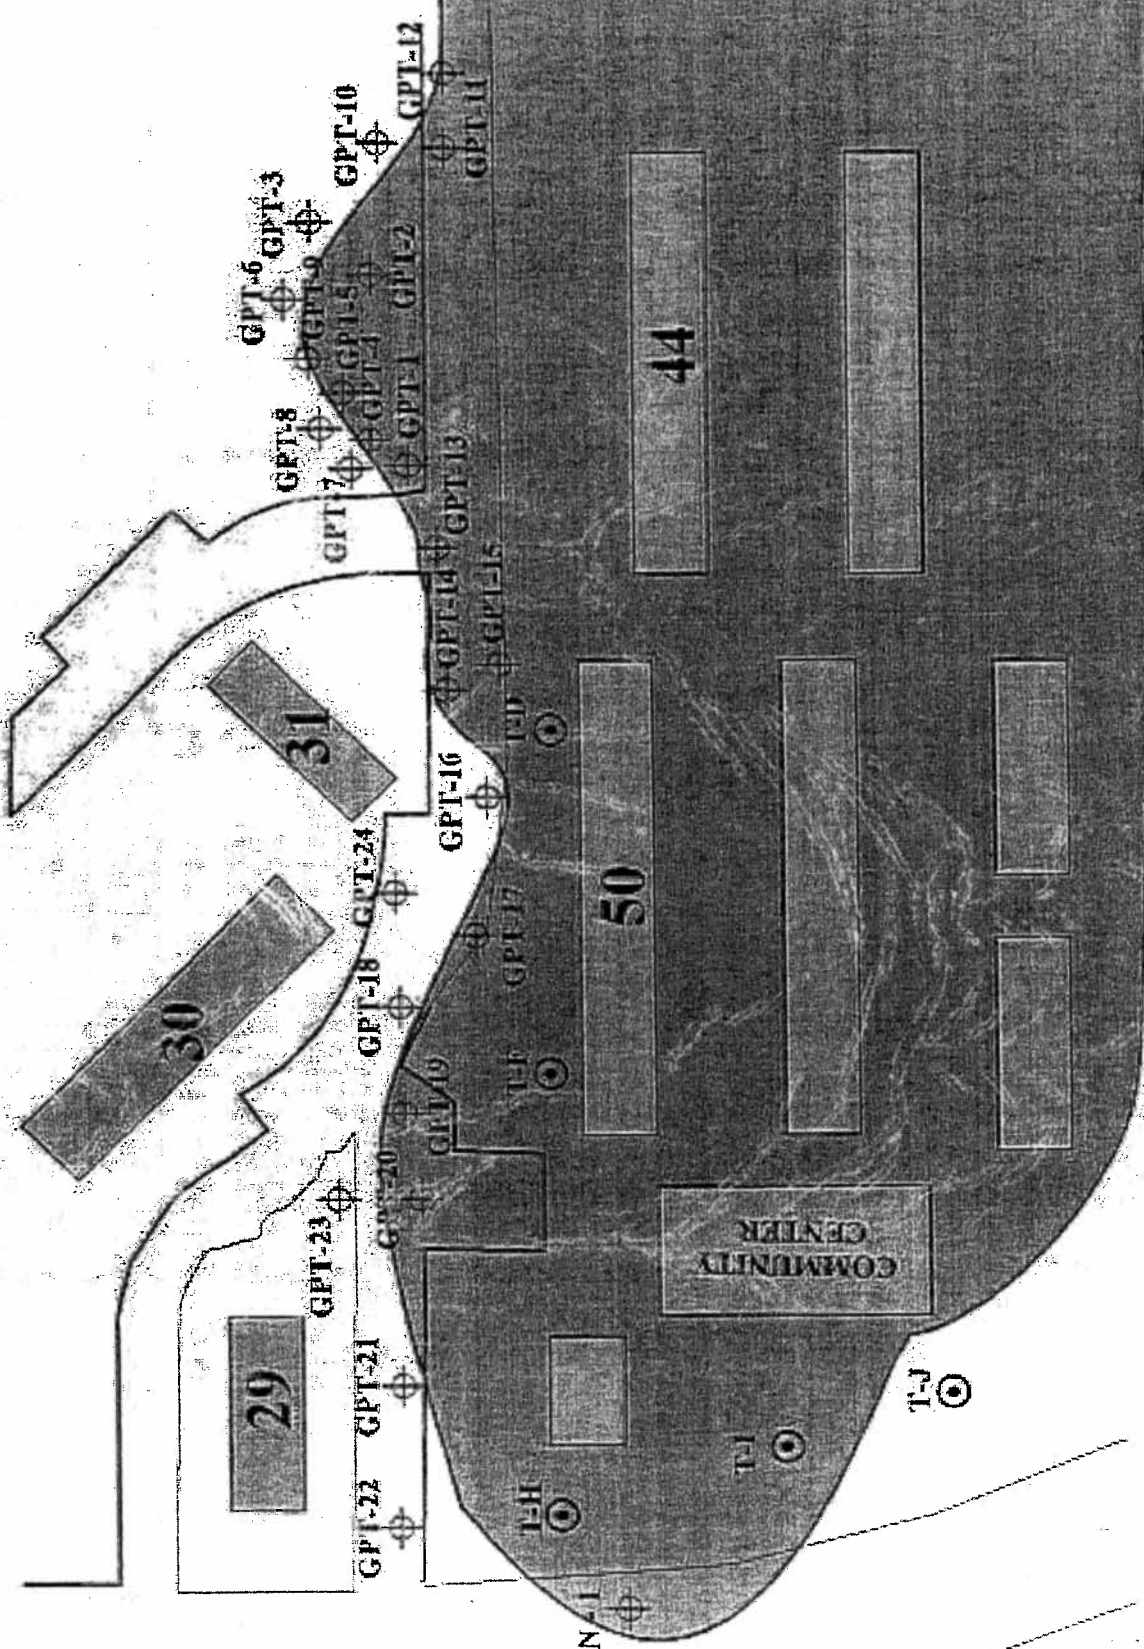
FIGURE 2-4

GEOPROBE BORING LOCATIONS

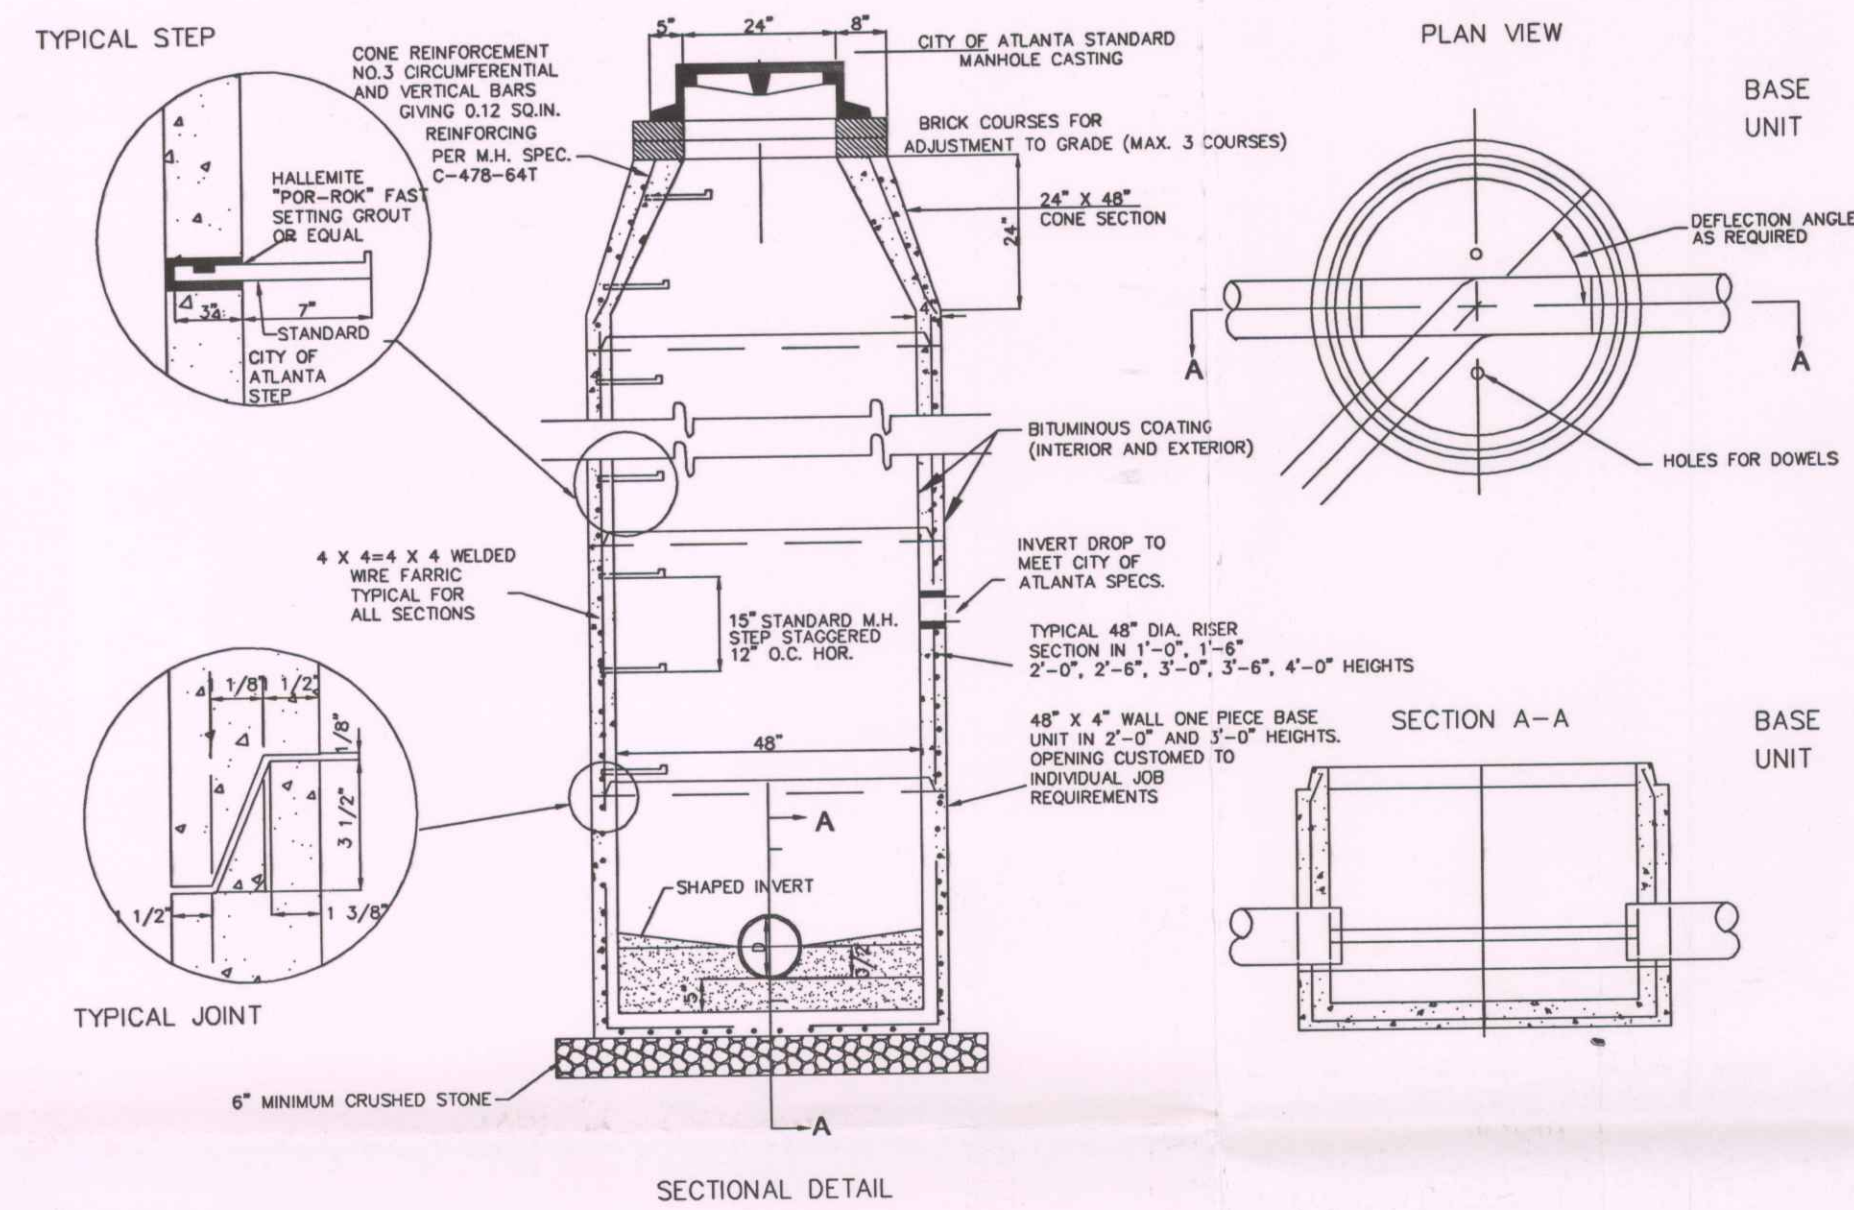
**1 PRECAST CONCRETE MANHOLE**  
CM1.1 NOT TO SCALE

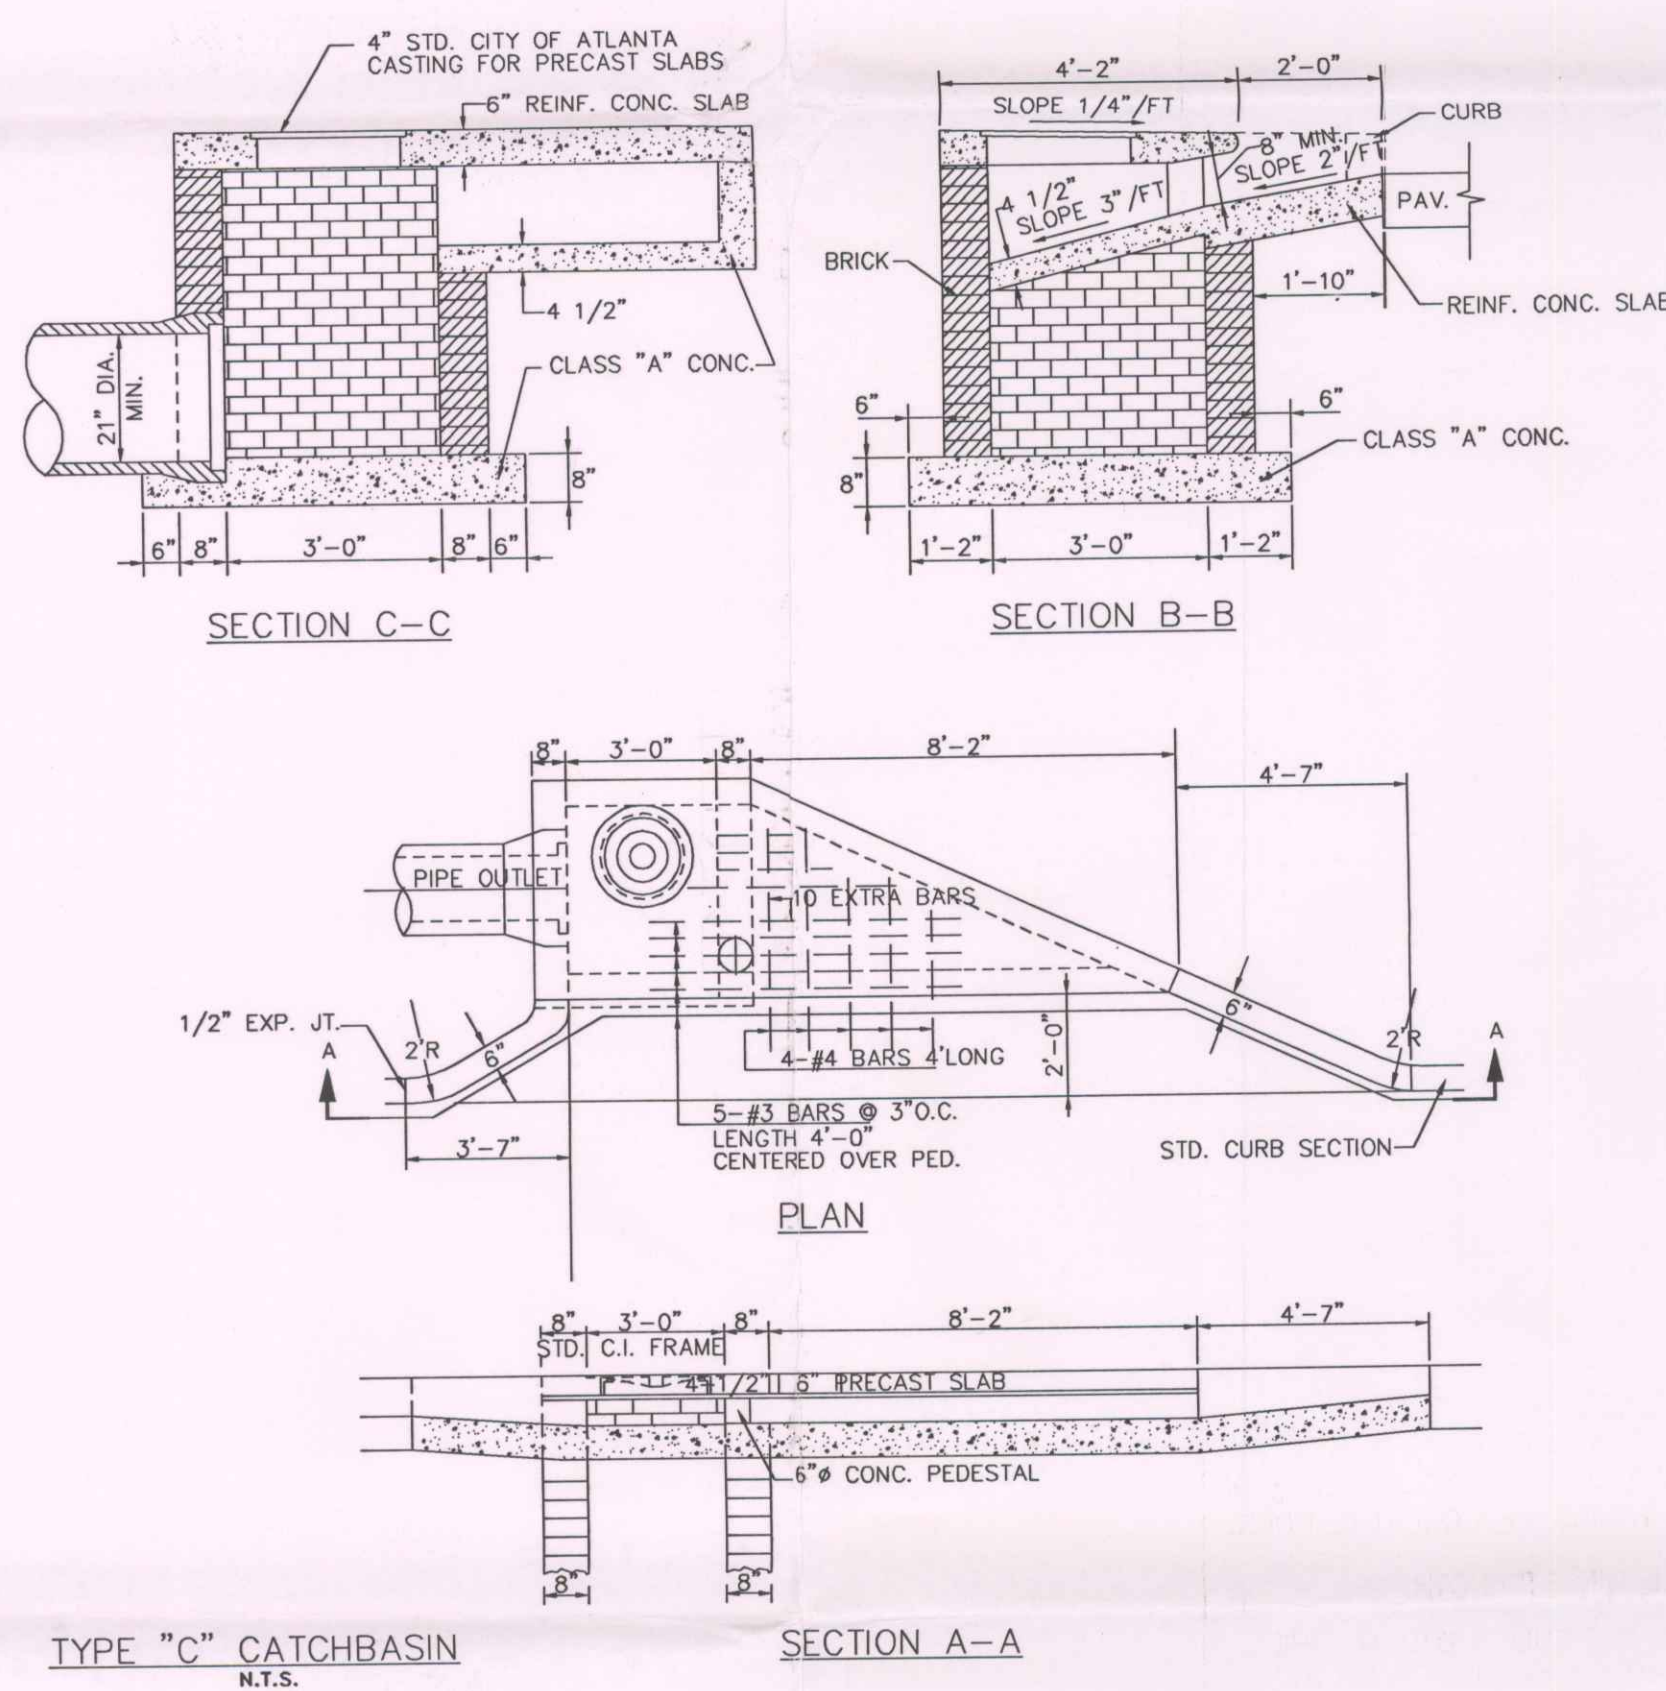
**2 TYPE C CATCHBASIN**  
CM1.1 NOT TO SCALE

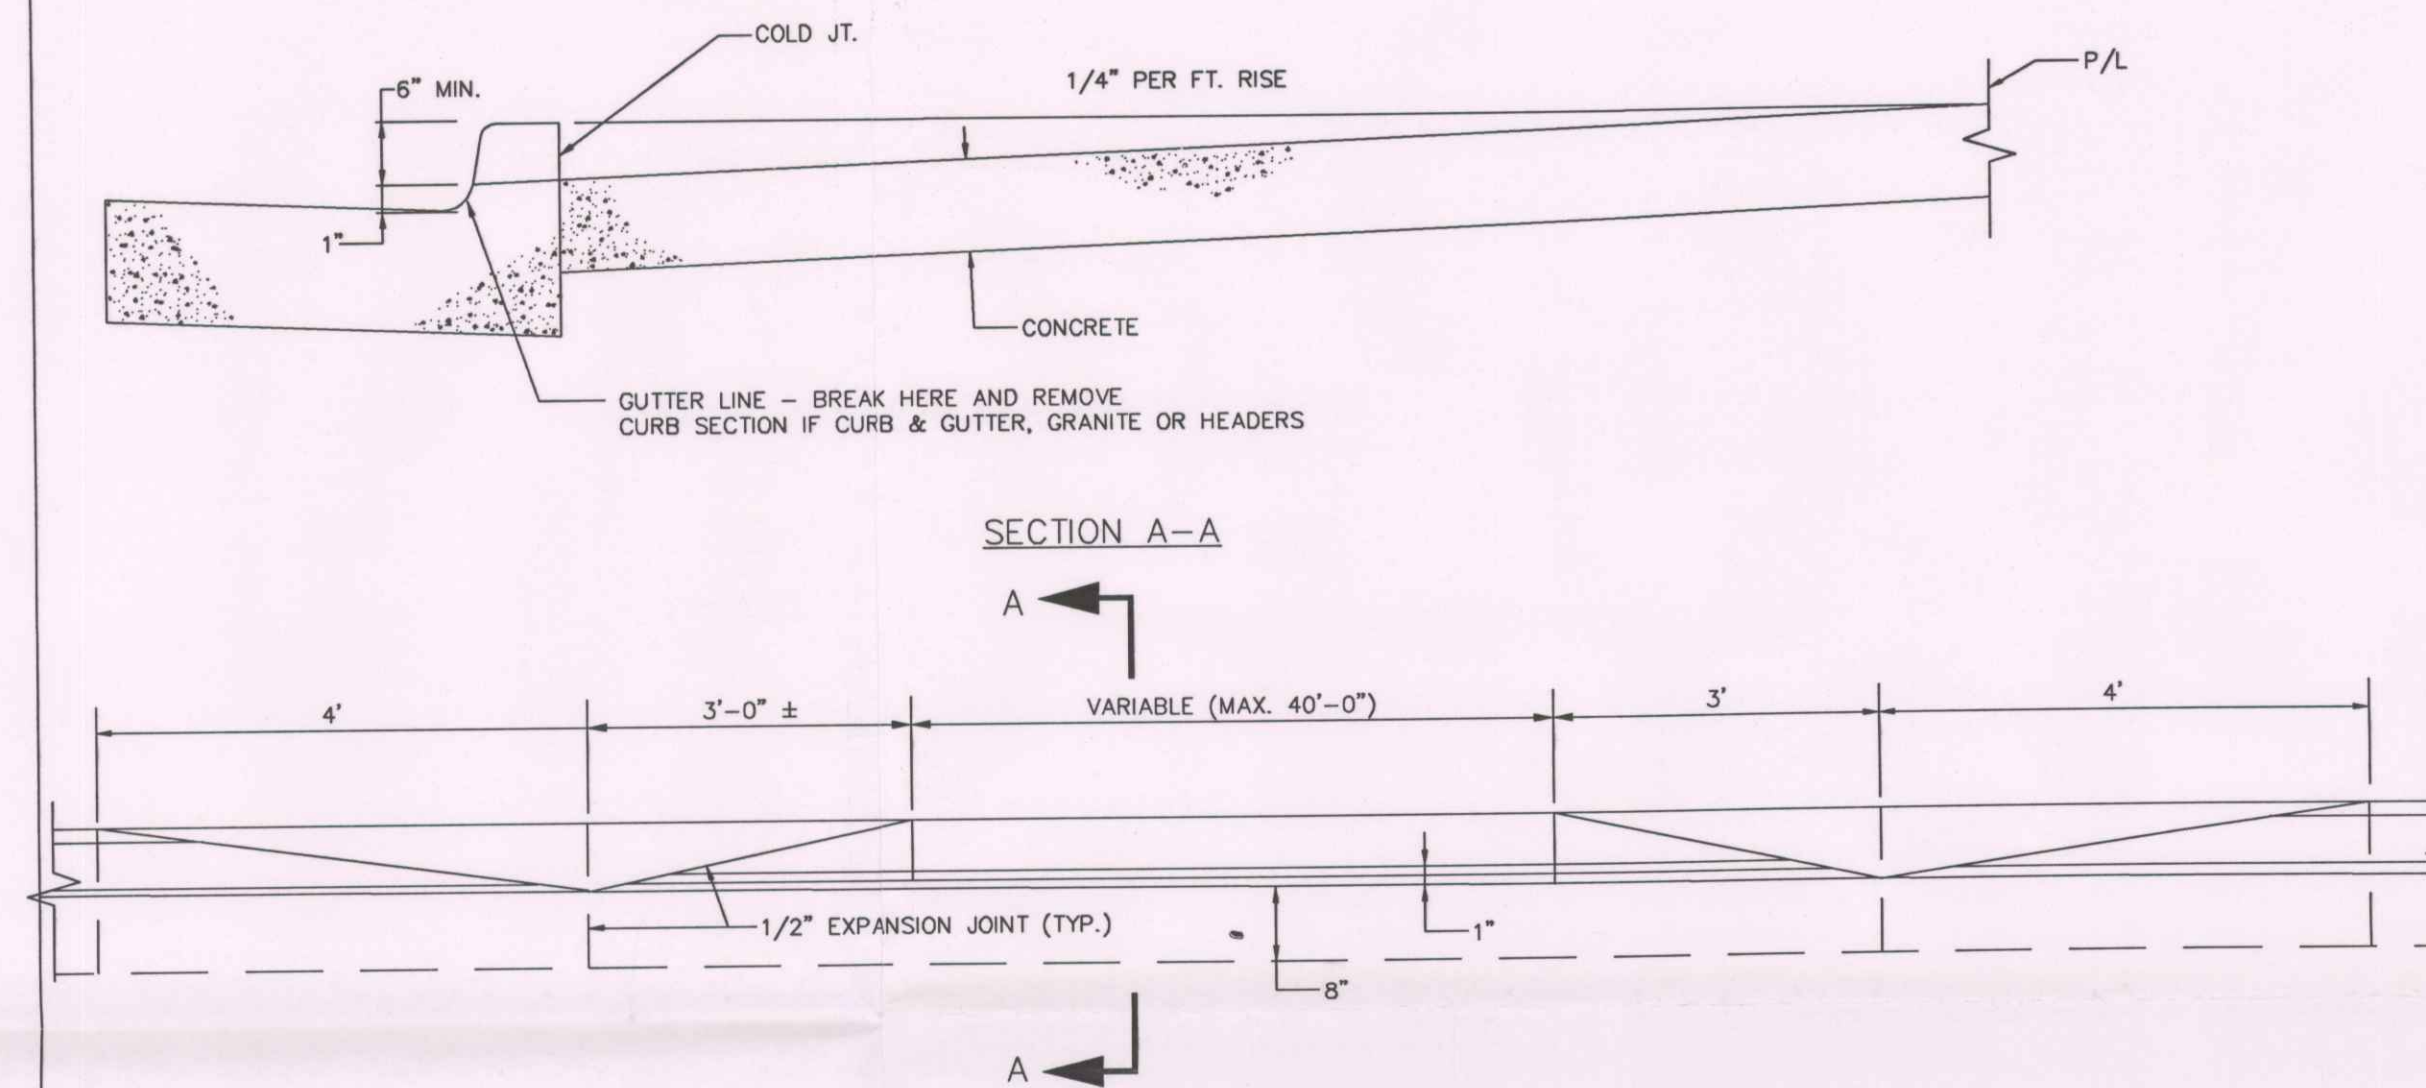
**3 STANDARD DRIVEWAY (AS BUILT)**  
CM1.1 NOT TO SCALE

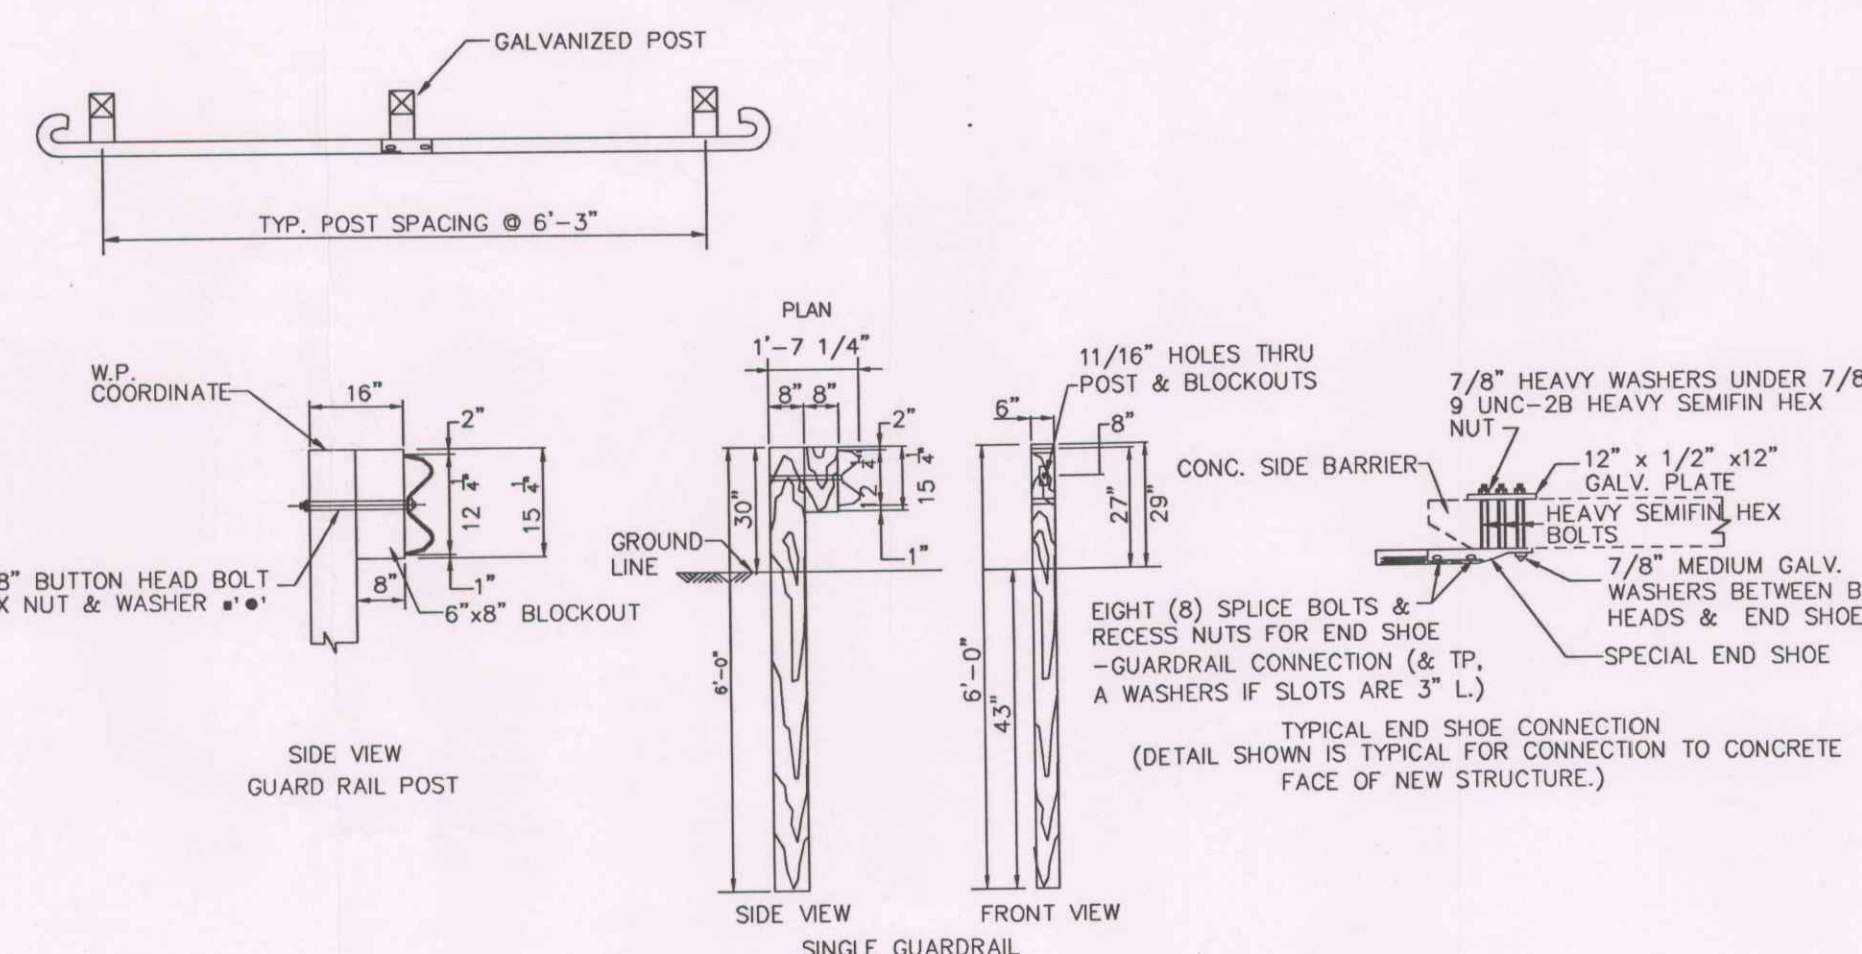
**4 GUARDRAIL DETAIL**  
CM1.1 NOT TO SCALE

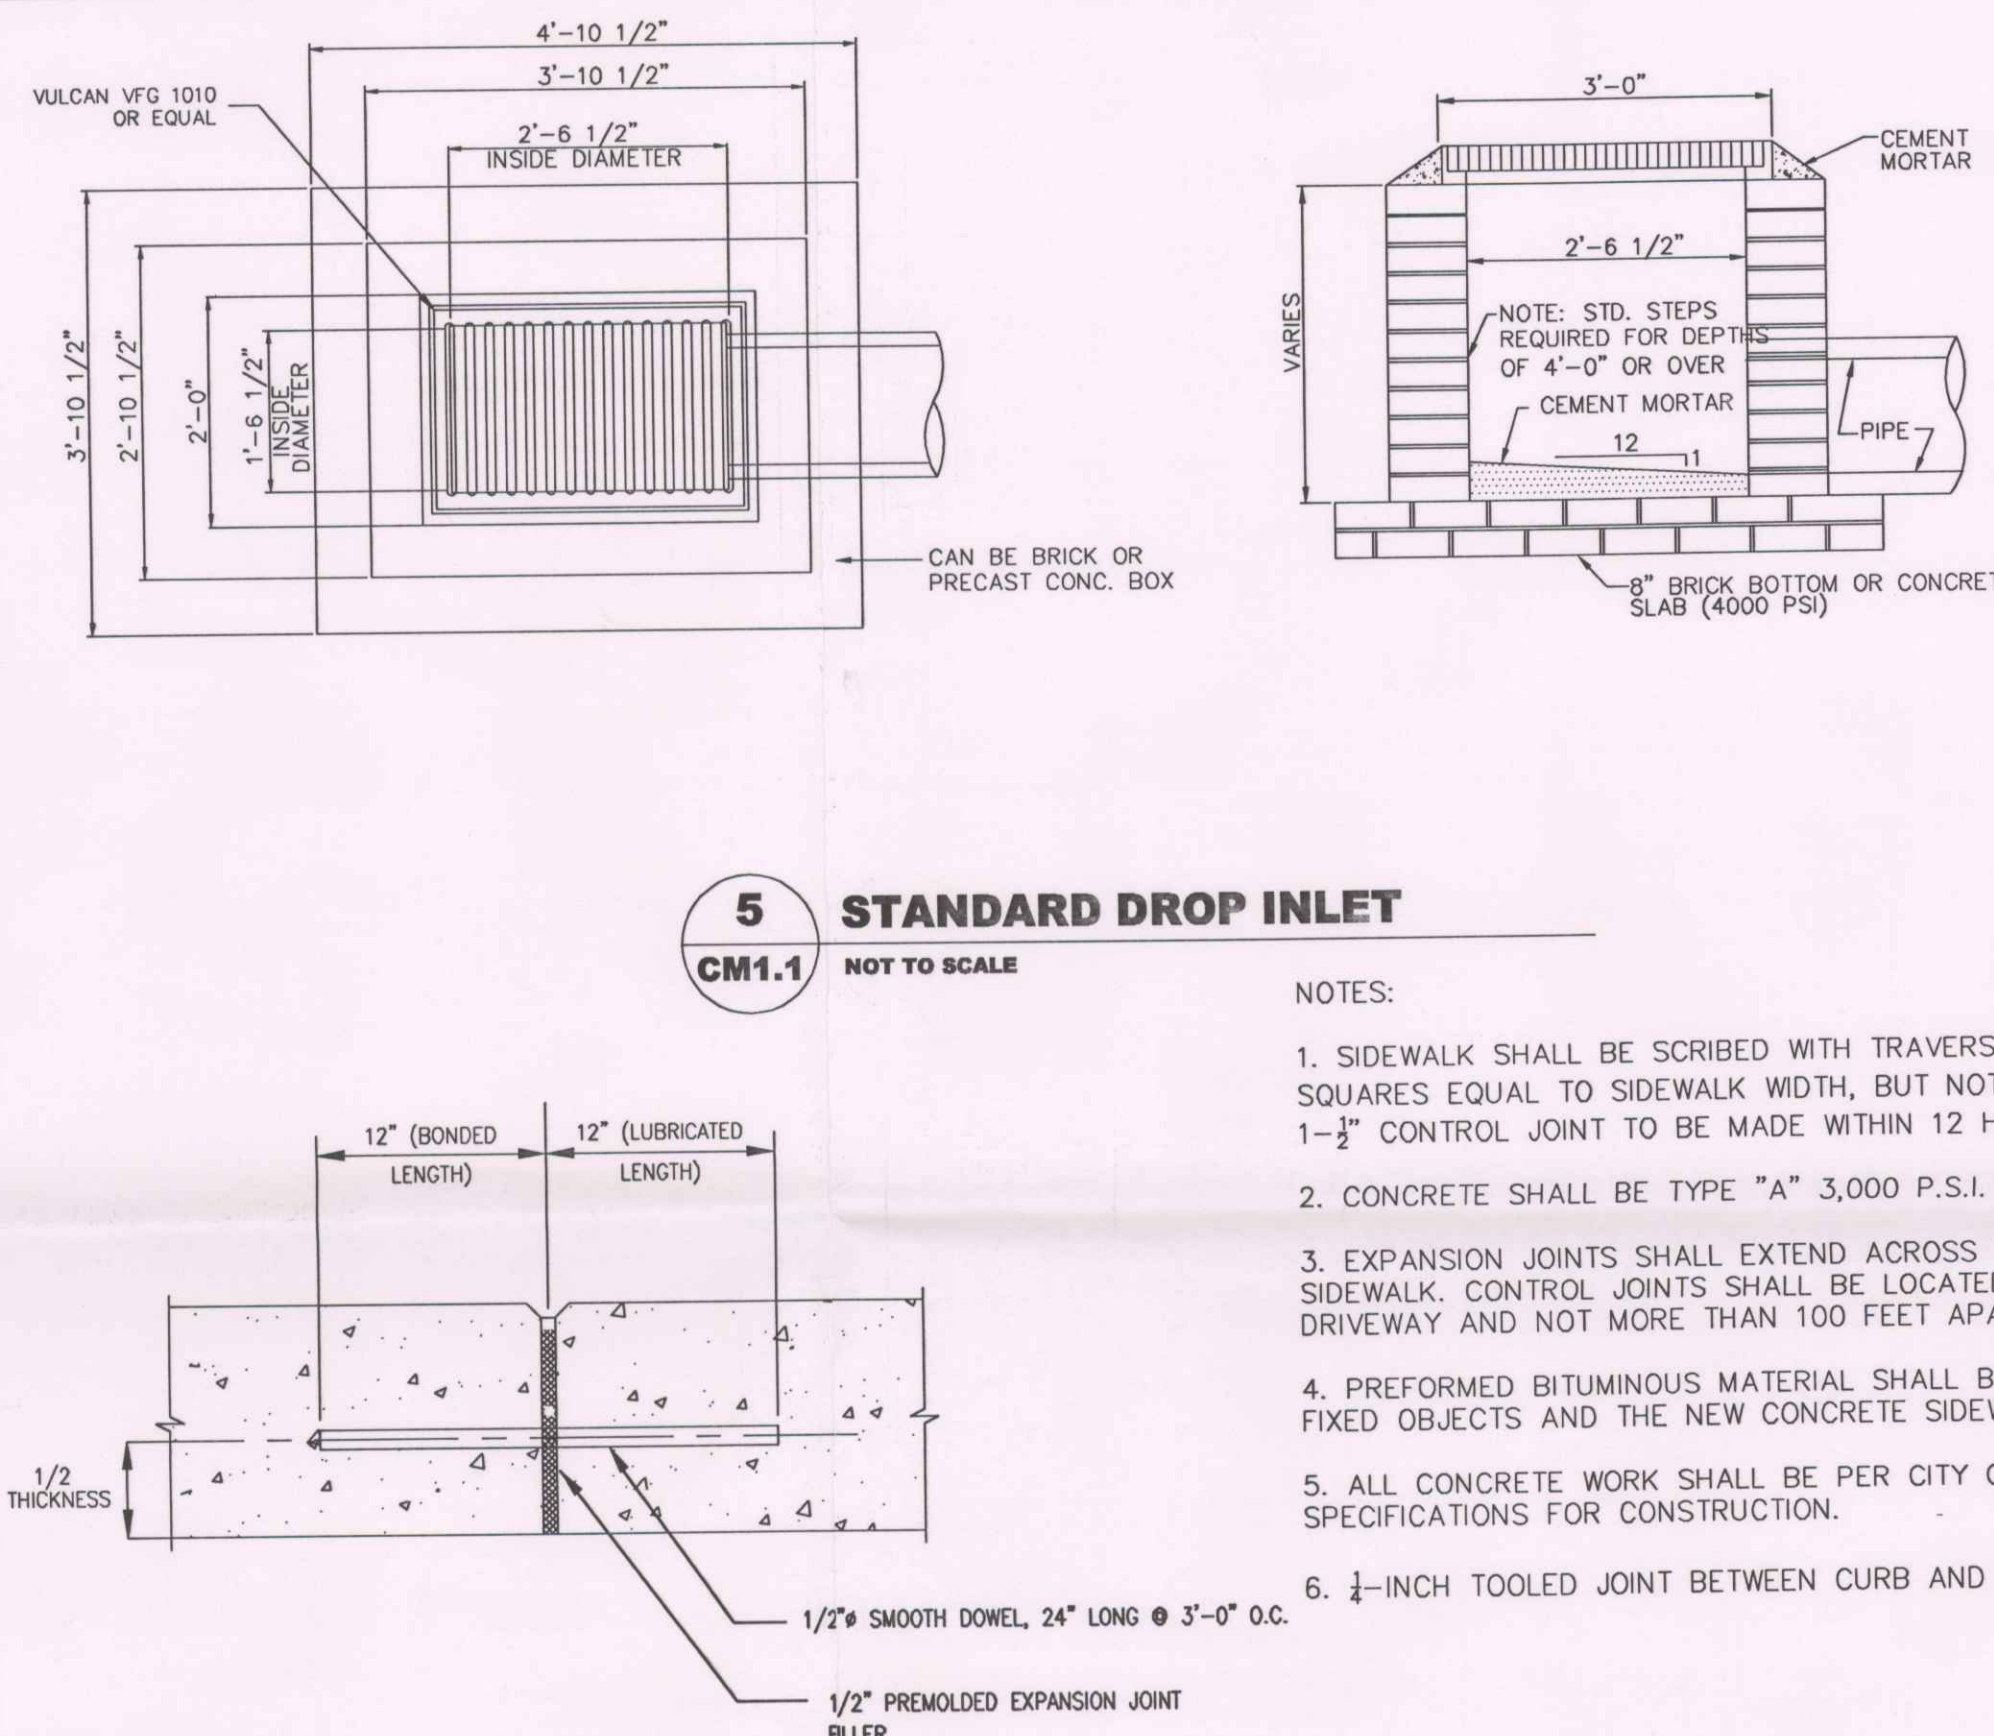
**5 STANDARD DROP INLET**  
CM1.1 NOT TO SCALE
