**COMPLIANCE STATUS REPORT**

**FOR FORMER TAX PARCEL 14-82-6-3**

**NORTHSIDE DRIVE LANDFILL**

**HAZARDOUS SITE INVENTORY SITE NO. 10222**

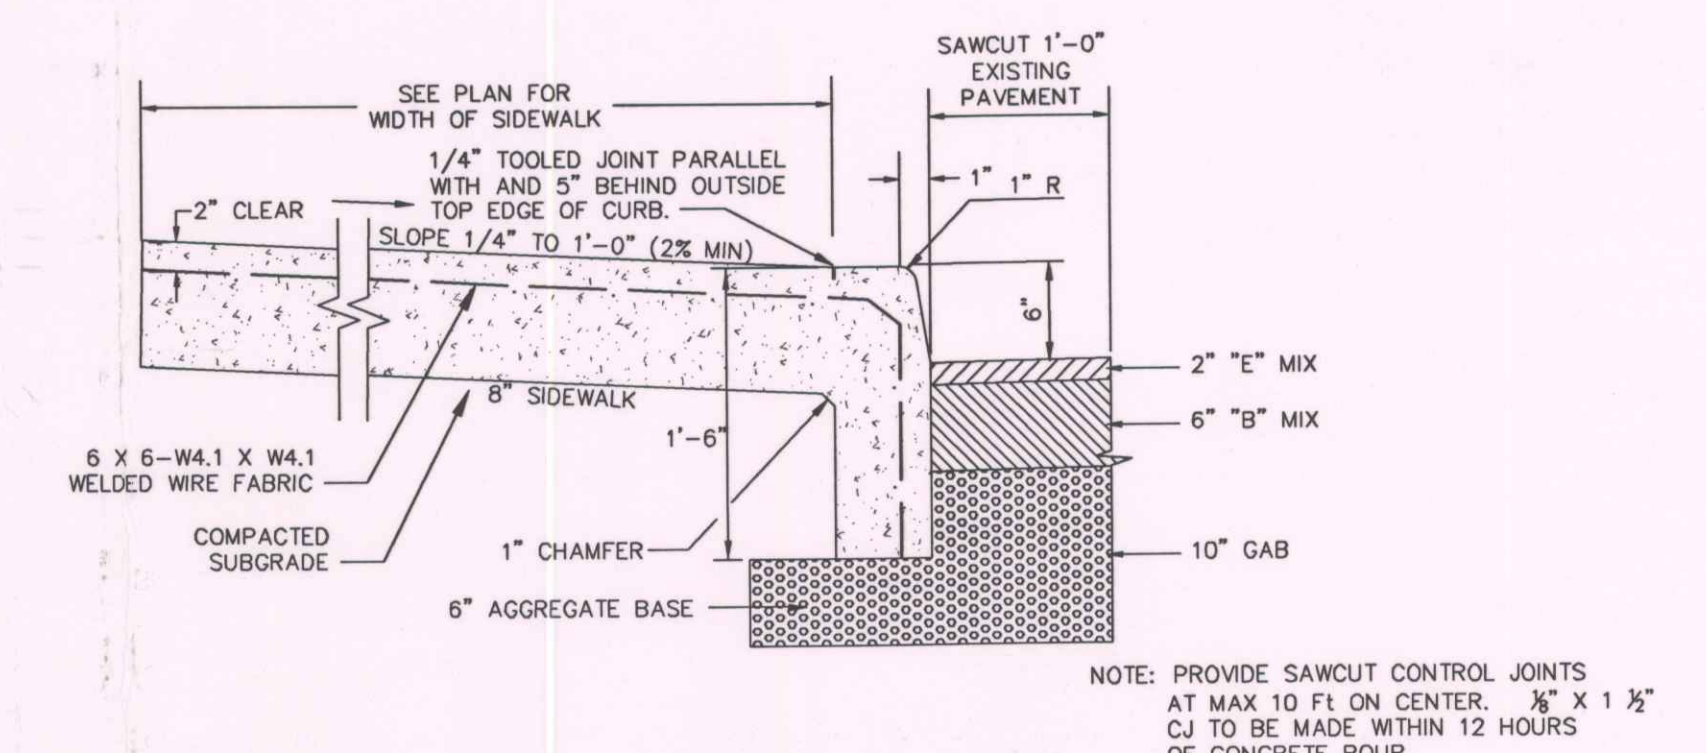
**A MONOLITHIC SIDEWALK AND CURB**  
CM1.1 NOT TO SCALE

- NOTES:
1. SIDEWALK SHALL BE SCRIBED WITH TRAVERSE CONTROL JOINTS IN SQUARES EQUAL TO SIDEWALK WIDTH, BUT NOT TO EXCEED 10 FEET.  $\frac{1}{2}$ \"/>
  - 2. CONCRETE SHALL BE TYPE \"A\" 3,000 P.S.I. MIN STRENGTH.
  - 3. EXPANSION JOINTS SHALL EXTEND ACROSS THE FULL WIDTH OF THE SIDEWALK. CONTROL JOINTS SHALL BE LOCATED ON EACH SIDE OF A DRIVEWAY AND NOT MORE THAN 100 FEET APART.
  - 4. PREFORMED BITUMINOUS MATERIAL SHALL BE PLACED BETWEEN ALL FIXED OBJECTS AND THE NEW CONCRETE SIDEWALK.
  - 5. ALL CONCRETE WORK SHALL BE PER CITY OF ATLANTA STANDARD SPECIFICATIONS FOR CONSTRUCTION.
  - 6.  $\frac{1}{2}$ \"/>

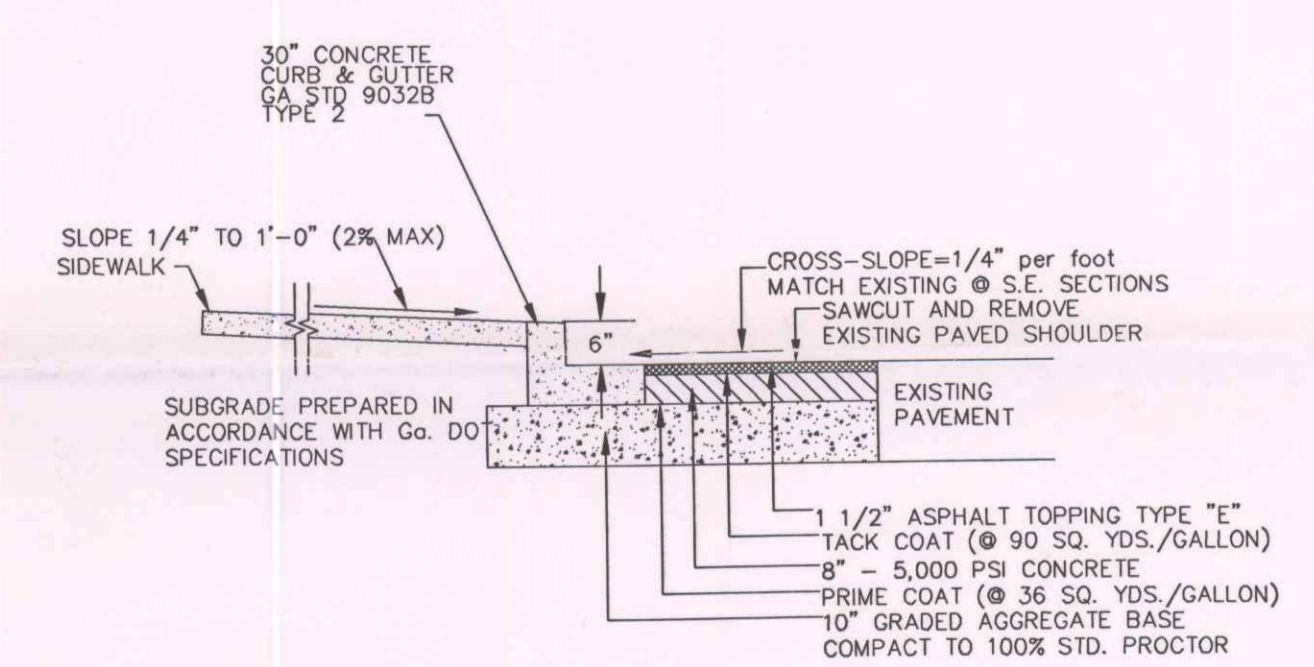
- NOTES:
1. CONCRETE SHALL BE 5,000 P.S.I. MIN STRENGTH.
  2. CONCRETE SLAB SHALL BE INCORPORATED AS A SINGLE UNDOING FOUR.
  3. EPOXY JOINTS SHALL BE APPLIED AT EXISTING PAVEMENT/PROPOSED PAVEMENT AND CURB/PROPOSED PAVEMENT INTERFACES.

**C PAVEMENT SECTION W/8\"/>**
