# WOODWARD CREEK WATERSHED MANAGEMENT PLAN

June 2020

Northwest Georgia Regional Commission

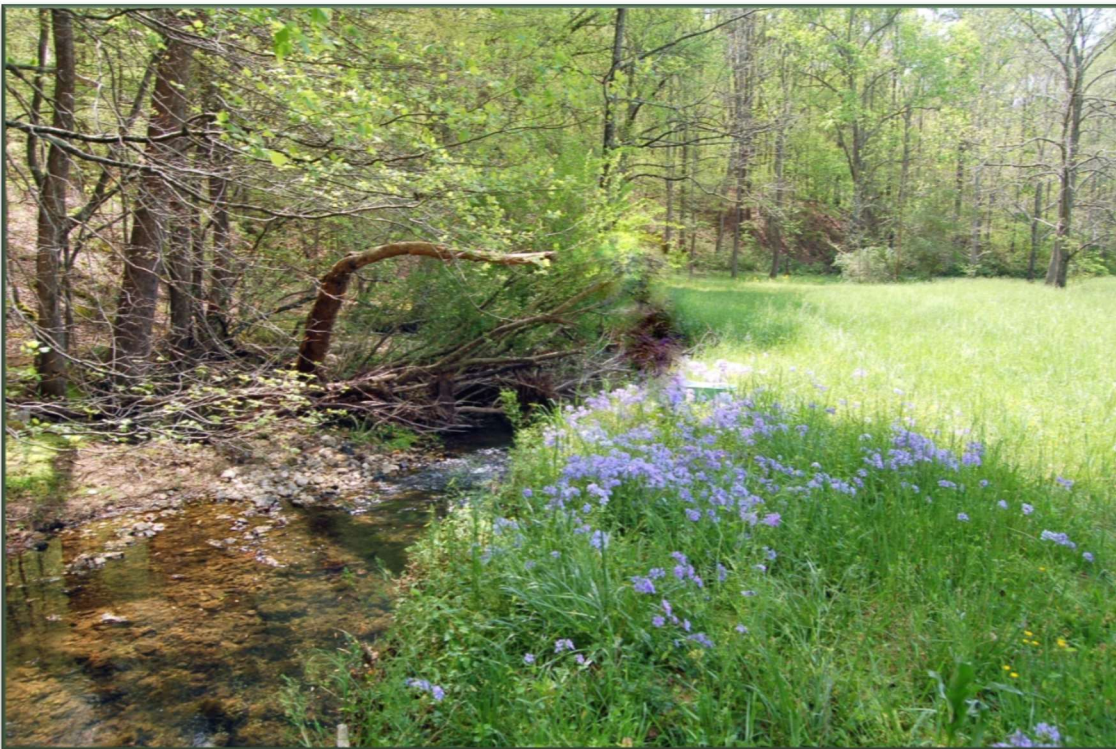
*Figure 1. Woodward Creek shows excellent water clarity at Autry Road crossing in the headwaters*

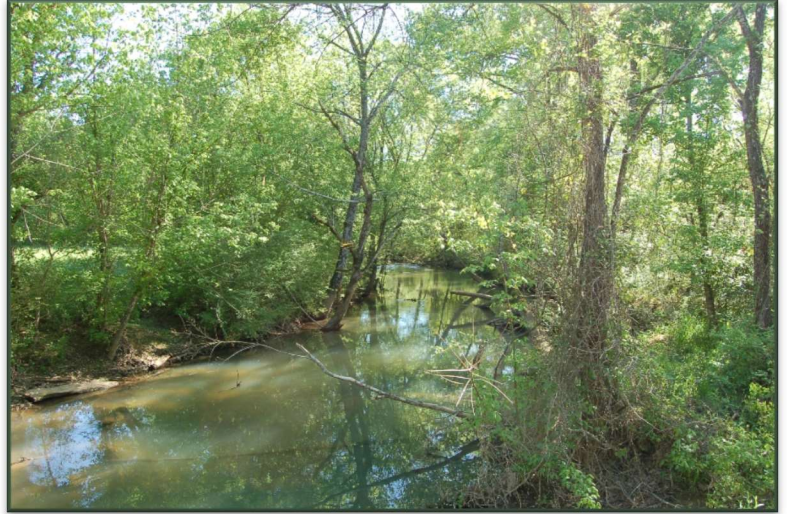
*Figure 2. Water clarity is often lower at Gaines Loop Rd crossing*

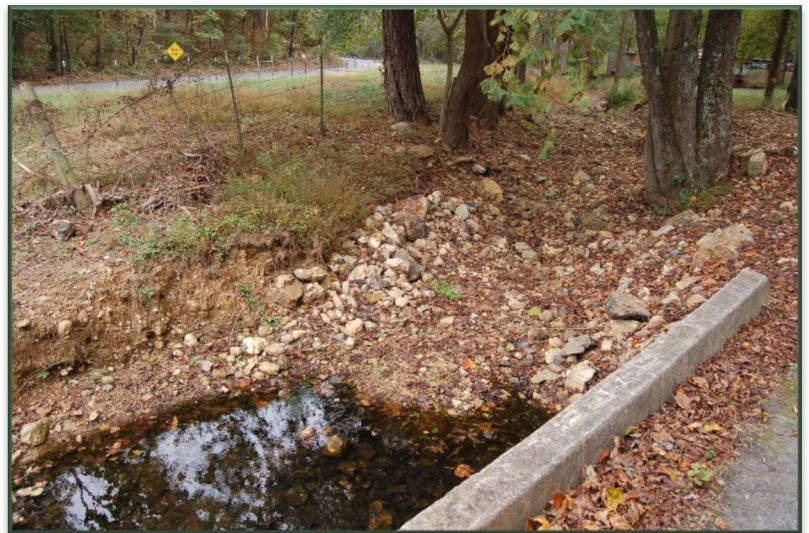
Figure 5. Woodward Creek dry streambed upstream of Autry Road Bridge in October 2018

The NWGRC staff observed the stream to be dry above Autry Road in October 2018 during the visual stream survey. Directly downstream of the bridge there was water in the creek. Further observations throughout 2019 showed that the stream was perennial at least up to that bridge crossing. There is a spring with good flow there that enters the creek just below the bridge. The Buttrum Road tributary was perennial downstream of the bridge at all seasons. On another tributary in the headwaters that crosses Big Oak Tree Road, the stream was dry in October 2018, and the landowner indicated it was frequently dry since an upstream landowner built a pond on the creek. Downstream, the flow at the Shannon drinking water intake is always sufficient for the water intake.

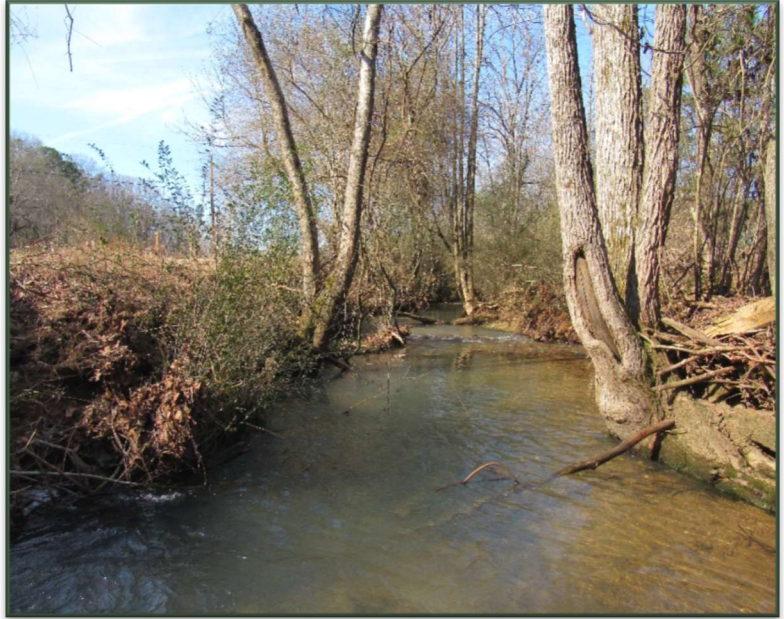
Figure 6. Tributary to Woodward Creek downstream of bridge at Buttrum Road.

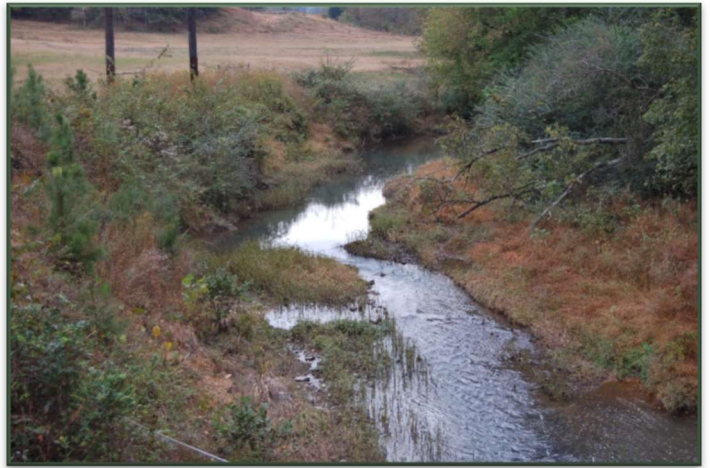
Figure 13. Upstream of Bell's Ferry Bridge.

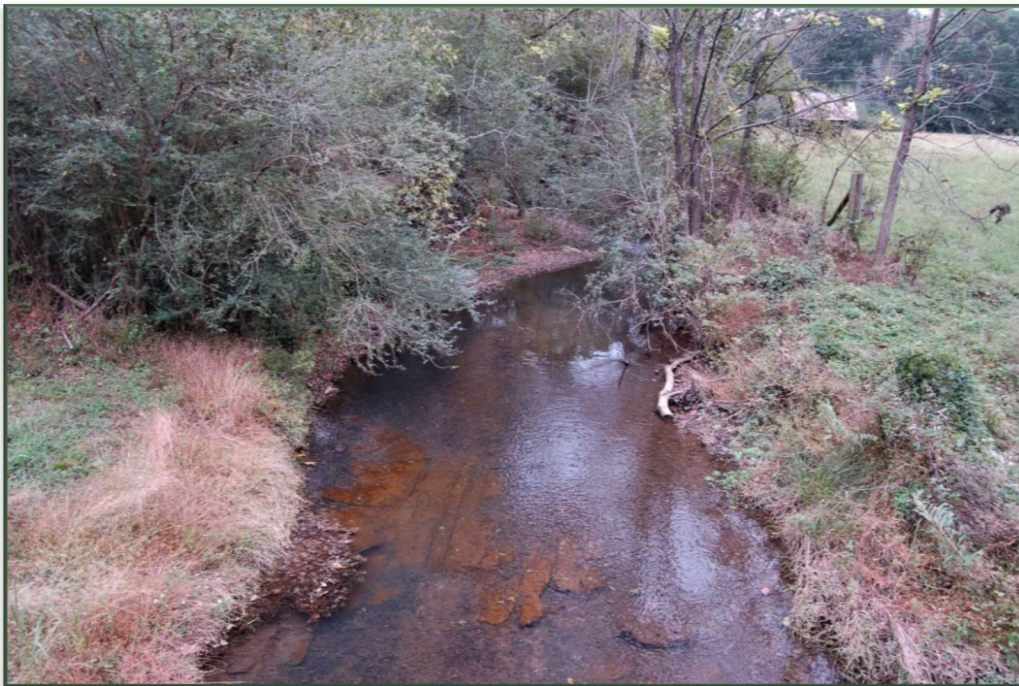
Figure 16. Woodward Creek downstream of Plainville Bridge

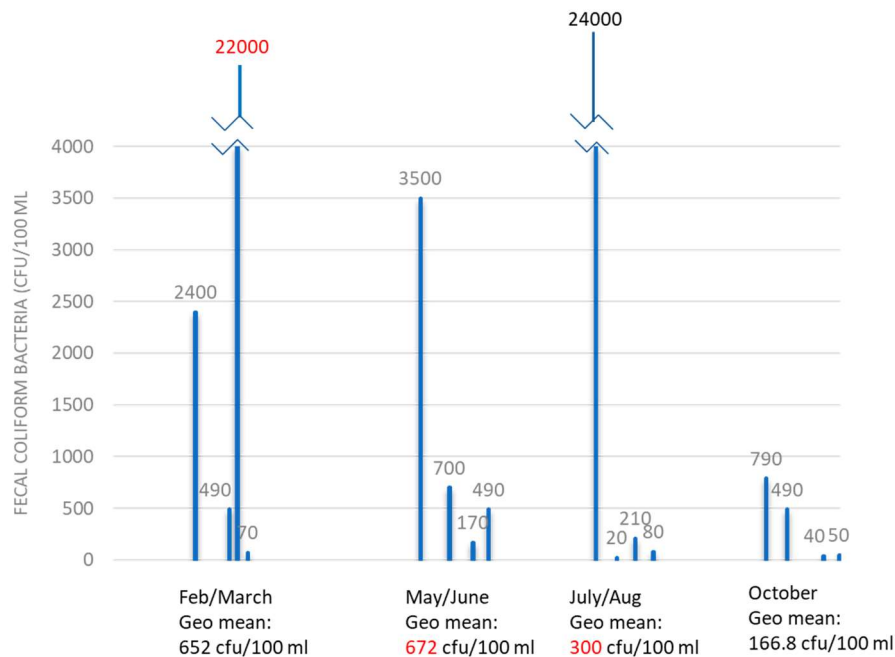
Figure 17. Georgia EPD Fecal Coliform Sampling Results 2001 at Bell's Ferry Road Bridge, Woodward Creek

The Georgia EPD sampled the water in Woodward Creek throughout 2001 at Bell's Ferry Road Bridge as part of the development of Total Maximum Daily Loads for fecal coliform bacteria for a number of creeks in the Coosa River Basin (DNR EPD 2004). See Figure 21 for a map showing the location of Bell's Ferry Road Bridge. The fecal coliform results are shown in Figure 17. The numbers in red show the violation of the standard. For the February/March series of four samples, the geometric mean did not exceed the wintertime geometric mean standard of 1000 cfu/100 ml, but the single measurement of 22,000 cfu/100 ml exceeded the wintertime instantaneous standard of 4000 cfu/100 ml. In May/June the geometric mean of 672 cfu/100 ml was above the summertime geometric mean standard of 200 cfu/100 ml, as was the July/August geometric mean of 300 cfu/100 ml. In October, the summertime geometric mean standard was not exceeded.

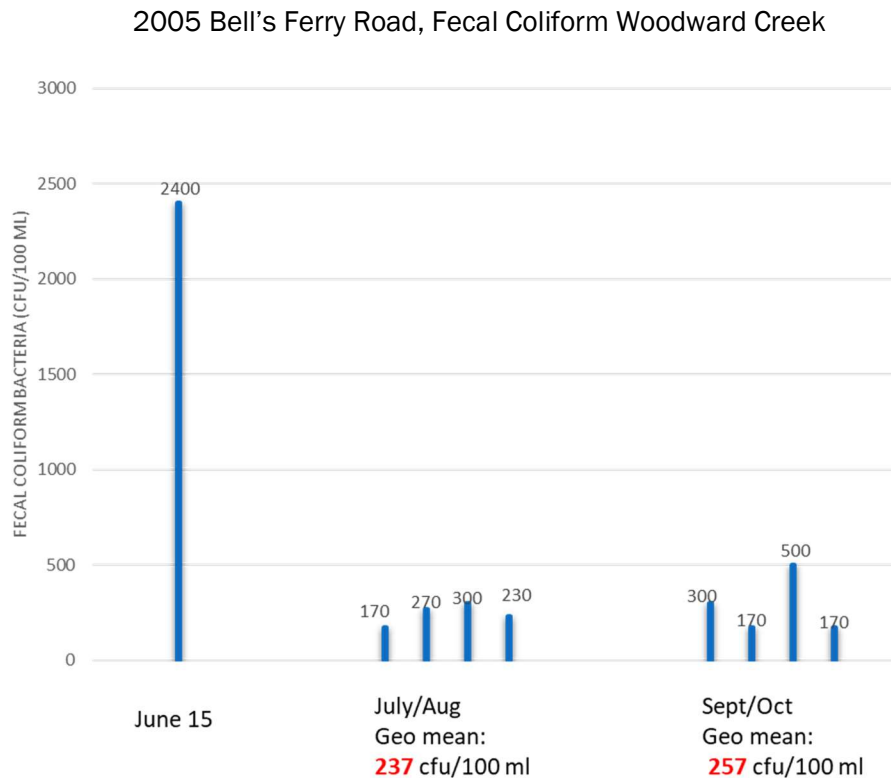
Figure 18. Georgia EPD Fecal Coliform Sampling results 2005 at Bell's Ferry Road, Woodward Creek

The Georgia EPD sampled again at Bell's Ferry Road Bridge in 2005. After a single high result of 2400 cfu/100 ml in June, they collected additional samples for calculating the geometric mean in July/August and September/October. In July/August the geometric mean of 237 cfu/100 ml exceeded the summertime geometric mean standard, as did the September/October sampling series of 257 cfu/100 ml. See Figure 18.

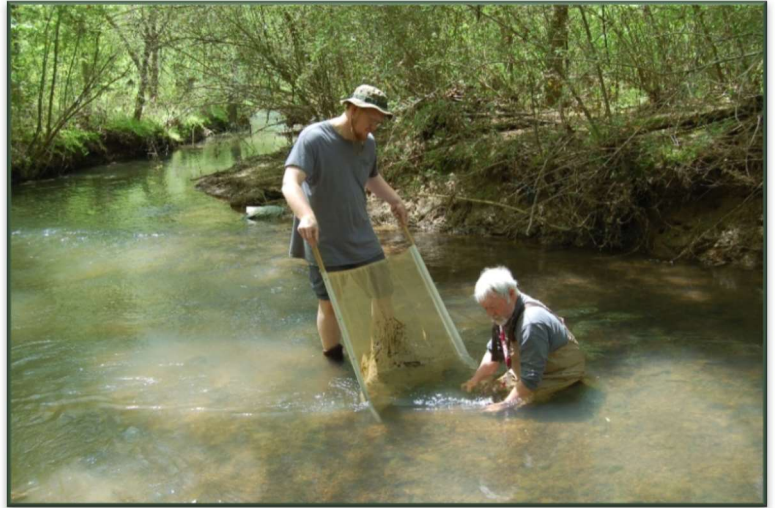
Figure 20. Sampling macroinvertebrates above Shannon Water Intake.

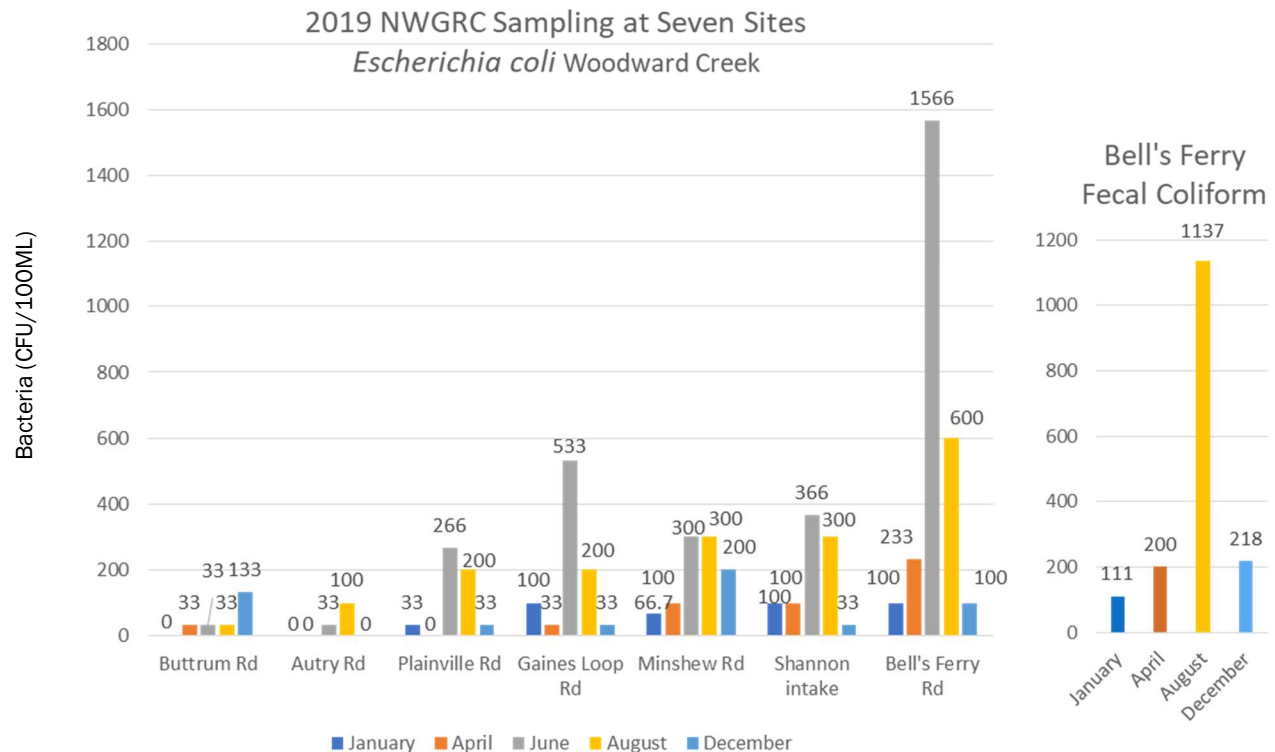
Figure 22. NWGRC sampling results for *Escherichia coli* at seven sites on Woodward Creek

The general category of fecal coliform bacteria was sampled at Bell's Ferry in January, April, August, and December, with the highest value, 1137 cfu/100 ml, found in August. In terms of how well the measured values of *E.coli* track with the expected 60-80% of fecal coliform, the measured value for *E.coli*, 600 cfu/100 ml in August is 53% of the

None of these values are the geometric mean of four samples taken within a month period at intervals of no less than 24 hours, the required sampling regime to evaluate the water for Georgia's list of impaired streams. However, these data show that there still are elevated levels of fecal coliform in the water in Woodward Creek, although not as high as the Georgia EPD measured in 2001 and 2005.

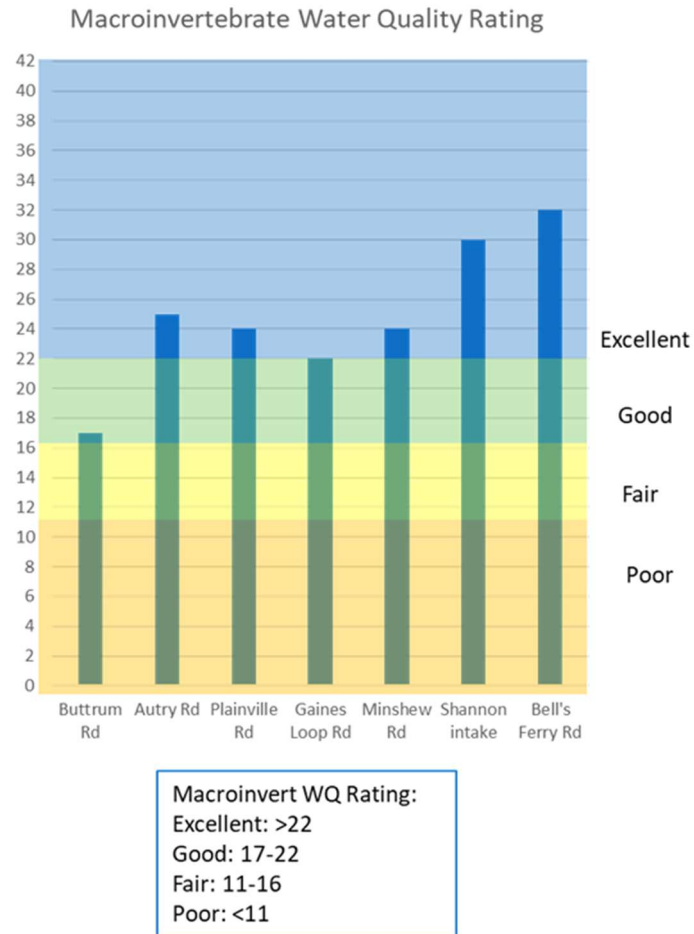
Figure 23. NWGRC macroinvertebrate sampling April 2019 Woodward Creek

affected by short-term and long-term pollution events. Pollution-sensitive mayflies and stoneflies were found at all sites, with mayflies being common or dominant at all sites and stoneflies common or dominant at all sites except Bell's Ferry Bridge. The sensitive group gilled snails were dominant at all the sites, indicating the availability of calcium carbonate in the water because of the limestone substrate.

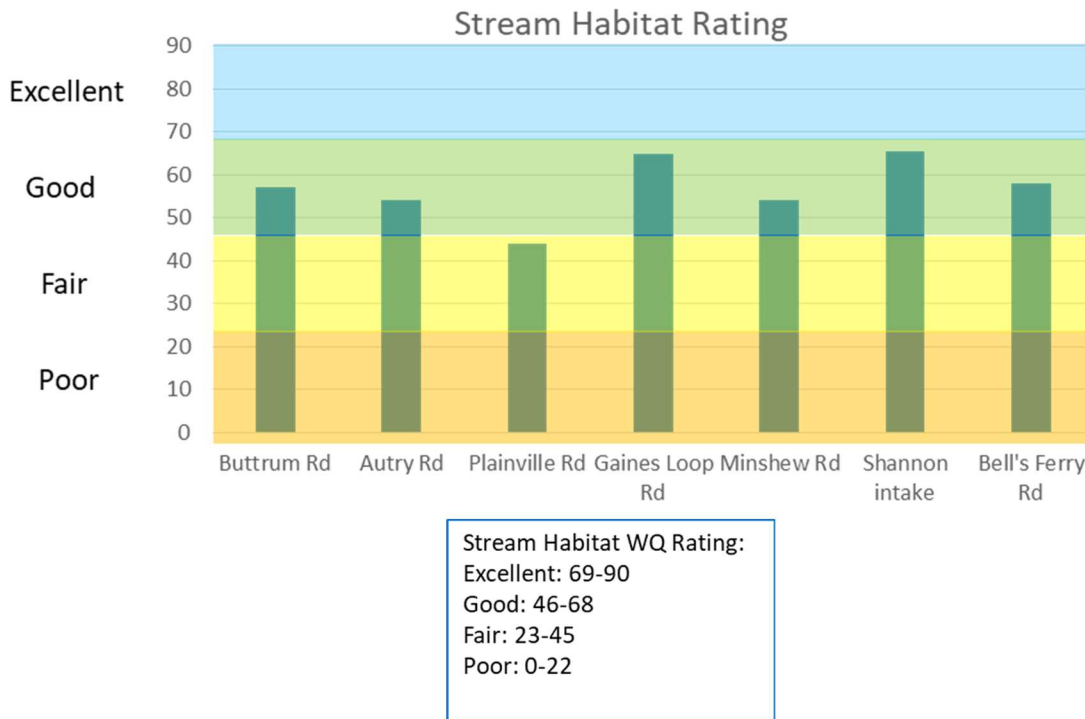
Figure 24. NWGRC Stream Habitat Survey August 2019 Woodward Creek

The AAS Stream Habitat Survey is a simple and efficient tool to rate the stream and its riparian area for suitable conditions for aquatic and riparian organisms and stability of streambanks. The survey evaluates such important factors as the amount of woody debris for fish cover and macroinvertebrate colonization, fine sediment levels, pool/riffle/run availability, width and diversity of riparian buffer and shade level, and degree of steep banks with exposed soil, and evidence of human-caused channel alterations. According to the survey completed in August 2019, none of the sites had excellent conditions, but almost all were in the good range, except for Plainville Road Bridge, which was fair (Figure 24).

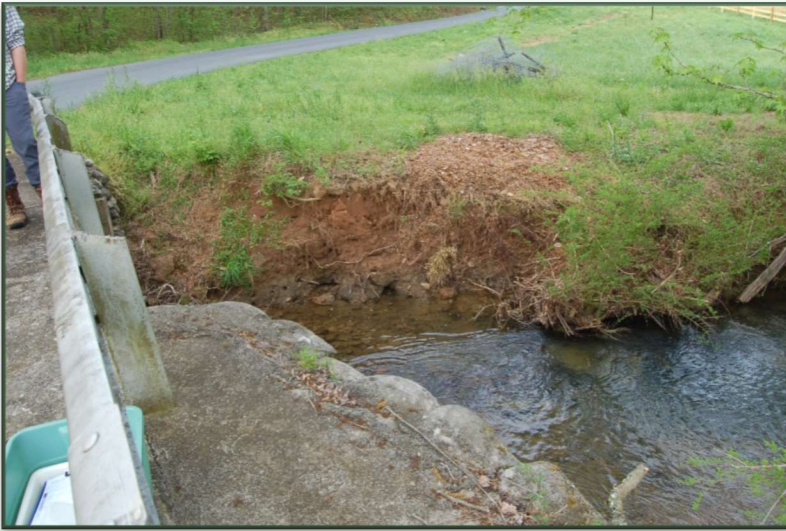
Figure 25. Eroding streambank at Buttrum Road Crossing.

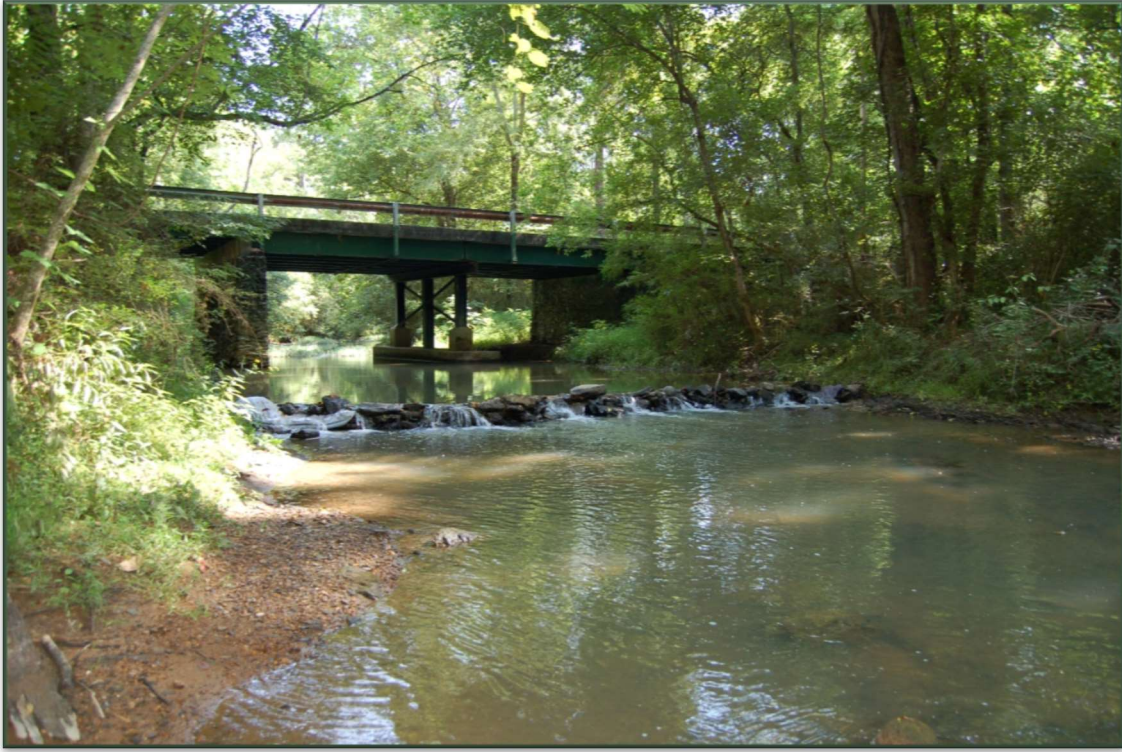
*Figure 27. Minshew Bridge outside of Shannon. Streamside buffers are present along the creek here.*

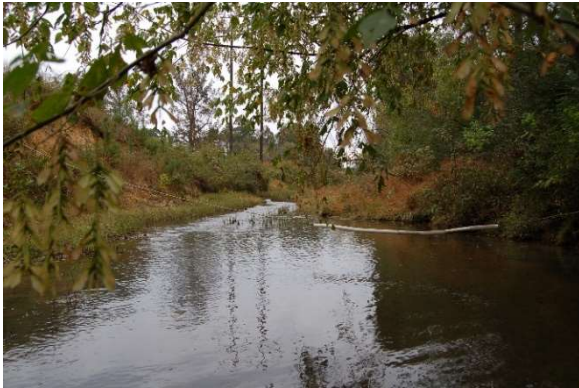
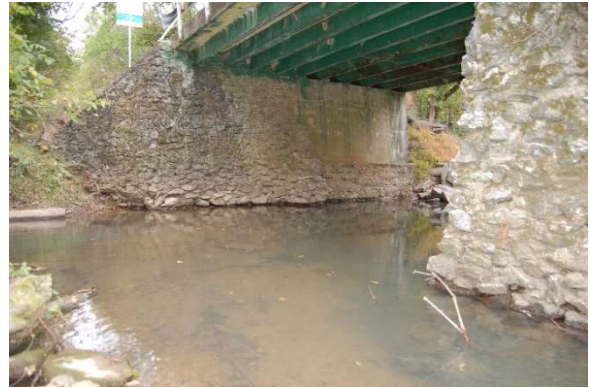
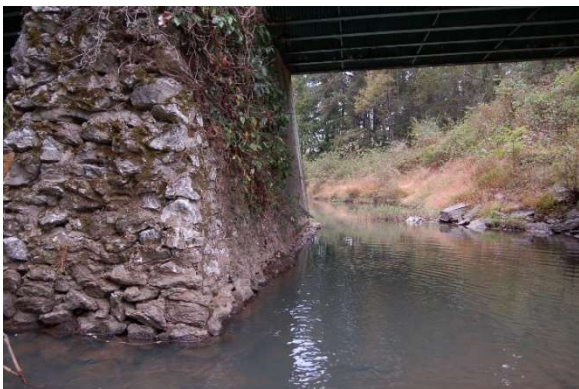
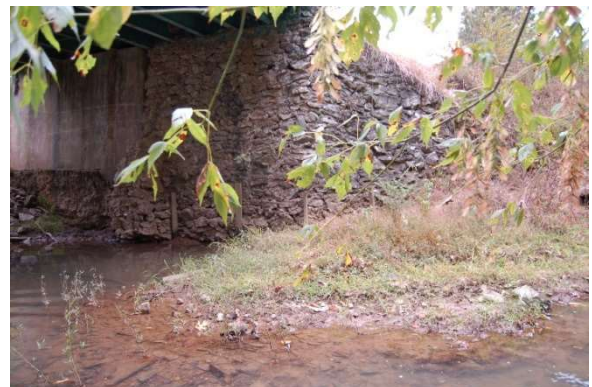
See attached visual survey form for observations. This site is on University of Georgia Northwest Georgia Research and Education Center land. The bridge crossing is at the upstream edge of the property. The stream flows through the experiment station before entering the Oostanaula River. Cattle pastures lay upstream and downstream of this site. On October 25, 2018, water was cloudy here. Bank instability was visible in upstream and downstream view of creek. The visual survey data sheet with field observations follows.

1. Bell's Ferry Road Bridge site looking upstream

2. Bell's Ferry Road Bridge site looking at right bank

3. Bell's Ferry Road Bridge site looking downstream

4. Bell's Ferry Road Bridge looking at left bank

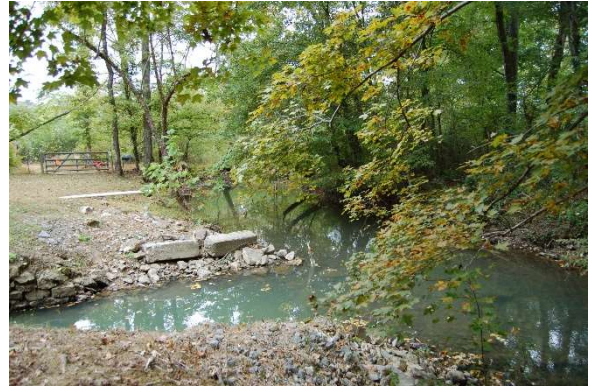
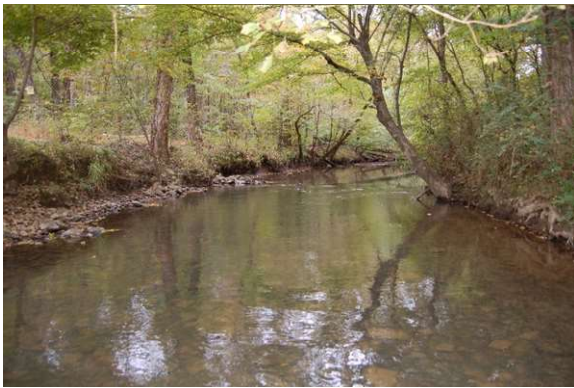
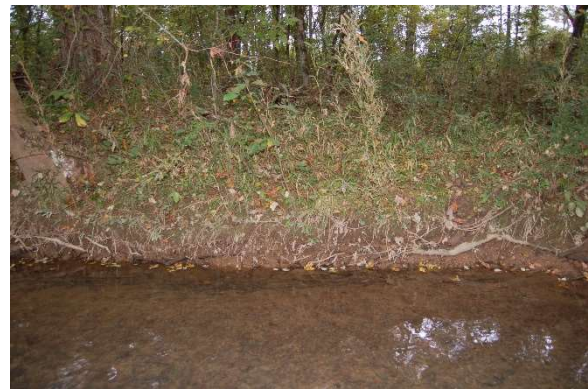
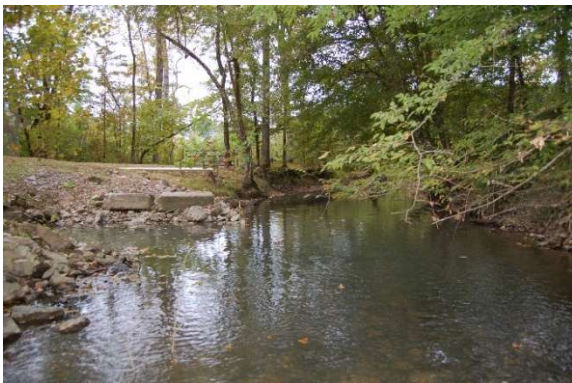
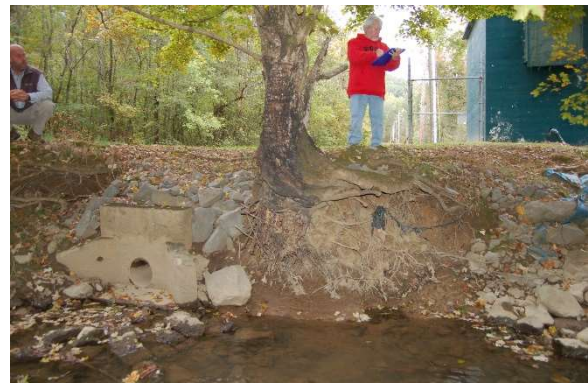
Bank condition was good and the area above and below the water intake is forested. The water is somewhat cloudy here. The public has limited access to this site because it is at the end of a gravel service road, although hunters do use the area. There was no trash. The visual survey data sheet with field observations follows.

5. Shannon water intake

6. Shannon water intake looking upstream

7. Shannon Water intake right bank

8. Shannon Water intake looking downstream

9. Shannon water intake left bank

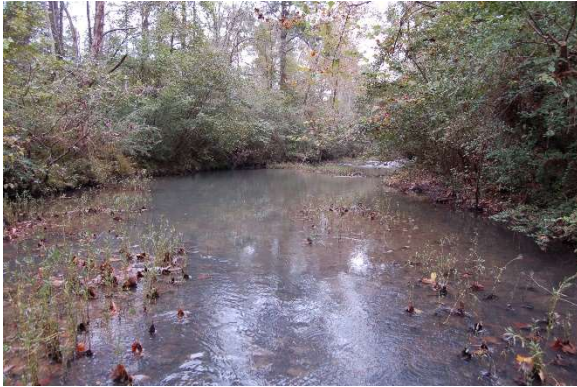
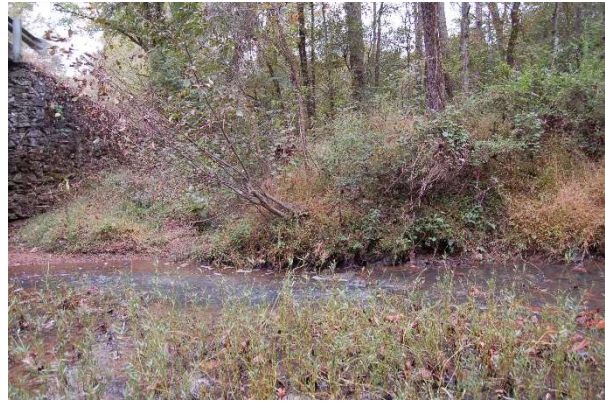
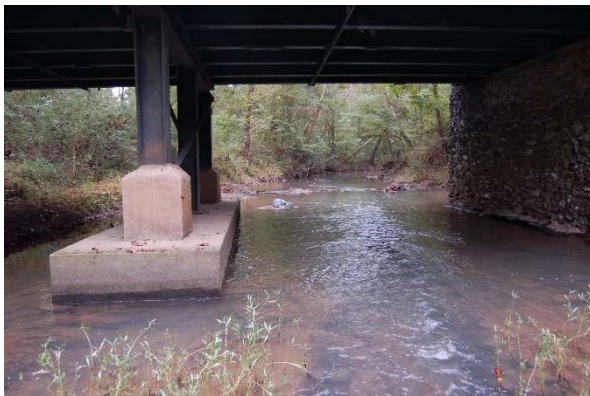
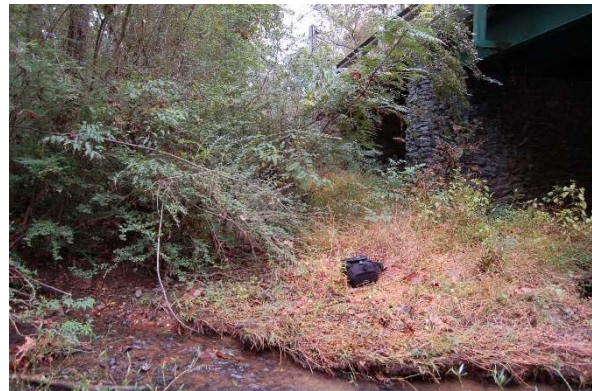
This site is located near the Shannon community and it gets a lot of recreational use. The site is fully wooded both upstream and downstream of bridge. On October 25, 2018, there was trash on the banks and two deer carcasses that had been thrown in the water. The water was somewhat cloudy here. The visual survey data sheet with field observations follows.

10. Minshew Road Bridge looking upstream

11. Minshew Road Bridge right bank

12. Minshew Road Bridge looking downstream

13. Minshew Road Bridge left bank

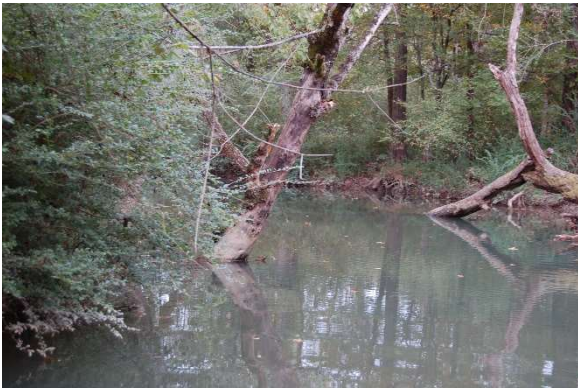
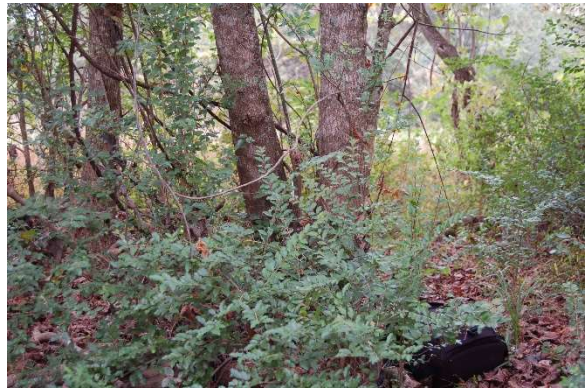
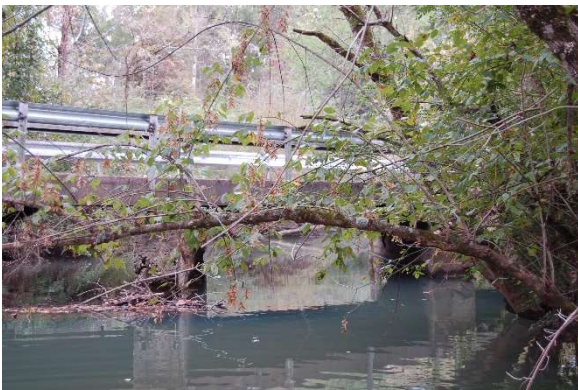
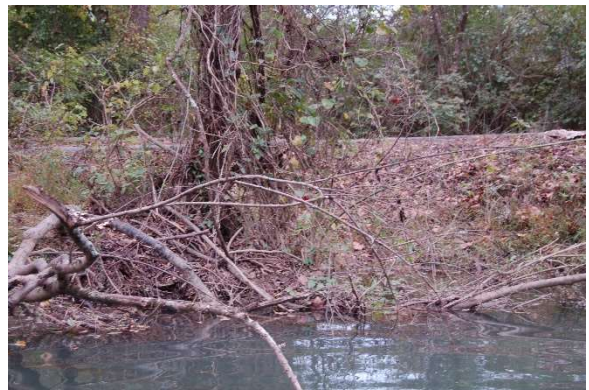
A beaver dam was impeding the flow just downstream below the bridge. This caused a pool of slack water at the site where the photos were taken. The water was somewhat cloudy here. The land on the right bank is grassed and flat and looks like a beaver meadow. The visual survey data sheet with field observations follows.

14. Gaines Loop Road Bridge looking upstream

15. Gaines Loop Road Bridge right bank

16. Gaines Loop Road Bridge looking downstream

17. Gaines Loop Road Bridge left bank

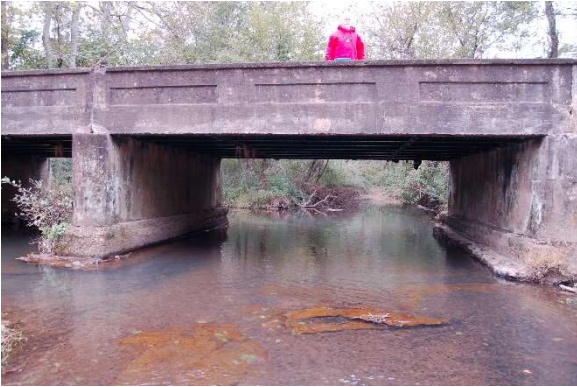
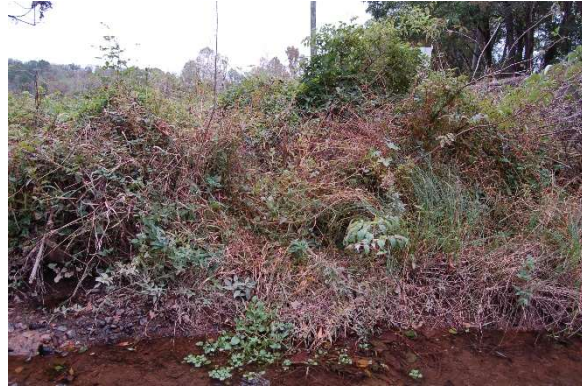
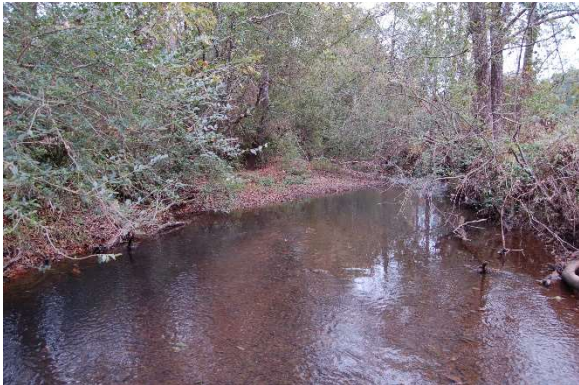
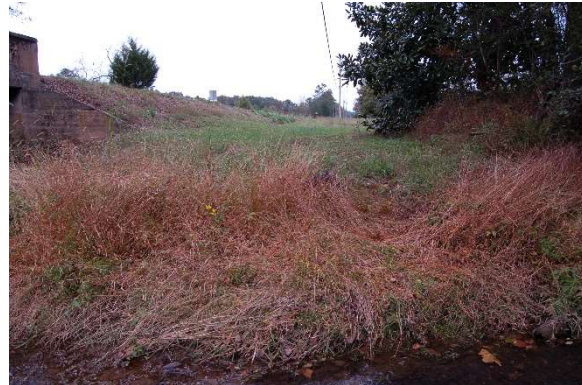
The land on either side at this site is grassy fields, but no cows were observed on this day. The water was clear here. There are scattered houses and a veterinarian clinic nearby. The visual survey data sheet with field observations follows.

18. Plainville Road Bridge looking upstream

19. Plainville Road Bridge right bank

20. Plainville Road Bridge looking downstream

21. Plainville Road Bridge left bank

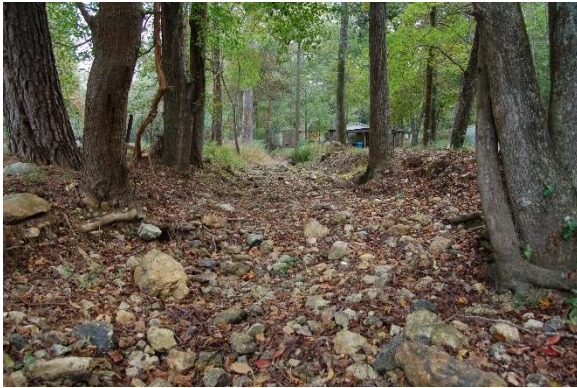
*22. Autry Road Bridge looking upstream-stream is dry*

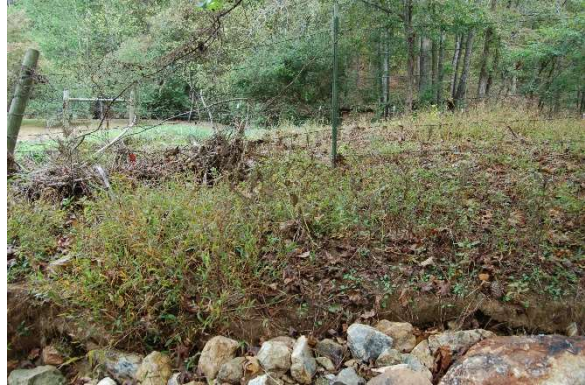
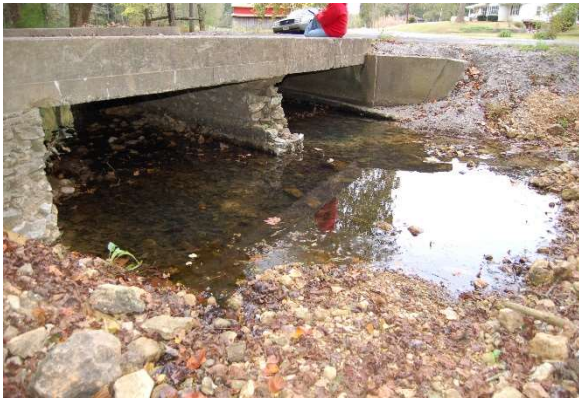
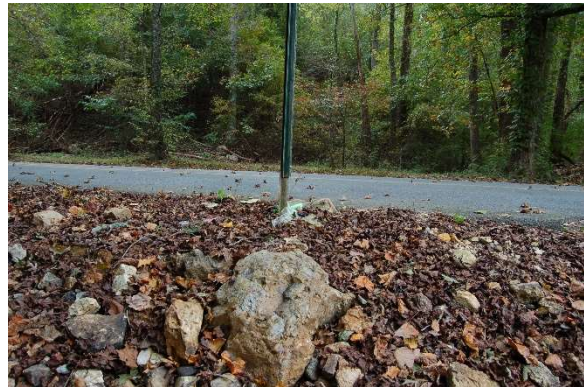
This crossing is in the upper part of the watershed. The stream was dry above the bridge except for the area directly under the bridge structure (see Figure 21). Downstream of the bridge, there was standing water. The water is very clear here. There is a spring downstream of the bridge on the left side. The visual survey data sheet with field observations follows.

*23. Autry Road Bridge right bank*

*24. Autry Road Bridge looking downstream of site*

*25. Autry Road Bridge left bank*

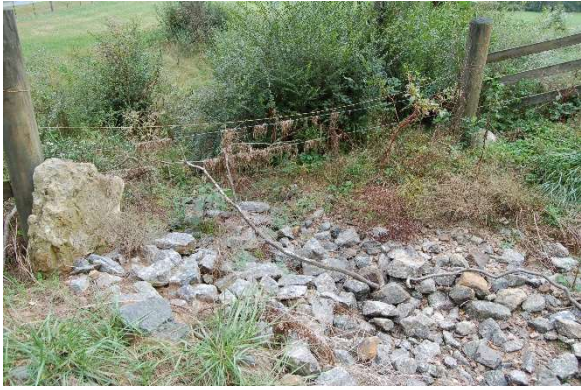
*26. Big Oak Tree Road Bridge tributary to Woodward-stream is dry*

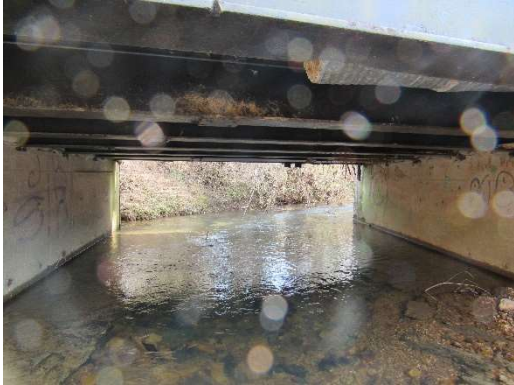
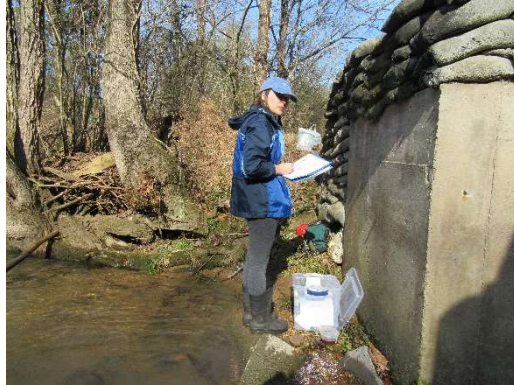
This tributary was chosen as an alternate for sampling because the other tributary was dry in October. These photos were taken January 10, 2019 when the stream was sampled for fecal coliform and chemical parameters. The landscape is a mix of forest and open fields. The flow was good here probably because of recent rainfall. . The water was somewhat cloudy here, possibly also because of the rain. There was a lot of trash, part of which we picked up. The chemical/bacterial data sheet with the same field observations as the visual survey form follows.

27. Buttrum Road Bridge tributary looking upstream

28. Buttrum Road Bridge tributary right bank

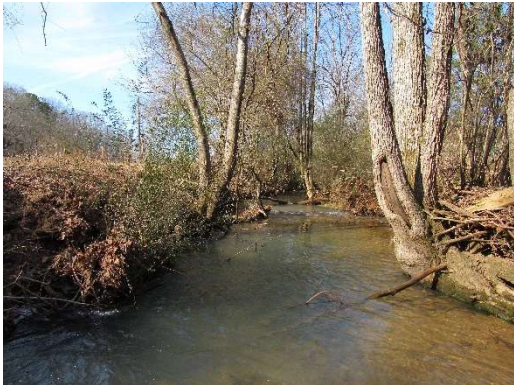
29. Buttrum Road Bridge tributary looking downstream

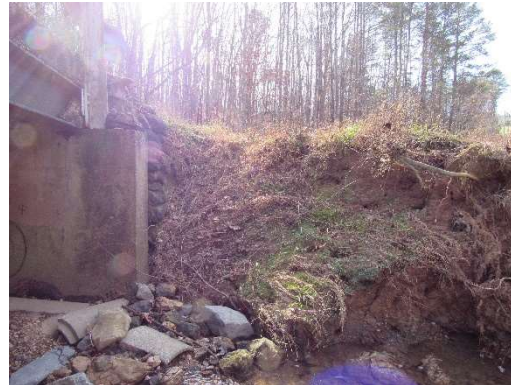
30. Buttrum Road tributary left bank
