# OPERATIONS AND MAINTENANCE (O&M) PLAN

Camilla Wood Preserving Site

Camilla, Mitchell County, Georgia

**February 2018**

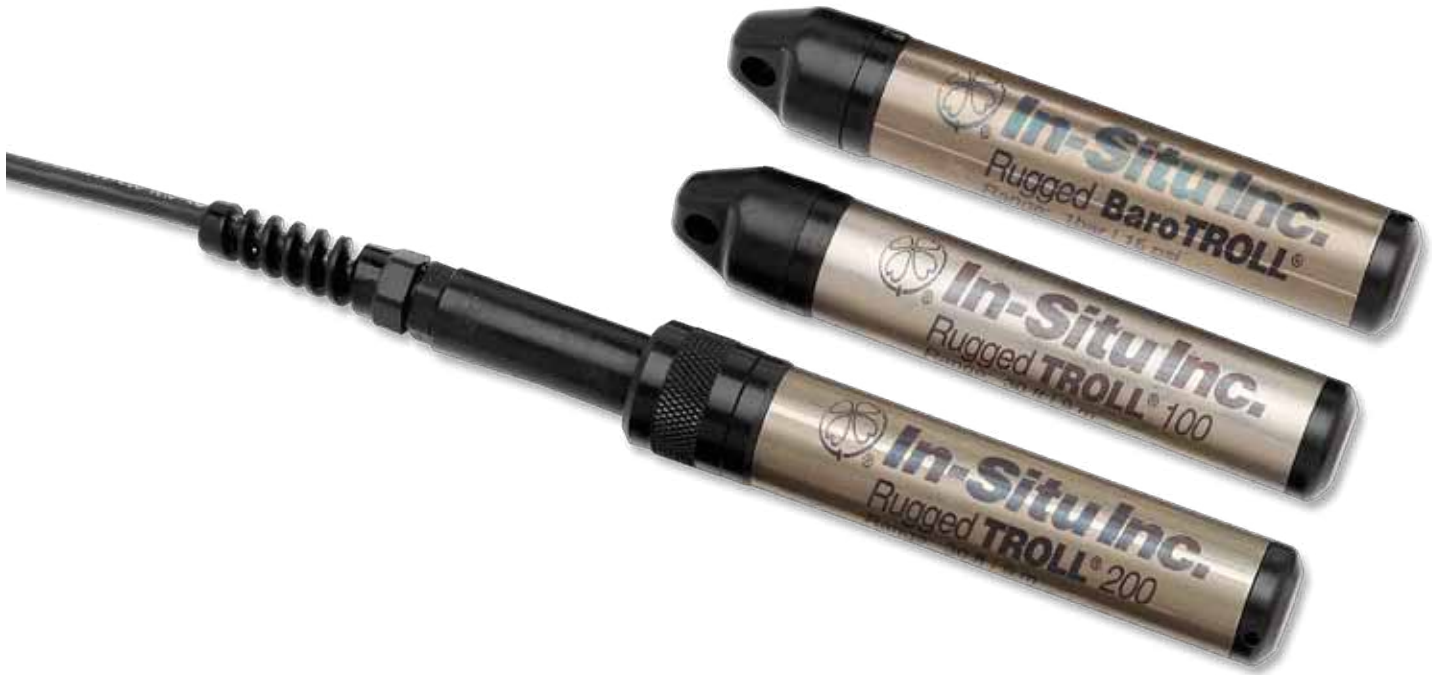
## Rugged **TROLL**® 100 and 200 Data Loggers

Rugged TROLL 100 and 200 Data Loggers are designed for long- and short-term groundwater and surface water monitoring. These non-vented (absolute) water level data loggers measure and record changes in water level, pressure, and temperature. Ensure accurate results by using a Rugged BaroTROLL® Data Logger. All loggers are compatible with user-friendly Win-Situ® Software, which guides you through programming steps, automates level corrections, and accelerates report generation.

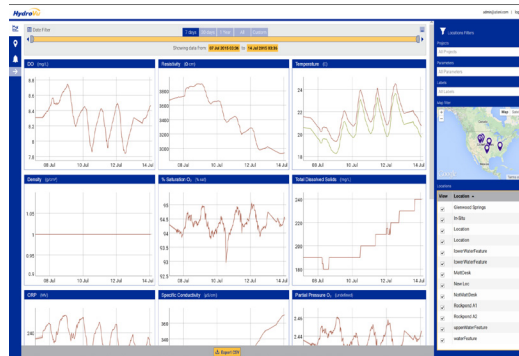
## Cellular Network Telemetry Systems

Quickly connect to remote monitoring stations by using cellular network technology. Economical, secure telemetry systems reduce data collection costs by providing real-time access to data, event notifications, and system status updates. Superior power supply management ensures long-lasting, independent operation at remote sites.
