**GEORGIA HAZARDOUS WASTE FACILITY
PERMIT APPLICATION**

**SAFT America Inc.
711 Gil Harbin Industrial Blvd.
Valdosta, GA 31601**

**Submitted: March 28, 2024
Revised: May 14, 2024
Revised: November 8, 2024
Revised: November 12, 2024
Revised: March 4, 2025
Revised: April 22, 2025
Revised: June 25, 2025**

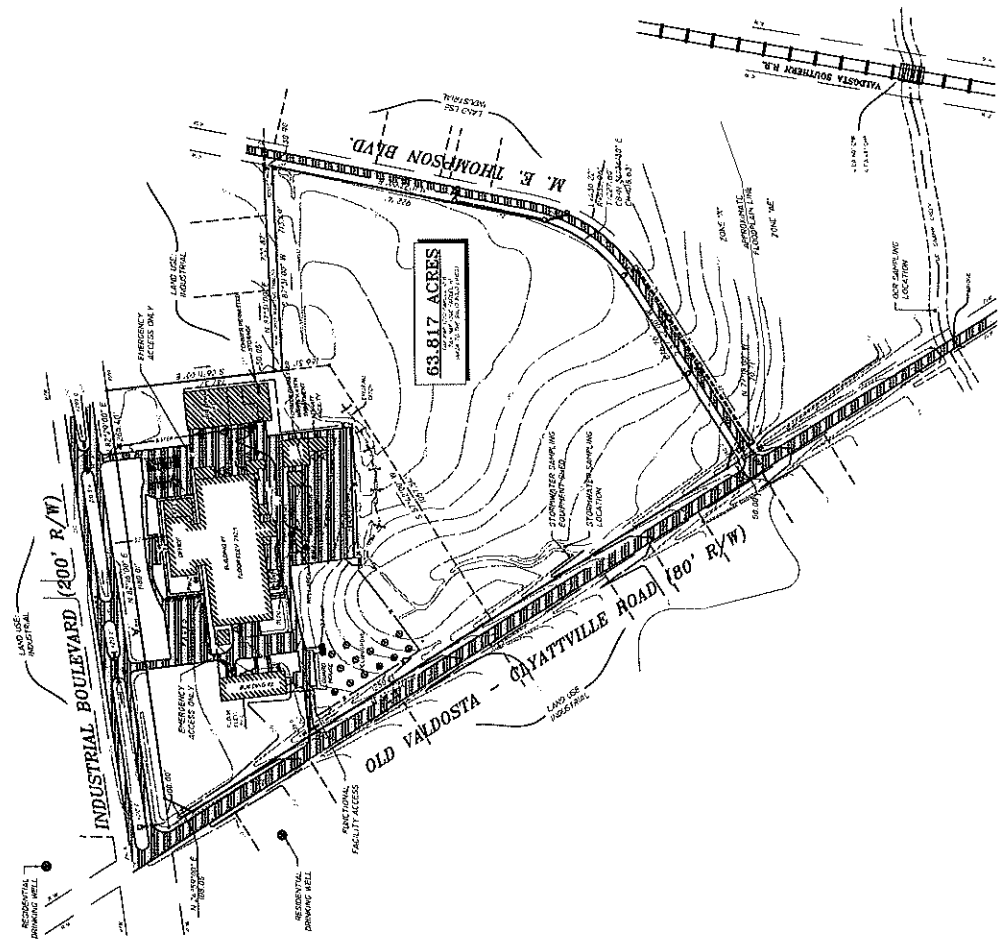
- Figure 2b is a Solid Waste Management Unit and topographic map similar to Figure 2a and specifically featuring the locations of the site's three closed Hazardous Waste Management Units (HWMUs) and the site's Solid Waste Management Units (SWMUs) 1 through 11.

NUMBER	DESCRIPTION
1	THE J-MATE SLUDGE DRYER AND ITS RELATED FILTERPRESS BEGAN OPERATIONS ON THE CHEMICAL PLANT PATIO IN 1986 AND WAS CLOSED IN 1996.
2	ELECTROLYTE RECYCLING OPERATIONS BEGAN IN THE RECYCLE FACILITY LOCATED IN THE SOUTH END OF BUILDING 3 IN 1993 AND WERE CLOSED IN 2007.
3	THE FORMER HAZARDOUS WASTE PERMITTED STORAGE AREA OPERATIONS IN THE SOUTH END OF BUILDING 3 IN 1993 AND WAS CLOSED IN 2023.

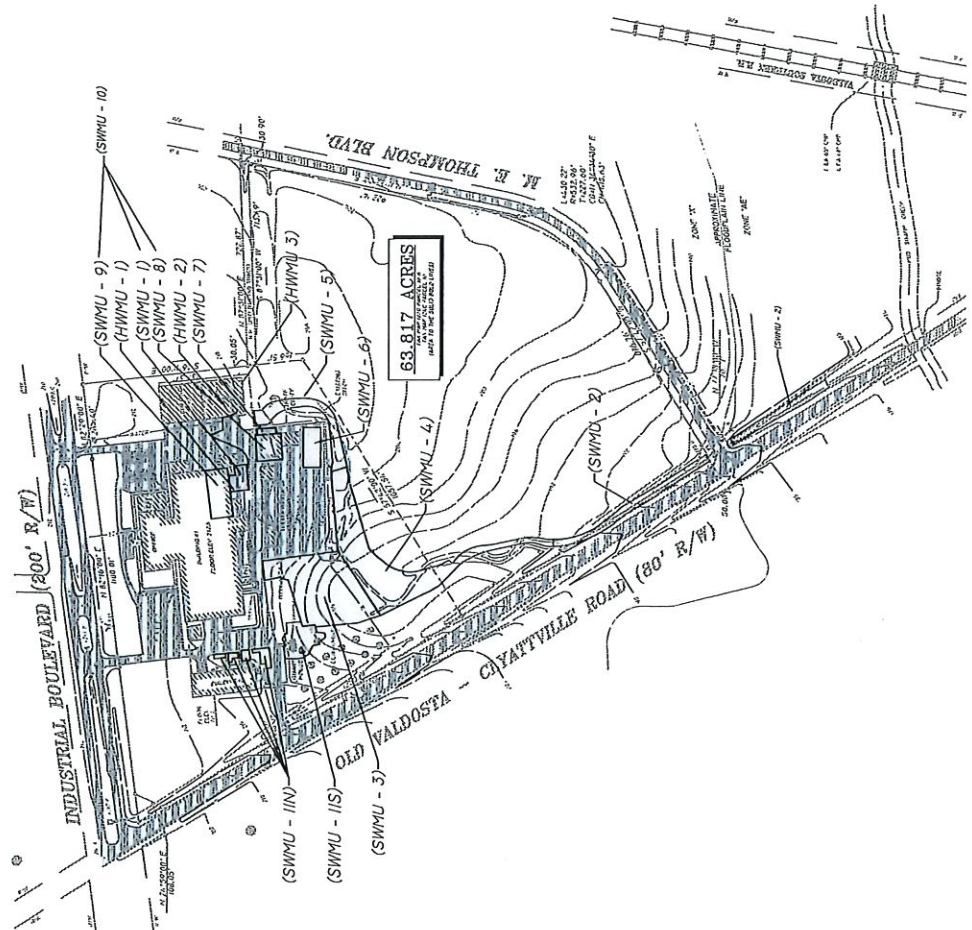
NUMBER	DESCRIPTION
1	CHEMICAL PLANT 10,000 GALLON TANKS WERE REMOVED AND DISPOSED DURING THE 1998-1999 SOIL REMEDIATION PROJECT. GROUNDWATER CORRECTIVE ACTION CONTINUES.)
2	CLAYVILLE DITCH (REMEDiated DURING 1998-1999 SOIL REMEDIATION PROJECT. NO FURTHER ACTION REQUIRED AT THIS TIME.)
3	BEGAN GROVE BOTTOM (REMEDiated DURING 1998-1999 SOIL REMEDIATION PROJECT. NO FURTHER ACTION REQUIRED AT THIS TIME.)
4	PROPERTY DRAINAGE DITCH (REMEDiated DURING 1998-1999 SOIL REMEDIATION PROJECT. NO FURTHER ACTION REQUIRED AT THIS TIME.)
5	TRUCKWELL DRAIN PIPE (REMEDiated DURING 1998-1999 SOIL REMEDIATION PROJECT. NO FURTHER ACTION REQUIRED AT THIS TIME.)
6	CLOSED CONTAINER STORAGE AREA (REMEDiated DURING 1998-1999 SOIL REMEDIATION PROJECT. NO FURTHER ACTION REQUIRED AT THIS TIME.)
7	SOLVENT STORAGE AREA (OPERATIONS CEASES PRIOR TO JULY 1992. SOIL INVESTIGATIONS YIELDED NO CONCERNS. NO FURTHER ACTION IS REQUIRED.)

8	WASTEWATER TREATMENT UNIT AND APPURTENANCES (AS DOCUMENTED IN THE OHM REMEDIATION SERVICES CORPORATION RCRA FACILITY INVESTIGATION REPORT DATED AUGUST 1994. ADDRESS DURING RFI INVESTIGATION.)
9	ALL TRANSPORT LINES USED TO TRANSPORT WASTE (AS DOCUMENTED IN THE OHM REMEDIATION SERVICES CORPORATION RCRA FACILITY INVESTIGATION REPORT DATED AUGUST 1994. ADDRESS DURING RFI INVESTIGATION.)
10	ALL SWMUS USED TO COLLECT WASTE (AS DOCUMENTED IN THE OHM REMEDIATION SERVICES CORPORATION RCRA FACILITY INVESTIGATION REPORT DATED AUGUST 1994. ADDRESS DURING RFI INVESTIGATION.)
11	BUILDING 2 FORMER BURN AREA (AS DOCUMENTED IN THE OHM REMEDIATION SERVICES CORPORATION RCRA FACILITY INVESTIGATION REPORT DATED AUGUST 1994. ADDRESS DURING RFI INVESTIGATION.)

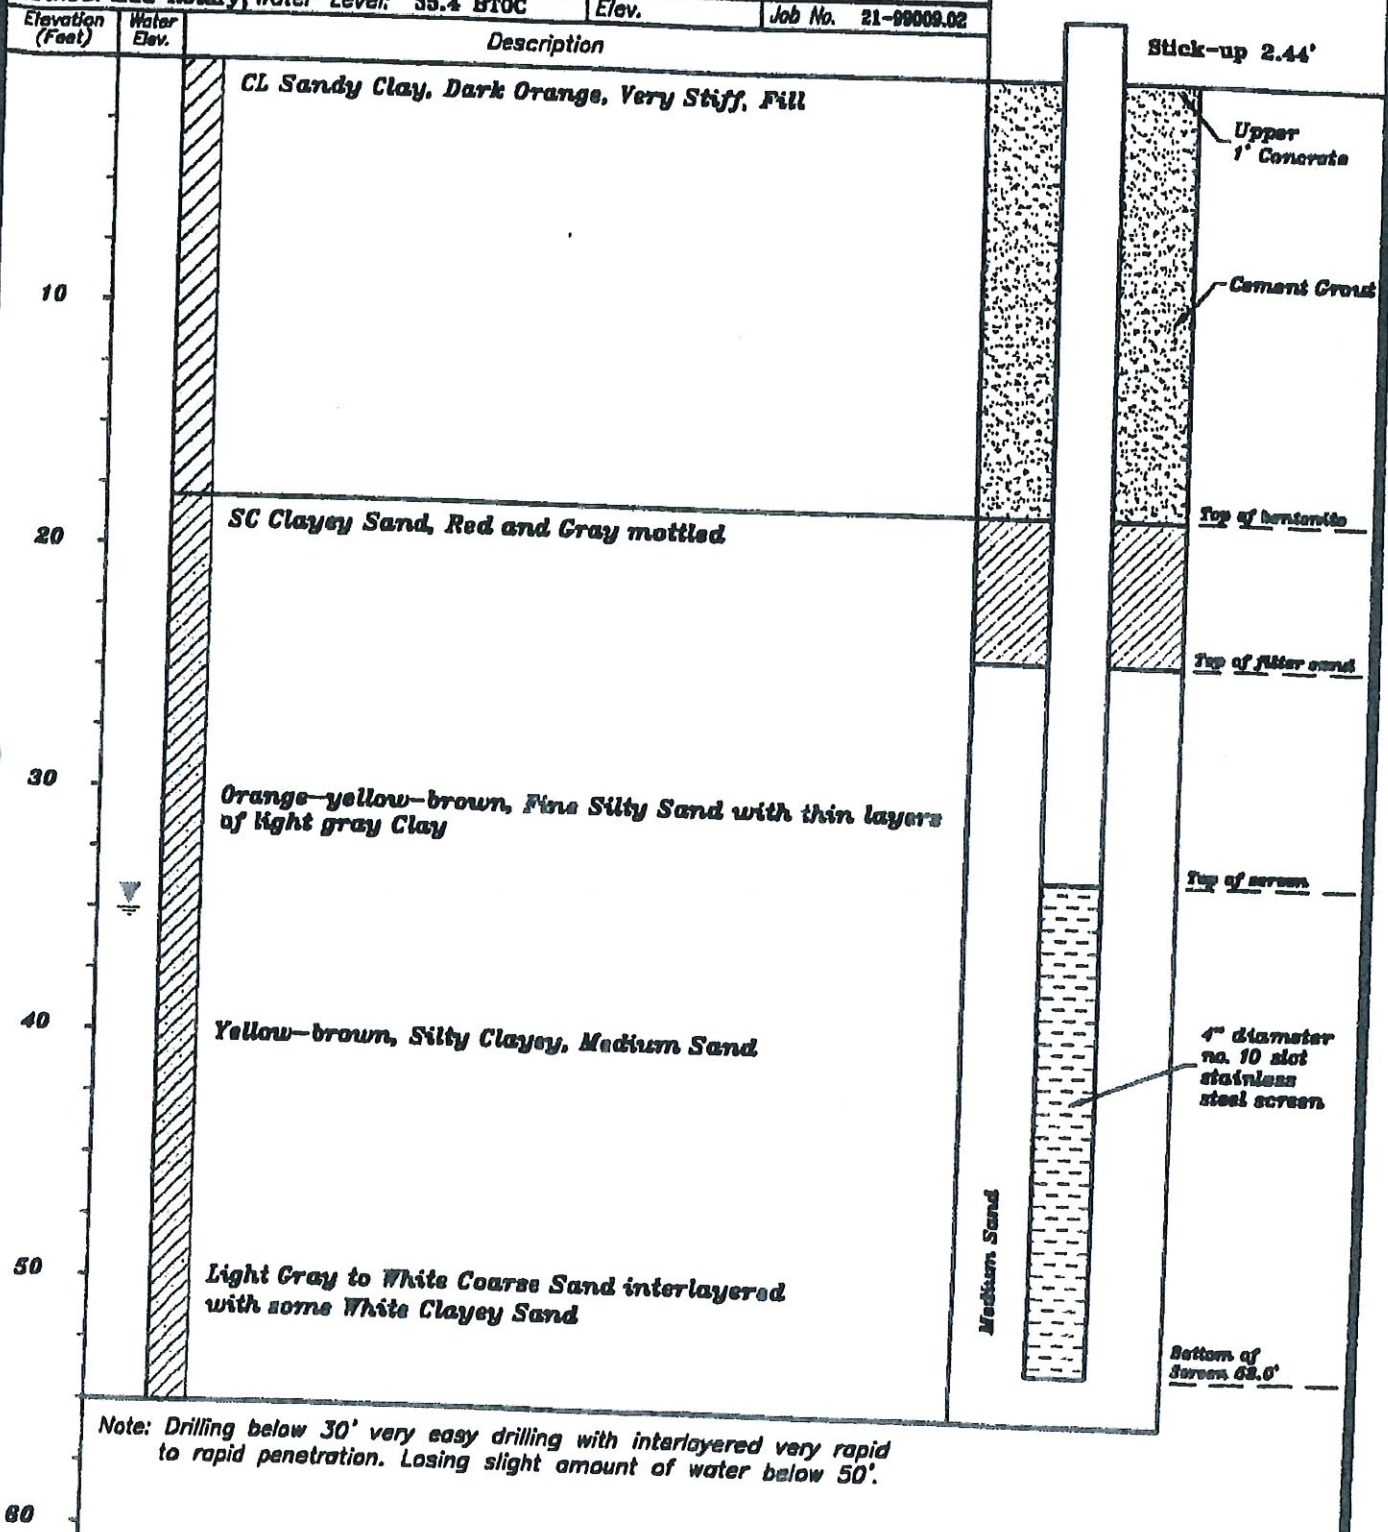
Log of Boring

Driller: E. Titcomb Total Depth: 55.0' Drill Date: Feb. 3-5, 89 Boring No. RW-2
 Method: Mud Rotary Water Level: 35.4 BTOC Elev. Job No. 21-88009.02

Note: Drilling below 30' very easy drilling with interlayered very rapid to rapid penetration. Losing slight amount of water below 50'.

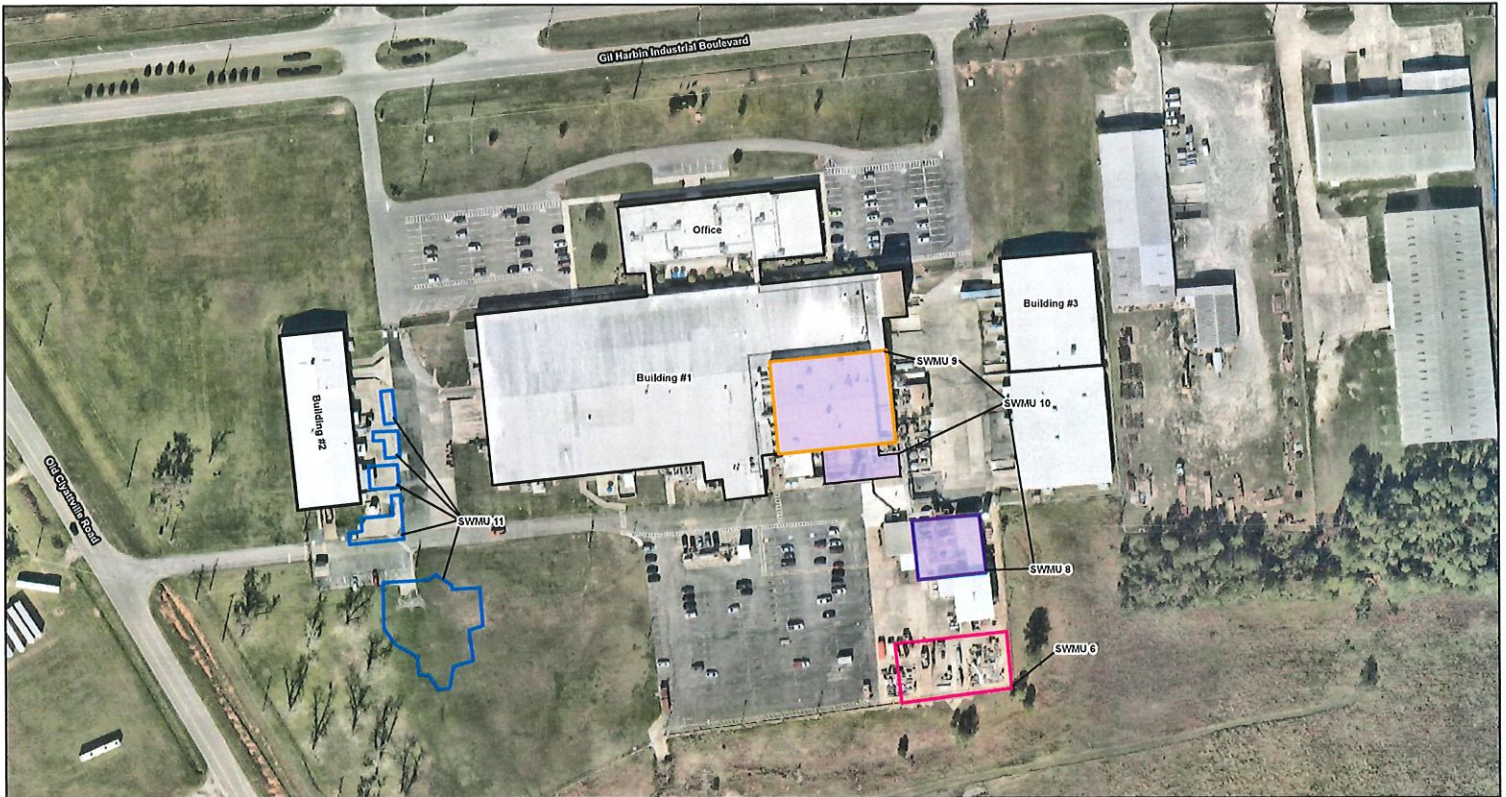
- Legend**
- Solid Waste Management Unit Areas**
- SWMU 6 - Closed Container Storage Area
 - SWMU 8 - Wastewater Treatment Unit and Appurtenances
 - SWMU 9 - All Transfer Lines Used to Transport Waste
 - SWMU 10 - All Sumps Used to Collect Waste
 - SWMU 11 - Building 2 Former Bum Area

Notes:
 1. Solid Waste Management Unit (SWMU) areas are approximate and based on ASA Engineering & Surveying, Inc. Figure 2b, dated 9 August 2024.
 2. Other site areas are based on aerial and site observation.
 3. Aerial Imagery: Nearmap, HERE, captured 16 November 2024.

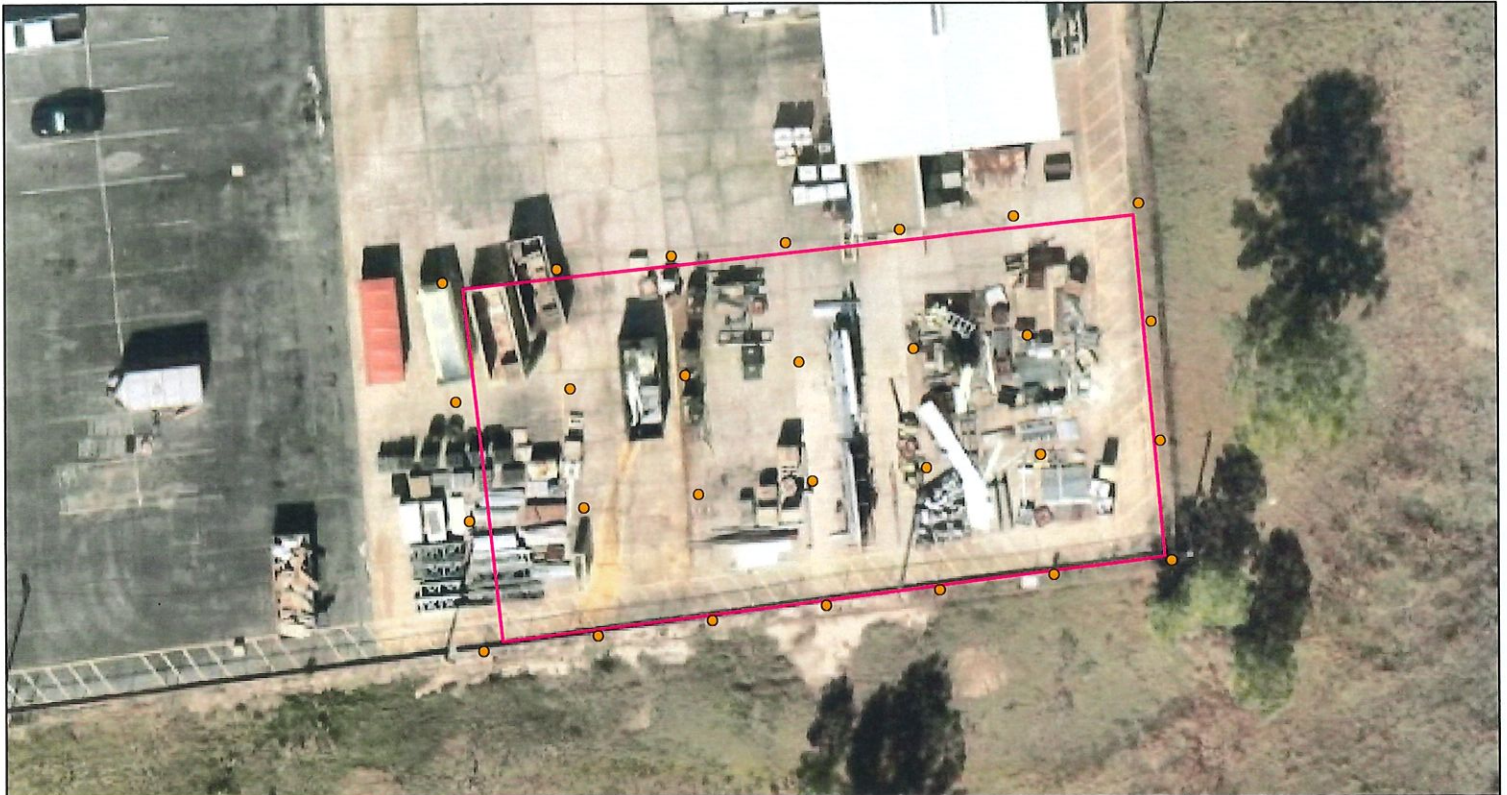
- Proposed Soil Boring Locations
- Solid Waste Management Unit Areas
- ▭ SWMU 6 - Closed Container Storage Area

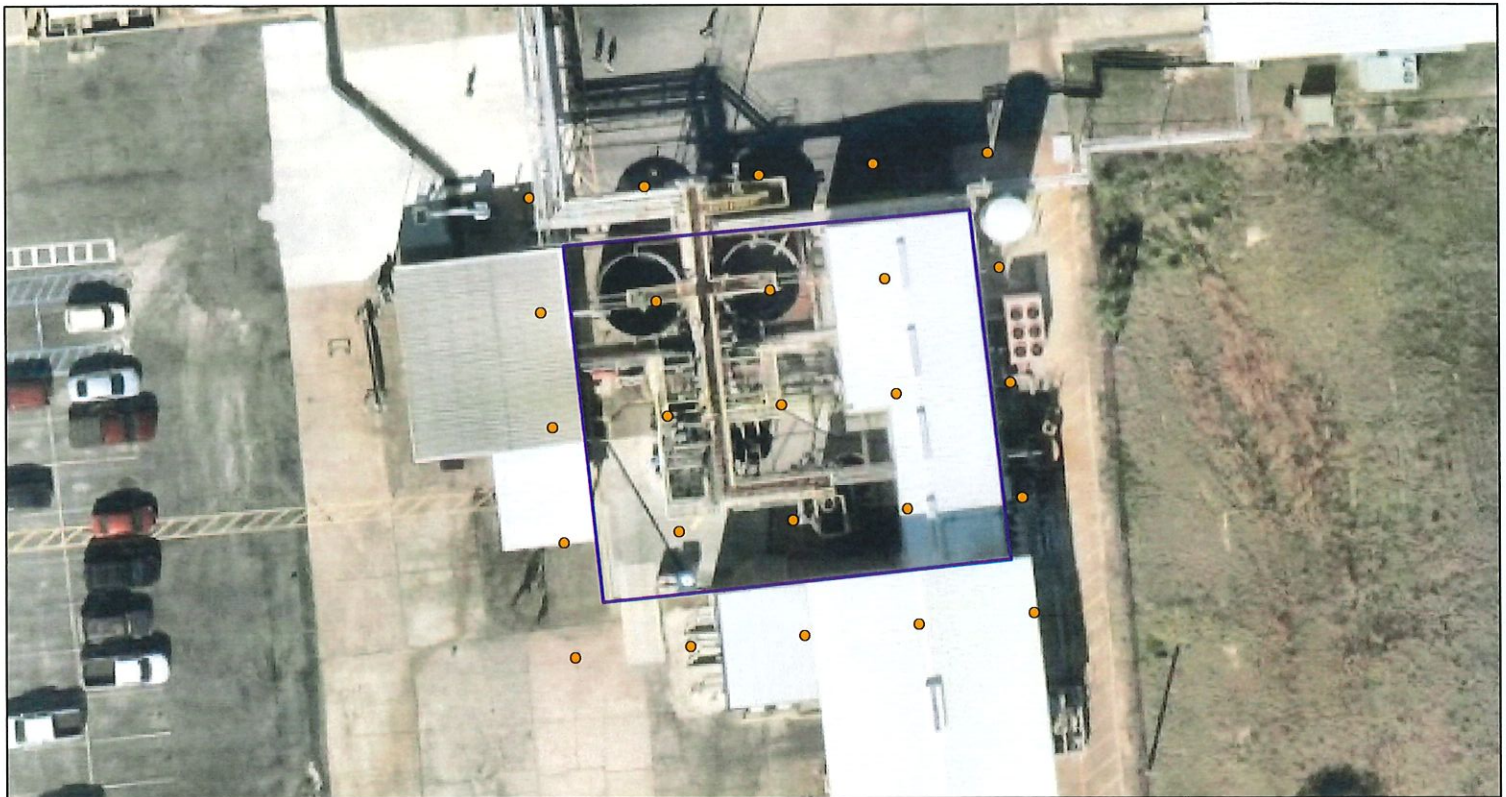
- Legend**
- Proposed Soil Boring Locations
 - Solid Waste Management Unit Areas
 - SWMU 8 - Wastewater Treatment Unit and Appurtenances

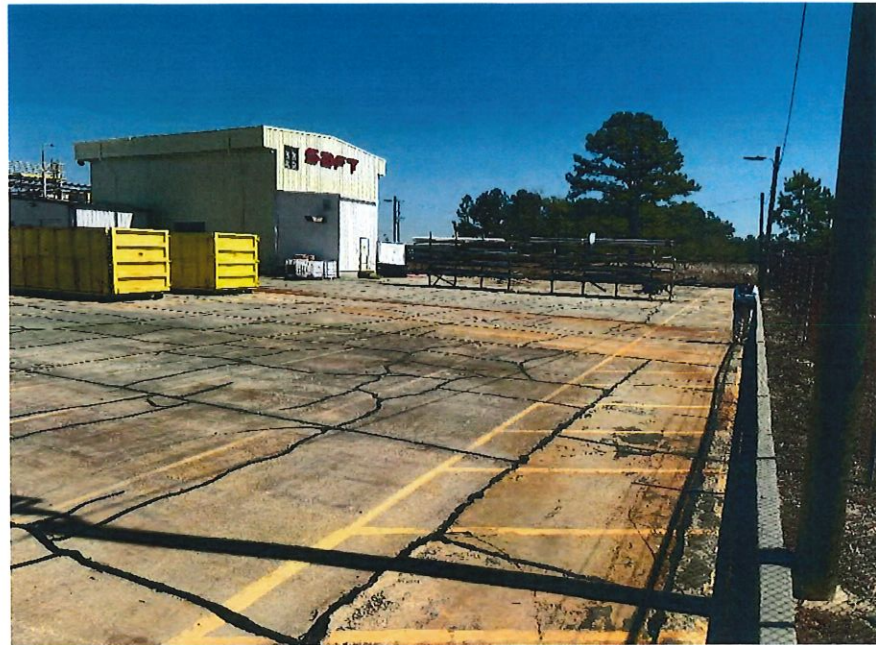
Comments: SWMU 6 – Closed Container Storage Area

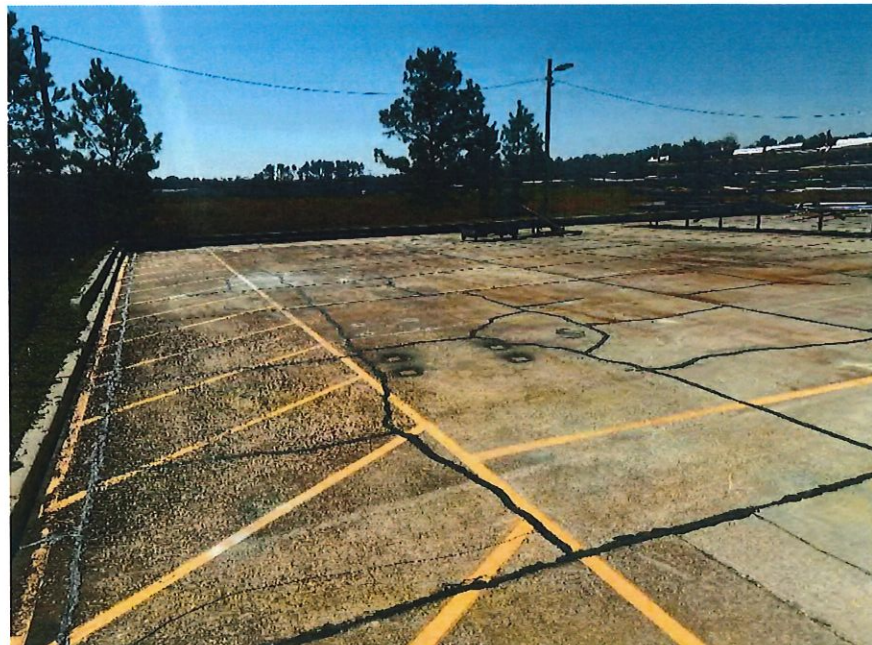
Photograph 2

Comments: SWMU 6 – Closed Container Storage Area

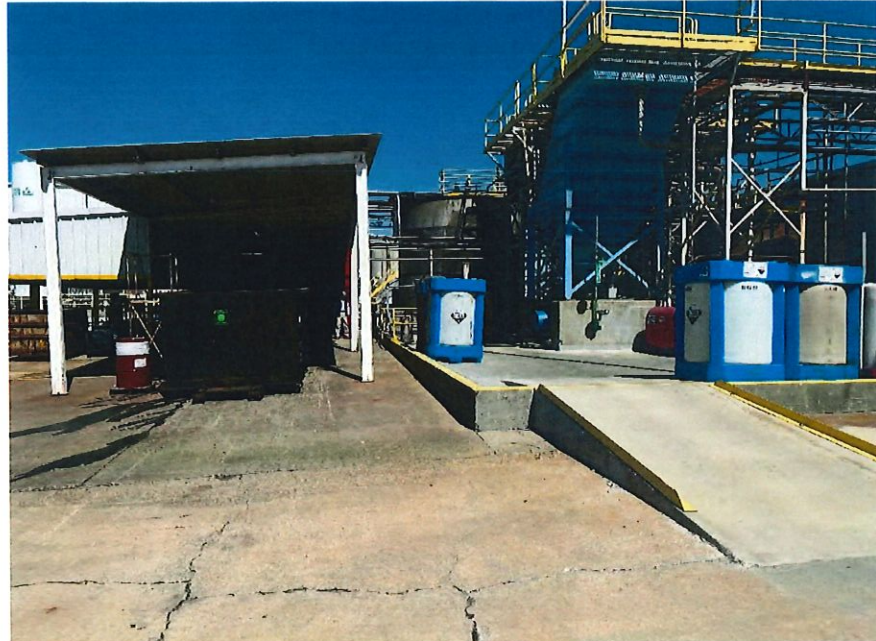
Comments: SWMU 8 – Wastewater Treatment Unit and Appurtenances

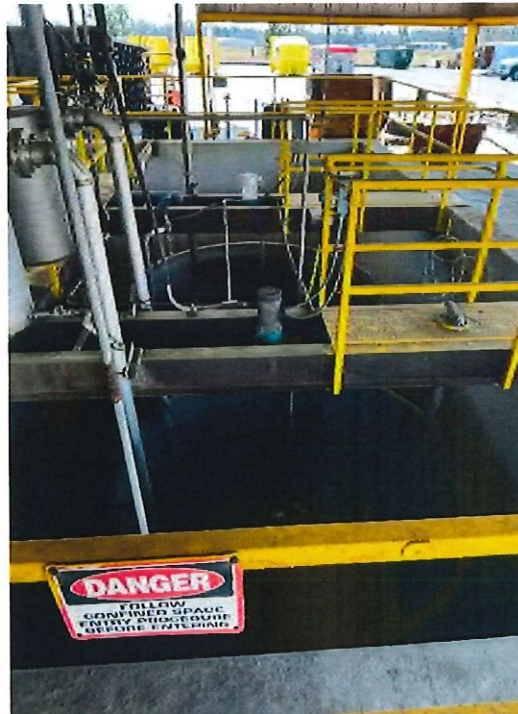
Photograph 4

Comments: SWMU 8 – Wastewater Treatment Unit and Appurtenances

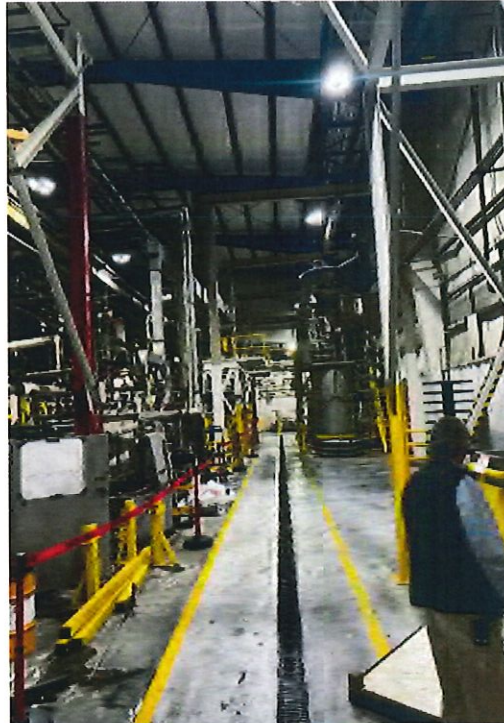
Comments: SWMU 9 – All Transfer Lines Used To Transport Waste / SWMU 10 – All Sumps Used to Collect Waste

The wastewater transfer lines which comprise SWMU 9 are located under the Chemical Plant. These lines were installed in 1974 when the Chemical Plant was being built and were used for transferring aqueous impregnation process wastes containing nickel, cadmium and caustic solutions from Chemical Plant operations to the 10,000-gallon underground (actually in-ground) sump. These lines are the subject of the 1994 Chemical Plant RFI. Broken transfer lines were discovered, and EPD required Saft to abandon these lines and install an in-floor trenching system for transporting wastewater. The lines were abandoned in 1995 and replaced as directed.

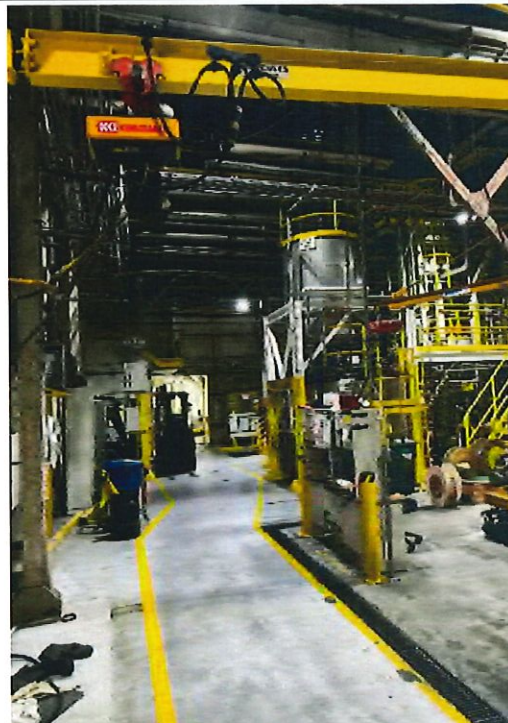
Photograph 6

Comments: SWMU 9 – All Transfer Lines Used To Transport Waste / SWMU 10 – All Sumps Used to Collect Waste

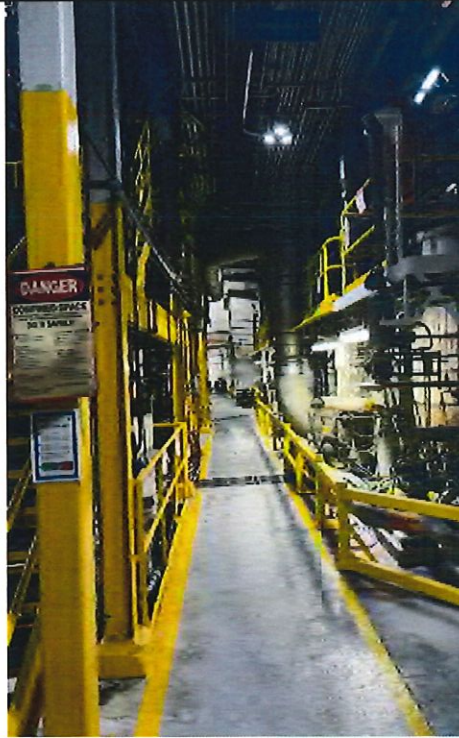
Comments: SWMU 9 – All Transfer Lines Used To Transport Waste / SWMU 10 – All Sumps Used to Collect Waste

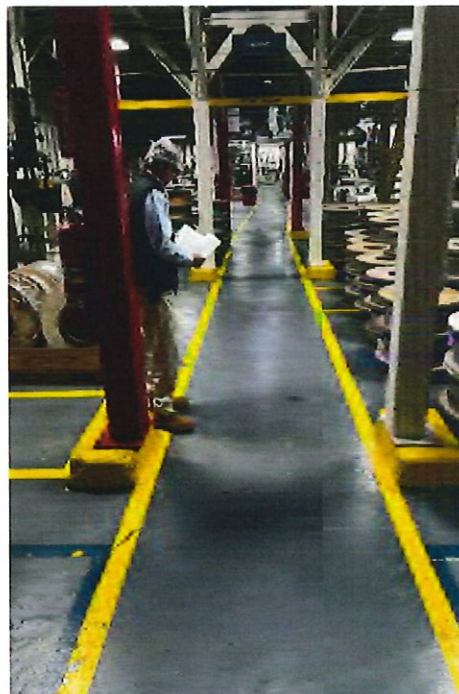
Photograph 8

Comments: SWMU 9 – All Transfer Lines Used To Transport Waste / SWMU 10 – All Sumps Used to Collect Waste

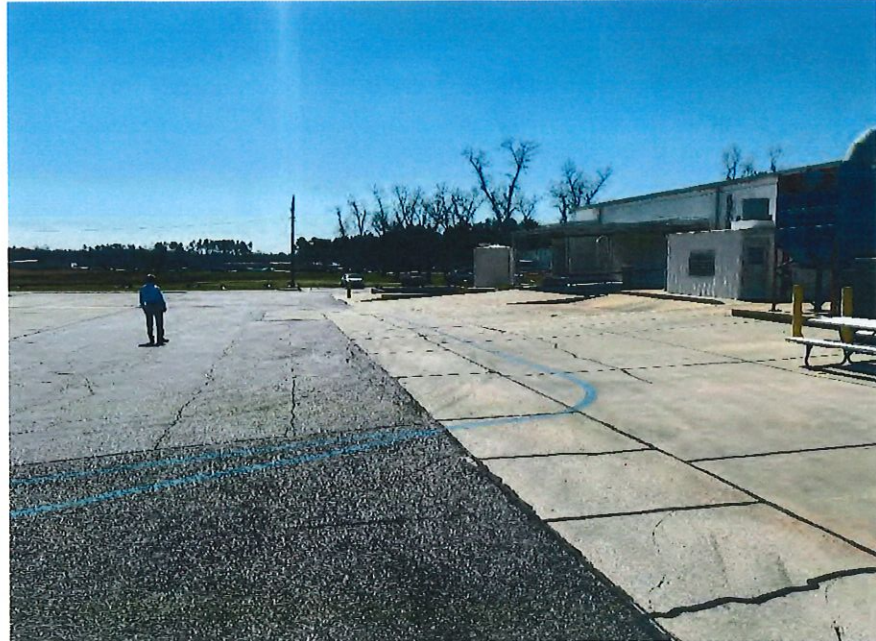
**Comments: SWMU 11
– Building 2 Former
Burn Area (Burn Area
North)**

The Building No. 2-Former Burn Area SWMU was discovered in May 2000, when soil that was excavated for new construction of an addition to Building 2 was tested and found to contain cadmium and nickel. This SWMU is located at the southeast corner of Building No. 2 and extends across the plant access road into the pecan grove. As mentioned above in the description of SWMU3, this former burn area SWMU encompasses an area where factory trash containing nickel and cadmium was burned for a few months during 1975. The SWMU was divided into two sections, Burn Area North and Burn Area South, for description and management purposes. The Burn Area North a roughly 55-foot by 200-foot area on the east side of Building 2 and is currently covered by structures and concrete, including a loading dock ramp and an aboveground storage tank within a concrete secondary containment structure. The former grassy areas next to the building have been capped with concrete. The Burn Area South is the portion of the SWMU located south of the access road that extends into the pecan grove. The Burn Area South very roughly approximates the shape of the state of Texas, covers approximately three-quarters of an acre, and is roughly 190 feet by 220 feet at its longest dimensions.

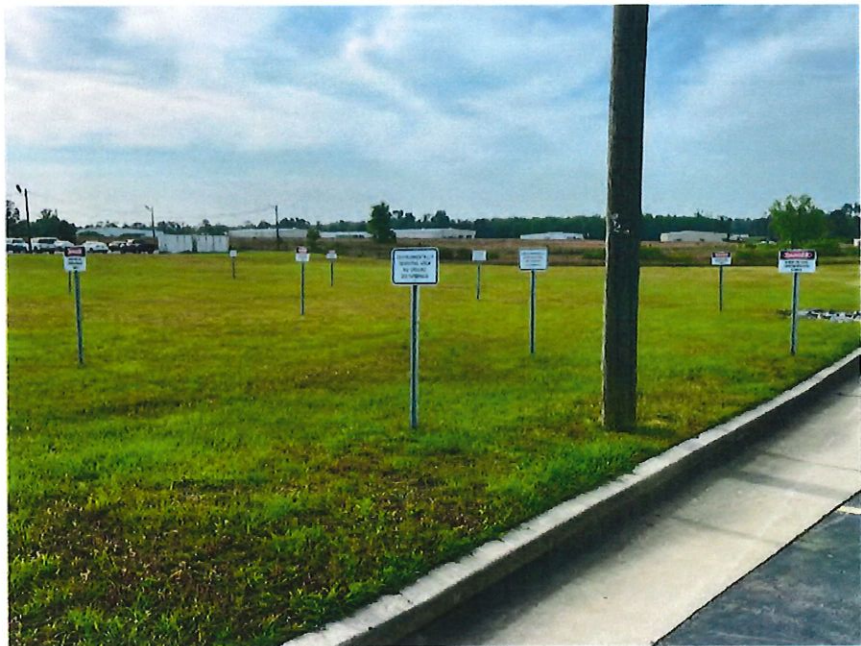
Photograph 10

**Comments: SWMU 11
– Building 2 Former
Burn Area (Burn Area
South)**

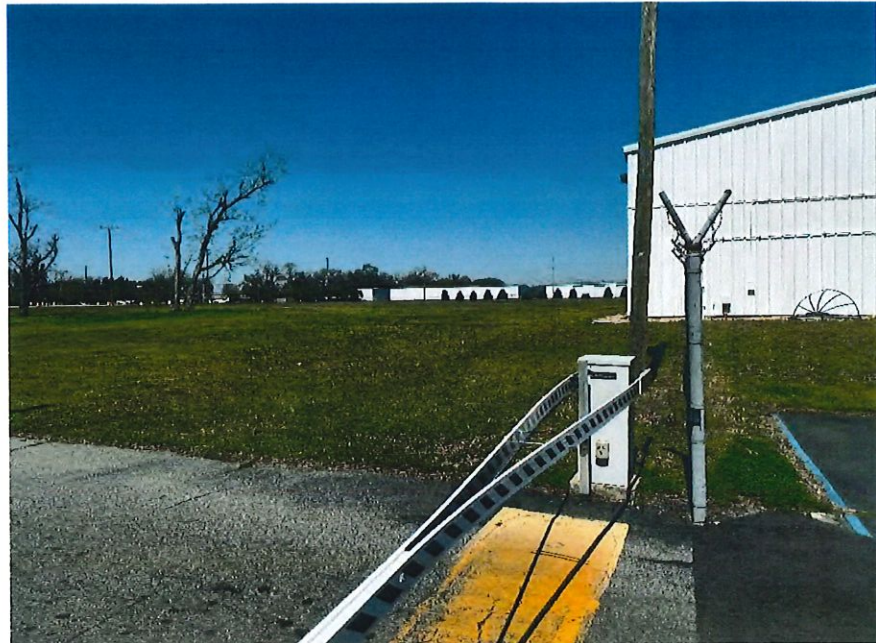
**Comments: SWMU 11
– Building 2 Former
Burn Area (Burn Area
North)**

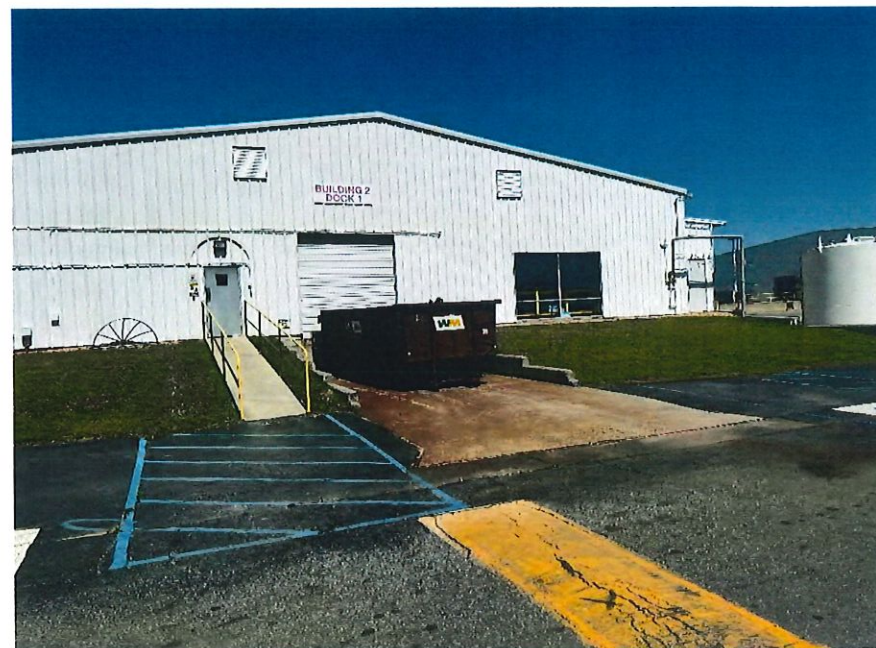
Photograph 12

**Comments: SWMU 11
– Building 2 Former
Burn Area (Burn Area
North)**
