# REPORT

Monitoring and Maintenance Plan  
Novel West Midtown – Phase I  
1330 Fairmont Ave.  
Atlanta, Fulton County, Georgia

RE: Monitoring and Maintenance Plan  
**Novel West Midtown – Phase I**  
1330 Fairmont Ave.  
Atlanta, Fulton County, Georgia  
Project No. CRCOM-20-GA-01147-04

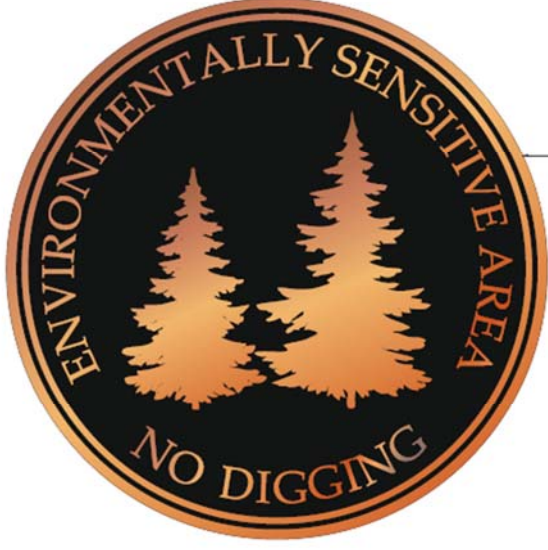
## Sign Specifications

### SPECIFICATIONS FOR BRONZE PLAQUE

- Bronze Plaque 10"W x 10"H
- 5/16" Thick
- Circular
- Raised Copy & Border
- Pebble With Polished Surface
- Double Line Border
- 2025 Black Painted
- Per Artfile Supplied
- Semi-Gloss Finish (15% Matte)
- Blind Mount - Standard Studs
- No Rosettes Required

Raised - Brushed Bronze with matte clear finish

Recessed - Pebble Finish Painted Black

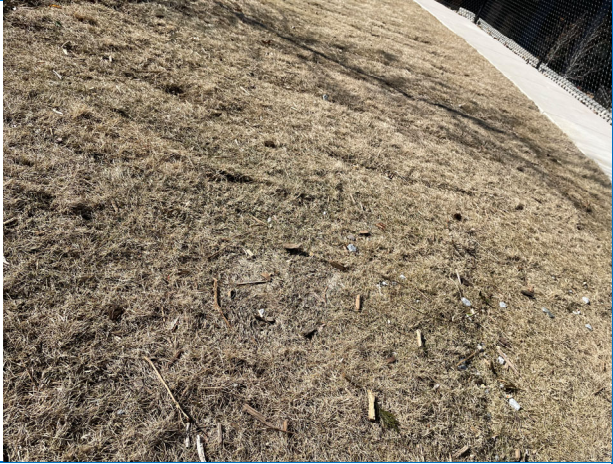
Photo 1: Soil cap cover and planted vegetation above soil nail wall.

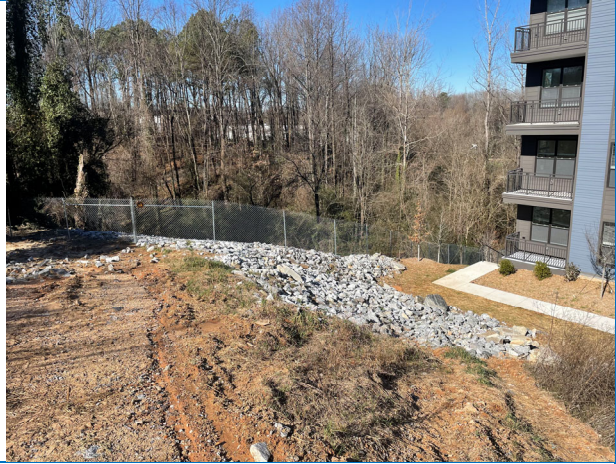
Photo 2: Rip rap embankment west of soil cap cover.

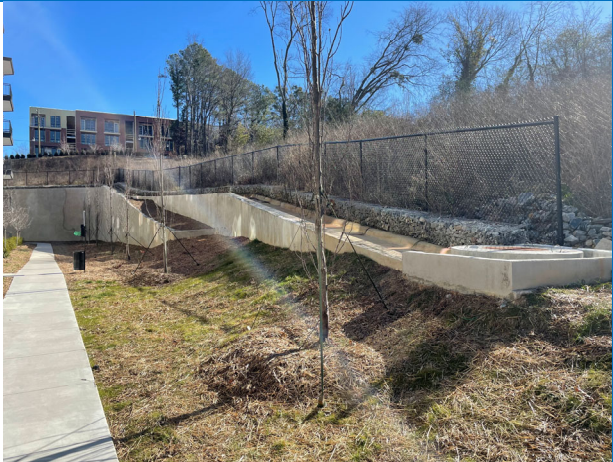
Photo 3: Soil nail wall south of development.

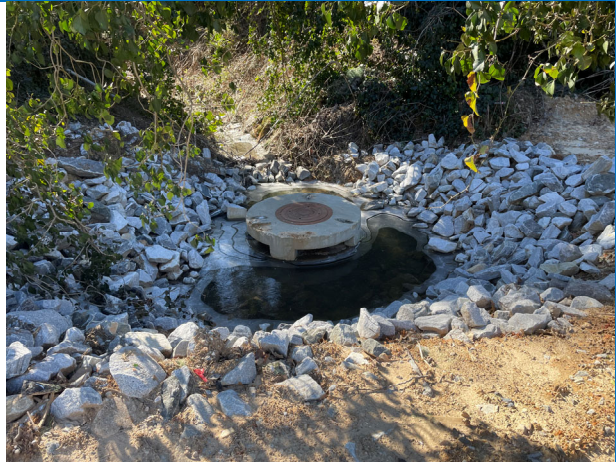
Photo 4: Surface water drop inlet

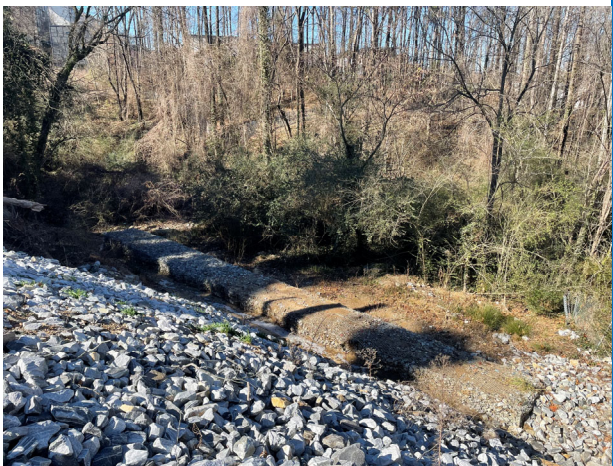
Photo 5: Gabion baskets south of rip rap embankment.

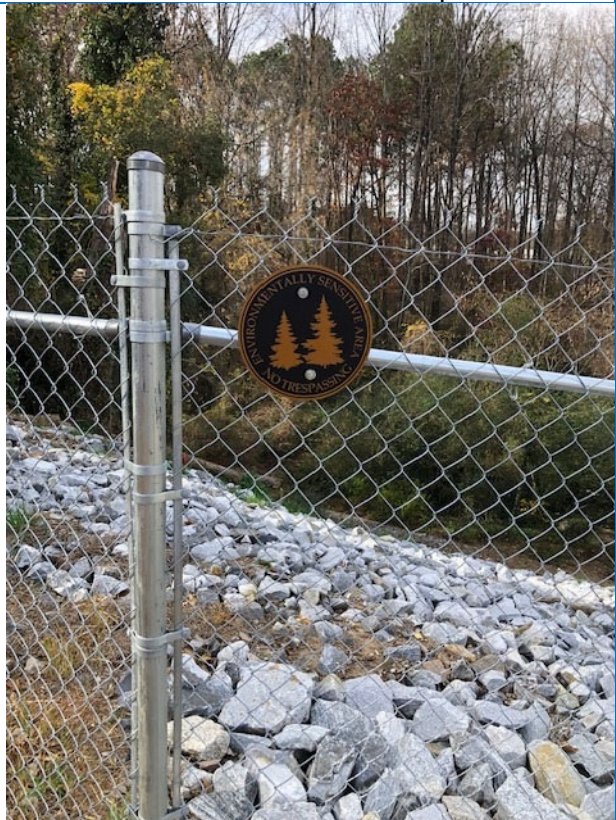
Photo 6: Fencing and signage.
