**Manor Timber Company
102 Black Ankle Road, Manor, Clinch County, GA
GAD061921053**

**RCRA PART B PERMIT RENEWAL APPLICATION FOR
POST CLOSURE CARE AND CORRECTIVE ACTION**

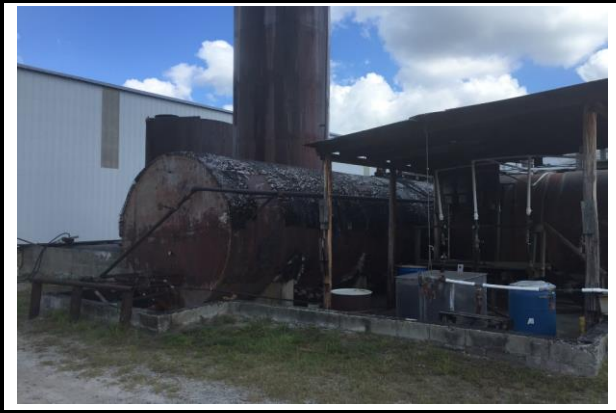
View: The activated carbon system was observed within a bermed area located in the center of the facility.

The groundwater treatment system including groundwater extraction pumps, lines, valves and groundwater filtration system consisting of granular activated carbon canisters are inspected daily for evidence of normal operation or leaks, cracks, corrosion, deterioration and other signs of potential failure. The groundwater filtration system is also tested daily for phenol breakthrough.

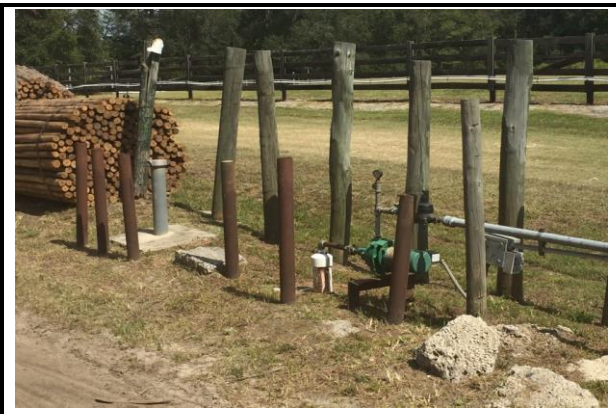
View: Recovery well outside of impoundment

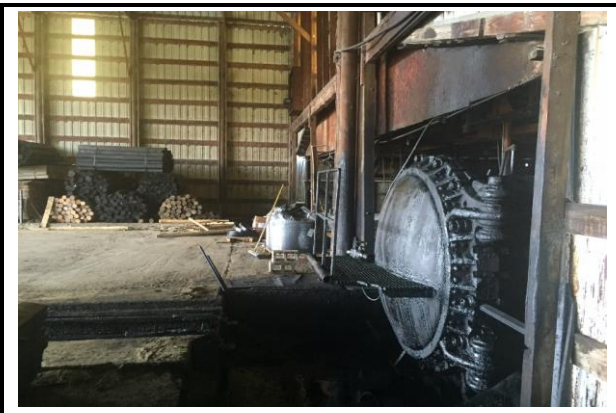
View: Creosote Retort at the central portion of the facility
