**PART B REVISED PERMIT**  
W.C. MEREDITH FACILITY  
2335 LAWRENCE STREET  
EAST POINT, GA 30344  
PERMIT No. HW-062(D)

**PART B REVISED PERMIT**  
 W.C. MEREDITH FACILITY  
 2335 LAWRENCE STREET  
 EAST POINT, GA 30344  
 PERMIT No. HW-062(D)

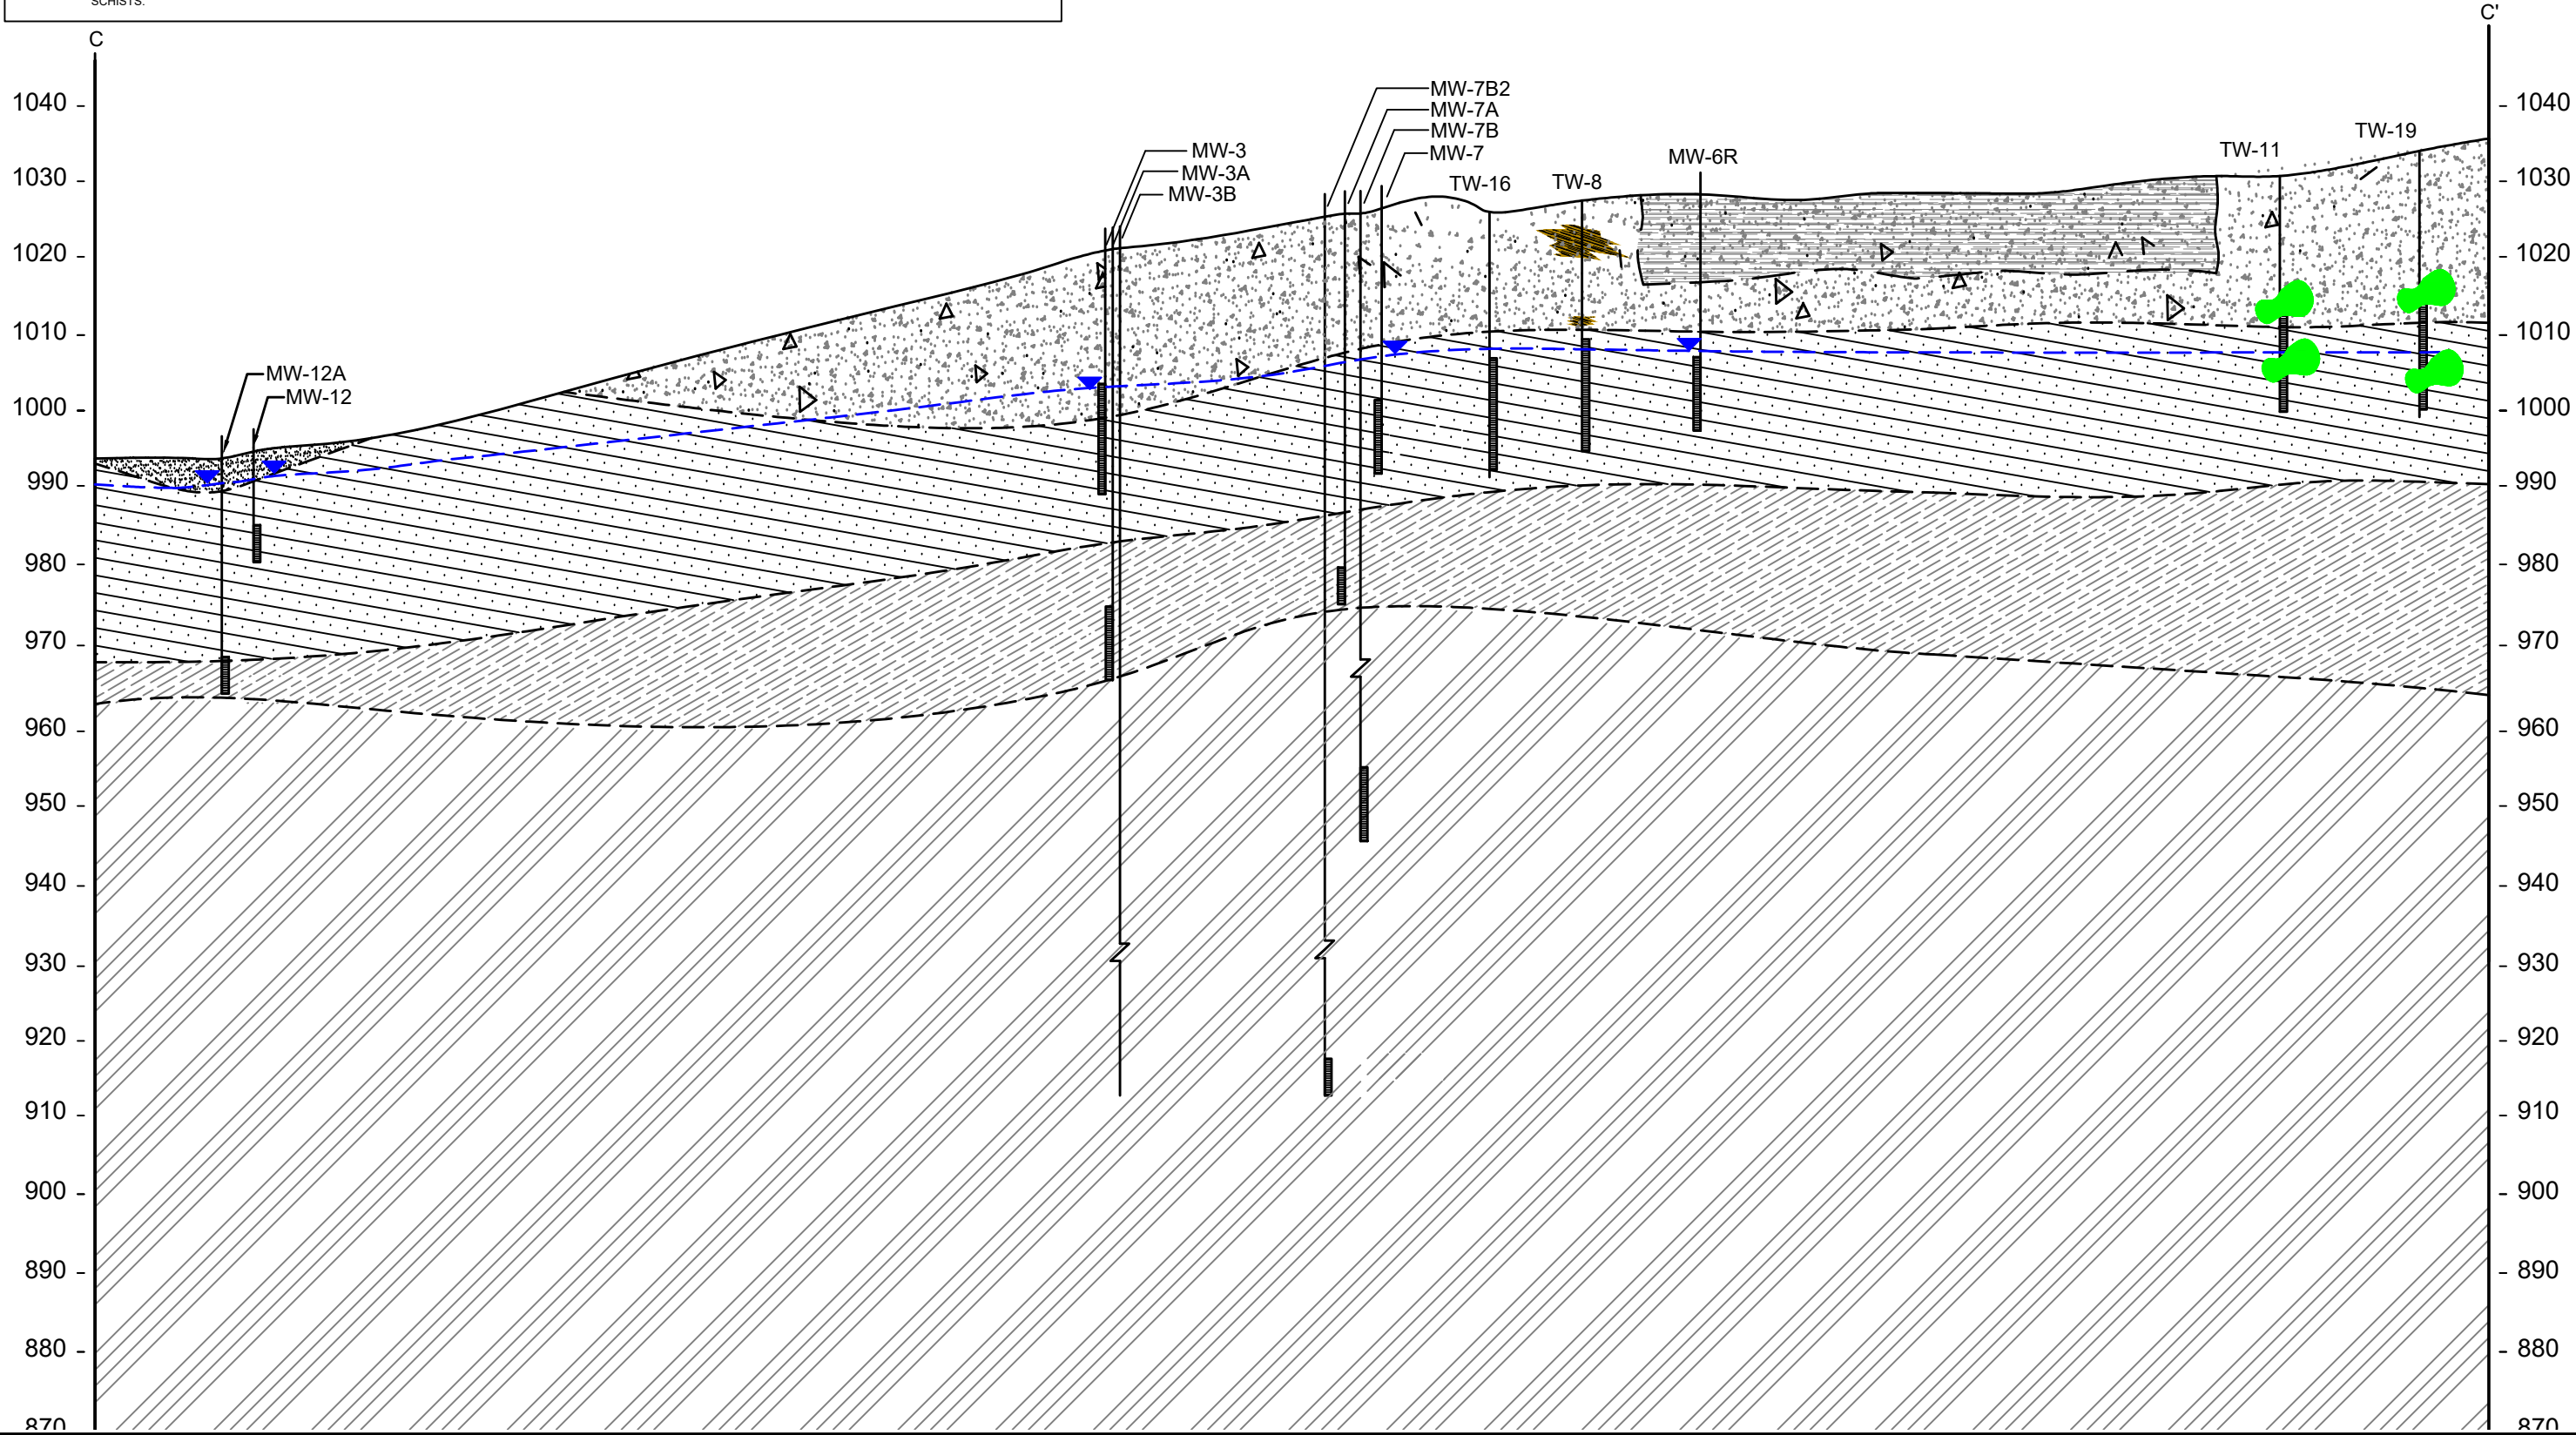
**FILL:**  
CONSISTS OF A MIXTURE OF GRAVEL, SAND, SILTY-SAND, CLAY, AND VARIOUS DEBRIS.

APPROXIMATE ELEVATION OF SHALLOW GROUNDWATER BASED ON 4/5/2023 MEASUREMENTS

**FRACTURED BEDROCK:**  
COMPETENT GRANITIC BIOTITE-RICH GNEISS APPARENT FRACTURING OBSERVED AT VARIOUS INTERVALS (SEE BORING LOGS/CORE LOGS FOR FURTHER DETAILS).

APPROXIMATE LOCATION OF NAPL FOUND IN SOIL BORING  
(SEE BORING LOGS FOR SPECIFIC LOCATIONS AND THICKNESS)

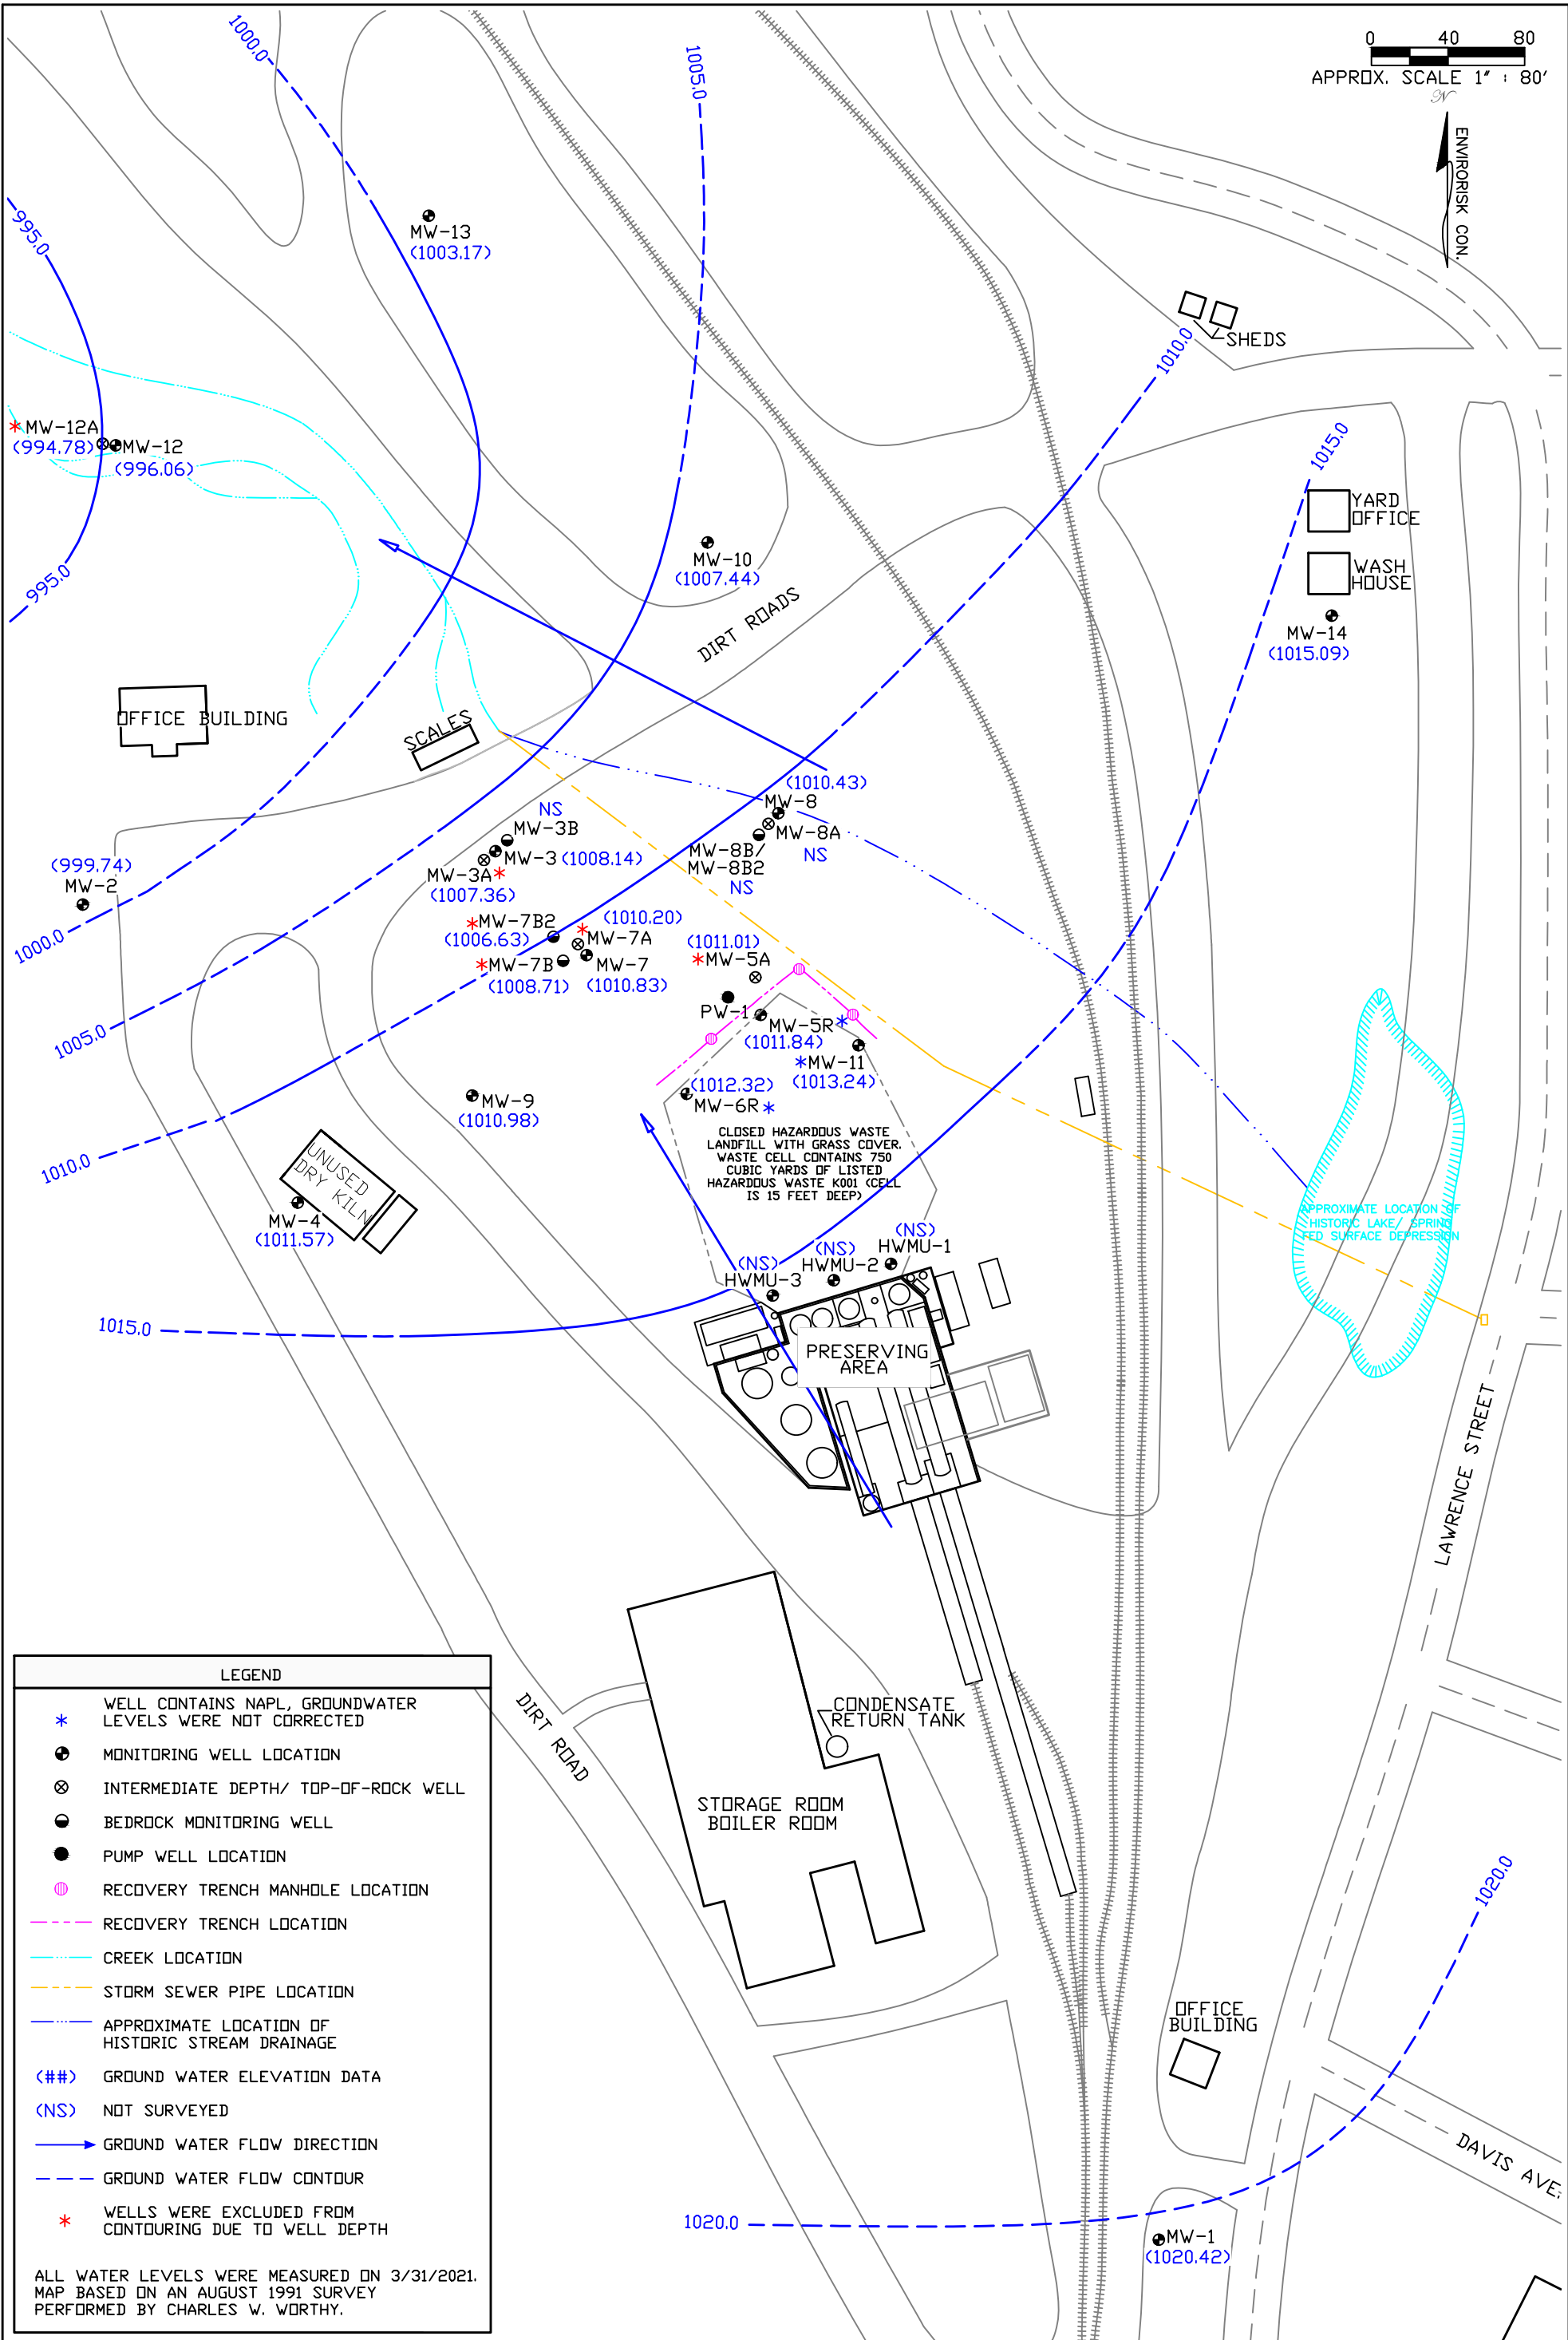
E-8A

ALL WATER LEVELS WERE MEASURED ON 3/31/2021.  
MAP BASED ON AN AUGUST 1991 SURVEY  
PERFORMED BY CHARLES W. WORTHY.

POTENTIOMETRIC SURFACE MAP (3/31/2021)

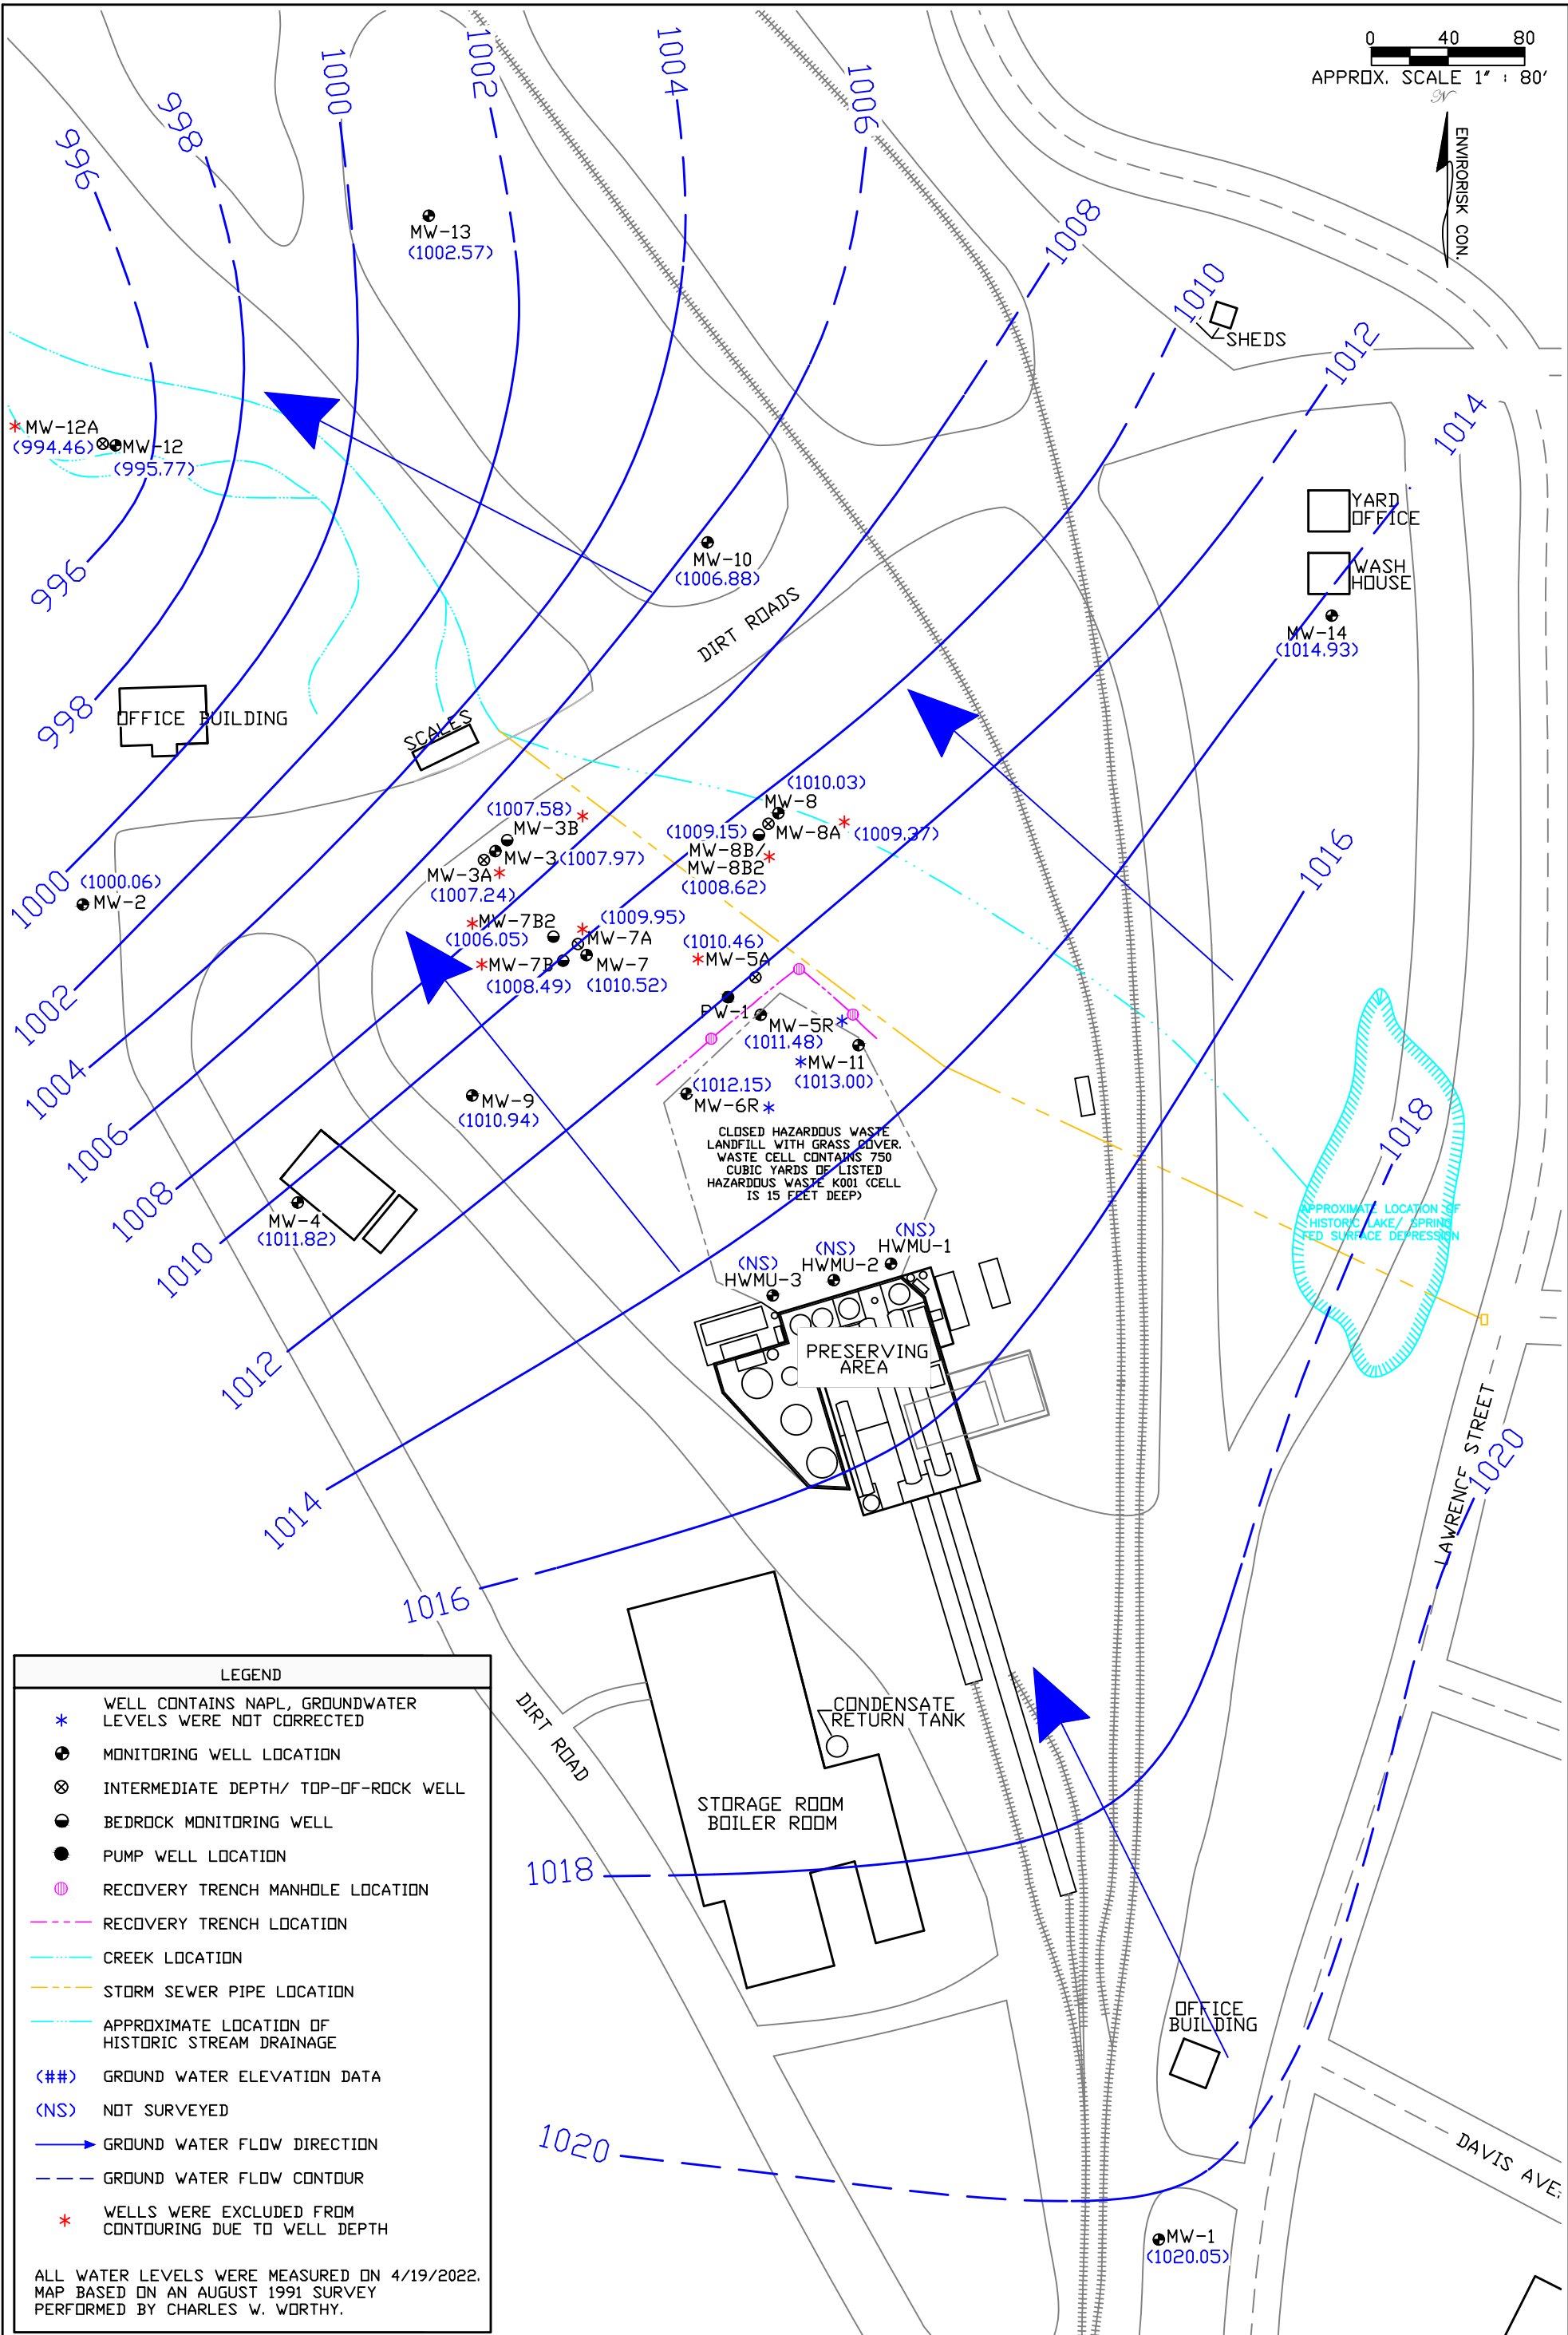
WELLS WERE EXCLUDED FROM CONTOURING DUE TO WELL DEPTH

ALL WATER LEVELS WERE MEASURED ON 4/19/2022. MAP BASED ON AN AUGUST 1991 SURVEY PERFORMED BY CHARLES W. WORTHY.

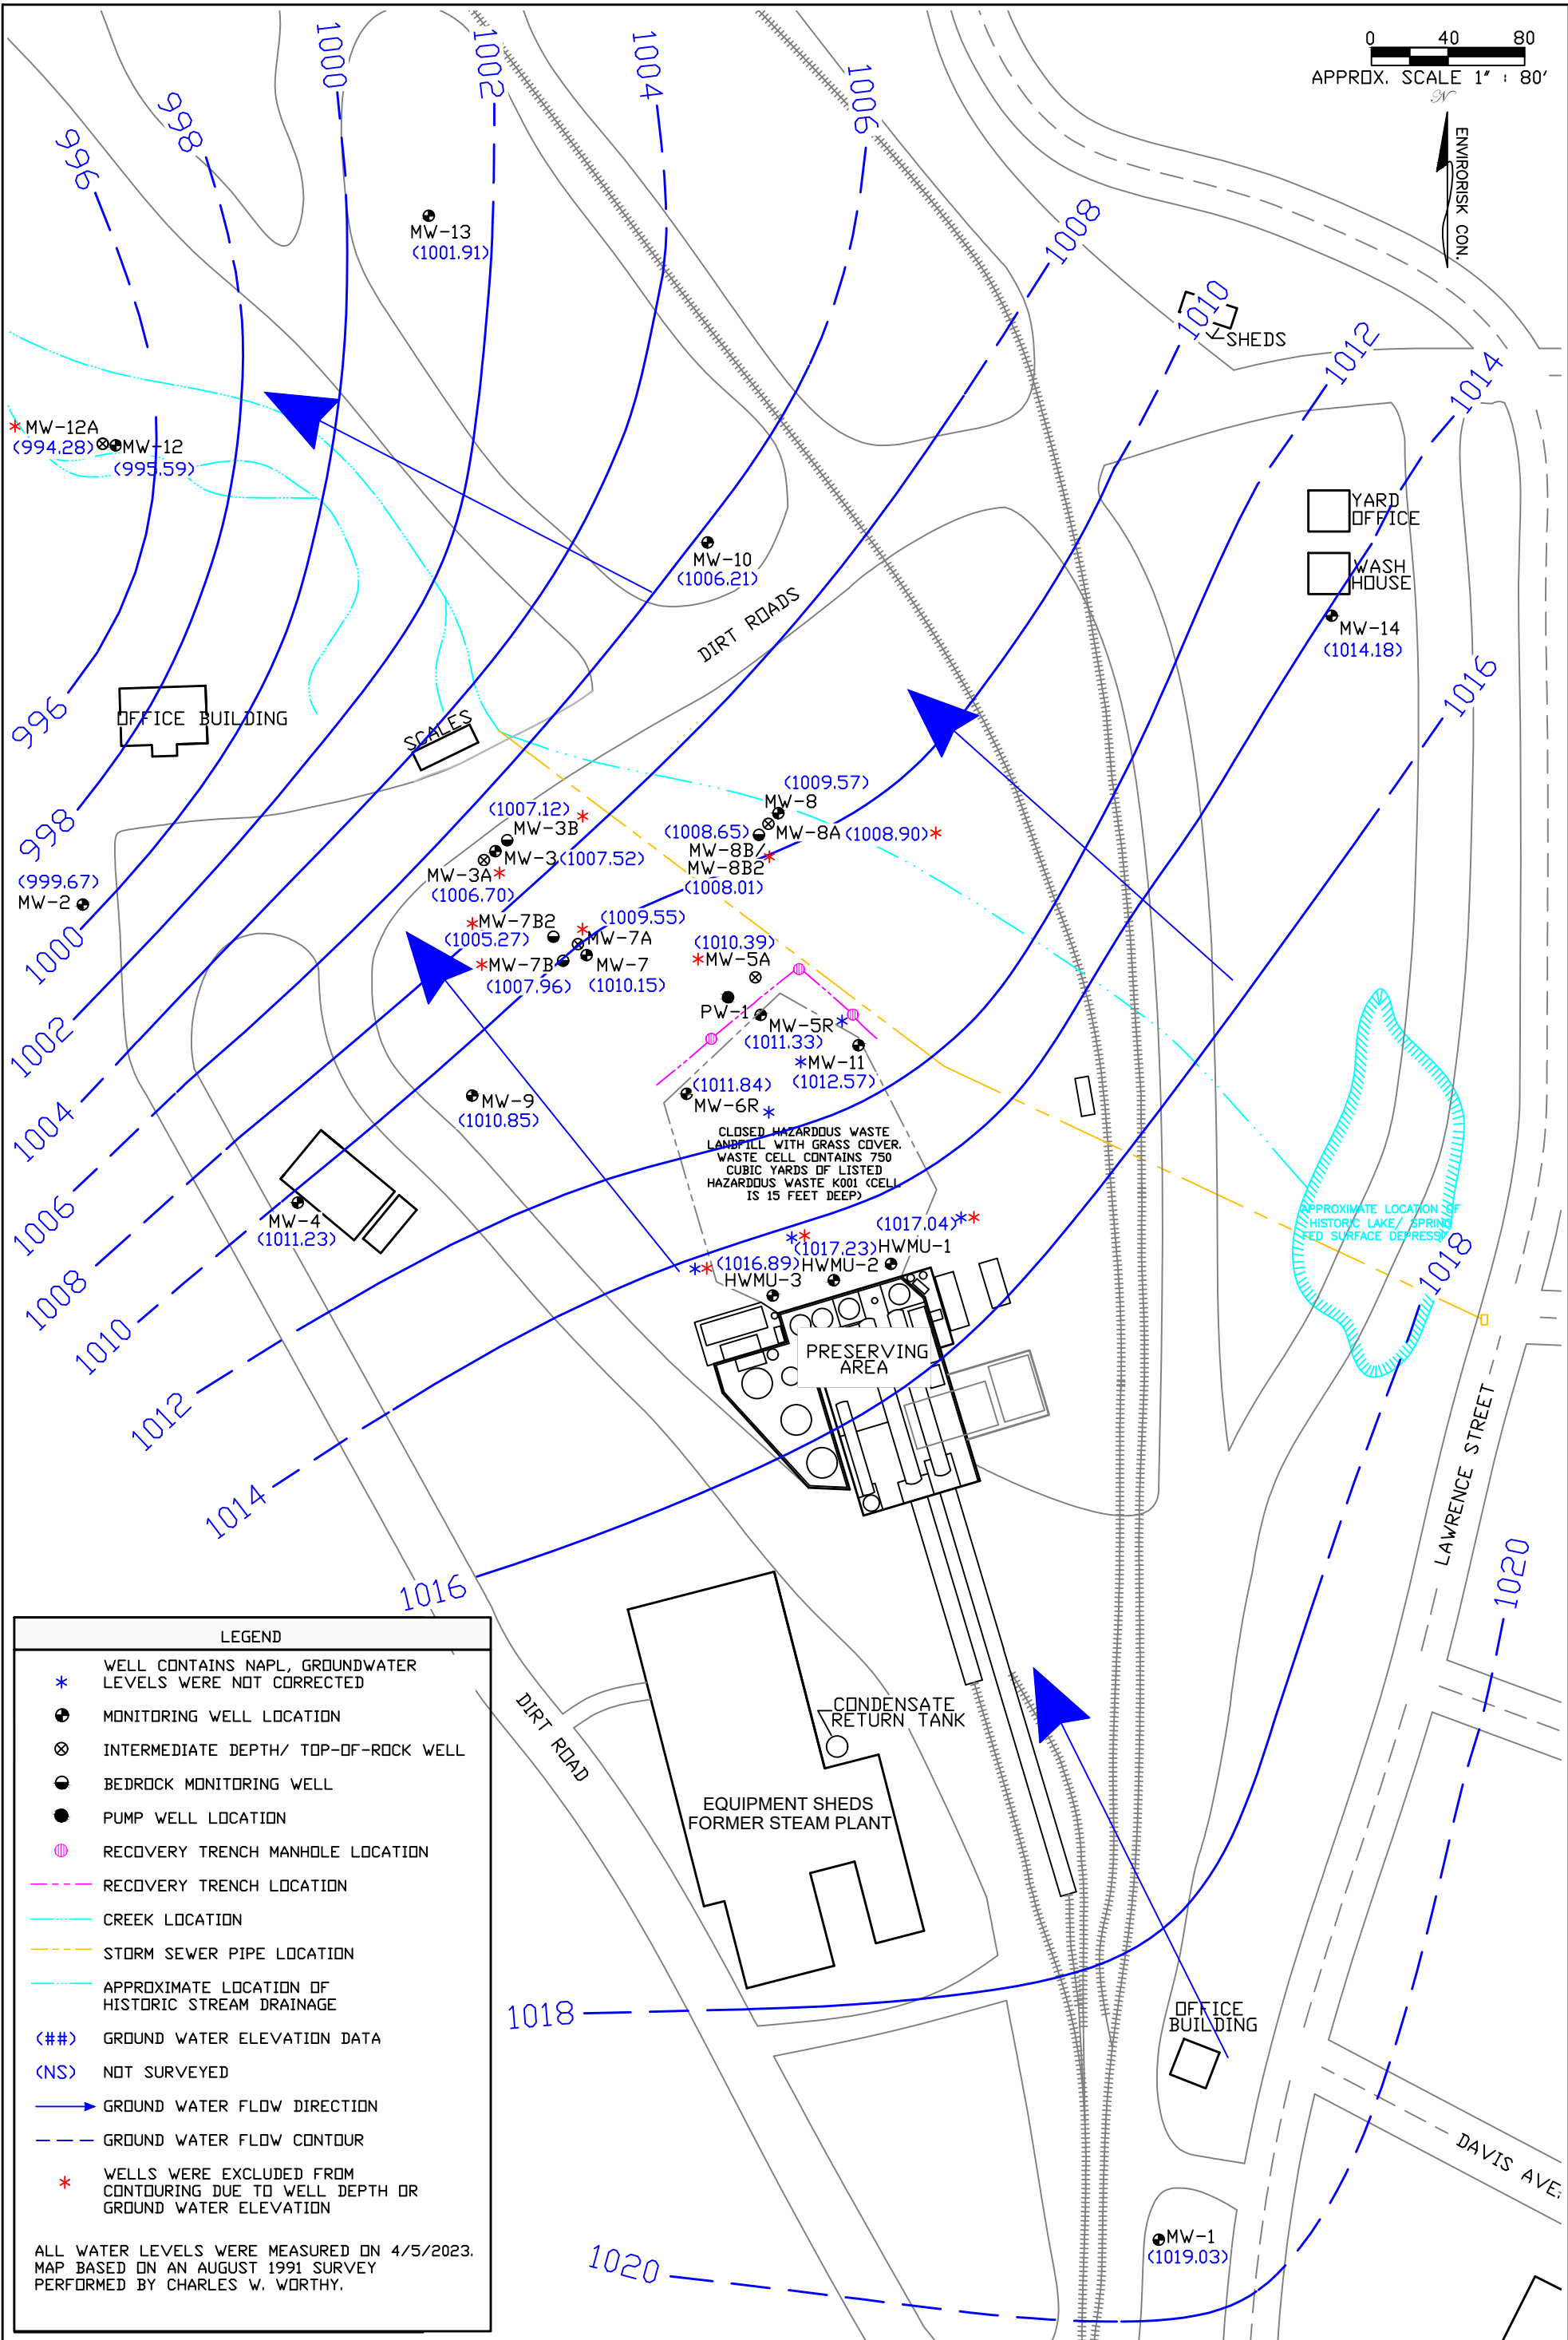
WELLS WERE EXCLUDED FROM CONTOURING DUE TO WELL DEPTH OR GROUND WATER ELEVATION

ALL WATER LEVELS WERE MEASURED ON 4/5/2023.  
MAP BASED ON AN AUGUST 1991 SURVEY  
PERFORMED BY CHARLES W. WORTHY.

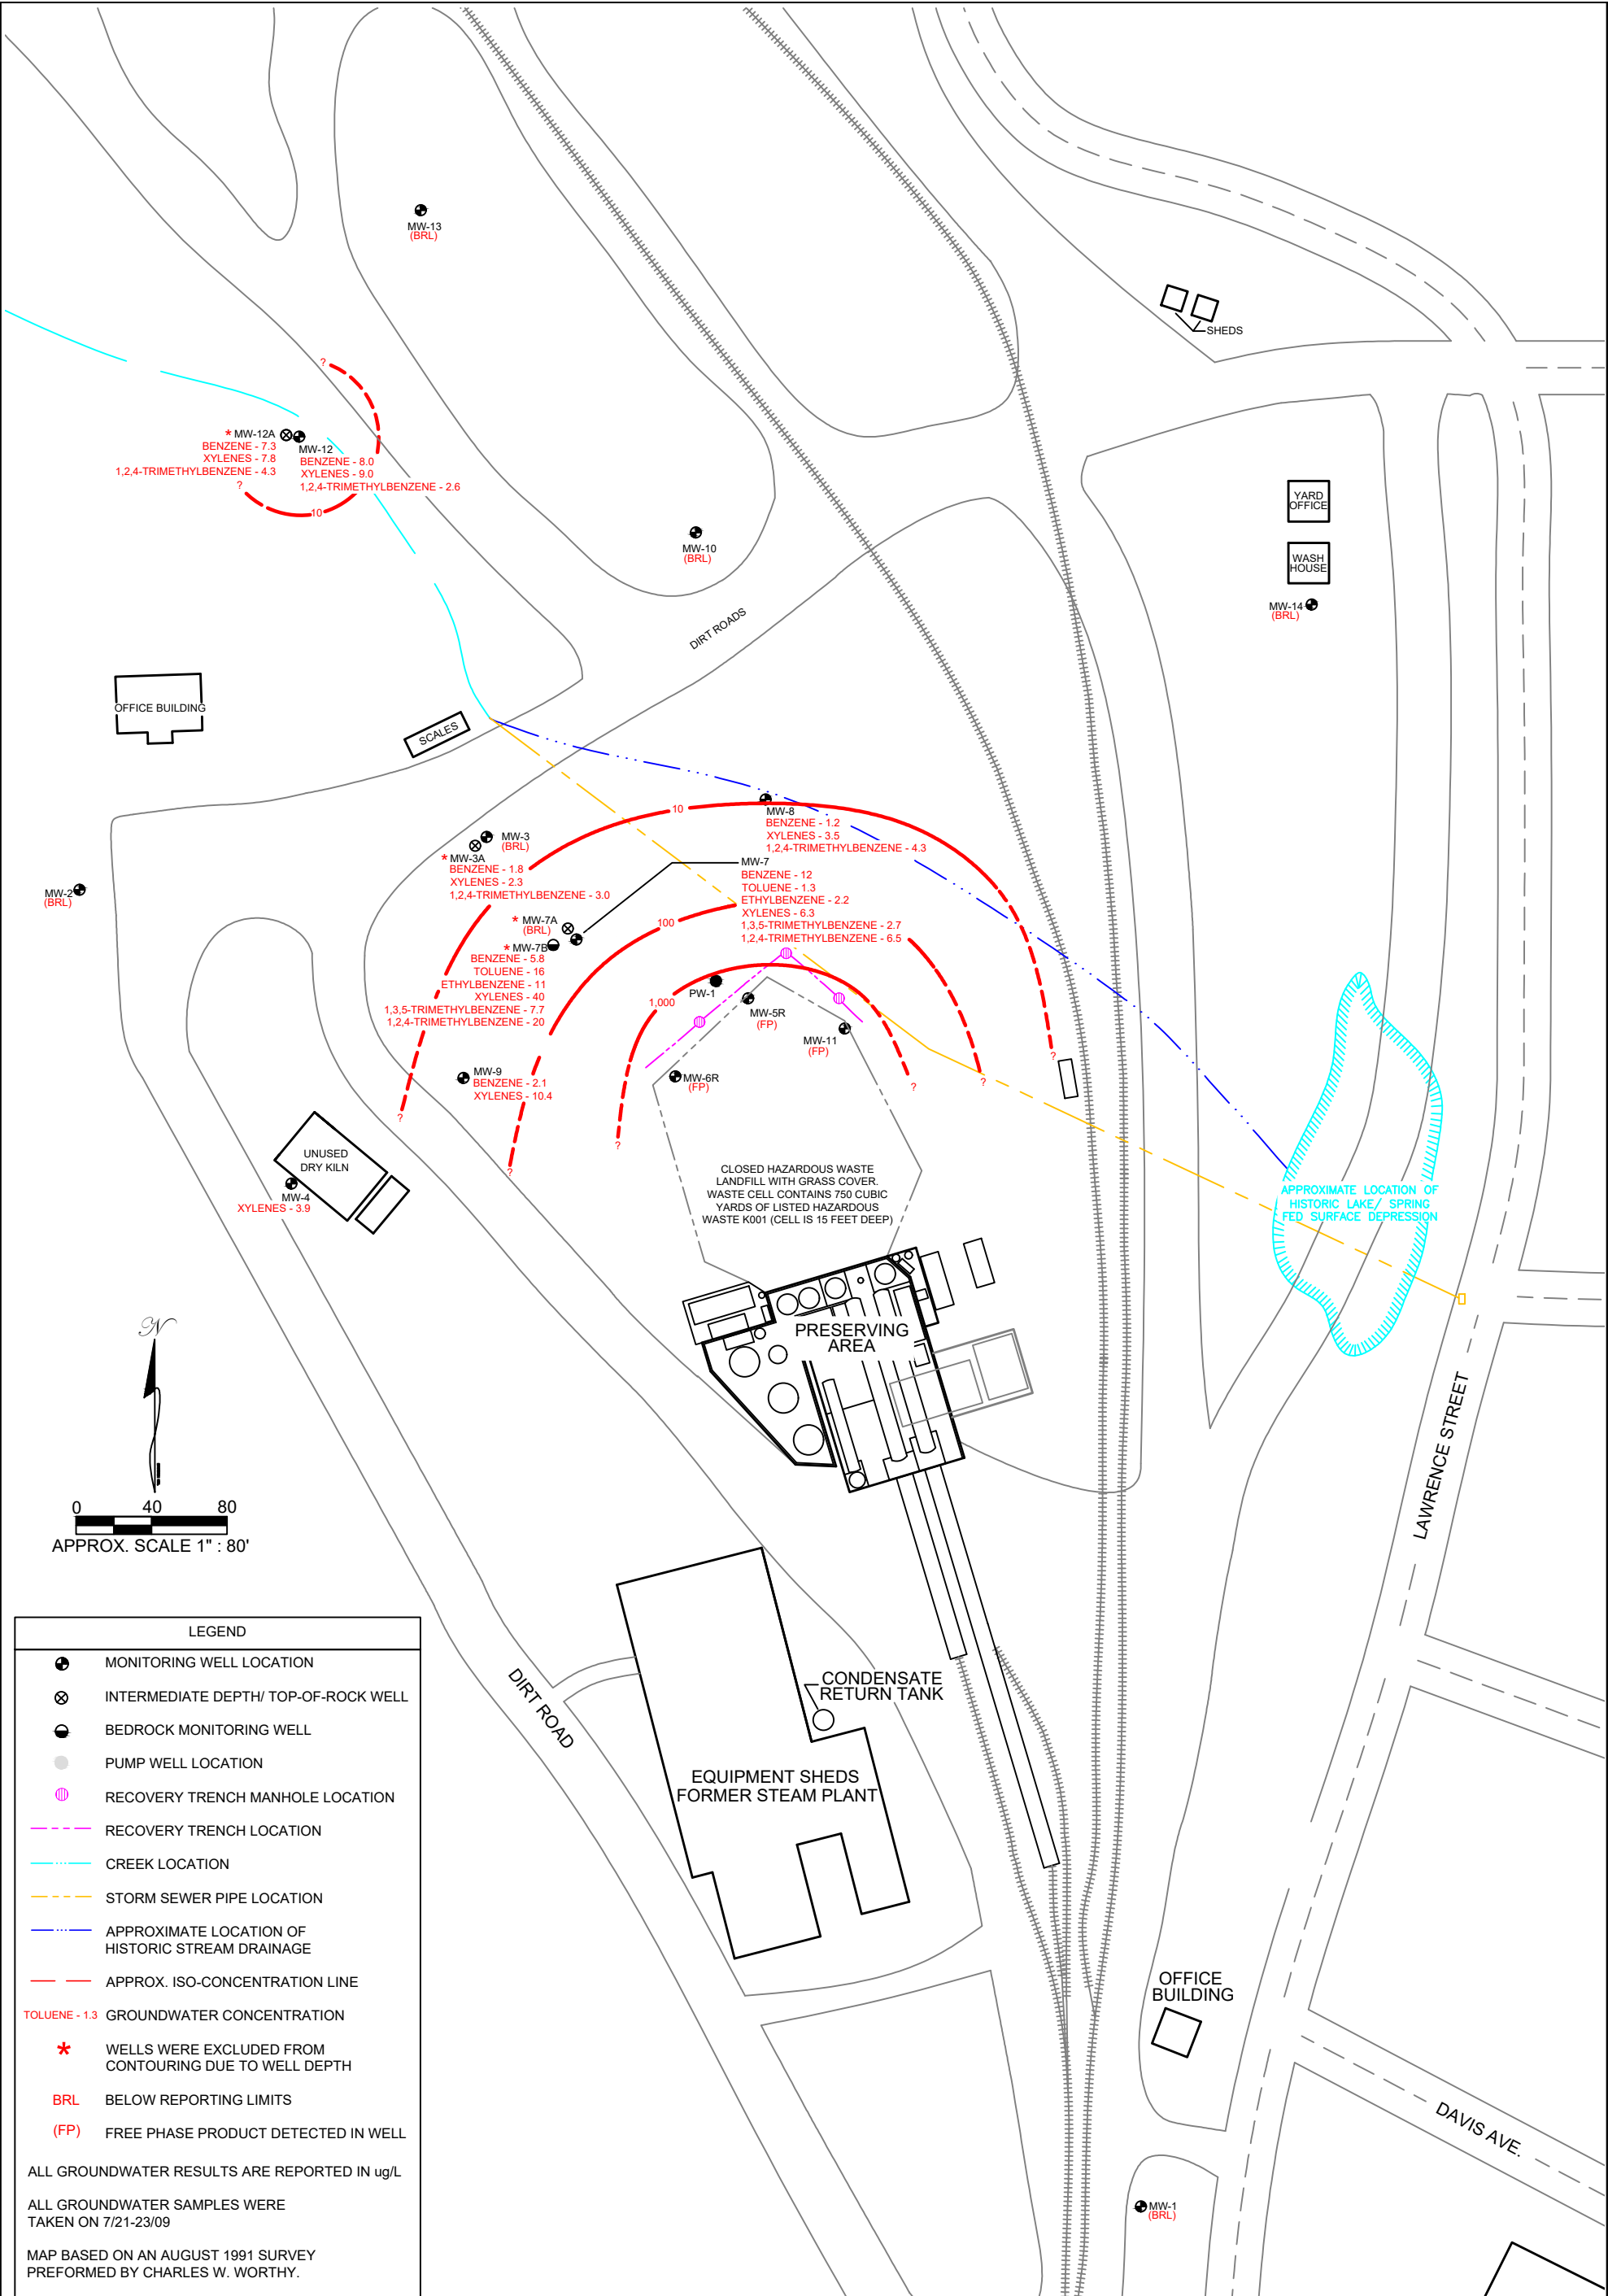
E-9B

HORIZONTAL EXTENT OF TOTAL NON CHLORINATED VOCs (7/2009)

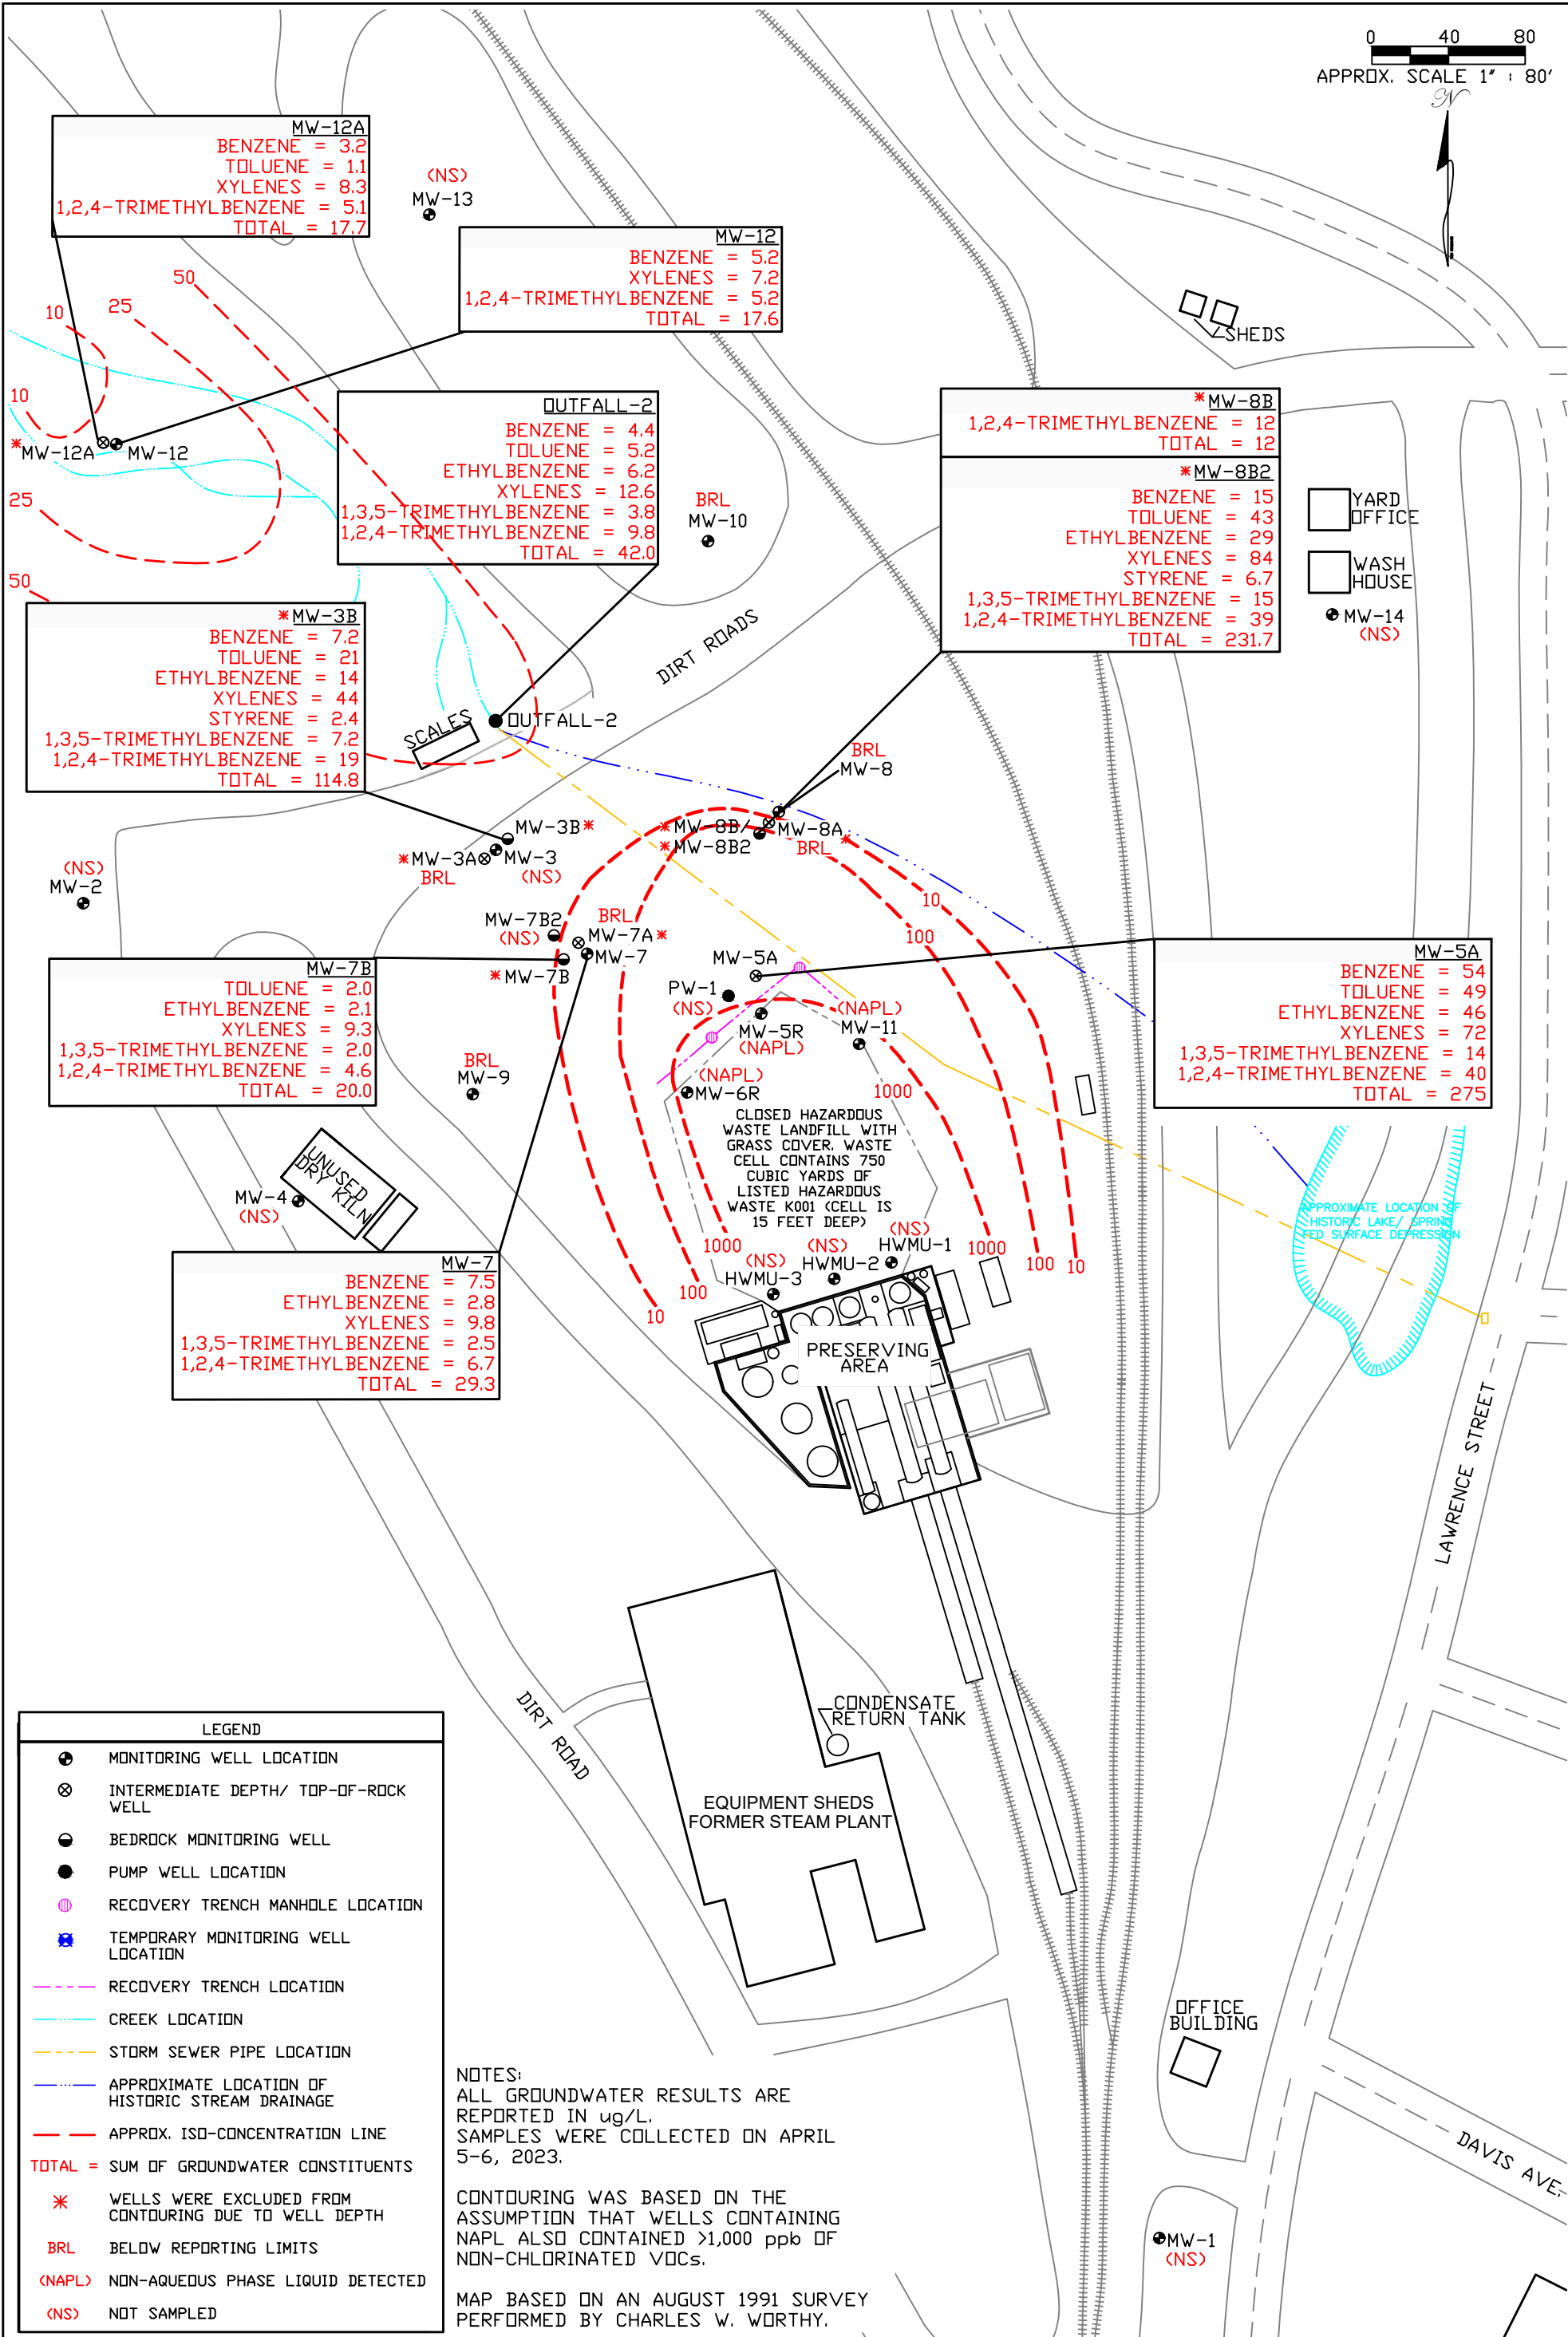
FIGURE NO  
**E-9D**

NOTES:  
ALL GROUNDWATER RESULTS ARE REPORTED IN ug/L.  
SAMPLES WERE COLLECTED ON APRIL 5-6, 2023.

CONTOURING WAS BASED ON THE ASSUMPTION THAT WELLS CONTAINING NAPL ALSO CONTAINED >1,000 ppb OF NON-CHLORINATED VOCs.

HORIZONTAL EXTENT OF TOTAL NON CHLORINATED VOCs  
(APRIL 2023)
