**PART B REVISED PERMIT**  
W.C. MEREDITH FACILITY  
2335 LAWRENCE STREET  
EAST POINT, GA 30344  
PERMIT No. HW-062(D)

**PART B REVISED PERMIT**  
 W.C. MEREDITH FACILITY  
 2335 LAWRENCE STREET  
 EAST POINT, GA 30344  
 PERMIT No. HW-062(D)

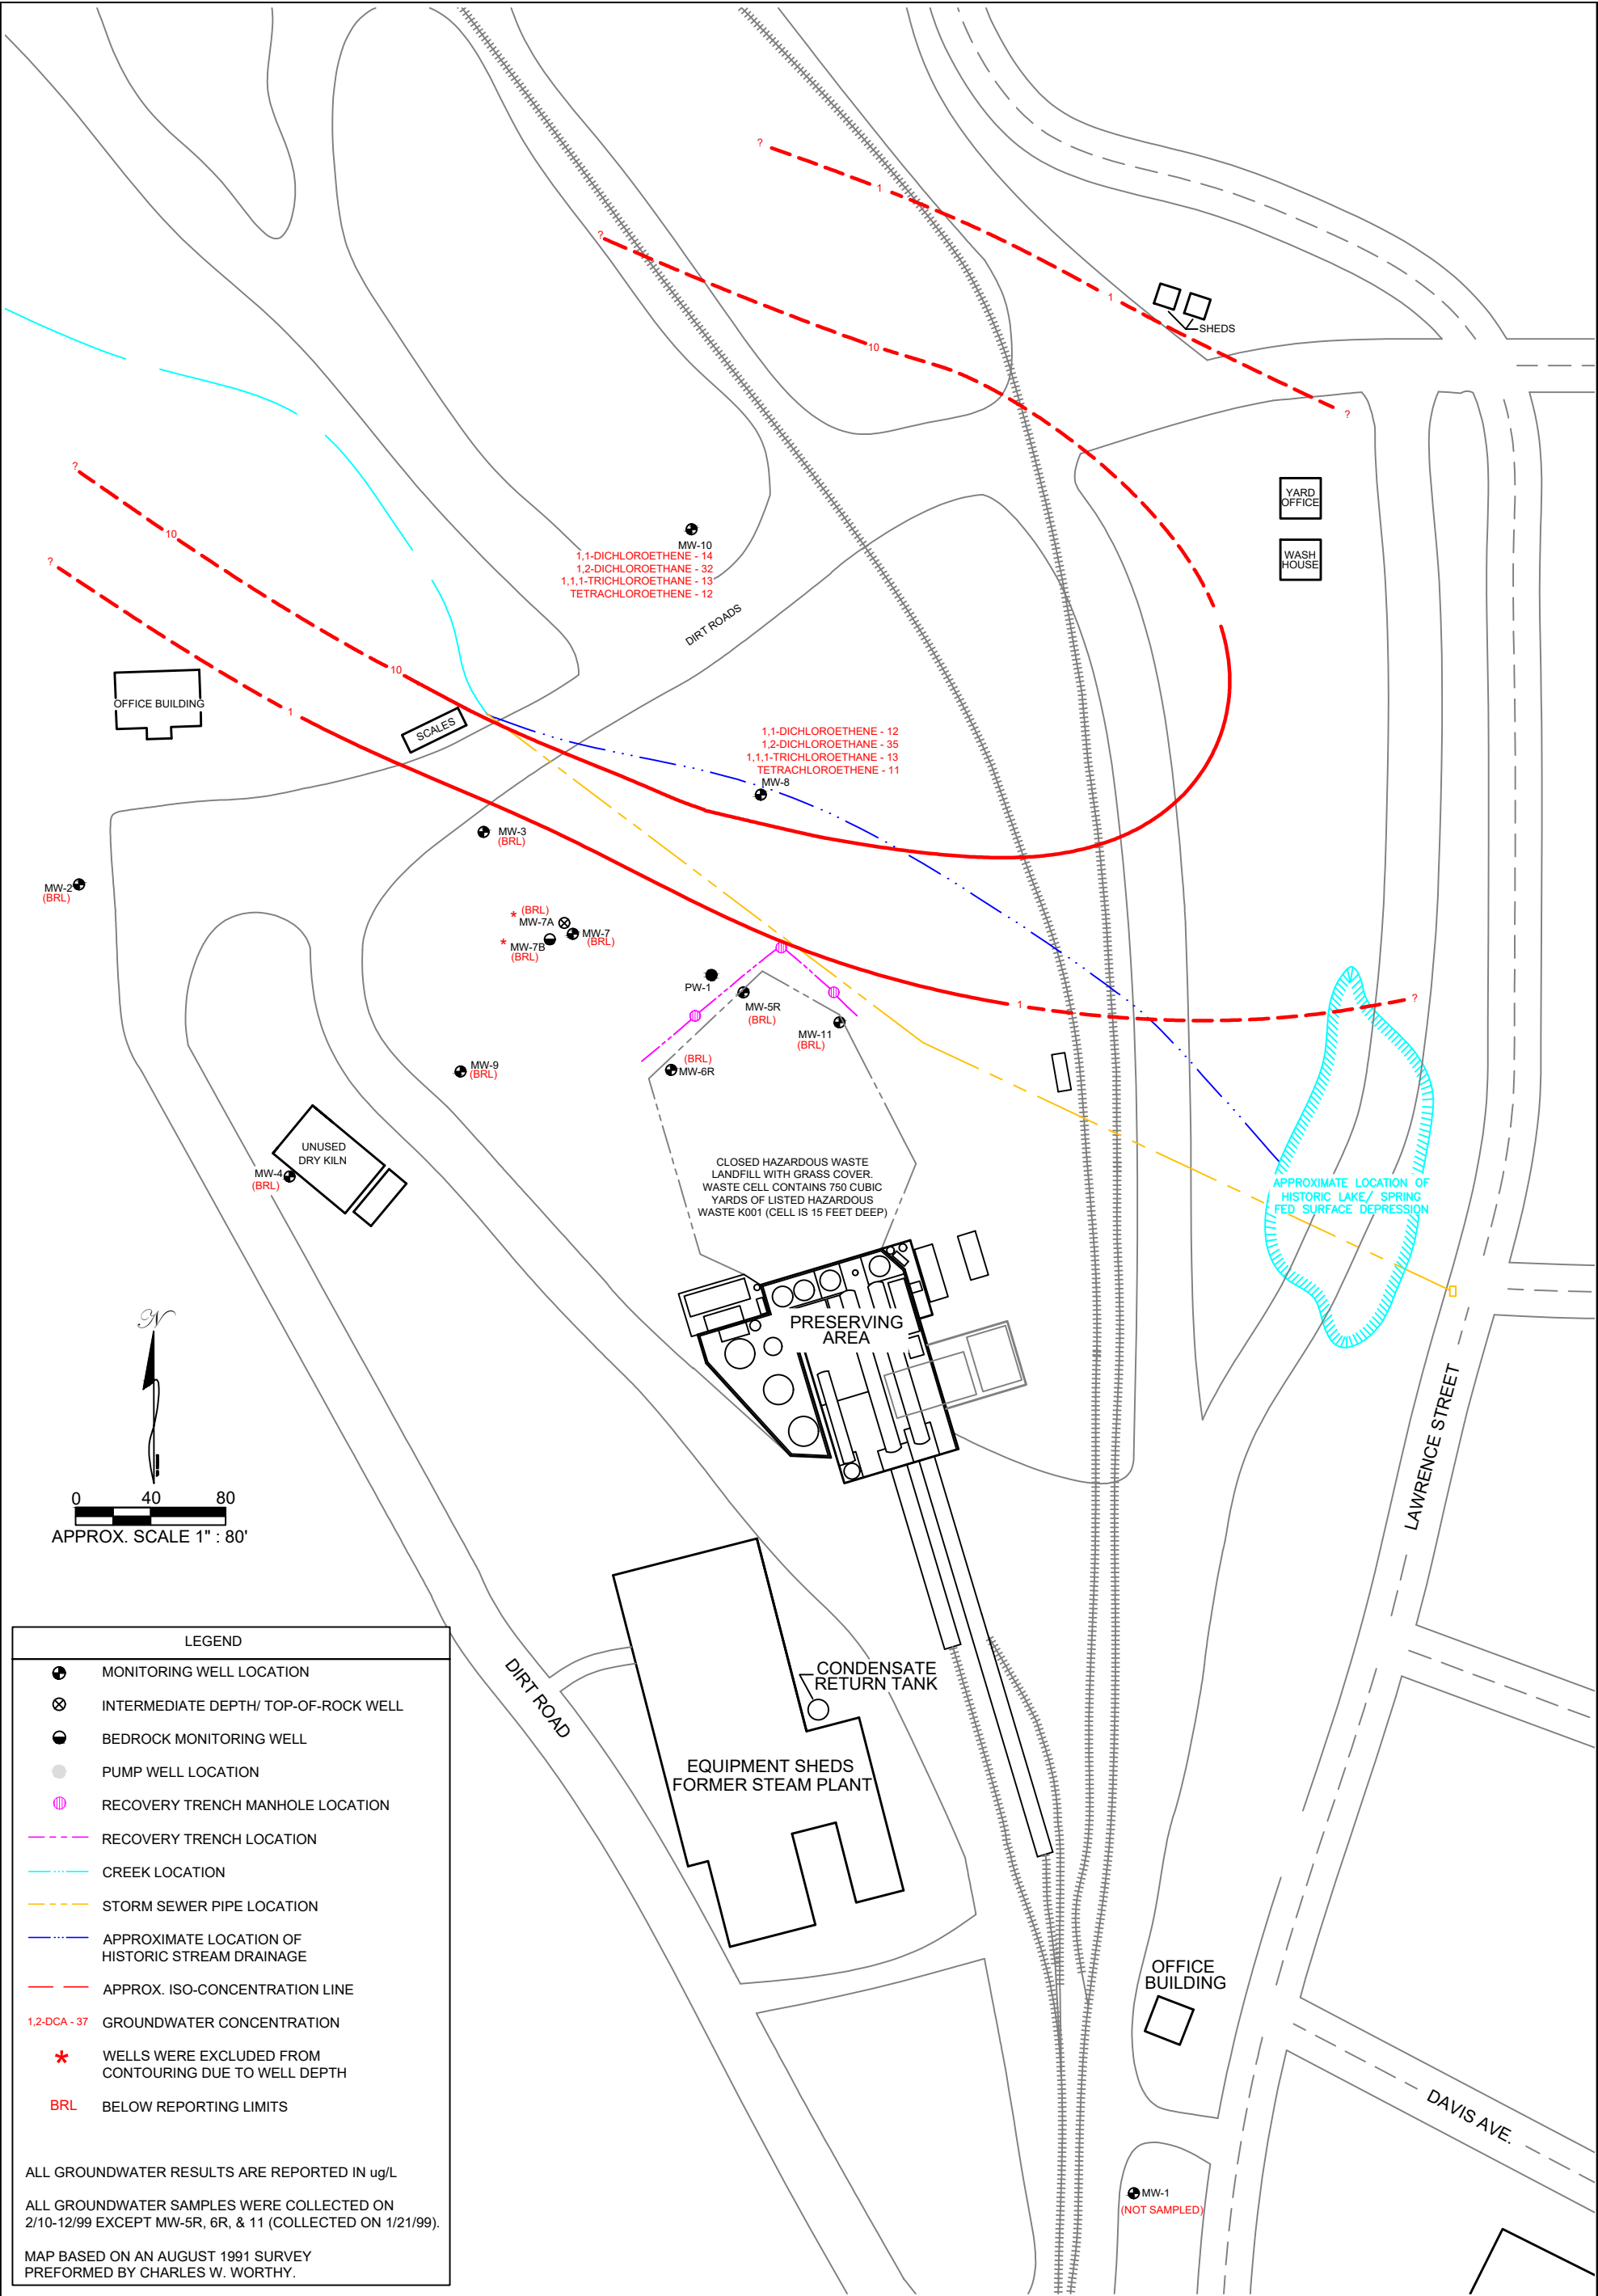
FIGURE NO  
**E-10A**

ALL GROUNDWATER SAMPLES WERE COLLECTED ON 2/10-12/99 EXCEPT MW-5R, 6R, & 11 (COLLECTED ON 1/21/99).

HORIZONTAL EXTENT OF CHLORINATED VOCs (2/1999)

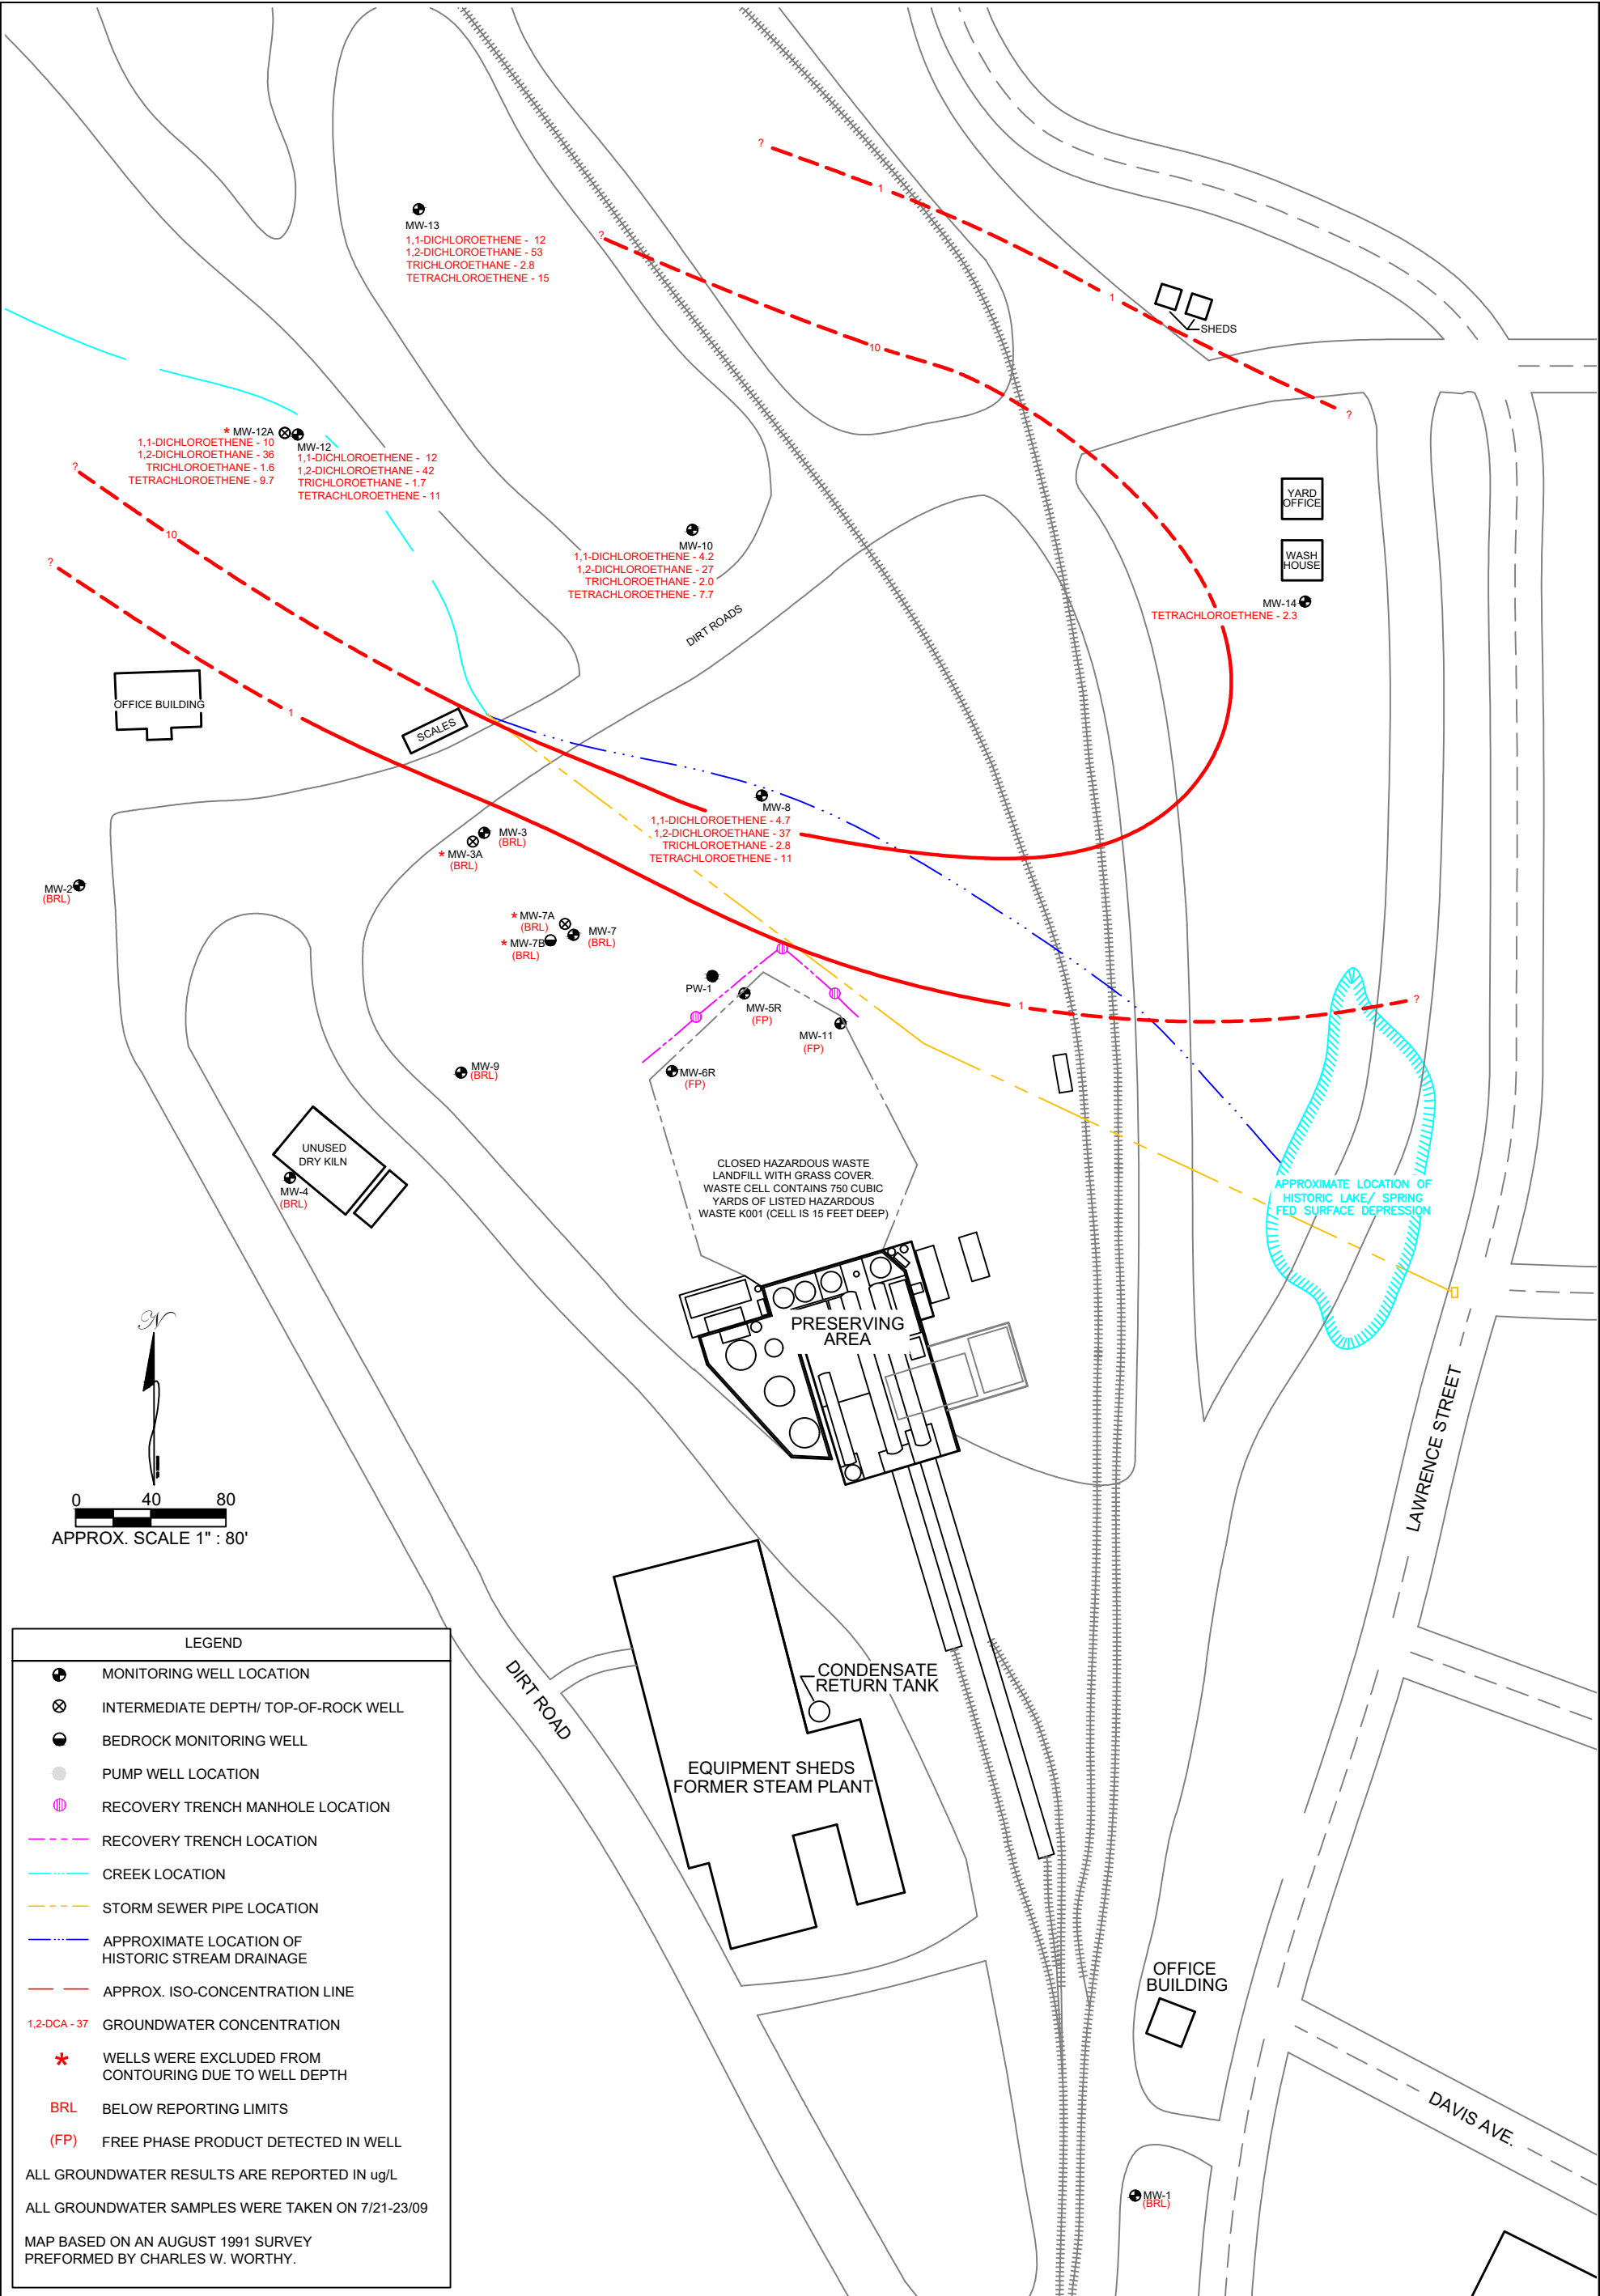
E-10B

HORIZONTAL EXTENT OF CHLORINATED VOCs (7/2009)

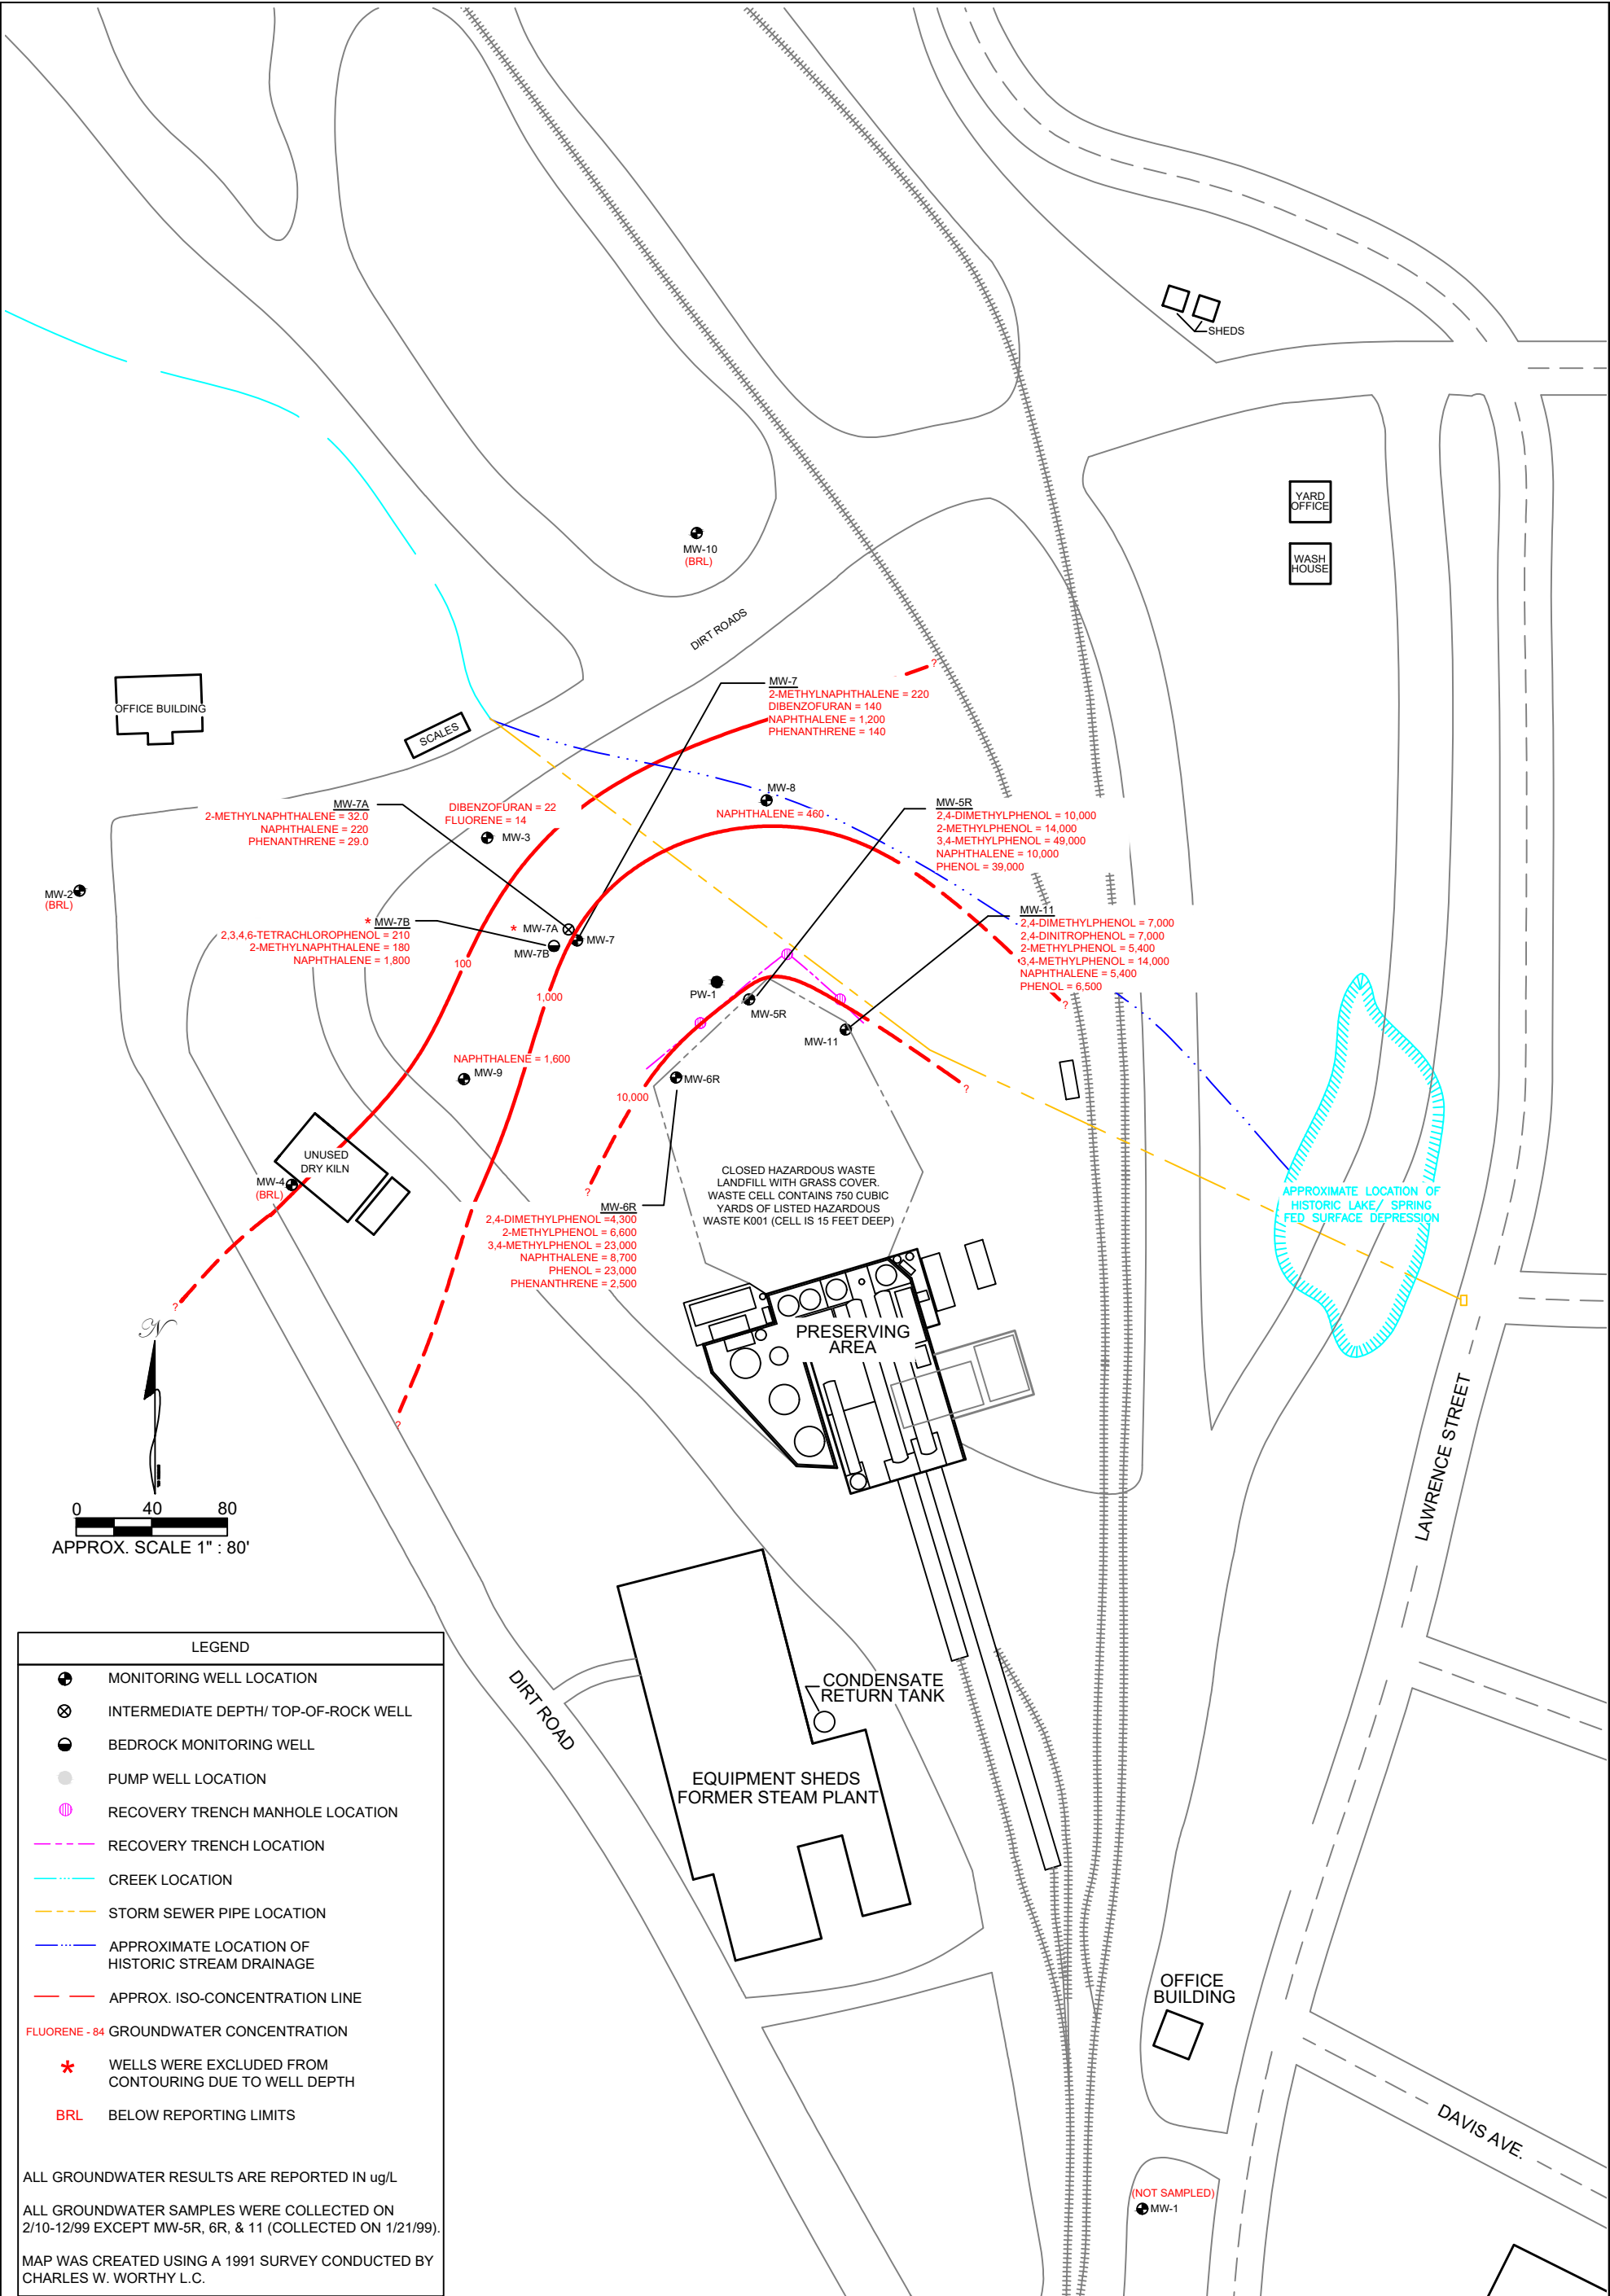
FIGURE NO  
**E-11A**

**HORIZONTAL EXTENT OF SVOCs (2/1999)**

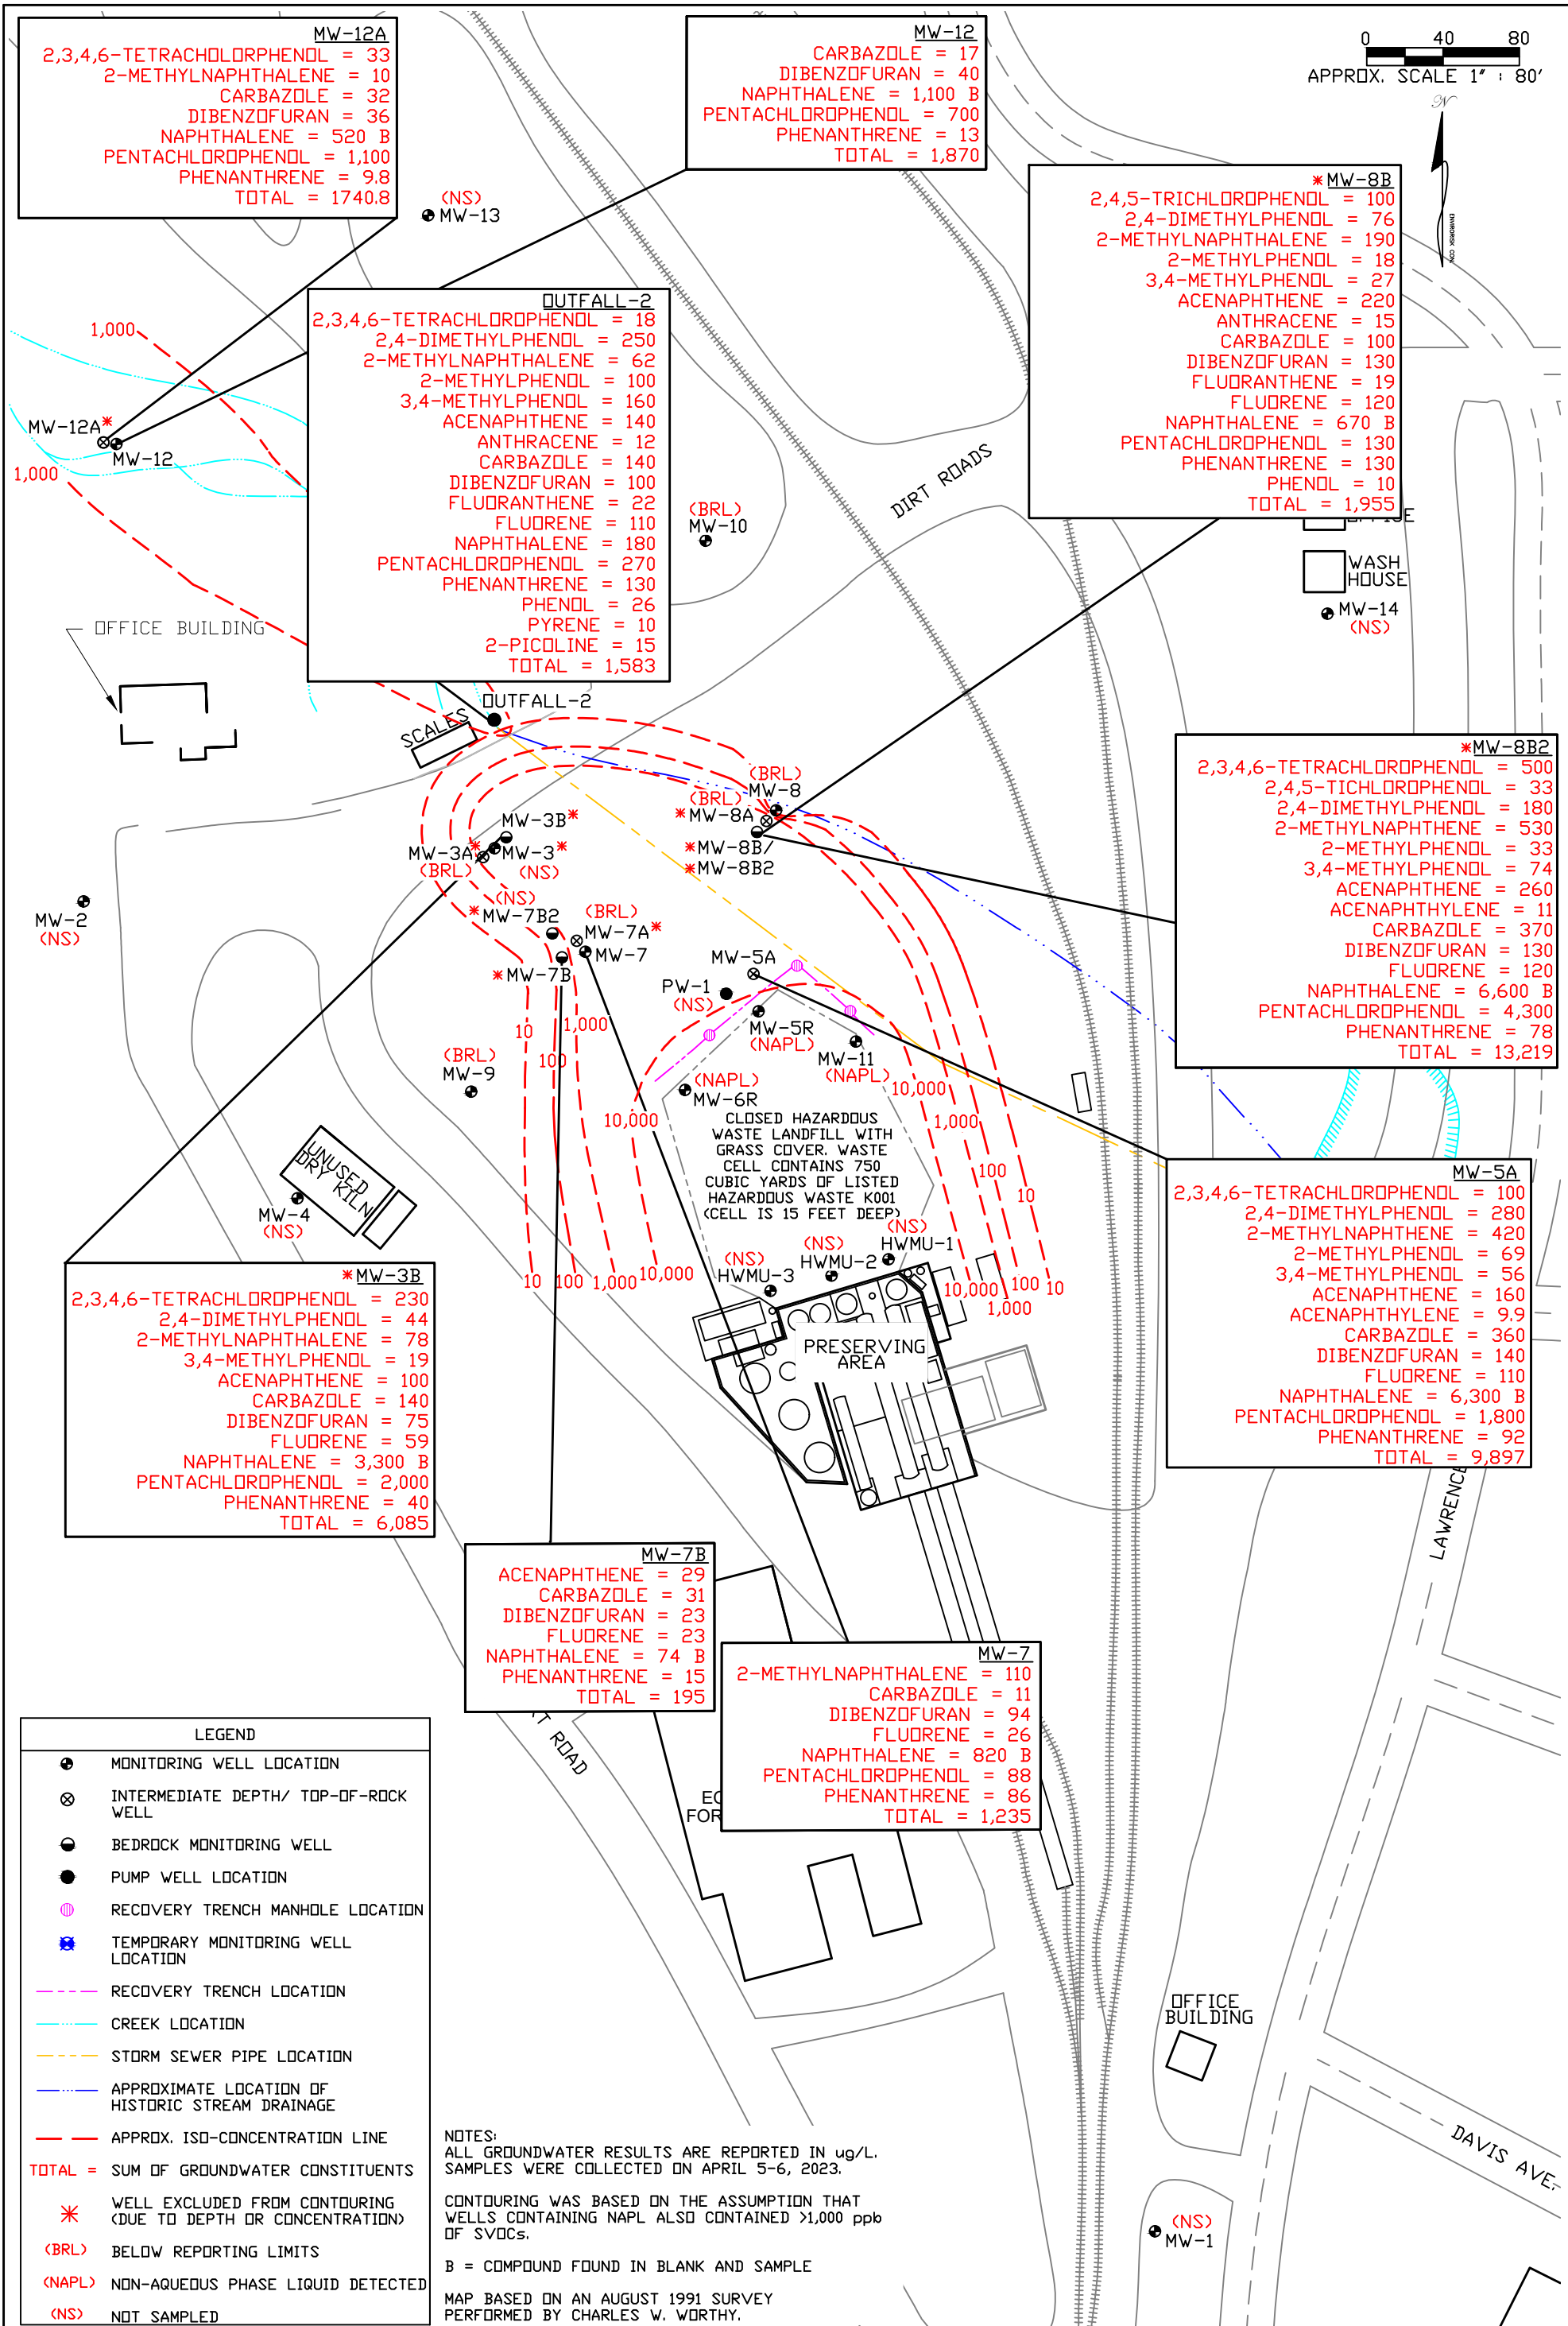
E-11D

HORIZONTAL EXTENT OF SVOCs (APRIL 2023)

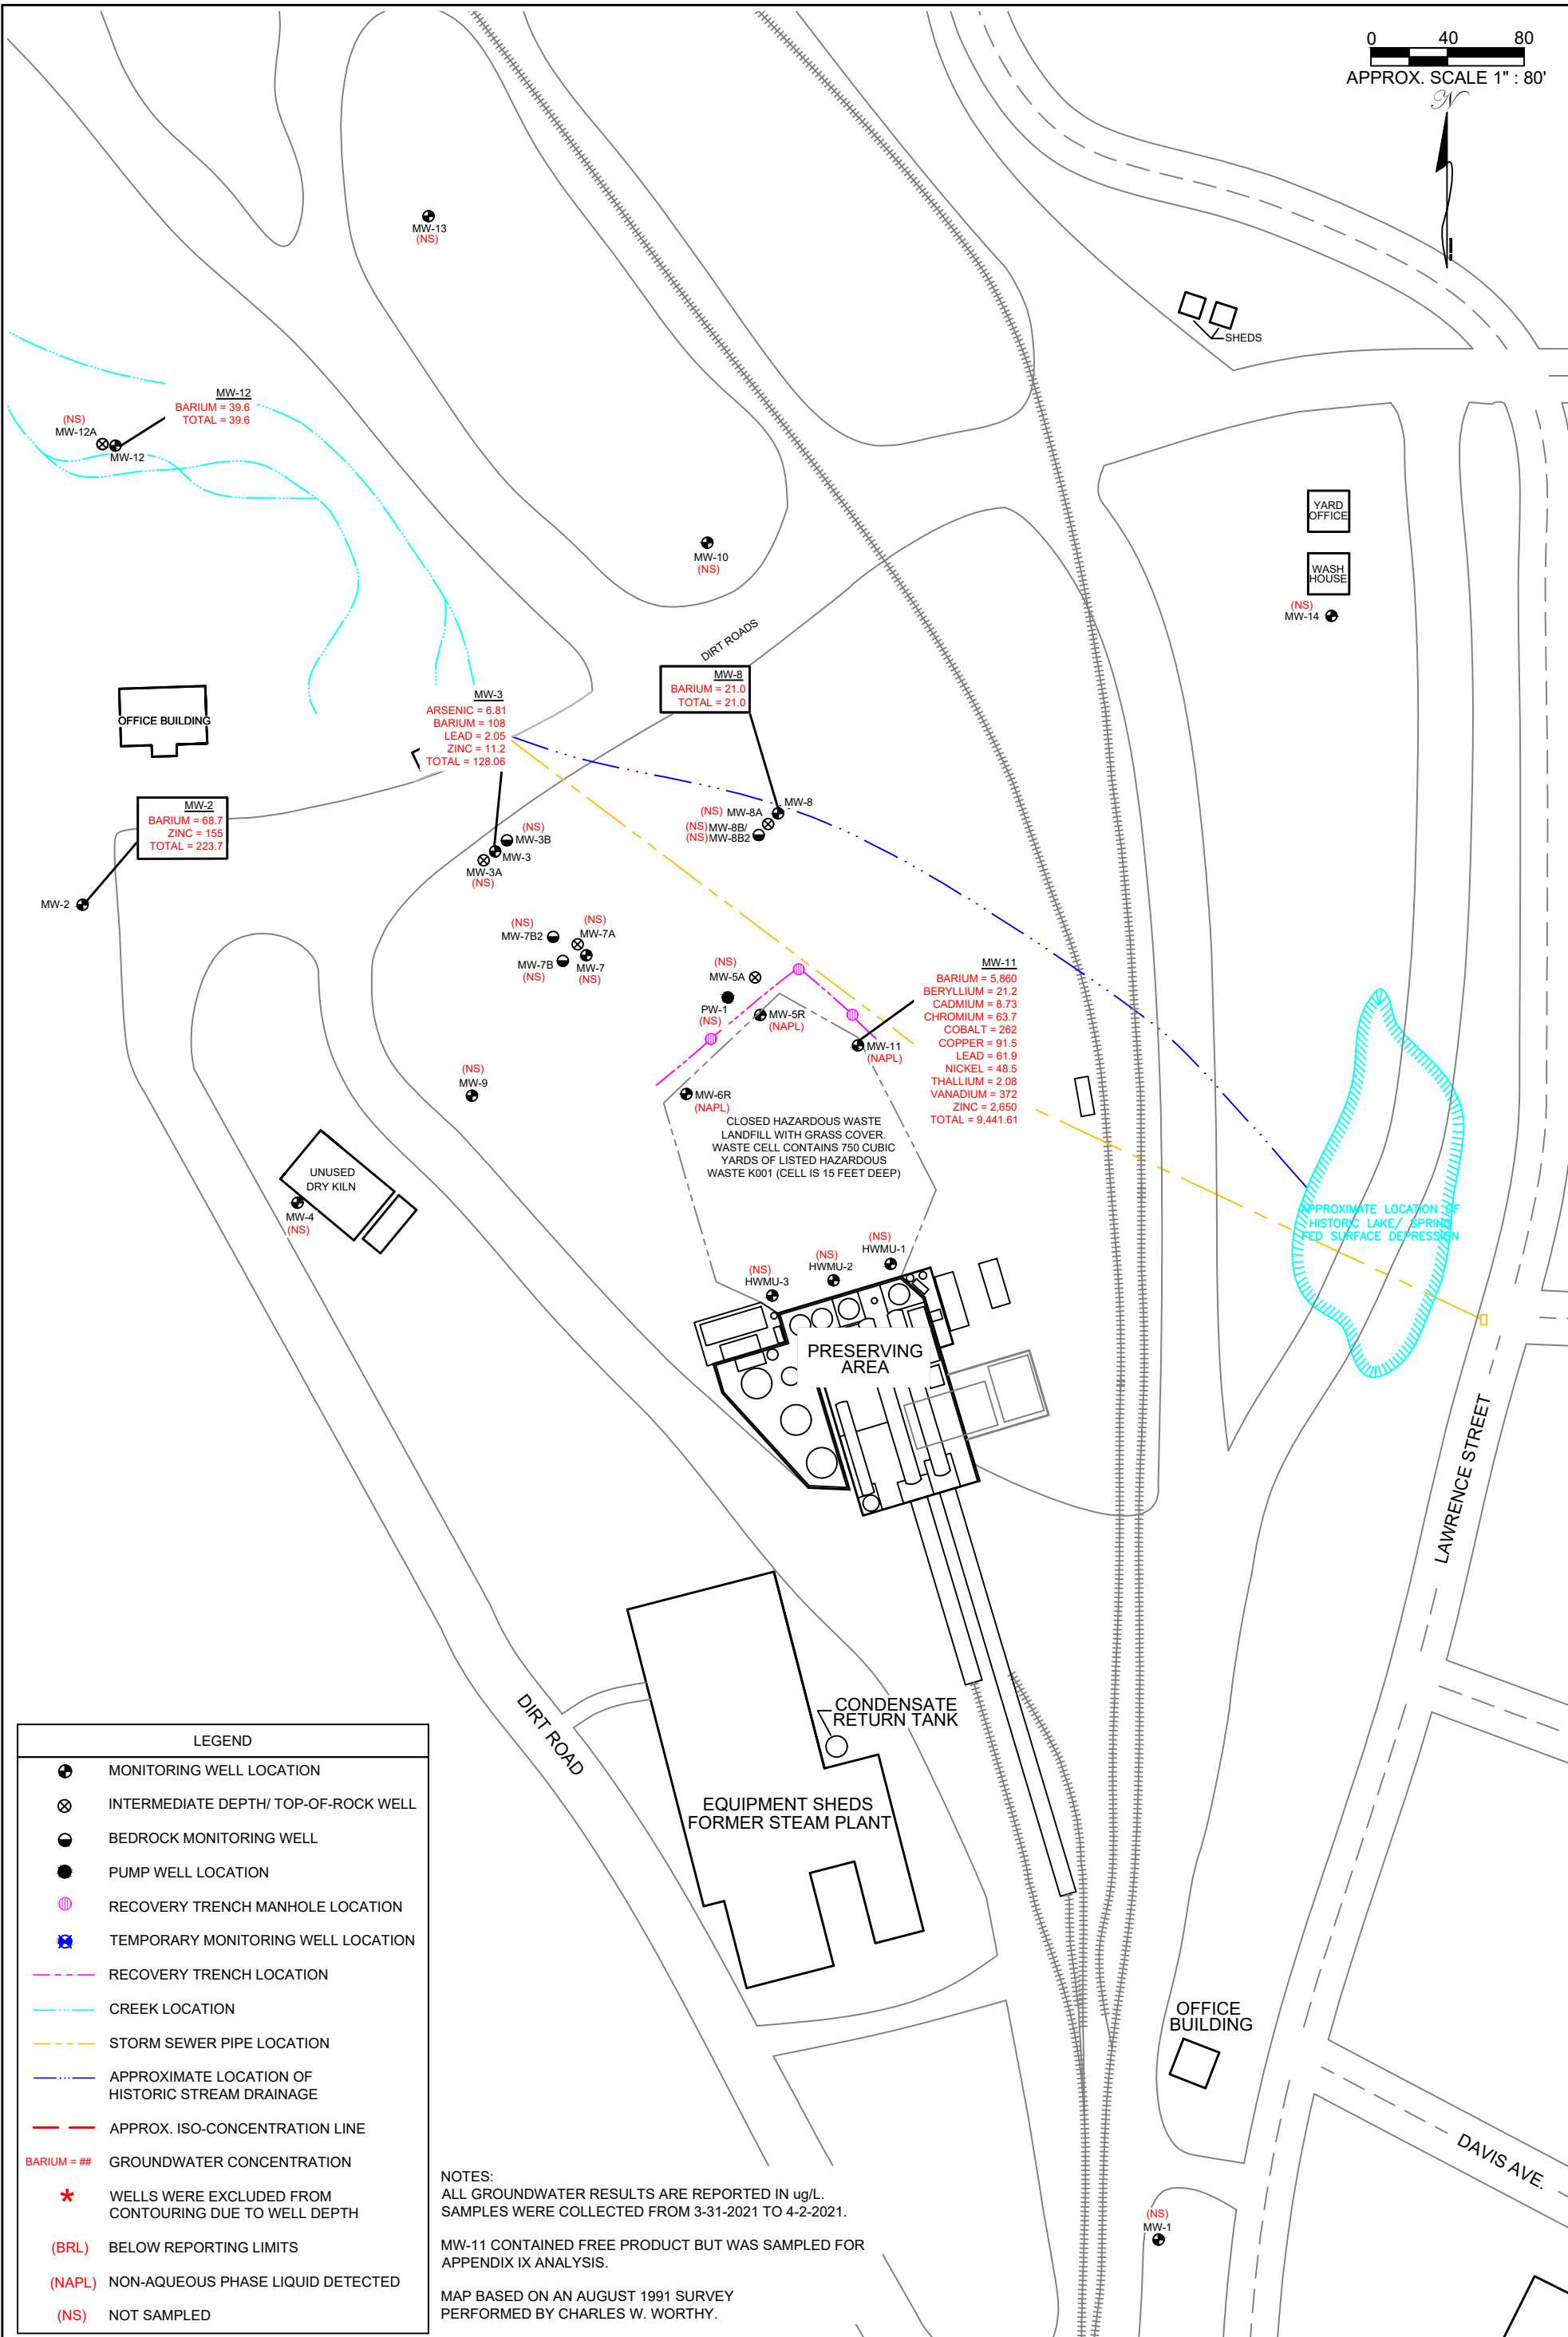
FIGURE NO  
**E-13A**

NOTE:  
THE EXTENT OF NAPL SURROUNDING WELLS IS UNKNOWN, BUT HAS BEEN ESTIMATED BASED ON BORING LOG DESCRIPTIONS. IN ADDITION, VOC CONCENTRATIONS IN THE NAPL FRACTION ARE UNKNOWN. CONTOURING WAS DONE FOR THE DISSOLVED PHASE ONLY BASED ON PRIOR POC SAMPLING DATA.

VERTICAL EXTENT OF VOCs (A-A')

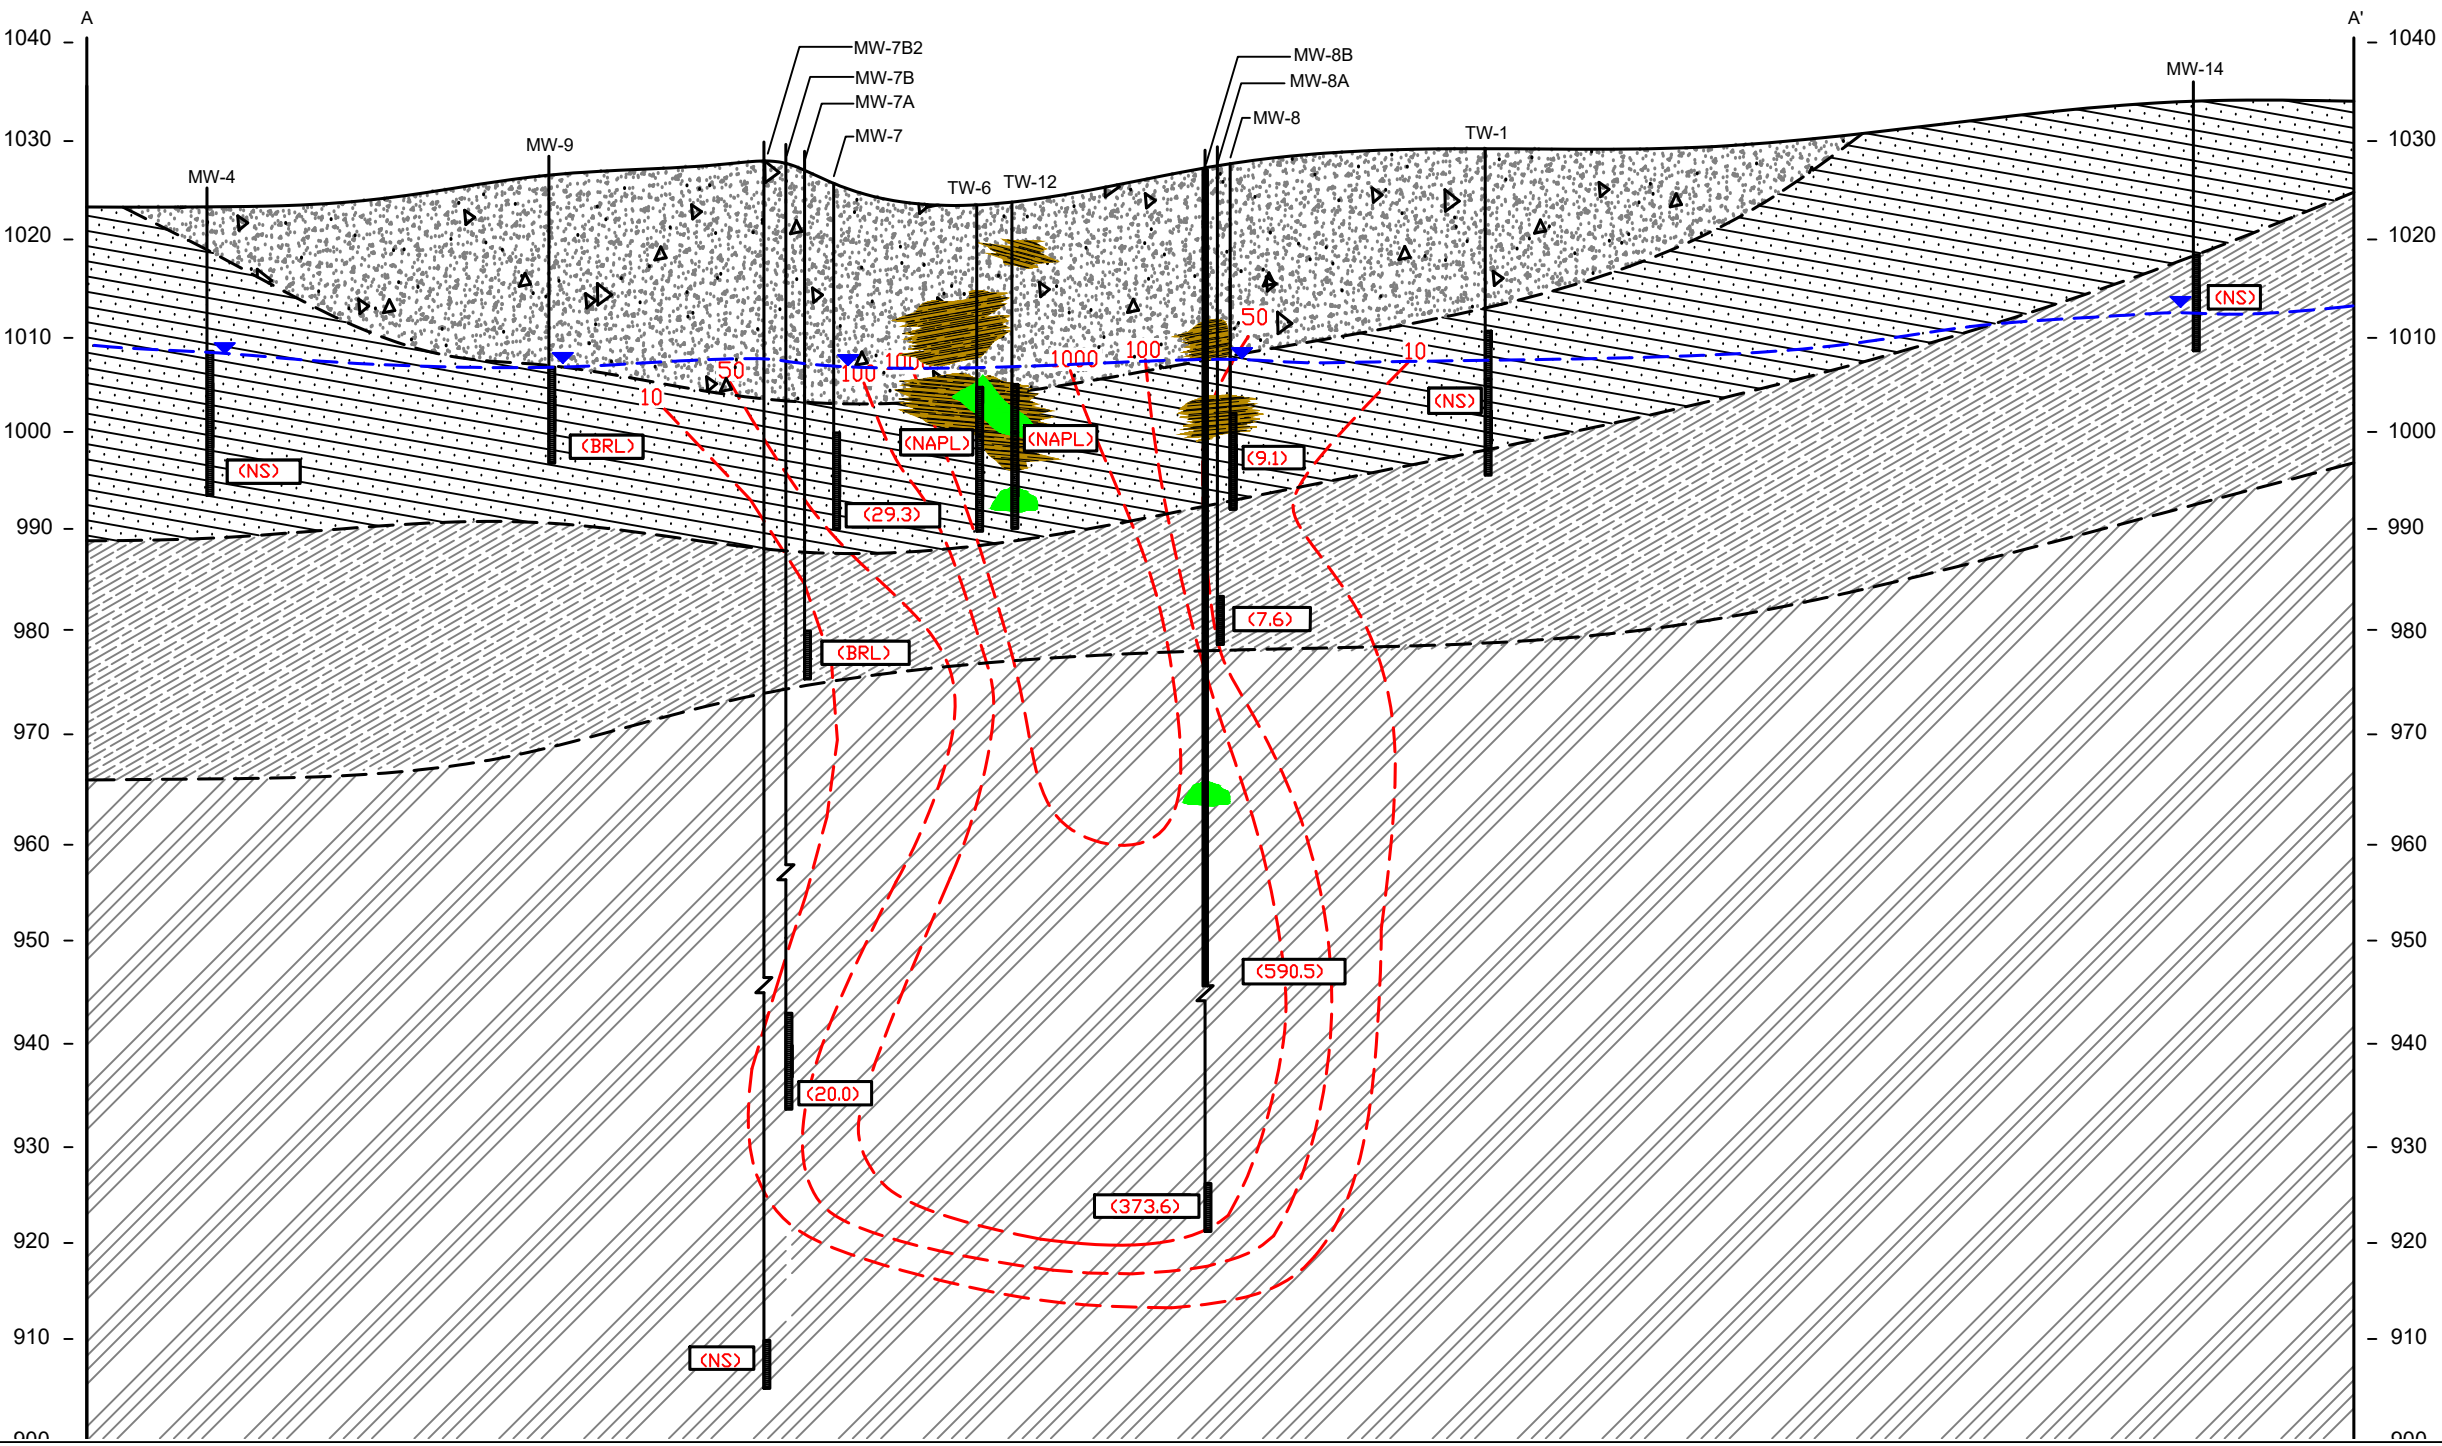
FIGURE NO  
**E-13B**

NOTE:  
THE EXTENT OF NAPL SURROUNDING WELLS IS UNKNOWN, BUT HAS BEEN ESTIMATED BASED ON BORING LOG DESCRIPTIONS. IN ADDITION, VOC CONCENTRATIONS IN THE NAPL FRACTION ARE UNKNOWN. CONTOURING WAS DONE FOR THE DISSOLVED PHASE ONLY BASED ON PRIOR POC SAMPLING DATA.

VERTICAL EXTENT OF VOCs (B-B')
