**PART B REVISED PERMIT**  
W.C. MEREDITH FACILITY  
2335 LAWRENCE STREET  
EAST POINT, GA 30344  
PERMIT No. HW-062(D)

**PART B REVISED PERMIT**  
 W.C. MEREDITH FACILITY  
 2335 LAWRENCE STREET  
 EAST POINT, GA 30344  
 PERMIT No. HW-062(D)

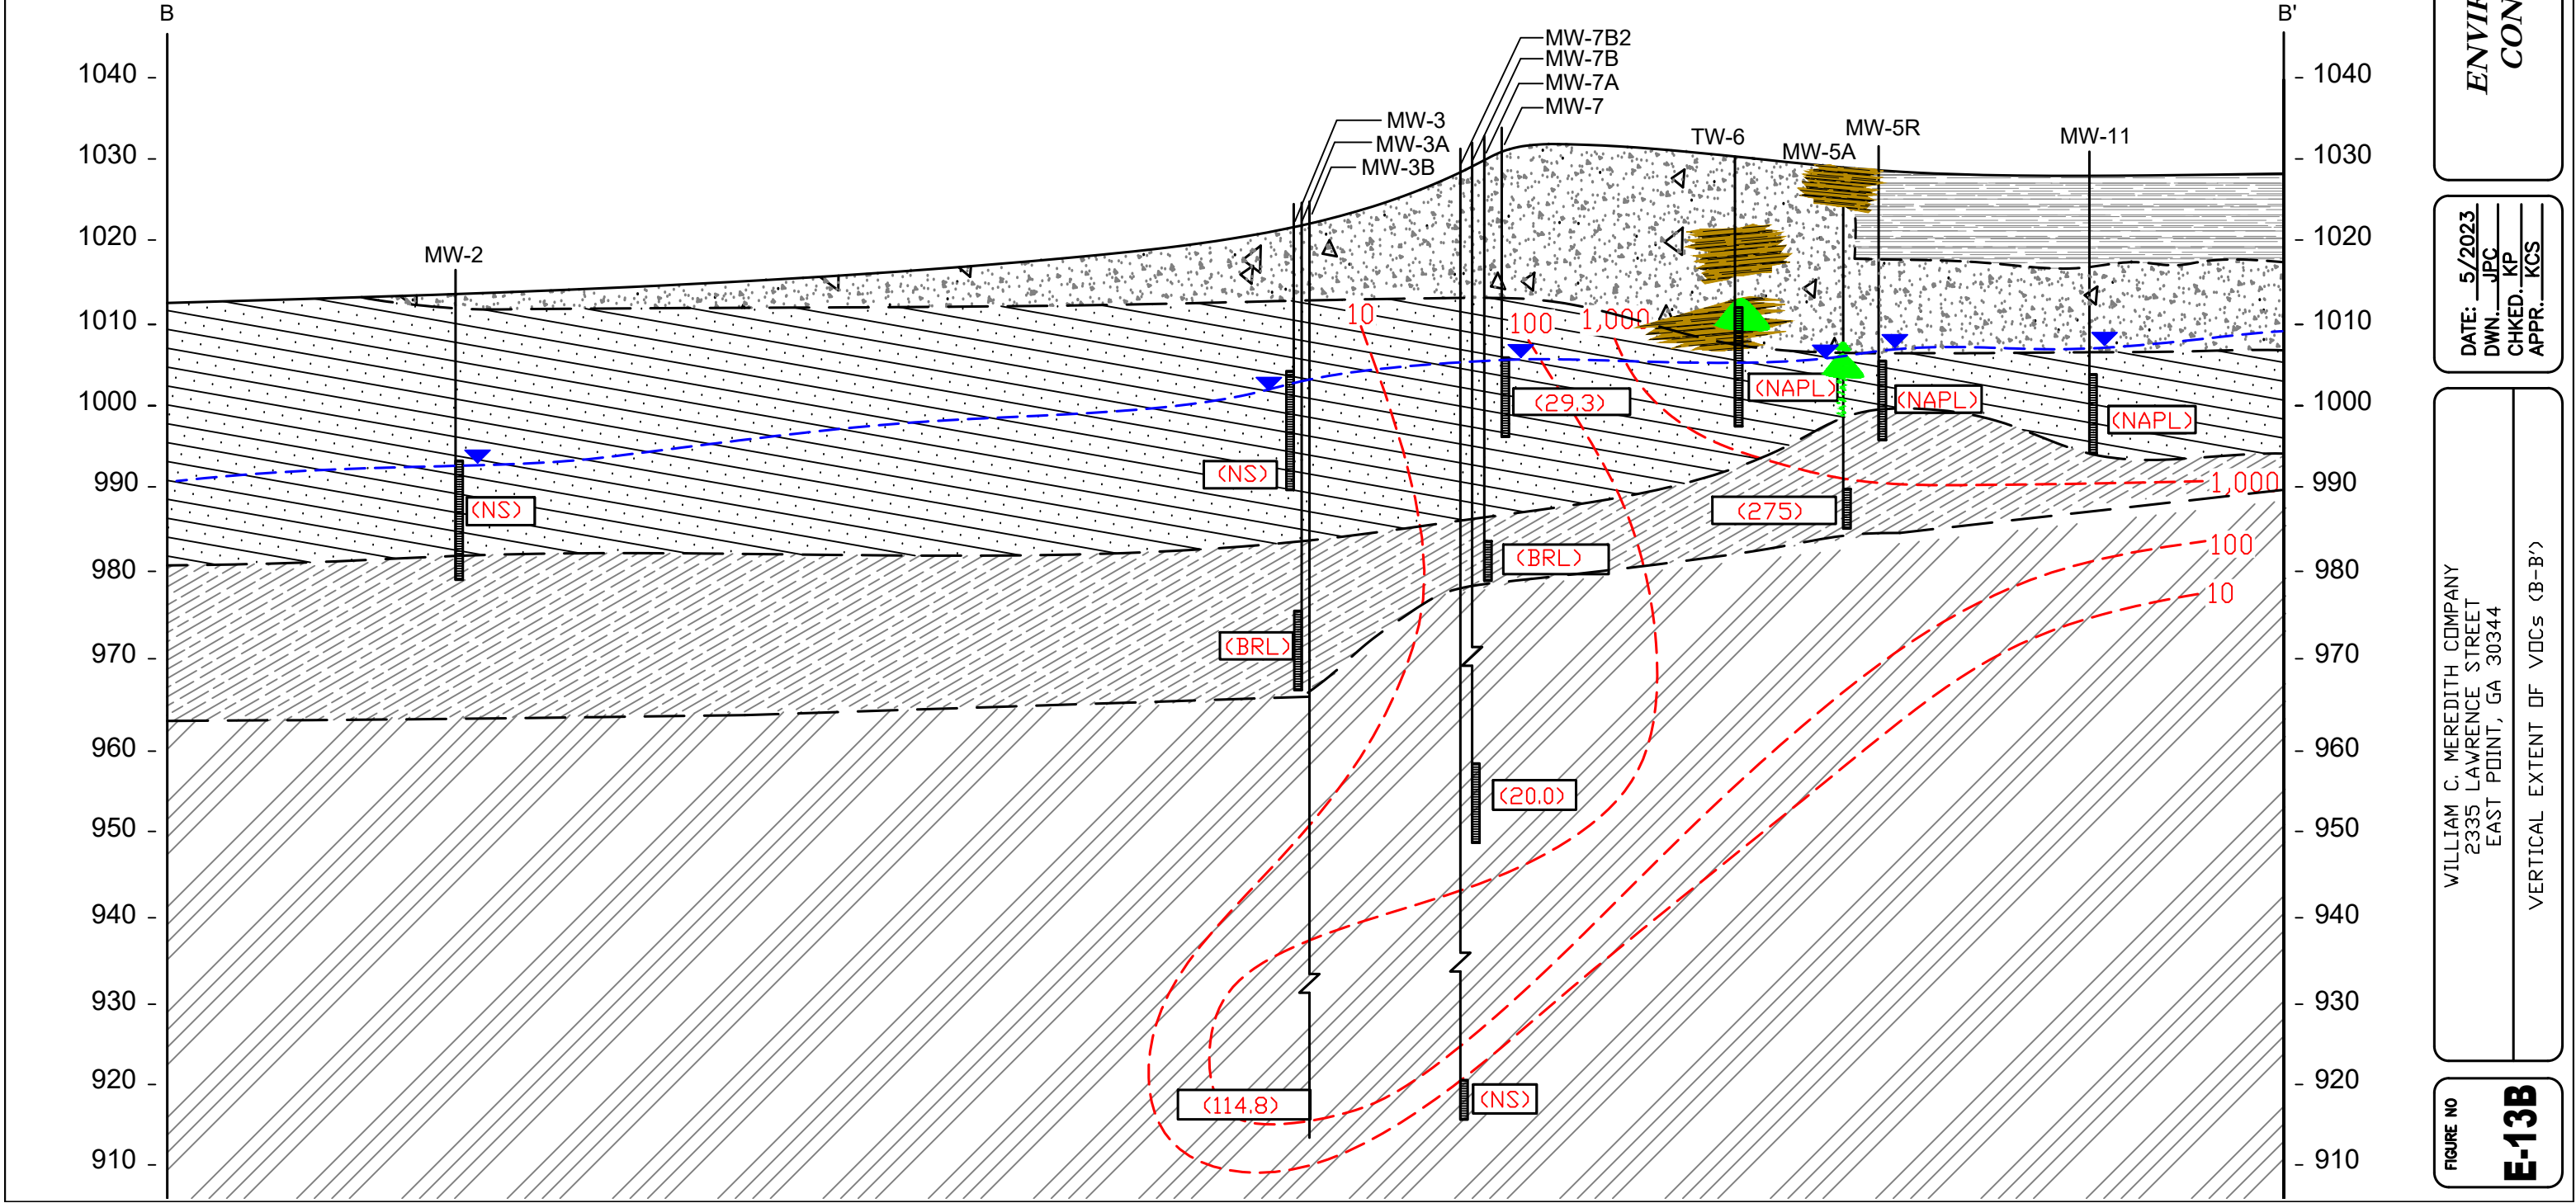
FIGURE NO  
**E-14B**

NOTE:  
THE EXTENT OF NAPL SURROUNDING WELLS IS UNKNOWN, BUT HAS BEEN ESTIMATED BASED  
ON BORING LOG DESCRIPTIONS. IN ADDITION, VOC CONCENTRATIONS IN THE NAPL FRACTION  
ARE UNKNOWN. CONTOURING WAS DONE FOR THE DISSOLVED PHASE ONLY BASED ON PRIOR  
POC SAMPLING DATA.

WILLIAM C. MEREDITH COMPANY  
2335 LAWRENCE STREET  
EAST POINT, GA 30344  
VERTICAL EXTENT OF SVOCs (B-B')

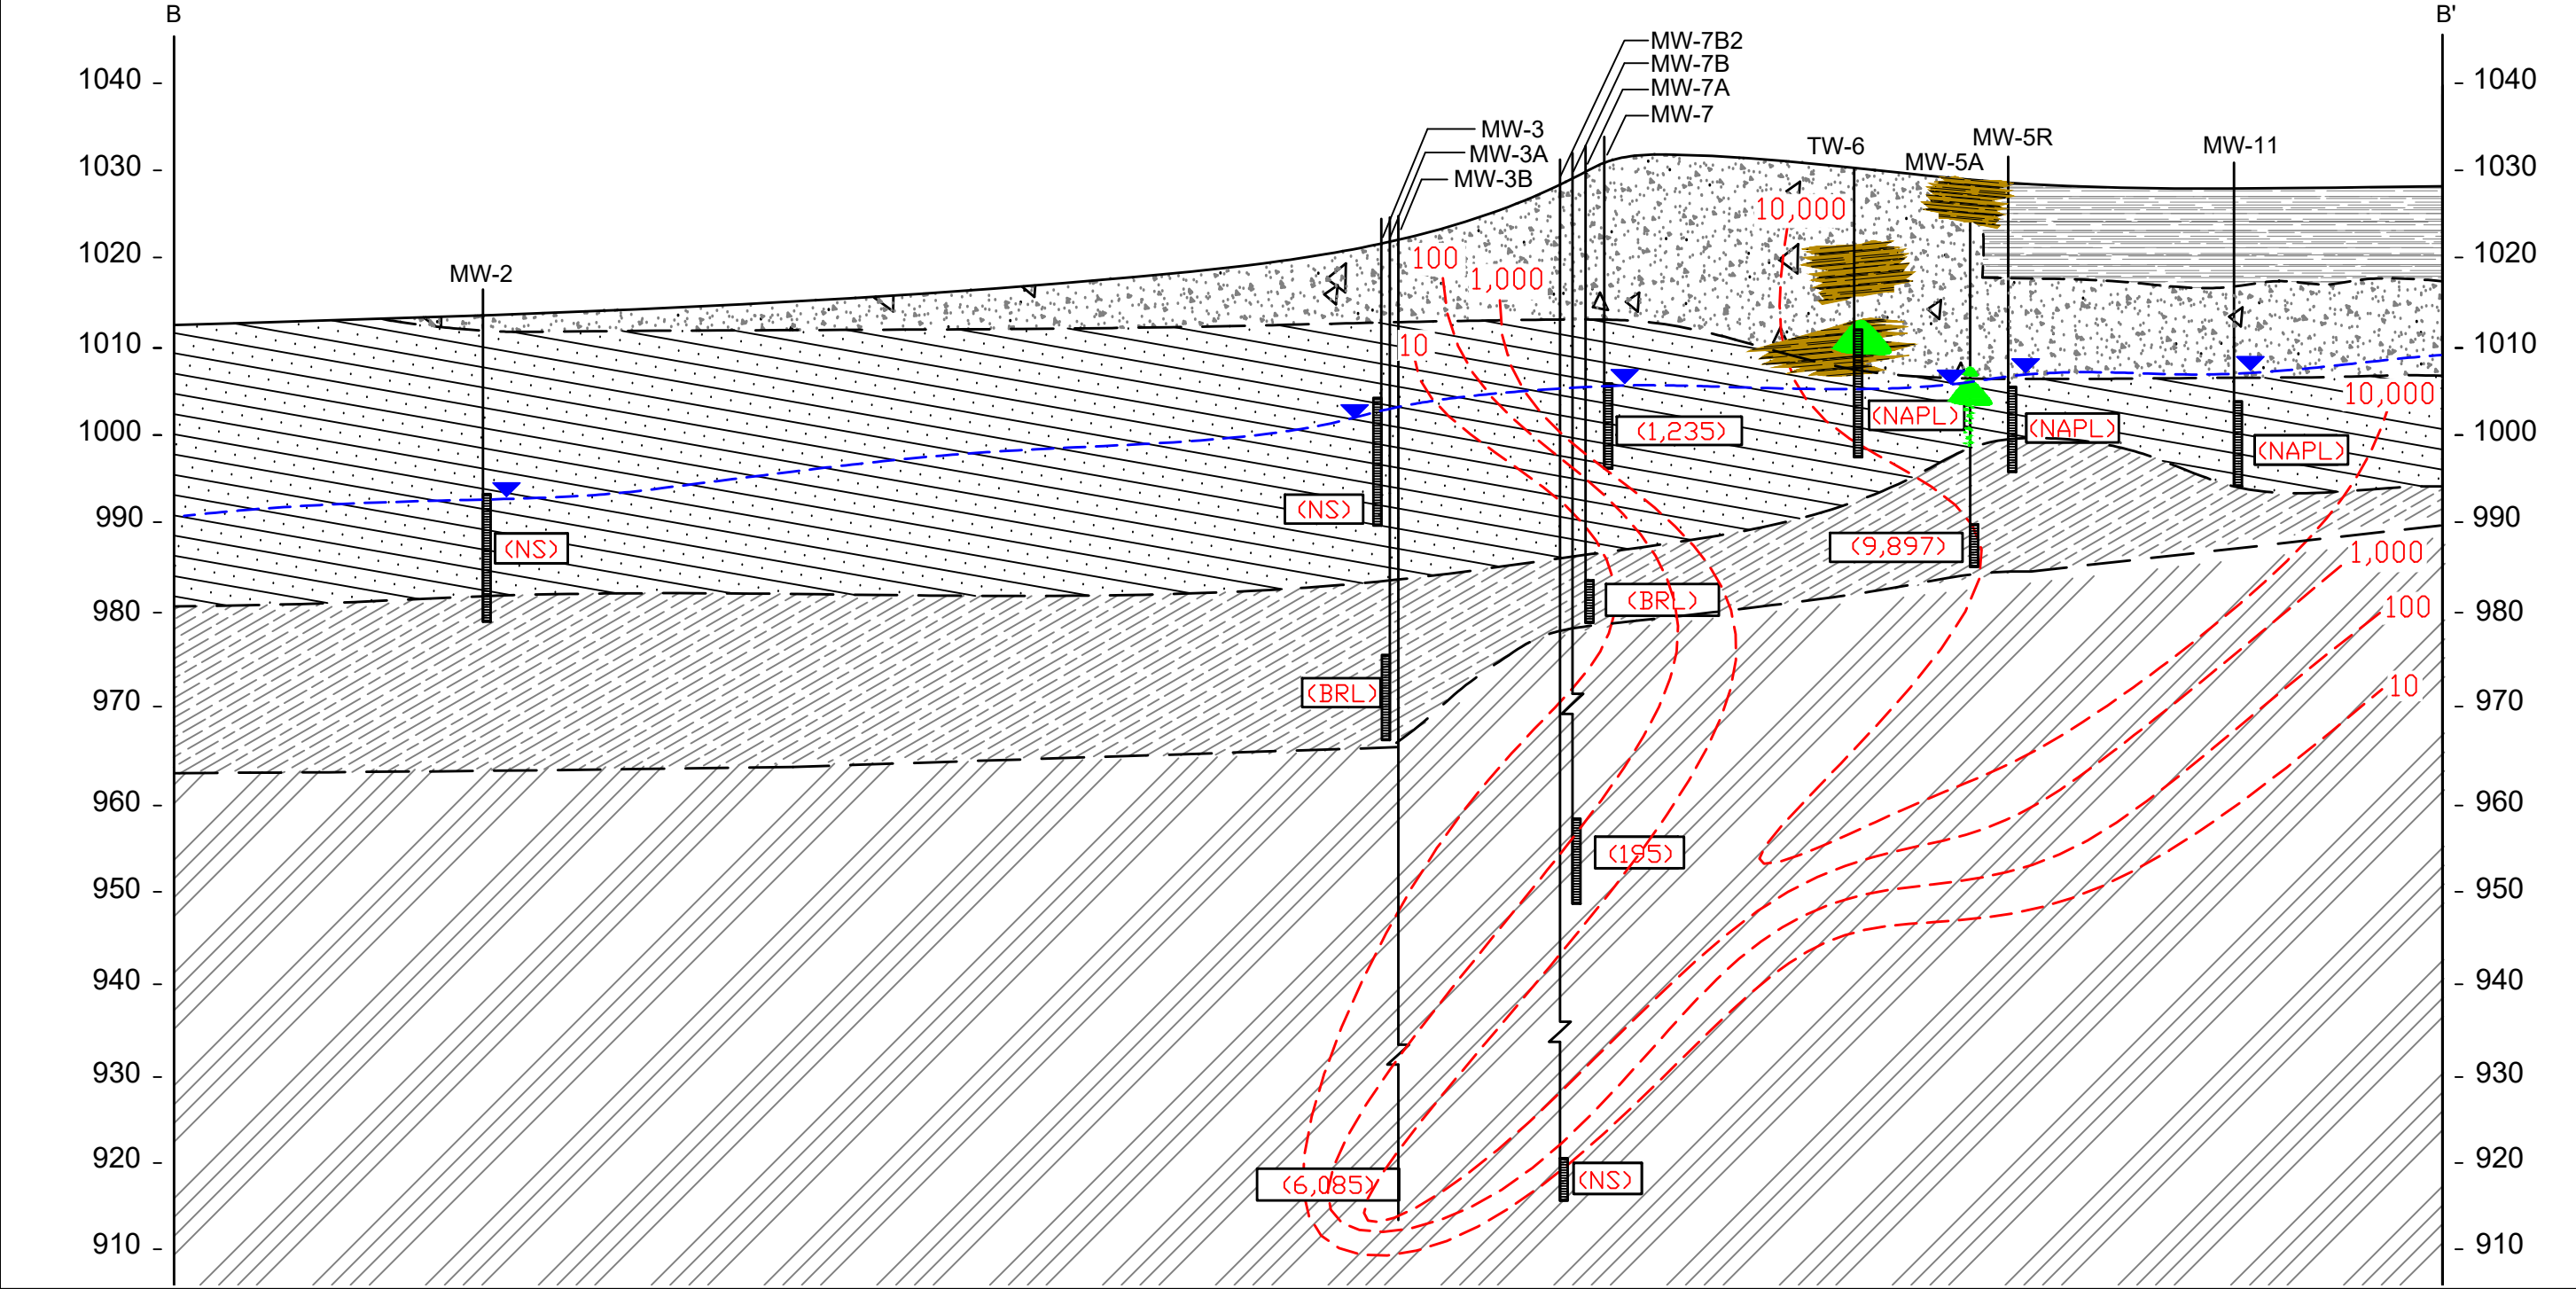
FRACTURED BEDROCK:  
COMPETENT BEDROCK - HARD BIOTITE GNEISS, GRANITIC GNEISS,  
AND AMPHIBOLITE GNEISS WITH POTASSIUM FELDSPAR, AND  
QUARTZ AUGENS AND LENSES OF MICA, PYRITE AND MUSCOVITE.

APPROX. LOCATION OF WOOD DEBRIS FOUND IN SOIL BORING  
(SEE BORING LOGS FOR SPECIFIC LOCATIONS AND THICKNESS)

APPROX. LOCATION OF NAPL FOUND IN SOIL BORING  
(SEE BORING LOGS FOR SPECIFIC LOCATIONS AND THICKNESS)

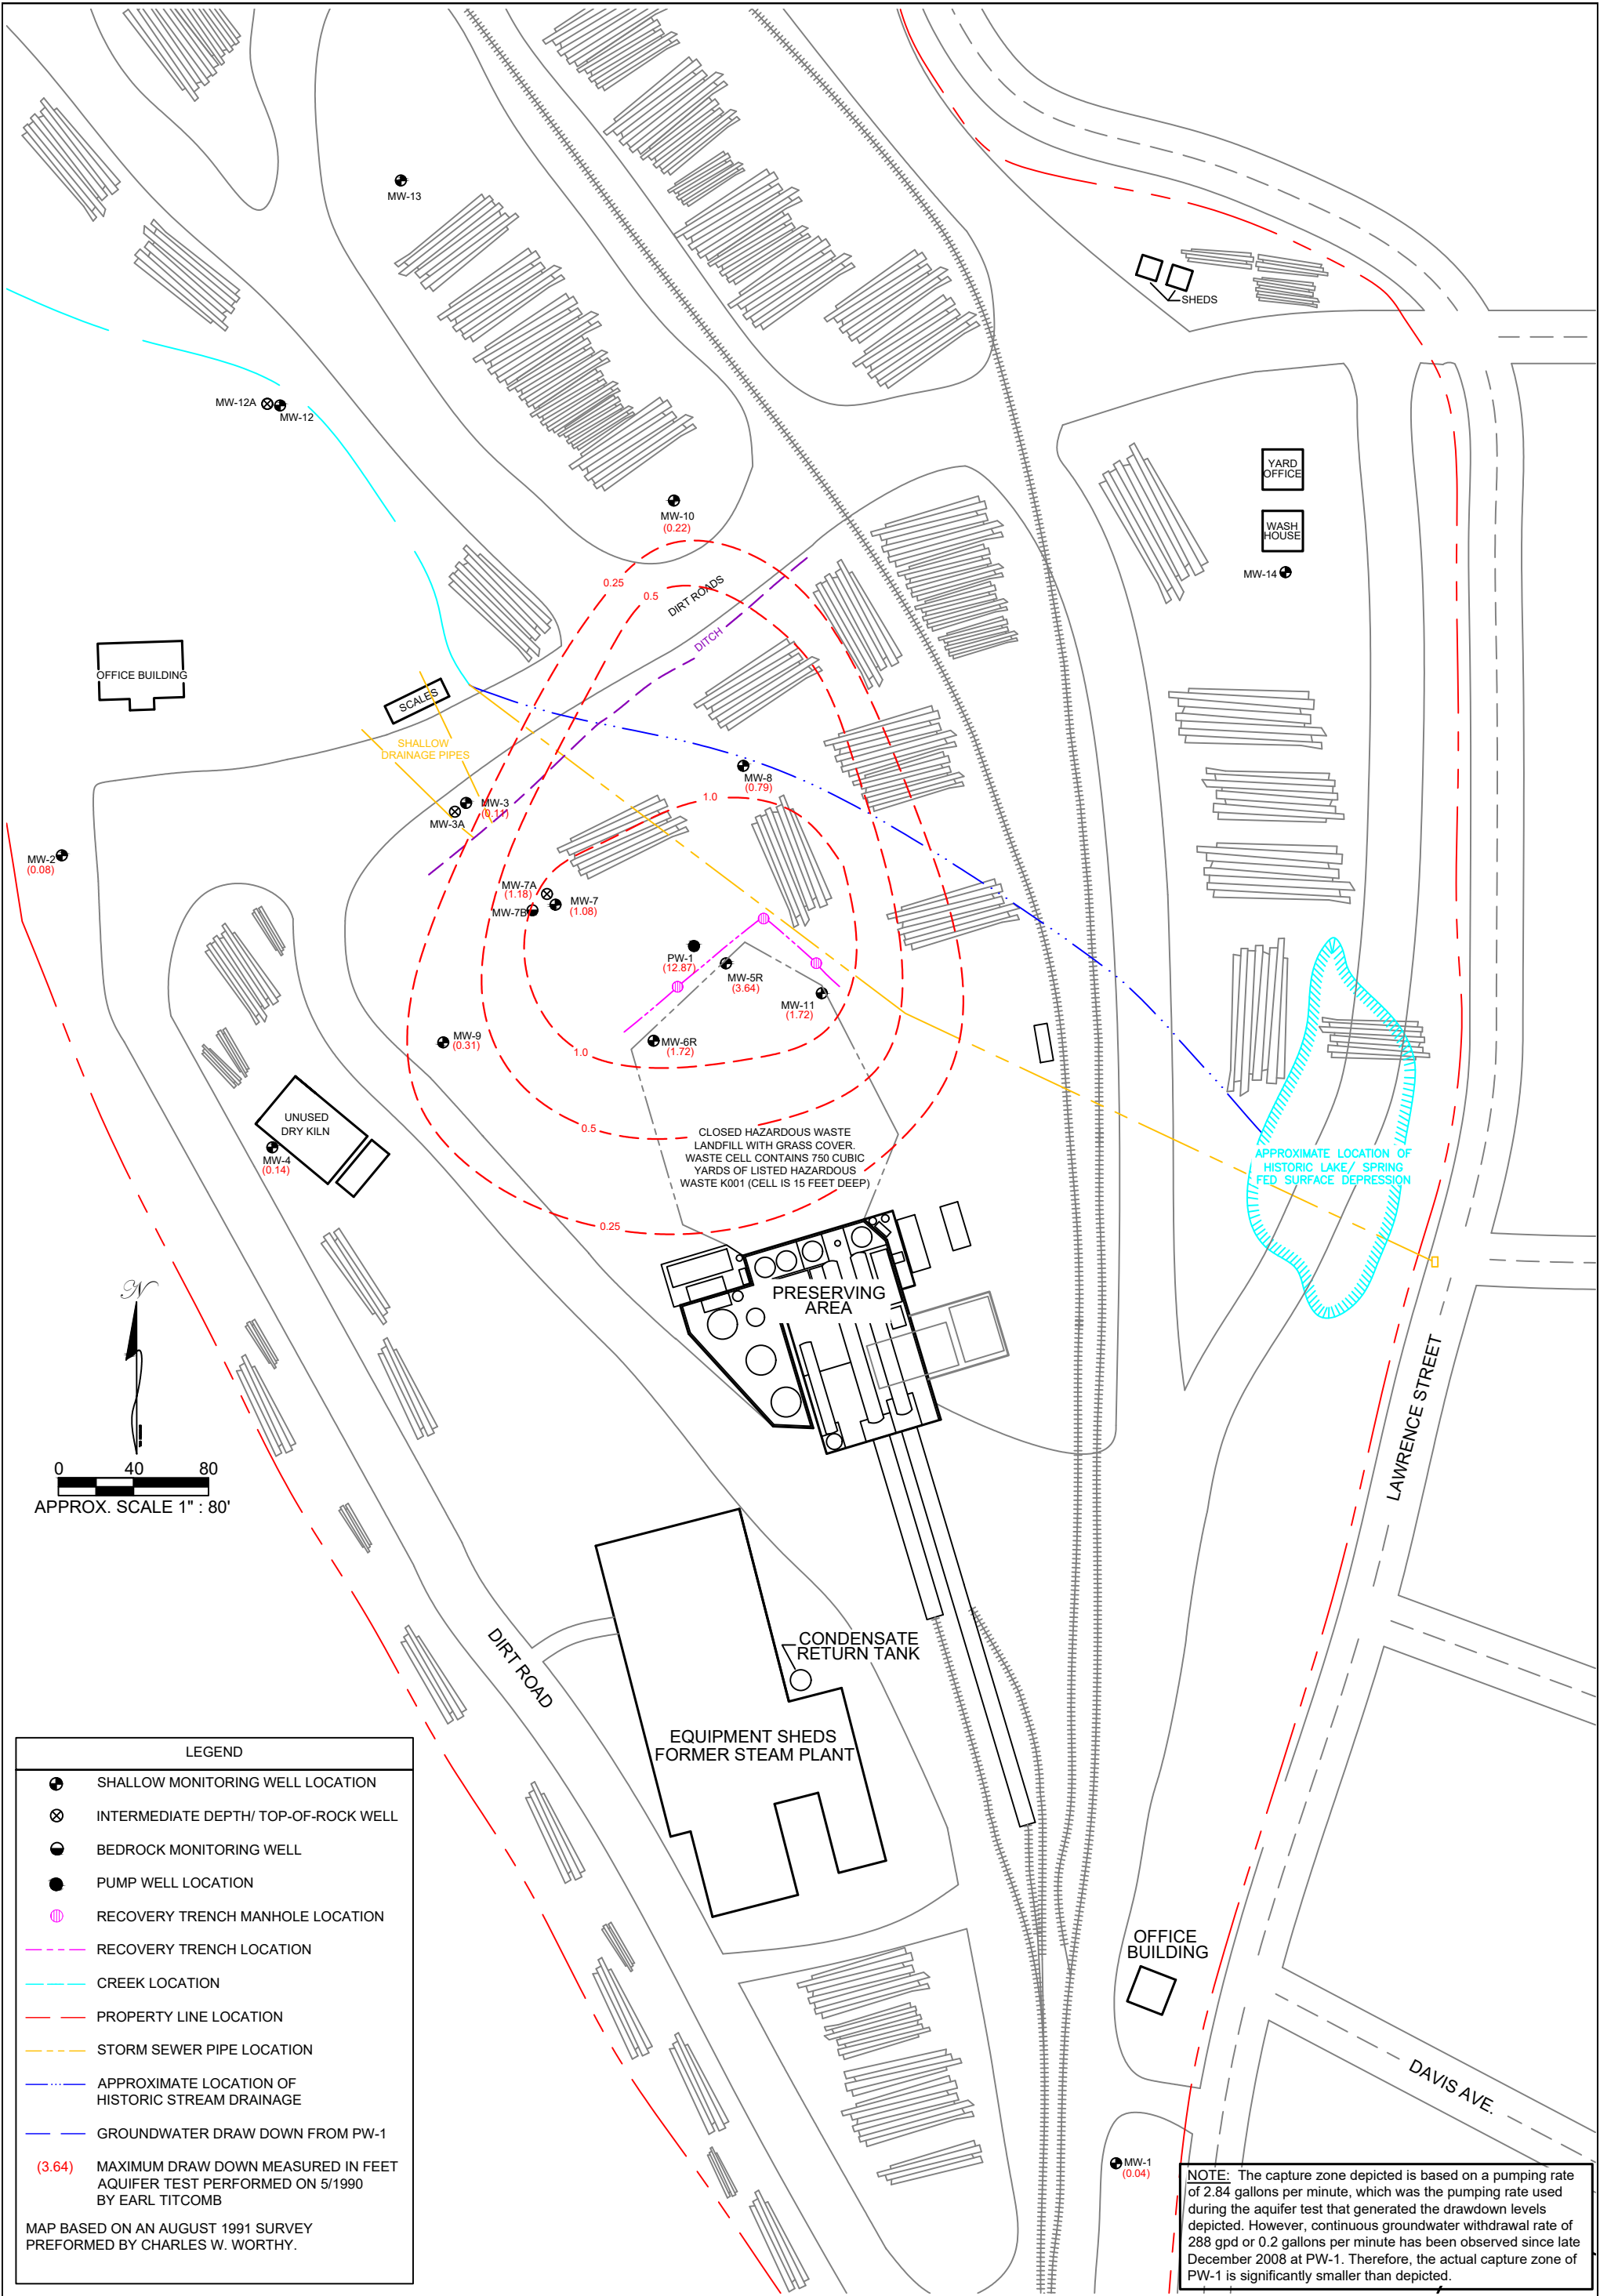
E-15

WELL CAPTURE ZONE FOR PW-1

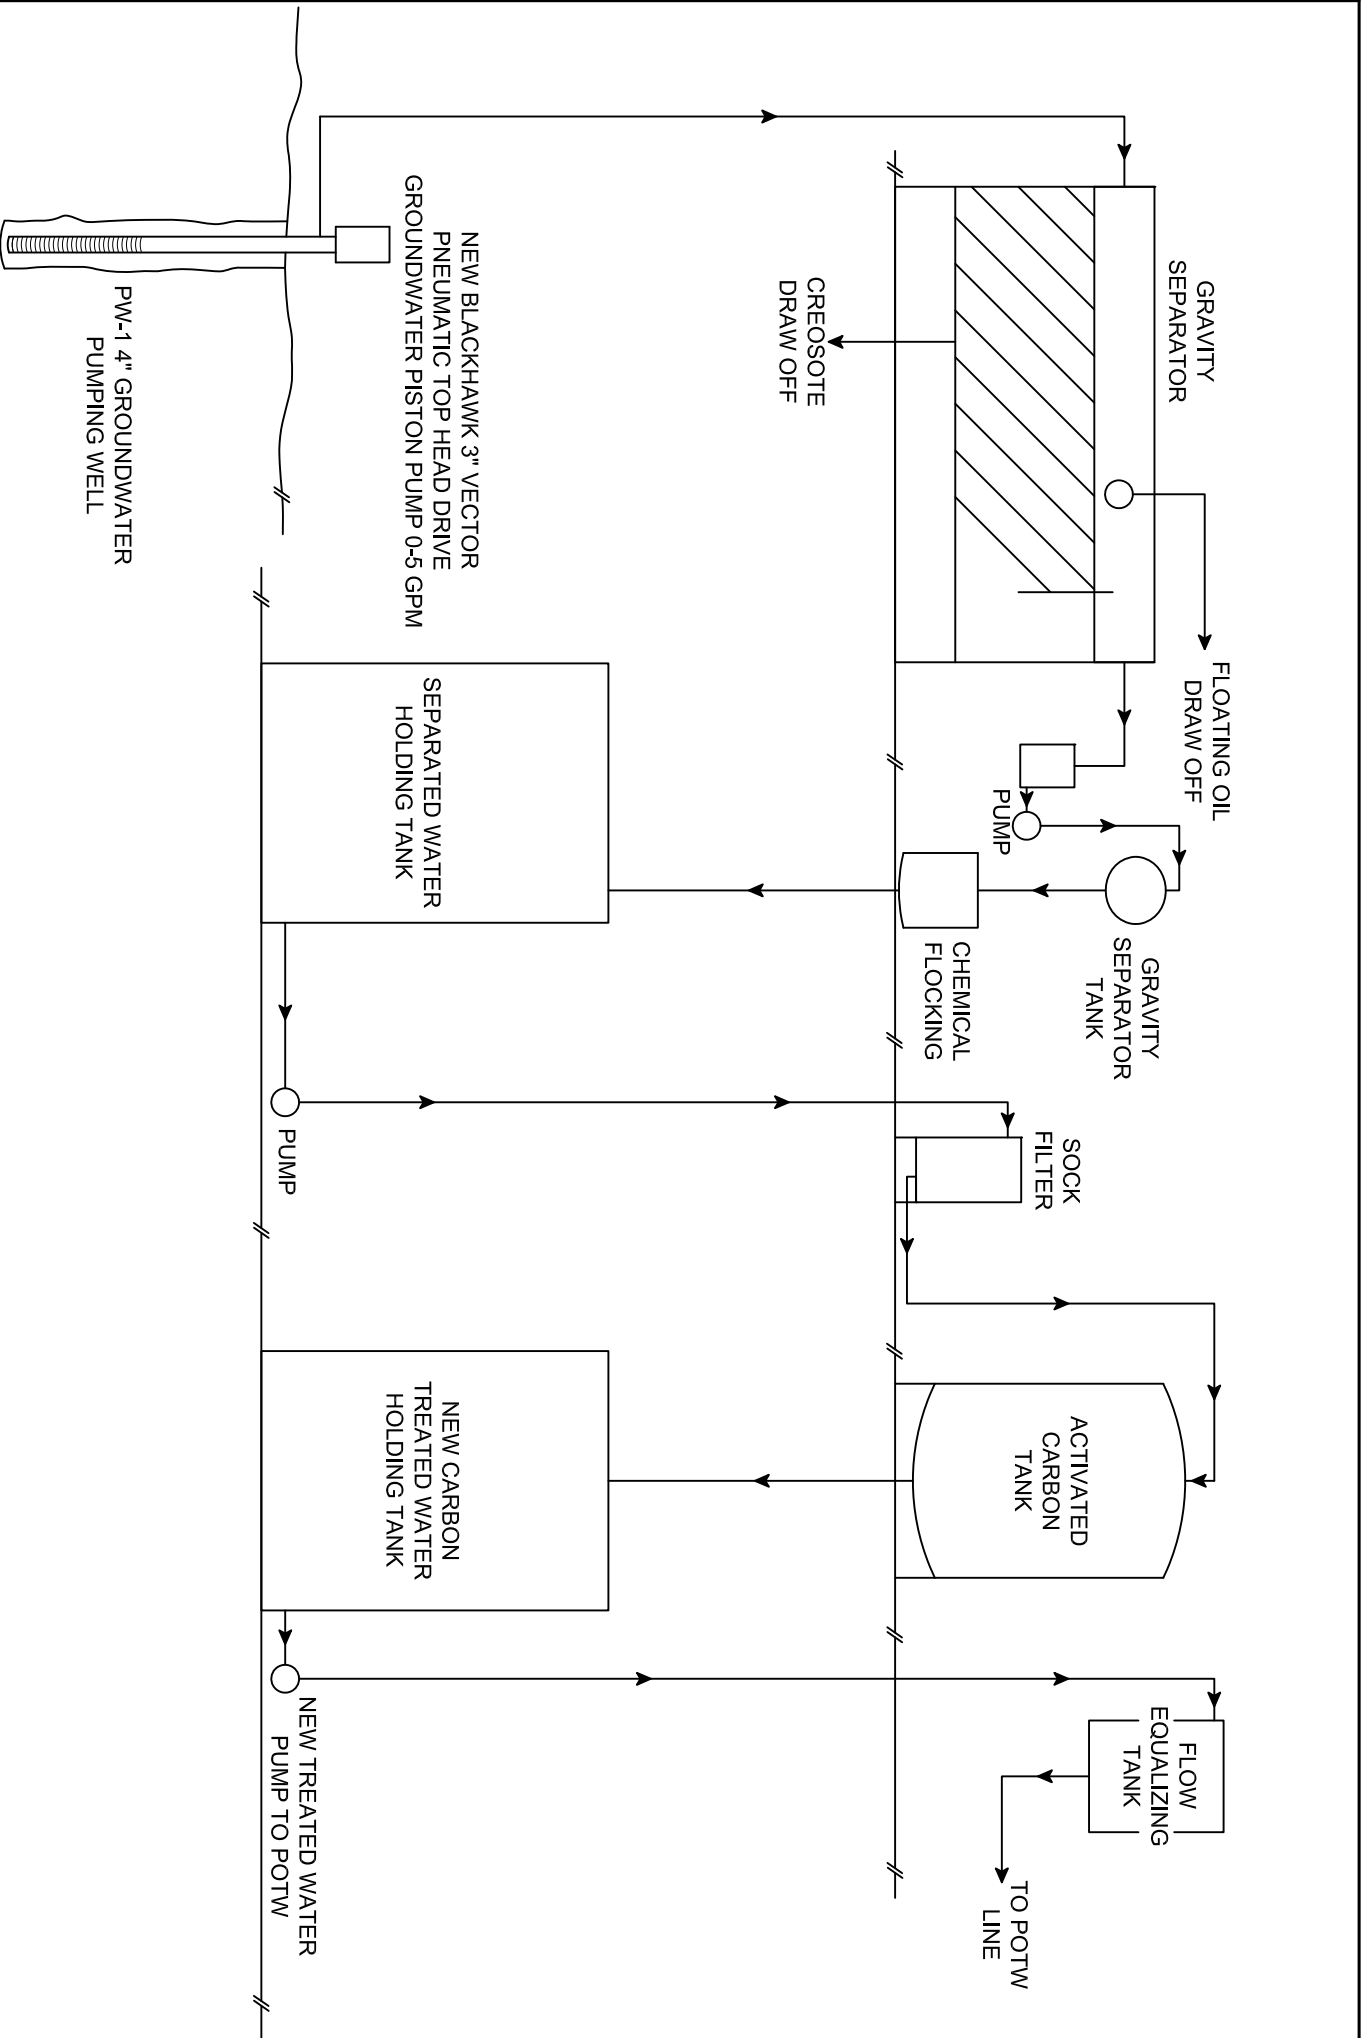
E-16

W.C. MEREDITH WOOD PRESERVING FACILITY  
2335 LAWRENCE STREET  
EAST POINT, GA 30344  
GROUNDWATER TREATMENT - SYSTEM DIAGRAM

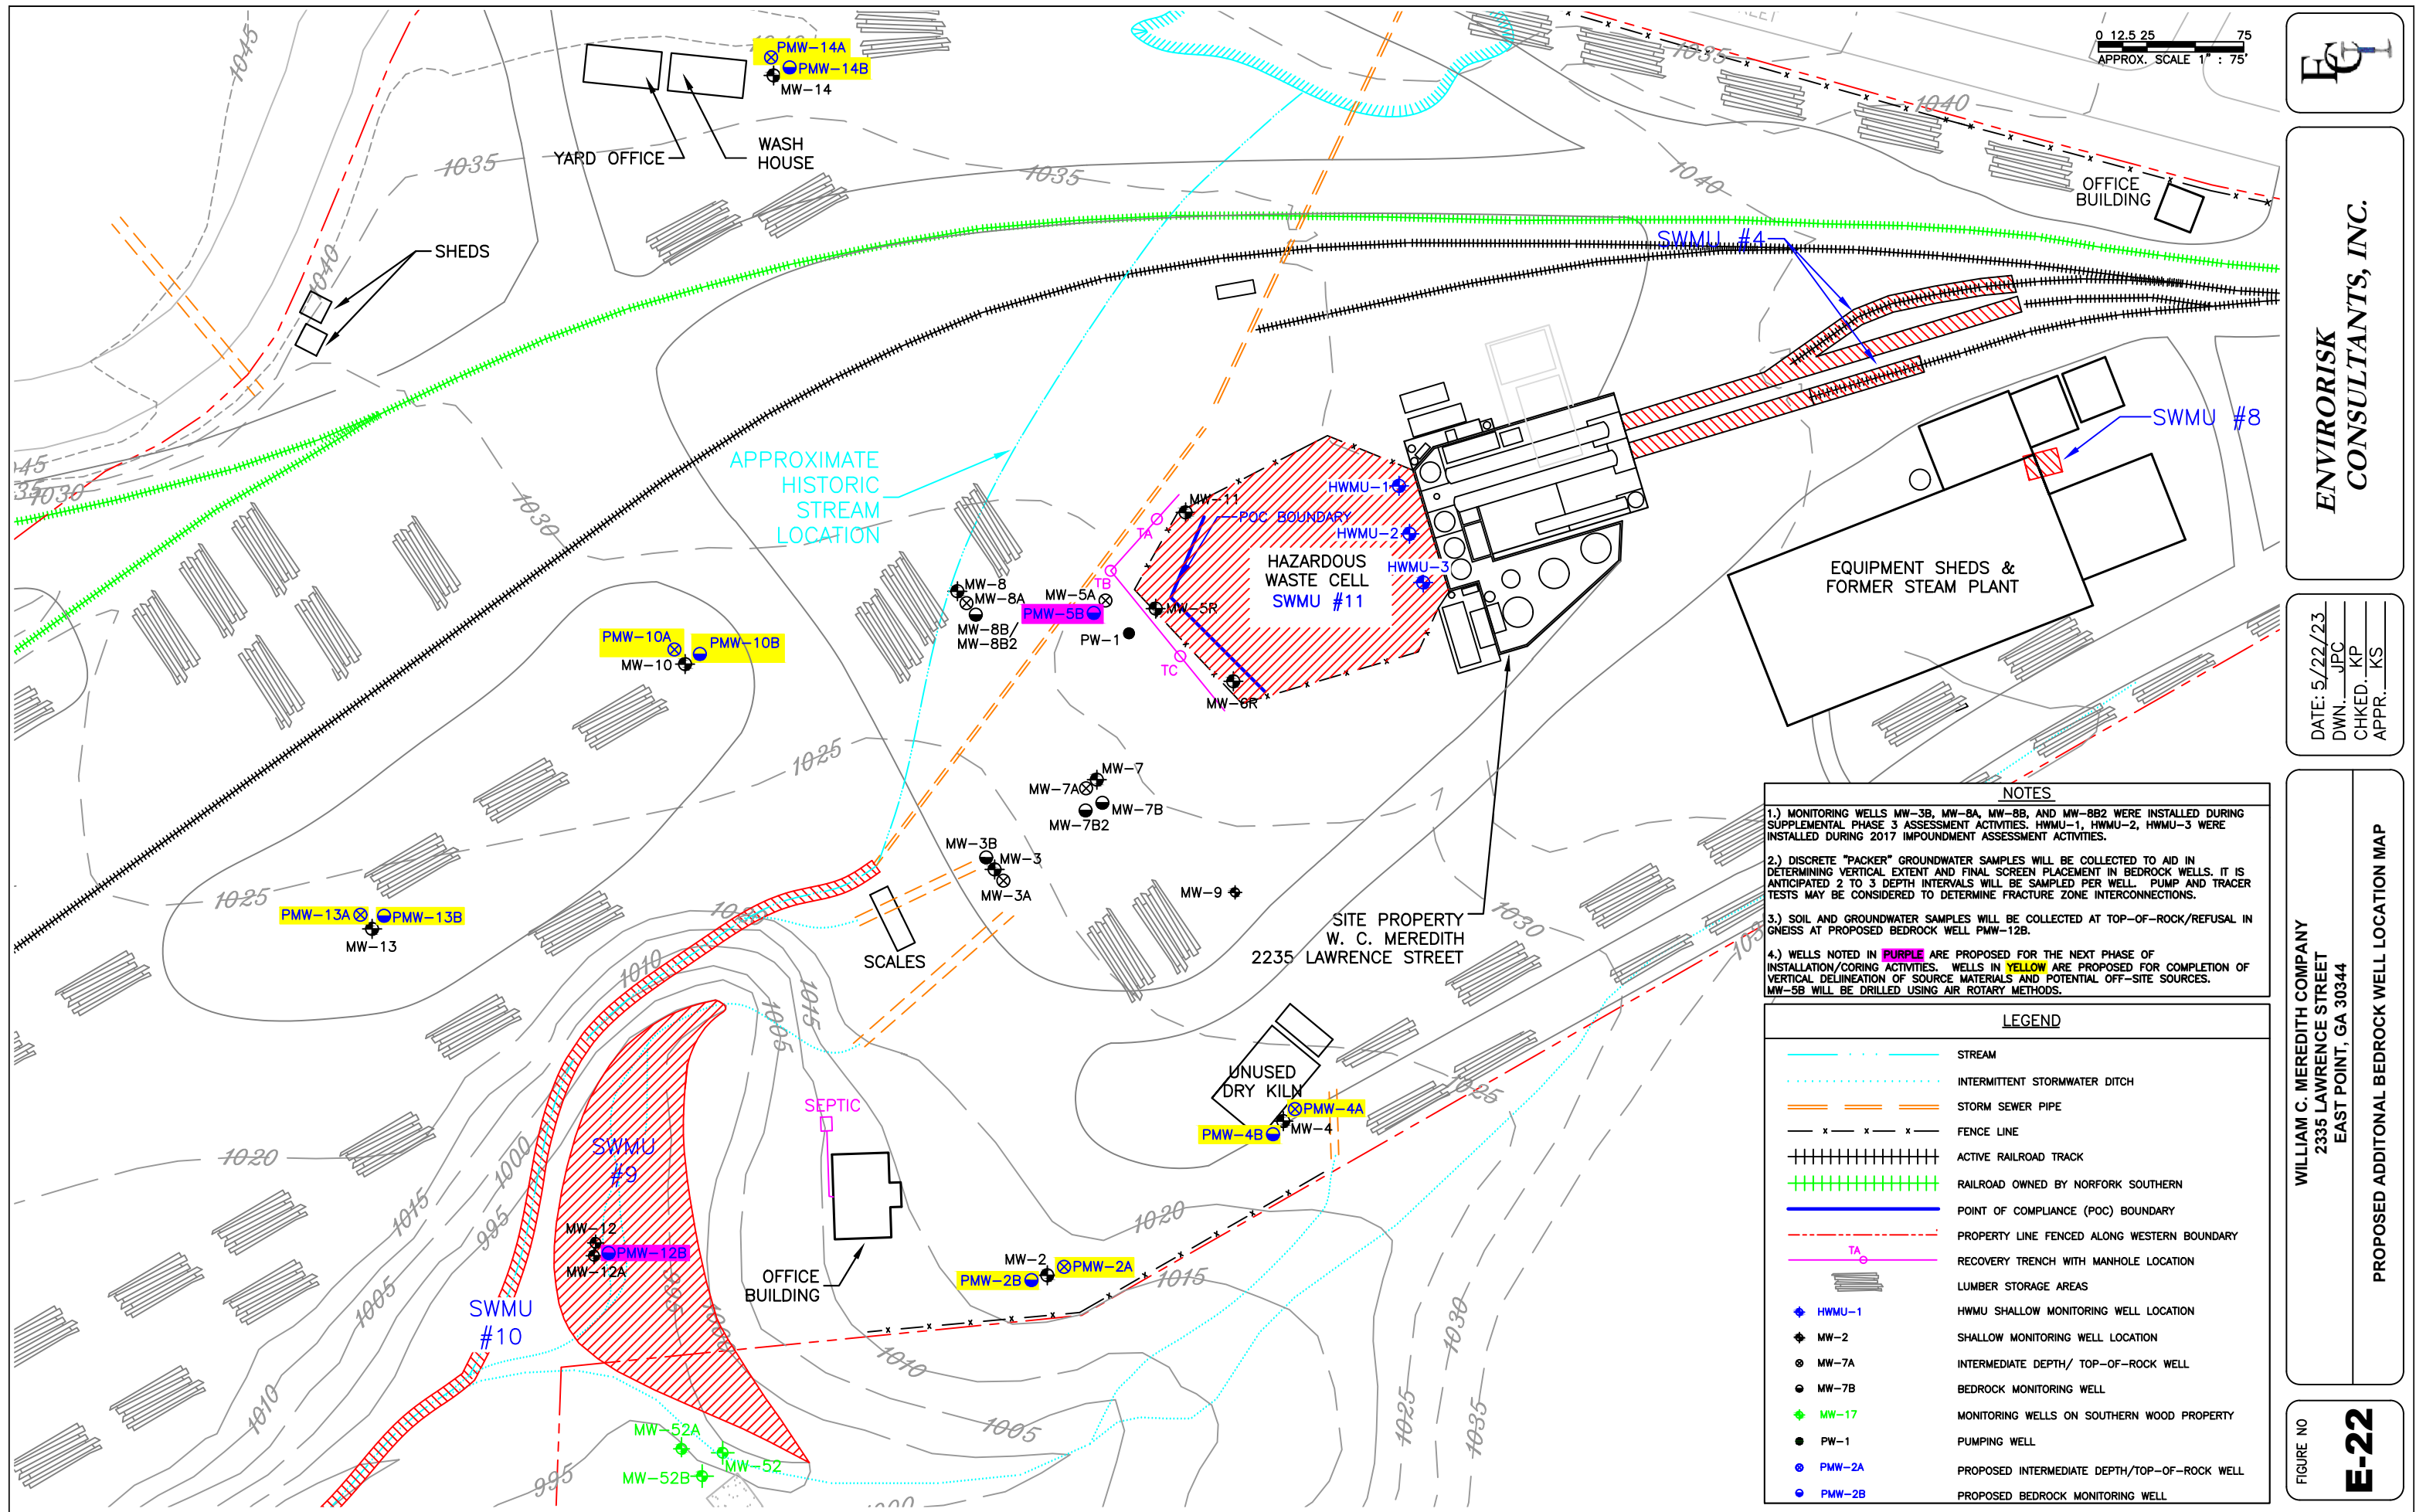
FIGURE NO  
**E-22**

PROPOSED ADDITIONAL BEDROCK WELL LOCATION MAP

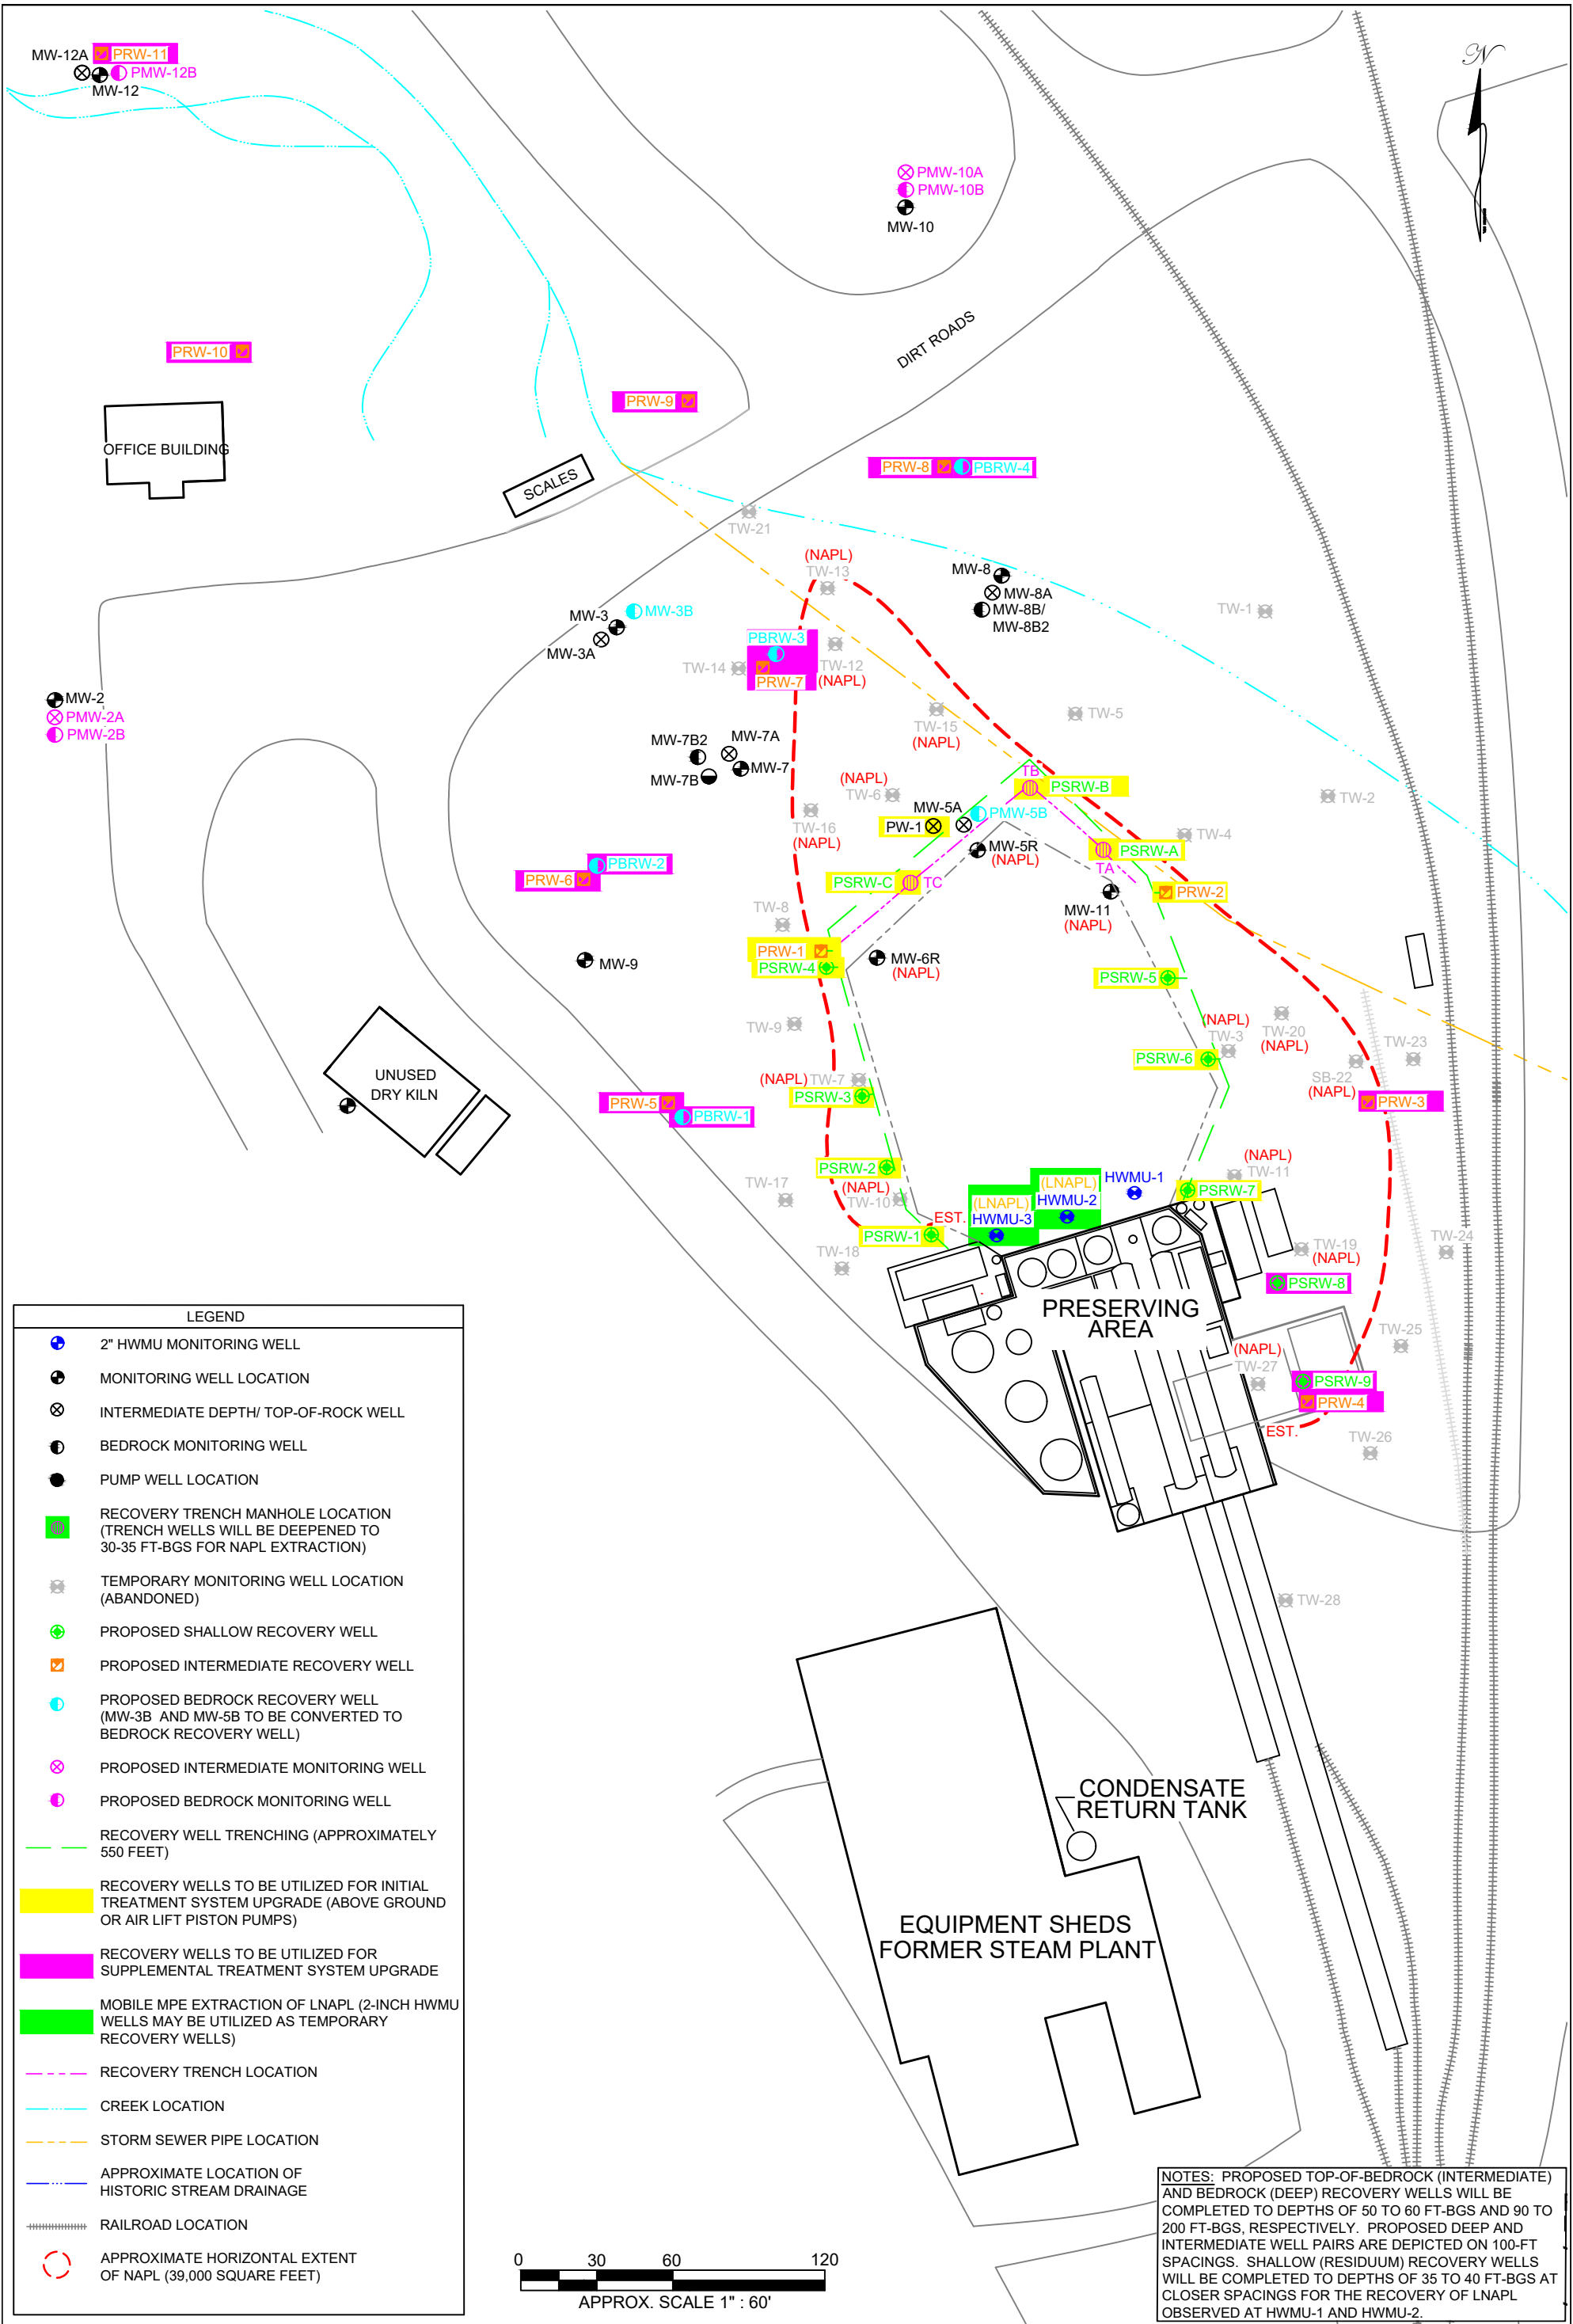
E-23

PROPOSED RECOVERY WELL LOCATION MAP
