**PART B REVISED PERMIT**  
W.C. MEREDITH FACILITY  
2335 LAWRENCE STREET  
EAST POINT, GA 30344  
PERMIT No. HW-062(D)

**PART B REVISED PERMIT**  
 W.C. MEREDITH FACILITY  
 2335 LAWRENCE STREET  
 EAST POINT, GA 30344  
 PERMIT No. HW-062(D)

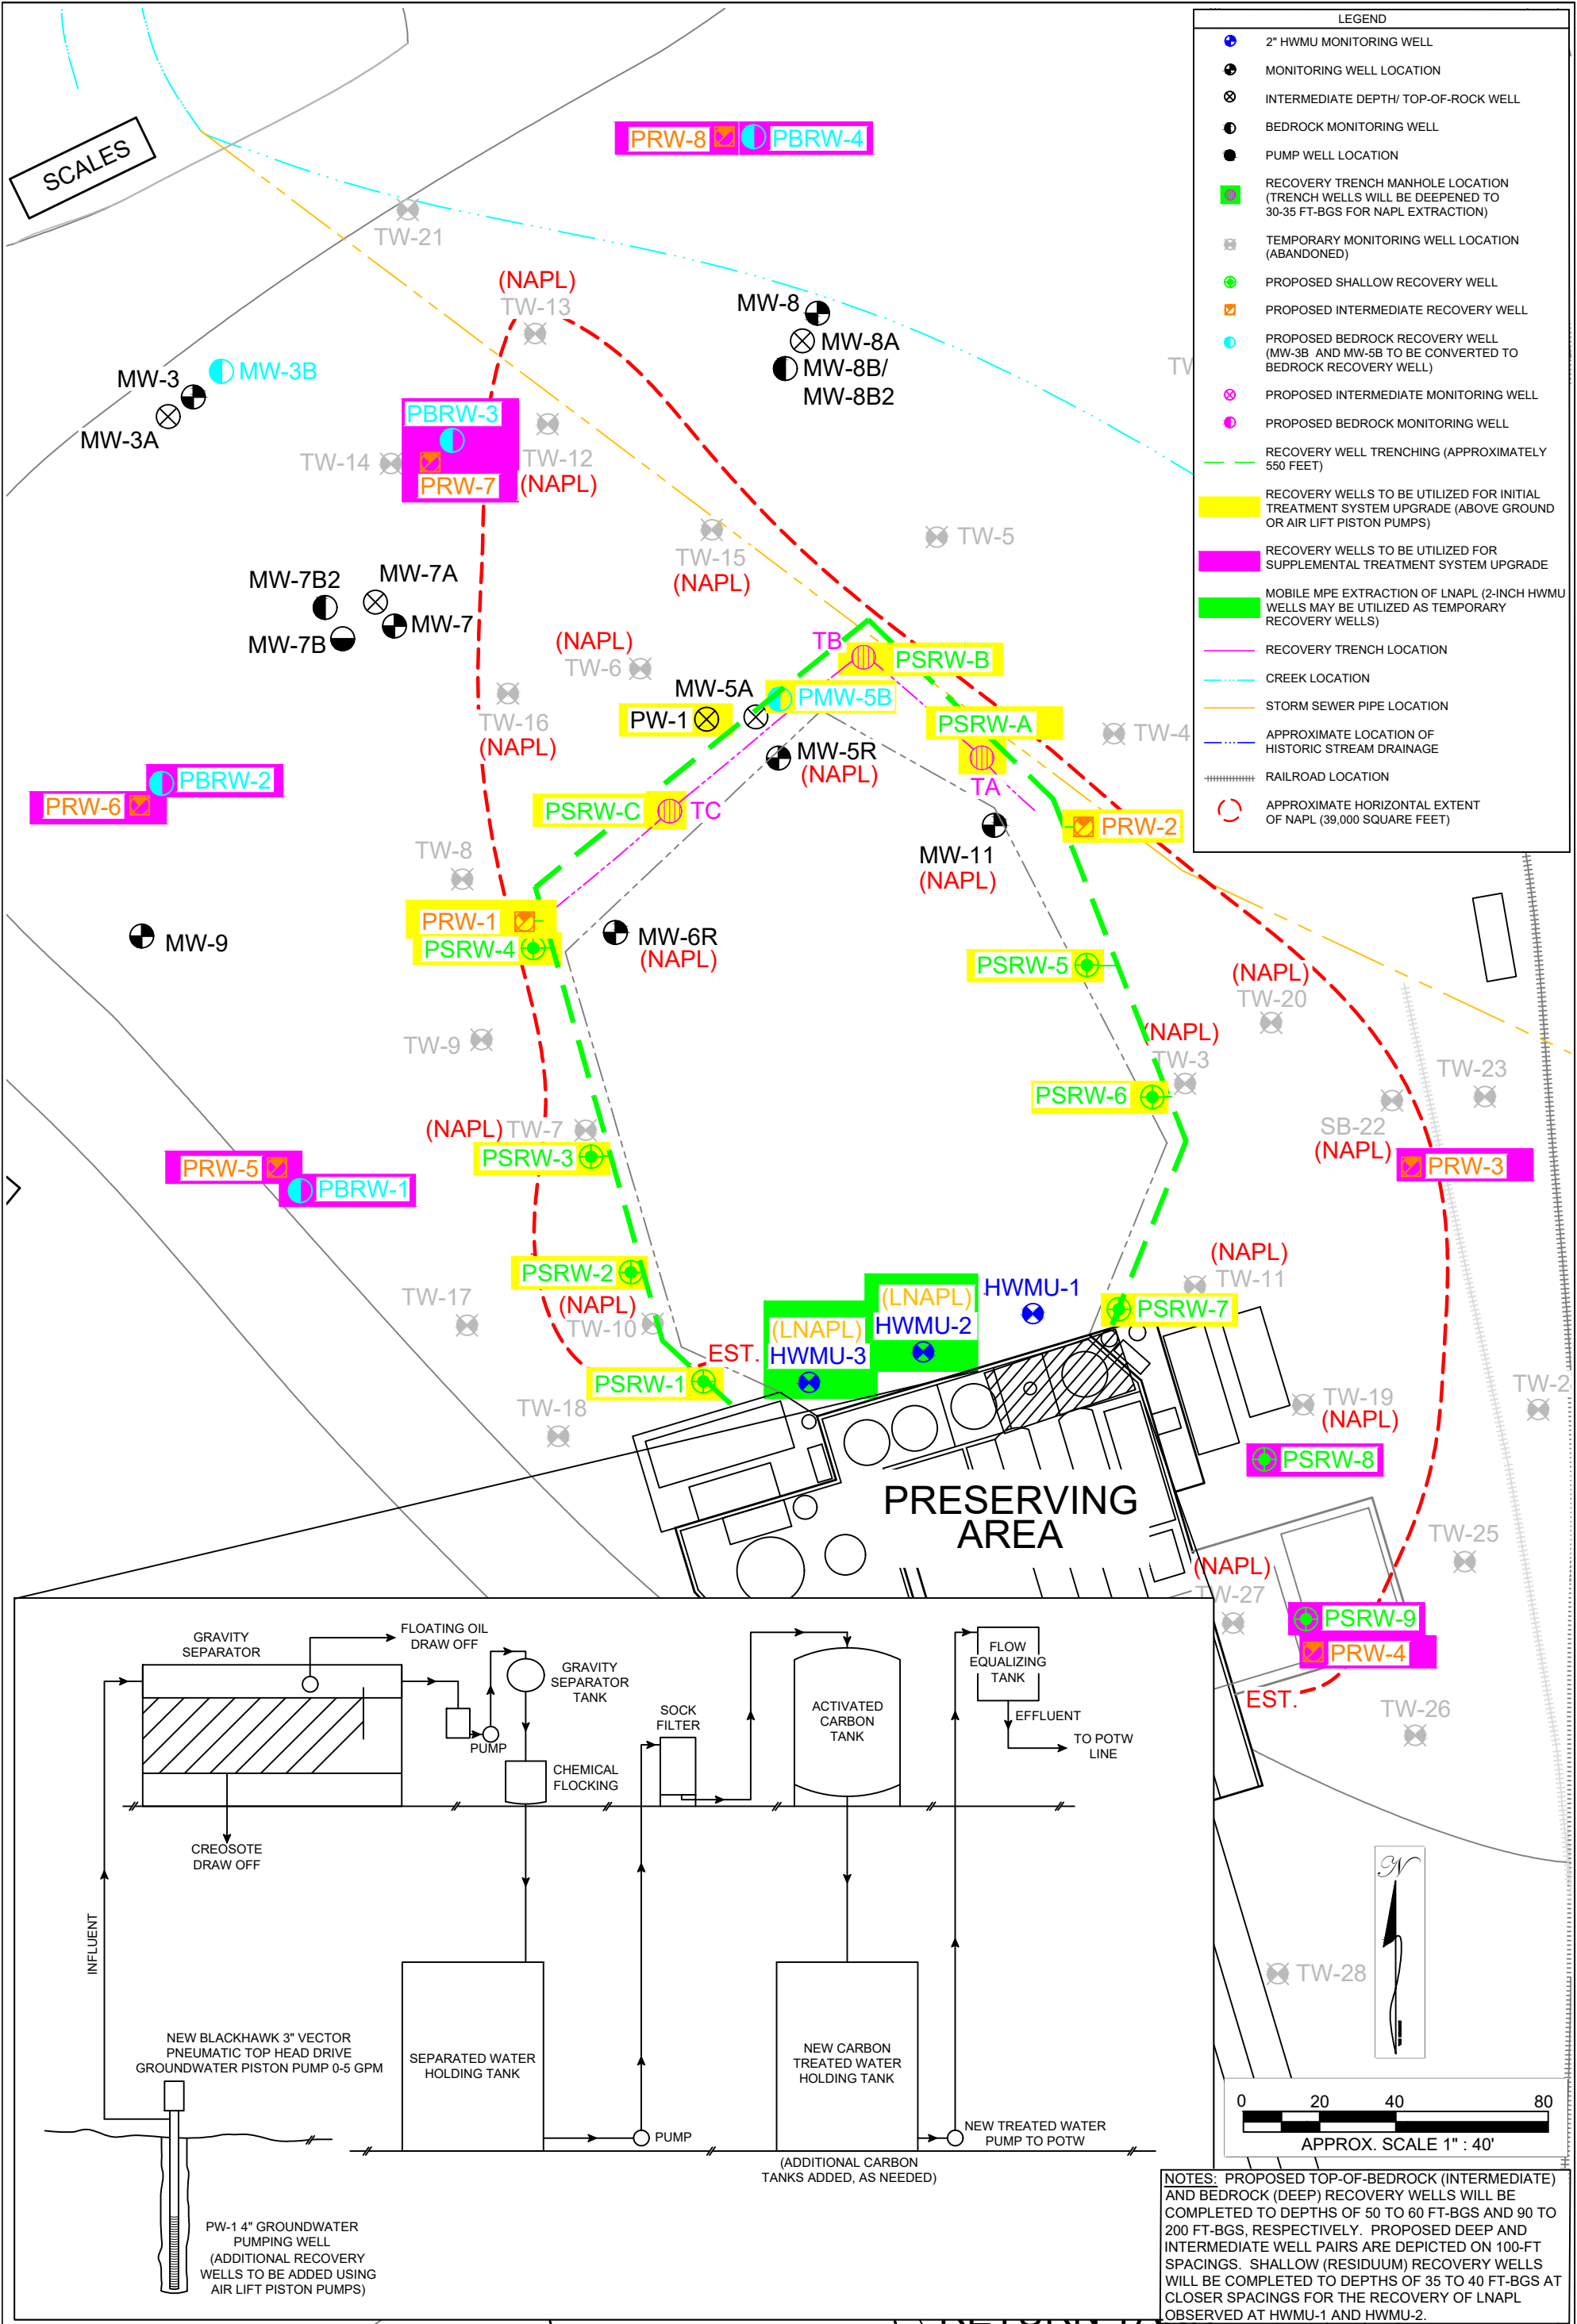
E-24

PROPOSED RECOVERY WELL LOCATION MAP  
WITH EXTRACTION DIAGRAM

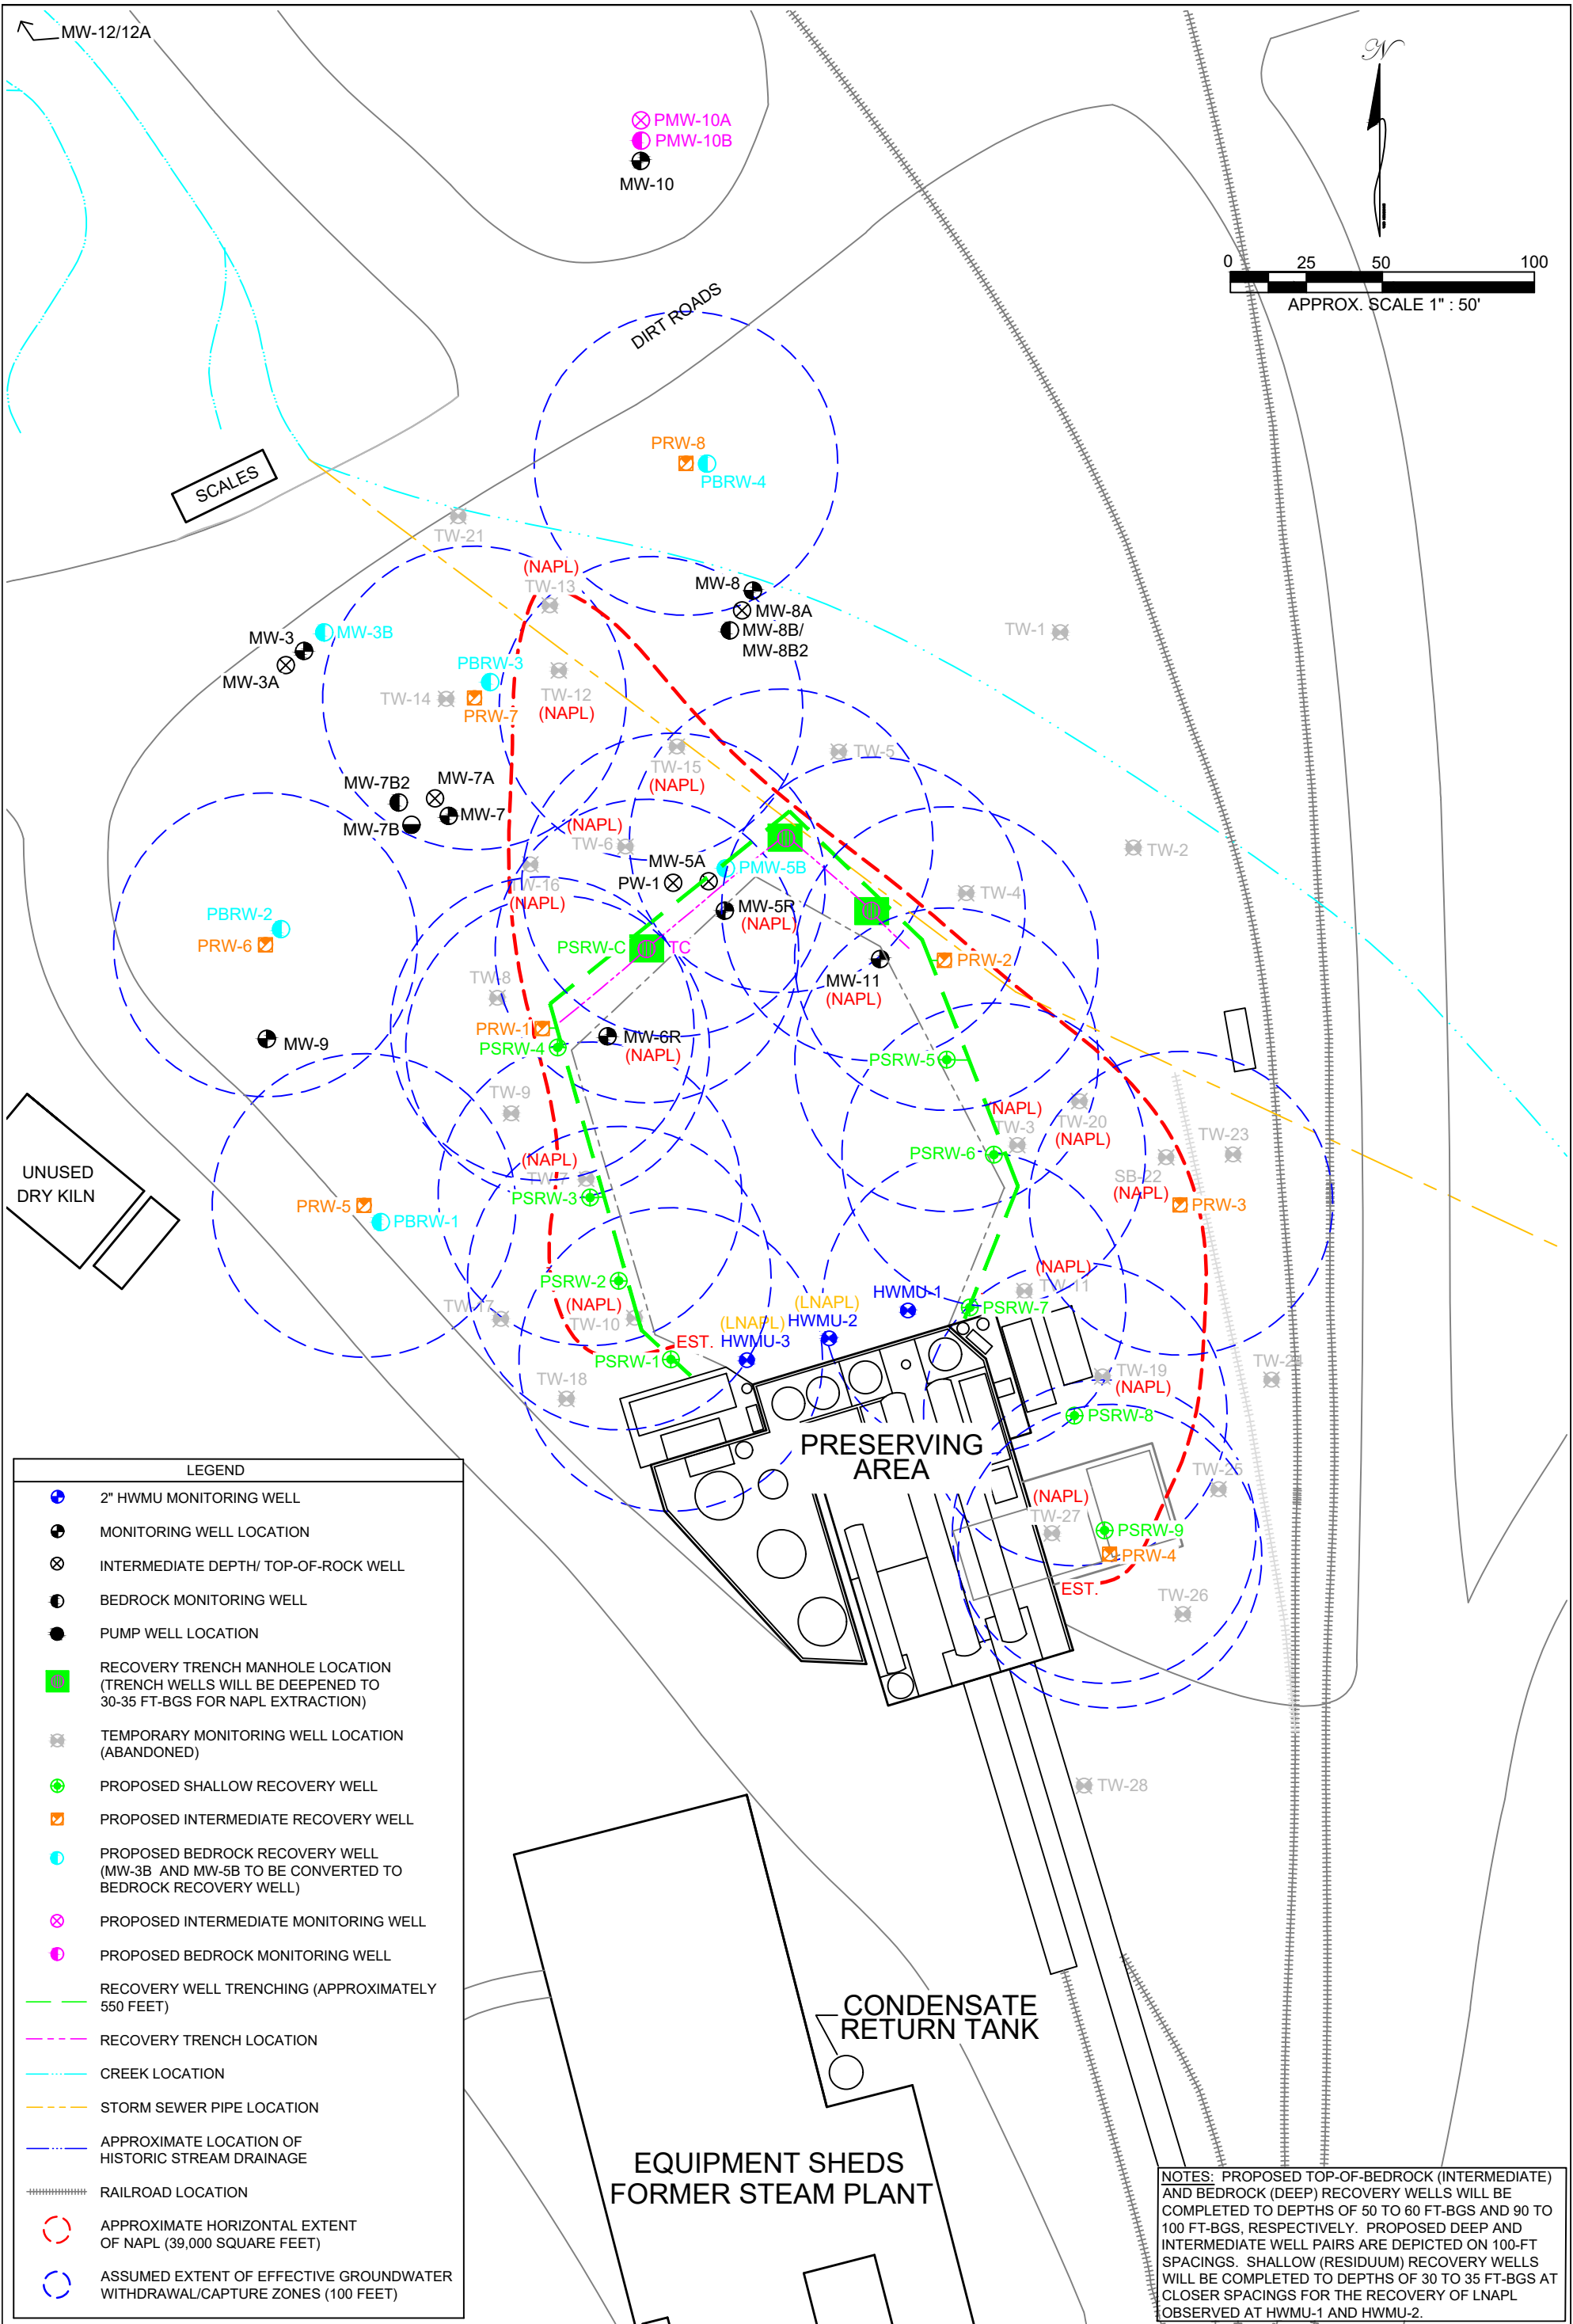
E-25

PROPOSED RECOVERY WELL CAPTURE ZONES

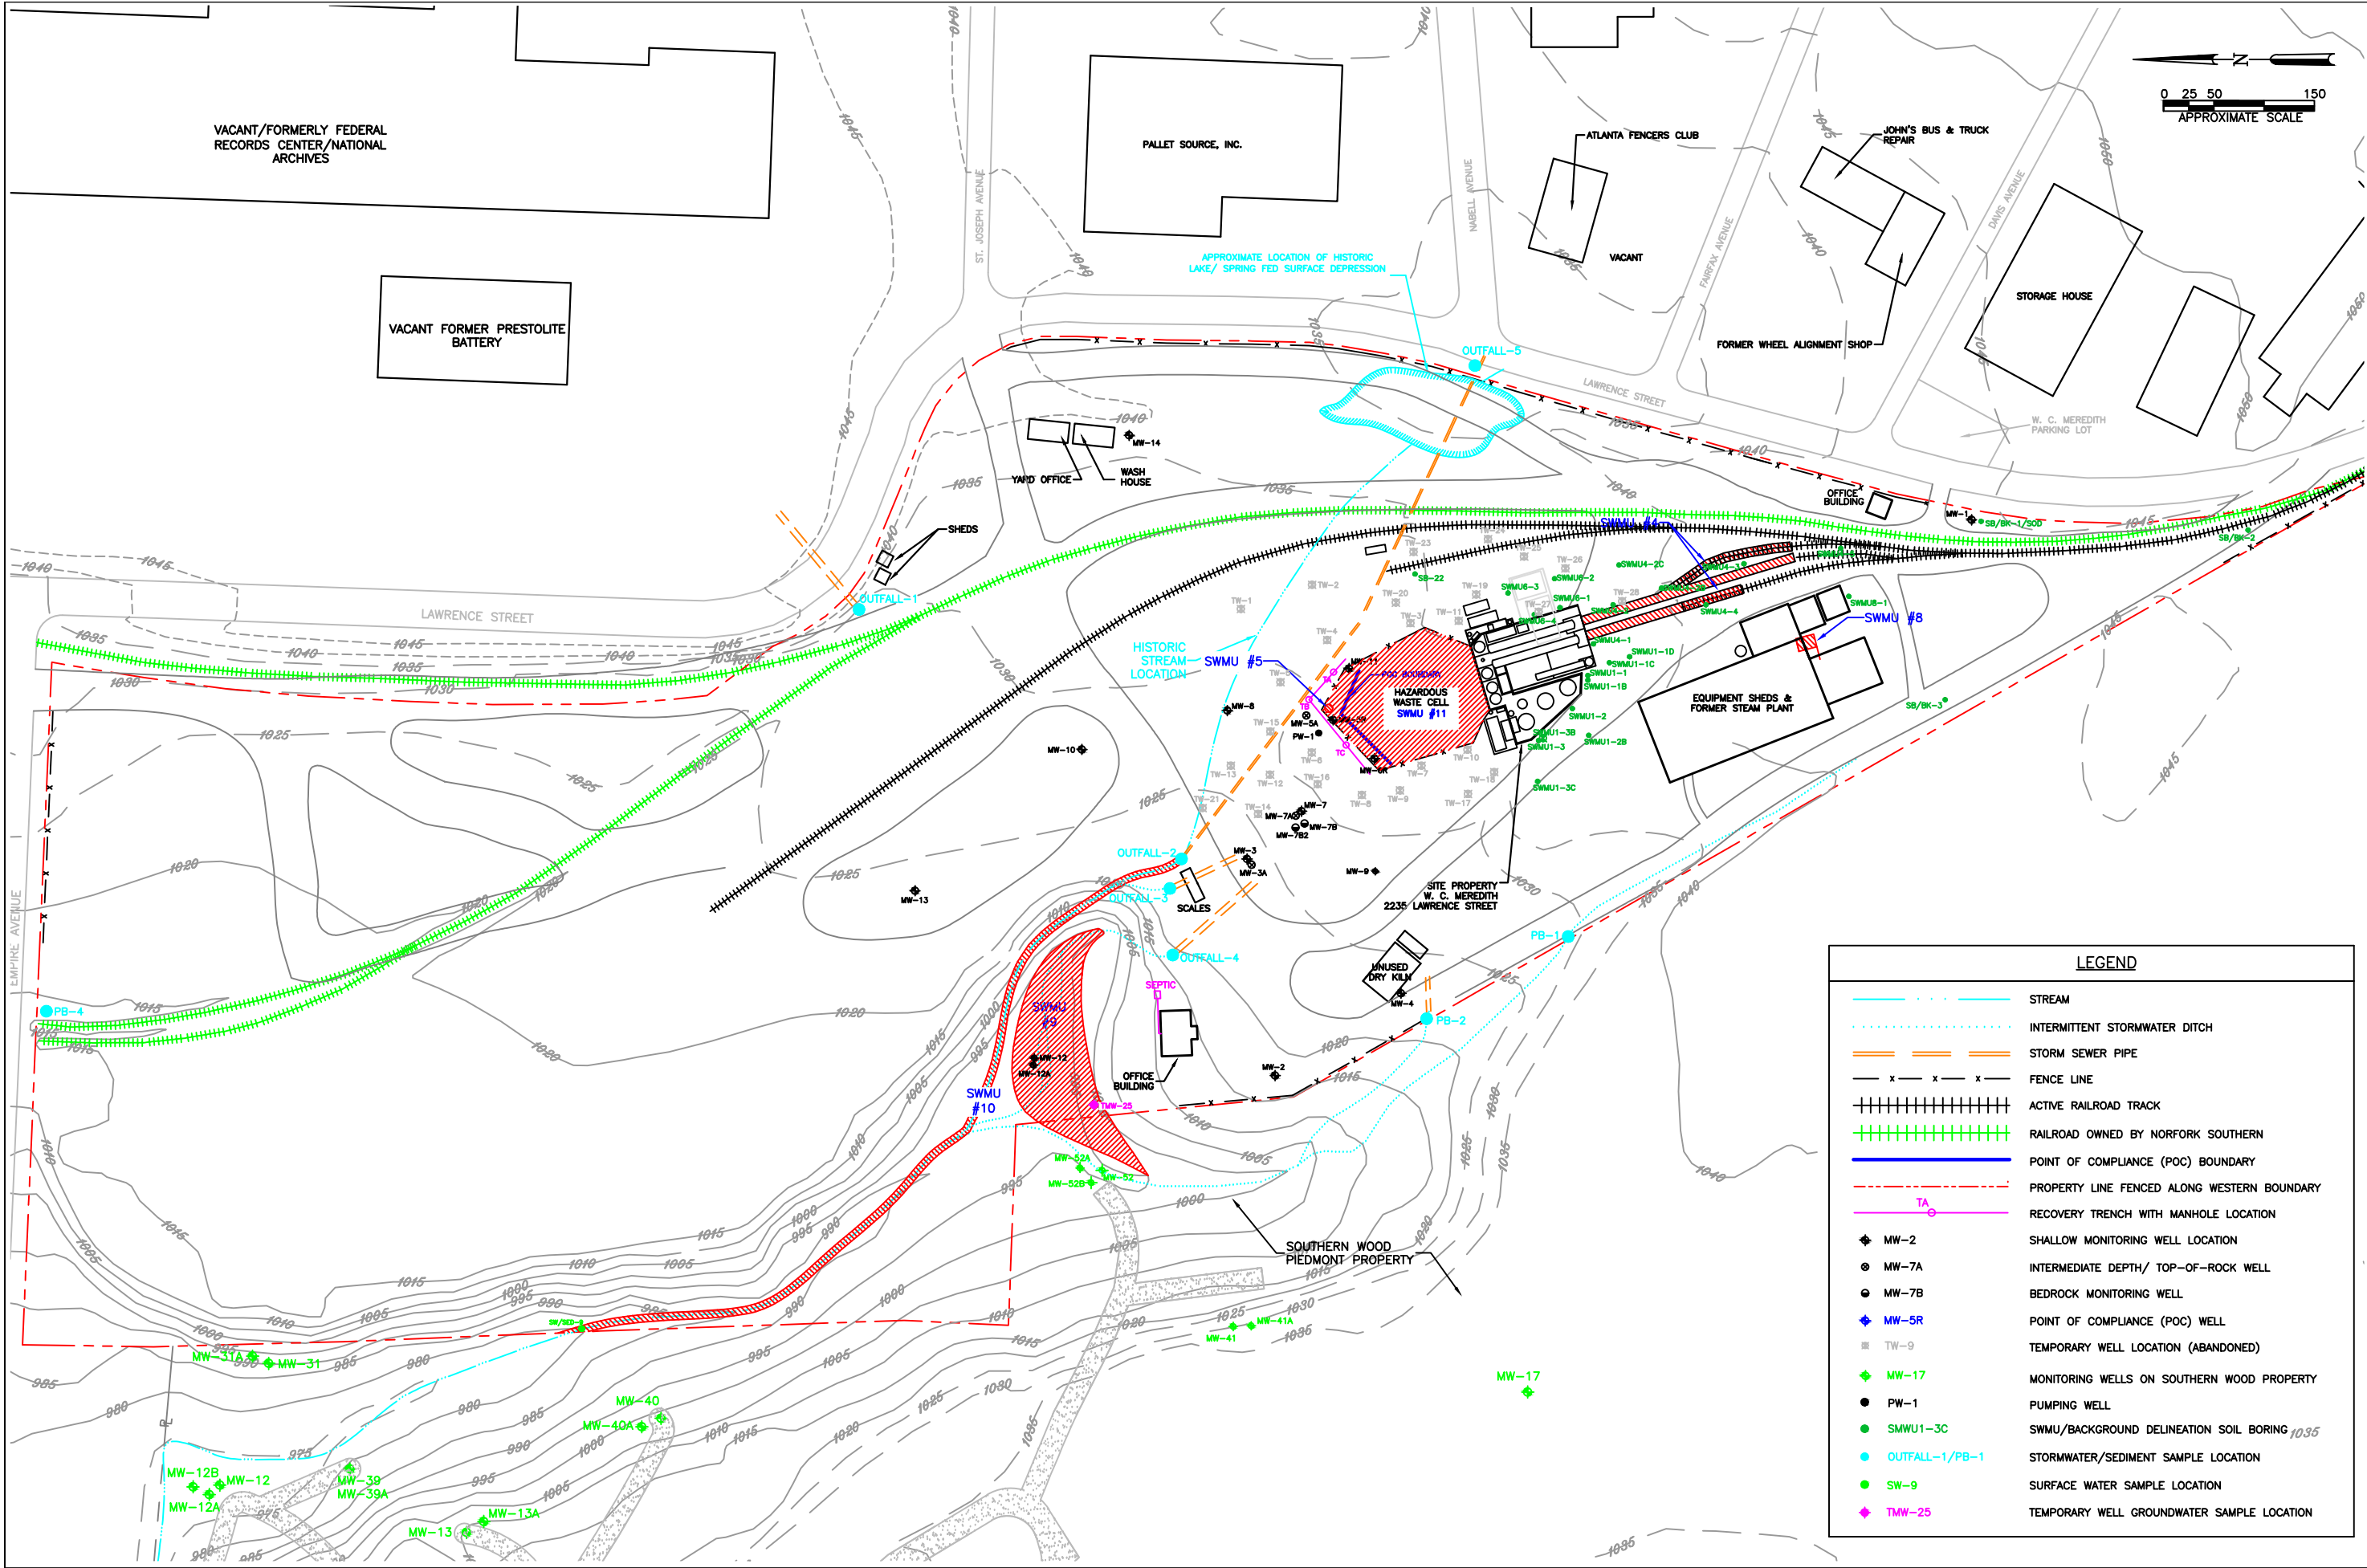
FIGURE NO  
**E-27**

INTERIM MEASURES STORMWATER, GROUNDWATER, AND  
SURFACE WATER SAMPLE LOCATION MAP
