WILLIAM C. MEREDITH COMPANY  
2335 LAWRENCE STREET  
EAST POINT, GA 30344

VERTICAL EXTENT OF SVOCs (B-B')

SWMU 9 SEDIMENT AND TW SOIL SAMPLING RESULTS – 2014-2015 (SVOCs)

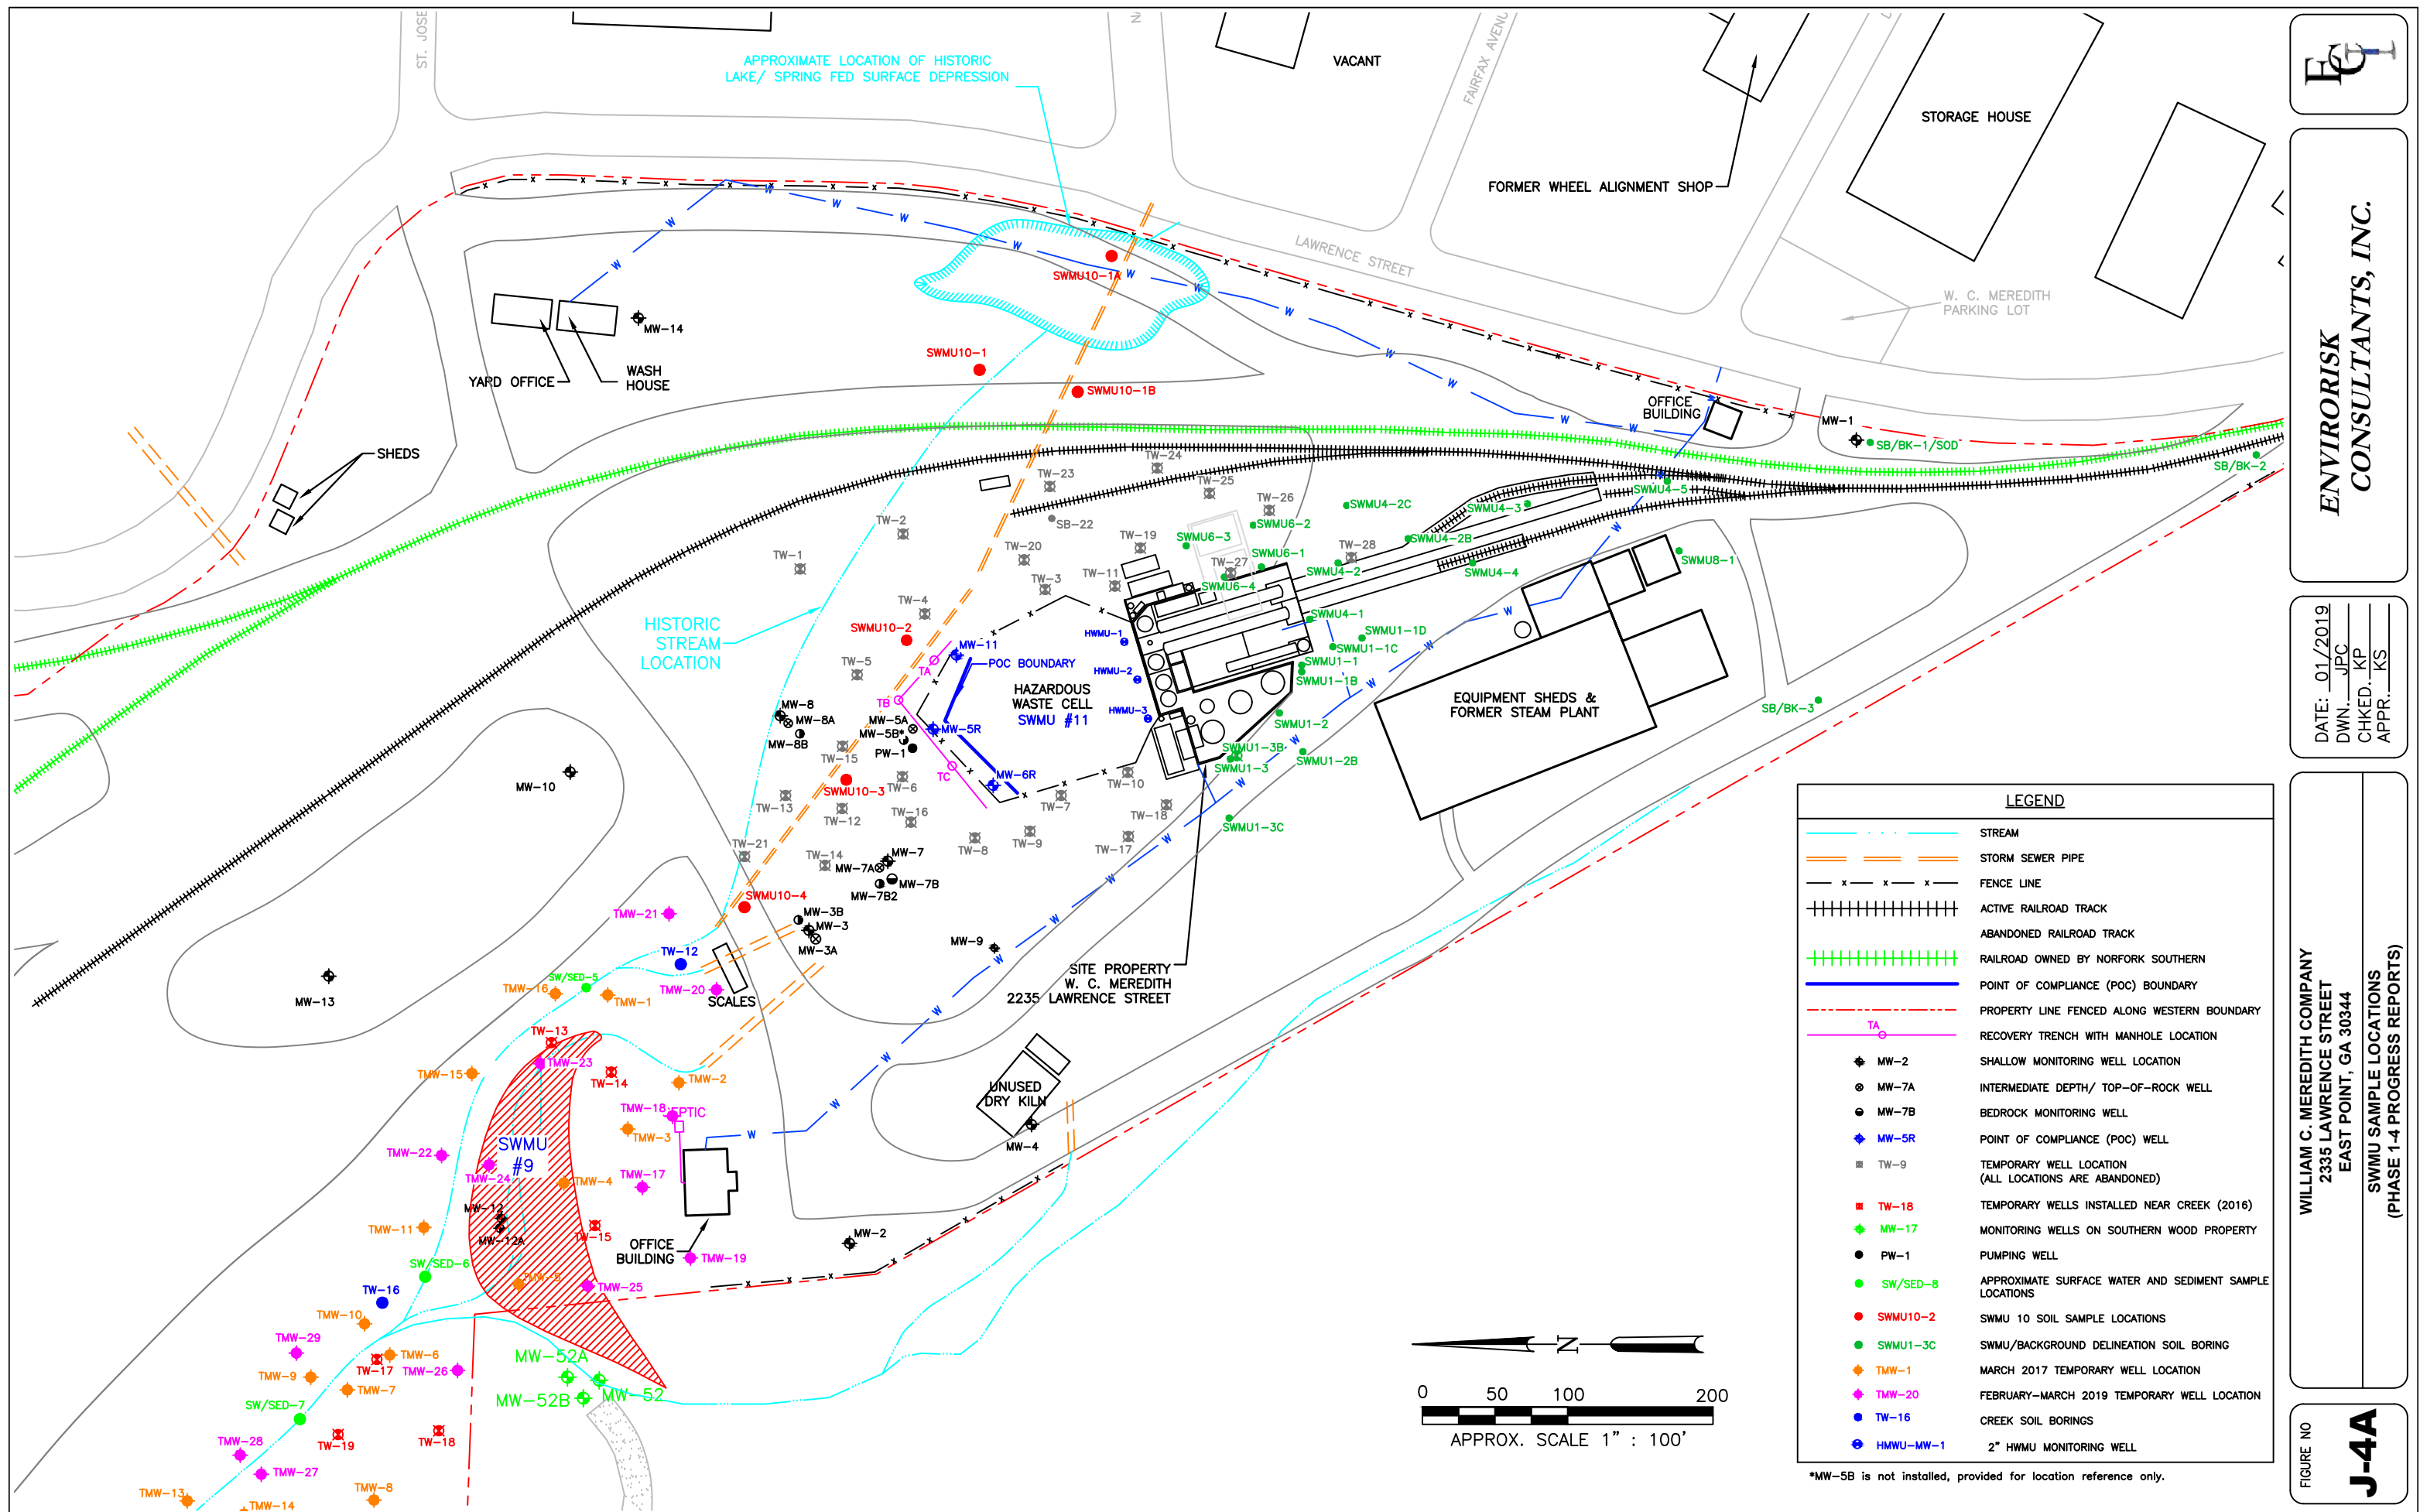
FIGURE NO  
**J-5A**

CROSS-SECTION LOCATION MAP

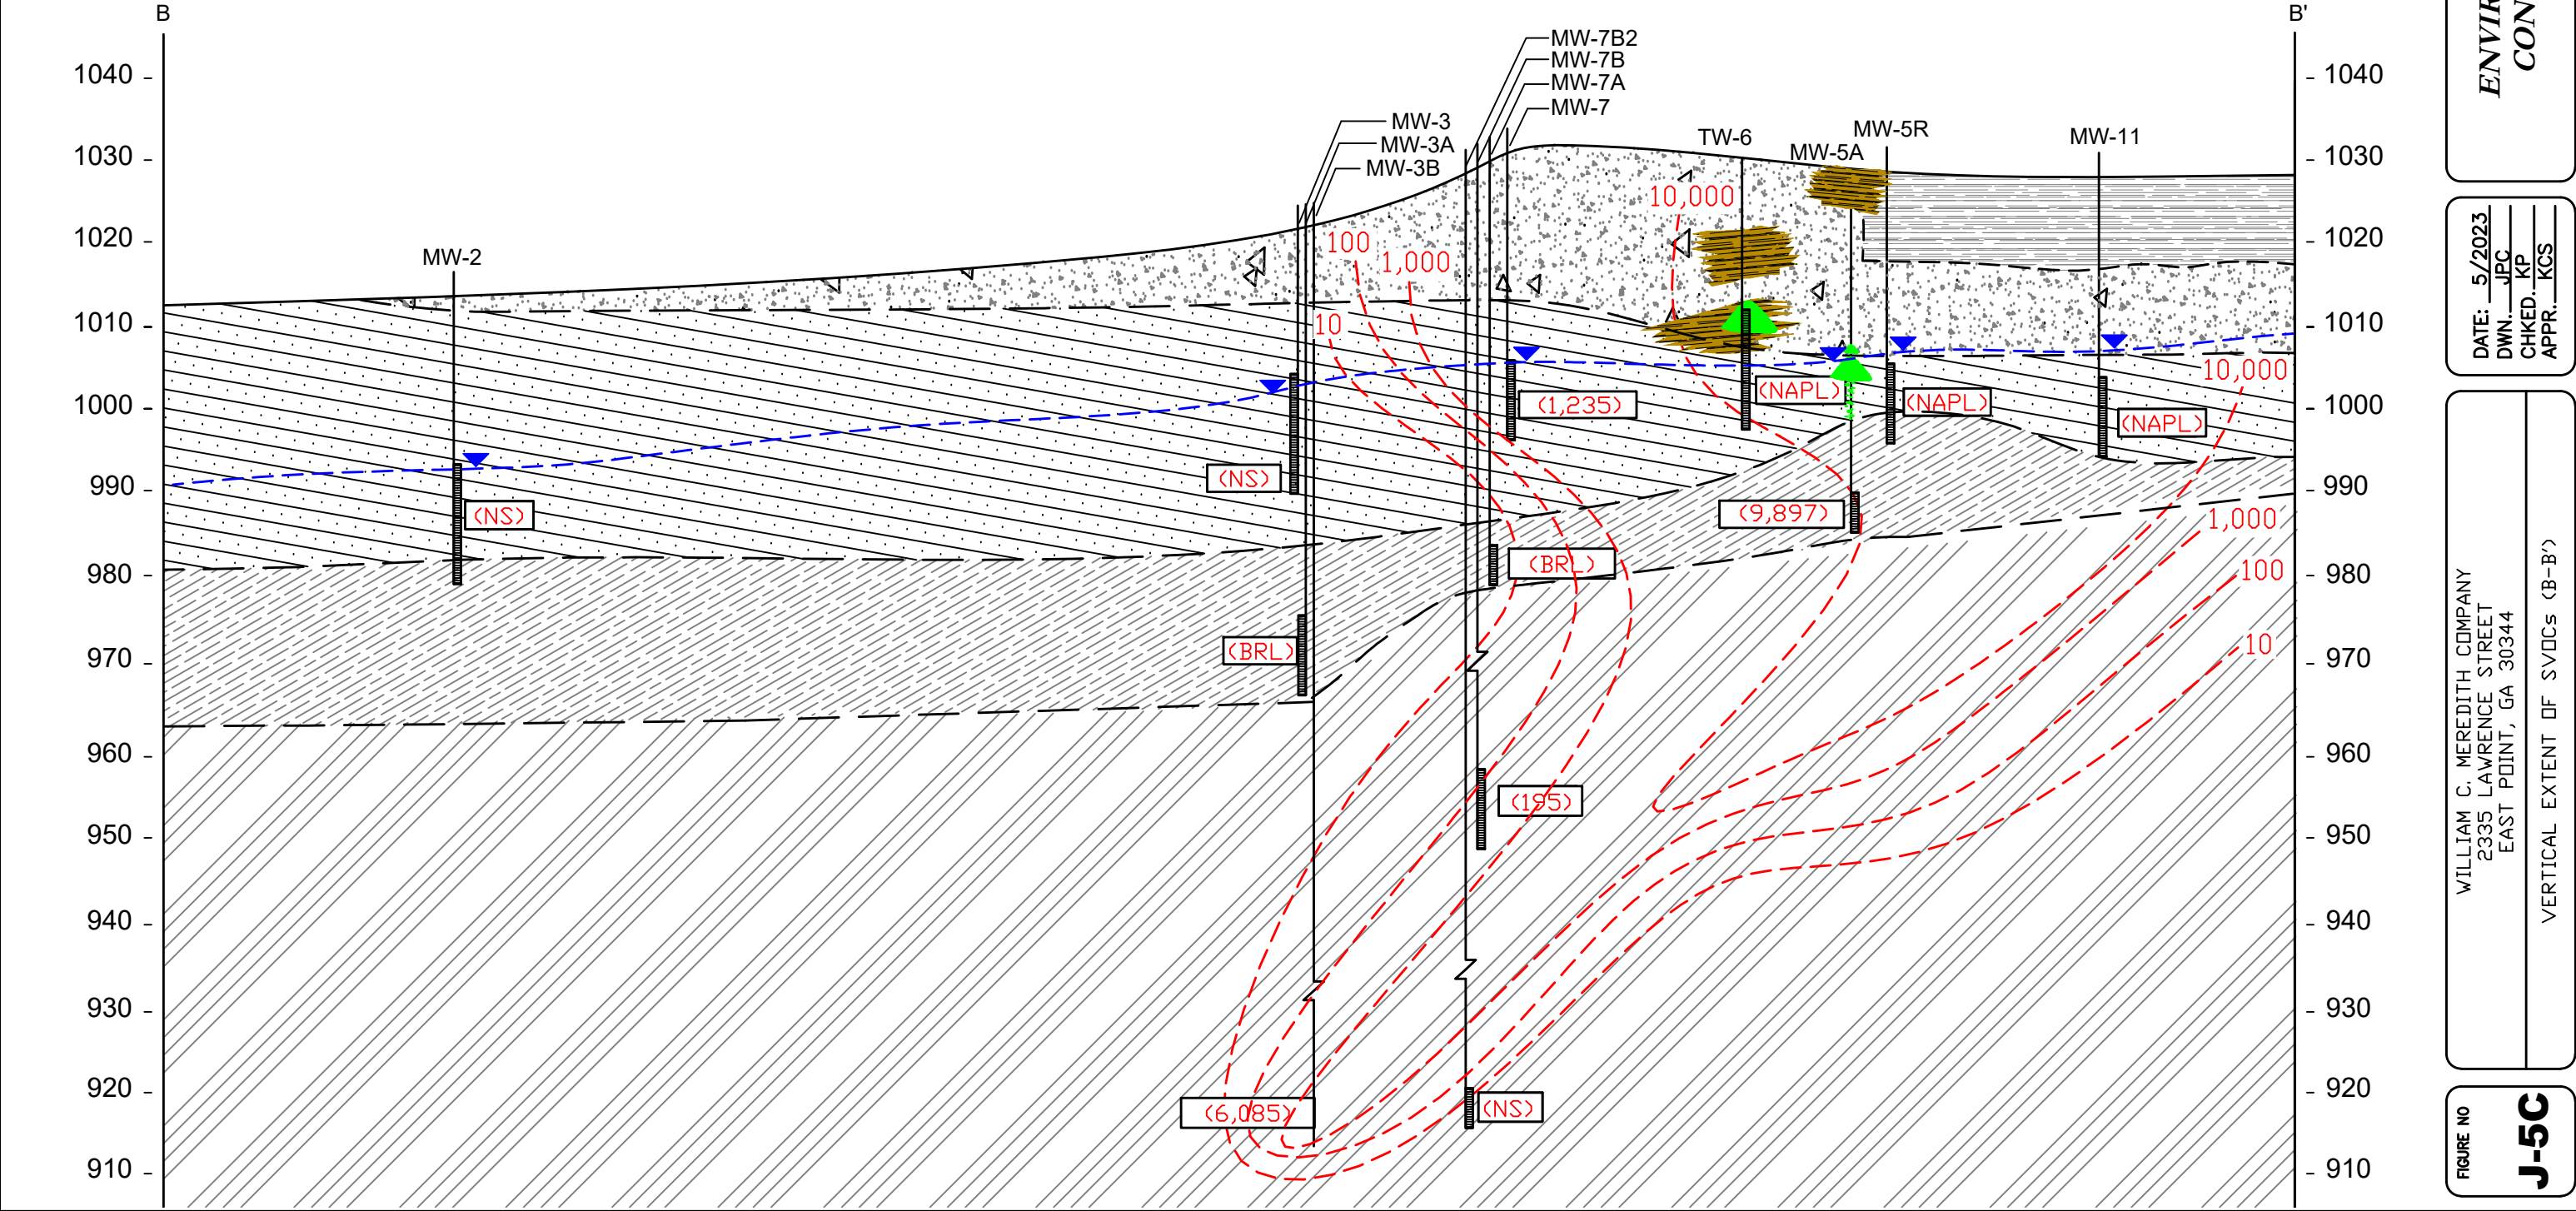
FIGURE NO  
J-5C

FILL:  
CONSISTS OF A MIXTURE OF GRAVEL, SAND, SILTY-SAND, CLAY,  
AND VARIOUS DEBRIS.

RESIDUUM SOILS:  
CONSISTS OF MICACEOUS SANDY-CLAYS, SILTY-SANDS,  
CLAYEY-SANDS, WITH EVIDENCE OF RELICT FOLIATION  
INDICATIVE OF GNEISS OR SCHIST BEDROCK WITH DEPTH.

PARTIALLY WEATHERED ROCK (PWR):  
CHARACTERIZED AS DENSER SOIL/ SAPROLITE (HIGH BLOW  
COUNT MATERIAL) CLASSIFIED AS WEATHERED MICACEOUS  
GRANITIC GNEISS, MICA SCHISTS, BIOTITE SCHISTS/ GNEISS,  
HORNBLende GNEISS/ SCHISTS.

FRACTURED BEDROCK:  
COMPETENT BEDROCK - HARD BIOTITE GNEISS, GRANITIC GNEISS,  
AND AMPHIBOLITE GNEISS WITH POTASSIUM FELDSPAR, AND  
QUARTZ AUGENS AND LENSES OF MICA, PYRITE AND MUSCOVITE.

NOTE:  
THE EXTENT OF NAPL SURROUNDING WELLS IS UNKNOWN, BUT HAS BEEN ESTIMATED BASED  
ON BORING LOG DESCRIPTIONS. IN ADDITION, VOC CONCENTRATIONS IN THE NAPL FRACTION  
ARE UNKNOWN. CONTOURING WAS DONE FOR THE DISSOLVED PHASE ONLY BASED ON PRIOR  
POC SAMPLING DATA.

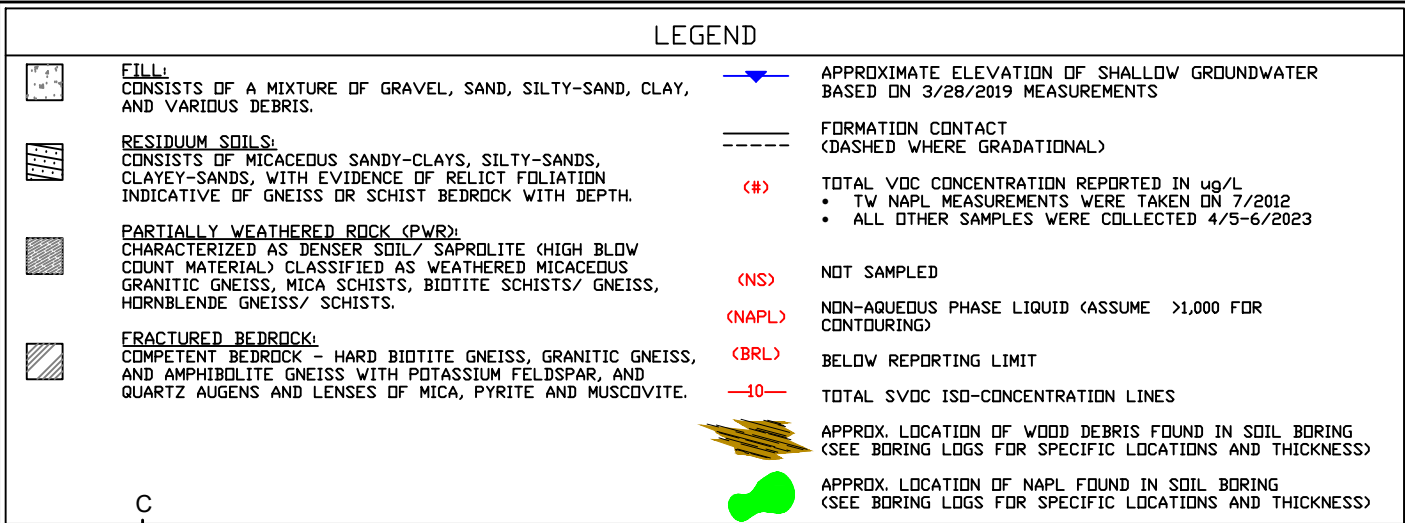
NOTE:  
THE EXTENT OF NAPL SURROUNDING WELLS IS UNKNOWN, BUT HAS BEEN ESTIMATED BASED  
ON BORING LOG DESCRIPTIONS. IN ADDITION, VOC CONCENTRATIONS IN THE NAPL FRACTION  
ARE UNKNOWN. CONTOURING WAS DONE FOR THE DISSOLVED PHASE ONLY BASED ON PRIOR  
POC SAMPLING DATA.

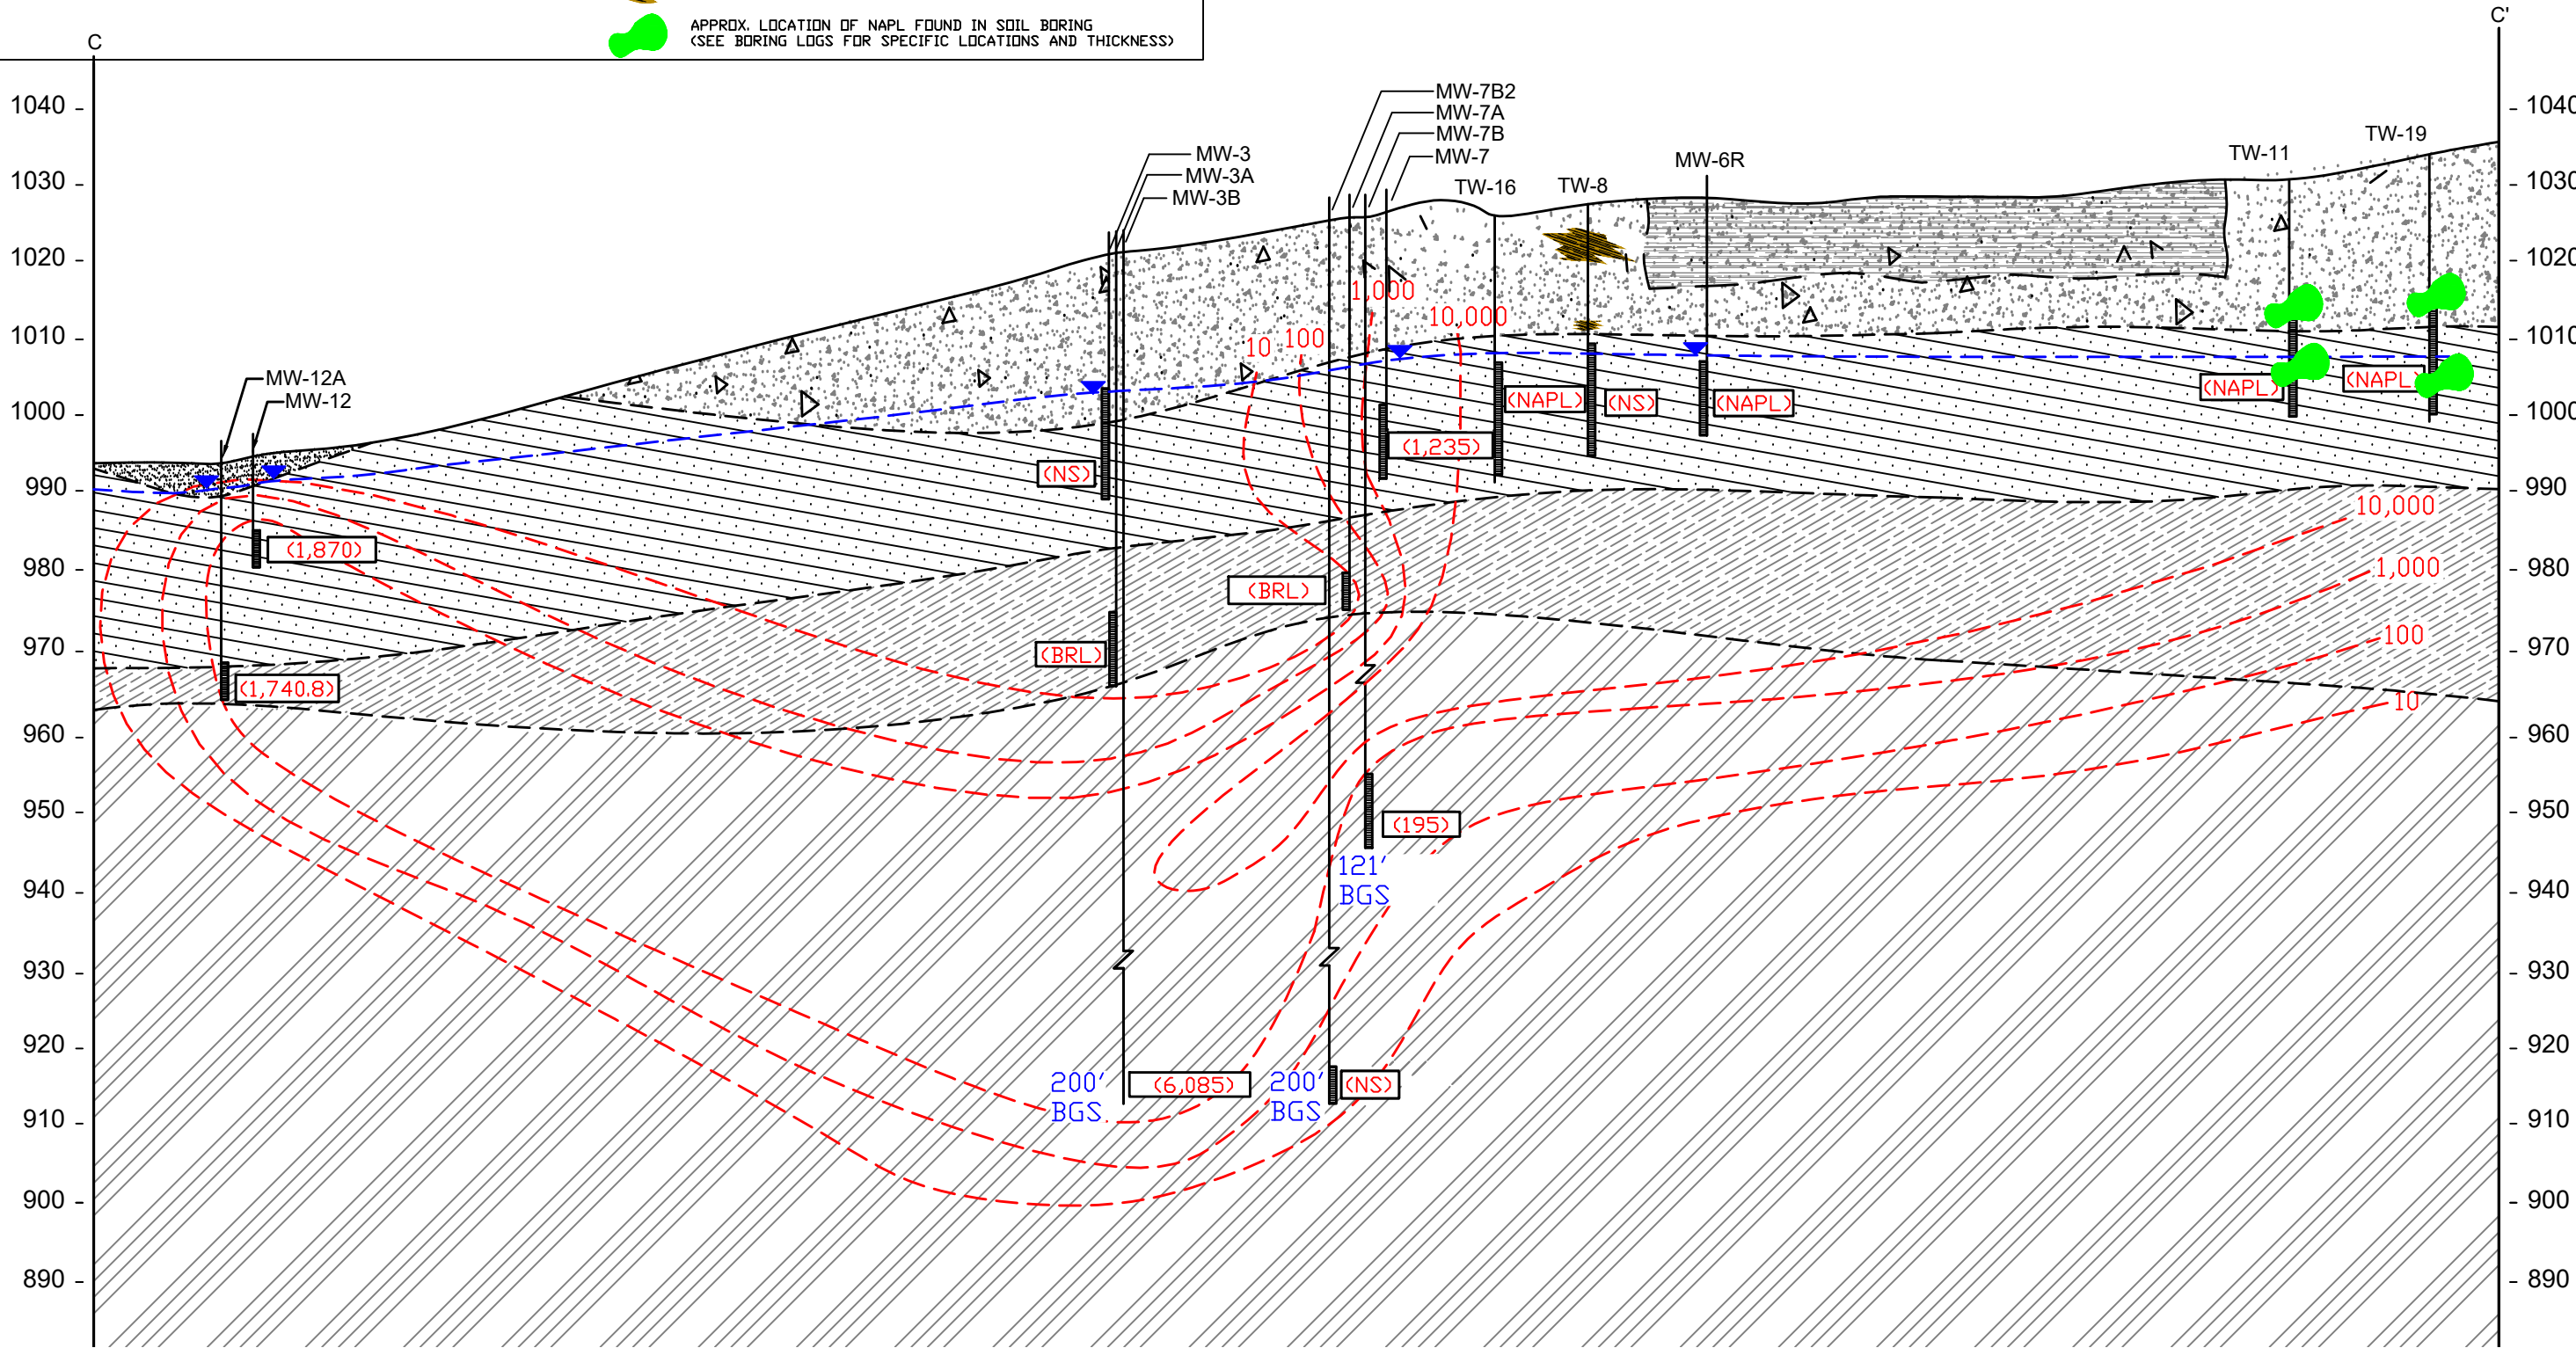
J-5D

VERTICAL EXTENT OF SVDCs (C-C')

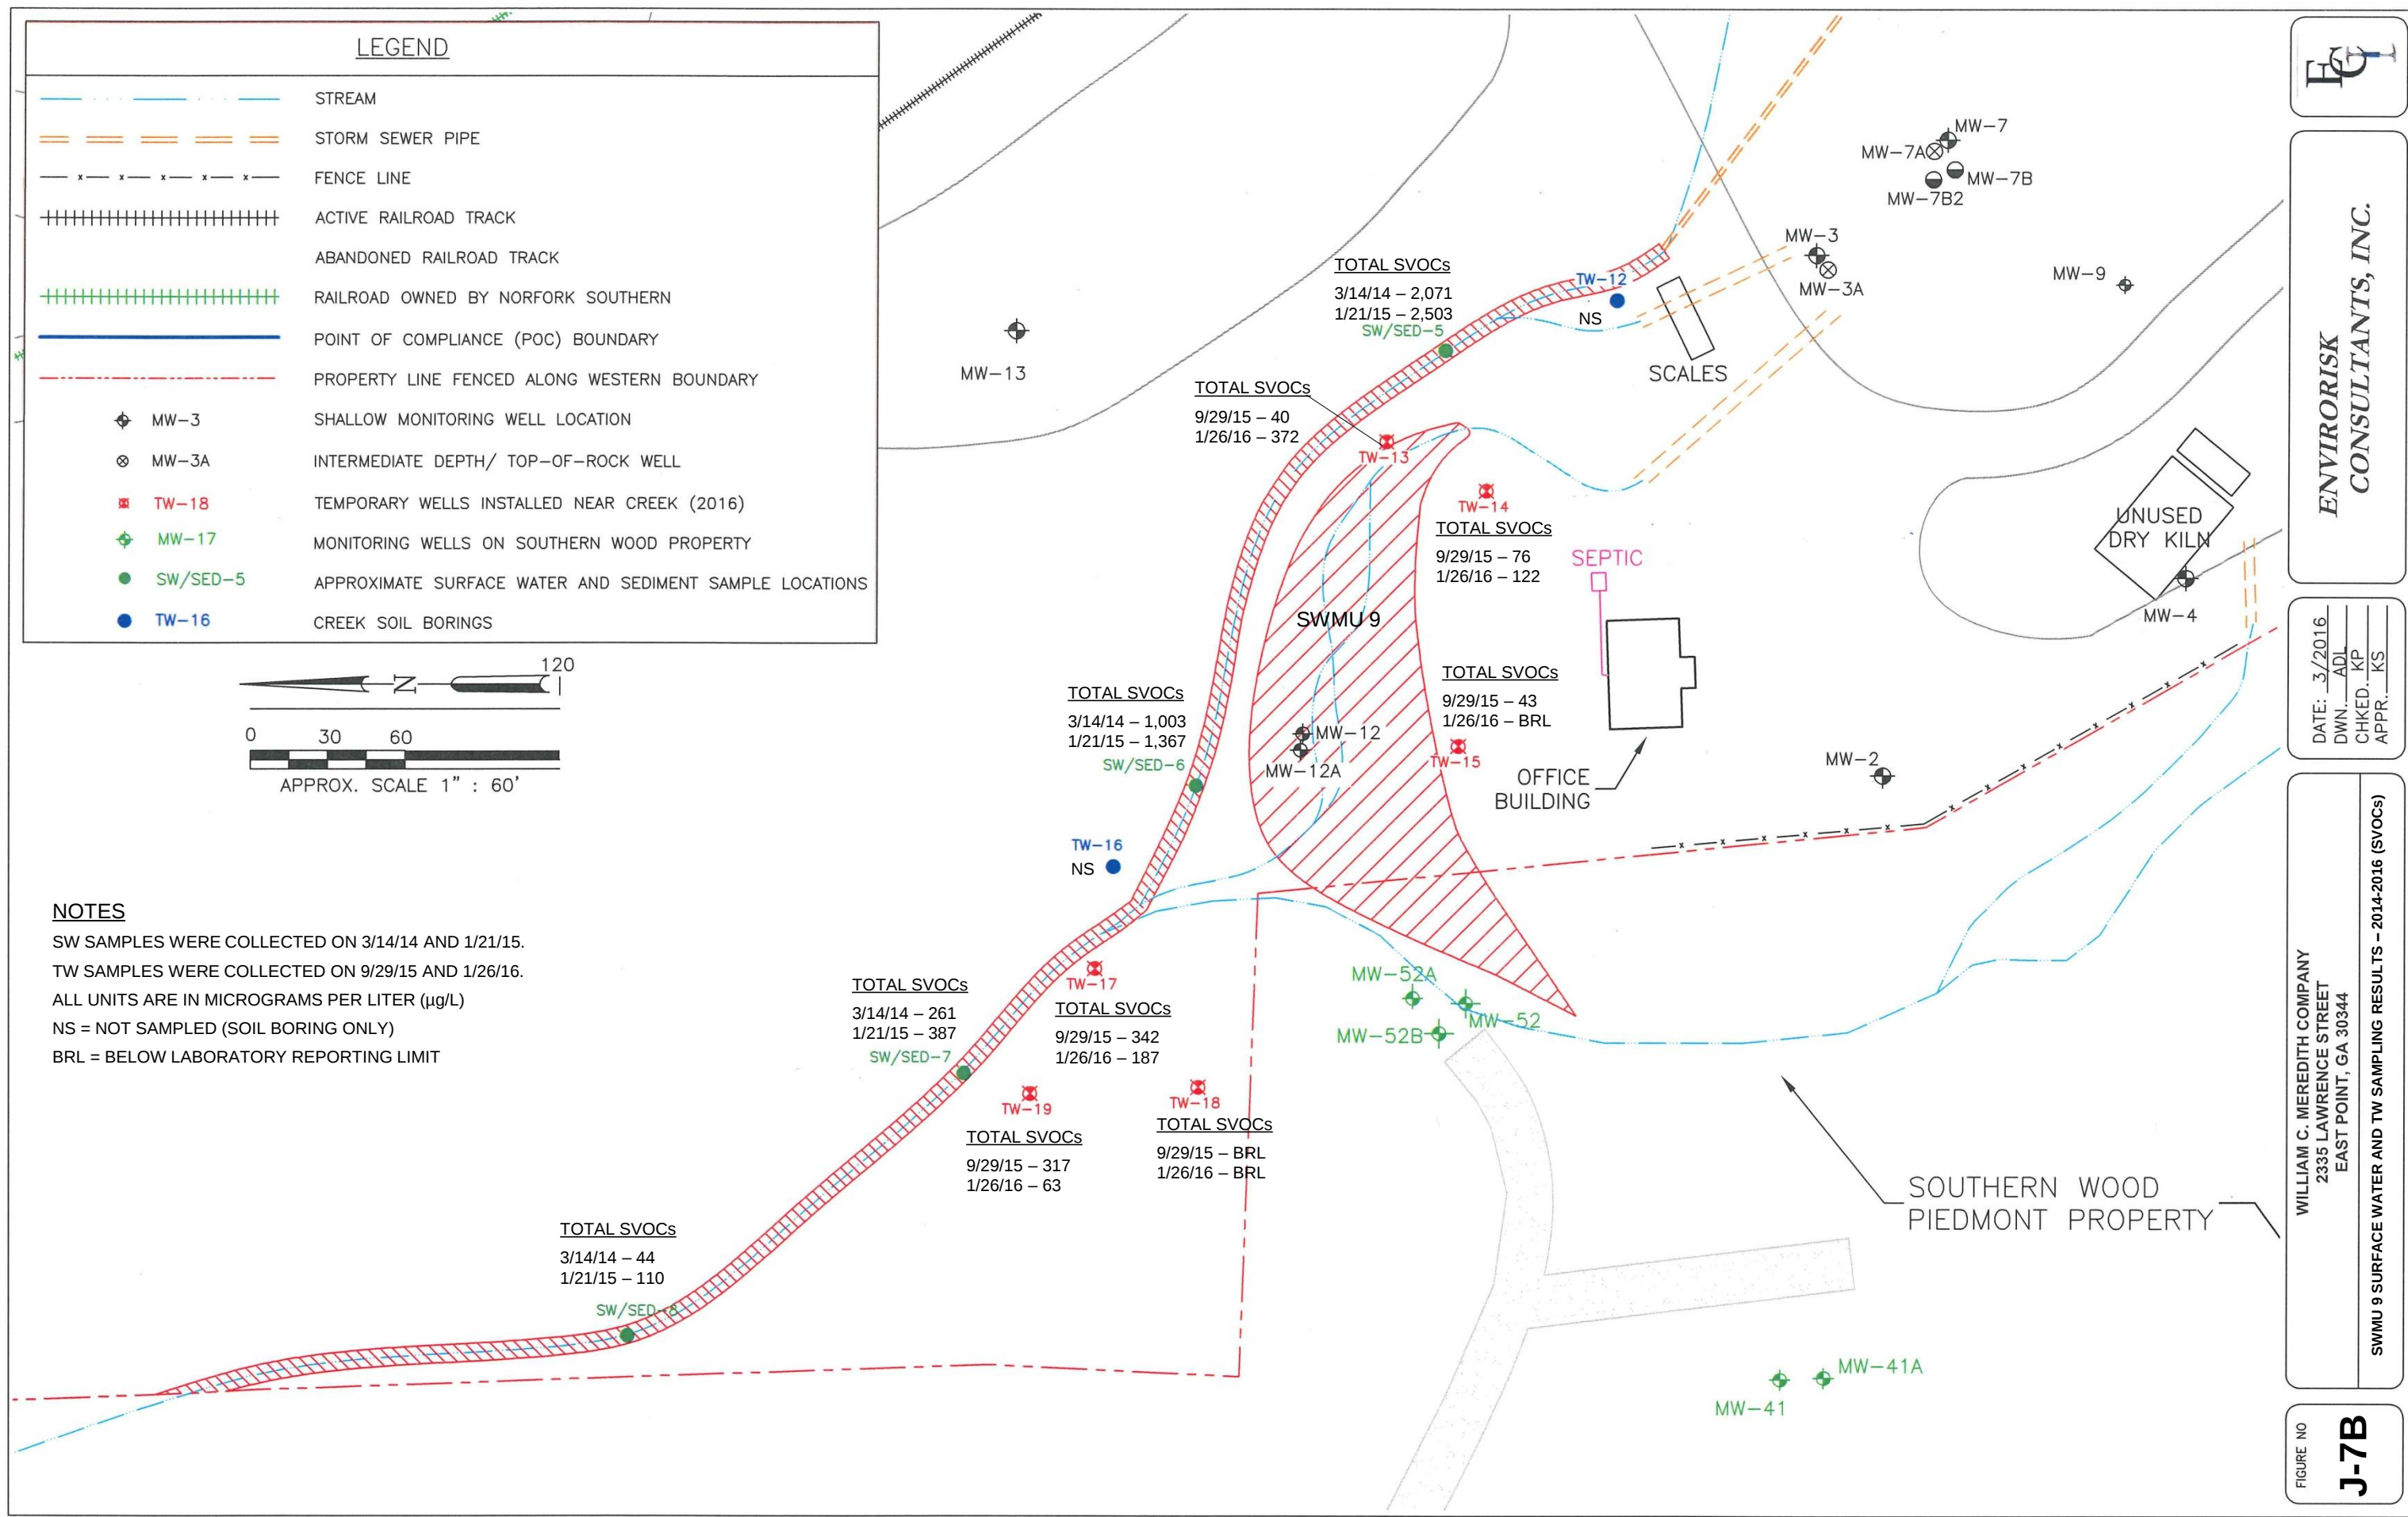
FIGURE NO  
**J-7B**

SWMU 9 SURFACE WATER AND TW SAMPLING RESULTS - 2014-2016 (SVOCs)

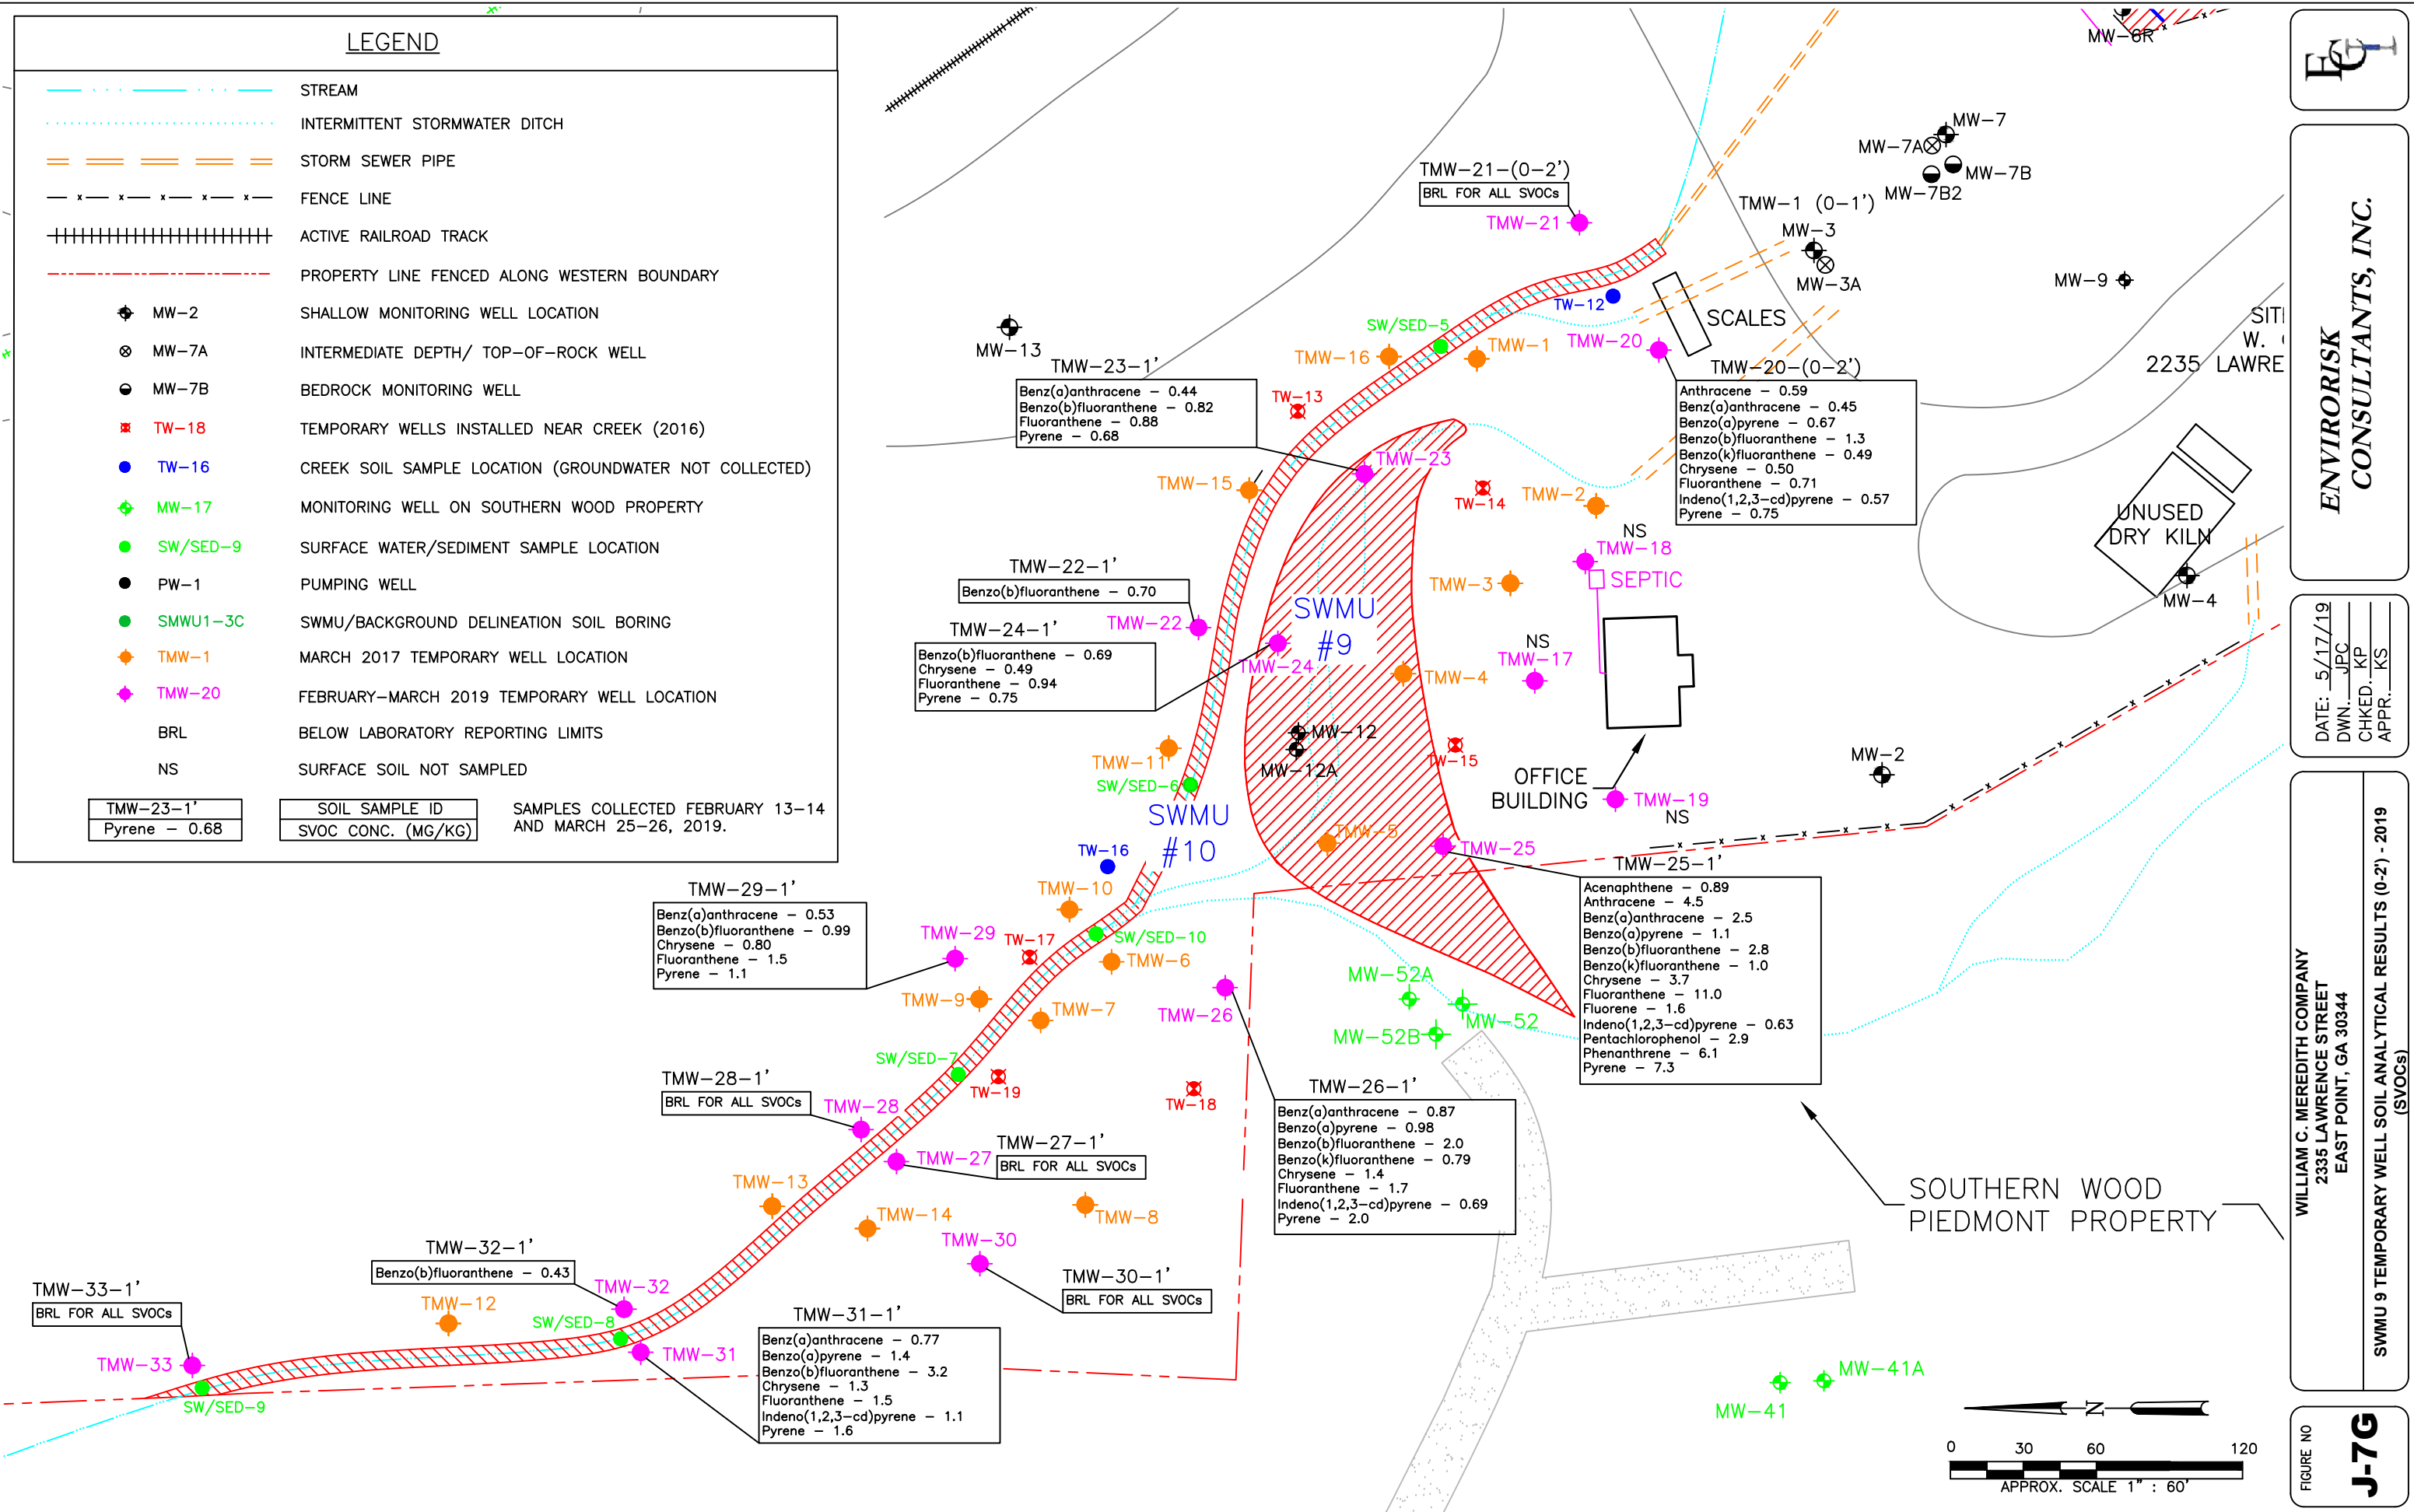
FIGURE NO **J-7G**

SWMU 9 TEMPORARY WELL SOIL ANALYTICAL RESULTS (0-2') - 2019 (SVOCs)

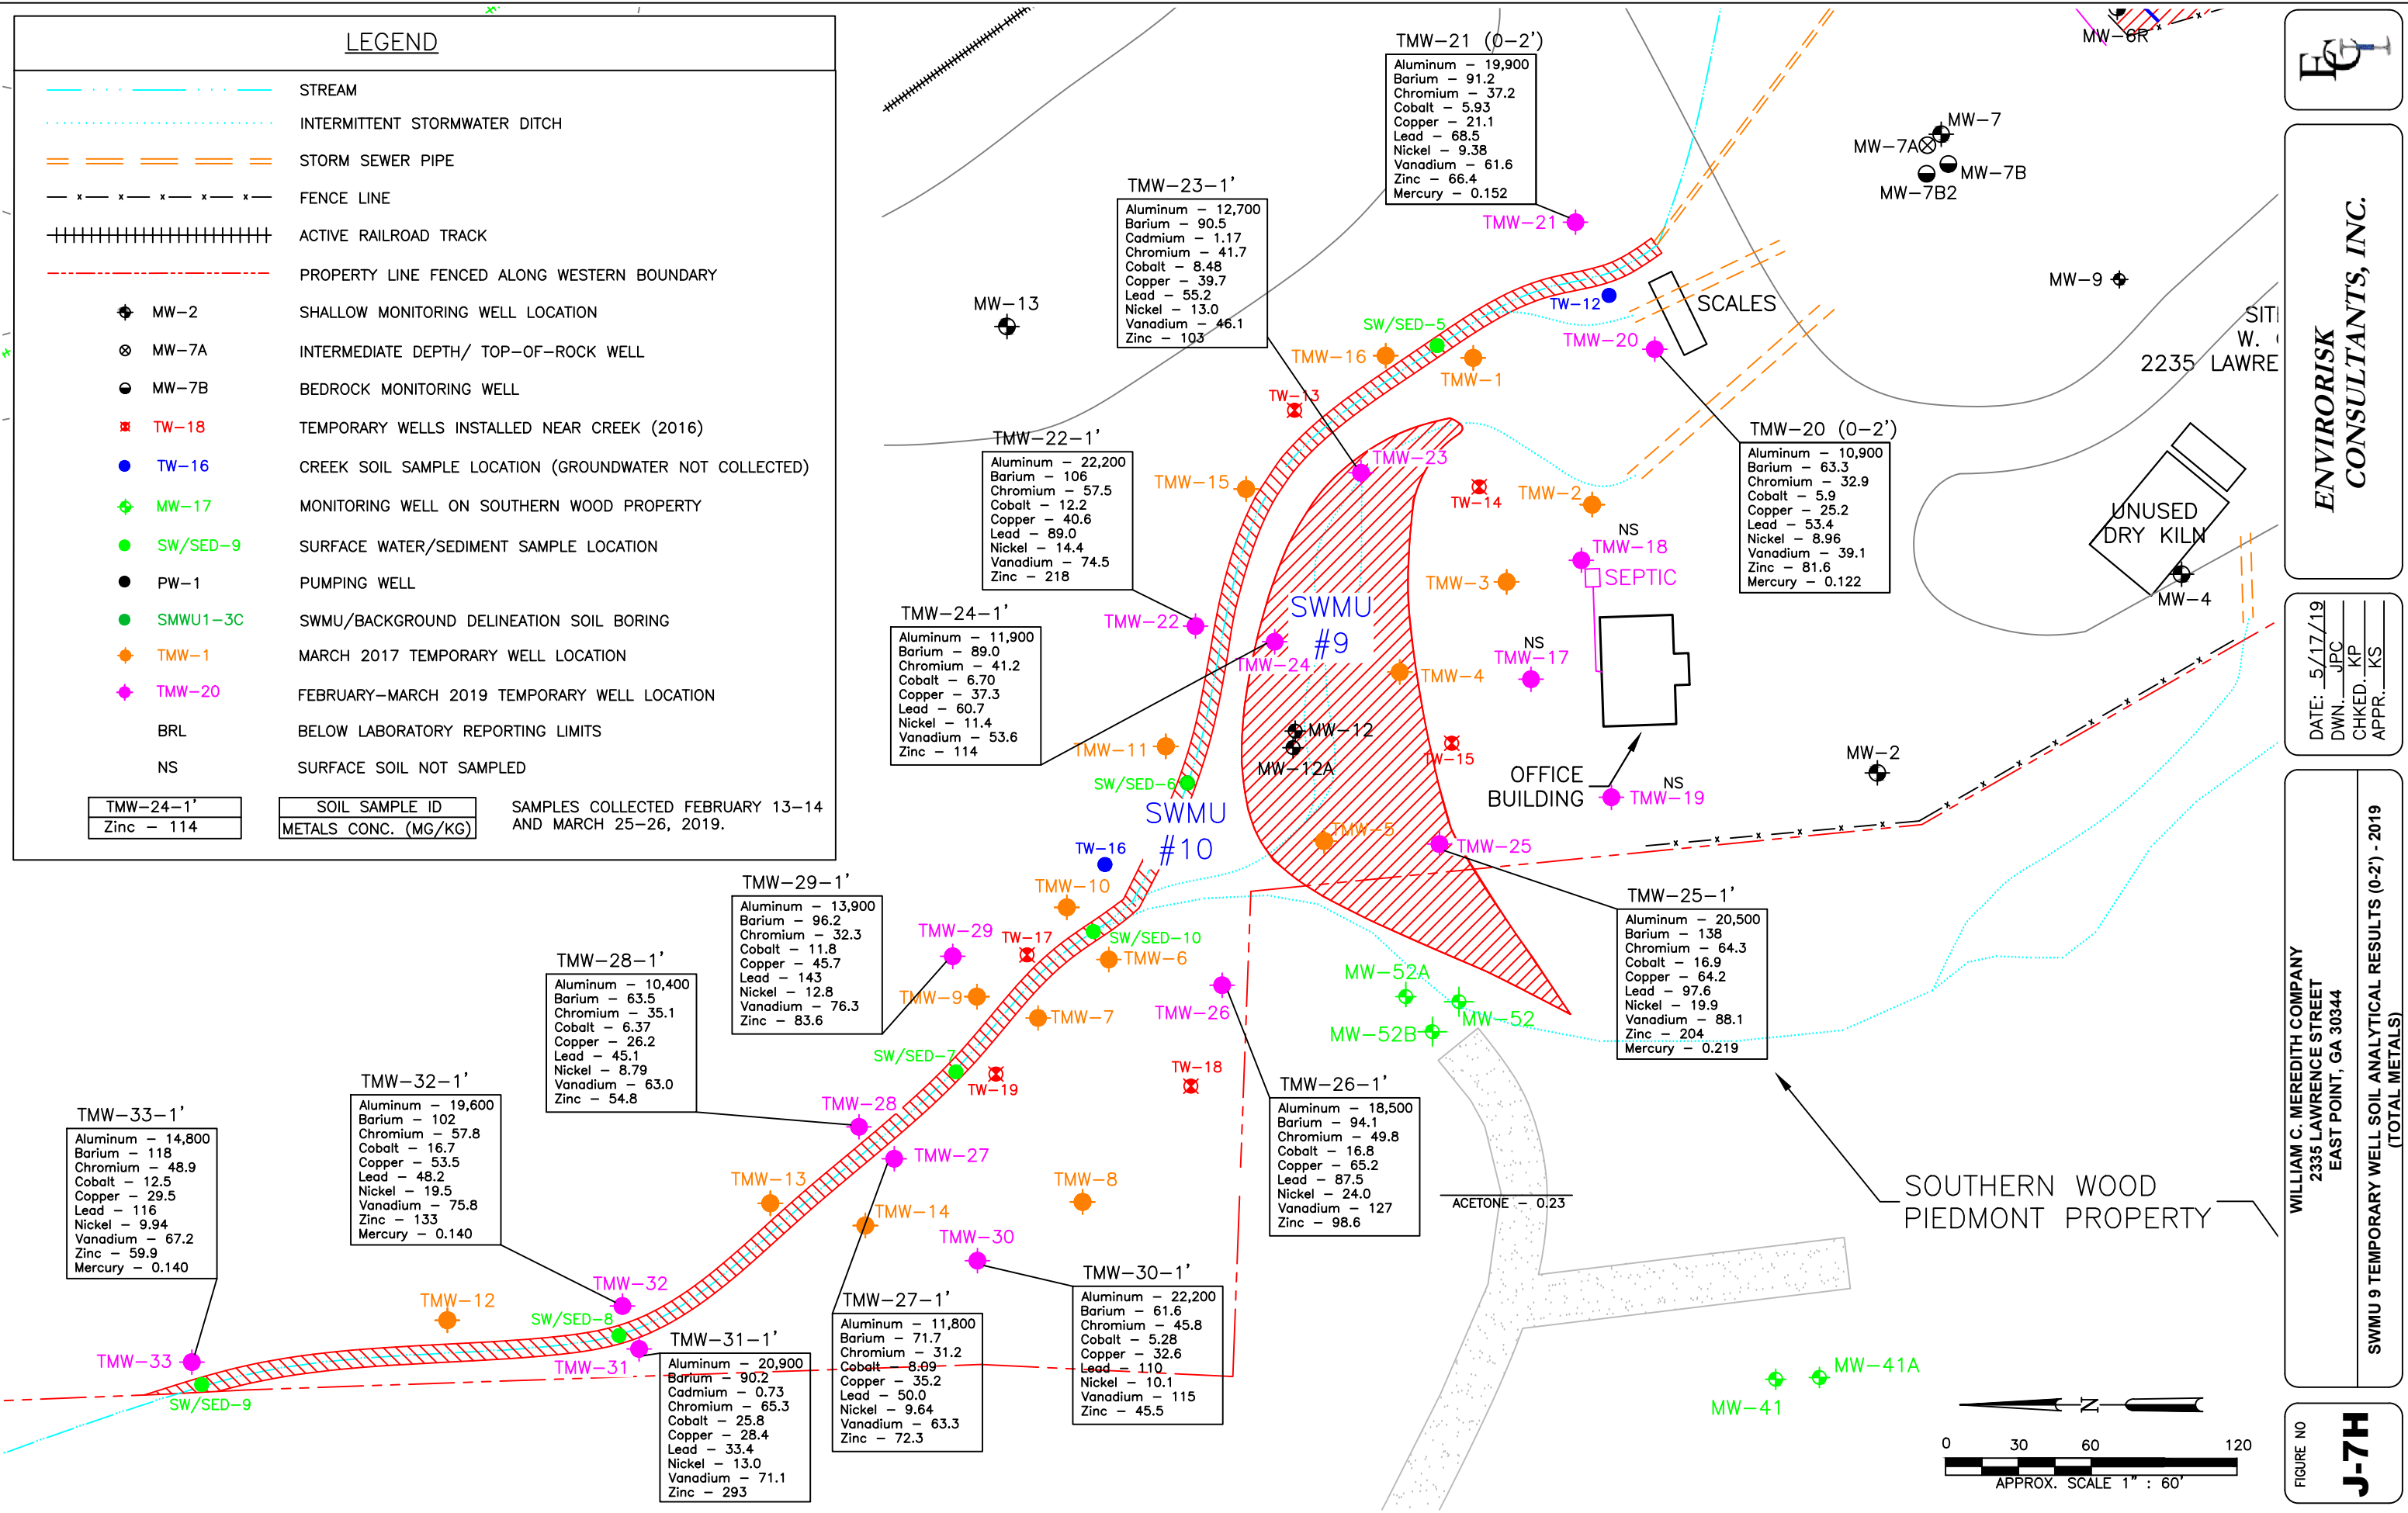
FIGURE NO  
**J-7H**

SWMU 9 TEMPORARY WELL SOIL ANALYTICAL RESULTS (0-2') - 2019  
(TOTAL METALS)
