WILLIAM C. MEREDITH COMPANY  
2335 LAWRENCE STREET  
EAST POINT, GA 30344

VERTICAL EXTENT OF SVOCs (B-B')

SWMU 9 SEDIMENT AND TW SOIL SAMPLING RESULTS – 2014-2015 (SVOCs)

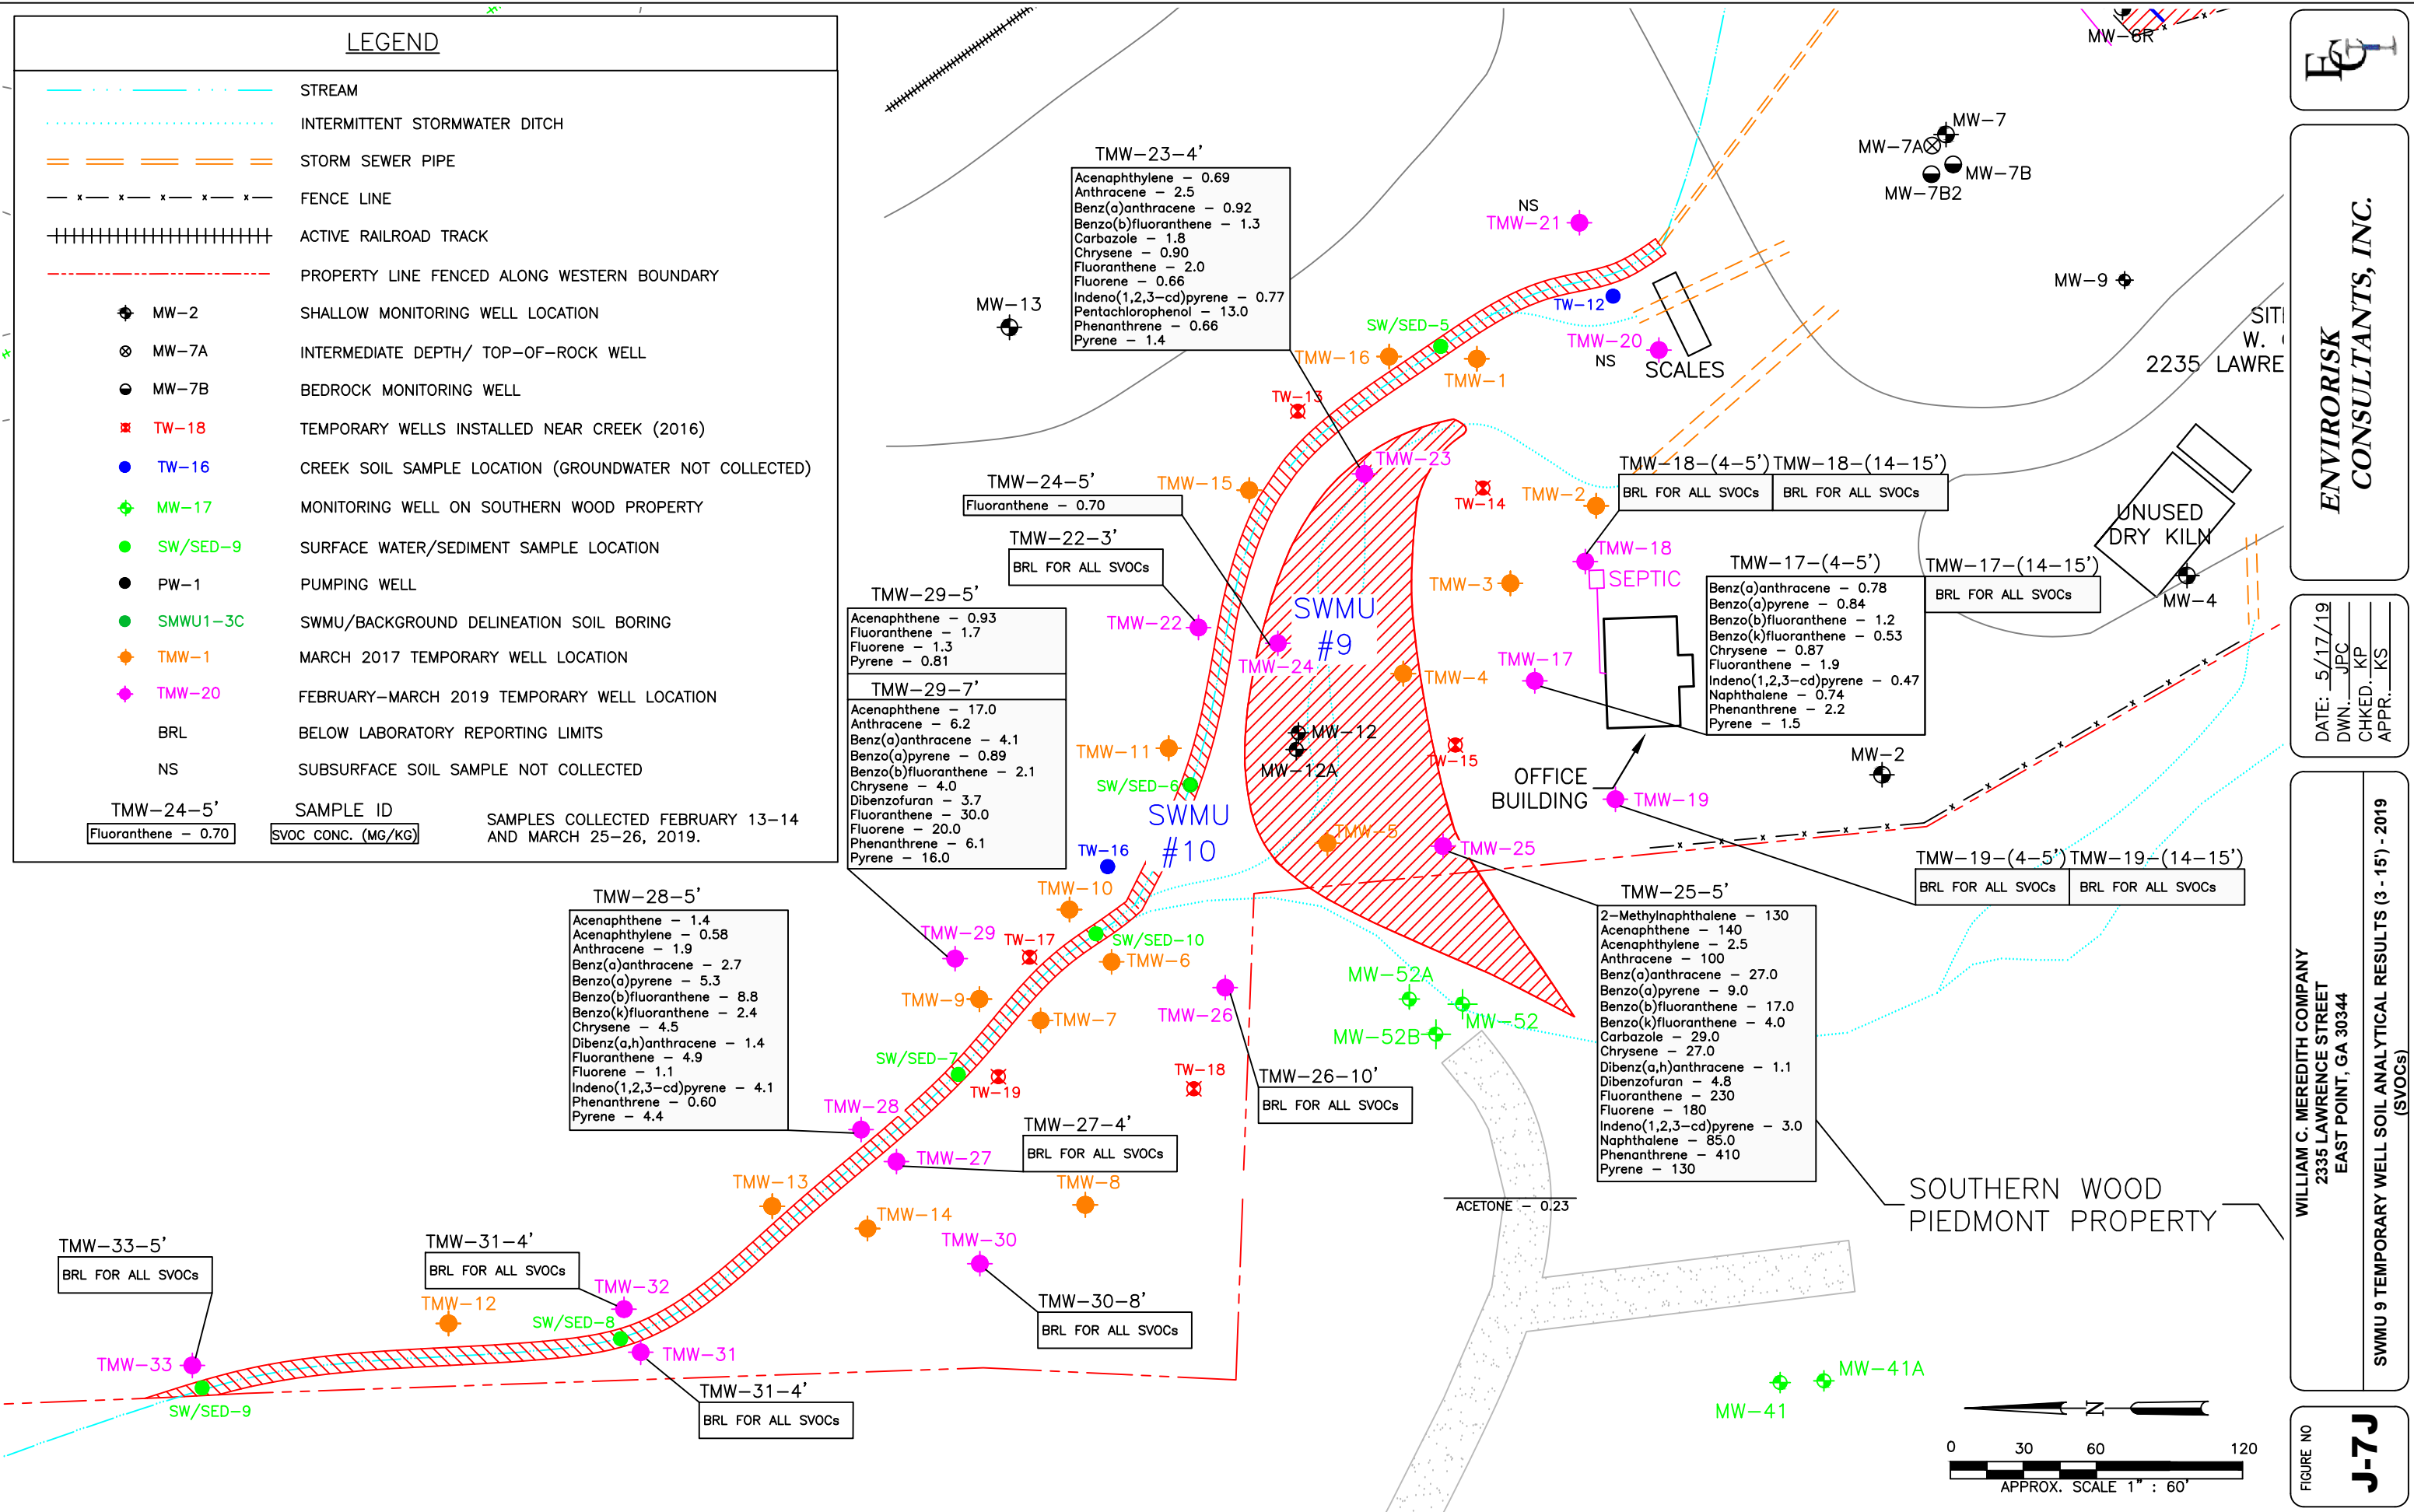
FIGURE NO  
J-71

SAMPLES COLLECTED FEBRUARY 13-14 AND MARCH 25-26, 2019.

SWMU 9 TEMPORARY WELL SOIL ANALYTICAL RESULTS (3 - 15') - 2019  
(VOCs)

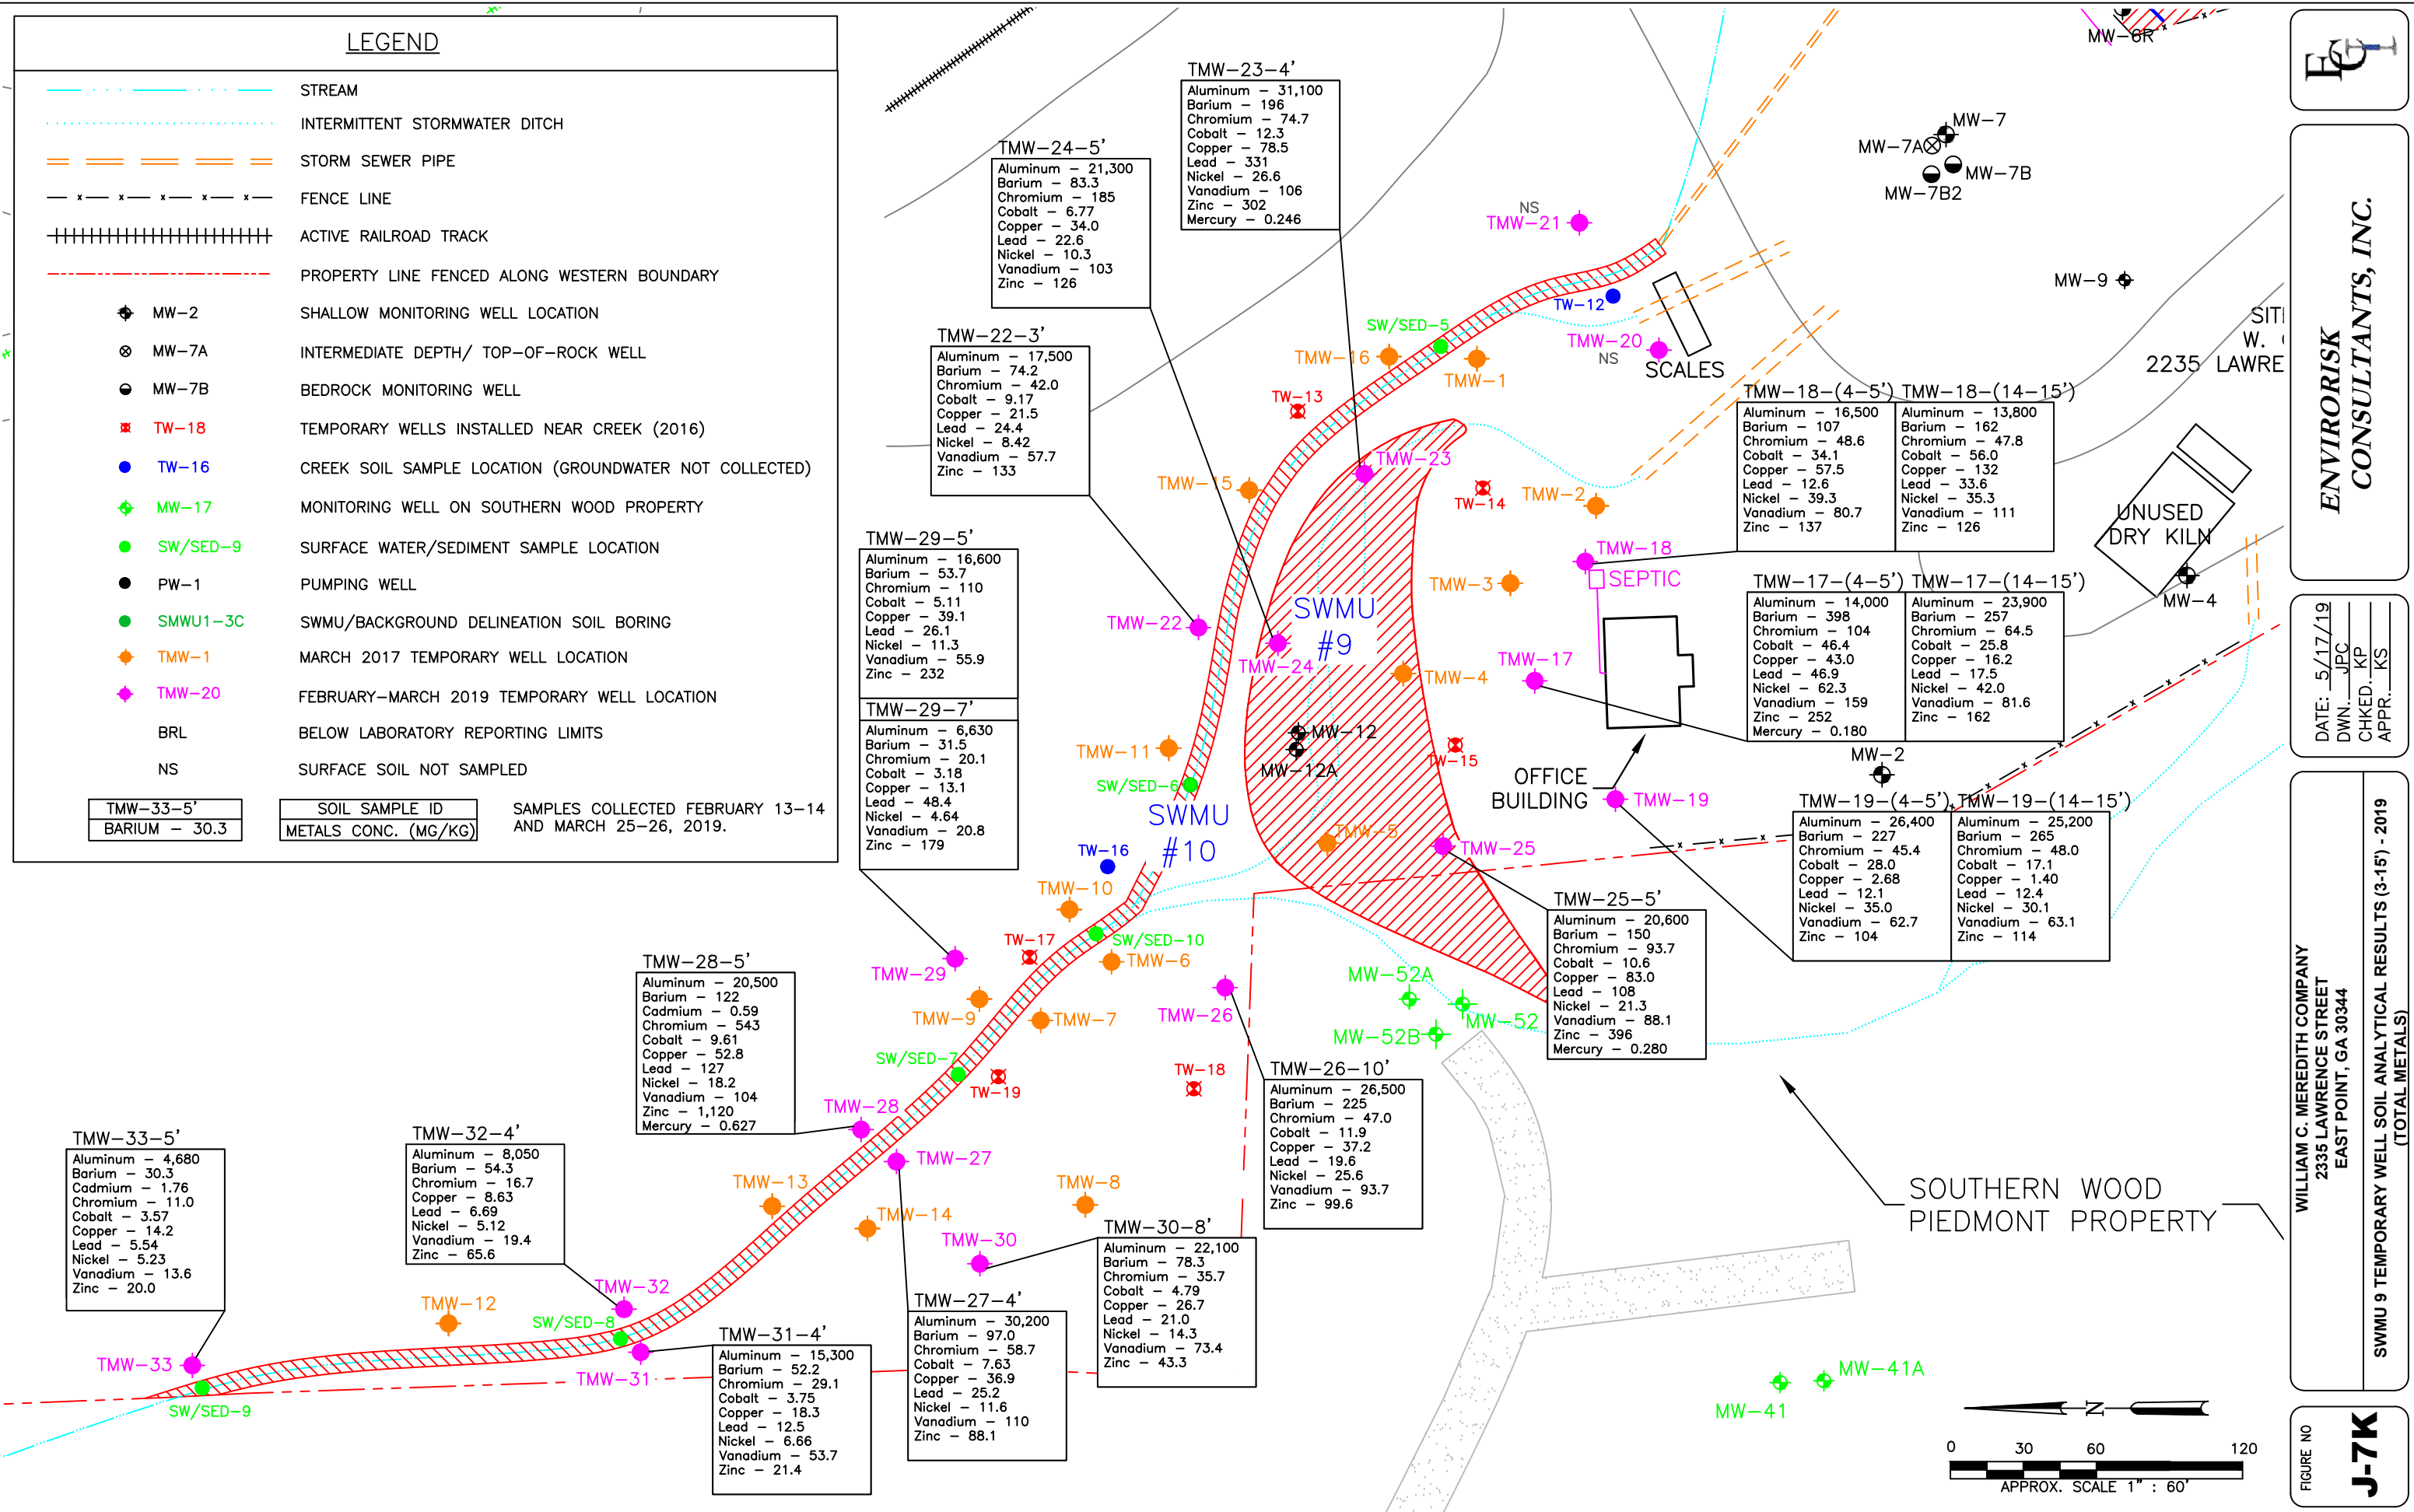
FIGURE NO  
**J-7K**

SWMU 9 TEMPORARY WELL SOIL ANALYTICAL RESULTS (3-15') - 2019  
(TOTAL METALS)

SAMPLES COLLECTED FEBRUARY 13-14  
AND MARCH 25-26, 2019.

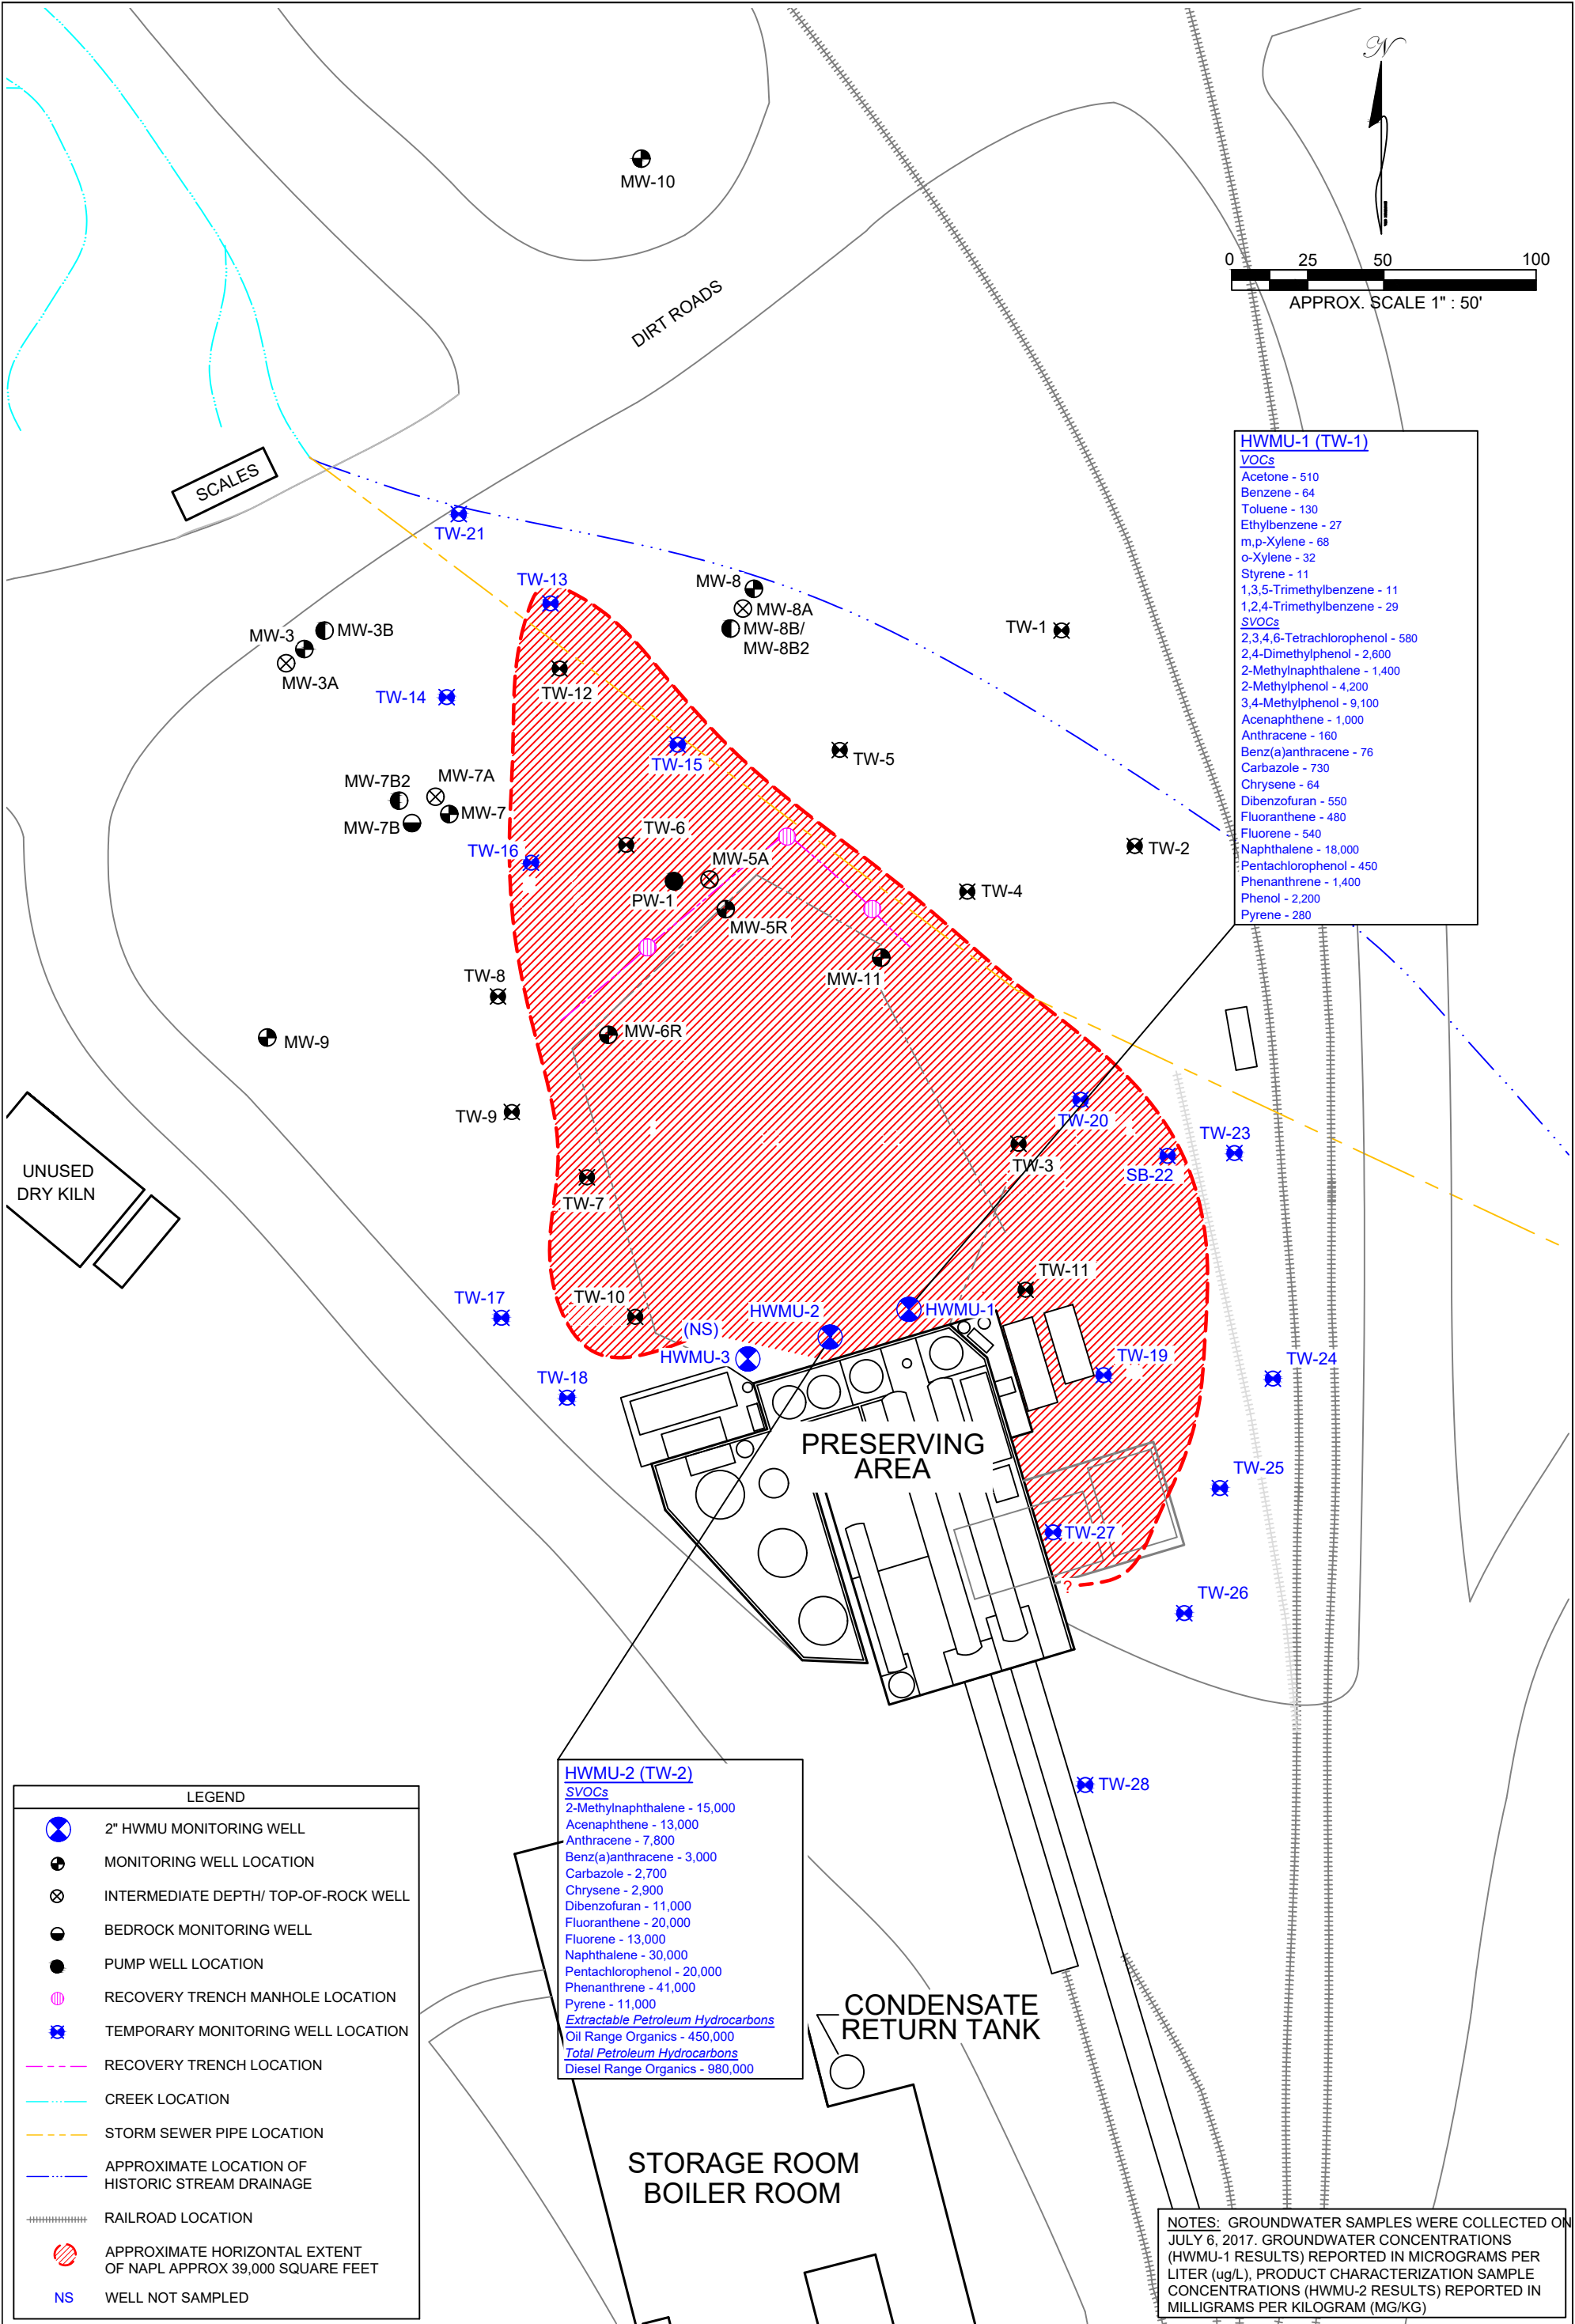
J-10

IMPOUNDMENT ASSESSMENT GROUNDWATER AND PRODUCT  
CHARACTERIZATION ANALYTICAL RESULTS
