Section B. Facility Description

B-1 General Description [40 CFR 270.14]

Facility Name: University of Georgia

Facility Location: 2450 South Milledge Avenue
Athens, Georgia 30605

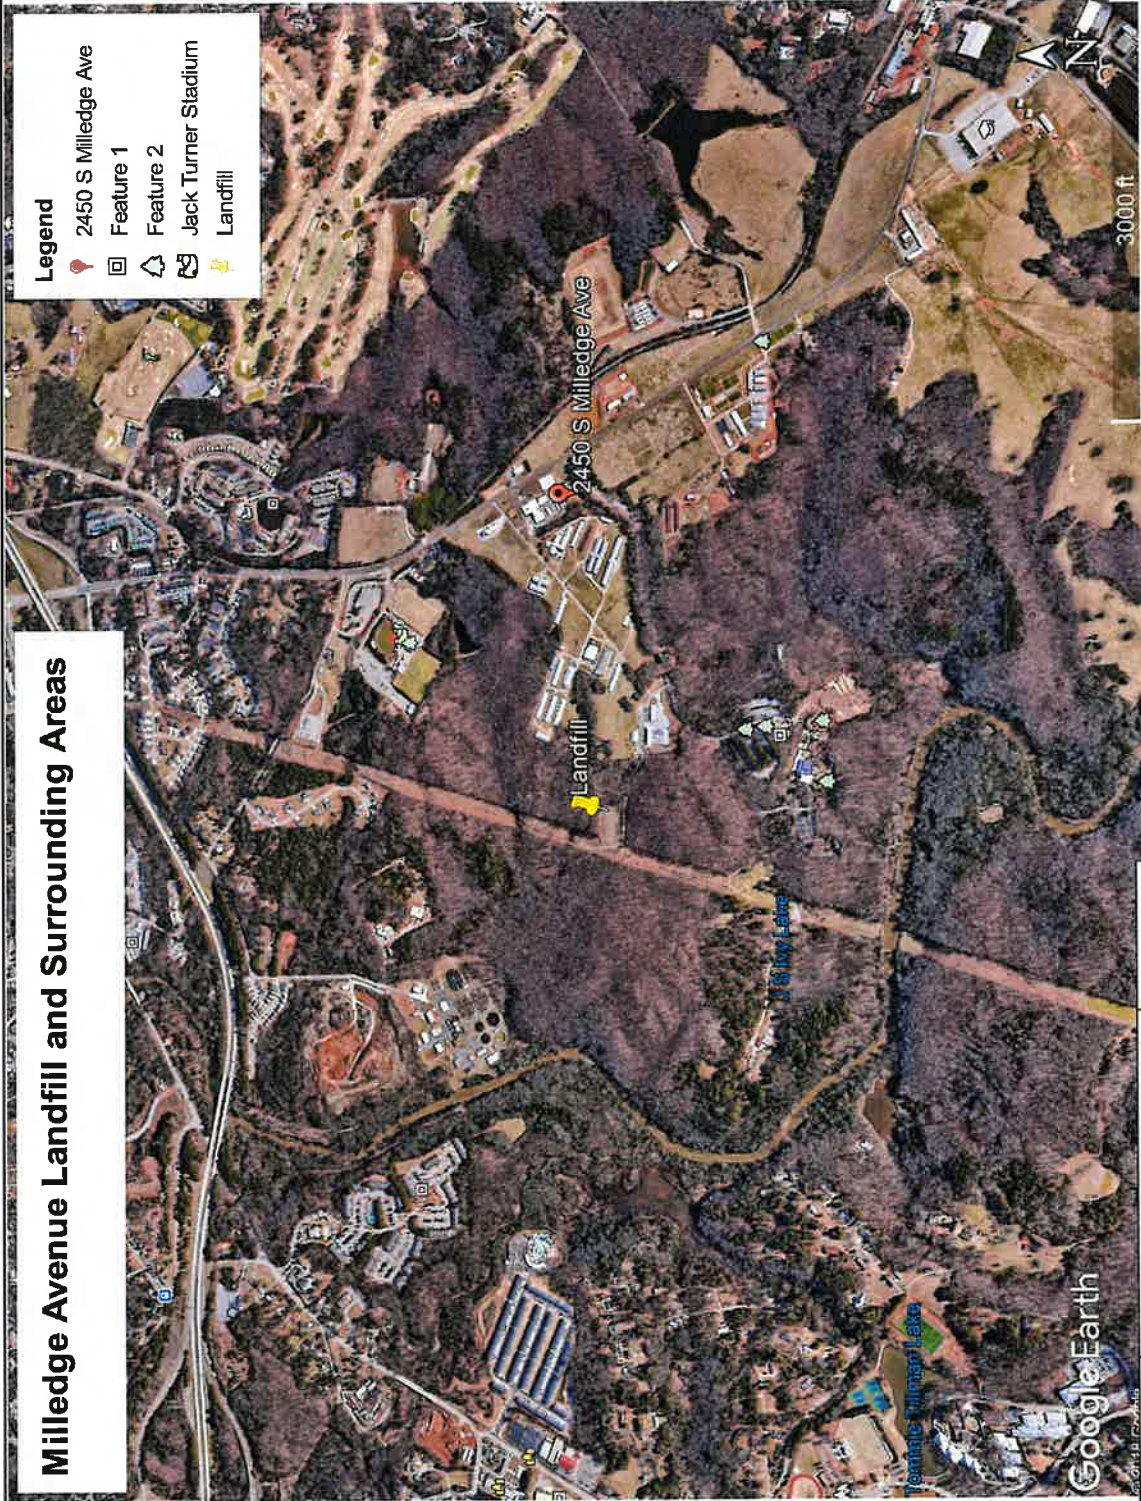
**Figure
B-2**

Milledge Avenue Landfill and Surrounding Areas

**Milledge Avenue Site
and Surrounding Areas**

Figure B-1 is a topographic map of the landfill; Figure B-2 is an aerial photo of the Landfill and the surrounding area; Figure B-3 is a flood risk map; and Figure B-4 is a wind rose diagram for the area. There are no flood control or drainage barriers in the vicinity of the Landfill. There are no known drinking water wells within 1 mile of the Landfill and while there is an onsite deep irrigation well located at the Botanical Garden Greenhouse, this well draws water from a separate drainage basin located southwest of the Site.

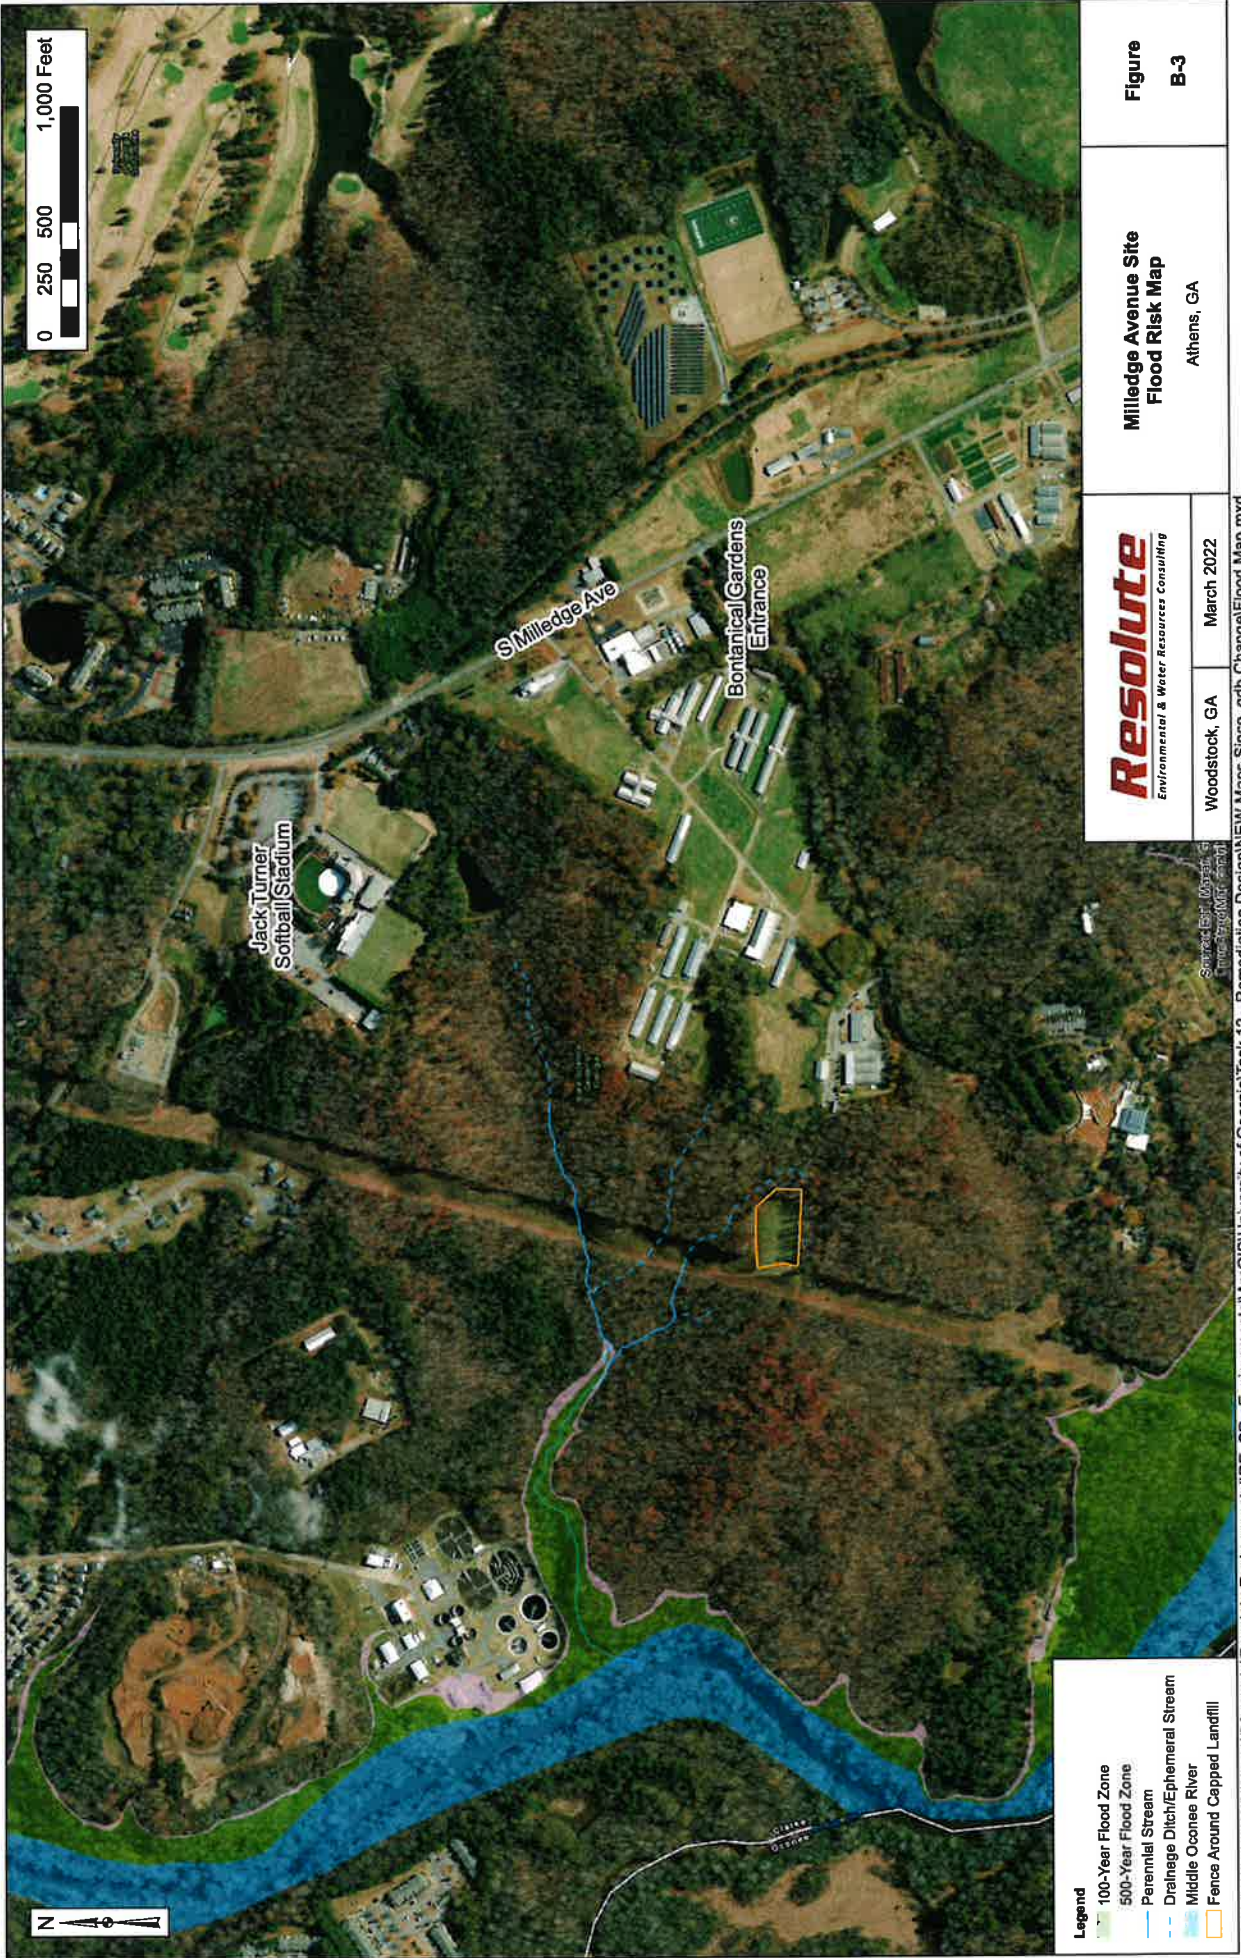
**Figure
B-3**

**Milledge Avenue Site
Flood Risk Map**

This section is not applicable since this is an existing facility that was sited before the enactment of RCRA. However, the Landfill is not located in the 100-year flood plain as defined by the National Flood Insurance Program. The 100-year flood plain is depicted on Figure B-3.

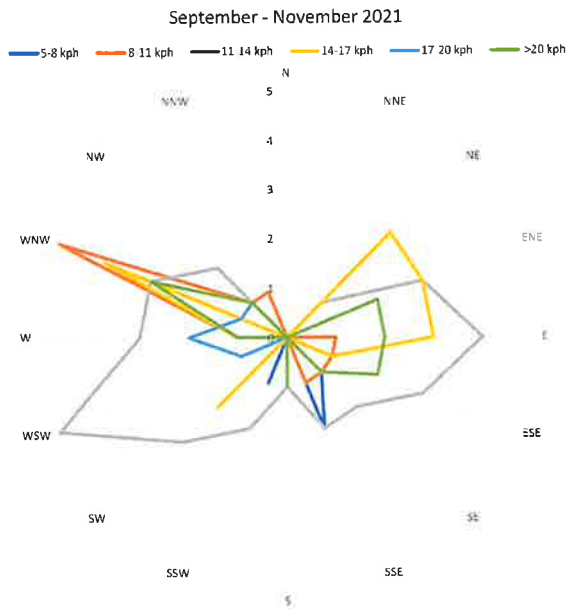
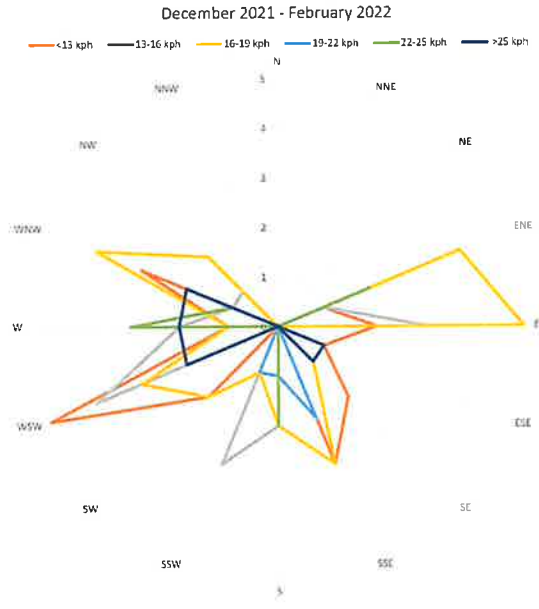
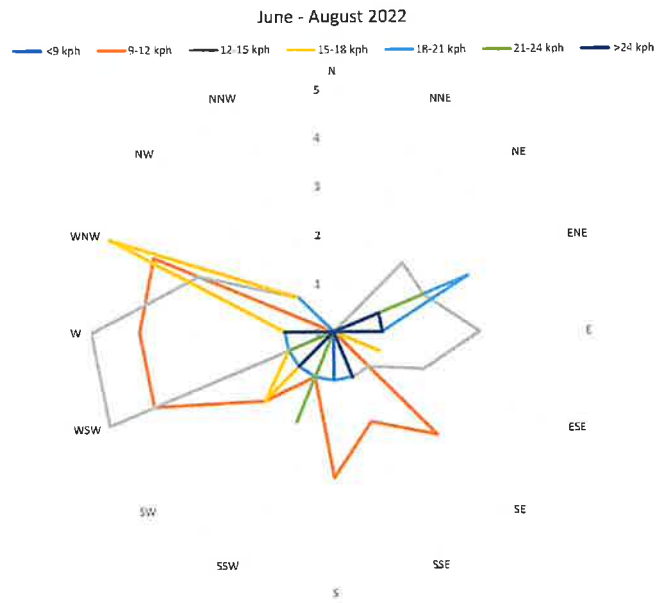
**Figure B-4
Wind Rose Diagram
Milledge Avenue Site
Athens, GA**

Average Wind Speed = 13.84 kph
Maximum Wind Speed = 25.9 kph (10/16/2021)
Minimum Wind Speed = 5.08 kph (11/30/2021)

Average Wind Speed = 17.47 kph
Maximum Wind Speed = 37.8 kph (01/16/2022)
Minimum Wind Speed = 7.6 kph (12/16/2021)

Average Wind Speed = 17.72 kph
Maximum Wind Speed = 37.1 kph (03/12/2022)
Minimum Wind Speed = 7.6 kph (05/31/2022)

Average Wind Speed = 13.84 kph
Maximum Wind Speed = 29.3 kph (07/10/2022)
Minimum Wind Speed = 5.5 kph (08/25/2022)

Notes:
Data obtained from: <https://www.visualcrossing.com/weather/weather-data-services/>
Data from following stations located in/around Athens, GA: 72311013873, KGV1, AFRG1, WKSG1, 72089799999, 0761W, 74948300394, KAHN, KLZU

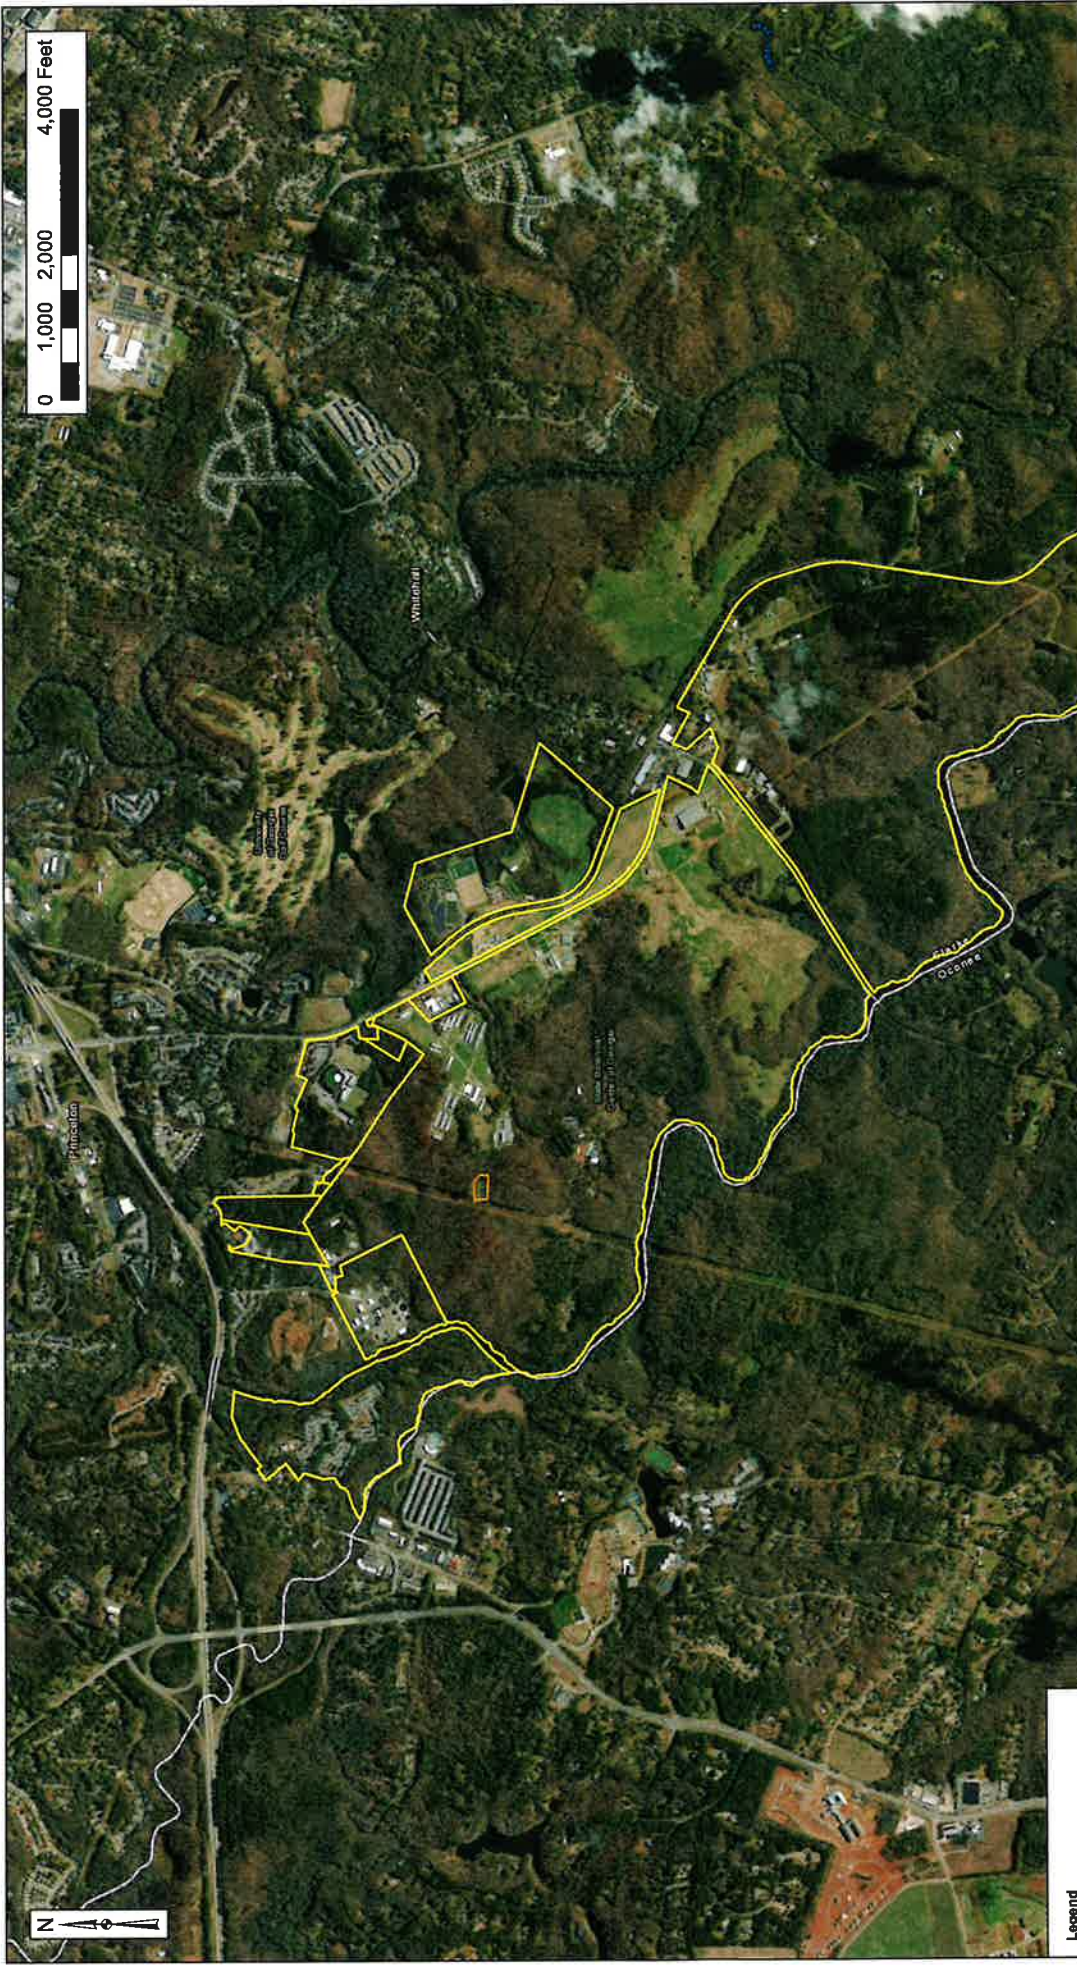
FIGURE B-5
PROPERTY BOUNDARIES

Figure B-5 shows the property boundaries and the area extending one mile beyond the property boundary.
