**COPY****RELEASE NOTIFICATION/REPORTING FORM**

2	EPA ID NUMBER (if applicable)				
3	Tax Map and Parcel ID Number:	020-009-001 and 020-010-001	Acreage	≈ 8.15	
4	Site or Facility Name	Booker T. Washington Apartments - Blocks A & B			
5	Site Street Address	500 5 <sup>th</sup> Street			
6	Site City	Columbus	County	Muscogee	Zip
7	Property Owner	The Housing Authority of Columbus Georgia			
8	Property Owner Mailing Address	P.O. Box 630			
9	Property Owner City	Columbus	State	GA	Zip 31902
10	Property Owner Telephone No.	706-571-2800			
11	Site Contact Person	N/A	Title		
12	Site Contact Company Name				
13	Site Contact Mailing Address				
14	Site Contact City		State		Zip
15	Site Contact Telephone No.				
16	Facility Operator Contact Person	J. Len Williams	Title	Executive Director	
17	Facility Operator Company Name	The Housing Authority of Columbus, Georgia			
18	Facility Operator Mailing Address	P.O. Box 630			
19	Facility Operator City	Columbus	State	GA	Zip 31902

The subject property (which is comprised of tax parcels 020-009-001 and 020-010-001) is located in downtown Columbus, Georgia. The subject property address is listed as 500 5<sup>th</sup> Street. The property totals approximat

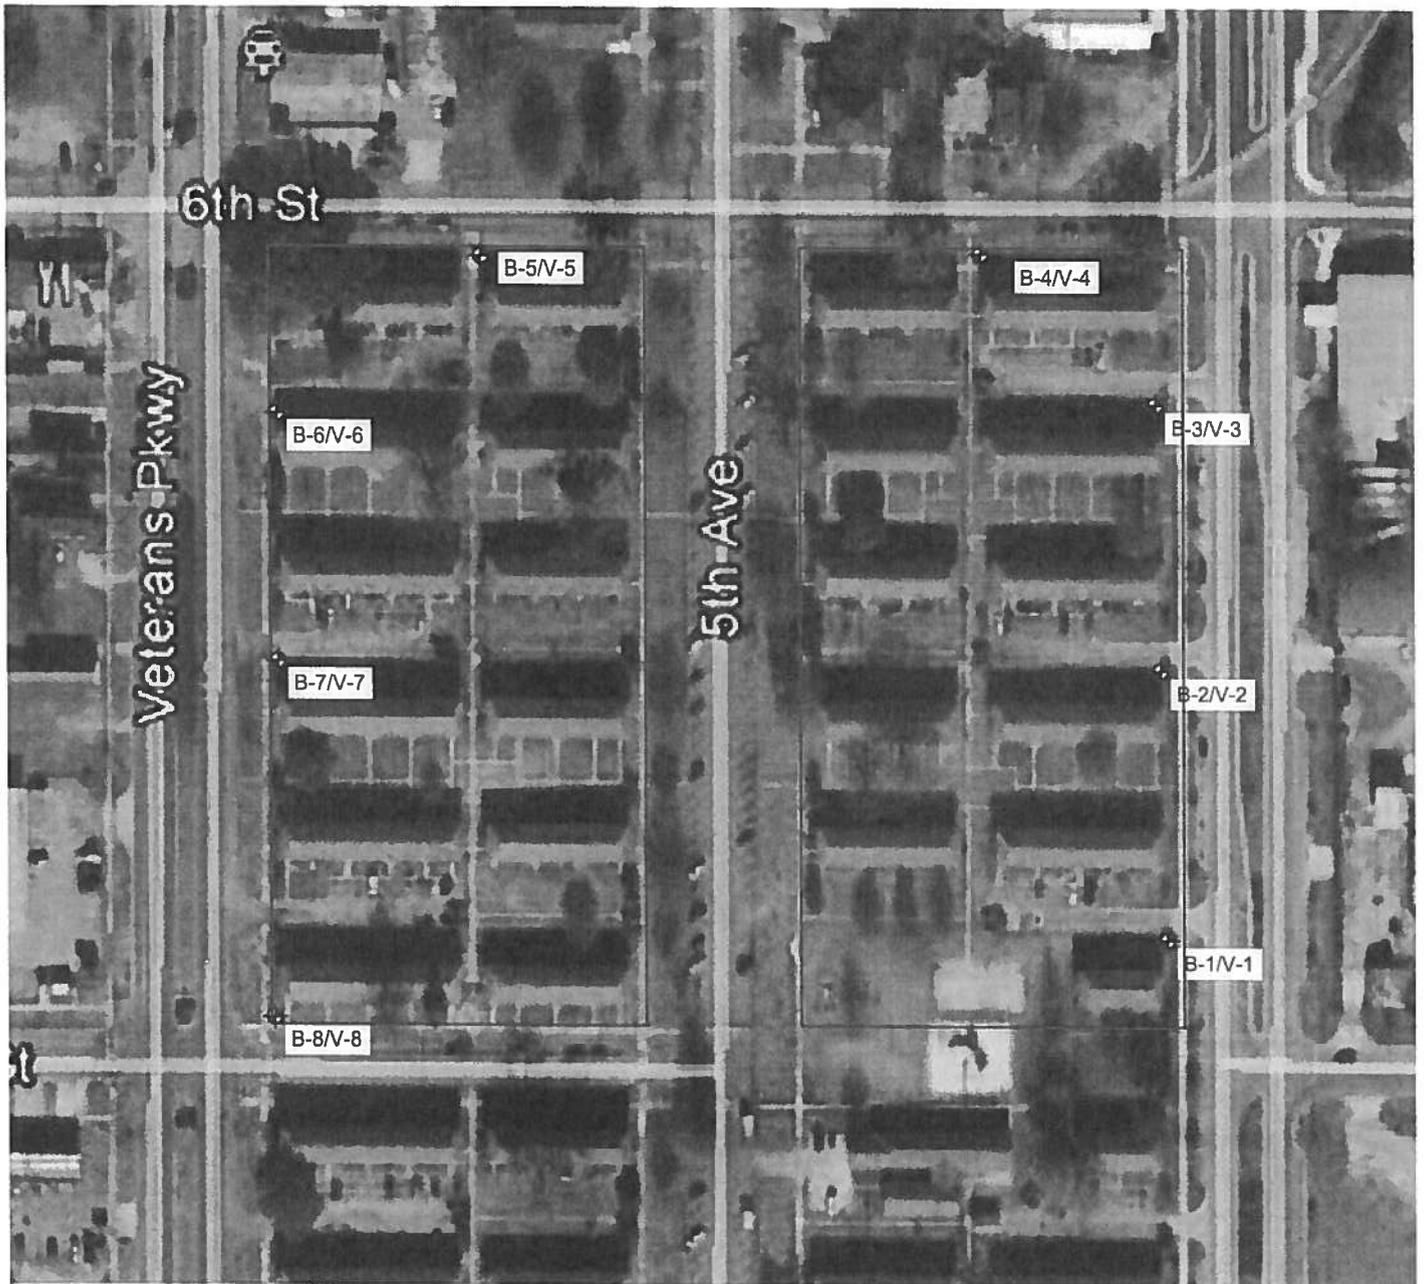
Figure 2  
 Boring Location Plan  
 Booker T. Washington Apartments  
 Blocks A & B  
 Columbus, Georgia  
 GEC Project No. 140250.340

The release was identified during a Phase II ESA (the report of which is dated May 30, 2014) performed at the site, to address the concerns noted above. Utilizing a truck-mounted CME-55 drill rig, equipped with hollow stem augers, eight borings were installed into the subsurface at the subject site, with a temporary monitoring well emplaced into all eight of the borings. The boring/temporary monitoring well locations are illustrated on the Boring Location Plan included in Attachment 2. Only a single soil sample was collected as part of the Phase II ESA, as the primary mechanism for contaminant transport onto the site was presumed to be groundwater migration.

◆ = Approximate Location of Boring/Well  
 B-1/V-1

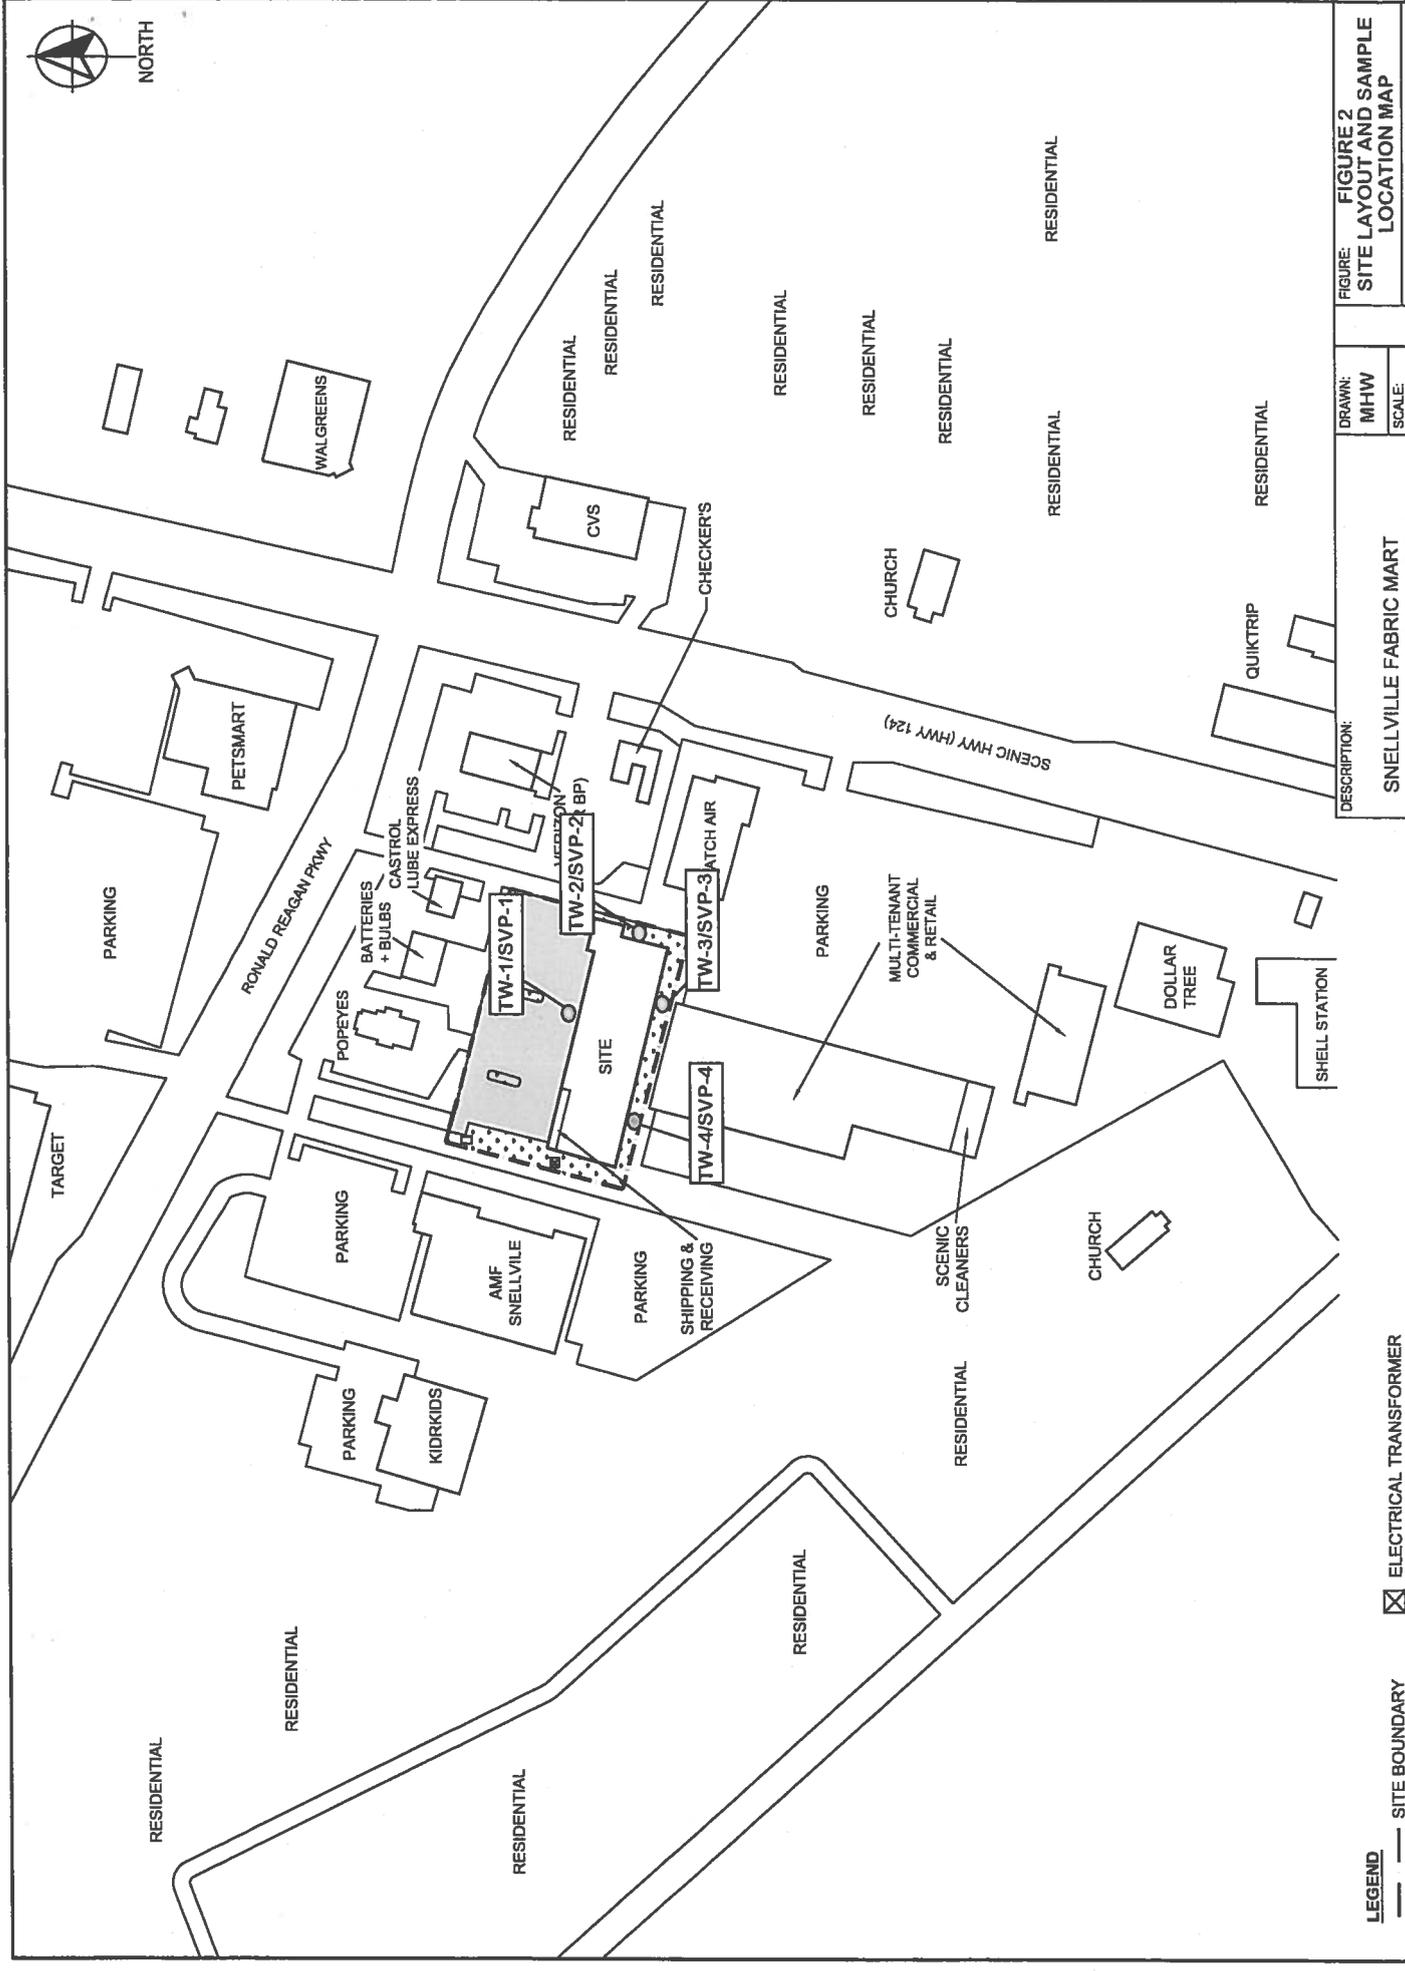
**FIGURE 2  
SITE LAYOUT AND SAMPLE  
LOCATION MAP**

- SITE BOUNDARY
- ELECTRICAL TRANSFORMER
- TEMPORARY GROUNDWAER AND SOIL VAPOR SAMPLING LOCATION
- GRASS
- SOLID WASTE ENCLOSURE

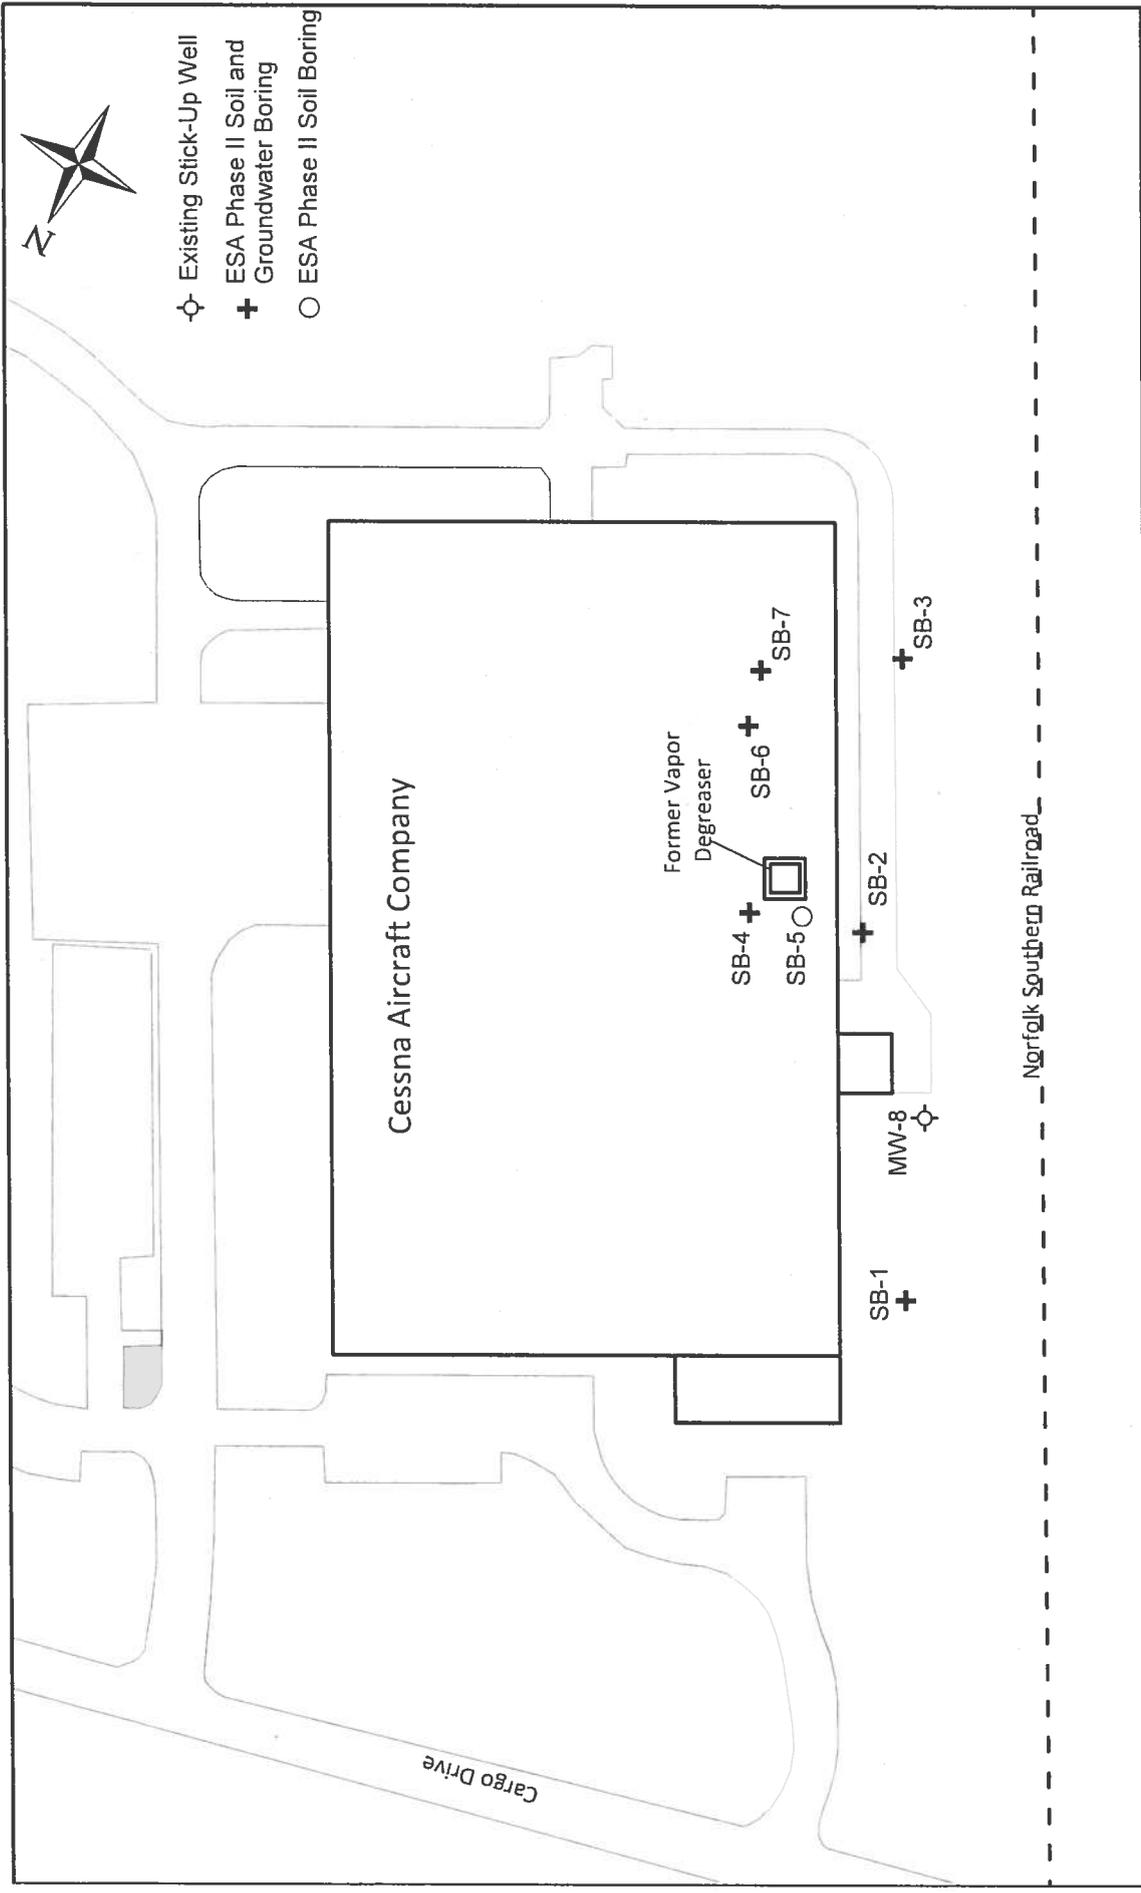
**Figure 1: Cessna Aircraft Site Map**

Groundwater samples were collected from six of the boring locations plus an existing stickup well located at the site (Figure 1). The locations having the most VOCs detected were SB-4 and SB-2. Similar to soil, the majority of the detected VOCs was TCE, which was found at a concentration of 16.6 mg/L at SB-4 and 2.2 mg/L at SB-2. TCE was the only compound found in groundwater that exceeded 1 mg/L.

- ⊕ Existing Stick-Up Well
- + ESA Phase II Soil and Groundwater Boring
- ESA Phase II Soil Boring

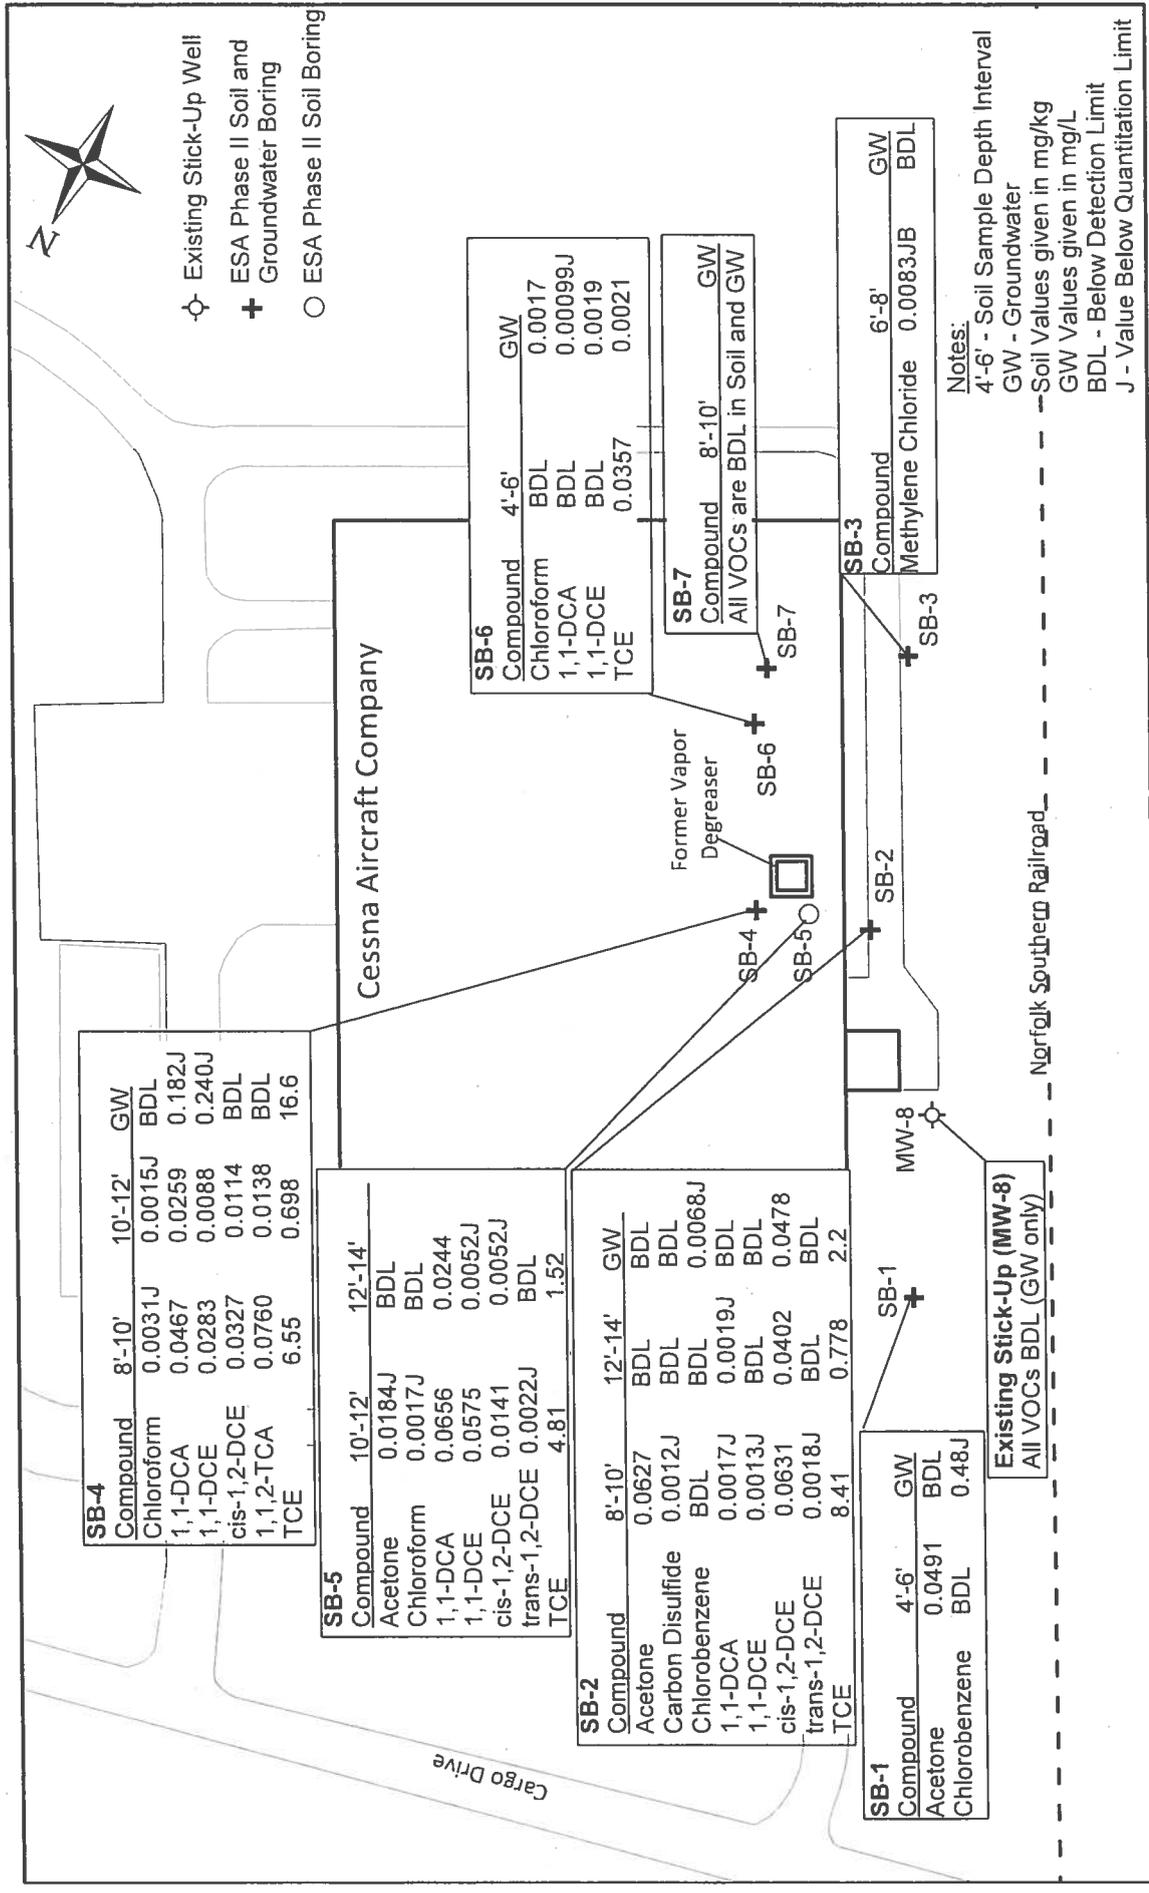
**Figure 2: ESA Phase II Detected Compounds**

Regulated Substance	CAS Registry Number	Highest Detected Concentration (mg/L)	Sample Depth Below Ground Surface (Feet)
1,1-Dichloroethane	75-34-3	0.182	24
1,1-Dichloroethene	75-35-4	0.240	24
Chlorobenzene	108-90-7	0.0068	24
Chloroform	67-66-33	0.0017	24
Trichloroethene	79-01-6	16.6	24

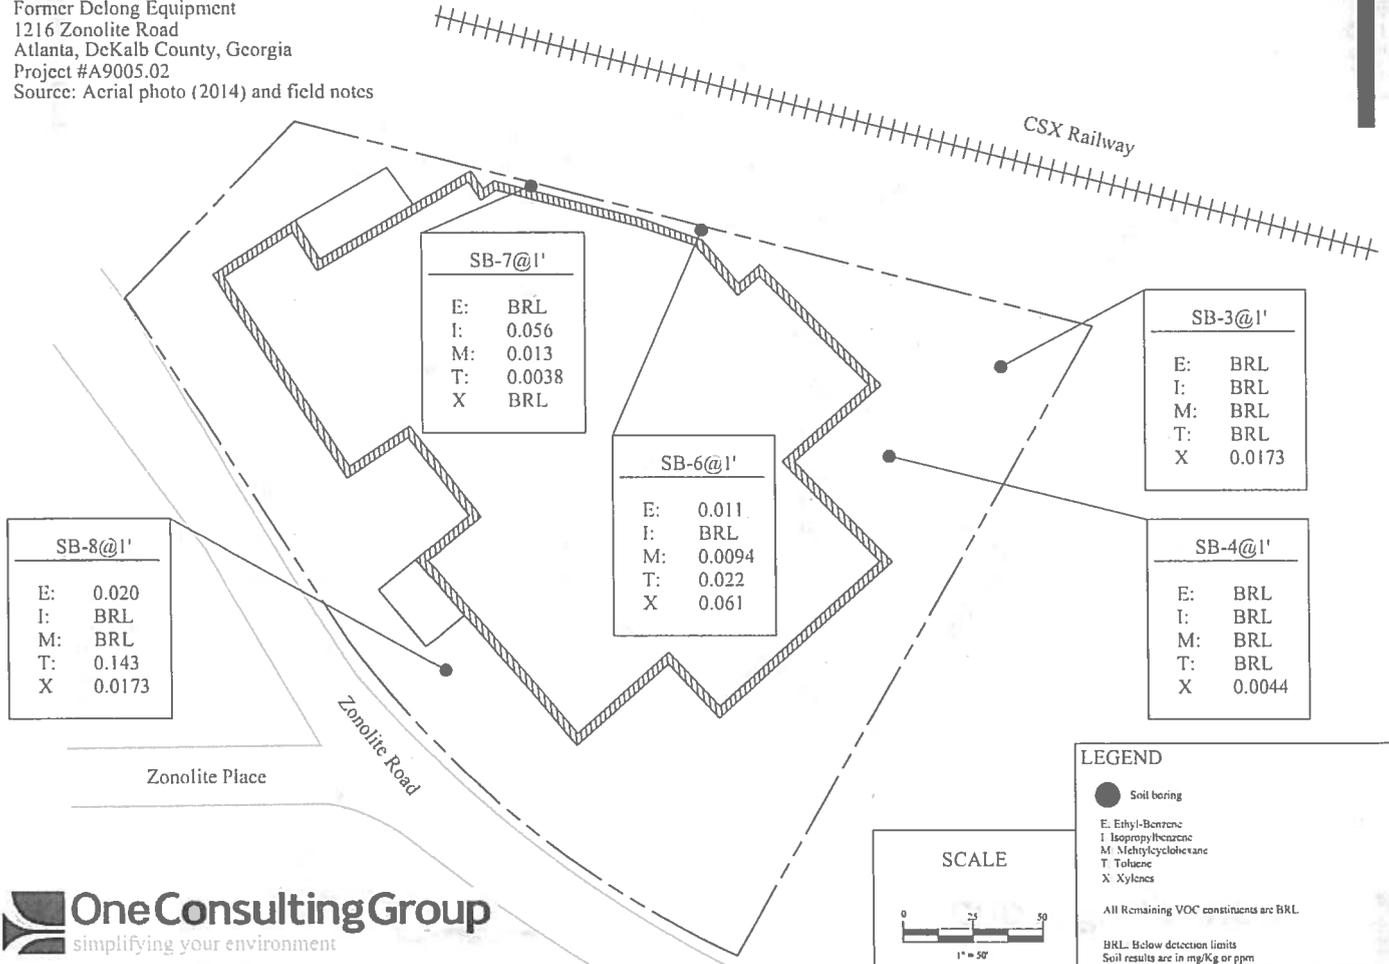
Figure 3A  
Soil Analytical - Volatile Organic Compounds (5.27.2014)

- Soil boring
- E: Ethyl-Benzene
- I: Isopropylbenzene
- M: Methylcyclohexane
- T: Toluene
- X: Xylenes

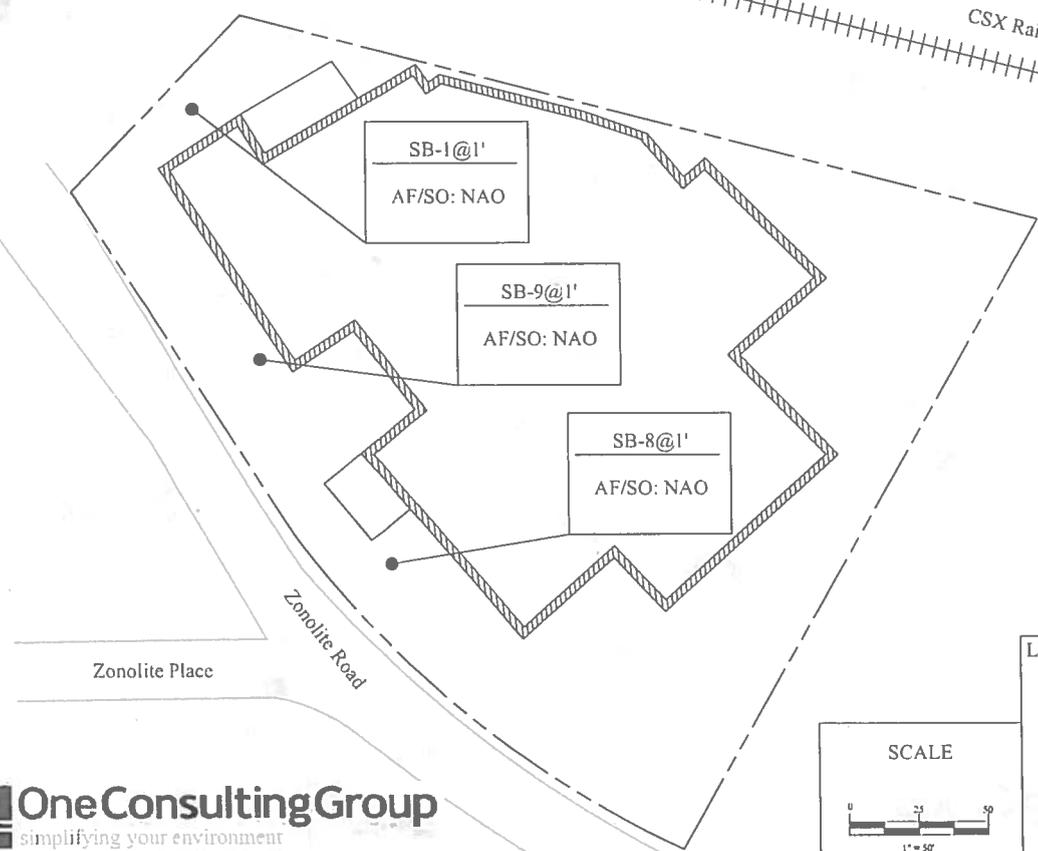
Figure 3C  
Soil Analytical - Asbestos in Soil (5.27.2014)

- Soil boring
- AF/SO - Asbestos Fibers in Soil
- NAO - No Asbestos Observed

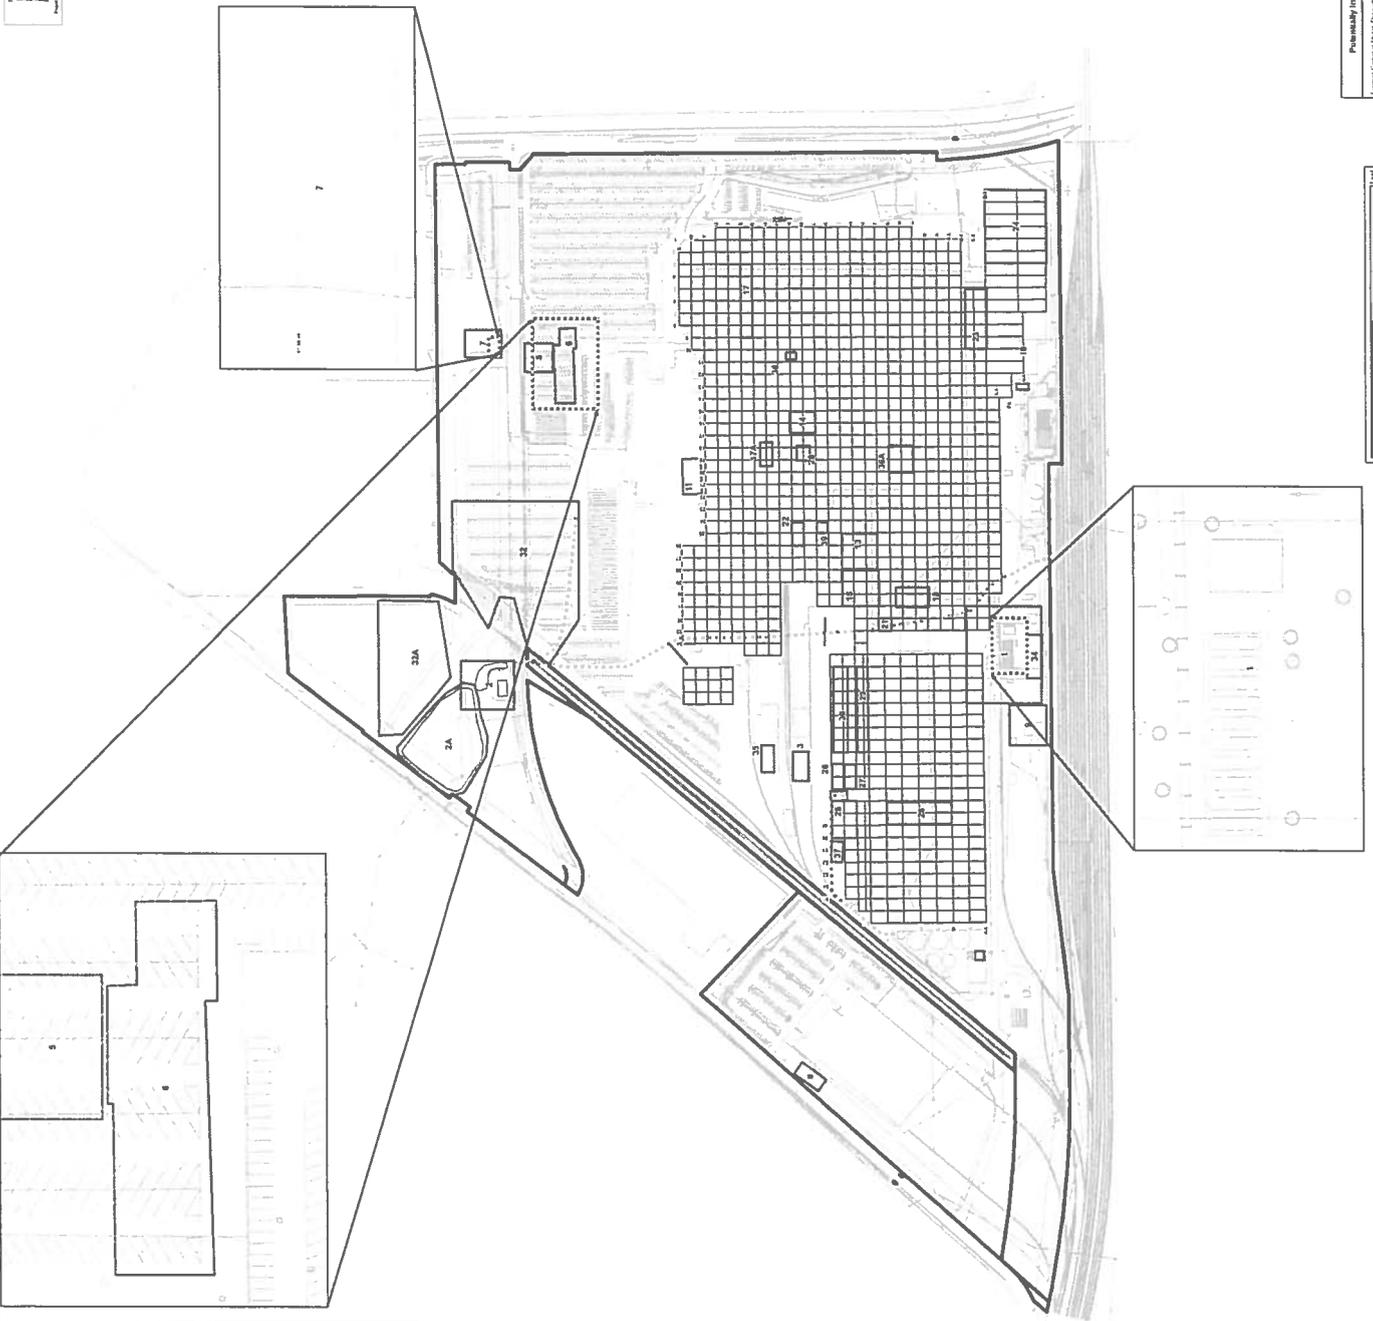
The attached Figure 1 identifies the 50 potentially impacted areas (PIAs) identified by document reviews, interviews, site reconnaissance and the sampling and testing efforts. Of these, 9 PIAs have been found to exhibit regulated substances in soil exceeding a notification concentration and 31 PIAs have been found to exhibit regulated substances in groundwater. Figure 2 is a USGS topographic map of the site and vicinity. Figure 3 shows the locations of soil borings and monitoring wells on the Property.

Area Name	Area Number
Area 1	1
Area 2	2
Area 3	3
Area 4	4
Area 5	5
Area 6	6
Area 7	7
Area 8	8
Area 9	9
Area 10	10
Area 11	11

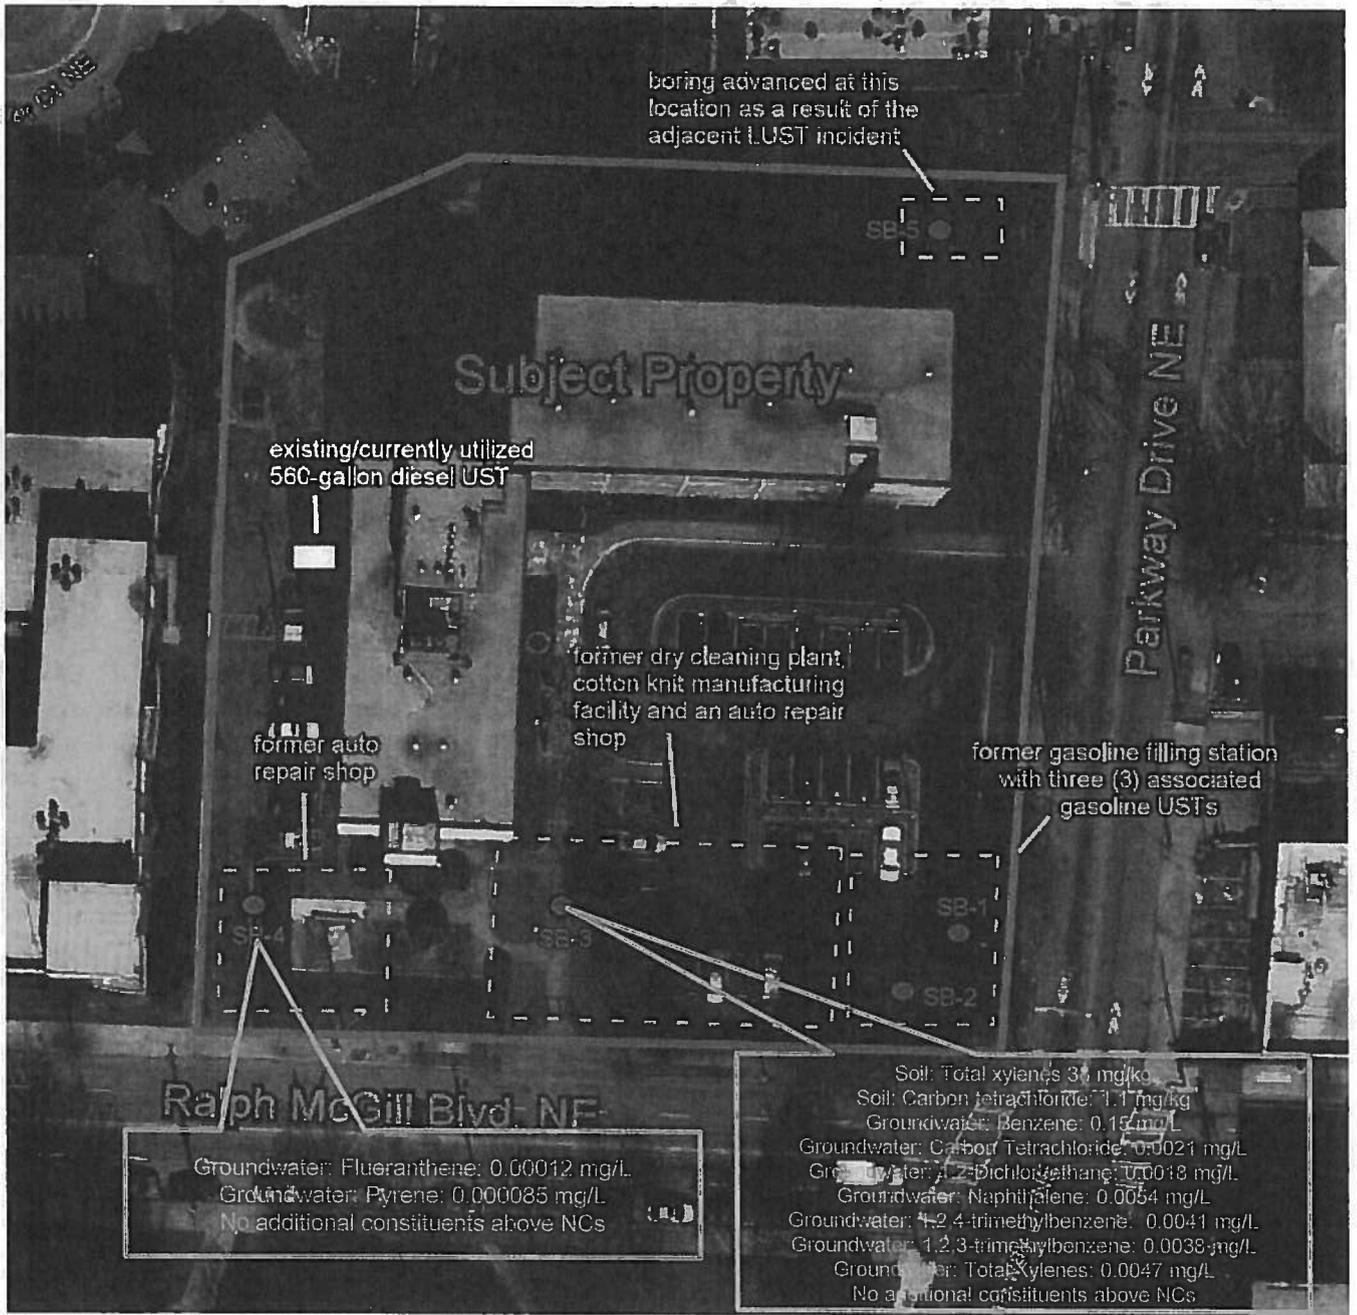
Groundwater: Fluoranthene: 0.00012 mg/L  
 Groundwater: Pyrene: 0.000085 mg/L  
 No additional constituents above NCs

Soil: Total xylenes 31 mg/kg  
 Soil: Carbon tetrachloride: 1.1 mg/kg  
 Groundwater: Benzene: 0.19 mg/L  
 Groundwater: Carbon Tetrachloride: 0.0021 mg/L  
 Groundwater: 1,2-Dichloroethane: 0.0048 mg/L  
 Groundwater: Naphthalene: 0.0054 mg/L  
 Groundwater: 1,2,4-trimethylbenzene: 0.0041 mg/L  
 Groundwater: 1,2,3-trimethylbenzene: 0.0038 mg/L  
 Groundwater: Total Xylenes: 0.0047 mg/L  
 No additional constituents above NCs
