**SEMI-ANNUAL GROUNDWATER  
MONITORING REPORT NO. 13  
JULY THROUGH DECEMBER 2014  
CHEMTRADE SOLUTIONS SITE  
EAST POINT, GEORGIA  
HSI# 10498**

Project Number GR5060

January 2015

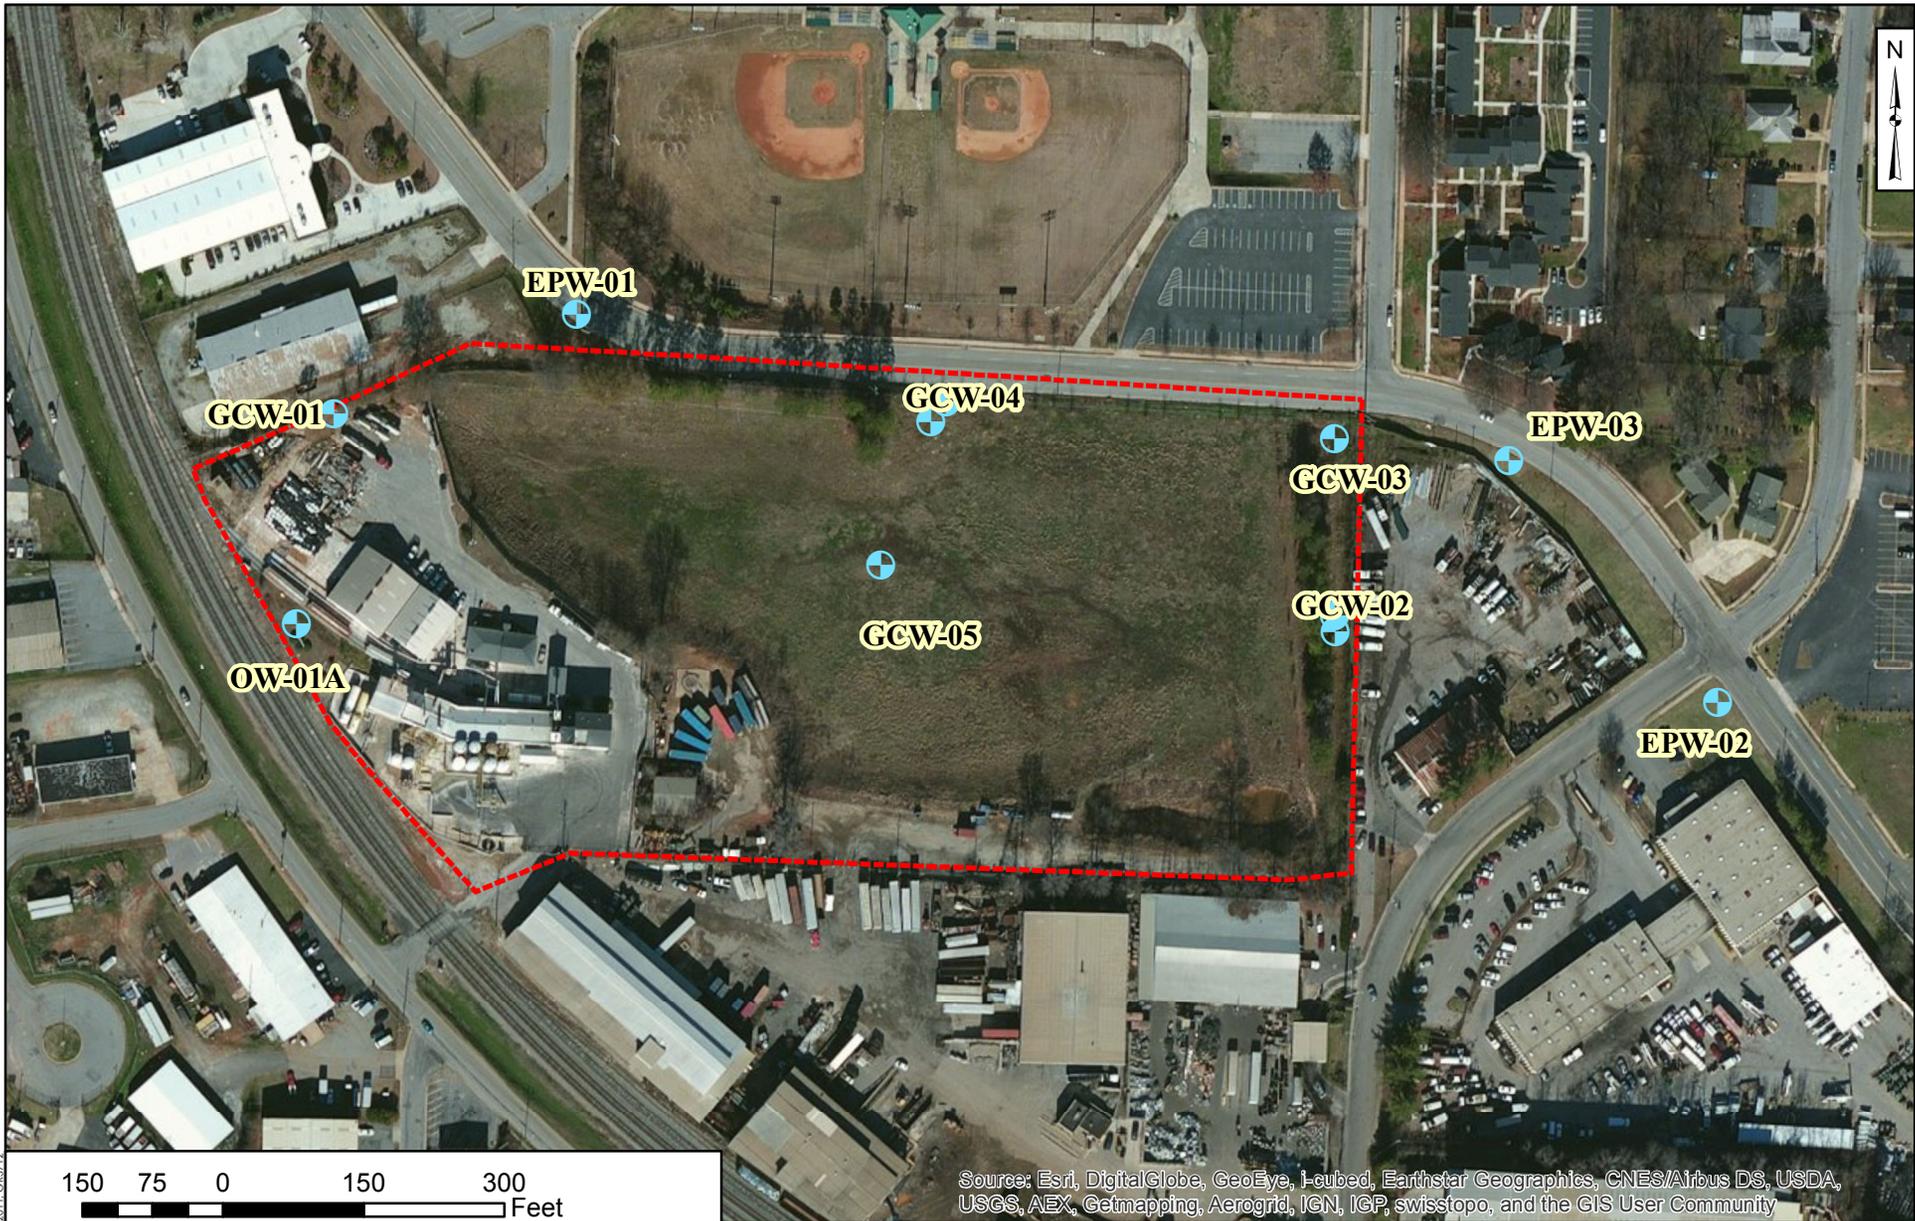
Figure  
 1-2

- Sampling of 6 on-site wells (**Figure 1-2**);
- Sampling of 3 off-site wells (**Figure 1-2**); and
- Sampling of surface water at one on-site and three off-site locations (**Figure 1-3**).

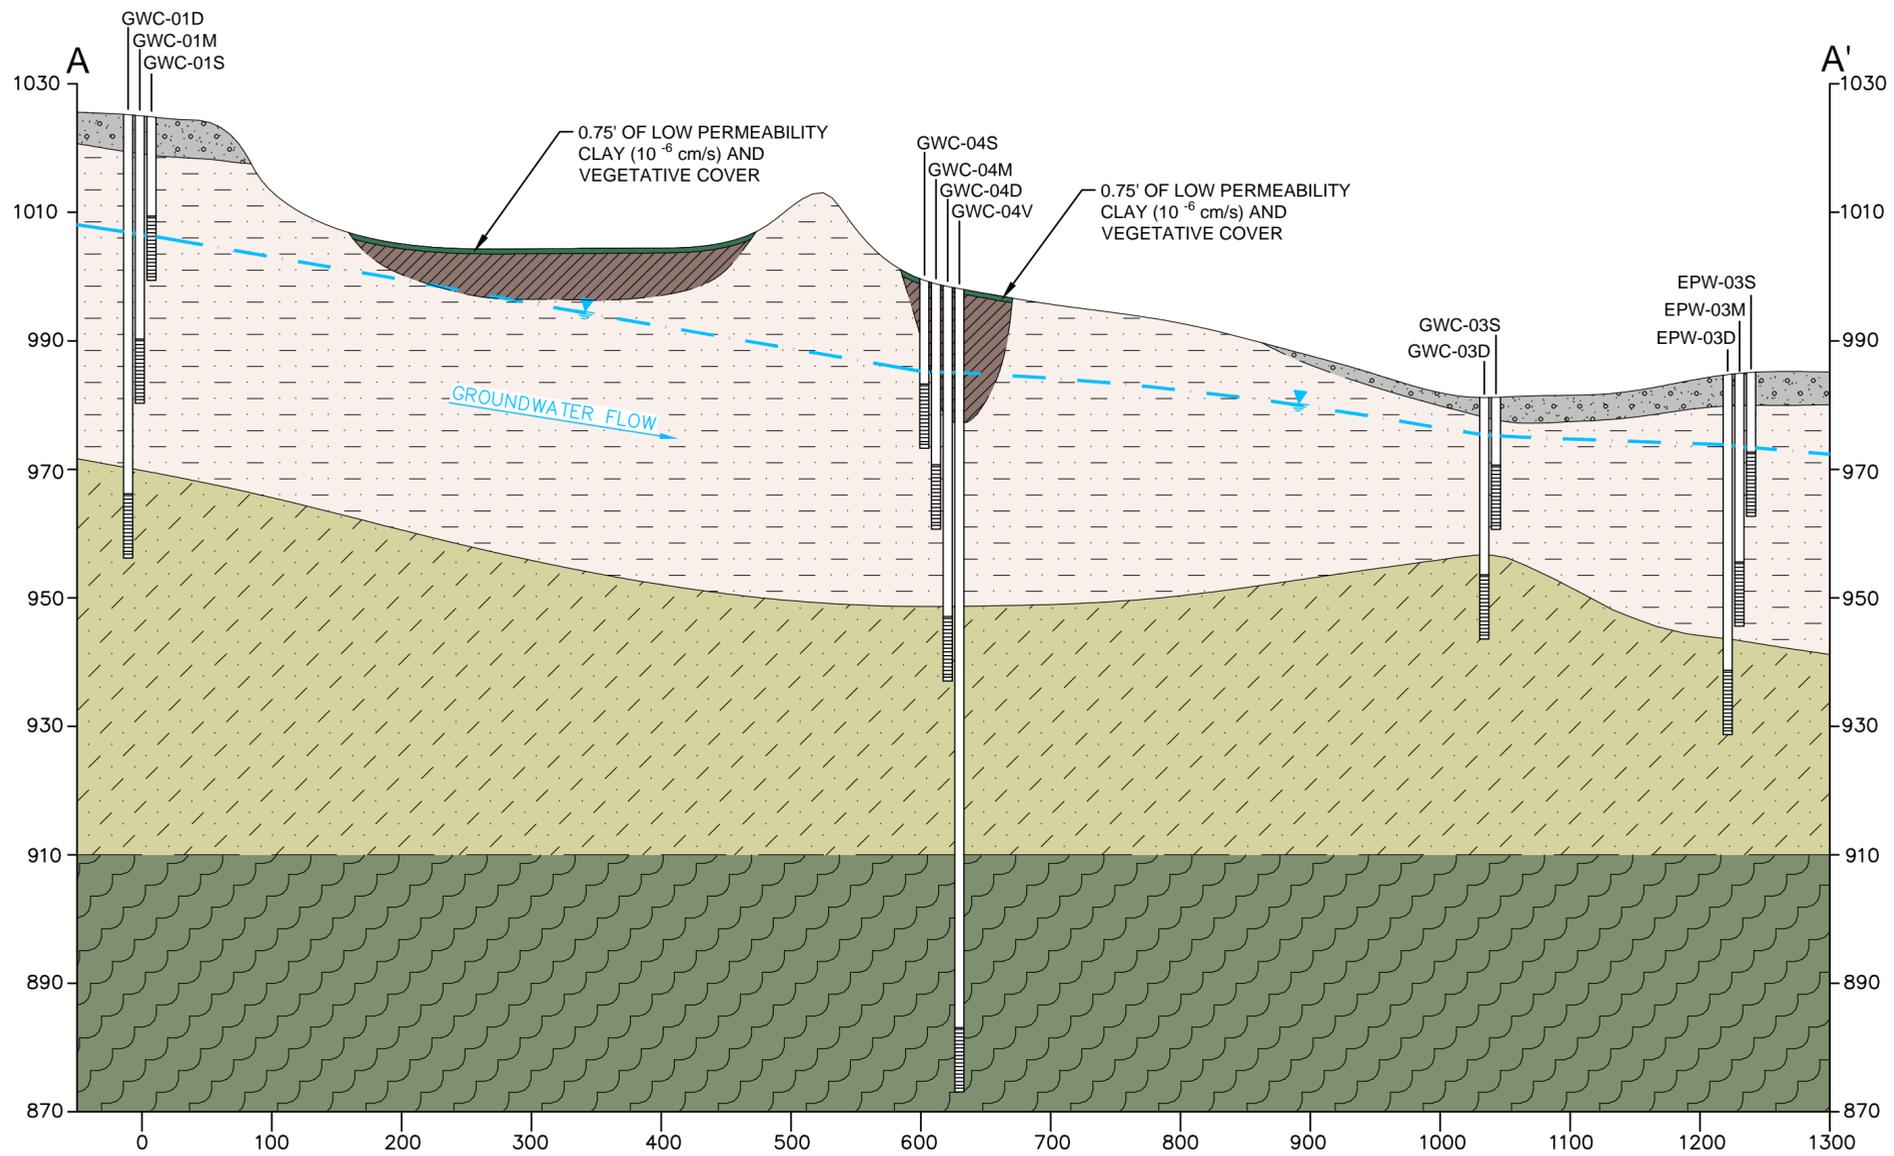
DATE: JUN-13	SCALE: AS SHOWN
PROJECT NO. GR5060/12	FILE NO. 5060F001
DOCUMENT NO. GA 130020	FIGURE NO. 2-1

The lithology of the Site consists primarily of clayey fill material overlying saprolite as depicted on **Figures 2-1 through 2-3**, which illustrate hydrogeologic cross-sections that show the Site features and geology. The fill material, which varies in thickness, covers most of the Site and consists of sandy to gravelly red micaceous clay. The saprolite, encountered in all fourteen of the monitoring wells drilled at the Site, consists of highly weathered schist consisting of orange to red clay with kaolinite and mica. Foliation and other relict rock texture are still well preserved and were visible in samples, but the material comprises mostly clay and mica which is formed by the deep weathering of the feldspar minerals. Competent bedrock, as defined by auger refusal, was generally encountered between 20 to 60 feet below ground surface (bgs).

# GEOLOGIC AND HYDROGEOLOGIC CROSS SECTION ALONG A-A'

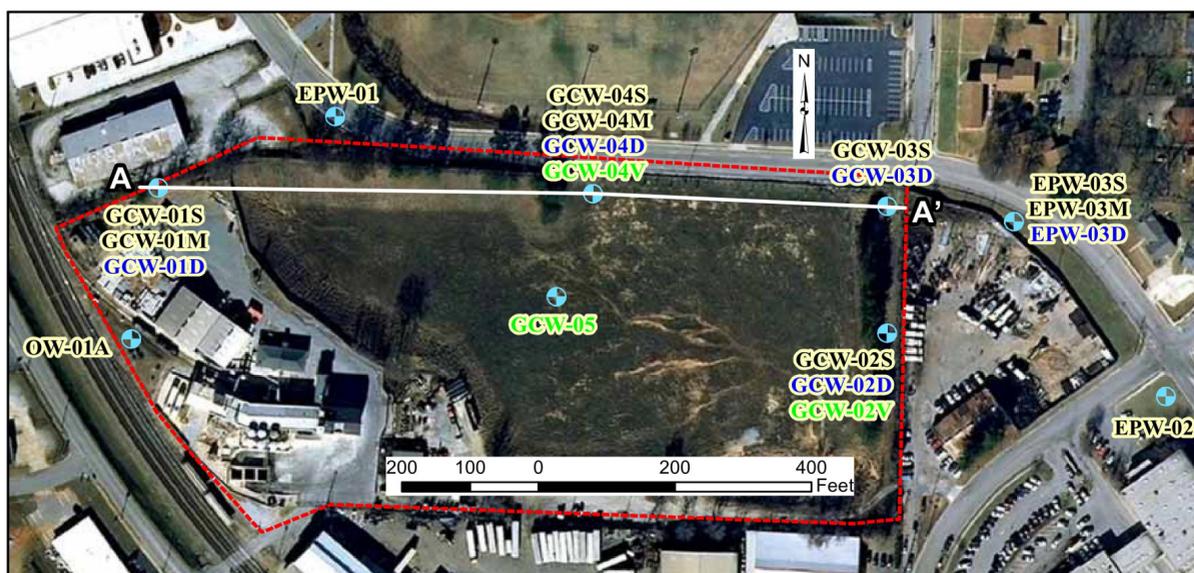
- 0.75' THICK LOW PERMEABILITY CLAY ( $10^{-6}$  cm/s) AND VEGETATIVE COVER
- GRAVELLY CLAY, FILL
- CLAY, FILL AFTER EXCAVATION
- SILTY SAND, RELICT SCHISTOCITY, MICACEOUS (SAPROLITE)
- PARTIALLY WEATHERED SCHIST
- BEDROCK (SCHIST)
- LITHOLOGIC CONTACT, DASHED WHERE INFERRED
- MONITORING WELL SCREEN ZONE WITH WATER ELEVATION (FEET MSL), NOVEMBER, 2012

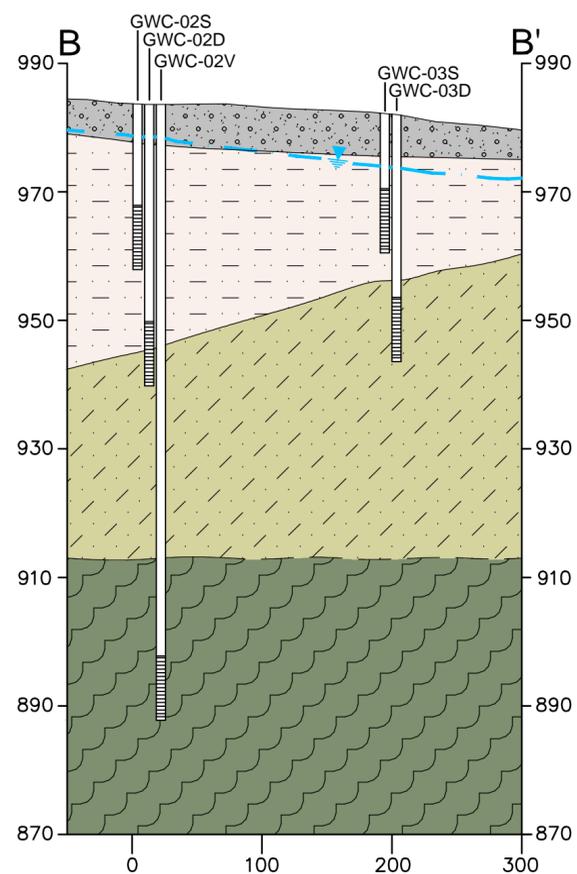
DATE:	JUN-13	SCALE:	AS SHOWN
PROJECT NO.	GR5060/12	FILE NO.	5060F001
DOCUMENT NO.	GA 130020	FIGURE NO.	2-2

# GEOLOGIC AND HYDROGEOLOGIC CROSS SECTION ALONG B-B'

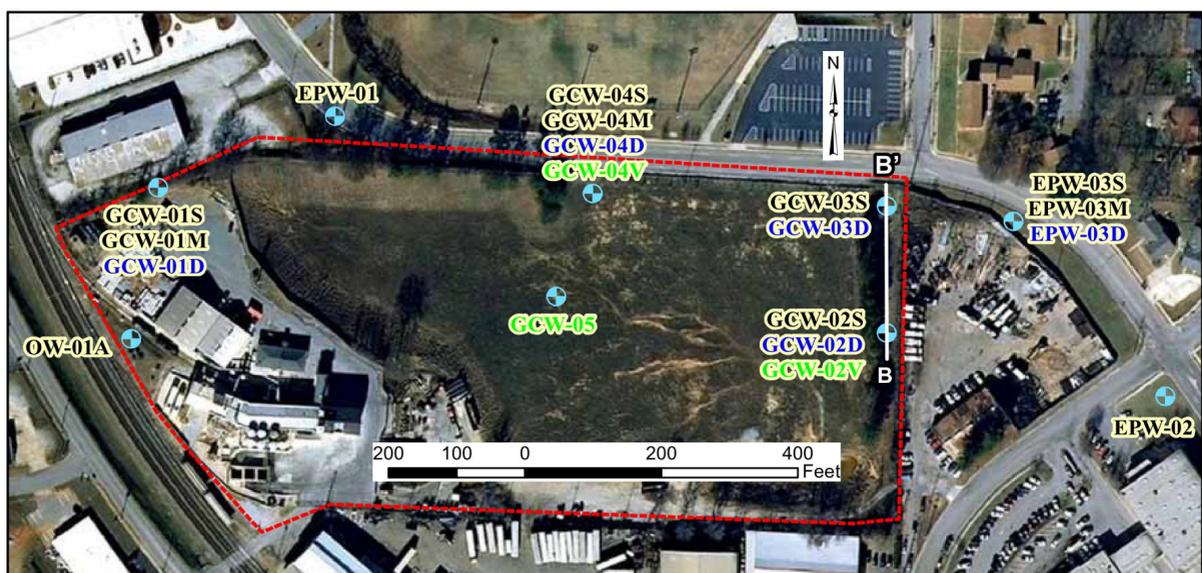
- GRAVELLY CLAY, FILL
- SILTY SAND, RELICT SCHISTOSITY, MICACEOUS (SAPROLITE)
- PARTIALLY WEATHERED SCHIST
- BEDROCK (SCHIST)
- LITHOLOGIC CONTACT, DASHED WHERE INFERRED
- MONITORING WELL SCREEN ZONE WITH WATER ELEVATION (FEET MSL), NOVEMBER, 2012

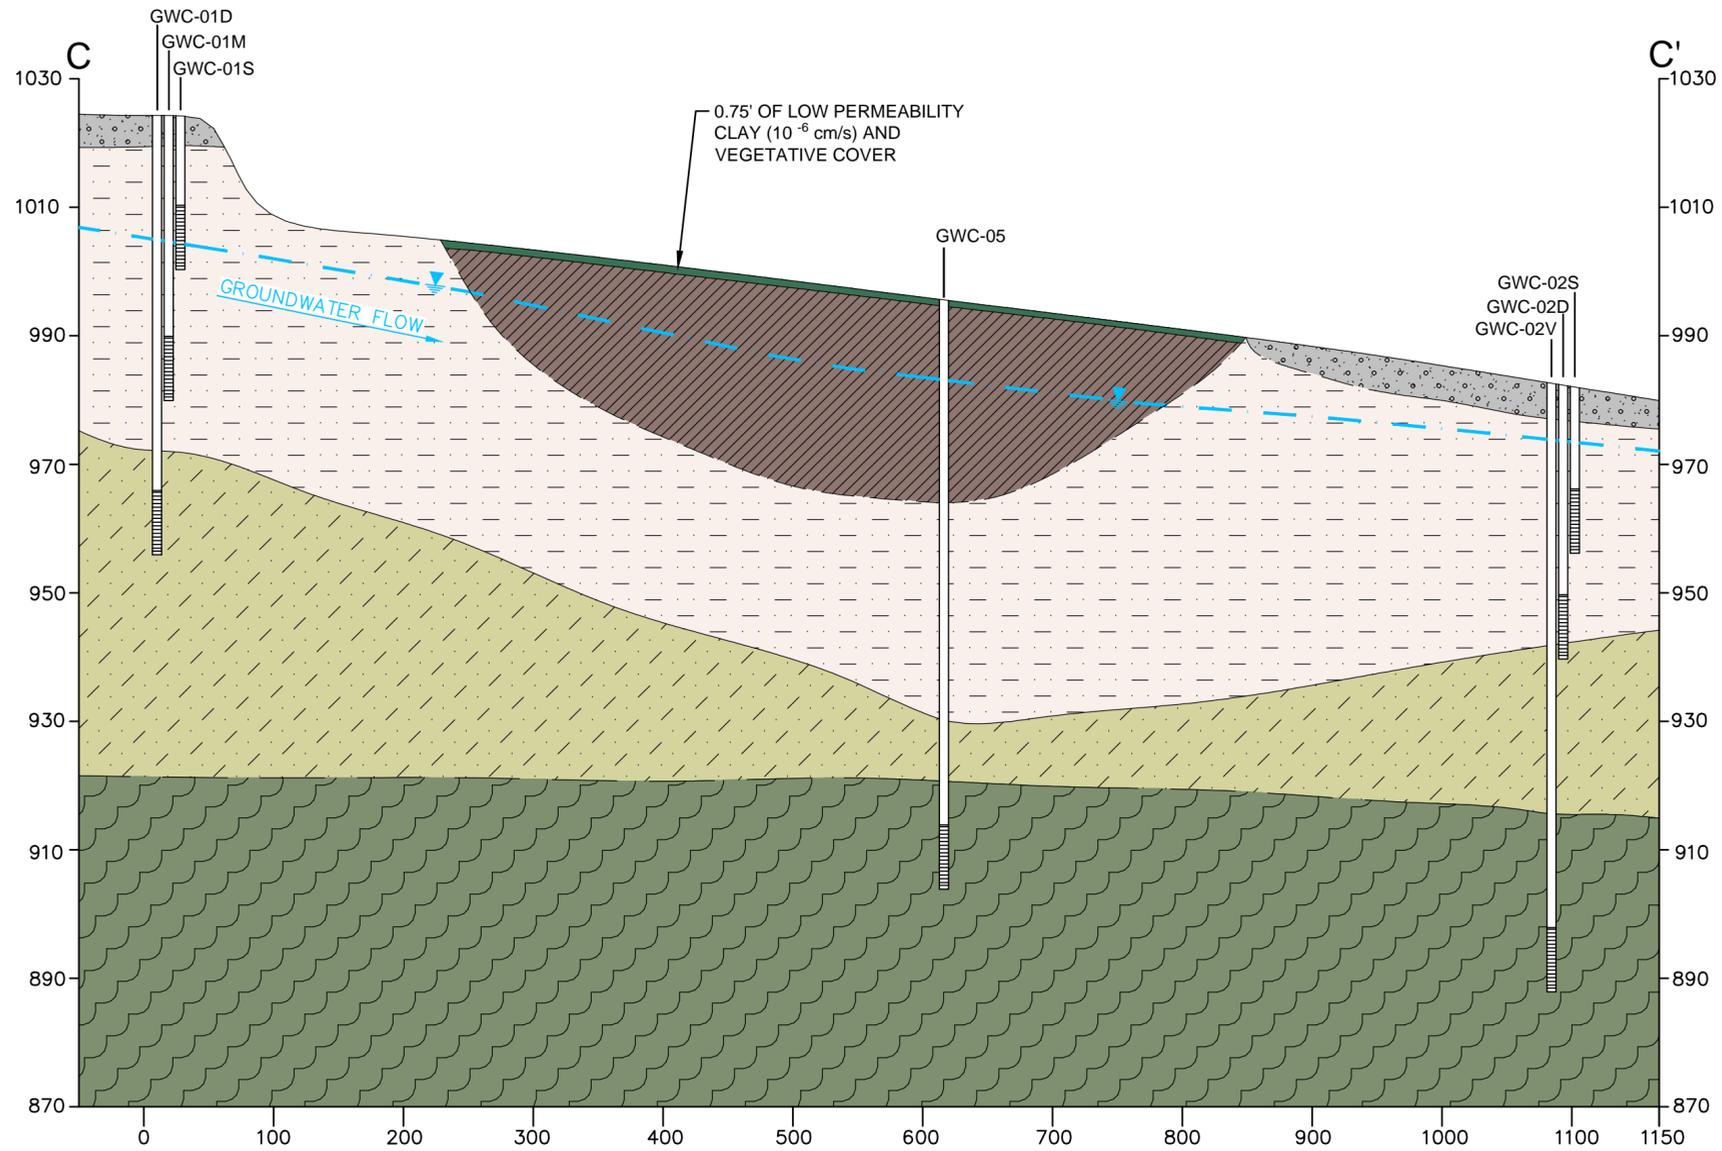
DATE:	JUN-13	SCALE:	AS SHOWN
PROJECT NO.	GR5060/12	FILE NO.	5060F001
DOCUMENT NO.	GA 130020	FIGURE NO.	2-3

# GEOLOGIC AND HYDROGEOLOGIC CROSS SECTION ALONG C-C'

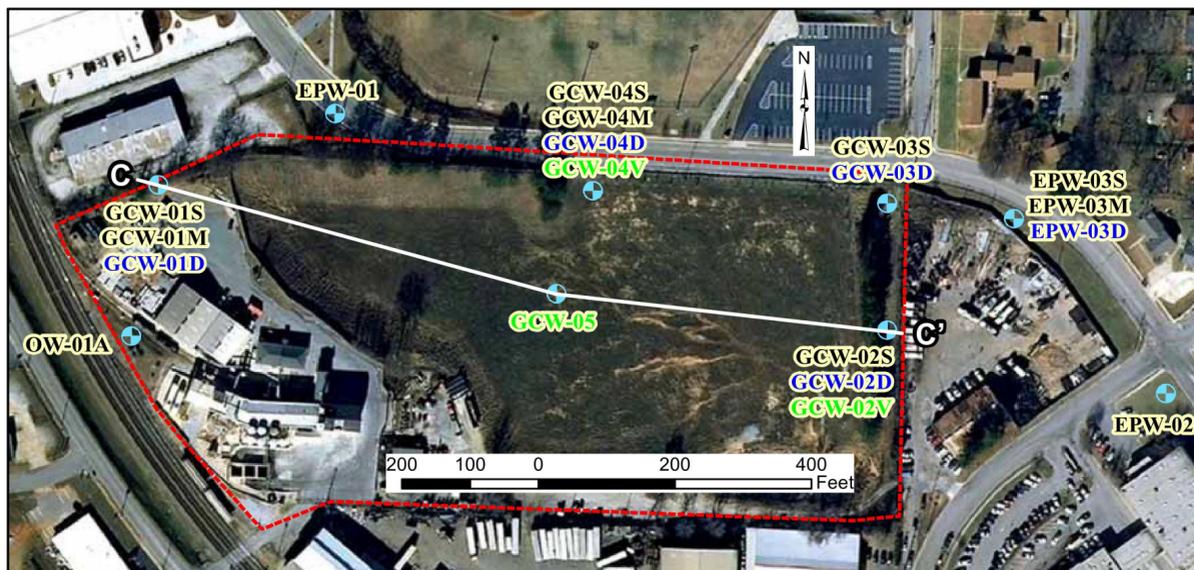
- 0.75' THICK LOW PERMEABILITY CLAY ( $10^{-6}$  cm/s) AND VEGETATIVE COVER
- GRAVELLY CLAY, FILL
- CLAY, FILL AFTER EXCAVATION
- SILTY SAND, RELICT SCHISTOCITY, MICACEOUS (SAPROLITE)
- PARTIALLY WEATHERED SCHIST
- BEDROCK (SCHIST)
- LITHOLOGIC CONTACT, DASHED WHERE INFERRED
- MONITORING WELL SCREEN ZONE WITH WATER ELEVATION (FEET MSL), NOVEMBER, 2012

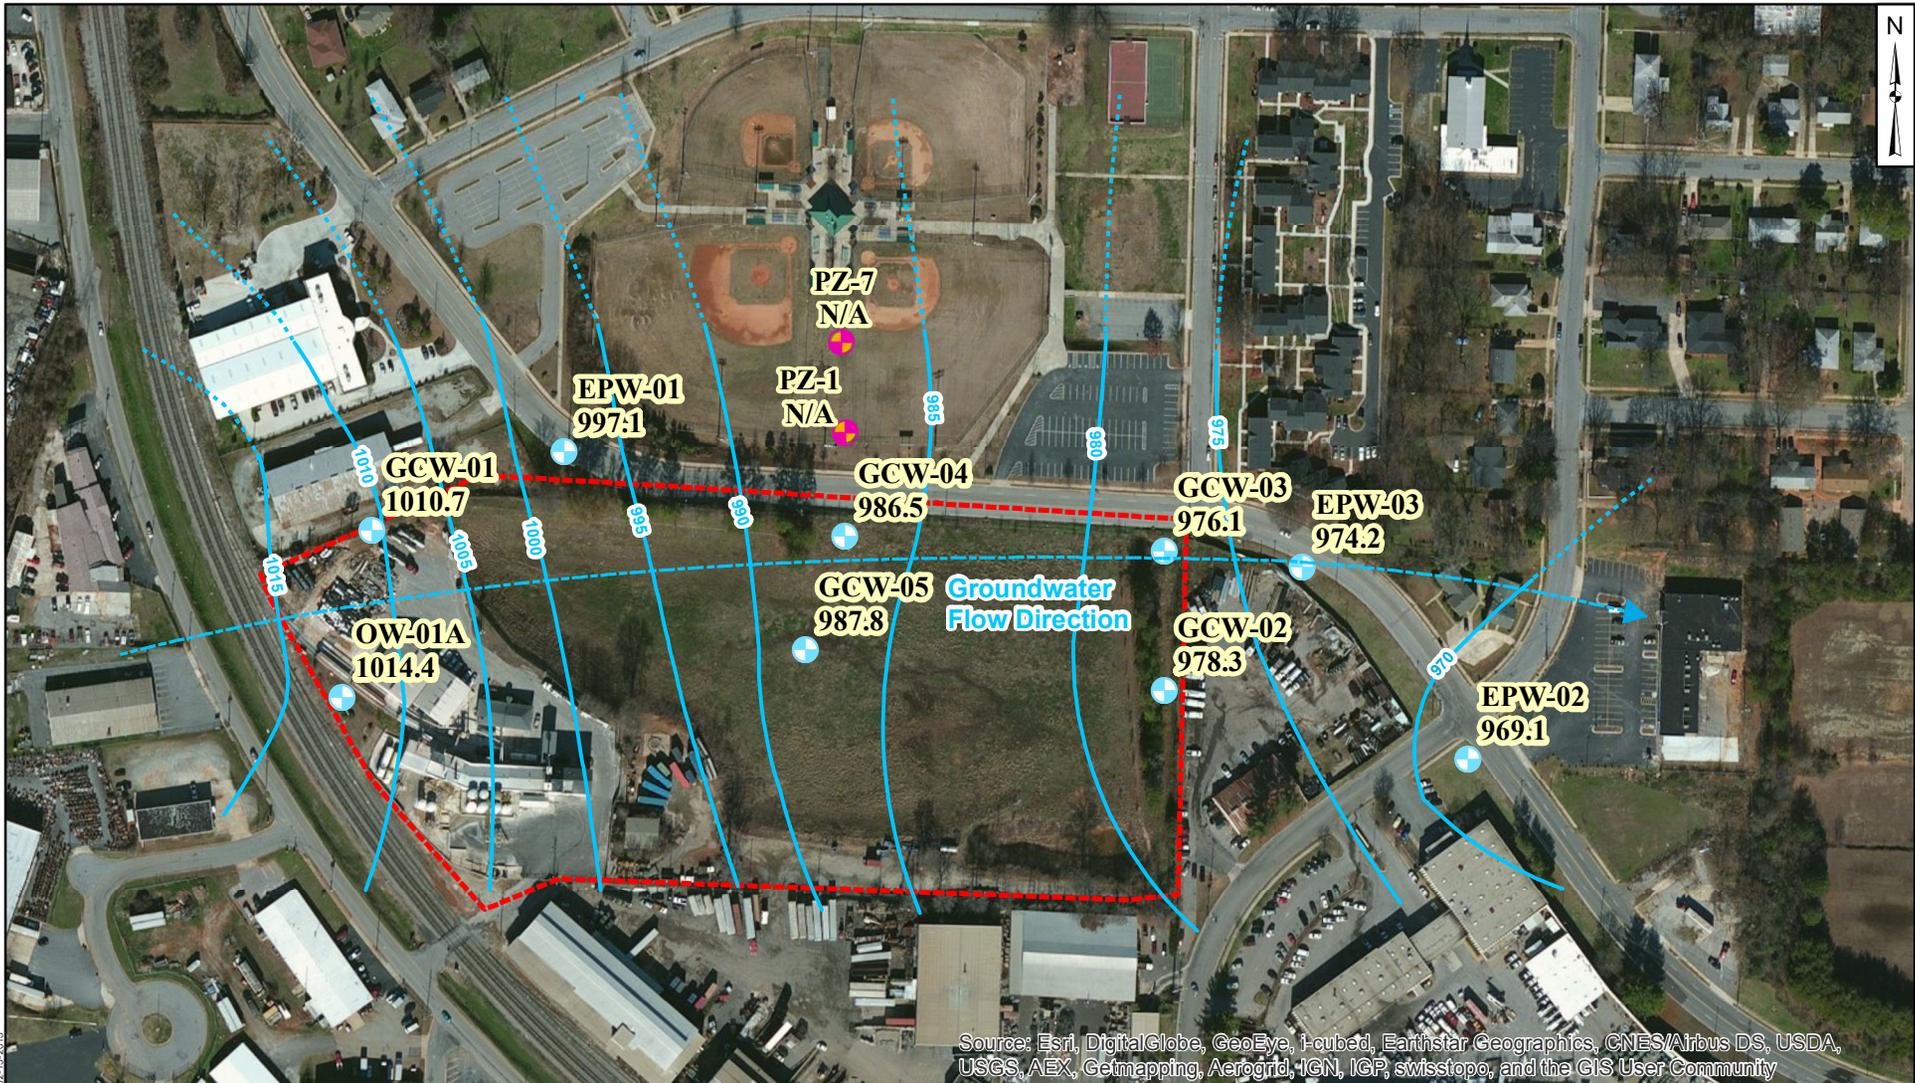
The potentiometric map for October 2014 readings is shown in **Figure 3-1**. This map shows the typical Piedmont pattern of flow following topography towards surface water features, which act as collectors and discharge points for the groundwater. Since there are no streams at the Site, the groundwater is flowing towards the local topographic low which is aligned parallel with North Martin Street and the storm drain system. The general potentiometric pattern is consistent with the overall drainage flow pattern to the east-southeast towards the South River.

Water level measurements were recorded in wells screened in saprolite and shallow competent rock. In preparing the potentiometric map from water level measurements, generally no distinction was made as to whether the wells were shallow or deep, in saprolite or bedrock. Such distinctions were not appropriate for two reasons: (i) the Piedmont is characterized by a single saturated zone consisting of saprolite and bedrock that are hydraulically connected; and (ii) the vertical components of the head gradient are similar or small compared to the horizontal components.

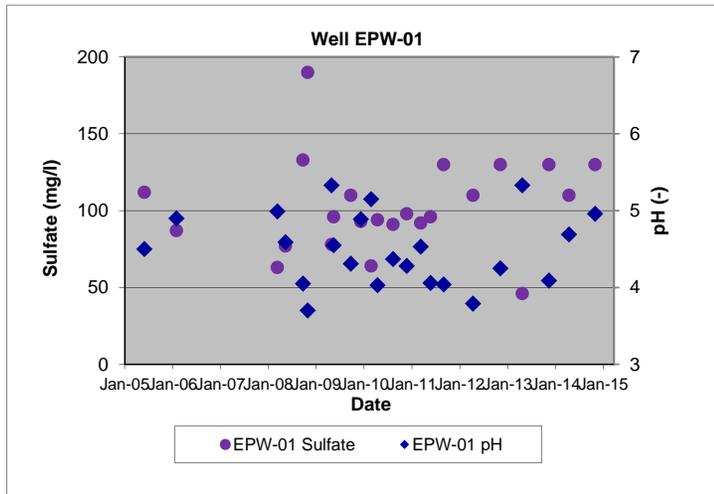
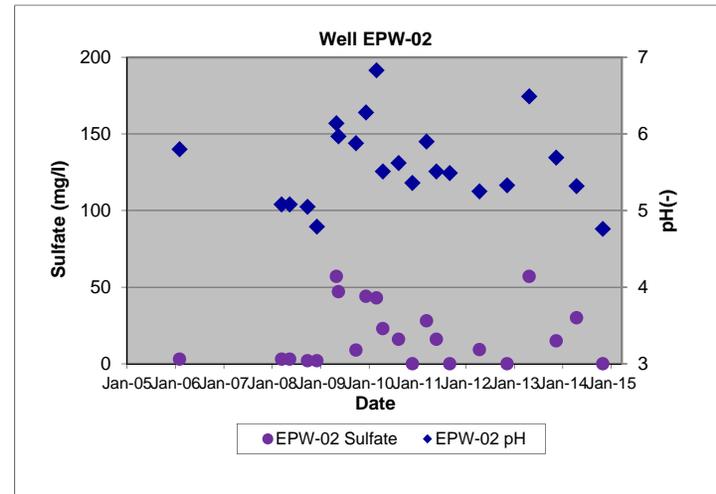
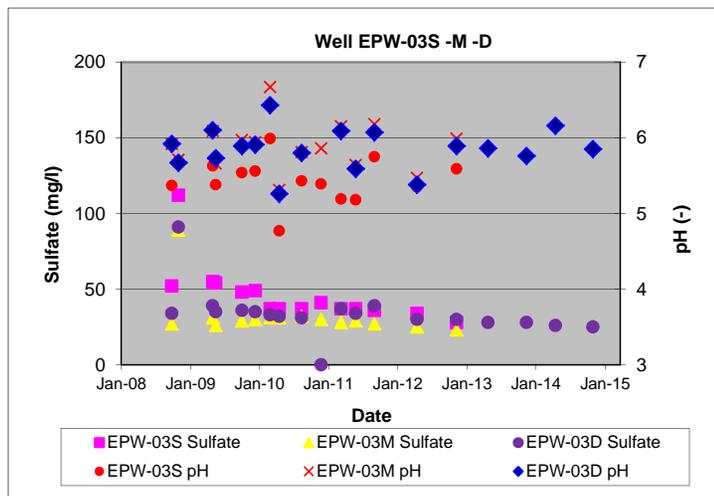
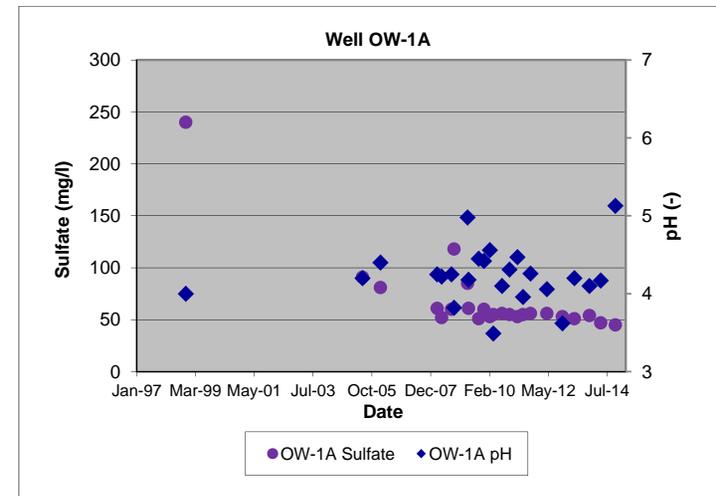
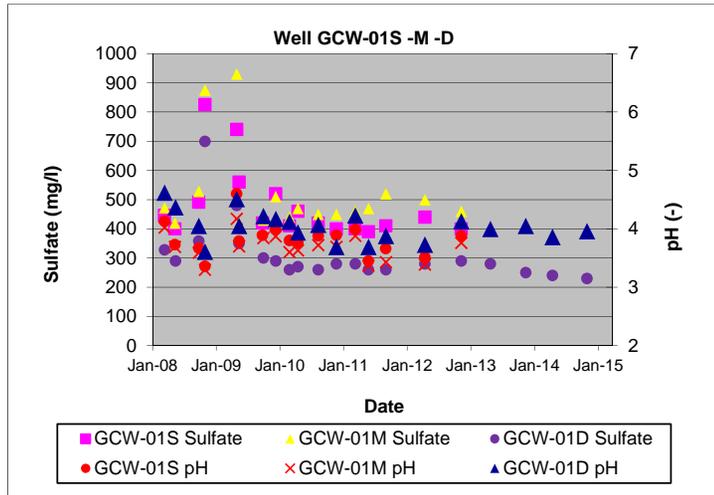
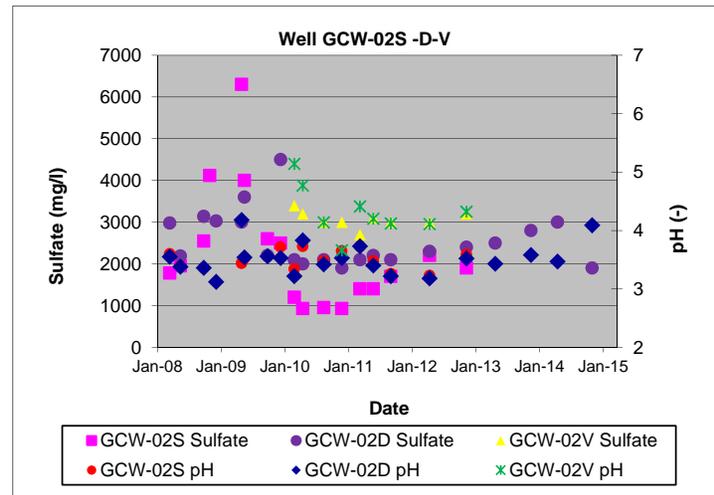
**Figure 3-2**  
**Monitoring Well Sulfate and pH Trends**  
**General Chemical Site**  
**East Point, Georgia**

Historical trend graphs for sulfate and pH are shown in **Figure 3-2**. Sulfate concentrations generally decreased or were stable in off-site and on-site wells in groundwater. The sulfate concentrations in monitoring wells GCW-01D, GCW-03D, GCW-04D, GCW-05, EPW-03D and OW-1A showed a statistically significant decreasing trend. This is consistent with the previous semi-annual report. Neither decreasing nor increasing trends were calculated for sulfate concentrations in monitoring wells GCW-02D, EPW-01 and EPW-02. Similarly, aluminum concentrations also decreased or were stable in groundwater. A statistically significant decreasing trend was calculated for aluminum in monitoring wells GCW-04D, EPW-02 and OW-01A. Neither decreasing nor increasing trends were calculated for aluminum in the remainder of the wells. The pH measurements were generally stable. The pH measured at on-site wells was generally lower than the pH measured at the off-site wells except for the source area well which had a pH similar to background.

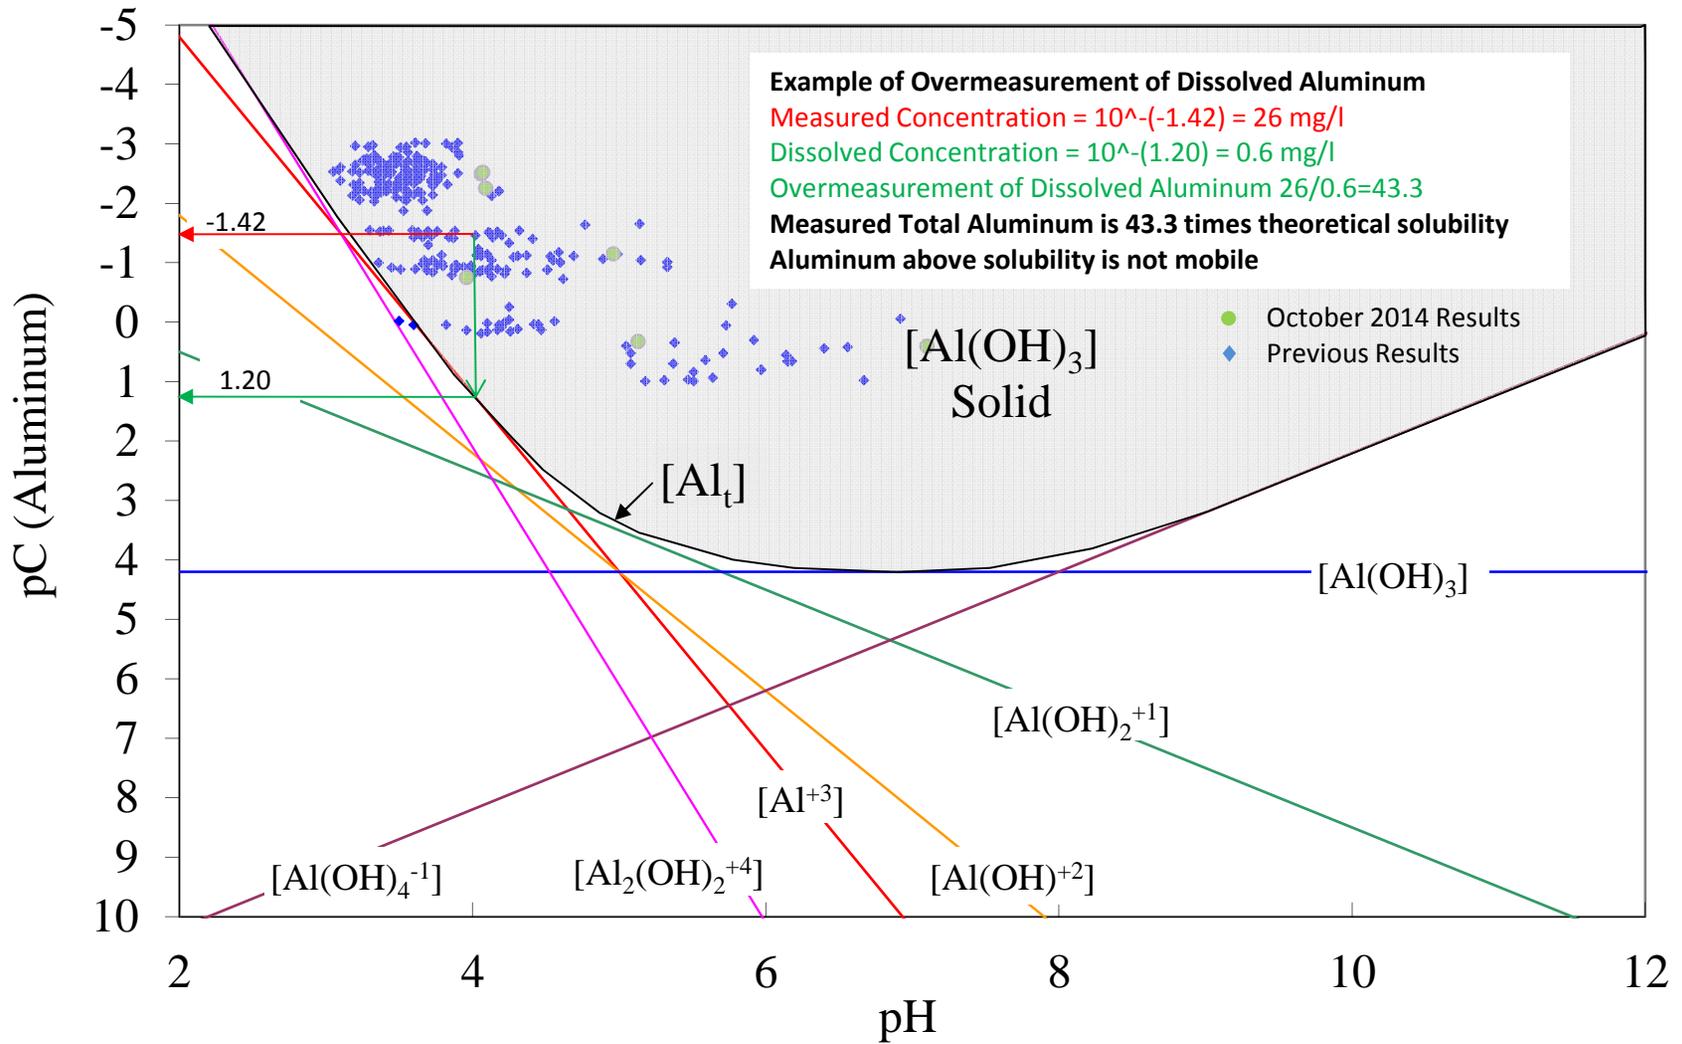
Figure 6-1  
 Chemtrade Solutions  
 Groundwater Sampling  
 October 2014  
 Aluminum Results Analysis

The results of the six years of data collection indicate concentrations of constituents of concern are generally showing significant decreasing trends for on-site monitoring wells. The HCA source material has been removed for over eight years. While many factors can influence concentrations at any given point in time, (e.g., time since removal of the source, hydrogeologic conditions, and precipitation patterns) it is encouraging to see that concentrations of monitored constituents in the latest round of sampling indicate a decrease and that the general trend is decreasing. Groundwater levels (elevations) have been generally stable since 2008.
