Subject: June 2012 Semi-Annual Voluntary Remediation Program Progress Report  
Former Manchester Tank Company (HSI No. 10765)  
Cedartown, Polk County, Georgia

**Figure 1:**  
**Site Plan**  
 June 2012 Status Report  
 Former Manchester Tank Company Site  
 (HSI #10765)  
 Cedartown, Polk County, Georgia

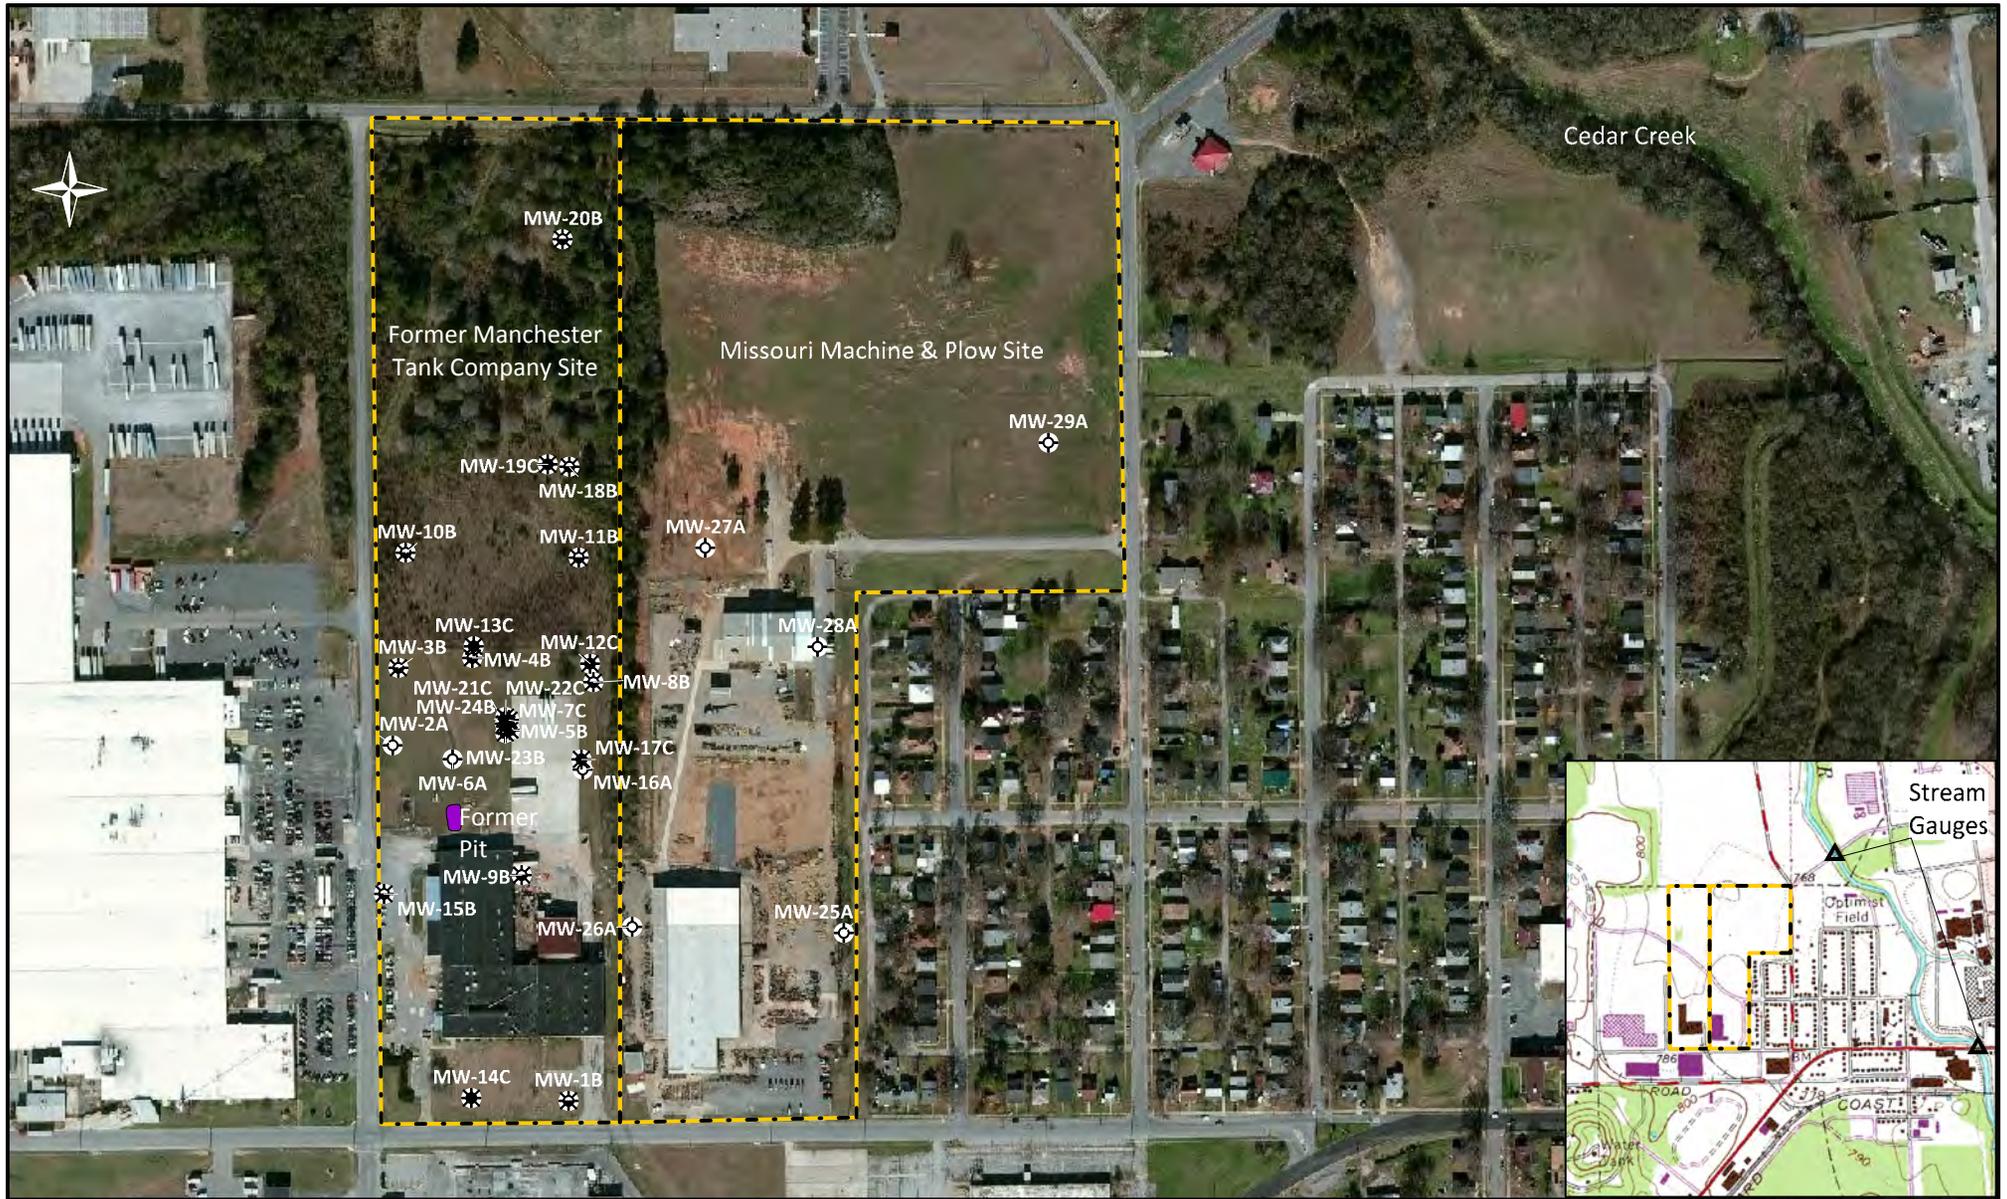
CDM Smith completed an inventory of existing monitoring wells on the Manchester Tank and Missouri M&P sites. The inventory results are summarized in **Table 1**, and the well locations are shown on **Figure 1**. CDM Smith has altered the well code nomenclature to minimize the potential for confusion that could result from monitoring wells having the same codes. In addition, a more consistent nomenclature has been developed for specific hydrogeologic zones. The residuum wells are now referred to as “A” wells, wells completed in shallow rock at the

CDM Smith also established two surface water gauging stations on Cedar Creek that will be surveyed and used to evaluate groundwater flow in the future. The staff gauge locations are also shown on Figure 1.

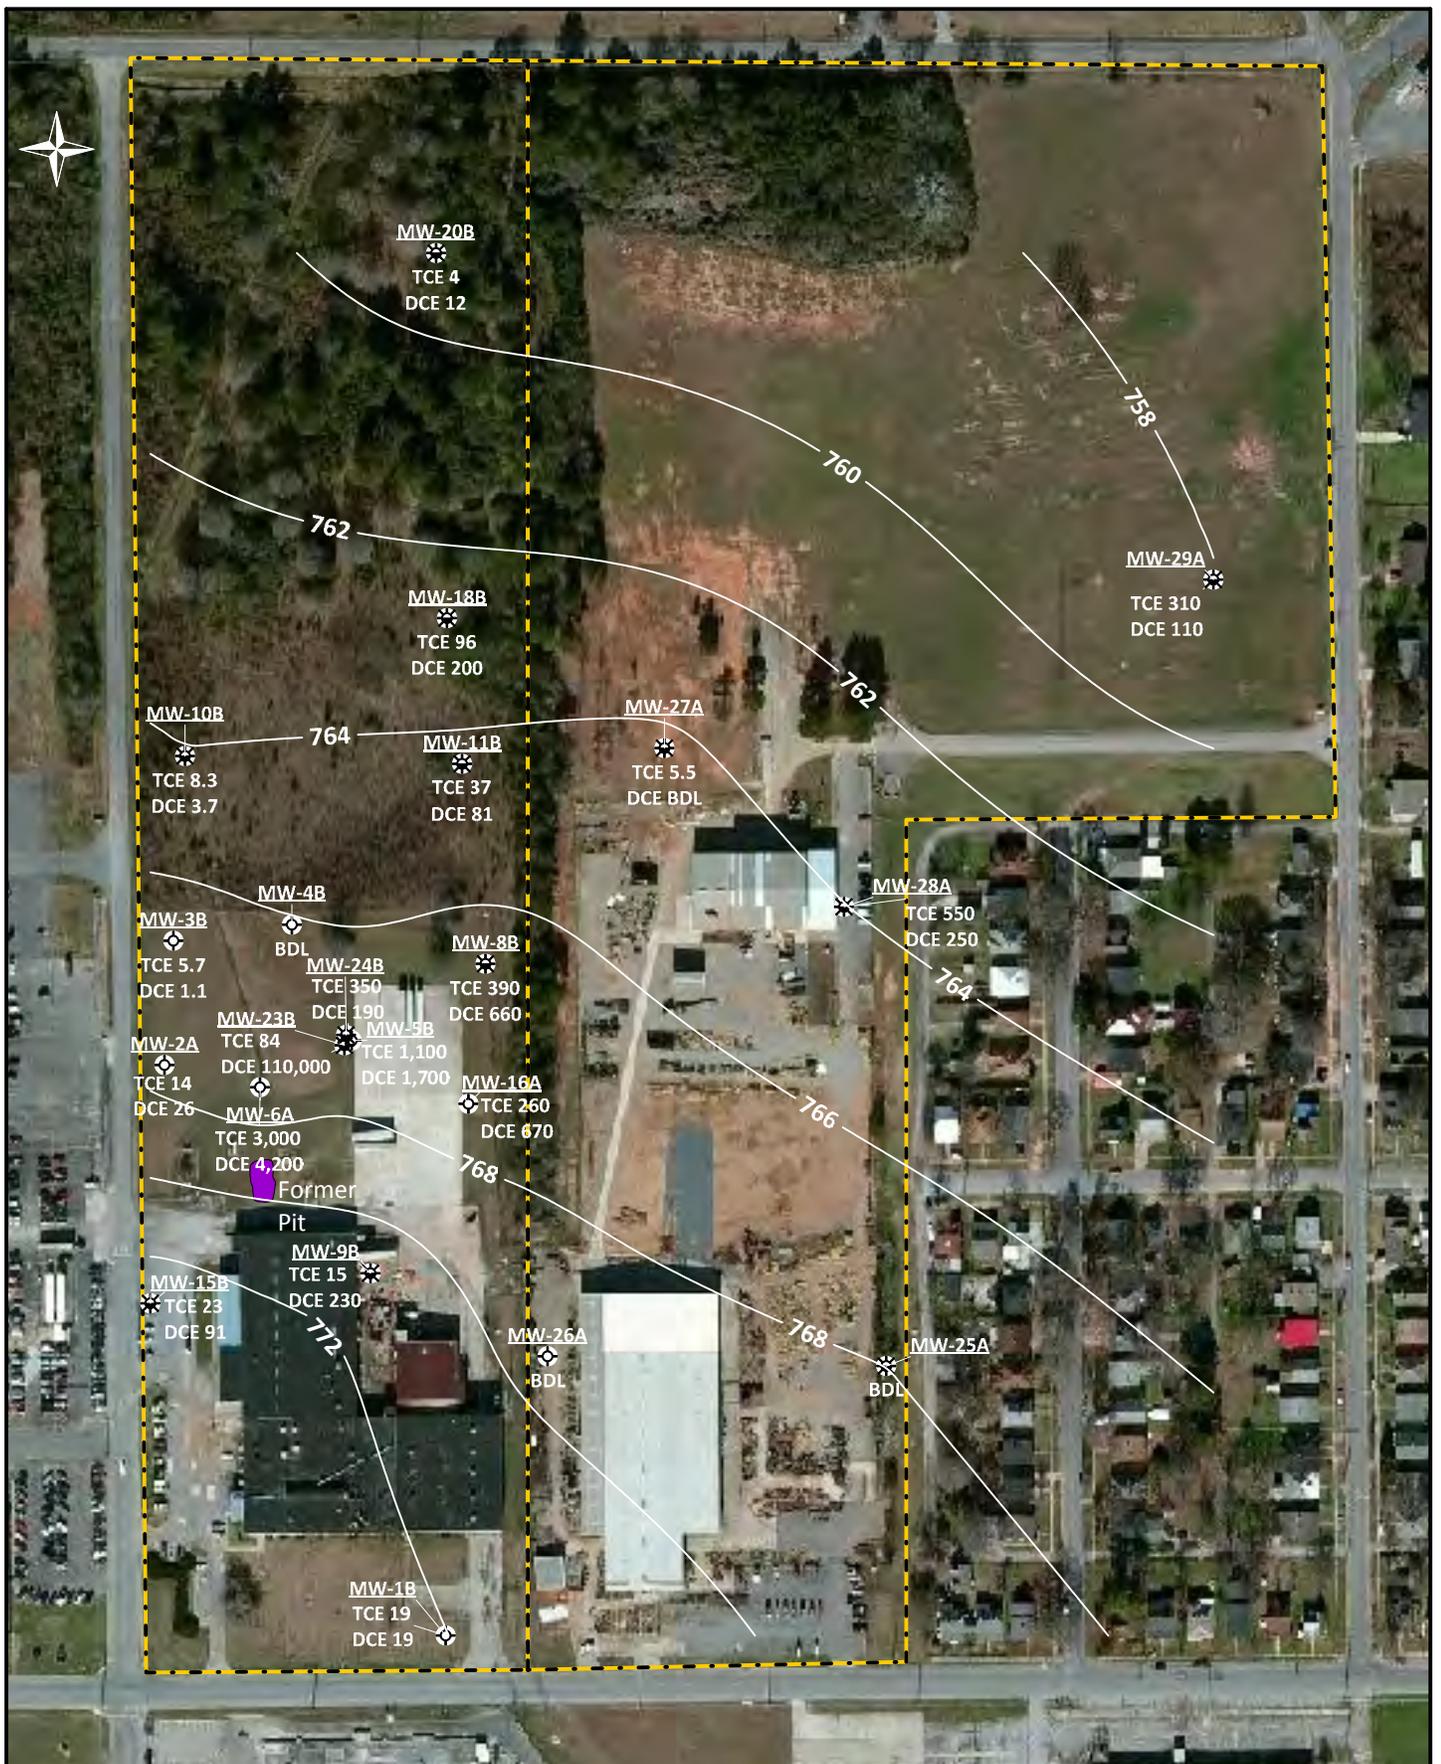
## Figure 2: Water Table Surface Map

As shown in Table 1, water level gauging was performed from the monitoring wells on both sites, and potentiometric surface maps have been prepared for the water table wells (**Figure 2**) and the bedrock wells (**Figure 3**). The apparent groundwater flow direction is consistent with previous mapping with the water table and bedrock directions of flow being north-northeast.

Posted concentrations are most recent in ug/L.

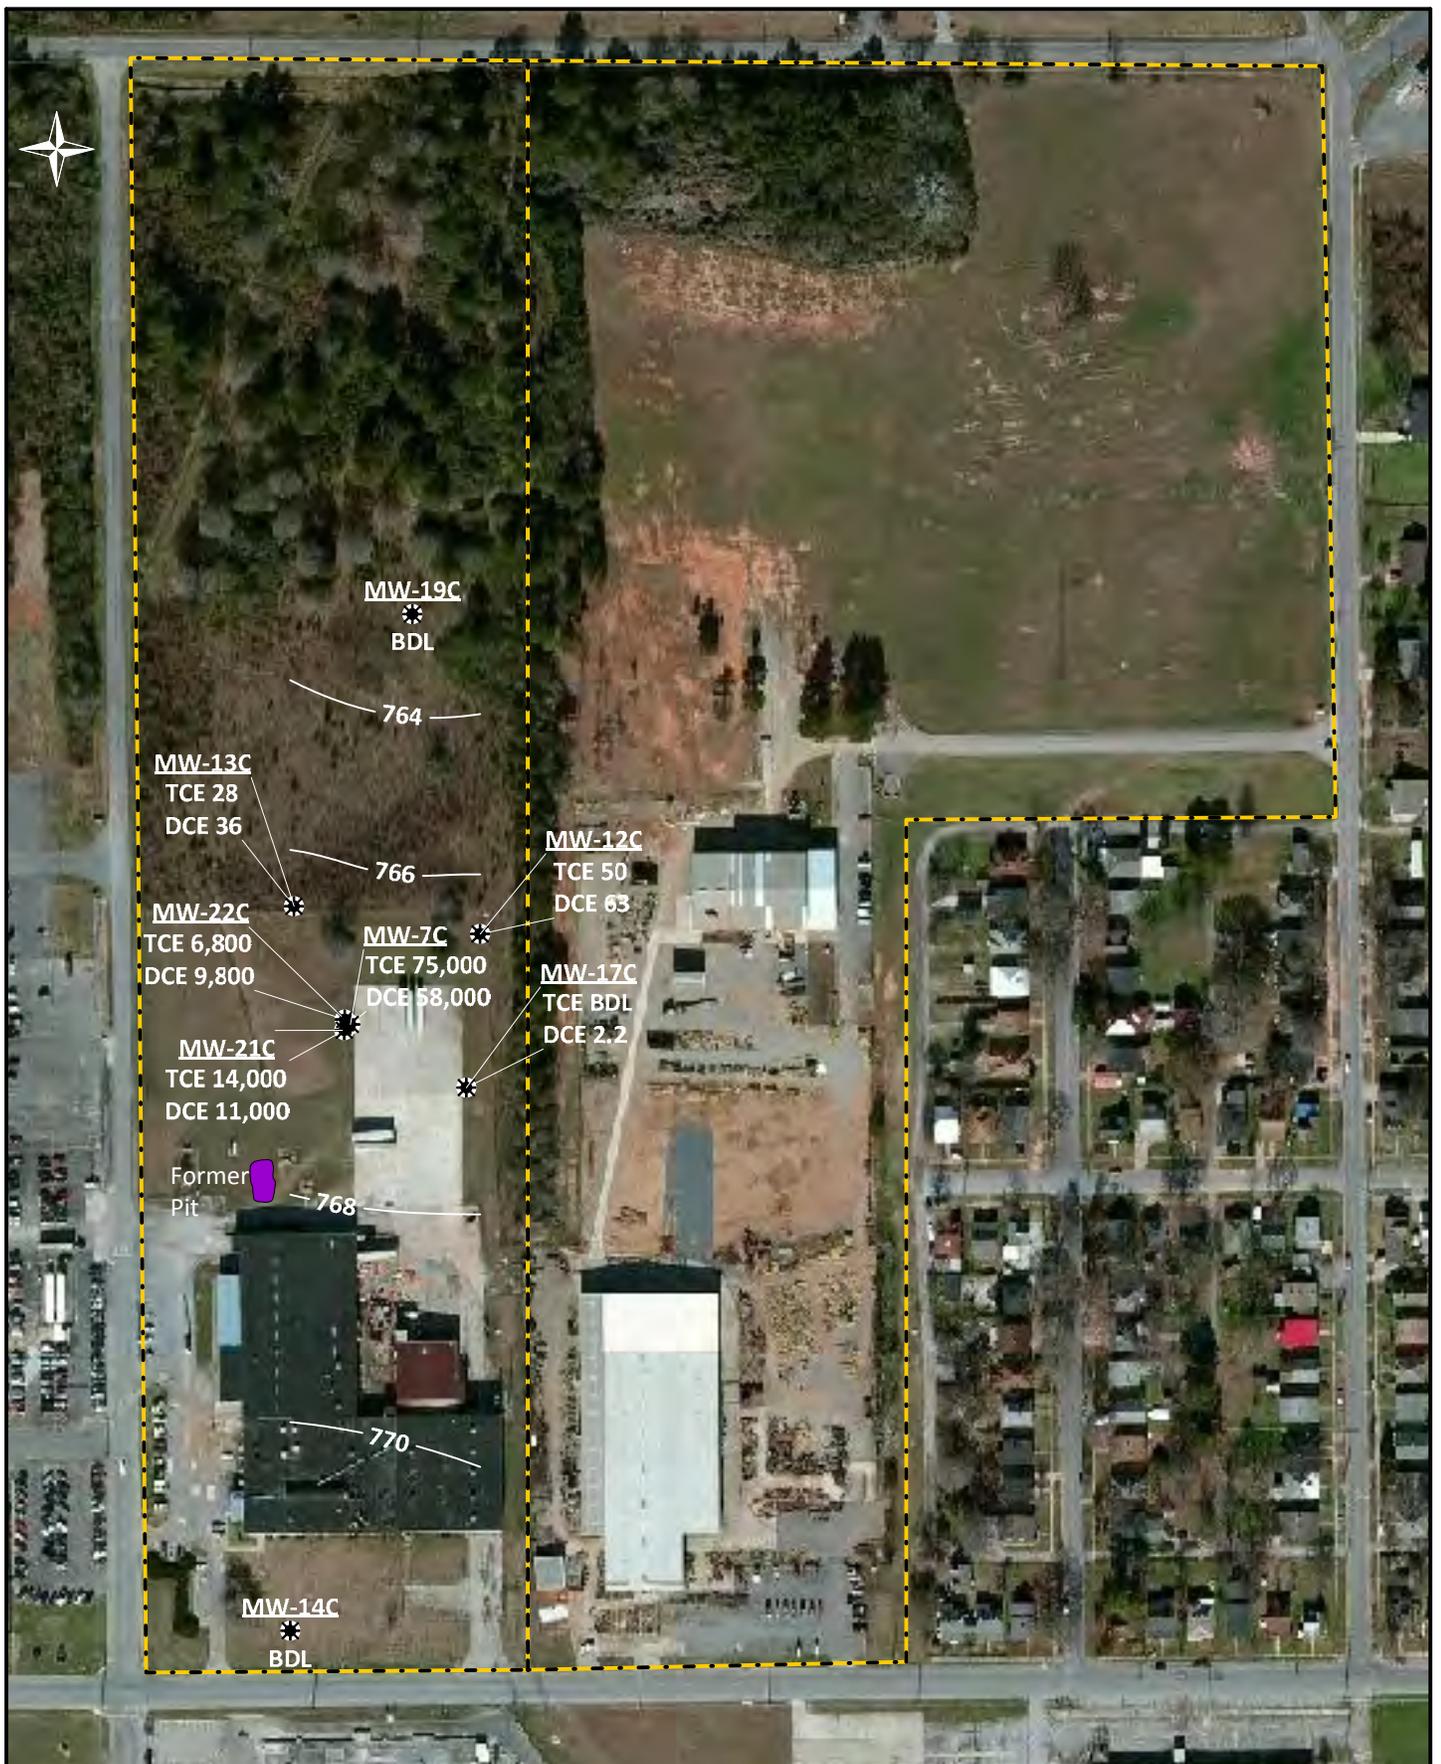
**Figure 3: Bedrock Potentiometric Surface Map**

Posted concentrations are most recent in ug/L.

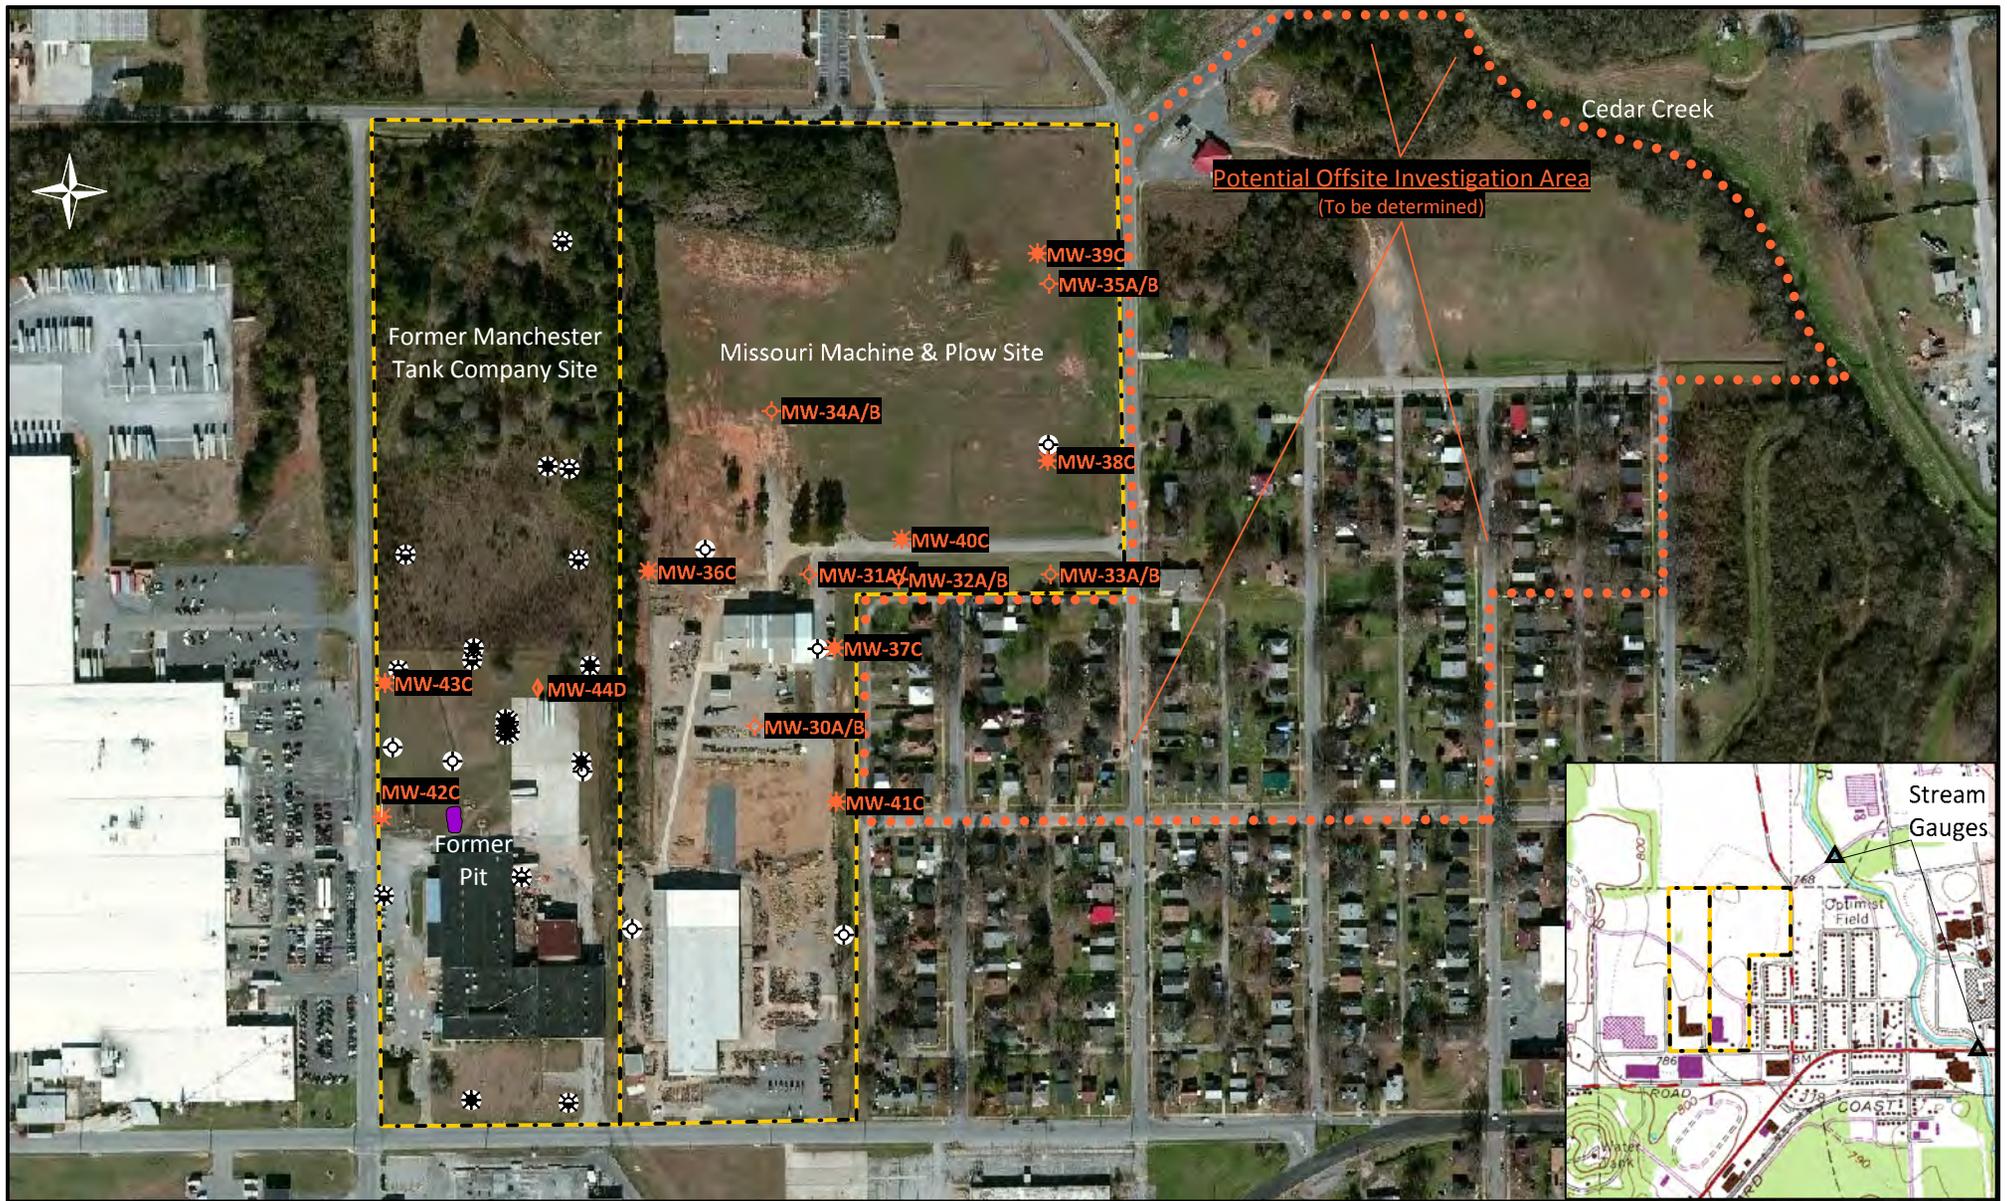
**Figure 4: Proposed Investigation Locations**  
 June 2012 Status Report  
 Former Manchester Tank Company Site  
 (HSI #10765)  
 Cedartown, Polk County, Georgia

The investigation on the Missouri M&P site will include an estimated six shallow groundwater monitoring wells that will be completed in the residuum and/or shallow bedrock (**Figure 4**), as necessary to penetrate the water table. These wells will be 1-inch diameter PVC wells installed using Geoprobe equipment constructed to the depth of bedrock, estimated to average approximately 15 to 20 feet below surface. If groundwater is not encountered in the residuum, a water table well will be installed into rock using air-hammer drilling techniques and completed as a 2-inch diameter well. Conventional monitoring well construction techniques and materials will be used.

- Residuum Well (A)
  - Shallow Rock Well (B)
  - Bedrock Well (C)
  - Vertical Delineation Well (D)

The proposed wells along the Missouri M&P site eastern boundary will be installed and sampled first during the investigation. Based on these data, the offsite groundwater investigation will be extended east of the Missouri M&P site. CDM Smith currently plans to use Geoprobe and temporary wells to screen for VOCs in groundwater within the general area shown on Figure 4. The purpose of this work will be to assess whether offsite issues such as potential vapor intrusion and/or discharge to Cedar Creek should be evaluated. Based on the results of the Geoprobe and temporary well data, permanent monitoring wells and/or characterization of Cedar Creek may be required.
