# **VOLUNTARY INVESTIGATION AND REMEDIATION PLAN**

**AMC INTERNATIONAL, INC.  
310 BROOKHOLLOW INDUSTRIAL BOULEVARD  
DALTON, WHITFIELD COUNTY, GEORGIA  
HSI SITE NO. 10405**

**AMEC Environment & Infrastructure, Inc.**  
1075 Big Shanty Road NW, Suite 100  
Kennesaw, Georgia 30144  
Project No: 6122-12-0076

**May 2012 / Revised June 22, 2012 / Revised April 12, 2013**

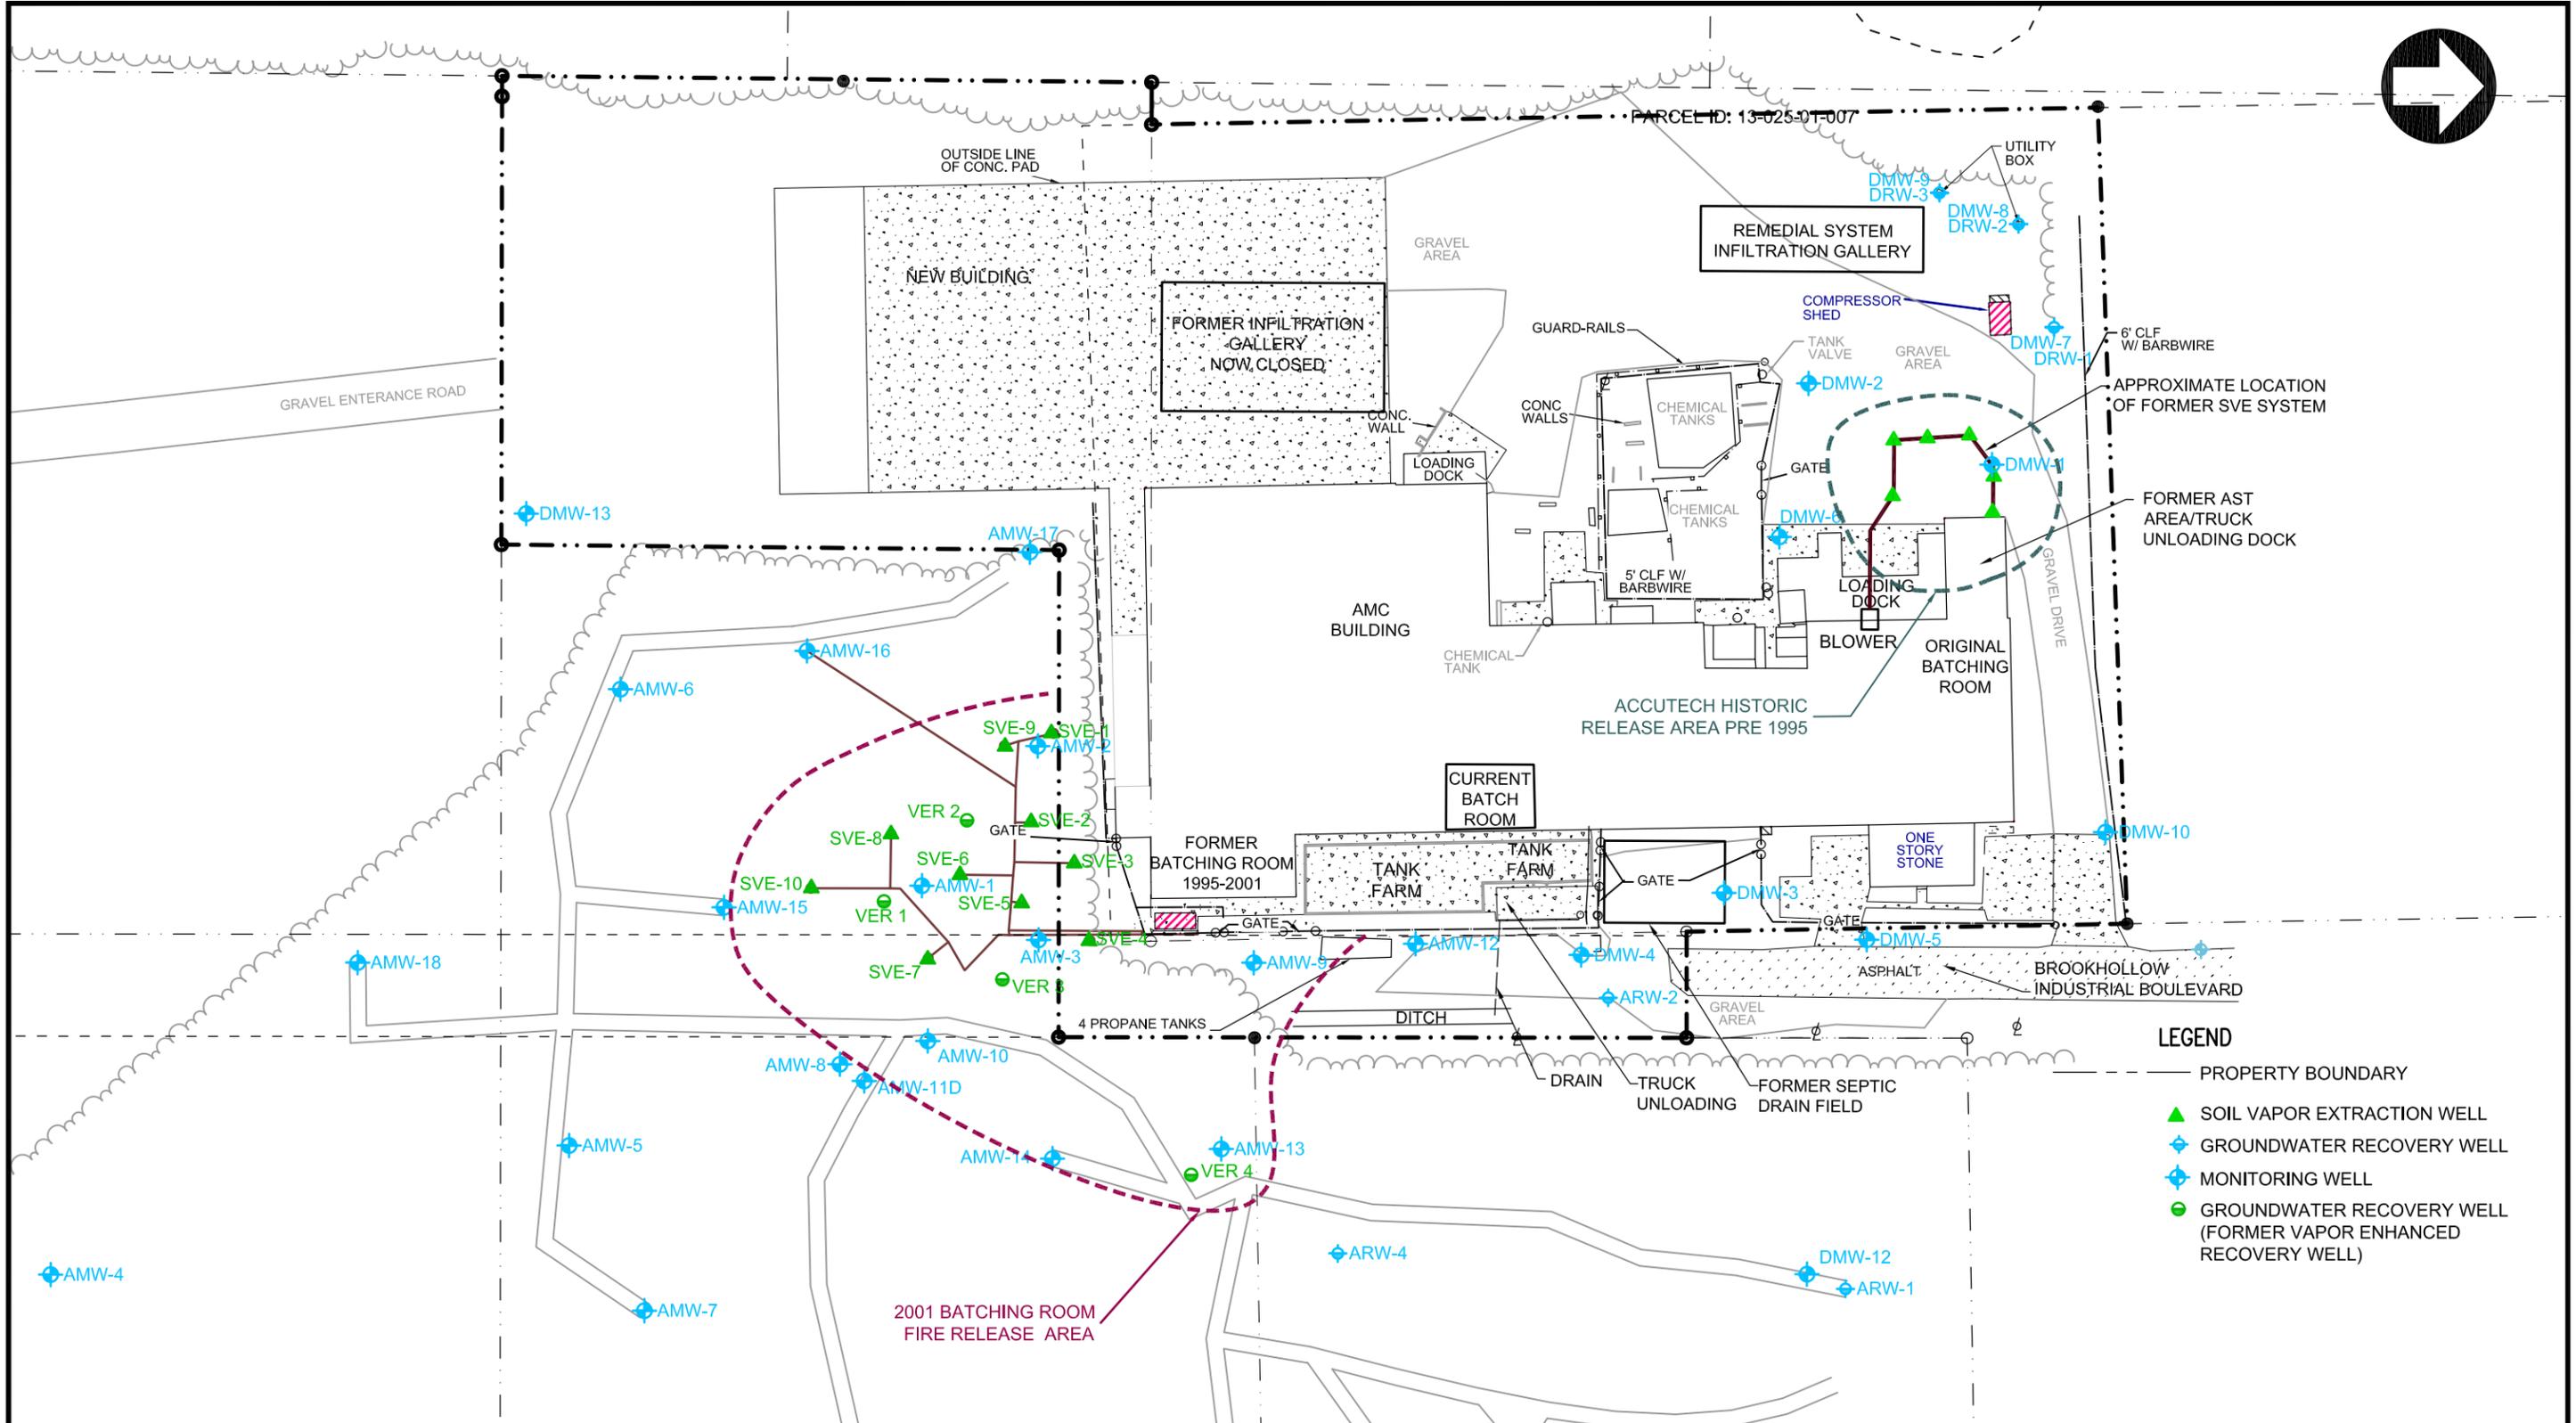
FIGURE 3

returned to the subsurface via the use of two separate infiltration galleries (Figure 3). Due to expansion and construction of a new building, initiated in April 2012, the infiltration gallery for the batching room fire groundwater recovery system was temporarily taken out of service and treated discharge was re-plumbed to the sanitary sewer for discharge under a publicly owned treatment works (POTW) pretreatment permit after air stripping and carbon polishing. The future use of the infiltration gallery will be determined following construction and planned evaluations.

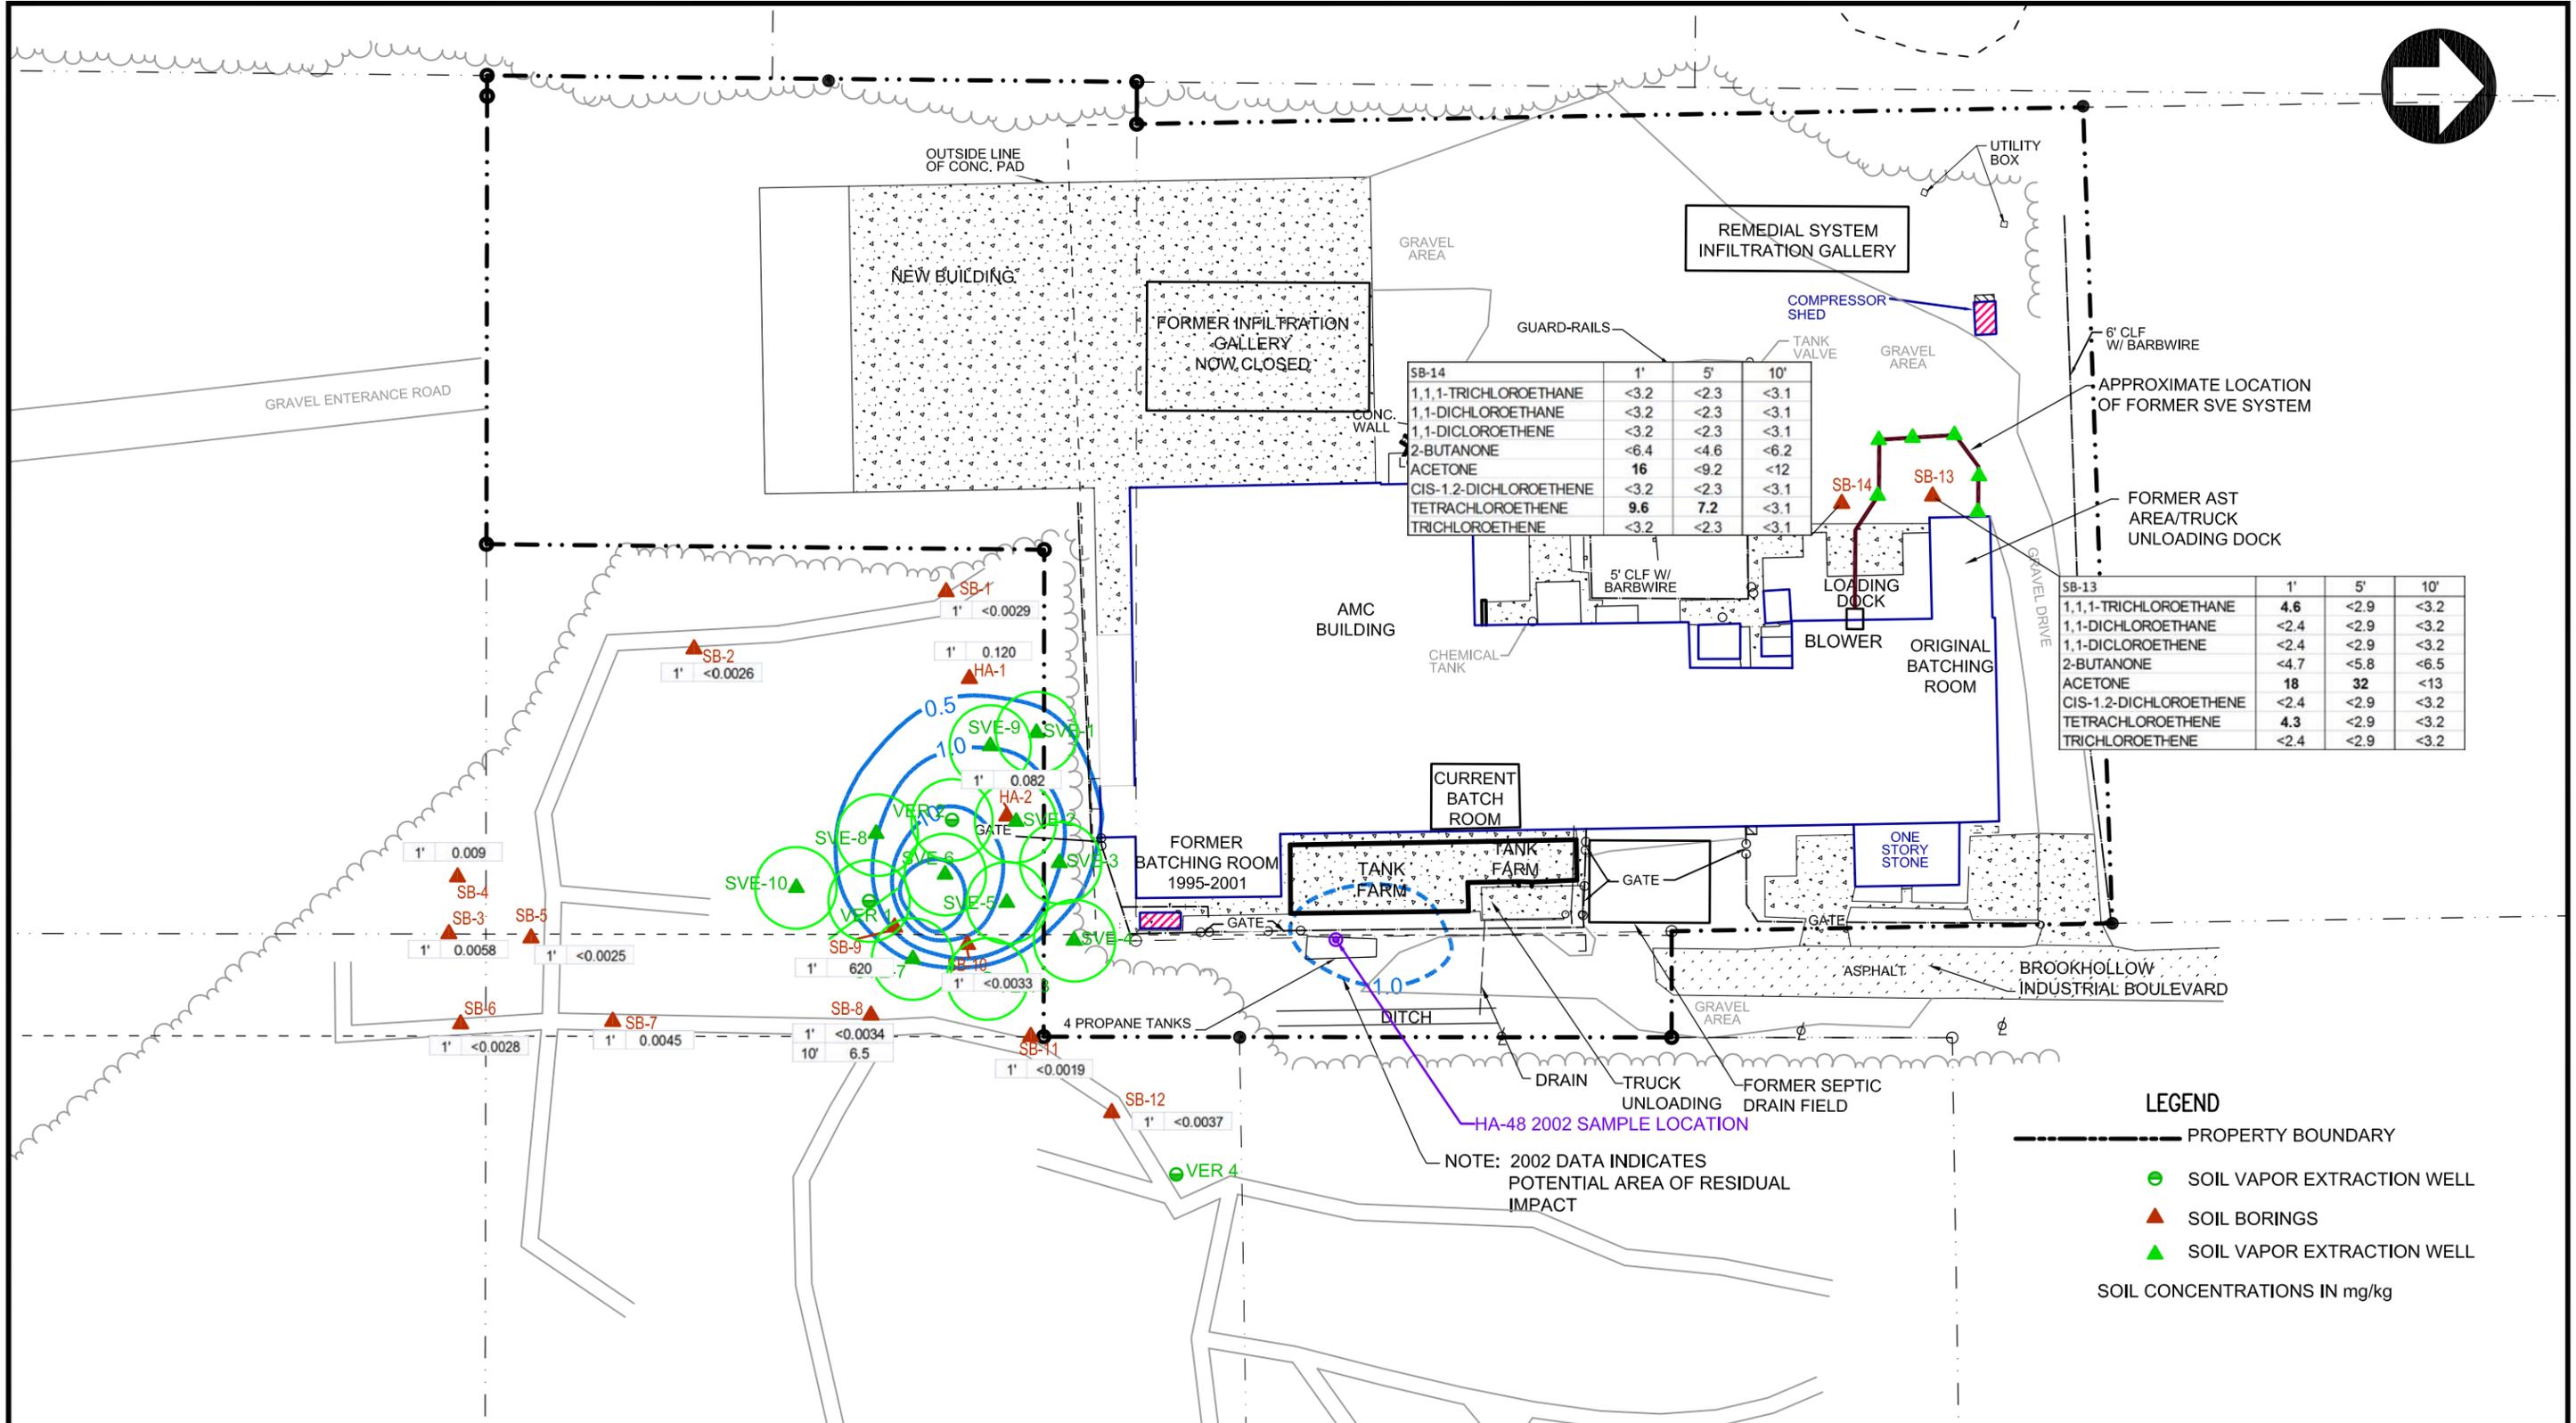
JOB NO. 6122-12-0076 FIGURE 5B

1'	5'	10'
SB-14			
1,1,1-TRICHLOROETHANE	<3.2	<2.3	<3.1
1,1-DICHLOROETHANE	<3.2	<2.3	<3.1
1,1-DICHLOROETHENE	<3.2	<2.3	<3.1
2-BUTANONE	<6.4	<4.6	<6.2
ACETONE	16	<9.2	<12
CIS-1,2-DICHLOROETHENE	<3.2	<2.3	<3.1
TETRACHLOROETHENE	9.6	7.2	<3.1
TRICHLOROETHENE	<3.2	<2.3	<3.1

1'	5'	10'
SB-13			
1,1,1-TRICHLOROETHANE	4.6	<2.9	<3.2
1,1-DICHLOROETHANE	<2.4	<2.9	<3.2
1,1-DICHLOROETHENE	<2.4	<2.9	<3.2
2-BUTANONE	<4.7	<5.8	<6.5
ACETONE	18	32	<13
CIS-1,2-DICHLOROETHENE	<2.4	<2.9	<3.2
TETRACHLOROETHENE	4.3	<2.9	<3.2
TRICHLOROETHENE	<2.4	<2.9	<3.2

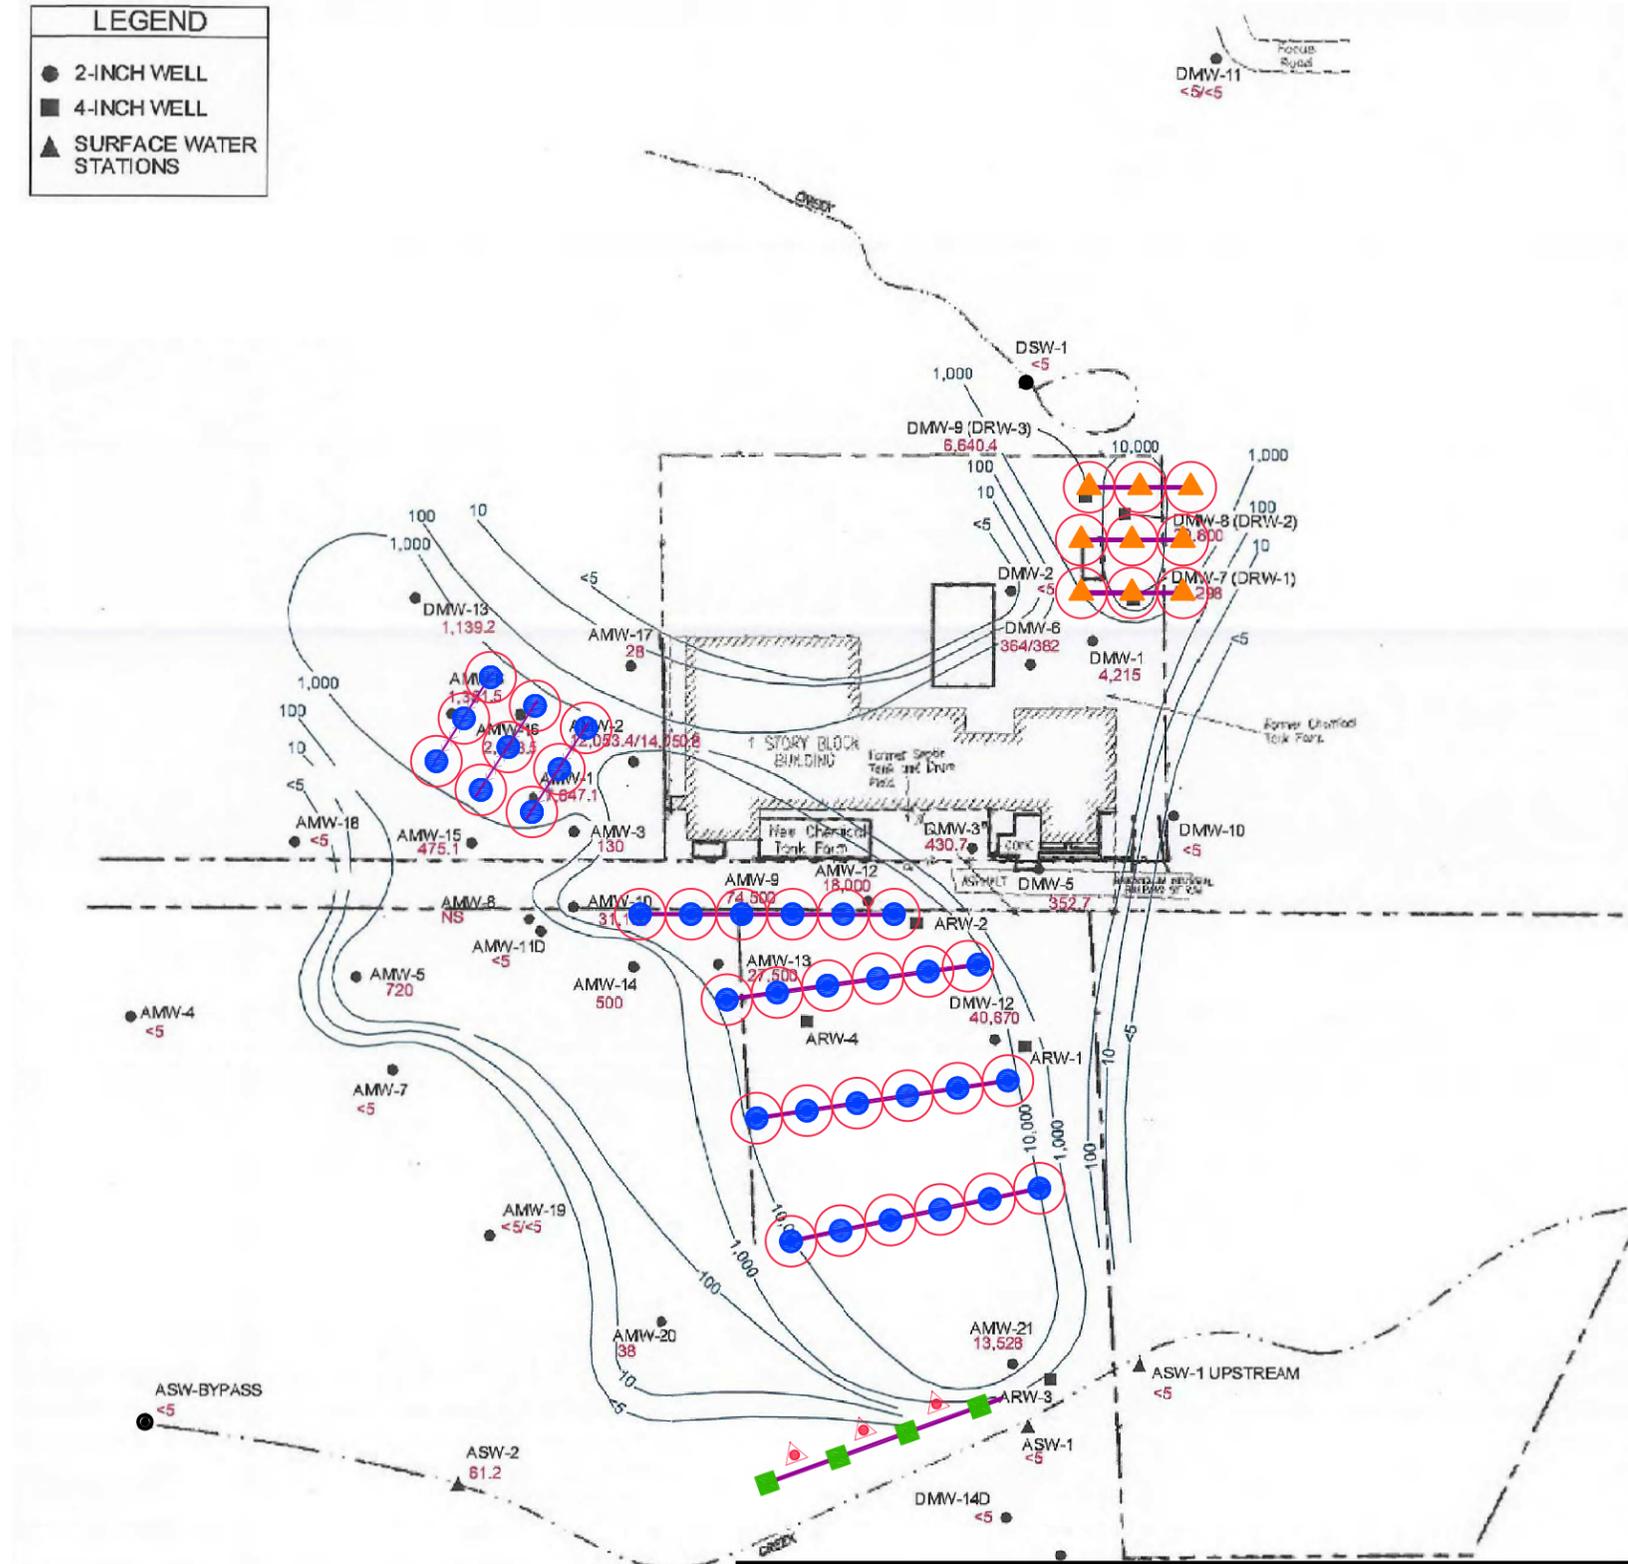
The proposed layout of the ISCO injection wells is shown on Figure 19. In the batch room fire release primary source area, the data suggests that both the residuum and upper fractured bedrock should be targeted for remediation. Three rows of 6 residuum injection wells and 3 bedrock injection wells are proposed in the batch room fire primary release area (total of 18 residuum injection wells and 9 bedrock injection wells). The residuum injection wells will be screened across the lower 10 feet of the residuum, and the bedrock injection wells will screen the upper 10 feet of the fractured bedrock. The radius of influence (ROI) in the residuum injection wells is expected to be approximately 15 feet, and the ROI in the bedrock injection wells is expected to be approximately 25 feet. The ROI estimates are based primarily on experience at similar sites in similar geologic settings and discussions with ISCO injection providers. Continued operation of downgradient pumping wells should also improve the

LEGEND	
✕	RESIDUUM/SAPROLITE INJECTION PERMANGANATE
■	PROPOSED RECOVERY WELL
●	WEATHERED ROCK INJECTION PERMANGANATE
▲	WEATHERED ROCK INJECTION PERSULFATE
▲	NEW PIEZOMETERS
○	ESTIMATED RADIUS OF INFLUENCE

In the downgradient portion of the batch room fire release area, the data suggest that impacts are limited to the upper 20 feet of fractured bedrock. Therefore, 4 rows of 6 fractured bedrock injection wells are proposed (total of 24 bedrock injection wells).

In the TCA plume, the data suggest that only the upper fractured bedrock should be targeted for remediation. A total of 3 rows of 3 bedrock injection wells (total of 9 bedrock injection wells) are proposed in the TCA plume area, and the wells will be screened across the upper 20 feet of the fractured bedrock.

In the batch room fire release area, approximately 2100 gallons of an approximate 2% permanganate solution will be injected in each residuum injection well, and approximately 3700 gallons of an approximate 5% permanganate solution will be injected in each of the bedrock injection wells. In the TCA plume area, approximately 3700 gallons of an approximate 5% persulfate solution will be injected into each of the bedrock injection wells. To estimate the chemical dosage rates, the porosities of the residuum (20%) and fractured bedrock (0.05%) were estimated based on typical literature values, and the pore volume of water within the assumed ROI was calculated. The assumed chemical dosage rates were on the high end of the typical range to be conservative since a pilot test is not proposed. For estimating purposes, we have assumed that three complete injection events will be conducted at approximate 9-month intervals in each area. However, the injection program will be re-evaluated each time, based on the observed results after each injection event. It is thought that operation of the groundwater recovery and treatment system will help distribute the oxidant solution throughout the impacted area after the injection events. Therefore, it will remain operational during the injection program.

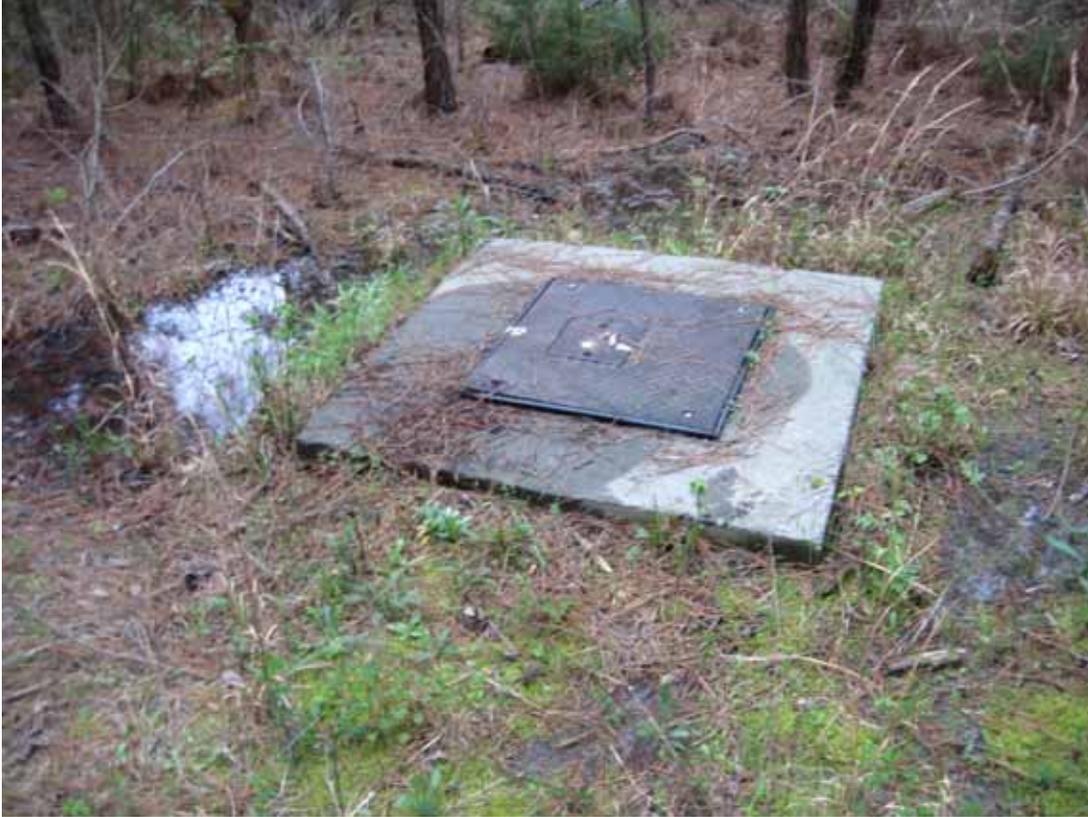
**Photograph No. 20:** Water inside RW-4 cover from probable leaking recovery pump line.

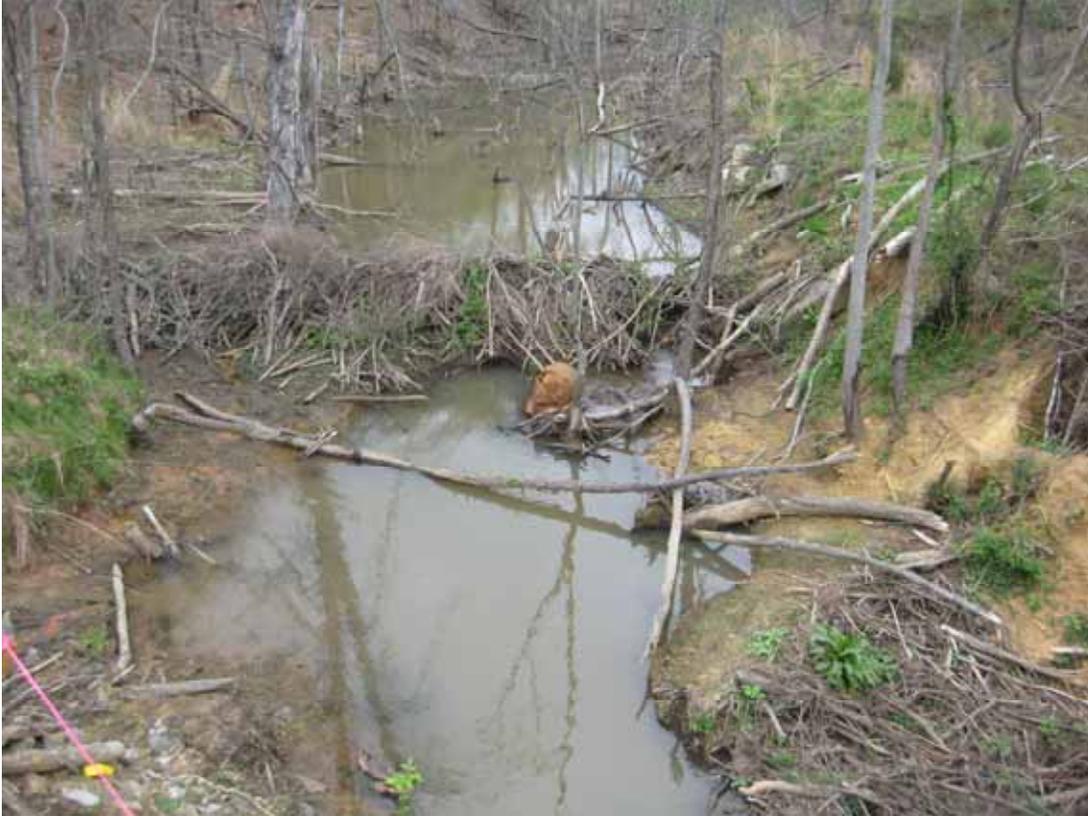
**Photograph No. 29:** Creek approximately ¼-mile south of the Site at Kraft drive looking north. Debris, used oil containers, and rusted drums from potential off-site properties have washed down here.
