# **Watershed Improvement Plan Phase II Revision**

## **Long Cane Creek**

**(Panther, Blue John & Long Cane Creeks, d/s LaGrange to Chattahoochee River)**

September 30, 2011

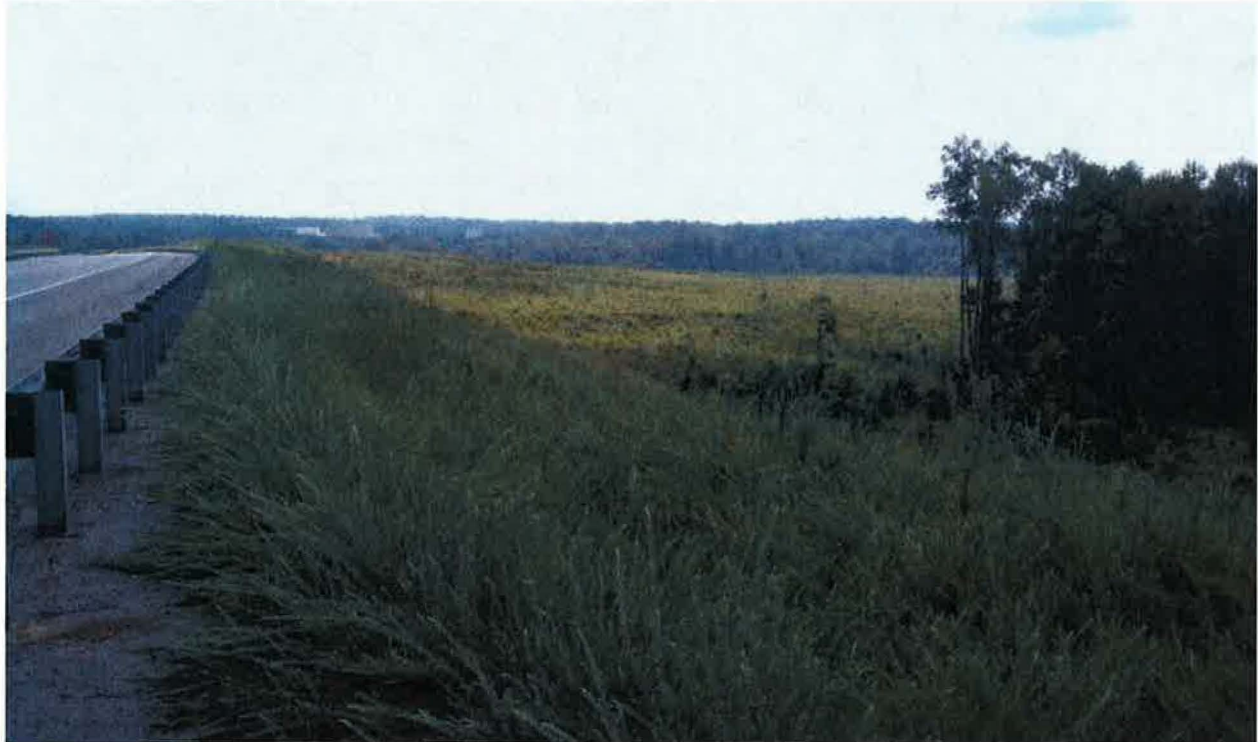
The photo below shows some of the vacant land associated with the Callaway South Industrial Park near the entrance to Sewan America Inc., which is Kia’s largest supplier.

Blue John Creek is located in the distance near the edge of the tree line. It empties into Long Cane Creek approximately a half mile from this location.

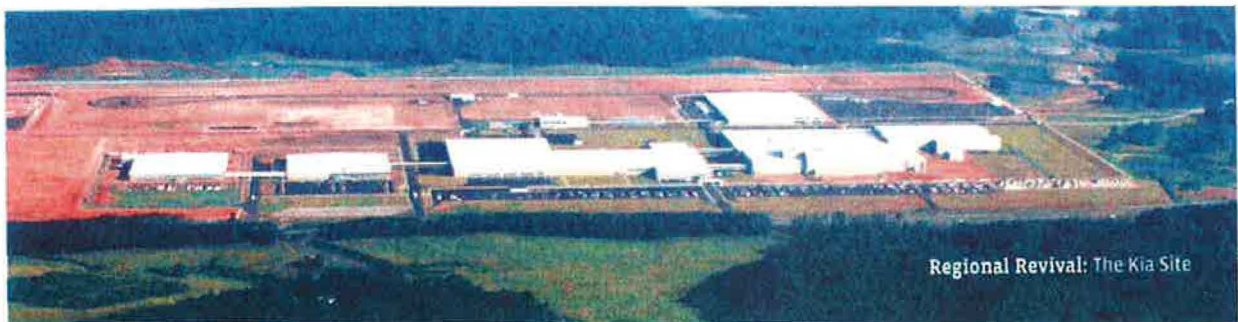
The photo below is an excerpt from Georgia Trend Magazine and shows the newly built Kia Motors Manufacturing Plant site. Long Cane Creek is located parallel to this site just beyond the tree line. This significant land use change is a special case and is the most extreme within the watershed. The 3,000 acre site was previously farmland, rural residential and vacant natural land.

According to the Joint Public Notice of the Department of the Army Permit required by Section 404 of the Clean Water Act for Kia site preparation; 9,909 linear feet of stream, 0.03 ephemeral stream channel was to be piped, and 25.2 acres of natural wetlands to be filled. The Long Cane Stream channel itself was not changed, though it makes up the western border of the Kia site.

The permit also indicates a conceptual mitigation plan was submitted to compensate for the loss of riparian corridors and wetland areas. The plan was to consist of on-site and near-site wetland preservation, enhancement, restoration, stream buffer preservation, riparian restoration, and stream channel restoration. The exact location of these improvements at the time of this WIP document is unknown. Further research can indicate how much these improvements contribute to the health of the Long Cane Creek watershed.

The greatest pollutant risk associated with industrial expansion, initially, is sediment/biota from clearing land for building. Increased sediment may have affected Long Cane Creek, since it flows directly adjacent to the site. Hopefully future watershed improvement plans will look at the sediment issue of the stream, since it is also listed for this parameter.

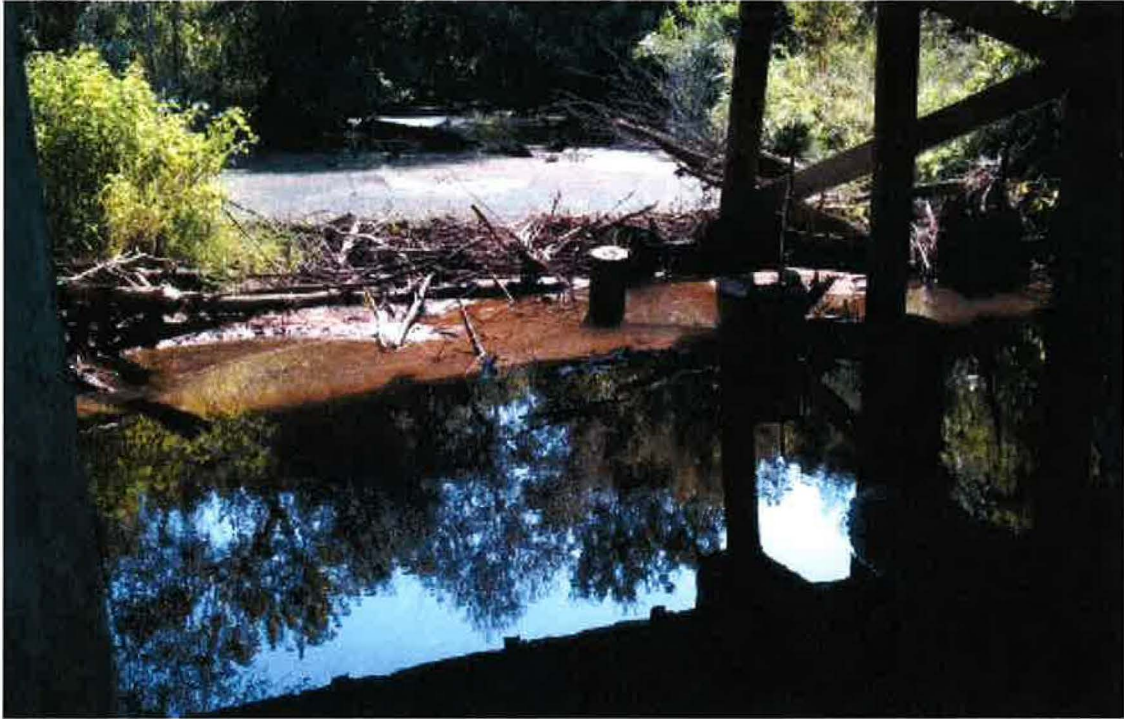
**Below is a photo of the creek at Site 1: New Hutchison Mill Road. Note the beaver dam impeding flow. Water sample was taken below the dam. September 23, 2010.**

Several stakeholders expressed concern over the high beaver population in portions of the Creek. Troup also has a high deer population (50 deer/square mile). Since large portions of the mid and lower watershed are forested, wildlife could have an impact on fecal loads.

- Additional Best Management Practices (BMPs) and other NRCS/RC&D programs could be utilized.
- Beaver dams under bridges continue to be a problem.
- Quite a few septic failures go unreported.
- EPD Adopt-a-Streams exist within the County, and the Long Cane Creek group has been inactive for a few years.

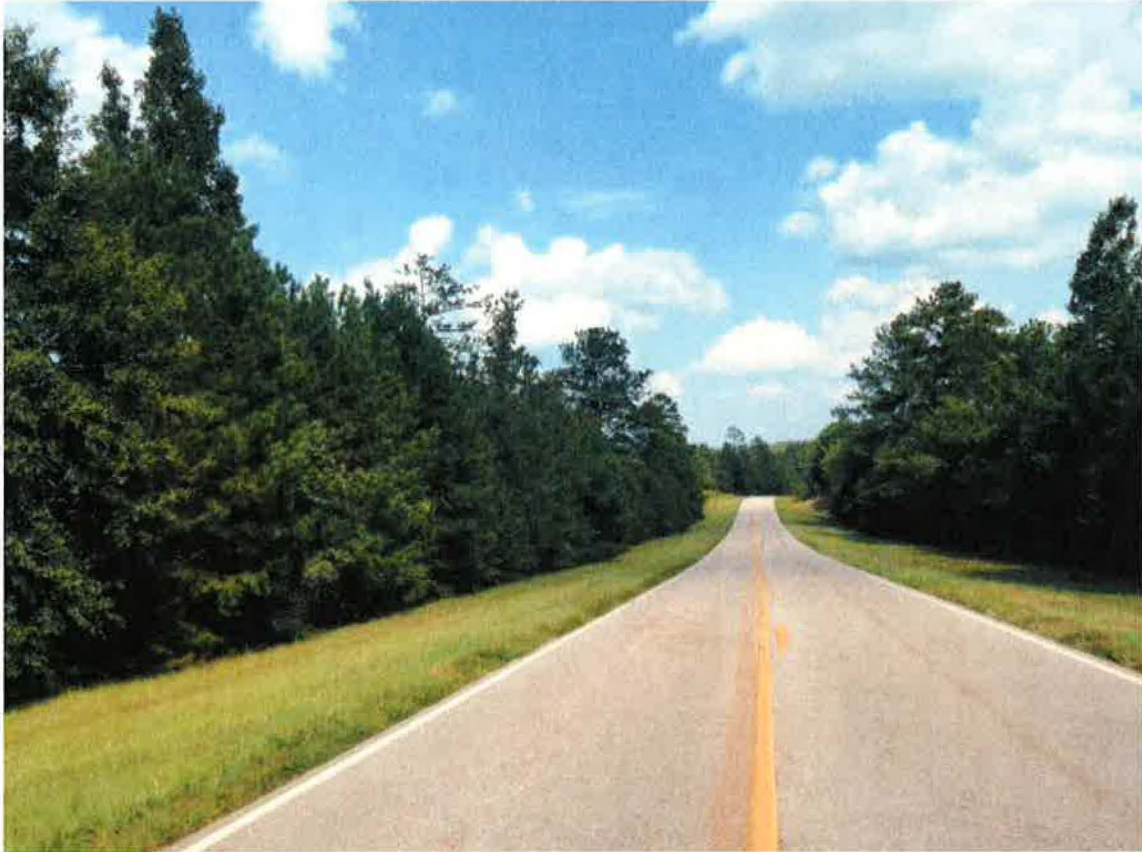
**Photo below was taken along Cannonville Road. Much of this segment of the watershed is forested and rural.**

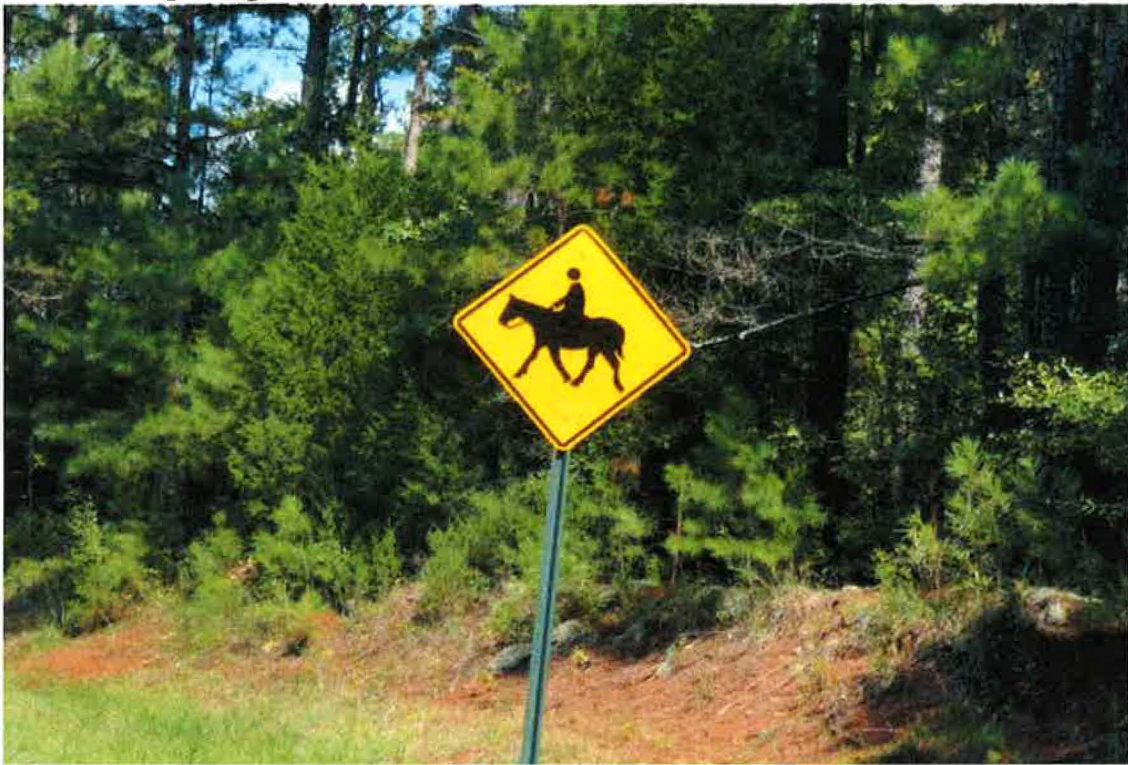
**Photo below was taken along Robert Taylor Road. As mentioned earlier, this is where the individual horse grazing is concentrated.**

The latest visual surveys conducted in September of 2010 revealed agricultural pasture land was still prevalent in the watershed. Very little agricultural land included active livestock or grazing and was mostly inactive except for hay production. This was observed via the adjacent roadways and not within the interior of parcels.

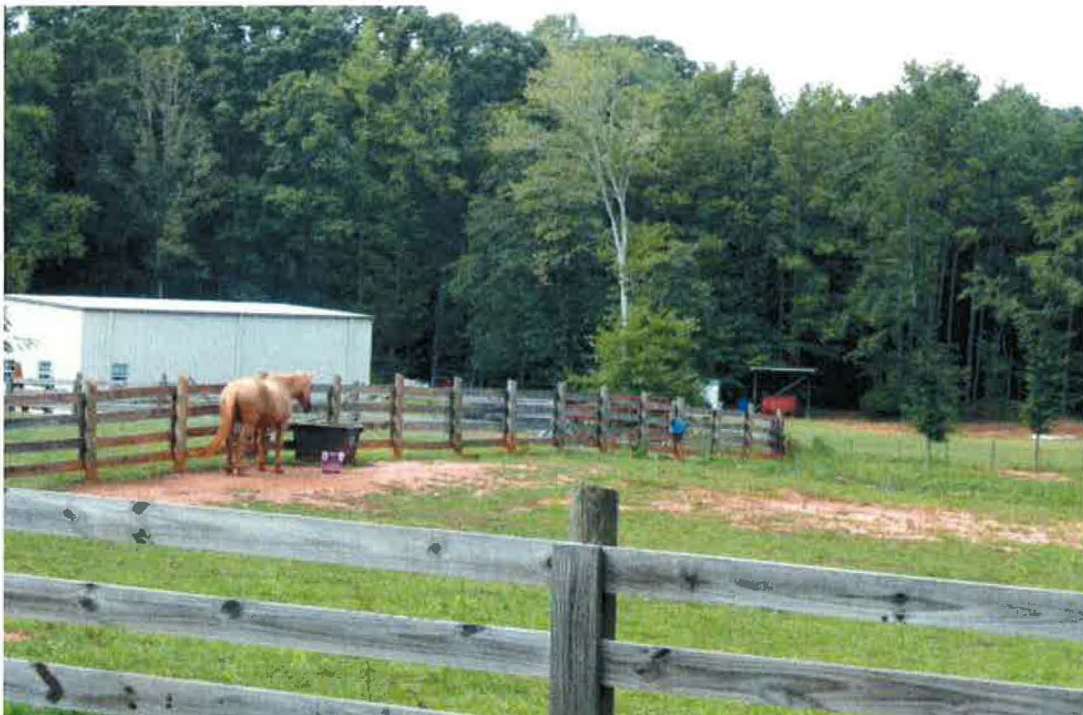
**Photo below is along Robert Taylor Road. Concentrated horse grazing is shown. September 2011.**

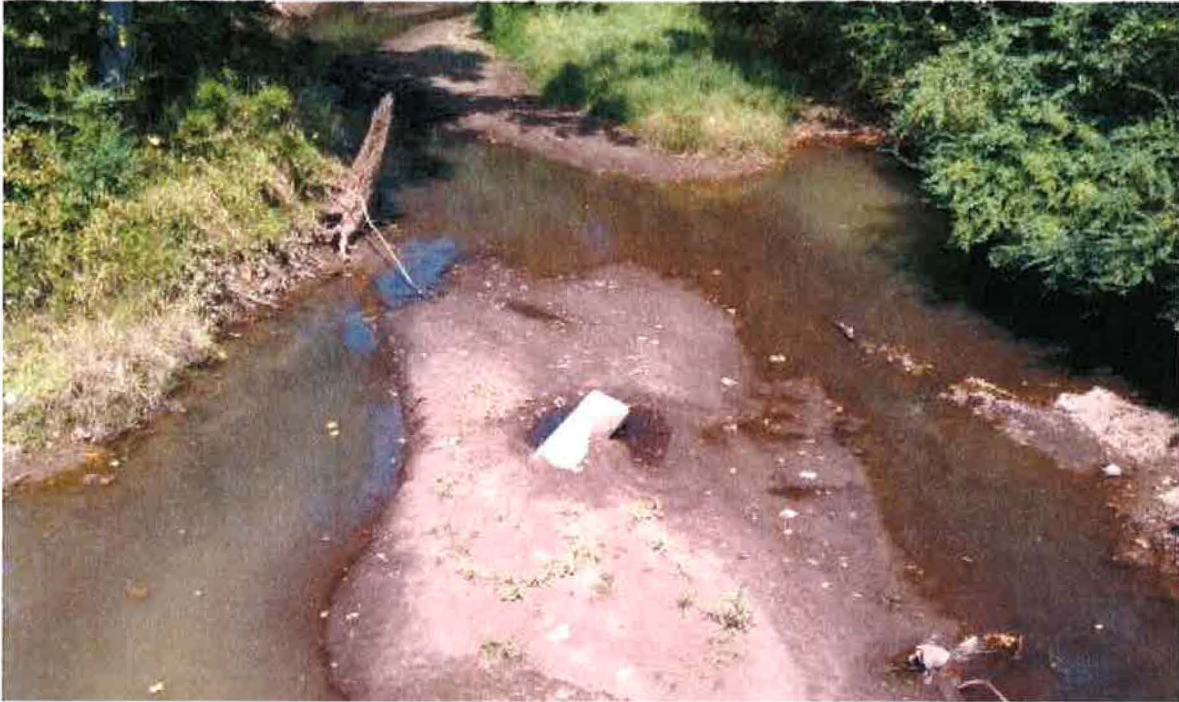
**Photo below was taken at Site 4: Webb Road. September 2010. Looking upstream.**

Sampling site 4.  
Near Kia Plant  
Water is muddy & cloudy  
Pools d/s - sand bars w/s  
Sand bars and low currents  
up-stream  
Turtles & water moccasin spotted.  
Water pools d/s with no visible current.  
No homes nearby - one burned

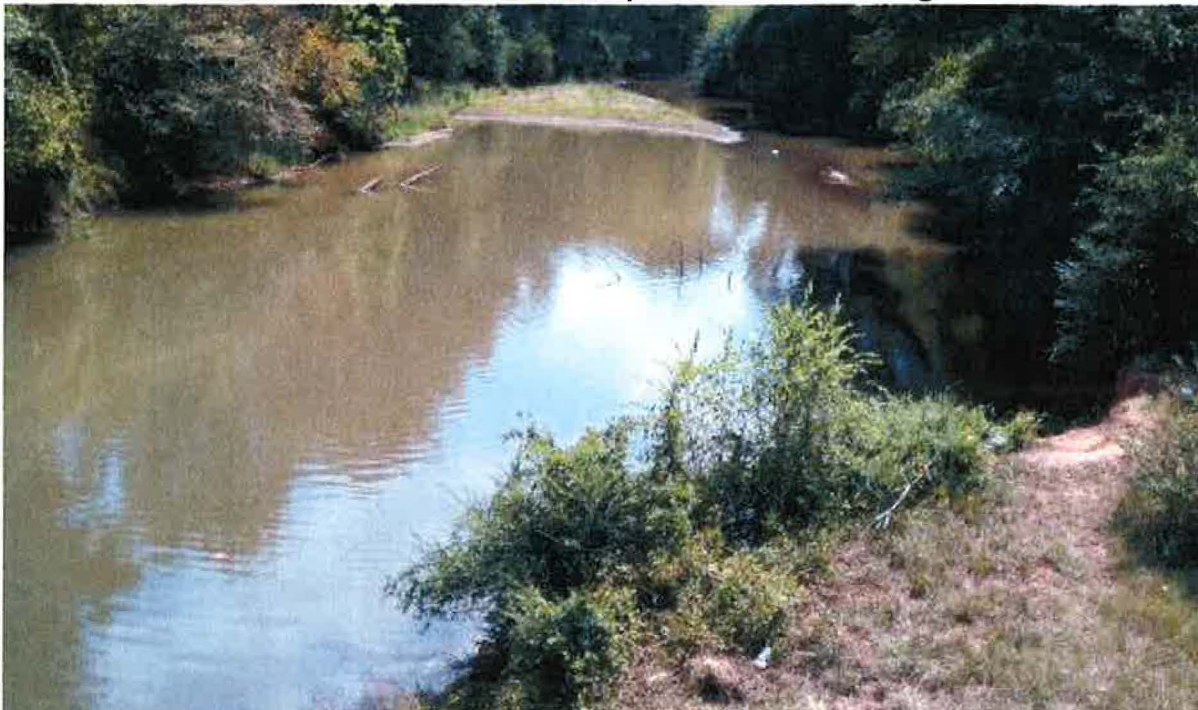
**Photo below was taken at Site 4: Webb Road. September 2010. Looking downstream.**

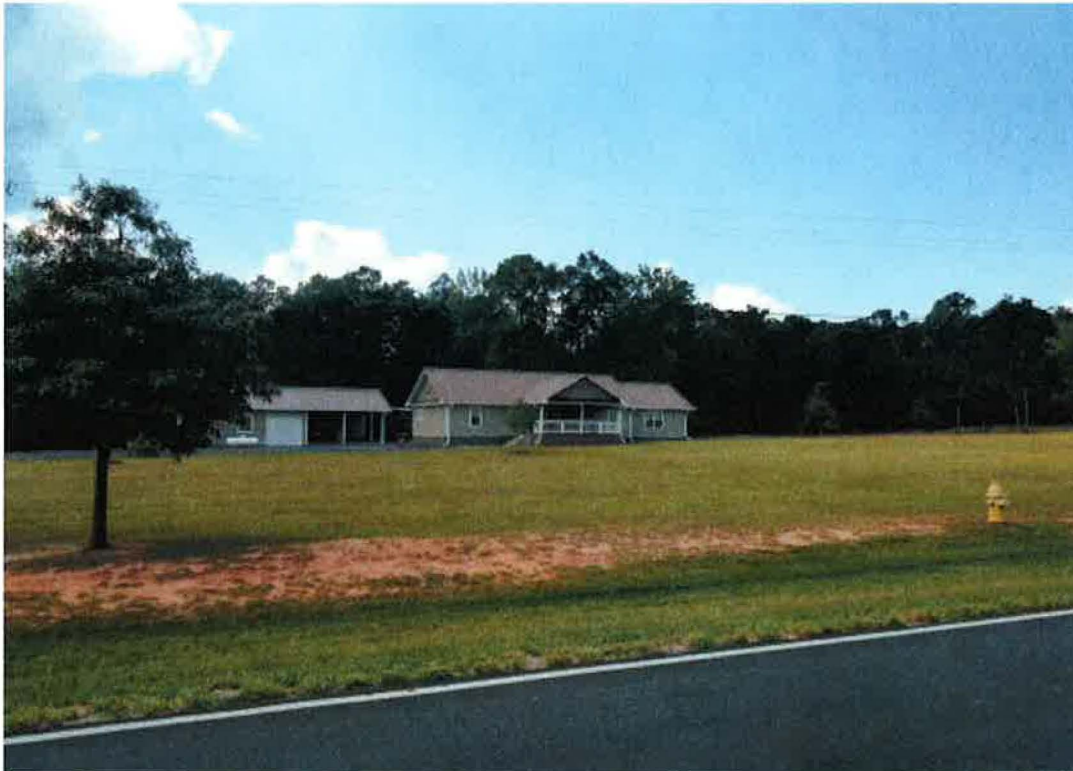
Photo taken September 2011. Example of the low density residential development within the watershed.

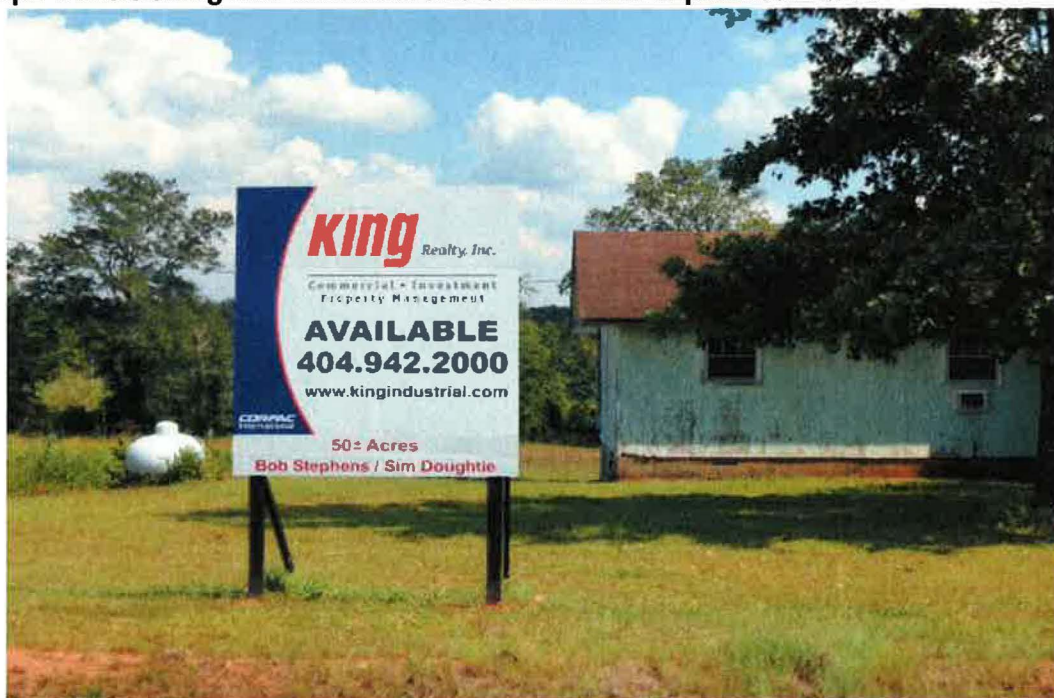
Photo taken along Warner Road just across from the Kia Plant. Photo shows the rural landscape transitioning into industrial and commercial. September 2011.

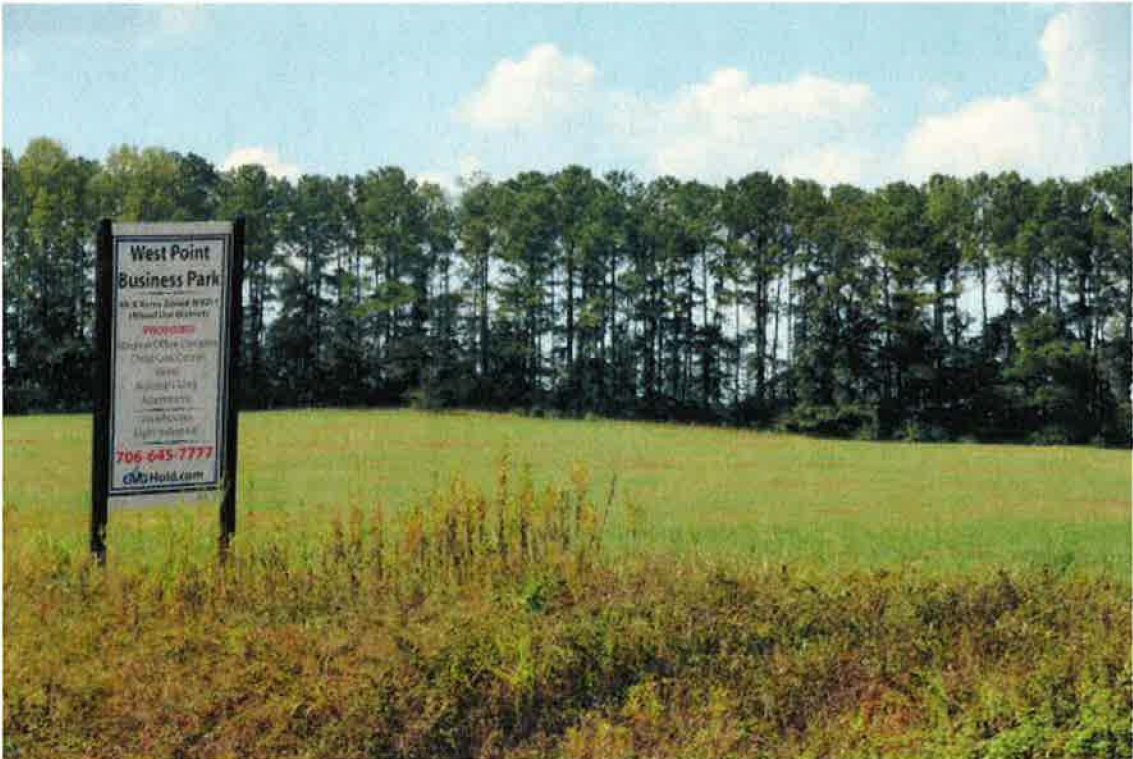
Photo below was taken along Webb Bartley Road. September 2011. Example of rural/vacant land with the potential for industrial or commercial use.

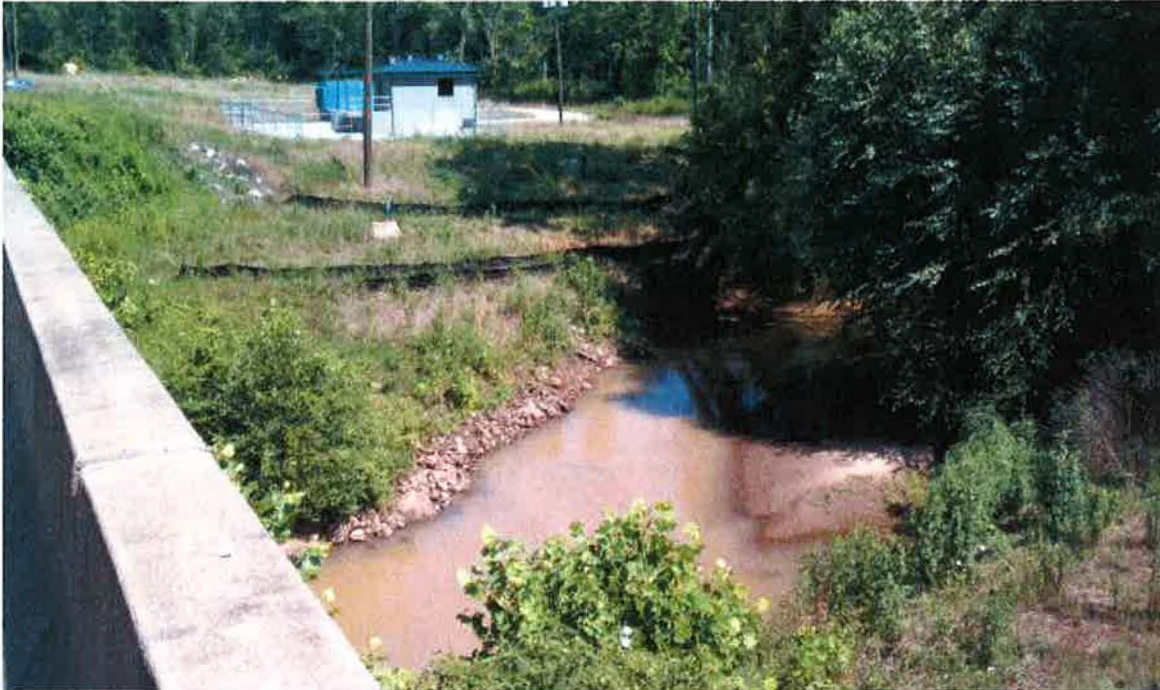
Photo below was taken at Site 5: Old West Point Road (E. 6<sup>th</sup> St.) showing recent sewer system upgrades by the City of West Point. Long Cane Creek and sewer caps visible below. September 2011.

With these industrial land use changes comes the extension of sanitary sewer lines which are more environmentally friendly than the current use of septic systems. The City of West Point has made sewer system improvements unrelated to the Kia site. This is evidenced in one of the visual survey photos.

Sewer lines are located within the floodplain in the cities of LaGrange and West Point. No leaks for overflows have been reported in the last two years.

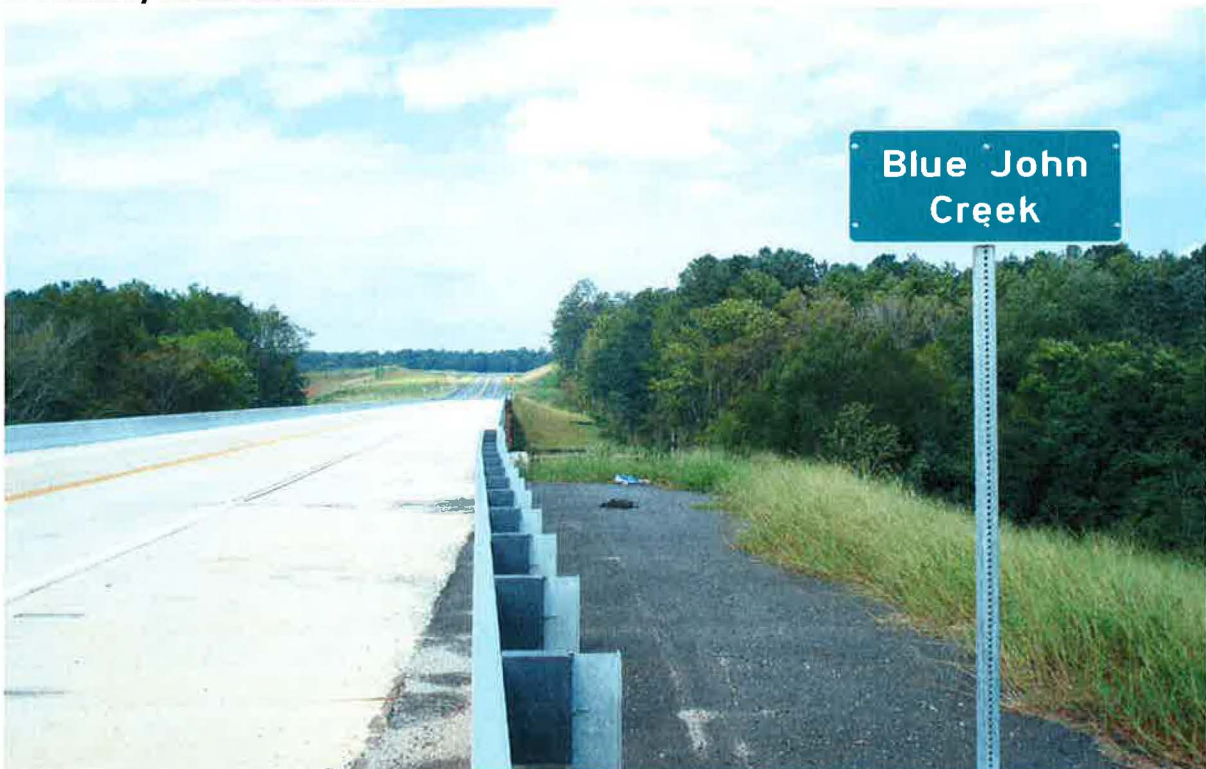
**Photo below taken on Pegasus Parkway in LaGrange looking to the bridge which crosses over Blue John Creek and the CSX Railroad. The picture also shows the undeveloped portions of the Callaway South Industrial Park.**

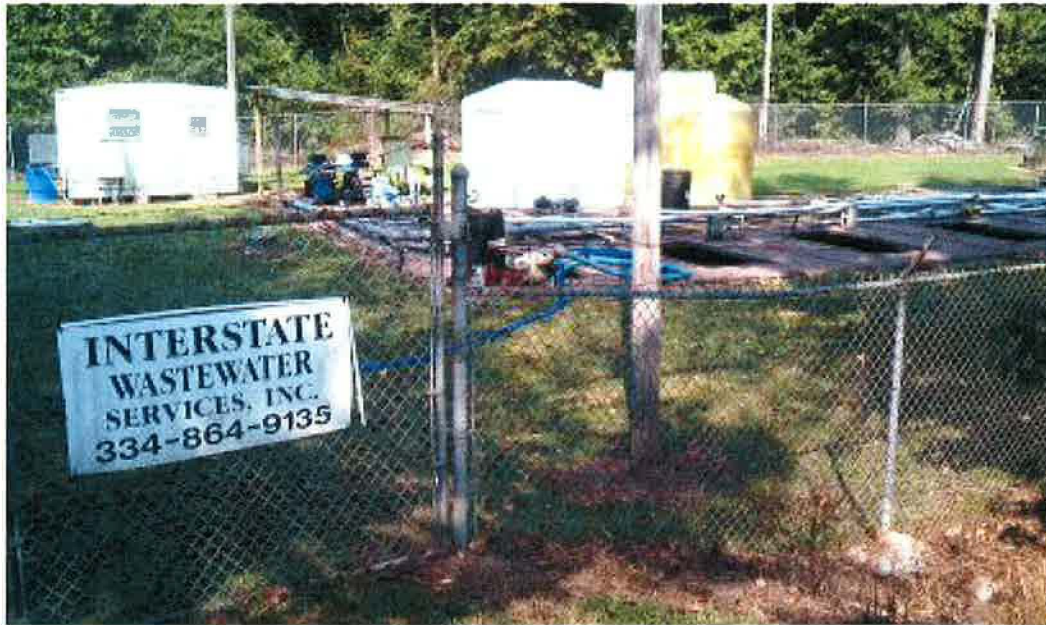
A small wastewater treatment plant operating under the name Raylar Corp (GA0032565) is located on Whitesville Road just north of Interstate 85, which is utilized by the nearby Pilot and Chapman's truck stops. A photo of the treatment plant is below.

- The City of LaGrange’s future annexation and expansion south for the Callaway South Industrial Park. This is located at the top of this study segment.
- Wastewater facility located on Whitesville Road identified as used for the nearby truck stop.
- Current flood zone maps do not truly show where flooding occurs along the creek corridor.
- The Flood Insurance Rate Maps (FIRMs) should be digitized and updated by now.
- Long Cane Elementary wastewater system has been failing and continues to fail leaking untreated sewerage into the watershed.
- Older homes near Kia and along Robert Taylor Road have had septic failures and repairs needed.
