SEMI-ANNUAL GROUNDWATER MONITORING REPORT NO. 16 JANUARY THROUGH JUNE 2016

CHEMTRADE SITE
EAST POINT, GEORGIA
HSI# 10498

Project Number GR5060

July 2016

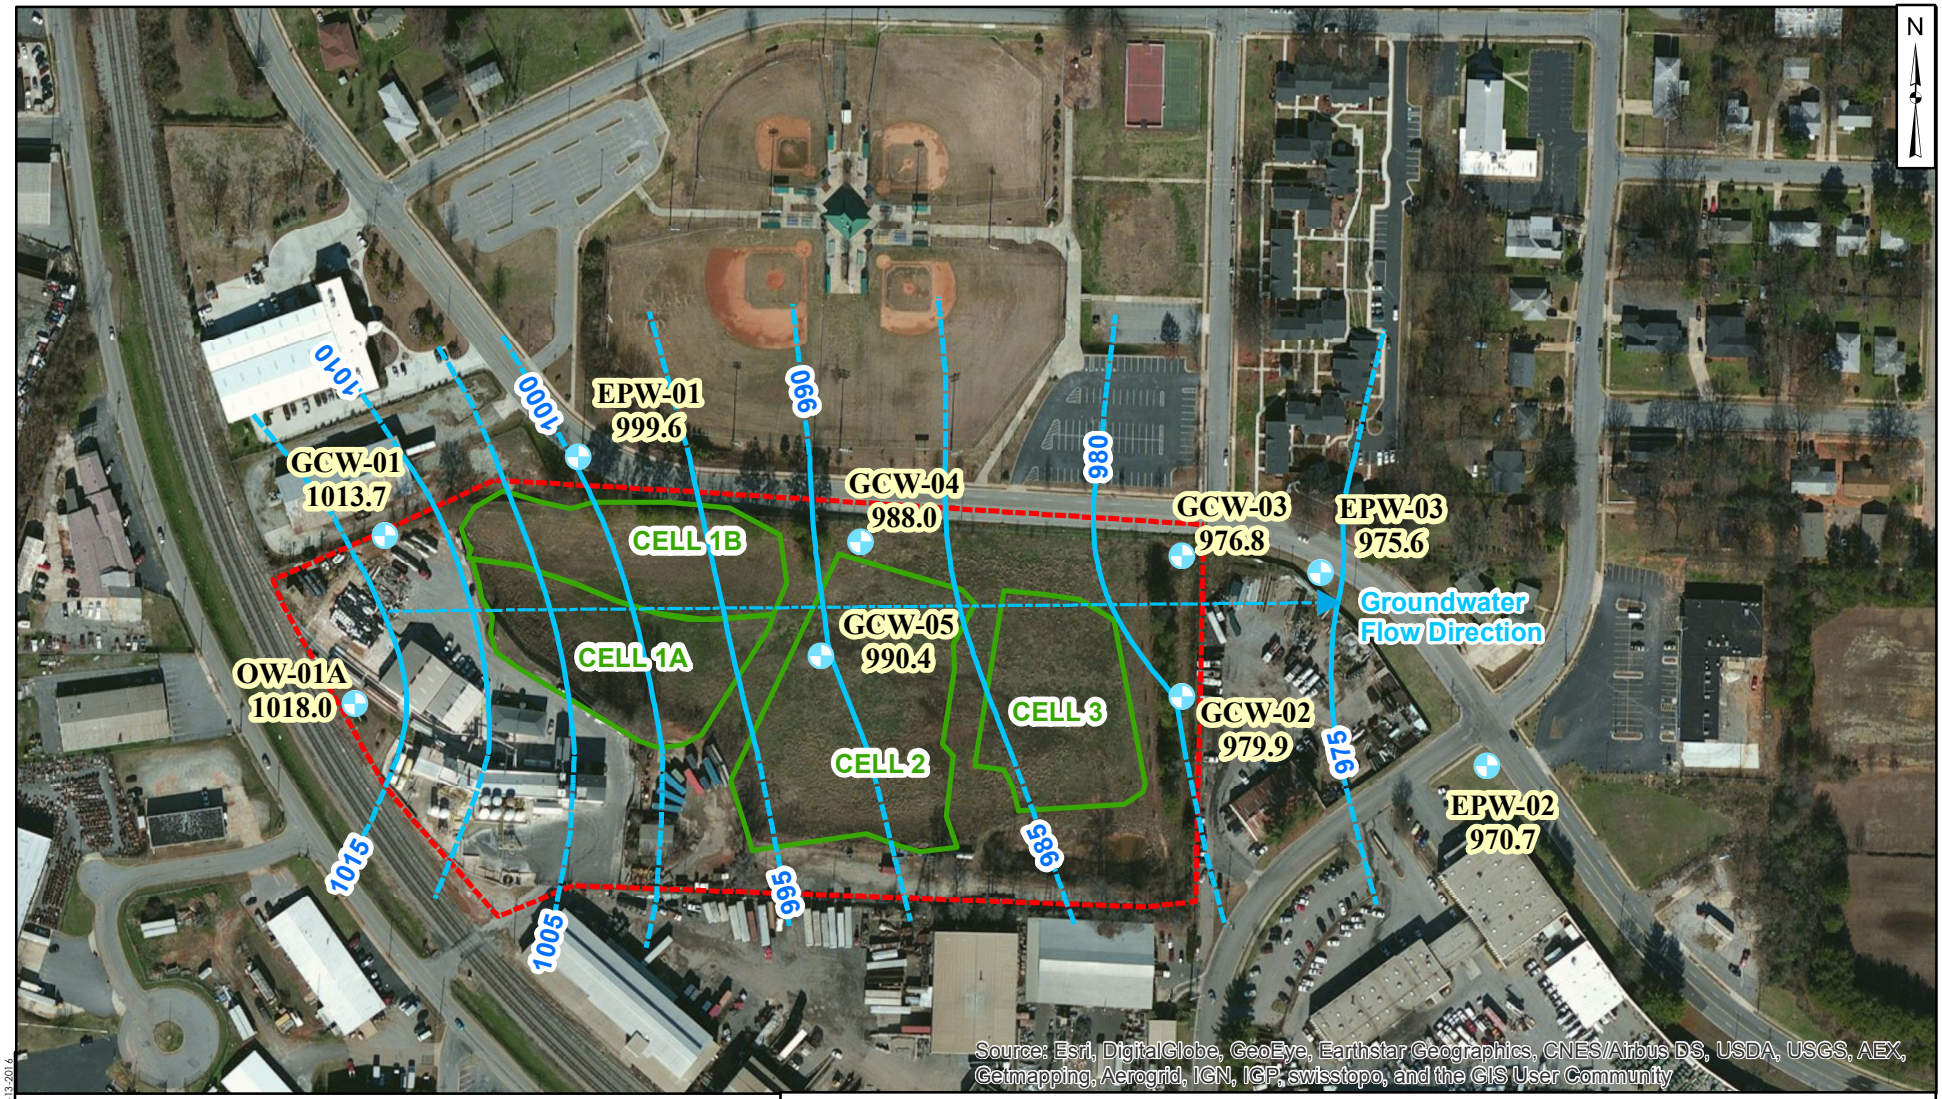
The potentiometric map for May 2016 readings is shown in **Figure 3-1**. This map shows the typical Piedmont pattern of flow following topography towards surface water features, which act as collectors and discharge points for the groundwater. Since there are no streams at the Site, the groundwater is flowing towards the local topographic low which is aligned parallel with North Martin Street and the storm drain system. The general potentiometric pattern is consistent with the overall drainage flow pattern to the east-southeast towards the South River.

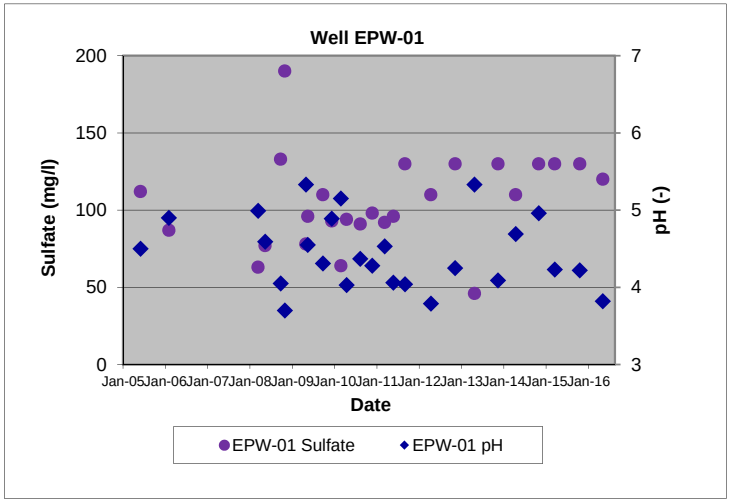
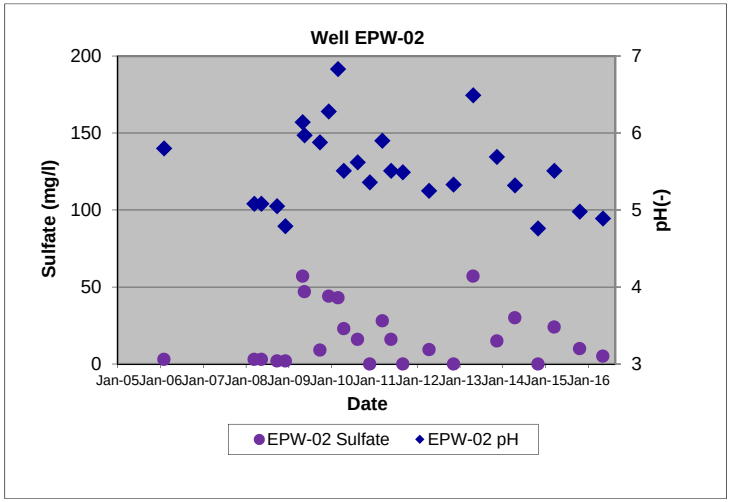
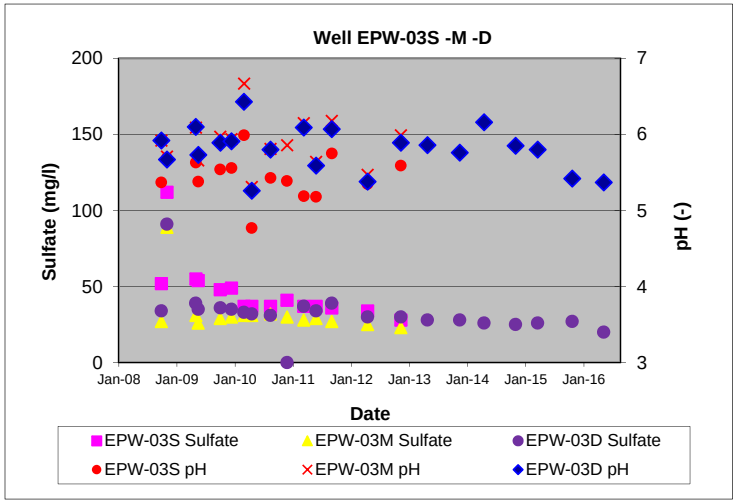
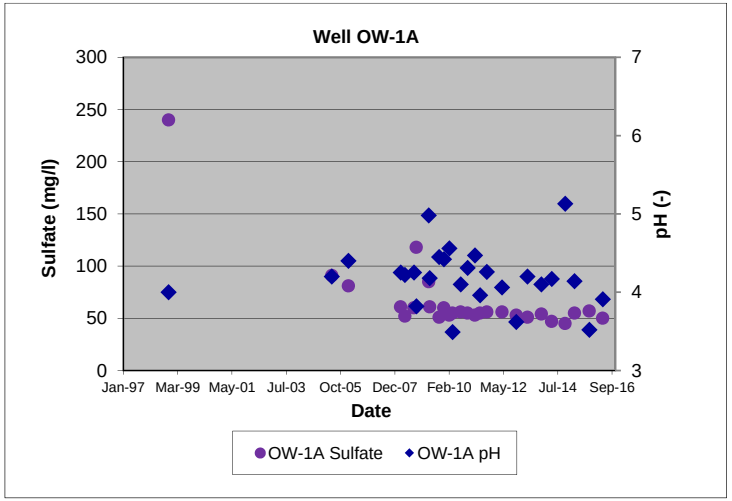
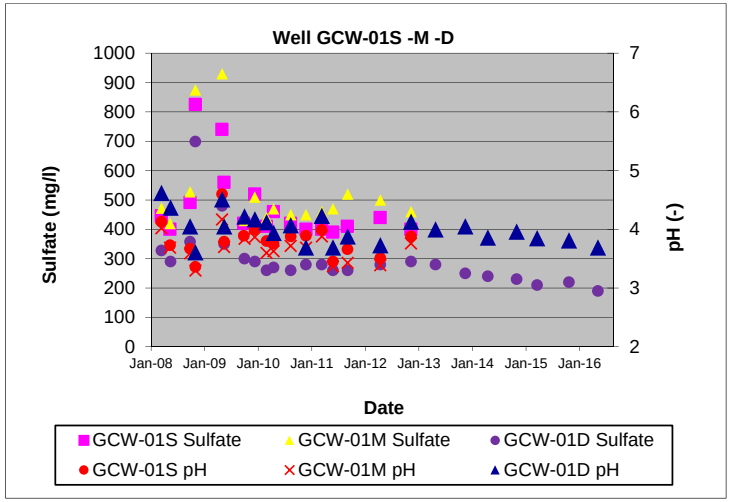
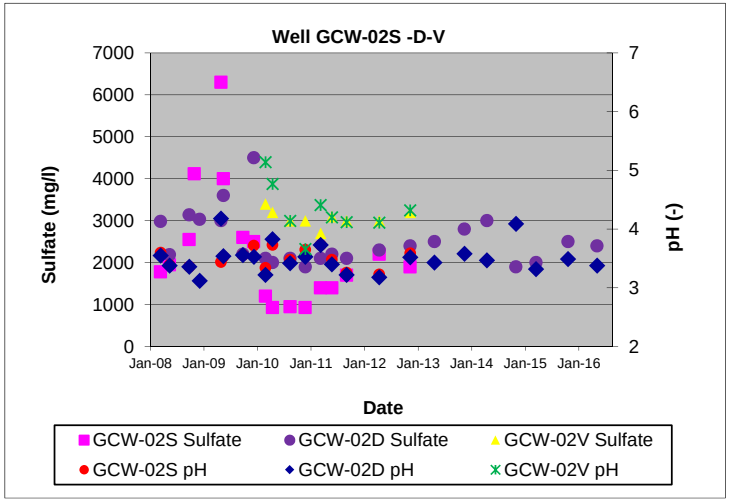
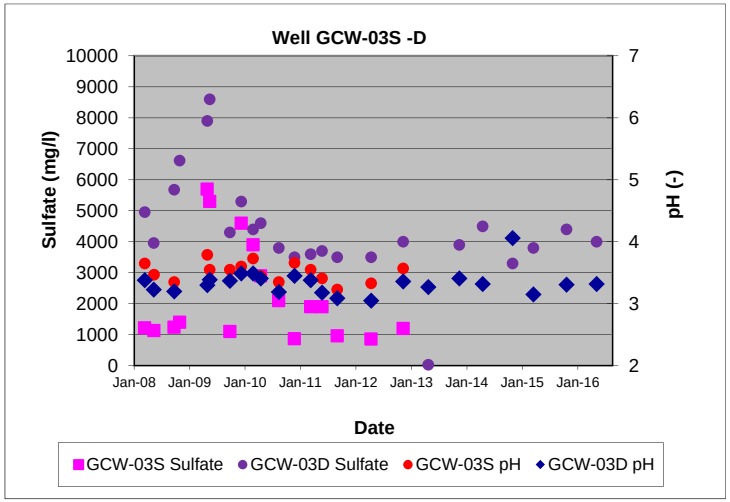
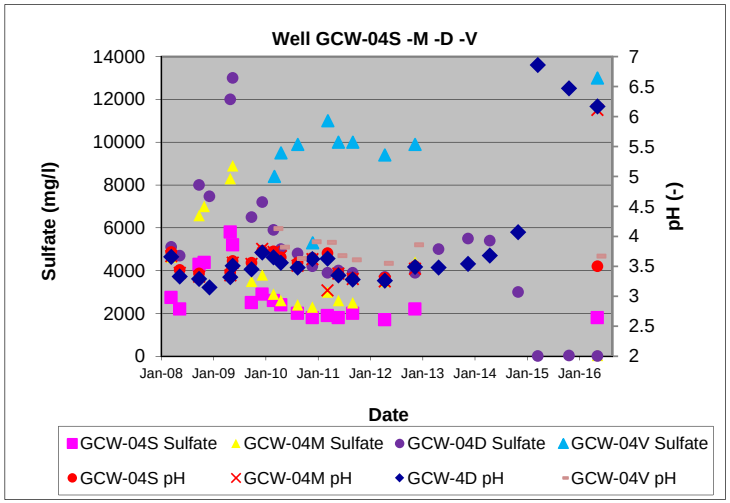
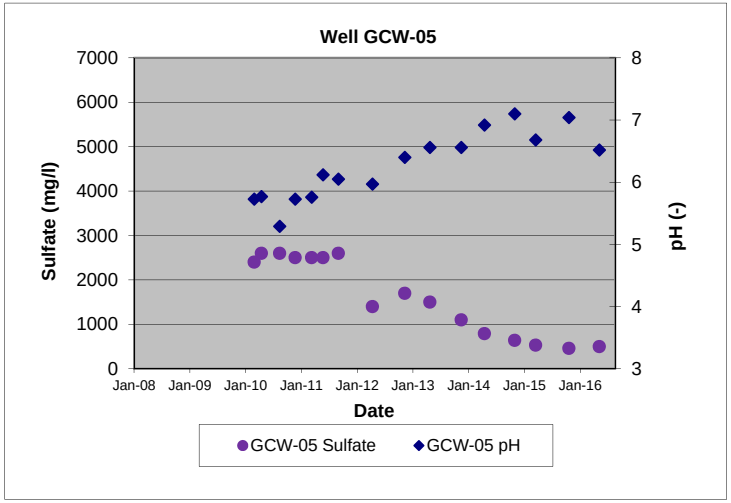
Figure 3-2
Monitoring Well Sulfate and pH Trends
Chemtrade Solutions Site
East Point, Georgia

Historical trend graphs for sulfate and pH are shown in **Figure 3-2**. Sulfate concentrations generally decreased or were stable in off-site and on-site wells in groundwater. The sulfate concentrations in monitoring wells GCW-01D, GCW-03D, GCW-04D, GCW-05, EPW-03D and OW-1A showed a statistically significant decreasing trend. EPW-01 is the only well that shows an increasing trend. This is consistent with the previous semi-annual report and EPW-01 is generally stable at 120 mg/l. Neither decreasing nor increasing trends were calculated for sulfate concentrations in monitoring wells GCW-02D and EPW-02. Similarly, aluminum concentrations also decreased or were stable in groundwater. A statistically significant decreasing trend was calculated for aluminum in monitoring wells GCW-04D, EPW-02 and OW-01A. Neither decreasing nor increasing trends were calculated for aluminum in the remainder of the wells. The pH measurements were generally stable. The pH measured at on-site wells was generally lower than the pH measured at the off-site wells except for the source area well which had a pH similar to background.

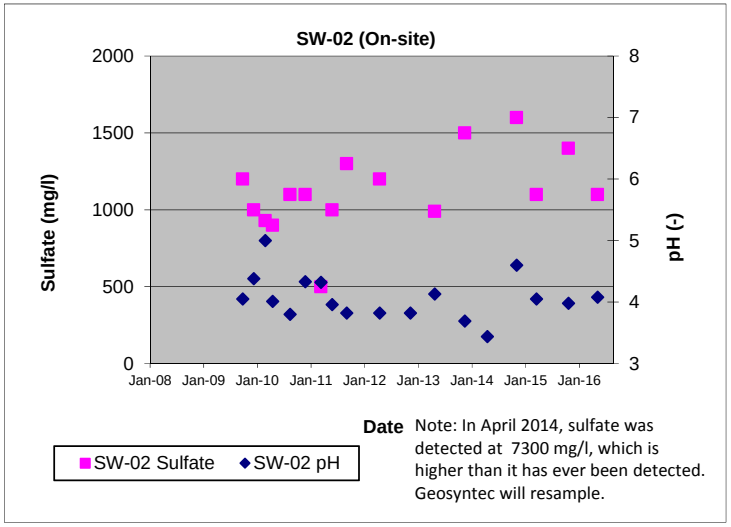
Figure 3-3
Storm Drain Sulfate and pH Trends
Chemtrade Solutions Site
East Point, Georgia

Note: In April 2014, sulfate was detected at 7300 mg/l, which is higher than it has ever been detected. Geosyntec will resample.

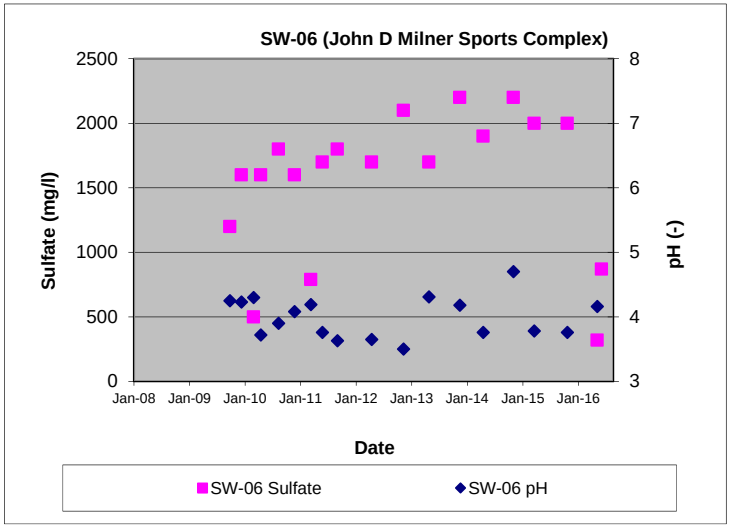
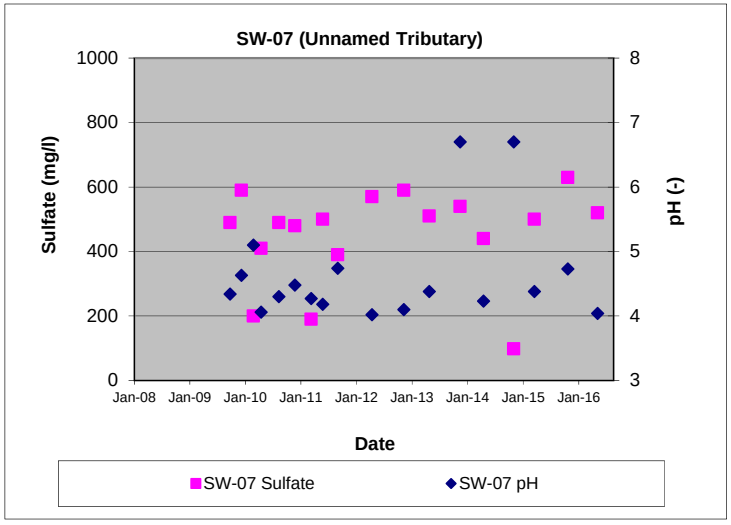
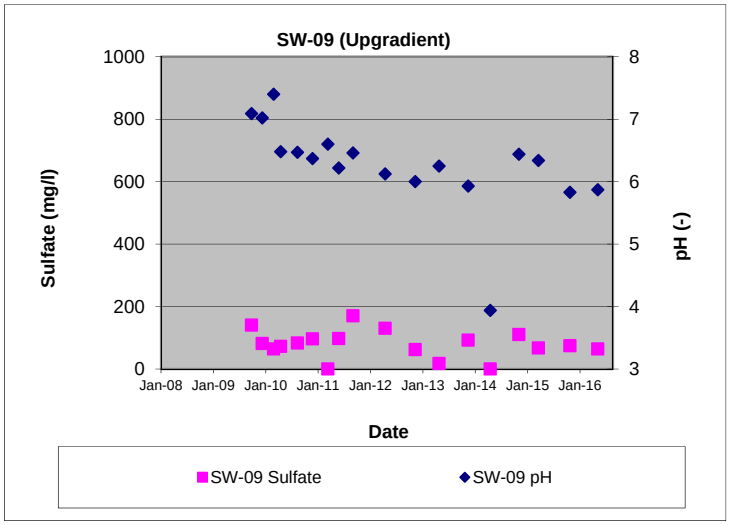
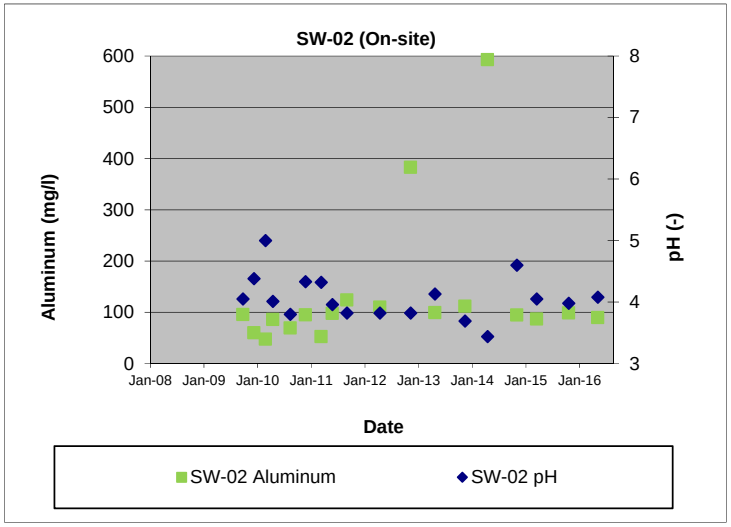
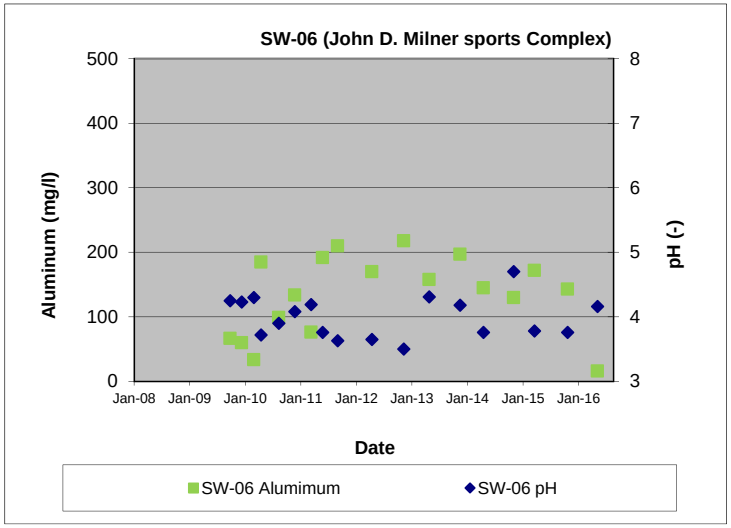
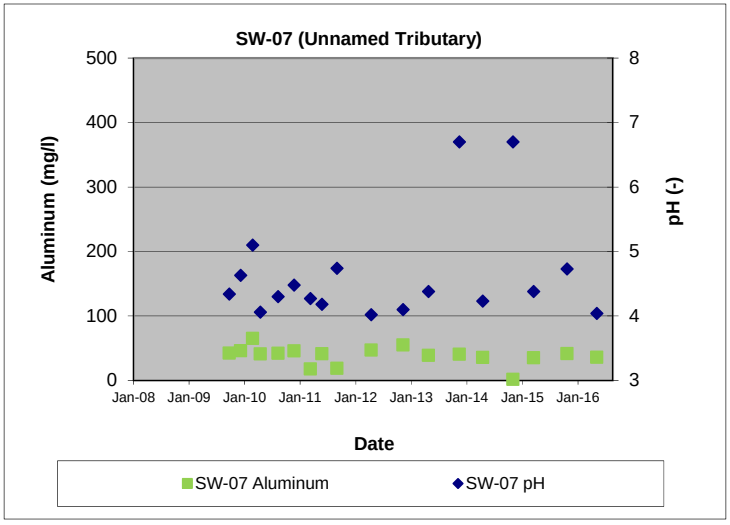
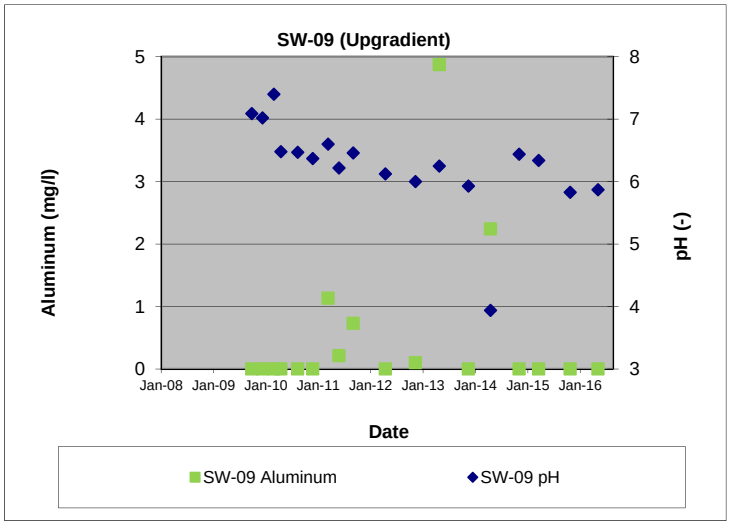
Historical trend graphs for sulfate, aluminum, and pH are shown in **Figure 3-3**. Sulfate concentrations were generally stable or slowly increasing. Aluminum concentrations were generally stable or slowly increasing between sampling events. The pH measurements were relatively stable showing minor changes between sampling events at the same location.

source has been removed and potential off-site sources likely remain the relative contribution from the Site would be expected to continue to decrease with time. As presented in **Figure 3-3**, the time trend analysis shows a continued impact from the cross-gradient SW-06, which is consistent with source removal on site and active potential impacts by a residual plume.

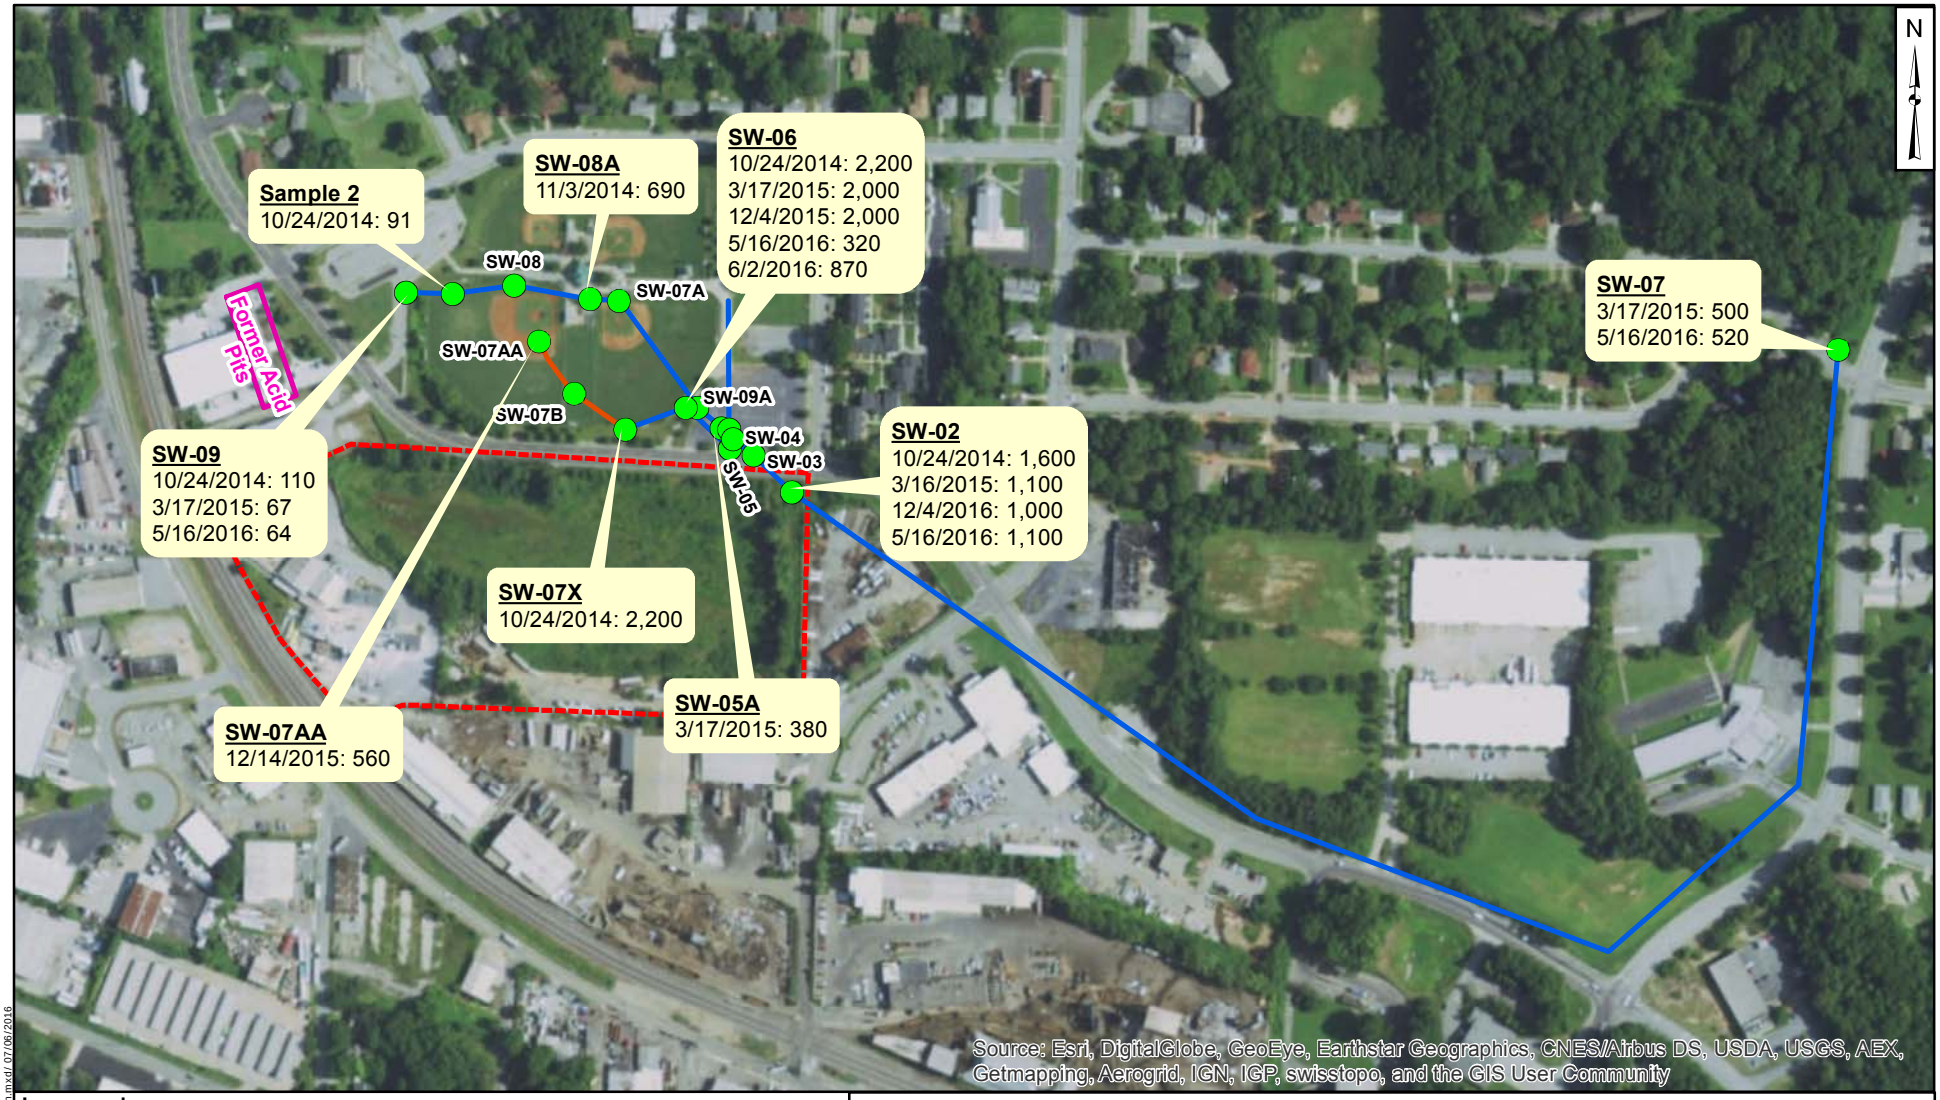
The sulfate results at SW-06 during both the regular sampling and resampling were not consistent with previous results. The sulfate concentration has previously been measured around 2000 mg/l. The cause of the change has not been identified.

- The area surrounding the Site has a number of other sources of sulfate in groundwater resulting from previous operations. These sources may be contributing the elevated sulfate concentrations noted at SW-02 that were measured at 1,100 mg/l. Potential sulfate sources include a former battery cracking plant, a former fertilizer manufacturer, two off-site HCA disposal areas operated by others, and a former agricultural chemical manufacturer.
