Subject: Quarters-36/37 Landfill Maintenance and Inspection Report
Northside Drive Landfill Site, Atlanta, Georgia

QUARTERS-36/37
LANDFILL MAINTENANCE AND INSPECTION REPORT
NORTHSIDE DRIVE LANDFILL SITE

GEORGIA WORLD CONGRESS CENTER

AUGUST 2013

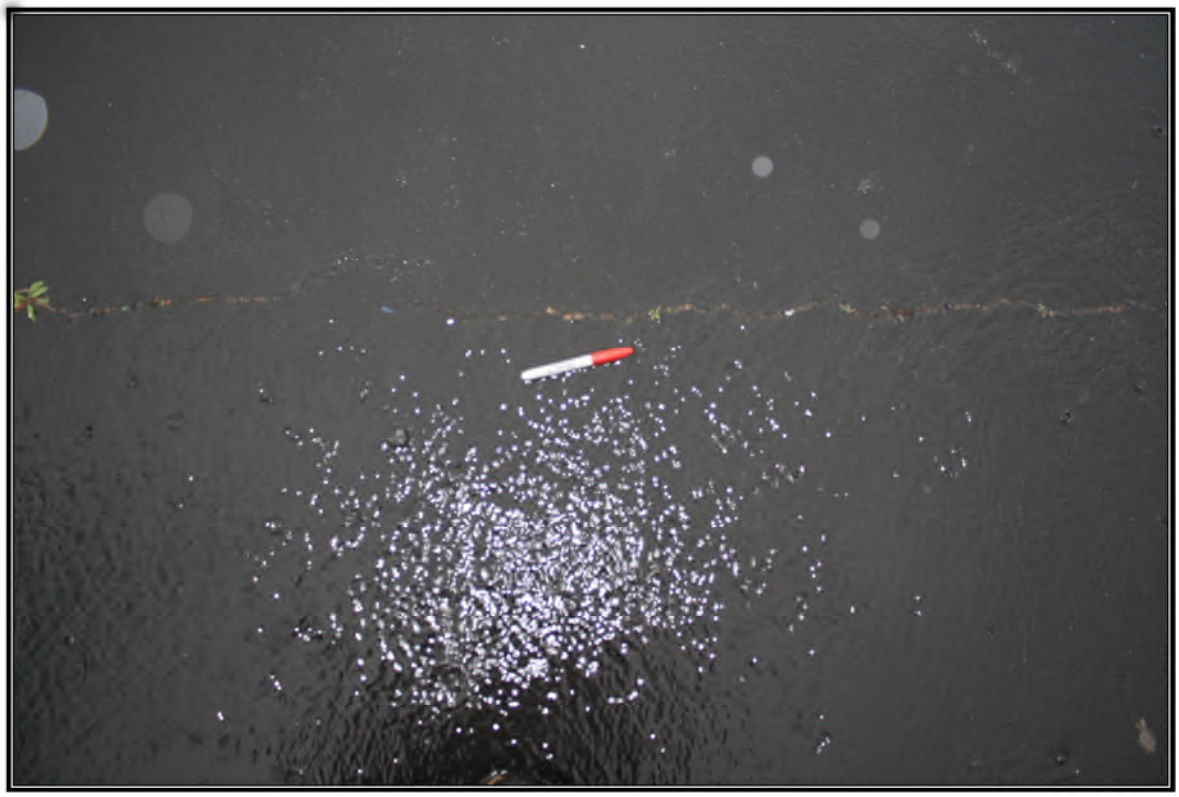
Subject: Example of another crack which runs east to west on the entrance way of the parking lot row. Over half of the rows have cracks similar to this one. They occur where the asphalt seams are joined. Like the previously observed crack, it is no larger than ¼ inch wide and ¼ inch deep.
