## **SEMI-ANNUAL PROGRESS REPORT #7**

1071 HOWELL MILL ROAD  
ATLANTA, FULTON COUNTY, GEORIGIA  
HSI SITE NO. 10637 (WELCOME YEARS, INC.)

**RE: Semi-Annual Progress Report #7**  
**1071 Howell Mill Road**  
**Atlanta, Georgia**  
**HSI Sub-Listed Site No. 10637 (Welcome Years, Inc.)**  
**Tax Parcel ID#17-0150-009-14**

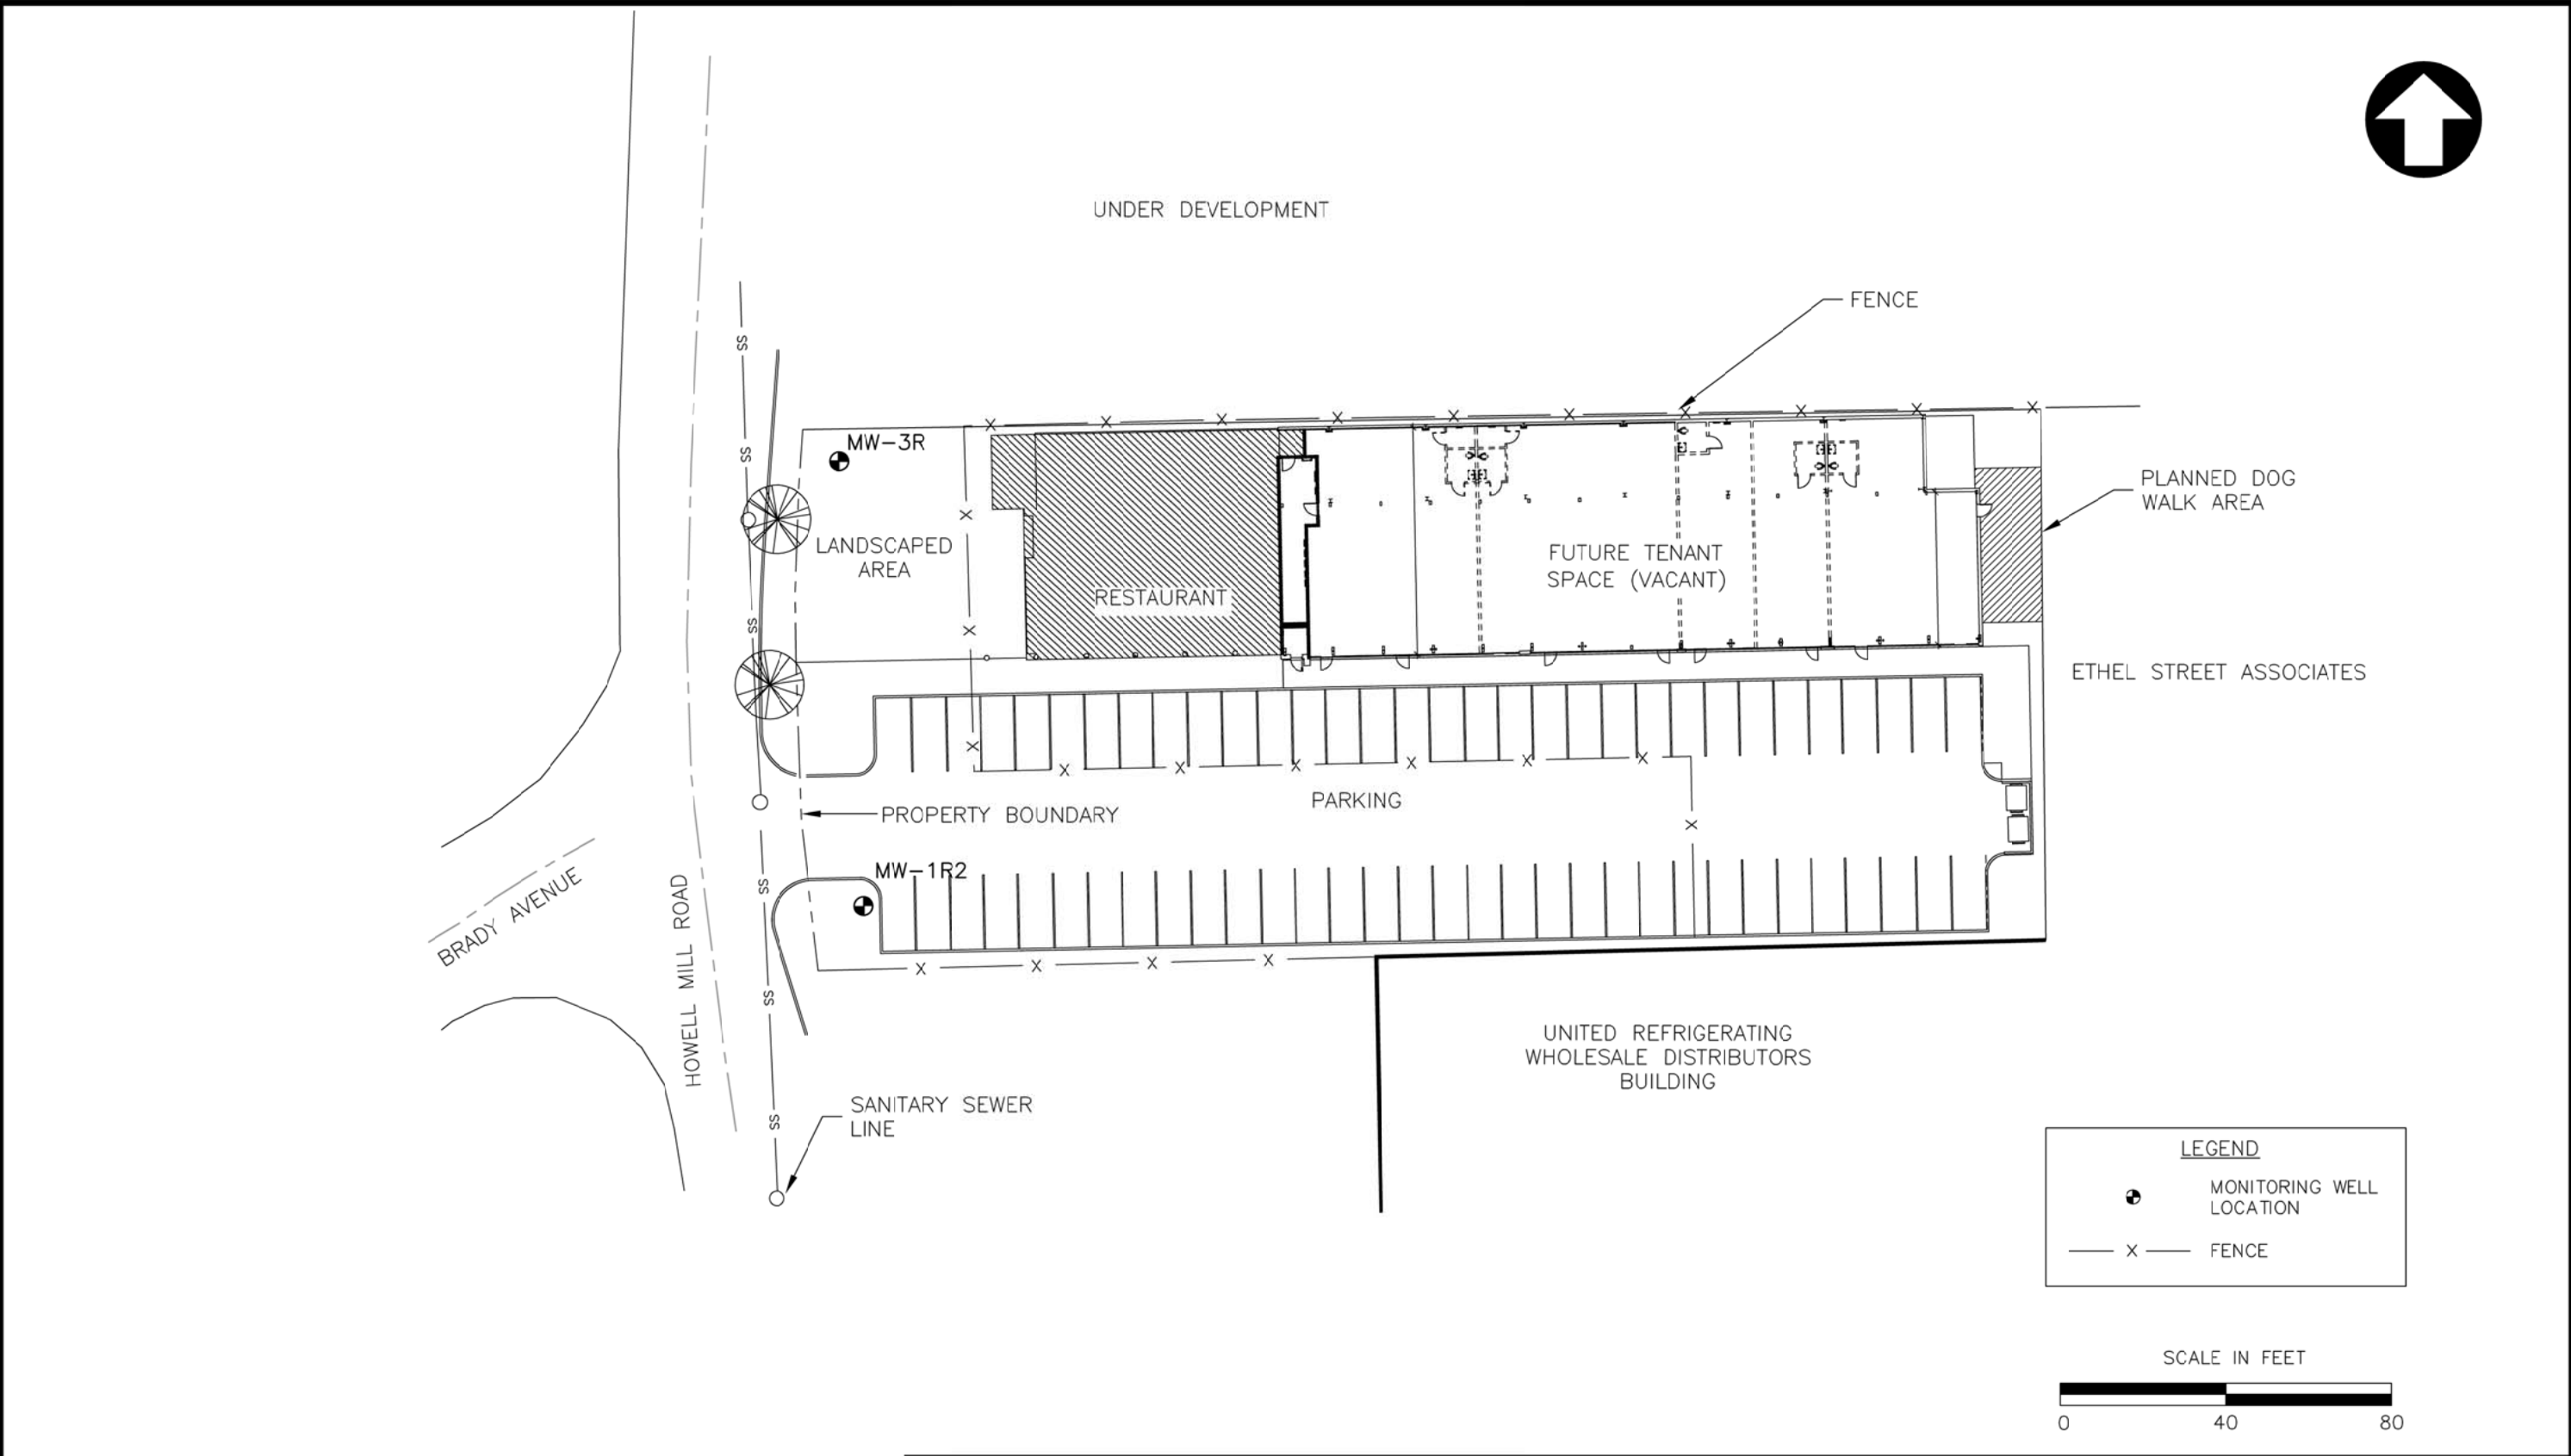
<b>amec foster wheeler</b> Environment & Infrastructure, Inc. 2677 BUFORD HIGHWAY ATLANTA, GEORGIA 30324 (404)873-4761		1071 HOWELL MILL ROAD ATLANTA, GEORGIA				SITE PLAN		
Job Number 6121-12-0124	Task 02	Date OCT. 2015	Scale AS SHOWN	Drawn By TG	Approved By SD	Figure 1

1071 WB, LLC has engaged a contractor, Structor Group, to renovate the existing building. As shown on the attached Figure 1, the building on the southern half of the Site has been demolished and the area converted to a parking lot by overlaying asphalt on the remaining building floor slab as the pavement hardcover. The remaining building on the northern half of the Site has been gutted for renovation, re-using the existing building super-structure and floor slab. A restaurant is under construction at the western end of the existing building. The remainder of the building is currently being built out to house a veterinary clinic. Floor slab penetrations reported in the Sixth Progress Report observed have been filled. An additional concrete floor slab has been poured in the restaurant space as well as throughout the remainder of the building (Photos 3 and 4).
