HSI SITE 10071, GEORGIA PORTS AUTHORITY-BAINBRIDGE TERMINAL

FIRST VIRP SEMI-ANNUAL PROGRESS REPORT

May 9, 2013

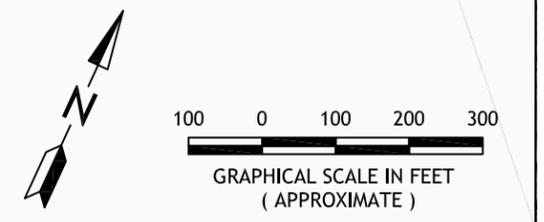
FIGURE 1: SITE MAP

EIC first prepared an extended base map to include MW-19 to facilitate better horizontal delineation of the contaminants of concern (COC). Figure 1 illustrates the extended site map. EIC then prepared a site health and safety plan for performing field activities. The following sections provide a summary of the subsequent tasks completed at the site.

EIC attempted to identify the location of three un-located wells, MW-2, MW-3, and MW-9 utilizing a magnetometer and visual observation. These wells are illustrated in Figure 1. EIC was successful in identifying the location of monitoring well MW-2 but was unable to locate the monitoring wells, MW-3 and MW-9. During the next trip to the site, EIC will utilize a licensed surveyor to identify locations of these wells and further attempt to locate these wells.
