SUPPORTING THE **GEORGIA WORLD CONGRESS CENTER**

February 12, 2016

**Subject:       Quarters-46/47 Landfill Maintenance and Inspection Report  
                  Northside Drive Landfill Site, Atlanta, Georgia**

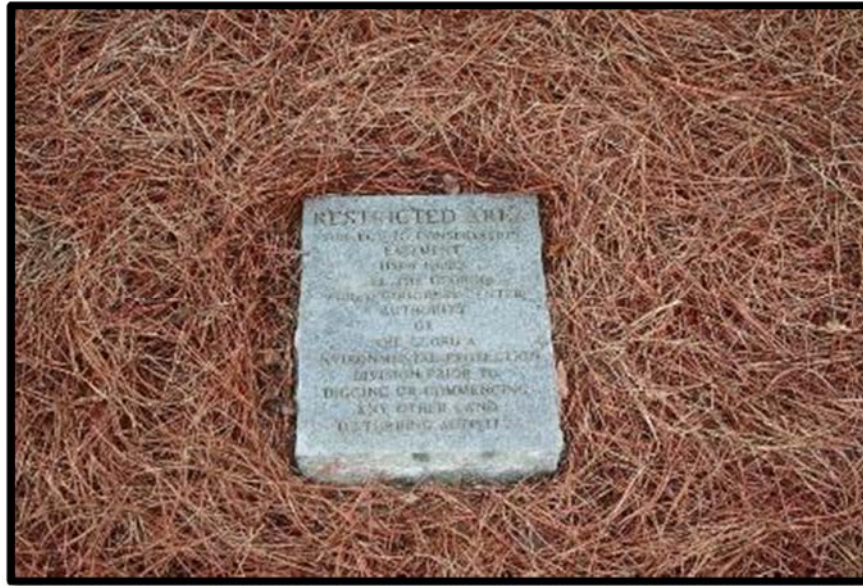
**OFFICIAL PHOTOGRAPH NO. 1**  
**TETRA TECH**

**Subject:** Granite plaque located on the east, southeast side of the north parking lot perimeter.

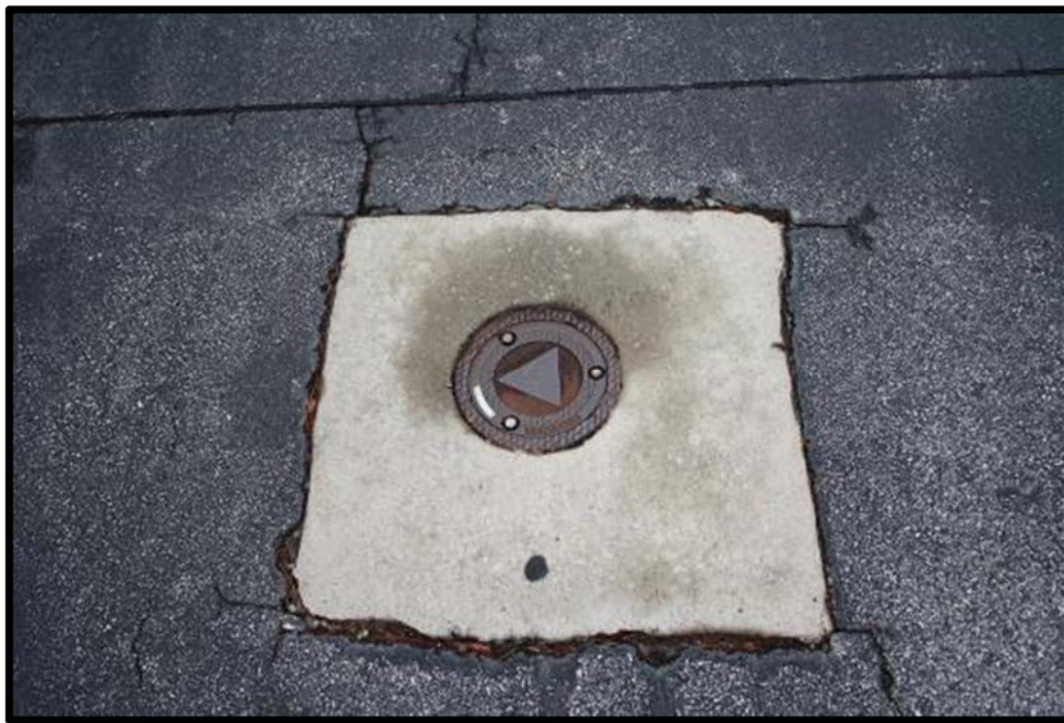
**OFFICIAL PHOTOGRAPH NO. 2  
TETRA TECH**

**Subject:** Background monitoring well, MM-04.

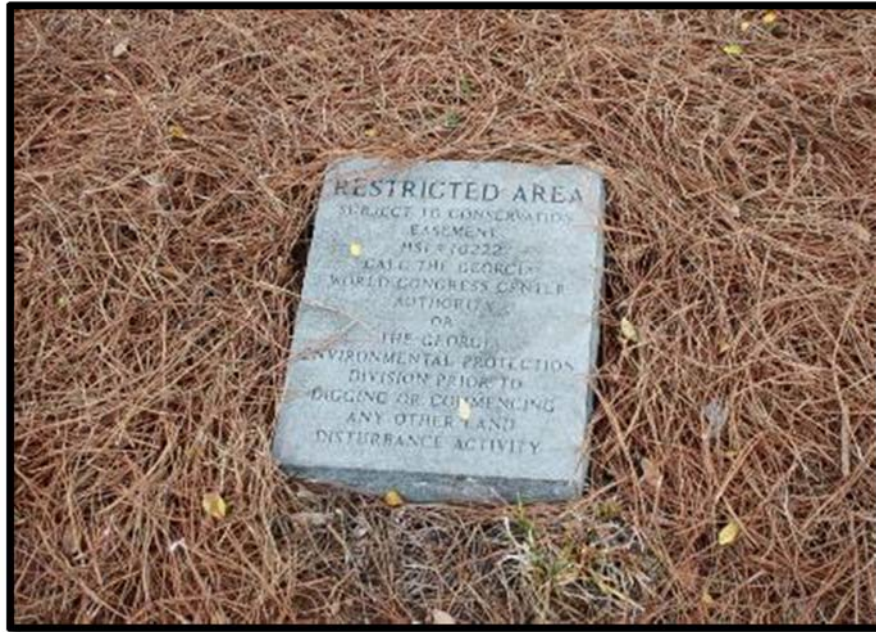
**OFFICIAL PHOTOGRAPH NO. 3**  
**TETRA TECH**

**Subject:** Granite plaque on the southeast corner of the property.

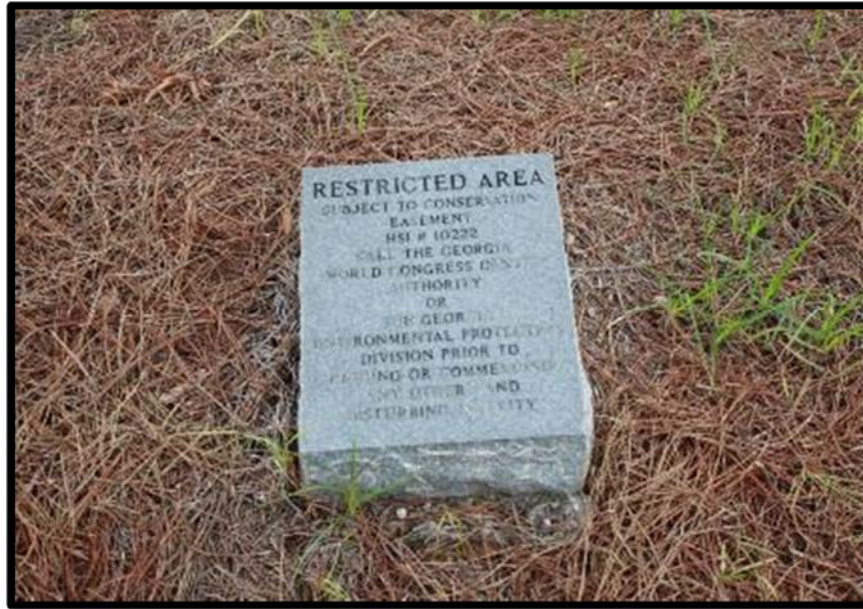
**OFFICIAL PHOTOGRAPH NO. 4**  
**TETRA TECH**

**Subject:** Granite plaque on the south side of the property.

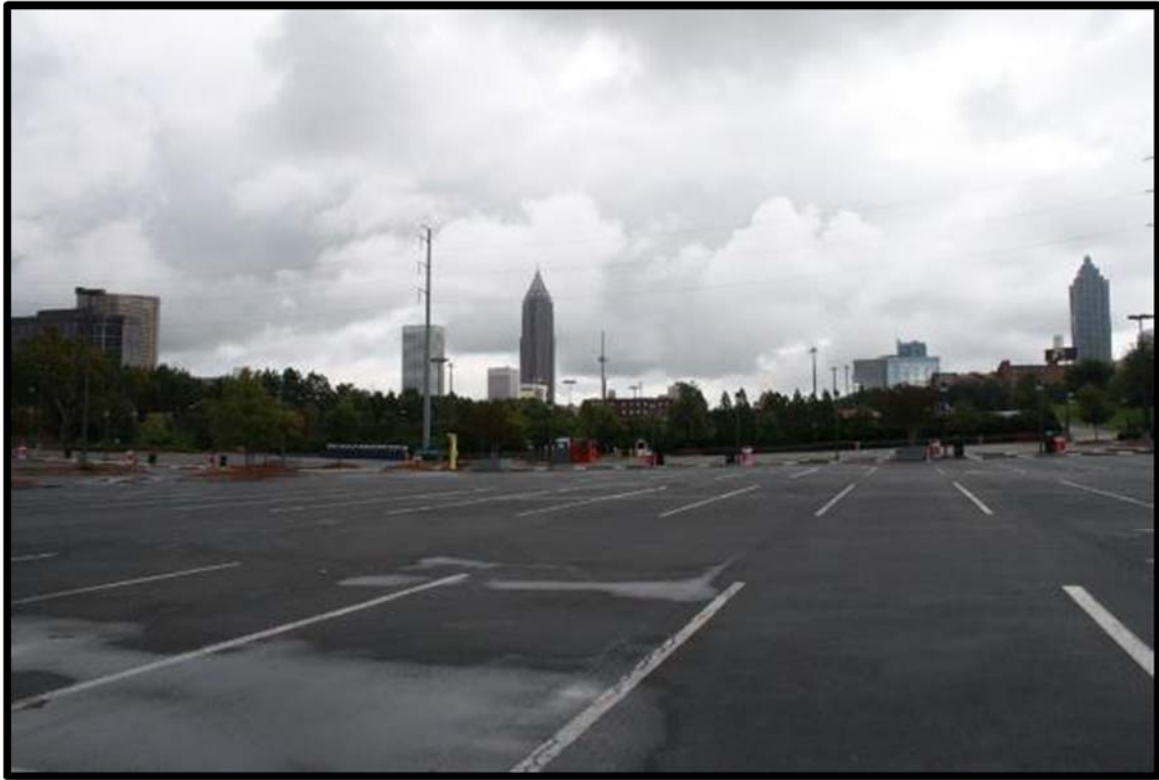
**OFFICIAL PHOTOGRAPH NO. 5**  
**TETRA TECH**

**Subject:** Eastern portion of the lot looking northeast.

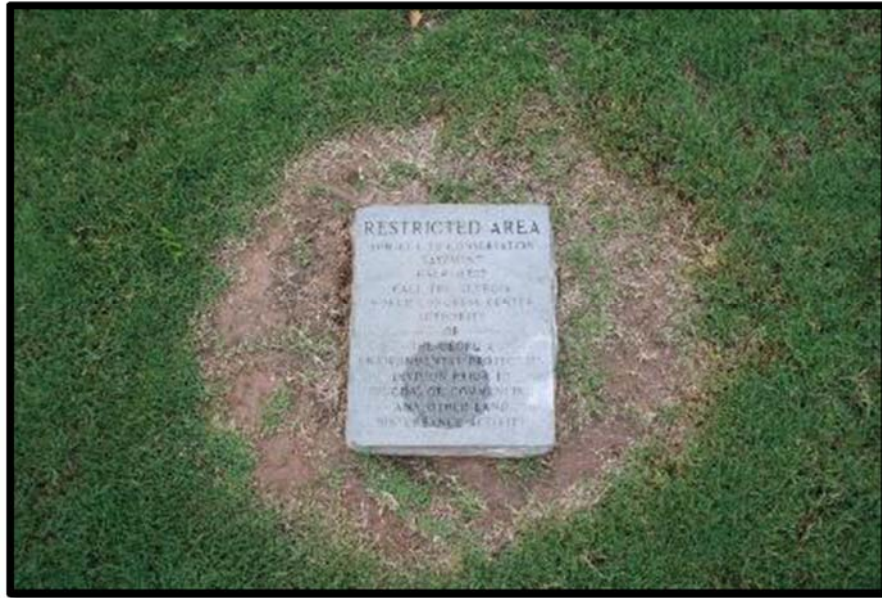
**OFFICIAL PHOTOGRAPH NO. 6**  
**TETRA TECH**

**Subject:** Granite plaque on the northeastern perimeter of the property.

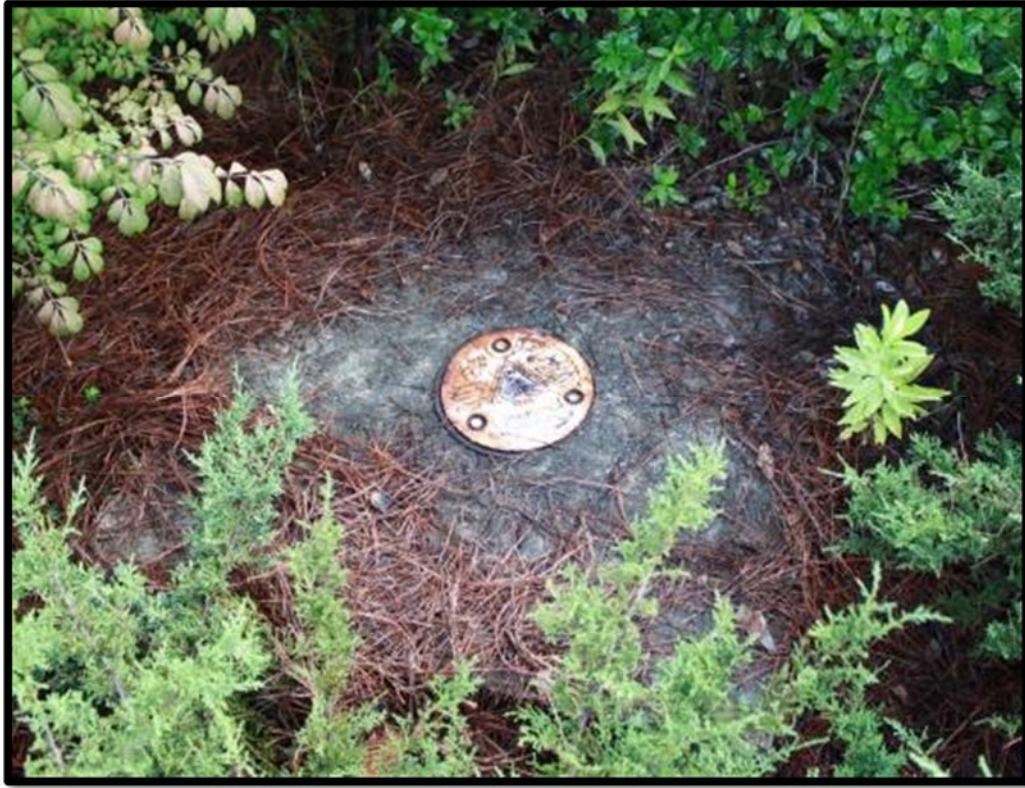
**OFFICIAL PHOTOGRAPH NO. 7**  
**TETRA TECH**

**Subject:** Monitoring well, MM-01.

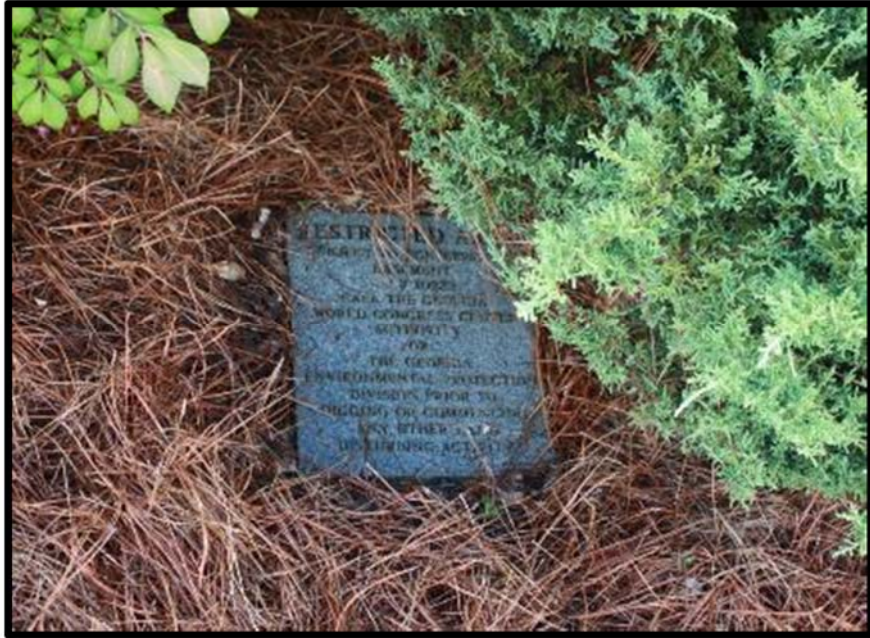
**OFFICIAL PHOTOGRAPH NO. 8**  
**TETRA TECH**

**Subject:** Granite plaque on the western perimeter of the property.

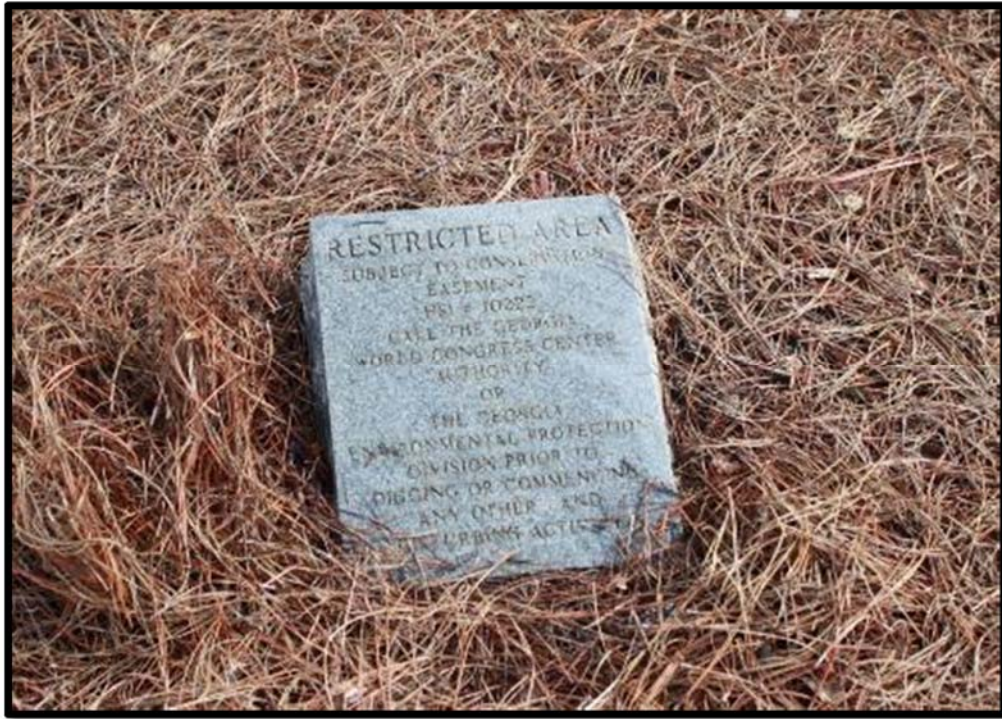
**OFFICIAL PHOTOGRAPH NO. 9**  
**TETRA TECH**

**Subject:** Granite plaque on the southwestern perimeter of lot.

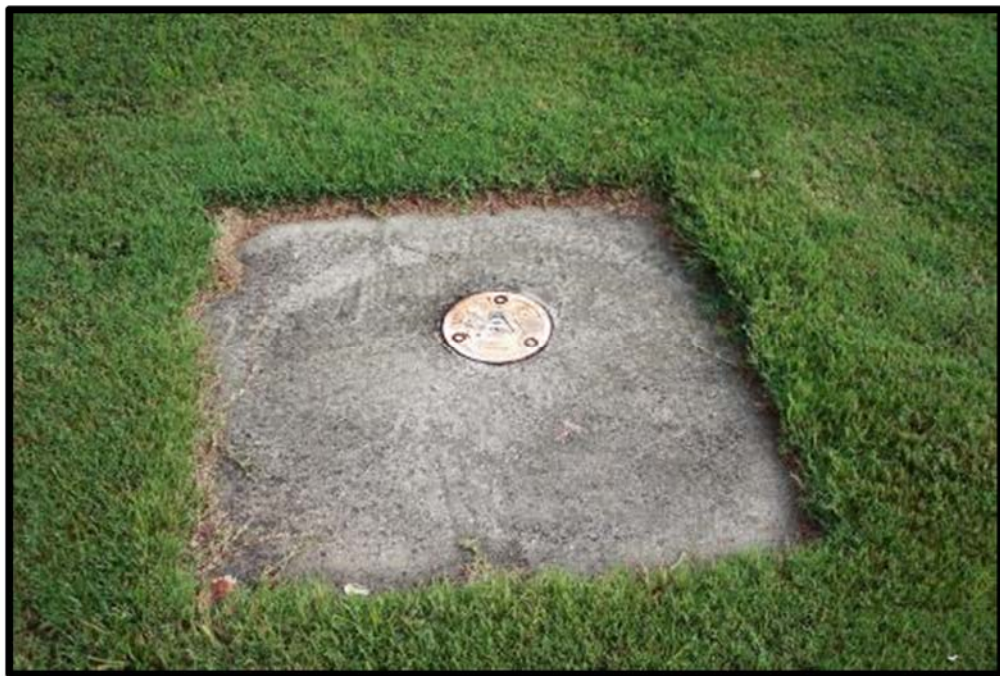
**OFFICIAL PHOTOGRAPH NO. 10**  
**TETRA TECH**

**Subject:** Dewatering well at the northwest perimeter of the property.

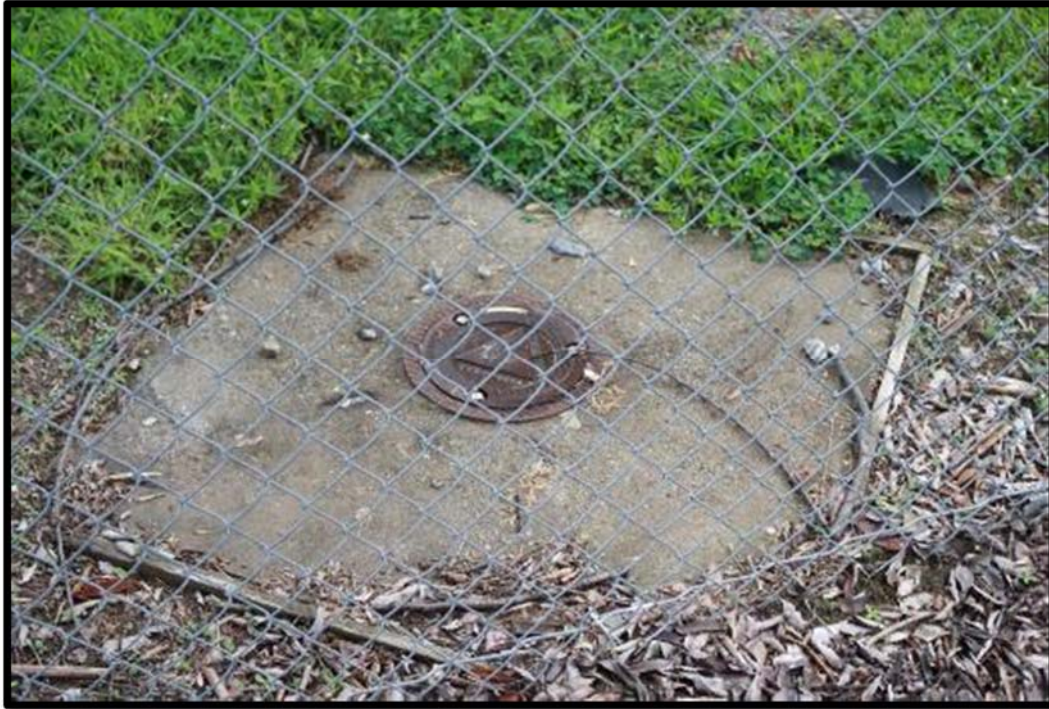
**OFFICIAL PHOTOGRAPH NO. 11**  
**TETRA TECH**

**Subject:** Monitoring well, MM-02 at the corner of John Street and Northside Drive.

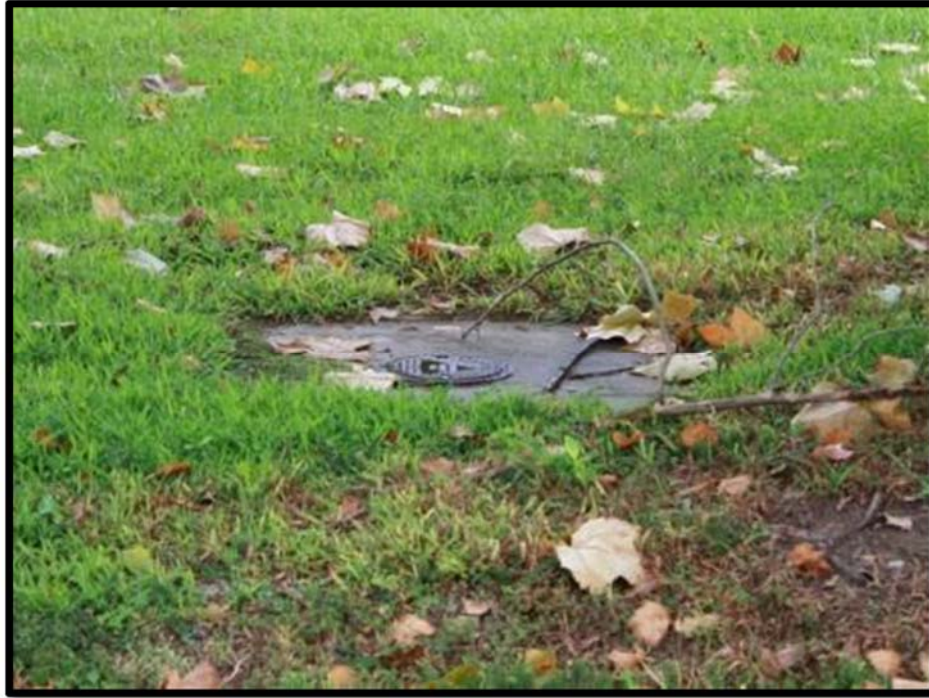
**OFFICIAL PHOTOGRAPH NO. 12**  
**TETRA TECH**

**Subject:** Monitoring well, MWC-3C at the corner of John Street and Northside Drive.

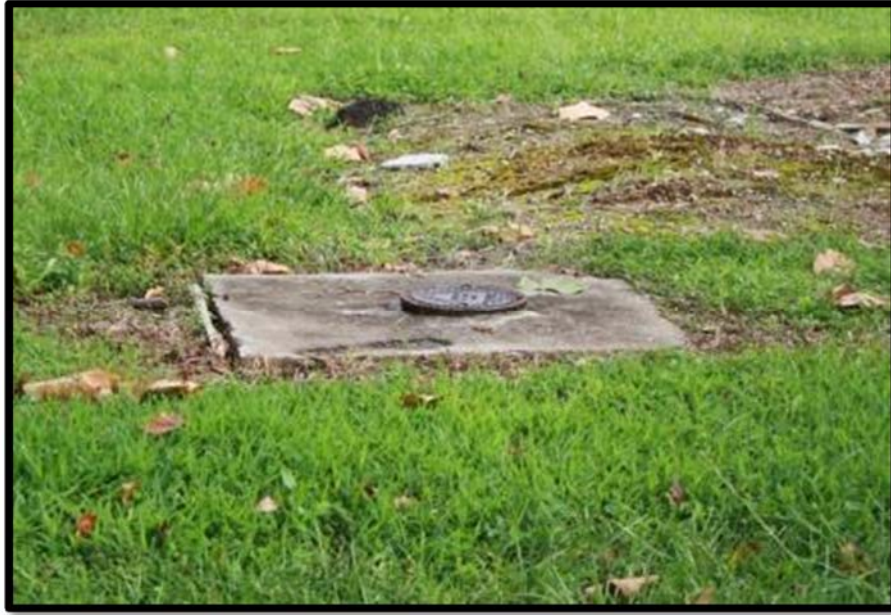
**OFFICIAL PHOTOGRAPH NO. 13**  
**TETRA TECH**

**Subject:** Monitoring well, MWC-3B at the corner of John Street and Northside Drive.

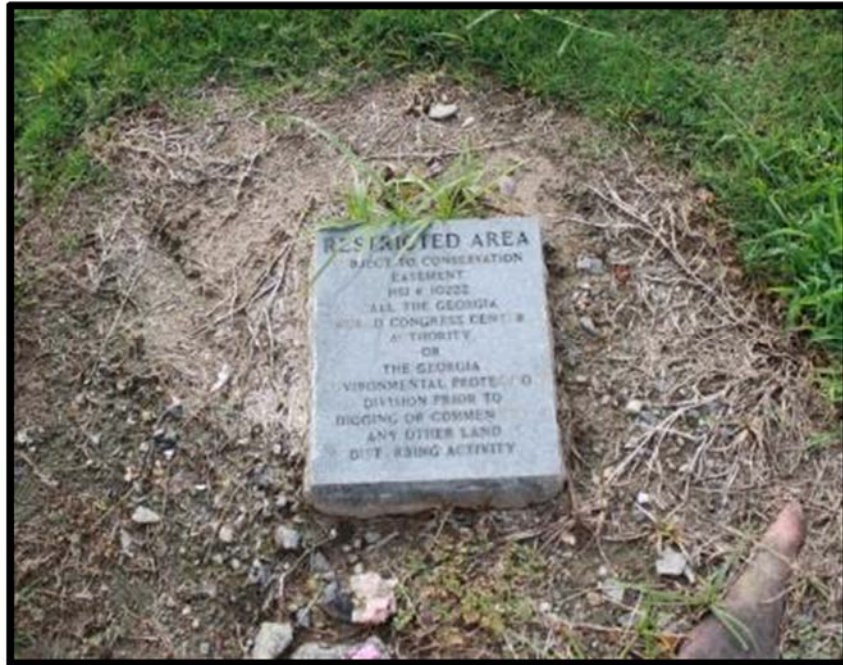
**OFFICIAL PHOTOGRAPH NO. 14**  
**TETRA TECH**

**Subject:** Granite plaque on the northwestern perimeter of the property.

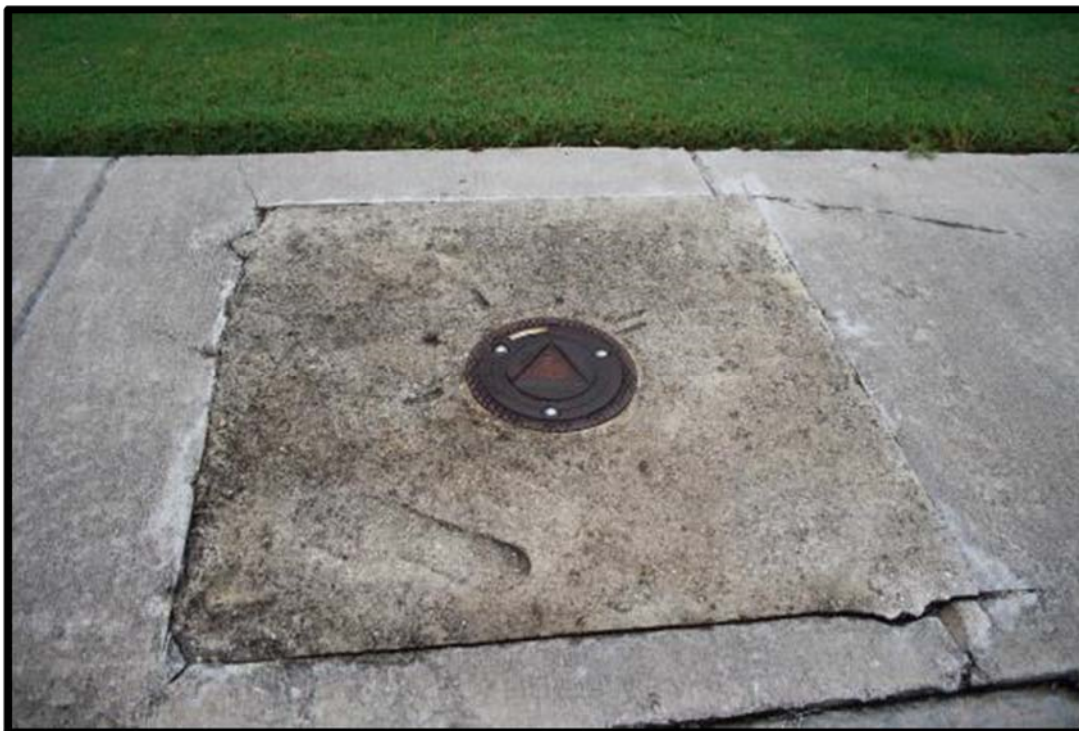
**OFFICIAL PHOTOGRAPH NO. 15**  
**TETRA TECH**

**Subject:** Monitoring well, MM-03.

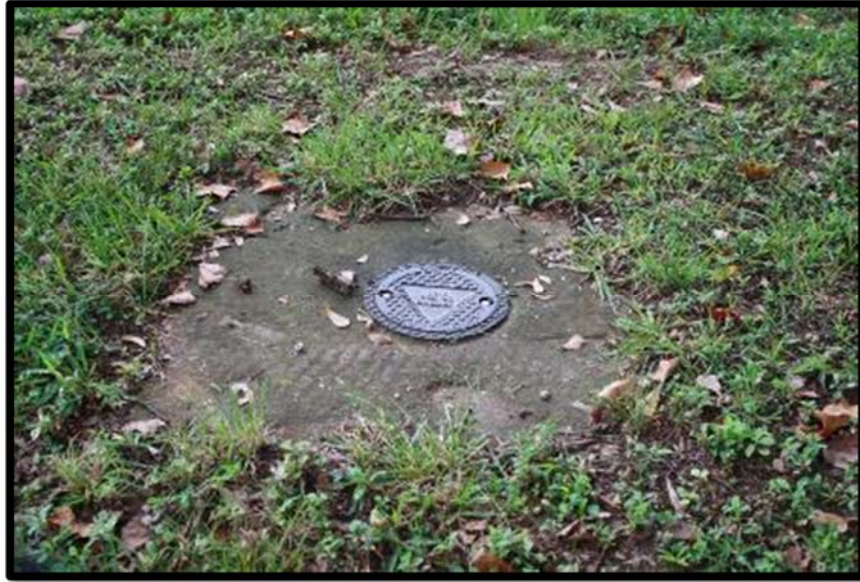
**OFFICIAL PHOTOGRAPH NO. 16**  
**TETRA TECH**

**Subject:** Monitoring well, MWC-1A at the corner of John Street and Gray Street.

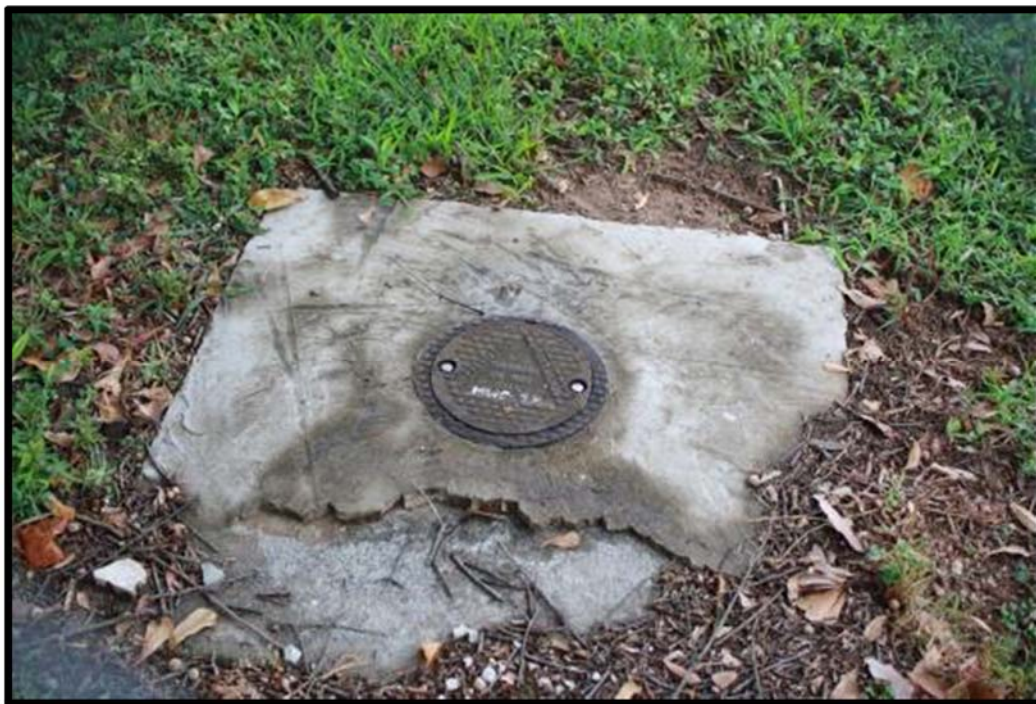
**OFFICIAL PHOTOGRAPH NO. 17**  
**TETRA TECH**

**Subject:** Monitoring well, MWC-1B at the corner of John Street and Gray Street.

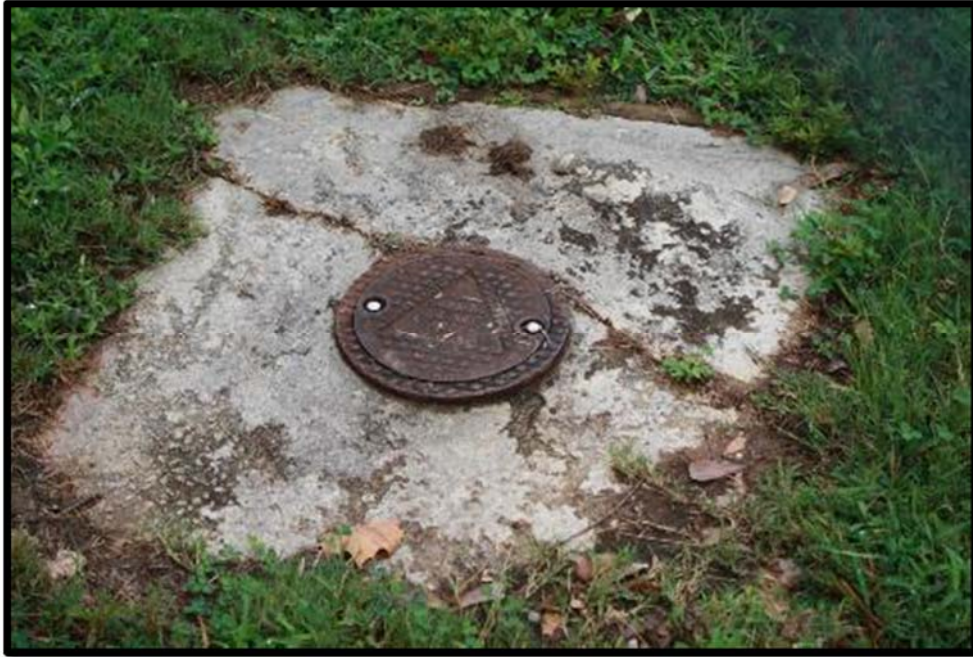
**OFFICIAL PHOTOGRAPH NO. 18**  
**TETRA TECH**

**Subject:** Monitoring well, MWC-1C at the corner of John Street and Gray Street.

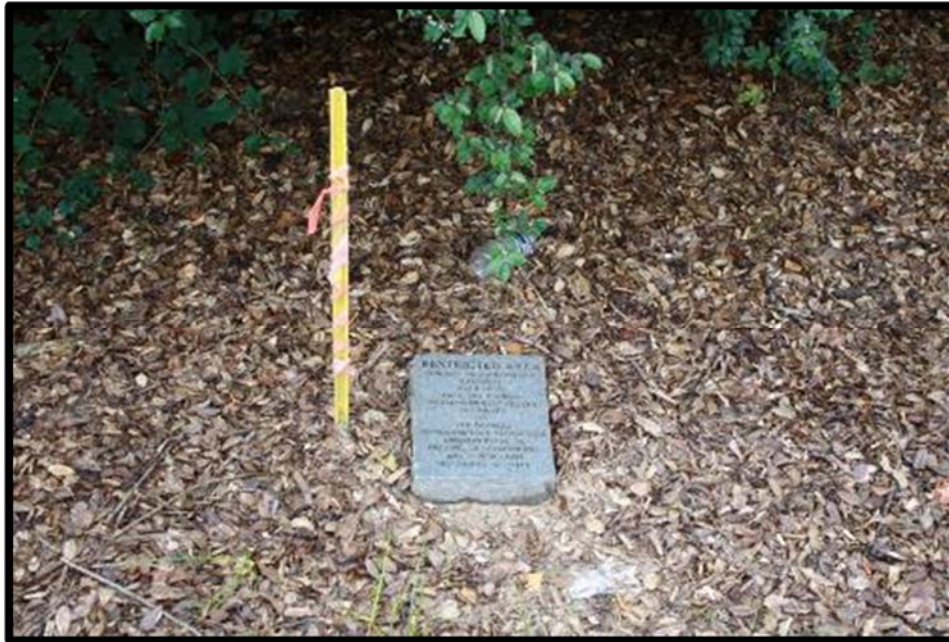
**OFFICIAL PHOTOGRAPH NO. 19**  
**TETRA TECH**

**Subject:** Granite plaque on the north perimeter of the property.

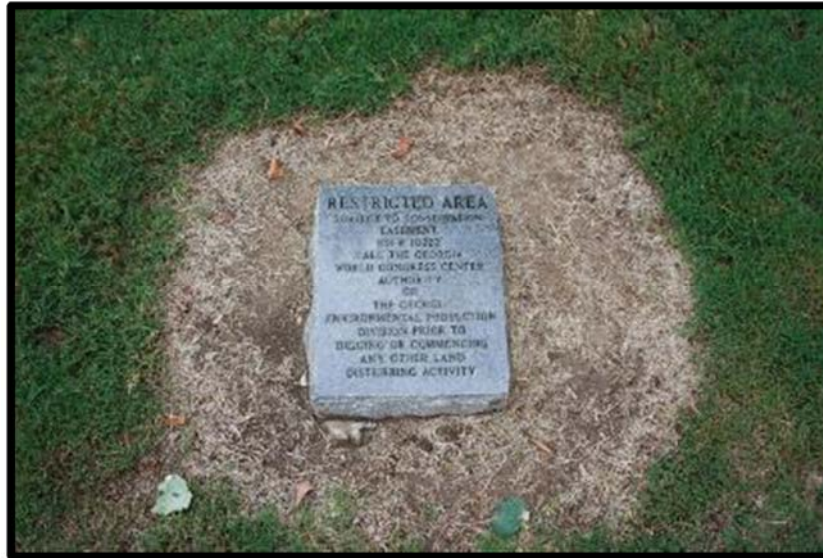
**OFFICIAL PHOTOGRAPH NO. 20**  
**TETRA TECH**

**Subject:** Granite plaque on the northeastern corner of the property.

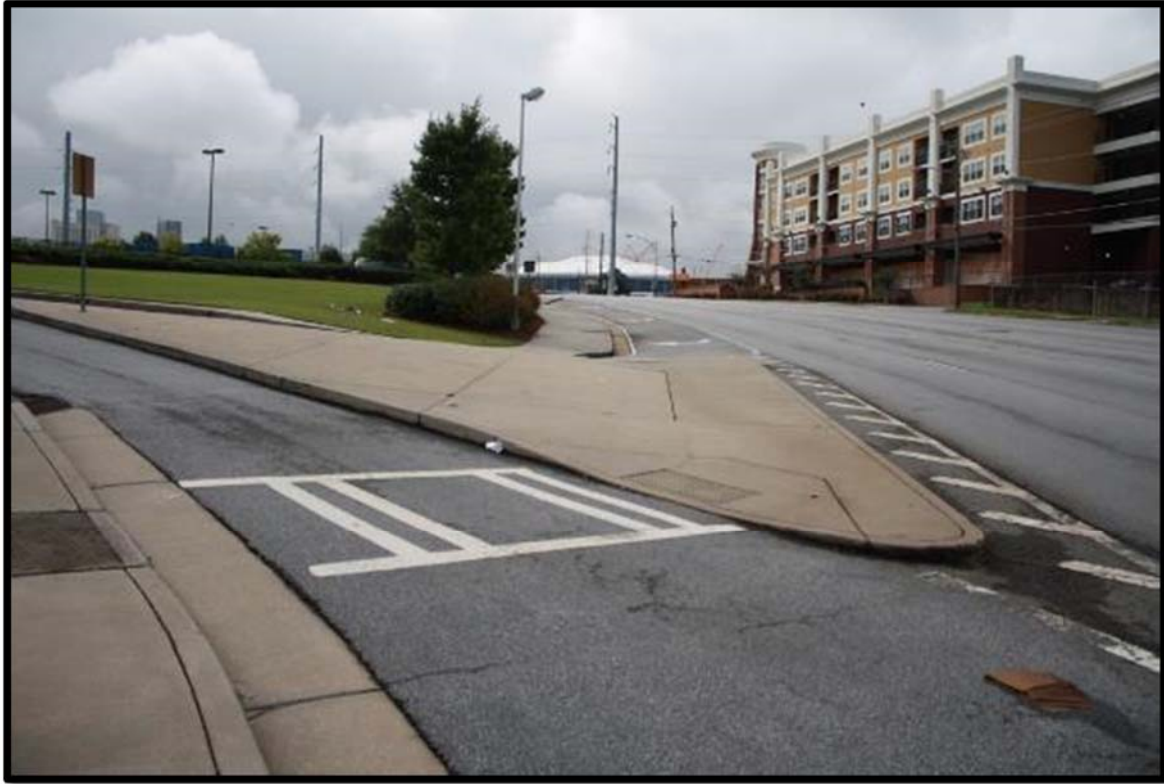
**OFFICIAL PHOTOGRAPH NO. 21**  
**TETRA TECH**

**Subject:** Concrete median at the intersection of Northside Drive and John Street.

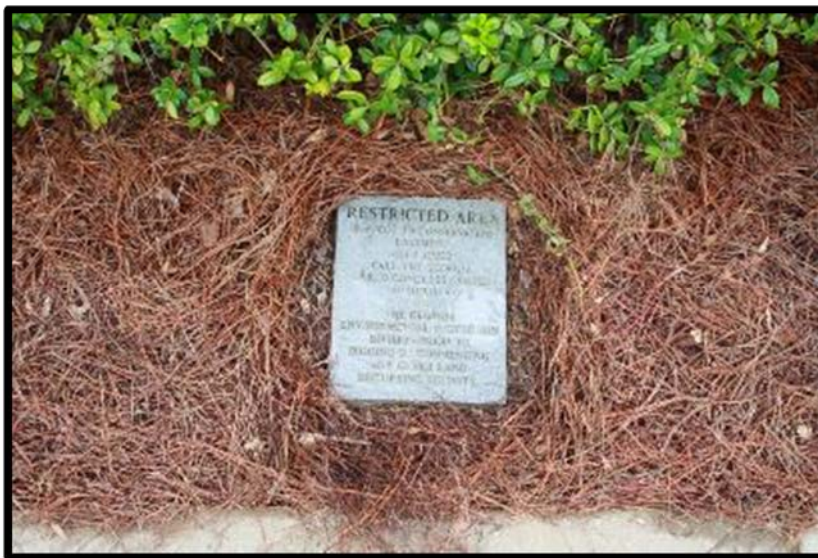
**OFFICIAL PHOTOGRAPH NO. 22**  
**TETRA TECH**

**Subject:** Granite plaque on the eastern perimeter of the property.

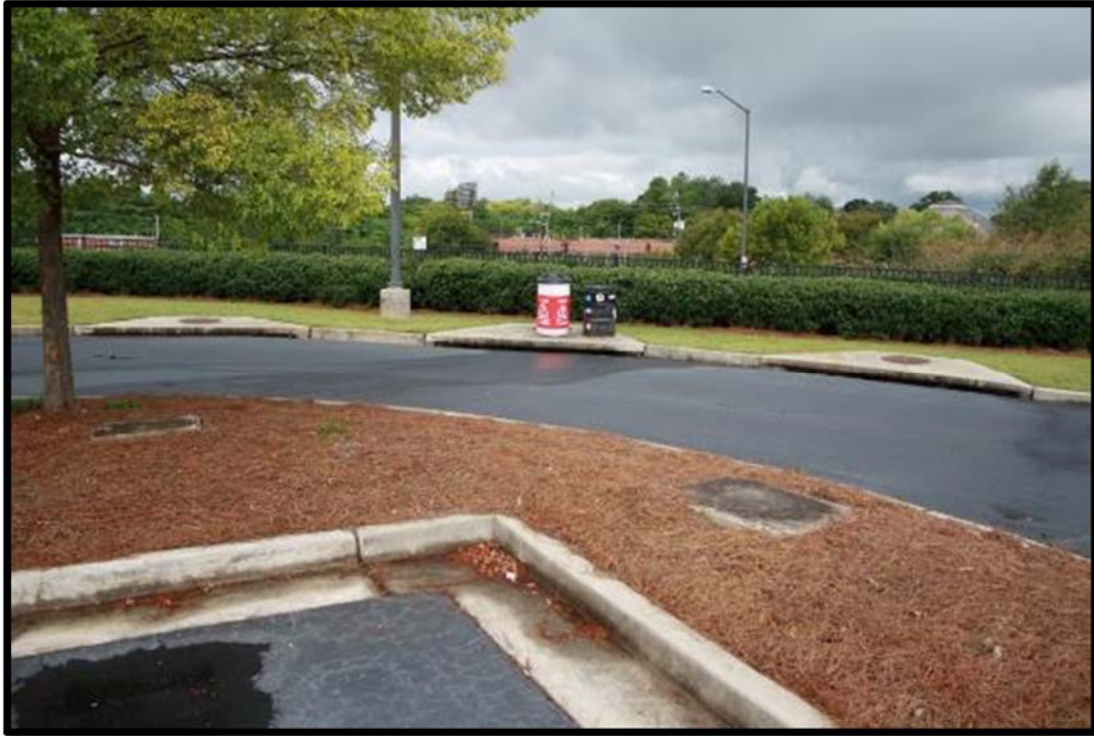
**OFFICIAL PHOTOGRAPH NO. 24**  
**TETRA TECH**

**Subject:** Stormwater drains located at the northwest parking lot perimeter.

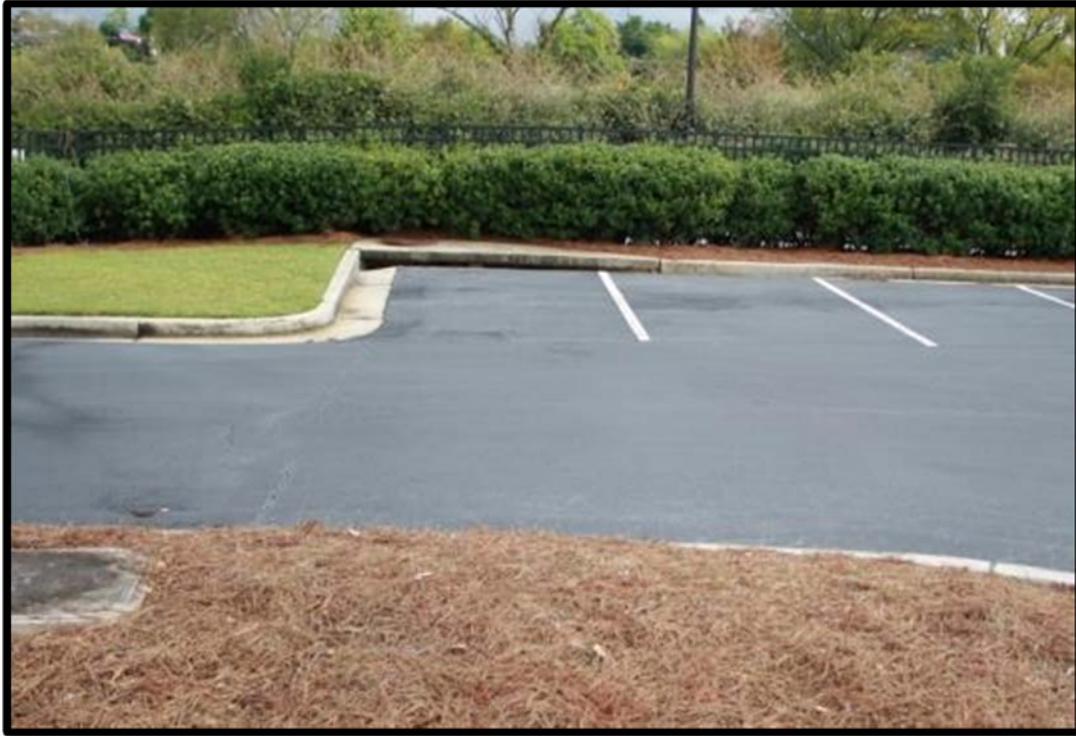
**OFFICIAL PHOTOGRAPH NO. 25**  
**TETRA TECH**

**Subject:** Stormwater drain located at the northwest parking lot perimeter.

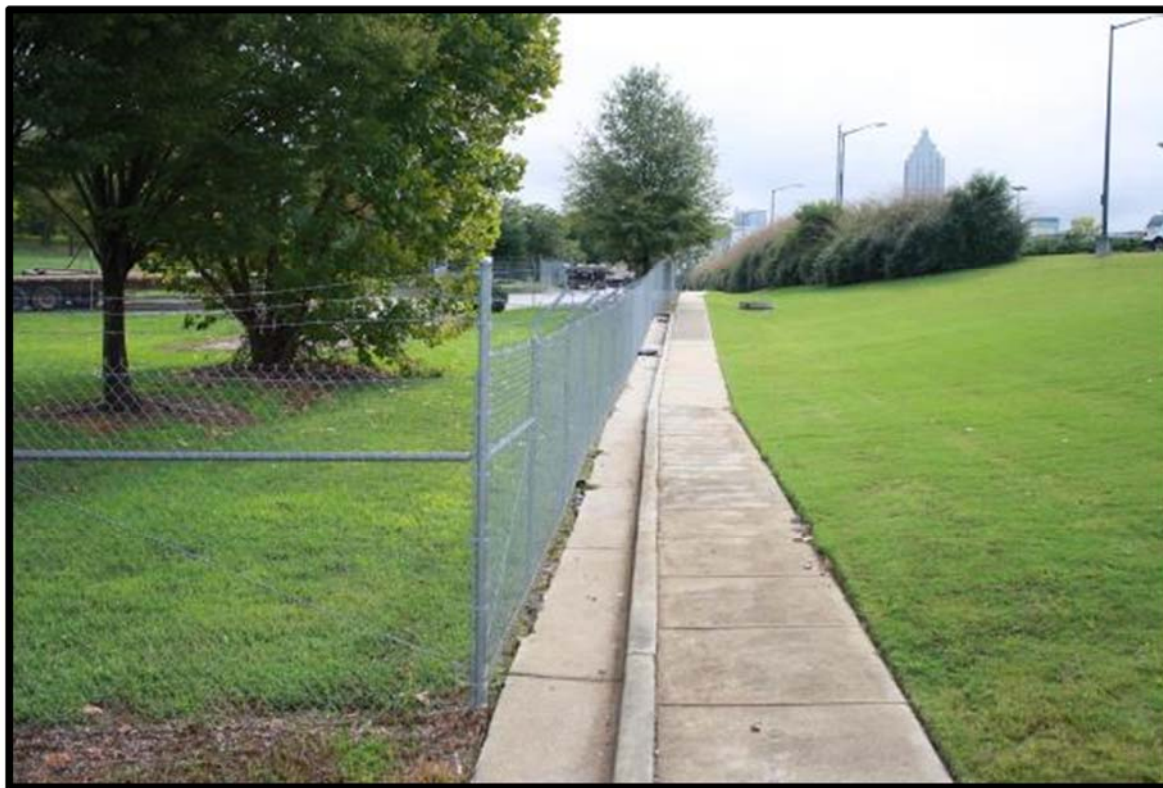
**OFFICIAL PHOTOGRAPH NO. 32**  
**TETRA TECH**

**Subject:** Monitoring wells, MM-02, MWC-3B and MWC-3C are inside the fence line between the trees.

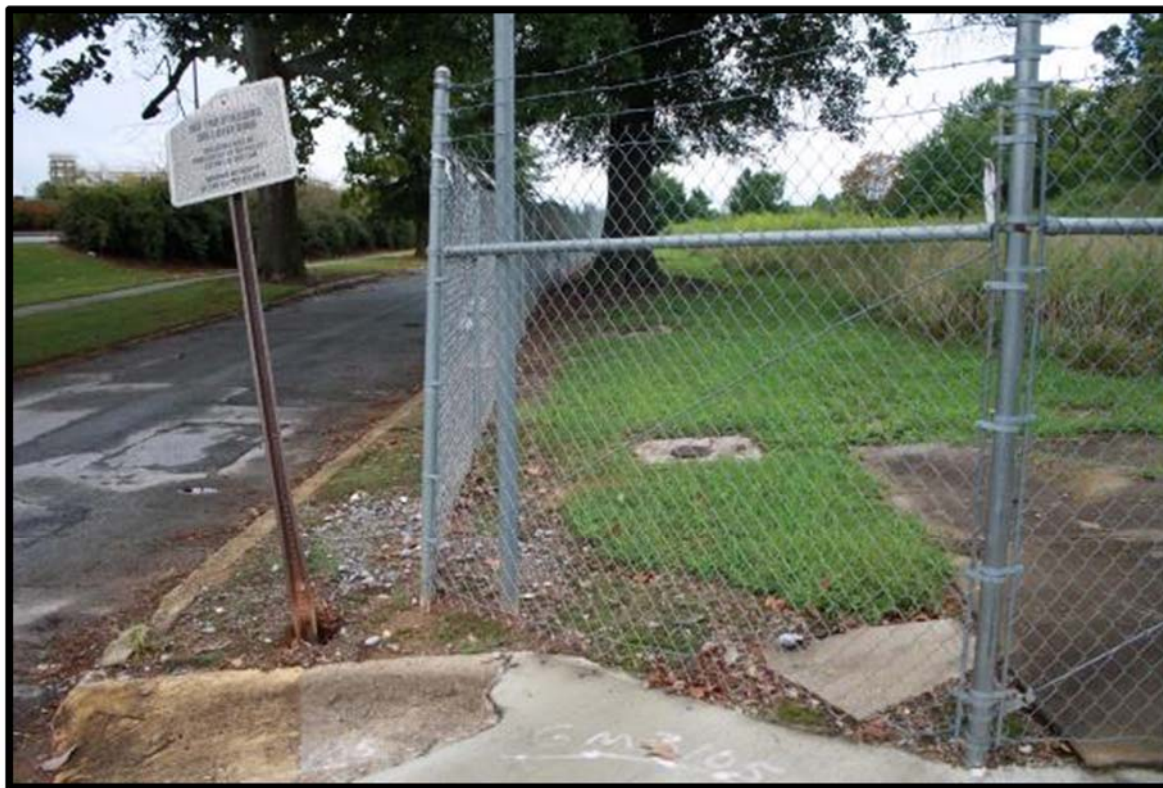
**OFFICIAL PHOTOGRAPH NO. 33**  
**TETRA TECH**

**Subject:** Monitoring wells, MW-1A, MW-1B and MW-1C at the corner of John Street and Gray Street.

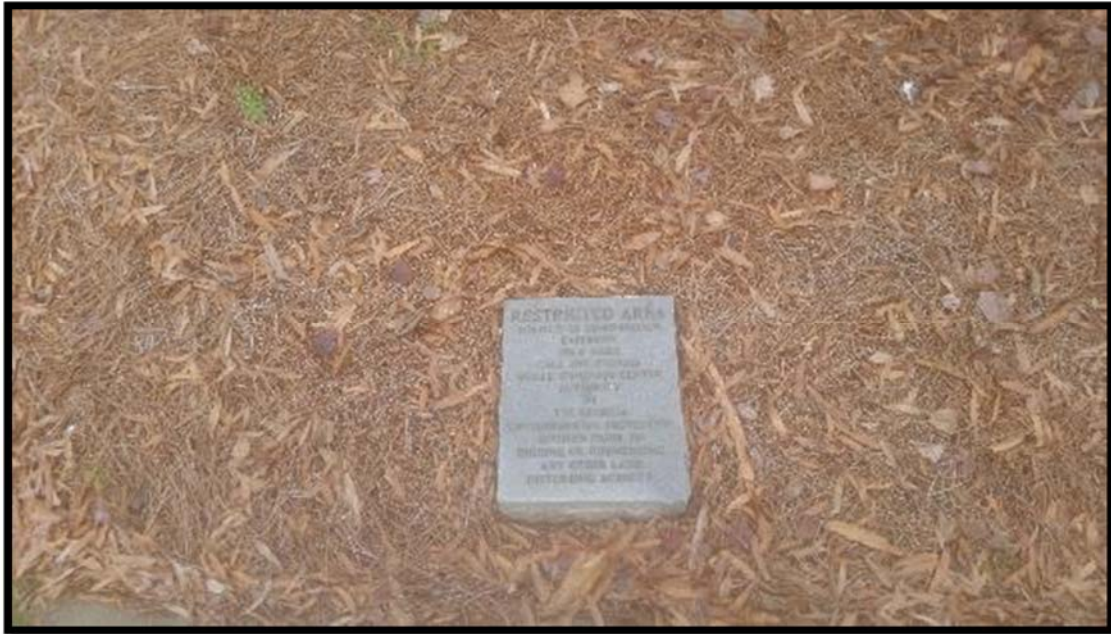
**OFFICIAL PHOTOGRAPH NO. 1**  
**TETRA TECH**

**Subject:** Granite plaque located on the east, southeast side of the north parking lot perimeter.

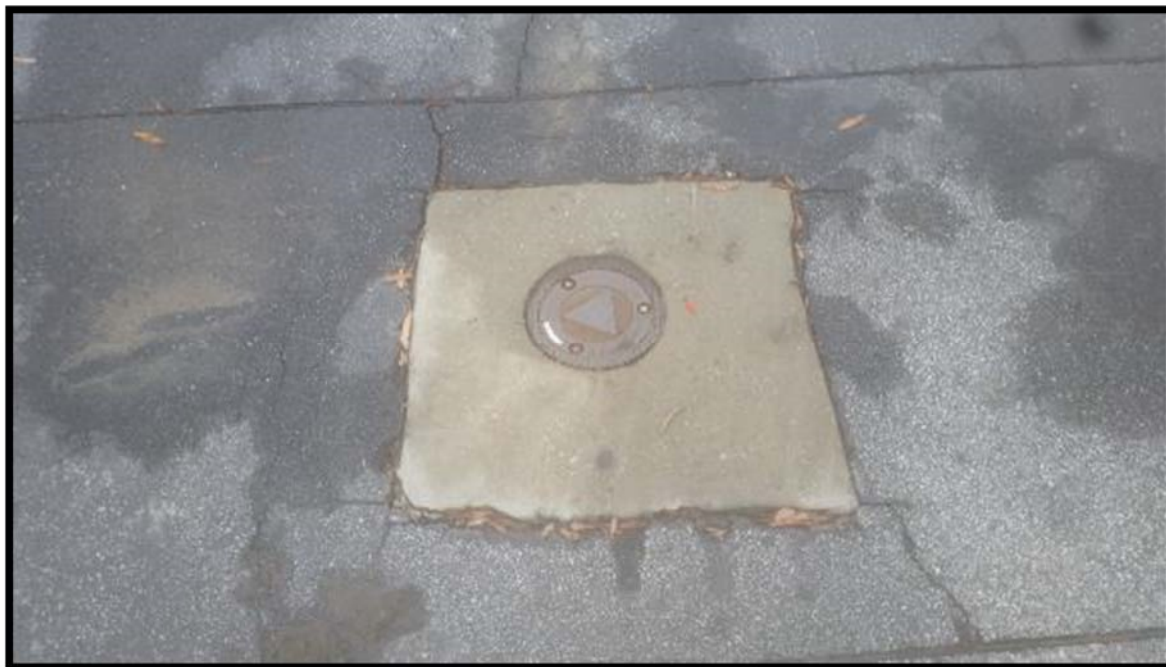
**OFFICIAL PHOTOGRAPH NO. 2  
TETRA TECH**

**Subject:** Background monitoring well, MM-04.

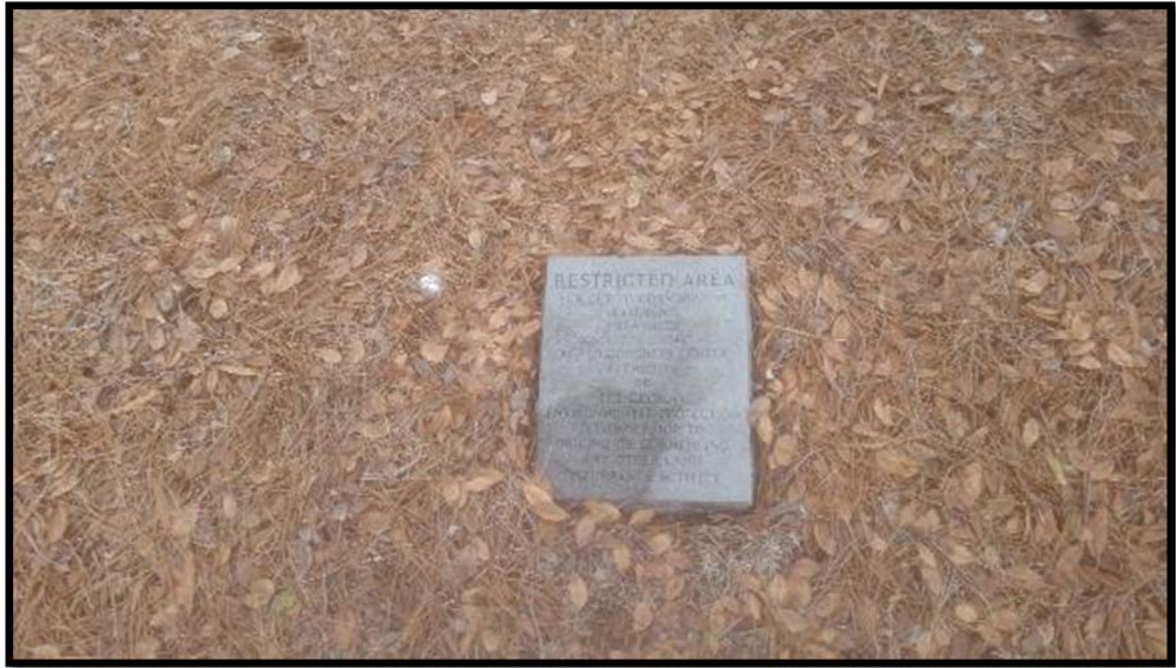
**OFFICIAL PHOTOGRAPH NO. 3**  
**TETRA TECH**

**Subject:** Granite plaque on the southeast corner of the property.

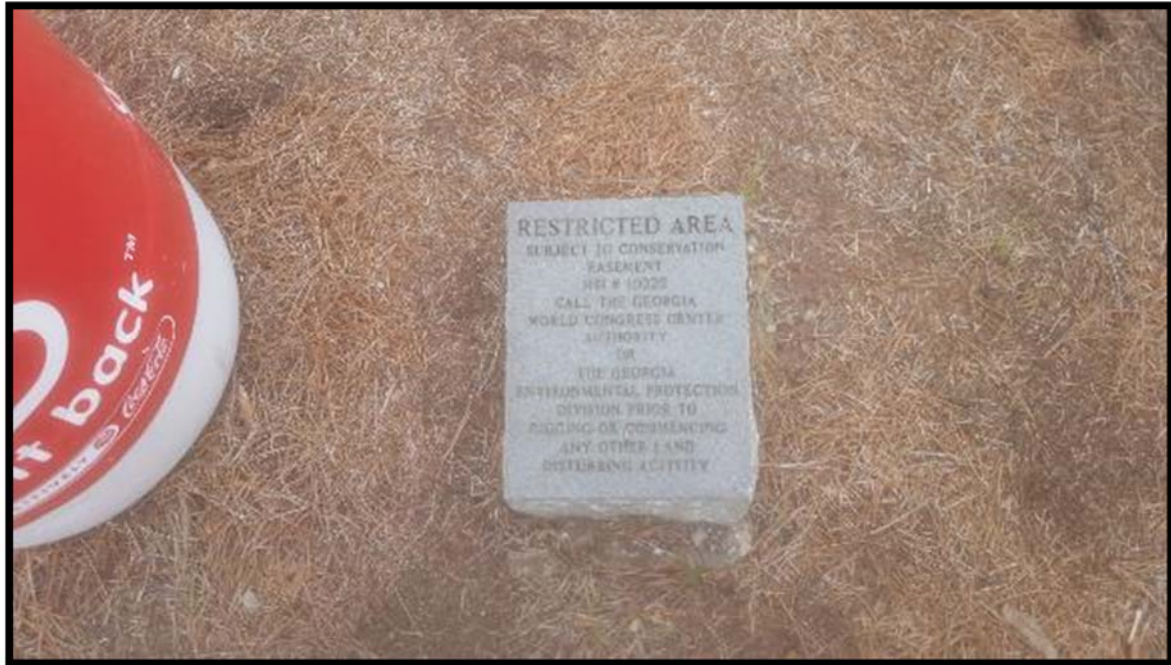
**OFFICIAL PHOTOGRAPH NO. 4  
TETRA TECH**

**Subject:** Granite plaque on the south side of the property.

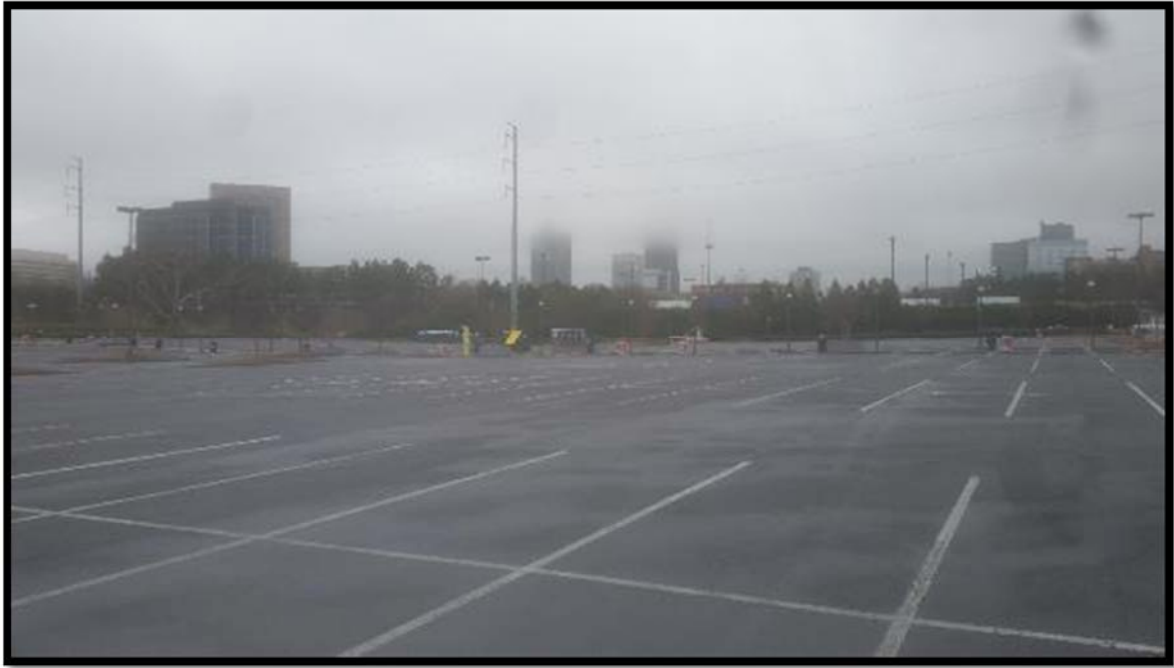
**OFFICIAL PHOTOGRAPH NO. 5**  
**TETRA TECH**

**Subject:** Eastern portion of the lot looking northeast.

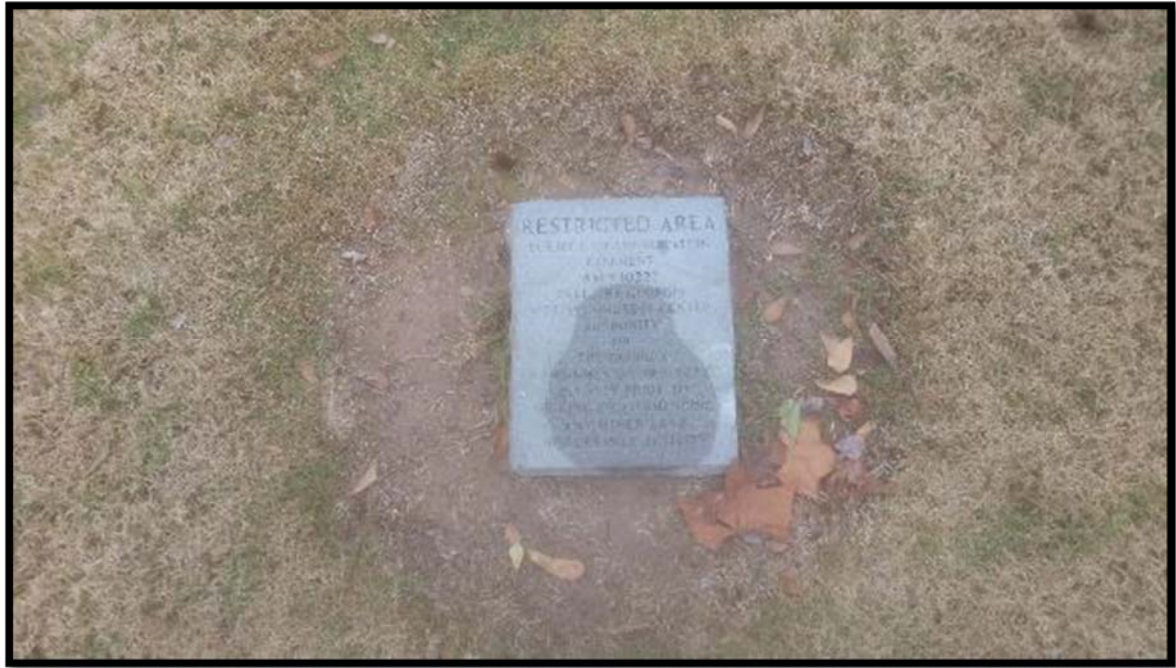
**OFFICIAL PHOTOGRAPH NO. 6**  
**TETRA TECH**

**Subject:** Granite plaque on the northeastern perimeter of the property.
