SUPPORTING THE **GEORGIA WORLD CONGRESS CENTER**

February 12, 2016

**Subject:       Quarters-46/47 Landfill Maintenance and Inspection Report  
                  Northside Drive Landfill Site, Atlanta, Georgia**

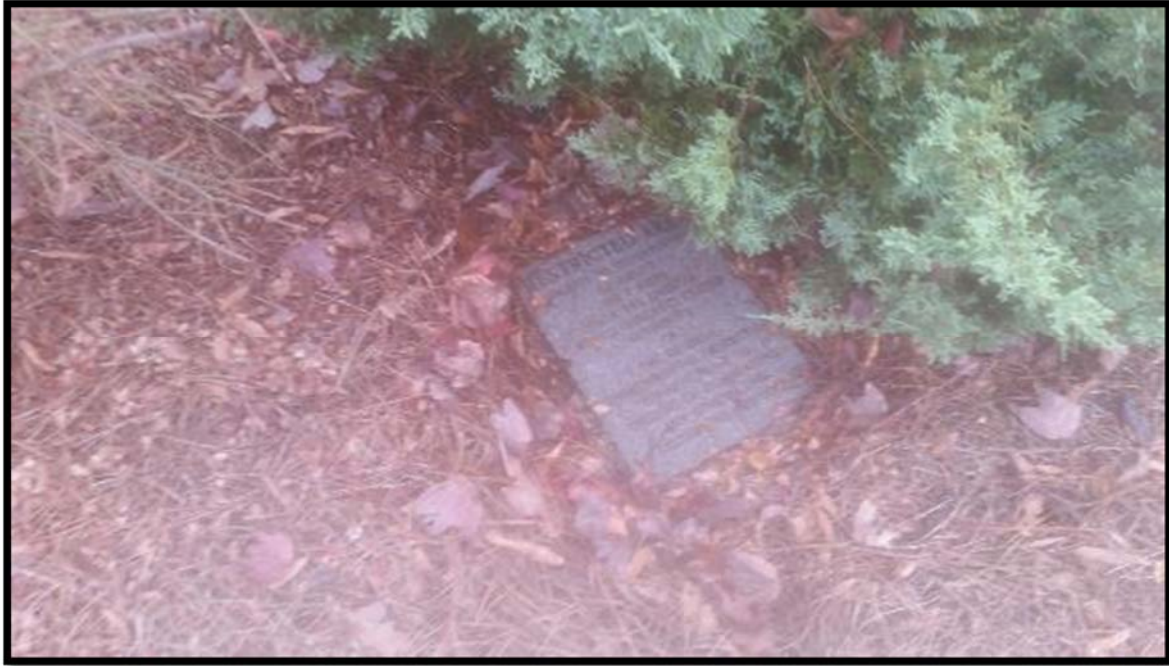
**OFFICIAL PHOTOGRAPH NO. 8**  
**TETRA TECH**

**Subject:** Granite plaque on the western perimeter of the property.

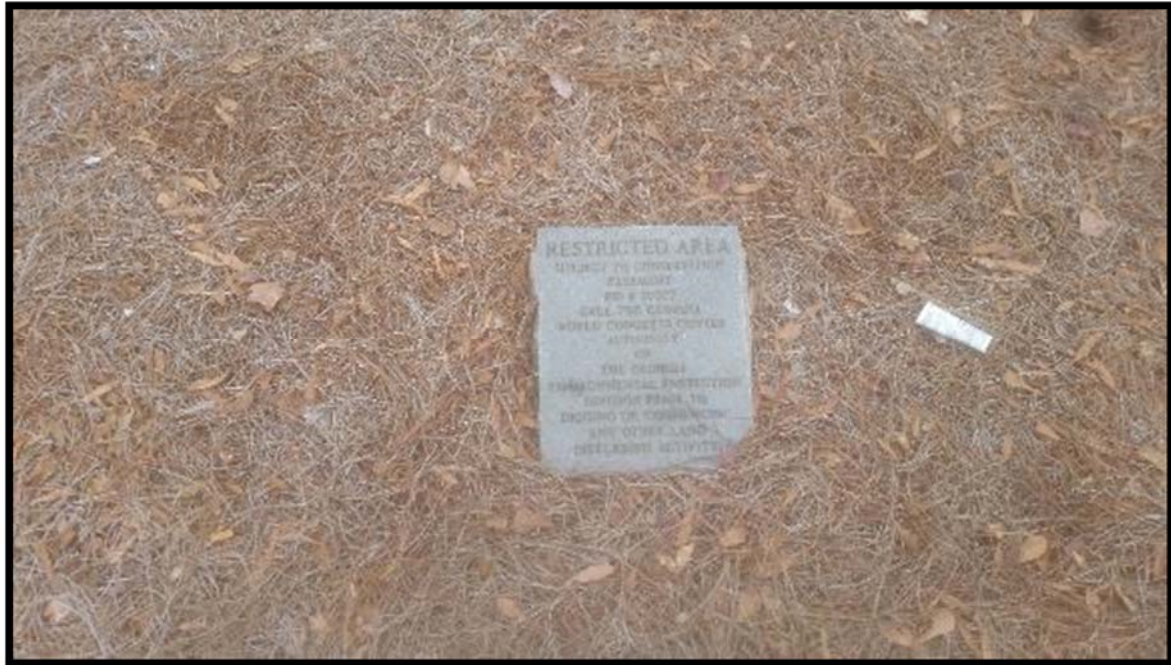
**OFFICIAL PHOTOGRAPH NO. 9**  
**TETRA TECH**

**Subject:** Granite plaque on the southwestern perimeter of lot.

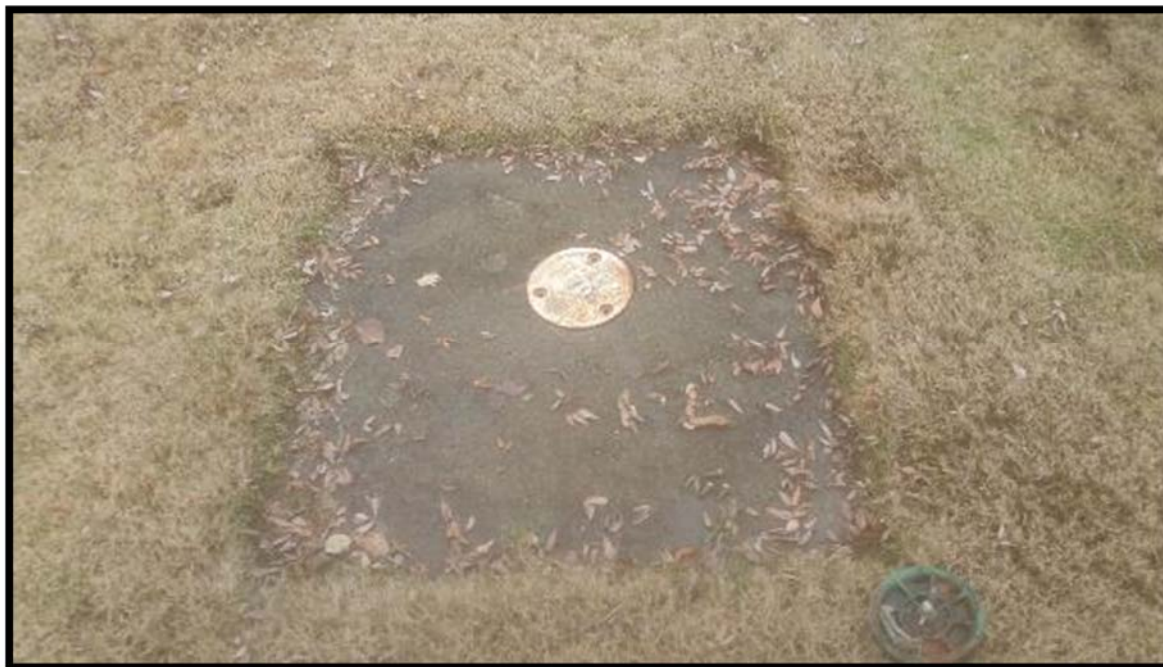
**OFFICIAL PHOTOGRAPH NO. 10**  
**TETRA TECH**

**Subject:** Dewatering well at the northwest perimeter of the property. Site gauging activities were being performed. Well cap was temporarily removed.

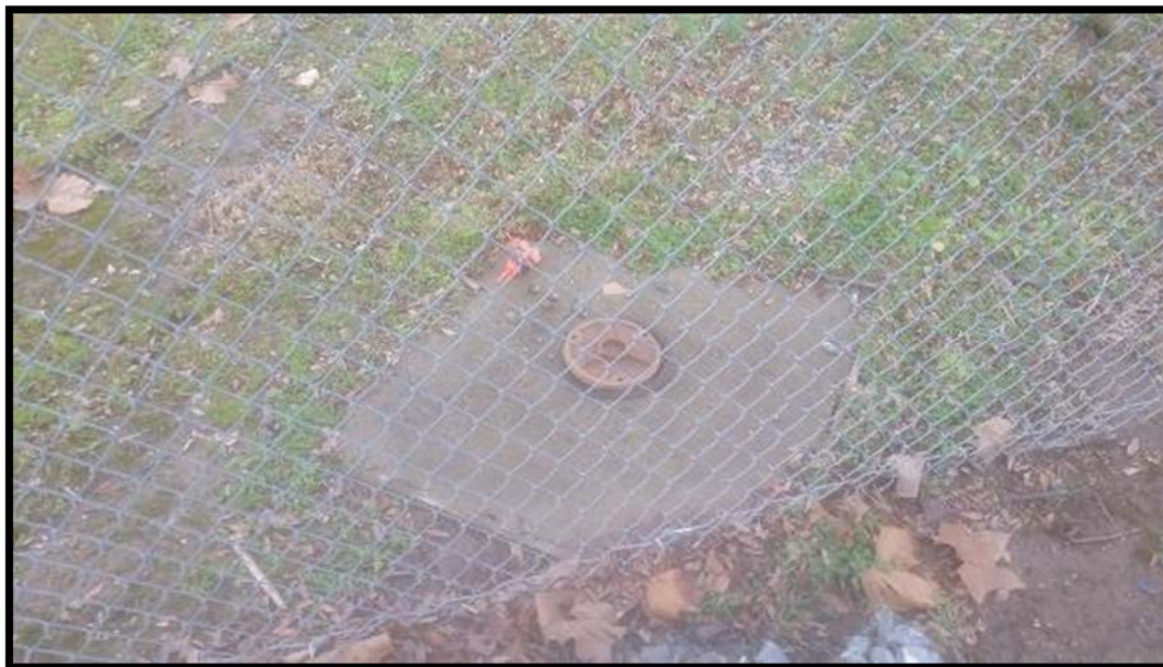
**OFFICIAL PHOTOGRAPH NO. 11**  
**TETRA TECH**

**Subject:** Monitoring well, MM-02 at the corner of John Street and Northside Drive.  
Site gauging activities were being performed. Well cap and lid were temporarily removed.

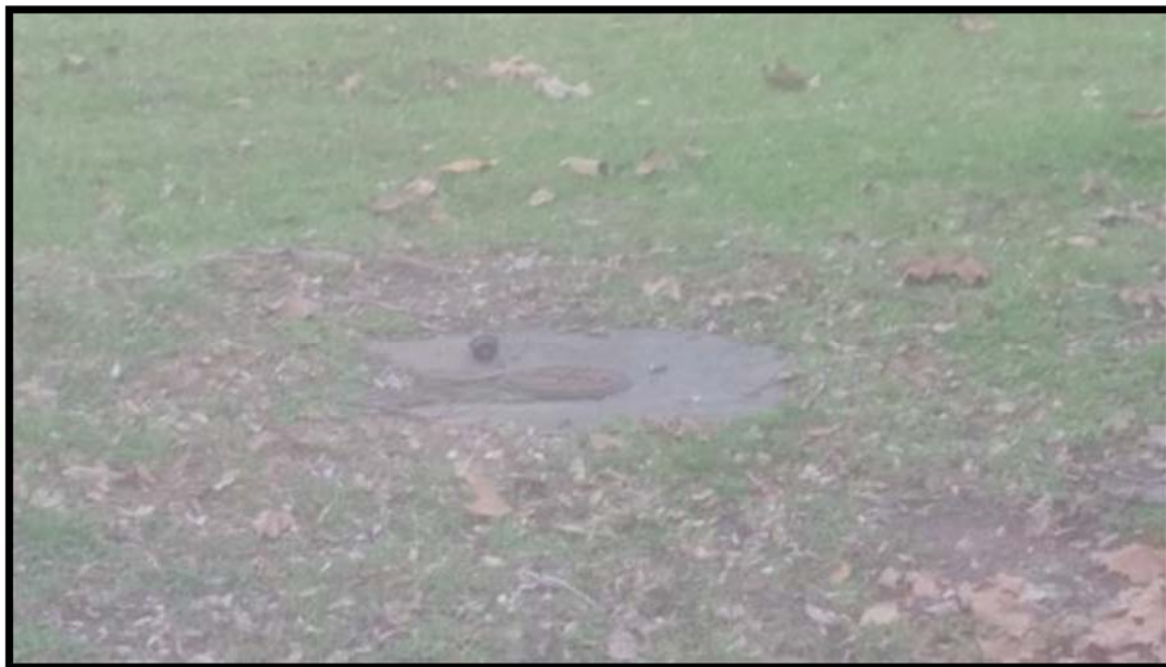
**OFFICIAL PHOTOGRAPH NO. 12**  
**TETRA TECH**

**Subject:** Monitoring well, MWC-3C at the corner of John Street and Northside Drive.  
Site gauging activities were being performed. Well cap and lid were temporarily removed.

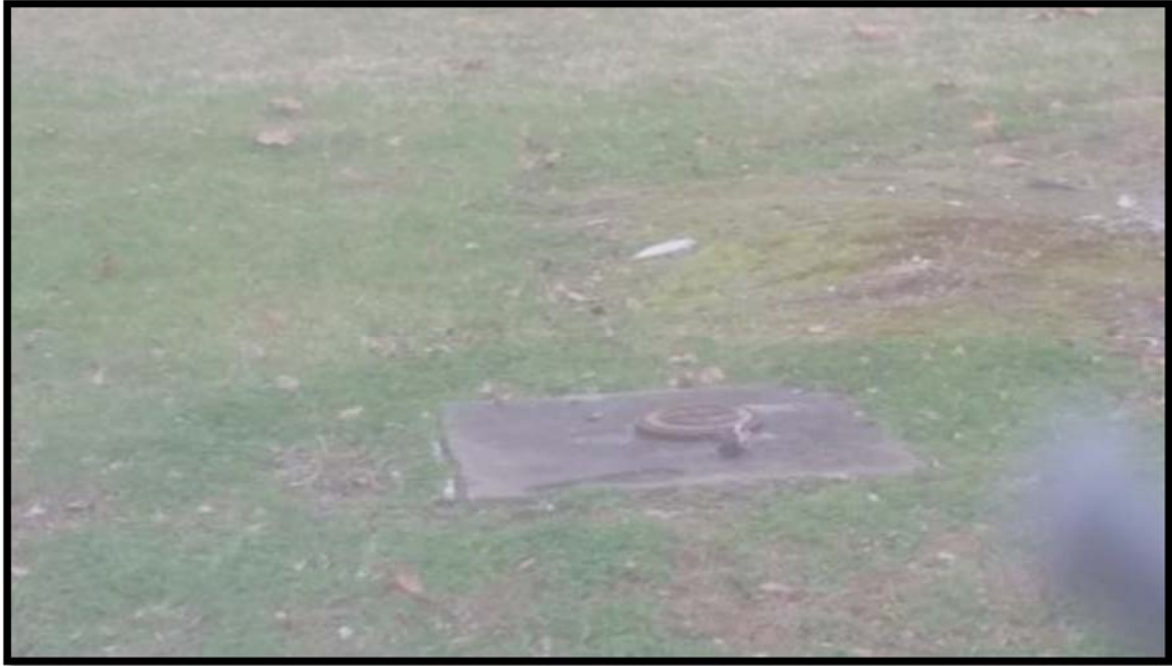
**OFFICIAL PHOTOGRAPH NO. 13**  
**TETRA TECH**

**Subject:** Monitoring well, MWC-3B at the corner of John Street and Northside Drive.  
Site gauging activities were being performed. Well cap and lid were temporarily removed.

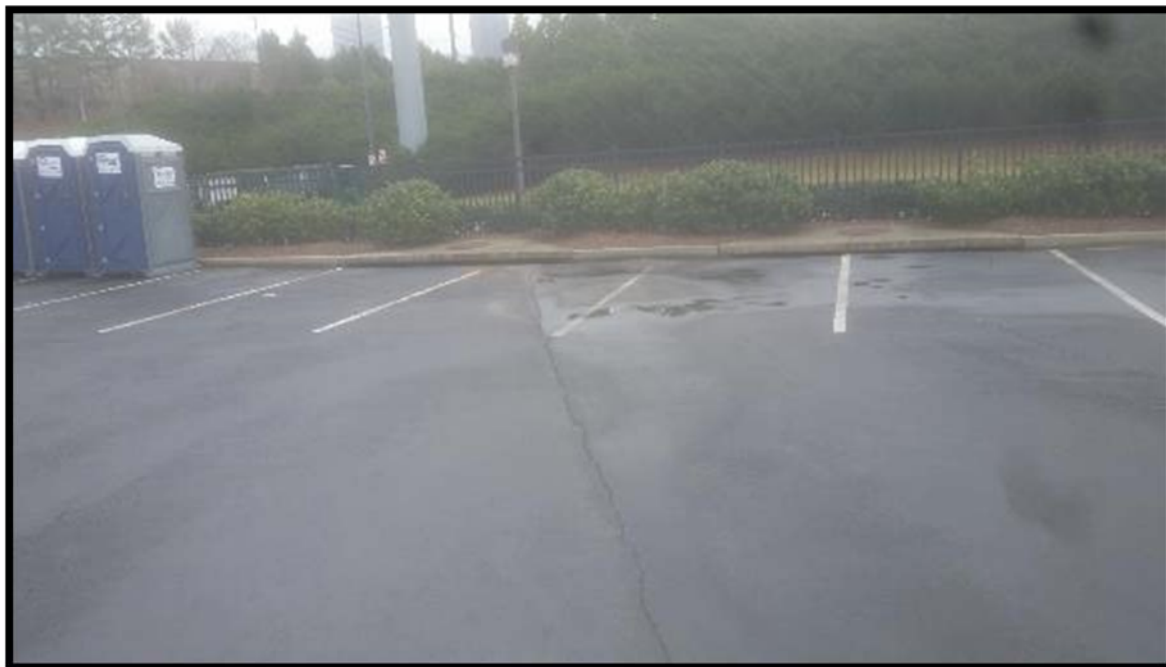
**OFFICIAL PHOTOGRAPH NO. 23**  
**TETRA TECH**

**Subject:** Storm water drains located at the eastern parking lot perimeter.  
The existing crack was still present, but had not increased in size.

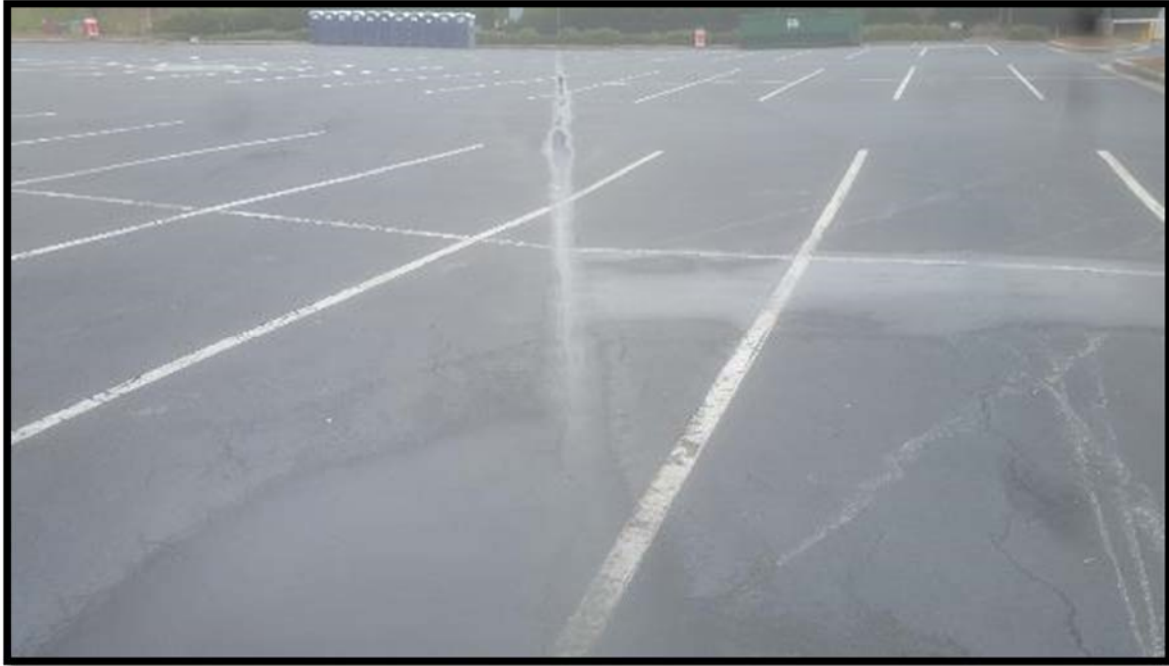
**OFFICIAL PHOTOGRAPH NO. 27**  
**TETRA TECH**

**Subject:** A small crack in the asphalt leading to the storm water drains on the eastern side of the parking lot. Storm water flows in this low point of the parking lot. The crack is estimated to be approximately 200 feet long, ¼ inch wide and ¼ inch deep. The existing crack was still present, but had not increased in size.

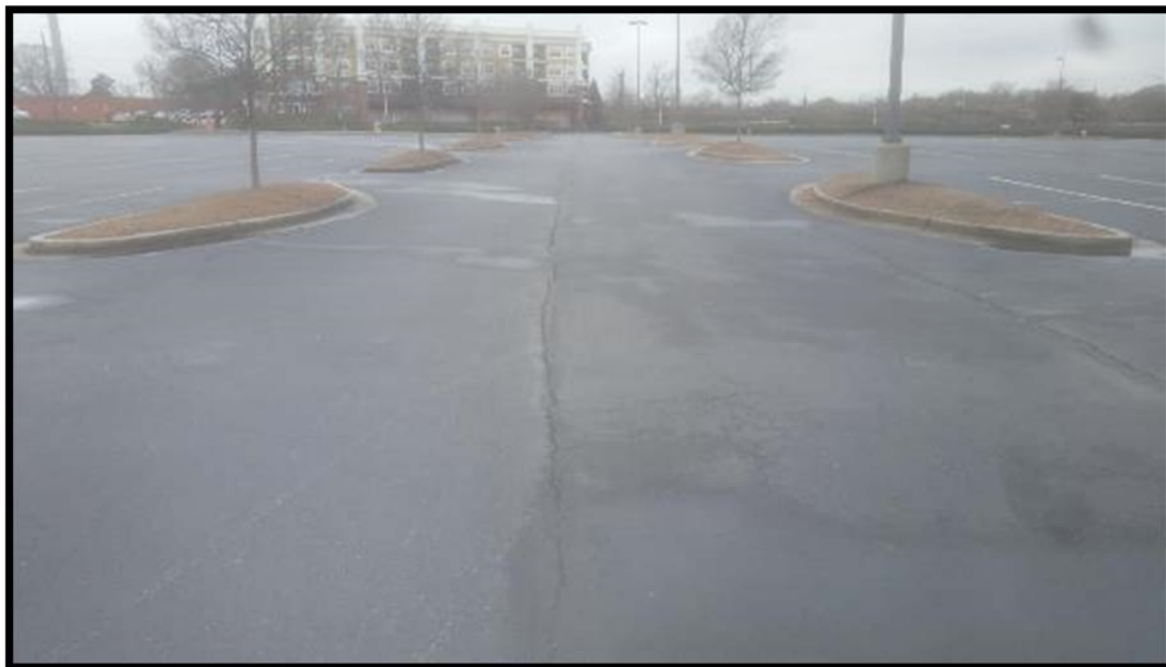
**OFFICIAL PHOTOGRAPH NO. 28**  
**TETRA TECH**

**Subject:** Example of another crack which runs east to west on the main entrance/exit roadway. Like the previously observed crack, it is no larger than  $\frac{1}{4}$  inch wide and  $\frac{1}{4}$  inch deep. This crack traverses almost the entire length of the entrance/exit roadway. The existing crack was still present, but had not increased in size.

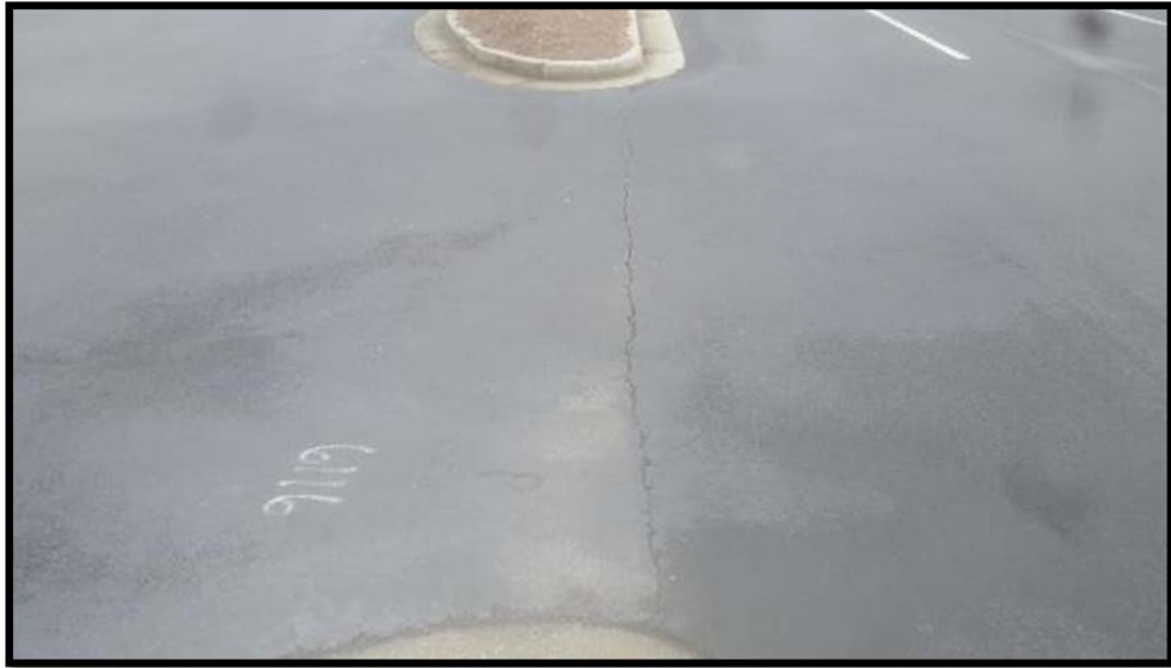
**OFFICIAL PHOTOGRAPH NO. 29**  
**TETRA TECH**

**Subject:** Example of another crack which runs east to west on the entrance way of the parking lot row. Over half of the rows have cracks similar to this one. They occur where the asphalt seams are joined. Like the previously observed crack, it is no larger than  $\frac{1}{4}$  inch wide and  $\frac{1}{4}$  inch deep. The existing crack was still present, but had not increased in size.

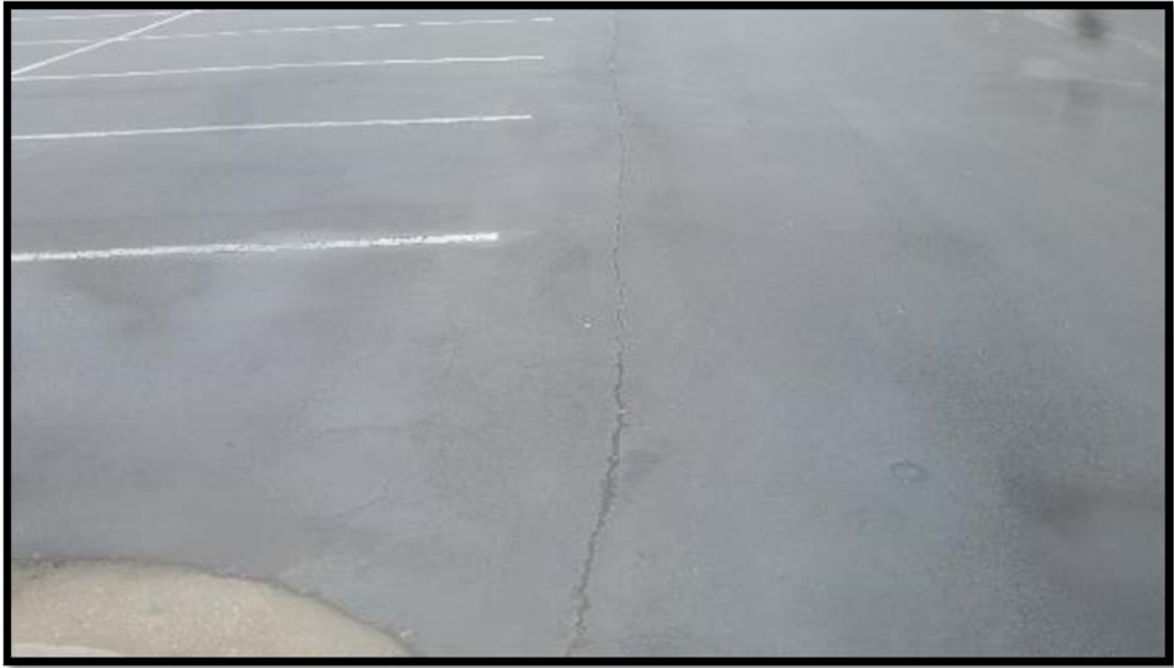
**OFFICIAL PHOTOGRAPH NO. 30**  
**TETRA TECH**

**Subject:** Example of another crack, which runs north to south on the western most row of the north parking lot. The width of this crack is typical of all cracks observed in the asphalt of the north parking lot. The existing crack was still present, but had not increased in size.

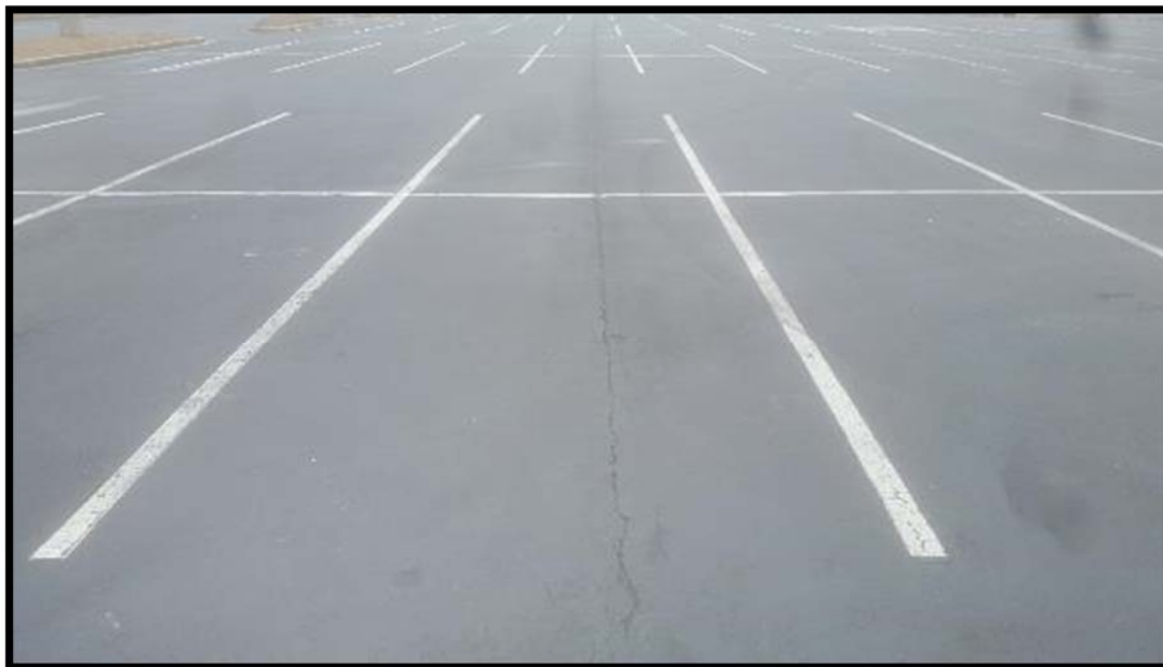
**OFFICIAL PHOTOGRAPH NO. 31**  
**TETRA TECH**

**Subject:** Example of another crack which runs east to west. This crack is located on the northern portion of the parking lot and traverses the entire parking lot west of the north/south walkway. Once again, this crack occurs where the asphalt seams are joined. Like the previously observed cracks, it is no larger than  $\frac{1}{4}$  inch wide and  $\frac{1}{4}$  inch deep. The existing crack was still present, but had not increased in size.

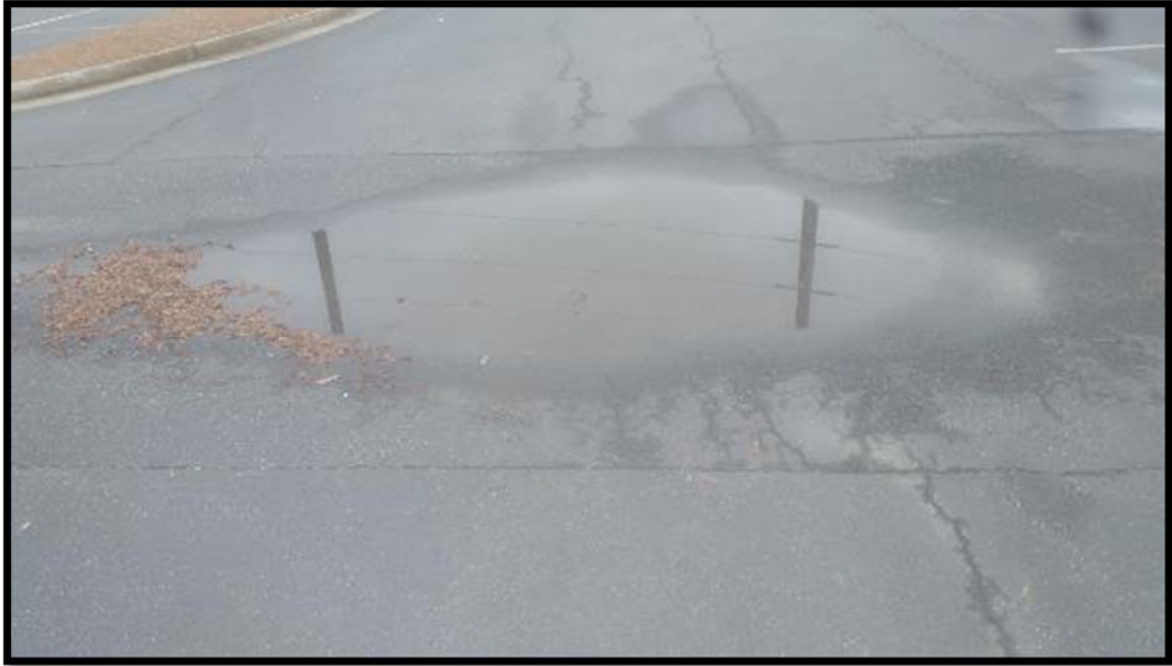
**OFFICIAL PHOTOGRAPH NO. 32**  
**TETRA TECH**

**Subject:** Standing water several hours after rain event on the south side of the parking lot.

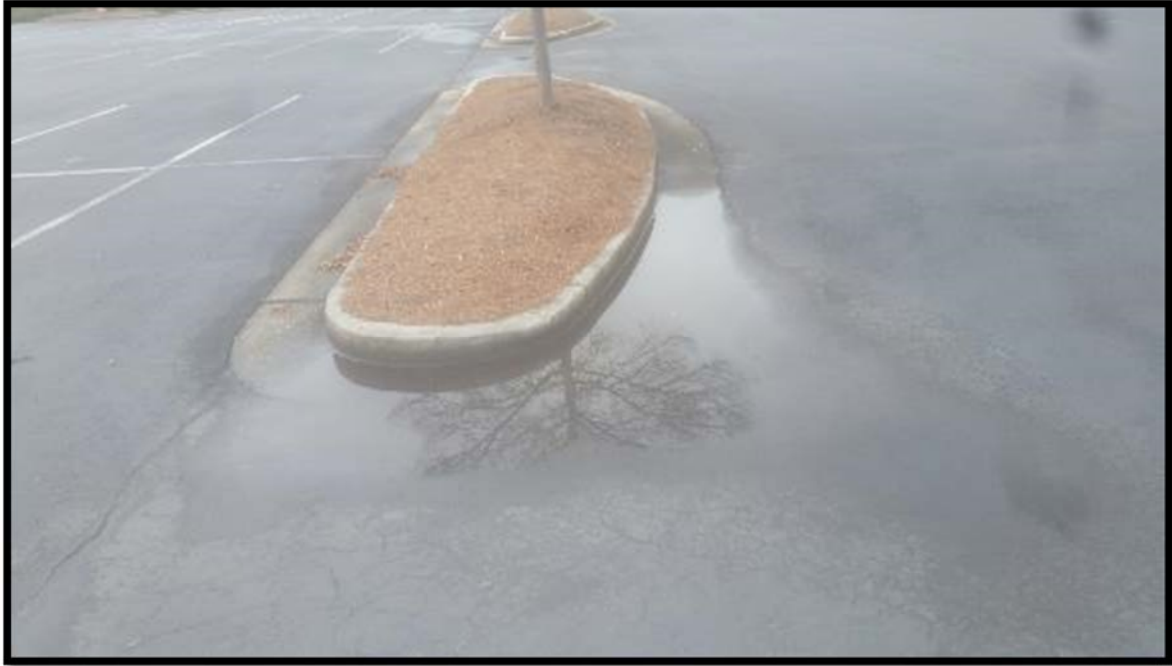
**OFFICIAL PHOTOGRAPH NO. 33**  
**TETRA TECH**

**Subject:** Standing water several hours after rain event in the central portion of the parking lot.

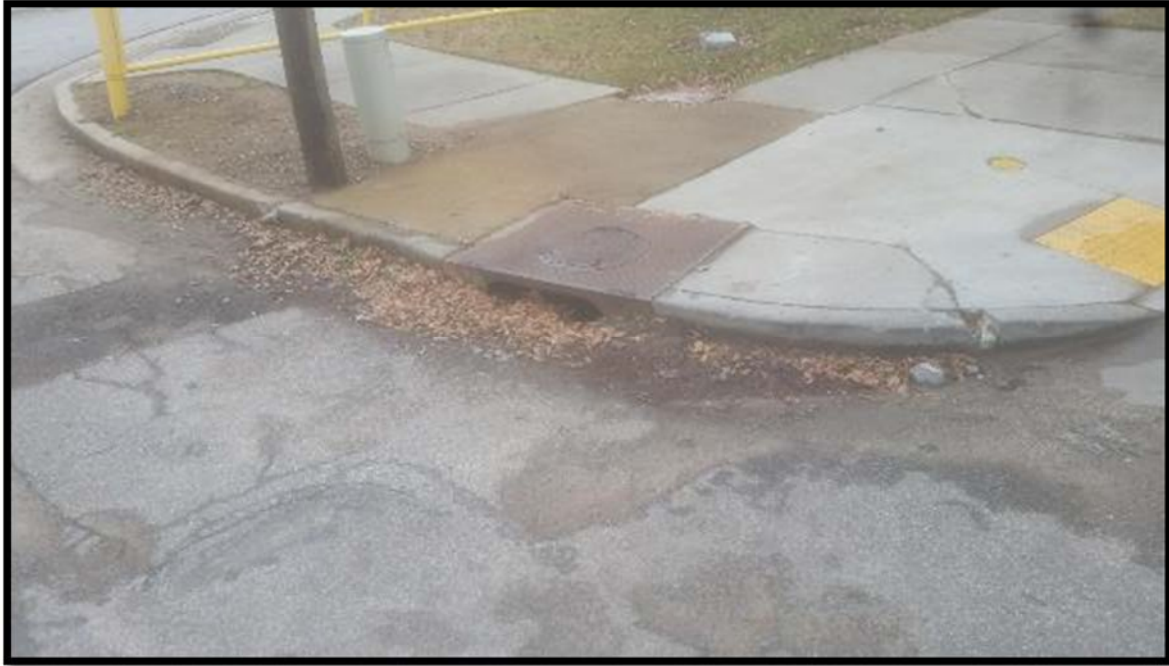
**OFFICIAL PHOTOGRAPH NO. 35**  
**TETRA TECH**

**Subject:** Accumulated sediment and vegetation partially obstructing storm drain at the southwest corner of the John Street and Gray Street intersection.

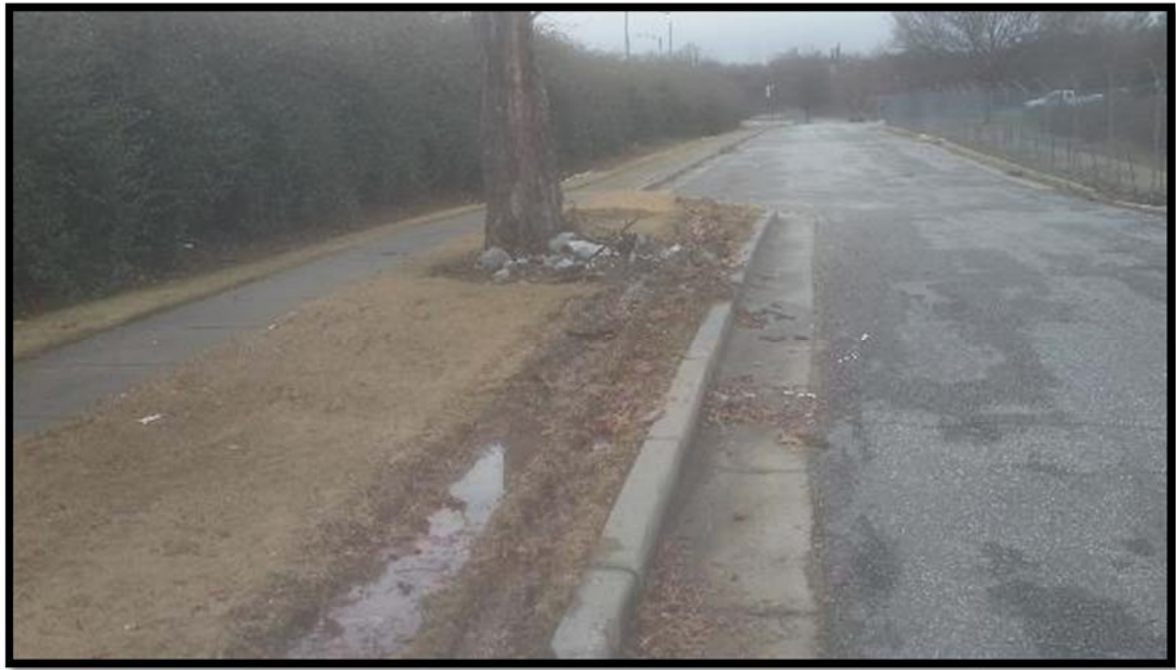
**OFFICIAL PHOTOGRAPH NO. 36**  
**TETRA TECH**

**Subject:** Rutted vegetation along (approx. 60'x 18" by 6") along John Street. Appears to have been caused by automobile.

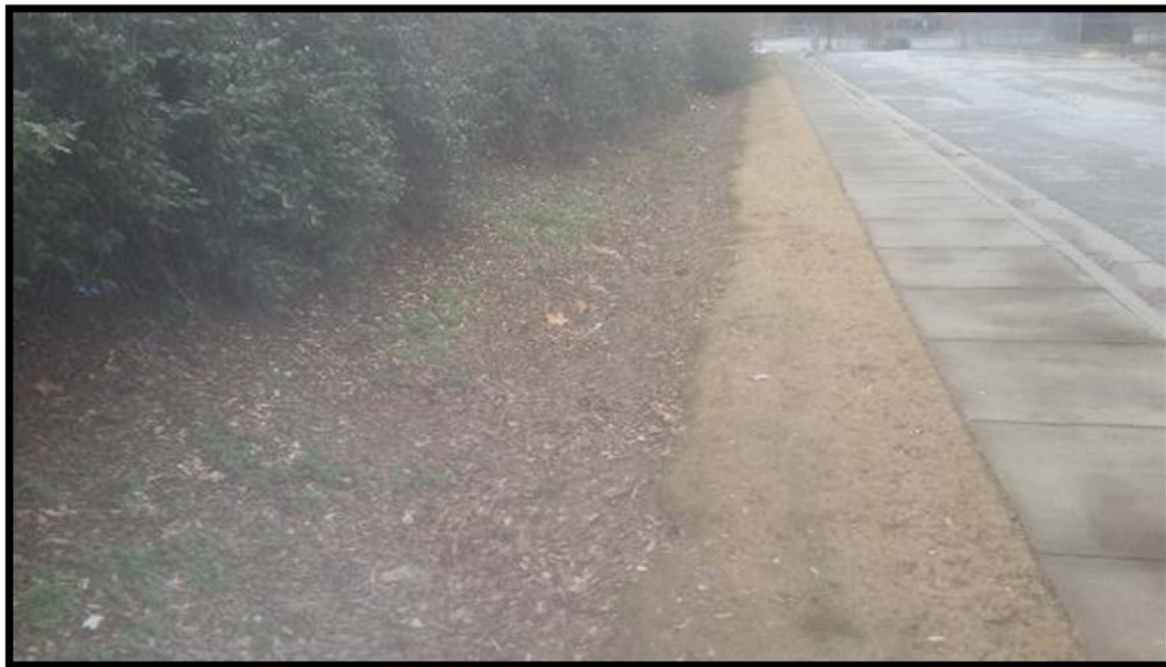
**OFFICIAL PHOTOGRAPH NO. 37**  
**TETRA TECH**

**Subject:** Significant washout along John Street for westward flowing storm water drainage. Washout appears to be undercutting sod.

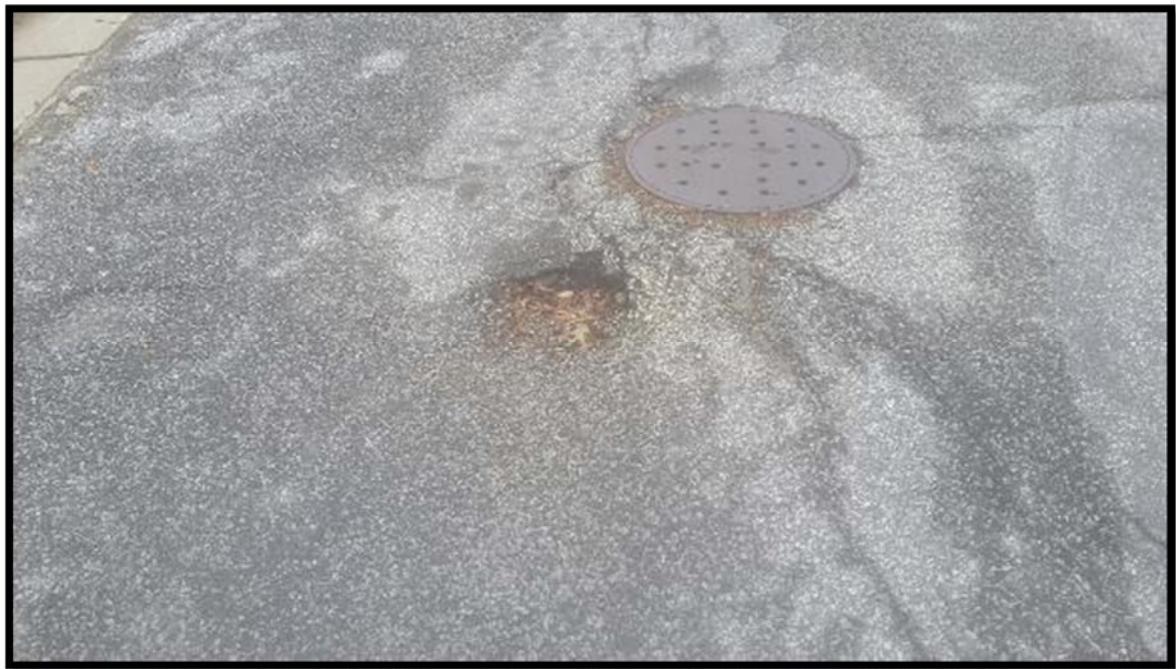
**OFFICIAL PHOTOGRAPH NO. 38**  
**TETRA TECH**

**Subject:** Pothole found near manhole in John Street – approx. 10” diameter and 4” deep.

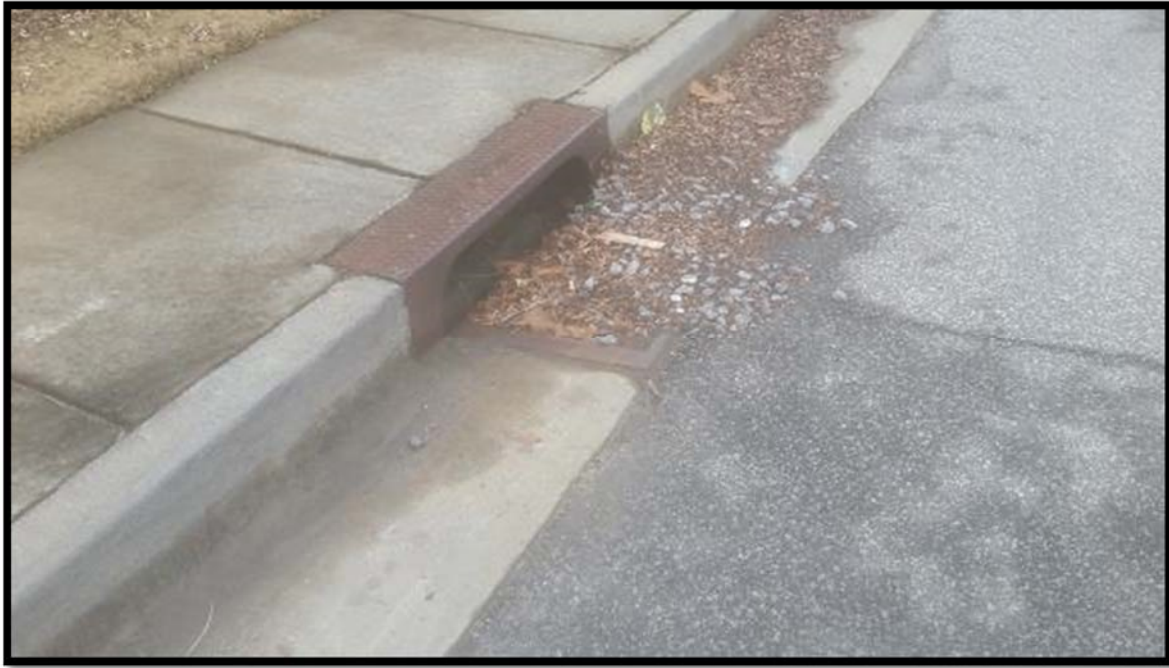
**OFFICIAL PHOTOGRAPH NO. 39**  
**TETRA TECH**

**Subject:** Storm drain on John Street partially obstructed with gravel, sediment, and vegetation.

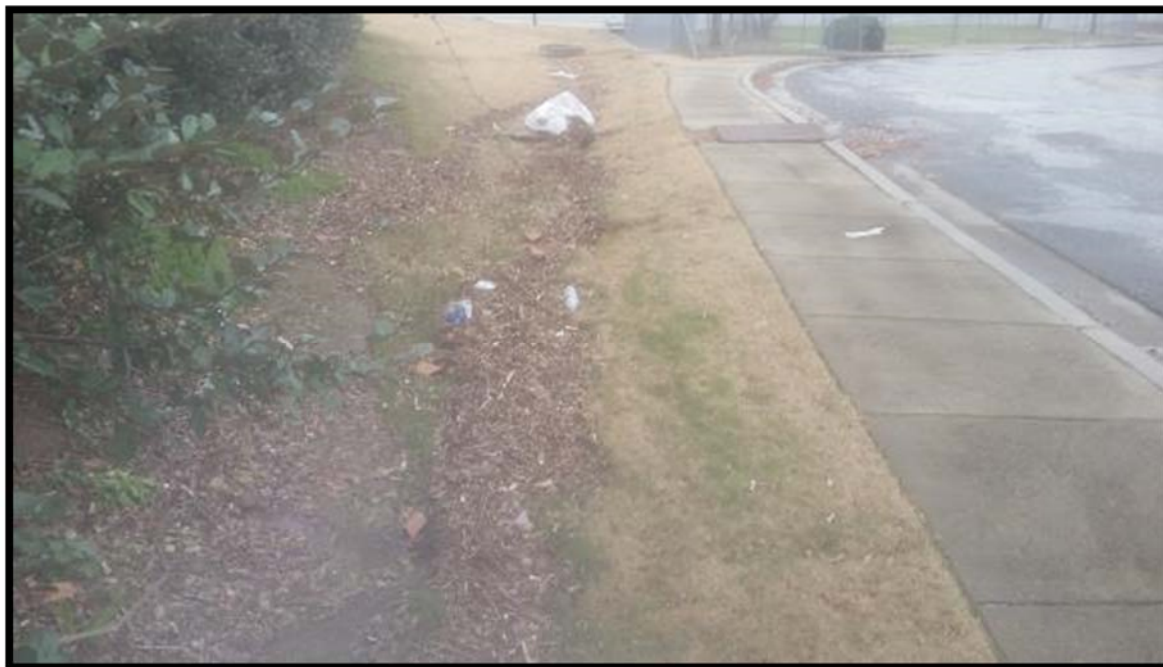
**OFFICIAL PHOTOGRAPH NO. 41**  
**TETRA TECH**

**Subject:** Storm water washout area along John Street. Note large amount of accumulated vegetation and landscaping mulch in the area. Washout appears to be undercutting sod.

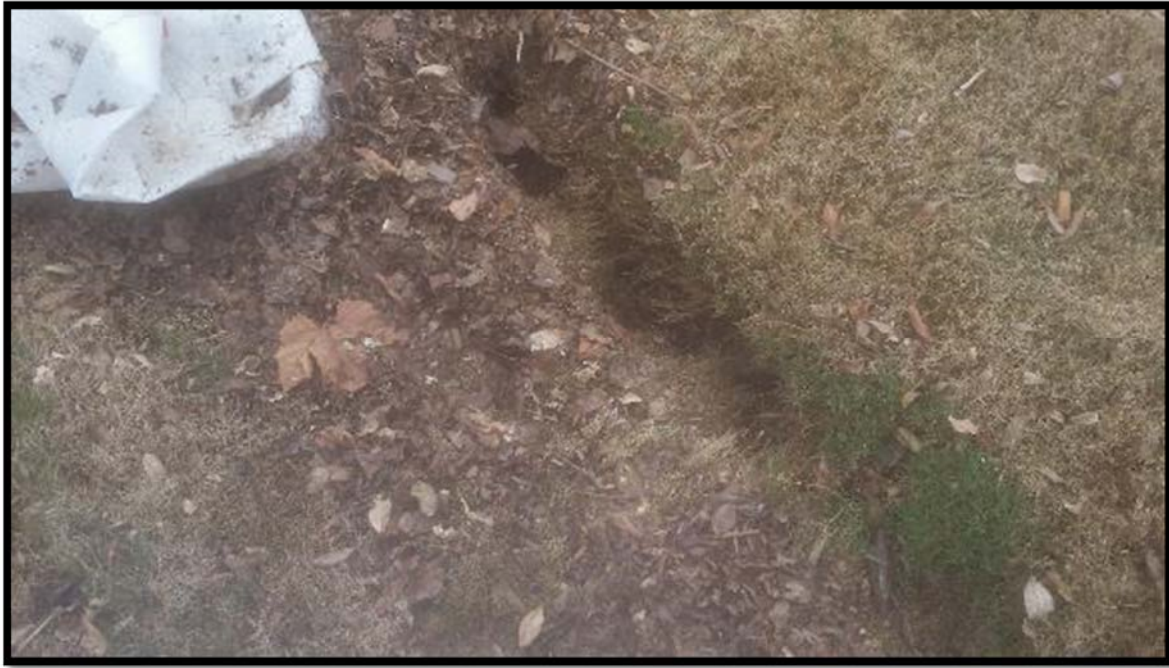
**OFFICIAL PHOTOGRAPH NO. 41A**  
**TETRA TECH**

**Subject:** Eroded soil in the storm water washout area along John Street. The storm water appears to have caused a clear separation and has undercut the sod. The hole is approximately 16" deep and extends approximately 8 feet. The accumulation of storm water debris prevented the full measurement of the compromise.

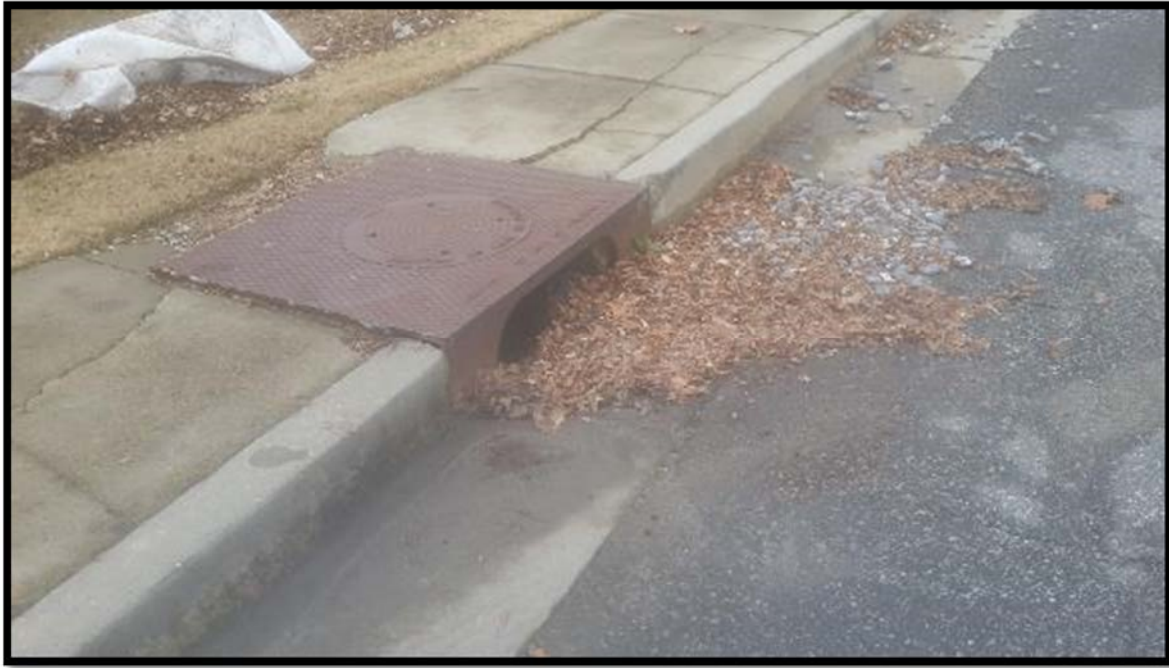
**OFFICIAL PHOTOGRAPH NO. 42**  
**TETRA TECH**

**Subject:** Storm water drain along John Street partially obstructed by gravel, sediment, and vegetation. This drain is located adjacent to the eroded area presented in Photograph 41A. Note the depressed concrete on the south side of the metal vault.

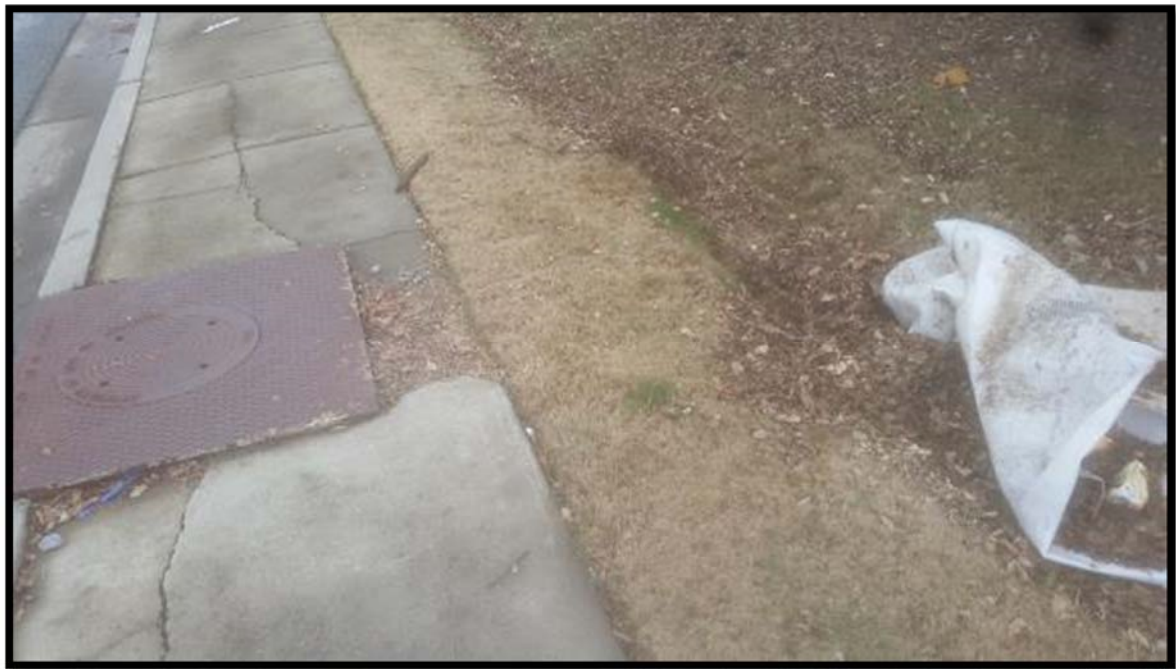
**OFFICIAL PHOTOGRAPH NO. 42A**  
**TETRA TECH**

**Subject:** Another view of the eroded soil area and metal storm drain vault presented in Photographs 41A and 42.

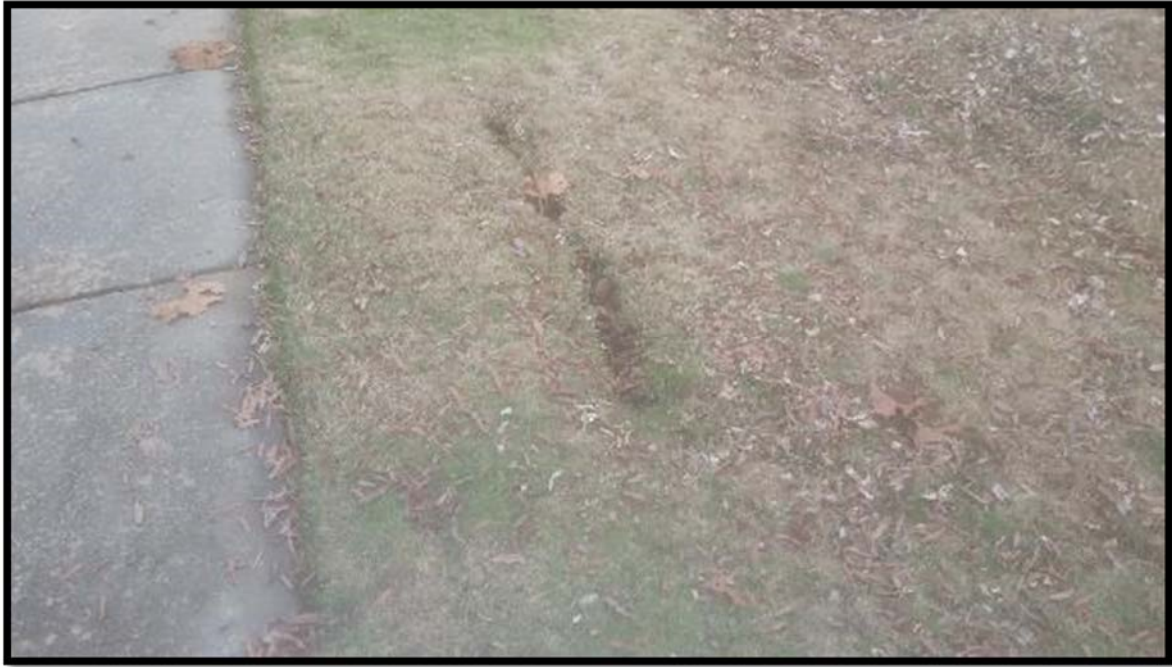
**OFFICIAL PHOTOGRAPH NO. 44**  
**TETRA TECH**

**Subject:** Another eroded soil area on the north side of the property. Eroded area is approximately 6'x6"x14".
