August 15, 2017

**Subject: Quarters-52/53 Landfill Maintenance and Inspection Report
 Northside Drive Landfill Site, Atlanta, Georgia**

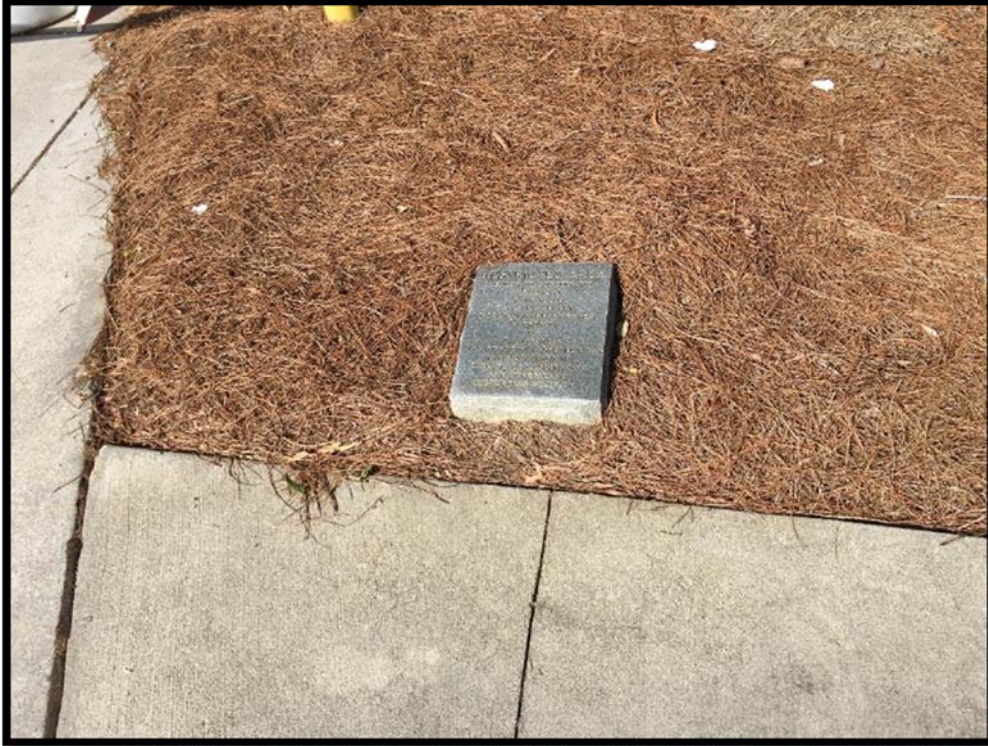
**OFFICIAL PHOTOGRAPH NO. 1
TETRA TECH**

Subject: Granite plaque located on the east, southeast side of the north parking lot perimeter.

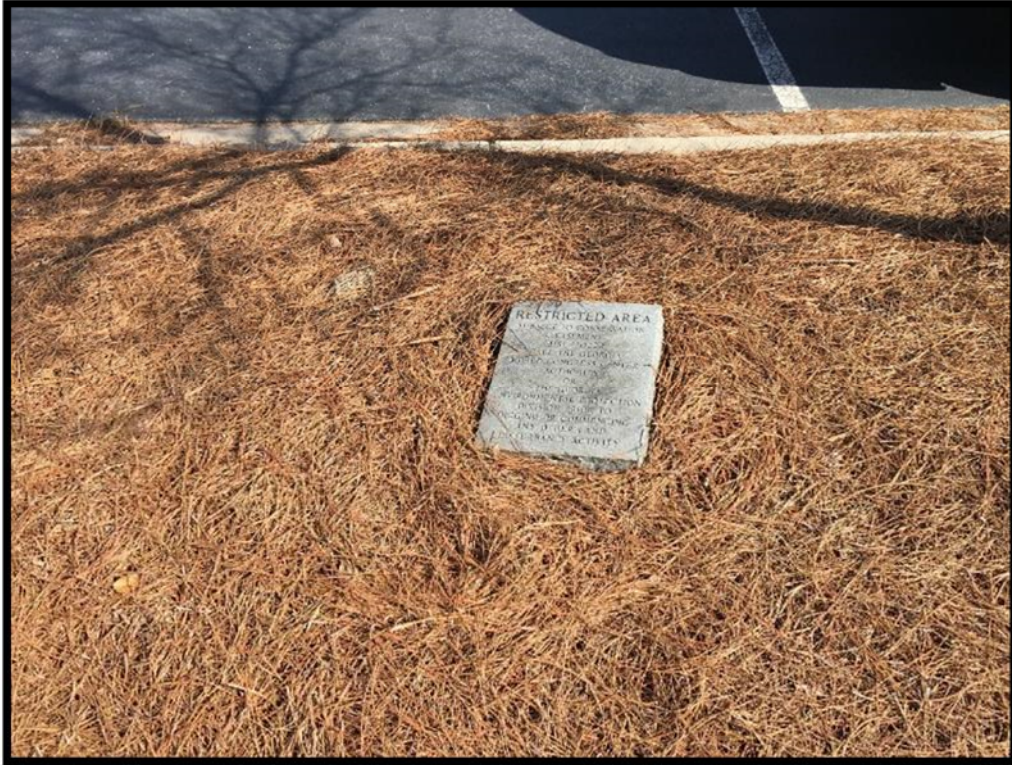
**OFFICIAL PHOTOGRAPH NO. 3
TETRA TECH**

Subject: Granite plaque on the southeast corner of the property.

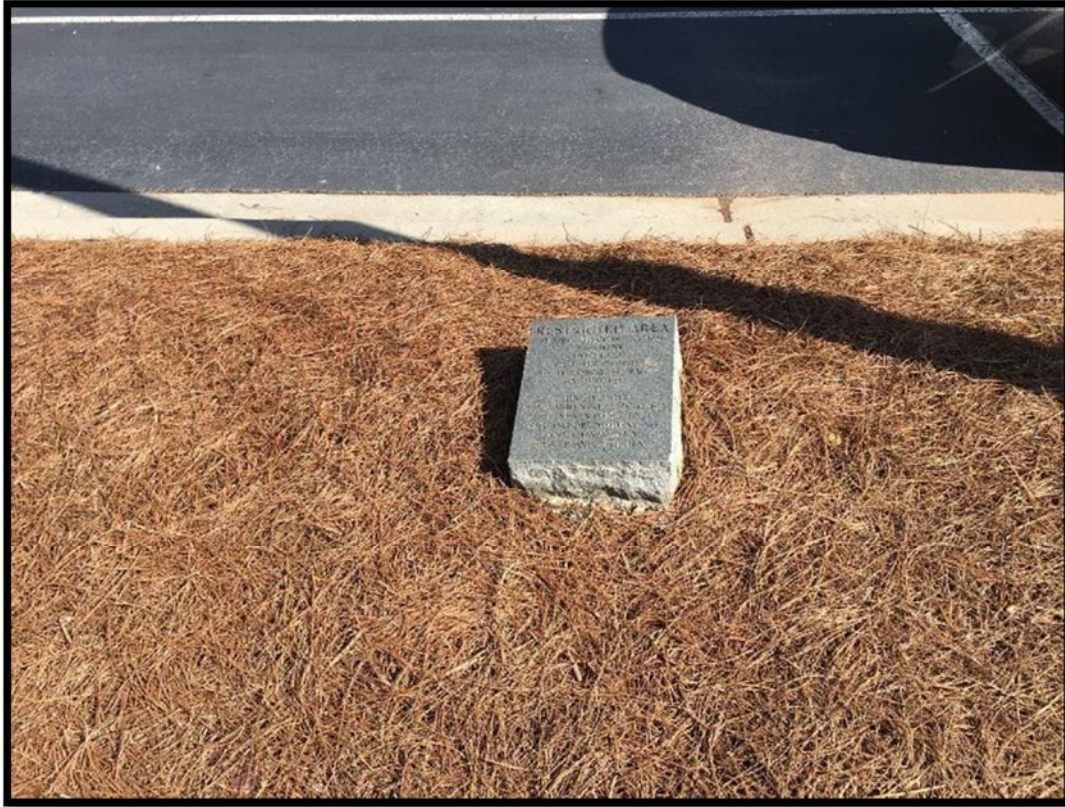
**OFFICIAL PHOTOGRAPH NO. 4
TETRA TECH**

Subject: Granite plaque on the south side of the property.

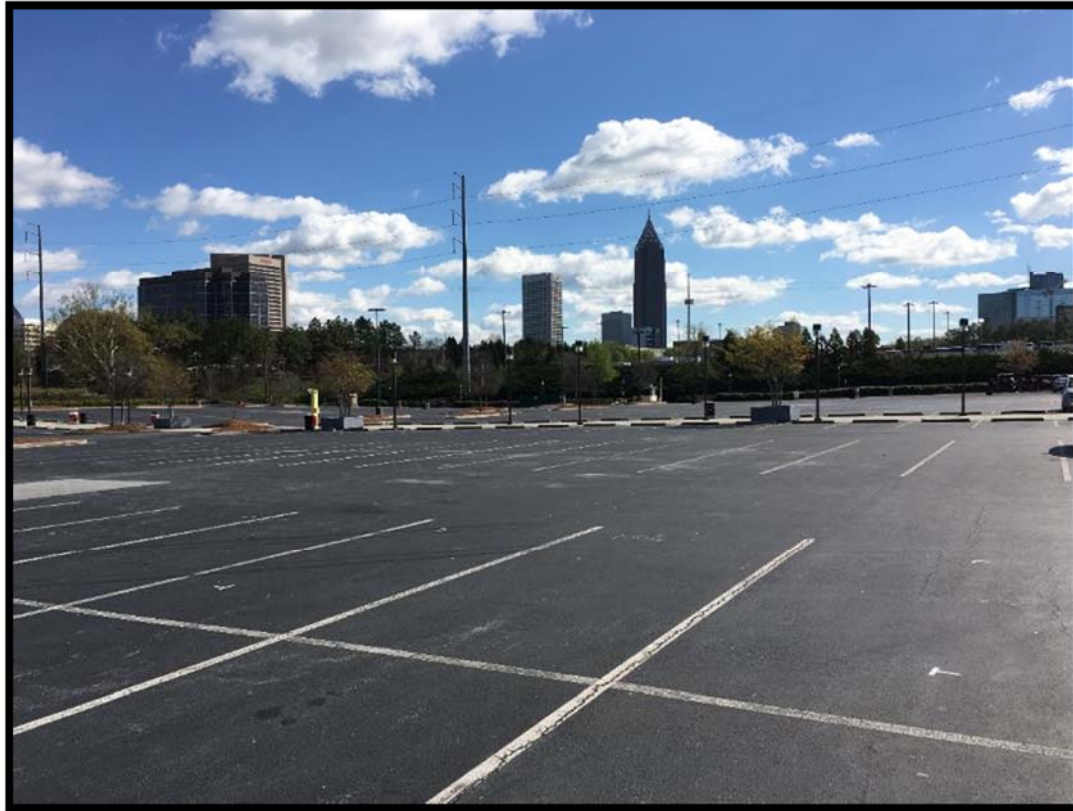
**OFFICIAL PHOTOGRAPH NO. 5
TETRA TECH**

Subject: Eastern portion of the lot looking northeast.

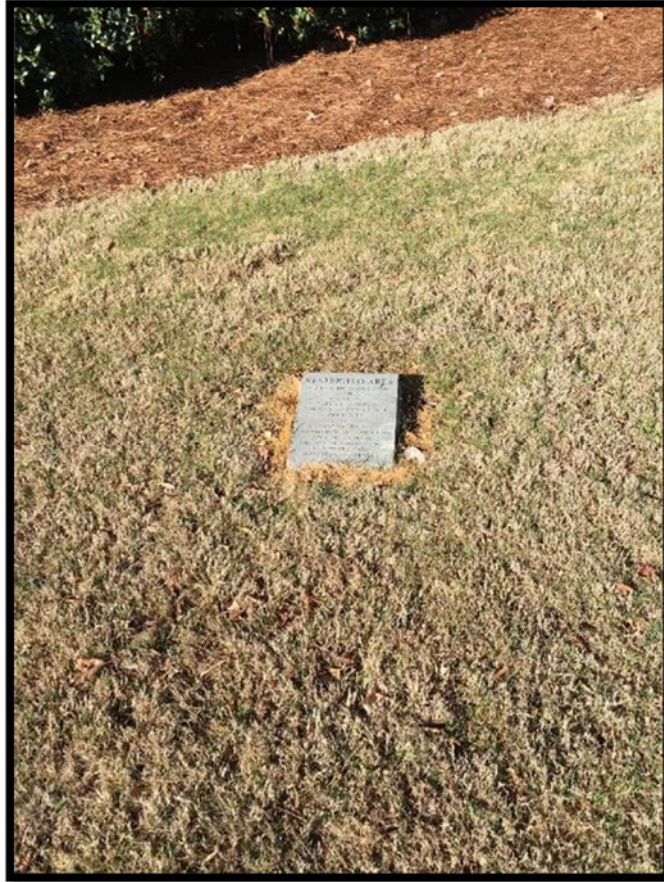
**OFFICIAL PHOTOGRAPH NO. 6
TETRA TECH**

Subject: Granite plaque on the northeastern perimeter of the property.

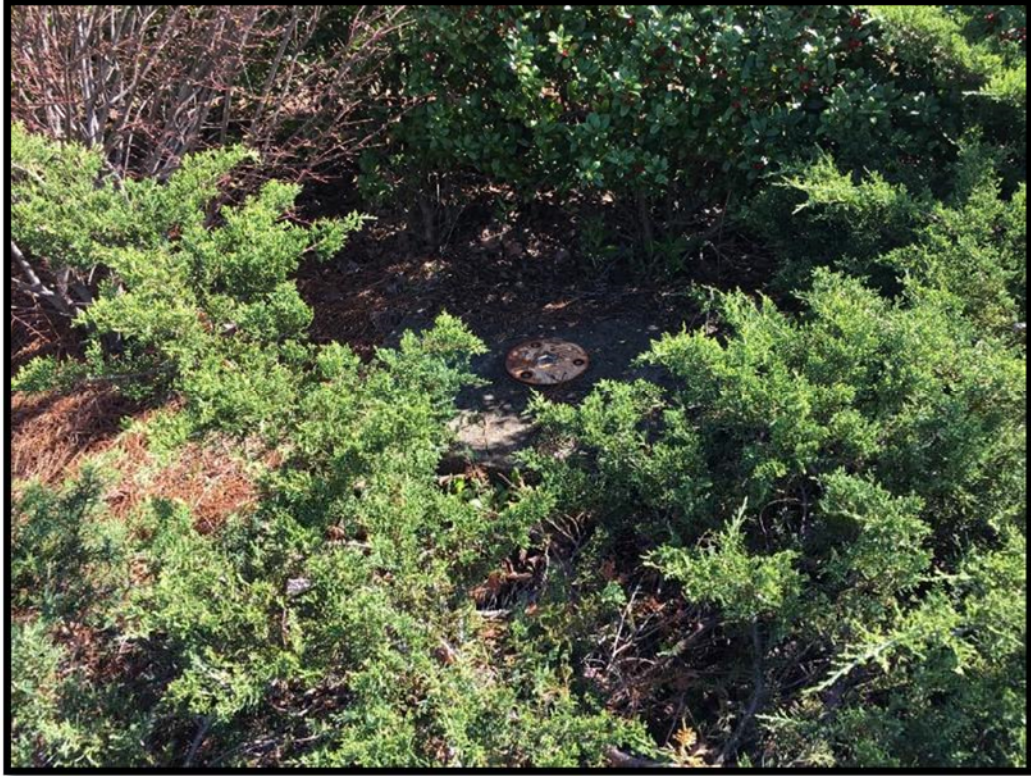
**OFFICIAL PHOTOGRAPH NO. 7
TETRA TECH**

Subject: Monitoring well, MM-01.

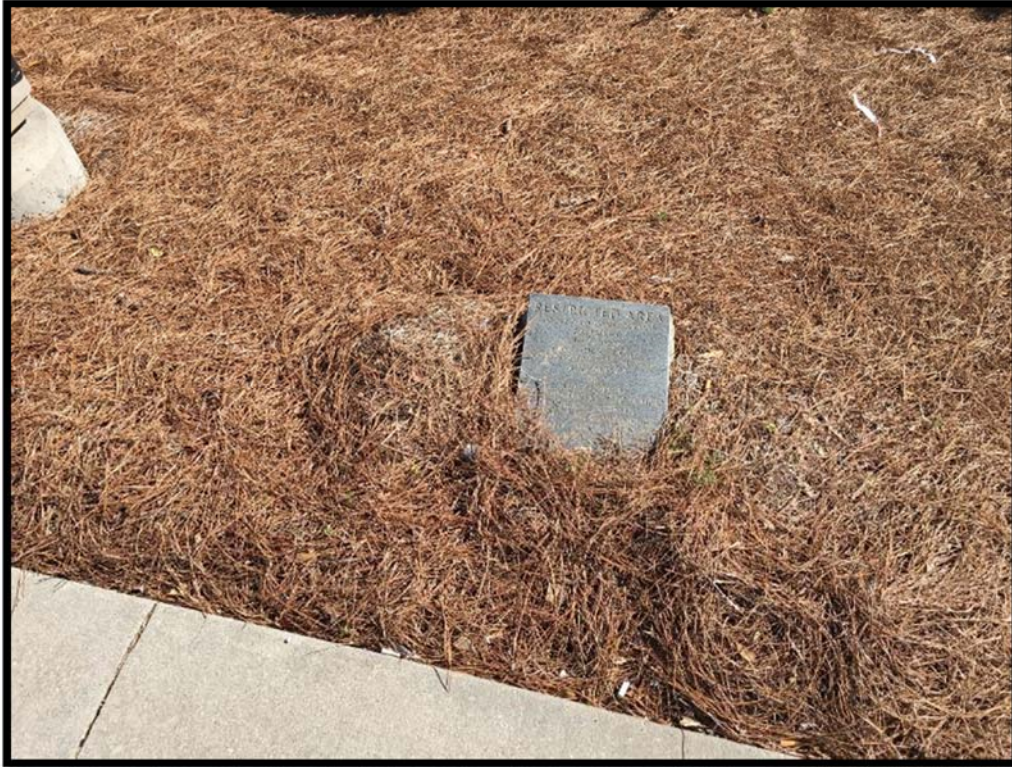
**OFFICIAL PHOTOGRAPH NO. 9
TETRA TECH**

Subject: Granite plaque on the southwestern perimeter of lot.

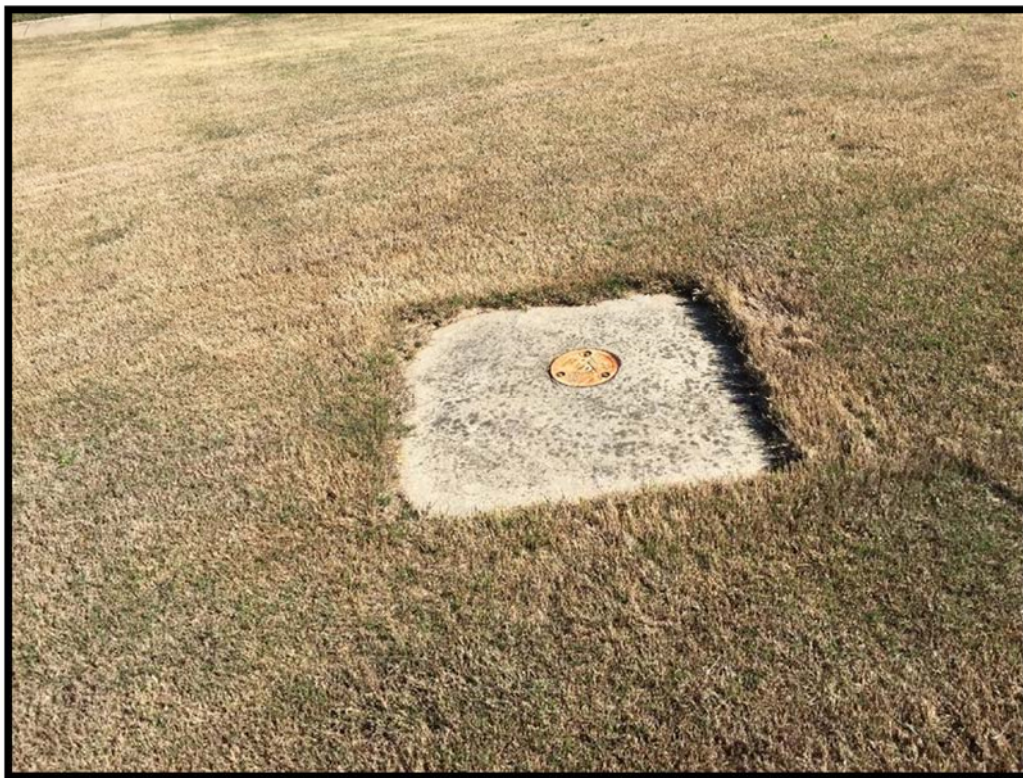
**OFFICIAL PHOTOGRAPH NO. 10
TETRA TECH**

Subject: Dewatering well at the northwest perimeter of the property.

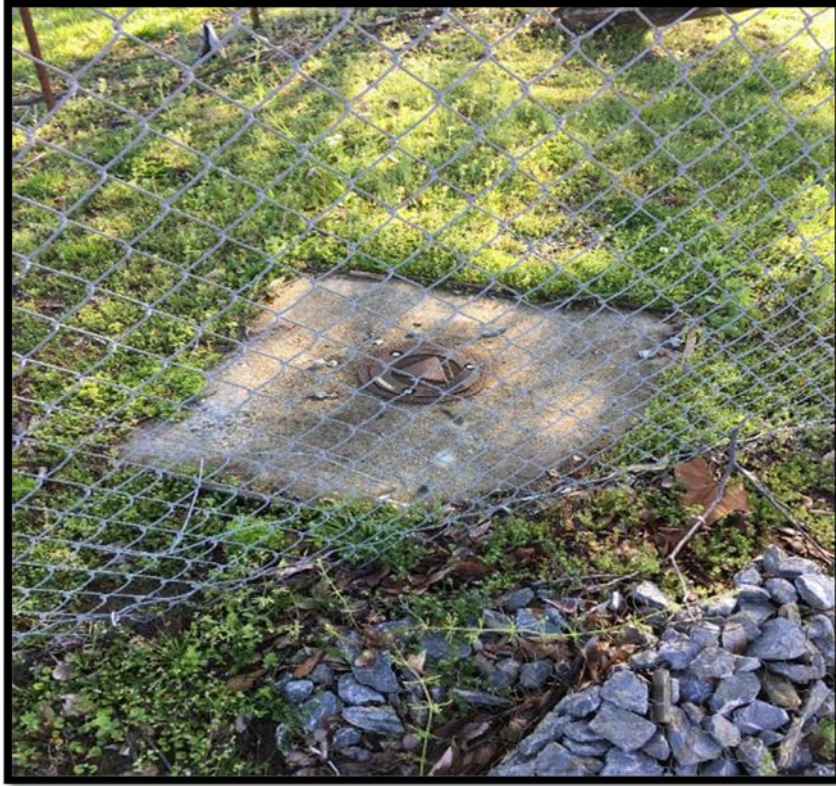
**OFFICIAL PHOTOGRAPH NO. 11
TETRA TECH**

Subject: Monitoring well, MM-02 at the corner of John Street and Northside Drive.

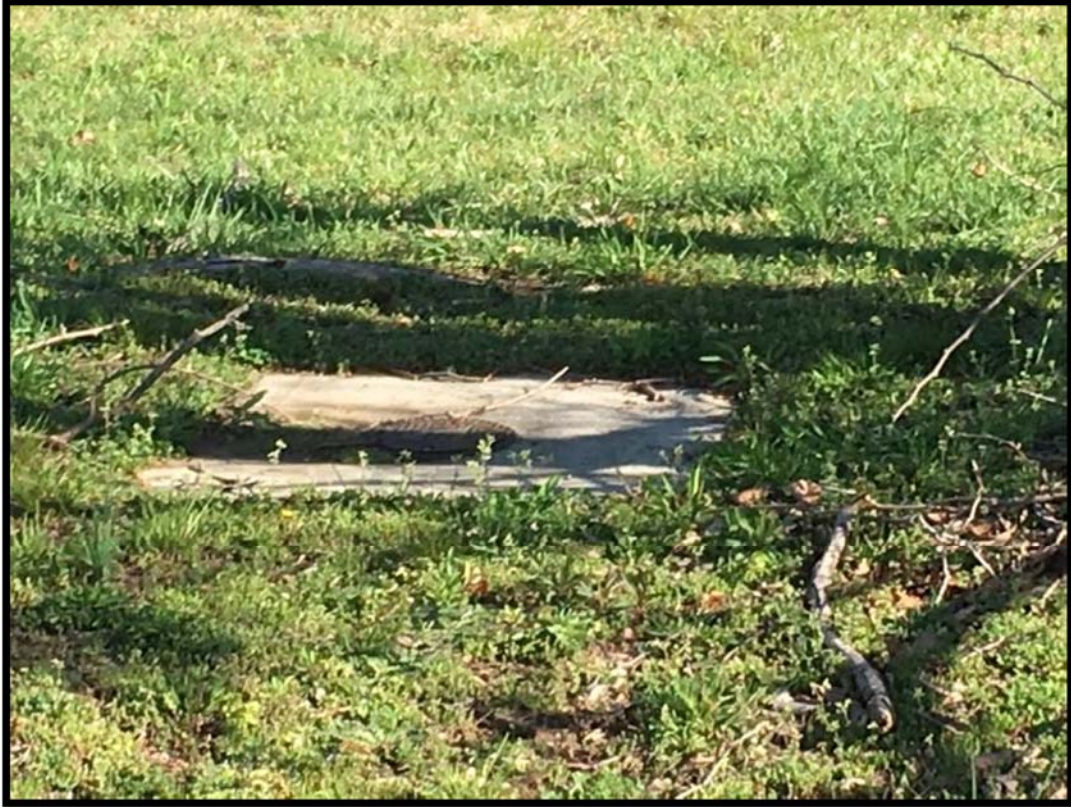
**OFFICIAL PHOTOGRAPH NO. 12
TETRA TECH**

Subject: Monitoring well, MWC-3C at the corner of John Street and Northside Drive.

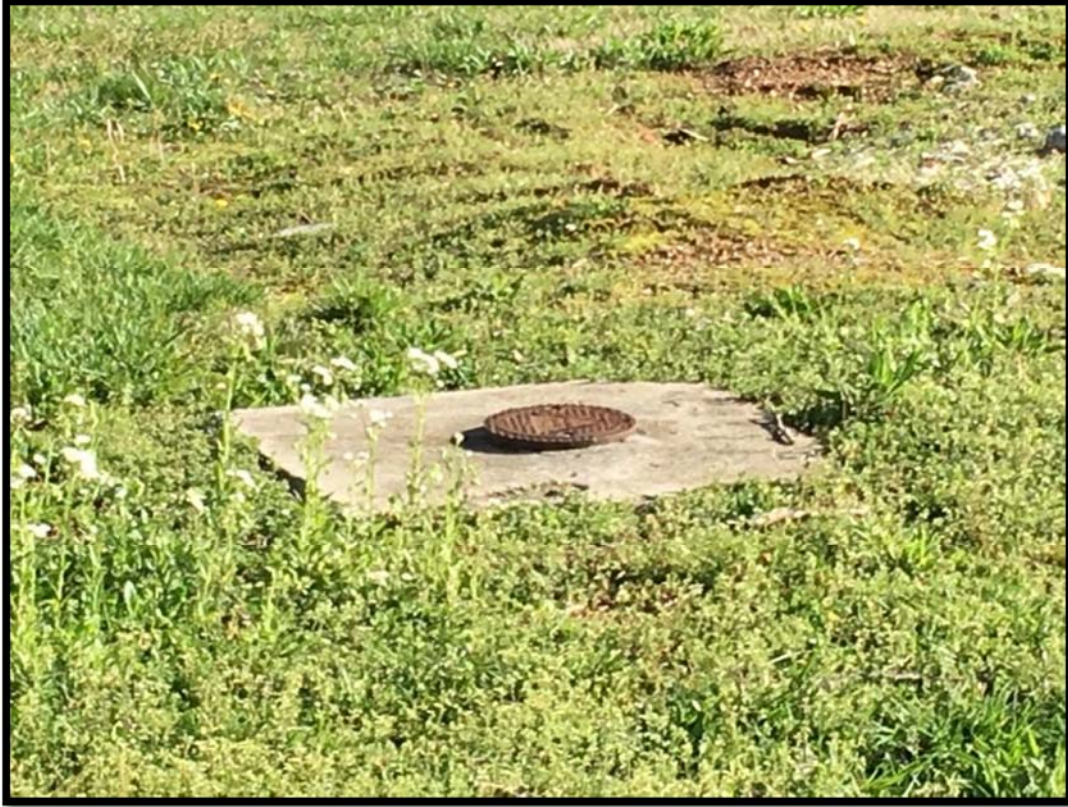
**OFFICIAL PHOTOGRAPH NO. 13
TETRA TECH**

Subject: Monitoring well, MWC-3B at the corner of John Street and Northside Drive.

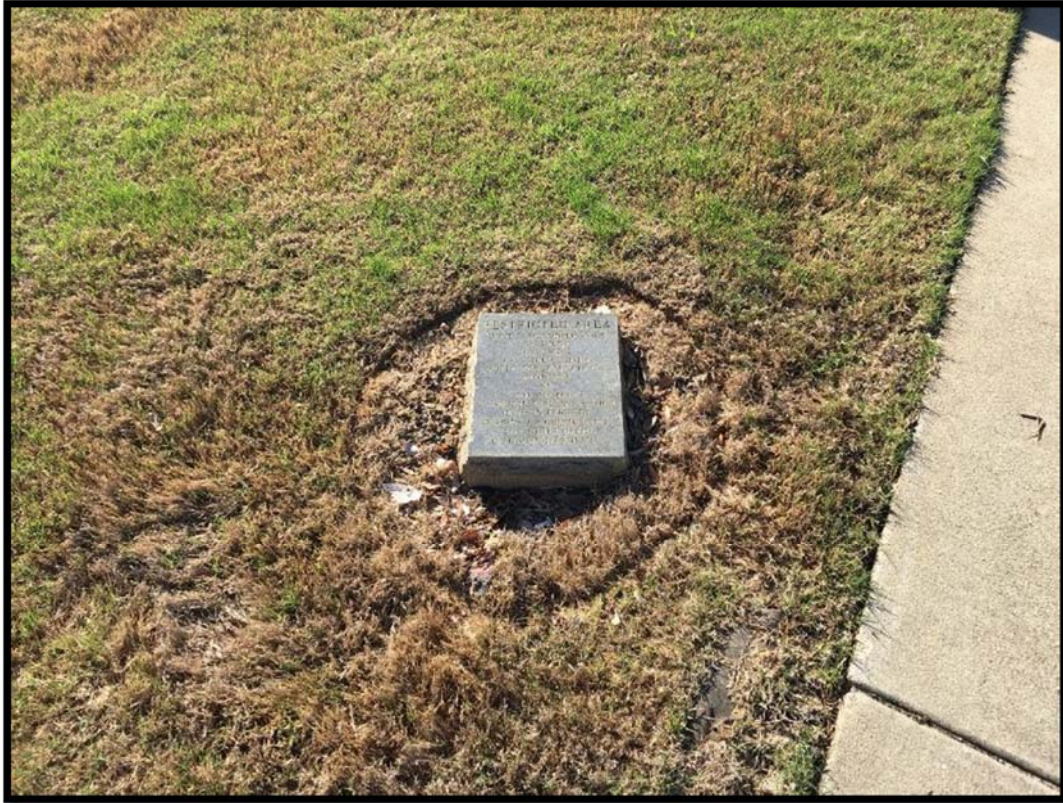
**OFFICIAL PHOTOGRAPH NO. 14
TETRA TECH**

Subject: Granite plaque on the northwestern perimeter of the property.

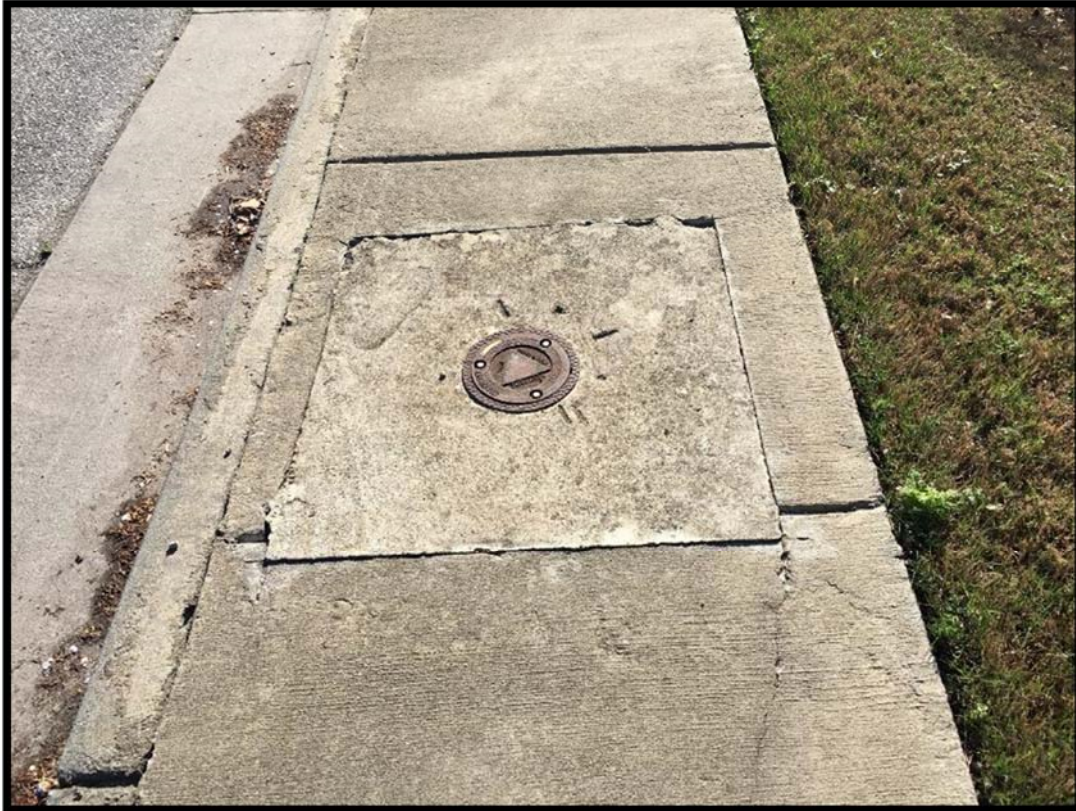
**OFFICIAL PHOTOGRAPH NO. 15
TETRA TECH**

Subject: Monitoring well, MM-03.

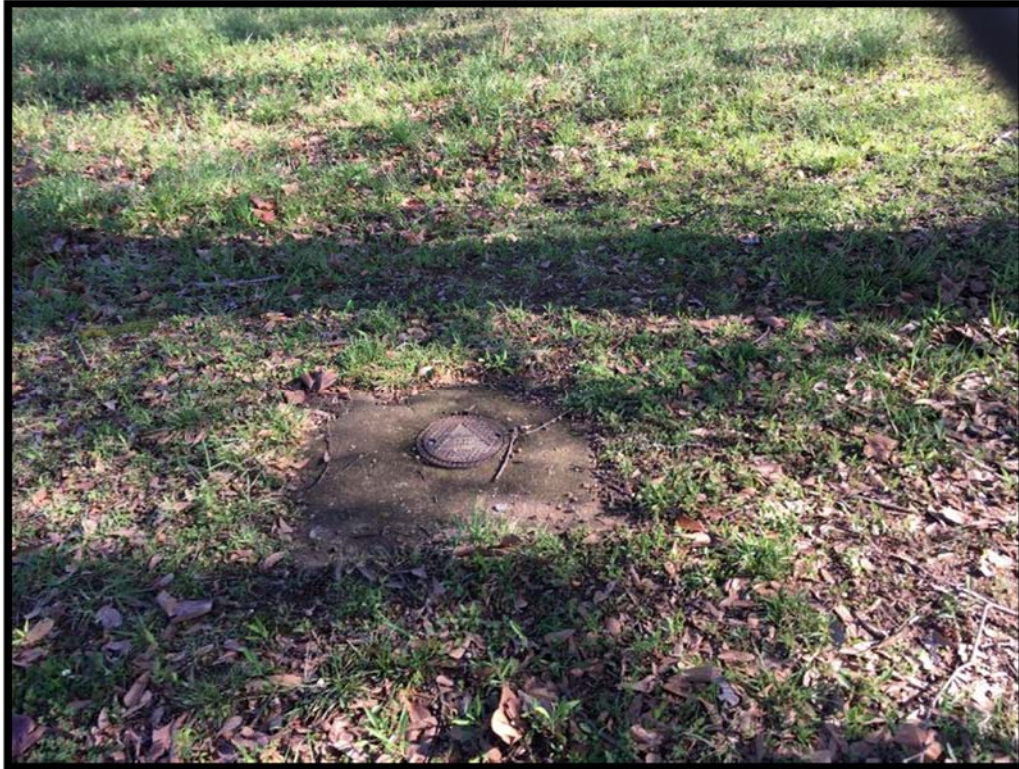
**OFFICIAL PHOTOGRAPH NO. 16
TETRA TECH**

Subject: Monitoring well, MWC-1A at the corner of John Street and Gray Street.

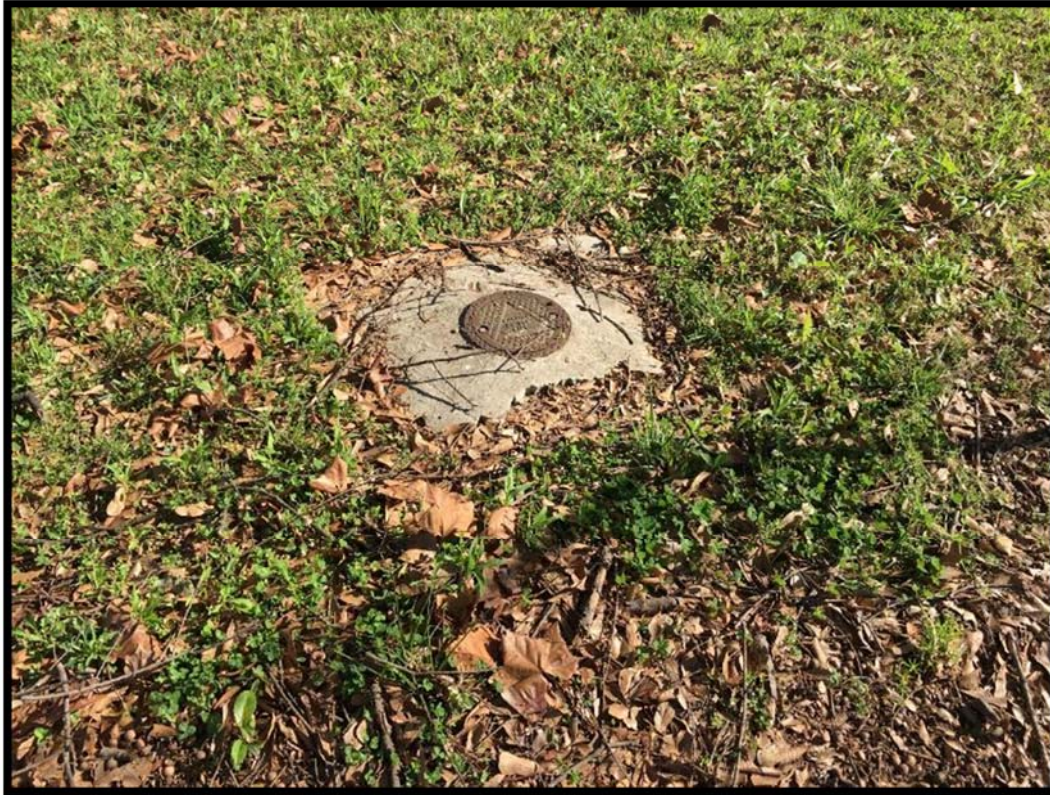
**OFFICIAL PHOTOGRAPH NO. 17
TETRA TECH**

Subject: Monitoring well, MWC-1B at the corner of John Street and Gray Street.

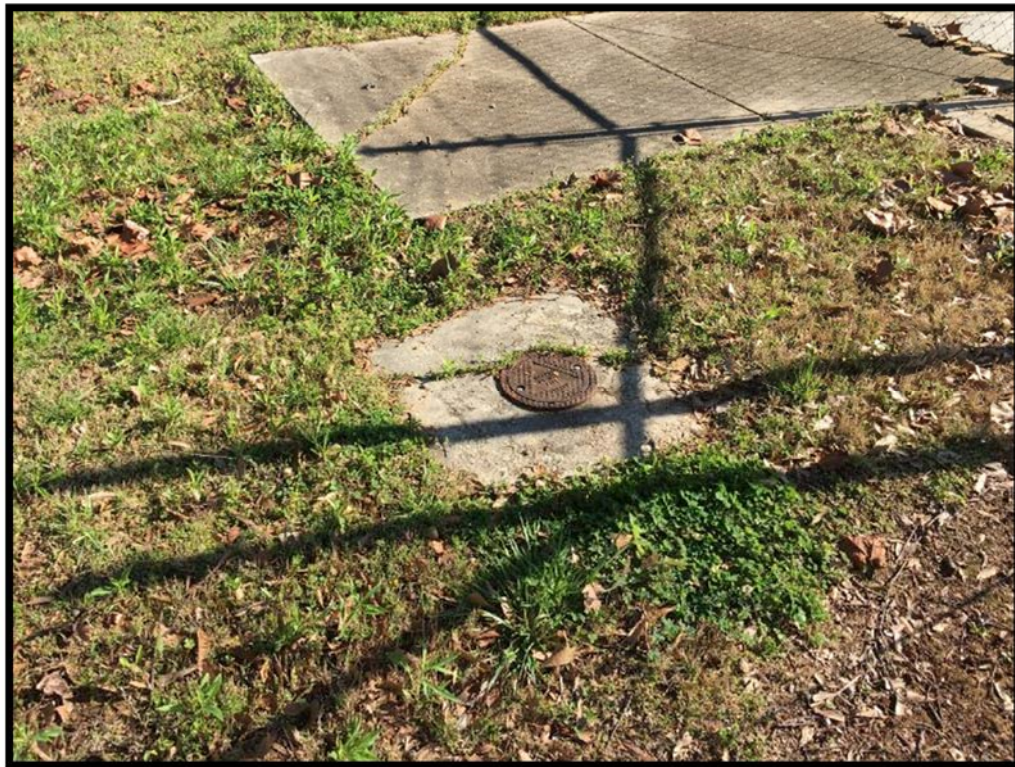
OFFICIAL PHOTOGRAPH NO. 18
TETRA TECH

Subject: Monitoring well, MWC-1C at the corner of John Street and Gray Street.

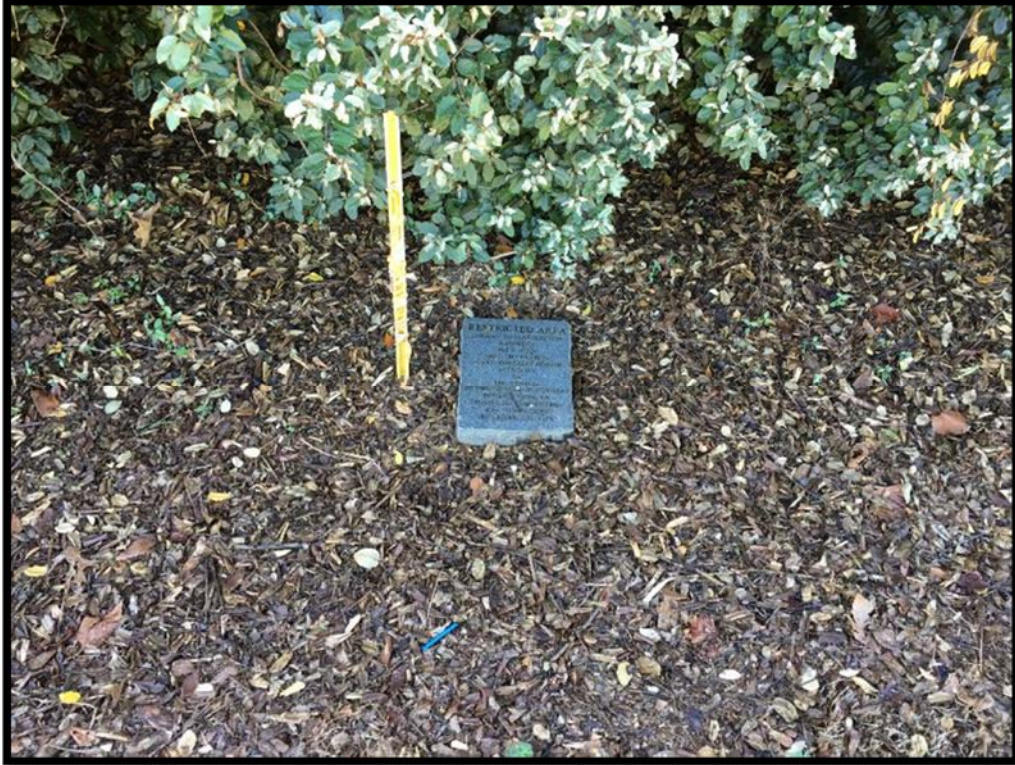
OFFICIAL PHOTOGRAPH NO. 19
TETRA TECH

Subject: Granite plaque on the north perimeter of the property.

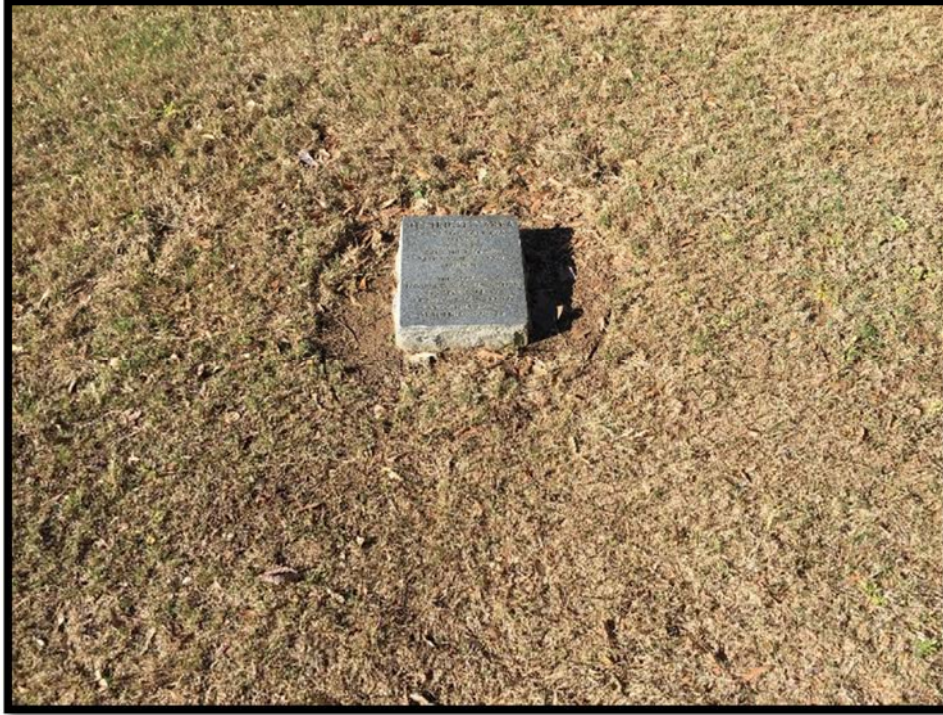
**OFFICIAL PHOTOGRAPH NO. 20
TETRA TECH**

Subject: Granite plaque on the northeastern corner of the property.

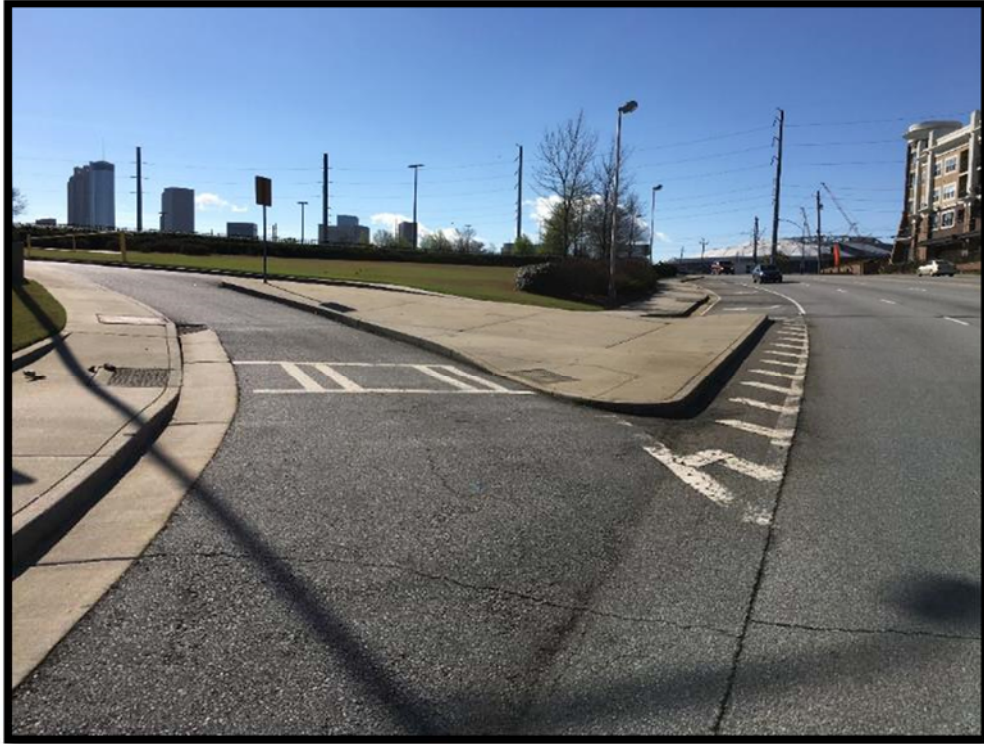
**OFFICIAL PHOTOGRAPH NO. 21
TETRA TECH**

Subject: Concrete median at the intersection of Northside Drive and John Street.

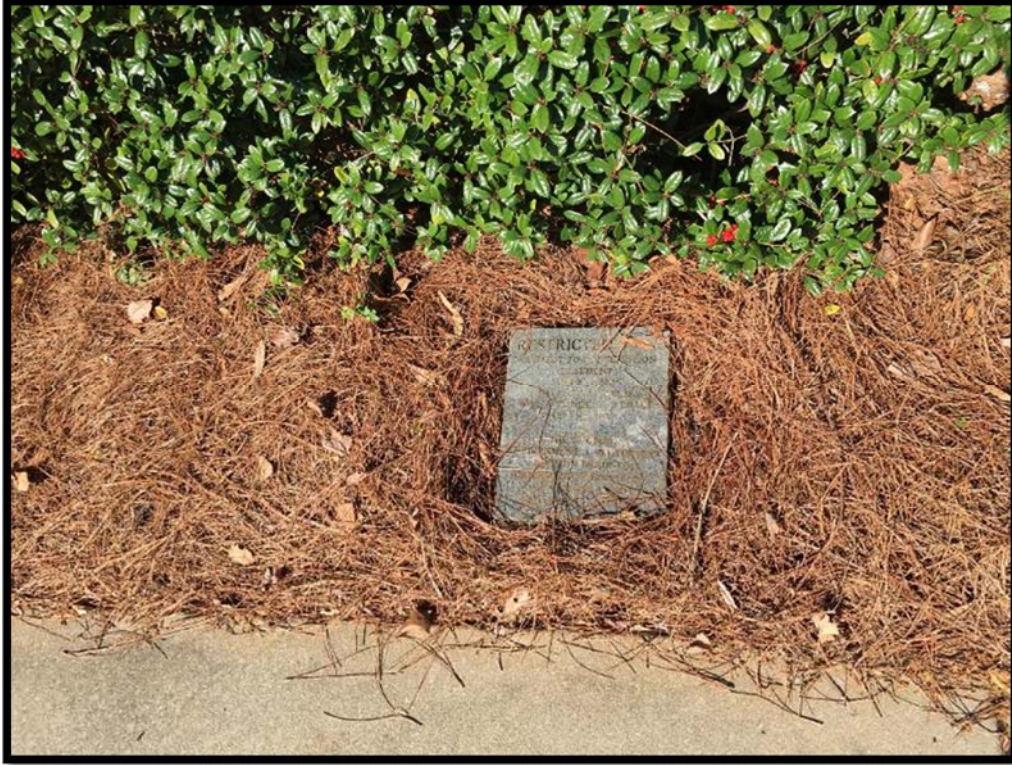
**OFFICIAL PHOTOGRAPH NO. 22
TETRA TECH**

Subject: Granite plaque on the eastern perimeter of the property.

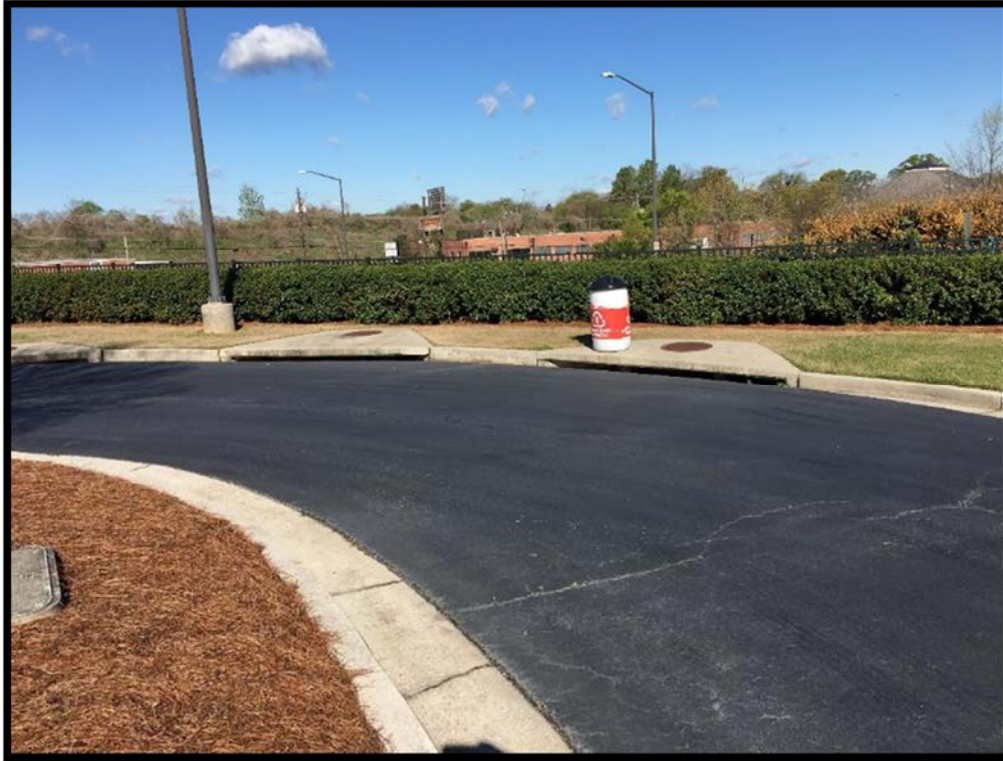
**OFFICIAL PHOTOGRAPH NO. 24
TETRA TECH**

Subject: Storm water drains located at the northwest parking lot perimeter.

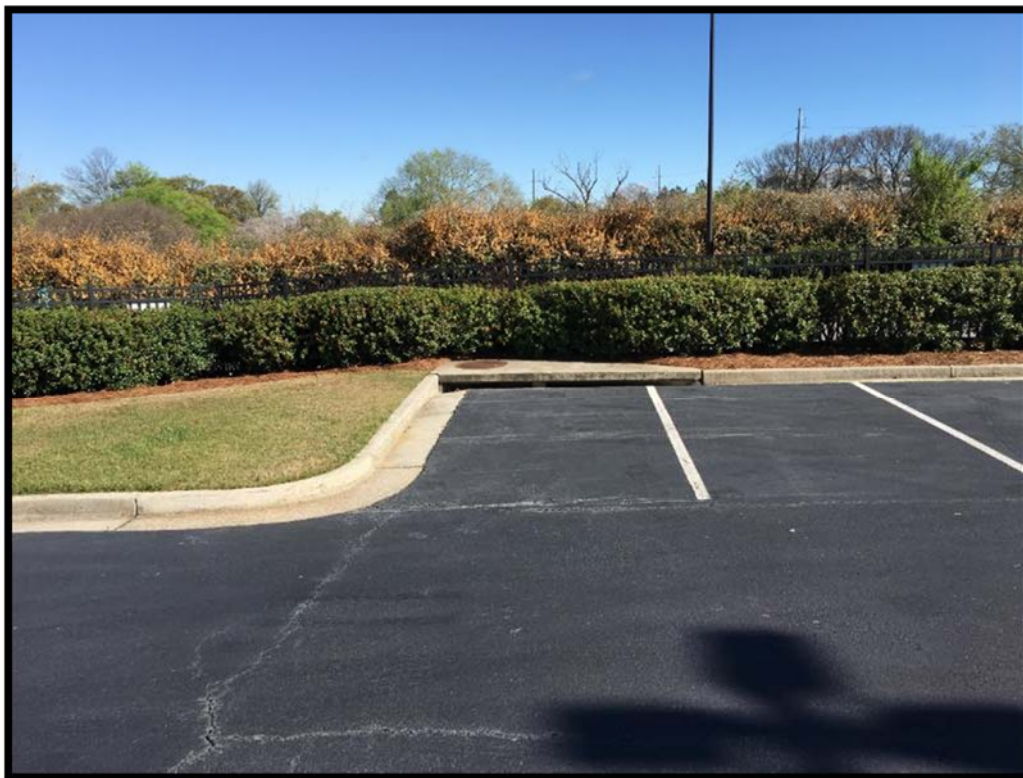
**OFFICIAL PHOTOGRAPH NO. 25
TETRA TECH**

Subject: Storm water drain located at the northwest parking lot perimeter.

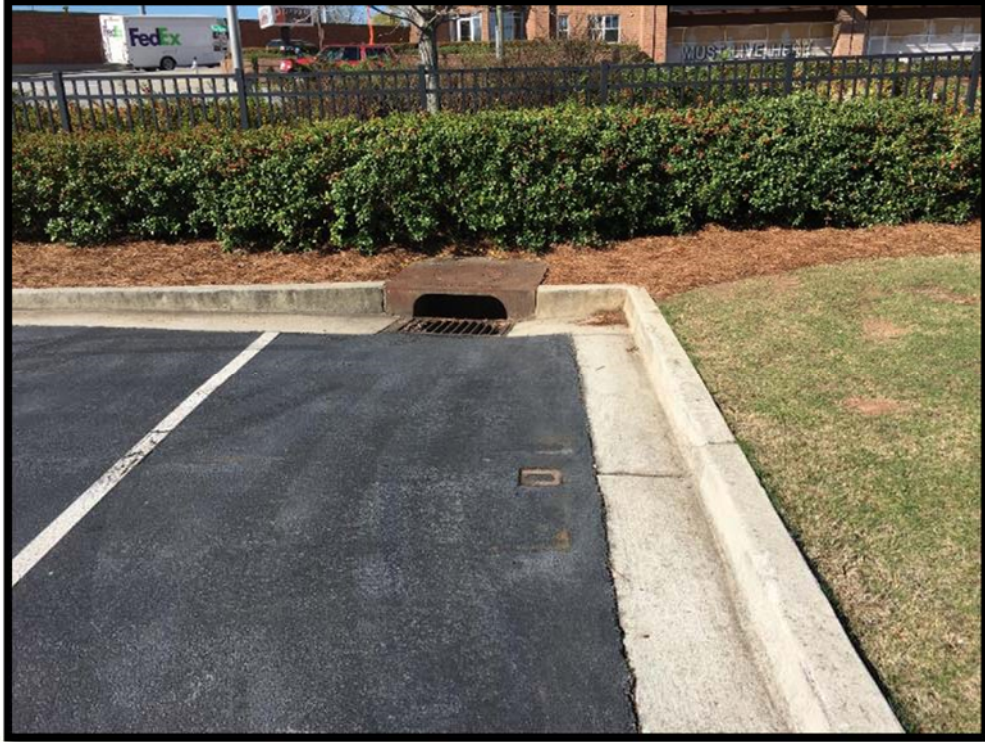
**OFFICIAL PHOTOGRAPH NO. 26
TETRA TECH**

Subject: Location of storm water drain on the west side of the parking lot perimeter.

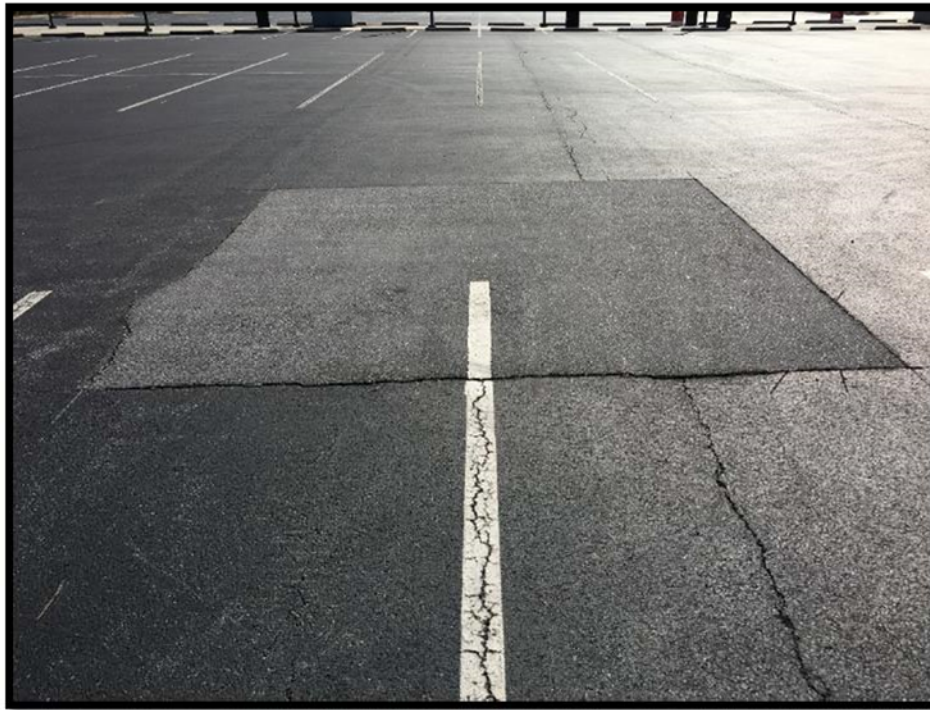
**OFFICIAL PHOTOGRAPH NO. 35
TETRA TECH**

Subject: Restored asphalt patch for direct push location DP-31, located in the north part of the parking lot.

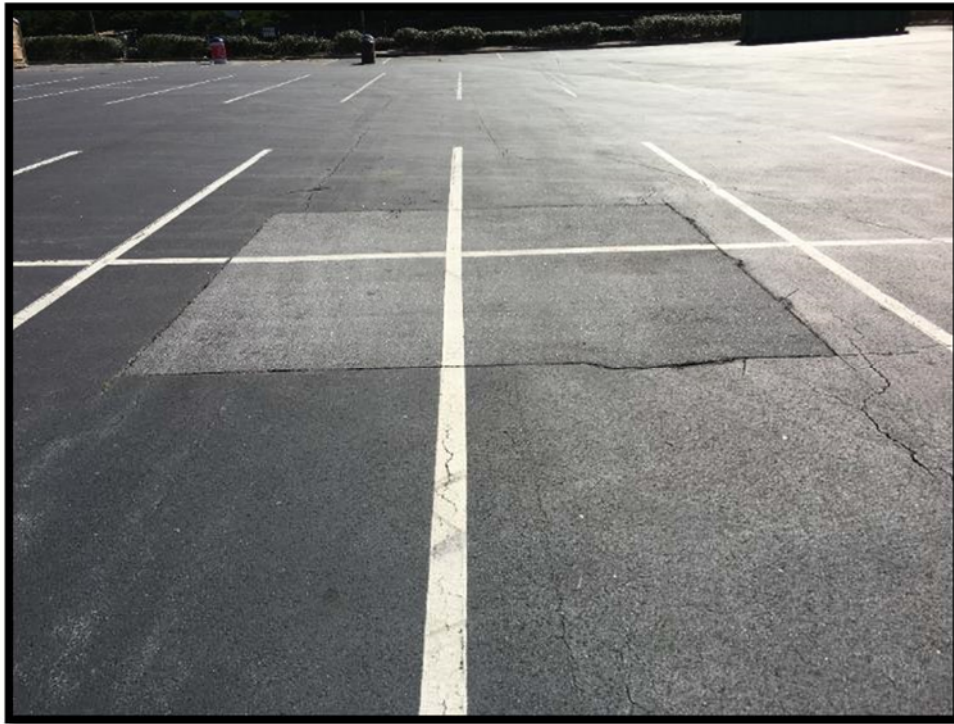
**OFFICIAL PHOTOGRAPH NO. 36
TETRA TECH**

Subject: Restored asphalt patch for direct push location DP-32, located in the northeast part of the parking lot.

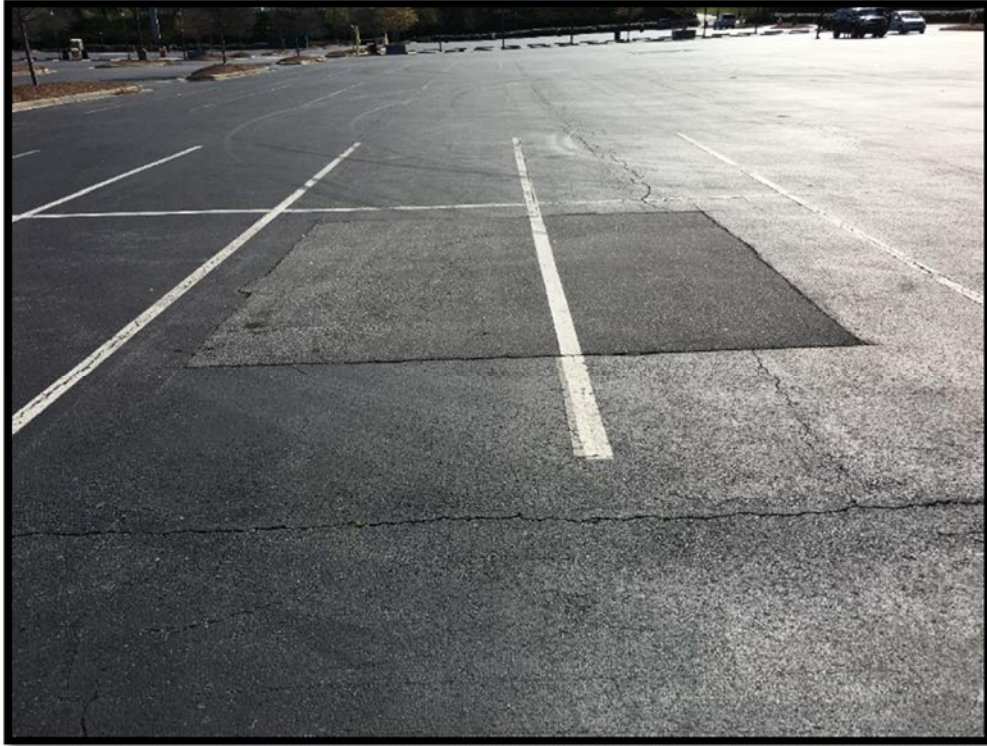
**OFFICIAL PHOTOGRAPH NO. 37
TETRA TECH**

Subject: Restored asphalt patch for direct push location DP-33, located in the southwest part of the parking lot.

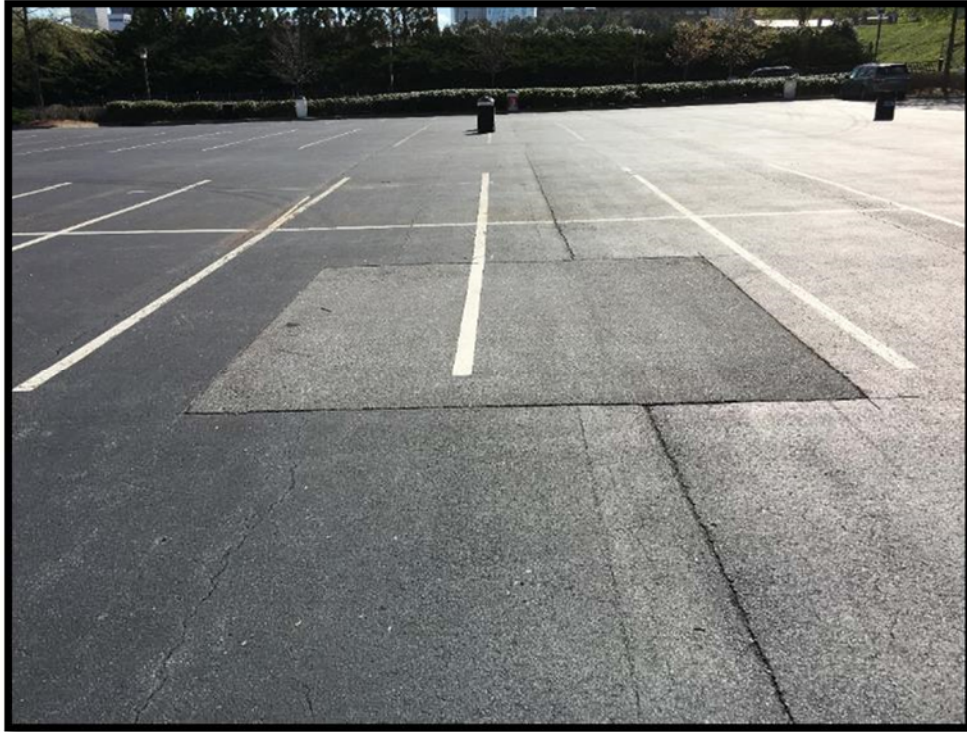
**OFFICIAL PHOTOGRAPH NO. 39
TETRA TECH**

Subject: Restored asphalt patch for direct push location DP-35, located in the southeast part of the parking lot.

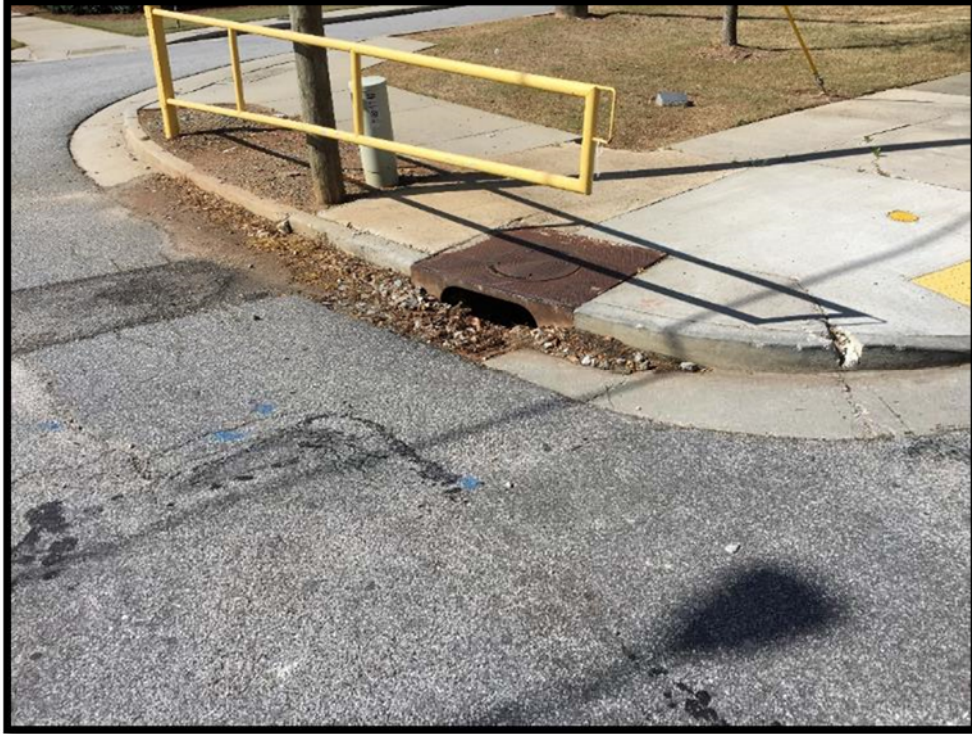
**OFFICIAL PHOTOGRAPH NO. 40
TETRA TECH**

Subject: Accumulated sediment and vegetation partially obstructing storm drain at the southwest corner of the John Street and Gray Street intersection.

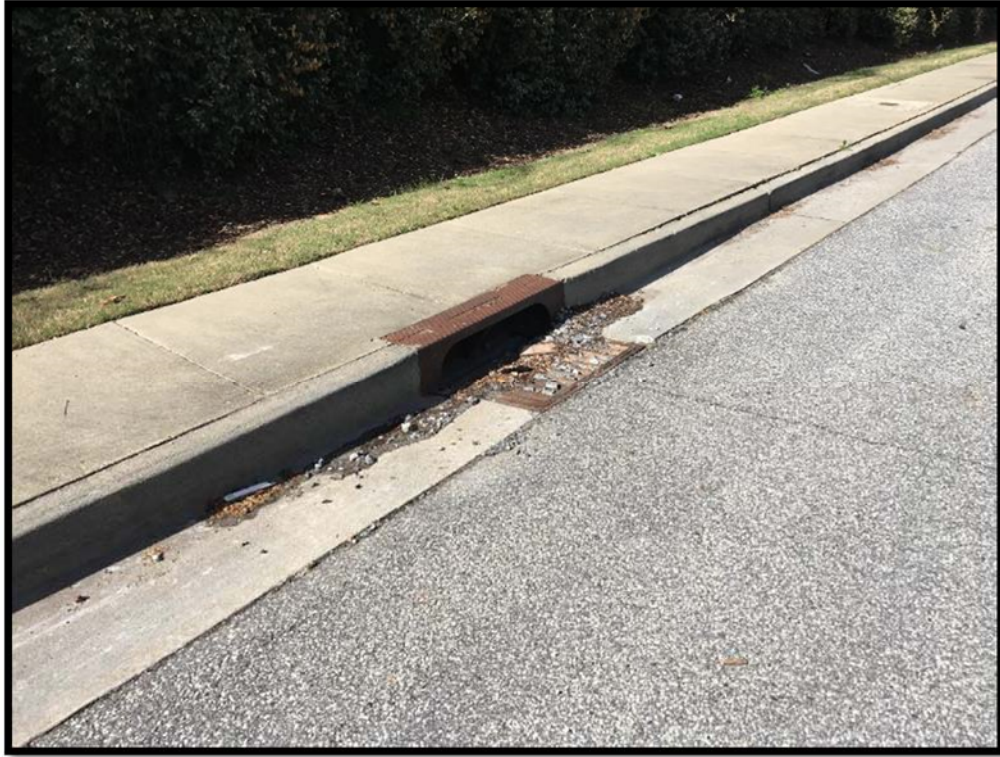
**OFFICIAL PHOTOGRAPH NO. 43
TETRA TECH**

Subject: Storm drain on John Street partially obstructed with gravel, sediment, and debris.
