August 15, 2017

**Subject: Quarters-52/53 Landfill Maintenance and Inspection Report
 Northside Drive Landfill Site, Atlanta, Georgia**

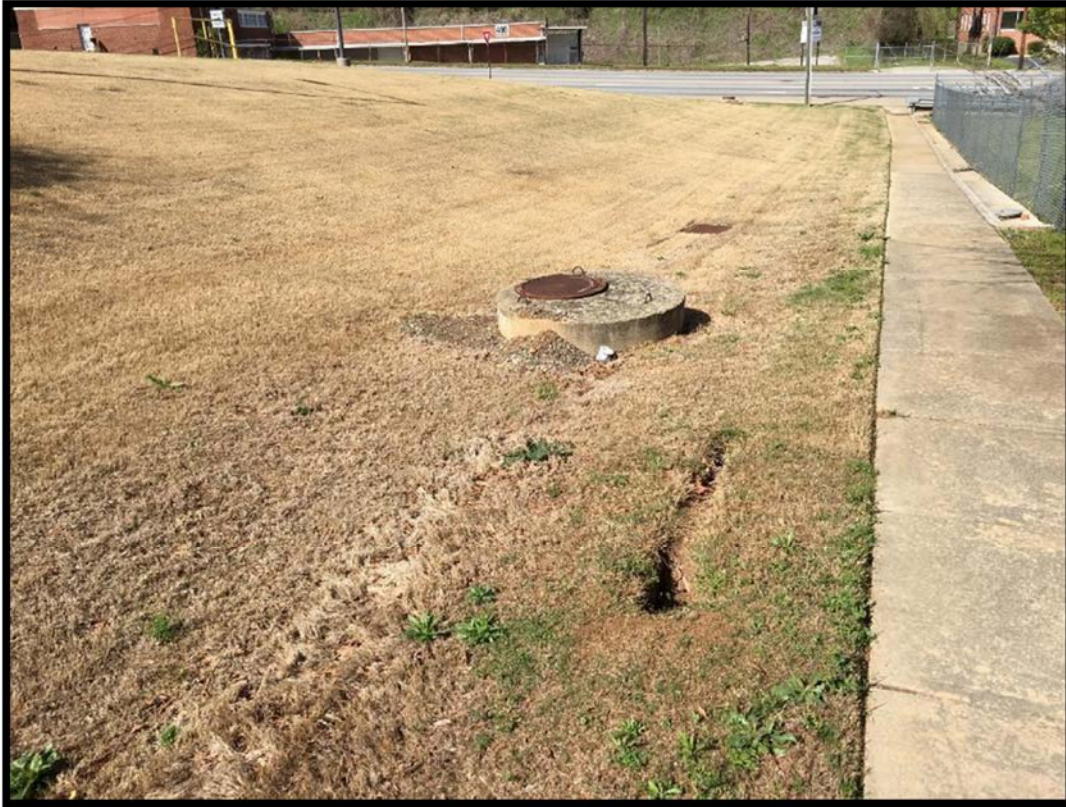
**OFFICIAL PHOTOGRAPH NO. 46
TETRA TECH**

Subject: Sewer manhole on the north side of the property at the lower end of the storm water drainage path area. Erosion around the sewer had been noted as more noticeable and more pronounced in the June 2016 report. Since then, gravel and fill material has been placed in the holes and voids at the manhole.

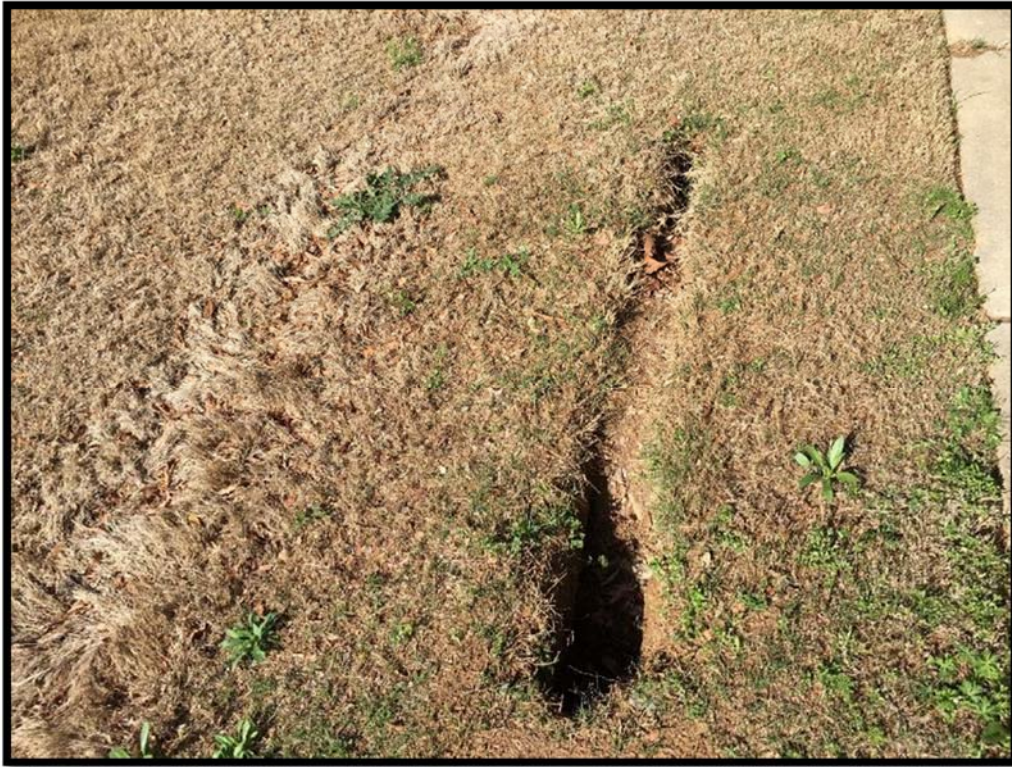
**OFFICIAL PHOTOGRAPH NO. 47
TETRA TECH**

Subject: Another eroded soil area on the north side of the property. Eroded area is approximately 6' x 6" x 14" and just east of the sewer manhole seen in Photograph 46. This void is approximately 18" deep and was noted in September 2016 as having worsened since the March and June 2016 site visits. This area is outside of the CAP but still should be investigated and repaired.

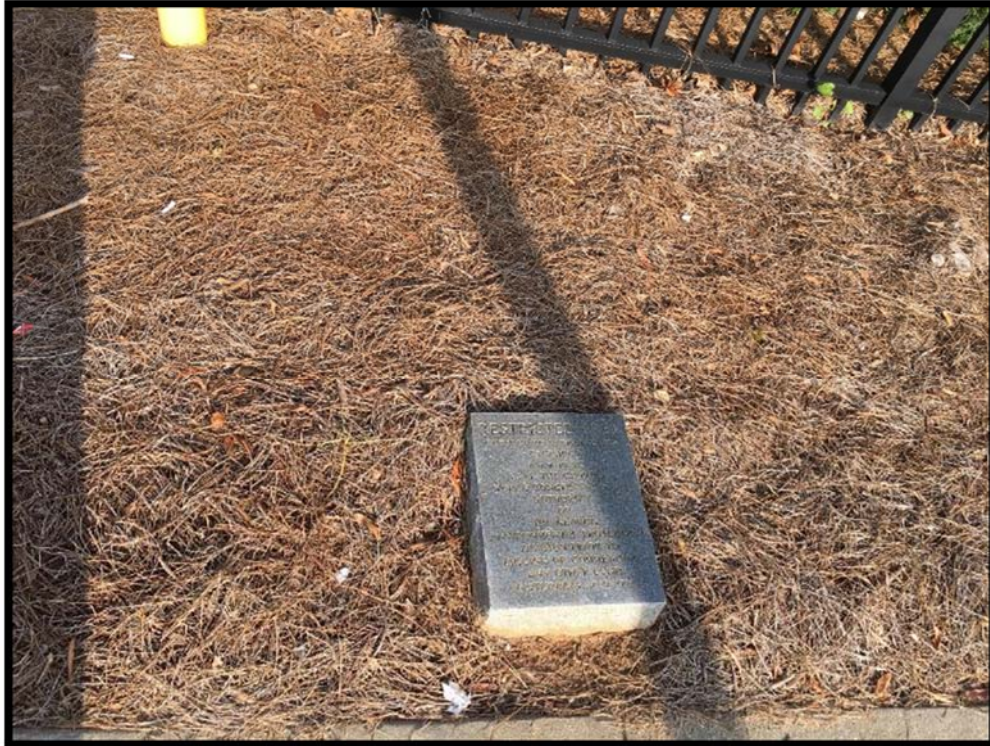
**OFFICIAL PHOTOGRAPH NO. 1
TETRA TECH**

Subject: Granite plaque located on the east, southeast side of the north parking lot perimeter.

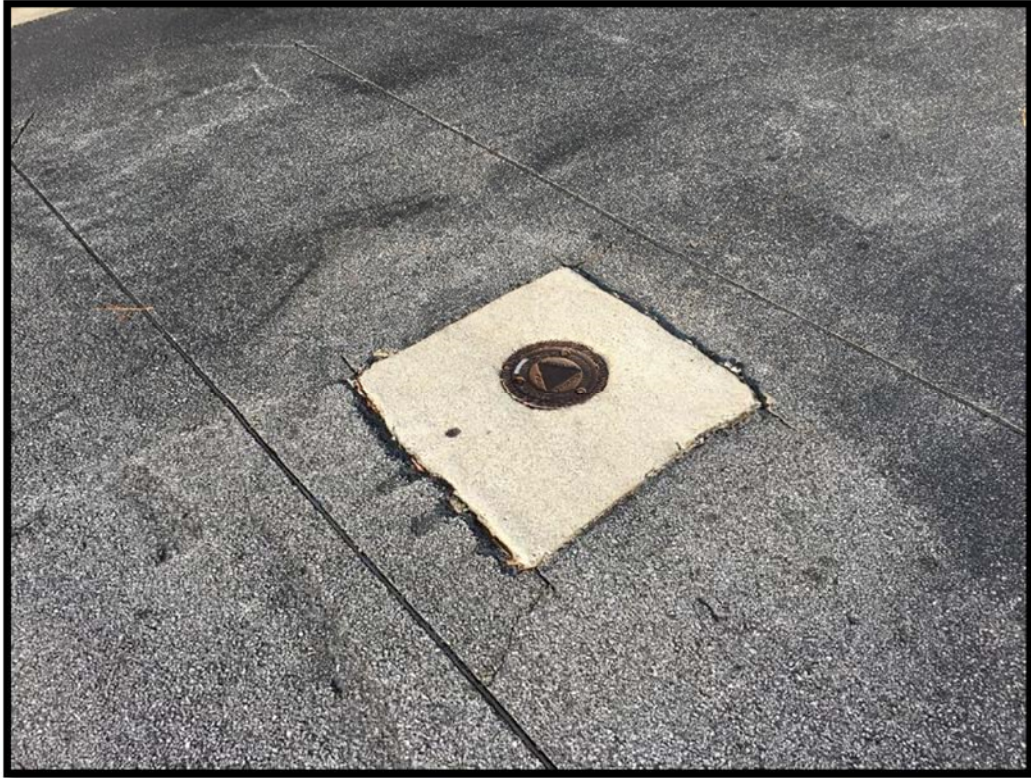
**OFFICIAL PHOTOGRAPH NO. 2
TETRA TECH**

Subject: Background monitoring well, MM-04.

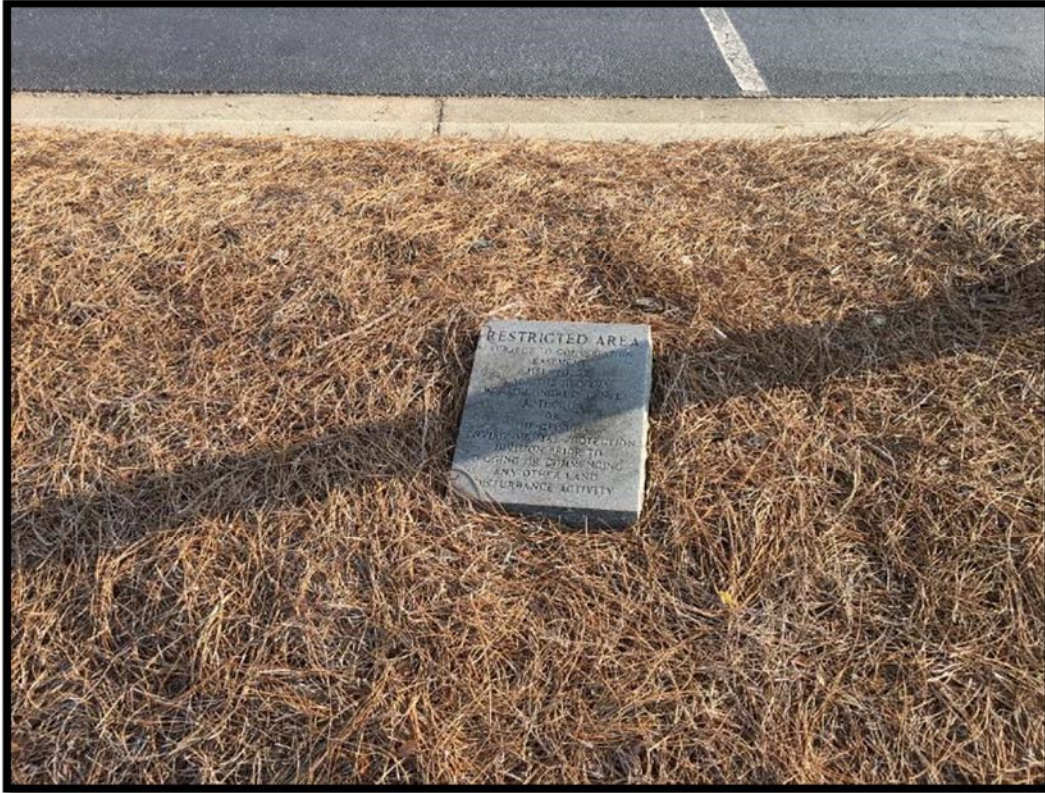
**OFFICIAL PHOTOGRAPH NO. 3
TETRA TECH**

Subject: Granite plaque on the southeast corner of the property.

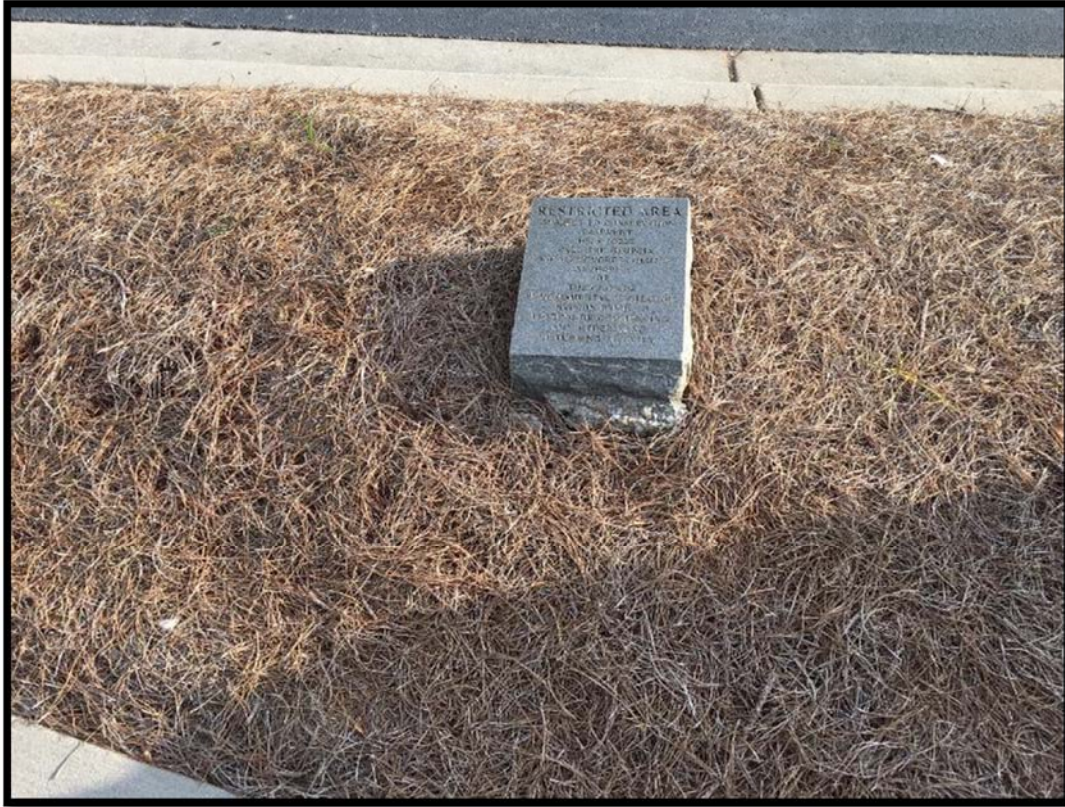
**OFFICIAL PHOTOGRAPH NO. 4
TETRA TECH**

Subject: Granite plaque on the south side of the property.

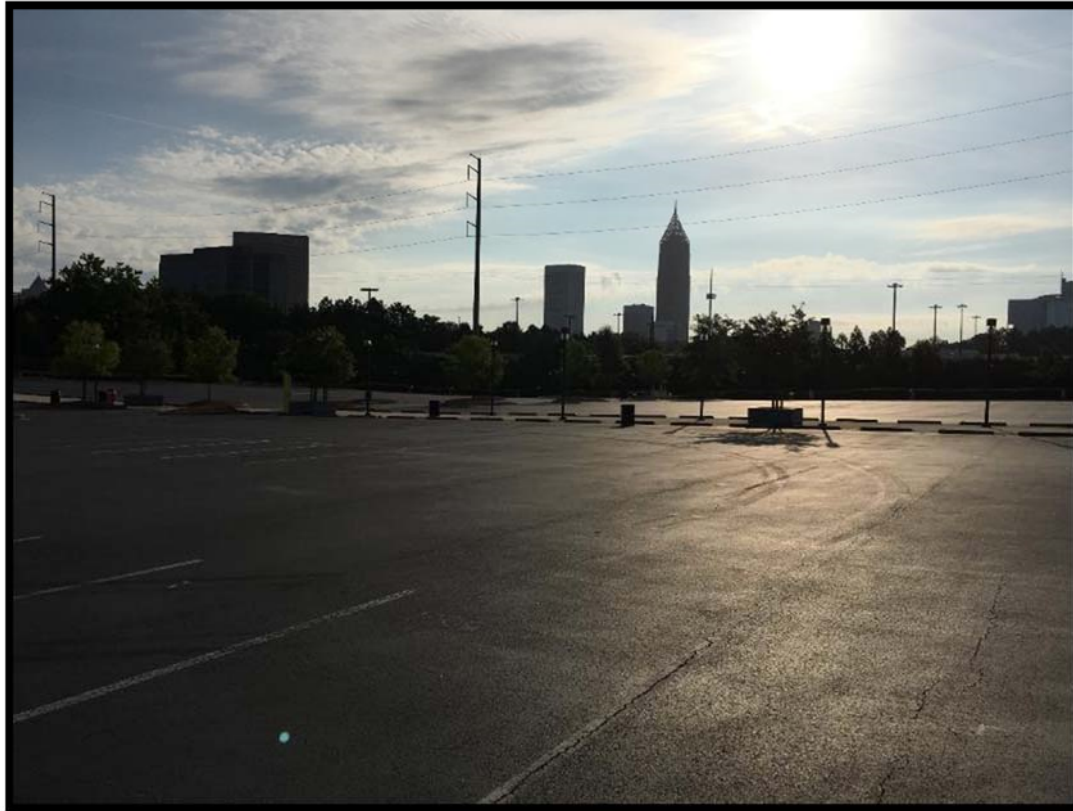
**OFFICIAL PHOTOGRAPH NO. 5
TETRA TECH**

Subject: Western portion of the lot looking northeast.

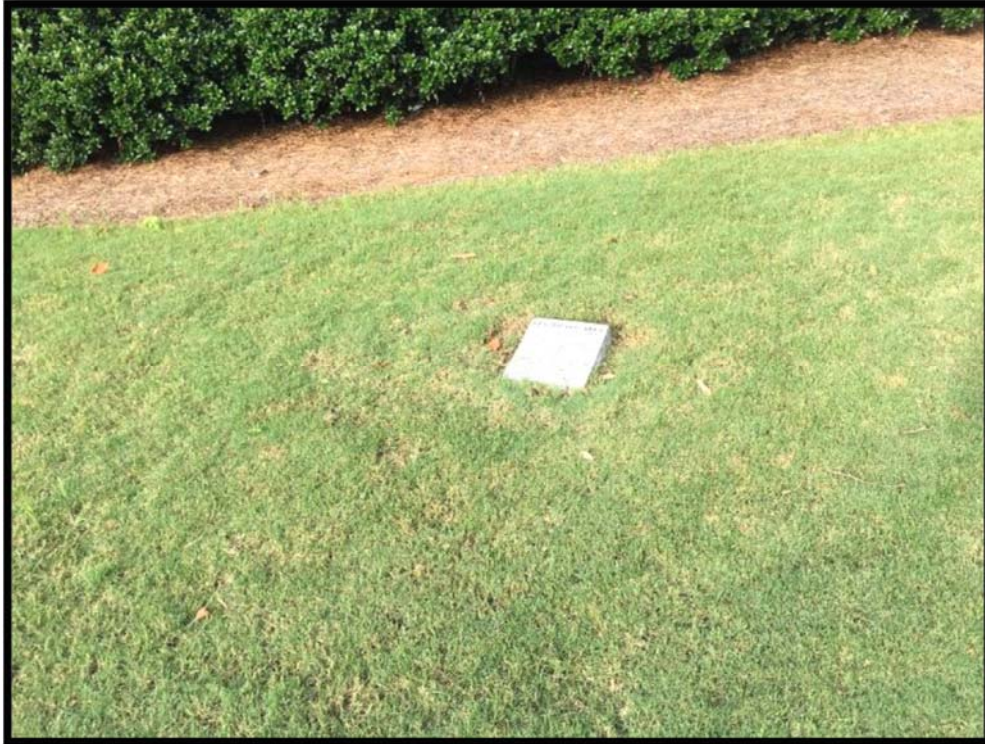
**OFFICIAL PHOTOGRAPH NO. 6
TETRA TECH**

Subject: Granite plaque on the northeastern perimeter of the property.

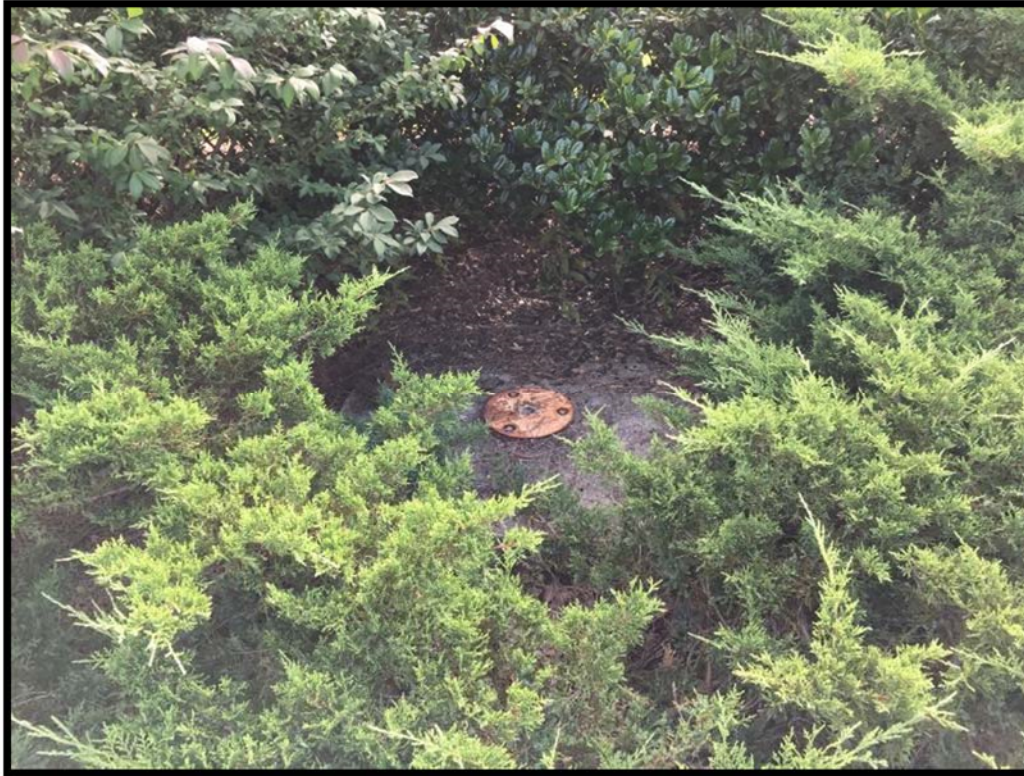
**OFFICIAL PHOTOGRAPH NO. 7
TETRA TECH**

Subject: Monitoring well, MM-01.

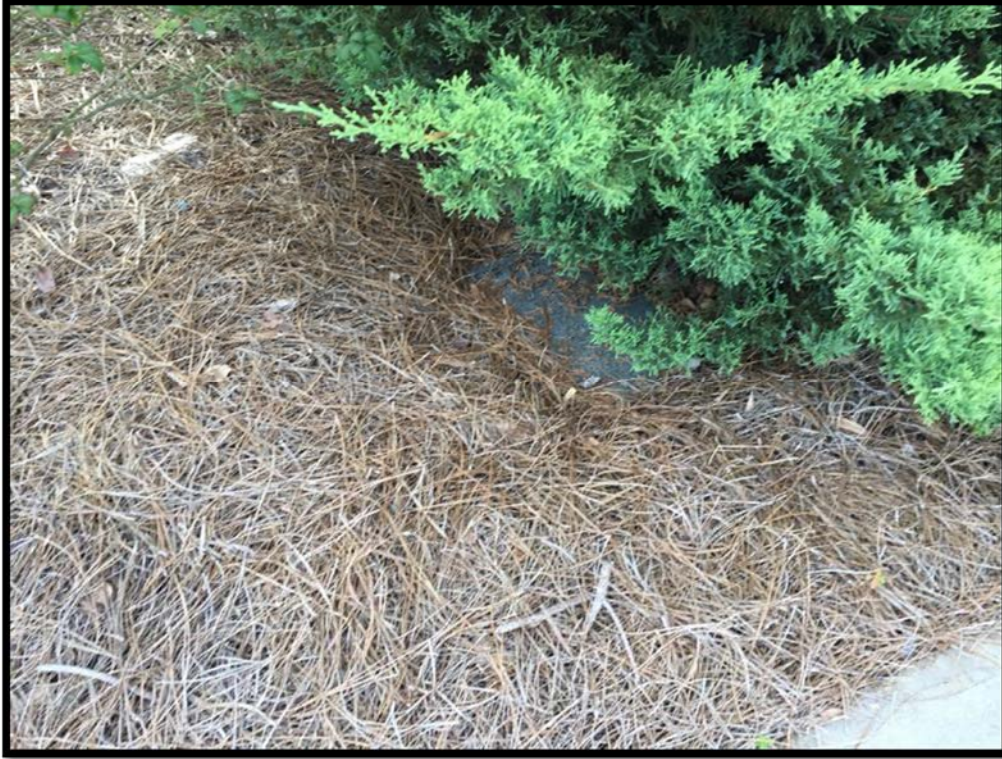
**OFFICIAL PHOTOGRAPH NO. 8
TETRA TECH**

Subject: Granite plaque on the western perimeter of the property.
Vegetation is overgrown.

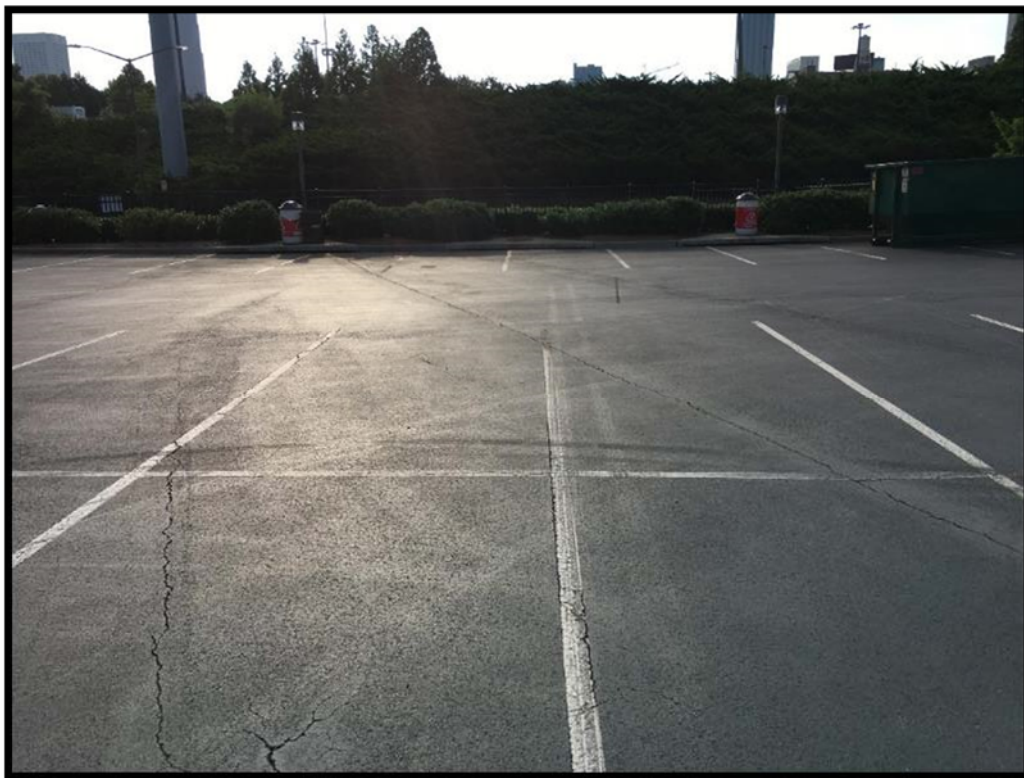
**OFFICIAL PHOTOGRAPH NO. 23
TETRA TECH**

Subject: Storm water drains located at the eastern parking lot perimeter.
The existing crack was still present, but had not increased in size.

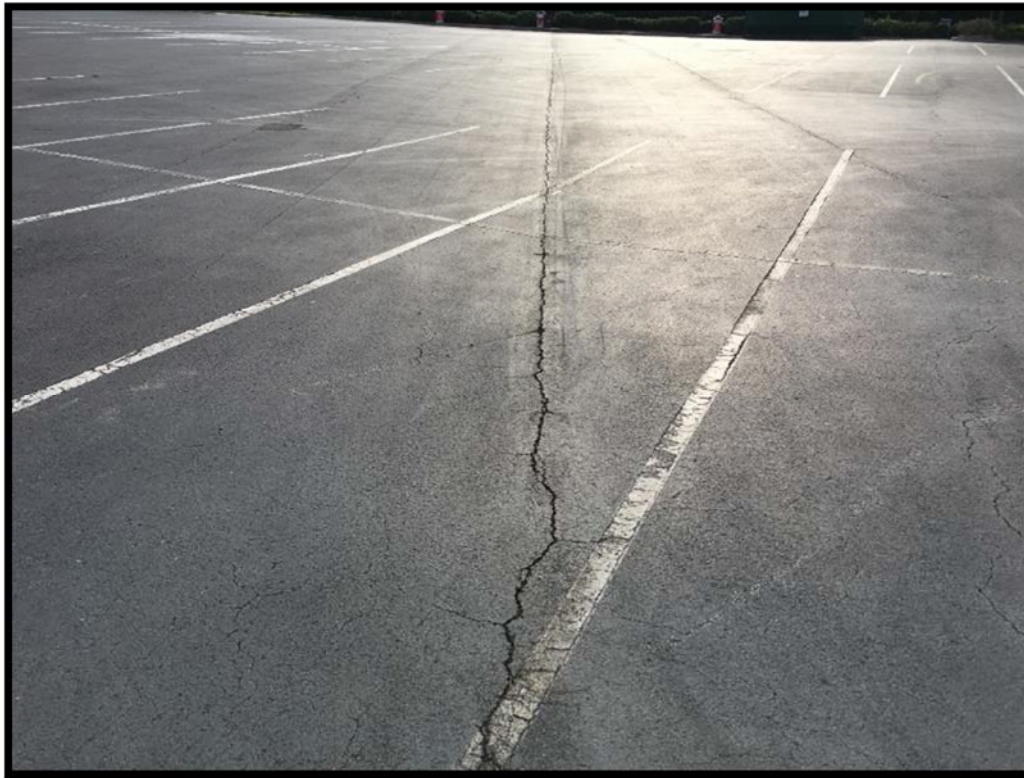
OFFICIAL PHOTOGRAPH NO. 27
TETRA TECH

Subject: A small crack in the asphalt leading to the storm water drains on the eastern side of the parking lot. Storm water flows in this low point of the parking lot, which has caused minor staining. The crack is estimated to be approximately 200 feet long, ¼ inch wide and ¼ inch deep. The existing crack was still present, but had not increased in size.

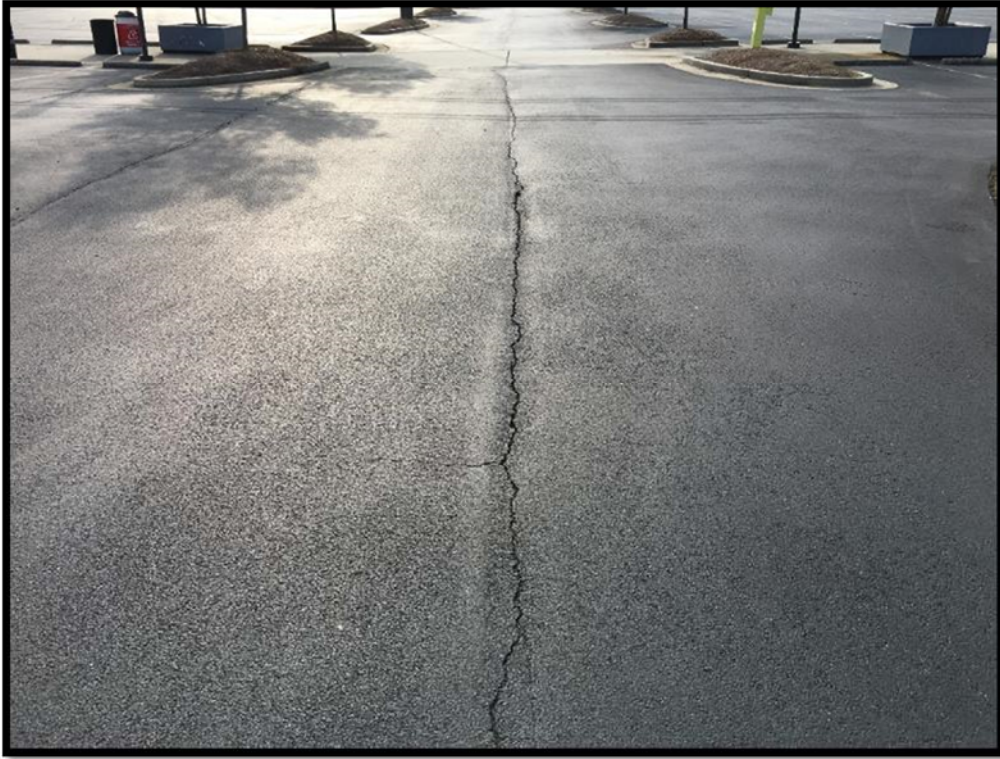
OFFICIAL PHOTOGRAPH NO. 28
TETRA TECH

Subject: Example of crack which runs east to west on the main entrance/exit roadway. Like the previously observed crack, it is no larger than $\frac{1}{4}$ inch wide and $\frac{1}{4}$ inch deep. This crack traverses almost the entire length of the entrance/exit roadway. The existing crack was still present, but had not increased in size.

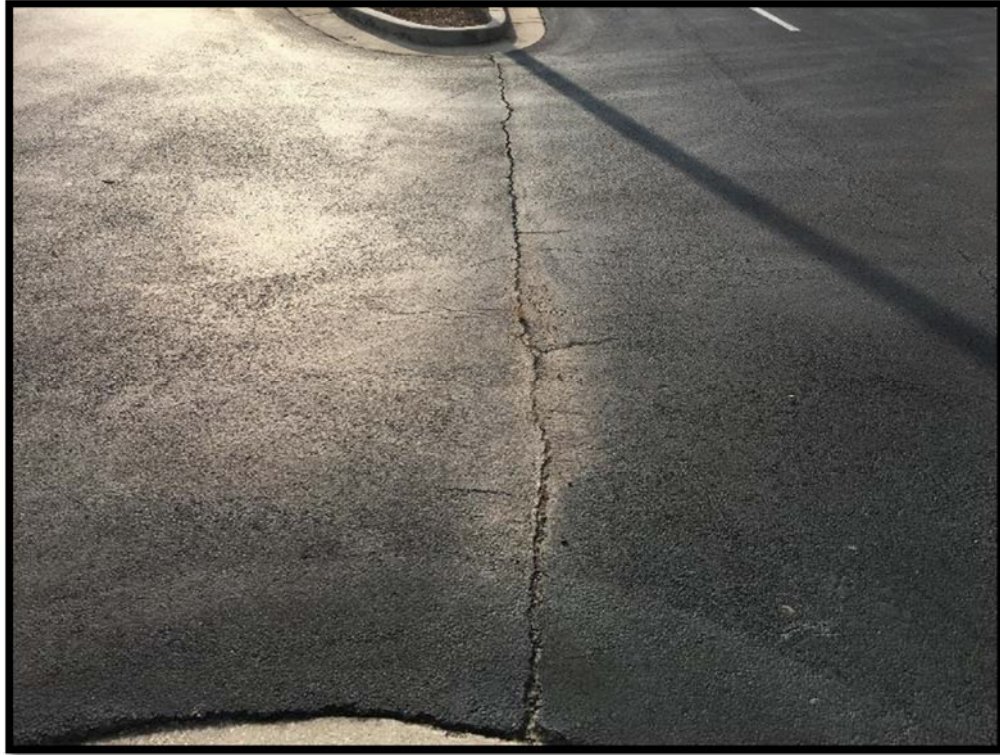
OFFICIAL PHOTOGRAPH NO. 29
TETRA TECH

Subject: Example of crack which runs east to west on the entrance way of the parking lot row. Over half of the rows have cracks similar to this one. They occur where the asphalt seams are joined. Like the previously observed crack, it is no larger than $\frac{1}{4}$ inch wide and $\frac{1}{4}$ inch deep. The existing crack was still present, but had not increased in size.

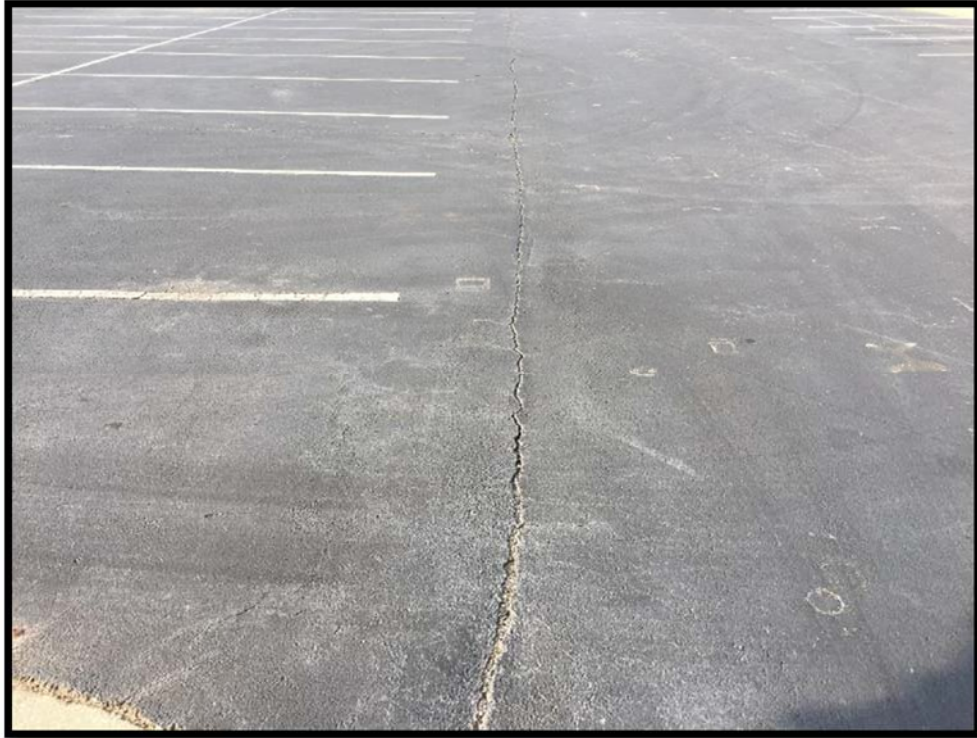
OFFICIAL PHOTOGRAPH NO. 30
TETRA TECH

Subject: Example of another crack, which runs north to south on the western most row of the north parking lot. A standard pen is used to show the approximate width of the crack. The width of this crack is typical of all cracks observed in the asphalt of the north parking lot. The existing crack was still present, but had not increased in size.

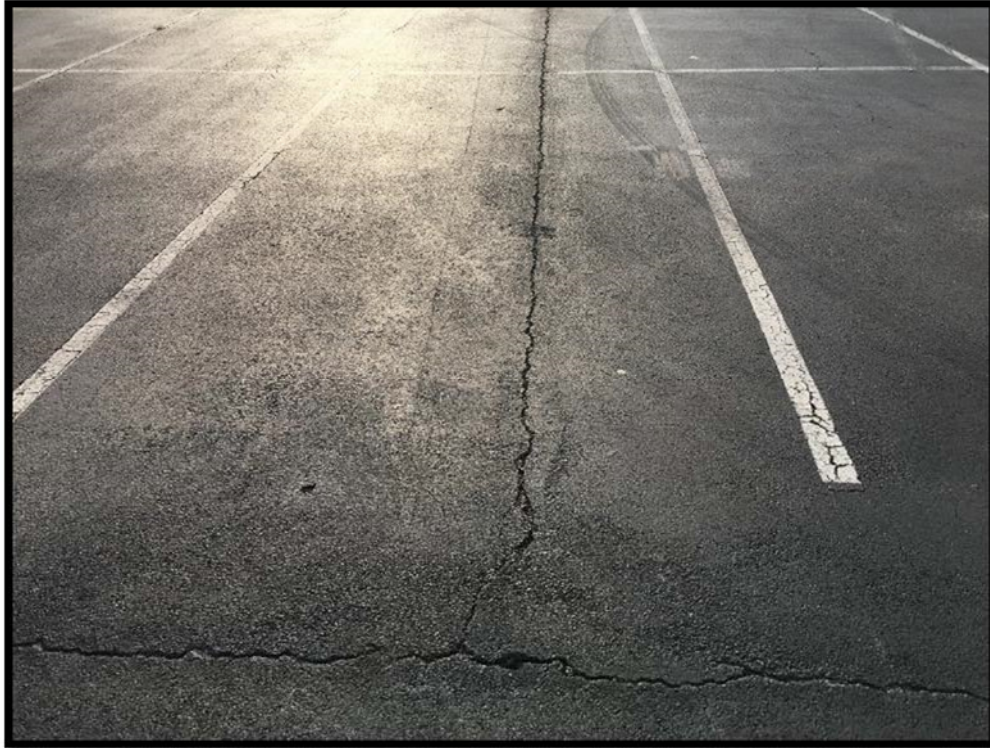
**OFFICIAL PHOTOGRAPH NO. 31
TETRA TECH**

Subject: Example of another crack which runs east to west. This crack is located on the northern portion of the parking lot and traverses the entire parking lot west of the north/south walkway. Once again, this crack occurs where the asphalt seams are joined. Like the previously observed cracks, it is no larger than $\frac{1}{4}$ inch wide and $\frac{1}{4}$ inch deep. The existing crack was still present, but had not increased in size. Note significant trailer storage was observed in this area of the parking lot.

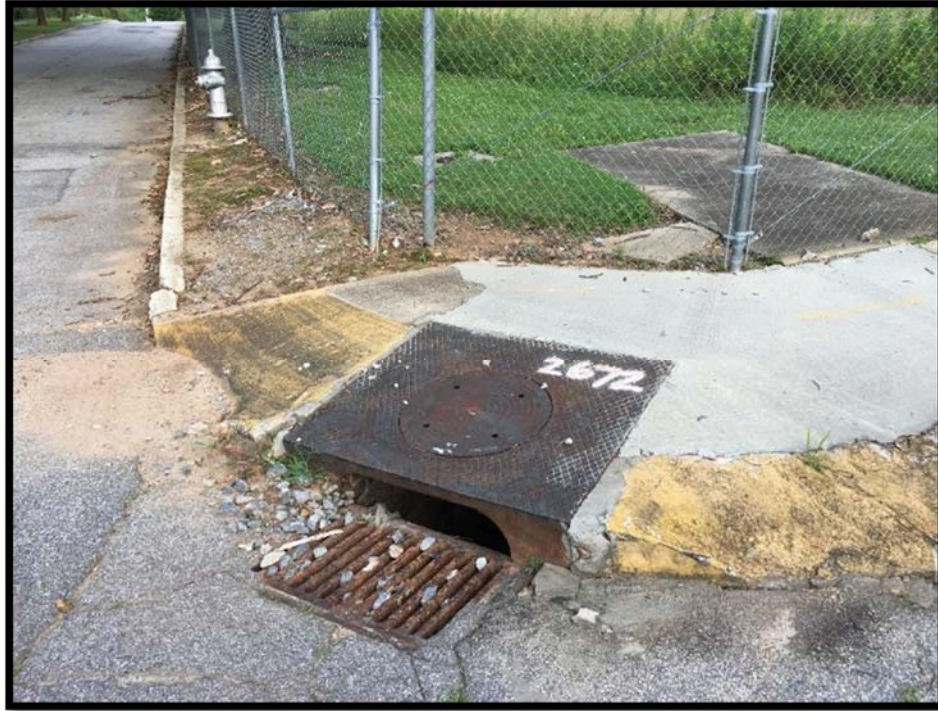
**OFFICIAL PHOTOGRAPH NO. 32
TETRA TECH**

Subject: Storm water drainage inlet at the northeast corner of the John Street and Gray Street intersection. The pavement around the inlet is in poor condition. Monitoring wells, MW-1A, MW-1B and MW-1C can be seen in the background.

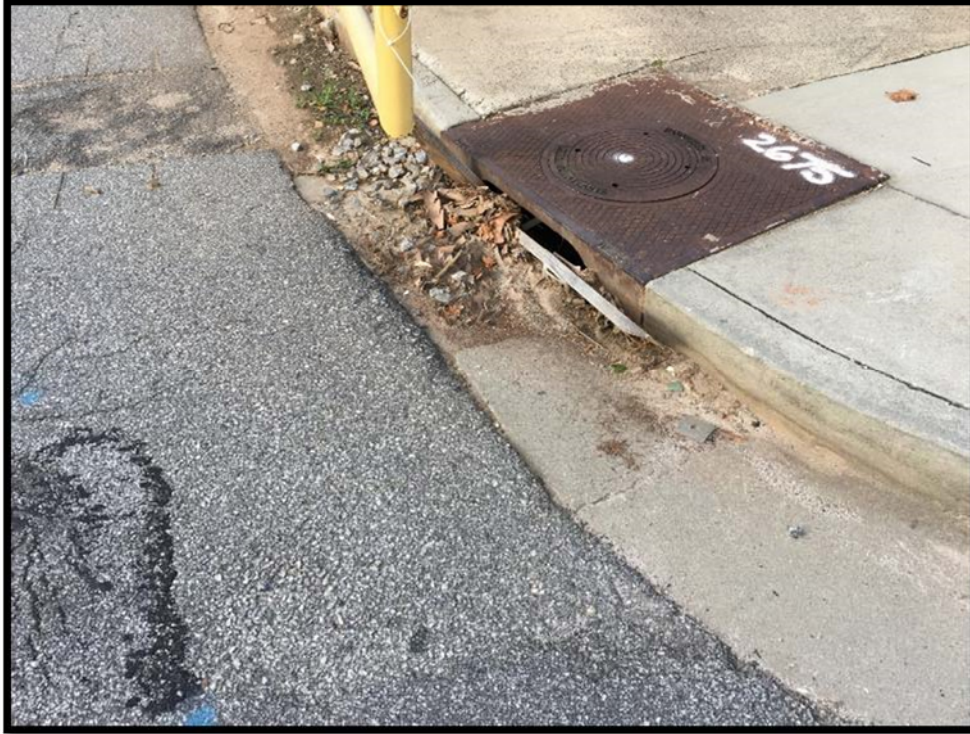
**OFFICIAL PHOTOGRAPH NO. 40
TETRA TECH**

Subject: Accumulated sediment, trash, and debris partially obstructing storm drain at the southwest corner of the John Street and Gray Street intersection.

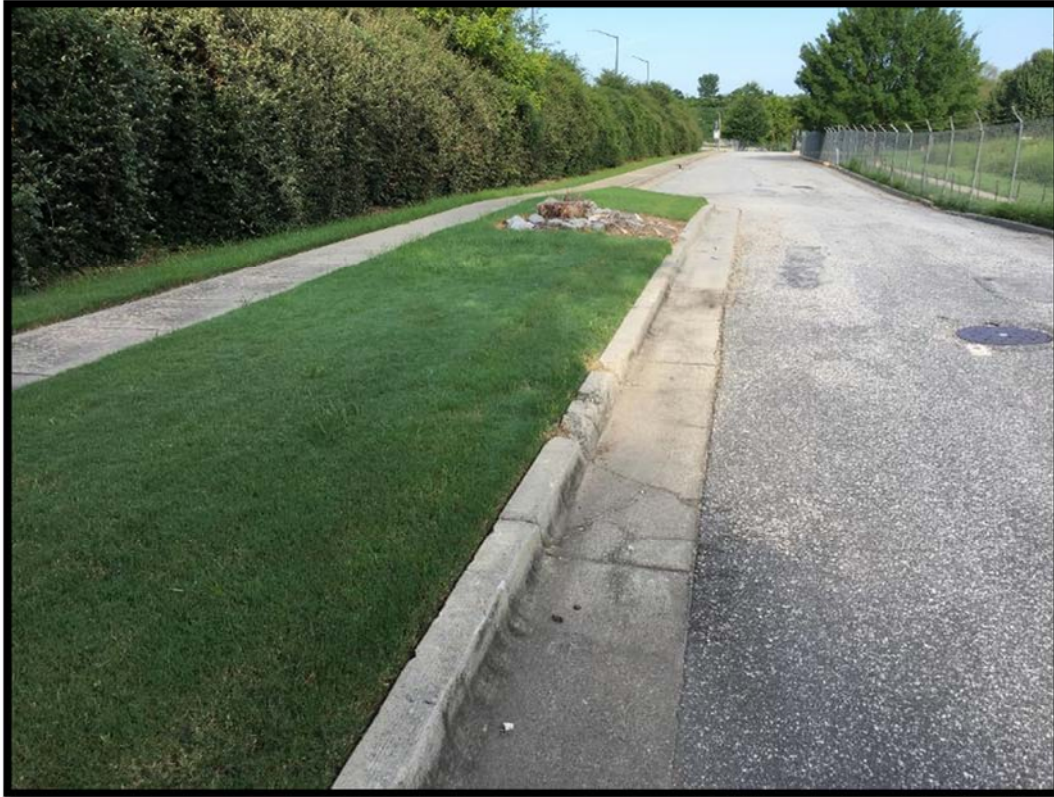
**OFFICIAL PHOTOGRAPH NO. 41
TETRA TECH**

Subject: Repaired rutted vegetation area (approx. 60' x 18" by 6") along John Street. The rut appeared to have been caused by automobile and was noted in the December 2015 and March 2016 inspections. Repair was made between March 23, 2016, and June 29, 2016. The repair appears sustained.

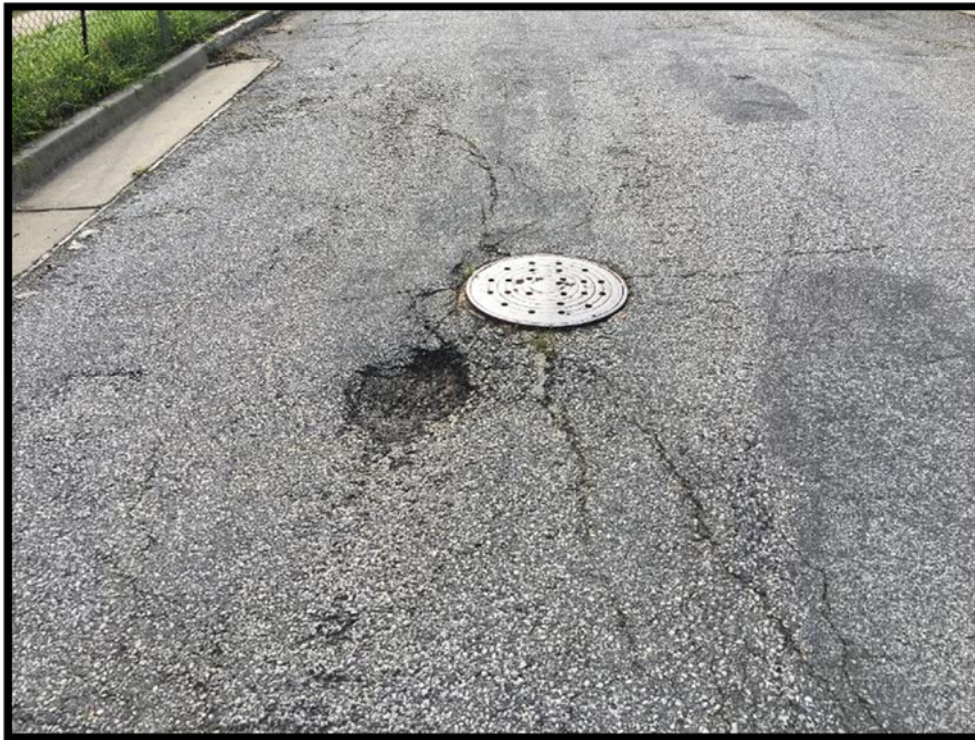
**OFFICIAL PHOTOGRAPH NO. 42
TETRA TECH**

Subject: Pothole found near manhole in John Street – approx. 10” diameter and 4” deep.

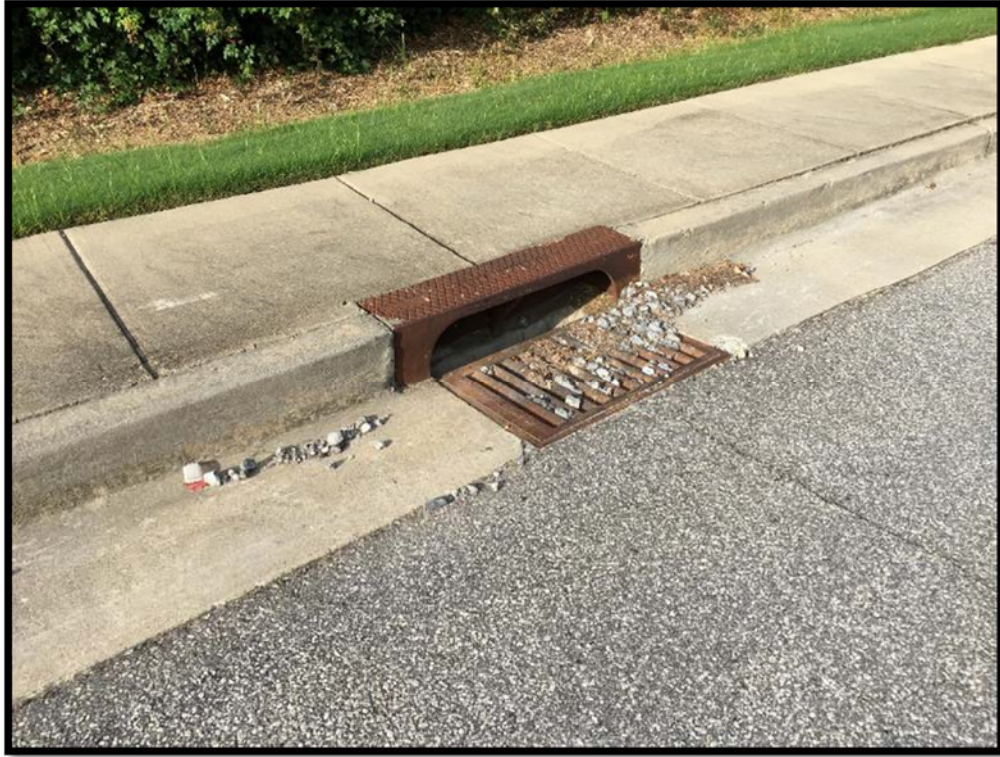
OFFICIAL PHOTOGRAPH NO. 43
TETRA TECH

Subject: Storm drain on John Street partially obstructed with gravel, sediment, and debris.

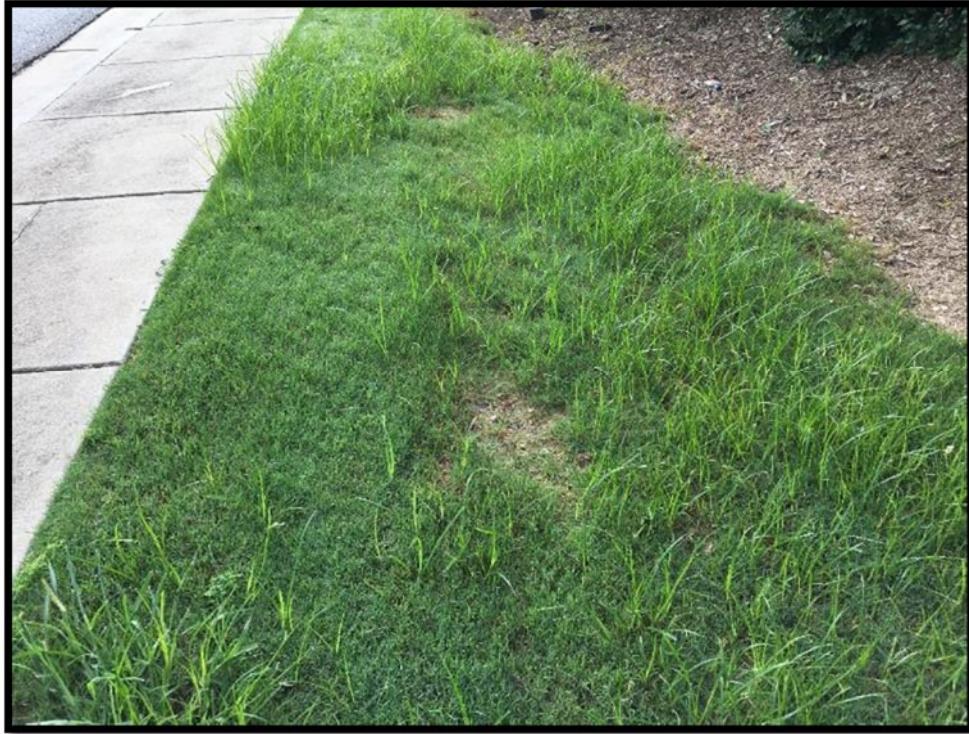
**OFFICIAL PHOTOGRAPH NO. 44
TETRA TECH**

Subject: Repaired eroded soil in the storm water drainage path along John Street. This area has been of note since the December 2015 inspection and has been repaired. A clear separation and storm water undercutting in the sod has been noted and should be monitored.

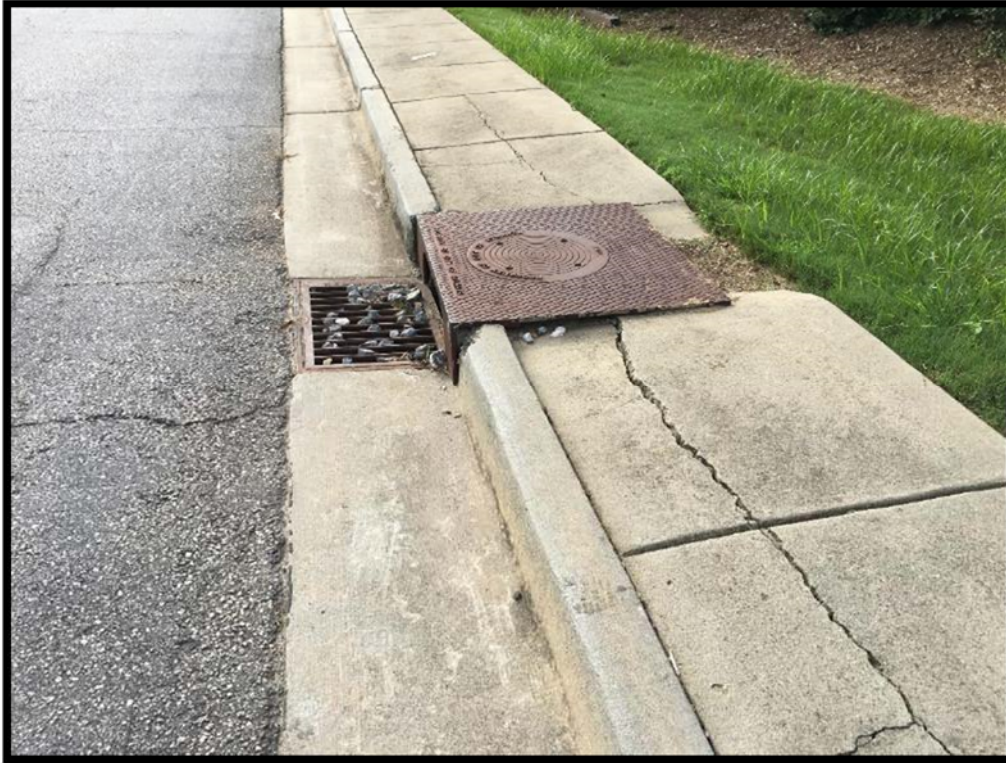
**OFFICIAL PHOTOGRAPH NO. 45
TETRA TECH**

Subject: Storm water drain along John Street partially obstructed by gravel, sediment, and vegetation. This drain is located adjacent to the repaired area presented in Photograph 44. Note the depressed concrete on the south and west sides of the metal vault.

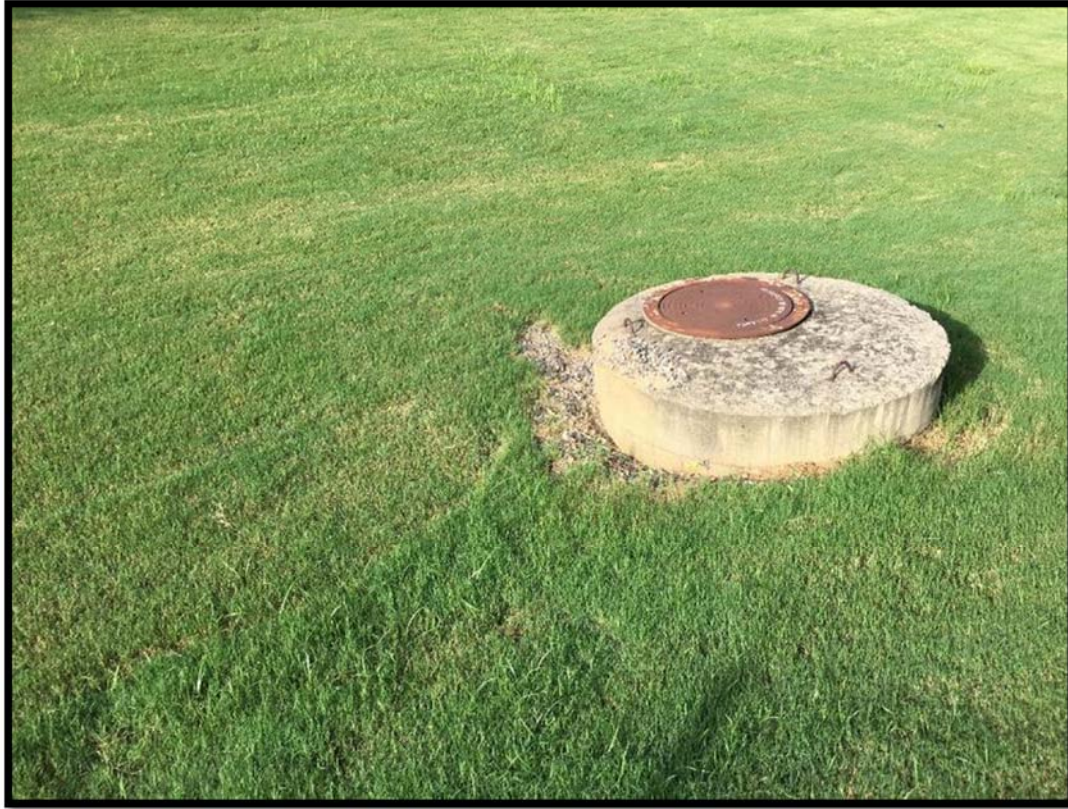
**OFFICIAL PHOTOGRAPH NO. 46
TETRA TECH**

Subject: Sewer manhole on the north side of the property at the lower end of the storm water drainage path area identified in Photographs 35 and 39. Erosion around the sewer had been noted in the June 2016 photo but repaired in the March 2017 event. The repair appears to be sustained..

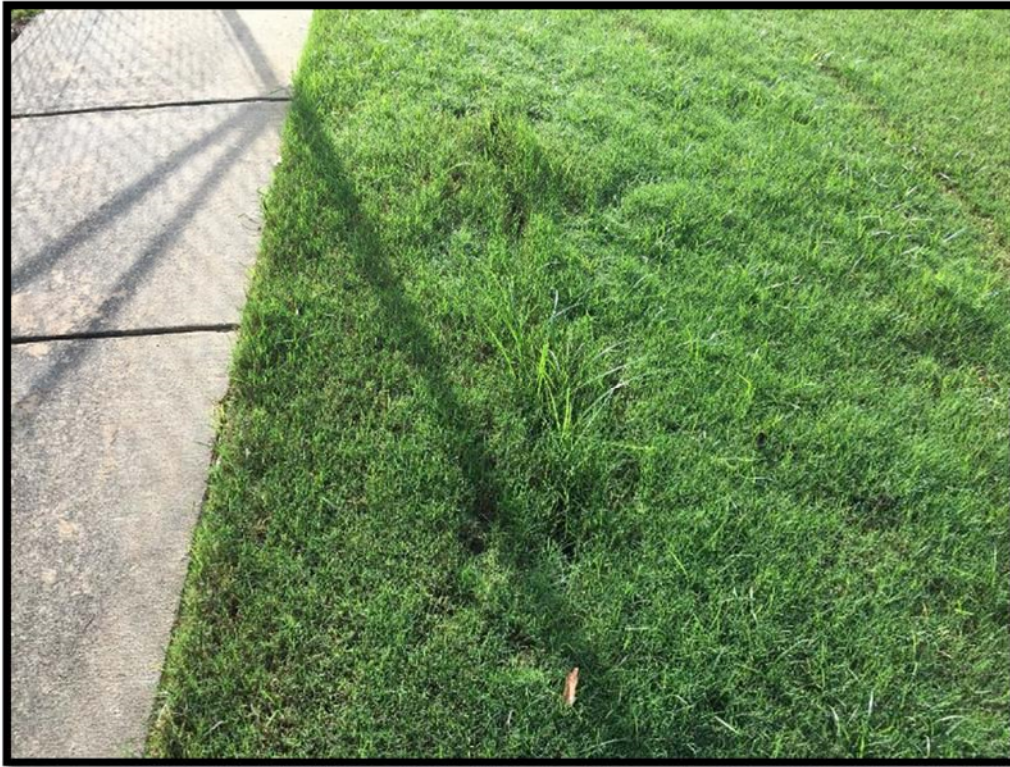
OFFICIAL PHOTOGRAPH NO. 47
TETRA TECH

Subject: Eroded soil area on the north side of the property. Eroded area is approximately 6'x6"x14'" and just east of the sewer manhole seen in Photograph 46. This void is approximately 18" deep and has been noted since the March 2016 site visit. This area is outside of the CAP but still should be monitored.
