### Construction Completion Report - Vapor Intrusion

# CONSTRUCTION COMPLETION REPORT

## STILLHOUSE CONTROL ROOM AND CHEMICAL PLANT CONTROL ROOM AND LABORATORY SUB-SLAB DEPRESSURIZATION SYSTEMS

### **Hercules/Pinova Facility Brunswick, Georgia**

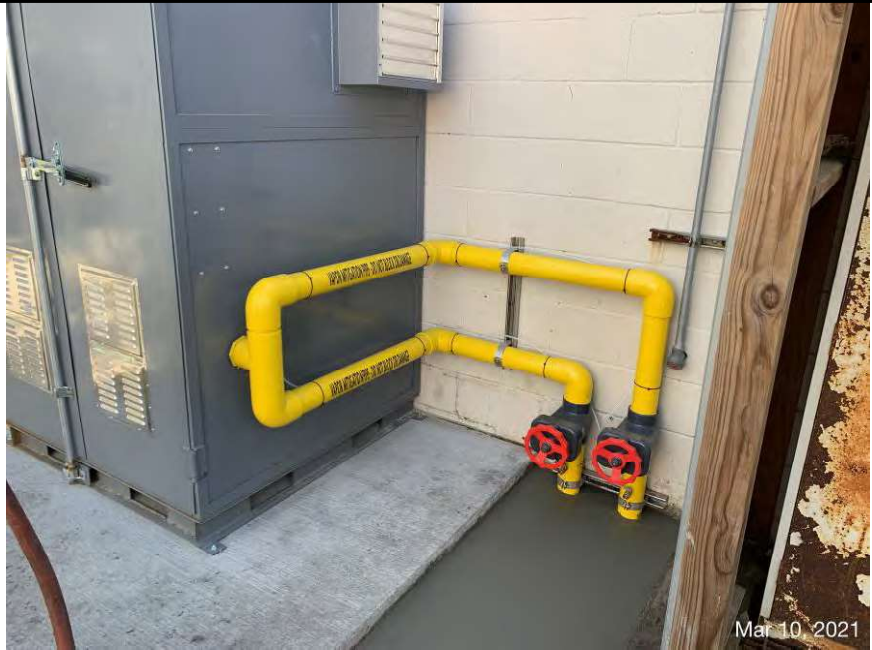
Comments:  
Finished, painted and  
labelled vapor recovery  
piping at the Chemical  
Plant Control Room and  
Laboratory.
