**REVISED CORRECTIVE ACTION PLAN (CAP)
AND FINAL PRELIMINARY RISK EVALUATION
FOR THE
DAVIDSON-KENNEDY COMPANY FACILITY
1195 VICTORY DRIVE
ATLANTA, FULTON COUNTY, GEORGIA**

HSI # 10866

MARCH 2015

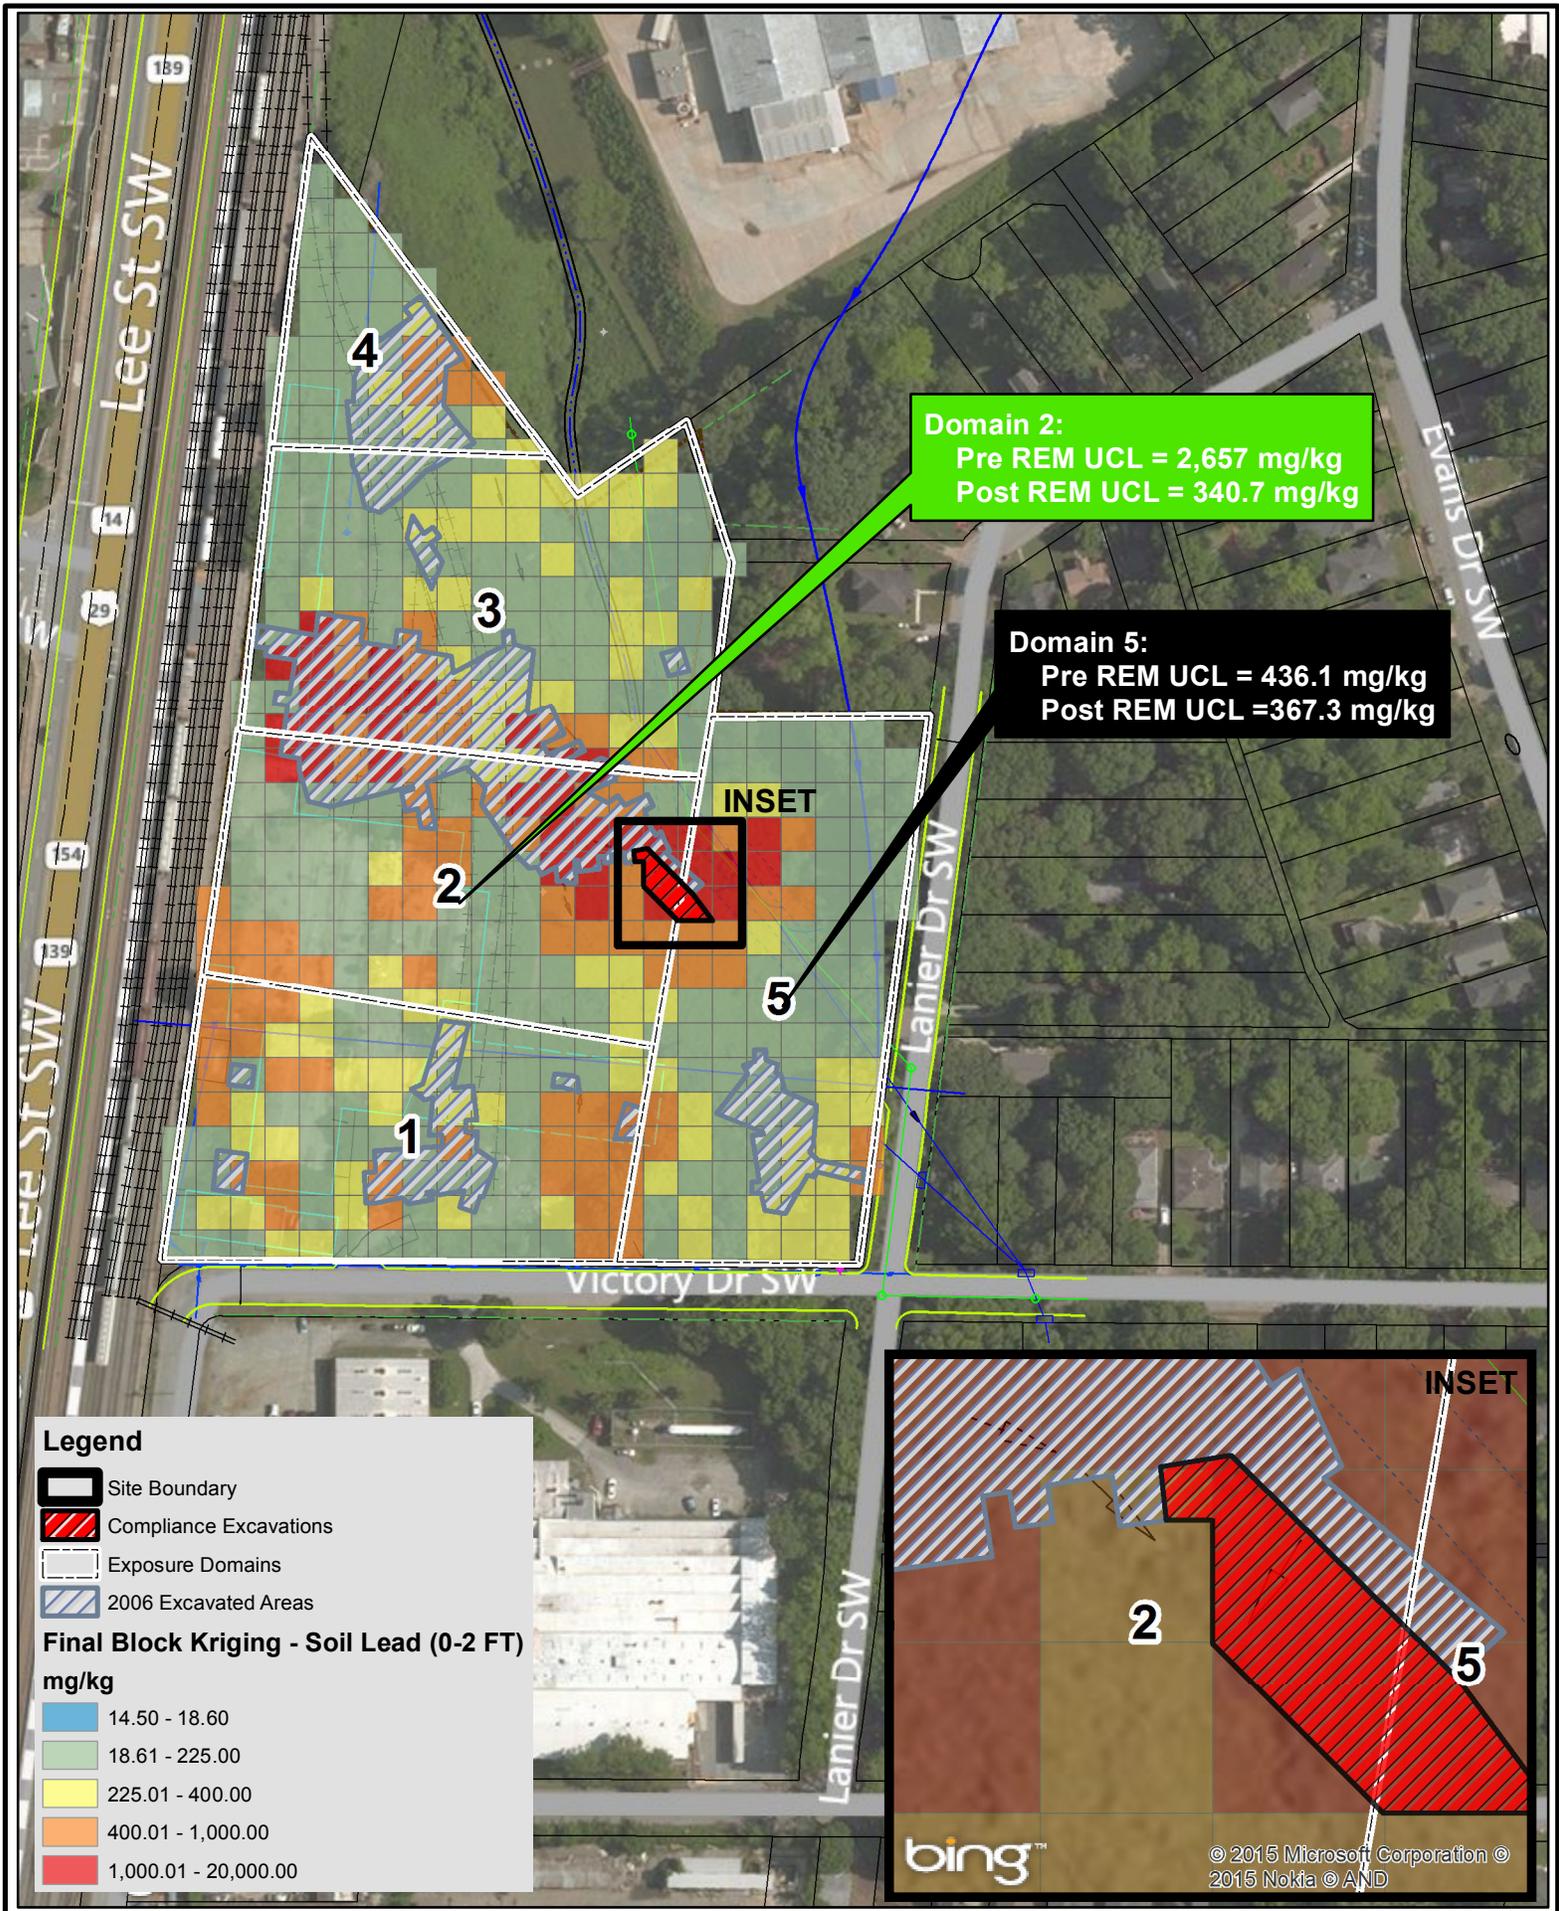
Figure No.
1

Davison-Kennedy Site
Corrective Action Plan

Excavated lead-contaminated material will be placed directly into transportation vehicles (i.e., dump trucks or trailers) or a roll-off box for off-site disposal. However, the extent of excavation of impacted soil will be confirmed through post-excavation verification sampling. The results of the post-excavation verification sampling will be entered into the Kriging model with the excavated soil results removed, and the excavation will continue if warranted based on the model output. The estimated area requiring excavation on-site is illustrated on **Figure 1**.

Peachtree personnel performed sediment and surface water sampling within the on-site stream on December 1, 2014. The samples were collected in general accordance with the U.S. Environmental Protection Agency (EPA) Region 4 Science and Ecosystem Support Division (SESD) Operating Procedures for Surface Water Sampling, dated February 28, 2013, and Sediment Sampling, dated August 21, 2014. The sample locations are depicted on **Figure 1**.

A Conceptual Site Model showing contaminant migration pathways is provided as Figure 1. Releases of metals likely occurred from aerial deposition and industrial operations from the surrounding area and from historical on-site metal-fabricating operations, impacting surface soil. From the surface soil, the metals may have percolated/infiltrated through subsurface soils to groundwater. The metals detected in sediment and surface water may have migrated to the stream via erosion and runoff of surface soil, aerial deposition, or migration groundwater flow and subsequent discharge to surface water.

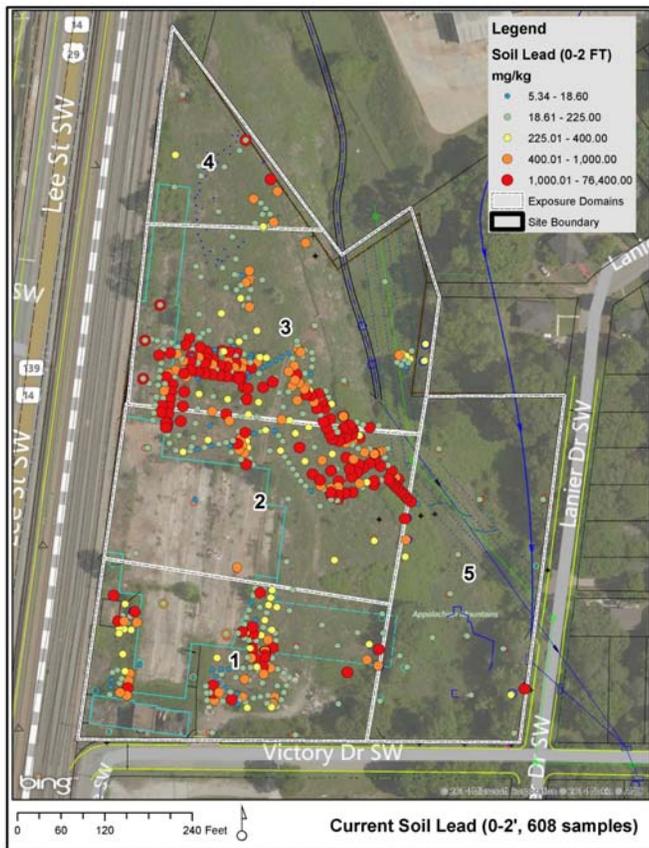
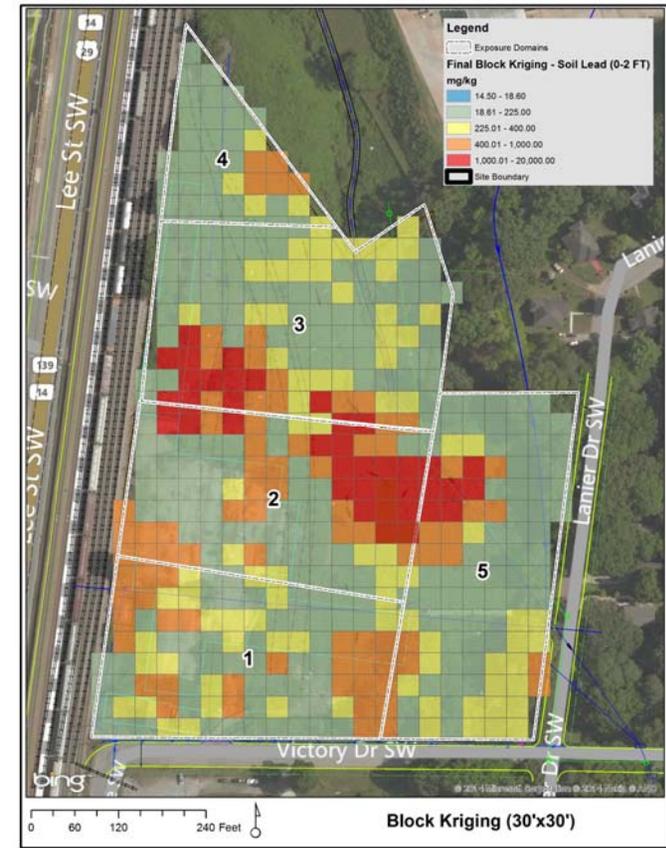
Step 2: Geostatistical Analysis (Block Kriging)

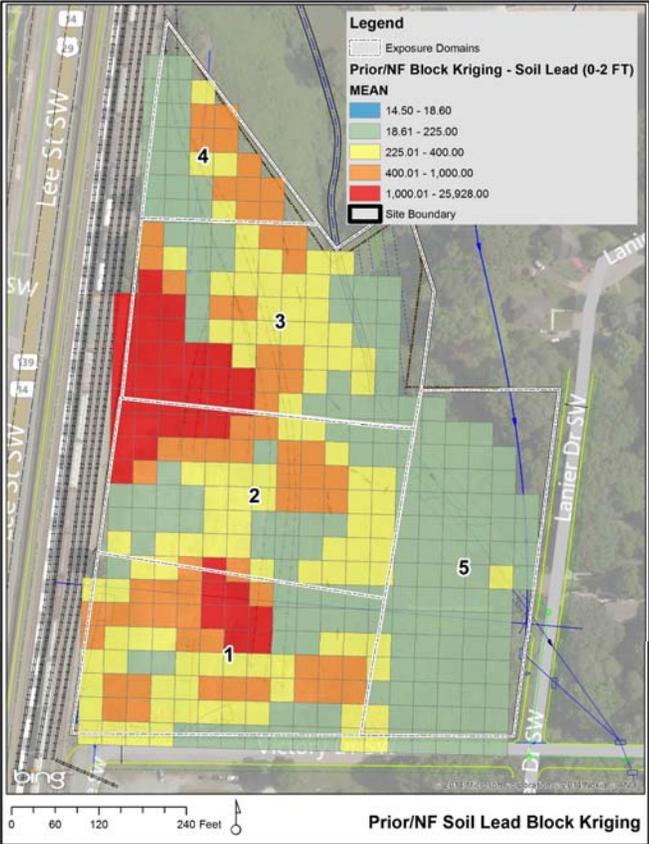
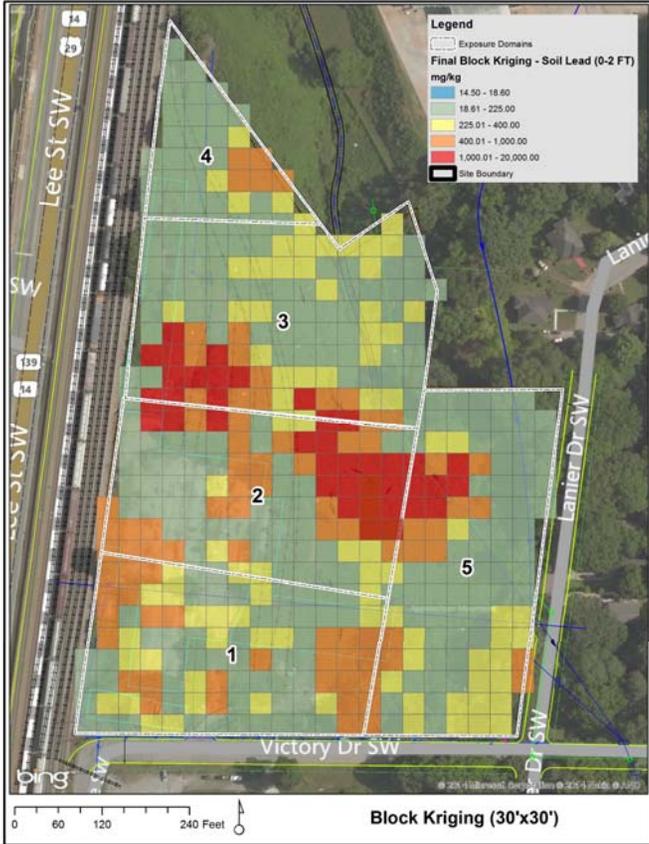
Previous Block Kriging vs. Current

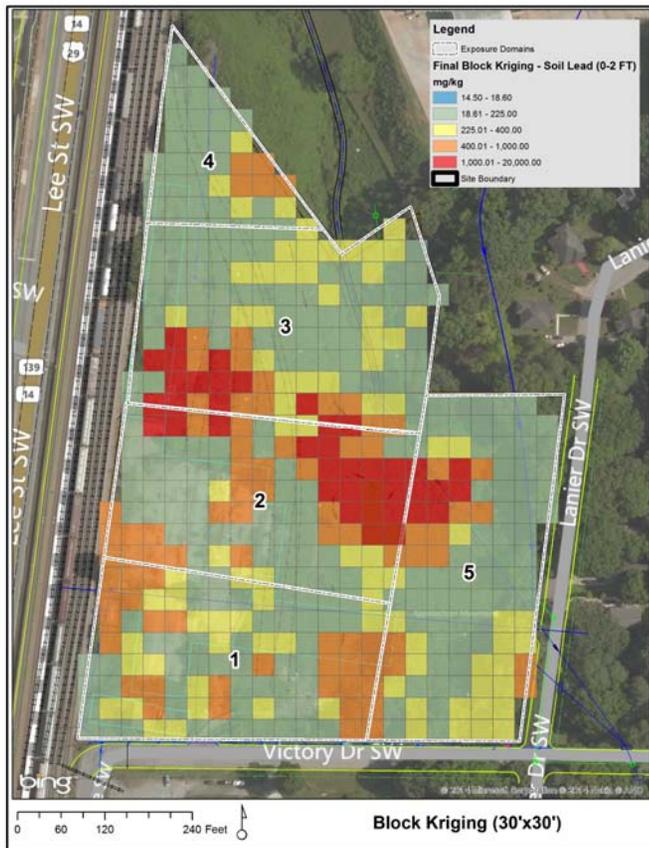
Step 3: Removal of Past Excavated Areas

Replace excavated blocks with a value of 36 ppm, which corresponds to backfill lead concentration

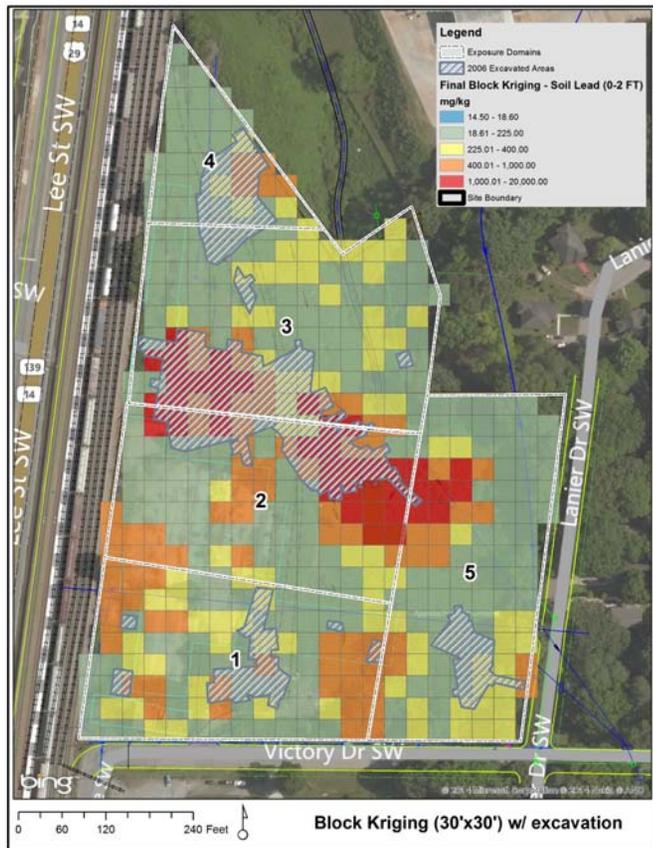
Step 4: Calculate Pre/Post Removal Domain Averages

Calculated 95% UCL of mean for each domain using kriged block values for pre-excitation and post excavation (36 ppm)

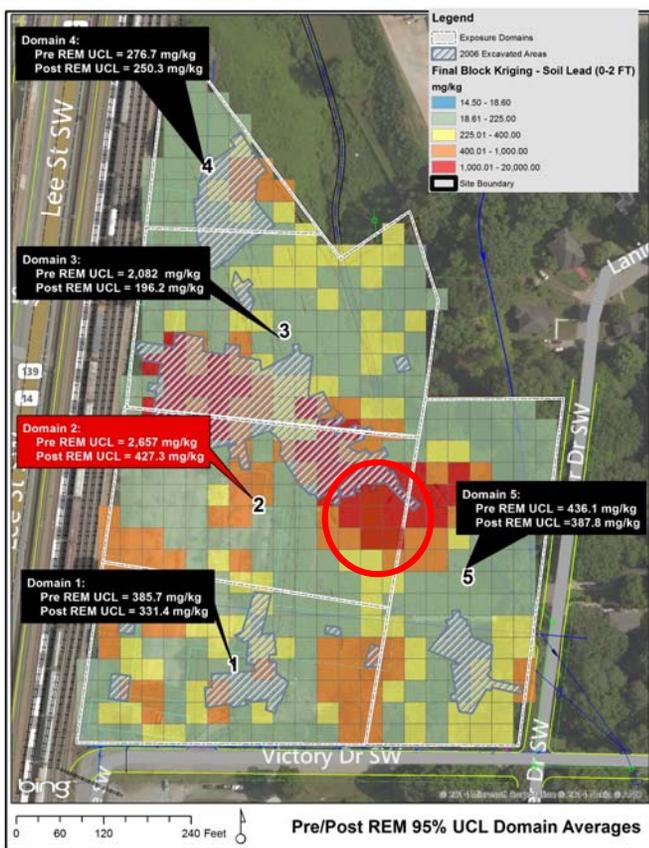
Step 5: Identify Exceedance Domains

Exposure Domain	Pre-Remedy Lead - ppm	Post-Remedy Lead - ppm
1	385.7	331.4
2	2,657	427.3
3	2,082	196.2
4	276.7	250.3
5	436.1	387.8

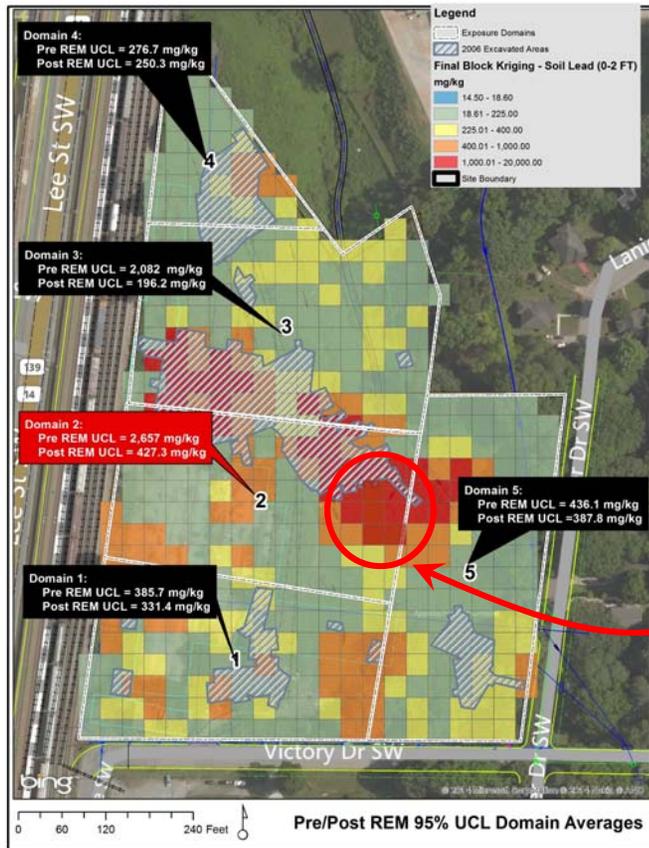
Step 6: Identify Blocks causing Domain Exceedances

Exposure Domain	Pre-Remedy 1 Lead - ppm	Post-Remedy 1 Lead - ppm	Post-Remedy 2 Lead - ppm
1	385.7	331.4	NA/Same
2	2,657	427.3	299.6
3	2,985	231.2	NA/Same
4	976.5	375.4	NA/Same
5	480.2	365.2	NA/Same

- If these blocks are removed:
 - UCL average passes 400 ppm criteria

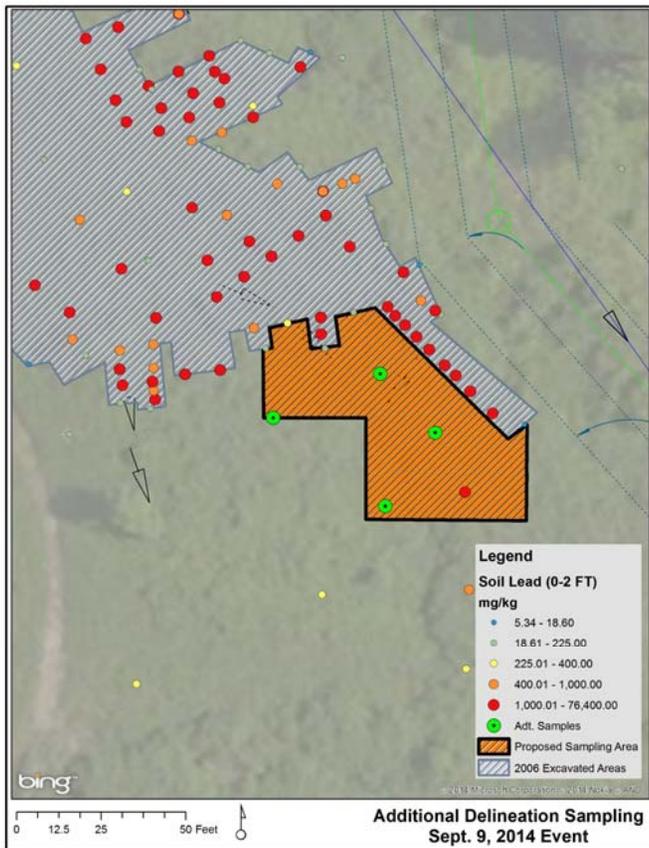
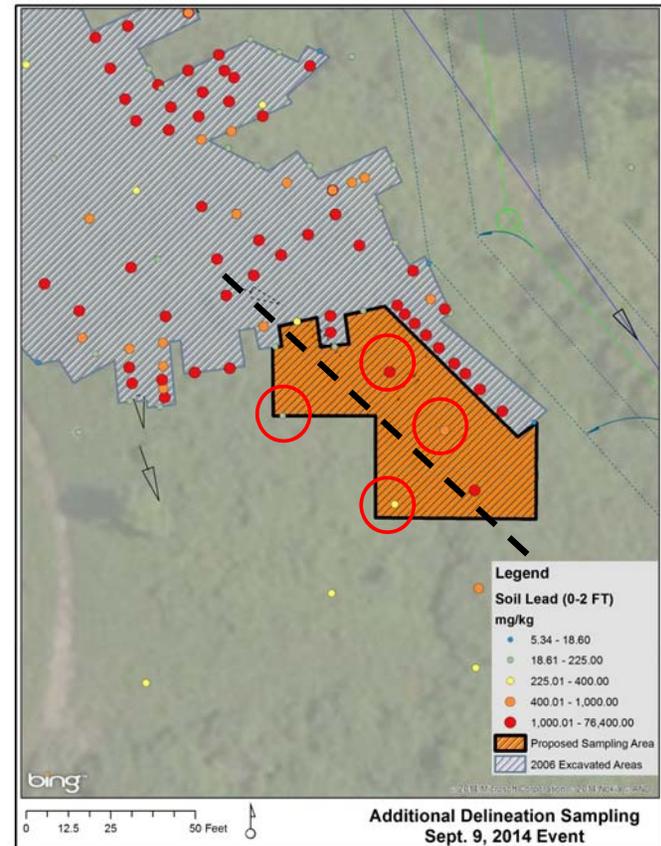
Area 5 – Further Sampling/Delineation

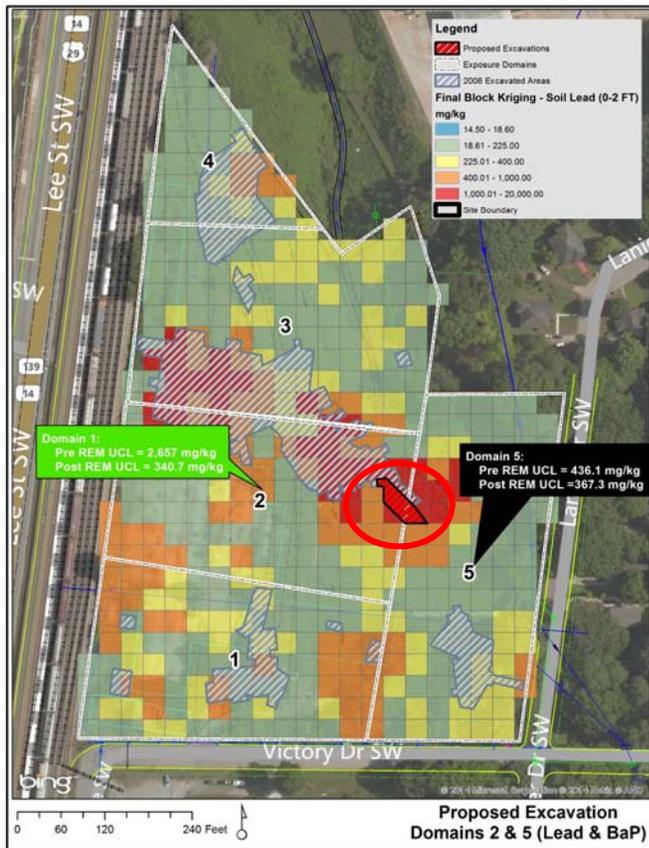
Domain 2 Removal Analysis (Lead & BaP)

Exposure Domain	Current Lead - ppm	Post-Remedy 1 Lead - ppm
1	331.4	NA/Same
2	485.4	340.7
3	196.2	NA/Same
4	250.3	NA/Same
5	387.8	367.3

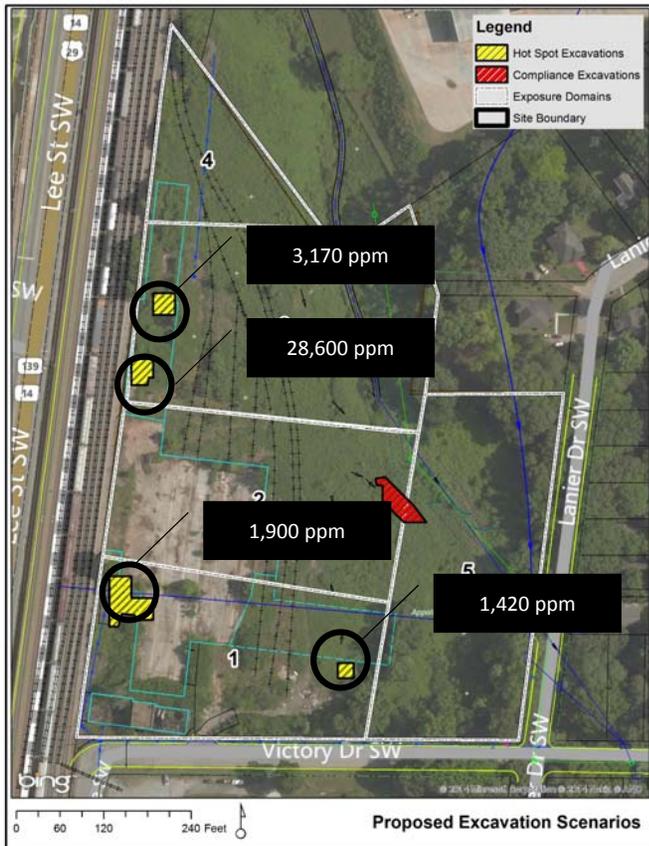
Hot Spots Removal Options

Exposure Domain	Current Lead - ppm	Post-Remedy 1 Lead - ppm	Post-Remedy 2 Lead - ppm
1	331.4	331.4	249.6
2	485.4	340.7	NA/Same
3	196.2	196.2	192.6
4	250.3	250.3	NA/Same
5	387.8	367.3	NA/Same
