MONITORING AND MAINTENANCE PLAN
Former TLC Cleaners
2060 Lower Roswell Road
Marietta, GA 30068

**MONITORING AND MAINTENANCE PLAN FOR
Former TLC Cleaners
2060 Lower Roswell Road
Marietta, Georgia 30068**

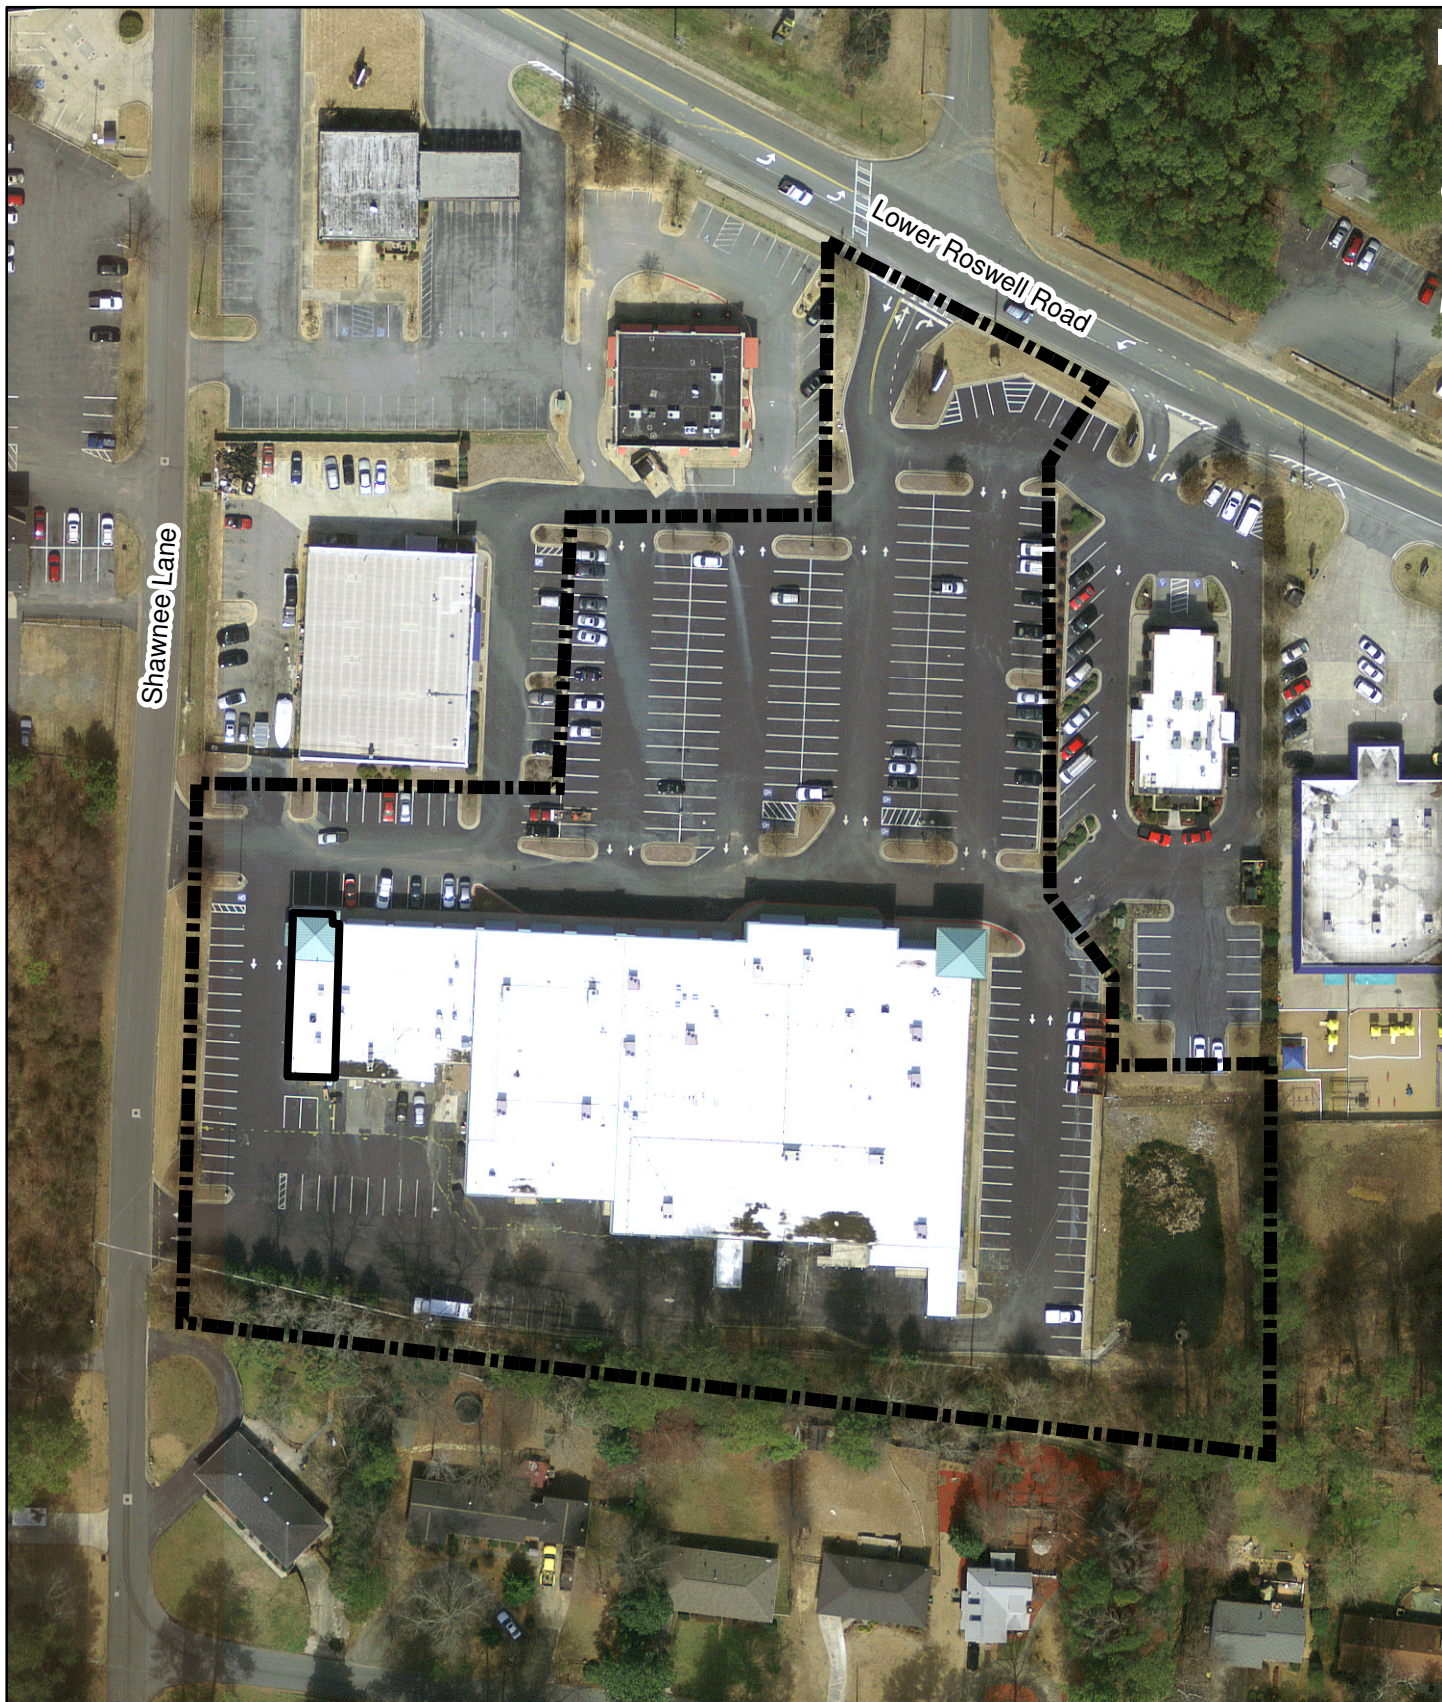
Site Plan

- Former Dry Cleaners
- Property Boundary
