UCC Woodbine, Camden County, Georgia Facility

Todd Creek Monitoring and Maintenance Plan

Revision 1

Union Carbide Corporation

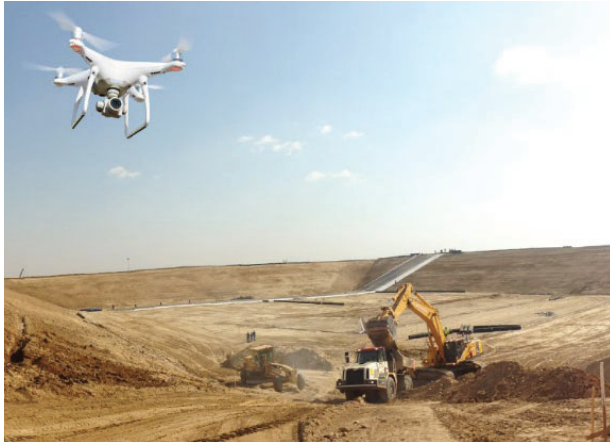
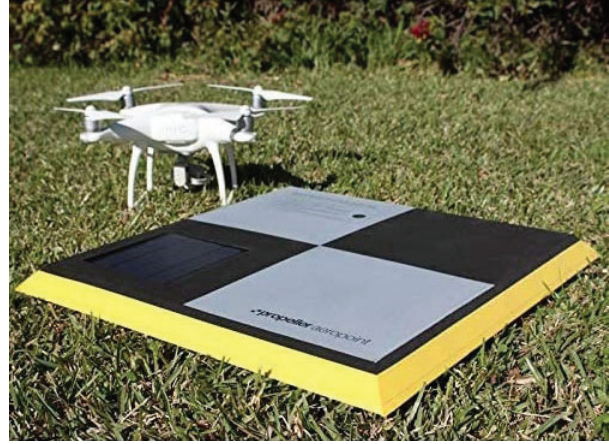
Exhibit 2. UAV Survey and Portable Ground Control Tile

Source: Propeller Aerobotics Pty Ltd

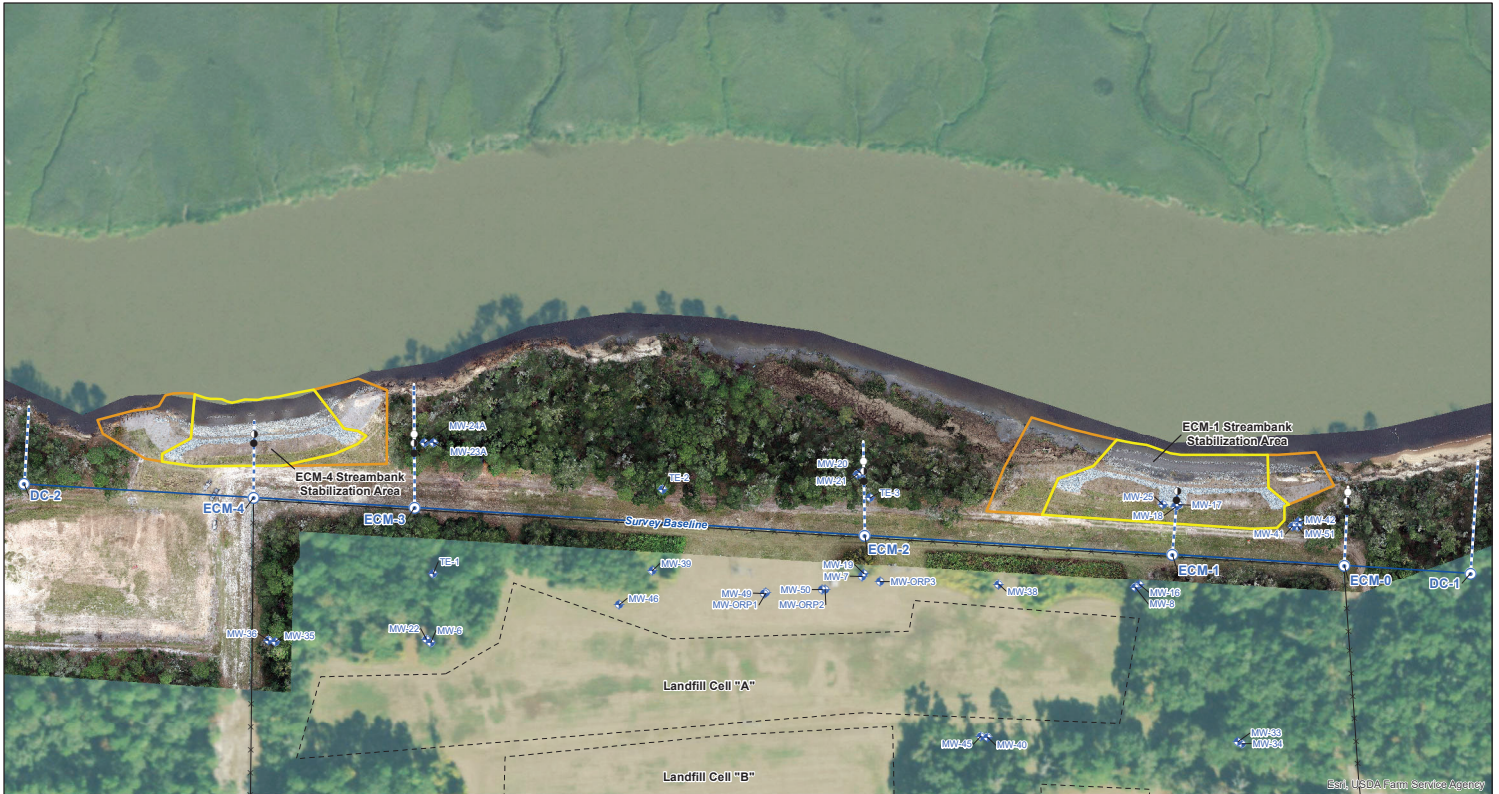
Figure 2. Streambank Monitoring Area and Features
Todd Creek Monitoring and Maintenance Plan
Union Carbide Corporation
UCC Woodbine, Camden County, Georgia

- LEGEND**
- Erosion Control Measurement (ECM) or Data Collection (DC) Line
 - Design Initiation Trigger Pin
 - Primary Contingency Pin
 - Secondary Contingency Pin
 - Monitoring Well
 - Fence
 - Reference Line
 - Landfill Boundary
 - Streambank Stabilization Areas
 - Transitional Grading Areas

to include ECM-4 and expanded again in 2017 to include ECM-0 and two data collection (DC) reference lines located upstream and downstream of the landfill (DC-1 and DC-2, respectively) (Figure 2).
