Voluntary Remediation Program Interim Final Compliance Status Report

Prepared for
Former MacGregor Golf Company Site
HSI Site No. 10398
Albany, Georgia
January 26, 2017

Submitted to the Georgia Environmental Protection Division

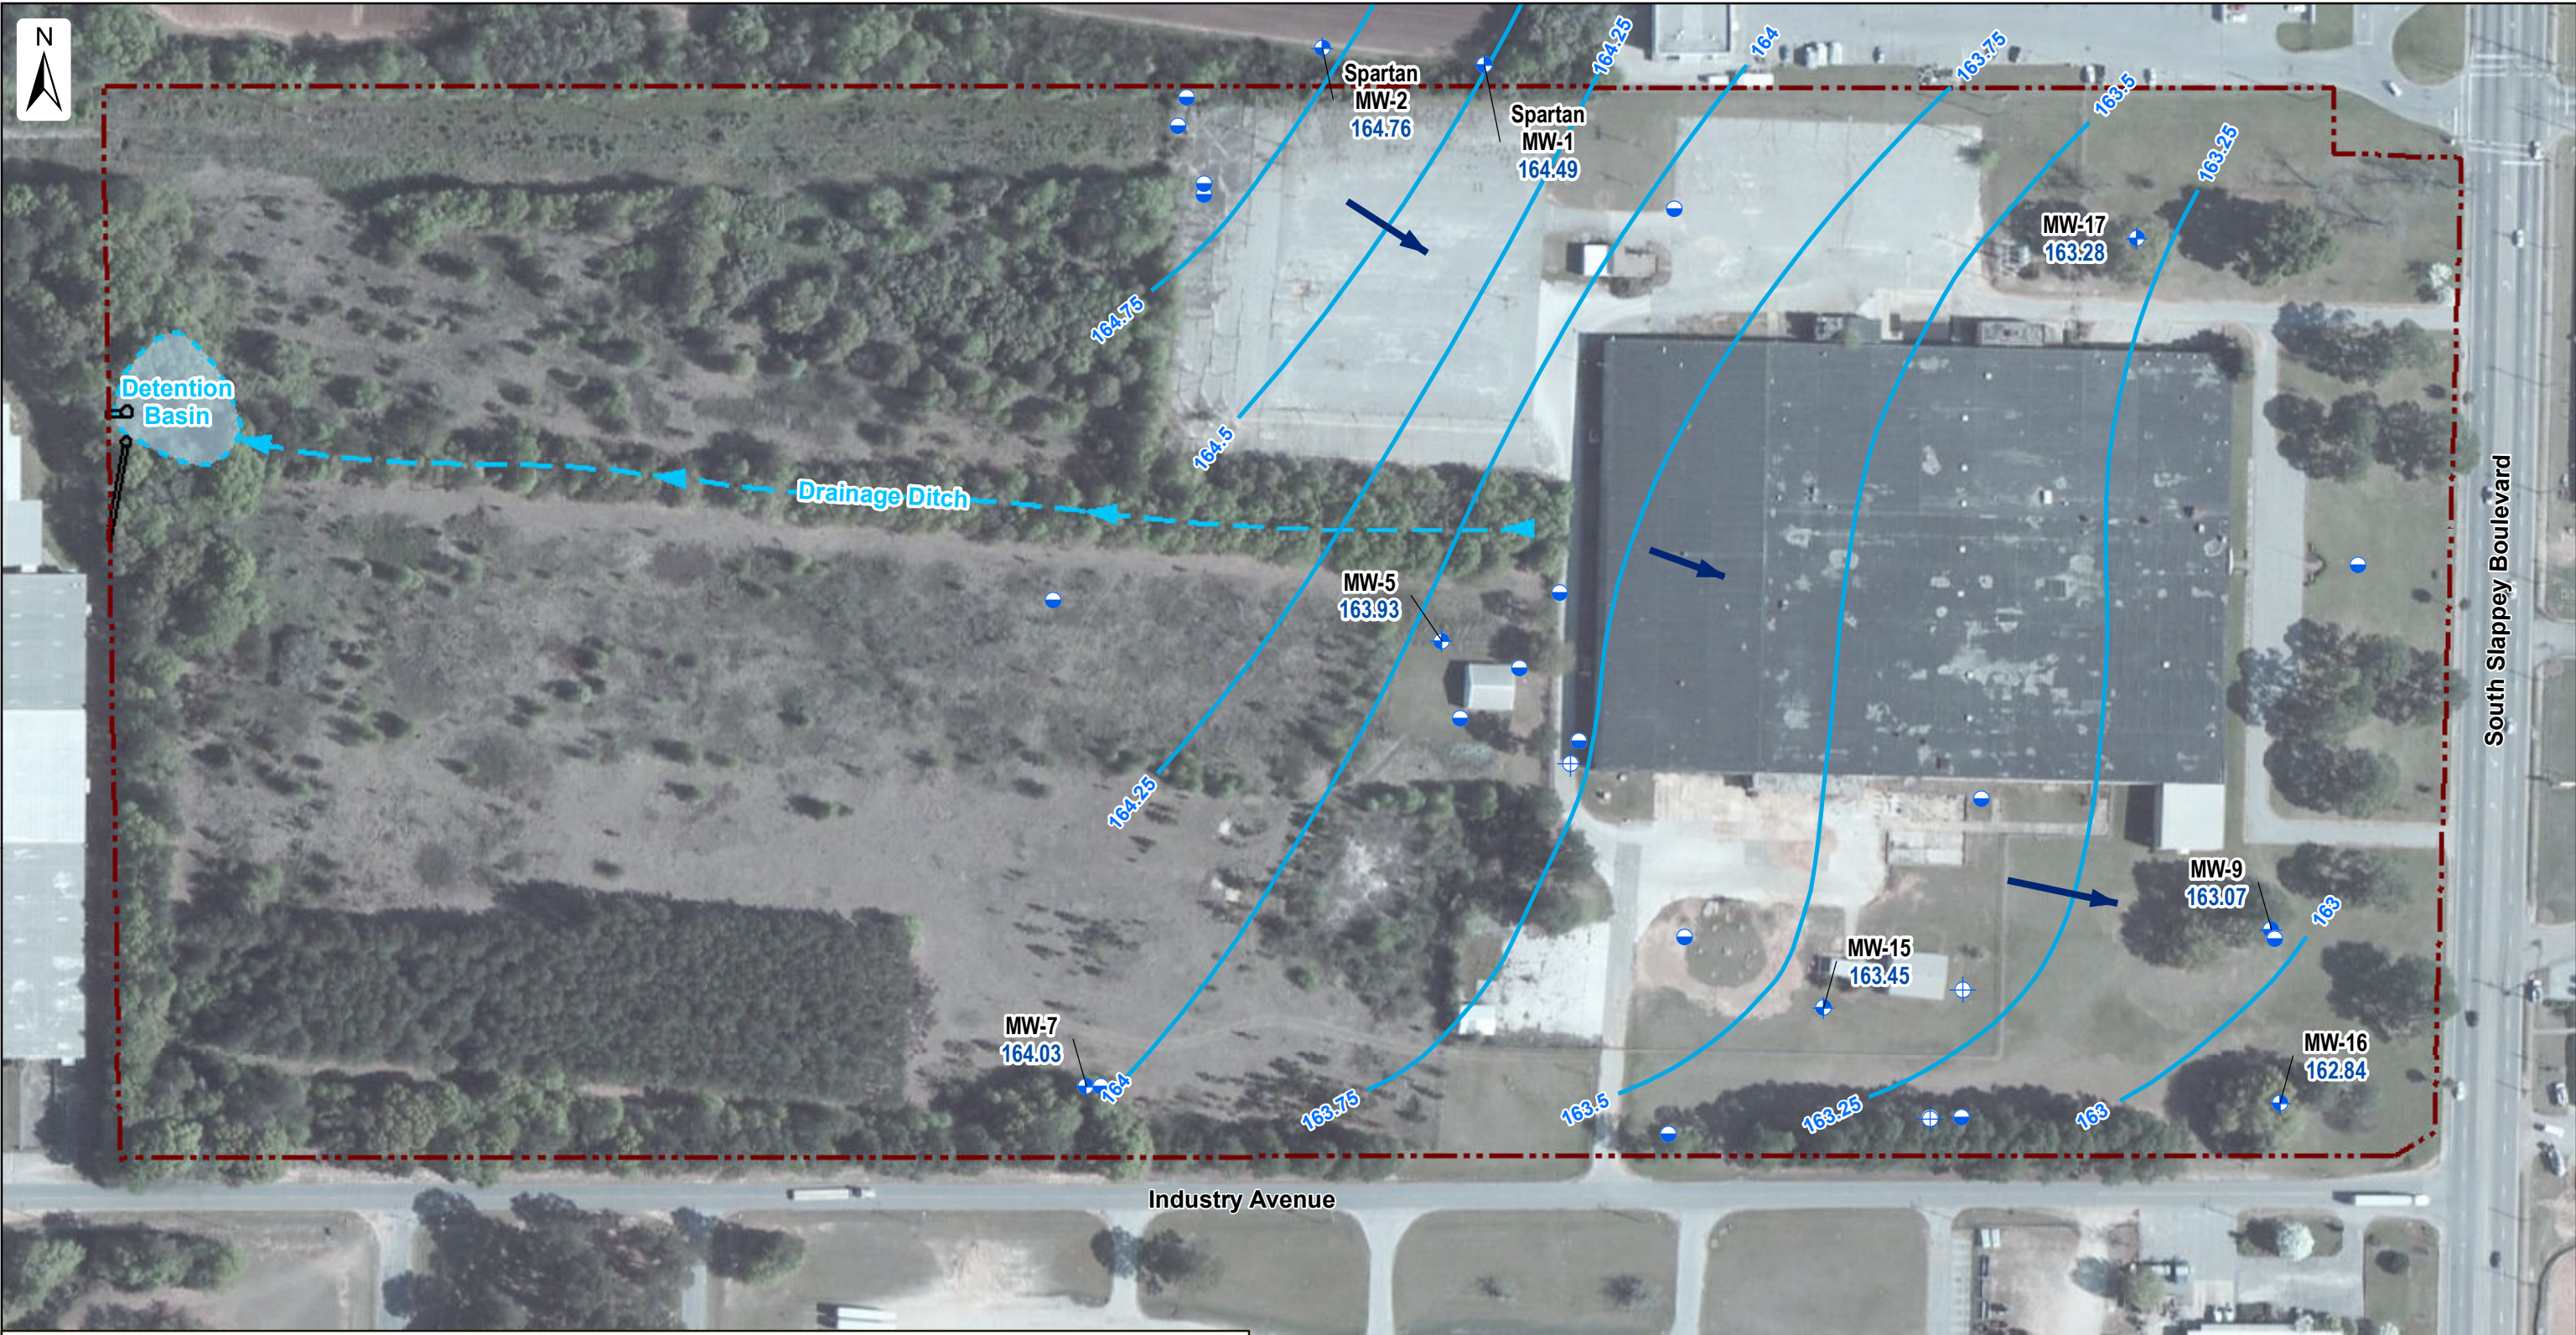
- 148.00 Groundwater Elevation (Feet NAVD88)
- Groundwater Elevation Contour (Contour Interval is 0.50 Feet NAVD88)
- - - Estimated Groundwater Elevation Contour
- Apparent Groundwater Flow Direction
- ⊕ Deep Monitoring Well
- ⊙ Shallow Monitoring Well
- ⊕ Well Not Included in the Current Monitoring Program
- ⊕ Deep Monitoring Well Installed by Others
- ⊕ Deep Temporary Monitoring Well
- Approximate Property Boundaries

The upper water bearing zone consists predominantly of silty sands, sandy silts, clays and chert of the weathered limestone residuum as illustrated on Figure 8. The thickness of the unconsolidated soil at the Site is approximately 40 to 50 feet with the thin layers of chert occurring at depths of 18 to 45 feet below ground surface (bgs). Beneath the chert, sediments increase in clay content with clay layers ranging from 1 to 6 feet thick. The lower boundary to this zone is the chalky limestone that occurs in the uppermost Ocala Limestone at 50 to 55 feet bgs. In the most recent Site-wide gauging event (April 2016), groundwater was encountered in the upper water bearing zone between 30 and 36 feet bgs (Table 1). The potentiometric surface measured in this event is illustrated on Figure 3.

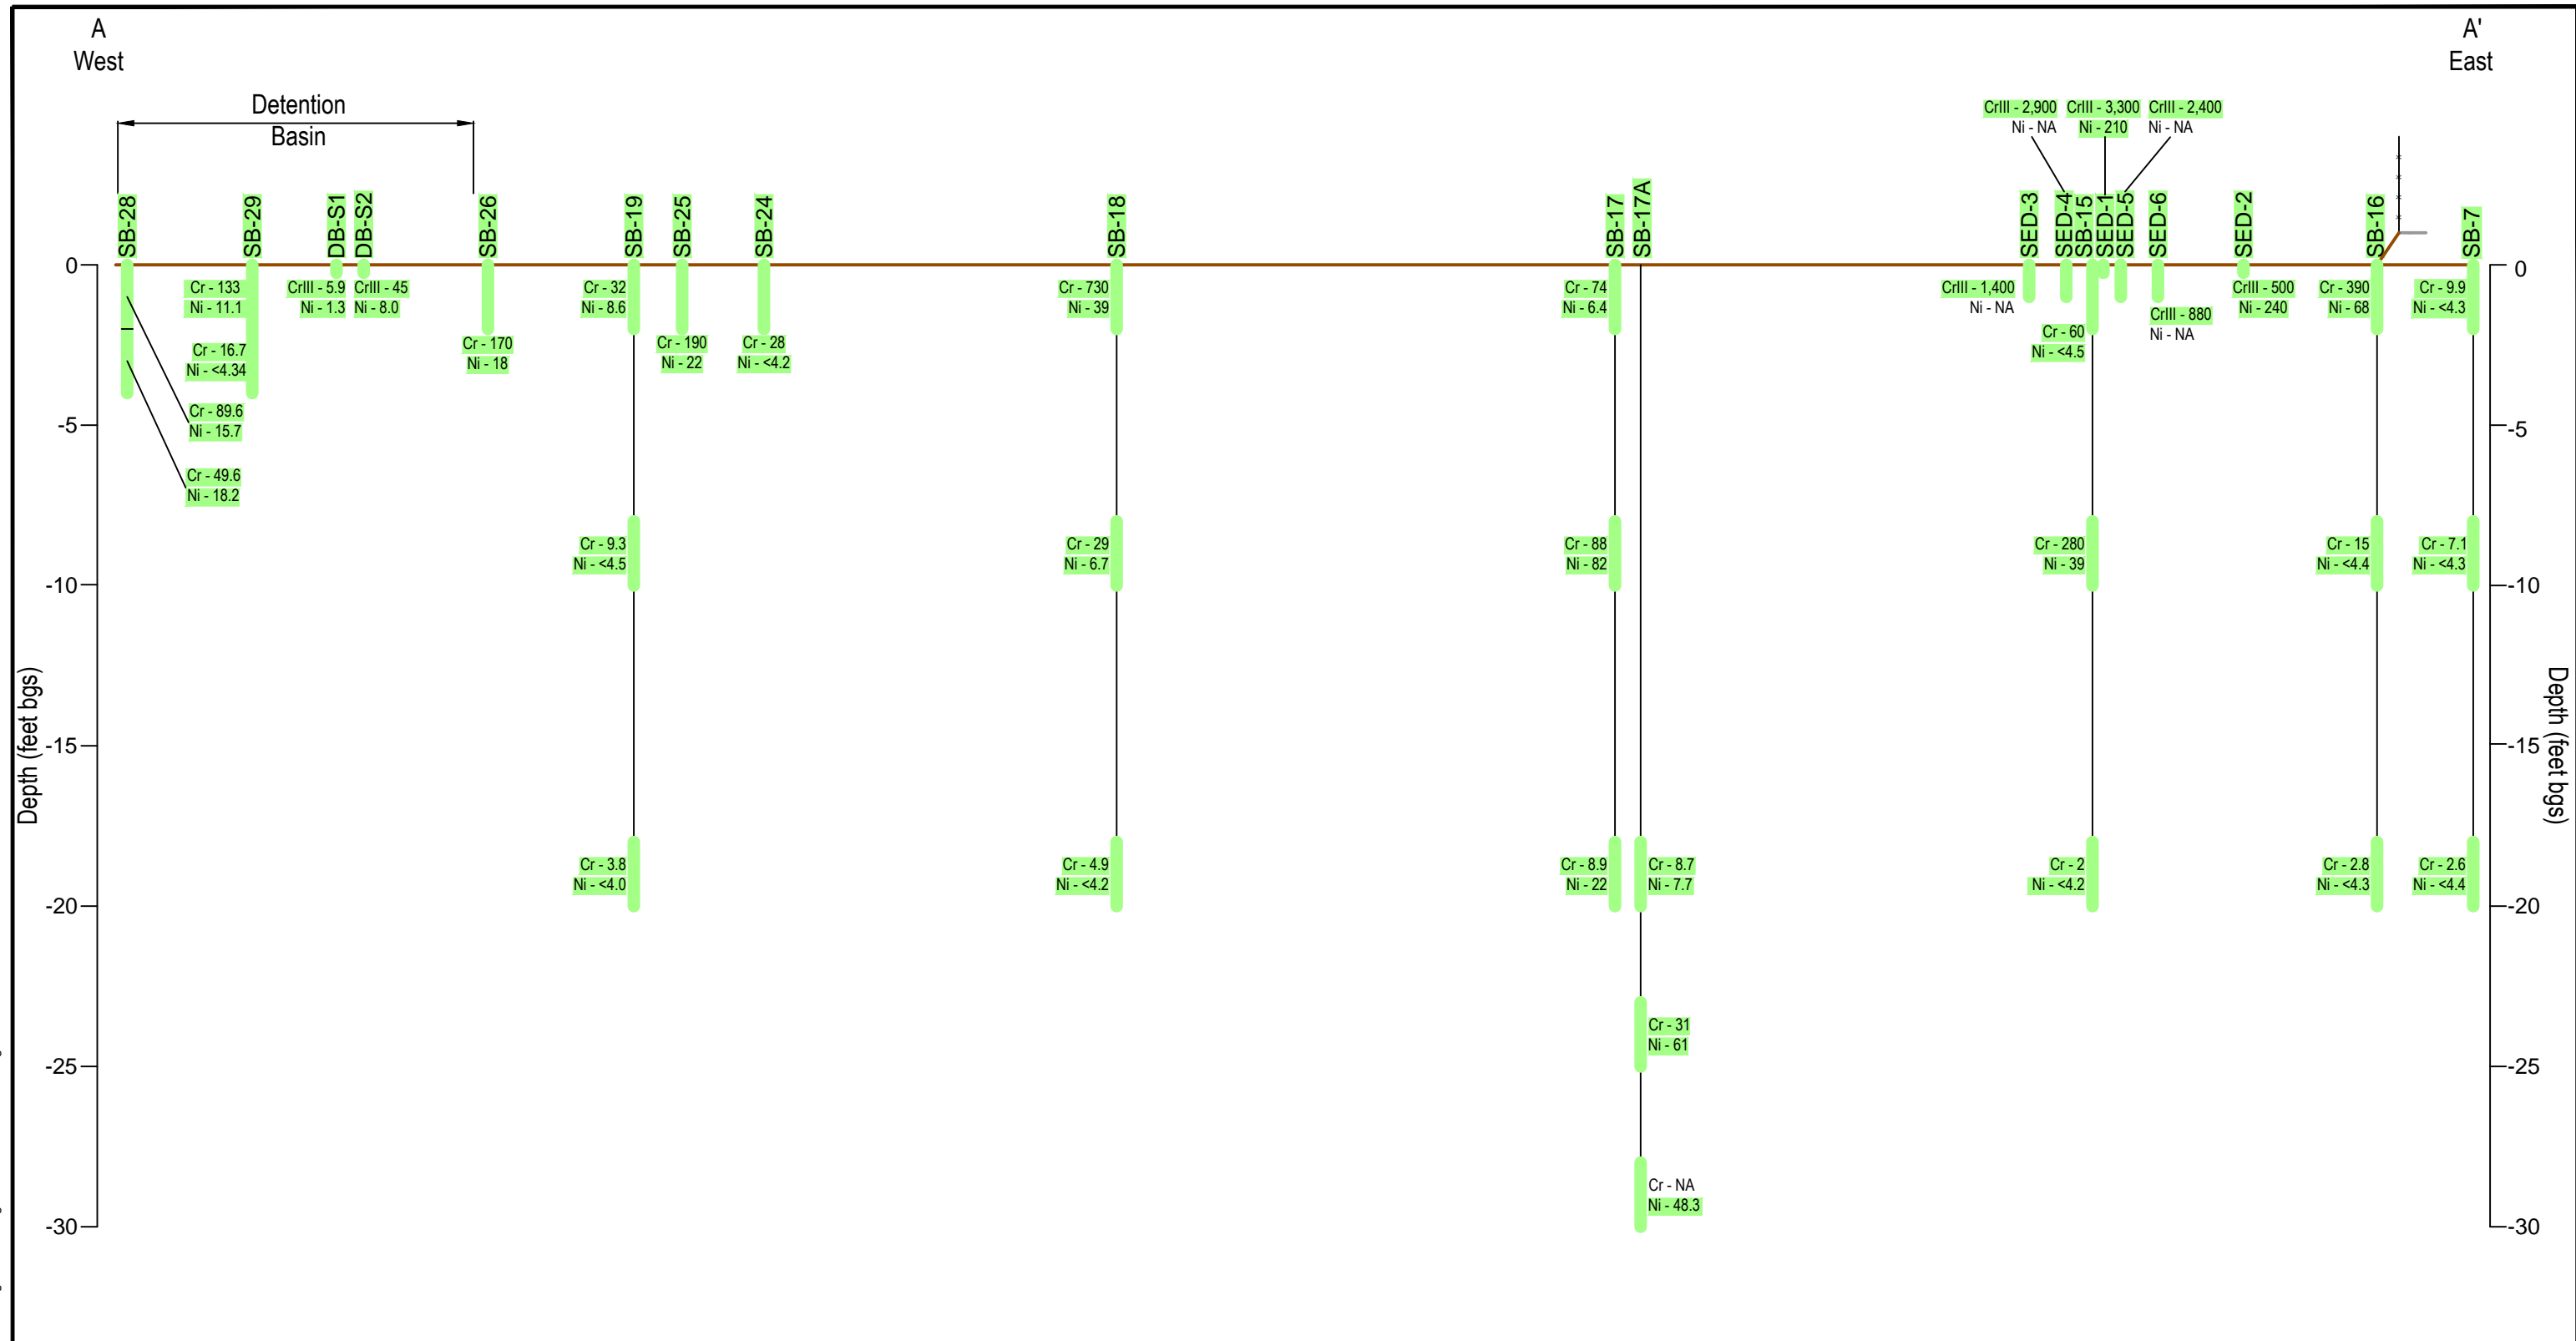
Figure 5b
Drainage Ditch Cross-Section A-A'
Soil Compliance Status

- Notes:
- 1) All concentrations are shown in milligrams per kilograms (mg/kg)-dry weight.
 - 2) All depths given as feet below ground surface (bgs). No points have surveyed elevations.
 - 3) The Nickel (Ni) cleanup standard is 2,665 mg/kg.
 - 4) The Total Chromium (Cr) cleanup standard is 1,200 mg/kg.
 - 5) The Trivalent Chromium (CrIII) cleanup standard is 3,066,000 mg/kg.
 - 6) All Results for Hexavalent Chromium (CrVI) and Cyanide were Below Detection Limits.

The soil and groundwater delineation status at the Site is discussed below and summarized in Table 4. Figures 5a, 5b, and 5c illustrate soil sampling locations relative to delineation standards, and Figures 6a, 6b, and 6c illustrate groundwater sampling locations relative to delineation standards.

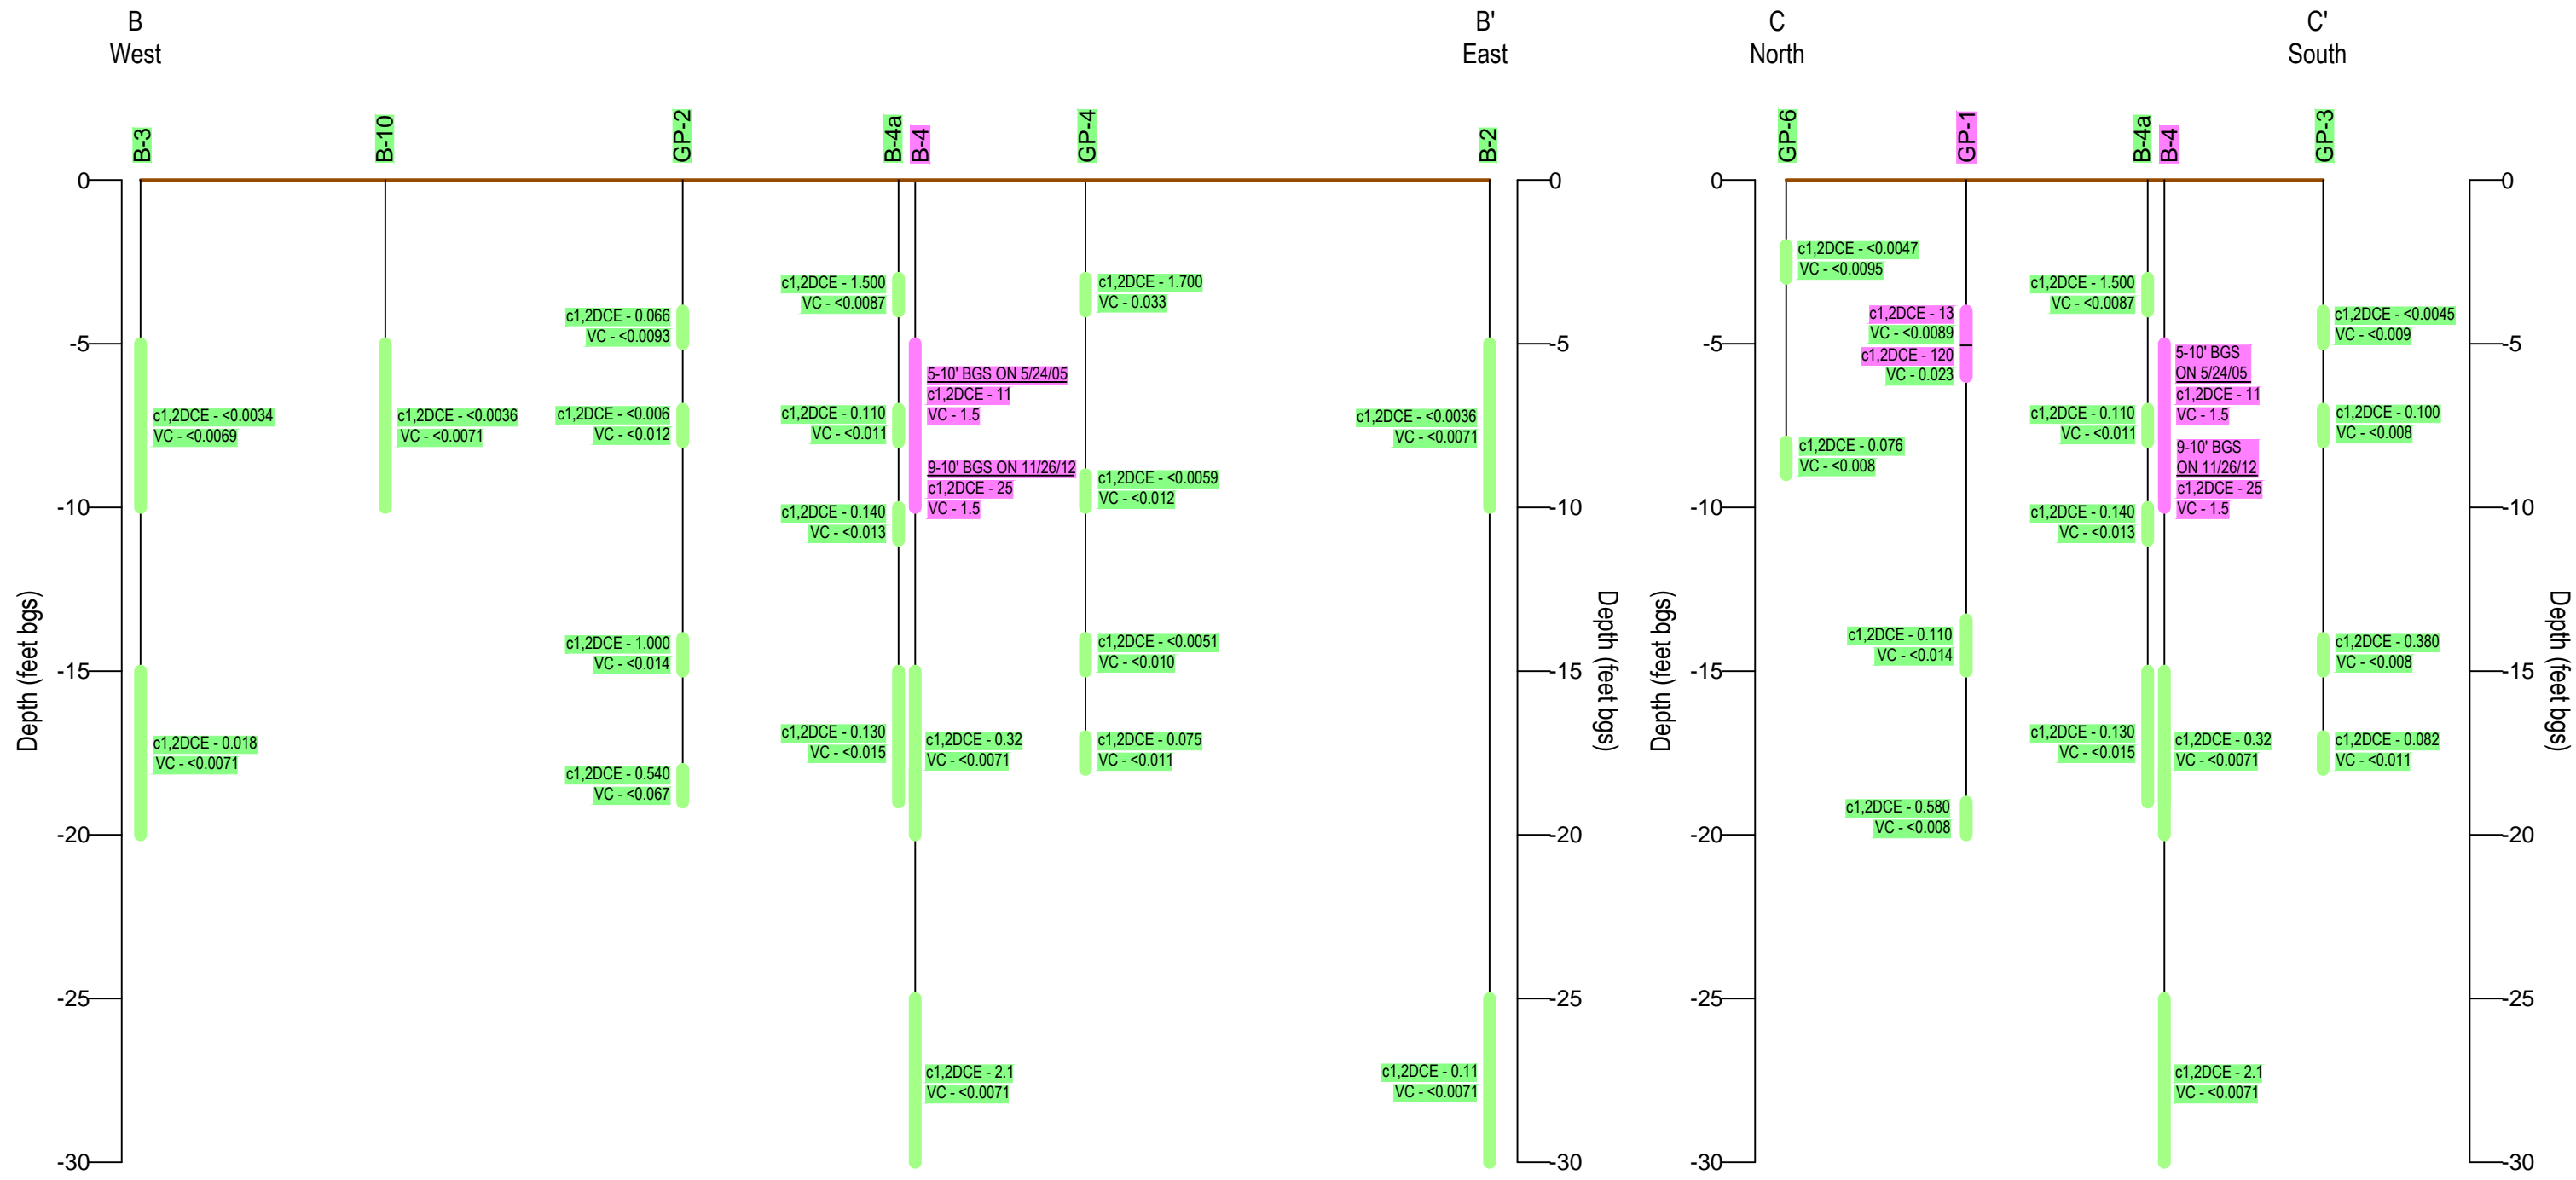
Figure 5c
 Former Source Area Cross-Sections B-B' and C-C'
 Soil Compliance Status

- Notes:**
- 1) All concentrations are shown in milligrams per kilograms (mg/kg)-dry weight.
 - 2) All depths given as feet below ground surface (bgs). No points have surveyed elevations.
 - 3) The cleanup standard for cis-1,2-Dichloroethene (c1,2DCE) is 7.0 mg/kg.
 - 2) The cleanup standard for Vinyl Chloride (VC) is 0.2 mg/kg.

The results from the soil samples collected from the primary borings indicated that cis-1,2-DCE was present at a concentration above the delineation and cleanup standard in one boring (GP-1) at depths of 4 to 5 feet bgs and 5 to 6 feet bgs). The cis-1,2-DCE concentration in the sample from 14 to 15 feet bgs was below the delineation and cleanup standard and thus cis-1,2-DCE was delineated vertically in this boring. In addition, vinyl chloride was not detected above the delineation and cleanup standard in any samples from this boring; thus, vinyl chloride was vertically and horizontally delineated in soil in this area. The remaining primary samples analyzed were all less than the delineation and cleanup standards. These results are shown on Figure 5c and Table 2.

Two soil samples collected from the former source area, B-4 and GP-1, contained cis-1,2-DCE and vinyl chloride at concentrations greater than the delineation standards. However, as shown in the cross-section views provided on Figure 5c, these constituents are both horizontally and vertically delineated within the source area.

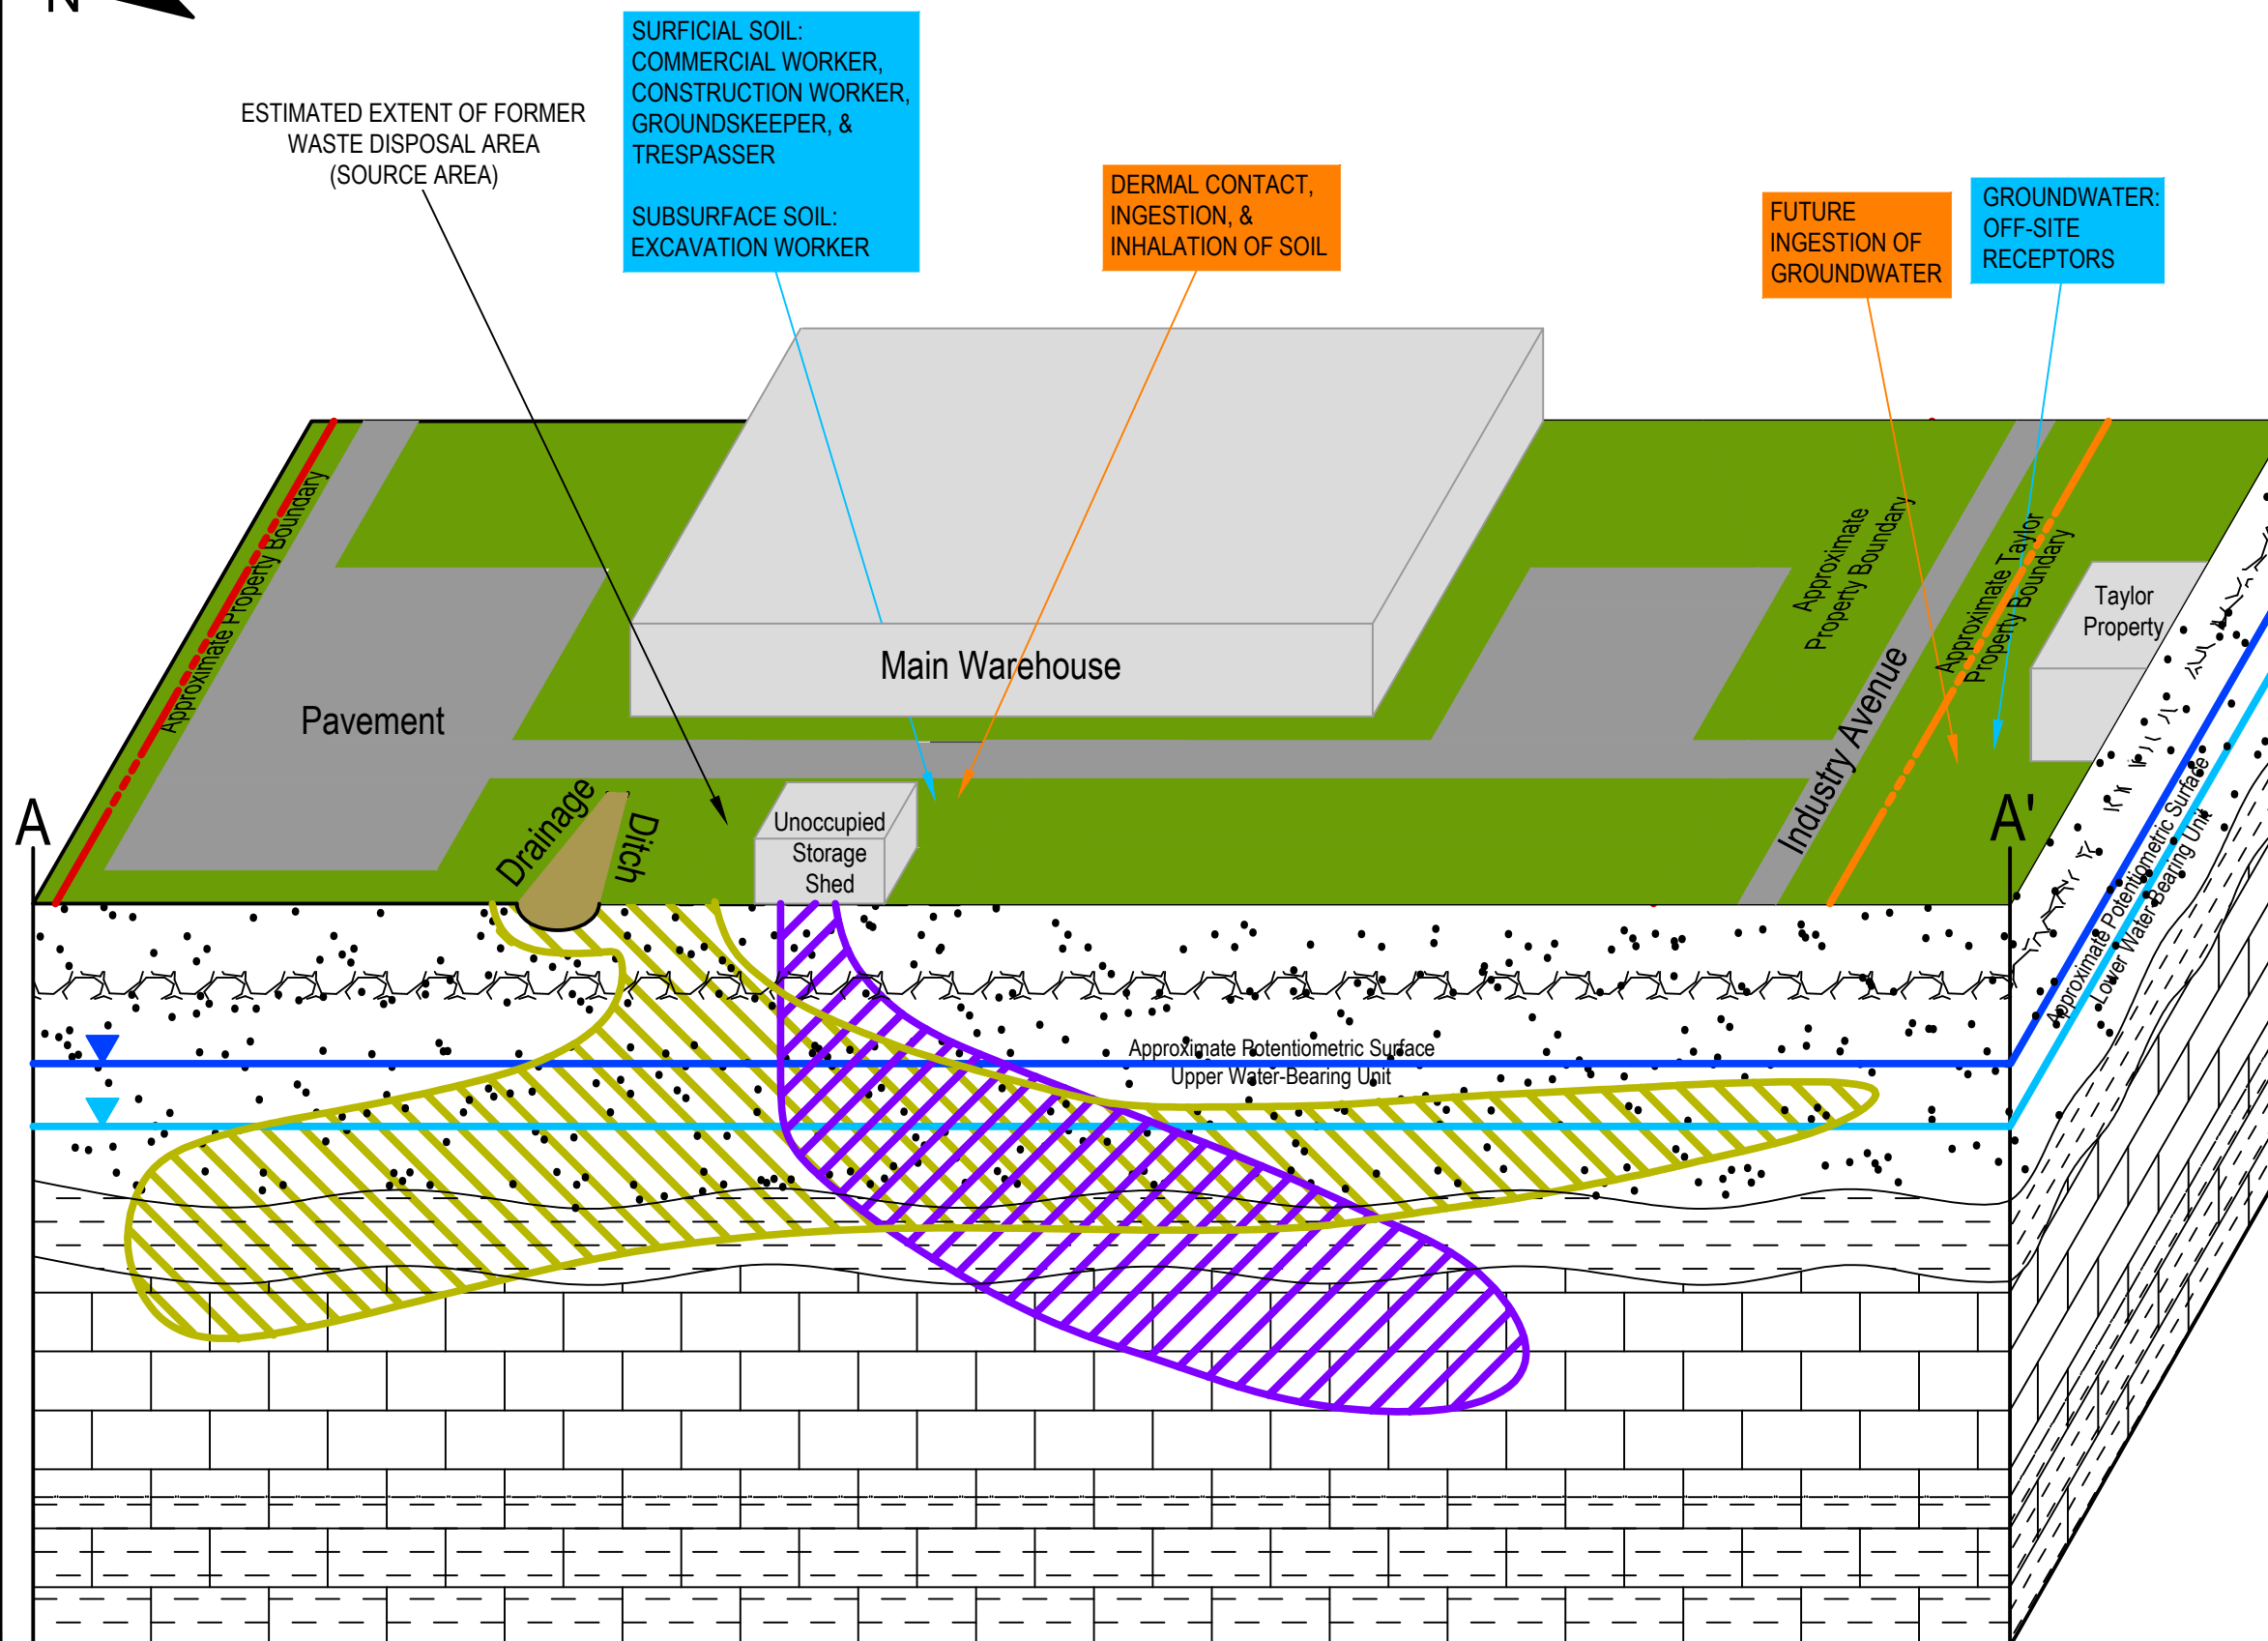
Figure 8
 Updated Conceptual Site Model
 Profile View

- Property Boundary
- Approximate Water Table in Upper Water-Bearing Zone
- Approximate Water Table in Lower Water-Bearing Zone
- Potential Exposure Pathways
- Potential Exposure Receptors
- Soil
- Chert
- Semiconfining Unit / Chalky Limestone
- Limestone Bedrock
- Lower Confining Unit / Limestone
- VOC impacts
- Inorganics impacts
