REPORT

Monitoring and Maintenance Plan
Williams Mesena Landfill Site
HSI #10021
1634 Mesena Road, Thomson,
McDuffie County, Georgia

Figure 1	Final Landfill Topography Map (prepared by AECS)
Figure 2	Site Layout Map (prepared by AECS)
Figure 3	Final Landfill Extent, Combined Landfill Extent., December 2020 (prepared by AECS)
Figure 4	Monitoring Well Locations (prepared by AECS)

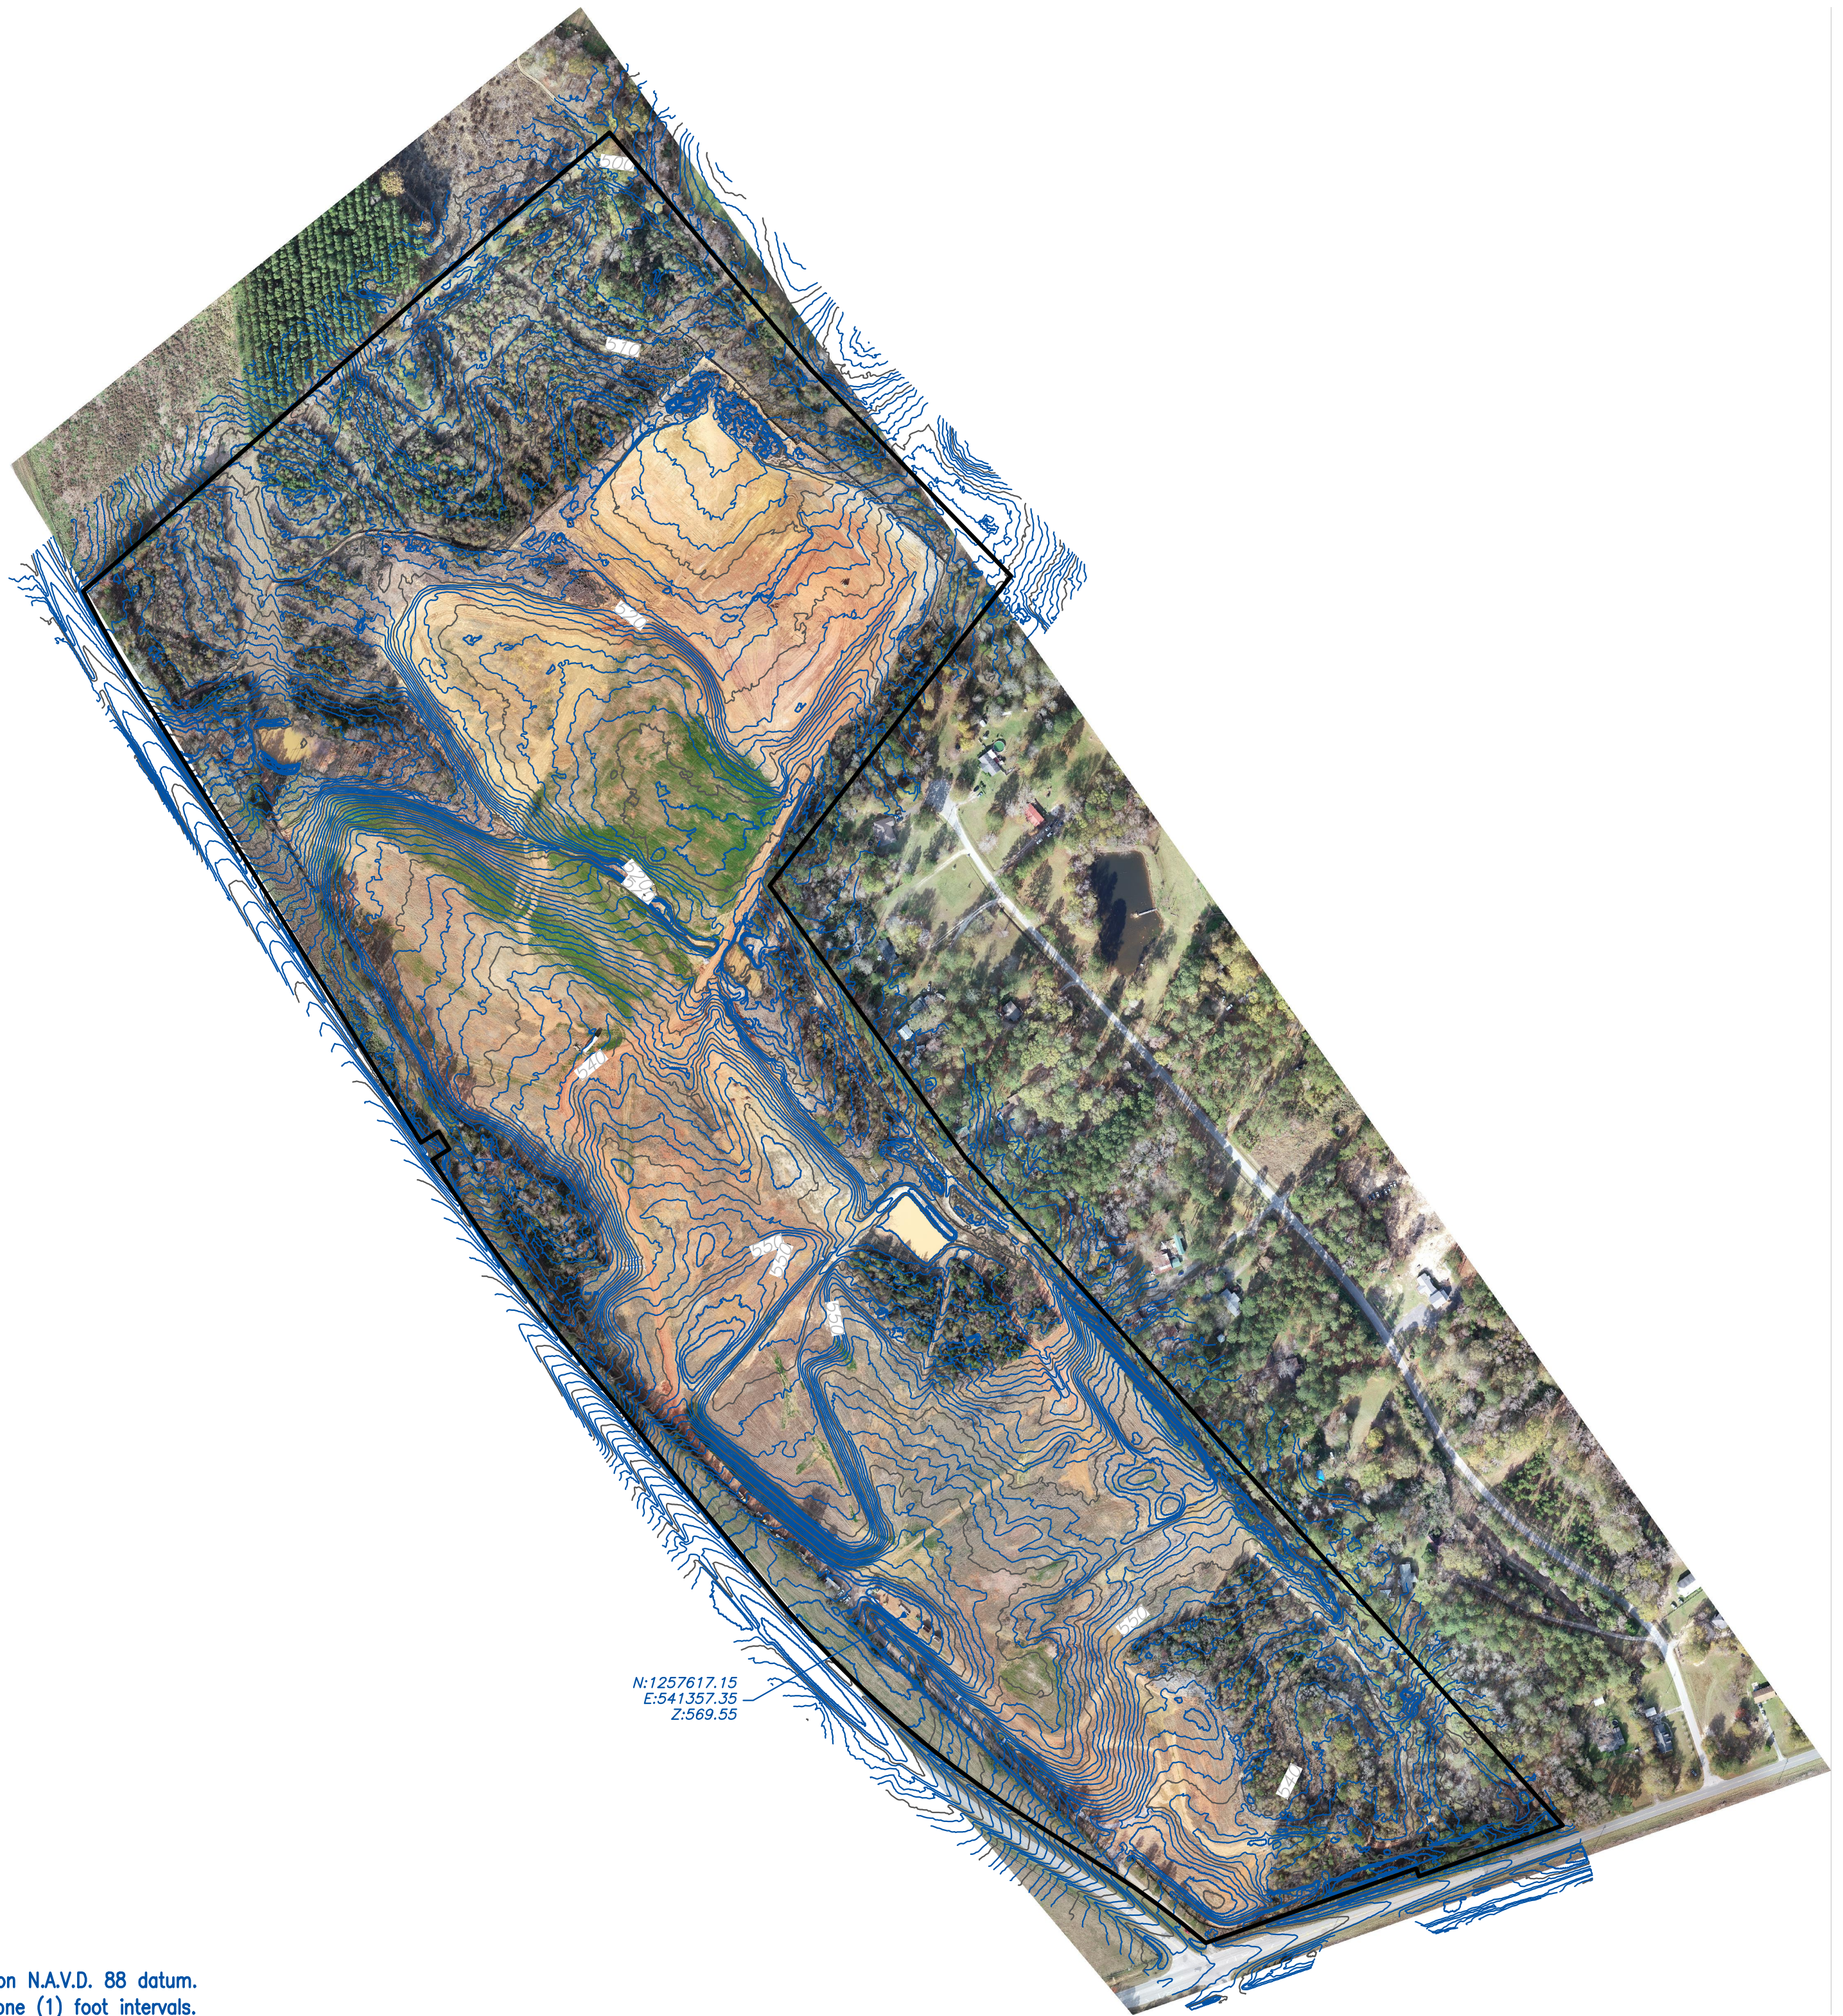
AERIAL LIDAR TOPOGRAPHY

1. Elevations are based on N.A.V.D. 88 datum.
2. Contour lines are at one (1) foot intervals.
3. Equipment used; LiDARUSA Reigl VUX, DJI Matrice 600, Leica CS20 data collector and Leica Viva GS16 receiver.
4. Software used: Microstation PowerDraft CONNECT Edition, TerraSolid Software Suite, Inertial Explorer, ScanLook Point Cloud Creation, Leica Captivate and Carlson Survey 2017.
5. Property lines shown on survey are approximate and only shown for reference.

The 122-acre Site is located at 1634 Mesena Road in Thomson, McDuffie County, Georgia. Topographic and site features maps are provided as Figure 1 and Figure 2, respectively. The geographic coordinates at the approximate center of the Site are 33.4609 degrees North latitude and -82.5444 degrees West longitude, [United States Geologic Survey (USGS) Topographic Quadrangle, Thomson West, Georgia]. The Site is bordered by residential properties to the east, forest and pasture to the north, a private farm to the west, and Mesena Road to the south.

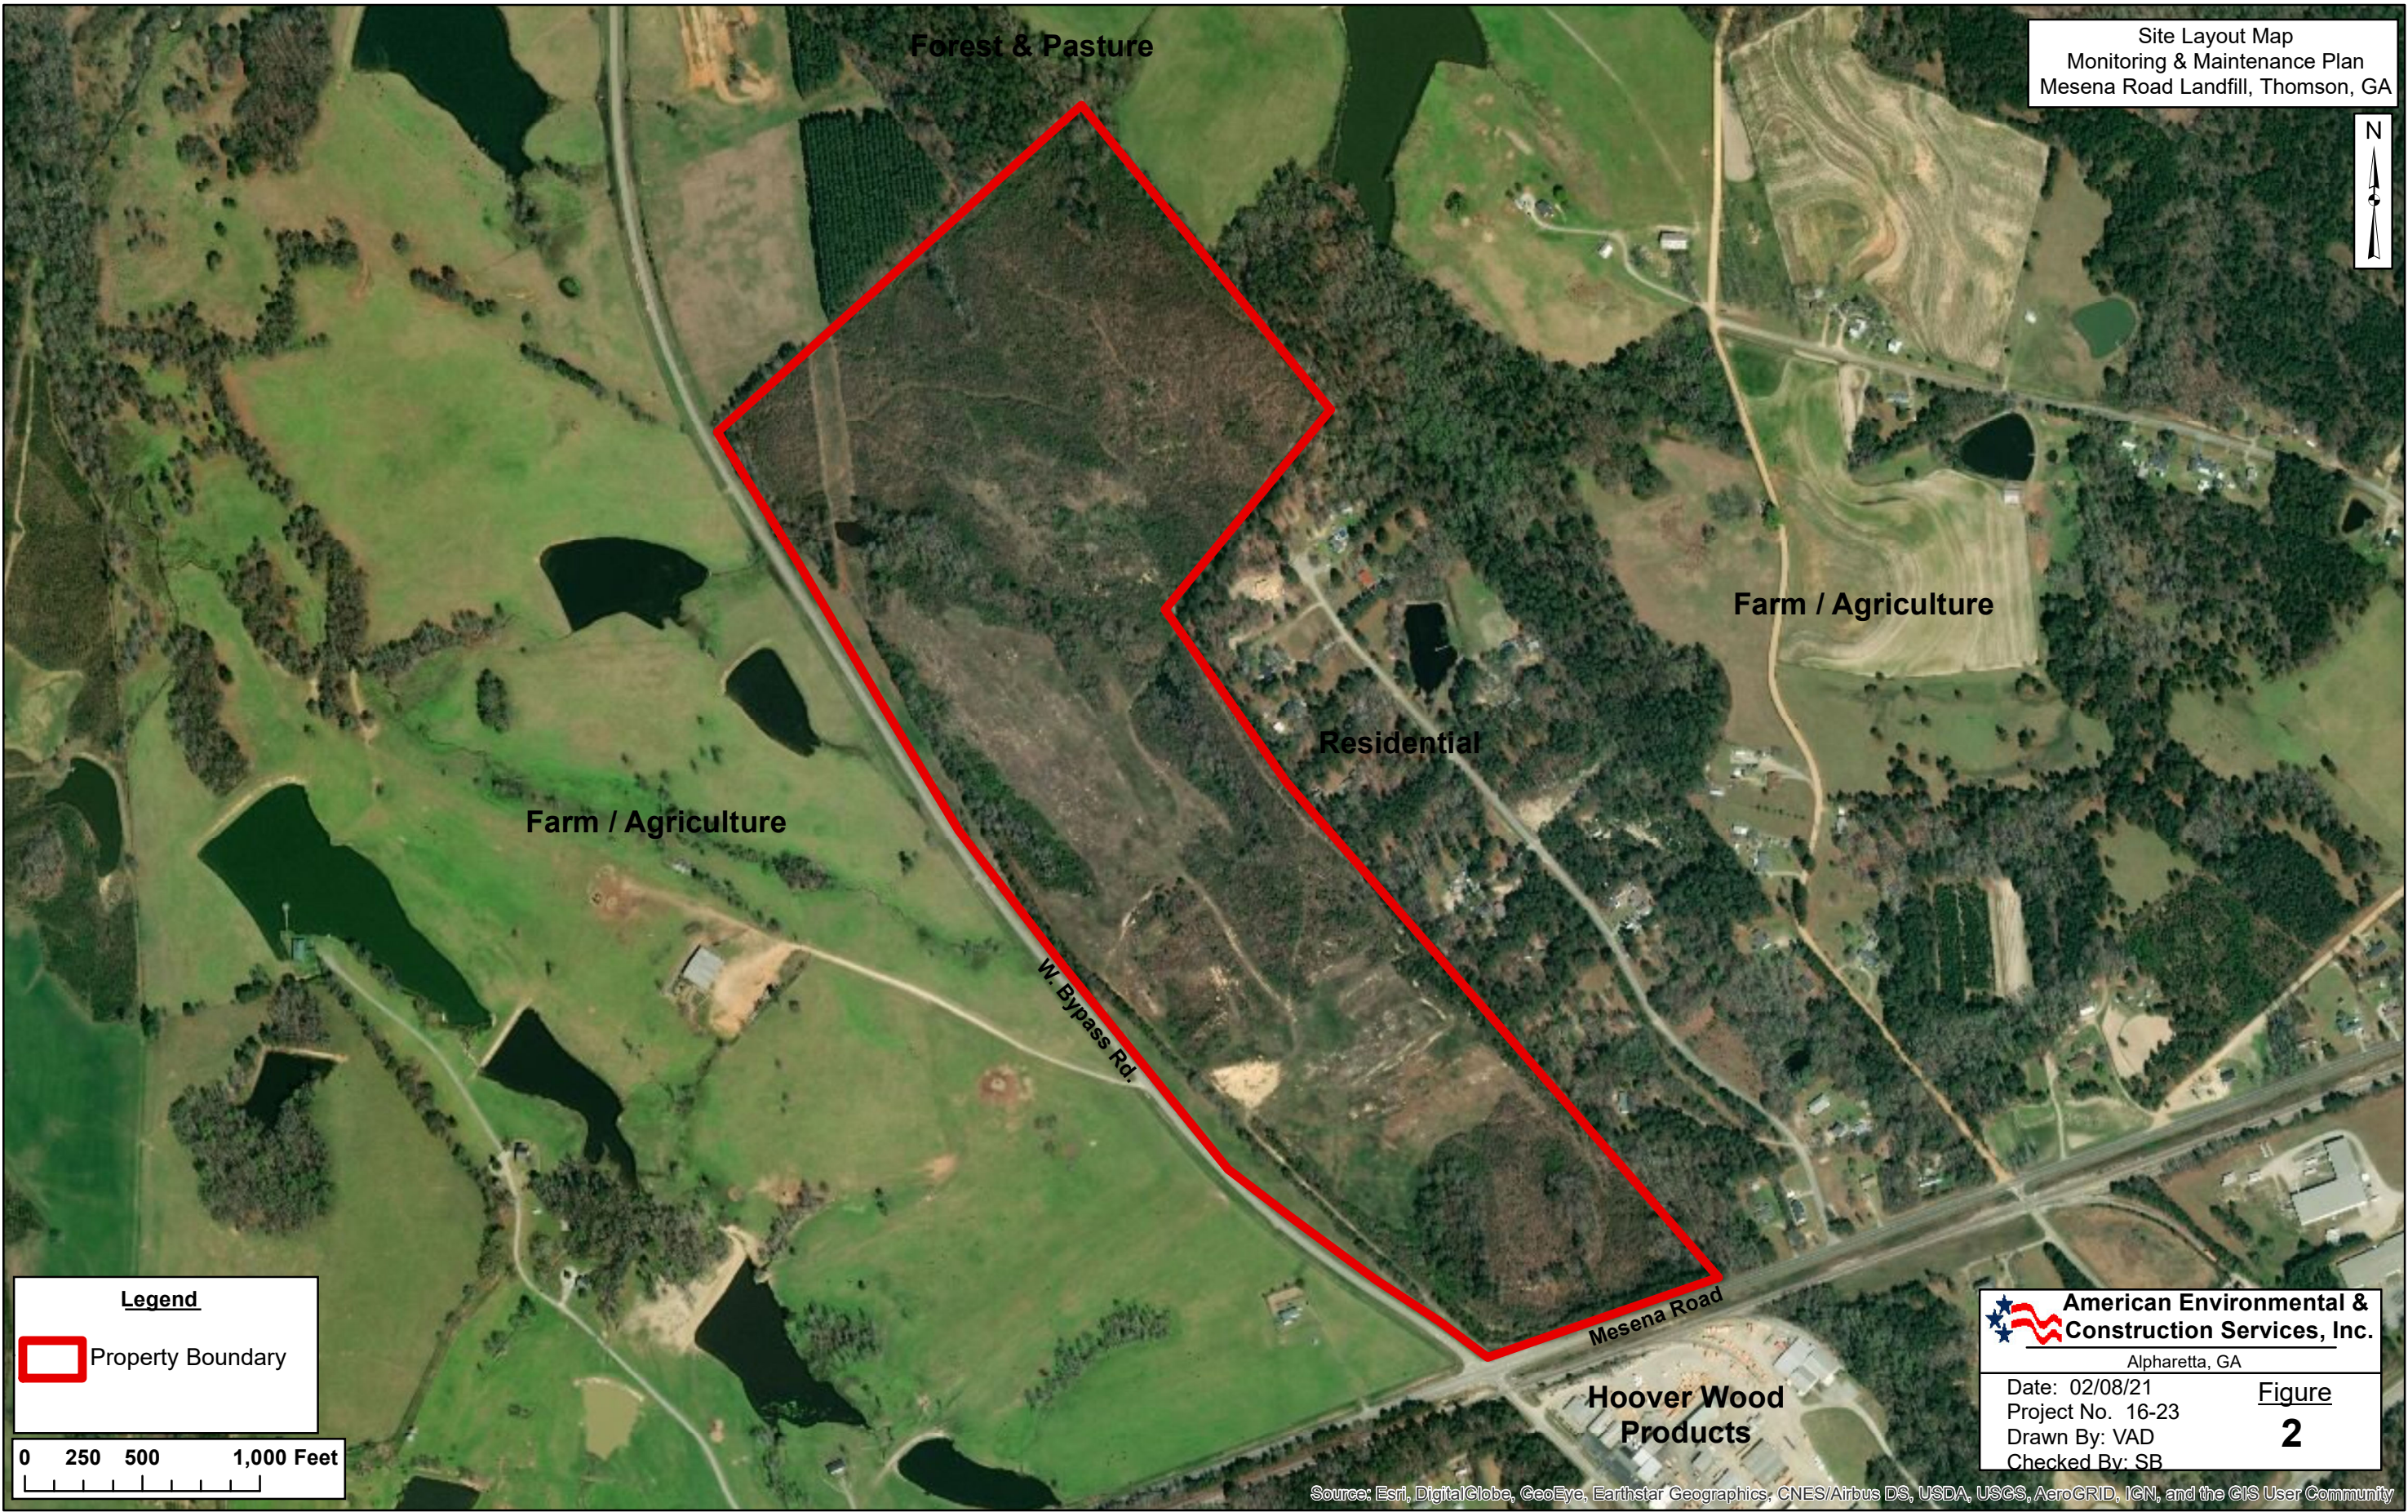
Date: 02/08/21	Figure
Project No. 16-23	2
Drawn By: VAD	
Checked By: SB

Forest & Pasture

Farm / Agriculture

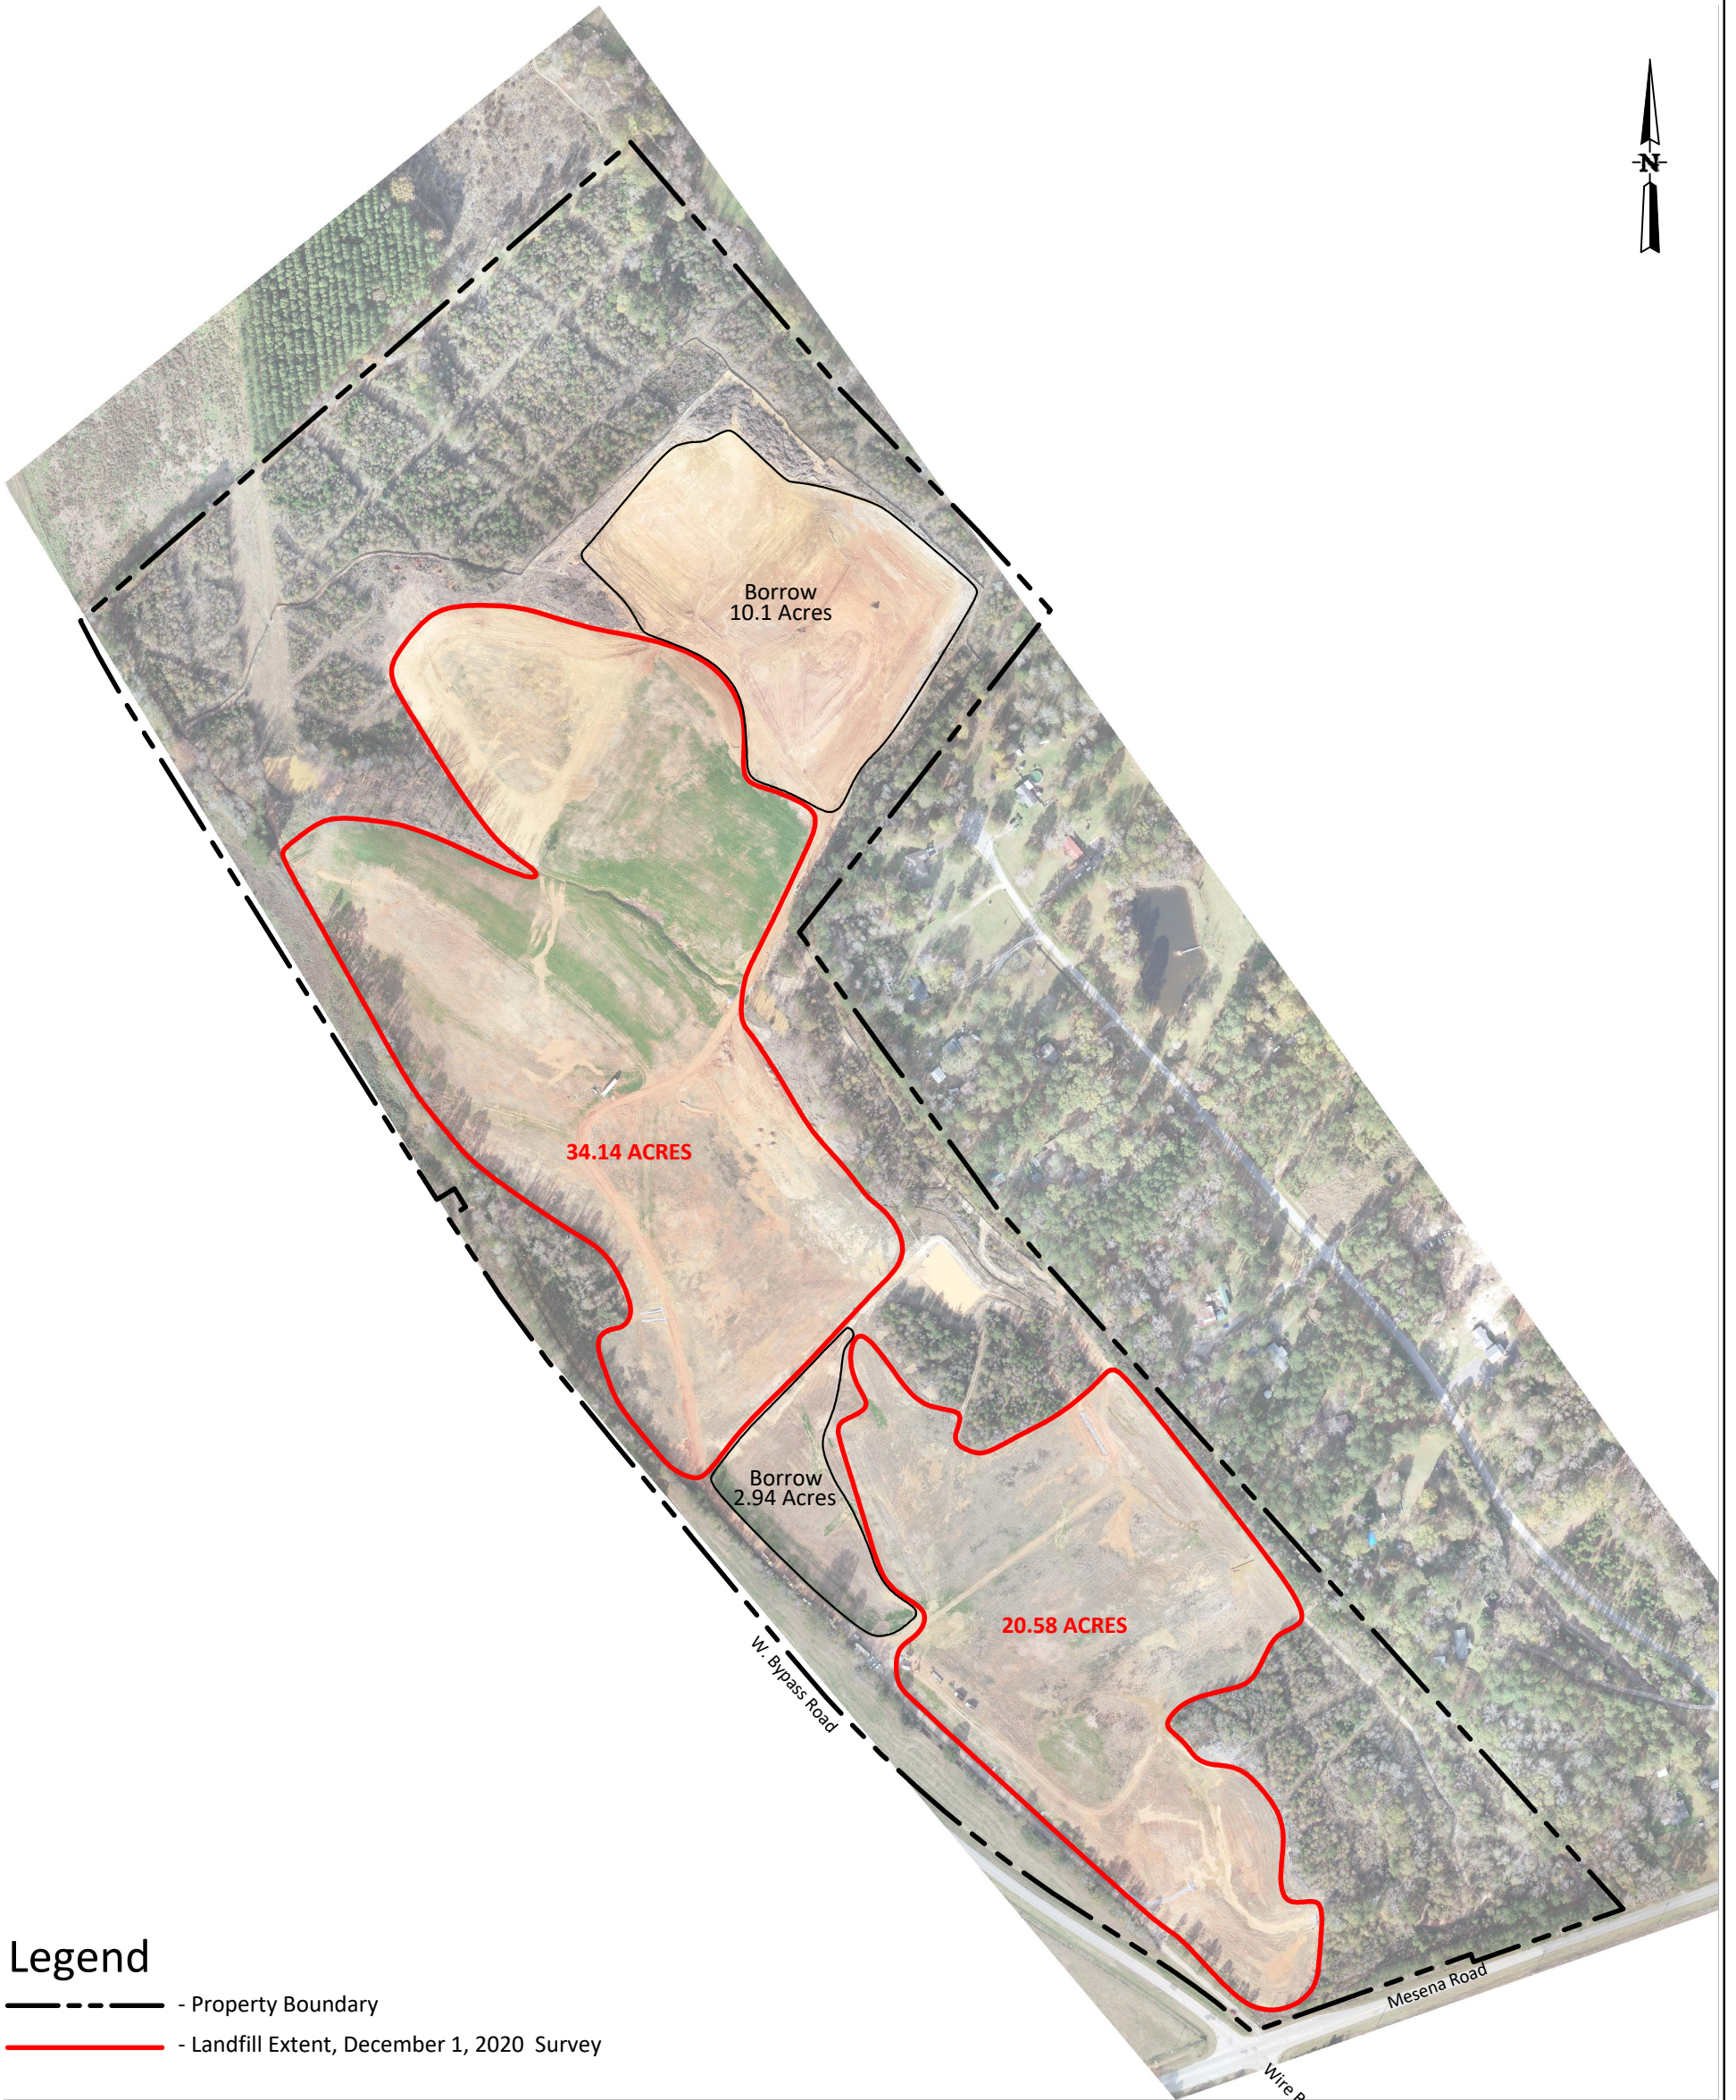
- Property Boundary
- Landfill Extent, December 1, 2020 Survey

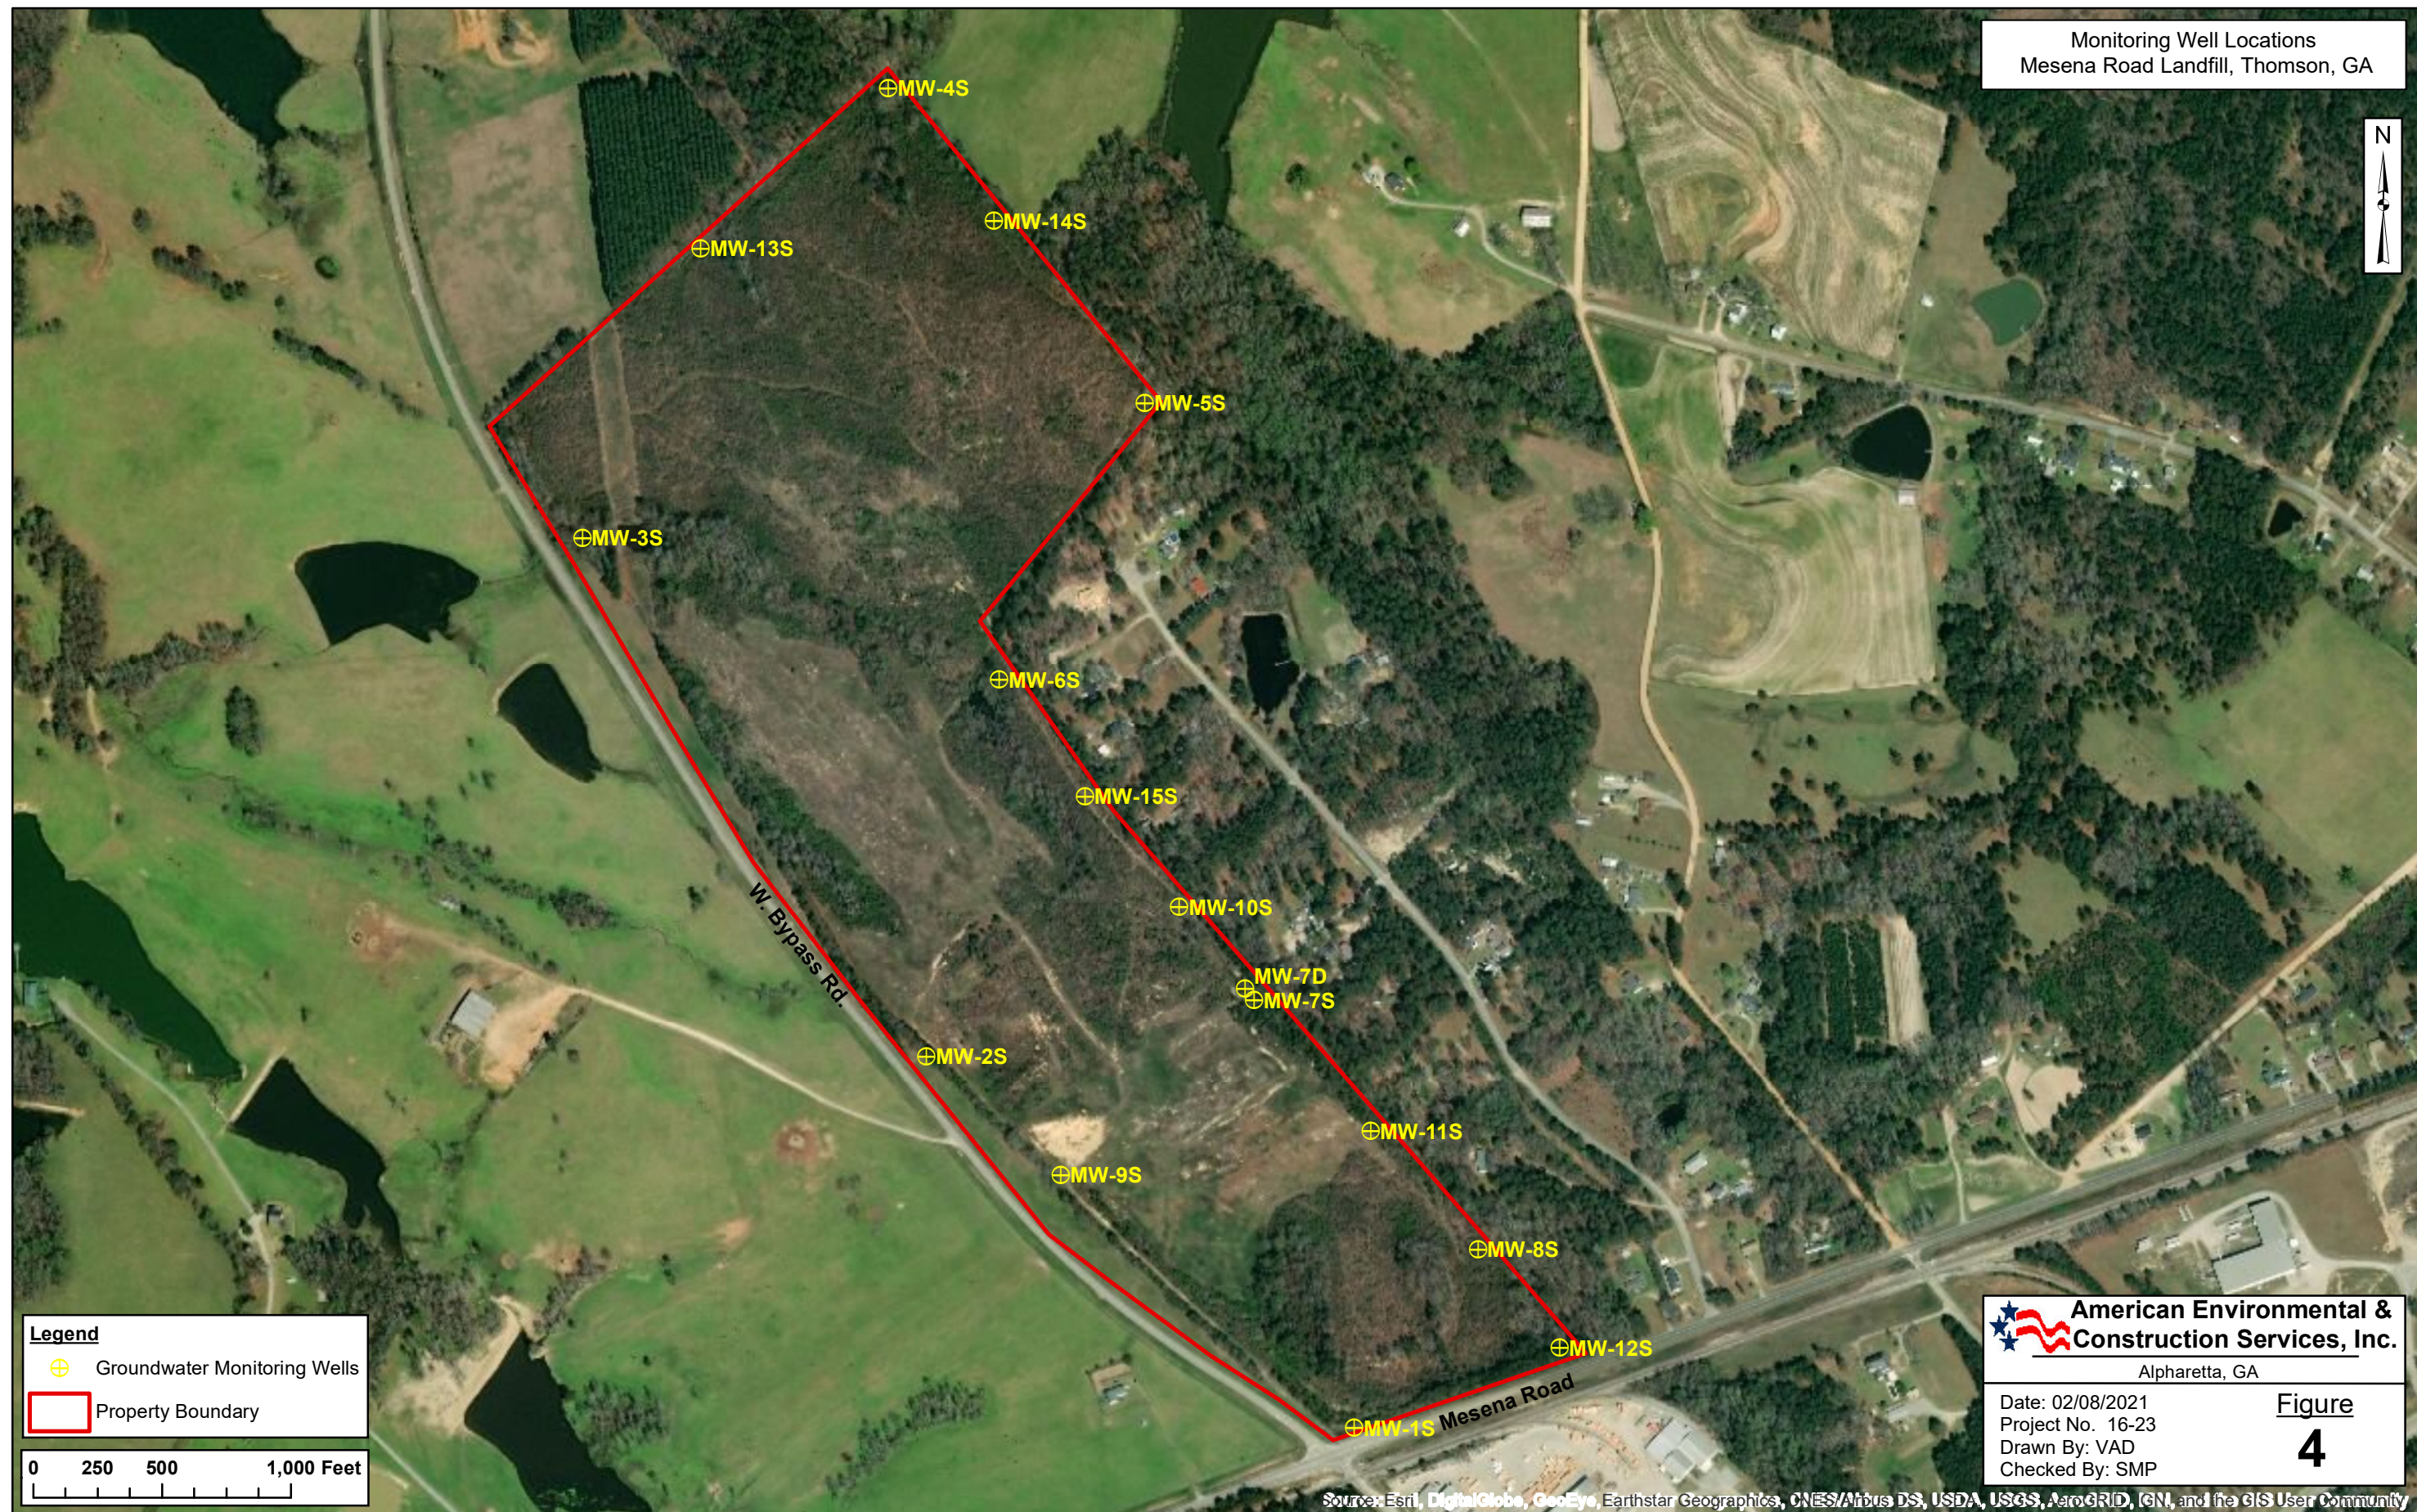
Monitoring Well Locations
Mesena Road Landfill, Thomson, GA

Legend
⊕ Groundwater Monitoring Wells
▭ Property Boundary
