REPORT

Monitoring and Maintenance Plan
Williams Mesena Landfill Site
HSI #10021
1634 Mesena Road, Thomson,
McDuffie County, Georgia

Figure 1	Final Landfill Topography Map (prepared by AECS)
Figure 2	Site Layout Map (prepared by AECS)
Figure 3	Final Landfill Extent, Combined Landfill Extent., December 2020 (prepared by AECS)
Figure 4	Monitoring Well Locations (prepared by AECS)

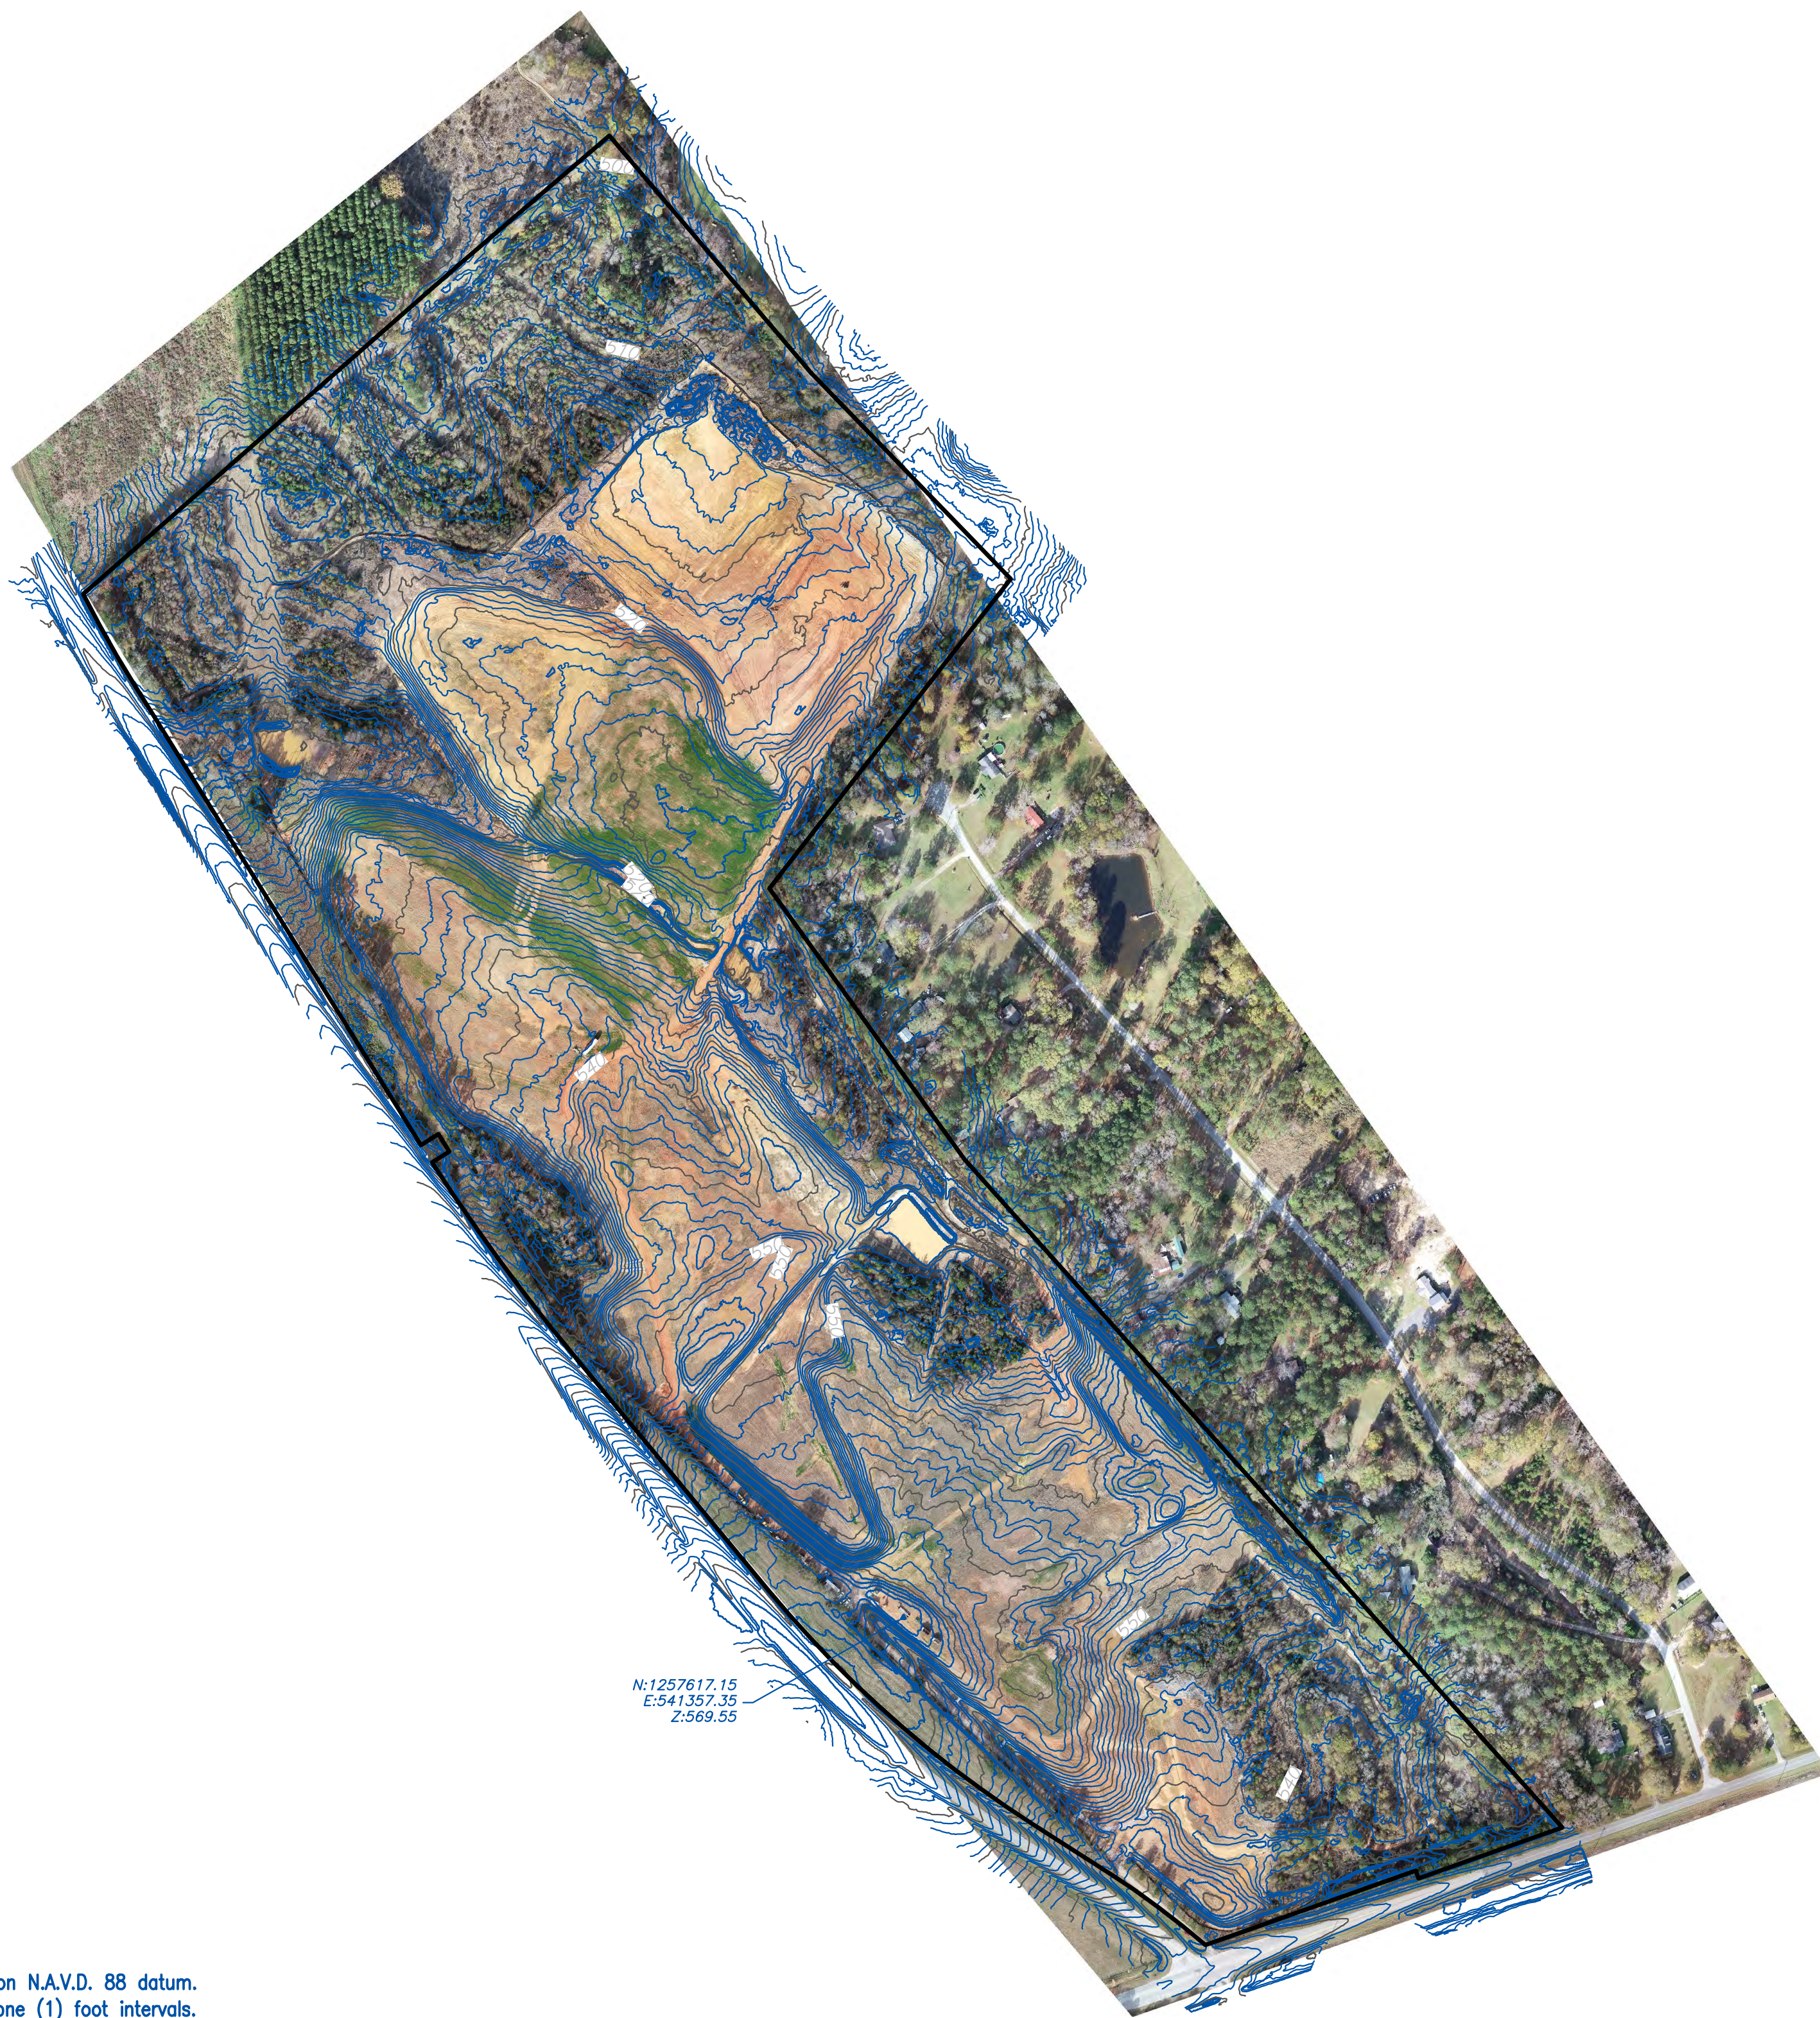
AERIAL LIDAR TOPOGRAPHY

1. Elevations are based on N.A.V.D. 88 datum.
2. Contour lines are at one (1) foot intervals.
3. Equipment used; LiDARUSA Reigl VUX, DJI Matrice 600, Leica CS20 data collector and Leica Viva GS16 receiver.
4. Software used: Microstation PowerDraft CONNECT Edition, TerraSolid Software Suite, Inertial Explorer, ScanLook Point Cloud Creation, Leica Captivate and Carlson Survey 2017.
5. Property lines shown on survey are approximate and only shown for reference.

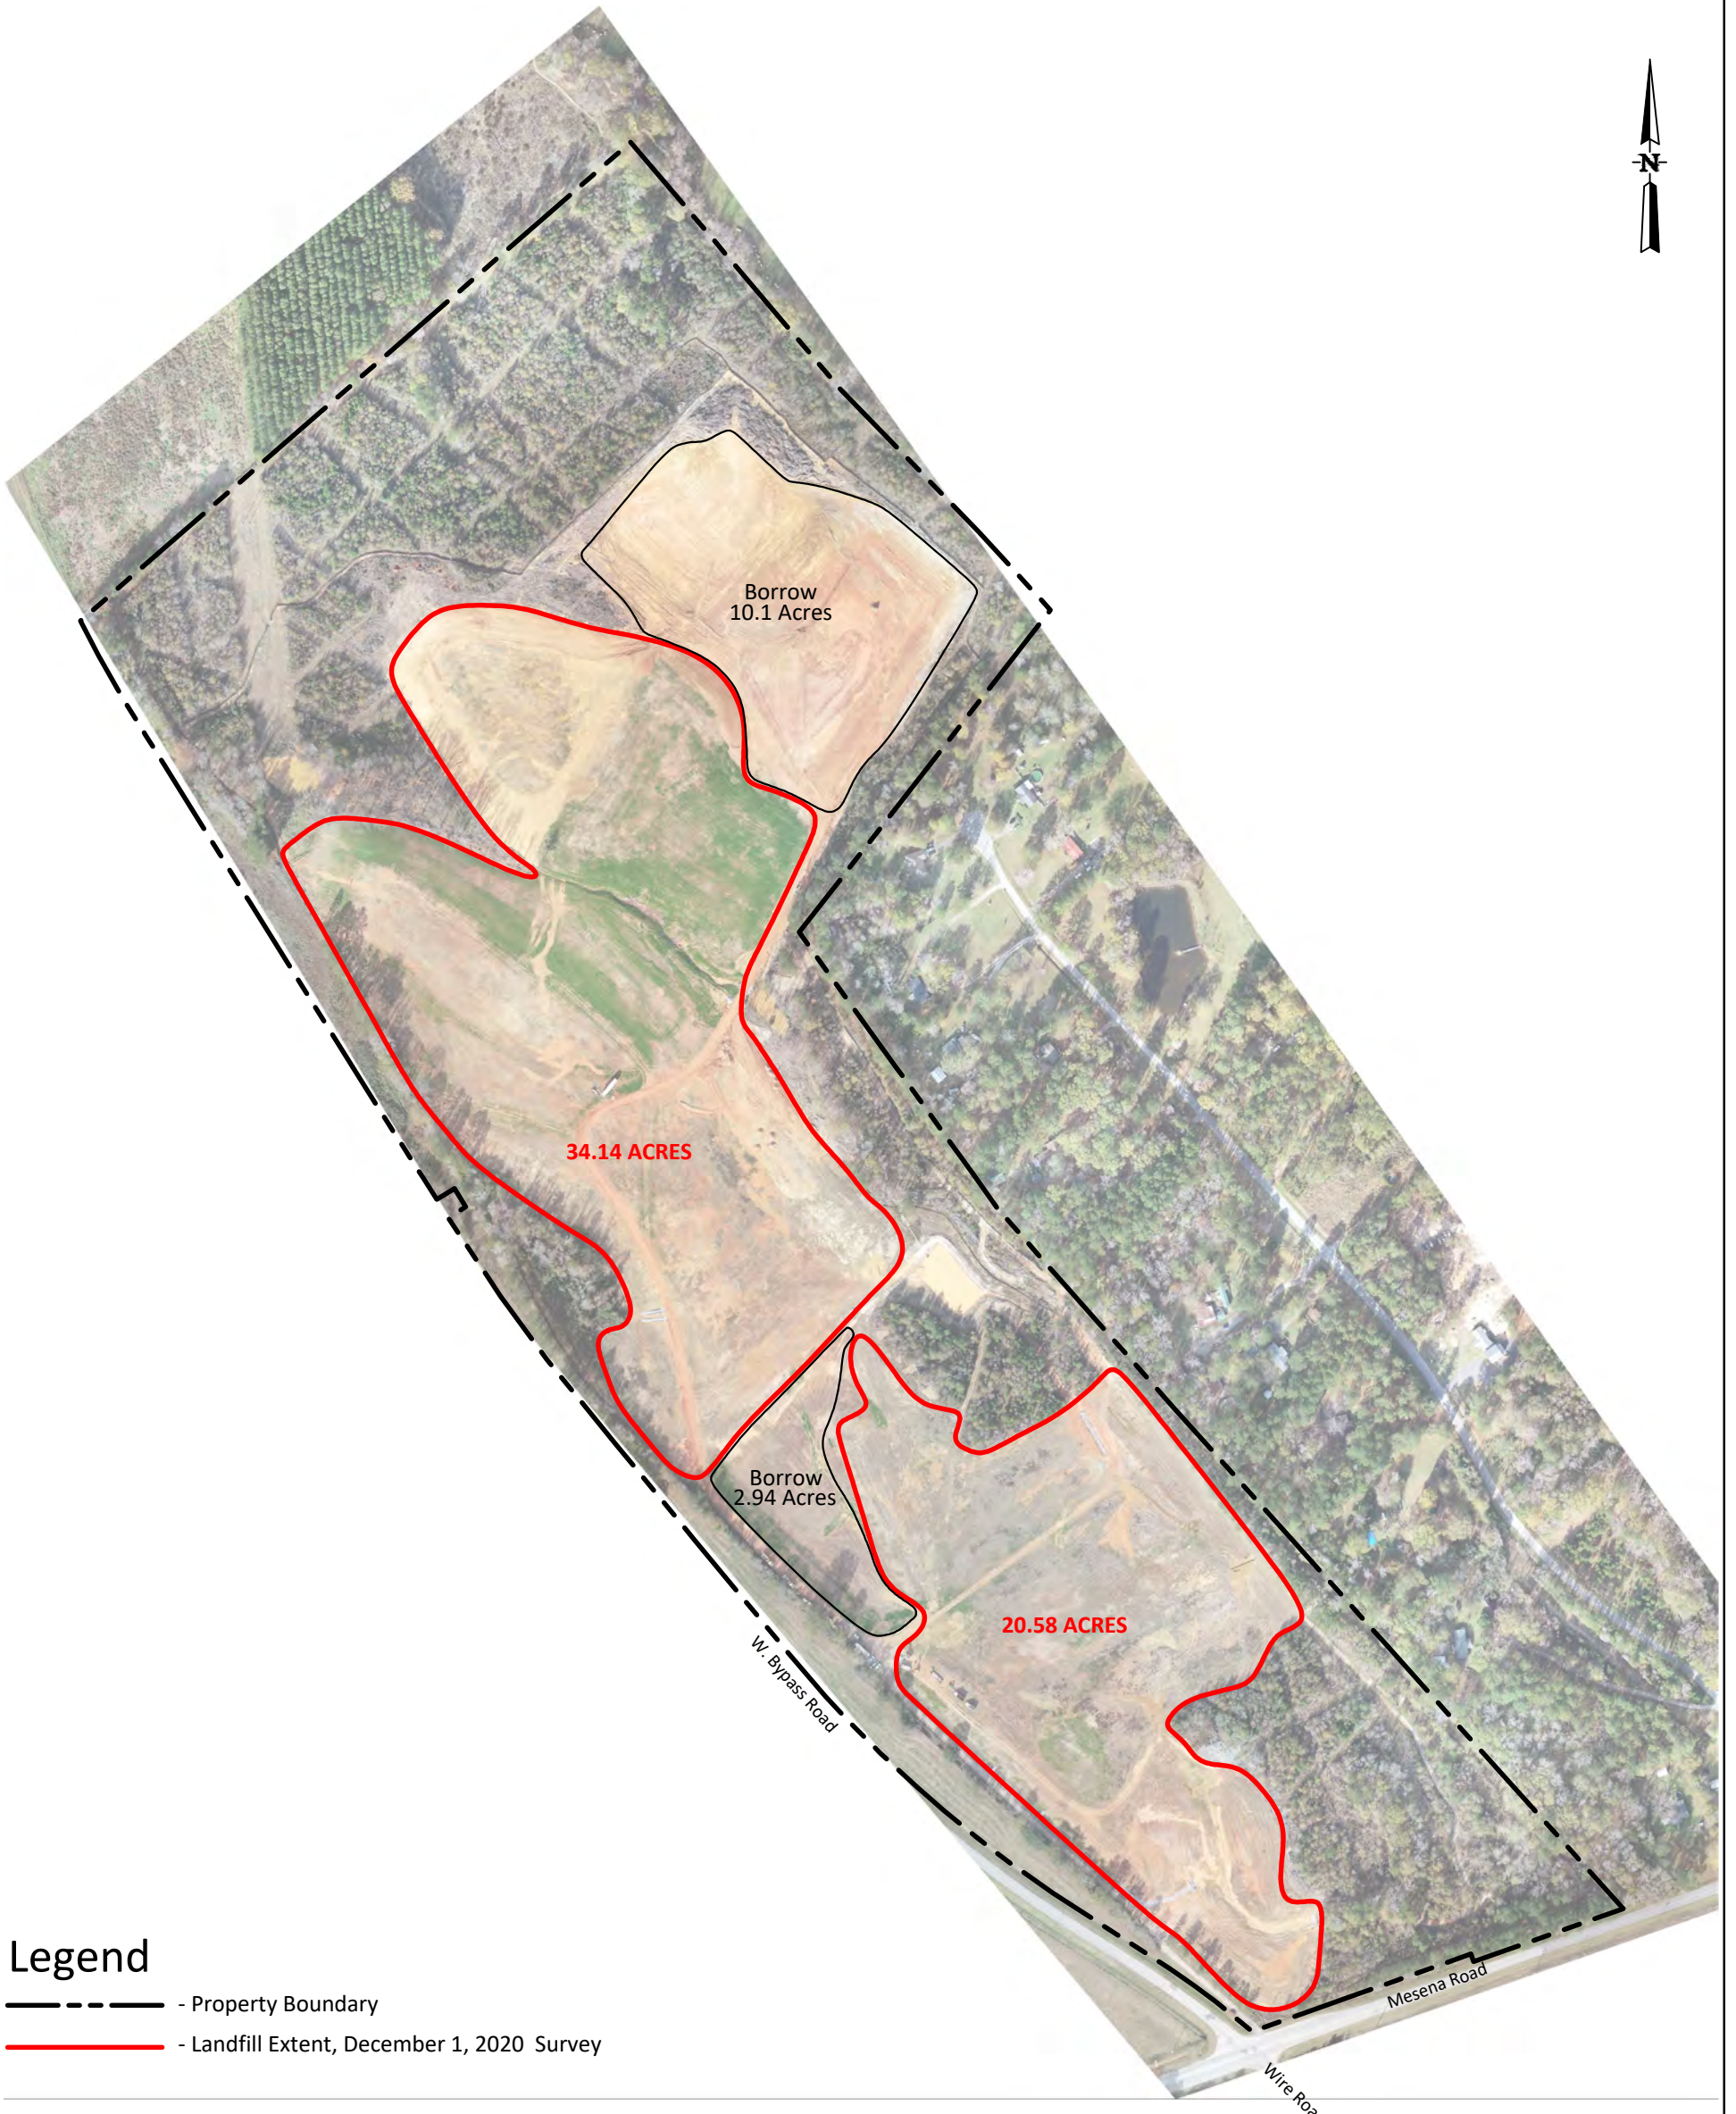
- Property Boundary
- Landfill Extent, December 1, 2020 Survey

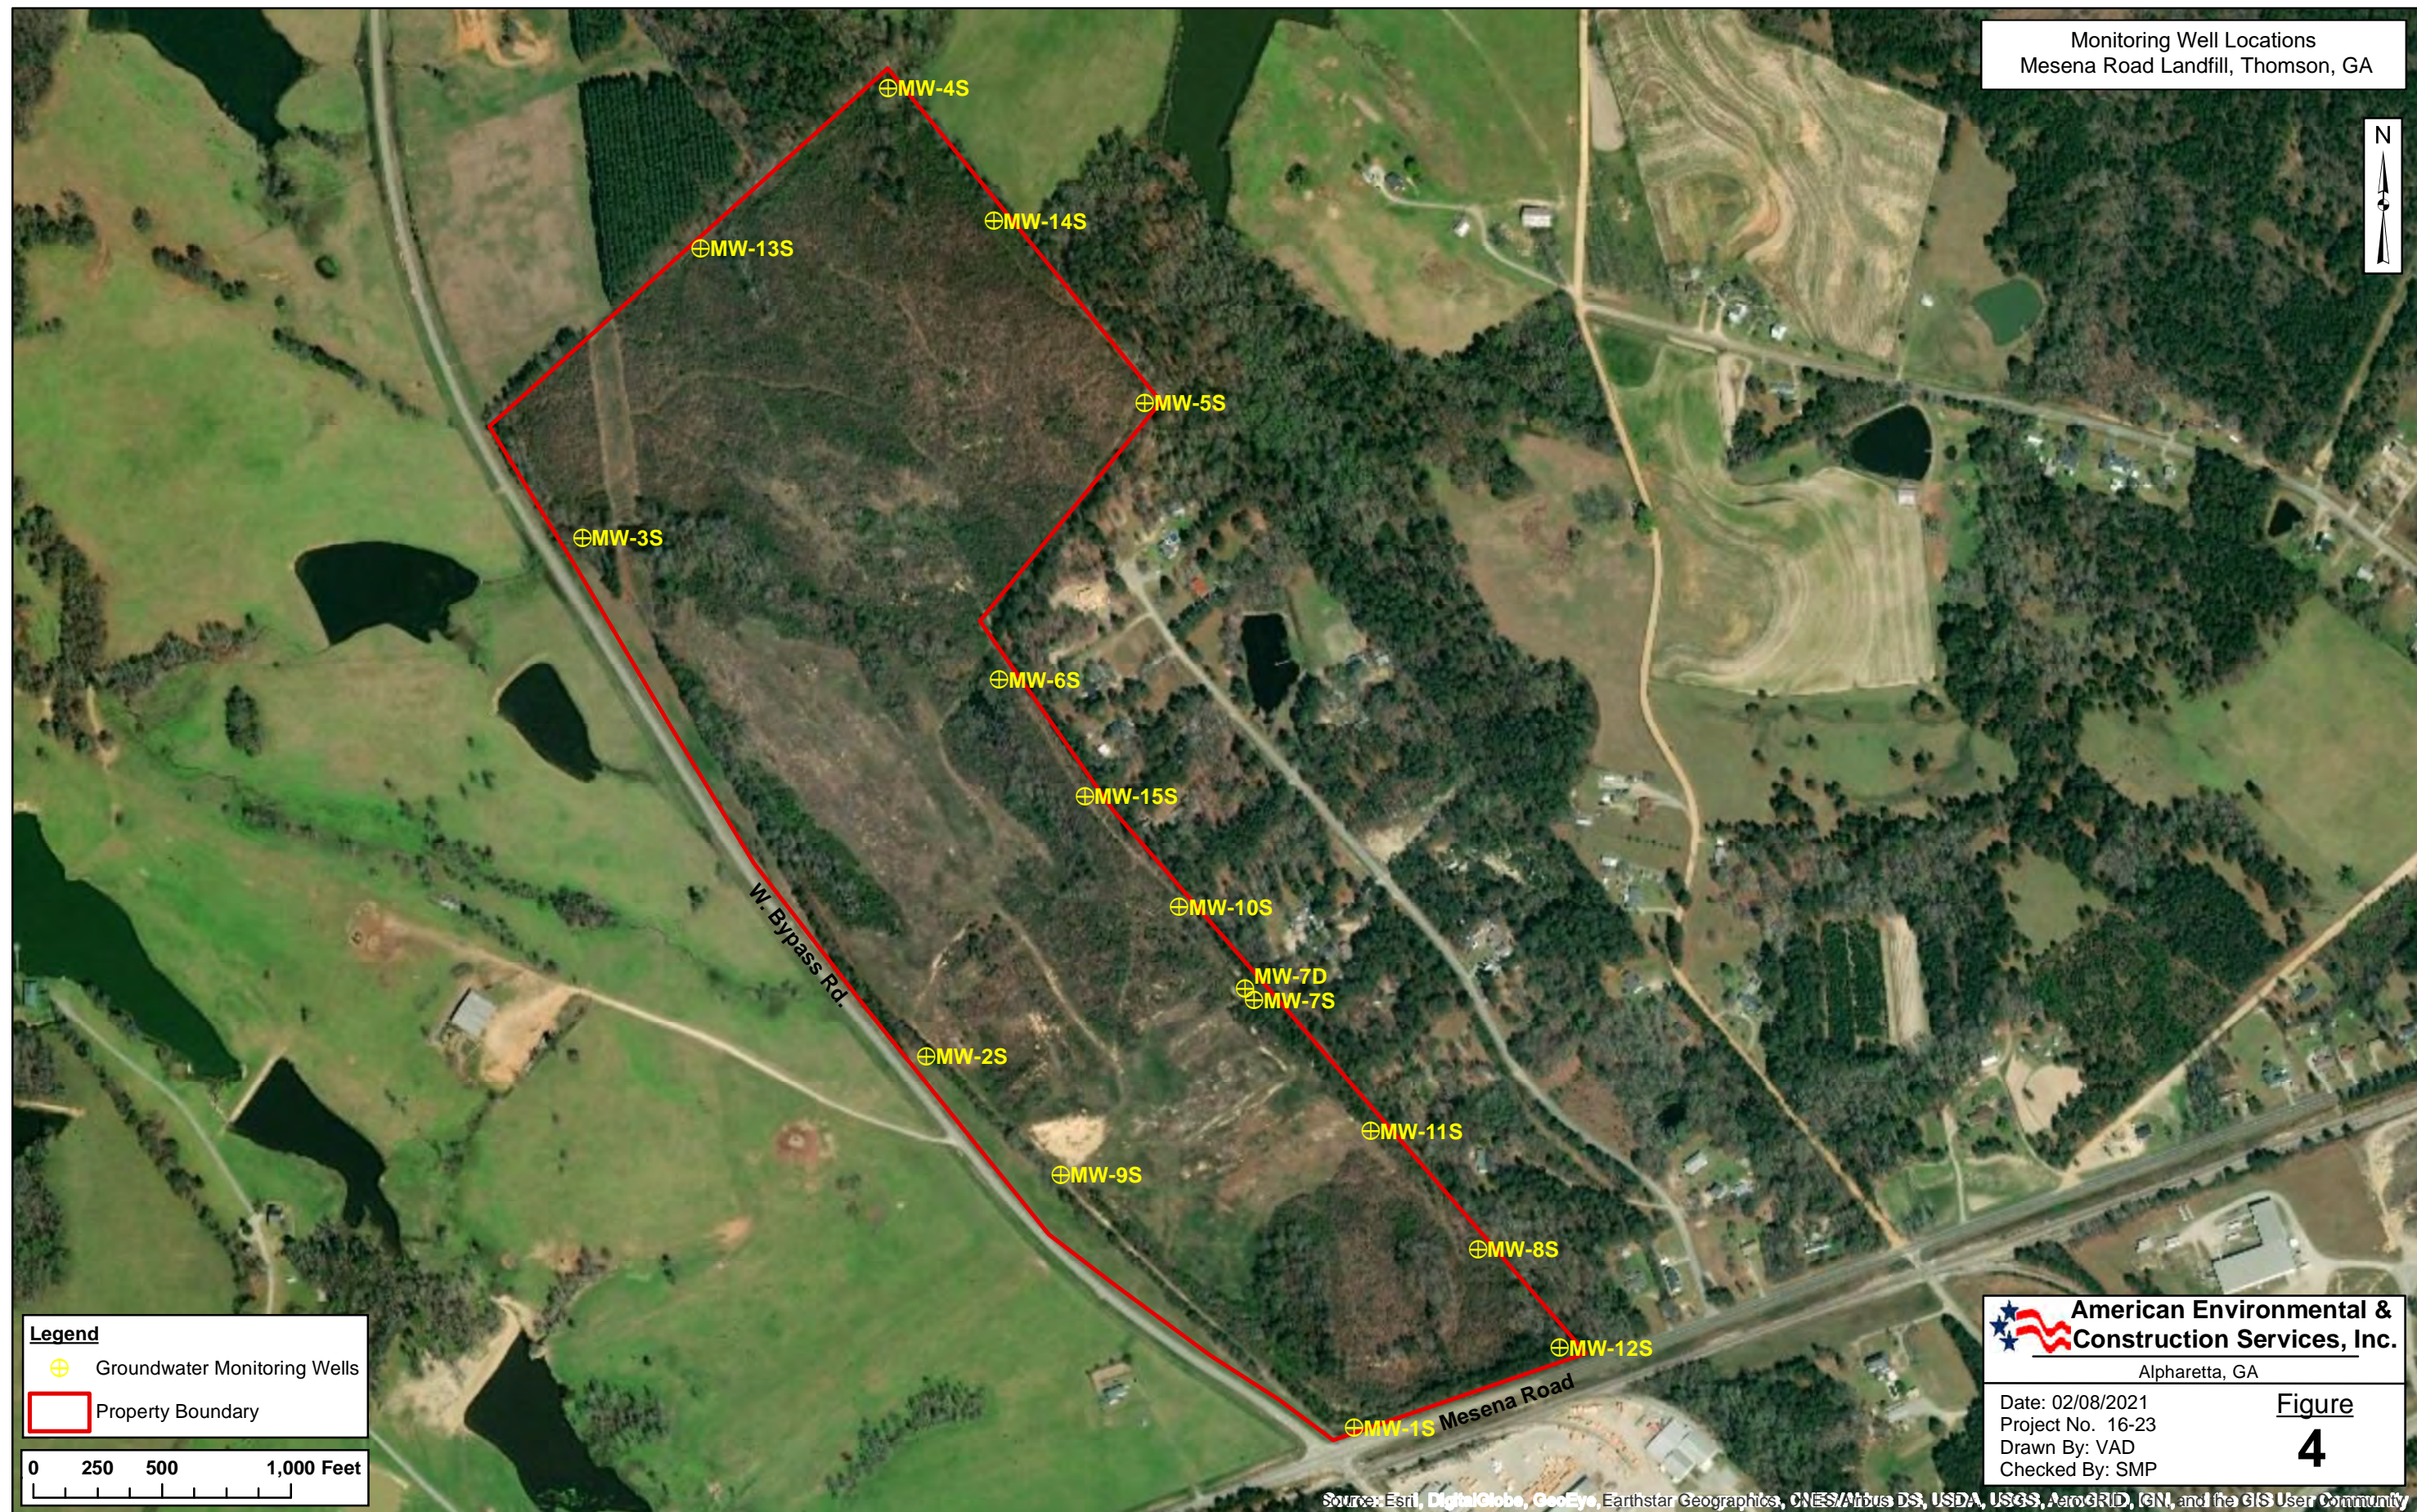
Monitoring Well Locations
Mesena Road Landfill, Thomson, GA

Legend
⊕ Groundwater Monitoring Wells
▭ Property Boundary
