**SOIL COVER, MONITORING, AND MAINTENANCE PLAN  
General Tire aka Continental Tire the Americas - Aldora Plant  
160 Aldora Street, Barnesville, Lamar County, Georgia**

**HAZARDOUS SITE INVENTORY SITE #10057**

**July 6, 2020; Revised June 12, 2023**

**ECS SOUTHEAST, LLP  
1281 Kennestone Circle NE  
Suite 200  
Marietta, GA 30066**

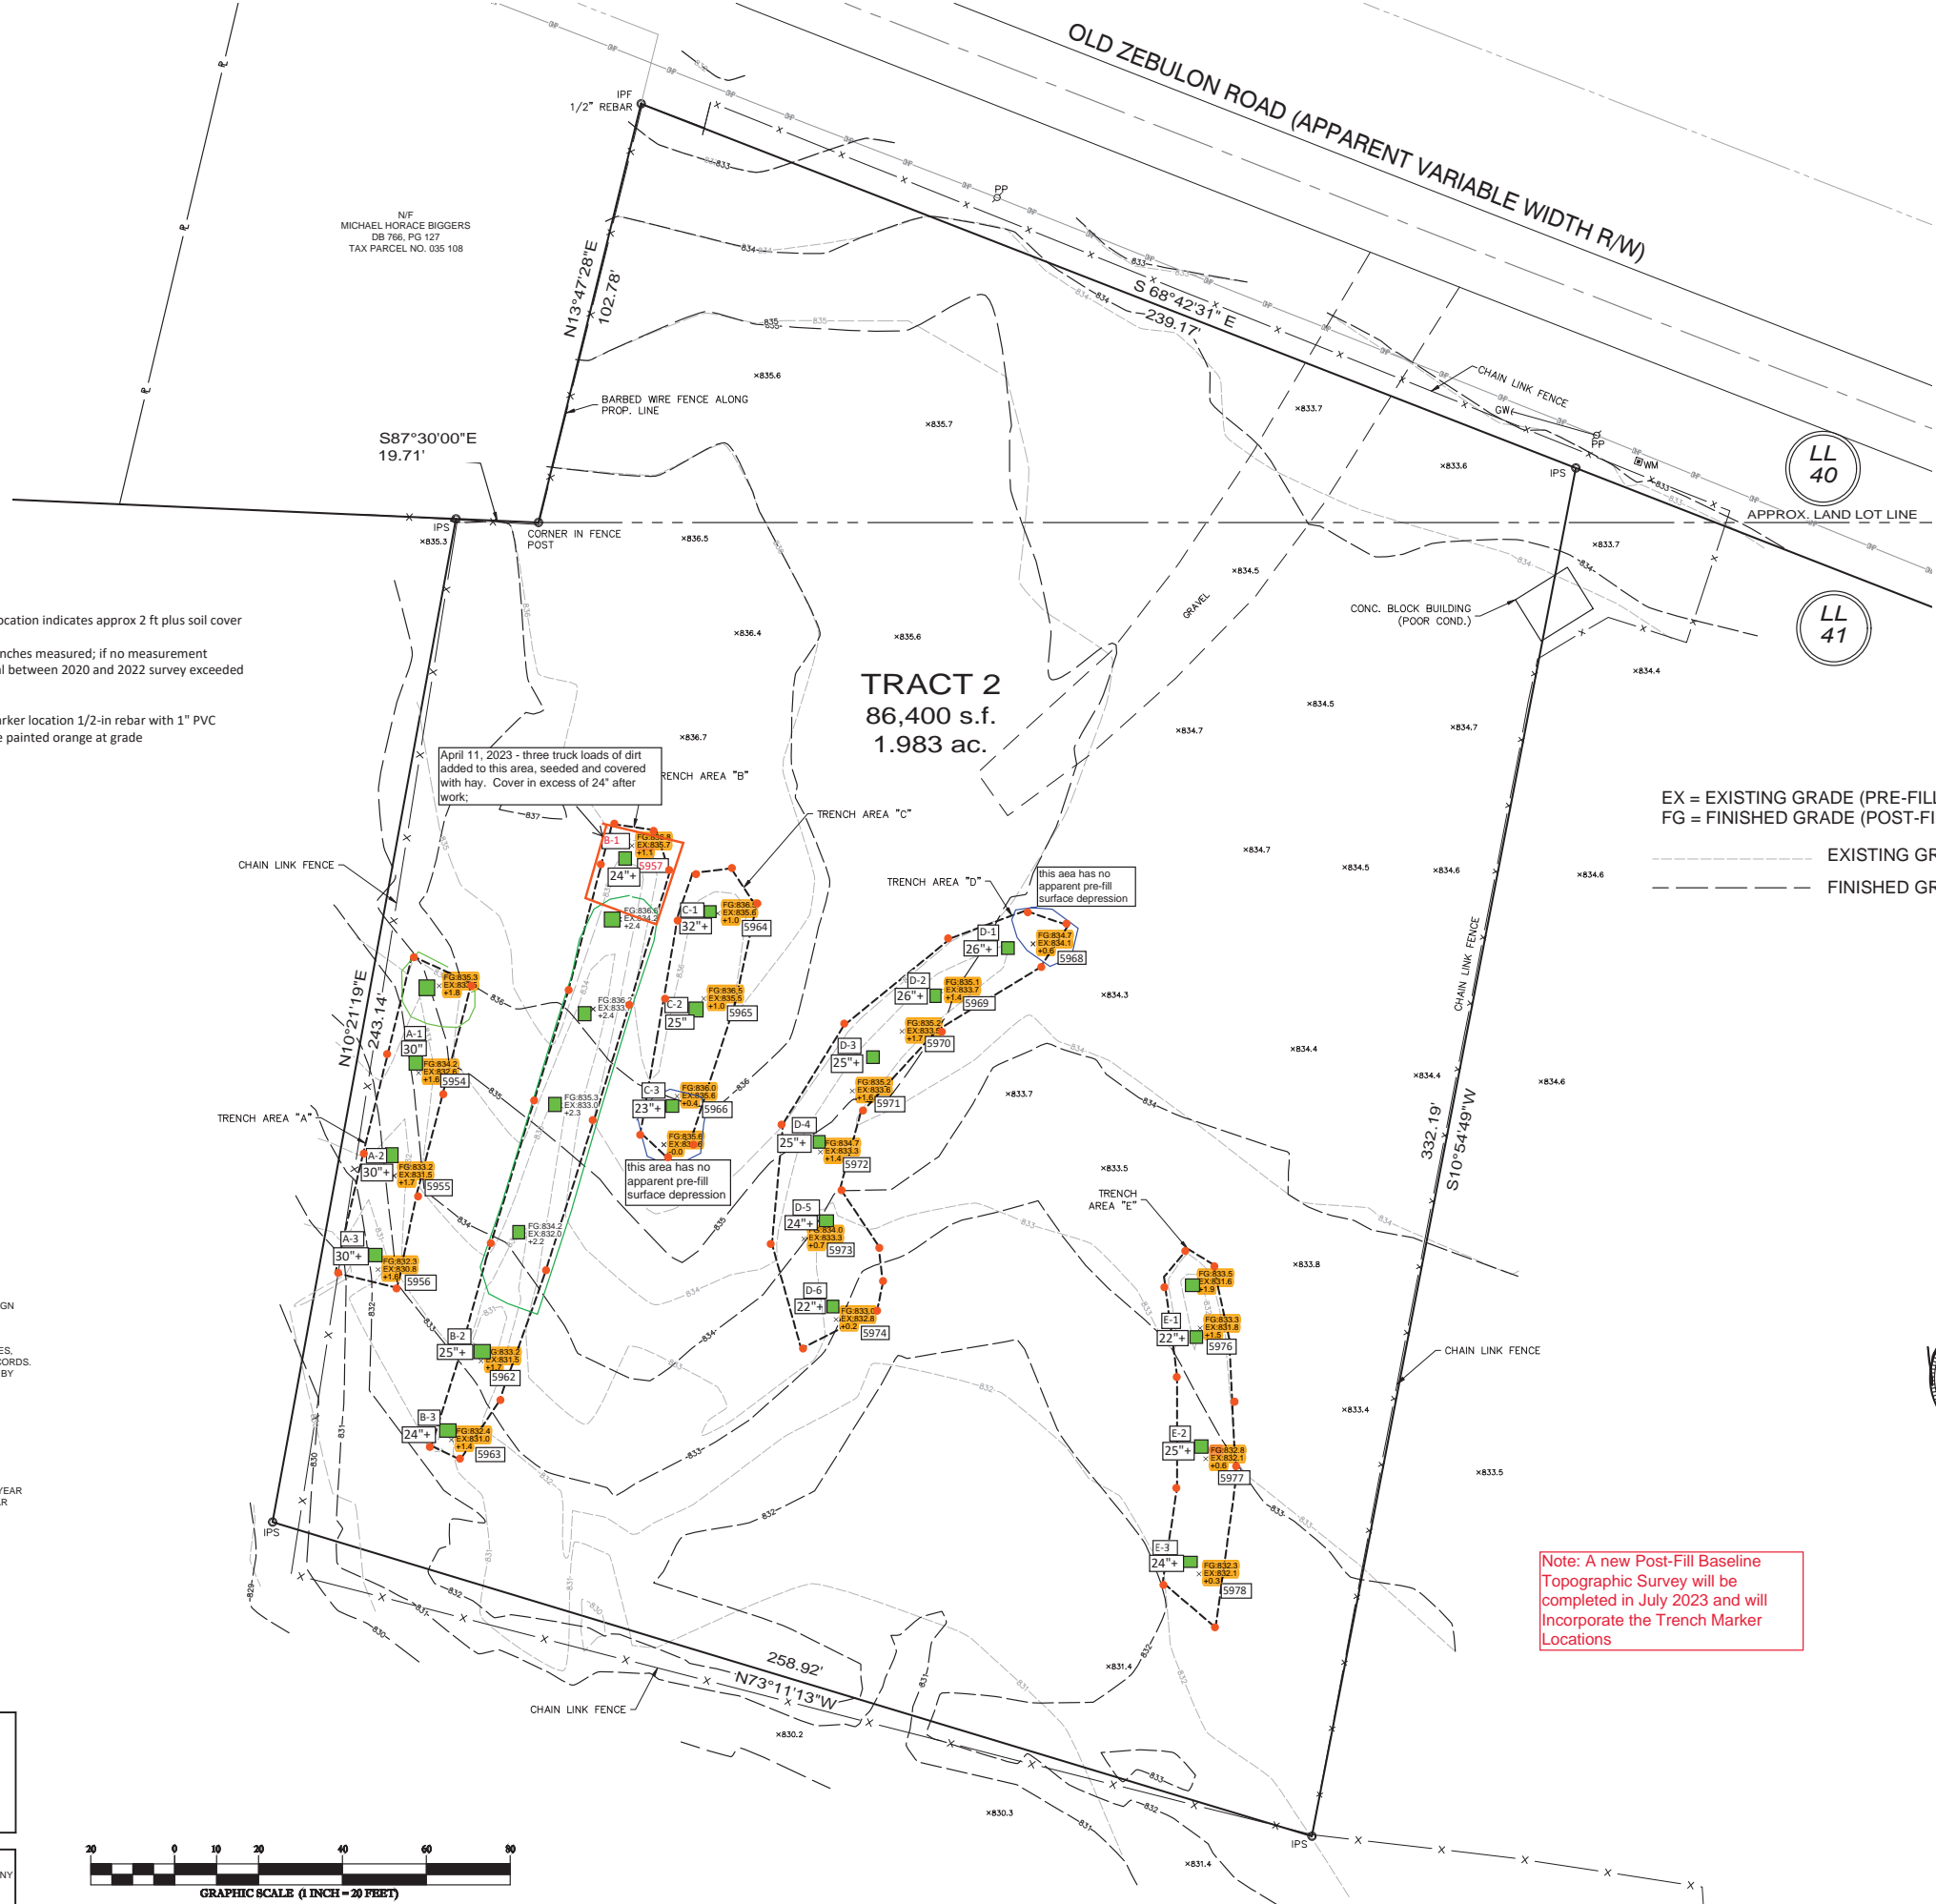
EX = EXISTING GRADE (PRE-FILL)  
FG = FINISHED GRADE (POST-FILL)

EXISTING GRADE CONTOUR (PRE-FILL)

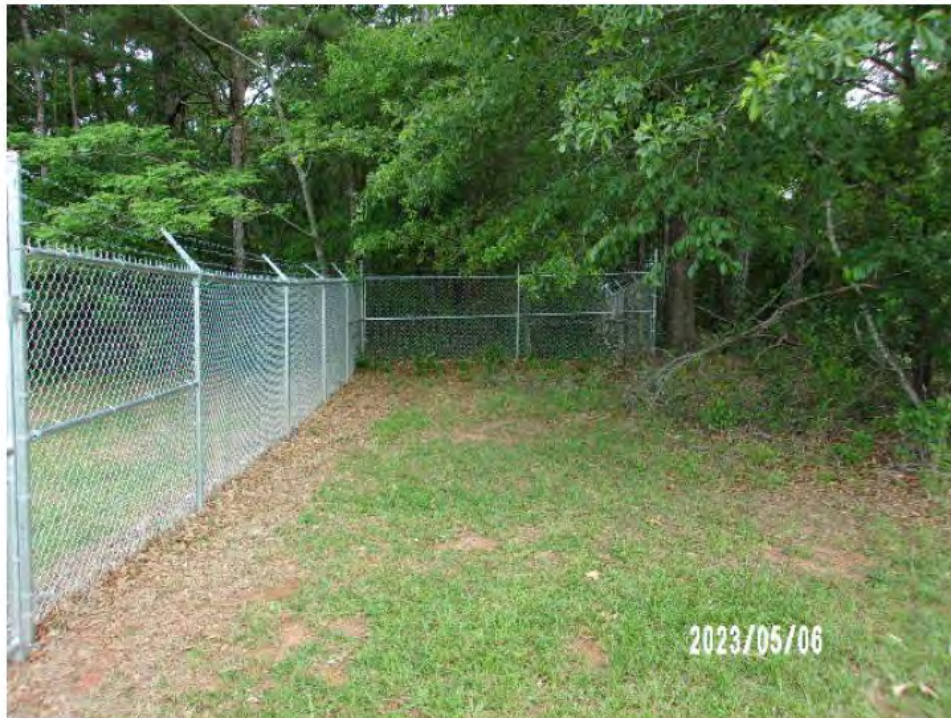
Photo 1 – Additional Fence Added October 2022 Beginning at top of photo – Northwest corner of Tract 2

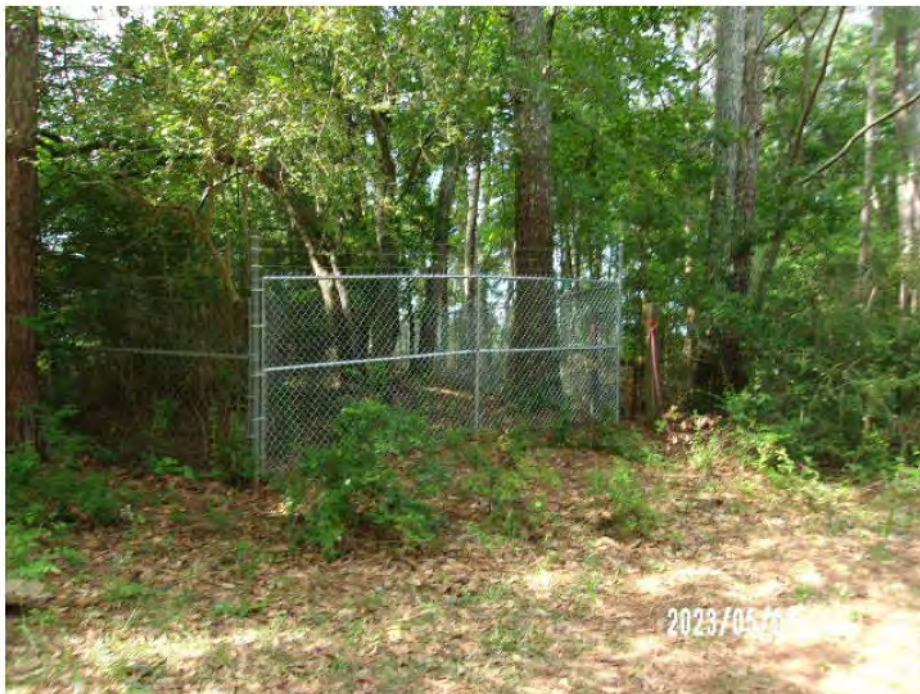
Photo 2 – New Fence Added October 2022 Northwest corner of Tract 2

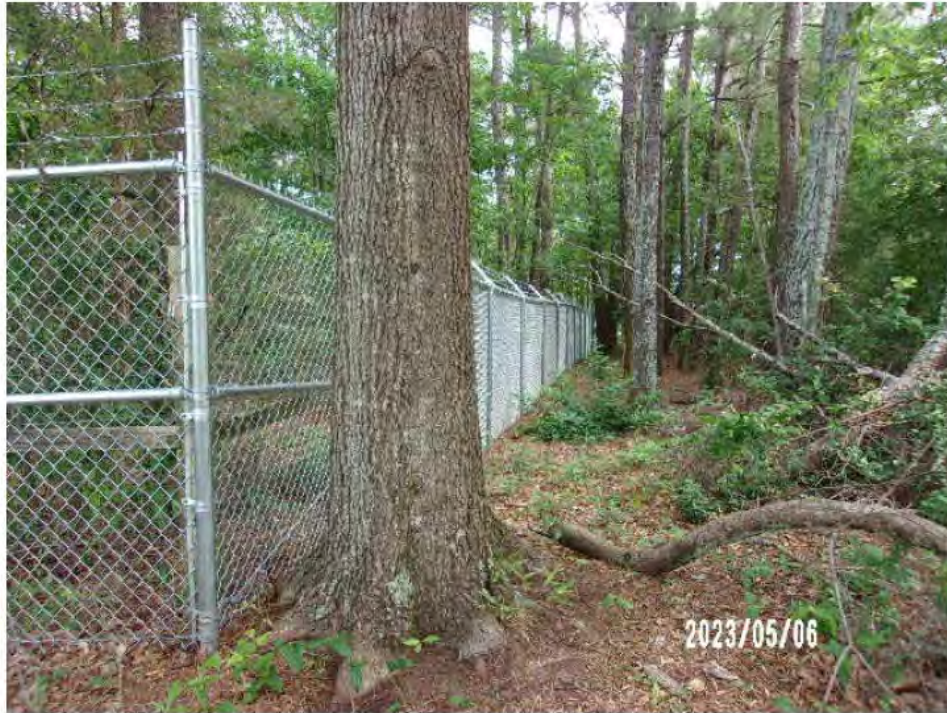
Photo 3 – New Fence Added October 2022 - Northwest Corner of Tract 2 (looking north)

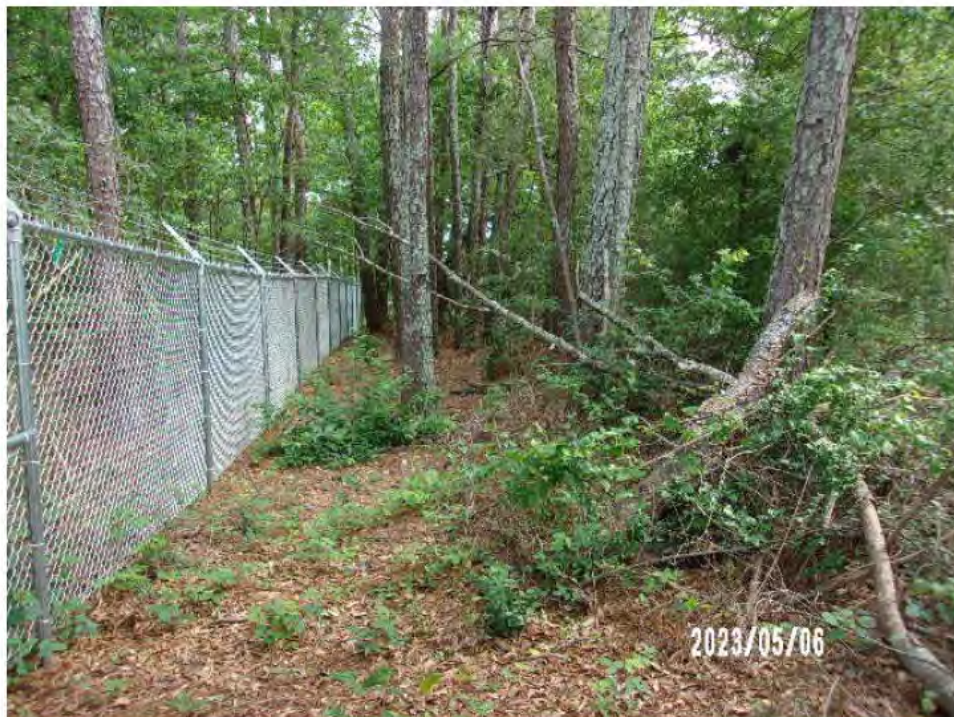
Photo 4 – New Fence Added October 2022 - Northwest Corner of Tract 2 (looking north)

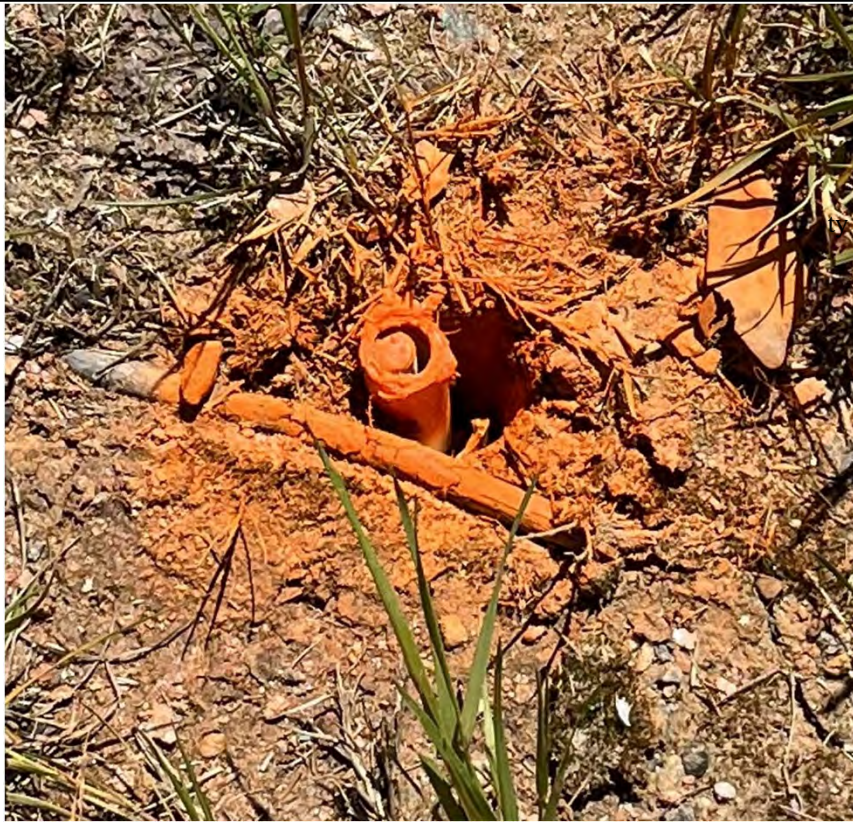
Photo 1 – Trench Marker (Typical Marker of 55, set at grade) –  $\frac{3}{4}$  " rebar set in 1-in PVC painted

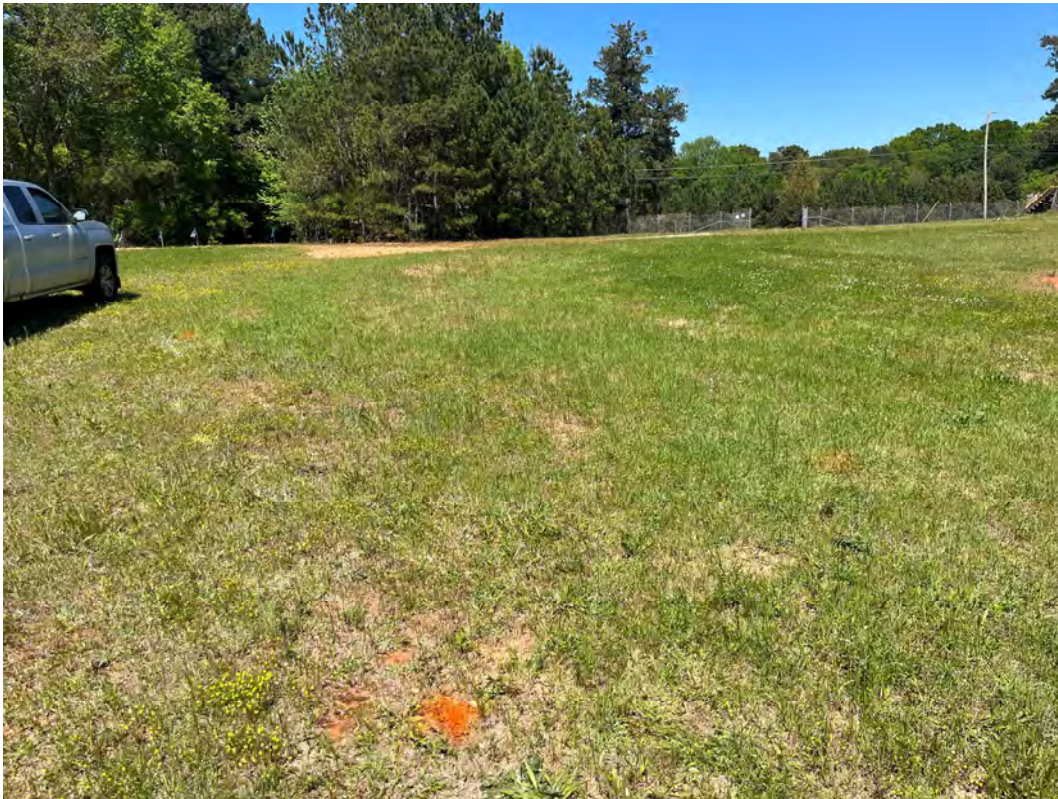
Photo 2 – View from south end of Trench "C" looking north

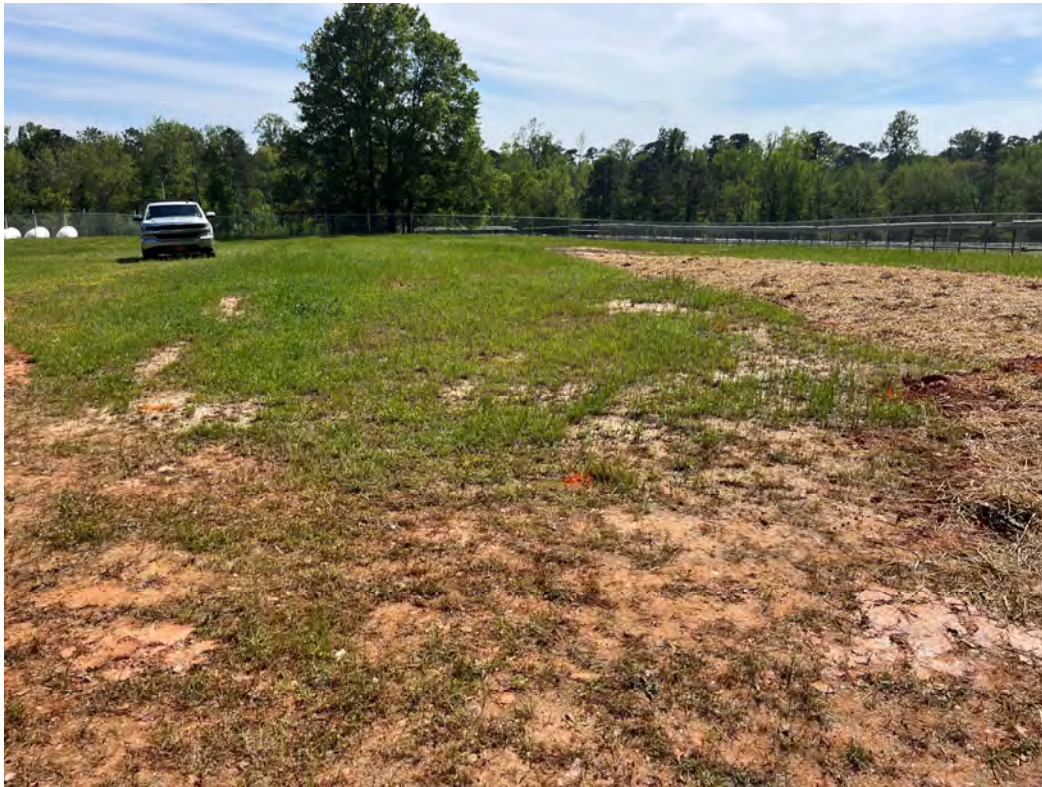
Photo 3 – View of markers at north end of Trench “B” looking south

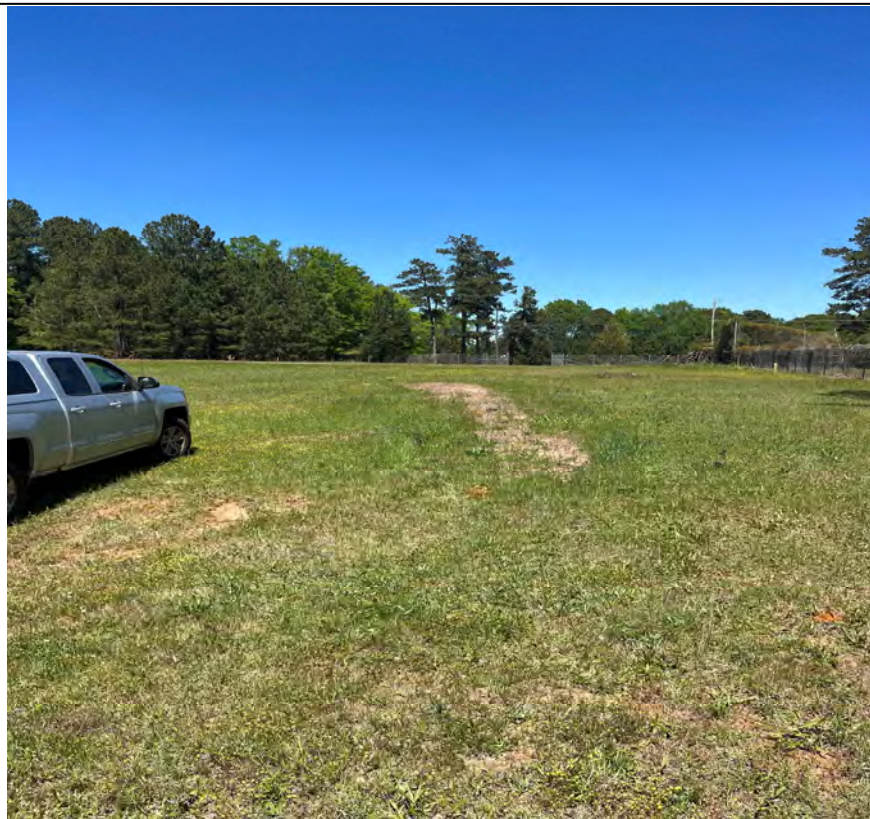
Photo 4 – View at Southwest side of Trench “E” looking to north toward Trench D and C

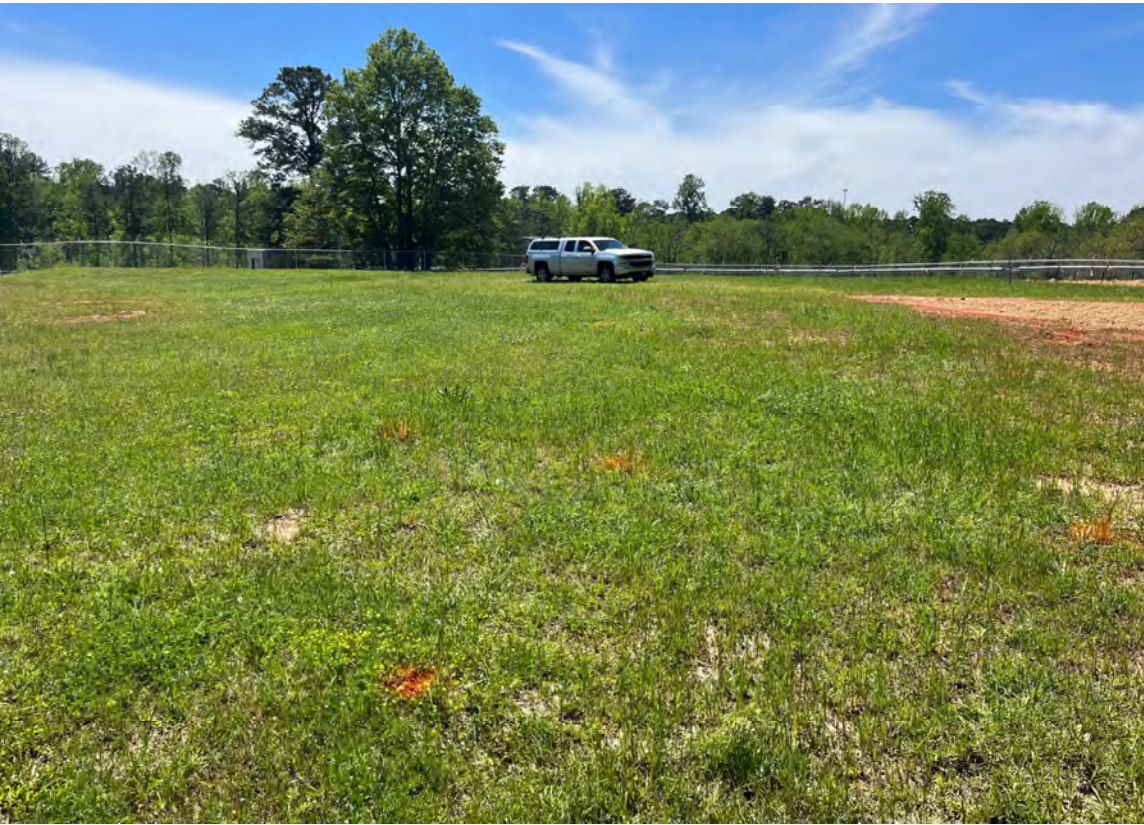
Photo 5 – View of markers at north end of Trench “D” looking toward Trench “E” to southeast

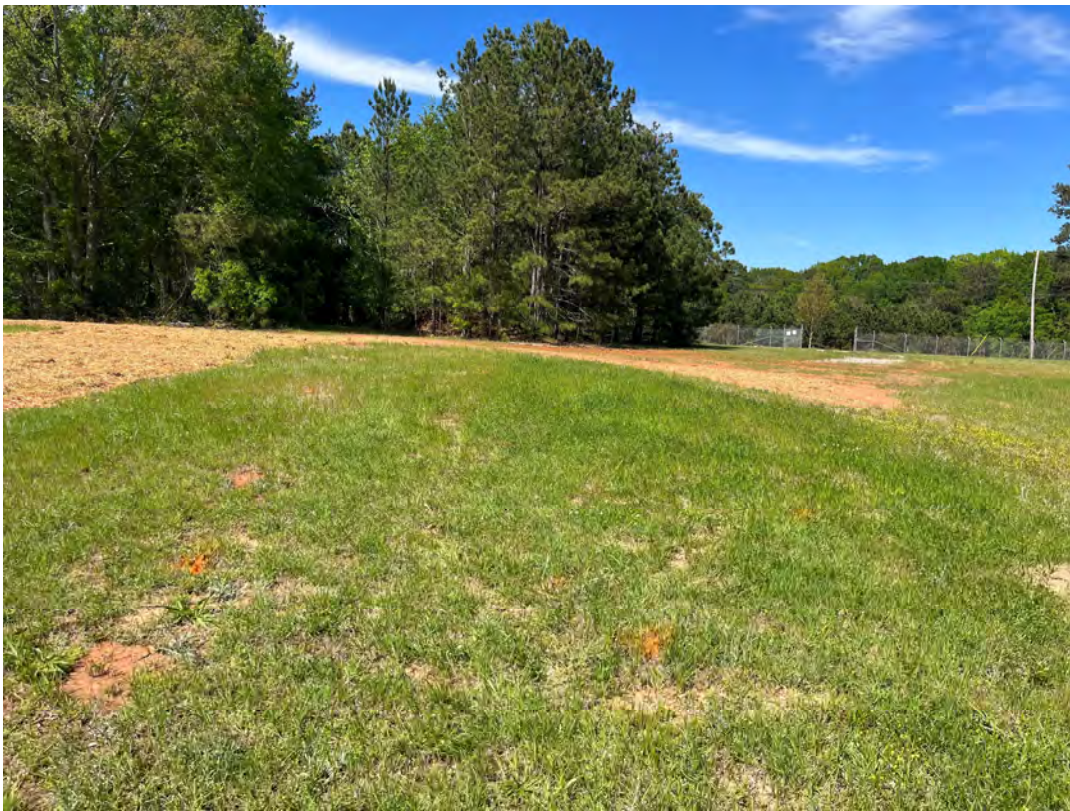
Photo 6 – View at South end of Trench B looking north toward area with added fill
