SEMI-ANNUAL PROGRESS REPORT #8

1071 HOWELL MILL ROAD ATLANTA, FULTON COUNTY, GEORGIA HSI SITE NO. 10637 (WELCOME YEARS, INC.)

RE: Semi-Annual Progress Report #8 1071 Howell Mill Road Atlanta, Georgia HSI Sub-Listed Site No. 10637 (Welcome Years, Inc.) Tax Parcel ID#17-0150-009-14

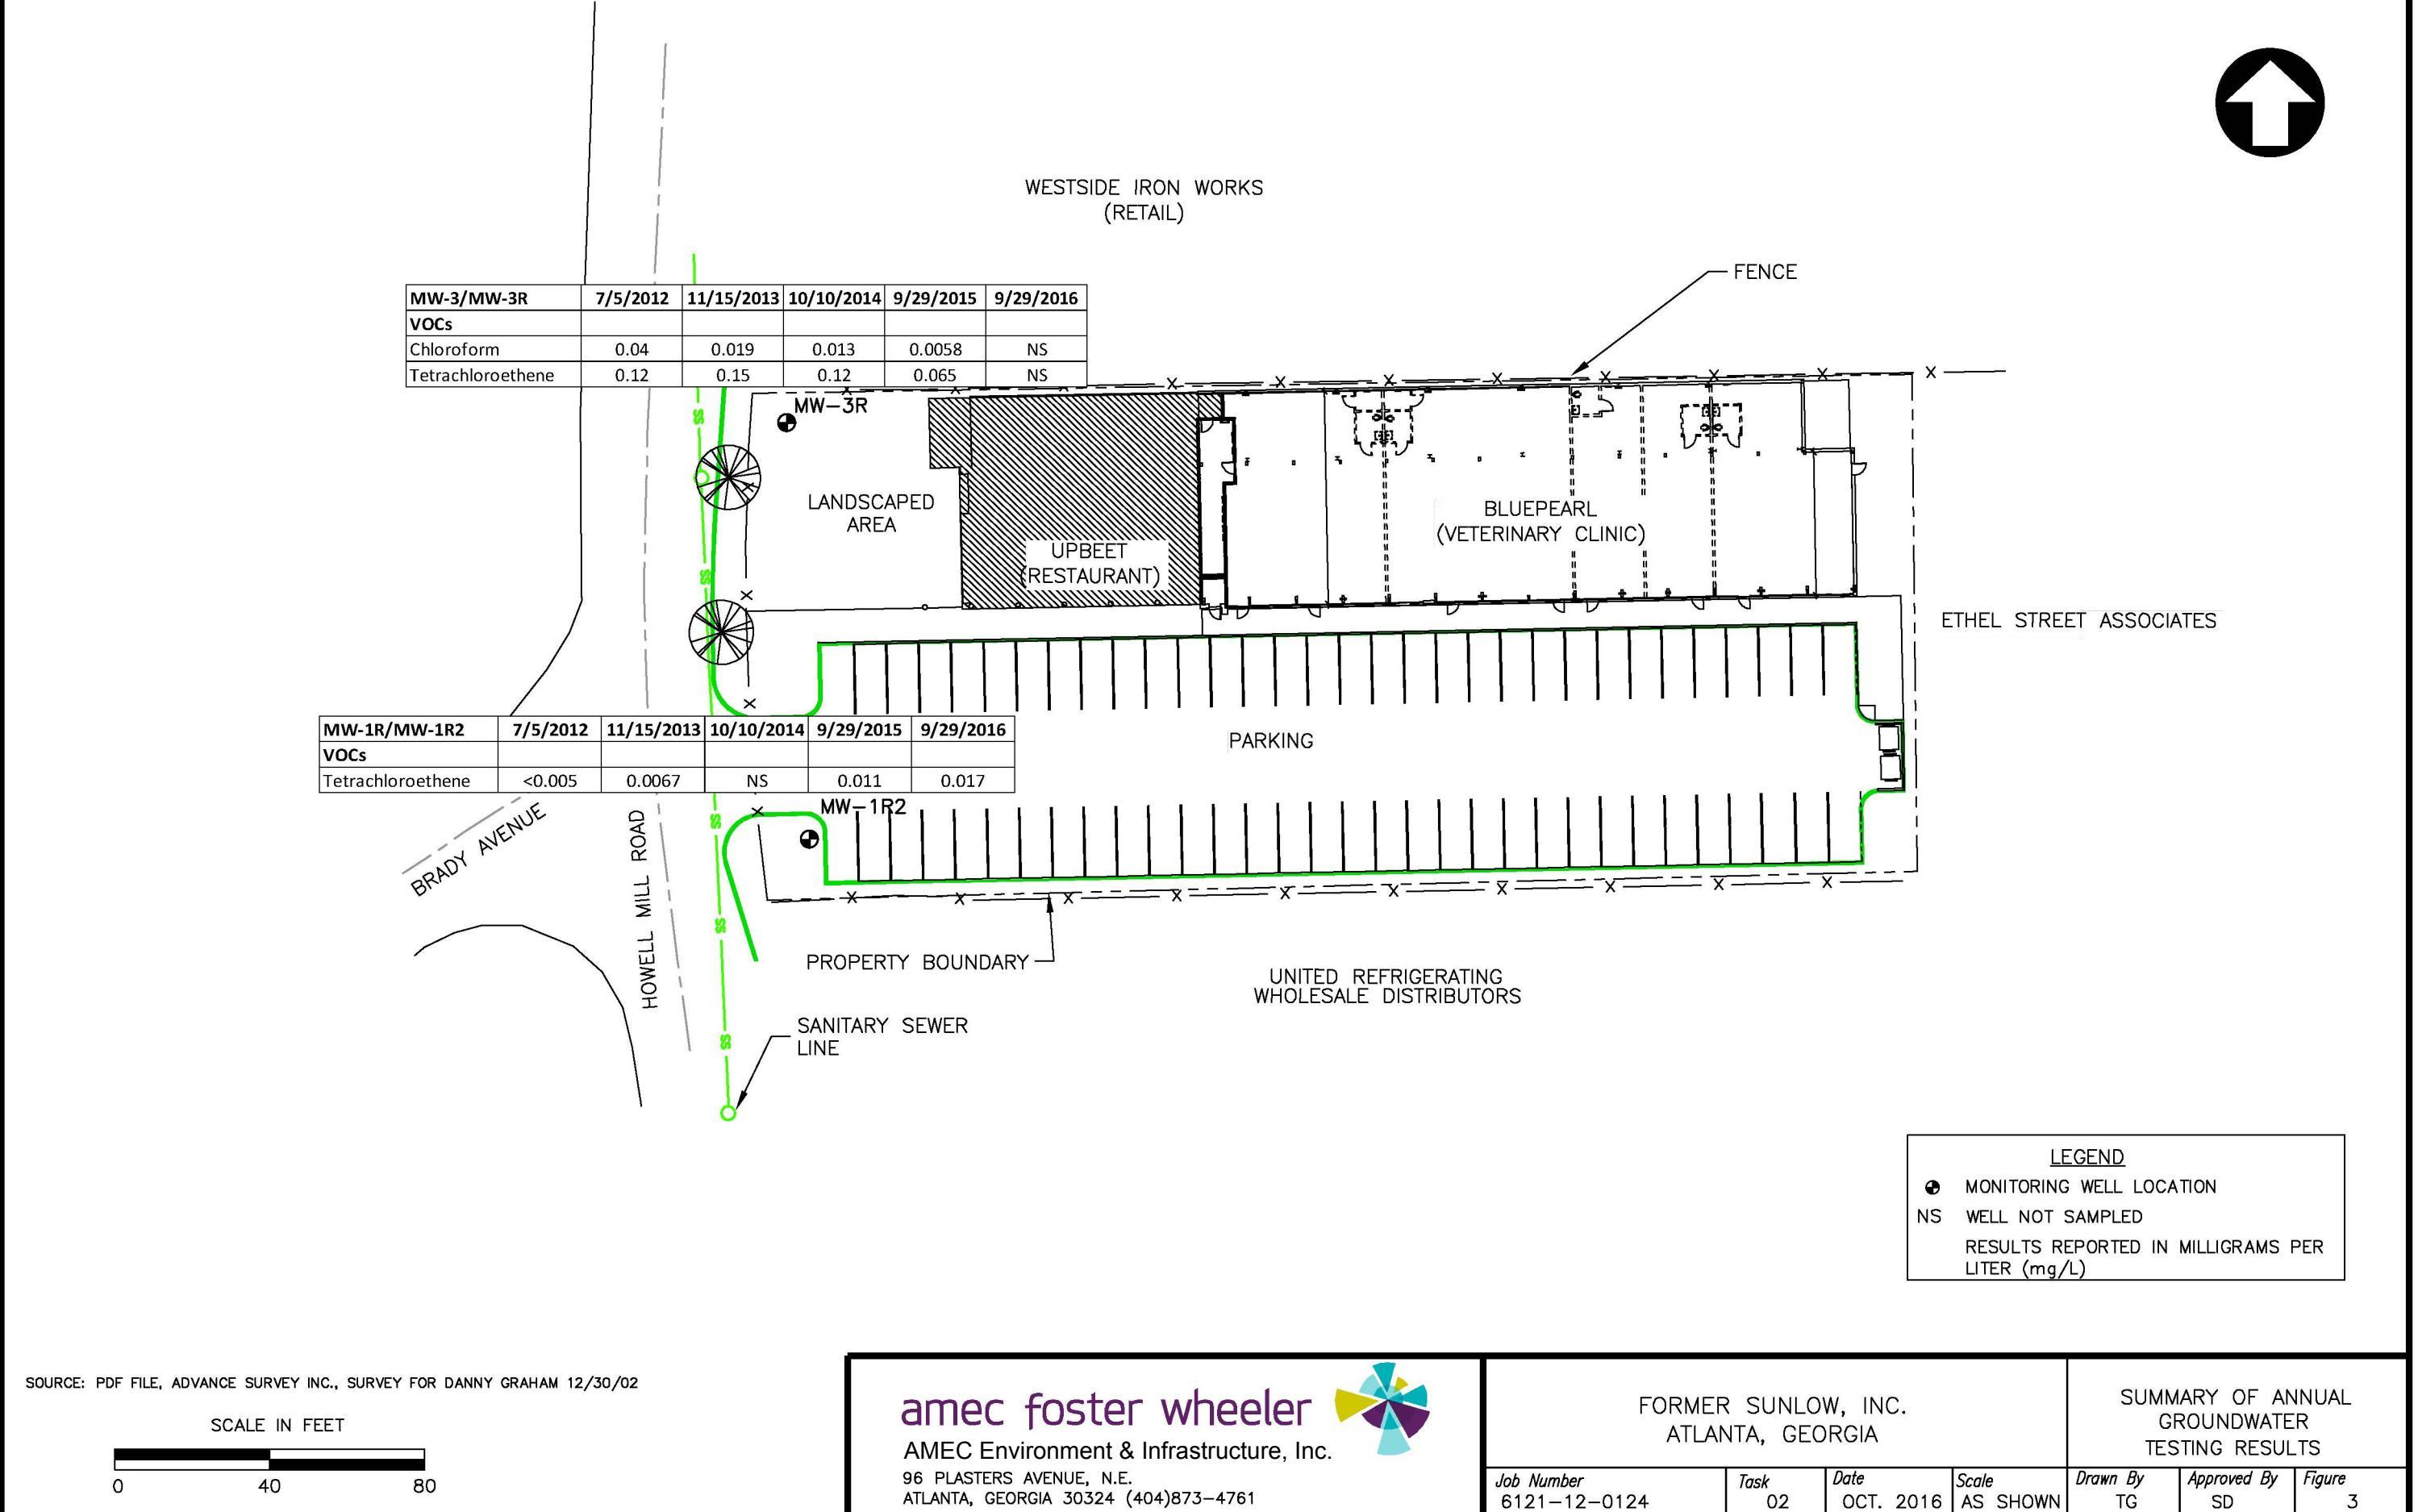
Figure 3 – Summary of Groundwater Testing

The groundwater sample was tested for volatile organic compounds (VOCs, SW-846 Test Method 8260B). The results of the monitoring event are summarized on the attached Figure 3, which also summarizes previous groundwater testing data from wells MW-1R/MW-1R2 and MW-3/MW-3R. The laboratory report is attached in Appendix B.

Groundwater testing results from MW-1R2 exhibited tetrachloroethene at a concentration of 0.017 mg/L, slightly higher than the previously detected concentration in MW-1R of 0.011 mg/L in September 2015.

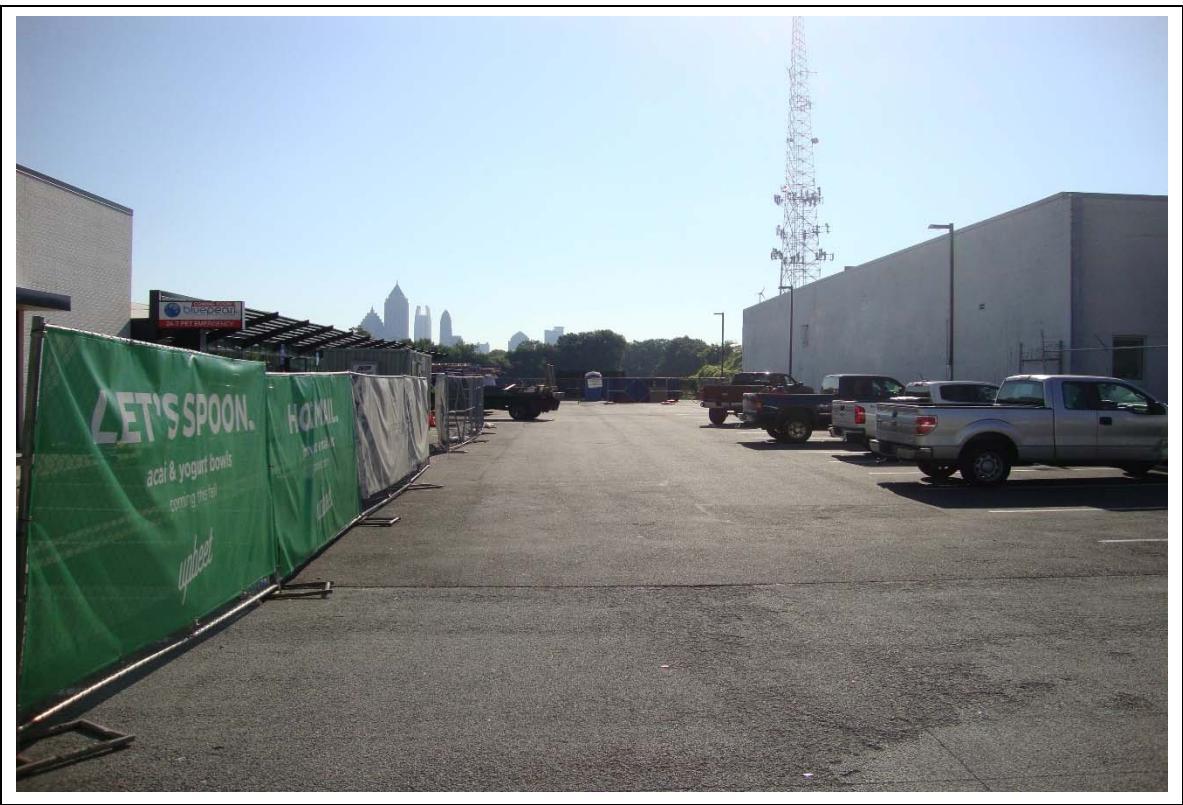
Photo 1. View east across site from site entrance on Howell Mill Road.

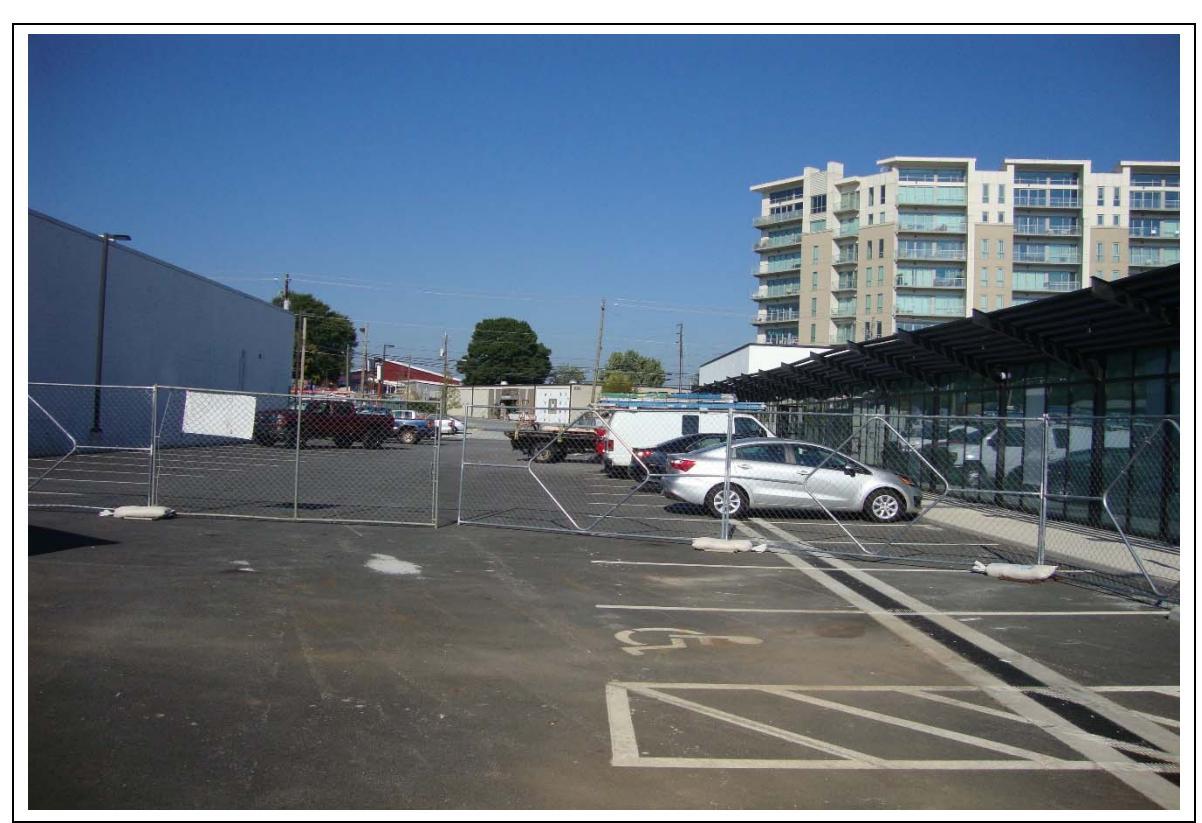
Photo 2. View west across property from east site boundary.

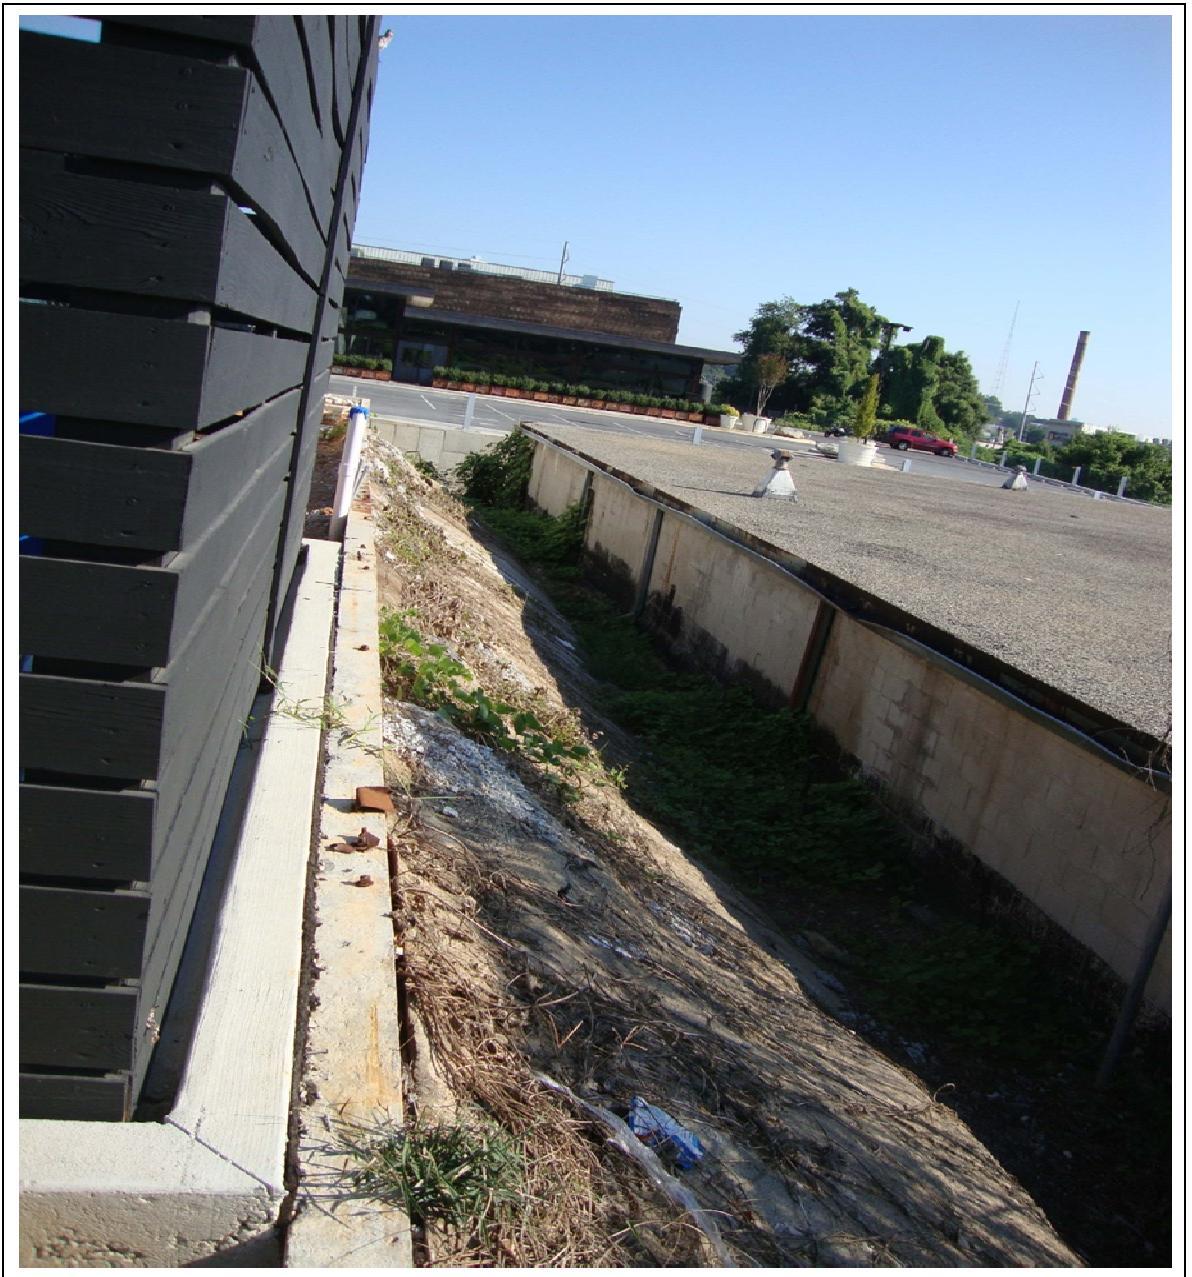
The spray-applied grout (gunite) placed as cover and for stabilization on the slope at the eastern property boundary has been cleared of vegetation.

Photo 5. View north along slope of east end of site. On-site portion of slope has been covered with shot-crete.

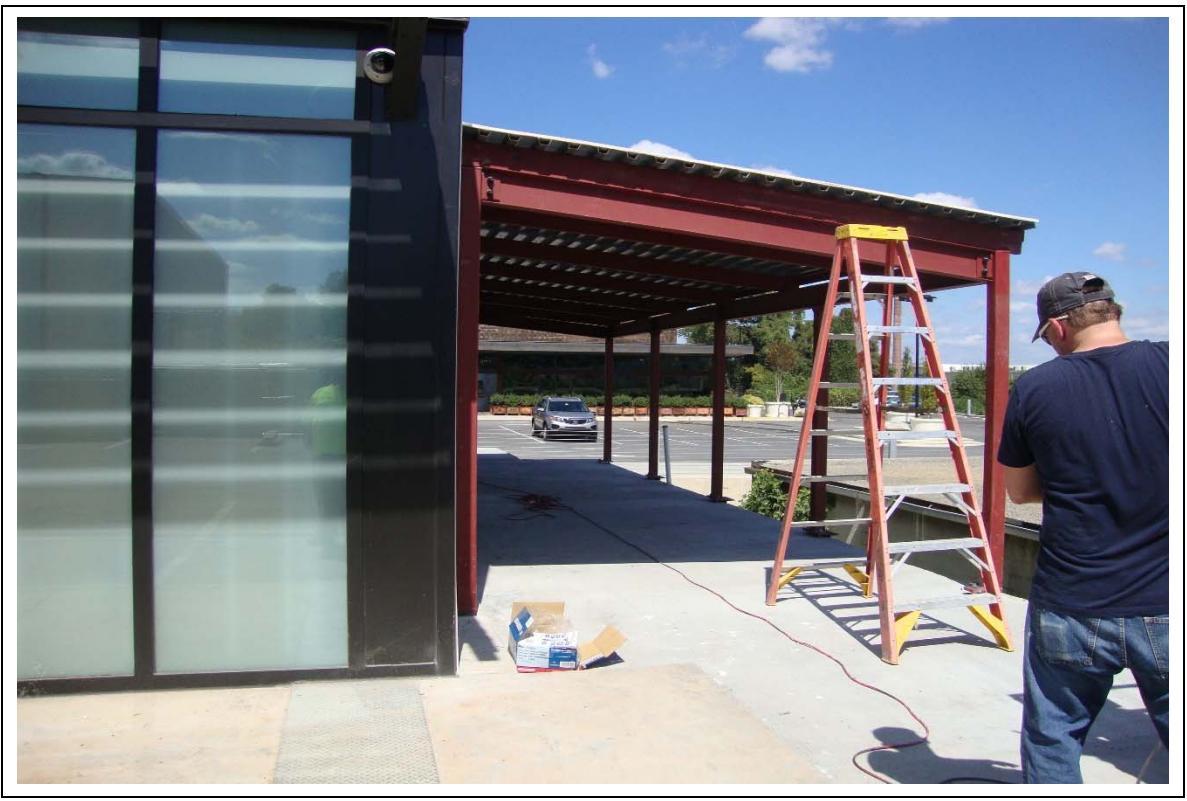
The dog walk at the east exterior of the building was completed, including the installation of footings to support a canopy. Fencing in the area has also been placed after construction of the dog walk.

Photo 6. Covered dog walk under construction at east end of building.

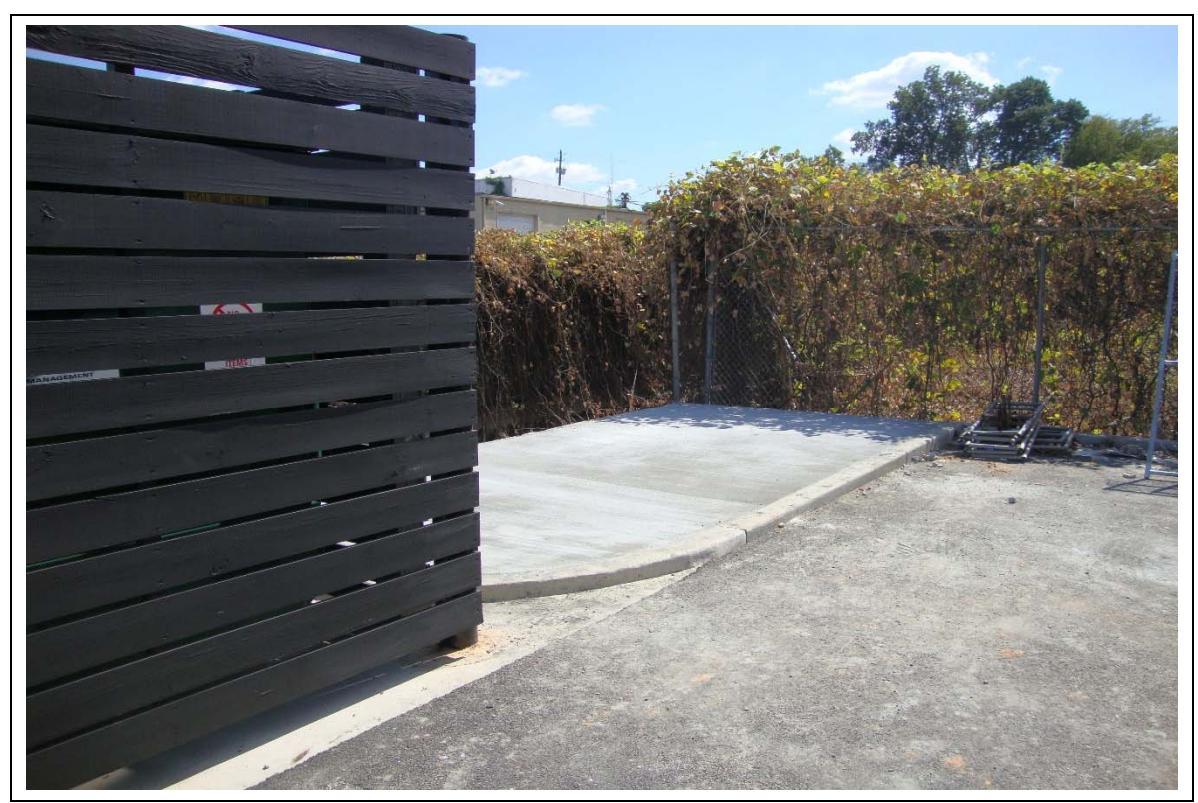
Photo 7. Future dog walk at east end of property, south of dumpster enclosure.

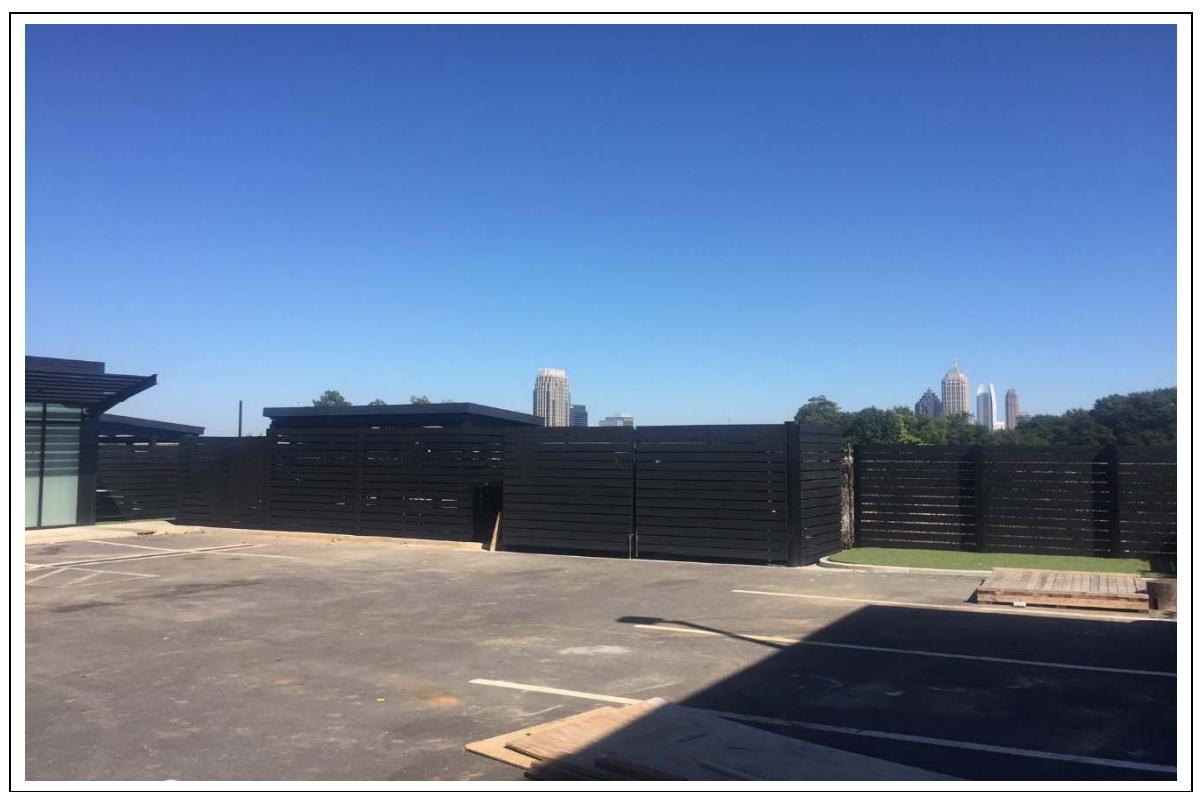
- All of the interior renovations requiring slab disturbances have been completed.
- Construction of the dog walk has been completed and fencing has been replaced.

Photo 8. Completed dog walks, dumpster enclosure and fencing at east end of property.
