Voluntary Remediation Plan and Application

Martha's Dry Cleaner 4608 Skidaway Road Savannah, Chatham County, Georgia HSI Site No. 10764

> October 27, 2011 Terracon Project No. ES117125

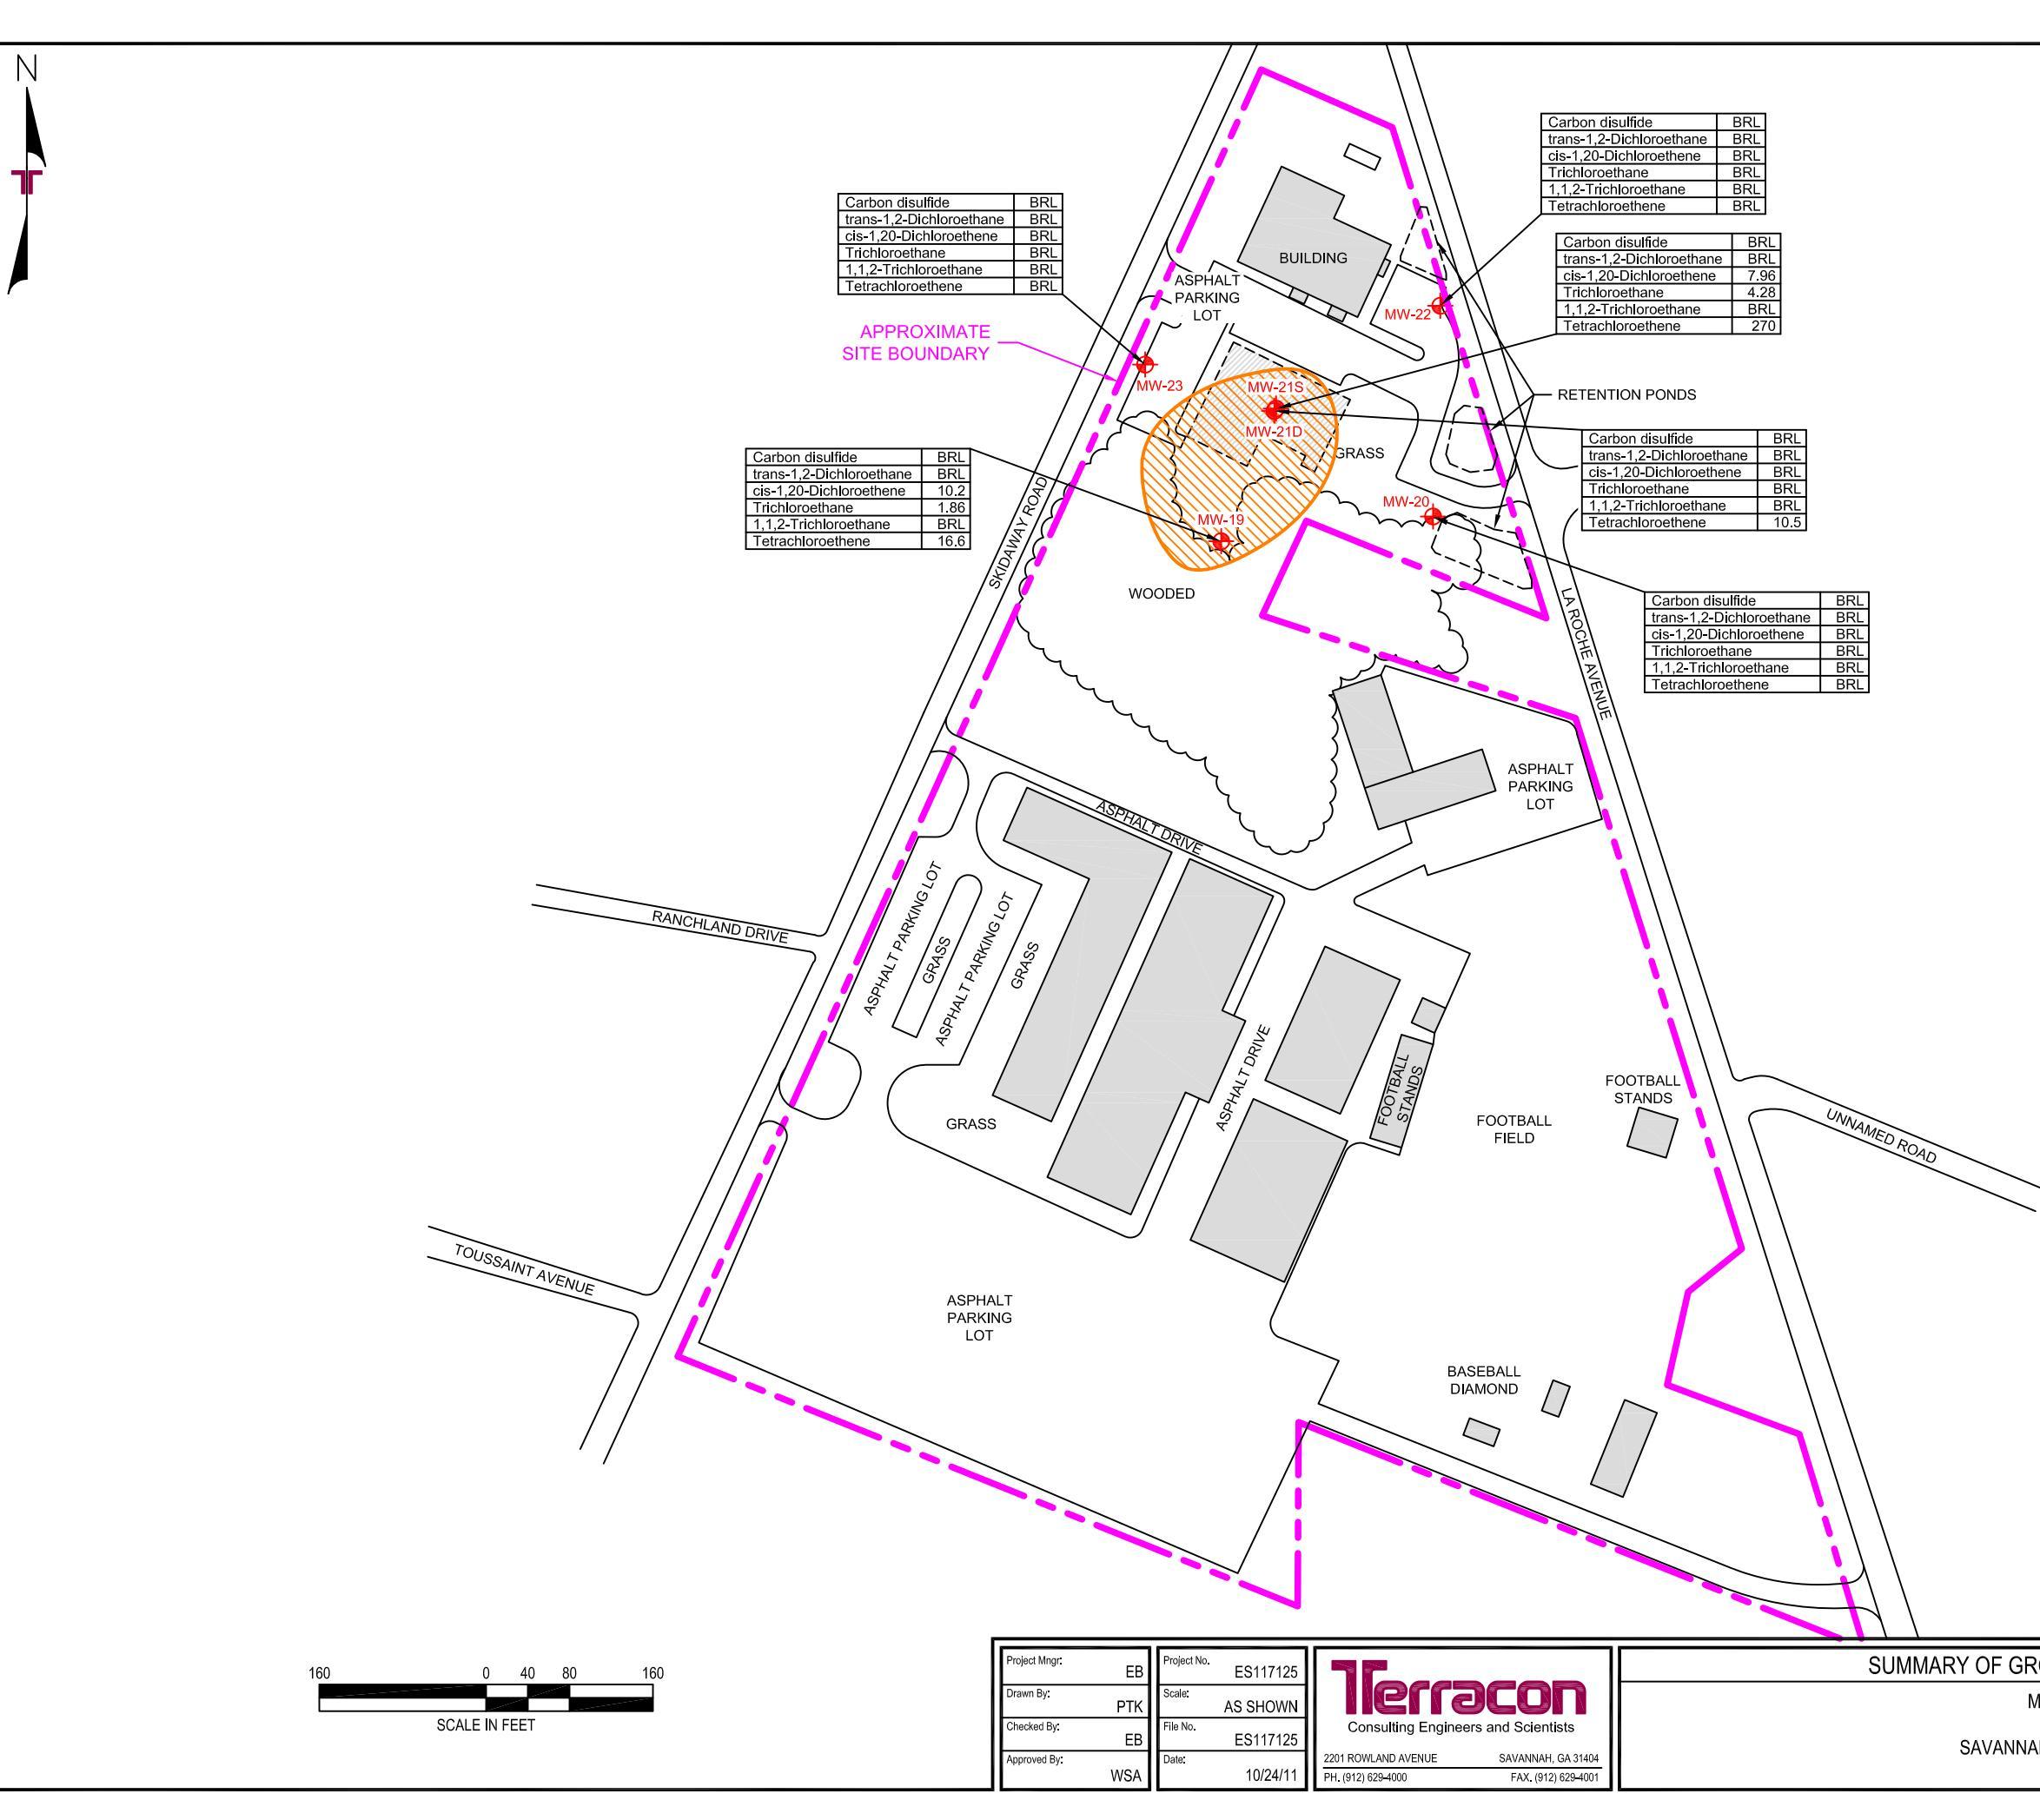
7

LEGEND
+	NEW MONITORING WELL LOCATION
	CURRENT BUILDING
	PAST LOCATION OF MARTHA'S DRY CLEANERS BUILDING
10.2	CONCENTRATION IN µg/L
BRL	BELOW REPORTING LIMIT
\bigcirc	APPROXIMATE TYPE 1 RRS BOUNDARY OF CONSTITUENTS OF INTEREST

OUNDWATER	ANALYTICAL	RESULTS

Groundwater testing indicated several VOCs present in the groundwater. In groundwater monitoring well MW-19, Cis-1,2-Dichloroethene, Trichloroethane, and Tetrachloroethene were detected at a concentration of 10.2 µg/L, 1.86 µg/L, and 16.6 µg/L, respectively. Carbon disulfide, trans-1,2-Dichloroethene, and 1,1,2-Trichloroethane were found to be below the reporting limit of 1 μ g/L. In groundwater monitoring well MW-20, all the VOC compounds tested during this sampling event were found to below the reporting limit of 1 µg/L. In groundwater monitoring well MW-21S, Cis-1,2-Dichloroethene, Trichloroethane, and Tetrachloroethene were detected at a concentration of 7.96 µg/L, 4.28 µg/L, and 270 µg/L, respectively. Carbon disulfide, trans-1,2-Dichloroethene, and 1,1,2-Trichloroethane were found to be below the reporting limit of 1 µg/L. In groundwater monitoring well MW-21D, Tetrachloroethene was detected at a concentration of 10.5 µg/L. All other compounds were found to be below the reporting limit of 1 μ g/L. In groundwater monitoring wells MW-22 and MW-23, all VOC compounds tested during this sampling event were found to be below the reporting limit of 1 µg/L. The detected Tetrachloroethene concentrations in MW-19, MW-21S and MW-21D were found to be exceeding the GEORGIA EPD HSRA Appendix III Groundwater Concentrations. All other detected VOC compounds were found to be below the GEORGIA EPD HSRA Appendix III Groundwater Concentrations.

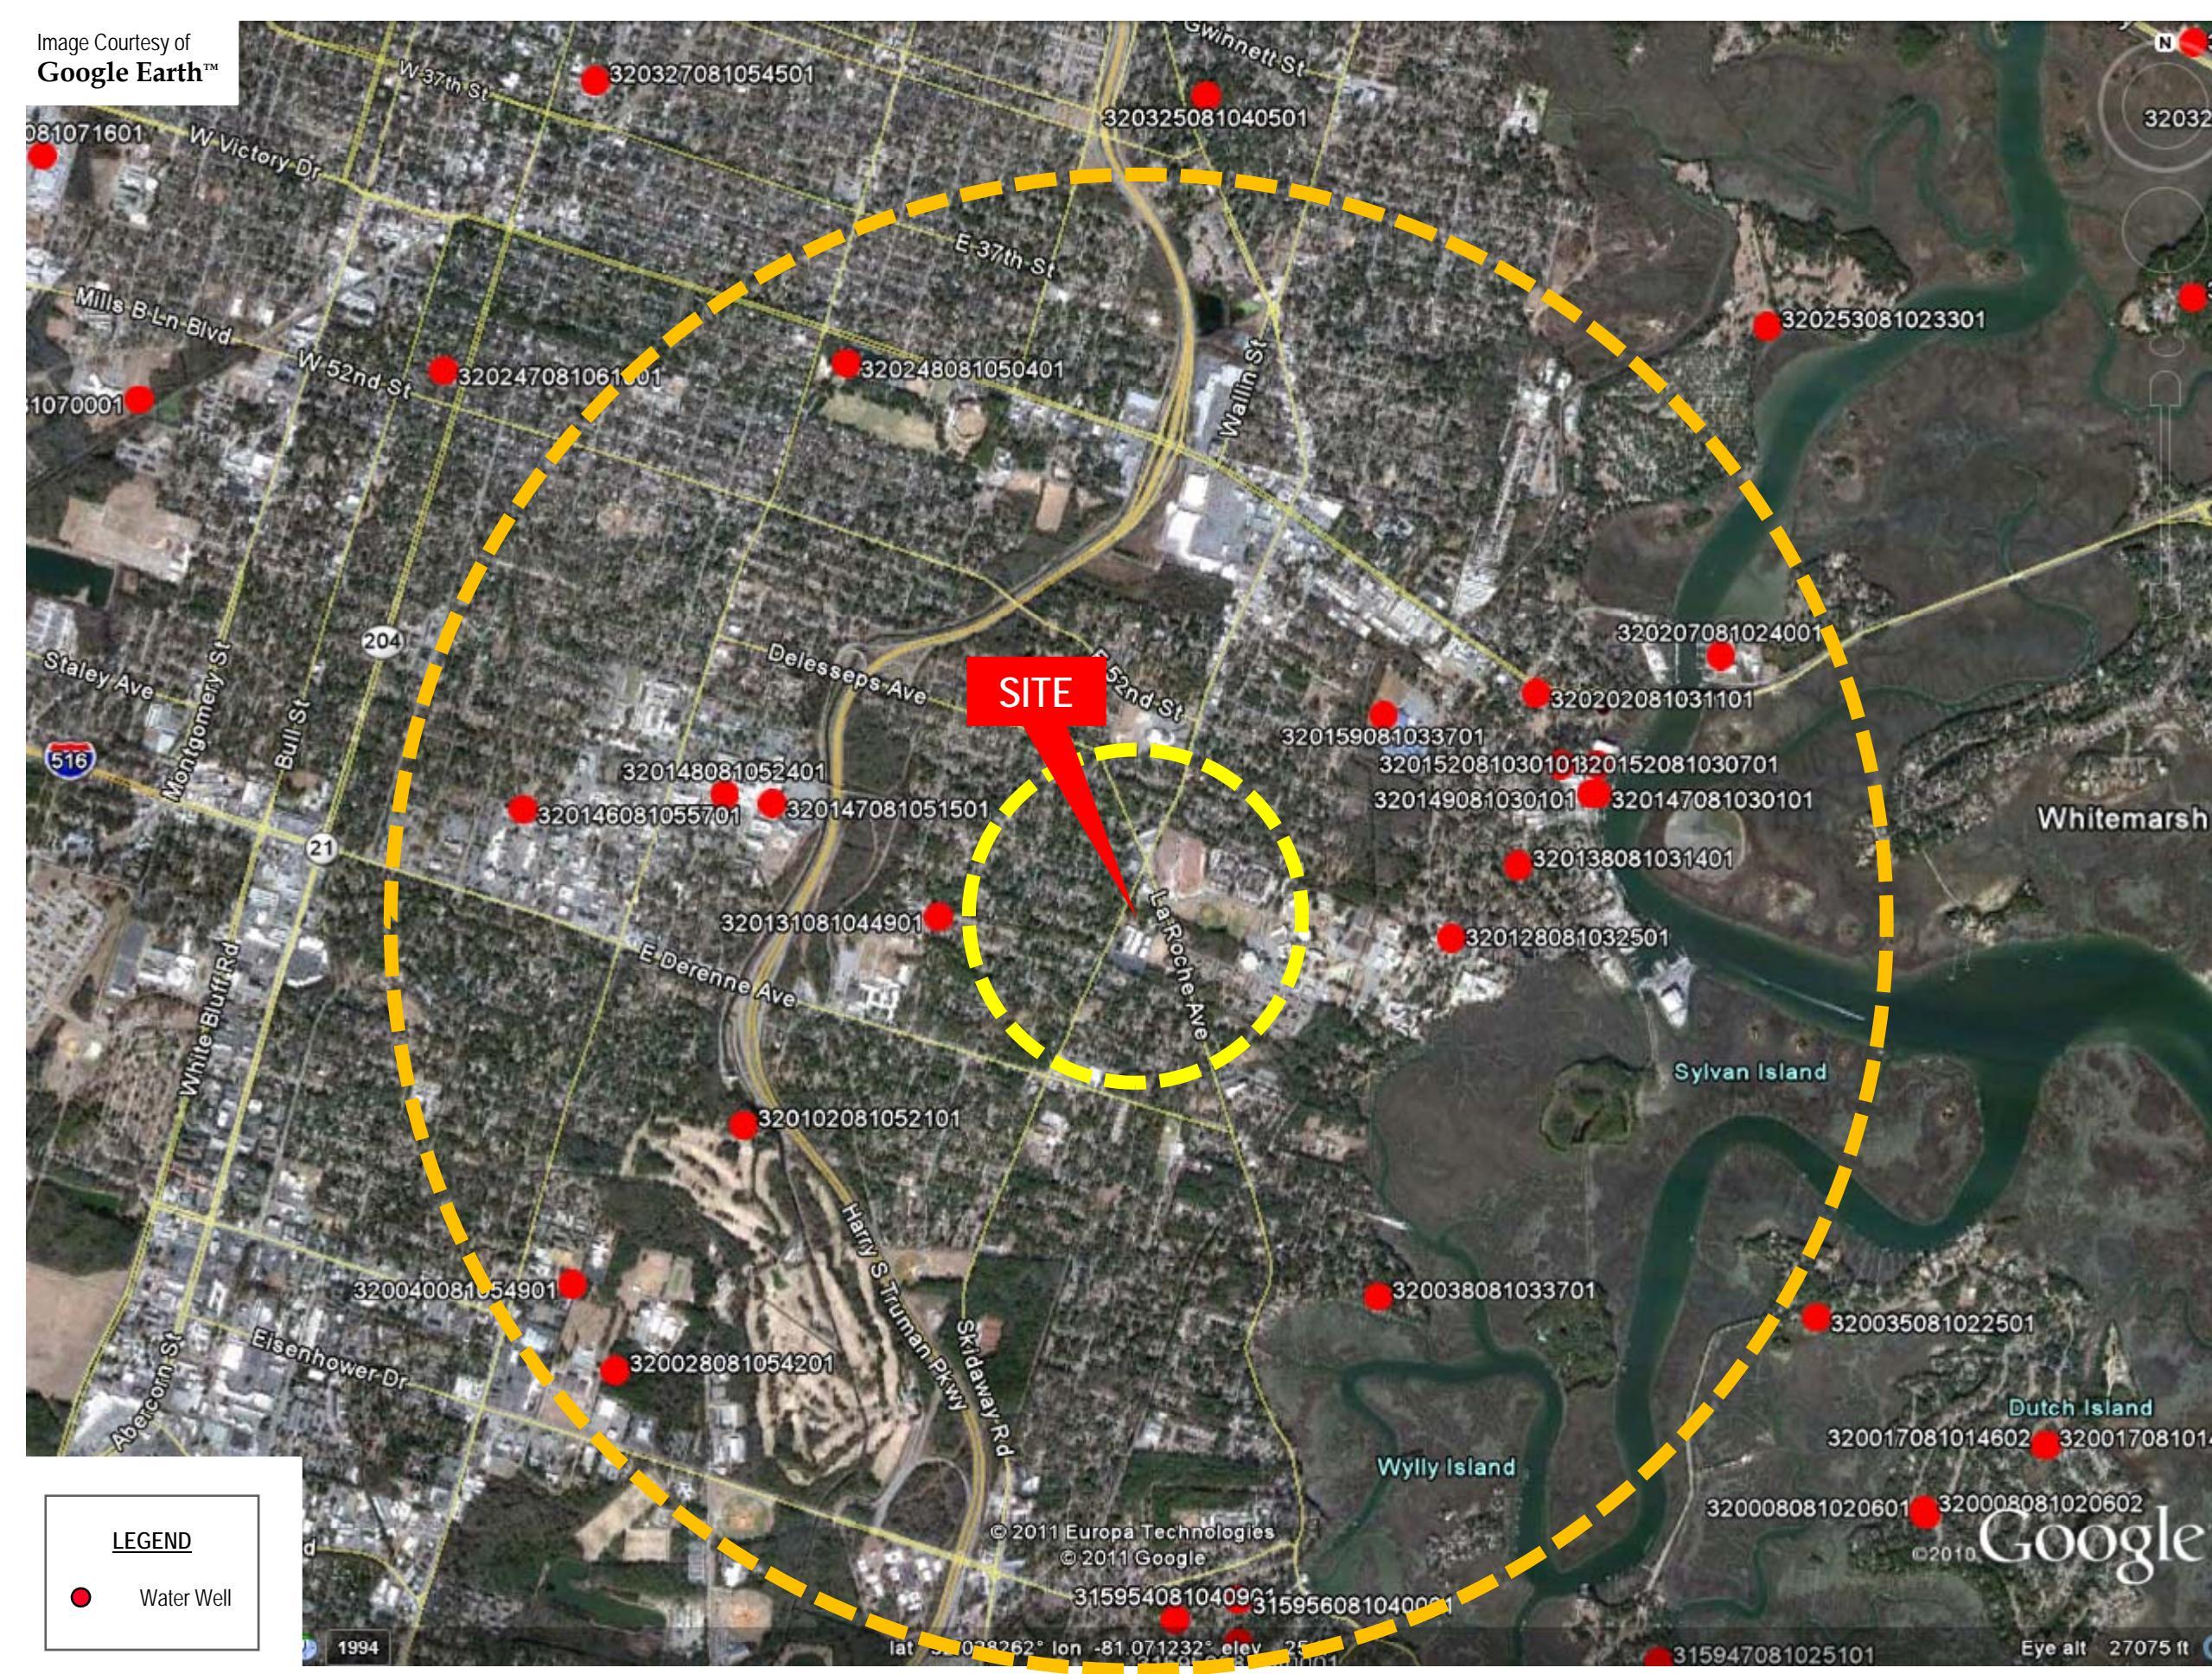
The yellow dashed line shows a ¹/₂-mile radius from the site; the orange dashed line represents a 2-mile radius.
