Coahulla Creek Watershed Management Plan

*A local stakeholder and Georgia EPD approved plan
that outlines the framework for improving water
quality in Coahulla Creek and its tributaries*

Watershed Management Plan

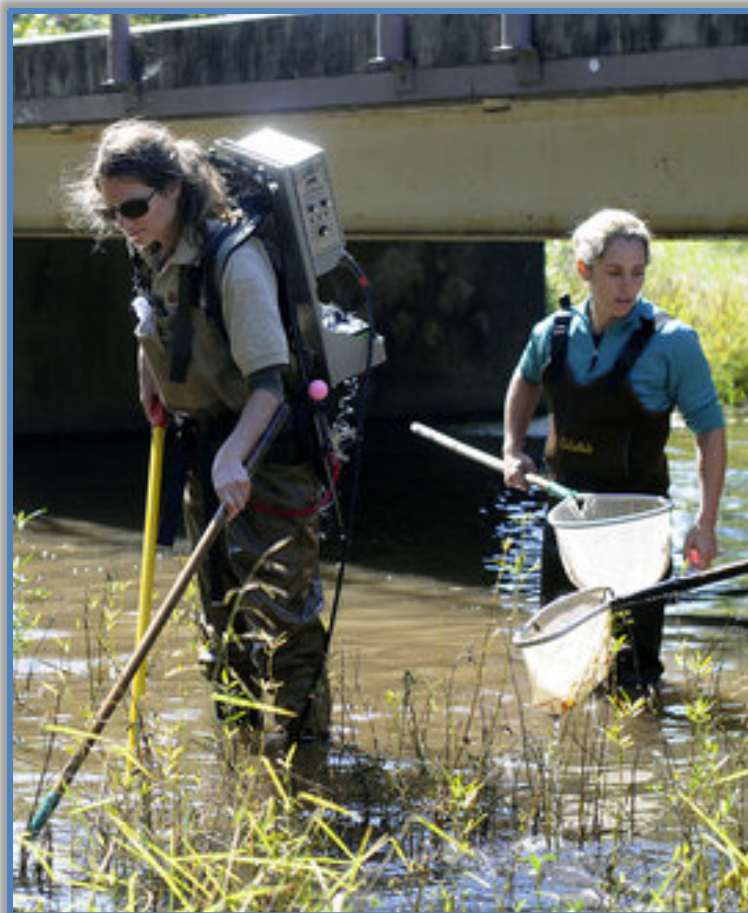
Figure 3.2.a. Sampling with backpack electrofishing equipment.

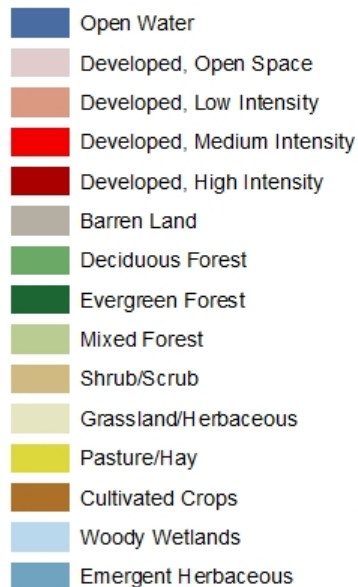
Figure 3.4.a. A map displaying the Coahulla Creek Watershed's more prominent land uses and their percentages within the watershed. More detailed definitions of land uses are listed in Appendix C.

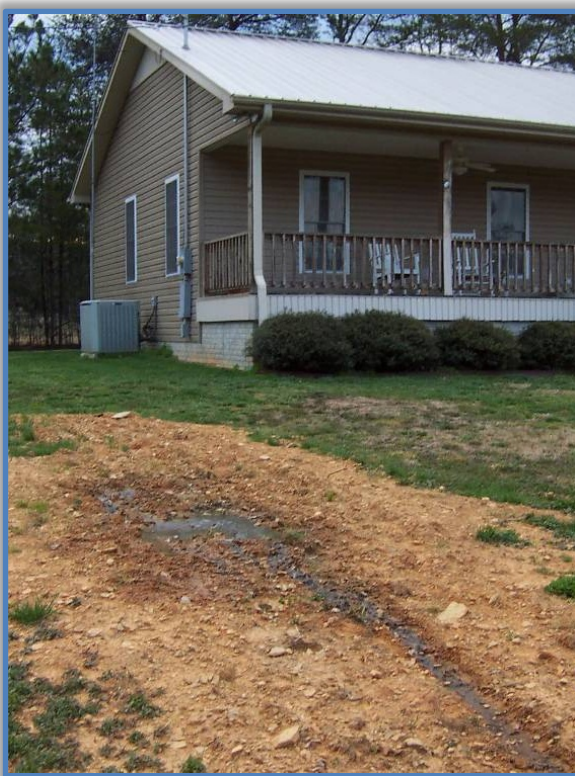
Figure 4.1.c. A failing septic system can introduce pathogens into nearby streams. This system has effluent surfacing in the yard, and drains into a nearby tributary.

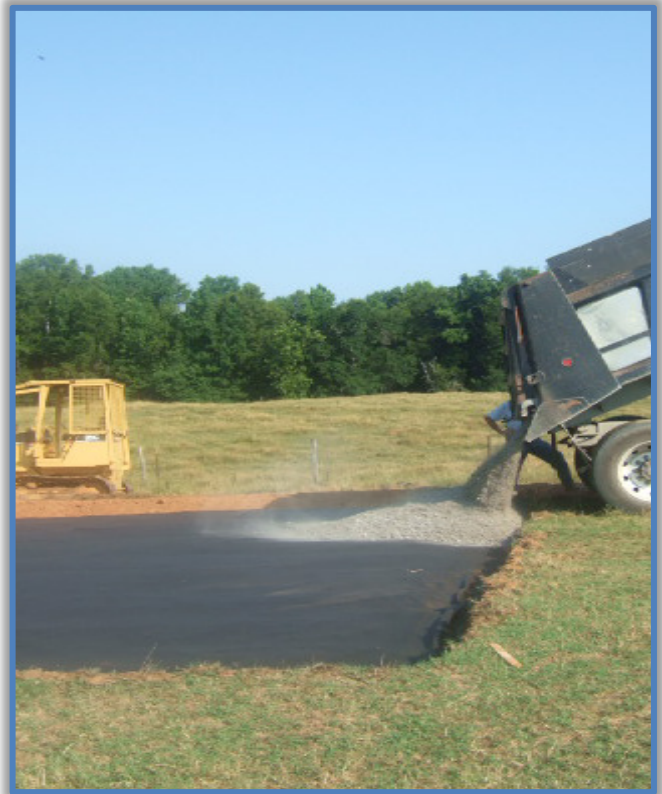
Figure 6.2.a. Constructing heavy use area pads for cattle feeding or watering areas can reduce erosion and sediment loads in the watershed.
