**VOLUNTARY REMEDIATION PROGRAM
PROGRESS REPORT # 5
Rheem Manufacturing Company
Milledgeville, Georgia**

June 2016

**RHEEM MANUFACTURING COMPANY
MILLEDGEVILLE, GEORGIA**

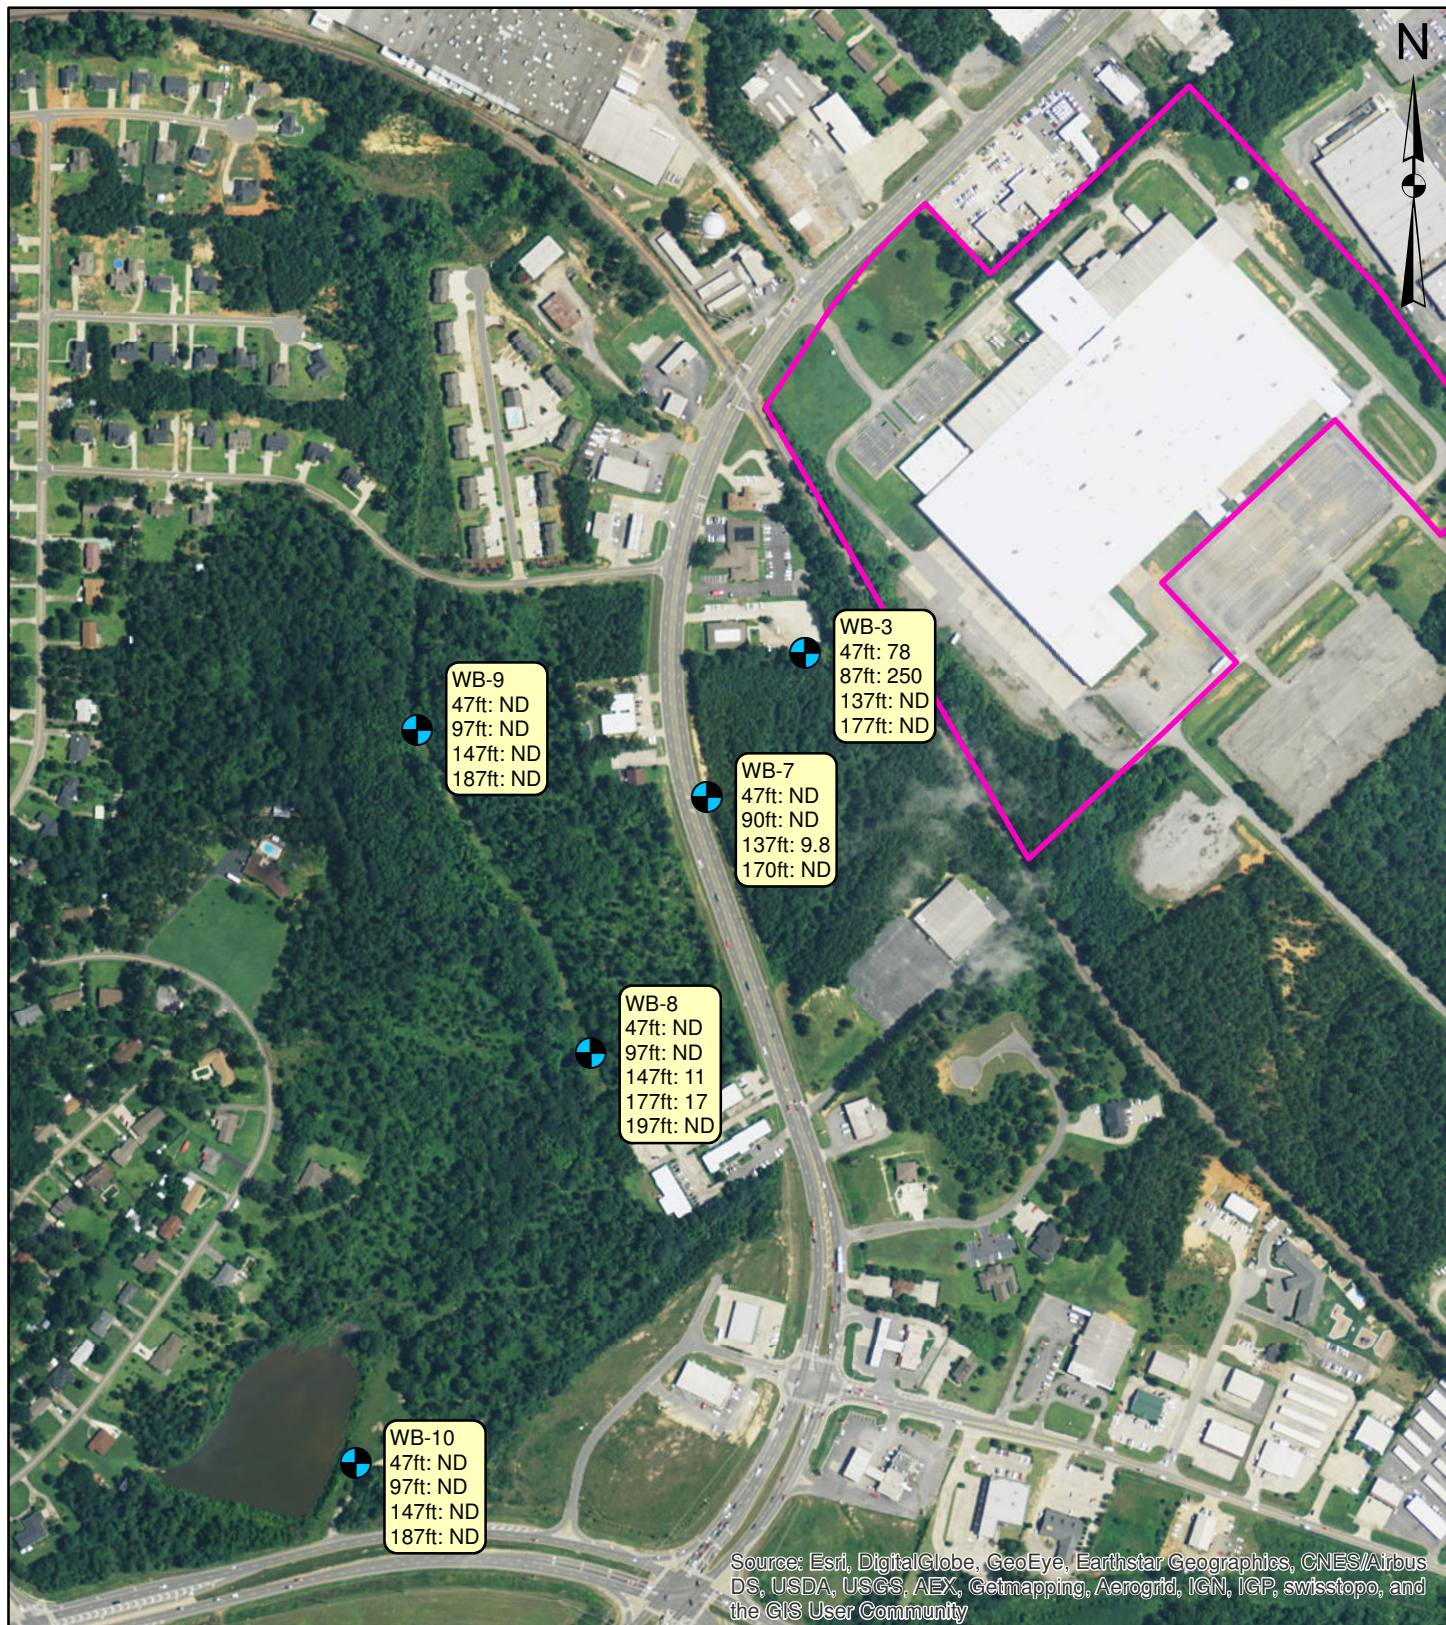
Vertical Groundwater Delineation Off-Property

Based upon data obtained from 5 packer-sample boring locations, the off-Property vertical distribution of TCE is shown on Figure 14B. Non-detect conditions were documented at all locations for the deepest samples (generally at a depth of about 175-190 ft-bgs).

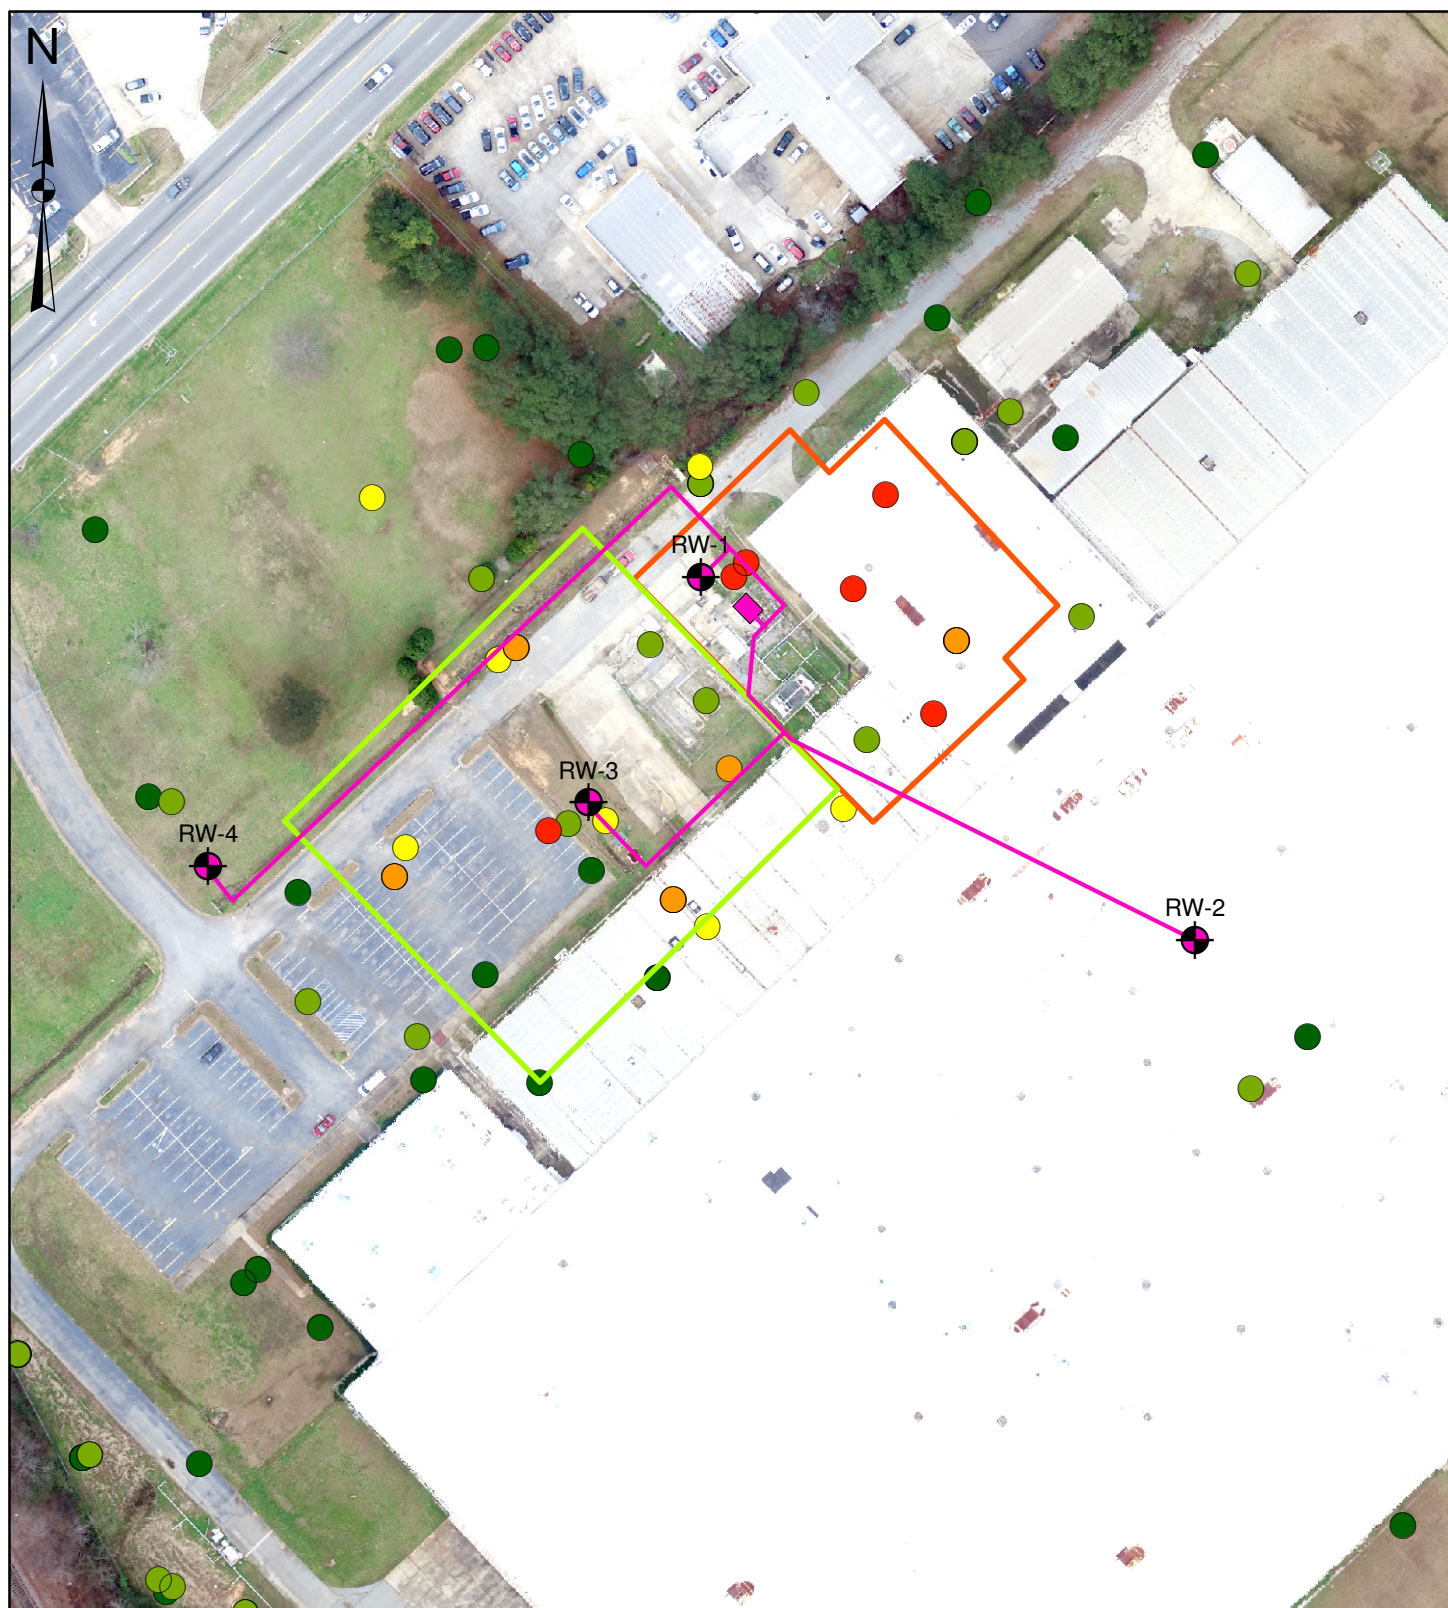
Figure No. 6

The strategy for the Release Area will encompass both methods of media placement. In the region of the former AST tank farm, injection well nests will be installed (Figure 6), with each nest constructed with vertically staggered screen sections to support placement of EVO and bioaugmentation culture across the full thickness of the aquifer. Installation of injection wells overcomes logistical limits imposed by the high infrastructure density in this area of the Site, as a greater radius of influence and larger injection volumes can be achieved with injection wells.

The remaining portion of the Release Area Zone will utilize a dense array of sonic drilling direct injection points, primarily within the interior of the facility. Each boring will be advanced through the overburden and PWR zone and terminated approximately 20 feet into bedrock. Media injections will be performed at the boring termination and then every five feet as the sonic drill rod is withdrawn. Anticipated direct injection locations in the interior of the facility are shown on Figure 6.

The Plume Zone groundwater will be addressed with installation of two bioremediation injection transects (“biobarrier”) oriented perpendicular to the direction of groundwater flow (Figure 6). The
