SUPPORTING THE GEORGIA WORLD CONGRESS CENTER

February 14, 2014

**Subject: Quarters-38/39 Landfill Maintenance and Inspection Report
 Northside Drive Landfill Site, Atlanta, Georgia**

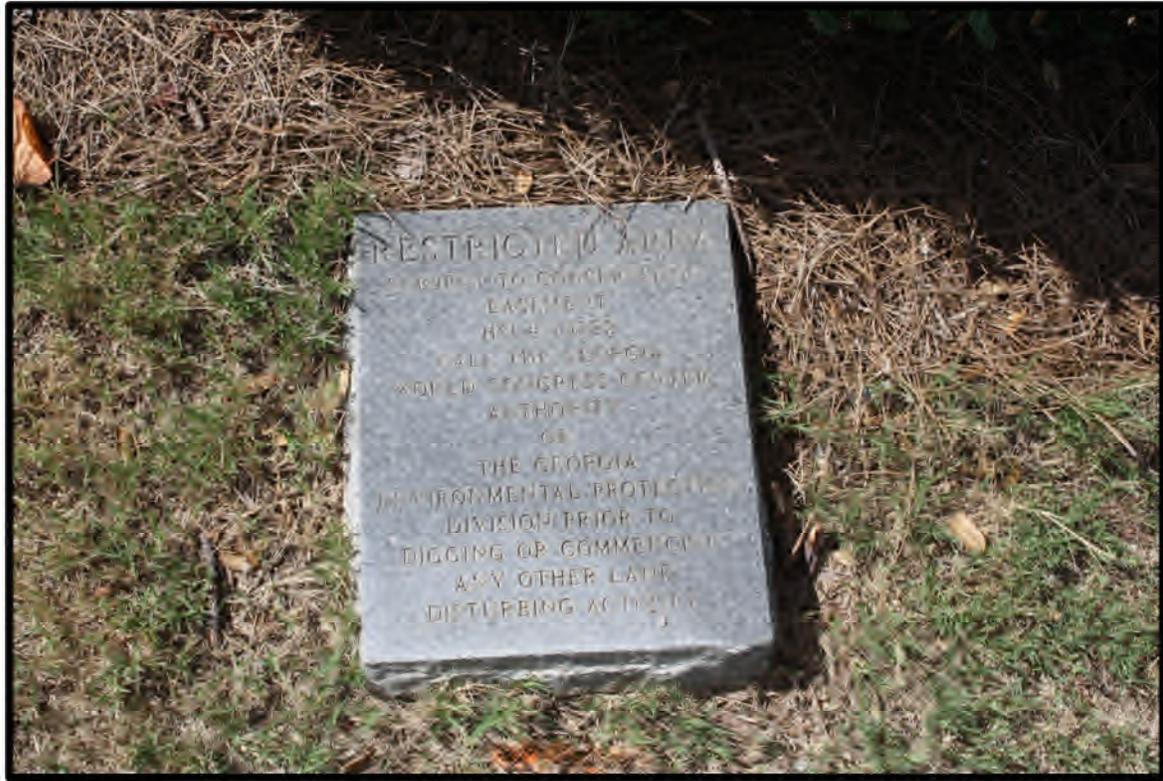
**OFFICIAL PHOTOGRAPH NO. 1
TETRA TECH**

Subject: Granite plaque located on the east, southeast side of the north parking lot perimeter.

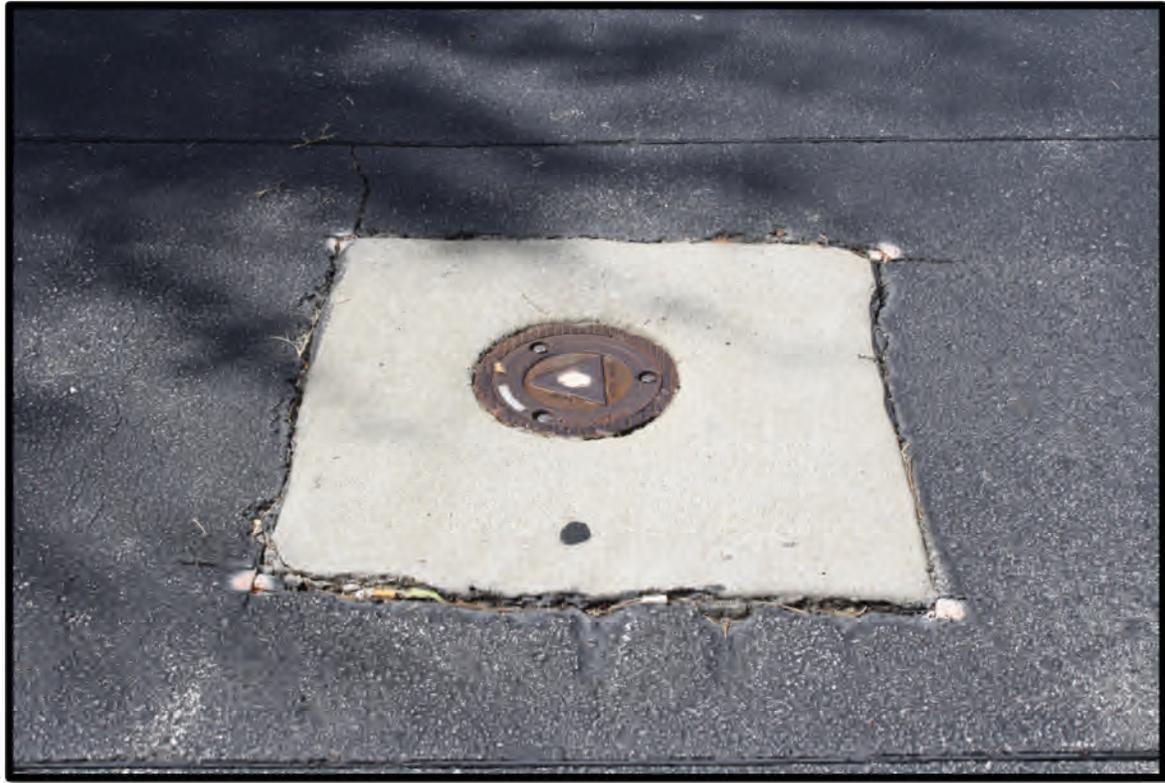
**OFFICIAL PHOTOGRAPH NO. 2
TETRA TECH**

Subject: Background monitoring well, MM-04.

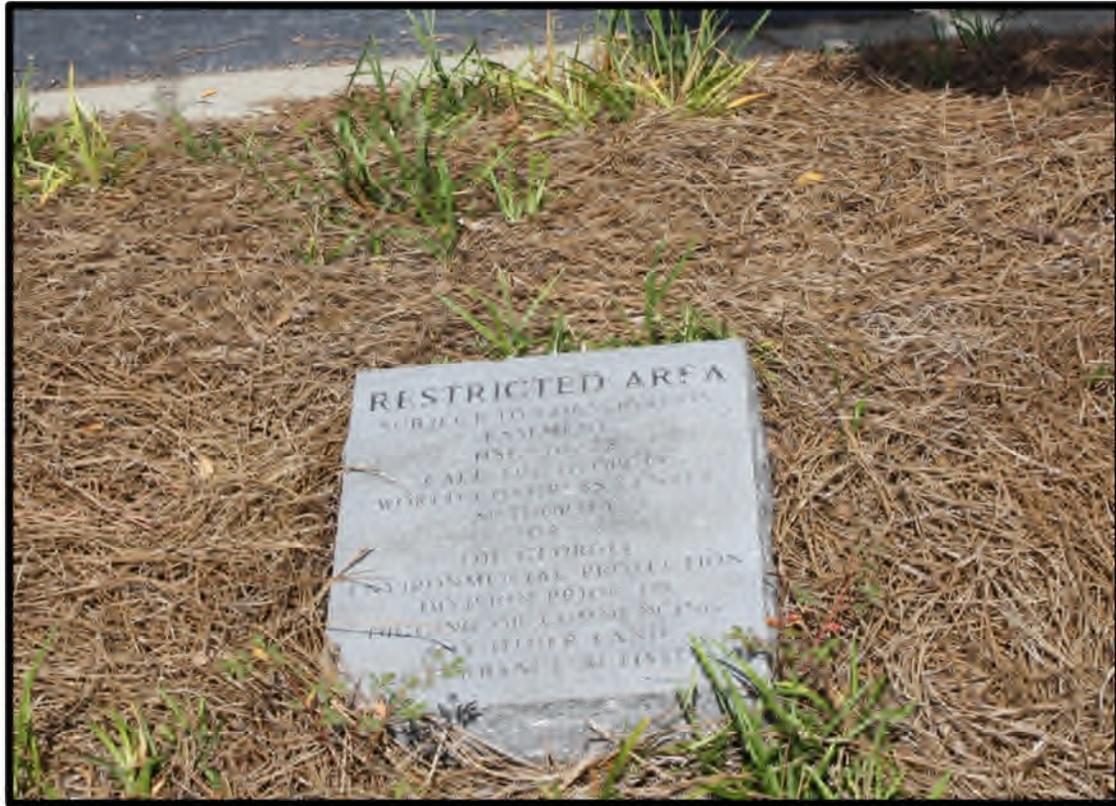
**OFFICIAL PHOTOGRAPH NO. 3
TETRA TECH**

Subject: Granite plaque on the southeast corner of the property.

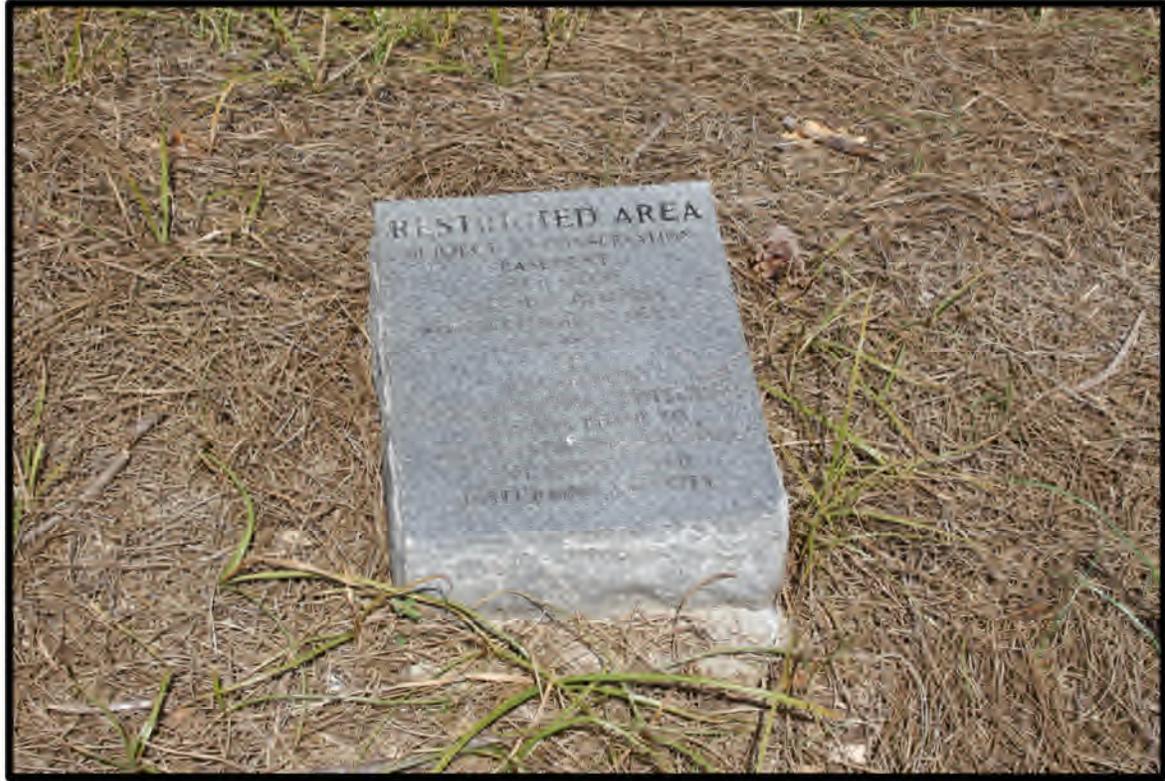
**OFFICIAL PHOTOGRAPH NO. 4
TETRA TECH**

Subject: Granite plaque on the south side of the property.

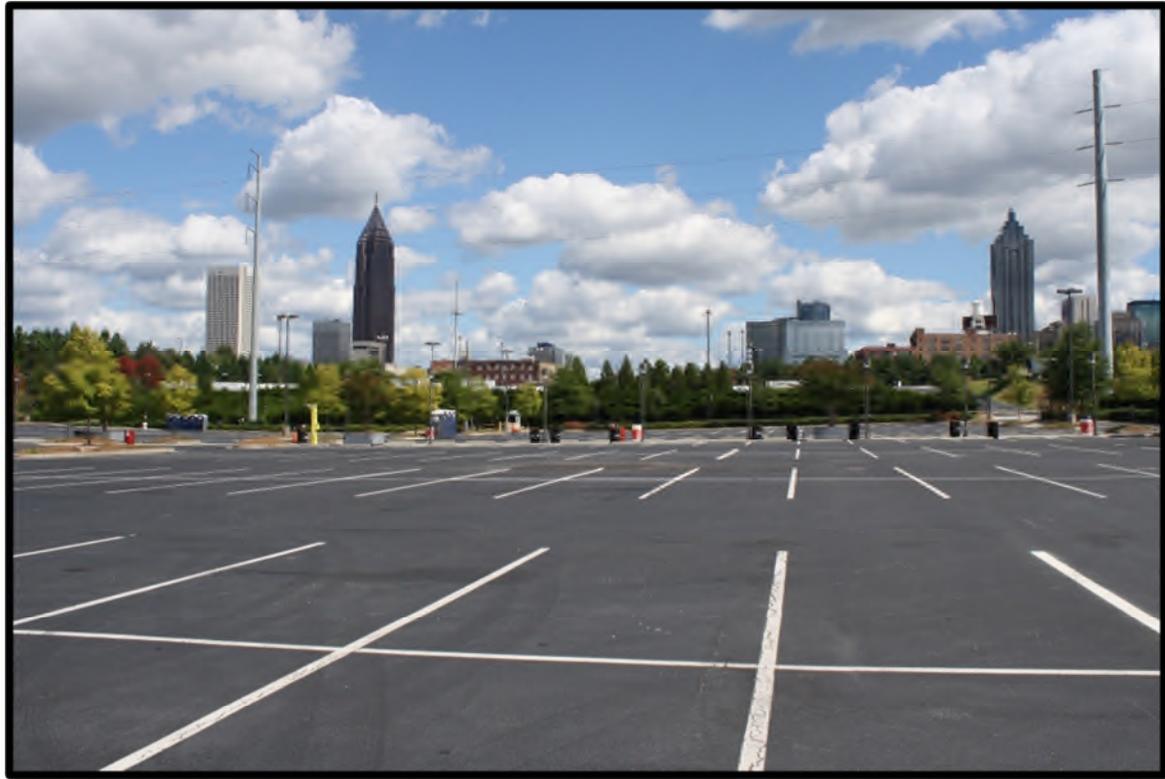
**OFFICIAL PHOTOGRAPH NO. 5
TETRA TECH**

Subject: Eastern portion of the lot looking northeast.

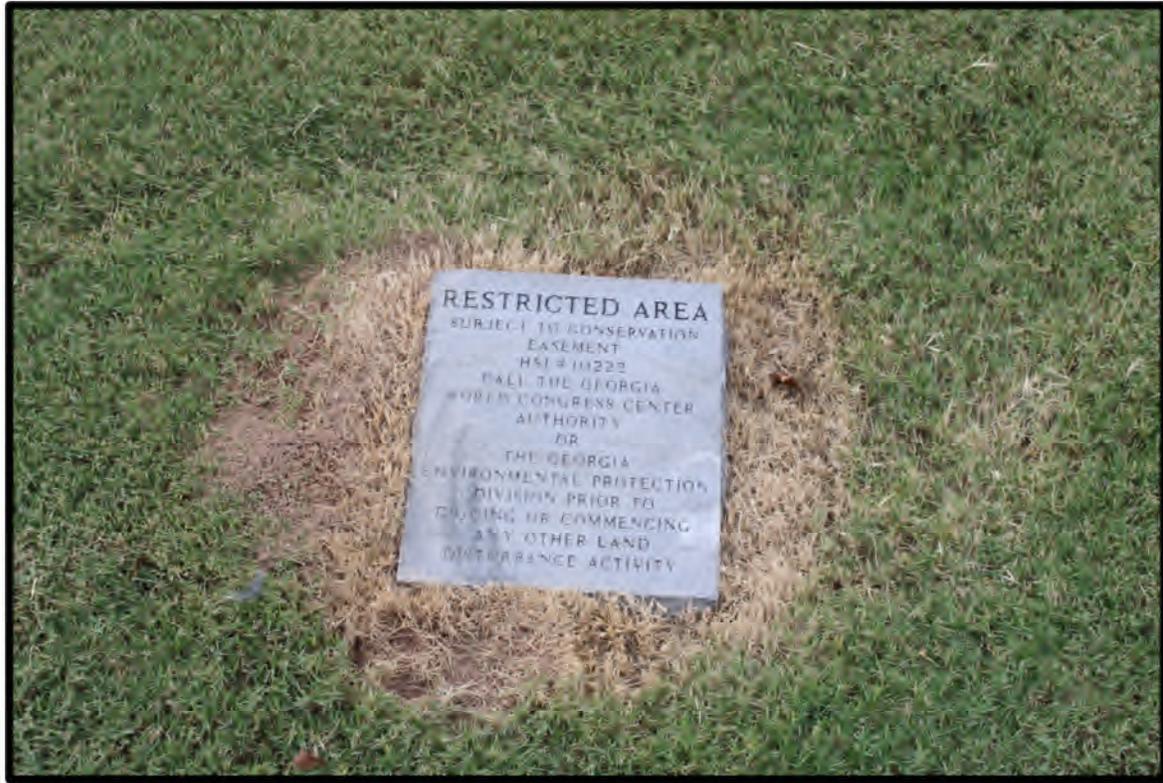
**OFFICIAL PHOTOGRAPH NO. 6
TETRA TECH**

Subject: Granite plaque on the northeastern perimeter of the property.

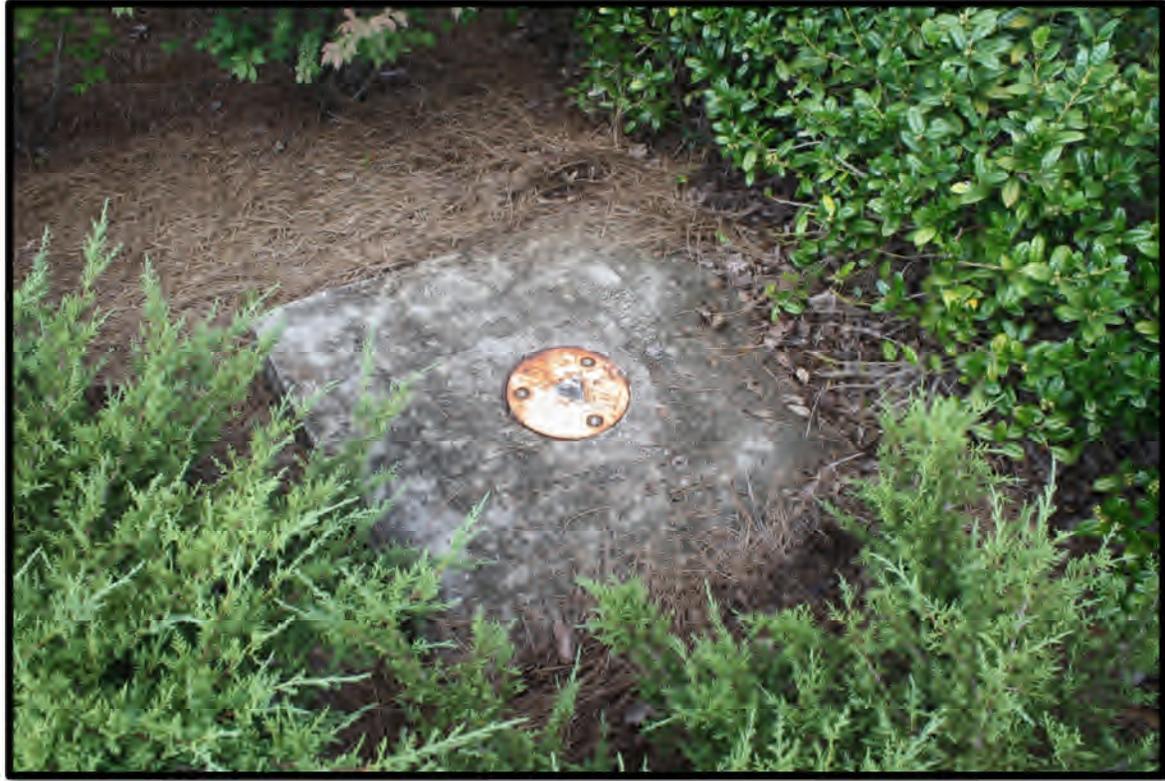
**OFFICIAL PHOTOGRAPH NO. 7
TETRA TECH**

Subject: Monitoring well, MM-01.

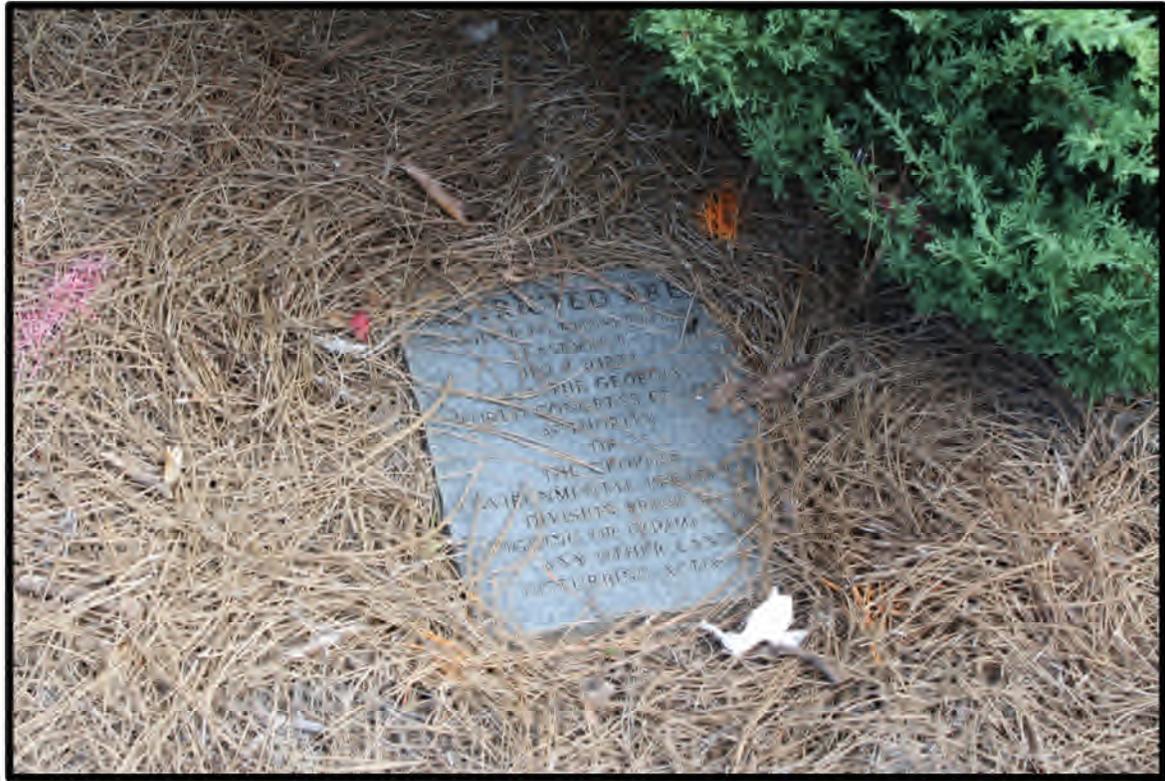
**OFFICIAL PHOTOGRAPH NO. 8
TETRA TECH**

Subject: Granite plaque on the western perimeter of the property.

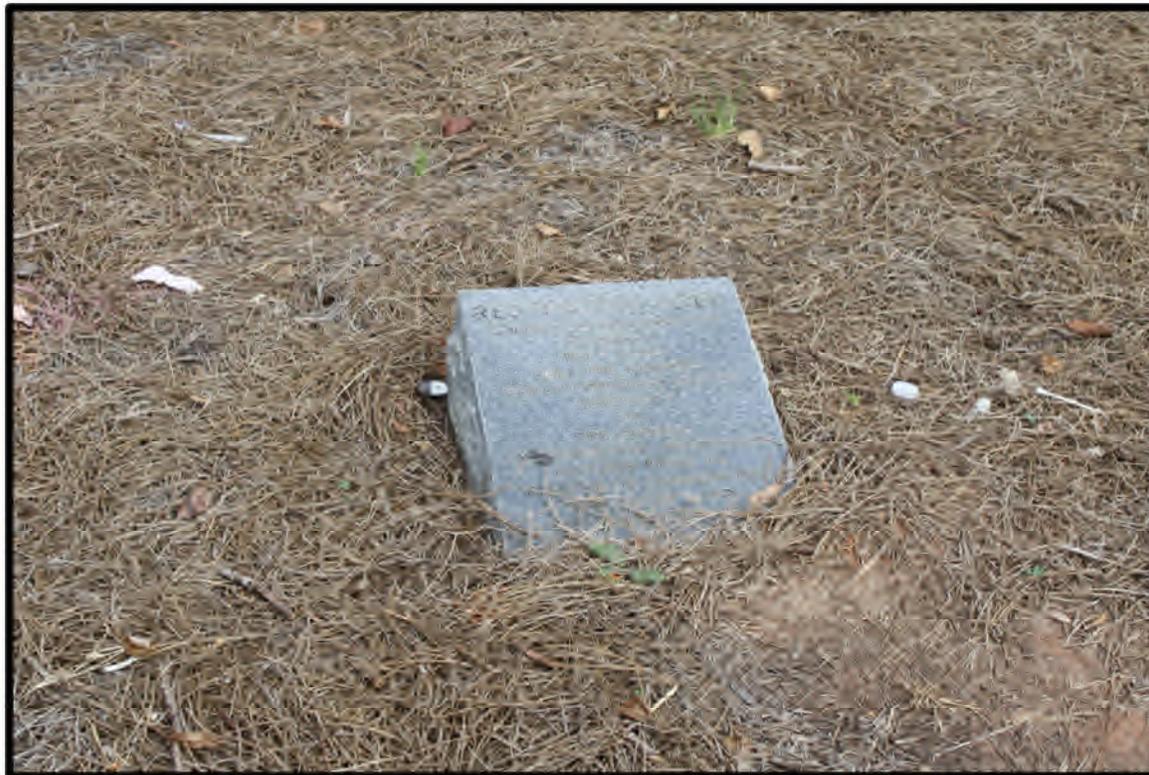
**OFFICIAL PHOTOGRAPH NO. 9
TETRA TECH**

Subject: Granite plaque on the southwestern perimeter of lot.

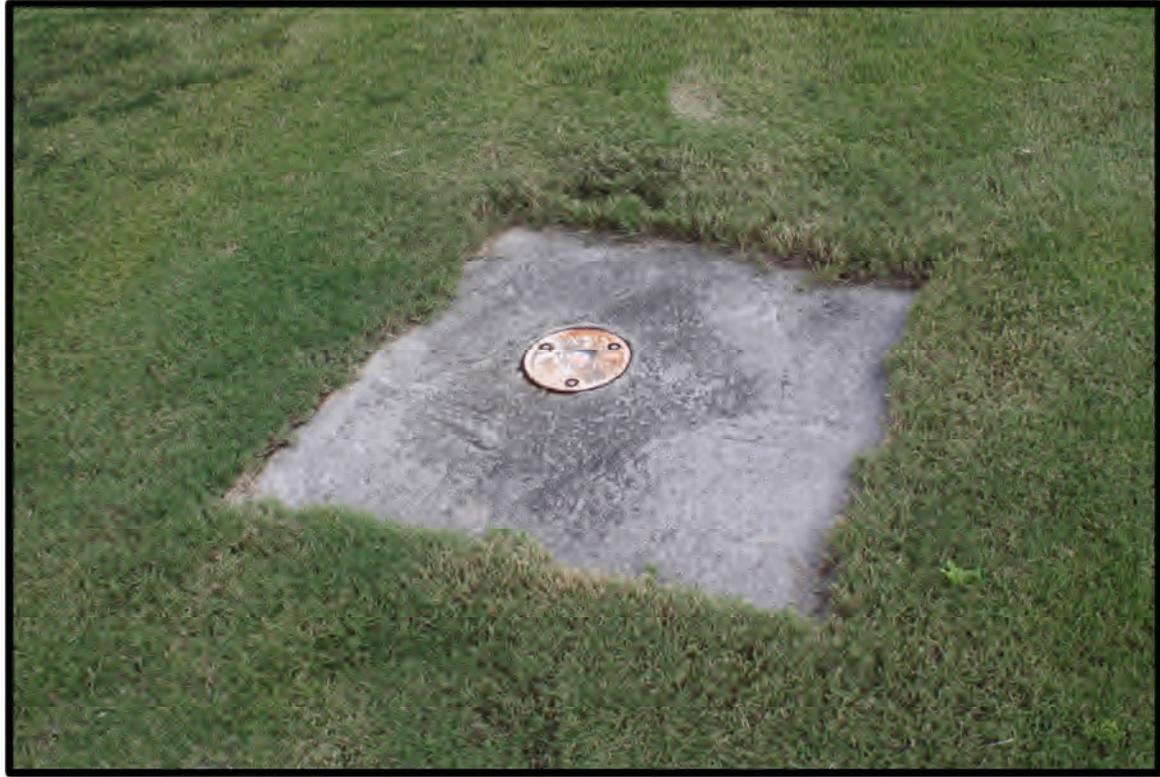
**OFFICIAL PHOTOGRAPH NO. 10
TETRA TECH**

Subject: Dewatering well at the northwest perimeter of the property.

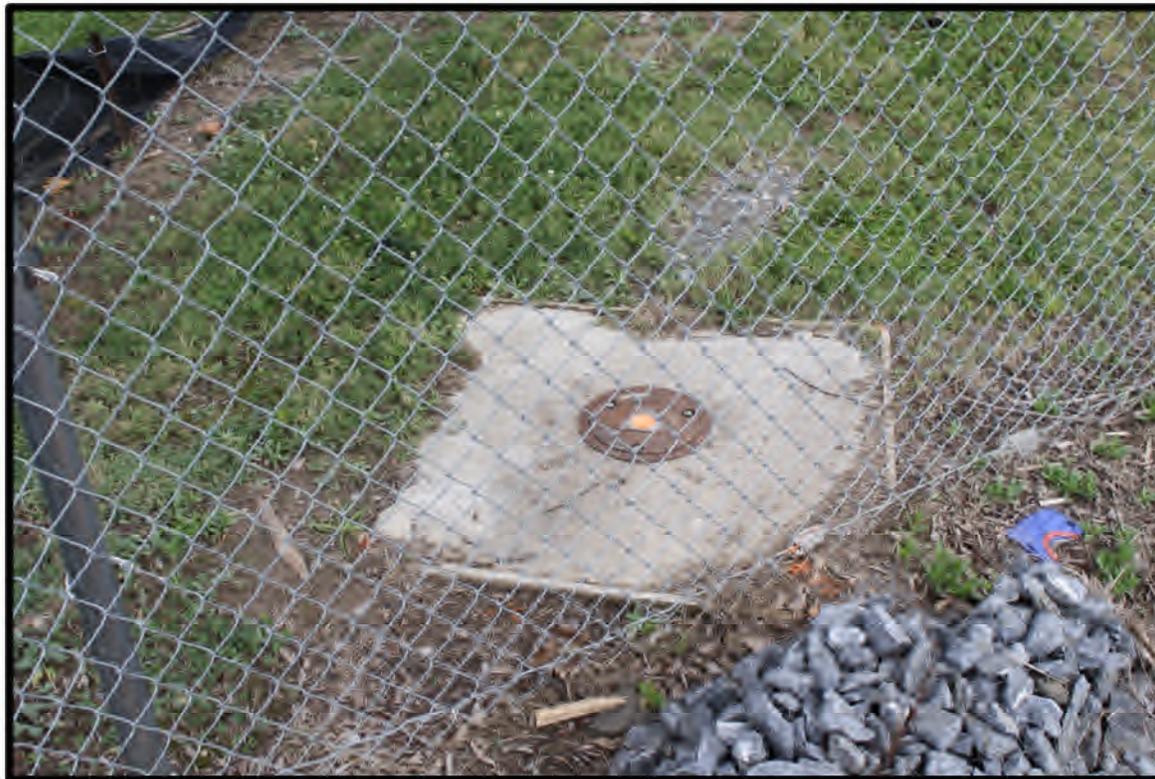
OFFICIAL PHOTOGRAPH NO. 11
TETRA TECH

Subject: Monitoring well, MM-02 at the corner of John Street and Northside Drive.

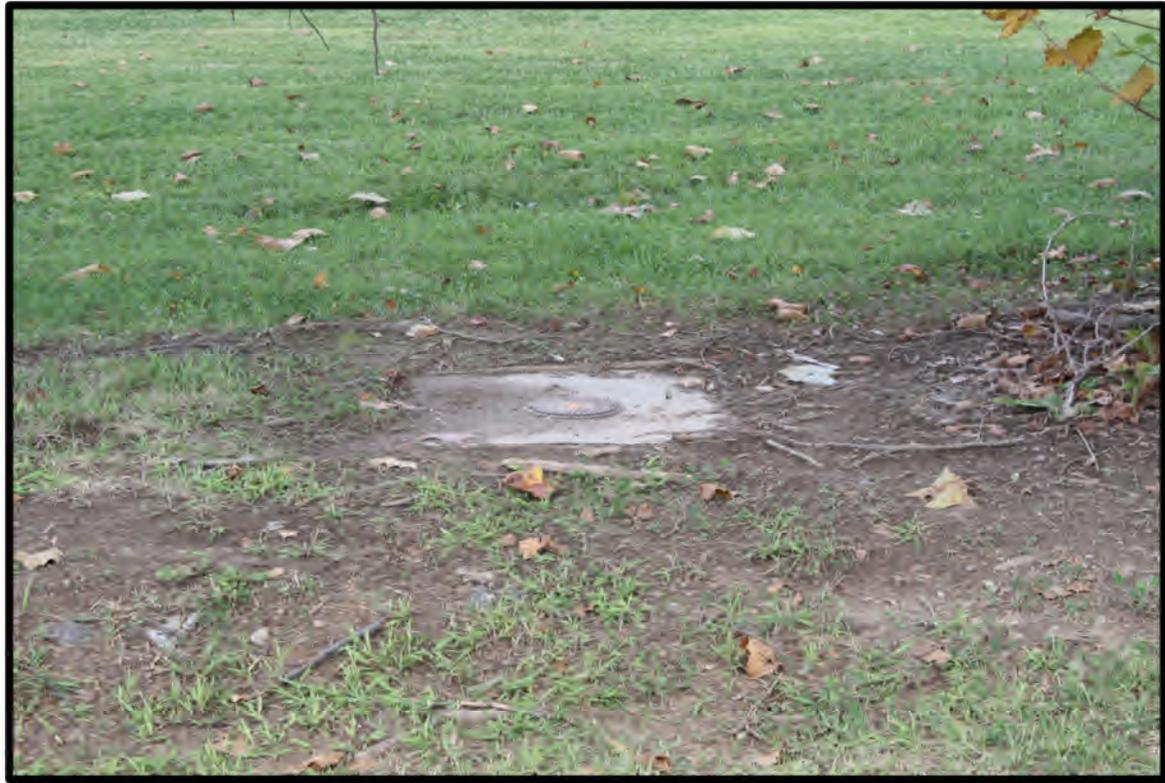
**OFFICIAL PHOTOGRAPH NO. 12
TETRA TECH**

Subject: Monitoring well, MWC-3C at the corner of John Street and Northside Drive.

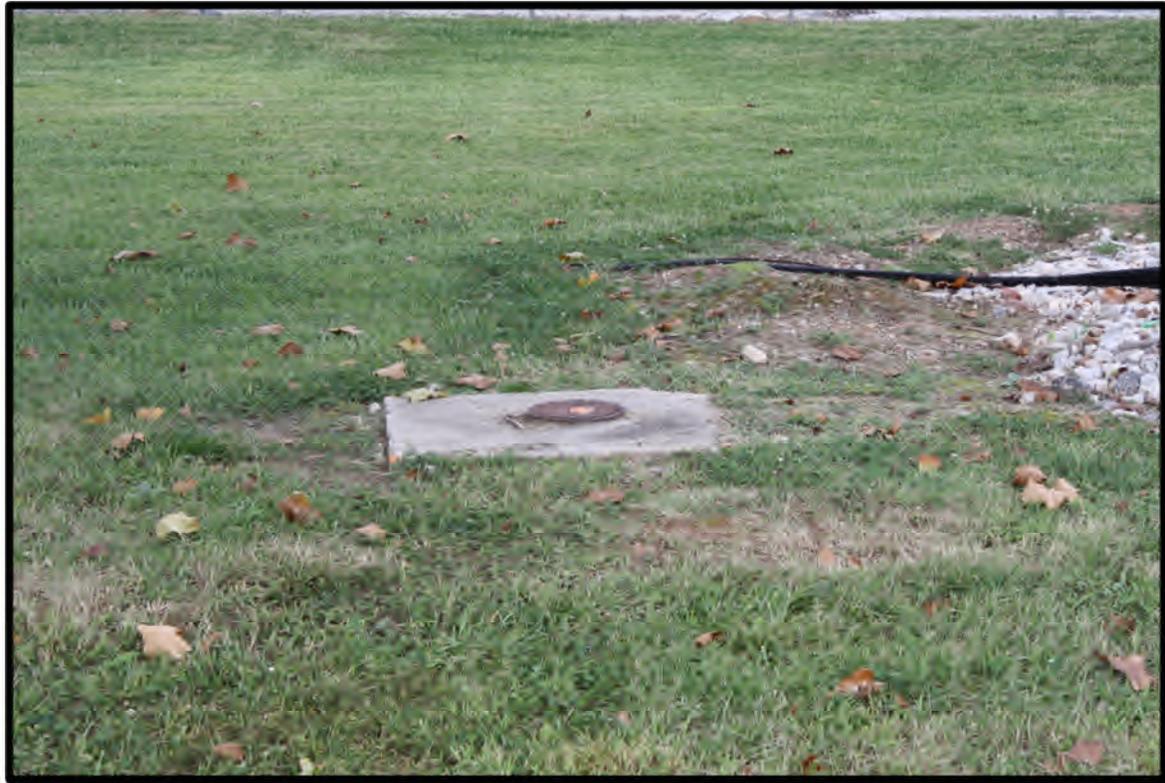
**OFFICIAL PHOTOGRAPH NO. 13
TETRA TECH**

Subject: Monitoring well, MWC-3B at the corner of John Street and Northside Drive.

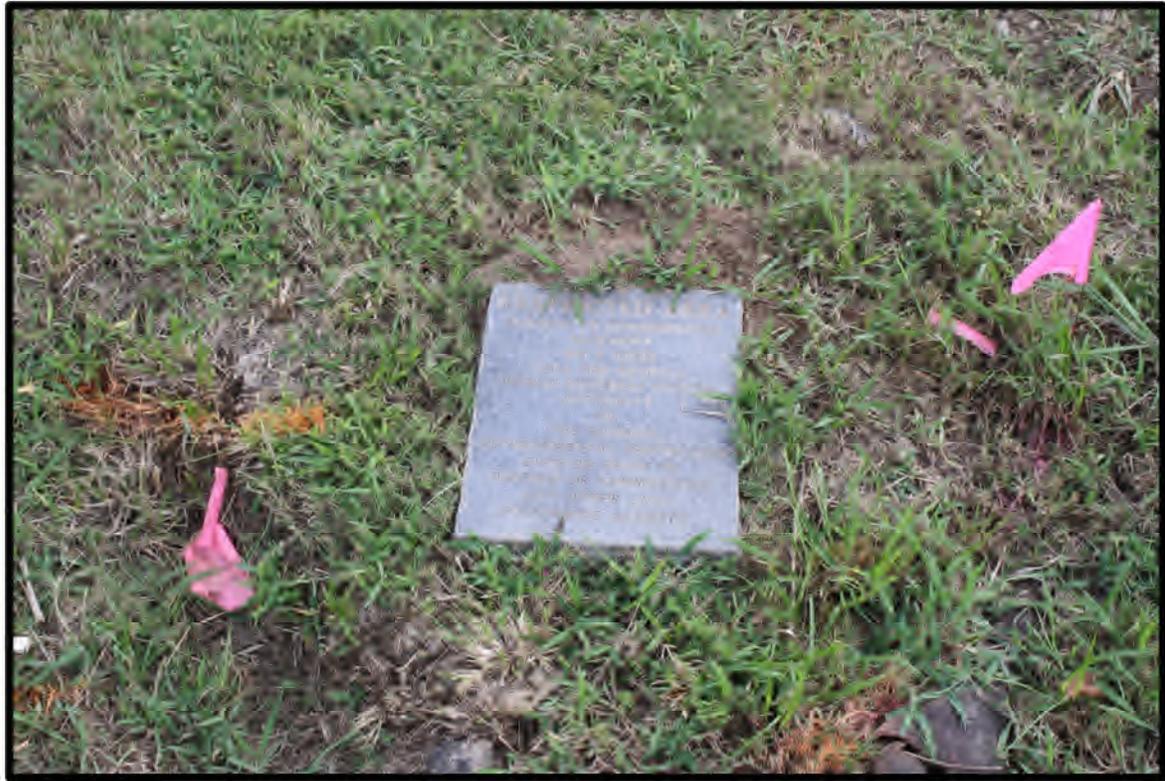
OFFICIAL PHOTOGRAPH NO. 14
TETRA TECH

Subject: Granite plaque on the northwestern perimeter of the property.

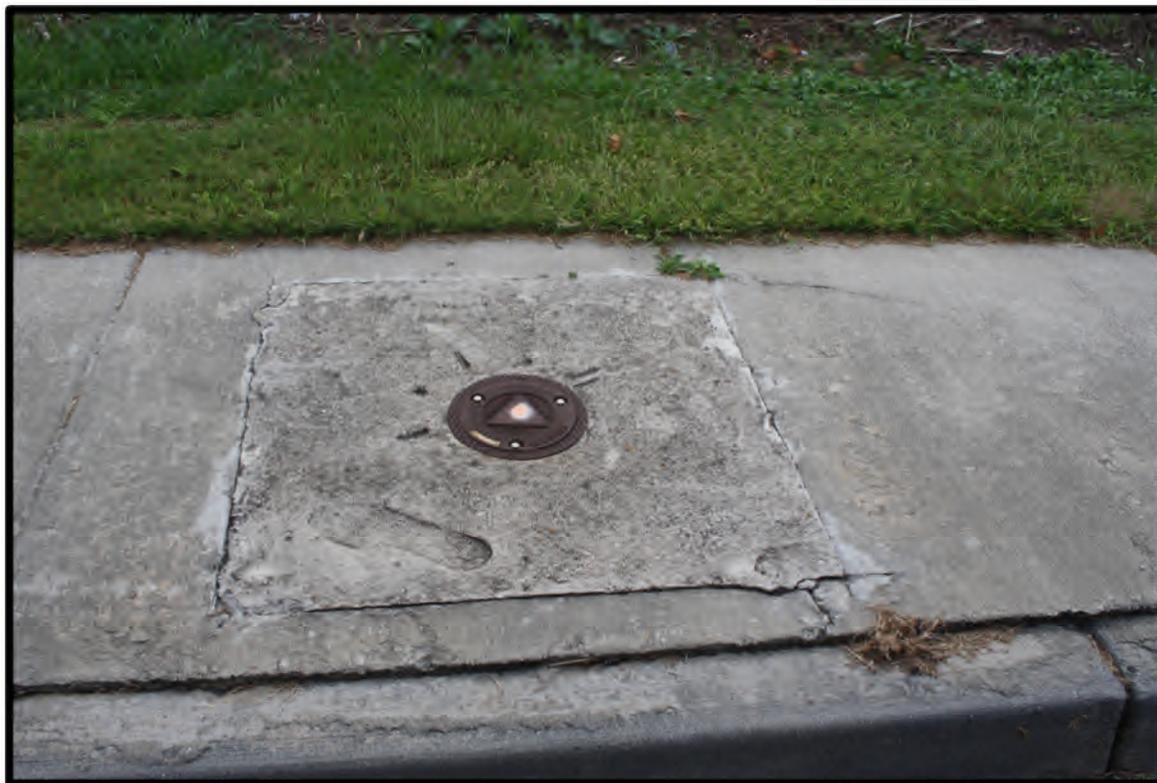
**OFFICIAL PHOTOGRAPH NO. 15
TETRA TECH**

Subject: Monitoring well, MM-03.

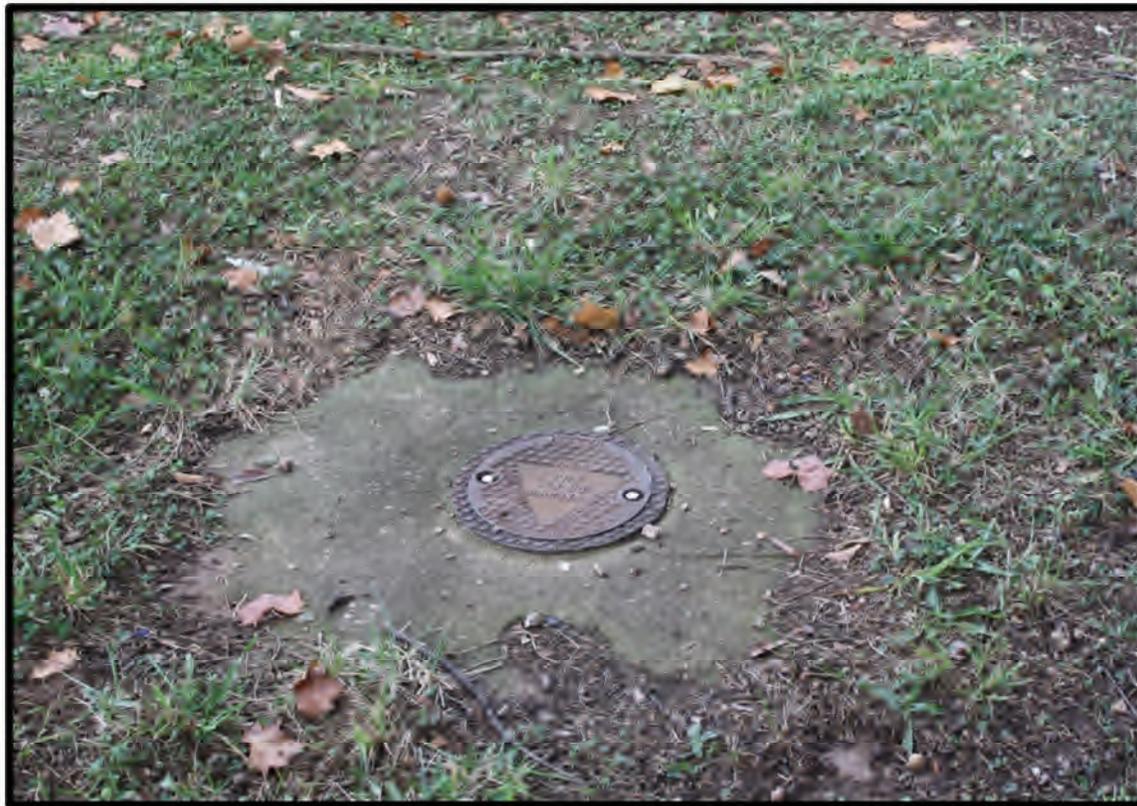
OFFICIAL PHOTOGRAPH NO. 16
TETRA TECH

Subject: Monitoring well, MWC-1A at the corner of John Street and Gray Street.

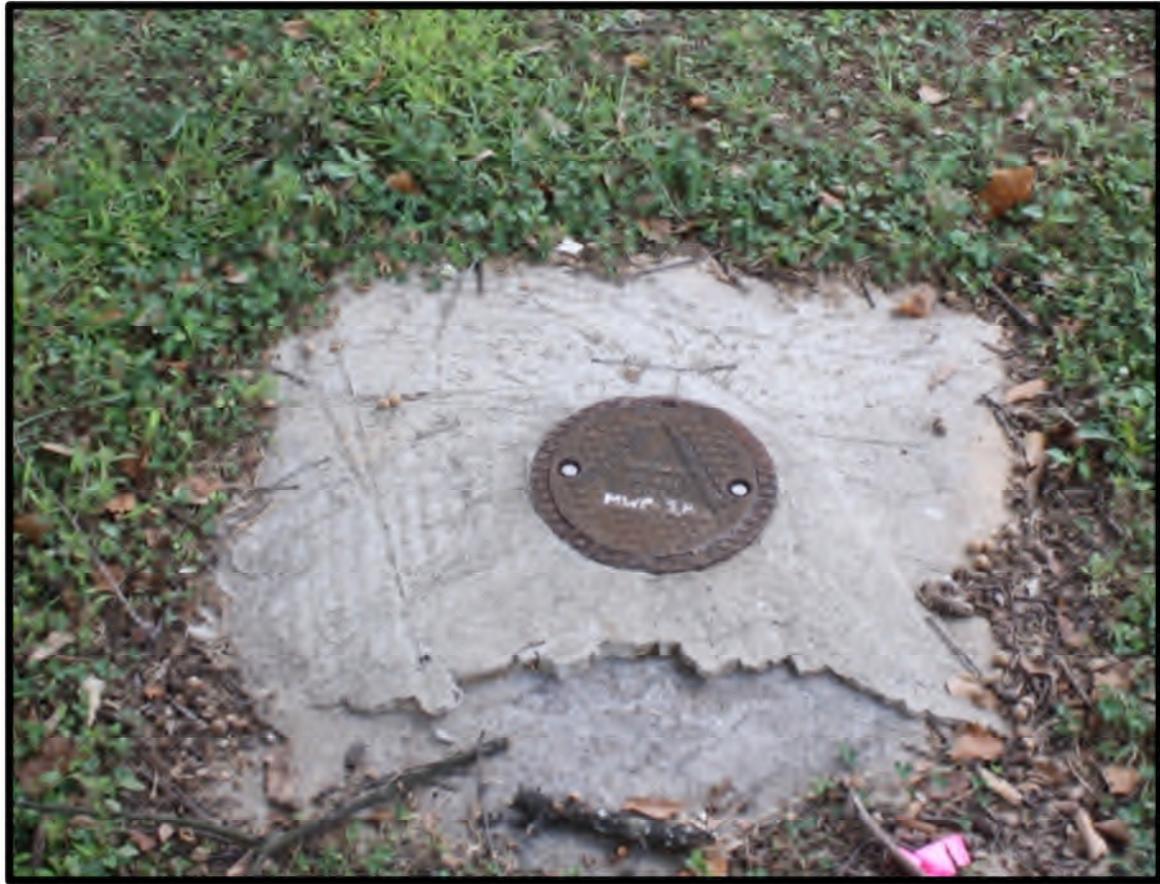
**OFFICIAL PHOTOGRAPH NO. 17
TETRA TECH**

Subject: Monitoring well, MWC-1B at the corner of John Street and Gray Street.

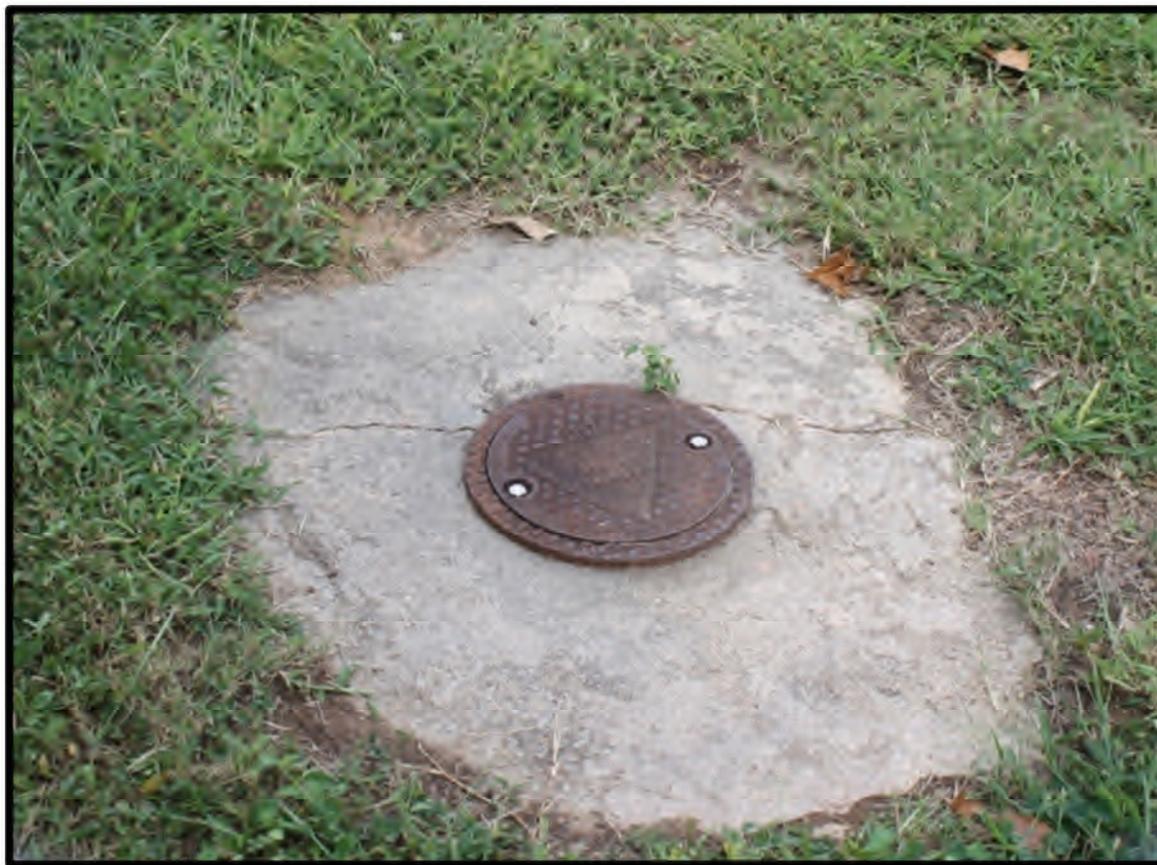
**OFFICIAL PHOTOGRAPH NO. 18
TETRA TECH**

Subject: Monitoring well, MWC-1C at the corner of John Street and Gray Street.

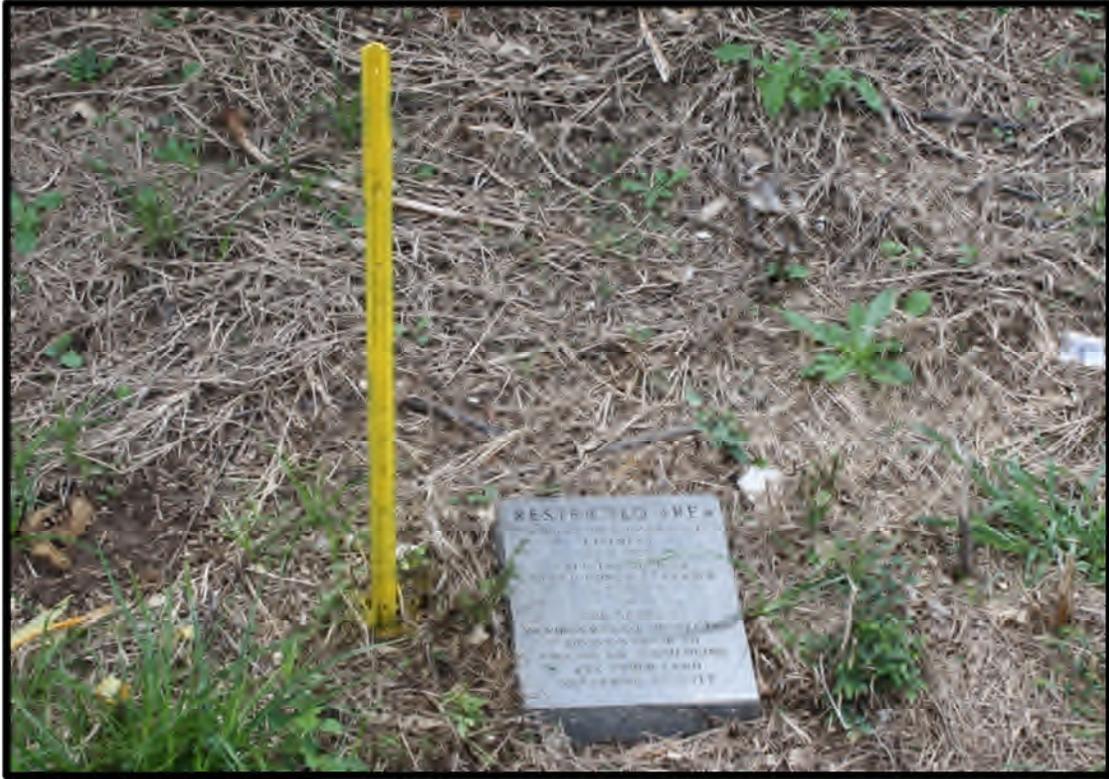
**OFFICIAL PHOTOGRAPH NO. 19
TETRA TECH**

Subject: Granite plaque on the north perimeter of the property.

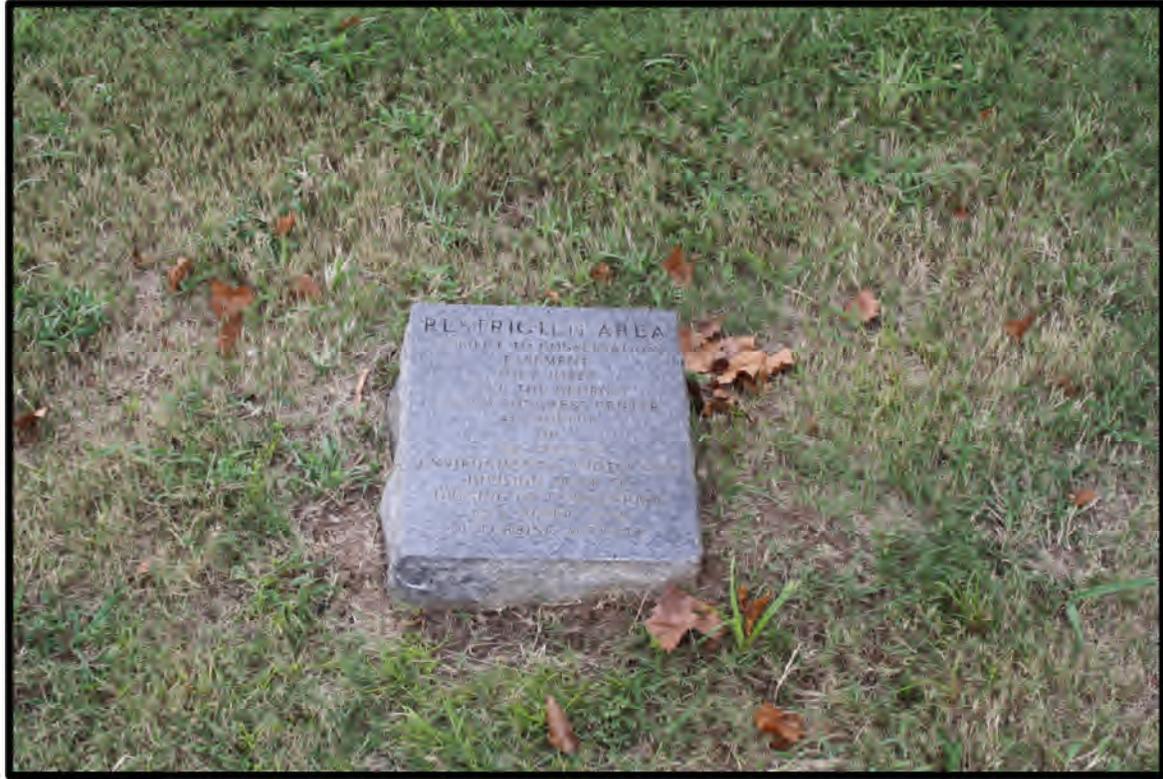
**OFFICIAL PHOTOGRAPH NO. 20
TETRA TECH**

Subject: Granite plaque on the northeastern corner of the property.

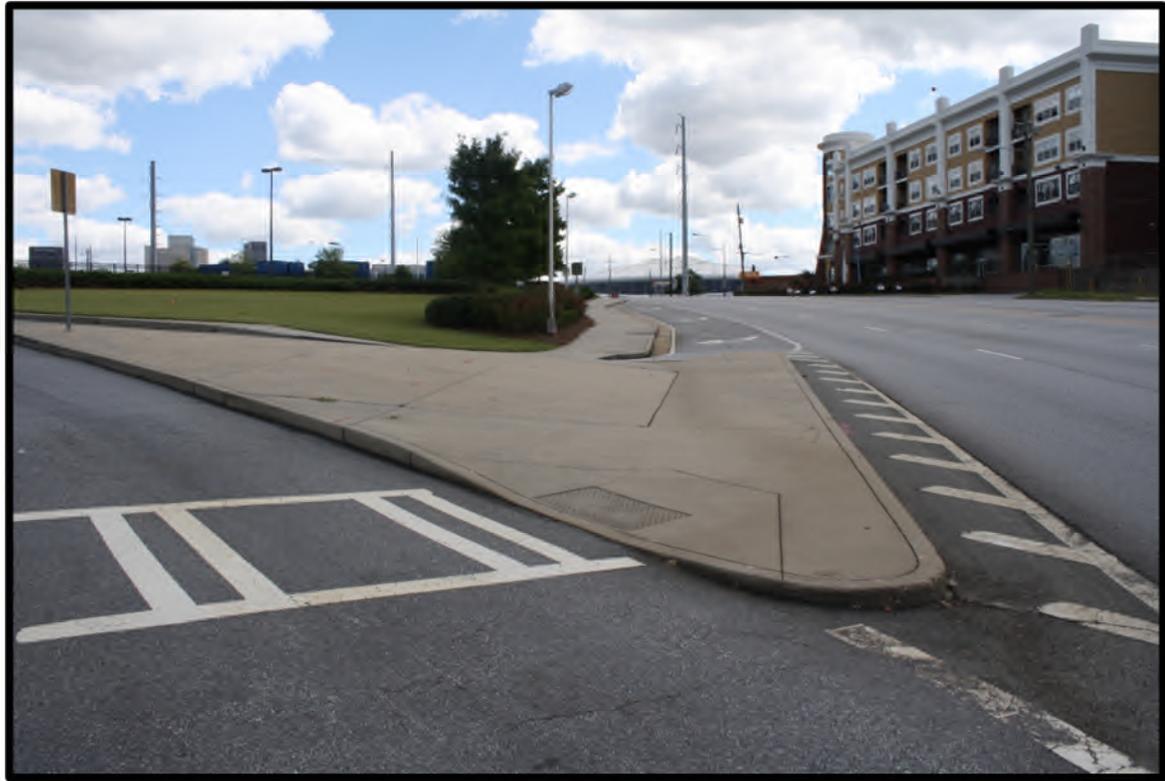
OFFICIAL PHOTOGRAPH NO. 21
TETRA TECH

Subject: Concrete median at the intersection of Northside Drive and John Street.

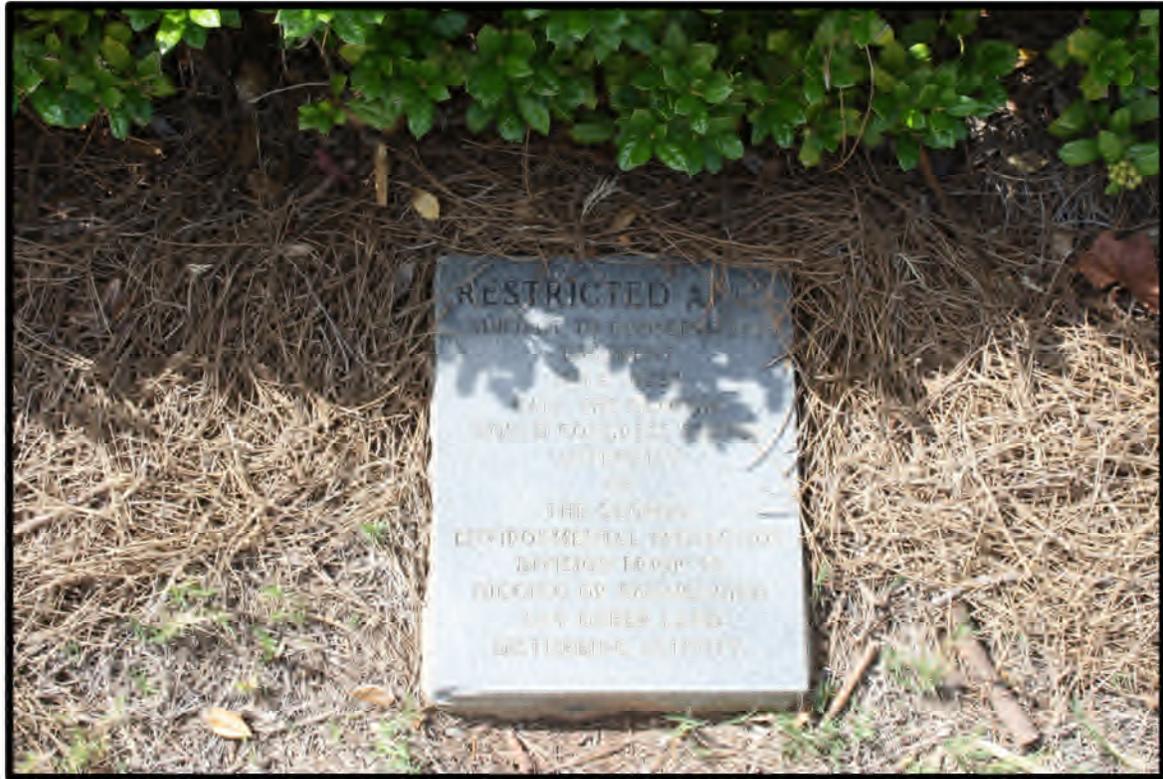
OFFICIAL PHOTOGRAPH NO. 22
TETRA TECH

Subject: Granite plaque on the eastern perimeter of the property.

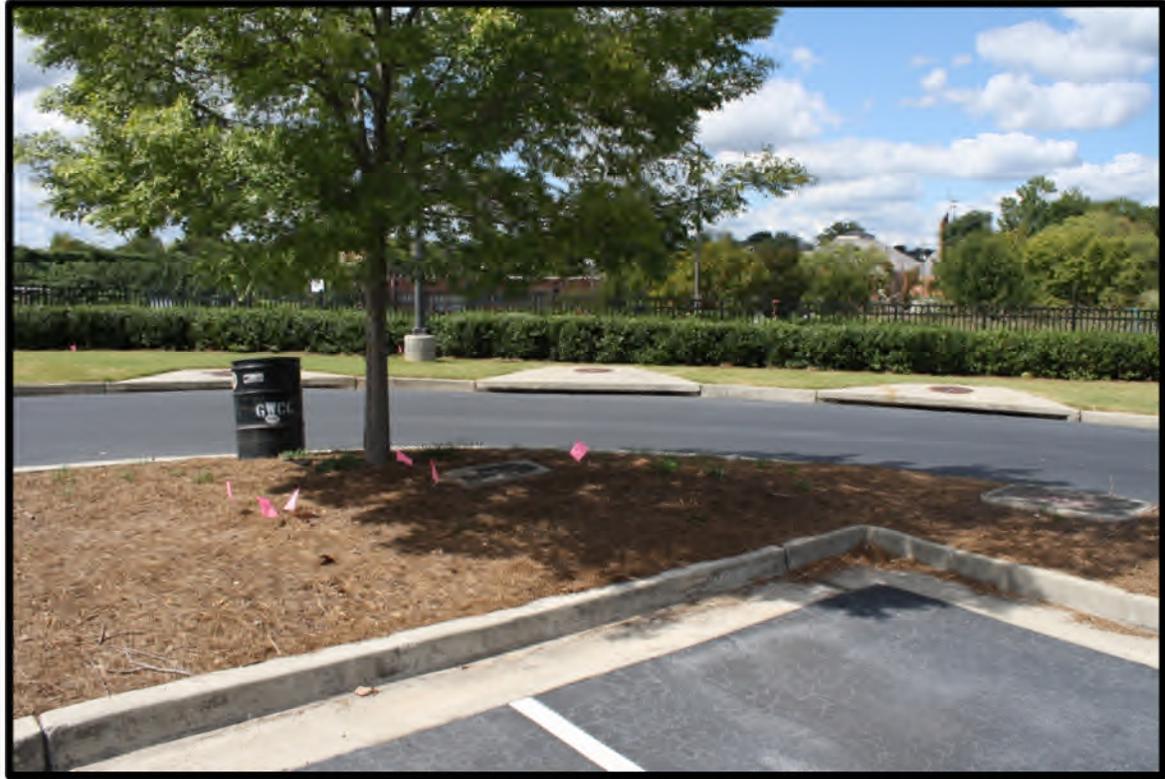
**OFFICIAL PHOTOGRAPH NO. 24
TETRA TECH**

Subject: Stormwater drains located at the northwest parking lot perimeter.

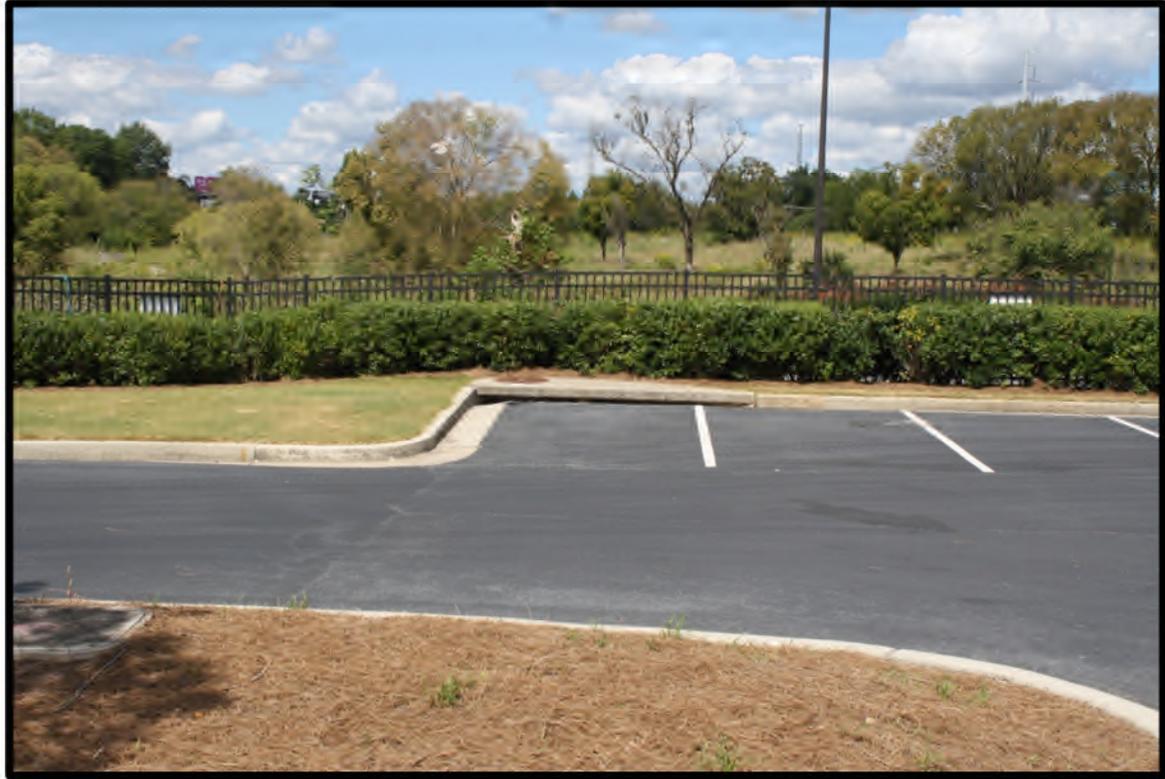
**OFFICIAL PHOTOGRAPH NO. 25
TETRA TECH**

Subject: Stormwater drain located at the northwest parking lot perimeter.
