SUPPORTING THE GEORGIA WORLD CONGRESS CENTER

February 14, 2014

**Subject: Quarters-38/39 Landfill Maintenance and Inspection Report
 Northside Drive Landfill Site, Atlanta, Georgia**

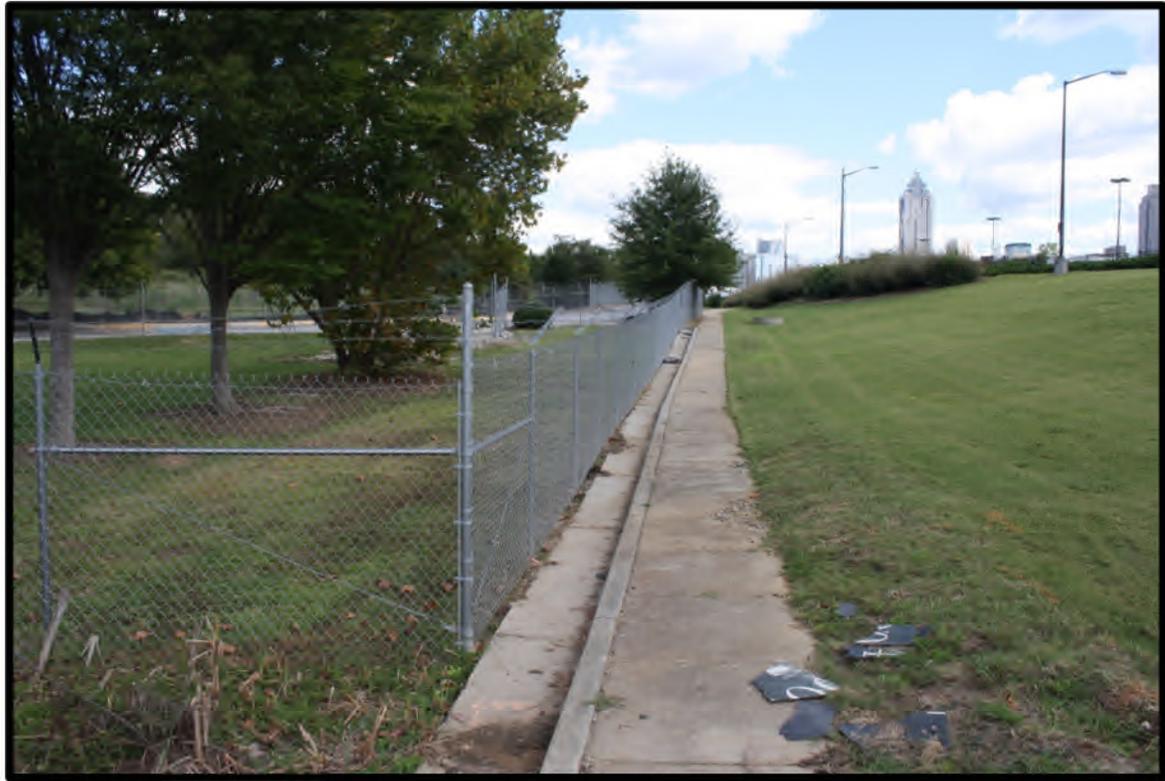
**OFFICIAL PHOTOGRAPH NO. 32
TETRA TECH**

Subject: Monitoring wells, MM-02, MWC-3B and MWC-3C are inside the fence line between the trees.

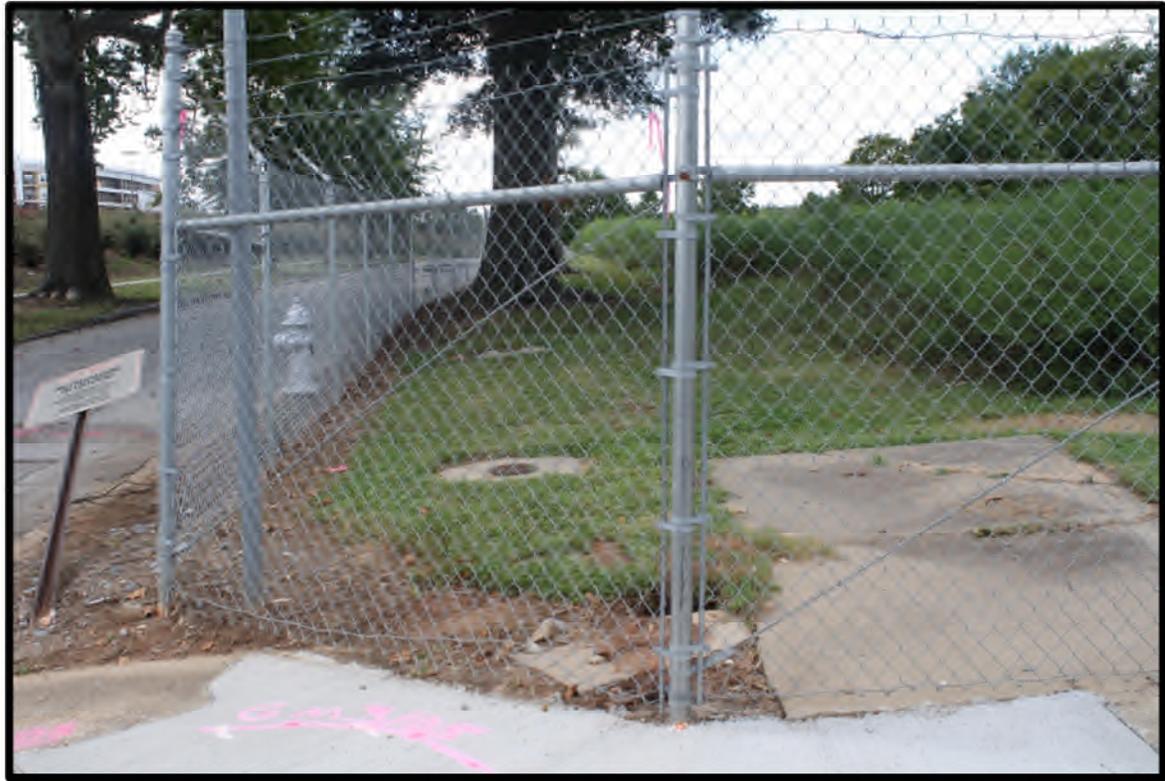
**OFFICIAL PHOTOGRAPH NO. 33
TETRA TECH**

Subject: Monitoring wells, MW-1A, MW-1B and MW-1C at the corner of John Street and Gray Street.

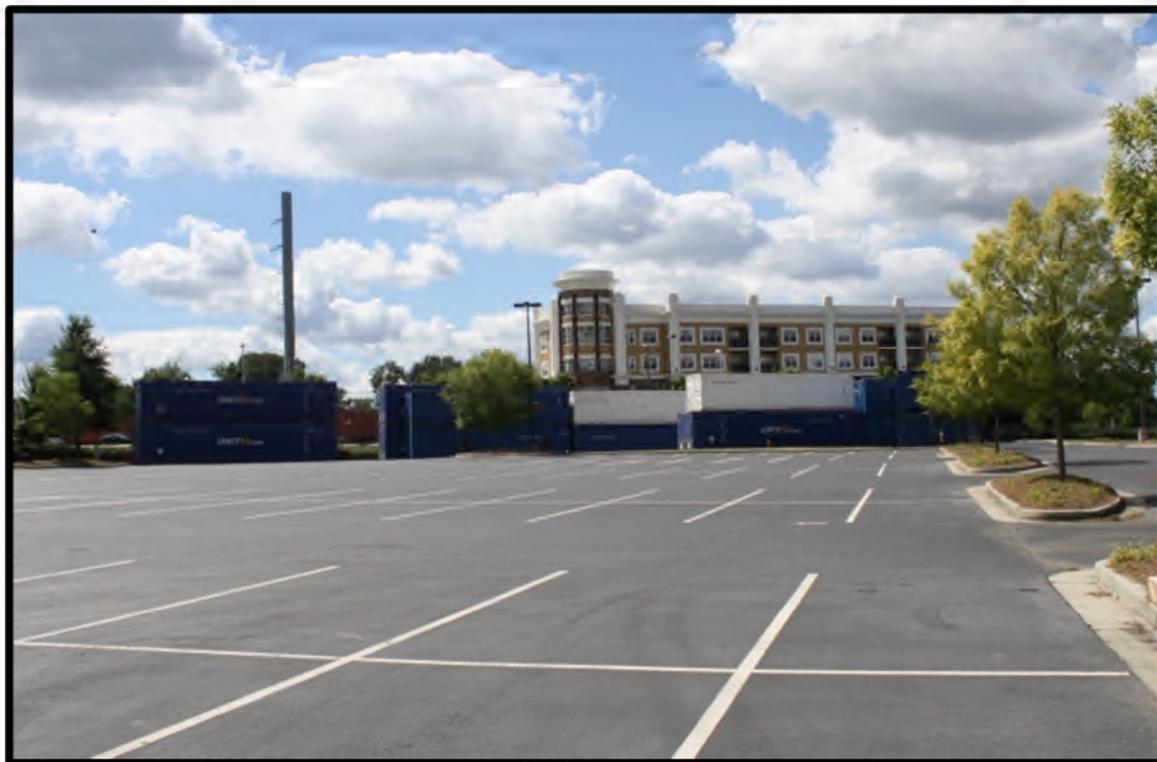
**OFFICIAL PHOTOGRAPH NO. 41
TETRA TECH**

During both the September and December 2013 inspections, Tetra Tech observed a number of sea-land shipping containers placed at the western end of the parking lot, adjacent to Northside Drive. The containers, shown in photograph 41 of the respective photographic logs, are located at the edge of the parking area, outside the limits of the slurry wall and no damage to the parking lot or landscaping structures was observed during our inspections. As shown in photograph 26A in each photographic log, the containers have been placed so that the storm drain present at that location is not blocked.

Subject: Cargo containers stored along the western side of the parking lot.

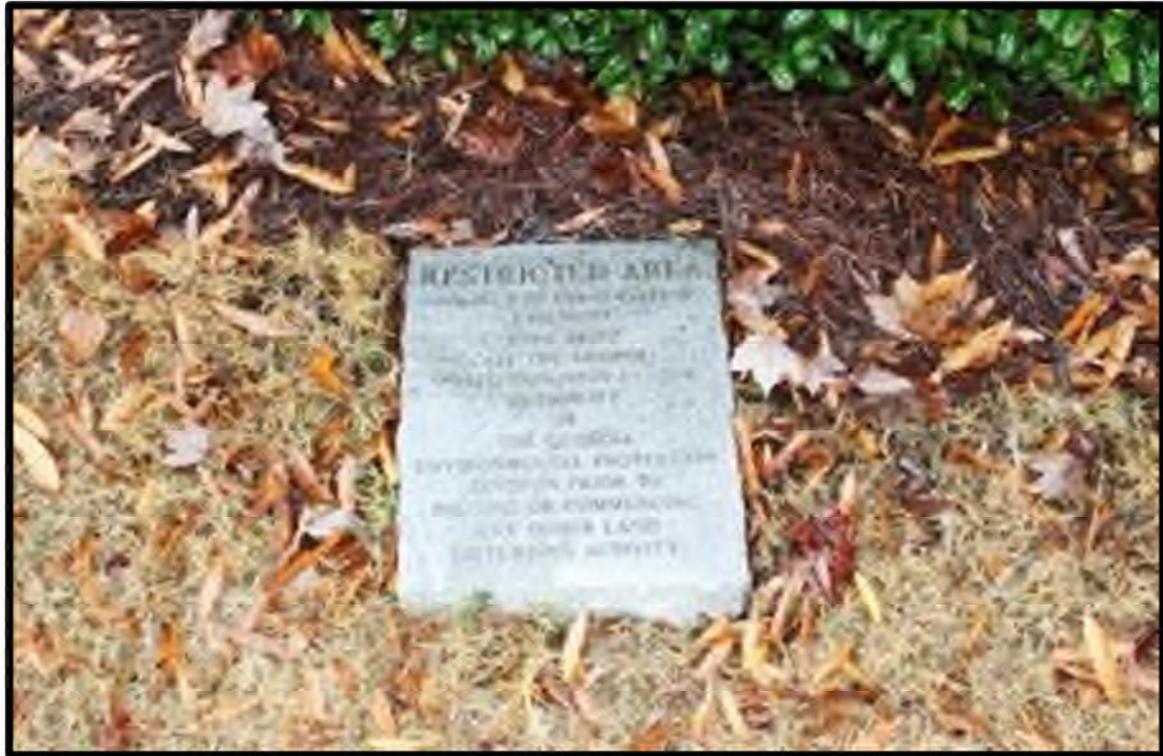
**OFFICIAL PHOTOGRAPH NO. 1
TETRA TECH**

Subject: Granite plaque located on the east, southeast side of the north parking lot perimeter.

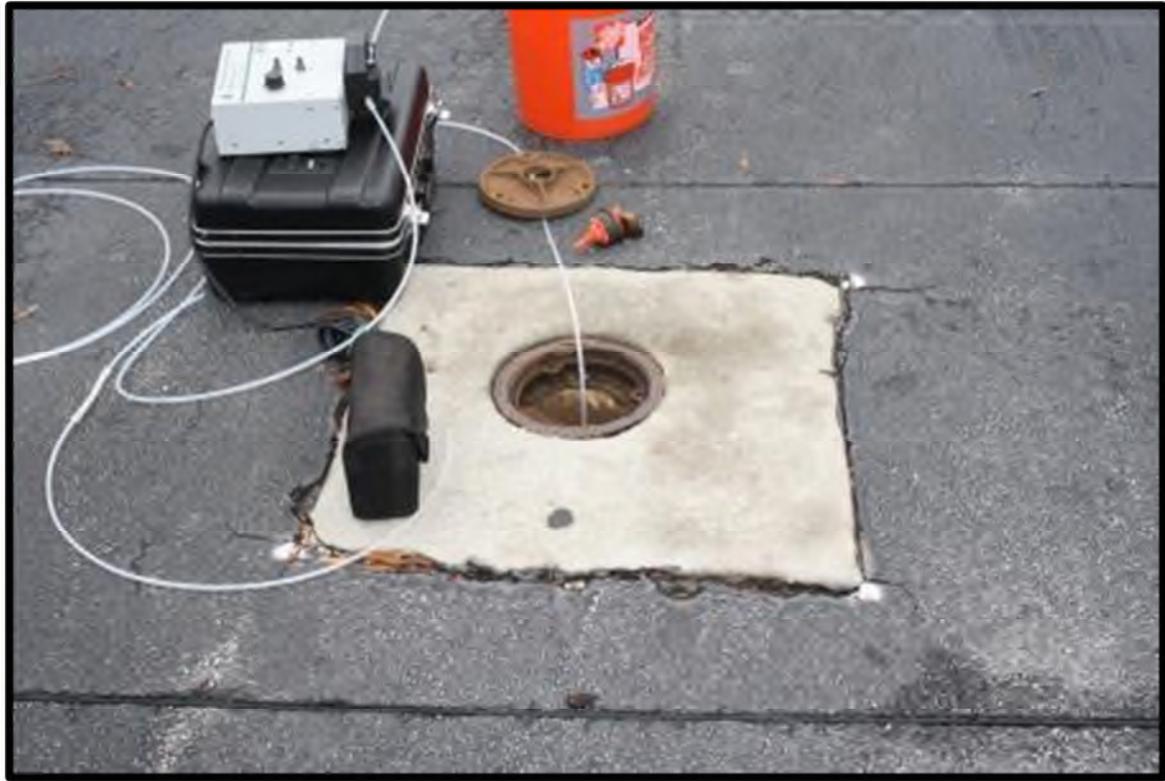
**OFFICIAL PHOTOGRAPH NO. 2
TETRA TECH**

Subject: Background monitoring well, MM-04.

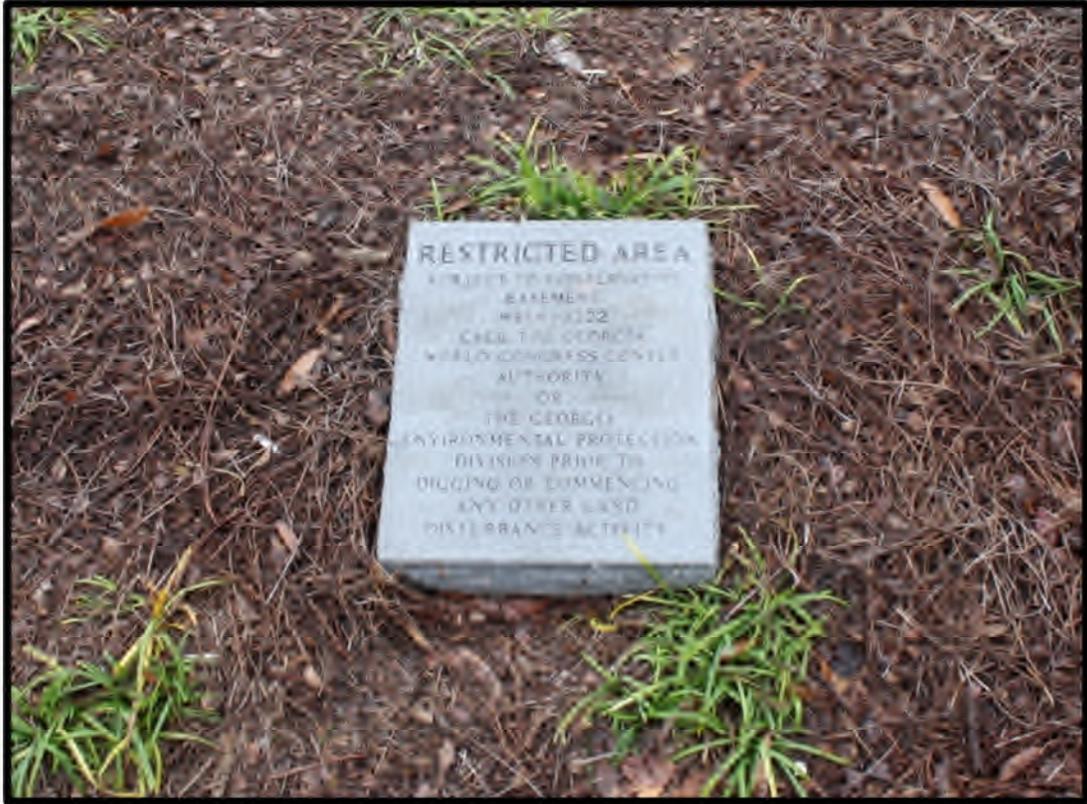
**OFFICIAL PHOTOGRAPH NO. 3
TETRA TECH**

Subject: Granite plaque on the southeast corner of the property.

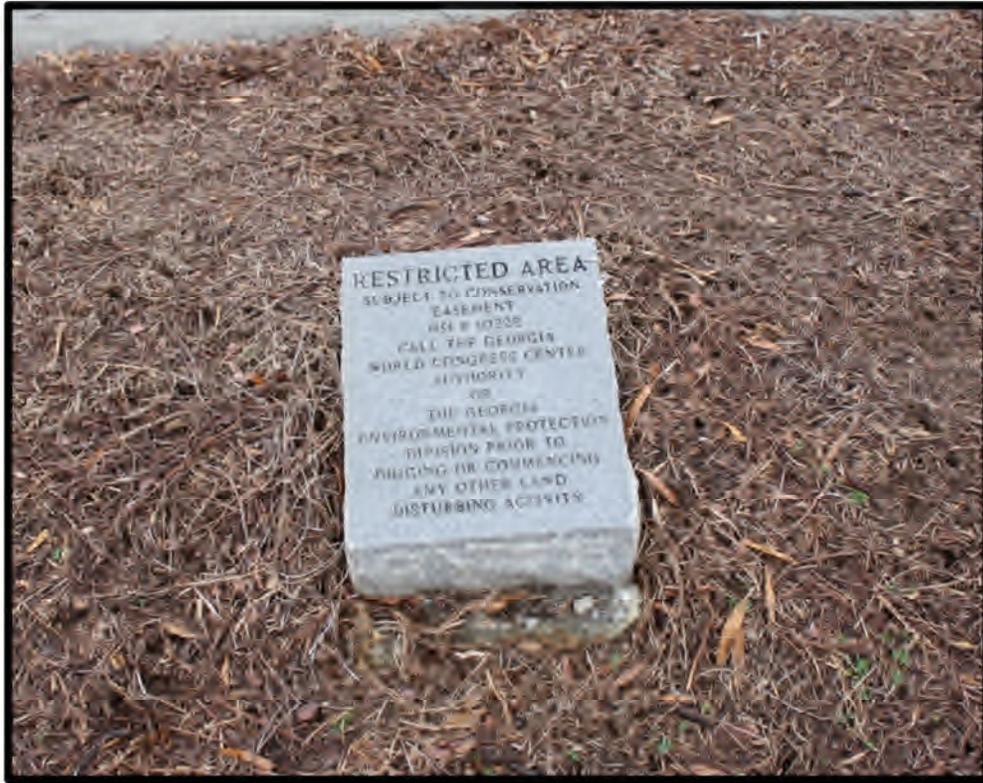
**OFFICIAL PHOTOGRAPH NO. 4
TETRA TECH**

Subject: Granite plaque on the south side of the property.

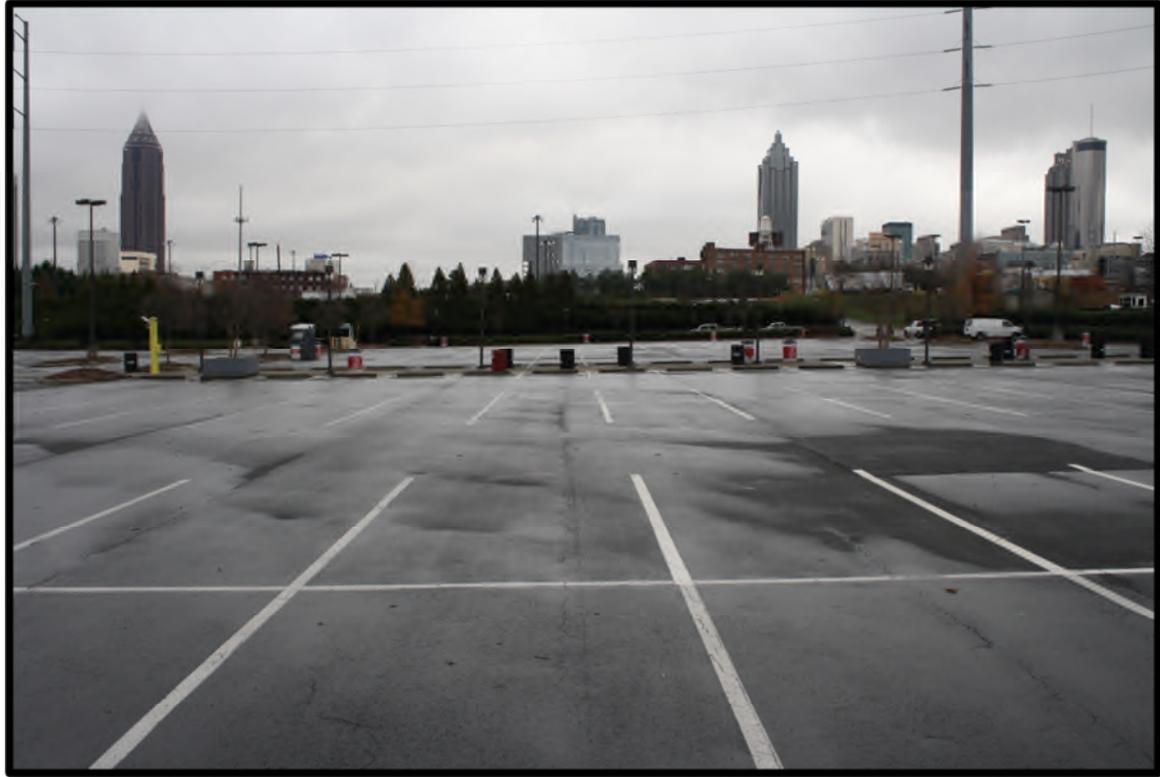
**OFFICIAL PHOTOGRAPH NO. 5
TETRA TECH**

Subject: Eastern portion of the lot looking northeast.

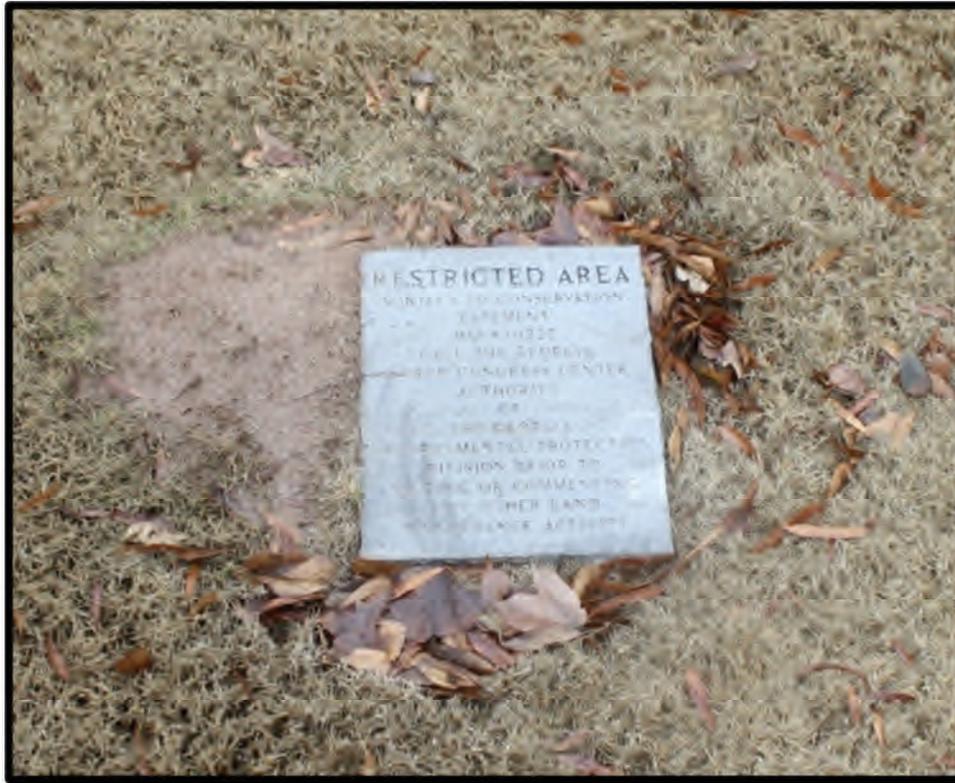
**OFFICIAL PHOTOGRAPH NO. 6
TETRA TECH**

Subject: Granite plaque on the northeastern perimeter of the property.

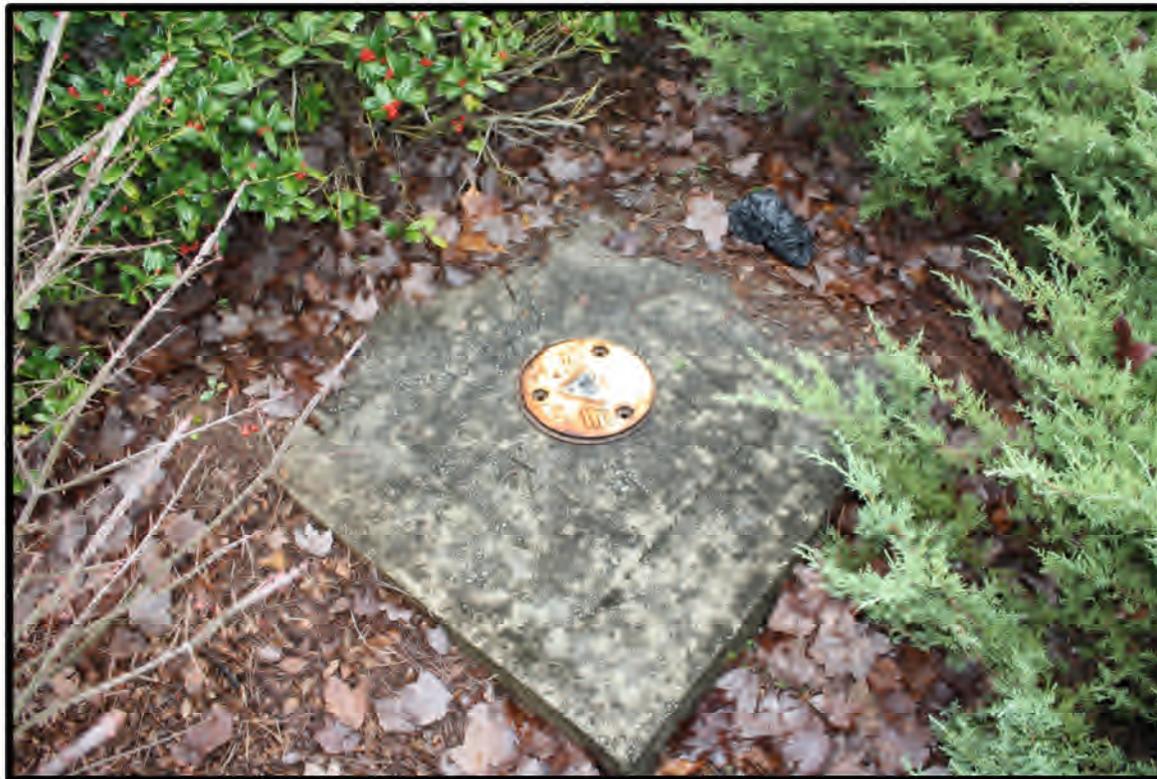
**OFFICIAL PHOTOGRAPH NO. 7
TETRA TECH**

Subject: Monitoring well, MM-01.

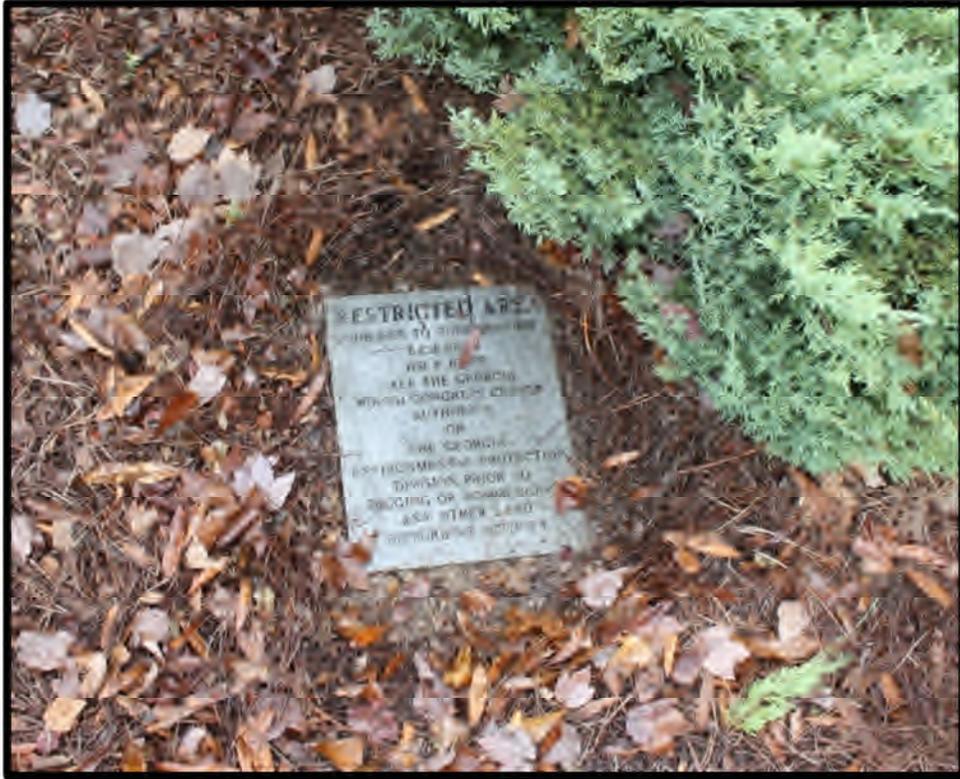
**OFFICIAL PHOTOGRAPH NO. 8
TETRA TECH**

Subject: Granite plaque on the western perimeter of the property.

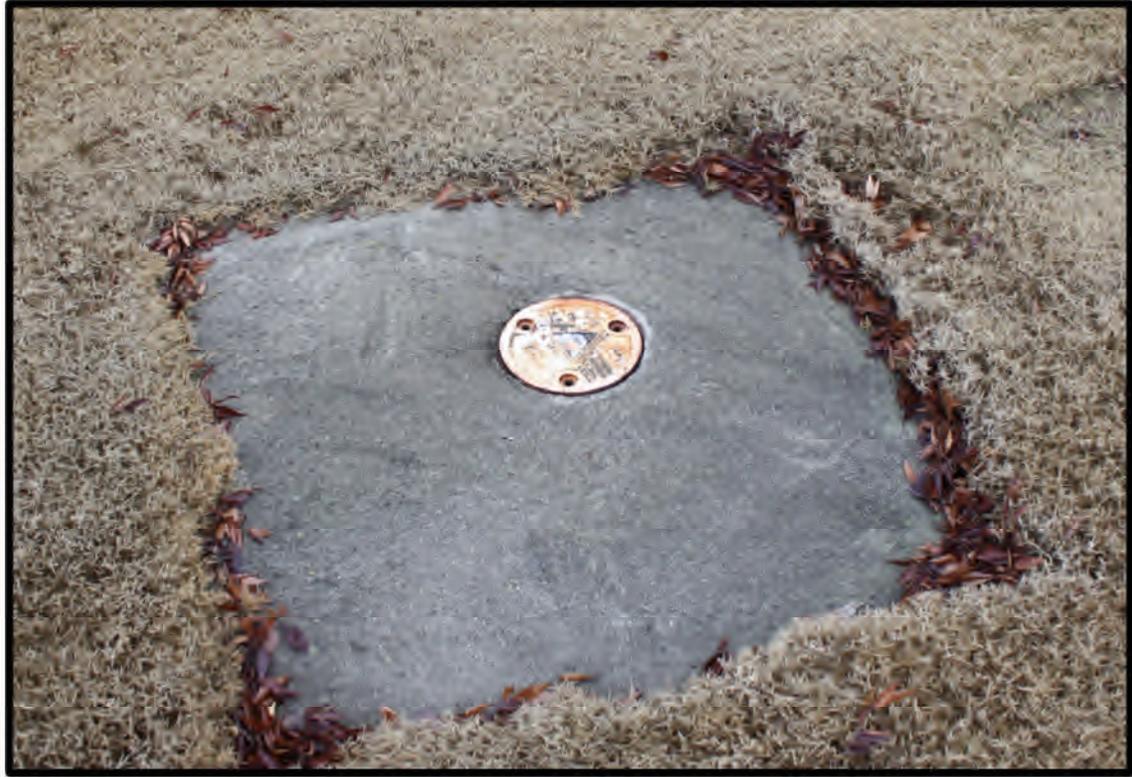
**OFFICIAL PHOTOGRAPH NO. 10
TETRA TECH**

Subject: Dewatering well at the northwest perimeter of the property.

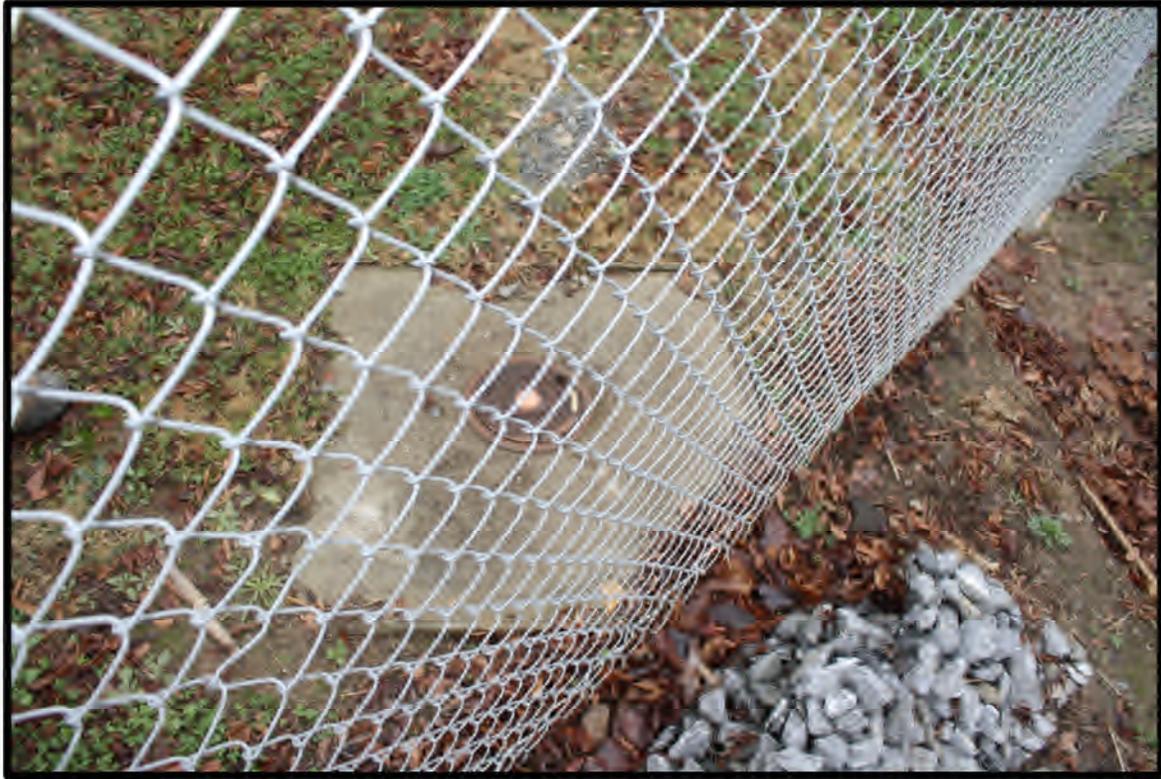
**OFFICIAL PHOTOGRAPH NO. 11
TETRA TECH**

Subject: Monitoring well, MM-02 at the corner of John Street and Northside Drive.

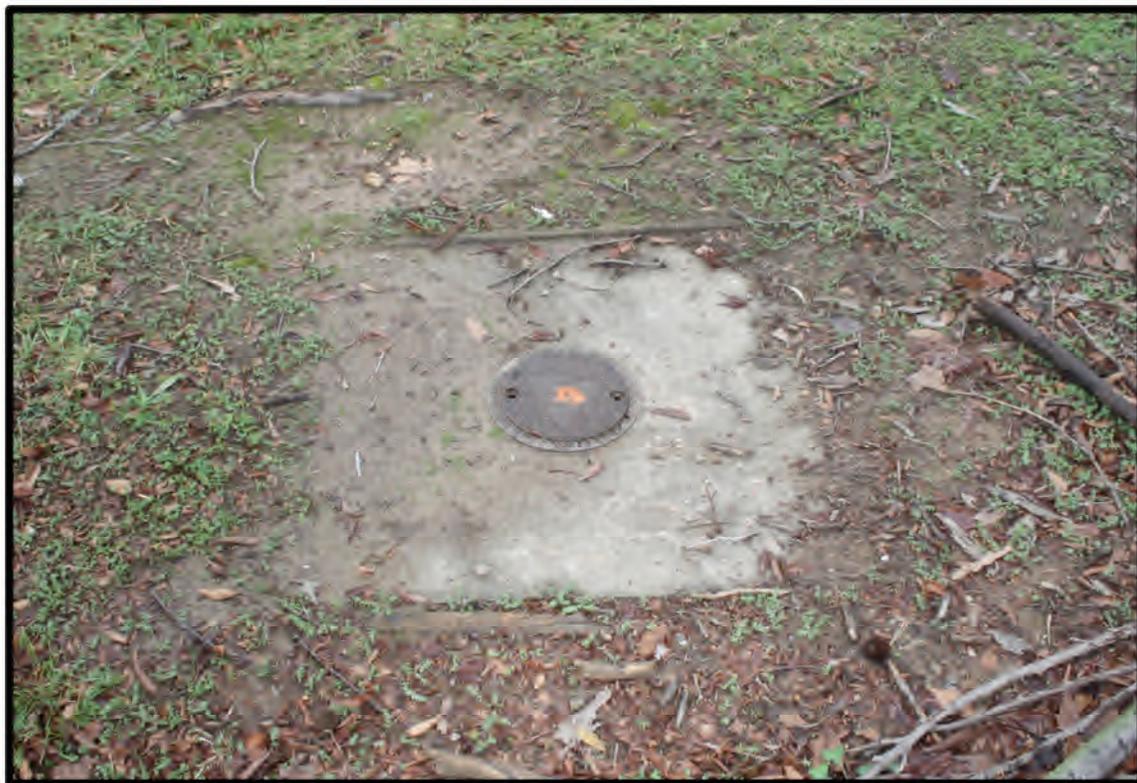
**OFFICIAL PHOTOGRAPH NO. 12
TETRA TECH**

Subject: Monitoring well, MWC-3C at the corner of John Street and Northside Drive.

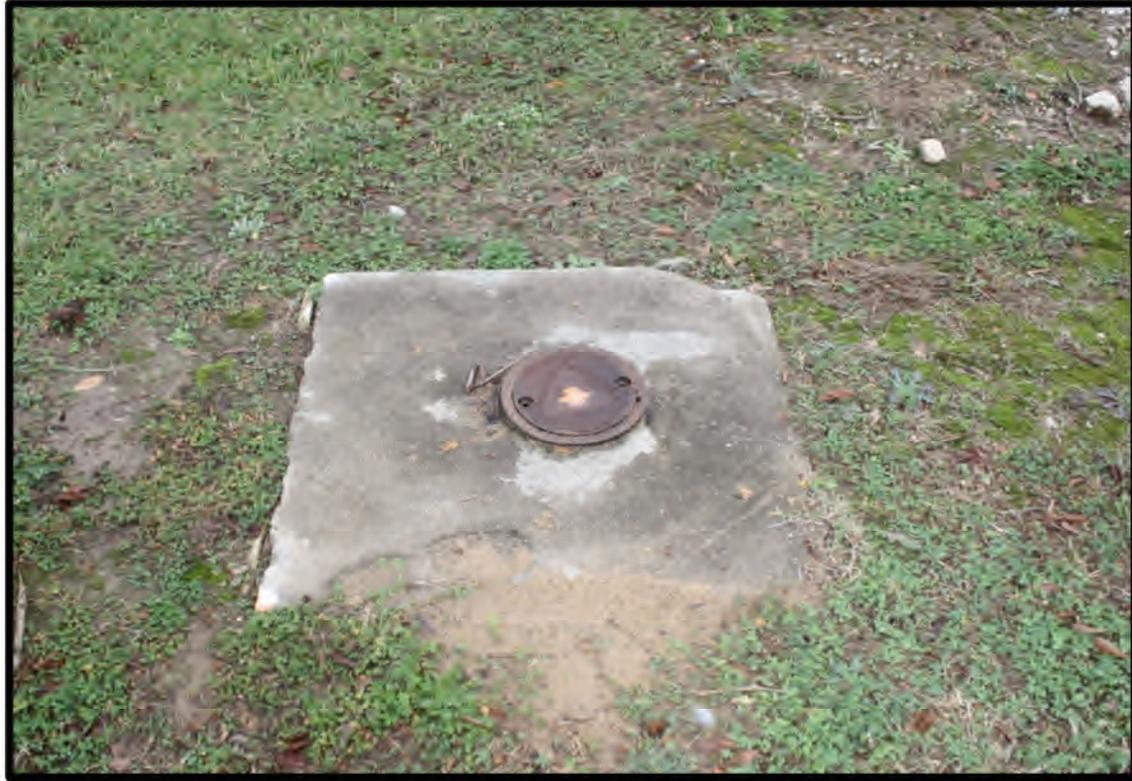
OFFICIAL PHOTOGRAPH NO. 13
TETRA TECH

Subject: Monitoring well, MWC-3B at the corner of John Street and Northside Drive.

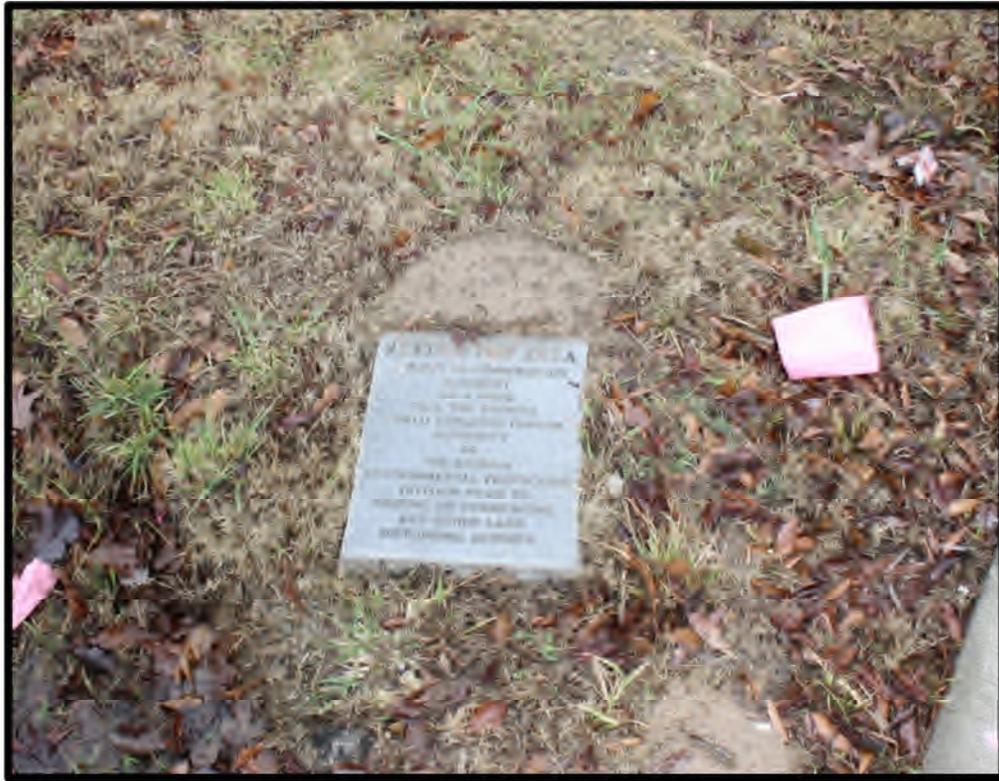
**OFFICIAL PHOTOGRAPH NO. 14
TETRA TECH**

Subject: Granite plaque on the northwestern perimeter of the property.

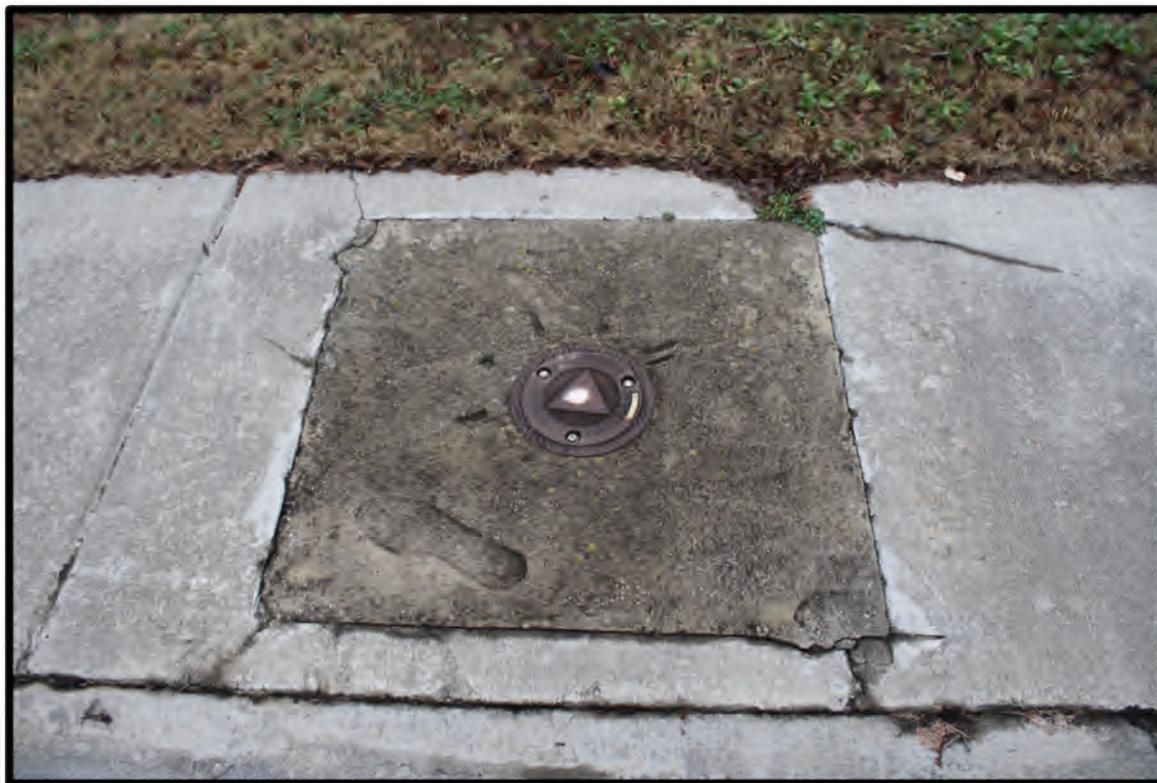
**OFFICIAL PHOTOGRAPH NO. 15
TETRA TECH**

Subject: Monitoring well, MM-03.

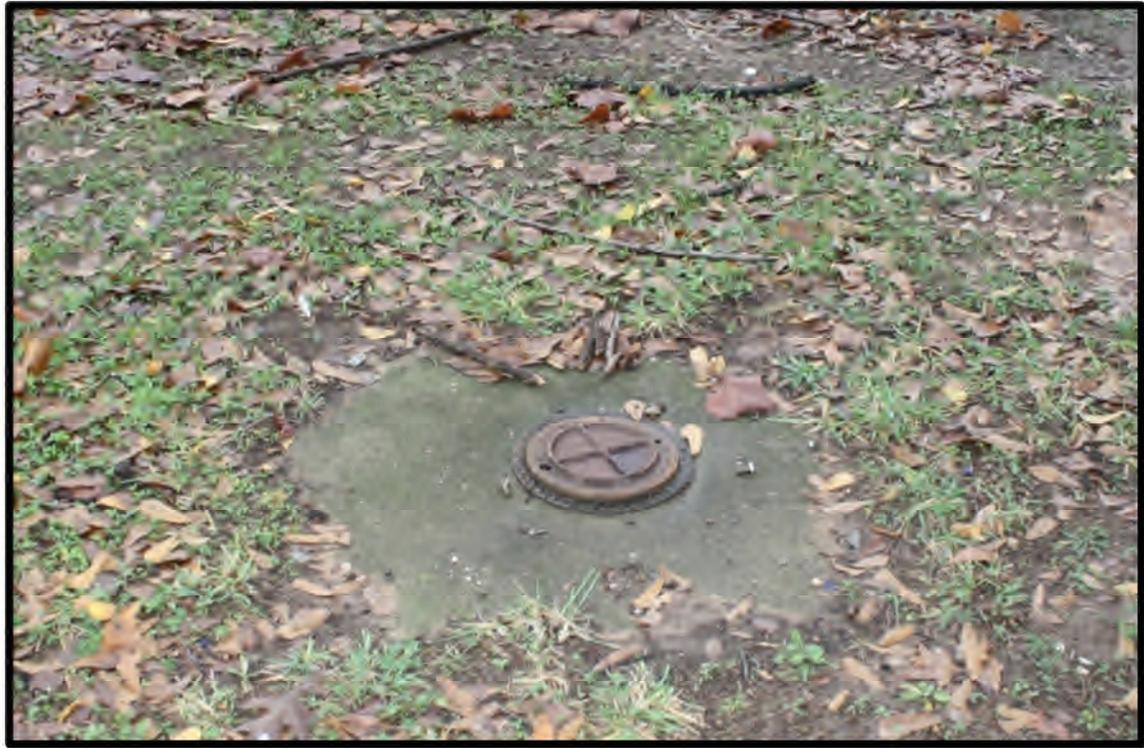
OFFICIAL PHOTOGRAPH NO. 16
TETRA TECH

Subject: Monitoring well, MWC-1A at the corner of John Street and Gray Street.

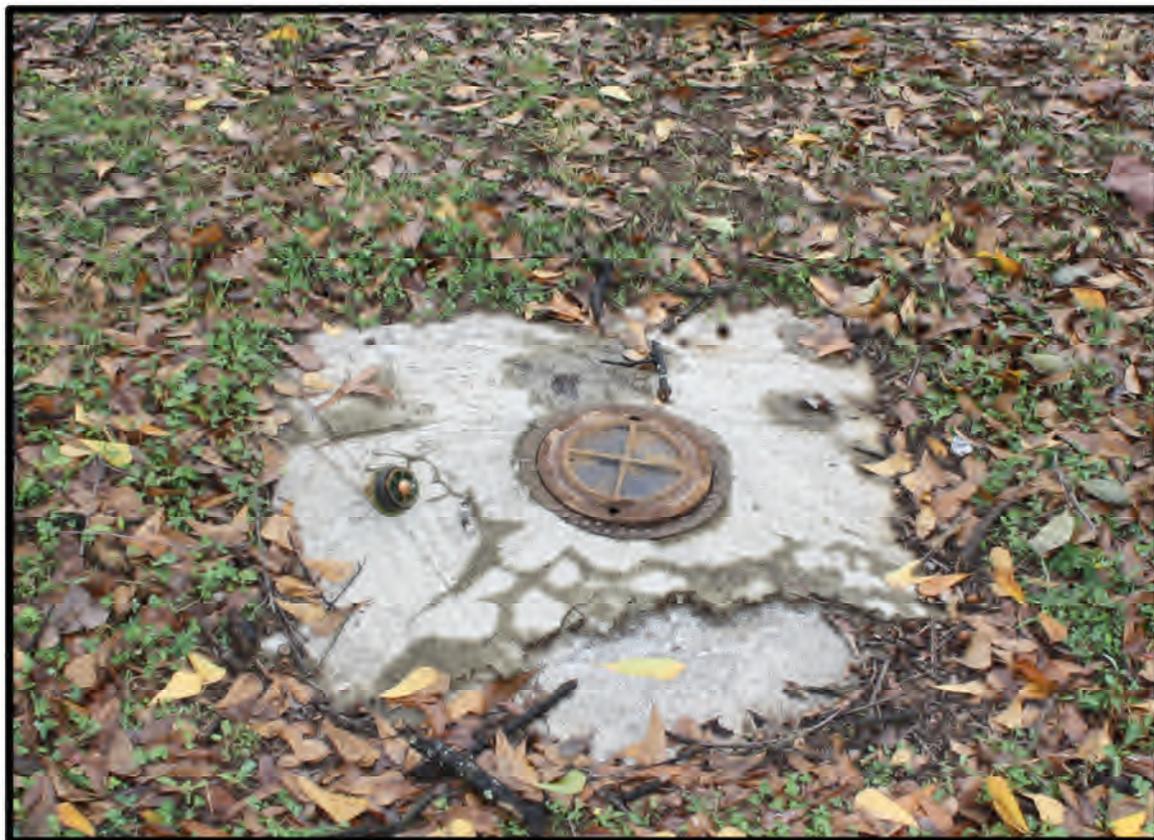
OFFICIAL PHOTOGRAPH NO. 17
TETRA TECH

Subject: Monitoring well, MWC-1B at the corner of John Street and Gray Street.

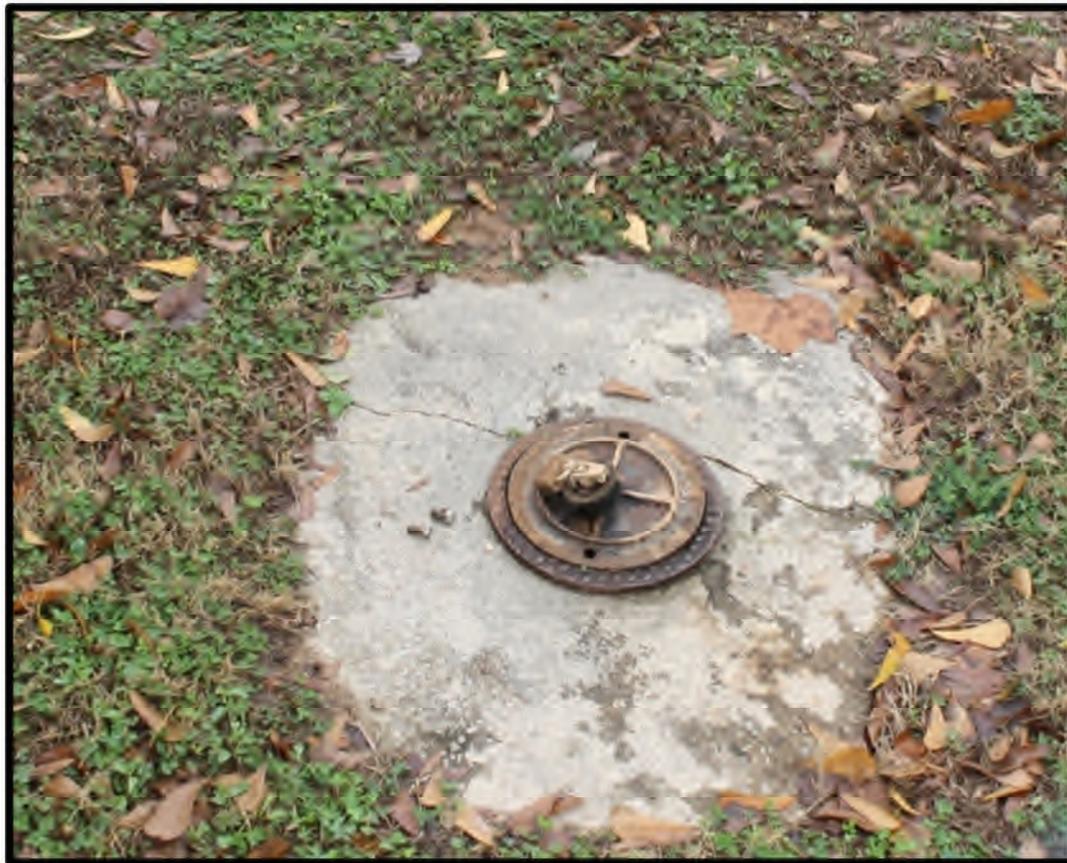
**OFFICIAL PHOTOGRAPH NO. 18
TETRA TECH**

Subject: Monitoring well, MWC-1C at the corner of John Street and Gray Street.

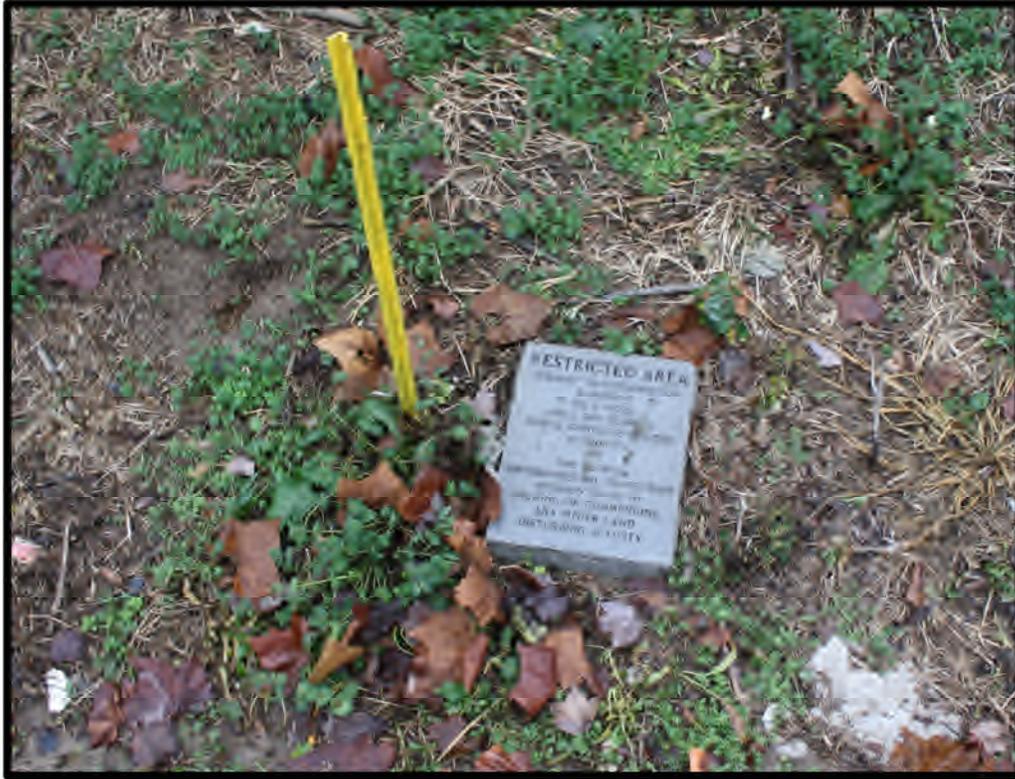
**OFFICIAL PHOTOGRAPH NO. 19
TETRA TECH**

Subject: Granite plaque on the north perimeter of the property.

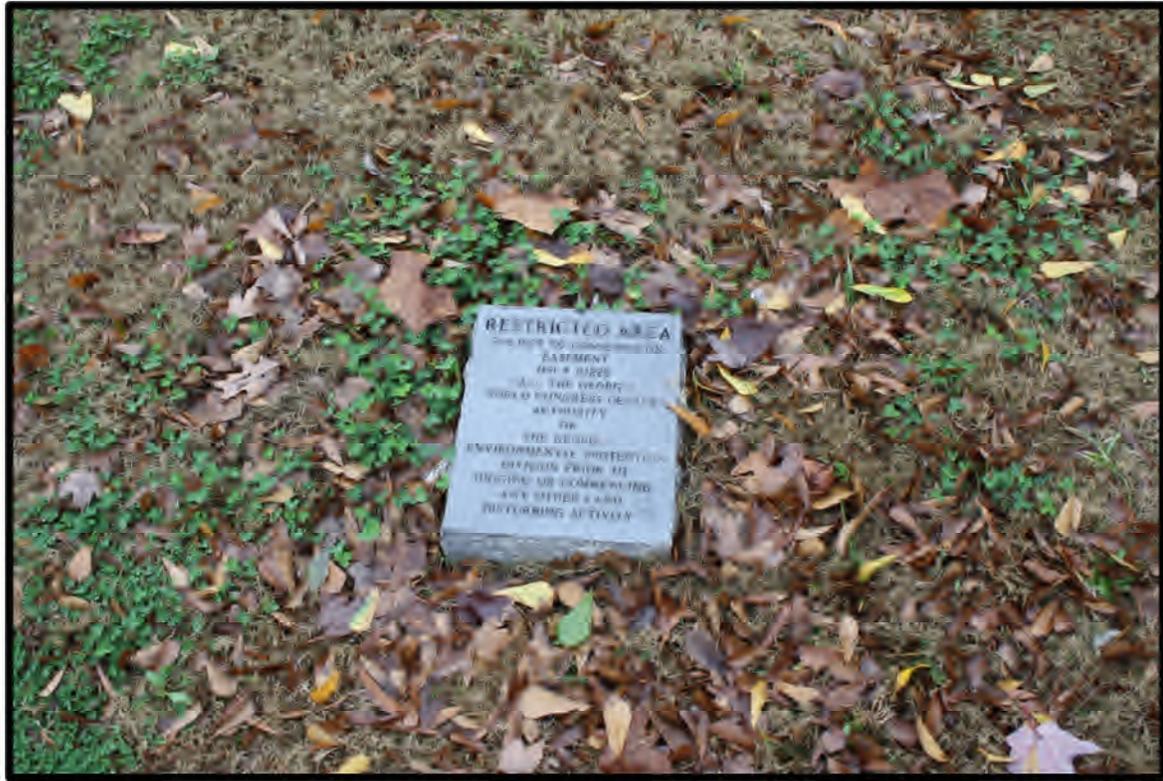
**OFFICIAL PHOTOGRAPH NO. 20
TETRA TECH**

Subject: Granite plaque on the northeastern corner of the property.

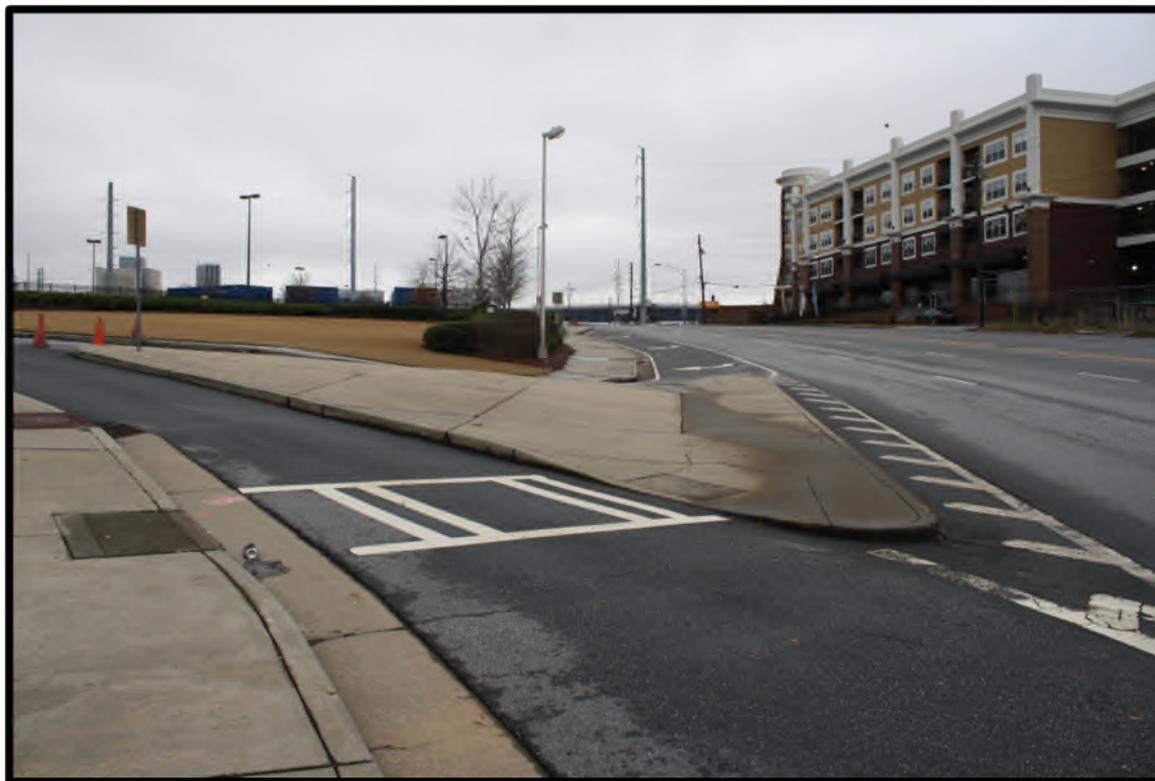
**OFFICIAL PHOTOGRAPH NO. 21
TETRA TECH**

Subject: Concrete median at the intersection of Northside Drive and John Street.

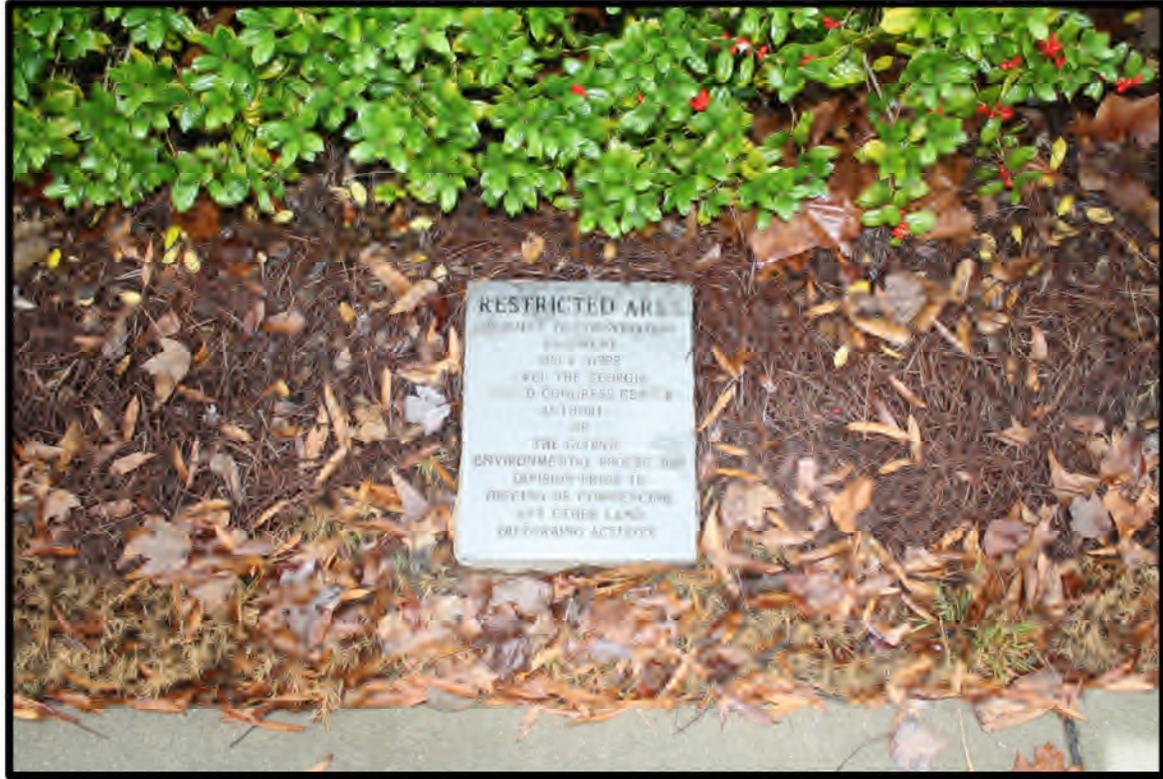
**OFFICIAL PHOTOGRAPH NO. 22
TETRA TECH**

Subject: Granite plaque on the eastern perimeter of the property.

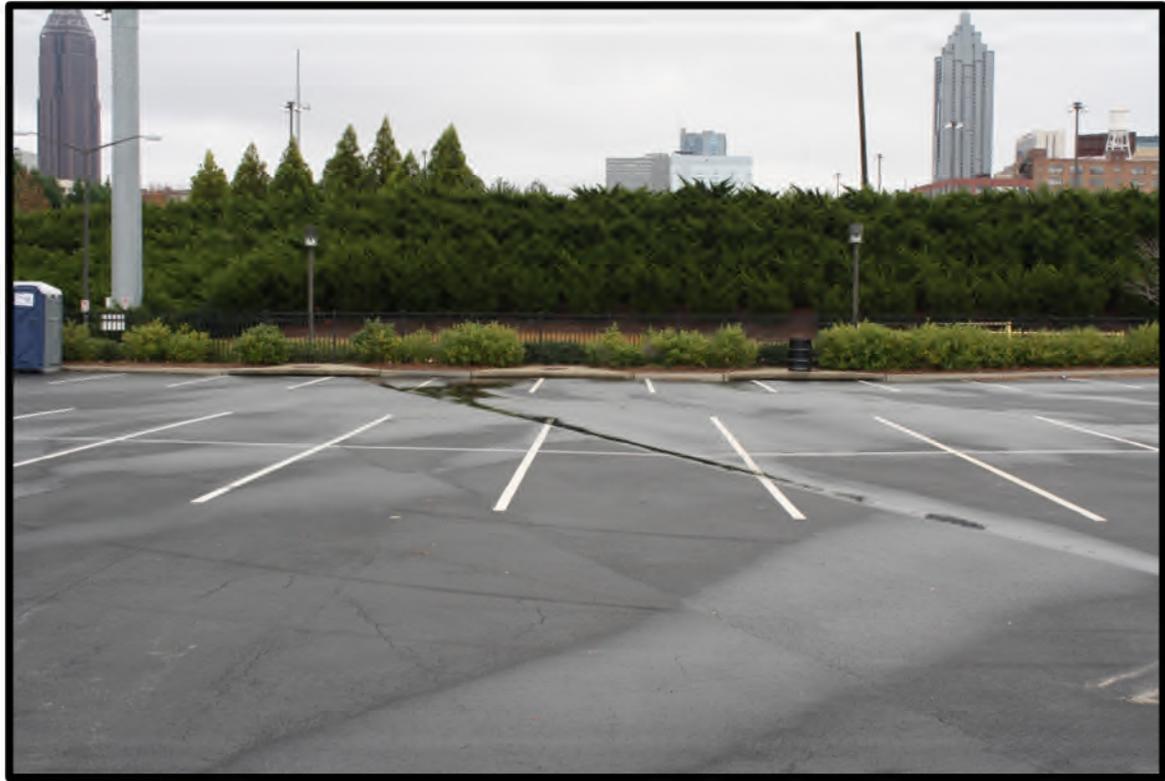
OFFICIAL PHOTOGRAPH NO. 23
TETRA TECH

Subject: Stormwater drains located at the eastern parking lot perimeter.
The existing crack was still present, but had not increased in size.
